# Annulus Void Fill Material for Rehabilitated Sliplined Culverts

Volume 1 of 9

Project ID Number: 109456

*Final Report*

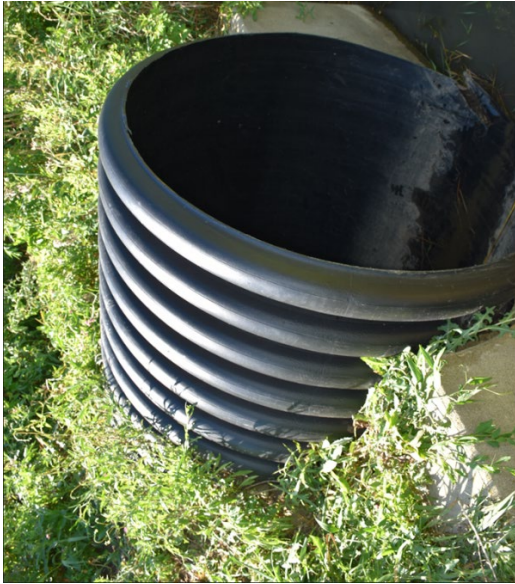
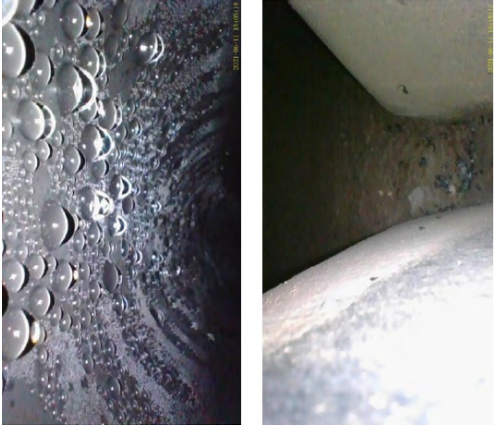
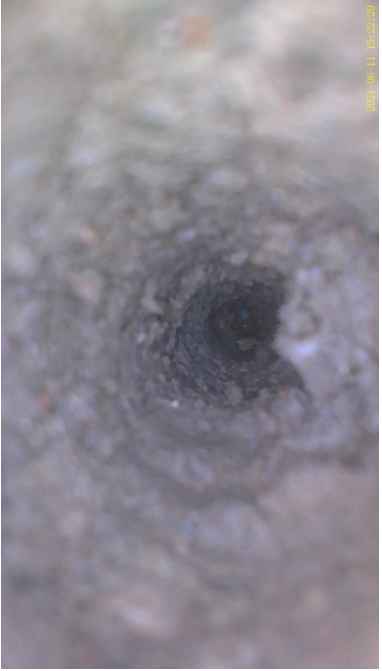
Figure C.11: Culvert Inspection and Map for LIC - 70 - 13.00 (District 5, Licking County)

<p style="text-align: center;">Empty</p>	<p style="text-align: center;">Culvert Access</p>

<p style="text-align: center;">Solid</p>	<p style="text-align: center;">Solid</p>

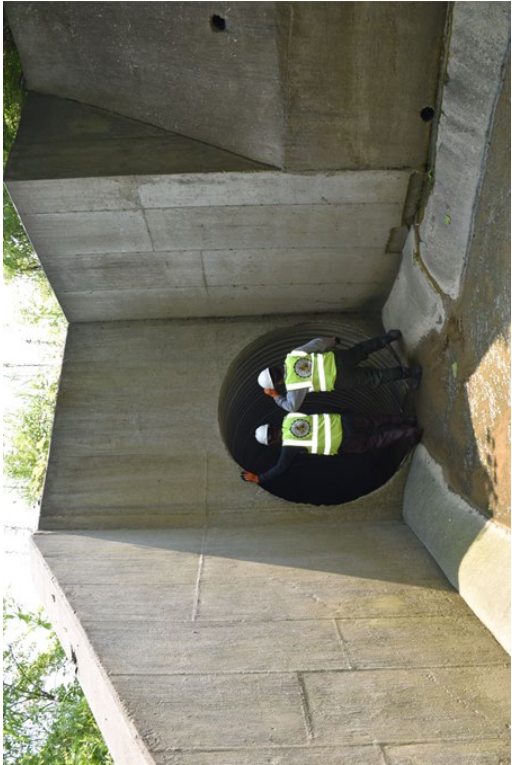
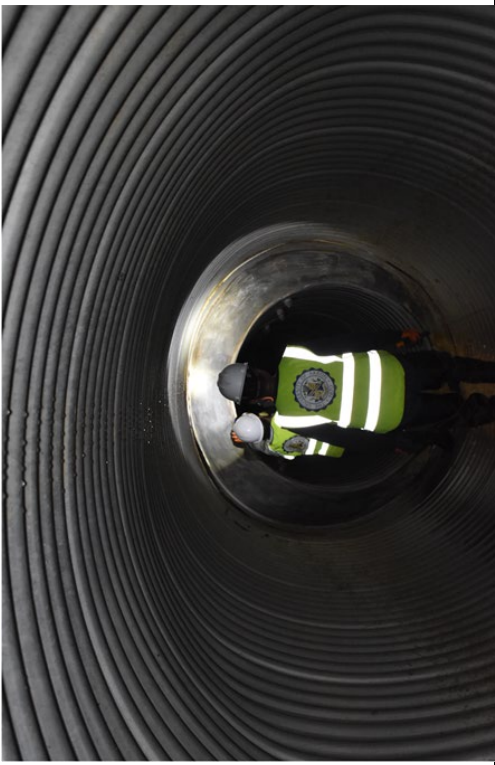
Figure C.11: Culvert Inspection and Map for LIC - 70 - 13.00 (District 5, Licking County) [Continued]

<p style="text-align: center;">Partial Void</p>

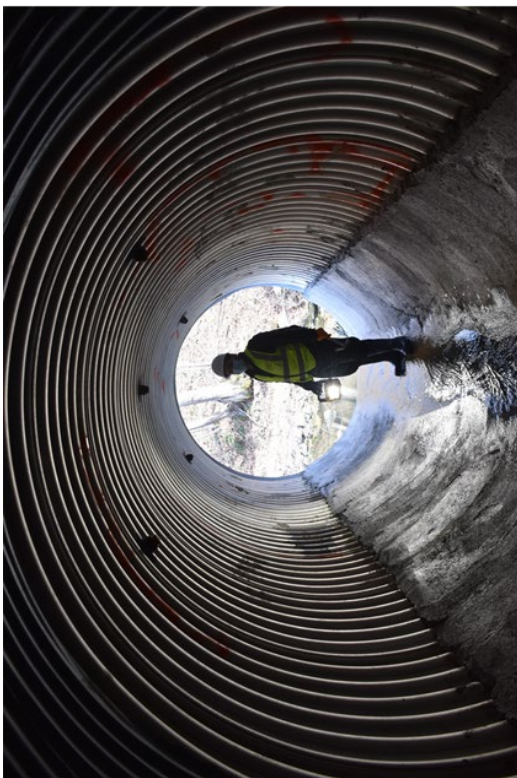
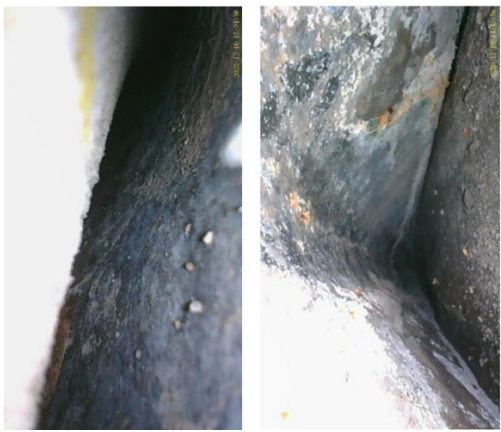
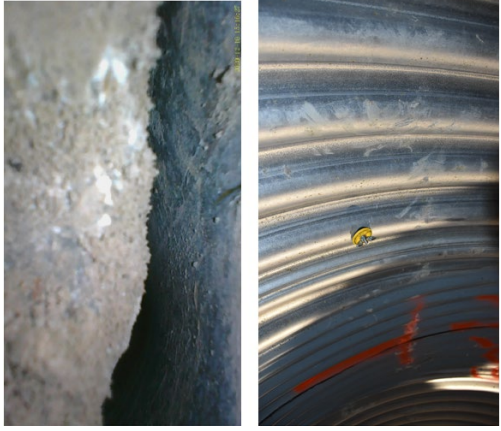
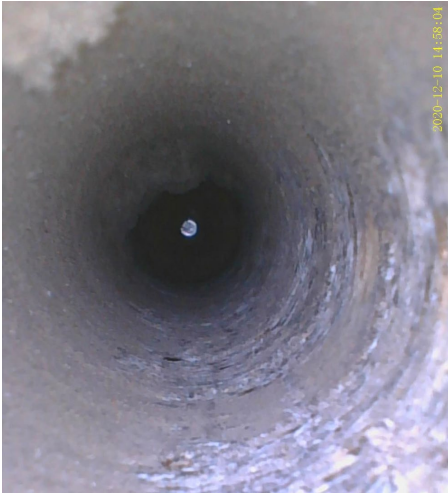
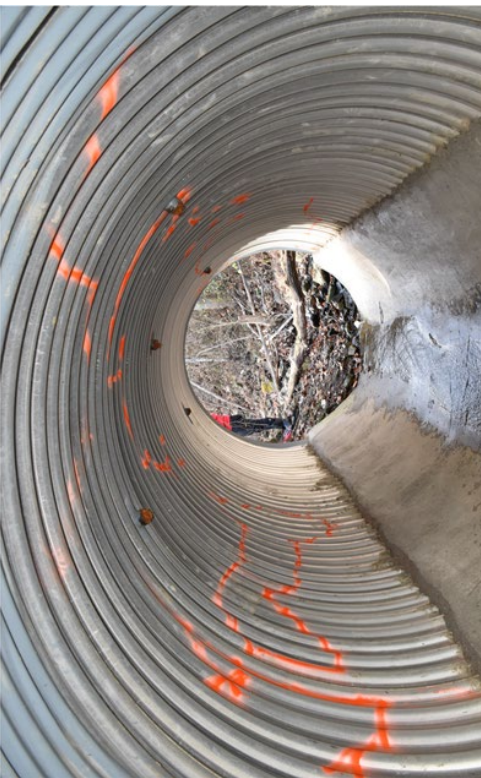
Figure C.15: Culvert Inspection and Map for PIK - 772 - 7.89 (District 9, Pike County)

<p style="text-align: center;">Partial Voids</p>

<p style="text-align: center;">Culvert Access</p>

<p style="text-align: center;">Solid</p>
---	--	---	---	--	--

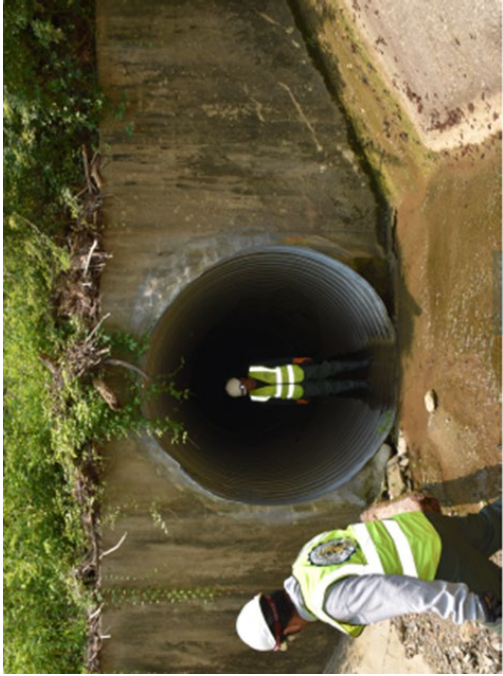
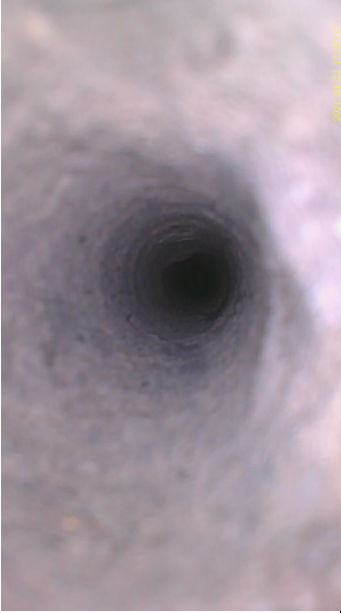
Figure C.16: Culvert Inspection and Map for BRO - 62 - 11.41 (District 9, Brown County)

<p style="text-align: center;">Delamination</p>

<p style="text-align: center;">Solid</p>
<p style="text-align: center;">Culvert Access</p>				<p style="text-align: center;">Solid</p>

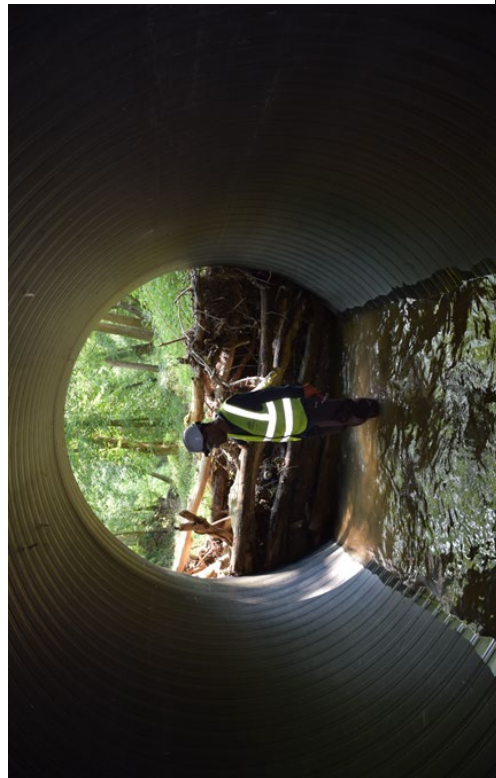
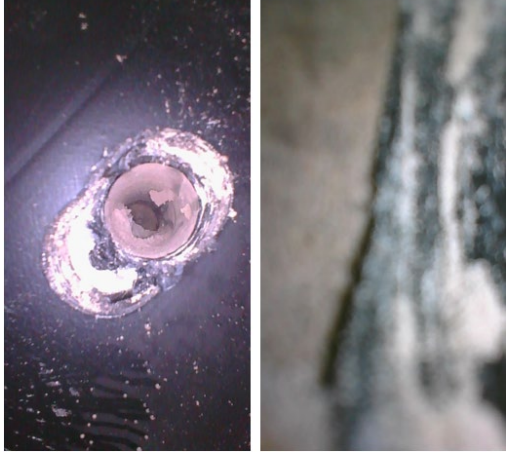
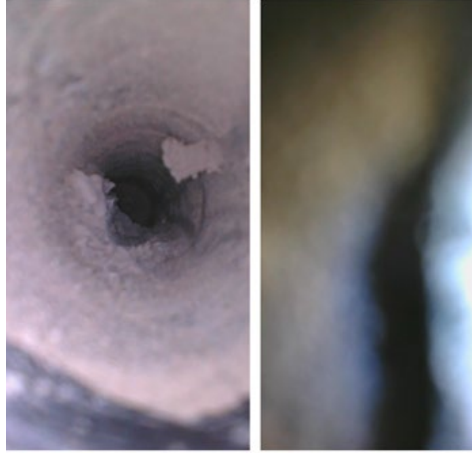
Figure C.17: Culvert Inspection and Map for BRO - 68 - 40.91 (District 9, Brown County) [Continued]

Solid

Culvert Access

Delamination

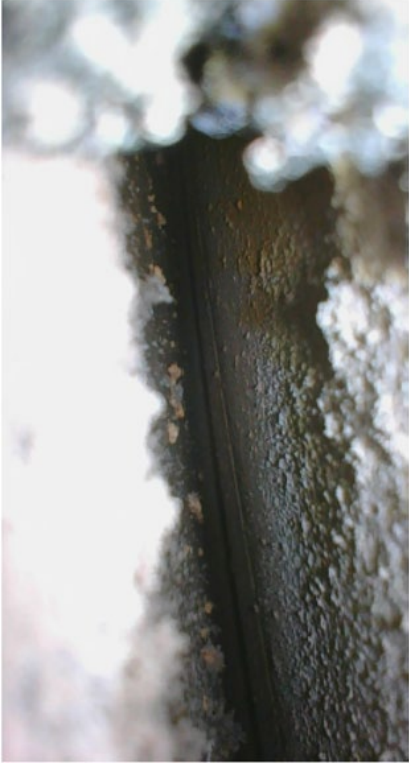
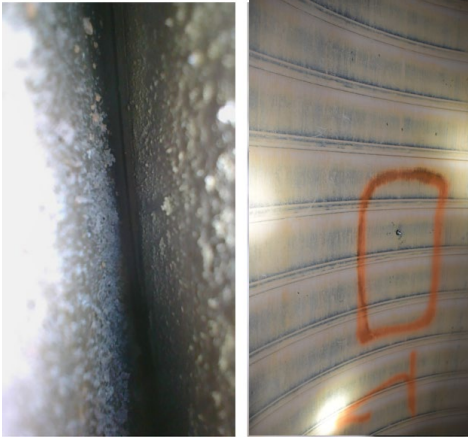
<p style="text-align: center;">Delamination</p>

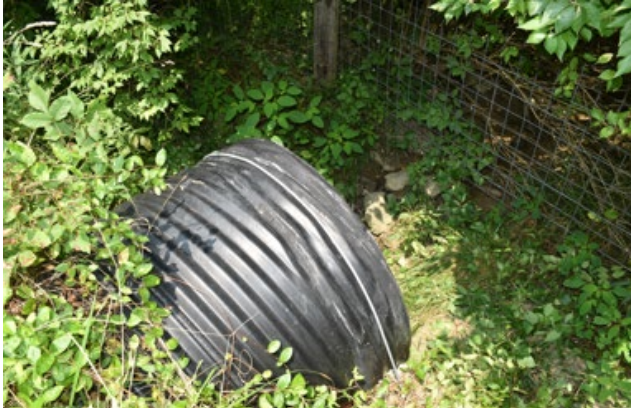
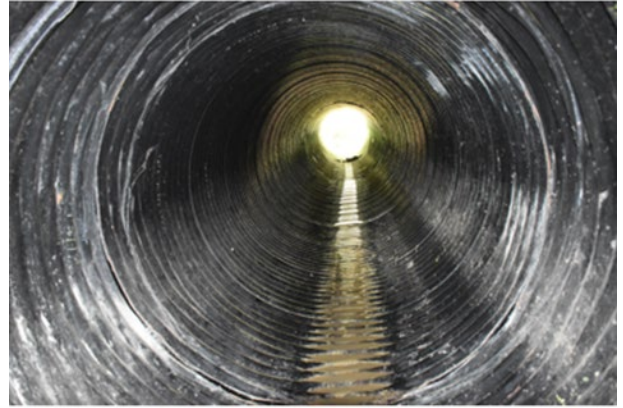
Figure C.26: Culvert Inspection for WAR - 22 - 1753 (District 8, Warren County)

Culvert was made from corrugated steel pipe coated with bitumen (not sliplined) and exhibited tearing of the coatings at the joints.

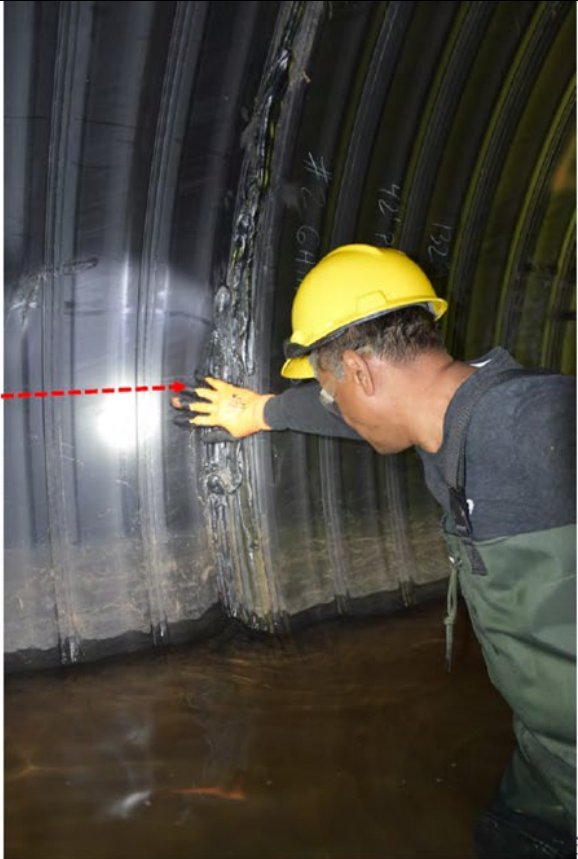
Several Cracks at the Bulkhead and Shape Distortion

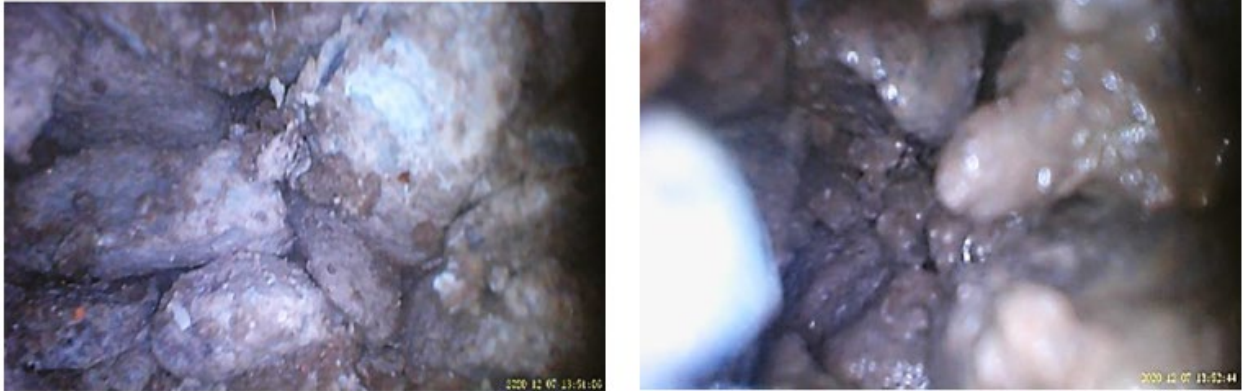
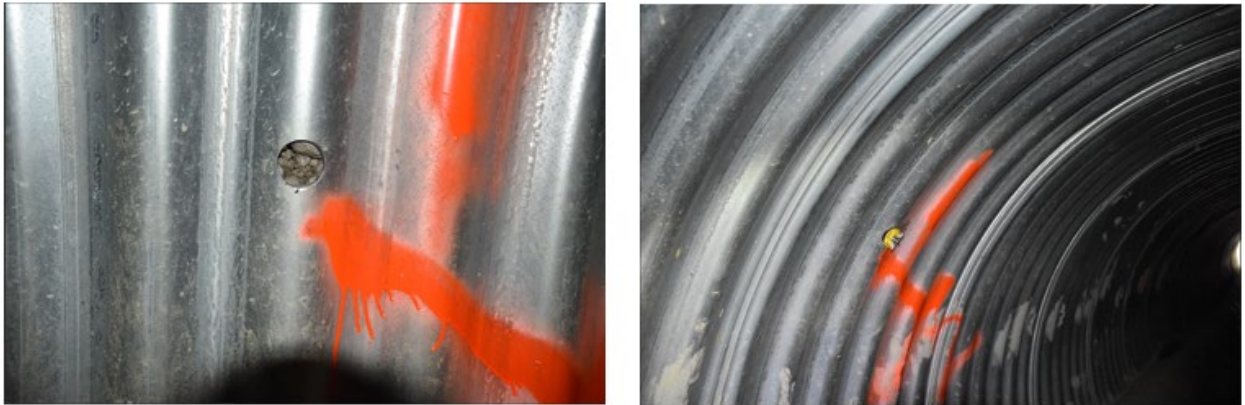
Loose limestone found at one culvert location.

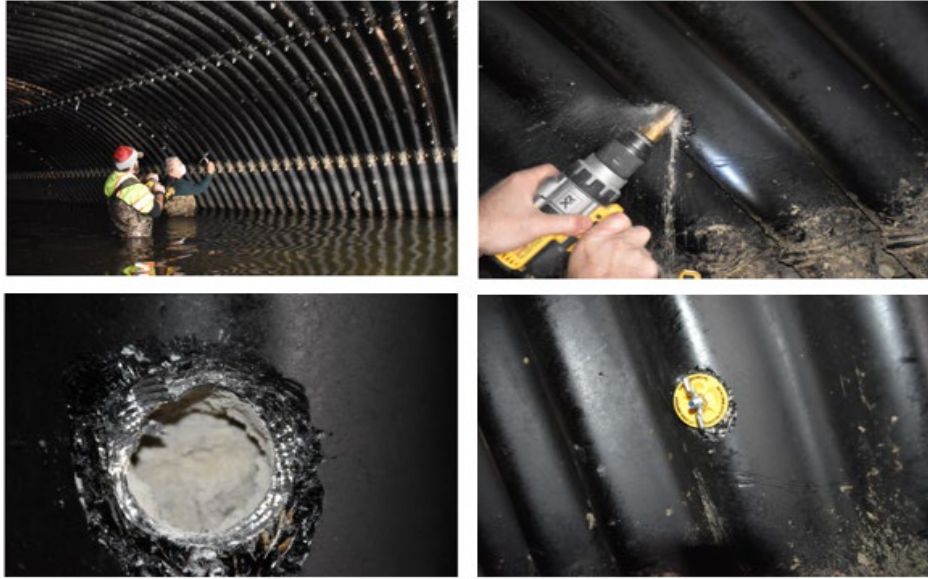
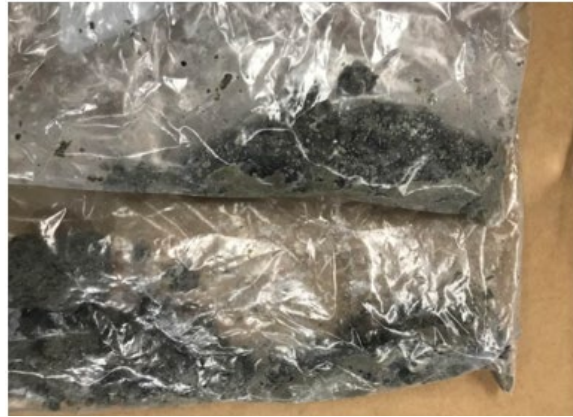
The cored void fill was very weak and crumbled easily (similar to wet soil).

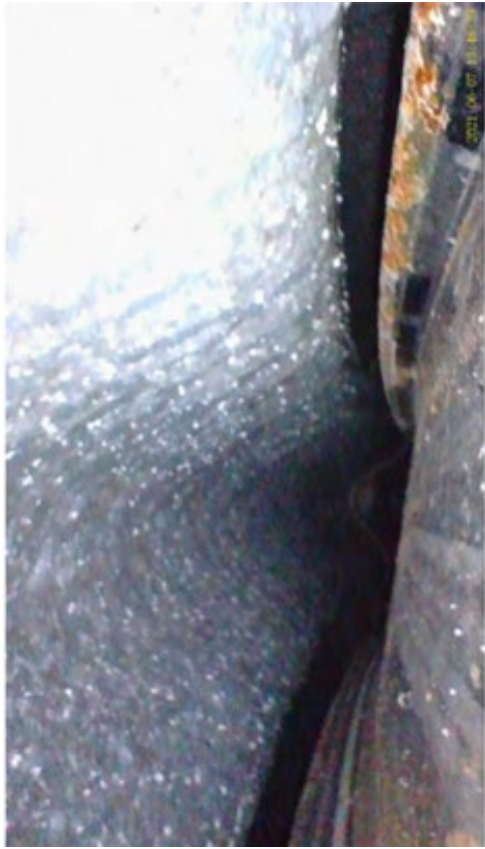
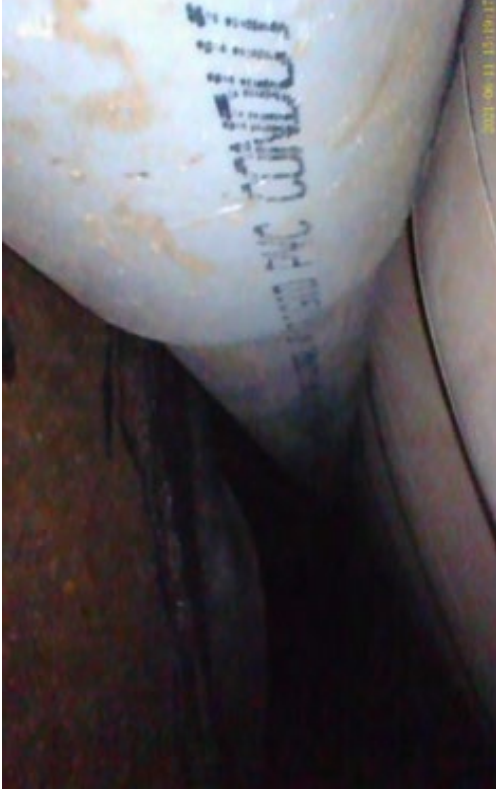
(a) Empty Voids

The second type of response is a hollow sound, indicating that the grout has not remained entirely in contact with either the host pipe or the liner pipe (or both). Hollow sounds can indicate four kinds of voids. The most common of these is delamination, where a gap between the liner pipe and the grout is present. This gap generally ranges from  $\frac{1}{8}$  inch to  $\frac{1}{4}$  inch but can be narrower (like a hairline) in some culverts. As a small gap size can be difficult for an inspector to see with the naked eye, it is necessary to use the side camera of the endoscope to identify such voids. A partial void can also produce a response with a hollow sound; when an endoscope camera was inserted into a hole drilled in one liner pipe at a location where a partial void was suspected, a gap between the grout and the host pipe was discovered. Some culverts evaluated in this study had a combination of partial voids and delamination.

The third type of response is pure metallic sound, which indicates that there is no grout between the host and liner pipe. Figure C.34 illustrates the types of voids that were frequently encountered in the sliplined culverts that were inspected in this study. A chart showing the correlation between the void shapes and the associated sounds is provided in Figure C.35.

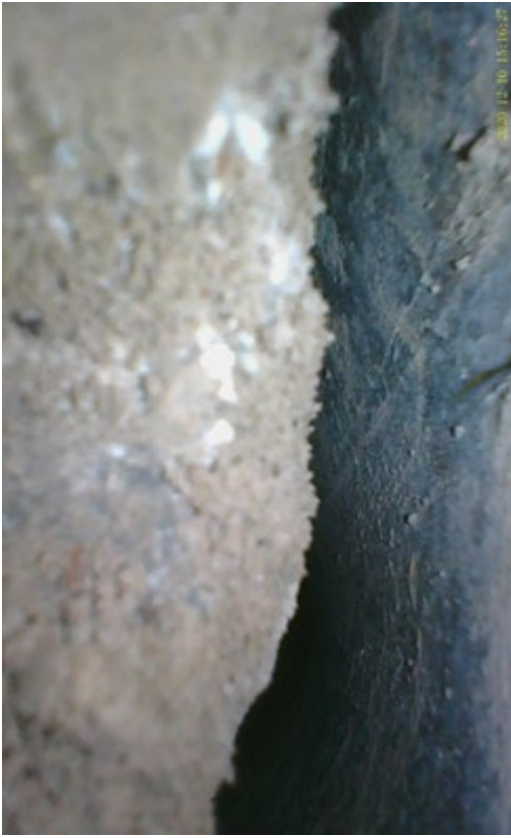
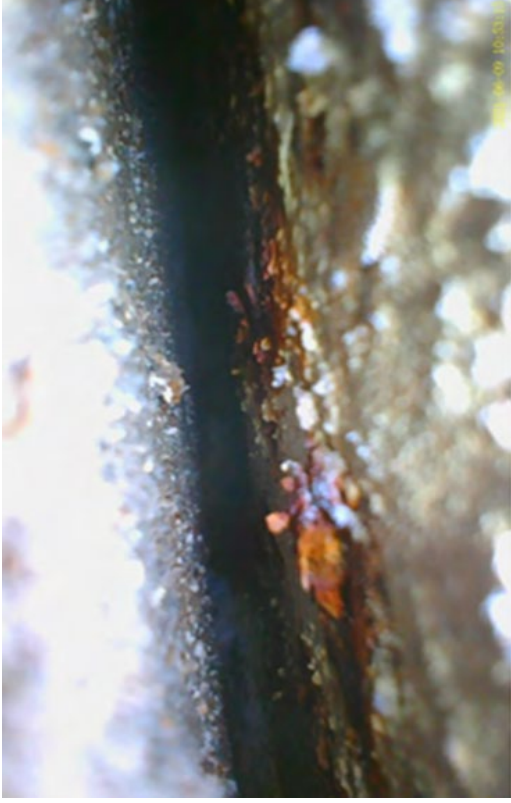
(c) Delamination (left: at the liner pipe; right: at the host pipe)

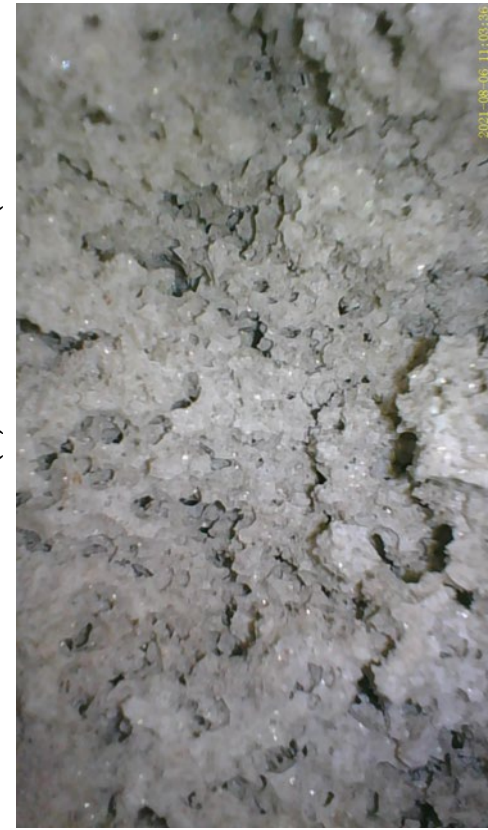
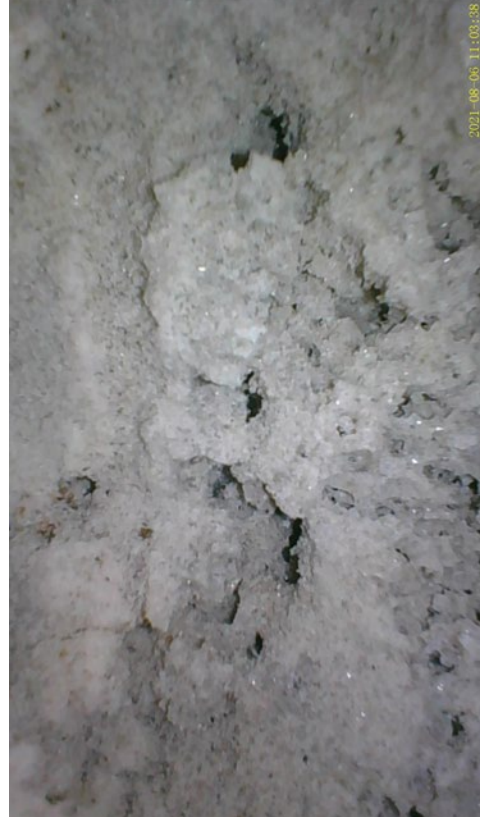
(d) Partial Voids (typical of cellular grouts)

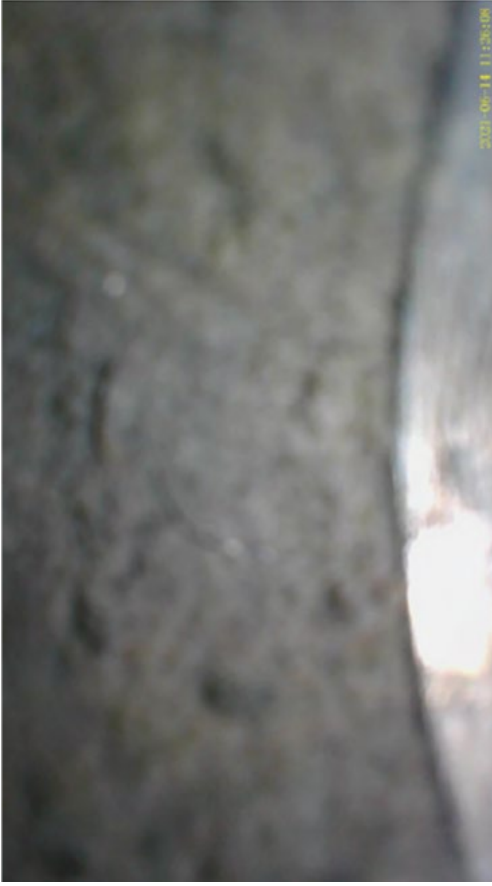
(e) Completely Solid

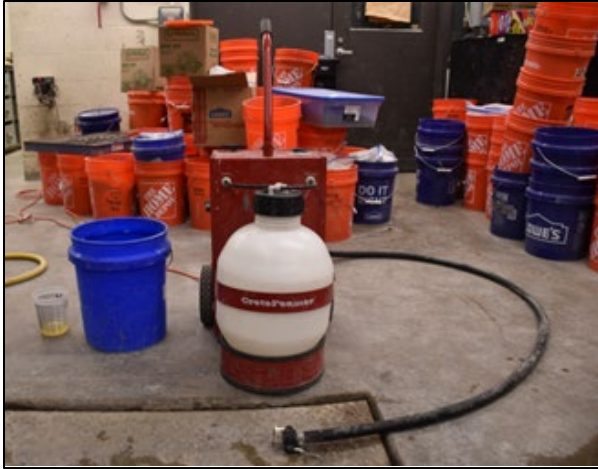
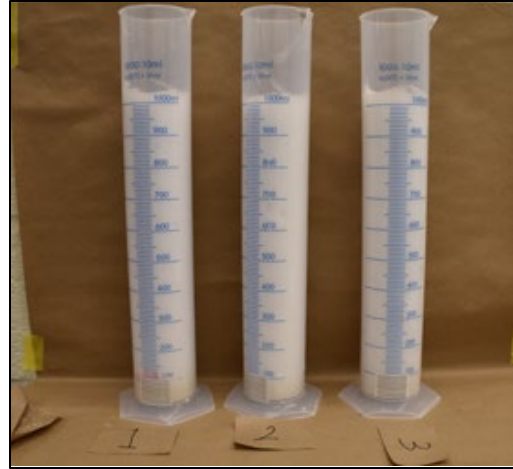
Figure E.1: Preparation of Foam.

(a) Setup for Foam Generator

(b) Measuring Foam Density

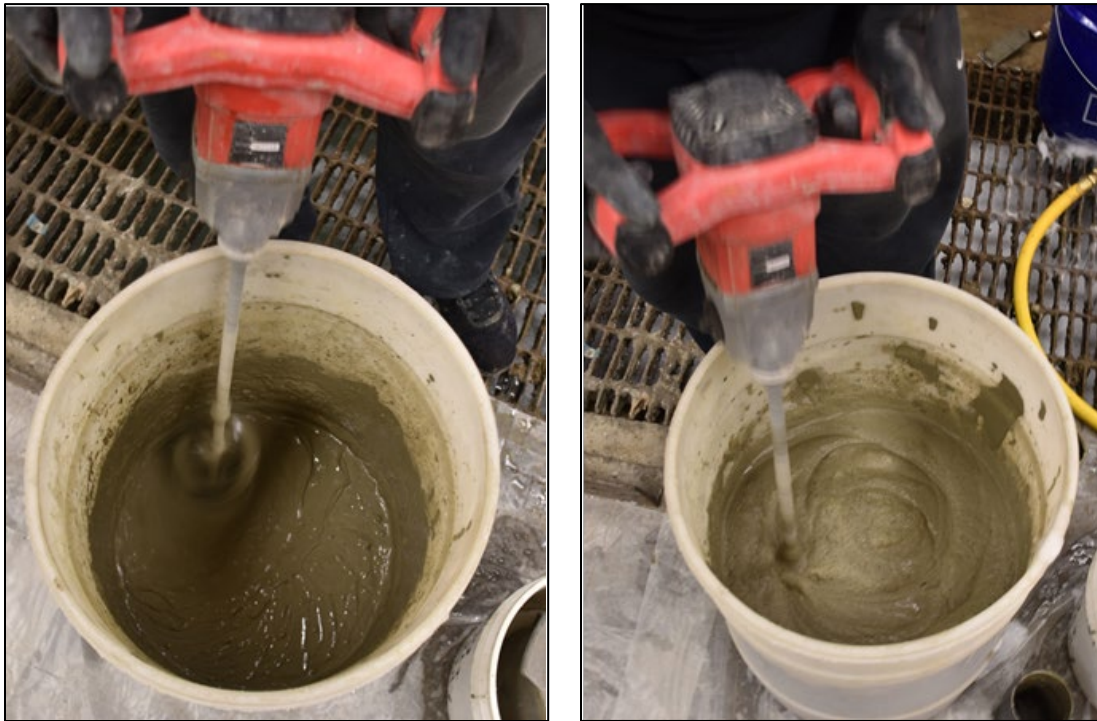
Figure E.4: Addition of Foam to a Cement Mixture:  
Before (*left*) and After (*right*) Addition of Foam.

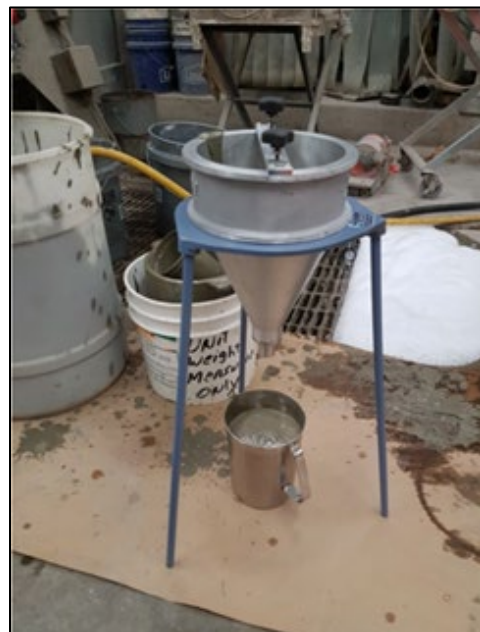
It is essential to monitor the flow of grout to ensure that the mix has adequate flowability, and the monitoring of the flow may be done either in the field or in the laboratory. In ASTM C939-16a "Flow of Grout for Preplaced-Aggregate Concrete" (ASTM, 2010), a standardized flow cone is used to determine the period of efflux of a given volume of cellular grout (as shown in Figure E.8.a). In the test setup, the flow cone is securely fastened to a frame to prevent vibration during the test. However, before using the flow cone for measuring grout flow, it is important to confirm that the setup yields accurate measurements. The ASTM standard requires that the length of time it takes for water to efflux as recorded by a stopwatch should be 8.0 seconds with a margin of error of  $\pm 0.2$  seconds. Also, it is preferred to measure the efflux time of the water within one minute before the grout sample is poured into the cone to ensure that the flow cone would have some moisture in it. The discharge end of the tube is then blocked with a finger until the surface of the grout rises high enough to make contact with the point gage, as illustrated in Figure E.8.b, and a sample of the grout is then poured into the cone. Following that, the finger is removed at the exact moment the stopwatch is activated. The length of time that elapses after a sufficient volume of grout has flowed through the flow cone to the point where light is visible through the discharge tube is recorded; this time duration is referred to as the *efflux time* of the grout. While an efflux time of less than 35 seconds is acceptable for the purposes of the ASTM test, there is no standard guidance regarding the range of efflux time that should be utilized to indicate good flow or acceptance.

(a) Flow Cone Test Setup.

(b) Photo of Flow Cone Test.

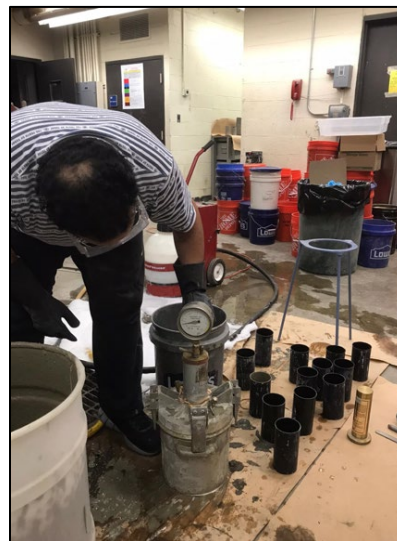
Figure E.9: Air Content Test of Cellular Grout per ASTM C231.

The air content of the freshly mixed cellular grout was determined according to ASTM C231-22a (ASTM, 2022). Figure E.9 depicts an air meter that meets ASTM specifications. The vertical air chamber was equipped with a measuring bowl and cap. The operational principle of this meter is to equalize a known volume of air at a known pressure in a sealed air chamber with the unknown volume of air in the cellular grout sample, with the dial on the pressure gauge calibrated in terms of percent air for the observed pressure at which equalization occurs. The measuring bowl was filled with cellular grout; no rodding was required for these fluid mixes. The measuring bowl's lid was then attached to the bowl. Next, the primary air valve between the air chamber and the measurement bowl was closed, and both cover holes were opened. Water was added through one petcock until water emerged from the opposite petcock. Next, the air chamber's air bleeder valve was closed, and the air was pumped into it until the gauge needle reached the beginning pressure line. The gauge hand was stabilized at the starting pressure line by pumping or bleeding out air as needed and lightly tapping the gauge. Finally, the main air valve between the air chamber and the measurement bowl was opened. The air content of cellular grout was displayed on the dial of the pressure gauge as a percentage of air. The pressure was released by opening both petcocks and removing the cap.

(b) Conducting Air Content Test.

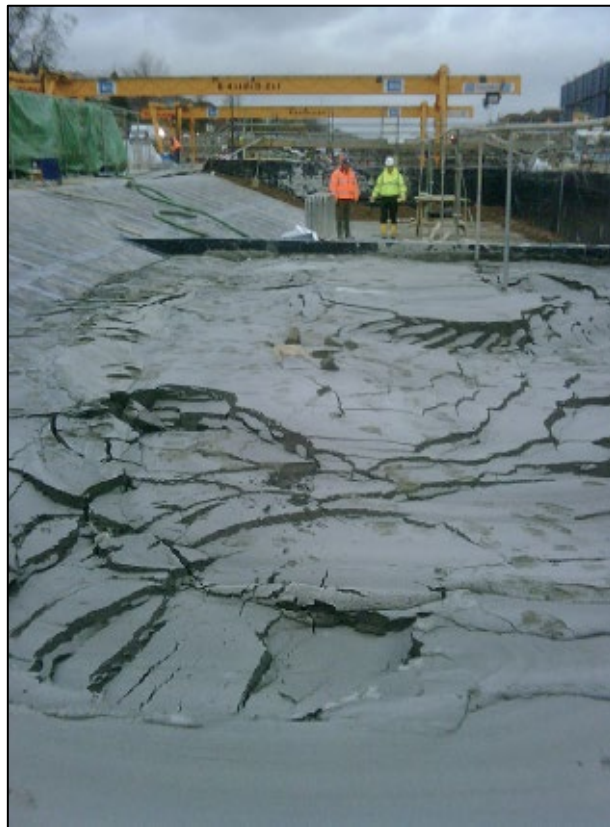
Figure E.10: Cellular Grout Instability on Site (Jones et al., 2016).

The stability of a cellular grout refers to the grout's capacity to maintain its initial form or volume without collapsing even after it has reached its hardened state. Figure E.10 shows a photo of cellular grout that became unstable 24 hours after field casting. There are two main factors that can influence the stability of cellular grout: external factors such as the temperature of the surrounding environment and internal factors, which include the density and temperature of the fresh grout.

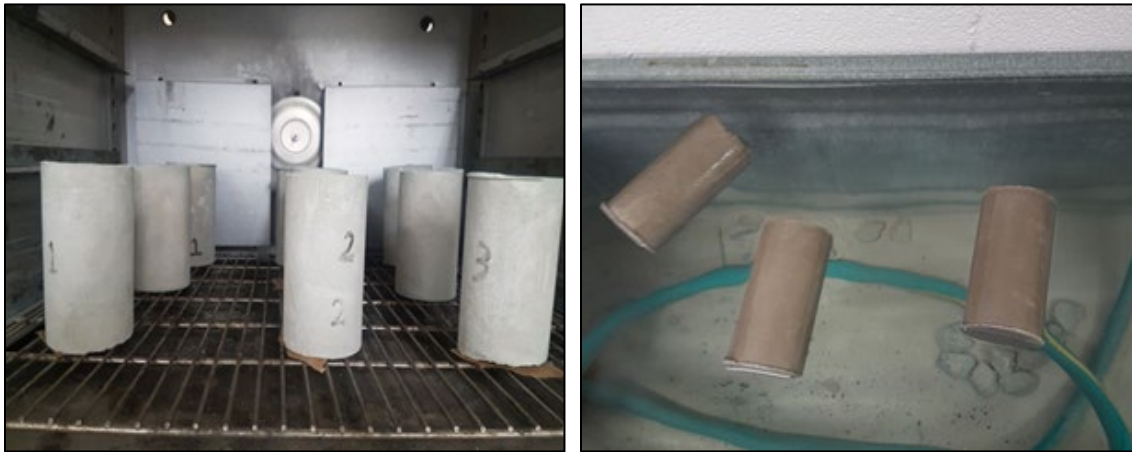
Figure E.12: Oven Drying and Water Absorption of Cellular Specimens.

(a) Oven-drying of Cylinder Specimens.      (b) Specimens Immersed in Water.

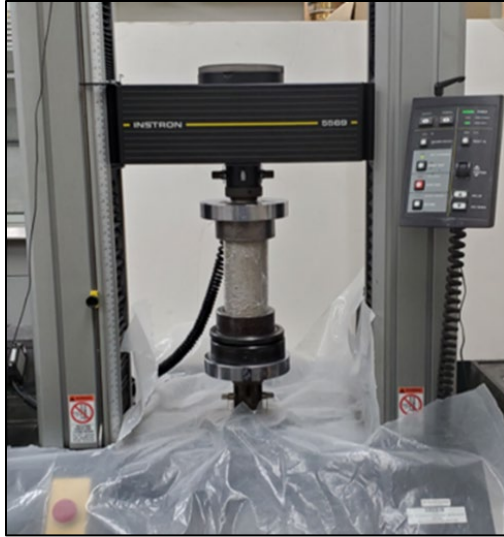
Figure E.13: Test Setup for the Unconfined Compressive Tests.

ASTM D4832-16 “Standard Test Method for Preparation and Testing of Controlled Low Strength Material (CLSM) Test Cylinders” (ASTM, 2016) was used to determine the unconfined compressive strength of the cellular grouts in this project. Molds were used to create 3-inch × 6-inch specimens of cellular grout. In order to determine the compressive strength of each mixture, at least three specimens were evaluated. After 24 hours of casting, the specimens were removed from the molds and placed in the curing room to complete the drying process. As the relative humidity in the curing room was at least 95%, the samples were taken out of the curing chamber after 28 days and allowed to dry for 24 hours before testing. The unconfined compressive strength test was carried out with the assistance of an Instron 5569 universal testing machine (Figure E.13). Compressive loading at a rate of 10 lb/sec was applied to the cylinder specimens to meet the standards of ASTM D4832-16 and guarantee that the cylinder would not fail in under 2 minutes. This was accomplished by applying compressive loading to the specimens in a cylinder. The following formula was used to determine compressive strength:

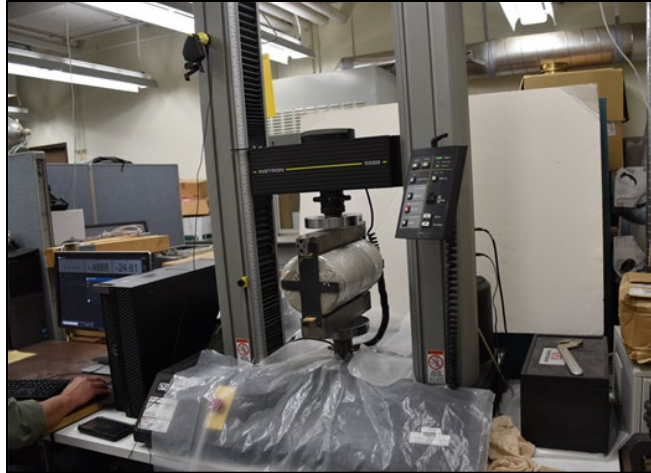
Figure E.14: Setup for Split Tensile Test.

ASTM C496-17 “Standard Test Method for Splitting Tensile Strength of Cylindrical Concrete Specimens” (ASTM, 2017) was used to perform tensile tests on the cellular grout. For this test, standard cylinders with a diameter of 6 inches and a length of 12 inches are used. At 24 hours after casting, the cellular grout specimens were removed from the molds and placed in a curing room with a relative humidity level of at least 95% to complete curing. After curing for 28 days, the specimens were removed from the curing room and were allowed to dry for 24 hours before being tested.

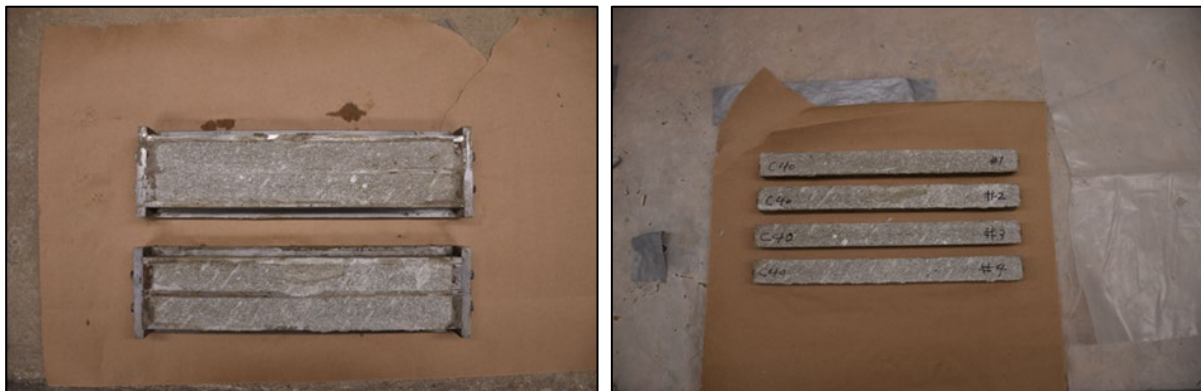
Tests were conducted following ASTM C596-18 “Standard Test Method for Drying Shrinkage of Mortar Containing Hydraulic Cement” (ASTM, 2018) and ASTM C157-17 “Standard Test Method for Length Change of Hardened Hydraulic-Cement Mortar and Concrete” (ASTM, 2017) to determine the length changes of prism samples of cellular grout mixtures. For each test combination, four prism samples measuring 1 inch by 1 inch by 10 inches were prepared, as shown in Figure E.15. The prism samples were removed from their molds after a casting time of 48 hours.

(a) Prism samples in molds.

(b) Air curing of prism samples.

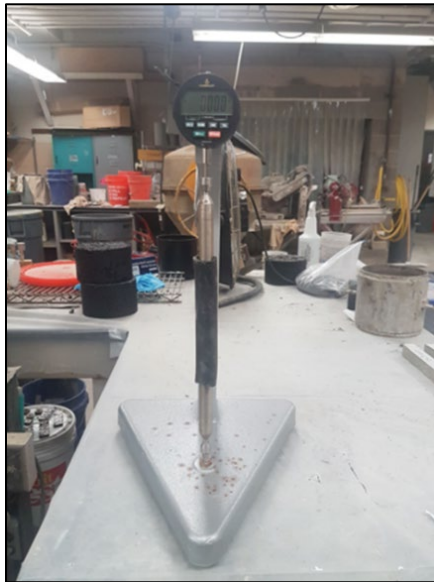
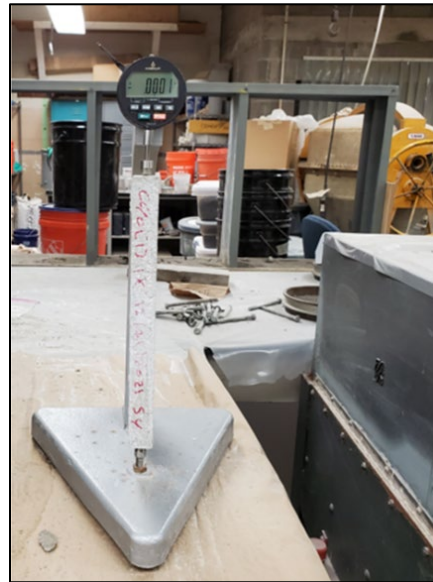
Figure E.16: Determination of the Change in Length of a Cellular Grout Sample per ASTM C157-17.

kept in a drying chamber at a relative humidity of 50% and a temperature of 73 °F. A length comparator equipped with a digital indicator (shown in Figure E.16) was utilized to collect data on a weekly basis throughout the next 28 days. After 28 days, there was no discernible change in any of the dimensions of the samples. Therefore, after taking the first reading from the comparator, the following formula is used to calculate the length change or overall net shrinkage of any specimen, regardless of its age:

(a) Invar Bar in Length Comparator.      (b) Length Comparator with Grout Sample.

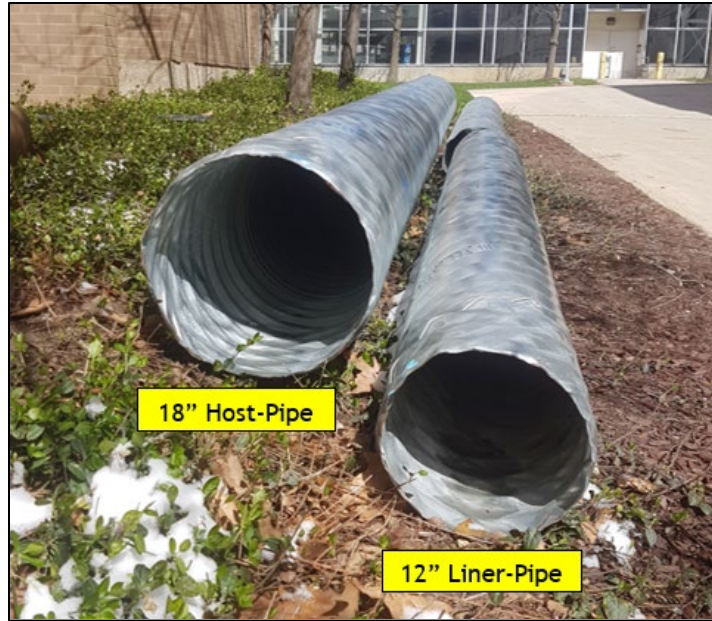
Figure E.18: Galvanized Corrugated Steel Pipes used as a Host Pipe and a Liner Pipe.

The host pipe and the liner pipe used for the sliplined culvert test specimens (shown in Figure E.18) were made from zinc-coated (galvanized) corrugated steel pipe that satisfied the specifications for corrugated steel pipe as specified in ASTM A929-18 (ASTM, 2018) and AASHTO M 218 (AASHTO, 2003). The host pipe had a nominal diameter of 18 inches, while the liner pipe had a nominal diameter of 12 inches. The pipes had a wall thickness of 14 gage (2 mm), and the nominal corrugation dimension was  $2\text{-}\frac{2}{3}$  inches with a spiral pitch of  $\frac{1}{2}$  inch. The pipes were made from a flat steel sheet with a tensile strength of 45 ksi, a yield strength of 33 ksi, and an elongation of over 2 inches (about 20%). The pipe was sourced from a local company, WinWater of Akron; the pipe was supplied in a length of 20-foot in each diameter. The host pipe and the liner pipe were cut into 12-inch-long segments, which satisfied the requirements set out by the ASTM D2412-21 standard for the parallel plate loading tests.

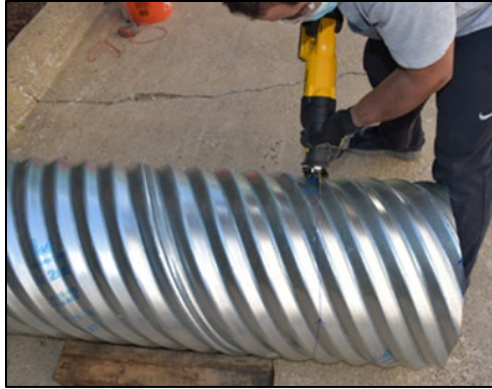
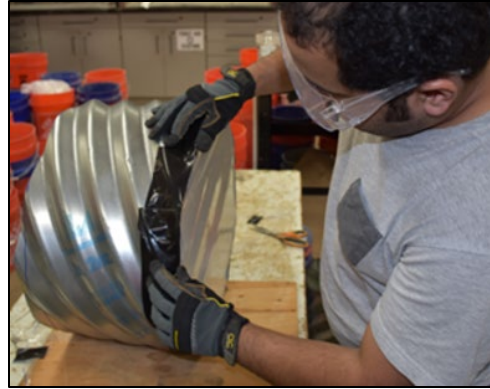
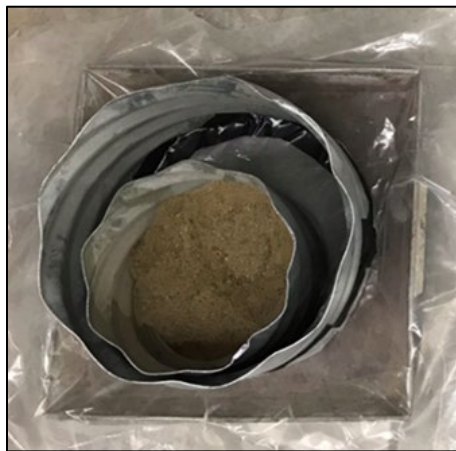
Figure E.20: Preparation of Host Pipe and Liner for Grouting.

The method for preparing the host pipe and liner for the sliplined culvert is shown in Figure E.20. First, 20-foot-long corrugated metal pipes were cut into 1-foot lengths. Next, one end of the host pipe was covered in plastic to prevent grout from leaking, and the host pipe was placed in an upright position with the test specimen's end wrapped with plastic at the bottom. The liner pipe was then installed in the host pipe in the same configuration as in an actual culvert, with the liner pipe located close to the wall of the host pipe at the 6 o'clock position. Lastly, sand was placed into the liner pipe to stabilize it when filling the annular area between the host pipe and liner pipe. Once the liner pipe was stabilized, the annular space was filled using the selected grout mix (Figure E.21).

(a) Cutting the host pipe.

(b) Wrapping the pipe end with plastic.

(c) Prepared host and liner pipe.

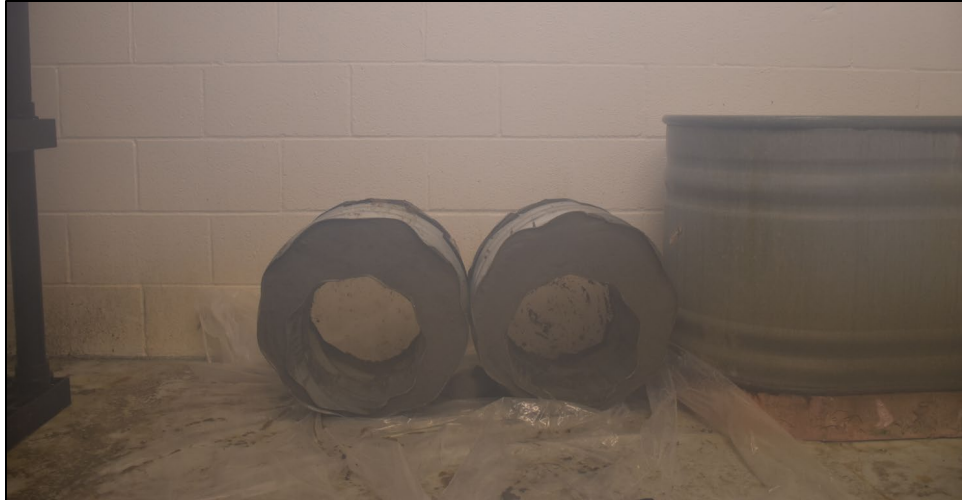
Figure E.25: Sliplined Culvert Samples in the Curing Room.

Three days after casting, the Styrofoam and tubes were removed from the test specimens to create the necessary void(s) (Figure E.24). The culvert specimens were then moved to a curing chamber with a minimum of 95% relative humidity, where they were left to cure for 28 days (Figure E.25). After 28 days of curing, parallel plate load tests were conducted on each culvert test specimen.

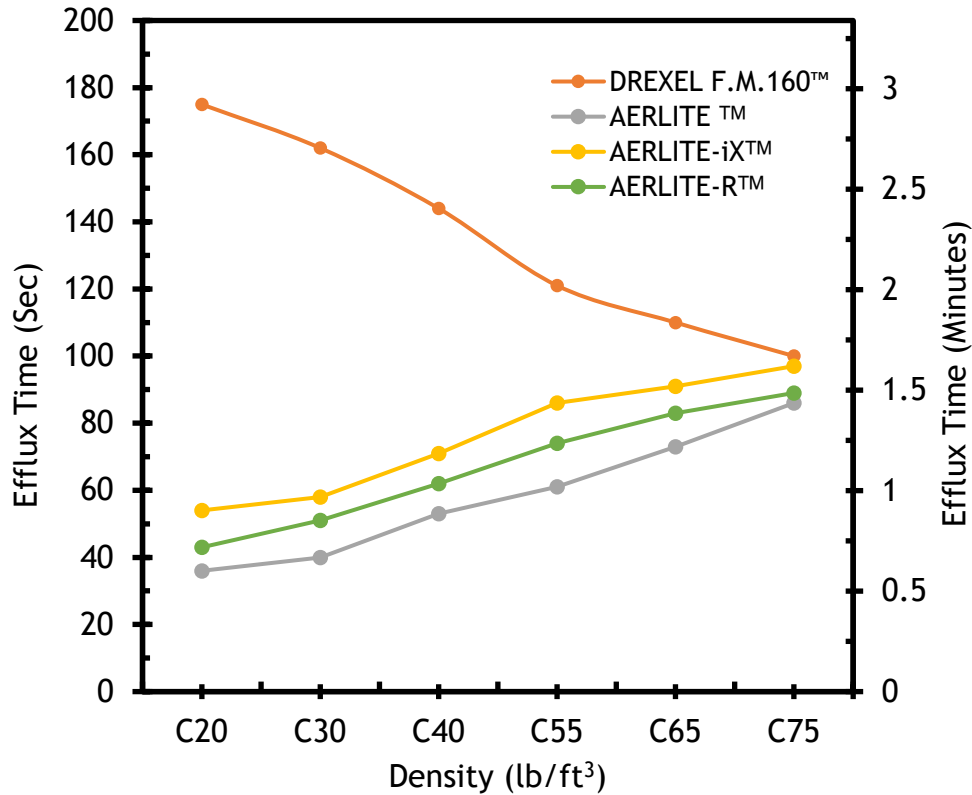
Figure E.37: Efflux Time from Flow Cone Test of Cellular Grout Mixtures.

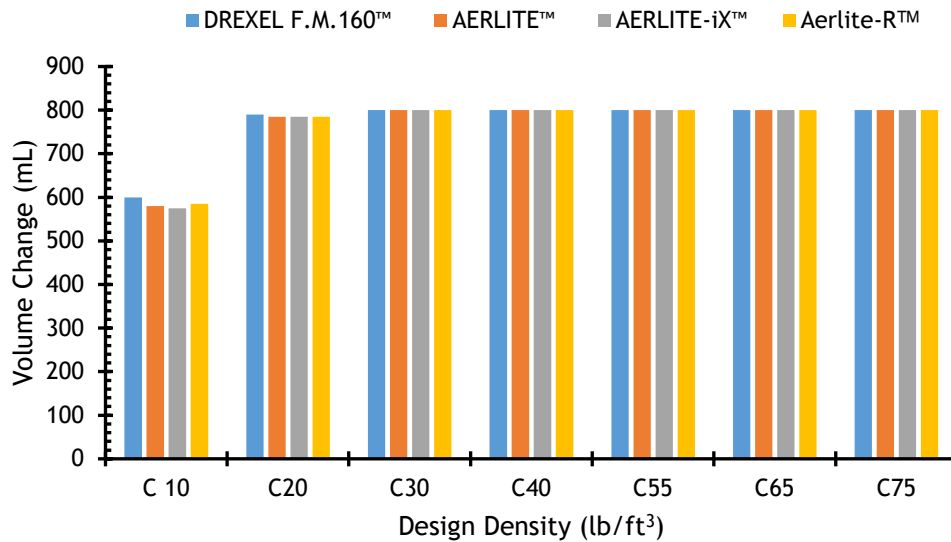
Figure E.38: Foam Stability During the First 24 Hours.

Several foaming agents were able to meet the minimum density requirements for foam as specified in ASTM C796 and ACI 523.3R-14. Mixing the foam with grouts at room temperature prevents instability of the foam volume before the foam is mixed into the cement slurry. In addition, the produced foam should not be exposed to high temperatures before being added to the slurry, as this leads to a decrease in the foam volume. Instability of cellular grout was noted when preparing a cellular grout with an extremely low density (such as C10), which resulted in instability throughout the hardening process (over a 24-hour period) as shown in Figure 6 and also observed by others (Figure 6).

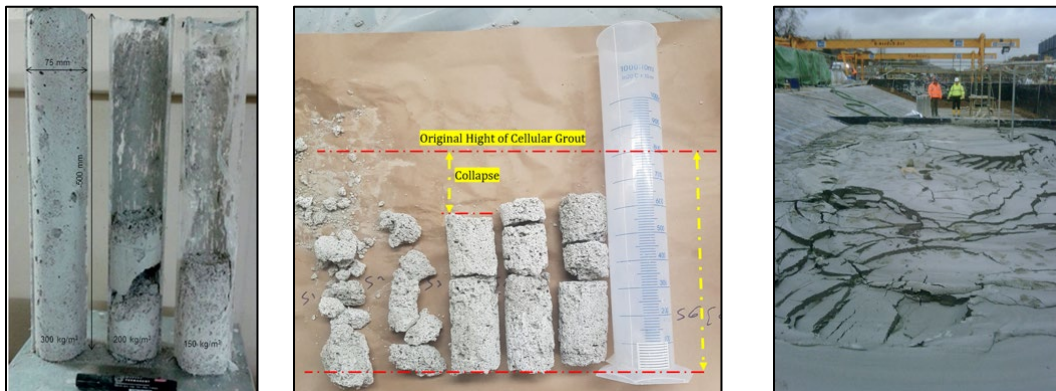
Figure E.39: Instability of Ultra-Low Cellular Grout: (a) Lab-prepared Grout from Jones et al. 2016 (left), (b) Lab-prepared Cellular Grout C10 (center), (c) and On-site Instability for Grout Reported by Jones et al. 2016 (right).

The stability of the cellular grout in the field may also be influenced by several other factors, and these factors can play an important role. For example, the temperature of the fresh mix as well as the temperature of the surrounding

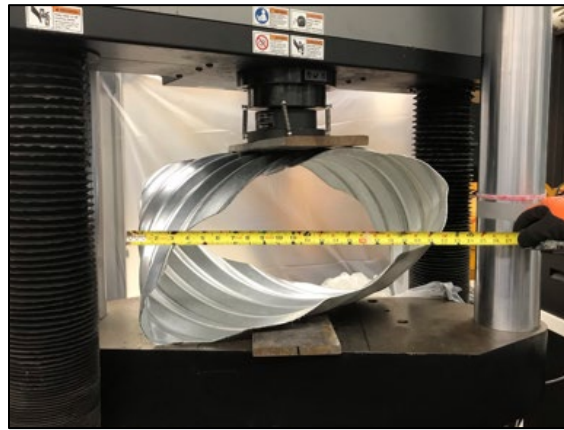
Figure E.53: Parallel Plate Loading Test of Corrugated Steel Liner Pipe.

(b) Liner Pipe after Loading.
