# Annulus Void Fill Material for Rehabilitated Sliplined Culverts

Volume 1 of 9

Project ID Number: 109456

*Final Report*

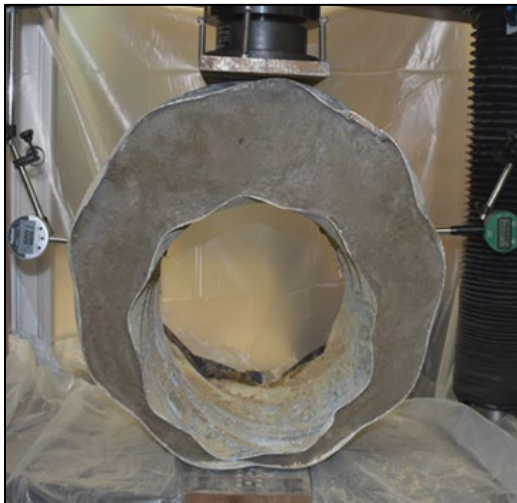
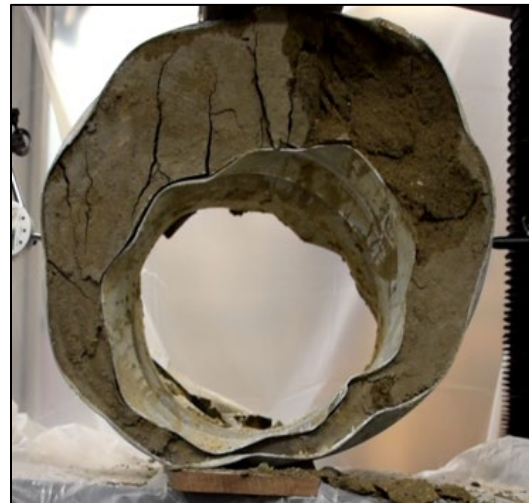
Figure E.54: Sliplined Culvert Using CLSM Grout Mix A, Before (*left*) and After (*right*) Parallel-plate Load Test.

Parallel-plate loading experiments were performed on sliplined culvert specimens with two different grouts, Mix A (a typical CLSM mix) and C40 cellular grout. The grout condition before and after the parallel-plate loading tests of culverts that were sliplined with Mix A and C40 are shown in Figure E.54 and Figure E.55, respectively. As a result of the many cracks that were found in the crown and springline locations, a large amount of Mix A grout spalled out of the culvert test specimen. In contrast, the sliplined culvert specimen that was made with C40 cellular grout exhibited only a few cracks at the crown and springline positions.

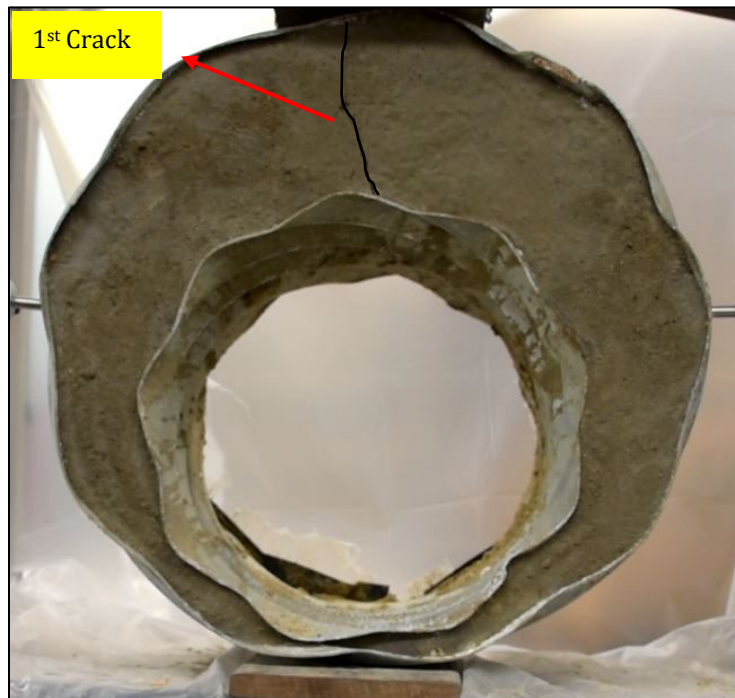
Figure E.57: First Crack Occurred in CLSM Mix A Grout at 1,300 lbf.

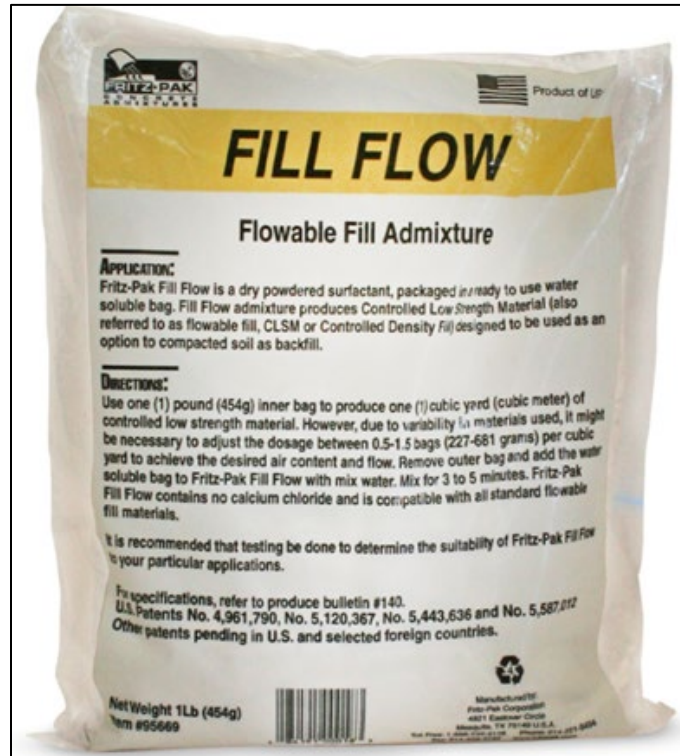
Figure F.2: Fill Flow Admixture.

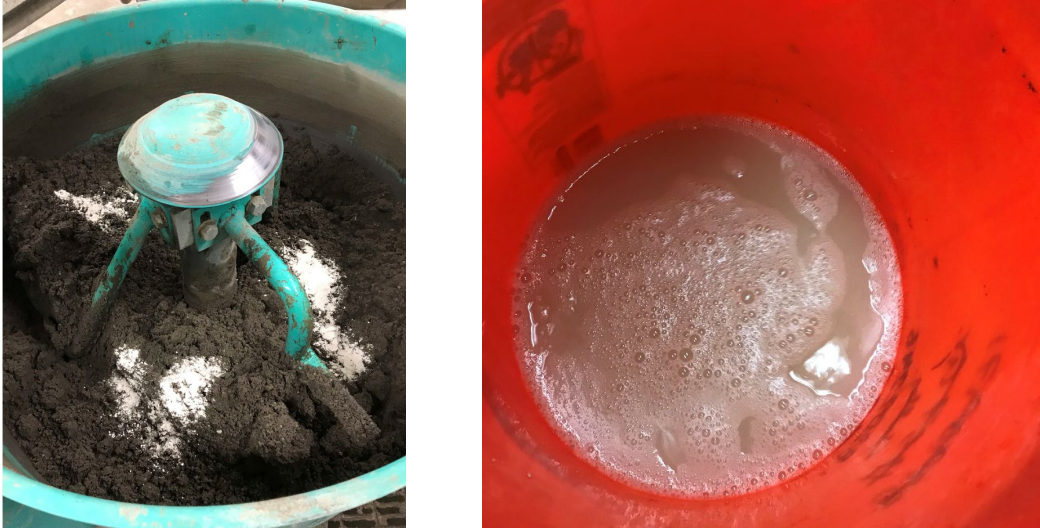
Figure F.3: Mixing Fill Flow: Adding Powder Directly to the Mix (left),  
Mixing Fill Flow with Water Prior to Adding it to the Mix (right).

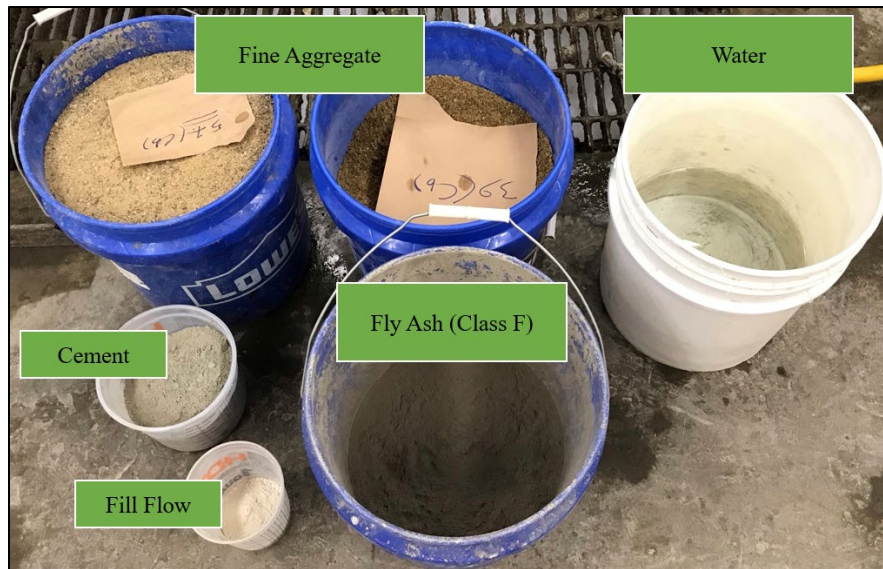
Figure F.4: Measured Mixture Components Needed to Produce One Cubic Foot of CLSM Mix.

CLSM is typically batched and mixed in the same way as a normal mortar/concrete mixture. In this study, the dry mixture components (i.e., cement, fly ash, fine aggregate, fill flow admixture, etc.) and water were pre-measured to produce 1-ft<sup>3</sup> CLSM mixtures (Figure F.4). An electric mortar mixer (Figure F.5) was used to prepare the CLSM mixes. The drum of the mixer has a total capacity of 4.25 ft<sup>3</sup> and a paddle speed of 38 rpm, which is sufficient for producing a homogenous mix. In the mix procedure, the dry components were mixed thoroughly using the mortar mixer for at least 1 to 2 minutes. After ensuring a homogenous distribution of the dry materials, water was added and mixed until a smooth grout was obtained (Figure F.6).

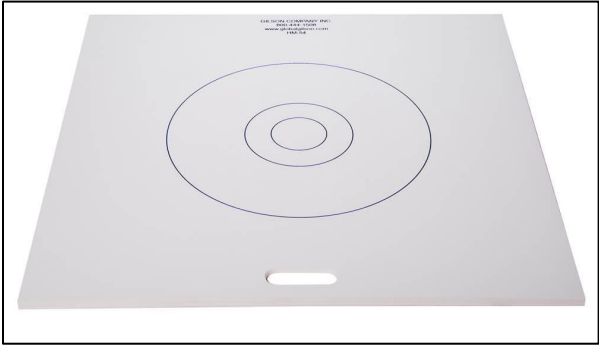
Figure F.7: Base Plate for Flow Consistency Test of CLSM.

Flowability of CLSM mixtures was measured in accordance with ASTM D6103-17 (ASTM, 2017). The test is performed using a 3-inch-diameter by 6-inch-high cylinder and a smooth, non-porous base plate with dimensions of 36" × 36" × 0.5", as shown in Figure F.7. The cylinder is filled to the top edge with CLSM mixture and is leveled with a stiff metal straightedge. The spillage from the cylinder is removed after striking off. The cylinder is then lifted quickly (within 5 seconds) to allow the fresh mix to freely flow over the smooth plate. It is recommended to complete the entire test (from the start of filling through to the removal of the flow cylinder) without interruption within an elapsed time of 60 seconds. The diameter of the largest resulting spread diameter of the CLSM grout is measured using measuring tape (as shown in Figure F.8) and recorded. Two measurements of the spread diameter (the second measurement is made perpendicular to the first) are taken, and the final spread is calculated by taking the average of the two measurements.

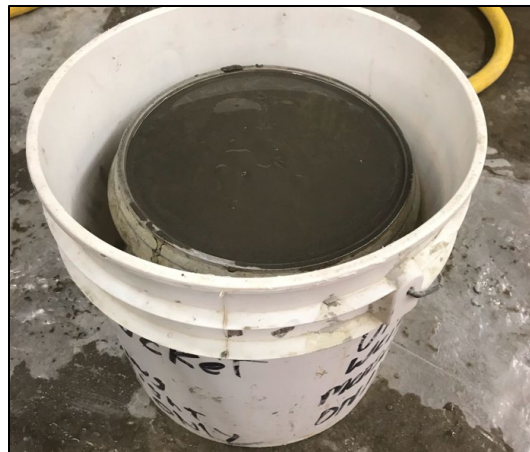
Figure F.10: Density Test for Freshly Mixed CLSM.

$$\text{Mold Volume} = \pi * (d^2h)/4 = \pi * 8^2 * 8.75/4 = 439.82 \text{ in}^3 = 0.25 \text{ cu. ft.}$$

$$\text{Grout Density} = \text{Grout Weight} / \text{Mold Volume} = \frac{30.3 \text{ lb}}{0.25 \text{ ft}^3} = 119 \text{ lb/ft}^3$$

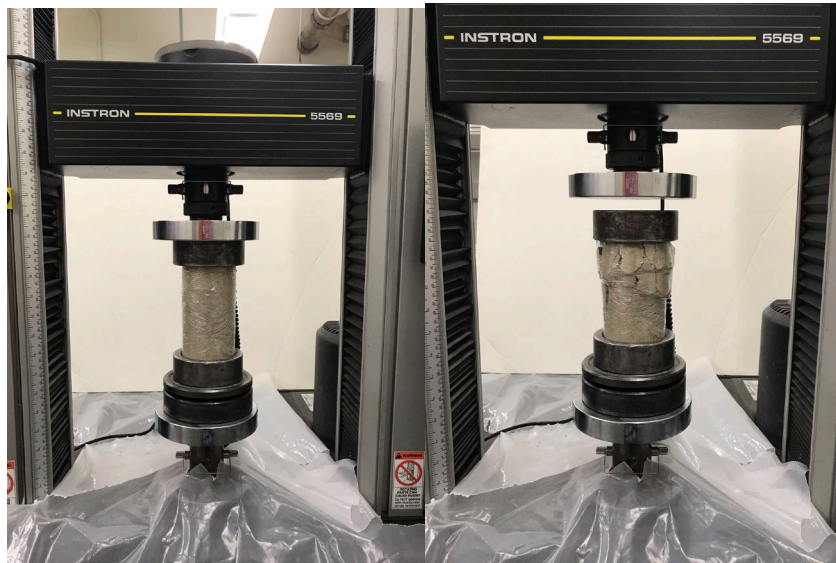
Figure F.13: Unconfined Compressive Strength Test: Setup with Specimen Loaded into Test Frame (*left*), Test Specimen that Failed when Loaded (*right*).

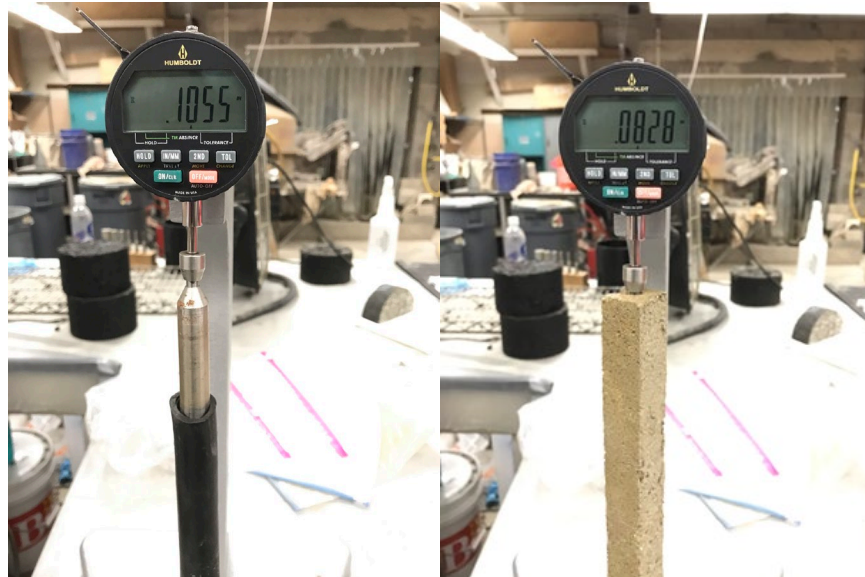
Figure F.15: Determination of the Change in Length of a CLSM Sample: Measuring an Invar Reference Bar in the Length Comparator (*left*), Length Comparator with a Shrinkage Sample of CLSM (*right*).

$$\Delta L_x = \frac{CRD - \text{initial } CRD}{G} \times 100 \quad (F.3)$$

where  $\Delta L_x$  is the length change (shrinkage) of the specimen at any age (%),  $CRD$  is the difference between the comparator reading of the specimen and the reference bar at any age, and  $G$  is the gauge length (10 in.).

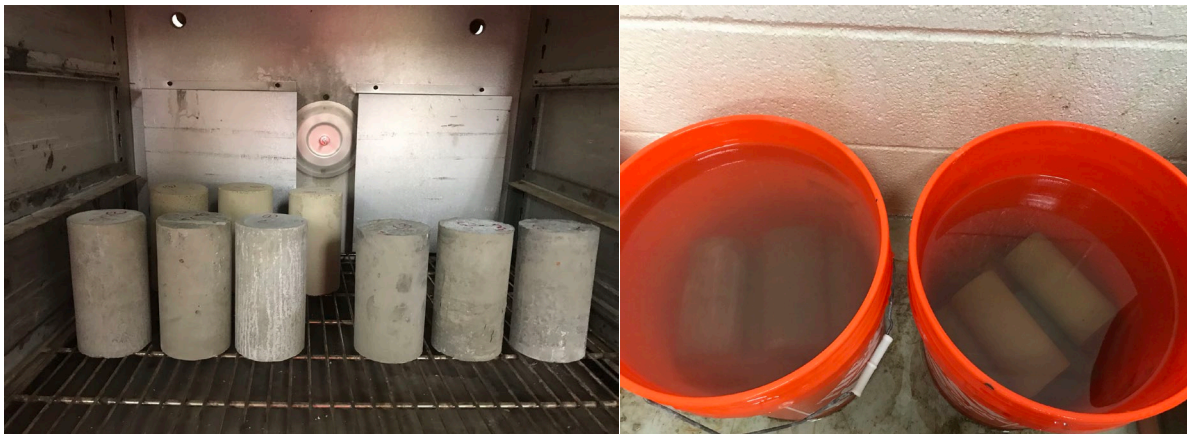
Figure F.16: Water Absorption Test of CLSM Specimens: CLSM Specimens in the Oven (*left*), CLSM samples Submerged in Water (*right*).

$$\text{Water Absorption (\%)} = \frac{\text{Volume of water absorbed by test specimen in 24 h}}{\text{Volume of test specimen}} \times 100 \quad (\text{F.4})$$

$$\text{Oven dry density (lb/ft}^3\text{)} = \frac{\text{Dry mass of the test specimen (lb)}}{\text{Volume of test specimen (ft}^3\text{)}} \quad (\text{F.5})$$

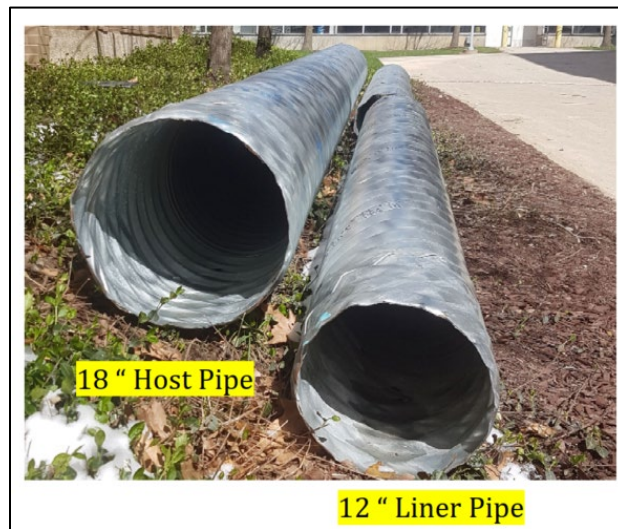
Figure F.17: Galvanized Corrugated Metal Pipe

Zinc-coated (galvanized) corrugated steel pipes (shown in Figure F.17) were utilized for both the host and liner pipes of the sliplined culvert specimens prepared in this project. This corrugated steel pipe meets the requirements of ASTM A929-18 (ASTM, 2018) and AASHTO M 218 (AASHTO, 2011). The nominal diameter of the host pipe was 18 in., and the nominal diameter of the liner pipe was 12 in. The wall thickness of both pipes was 14 gauge (2 mm), and the nominal corrugation size was  $2\frac{2}{3}$  in.  $\times$   $\frac{1}{2}$  in. ASTM A929-18 requires that the flat steel sheet used to fabricate the pipe should have a tensile strength of 45 ksi, a yield strength of 33 ksi, and an elongation over 2 in. of 20%. In this project, 20-ft lengths of pipe of each diameter, which were procured from WinWater of Akron, were cut into 12-in. sections to meet the requirements of the parallel plate loading test, per ASTM D2412-21 (ASTM, 2021).

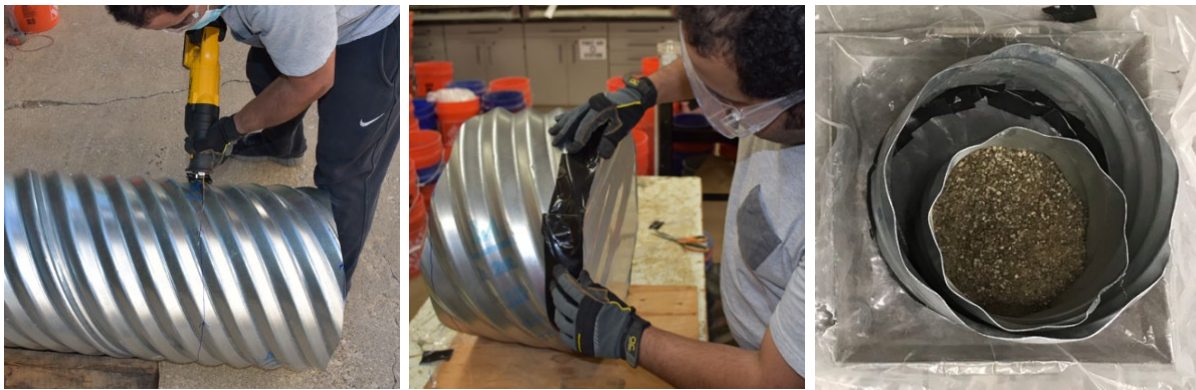
Figure F.20: Preparation of Host Pipe and Liner: Cutting the Liner Pipe (*left*), Wrapping the Bottom of Host Pipe with Plastic (*center*). Liner Pipe Packed with Sand (*right*).

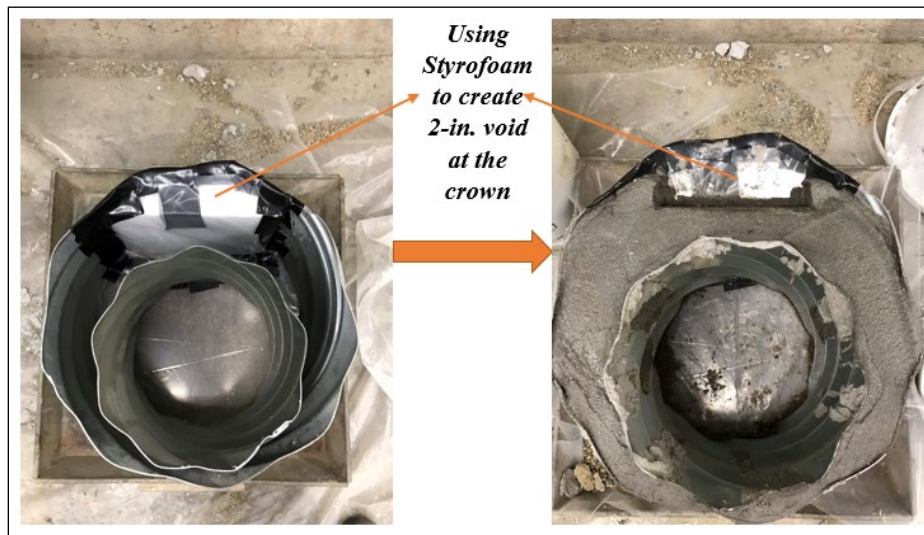
Figure F.22: Creating a Crown Void in the Sliplined Culvert.

Figure F.22 and Figure F.23 show the process for creating voids at the crown and springline of the Type II and Type III culvert test specimens, respectively. The 2-inch void at the crown of the sliplined pipe of the Type II culvert specimen was created by attaching Styrofoam at the crown position of the host pipe. Similarly, two cardboard tubes with diameters of 2 in. and a length of 12 in. were placed at the 3 o'clock and 9 o'clock positions of the Type III culvert specimen to create voids at the springline. The Styrofoam and tubes were removed from the culvert specimens 3 days after casting. The resulting specimens are shown in Figure F.24.

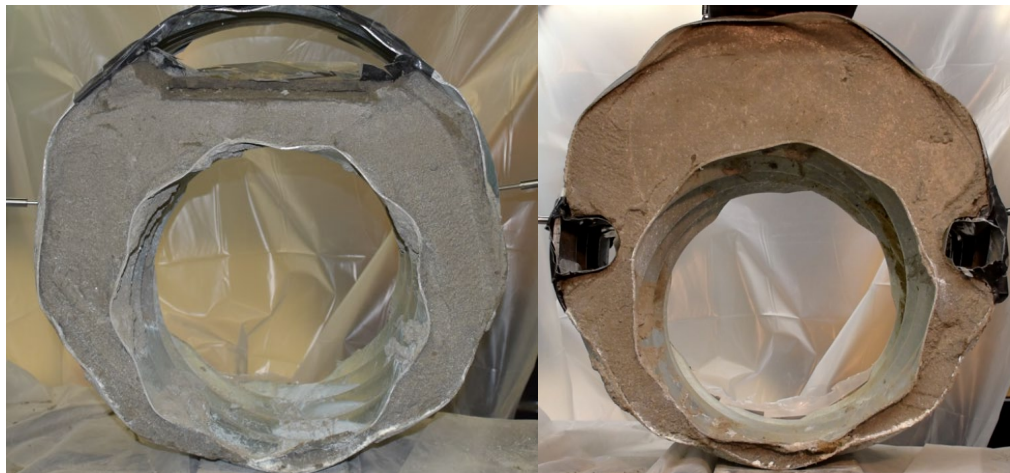
Figure F.24: Sliplined Culvert Specimens: One with a Void at Crown (*left*) and One with Two Voids at the Springline (*right*).

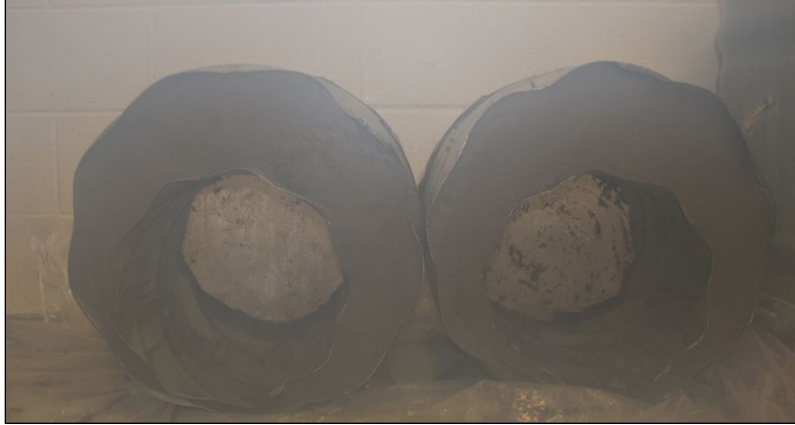
Figure F.25: Sliplined Culvert Specimens in the Curing Room.

Eventually, all of the sliplined culverts specimens were moved to the curing room (which was maintained at a relative humidity of 100%) and cured for 28 days (as shown in Figure F.25) before being subjected to parallel plate load tests.

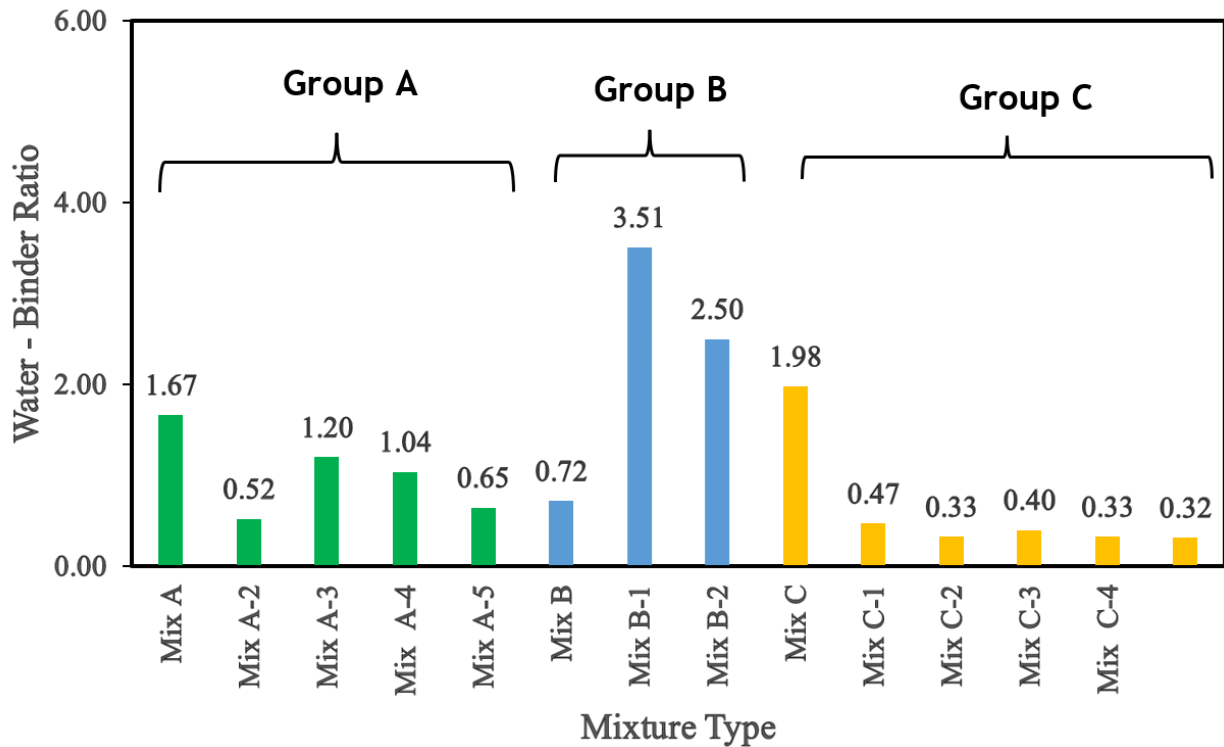
Figure F.27: Water-Binder Ratios of CLSM Mixtures.

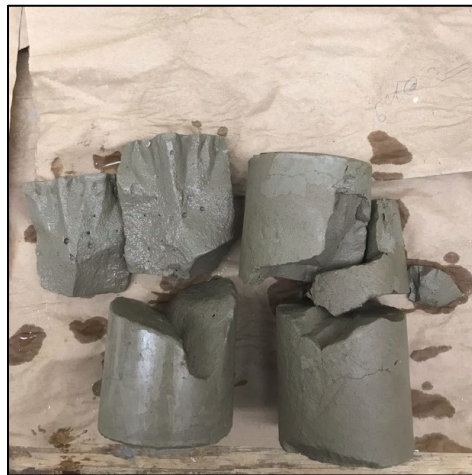
Figure F.37: Broken Water Absorption Sample (Mix C).

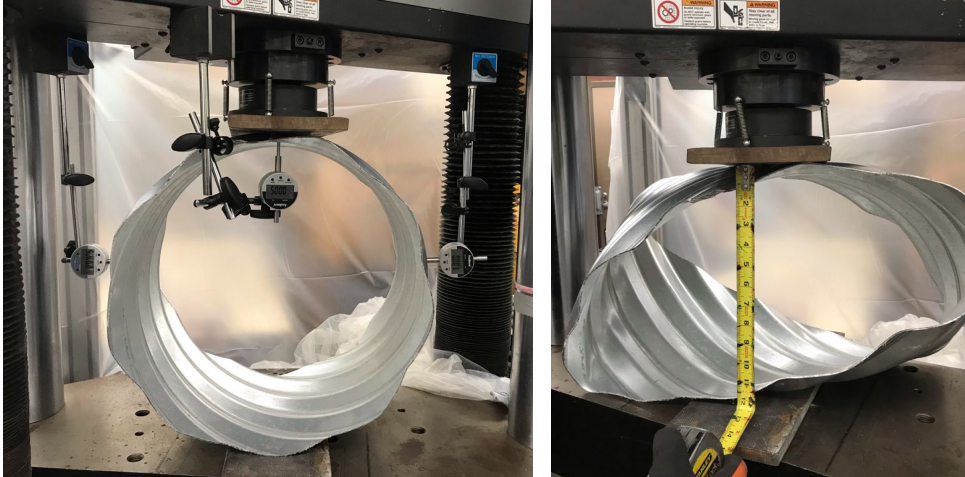
Figure F.41: Parallel-Plate Loading Tests:  
Liner Pipe Before (*left*) and After Loading (*right*)

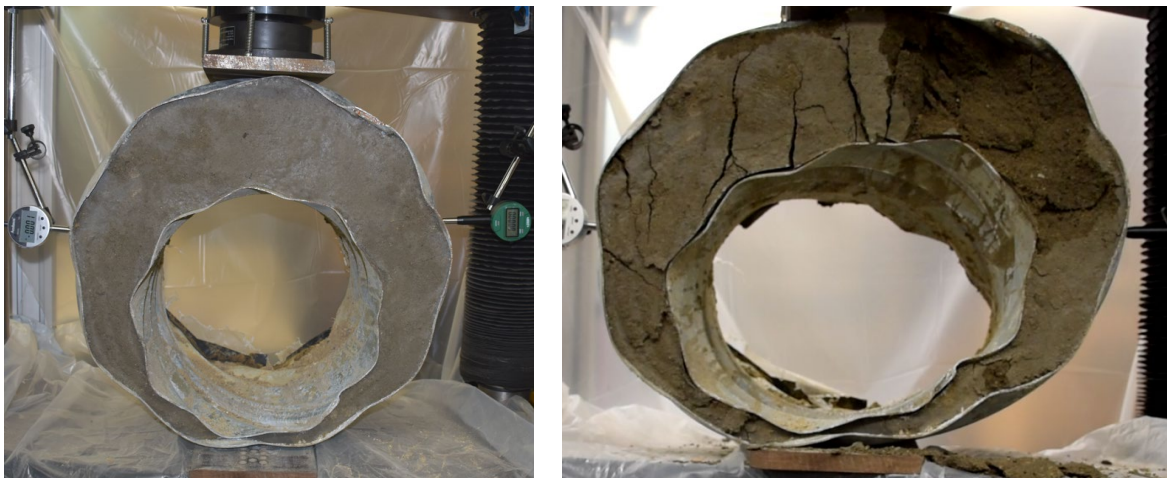
Figure F.42: Sliplined Culvert with CLSM grout Mix A Before (*left*) and After (*right*) the Parallel-Plate Loading Test.

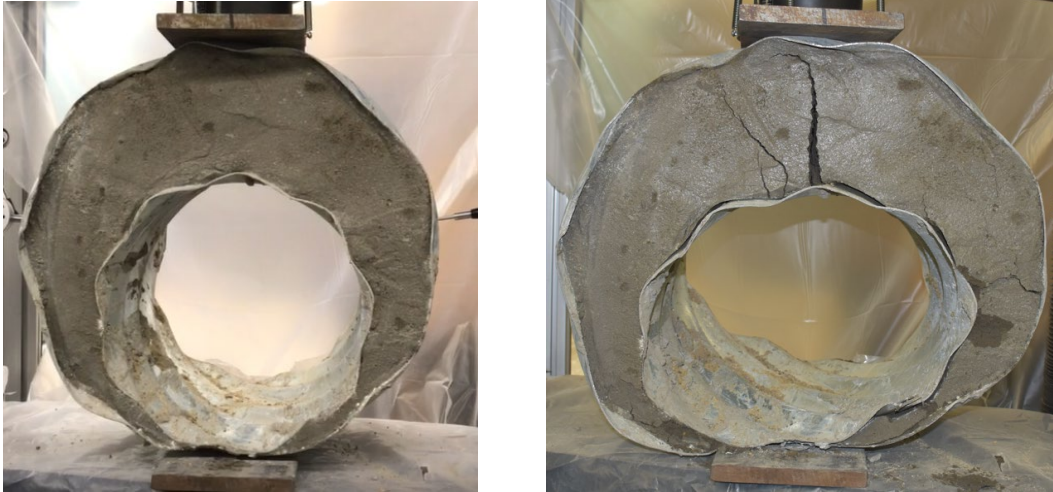
Figure F.43: Sliplined Culvert with CLSM grout Mix A-5 Before (*left*) and After (*right*) the Parallel-Plate Loading Test.

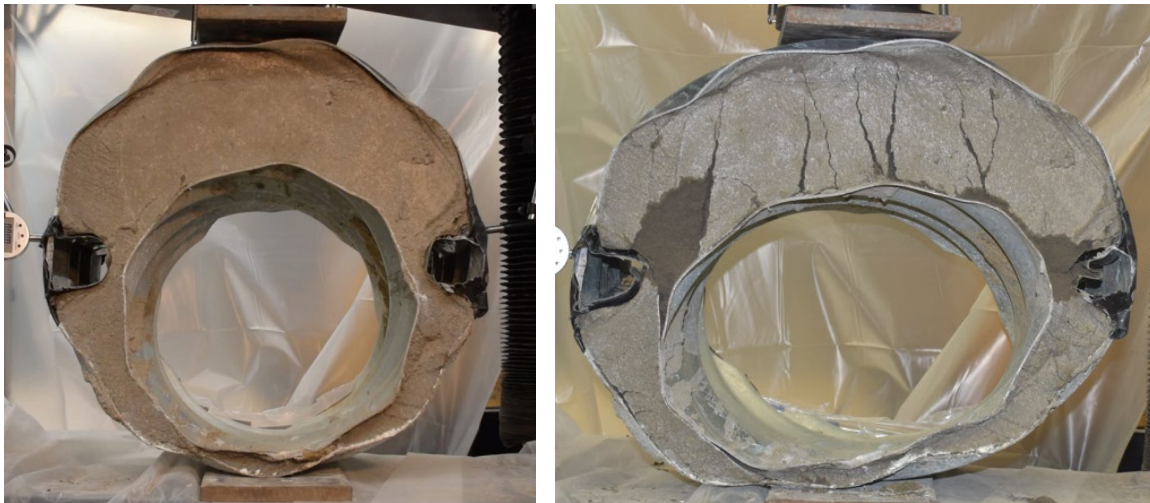
Figure F.47: Sliplined Culvert with Voids at the Springline, Before (*left*) and After (*right*) the Parallel-Plate Loading Test.

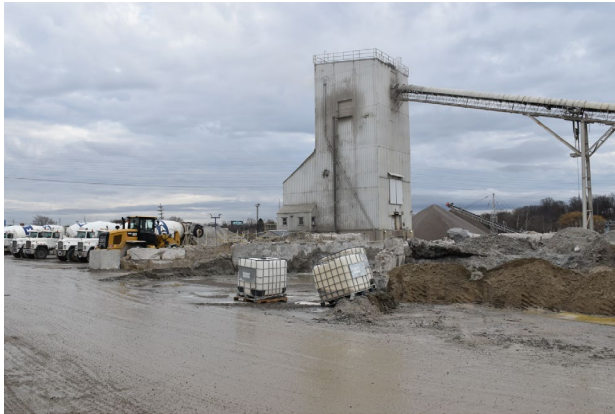
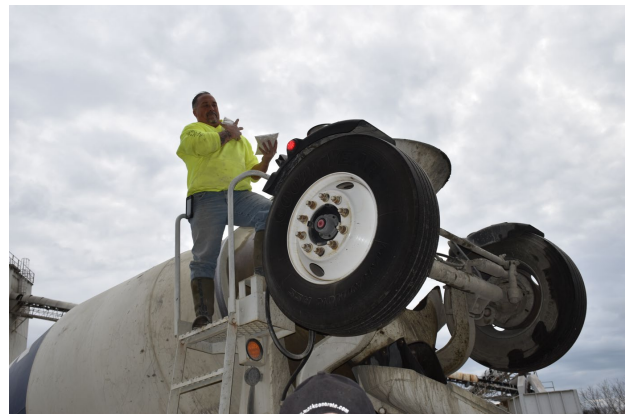
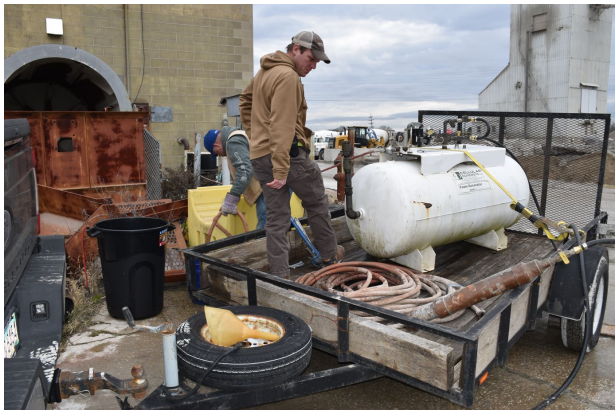
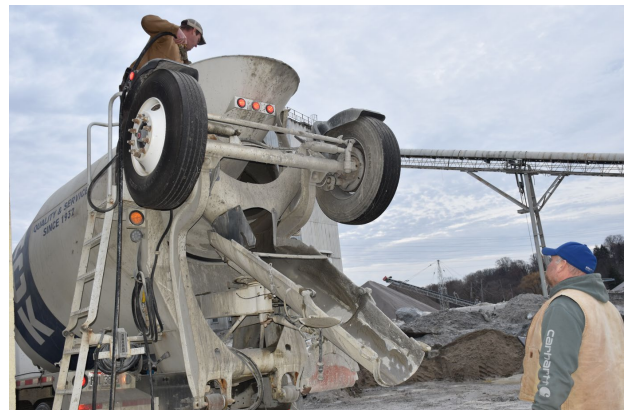
(a) Mack Ready Mix Concrete Facility

(b) Adding Fill Flow to CLSM Mix A5

(c) Creating Foam with a Foam Generator

(d) Adding Foam to the Mixer Drum

Figure G.1: Preparation of Large Batches of Grout Mixtures.

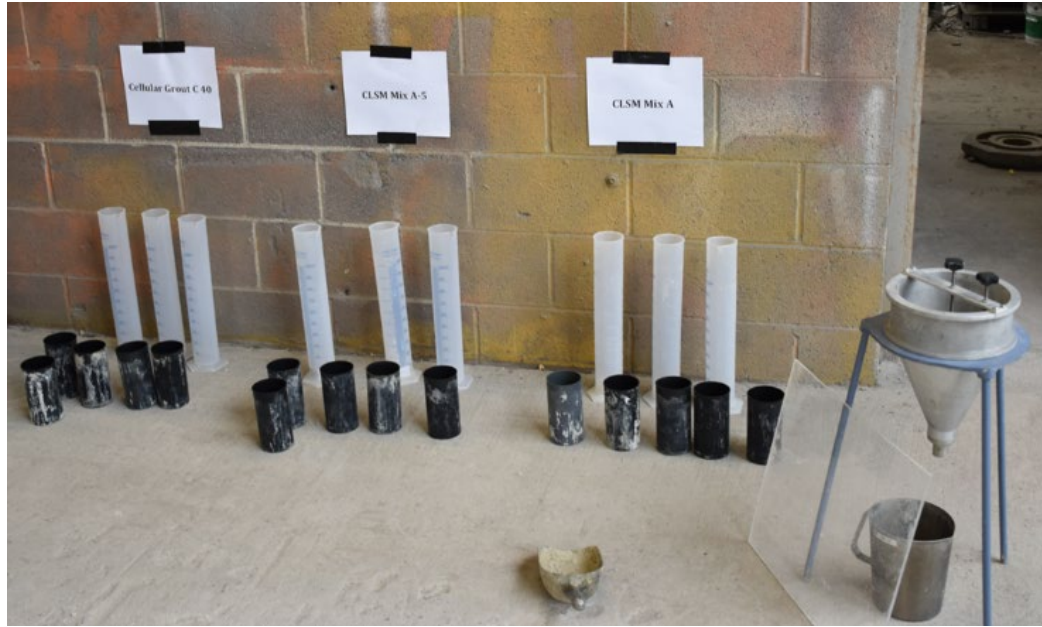
Figure G.2: Test Station for Tests on Fresh and Hardened Properties of the Cellular Grout and CLSM Grouts.

The tests listed in Table G.3 were performed at the batching facility using the setup shown in Figure G.2 to determine if the physical properties of the large batches of grouts would be comparable to the results for tests conducted in the laboratory for smaller-sized batches. In order to decide whether or not to proceed with the mix design, it was crucial to measure each grout's cast wet density (i.e., fresh density) using ASTM C796/C796M. In this test, a standard steel cylinder (12 inches tall and 8 inches in diameter) is filled with grout and leveled off at the top. An electronic scale is then used to determine the mass of the grout, and the density of the grout is calculated from the mass of the grout. The density is considered to be acceptable when the fresh wet density is within  $\pm 3$  lb/ft<sup>3</sup> of the design density. Another conventional container, a vertical air chamber that conforms to the requirements of ASTM C23, was employed to determine the air content of the grout. Next, the flow properties of the grout were evaluated using a flow cone test in which grout was poured into a flow cone with a volume of 1,725  $\pm$  5 mL and the grout was permitted to flow under its own self-

weight through a flow cone with a ½-inch diameter. A spread test was also conducted according to ASTM D6103. In this test, a 6-in.-long plastic bottomless cylinder with a diameter of 3 in. is filled with grout and is then lifted vertically to allow the grout to spread. The resulting spread of the grout is measured using a tape measure.

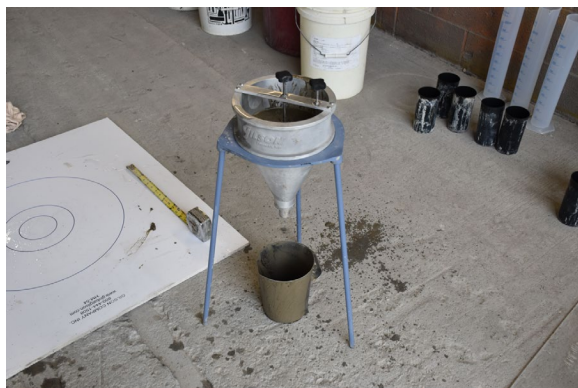
(a) Flow Cone Test for CLSM Mix A

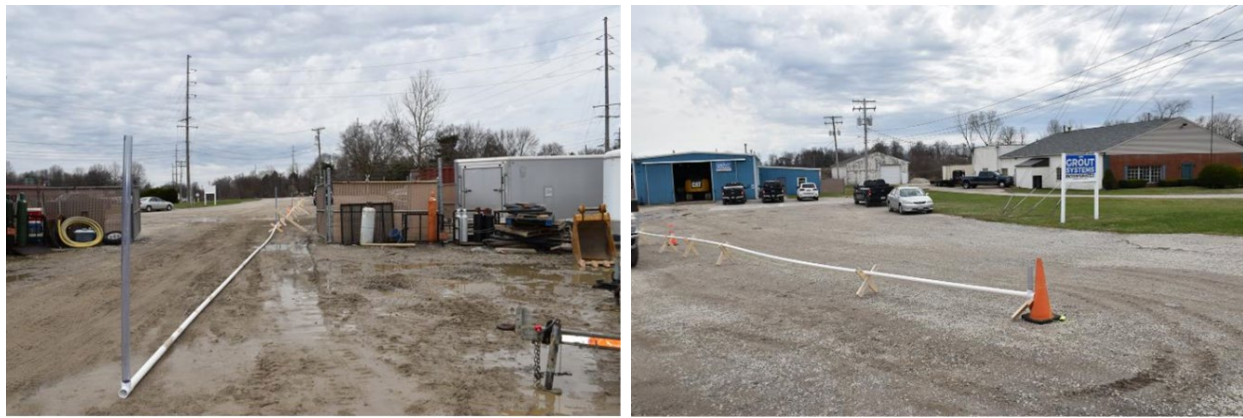
(a) Start Location (Point 1)

(b) Discharge End (Point 3)

To investigate the pumpability of the grout mixtures, grouts samples were collected at three different points along the pumping route (Figure G.7). Prior to pumping, the density of the grout at Point 1 (the start location) was measured to ensure that the mix design achieved the required density; if not, adjustments were made to the mix before pumping proceeded. Point 2 was located approximately midway along the length of the pipe (approximately 100 ft from the start point), while Point 3 (the discharge end) was located approximately 200 ft from the start point. Prior to beginning each test, the PVC pipe was flushed with water to ensure that grout would not stick to the walls of the pipe. Transparent 2-inch tubes were fixed to the pipe at different locations to observe the grout as it was pumped. The top vents of the transparent tubes were capped off to allow the grout to continue traveling the entire length of the pipe.

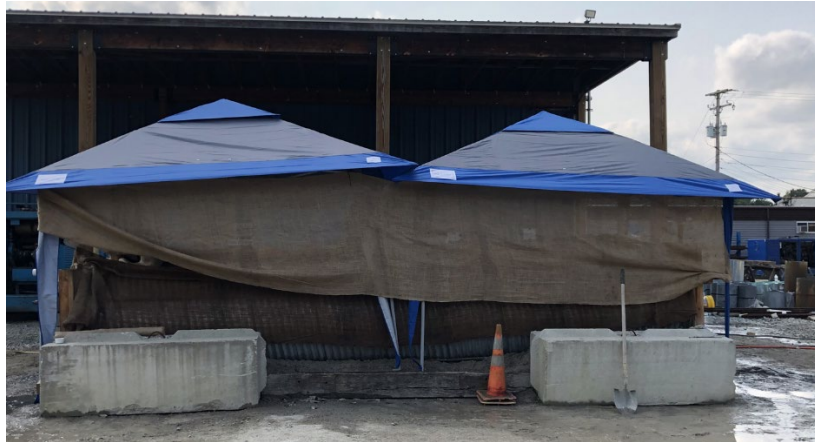
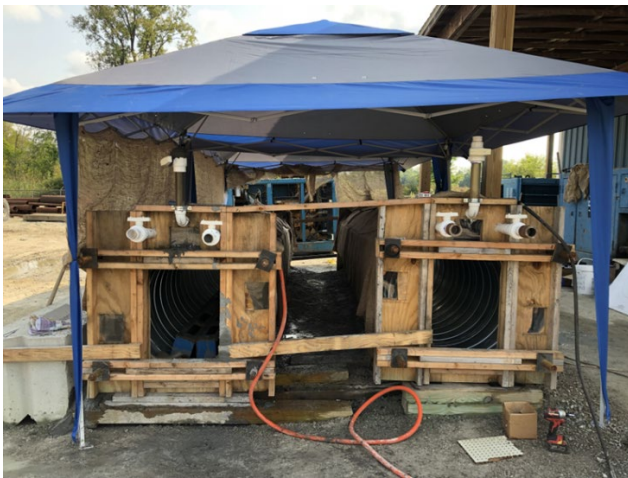
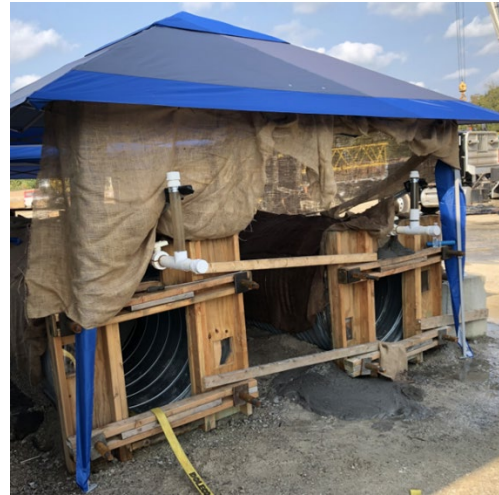
(a) Side view of culvert

(b) Inlet side of culvert inlet

(c) Outlet side of culvert

Figure G.10: Preparation of Culverts for Phase 3 Testing.

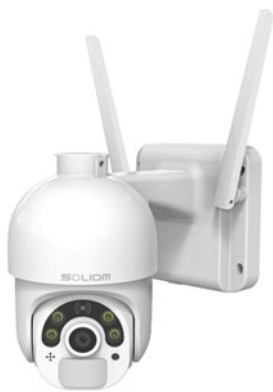
(a) Soliom wireless camera

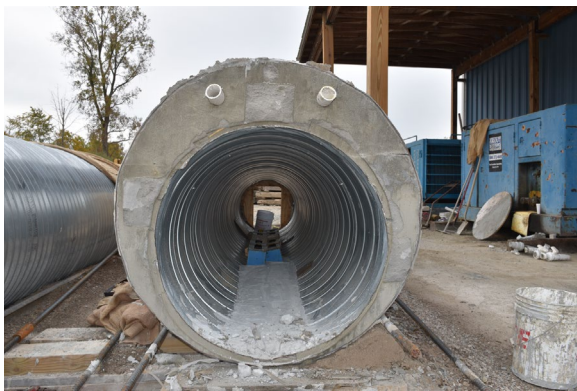
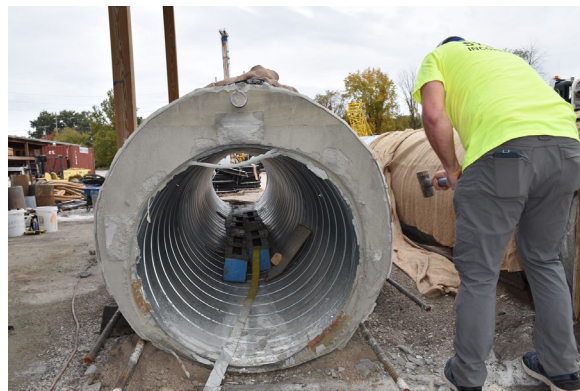
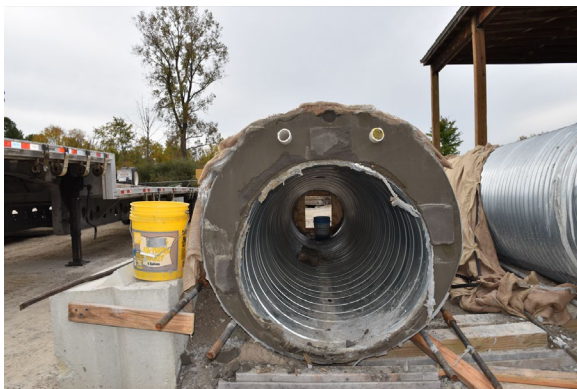
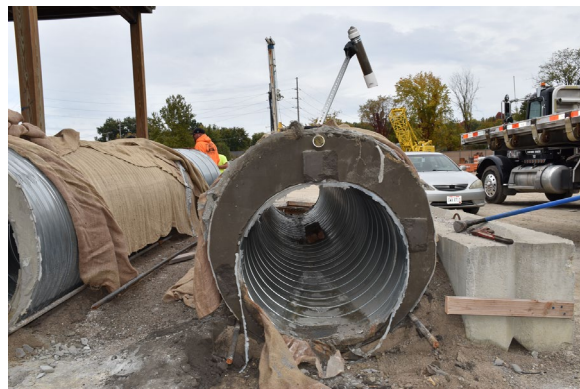
(a) Cellular Grout C40 at inlet

(b) Cellular Grout C40 at outlet

(c) CLSM Mix A5 at inlet

(d) CLSM Mix A5 at outlet

Figure G.16: Ends of the Culverts After Bulkheads Were Removed.

At 28 days after grout installation, visual checks were made to determine if the grouts were able to completely fill the annulus voids and harden as designed. This was accomplished by removing the bulkheads at the inlets and outlets of the culverts to expose the grouts and allow a visual examination to be conducted (Figure G.16). For both sliplined culvert test specimens, the annular spaces at the two ends of the culvert were found to be completely filled with grout, and no voids were present. Using a commercial concrete cutting saw, each sliplined culvert was then cut into four pieces (at the cutting locations shown in Figure G.17) by a skilled crew from Concrete Cutting Systems (Akron, Ohio) to allow examination of the grouts at the interior locations within the culvert test specimens. Cuts in each culvert were first made from the 9 o'clock position to the 3 o'clock position through the crown position at three locations. Each culvert was then turned using a crane in order to allow the crew to cut the remaining portions. The cut ends of all four segments of both pipes were then inspected, and all segments of the two sliplined culverts were found to be completely filled with grout (Figure G.18).

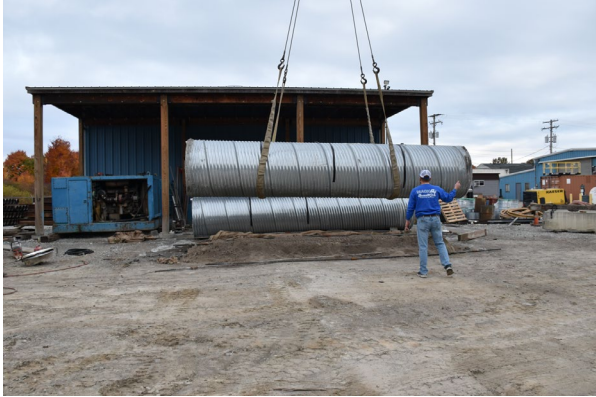
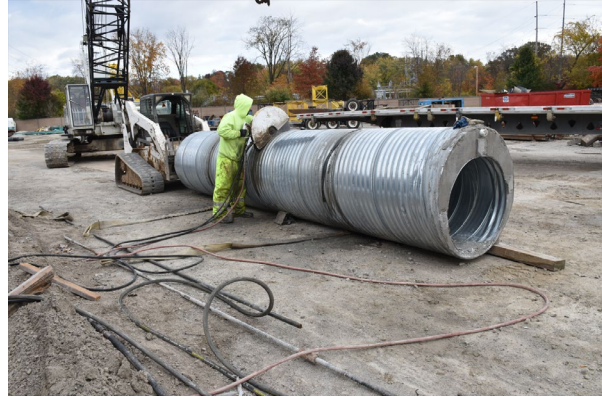
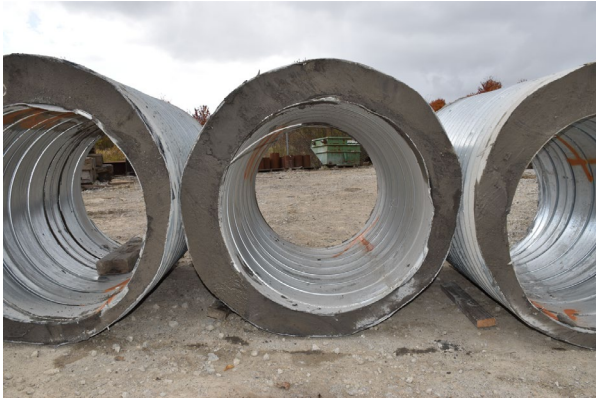
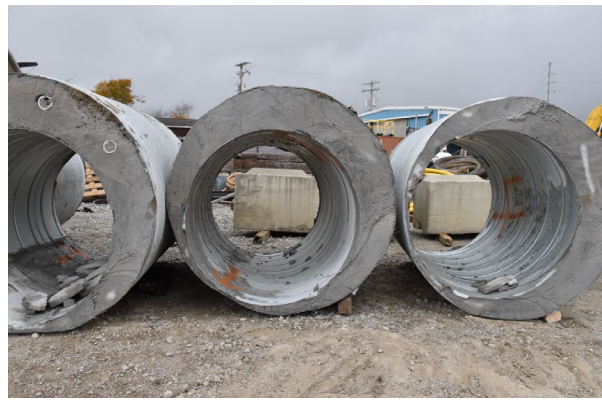
(a) Lifting of culvert specimens

(b) Cutting of culvert specimens

(c) CLSM Mix A5 segments

(d) Cellular Grout Mix C40 segments

Figure G.18: Cutting of the Culverts into Segments.
