U.S. Department
of Transportation
Federal Railroad
Administration

Fire Performance of a Cryogenic ISO UN-T75 Storage Tank Using Analytical Methods and Fire Testing Phase 2: Testing with LNG in an ISO Tank

1. AGENCY USE ONLY (Leave blank)		2. REPORT DATE October 24, 2023		3. REPORT TYPE AND DATES COVERED Final Report, 09/2016 to 08/2017
4. TITLE AND SUBTITLE Fire Performance of a Cryogenic ISO UN-T75 Storage Tank Using Analytical Methods and Fire Testing, Phase 2: Testing with LNG in ISO Tank			5. FUNDING NUMBERS 693JJ622C000003

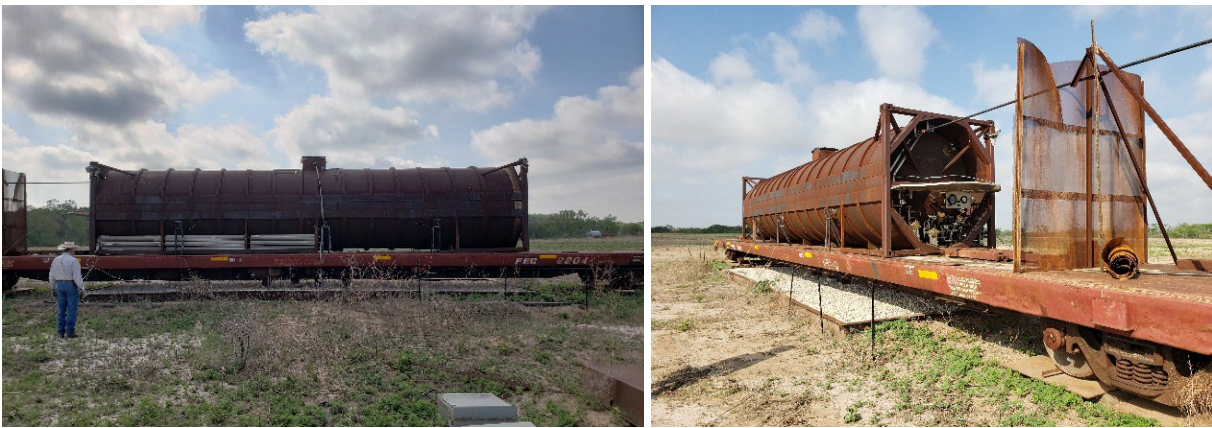
Figure 1. ISO Tank Photograph Prior to Testing (left: View from West; right: View from Northeast)

An ISO UN-T75 storage tank, outfitted for LNG service, was procured from Cryogenic Vessel Alternatives (CVA)³. The tank's model number is CVA-12K-114-ISO and it measures 40 ft long, 8.5 ft high, and 8 ft wide. [Figure 1](#) provides selected photographs of the tank used in this experiment. Additional figures may be referenced in [Appendix A](#) of this report.

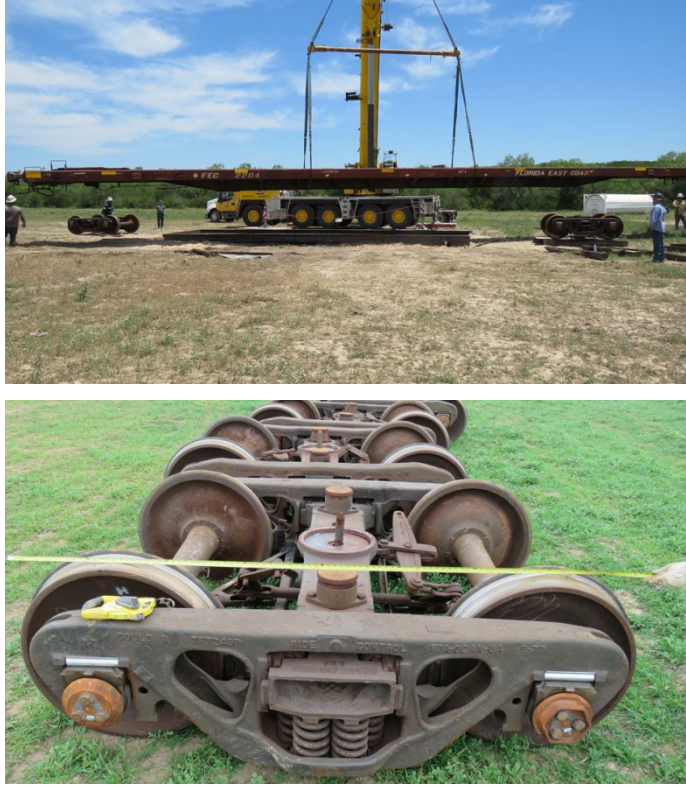
Figure 2. Flatcar Photographs (top: Flatcar Being Installed; bottom: Flatcar Trucks)

Florida East Coast Railway (FECR) donated a flatcar for this project. This car consists of two connected cars. One of these cars was used for Phase I fire testing, and the second car was used in this Phase 2 testing. [Figure 2](#) shows a photograph of the flatcar and the trucks at the remote test site.

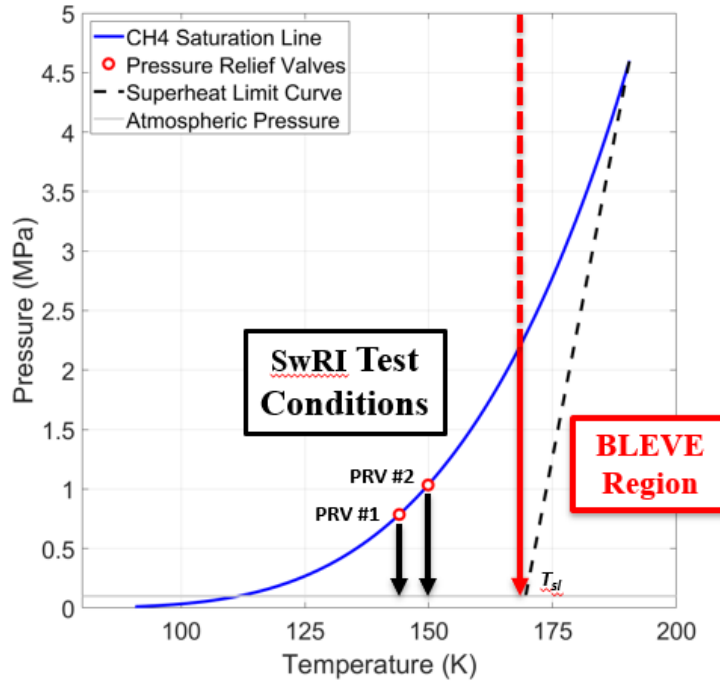
Figure 3. BLEVE Conditions Illustrated on Methane Saturation Curve

Total potential energy released during BLEVE event defines the degree of hazard. However, BLEVE theory states that instantaneous nucleation and volumetric boiling of liquid content requires the temperature of the multiphase mixture be at or above the superheat limit temperature (T_{sl}) [1, 2]. For BLEVE events that move from the saturation curve to ambient pressure directly, the total mechanical energy release is substantially reduced [3, 4]. [Figure 3](#) shows the saturation curve for methane (CH_4) as well as the superheat limit temperature as a function of temperature and pressure. The pressures noted relate to the nominal operating pressures observed in Phase 1 testing and are labeled "SwRI Test Conditions." The region of the graph contained within the red, blue, and black dotted lines are the critical conditions for a BLEVE.

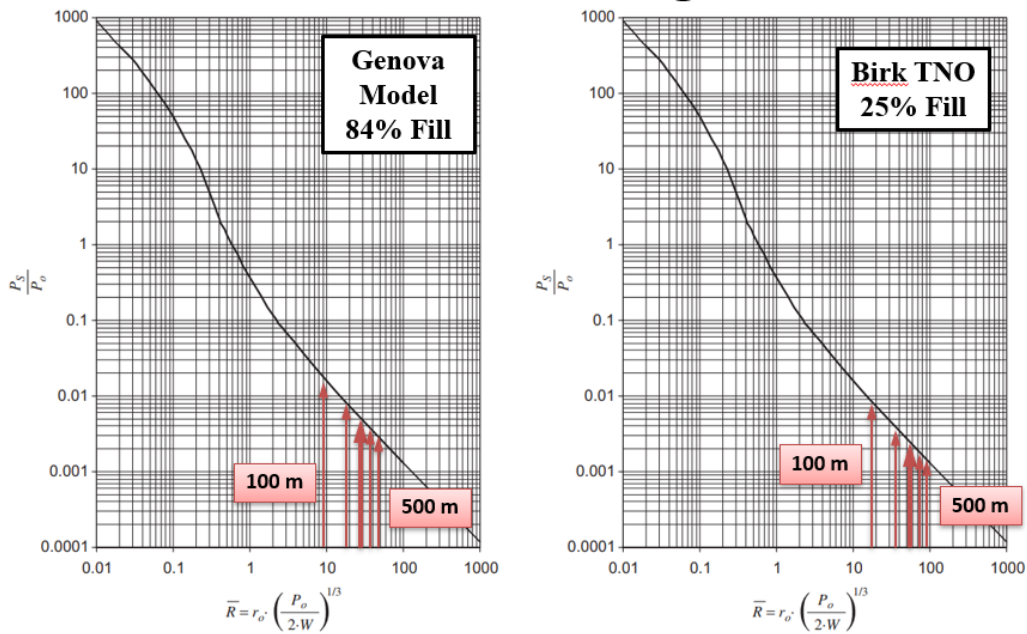
Figure 5. Sach's Scaling Summary Results

- Using the Genova model, at 300 m, the shock overpressure is \approx 500 Pa (0.07 psi)
- Using the Birk TNO model, at 300 m, the shock overpressure is \approx 200 Pa (0.03 psi)

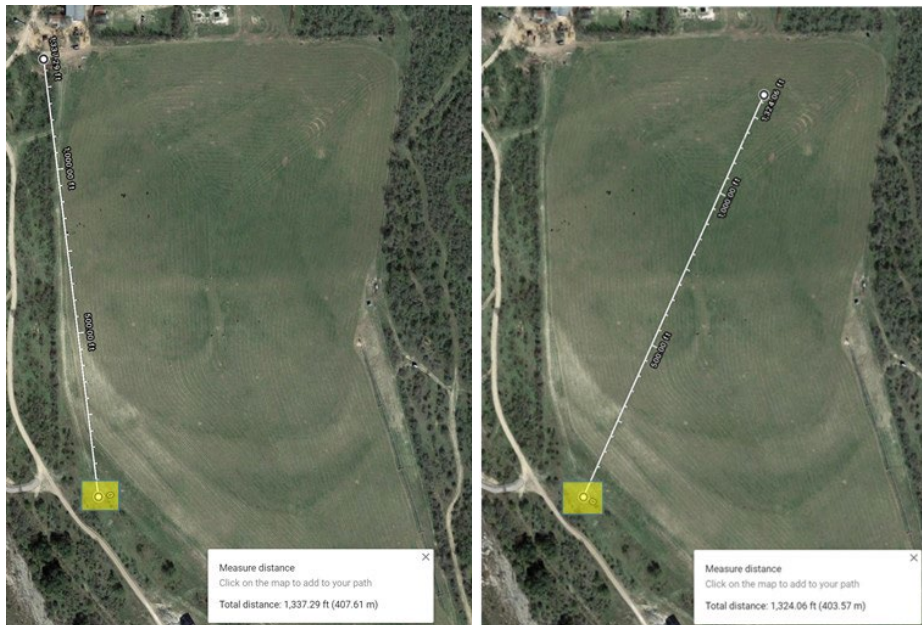
Figure 6. Location of Staff Bunker (yellow box) During Phase 2 Test (left: 408 m from Bunker to Propane Tank; right: 404 m from Bunker to Test Article)

Based on the calculations above, the location of the staff bunker during testing was located approximately 400 m from the test article and LNG source for the exposure fire. Figure 6 show these nominal locations at the remote test site. In each figure, the yellow highlighted box represents where the data collection and witnessing observers were located during the test.

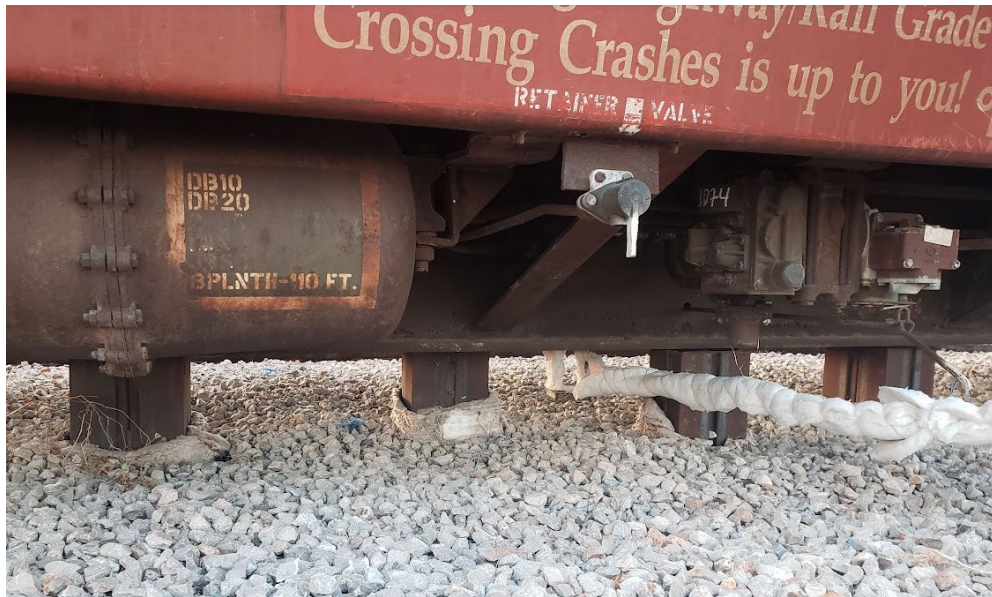
Figure 7. Structural Steel Pilons Installed to Support the Flatcar During the Test

Finally, additional structural supports were added under the flat car, within the fire burner. In Phase 1, the flatcar was observed to sag during the fire exposure, which can affect the heat transfer into the test article in a non-conservative way. For Phase 2, the team decided to provide additional support and delay or prevent the sagging of the flatcar during the test to maximize the heat input. [Figure 7](#) shows a photograph of these additional supports.

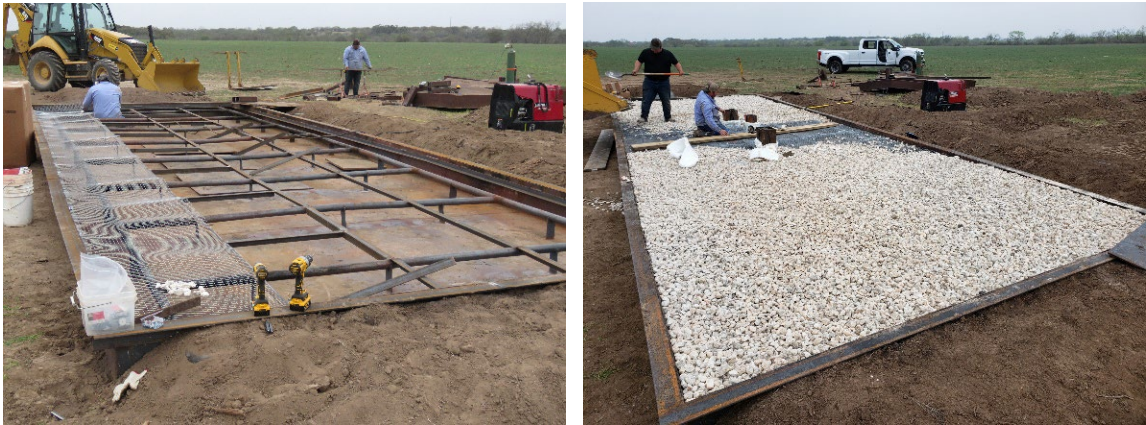
Figure 9. Phase 2 Propane Test Burner Photographs

[Figure 8](#) shows a schematic of the Phase 2 burner construction and [Figure 9](#) shows two photographs of the burner under construction and at final installation.

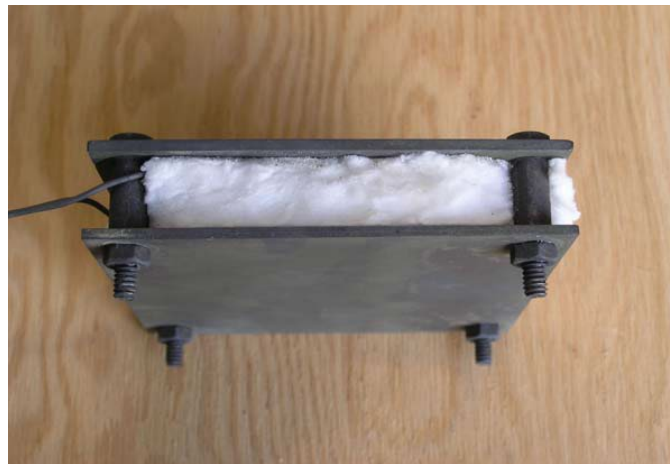
Figure 14. Directional Flame Thermometer

The DFT was originally developed for measuring temperatures and heat fluxes in pool fires [11]. The DFT is conceptually like the plate thermometer but consists of two 3-mm thick, 120 × 120-mm Inconel plates with a 25-mm thick ceramic fiber blanket in between (see Figure 14). The blanket is compressed to 19-mm thickness. A 1.6-mm diameter sheathed Type K TC with insulated junction is in a groove on the inside of each plate.

An advantage of the DFT over the plate thermometer is that the heat transfer through a DFT can be calculated with an inverse heat transfer code such as IHCP1D [12]. The use of these devices in fire experiments has been standardized recently in ASTM E3057 [13].

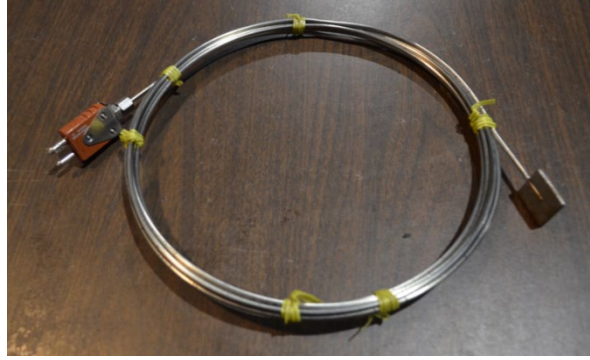
Figure 15. Weld-Pad Surface Temperature Thermocouple Probe

The Weld-Pad Surface Temperature Thermocouple Probe is designed for use in industrial applications to measure surface temperature by way of weld, braze, or clamp attachment. The pad is flexible to form to the contour of a flat or curved surface. The pad material is 304 stainless steel and measures 1.0 × 1.0 × 0.01 in. (25-mm × 25-mm × 0.25 mm) and the TC is Type K.

Figure 15 shows a photograph of one of the weld-pad TCs.

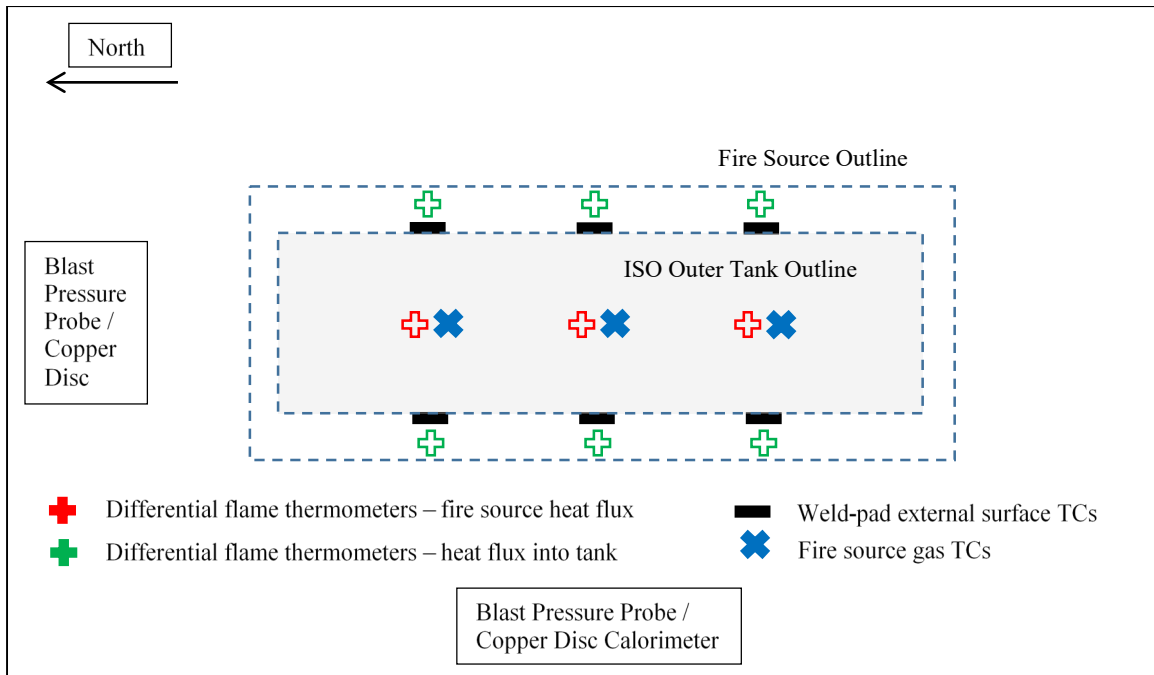
Figure 17. External Instrumentation Sketch

Figure 17 provides a plan view general layout of the external instrumentation at the remote site. Figure 18 provides a sketch of the additional weld-pad TCs that were added to obtain additional model validation data. Note that the fire source differential flame thermometers depicted in red were located between the fire source and underside of the flatcar. The differential flame thermometers depicted in green were located approximately 2 in. from the outer tank wall at the same nominal location as the weld-pad TCs and internal TCs at the same baffle position.

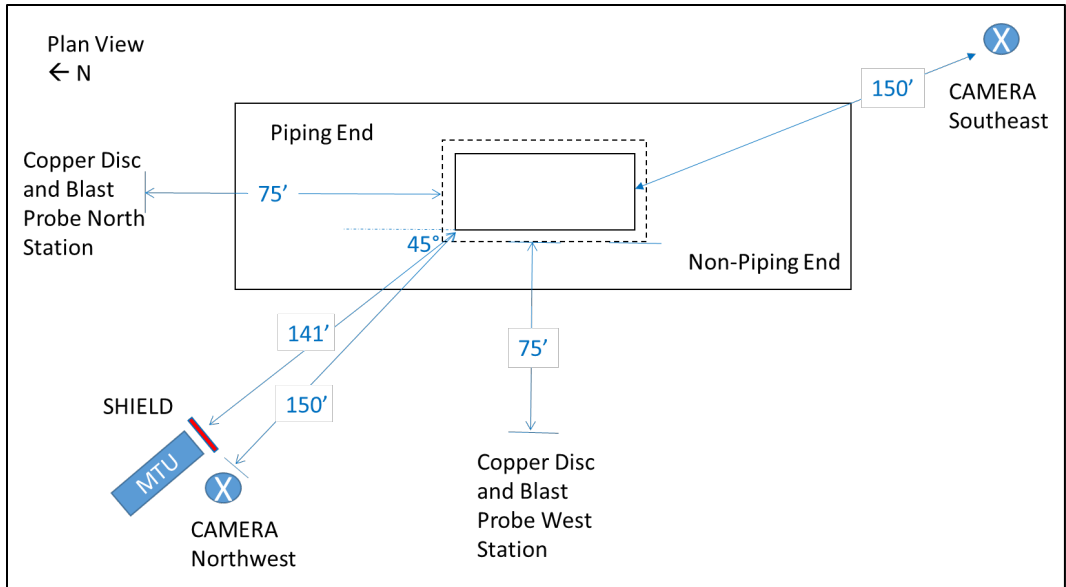
Figure 19. External Instrumentation Sketch (Nominal Distances to Cameras and Instrumentation)

Figure 19 provides a similar plan view with distances to cameras and instrumentation. Figure 20 and Figure 21 provide elevation view details of the location of weld-pad TCs and DFTs. The additional Weld-Pad TCs that are shown schematically in Figure 18 were installed approximately 17 in. below and 24 in. above the centerline positions shown in Figure 20. These dimensions are not shown on Figure 20 for clarity of viewing.

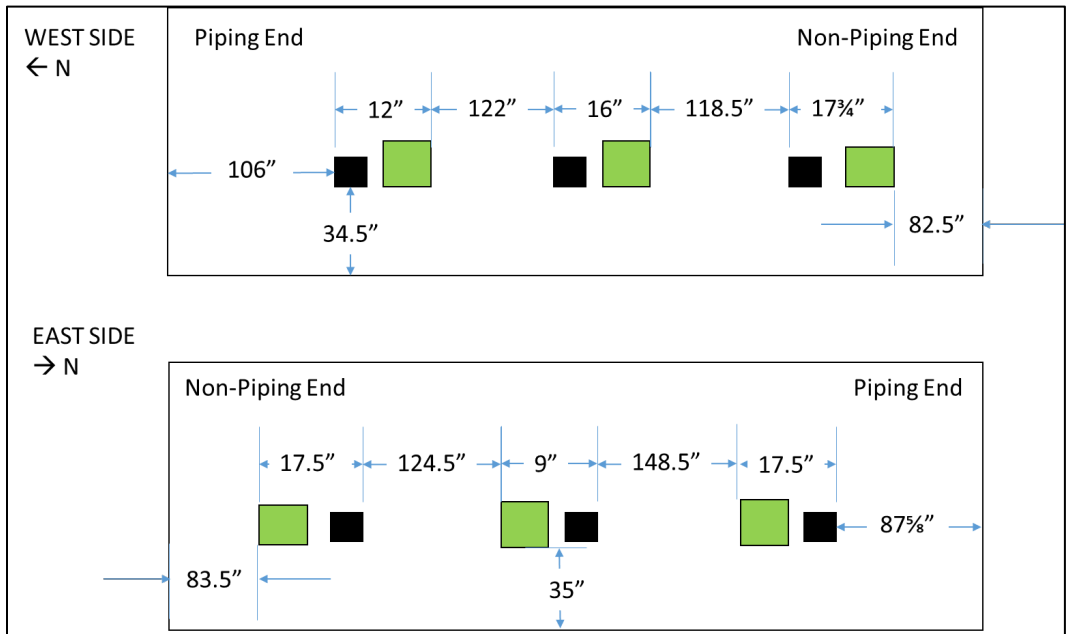
Figure 20. Centerline Weld-Pad TCs (black squares) and DFT Locations (green squares) – Elevation View from the East and West

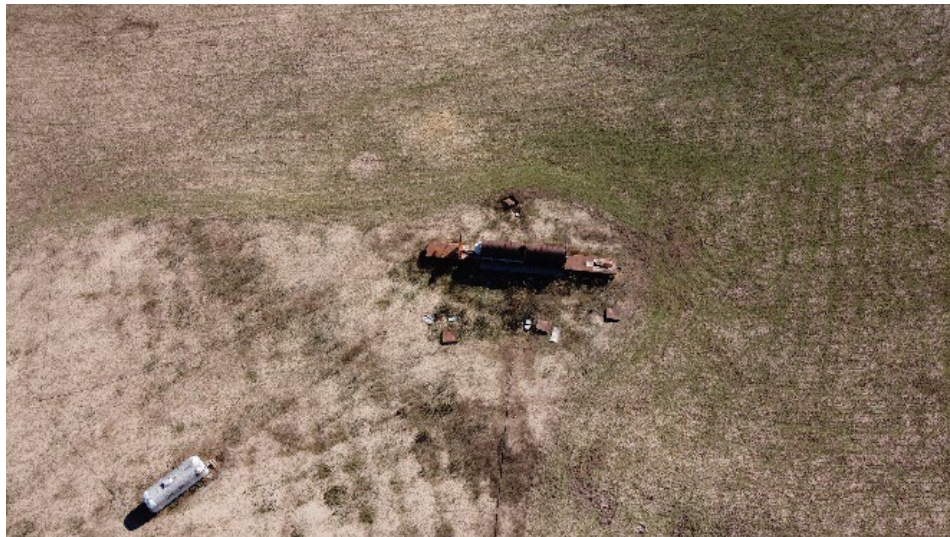
Figure 22. Drone Footage Still Shot of Test Tank and DAQ Location

The team opted to incorporate drone video footage into Phase 2. The team used multiple drones and battery packs so that a second drone could be deployed immediately after the return of the first drone to ensure more continuous footage. After the drone returned to base, the battery was replaced, memory card checked for available space, and the drone prepared to re-deploy when necessary. [Figure 22](#) shows a still shot from one of the drones during checkout tests of the test tank installed at the remote test location.

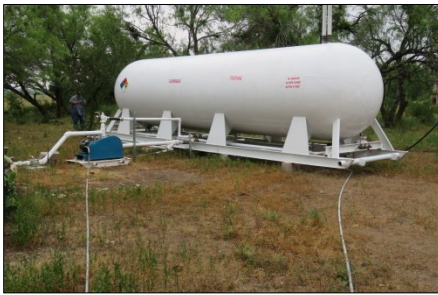
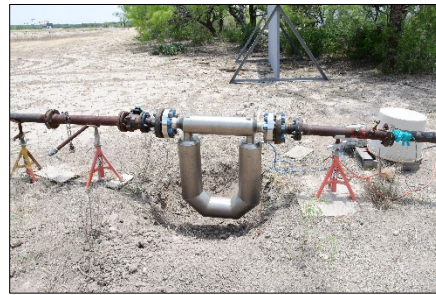
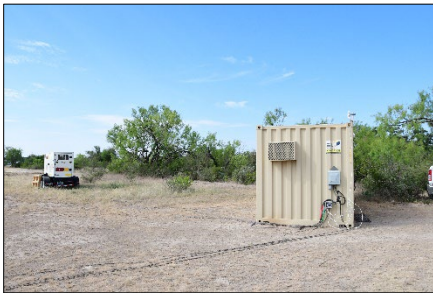
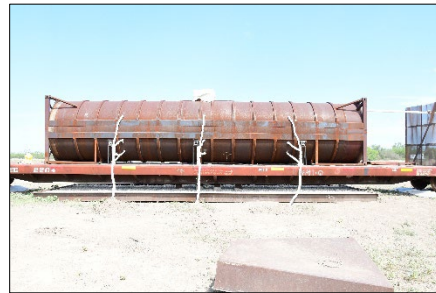
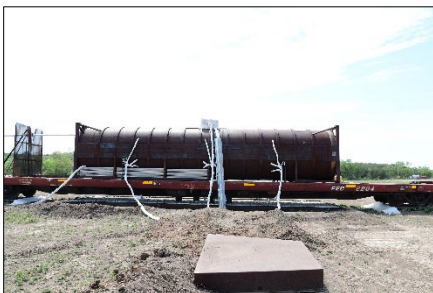
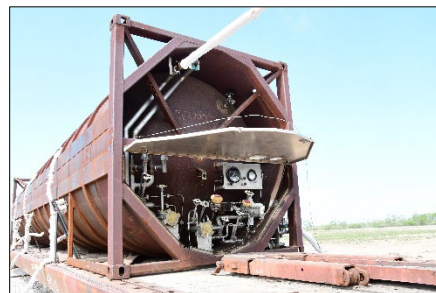
Figure 23. Selected Setup and Pre-Test Photographs

[Figure 23](#) – [Figure 25](#) show the test setup and pre- and post-test condition of the tank.

LPG Supply Tank, Pump and Bypass

PG Flow Meter

ISO Tank (east side)

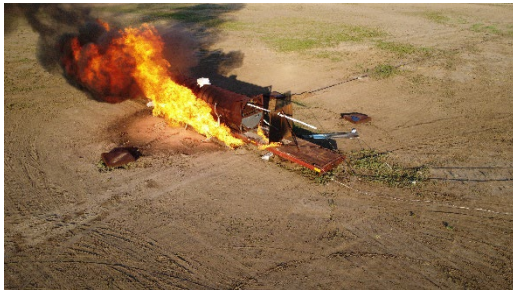
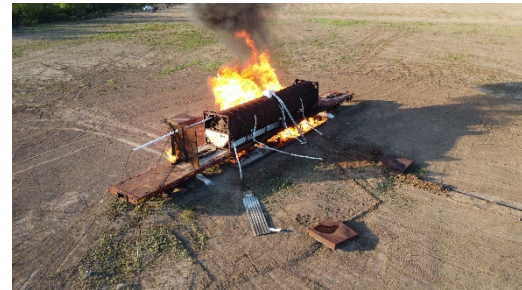
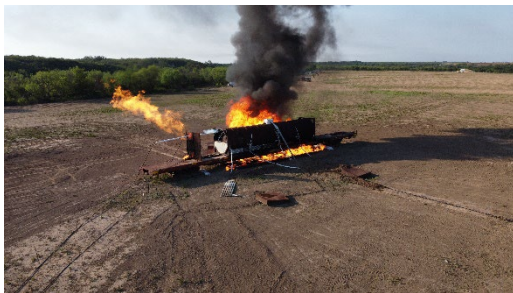
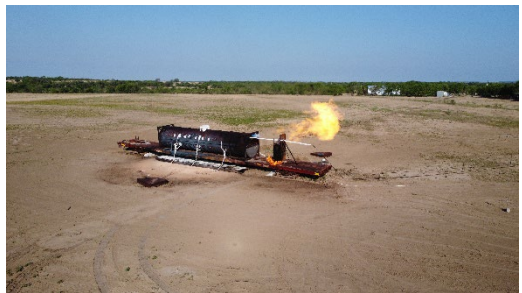
Figure 24. Selected Testing Photographs

Test in Progress (view from east side)

Test in Progress (view from west side)

Test in Progress (PRV operating)

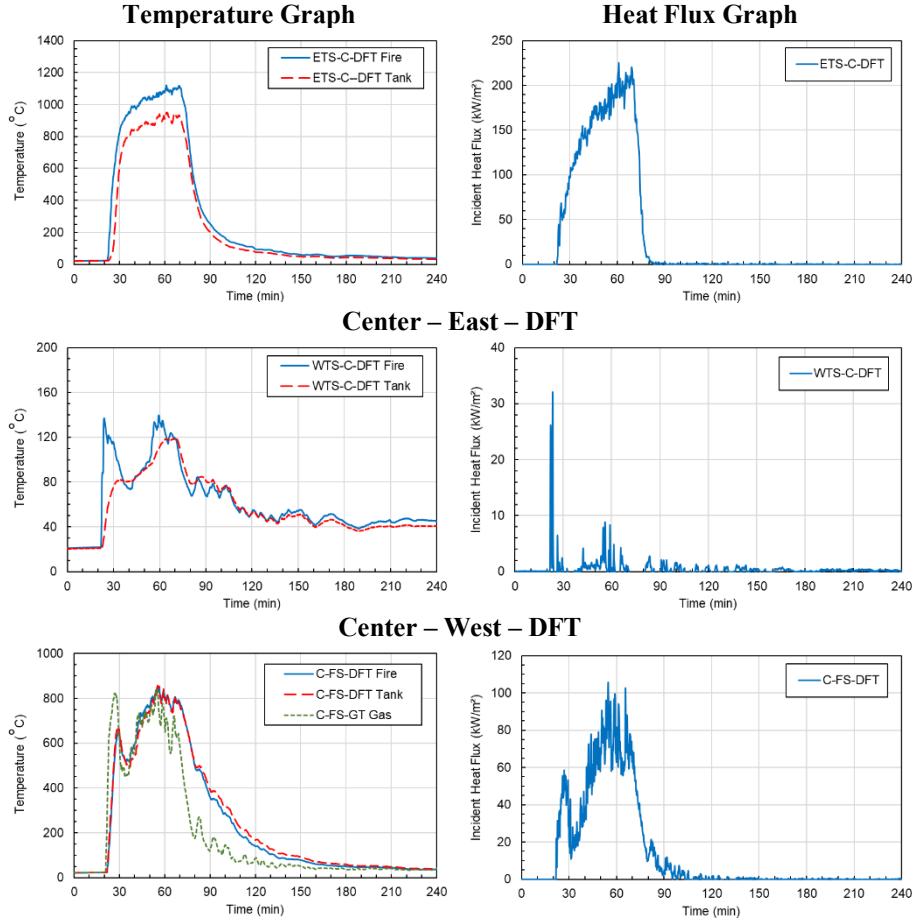
Figure 26. Selected DFT Heat Flux Data

As seen in Figure 26, the fire exposure to the tank was not uniform likely due to wind conditions. This resulted in a more severe exposure on the east side of the tank compared to the west side. The peak incident heat flux to the east side of the tank was 225.2 kW/m² and the peak incident heat flux to the west side of the tank was 32.1 kW/m². The peak incident heat flux from the fire source to the bottom of the flatcar was 105.7 kW/m².

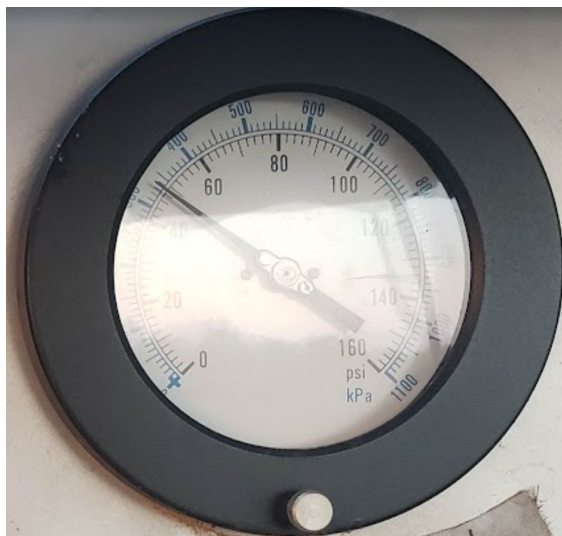
Figure 35. Pressure Gauge on Tank Indicating ~49 psig (337,843 Pa gage) 1 h Prior to Test

The pressure sensor was positioned in a box in the ground approximately 3 m (10 ft) below the tank's standard pressure gauge (Figure 35). This equates to an increase in pressure (based on $P = \rho \cdot g \cdot h$) of 12,449 Pa (1.8 psi) from the tank's pressure gauge and the in-ground pressure sensor and corresponds with the ~ 2 psi difference between the two readings (see Table 6).

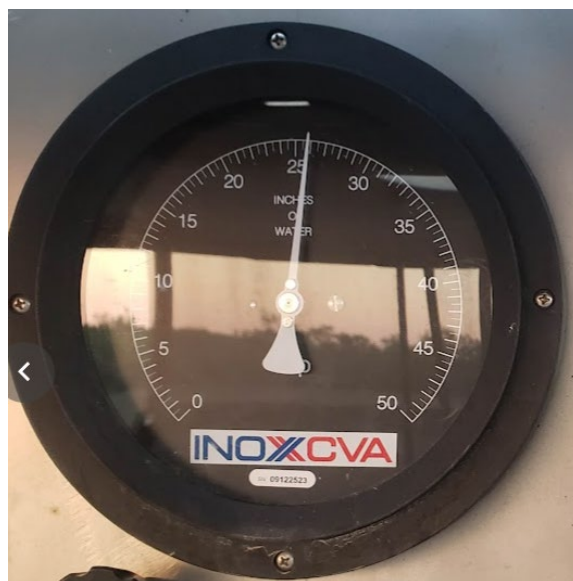
Figure 36. Liquid-level Gauge on Tank Indicating ~25.9" H₂O 1 H Prior to Test

The initial conditions of the tests are provided in Table 6. The tank was filled around 4:30 pm on June 28, 2022. The fill volume was measured via a gauge on the filling truck. The fill level was checked using the analog liquid level gauge on the tank approximately 1 hour prior to the test (Figure 36). A liquid level sensor (Rosemount 2051C Coplanar Pressure Transmitter; Emerson) was used to estimate the volume of fluid throughout the test. The conversion of ΔP to a volume quantity requires the use of a formula which was provided in the form of a lookup table by Taylor Wharton. This lookup table assumes a liquid density of 423 kg/m^3 .

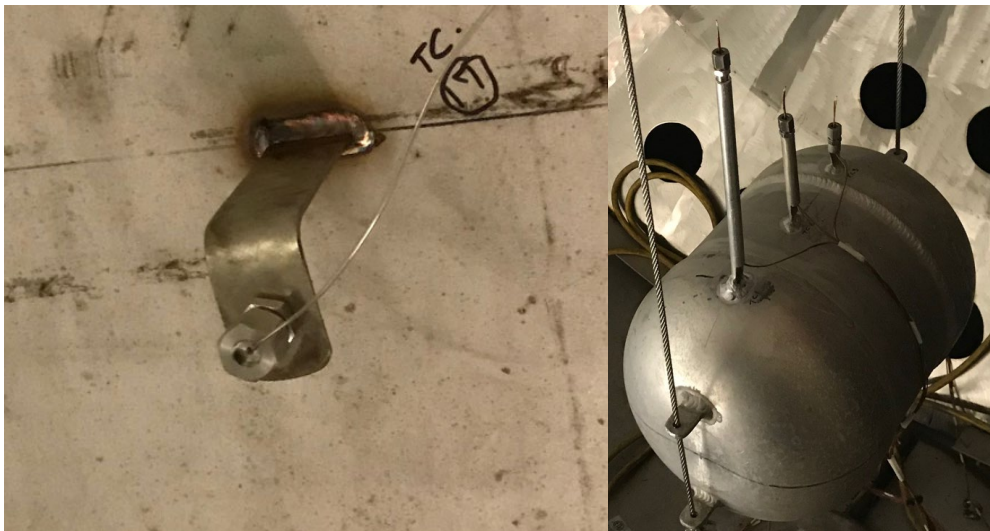
Figure 38. Vapor-space TCs; Tank-mounted (left), Float-mounted (right)

The float-mounted vapor-space TCs were designed to sit 6.5 to 14 in. above the surface of the liquid. At the start of the test the tank-mounted vapor-space thermocouples were located 50-127 mm (2-5 in.) above the surface of the liquid (at 74-78 percent fill).

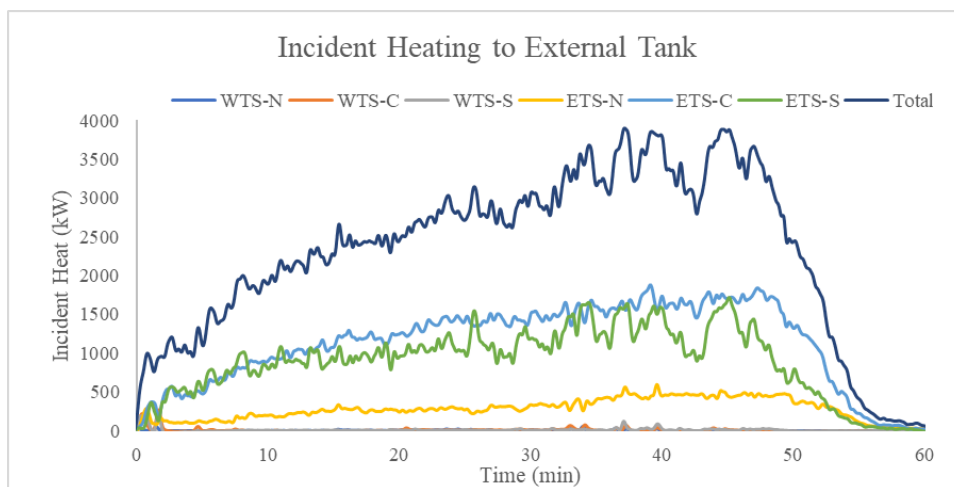
Figure 40. Incident Heating to External Tank During Fire Test

Based on the data and FDS simulations the total incident heat applied to the external tank progressively increased throughout the test and was calculated to peak at 3900 kW at 37.2 min and at 3885 kW at 44.7 min as shown in Figure 40.

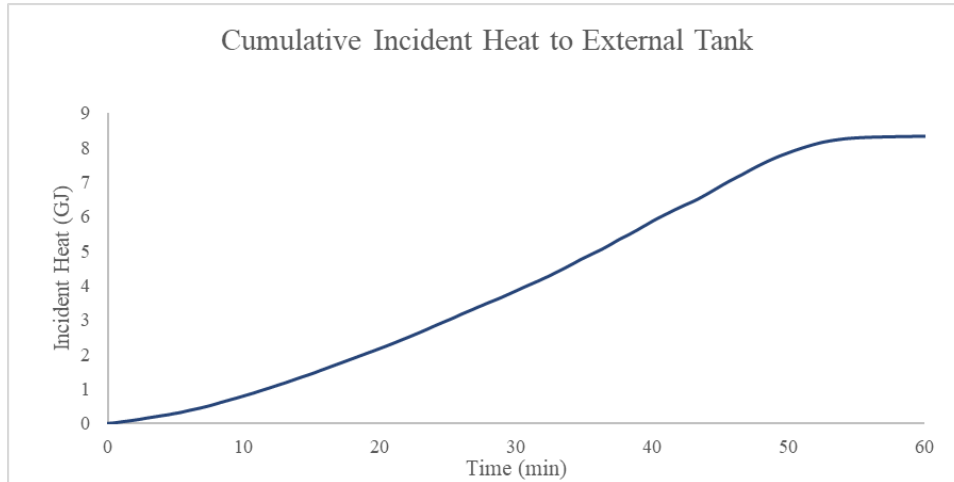
Figure 41. Cumulative Incident Heating to External Tank During Fire Test

The average incident heat during the last 10 minutes of active propane flow (t=38 min to t=48 min) was 3497 kW, while the average heating for the preceding 10 min was 10 percent lower at 3129 kW. The cumulative heat applied to the tank (Figure 41) was calculated to be 7.35 GJ during the 48 min of full propane flow and 8.29 GJ during the 56 min of the fire test.

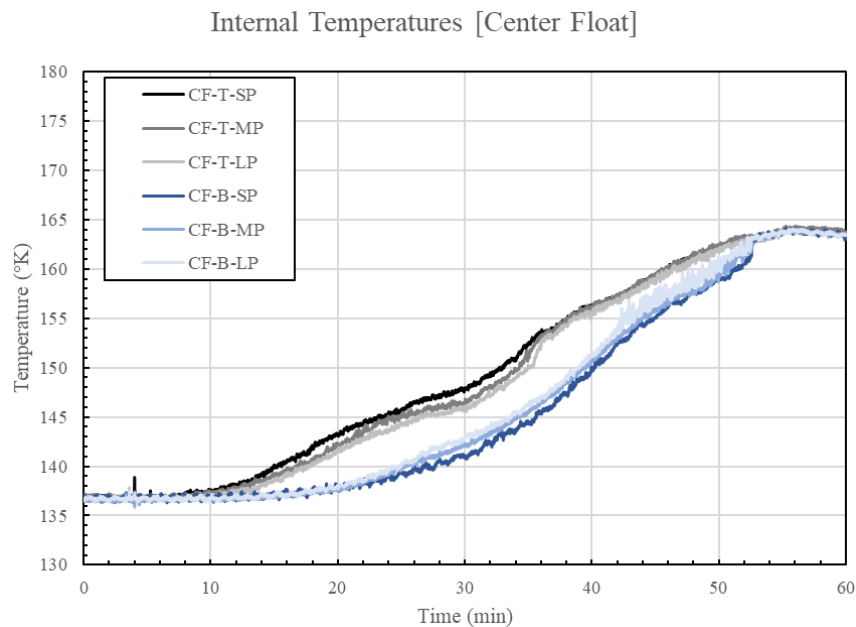
Figure 42. Center Float Thermocouples: “T” Denotes Gas Phase Region & “B” Denotes Liquid Phase Region

The internal tank temperatures were recorded with numerous TCs located within the nominal liquid and vapor space. The data recorded by these sensors are provided in Figure 42 through Figure 46.

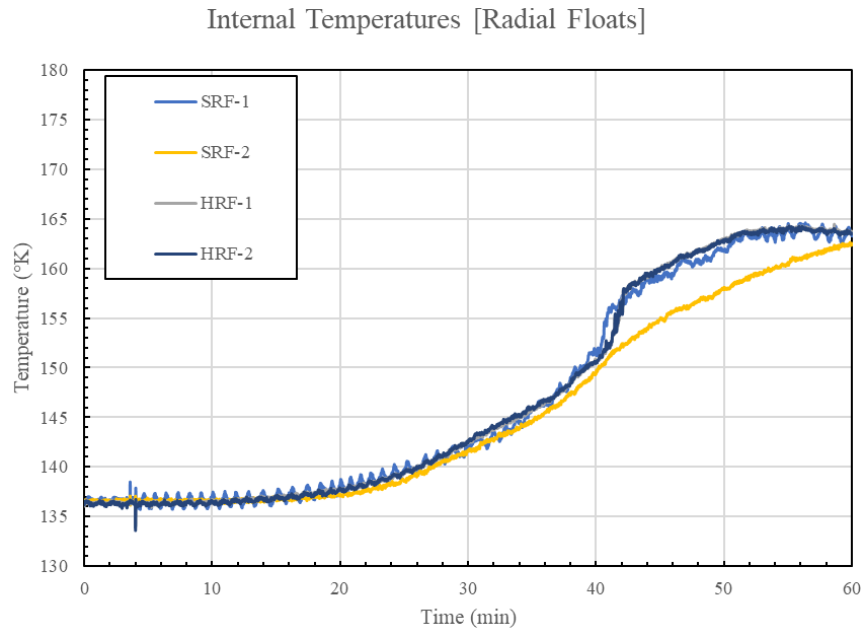
Figure 43. Radial Float Thermocouples: “SRF” Denotes Shell Radius & “HRF” Denotes Head Radius

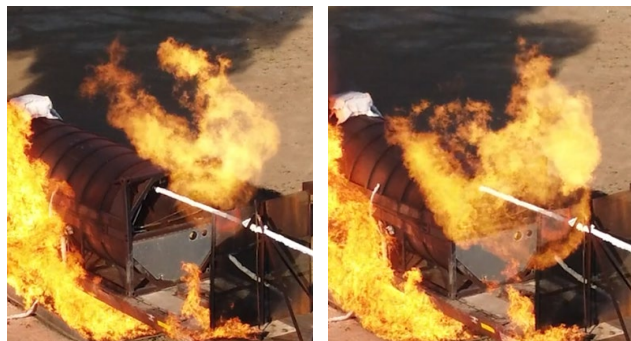
Figure 50. PRV Flame Comparison Prior to (left) and During (right) the Rapid Pressure Drop [~00:38:30]

A rapid decrease in pressure from 00:38:30-00:38:45 (~15 second duration) occurred at the same time and for the same duration that the PRD jet flame was observed to significantly increase in size (Figure 50). The cause of this response is unknown but may be due to the opening and re-closing of the second PRV.

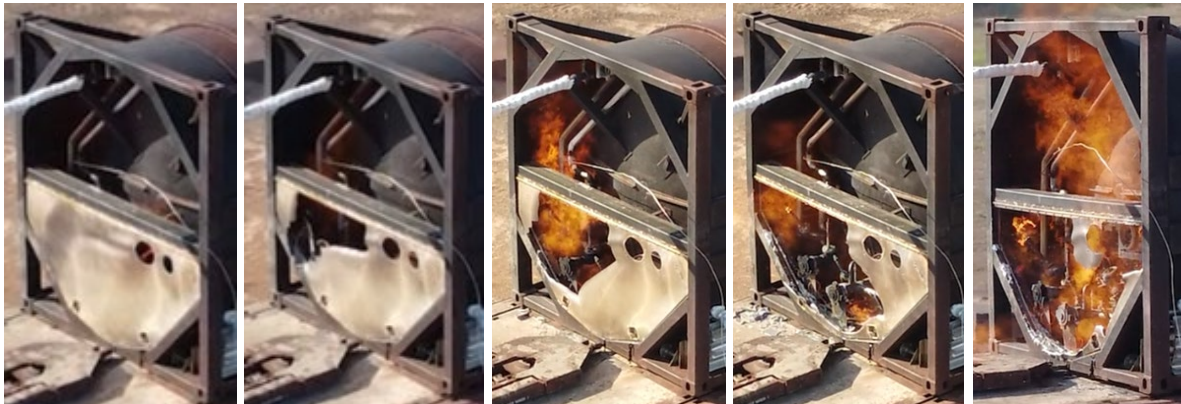
Figure 52. Progression of Piping Cabinet Door Failure over ~3 Min 50 s; Note the Increase in Fire Size as More of the Door is Melted [1:21:47 – 1:25:37]

A substantial pressure drop was noticeable approximately 87 min into the test (Figure 51). This occurred shortly after the piping end cabinet became fully engulfed in flames following the failure of the aluminum service panel (Figure 52).

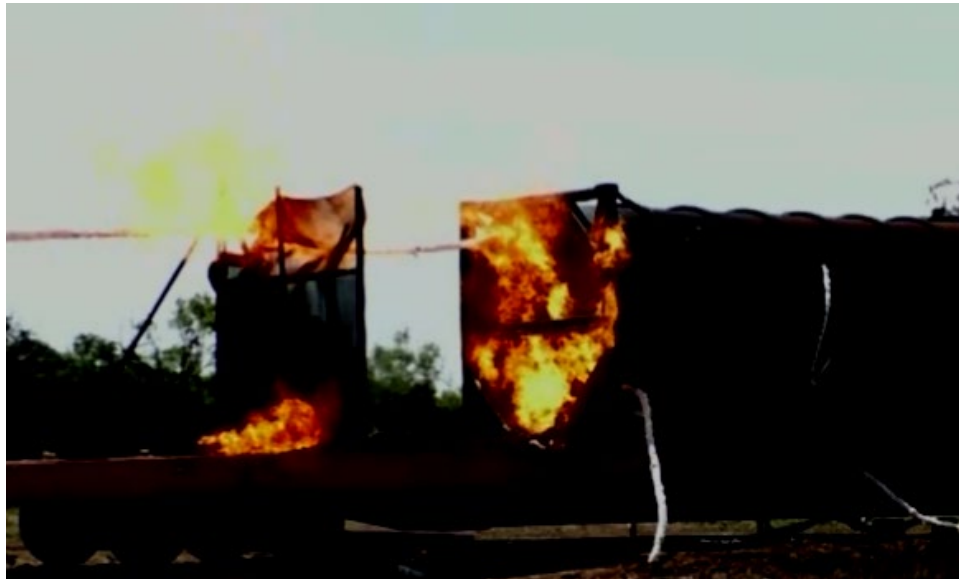
Figure 55. Typical Post-Test Piping Cabinet Fire Behavior [04:23:33]

The size of the PRV exhaust cloud and flame decreased significantly, but did not stop, after 90 min. This is coincident with the internal tank pressure dropping below the required PRV closing pressure (102.6 psig). One or both PRVs were most likely thermally damaged and unable to fully seal by this point even though the internal pressure had dropped below their designed closing pressure. The PRV exhaust and piping cabinet valve leaks continued to burn for the duration of the video (6 h) with behavior like that shown in [Figure 55](#).

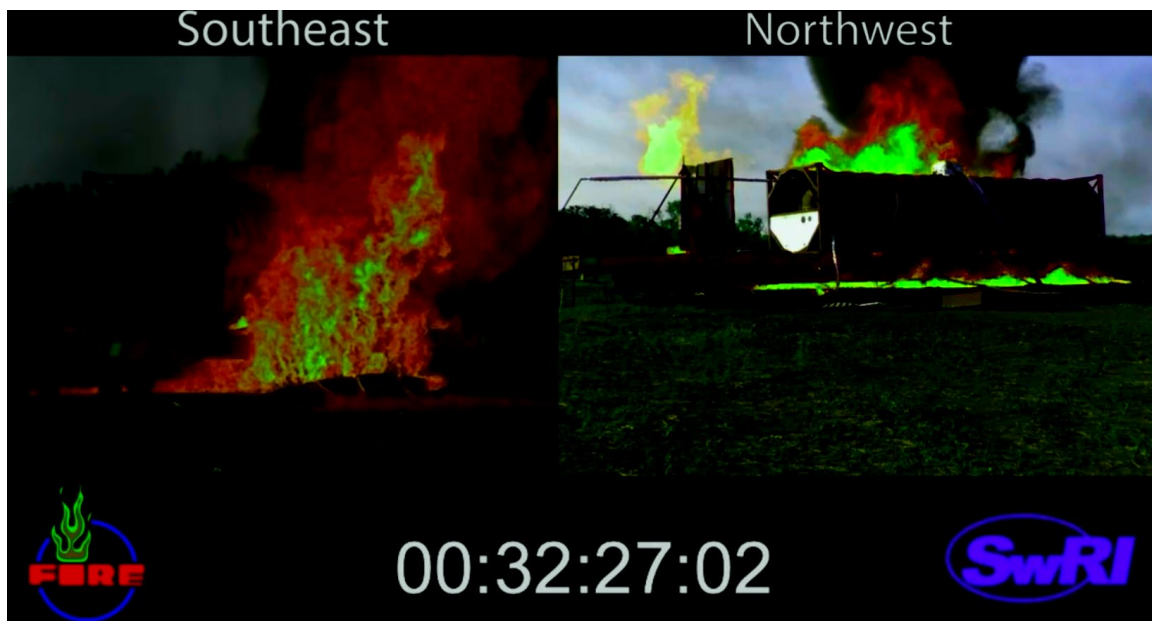
Figure 63. Jet Flame Geometry at Internal Tank Pressure of 114 psi (PRD setting)

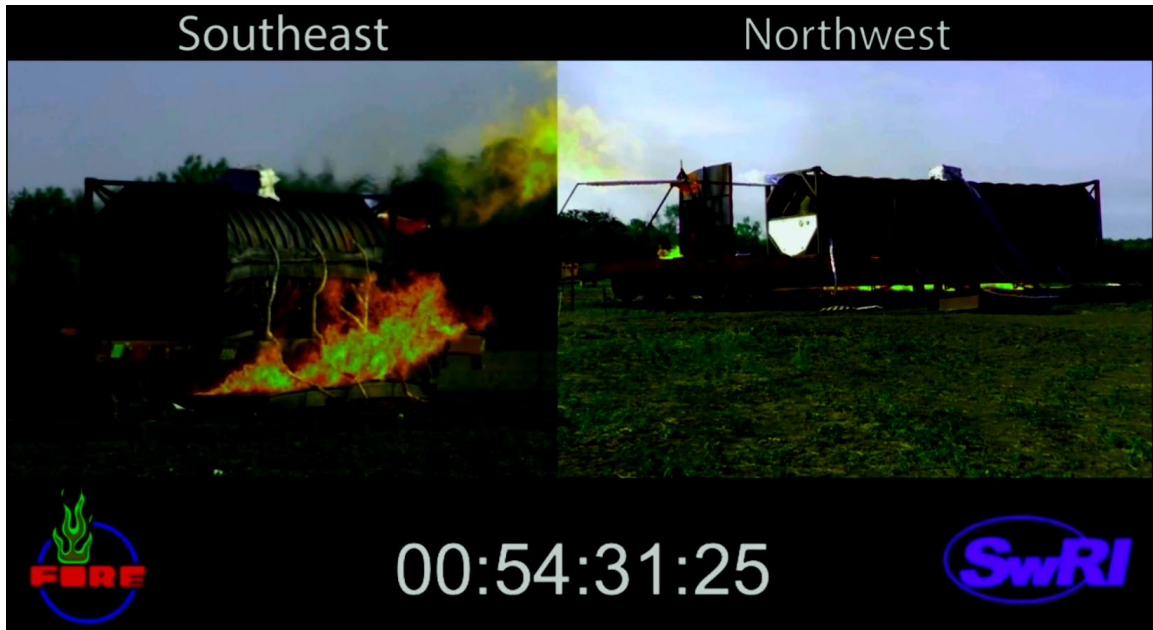
Figure 66. Jet Flame Geometry at Maximum Internal Tank Pressure (180 psig); Note how Horizontal the Jet is with Most of the Flame Off-Screen to the Left

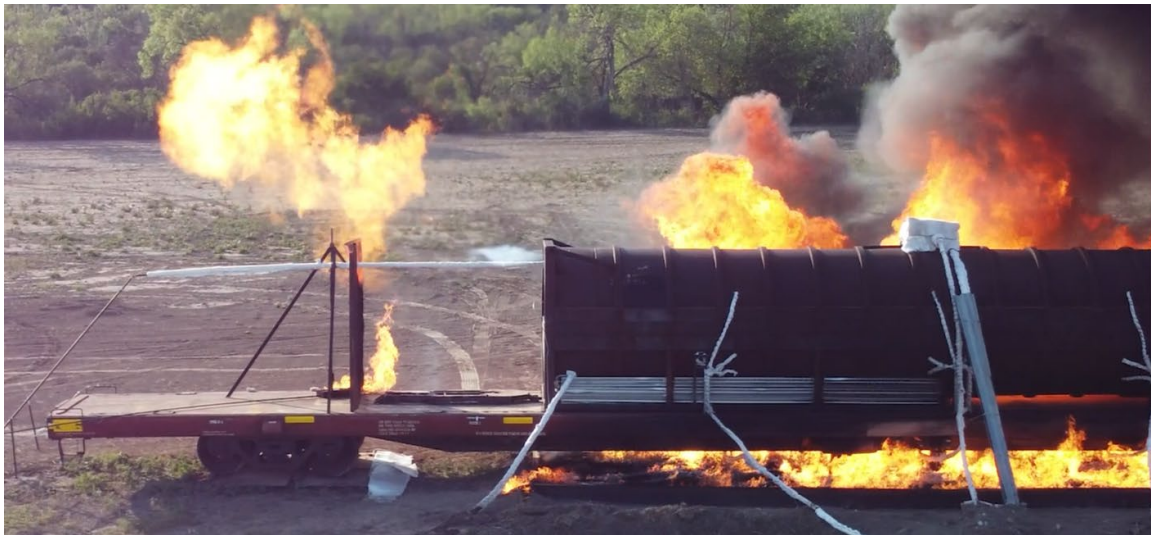
Figure 67. Jet Flame at Internal Tank Pressure of ~129 psig (view from drone) [~00:41:15]

The PRV exhaust ignited within 1 s of the valve opening. A mesh screen was positioned approximately 2 meters downstream of the exhaust to mitigate the chance of flashback. The screen also improved visualization of the flame and provided some obstruction to its motion. The “northwest” views in Figure 63, Figure 64, Figure 65, and Figure 66 show the difference in flame size based on the internal tank pressure. Greater tank pressure is clearly associated with greater PRV jet flame length in this scenario. Similar behavior can be observed from the drone-captured images in Figure 67, Figure 68, Figure 69.

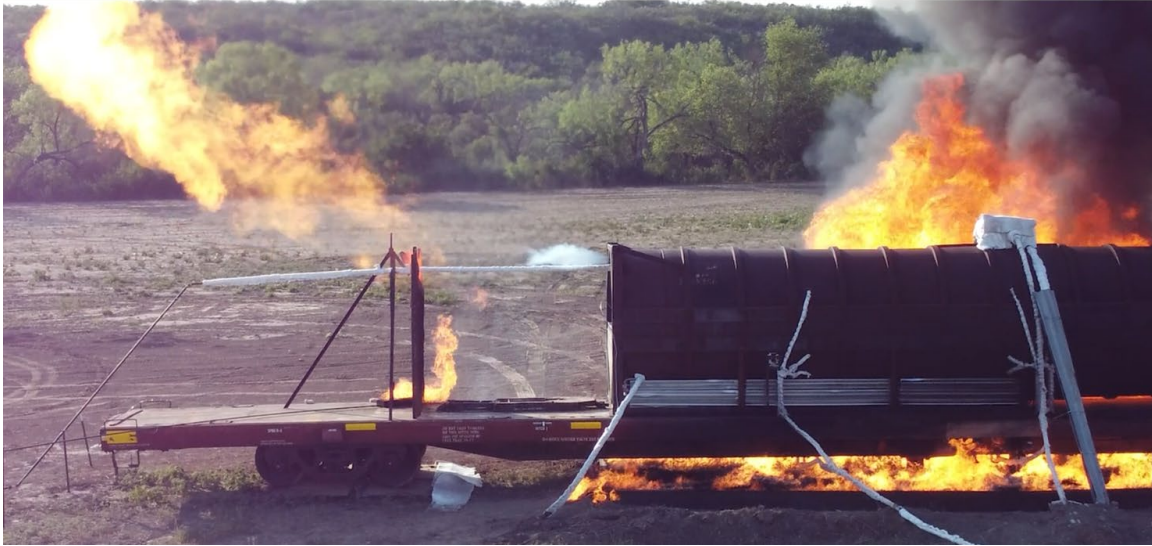
Figure 68. Jet Flame at Internal Tank Pressure of ~156 psig [00:46:52]

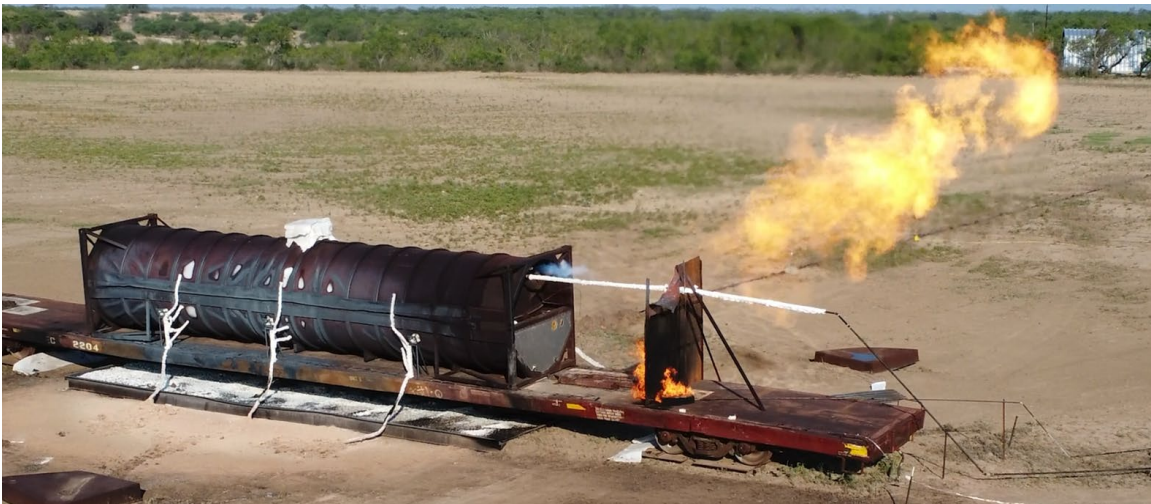
Figure 69. Jet flame at Internal Tank Pressure of ~180 psig [00:56:00]

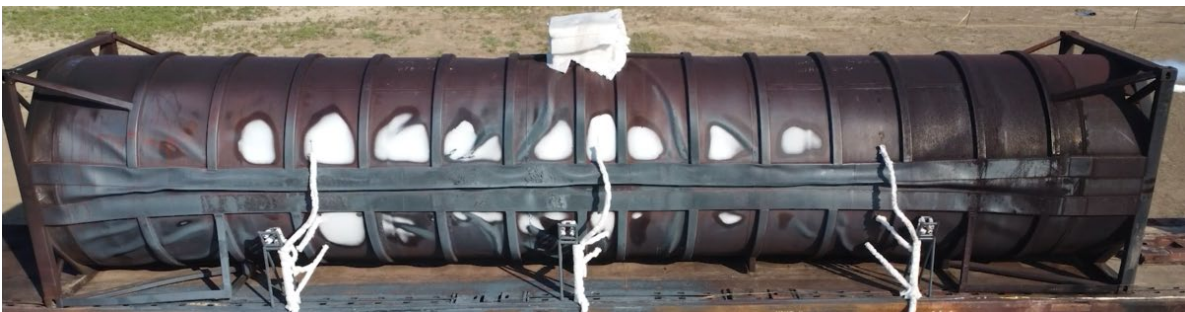
Figure 70. Frost on Deformed External Tank Jacket [1:07:24]

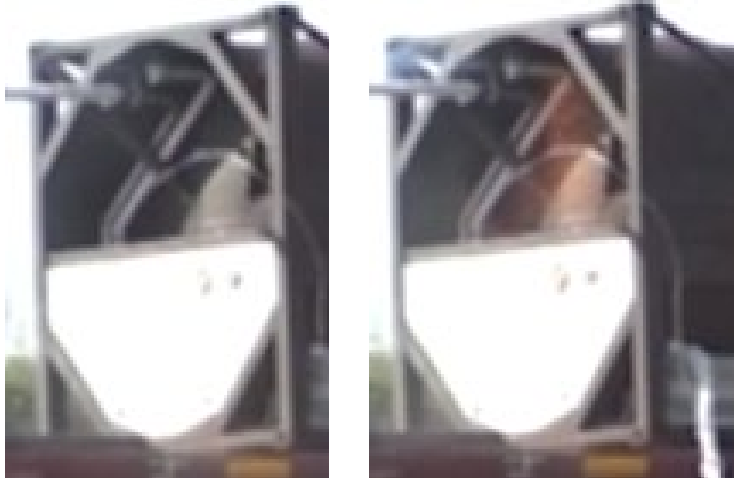
Figure 73. View of Piping Cabinet Prior to (left) and Subsequent to (right) the Ignition of Leaked Gas [~1:12:20]
