**EVALUATION OF CURB RAMP
COMPLIANCE: REVIEW OF TOOLS,
METHODS, AND TIME TO DEVELOP
ERROR TOLERANCES**

Final Report

SPR 844

Oregon Department of Transportation

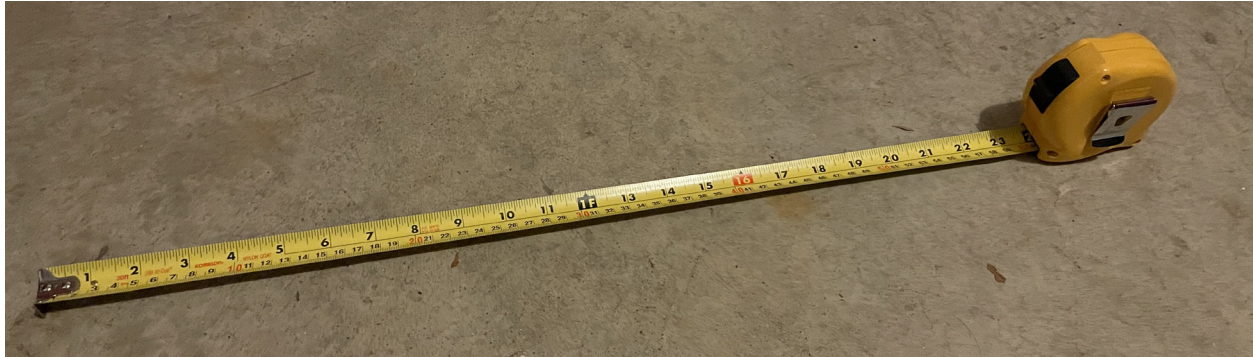
Figure 2.1: Basic measuring tape.

Measuring tapes (Figure 2.1) are the most common tools to measure distances because they are small and easy to use. The measurements can usually be obtained with a precision of 1/16 in or 2 mm. NIST tolerances for metal tapes are 1/32 in (1 mm) for a 6 ft (1.8 m) or less measuring tape. This precision is ordinarily sufficient for accessing the ADA compliance of a curb ramp in terms of dimension. There are several factors that could result in errors in dimensional measurement; however, given the 6 in (15 cm) tolerance in design (Table 2-2), most of these errors (with the

exception of gross blunders) will be minimal. Some factors relate to user operation, such as not placing the tape directly on the surface and introducing sag, measuring from incorrect locations, and misalignment resulting in measurements obtained at a slight angle across the surface. These operating errors will typically result in larger reported values than the actual dimension. If the tape has been stretched with repeated usage or the metal hook is loose, the reported measurements will be smaller than the actual measurement.

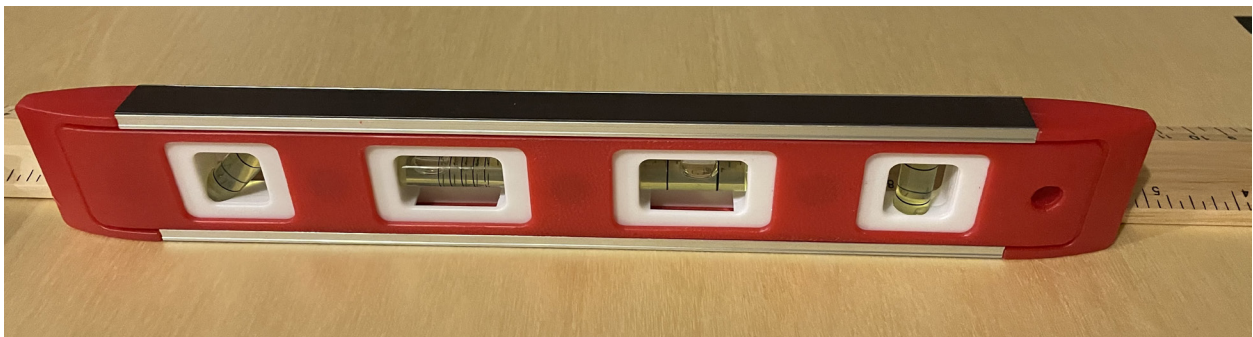
Figure 2.2: Basic carpenter’s level

Carpenter’s levels (Figure 2.2) are used to check level and plumb (some also have 45-degree inclination) in construction. They usually come with one or more physical level bubbles. To determine the slope of a curb ramp, they need to be used in combination with measuring tapes. However, this way of determining a slope can be highly error prone. Further the gradations on the level bubbles are often at very coarse intervals, resulting in poor precision in measurements.

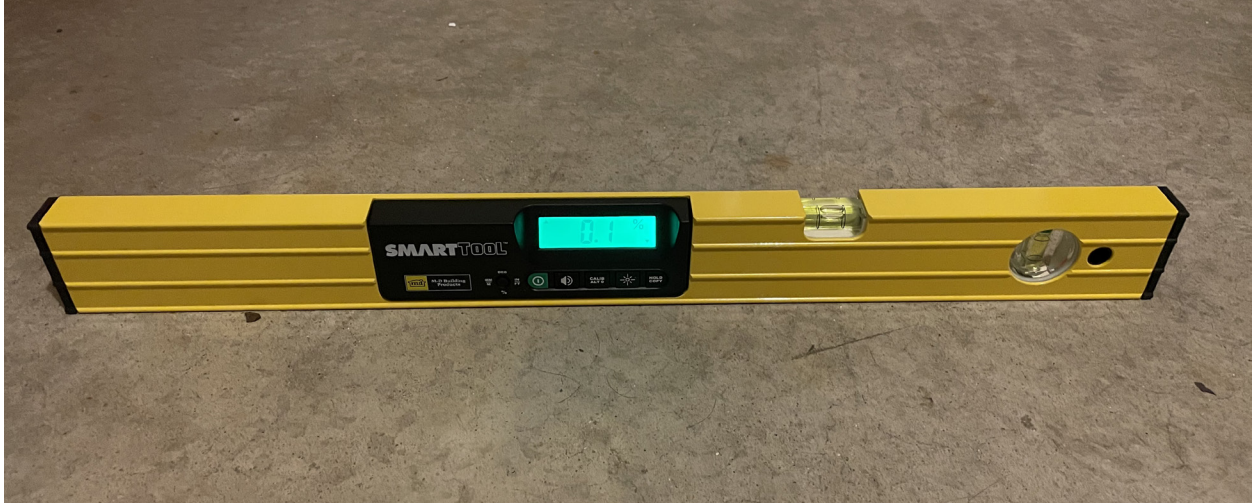
Figure 2.3: Example SmartTool[®] digital inclinometer (2-ft or 60-cm length).

when the device is level/plumb and 0.2° when oriented at other angles. SmartTool[®] produces several models of smart levels as well as in several different lengths (e.g., 1, 2, and 4 ft, or 30, 60, 120 cm). All of the models, including Gen2 and Gen3, have the same sensor design and share the same accuracy. The “slope walker” model (Figure 2.4) is essentially a 1-ft (30-cm) smart level with a stand and handle to simplify the field effort as well as ensure the instrument is not placed on debris that could bias the readings.

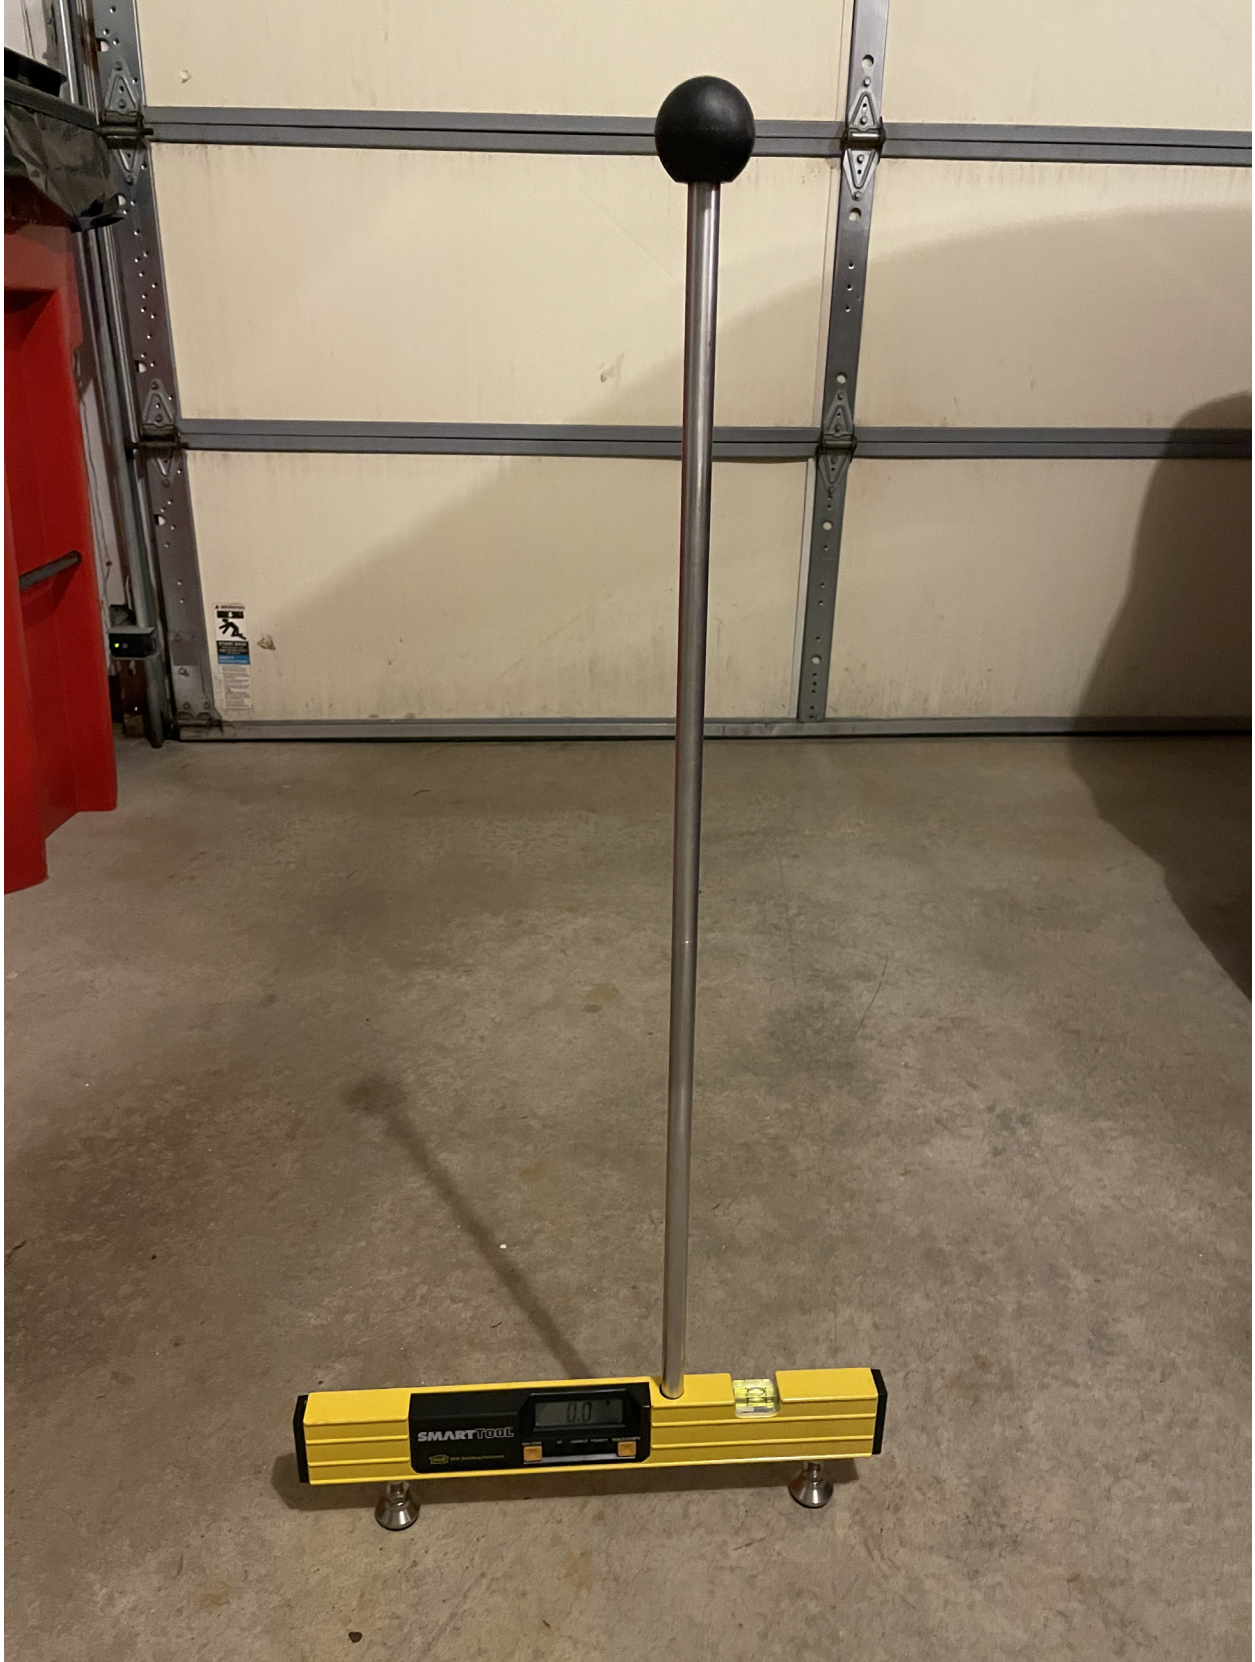
Figure 2.4: Slope walker digital inclinometer with handle.

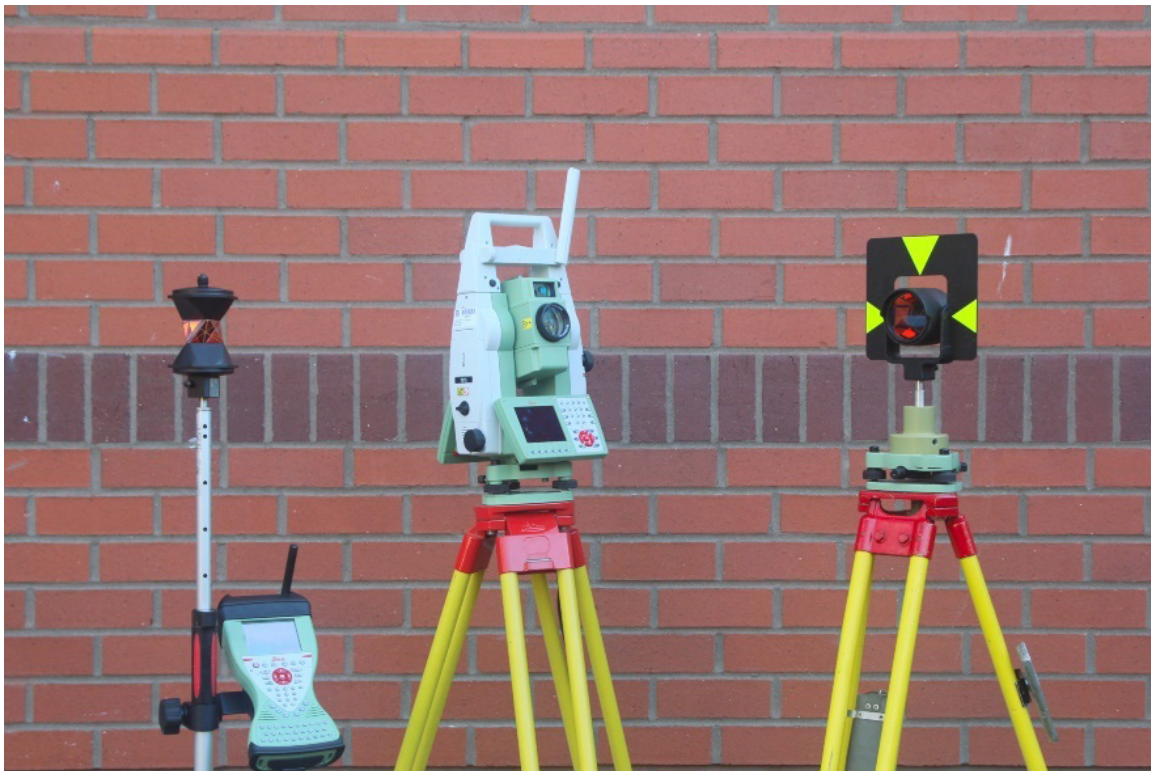
Figure 2.5: Total station, remote controller, and prism.

There are several limitations in using the device routinely for compliance checks. First, a total station typically costs (\$5,000 - \$30,000) depending on the desired precision and features. Second, operating a total station requires a lot of training and experience. Third, setting up the instrument, including leveling, can be time-consuming. Fourth, it is somewhat heavy to carry from one setup location to another. Although it is not applicable for assessment on a regular basis, it is very suitable for controlled testing to obtain high accuracy baseline data. It could also be used in a more detailed investigation by a more experienced crew as a second check on the readings of a coarser smart level measurements when the curb ramp is on the border of passing and failing.

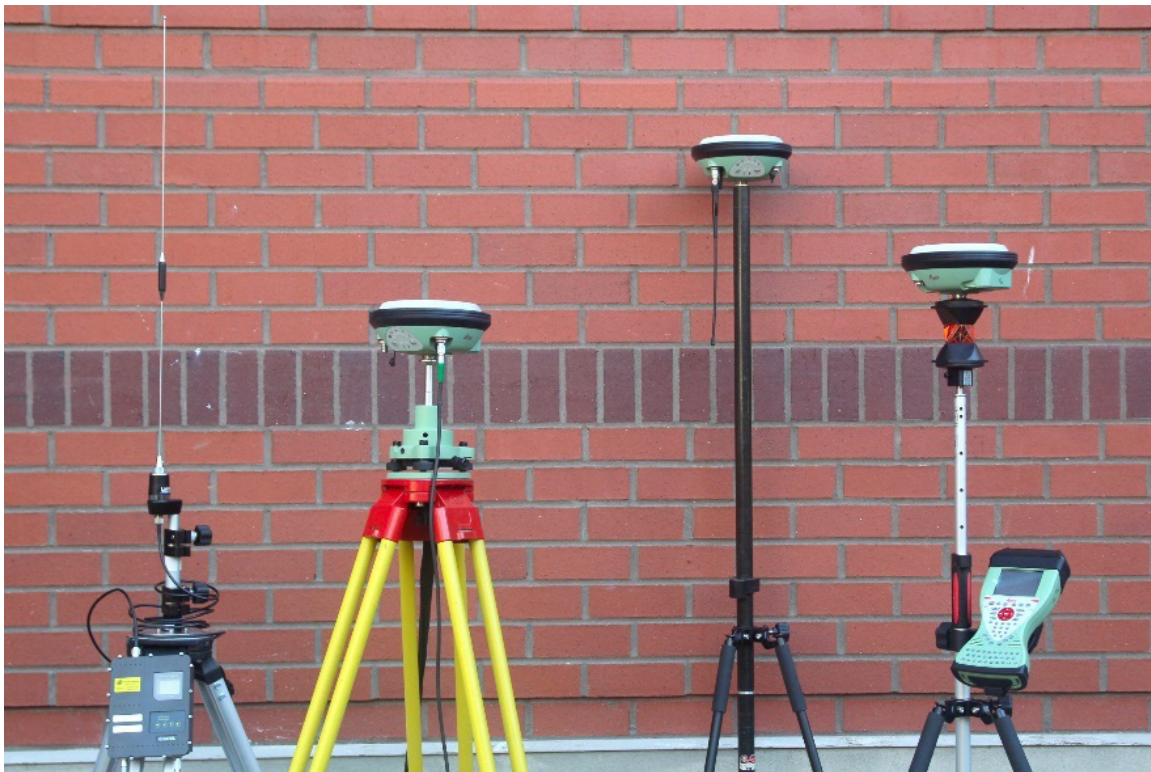
Figure 2.6: GNSS receivers mounted in different configurations.

GNSS (Figure 2.6) is available in a range of devices from common mobile devices to survey grade GNSS receivers. GNSS can be used to determine the 3D global location of a point of interest. Depending on the GNSS unit, observation time, and the satellite visibility at a curb ramp, the accuracy of a measurement can be from the millimeter to meter level. In principle, GNSS can be used to determine the geometry of a curb ramp directly by observing a number of key points. Realistically, a GNSS measurement can achieve 3D accuracies of a few inches or centimeters if there is good satellite visibility during the survey. The error in the vertical is usually 2 – 3 times higher than the error in the horizontal. As a result, these larger vertical errors can significantly affect the ADA-compliance assessment, particularly for slope measurements. Nevertheless, although GNSS is not currently suitable to accurately measure slopes accurately over a small area (e.g., few feet or meters), GNSS can still be useful to georeference other local survey approaches and techniques. This geolocation is crucial for developing a usable sidewalk or curb ramp inventory database.

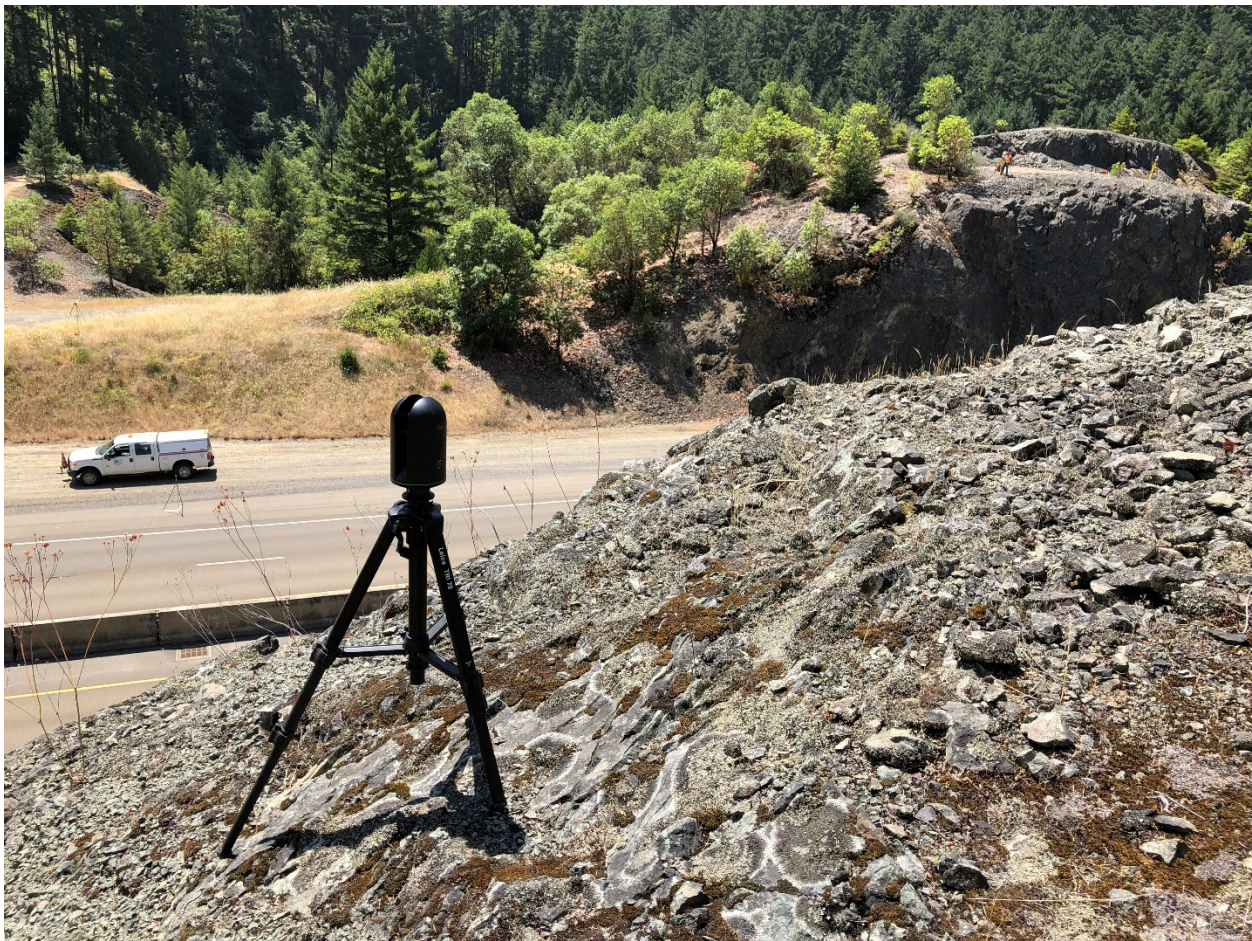
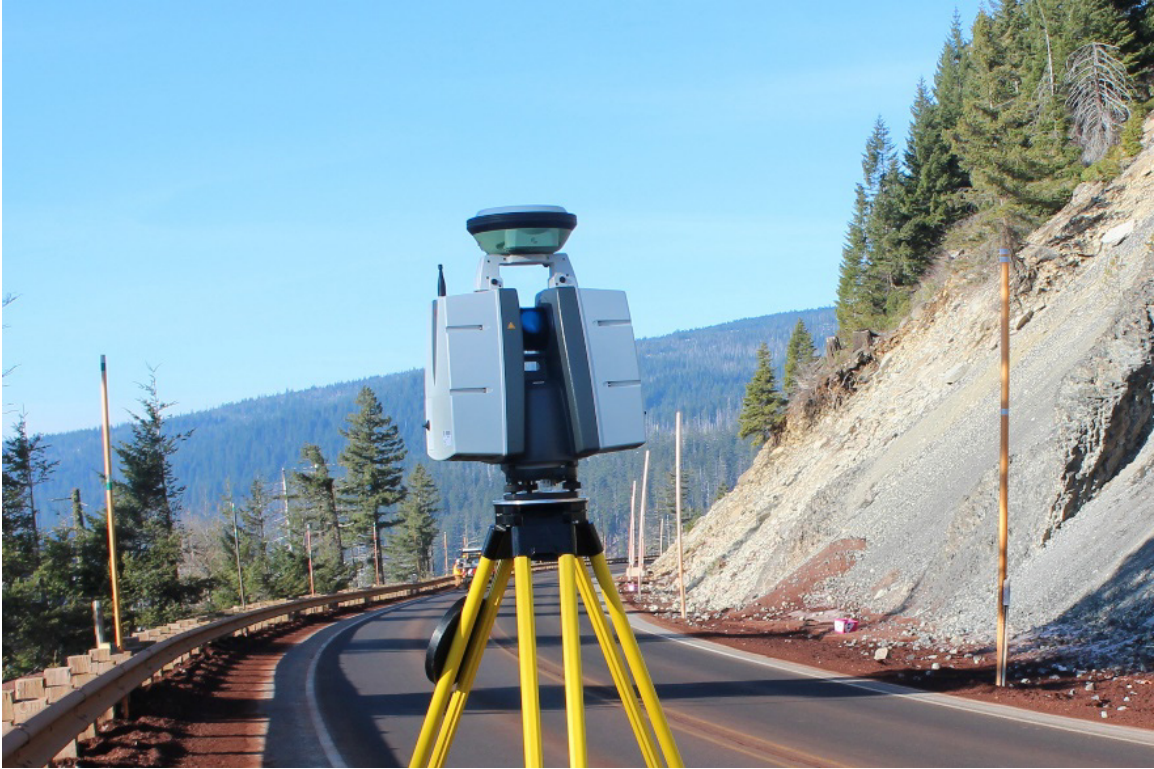
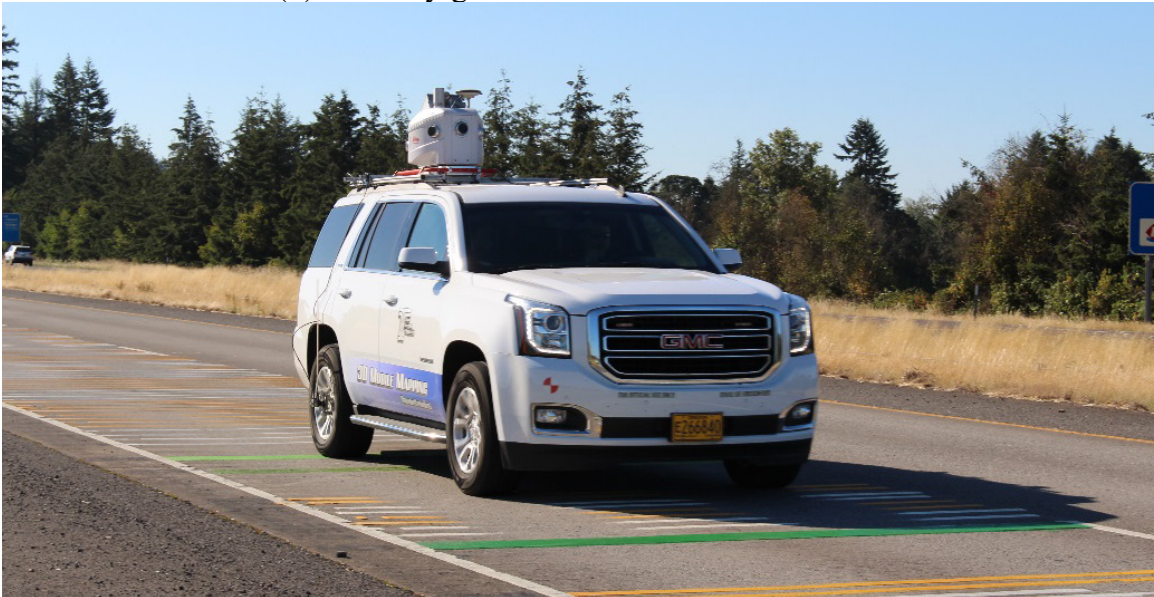
(a) a small, lightweight Leica BLK 360

(b) A survey-grade Leica ScanStation P40 scanner

(c) Leica Pegasus:Two mobile laser scanner

Figure 2.7: Examples of different platforms for laser scanners.

various applications in transportation (Olsen et al. 2013) and can potentially be used for inventory and assessment of curb ramps. Not only can a laser scanner capture a curb ramp with thousands of measurements, but it also provides context of the surroundings, which can support more advanced and comprehensive analyses of a site without requiring repeat visits or extensive manual measurements in the field. Another key value to laser scanning is that measurements can be systematically extracted and visualized in context of the entire ramp. In the field, determining the precise center of the ramp to obtain measurements can be difficult. With a point cloud, the center can be located more precisely. The redundancy of measurements also improves the accuracy and precision of the resulting measurements. Nevertheless, the technology has not yet been proven fully for ADA compliance. There are some promising studies that have investigated the effectiveness of laser scanning to assess the ADA compliance of curb ramps that will be summarized in this section.

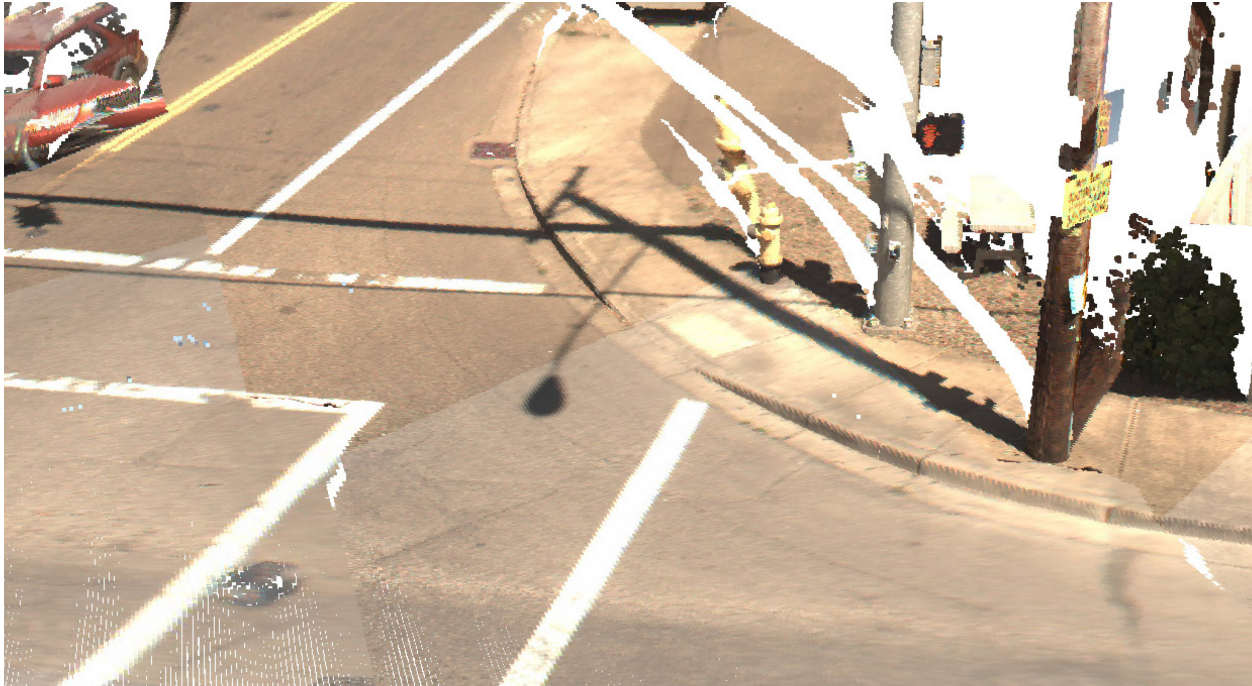
Figure 2.8: Example of pointcloud data at a curb ramp collected by Leica Pegasus: Two mobile lidar system.

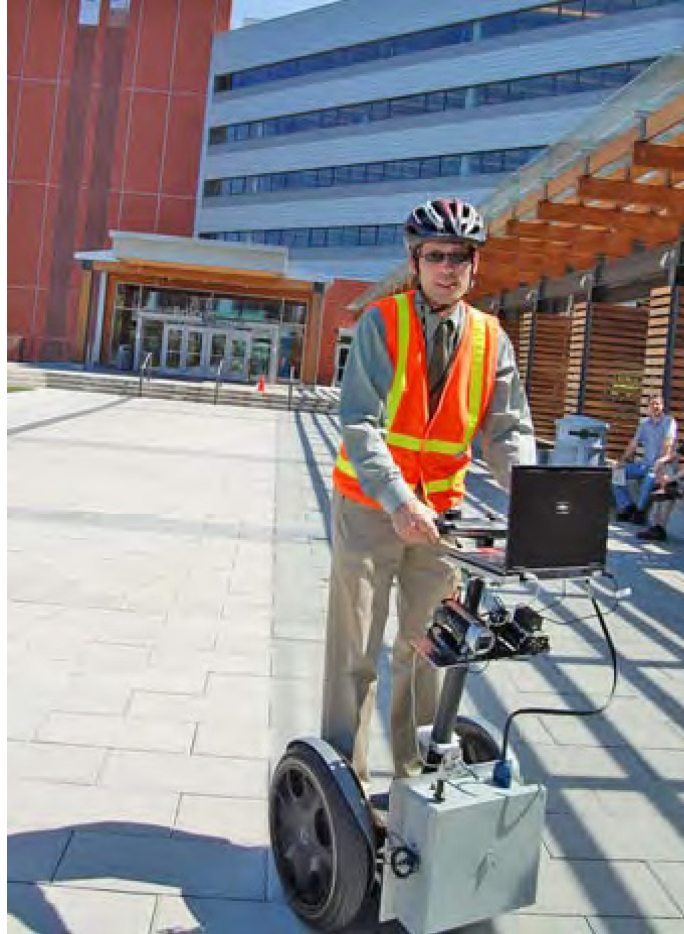
(a) ULIP- Ultra Light Inertial Profiler for sidewalk evaluation (Photograph from <https://www.corada.com/products/starodub-inc-ultra-light-inertial-profiler-ulip-for-sidewalks>)

Some systems are built on a mobile platform (Figure 2.9) to measure the longitudinal slope, cross slope, flatness, and other characteristics for assessing the ADA compliance of primarily sidewalks. By building the sensors on a mobile platform, it makes it possible to cover the sidewalk across a large area efficiently with high resolution. For example, the Ultra-Light Inertial Profiler Sidewalks (ULIPs) device developed by Starodub, Inc. was used for the sidewalk inventory in Bellevue, WA. A comprehensive test of this system has been conducted and reported including distance measuring instrument (DMI) calibration, grade and cross slope validation, grade and cross slope averaging window size, rider stability. The test results were compared against digital inclinometer (smart level) readings and show that the accuracy of the system is adequate for assessing sidewalks. However, the tests at the curb ramps show significant discrepancies. One of the possible reasons for this is that at a curb ramp, there is more variation in terms of the surface characteristics comparing against the sidewalks, and the system is averaging measurement with a given interval to reduce noise in the raw measurements. There are also other similar systems such as the SSI CS8900 ADA Access Profiler, which can acquire surface characteristics including running slope, cross slope, evenness/roughness, and ride index.

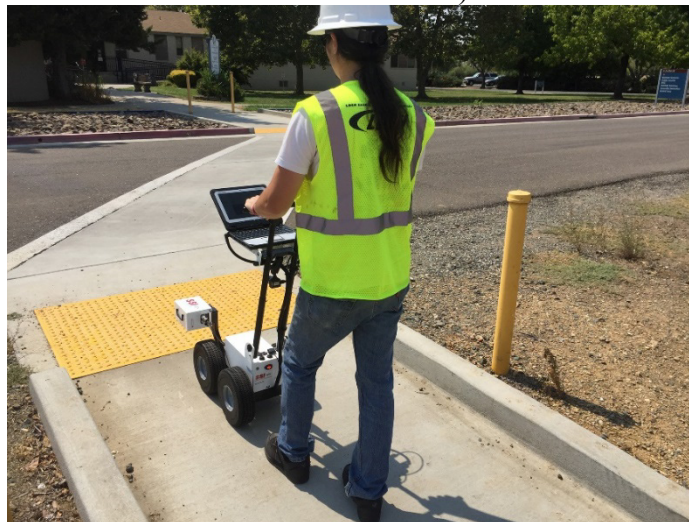
Figure 2.9: Examples of surface profiler systems.

(b) SSI CS8900 ADA Access Profiler from <https://www.smoothroad.com/cs8900-ada-access-profiler>

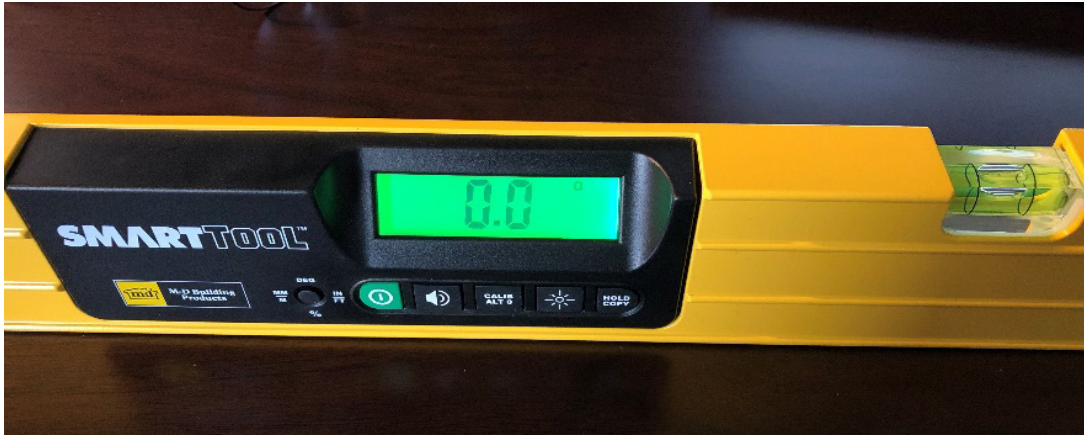
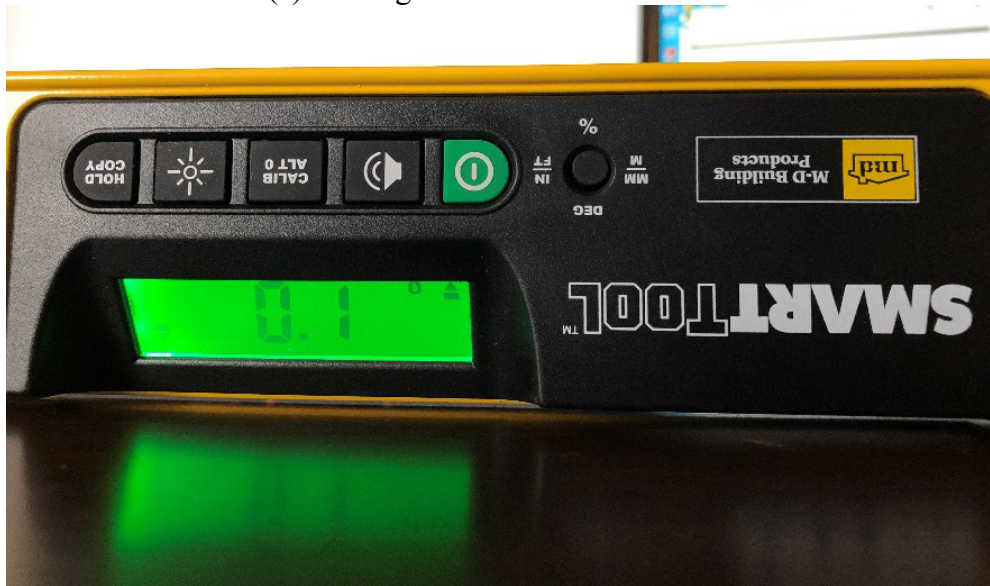
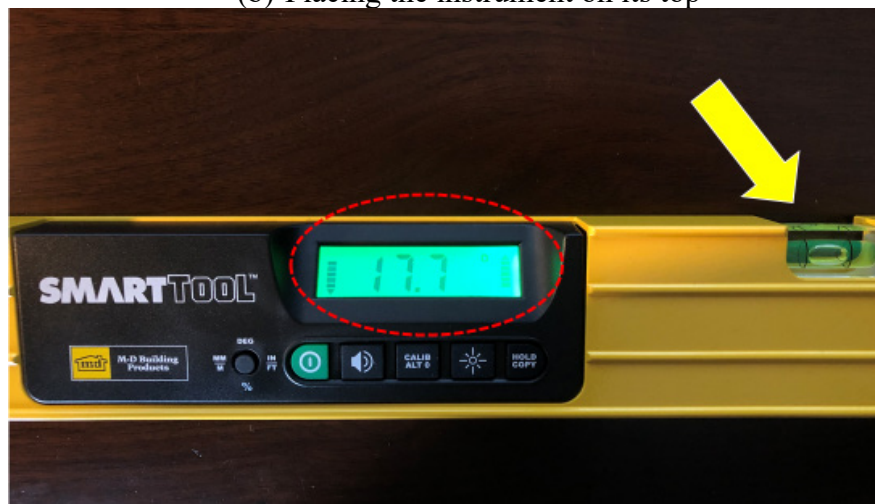
Figure 3.1: Valid measurements can be acquired by placing the smart level on its bottom and top while placing it on its back provides invalid readings.

The smart level device is also sensitive to the orientation at which it is placed on the surface. It should be operated by attaching its top or bottom side to the surface to be measured. Although it is convenient to place it on its back for readability, this orientation results in invalid readings. Figure 3.1 shows examples of measurements taken on the top, bottom, and back. When placed on its back, the device displays an invalid measurement, despite the physical bubble indicating that it is level.

(a) Placing the instrument on its bottom

(b) Placing the instrument on its top

(c) Placing the instrument on its back

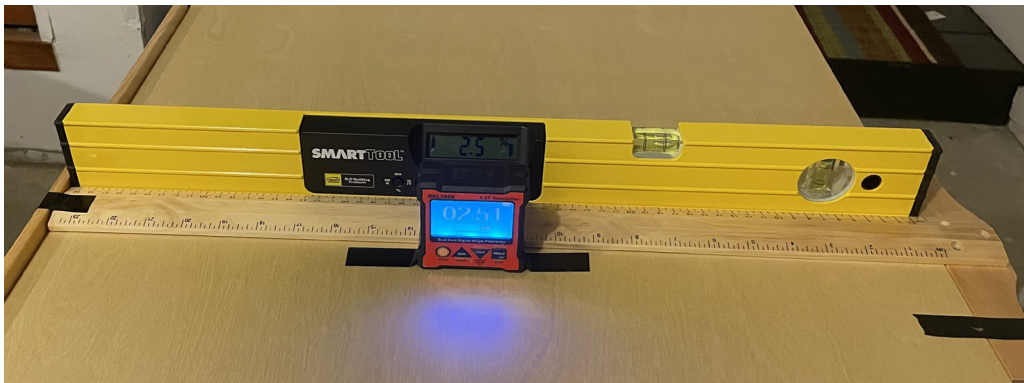
Figure 3.3: Example setup with a smart level and smaller digital inclinometer.

Based on the summary provided in the literature review, it can be seen the measuring scale and sampling interval are critical in defining a metric that can reliably evaluate the flatness, smoothness, and roughness of a surface. To measure the slope on a curb ramp, a digital inclinometer or smart level is commonly used. Because the smart levels have different size options (e.g., 1 ft, 2 ft, 4 ft, or 30 cm, 60 cm, 120 cm), the slope is actually measured from different scales. This can cause some discrepancies in slope measurement where a shorter smart level can capture more detailed information (e.g., roughness) of a slope whereas the longer one can yield a more representative slope measurement. For example, in a test conducted by the research team, a 2-ft (60-cm) smart level was placed on a board which is visually flat, meaning there is no gap observable below the bottom of the smart level (Figure 3.3).

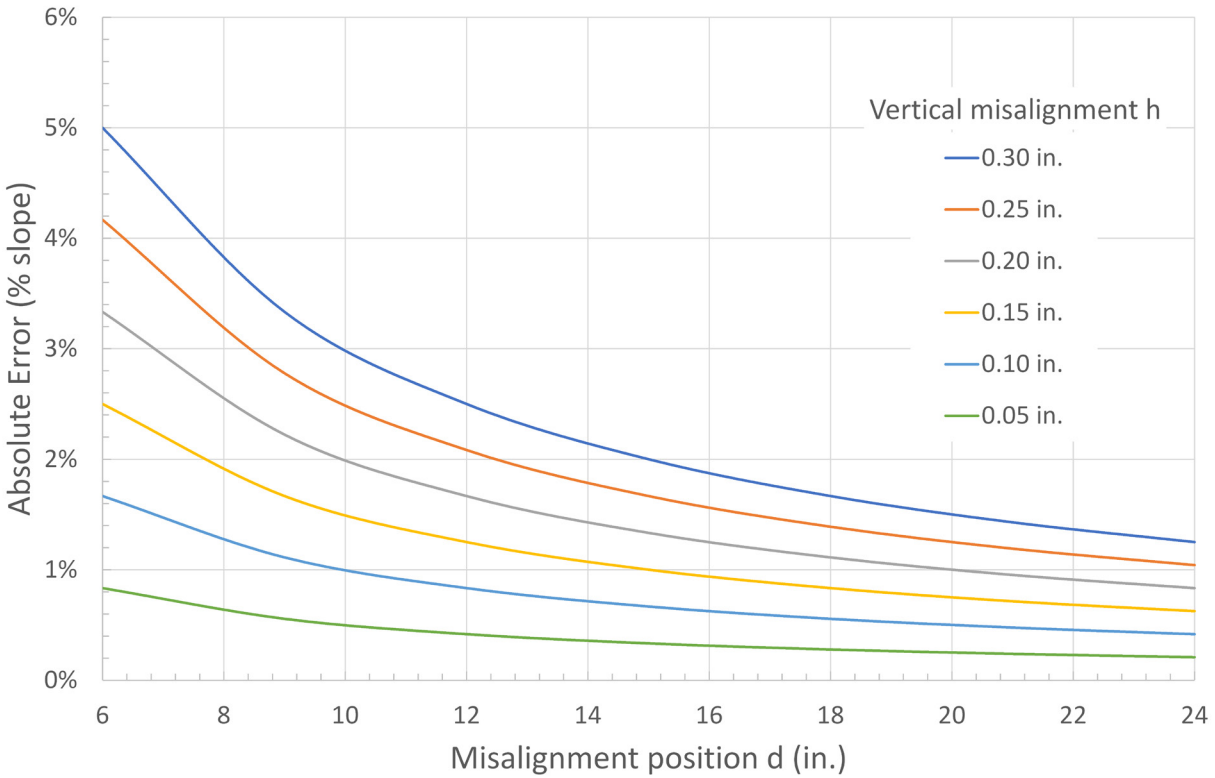
Figure 3.6: Correlation between vertical misalignment position and absolute error in slope measurement.

error increases. Notably, a longer smart level has the advantage in terms of mitigating vertical misalignment. Additionally, it is also worth noting that d_ϕ should be longer than half of the length of the smart level such that it can be stably placed on the surface. A key practical consideration based on ADAAG is that the truncated domes on the detectable warnings are specified as 0.2 in (5 mm) and trip hazards are defined as a change in height over 0.25 in (6 mm). The measurement errors with such vertical displacement are significant and exceed the tolerances for design and construction. Thus, it is necessary to avoid placing the instrument partially on the truncated domes or other objects.

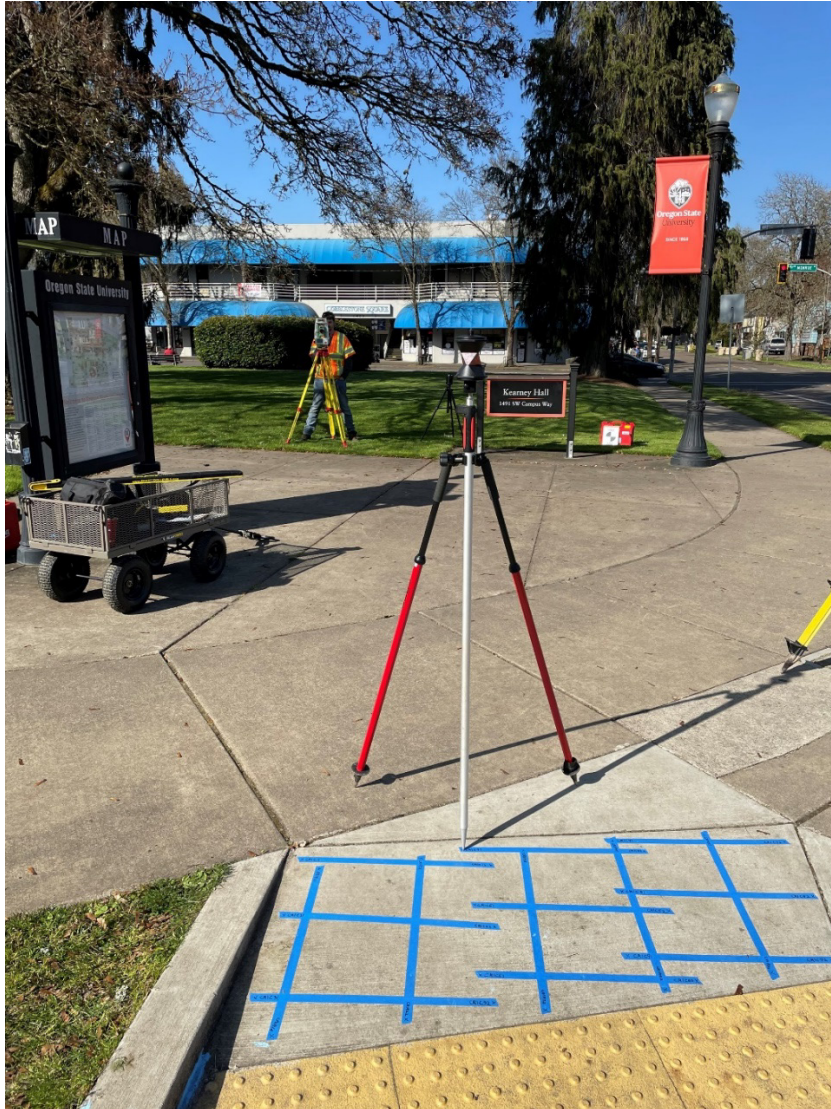
Figure 4.3: Total station measurement using Leica 360° prism with a bipod.

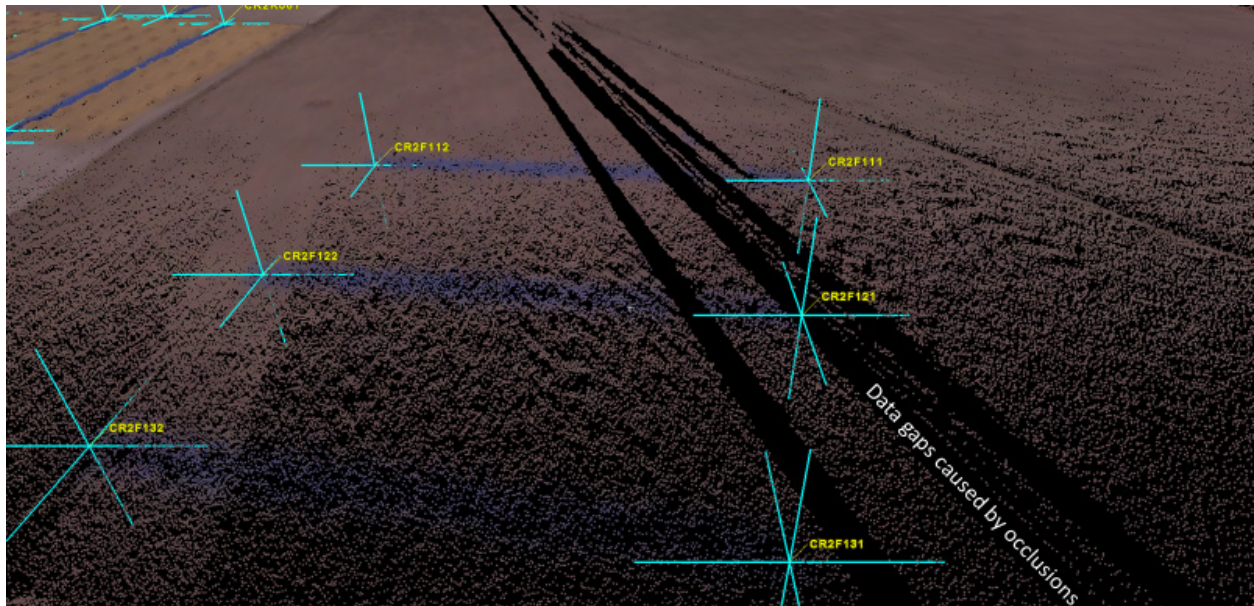
Figure 4.7: Example of data gaps due to occlusions resulting in measurement errors.

m). The high error value of this particular point is caused by low point density due to occlusions in the scan (Figure 4.7), leading to incorrect values when compared against the nearest neighbor.

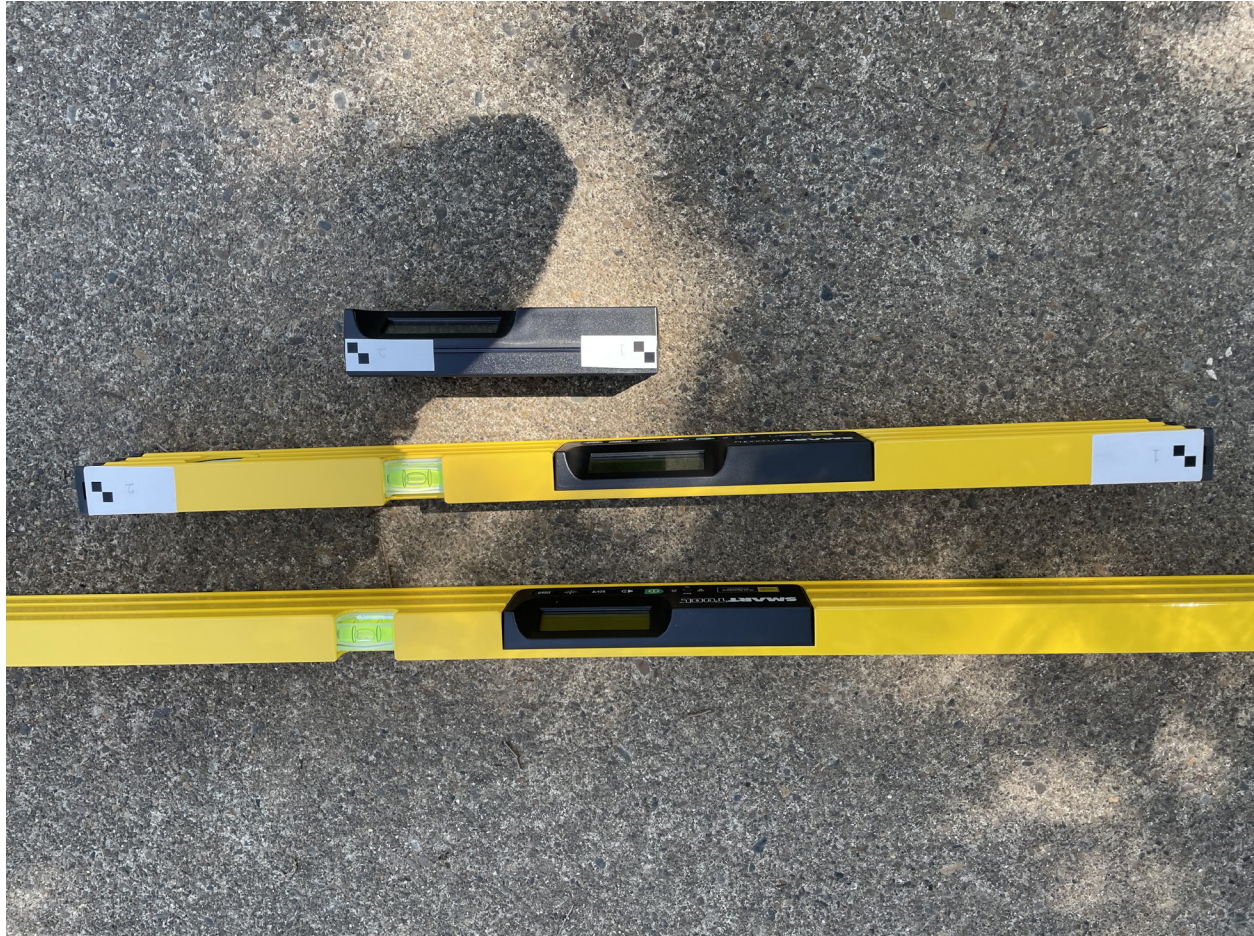
Figure 5.2: Smart levels used in the operator variability test with end points marked.

Each operator was instructed to place the smart level on its direct and reverse face for each set observations. The operator then left the slab and walked to the “reset” area before making another set of observations to keep each set of readings independent. Three instruments were tested in this experiment including a 6-inch, 2-ft, and 4-ft smart level. Both ends of each smart level were marked with targets so that the position and orientation of the smart level could be precisely measured with total station during the test (Figure 5.2).

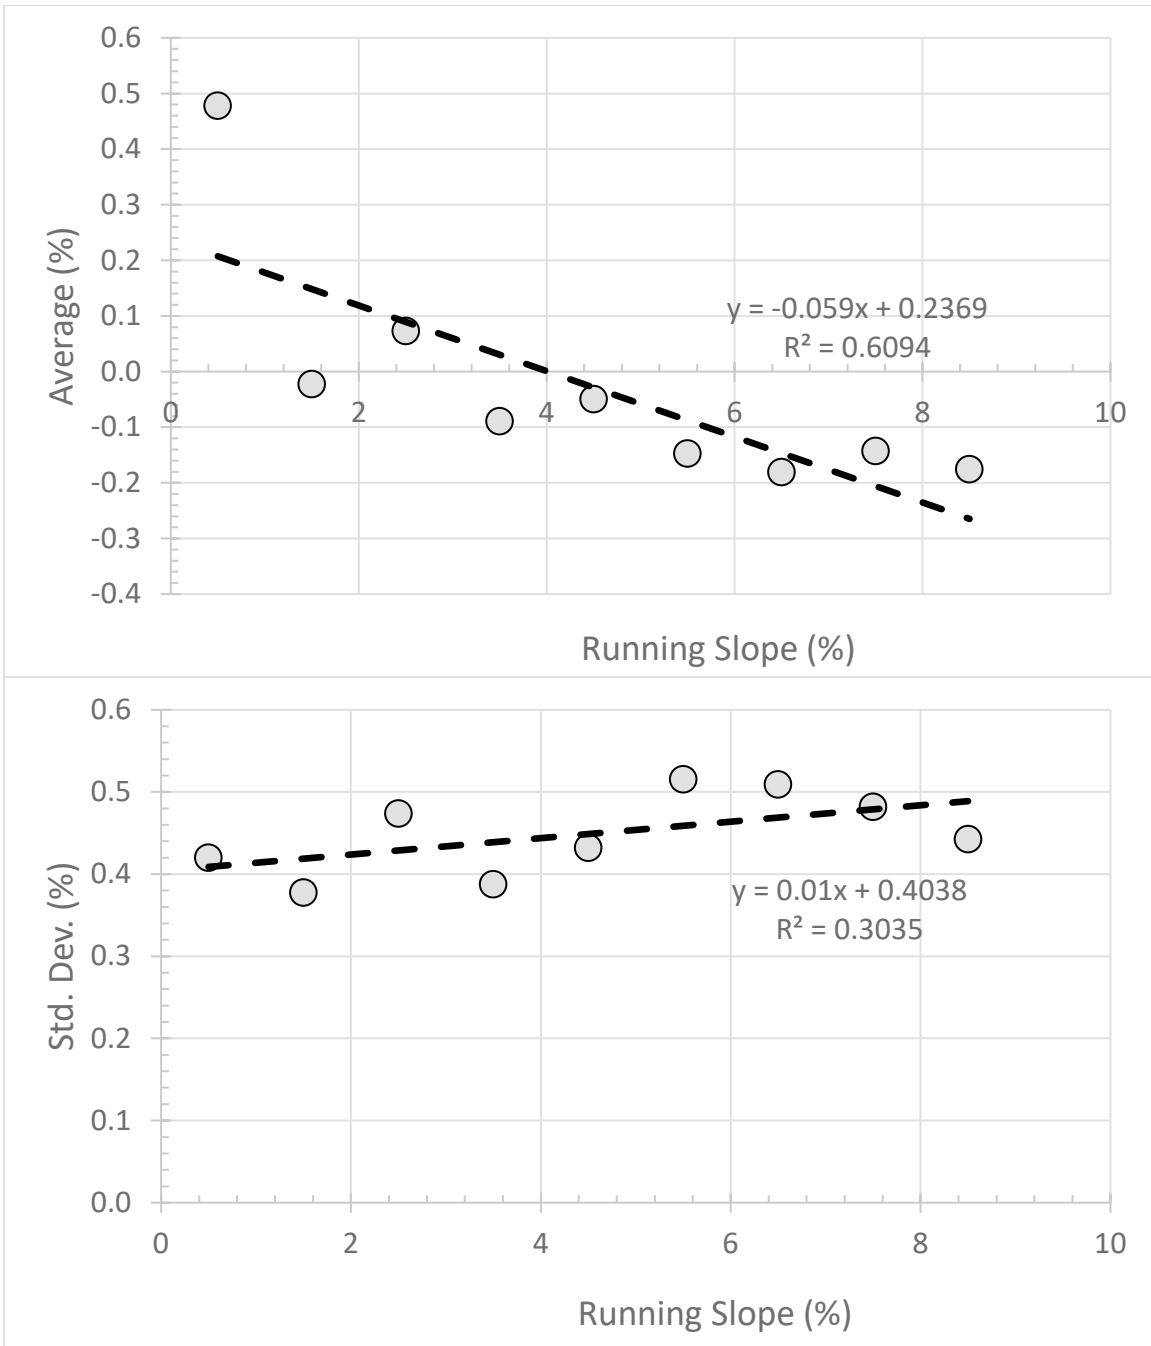
Figure 5.6: (a) Average and (b) Standard Deviation of differences in running slope measurements between inspectors undergoing certification and ground truth measurements in 1% bin increments with blunders removed.

Following the 3-sigma test, data were plotted in the same format as in Section 5.2.1 with Table 5.3 providing a statistical analysis of these differences for each of the bins and the dataset as a whole and Figure 5.6 plotting the average and standard deviation values for each bin. The same trends of higher values of slope for shallower ramps and lower values of slope for steeper ramps are observed, but with a lower correlation. Overall, the average difference is -0.09% which is within the specifications of the smart level. However, the standard deviation remains relatively high at 0.48%. The higher variability is likely a result of (1) differences in equipment used, (2), differences in calibration, and (3) differences in inspector procedures and measurement locations.

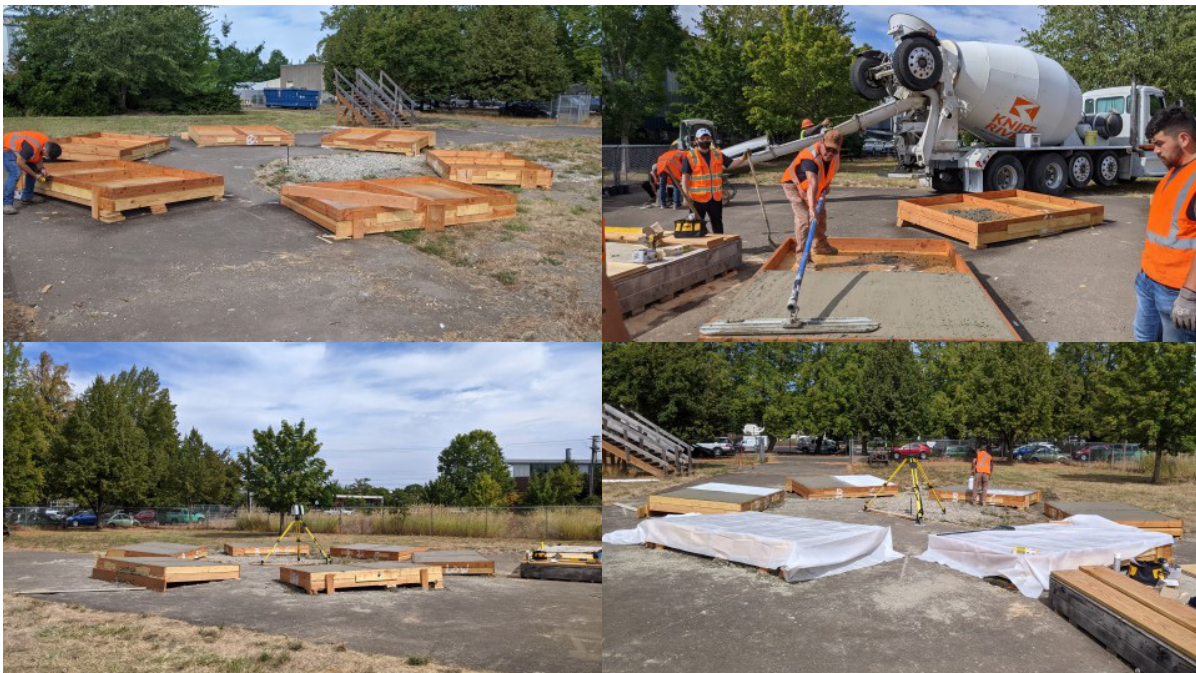
Figure 6.2: Ramp construction and survey configuration of the lab test for the concrete evaluation.

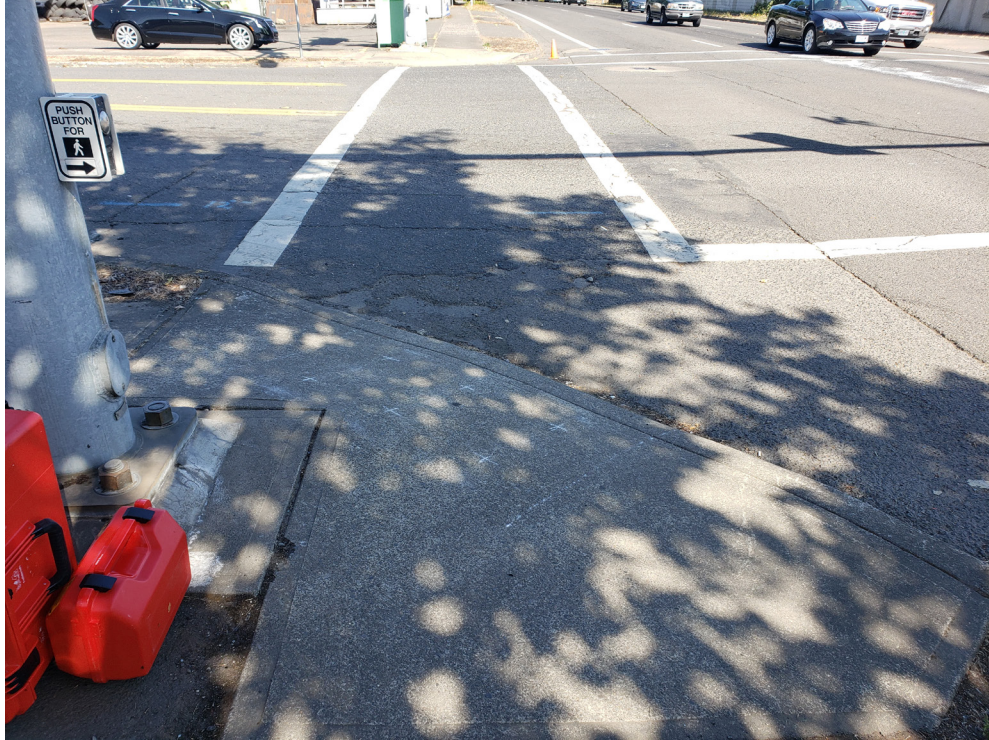
Figure 7.2: Example of a non-compliant curb ramp at the site of Salem, OR.
