**EVALUATION OF CURB RAMP
COMPLIANCE: REVIEW OF TOOLS,
METHODS, AND TIME TO DEVELOP
ERROR TOLERANCES**

Final Report

SPR 844

Oregon Department of Transportation

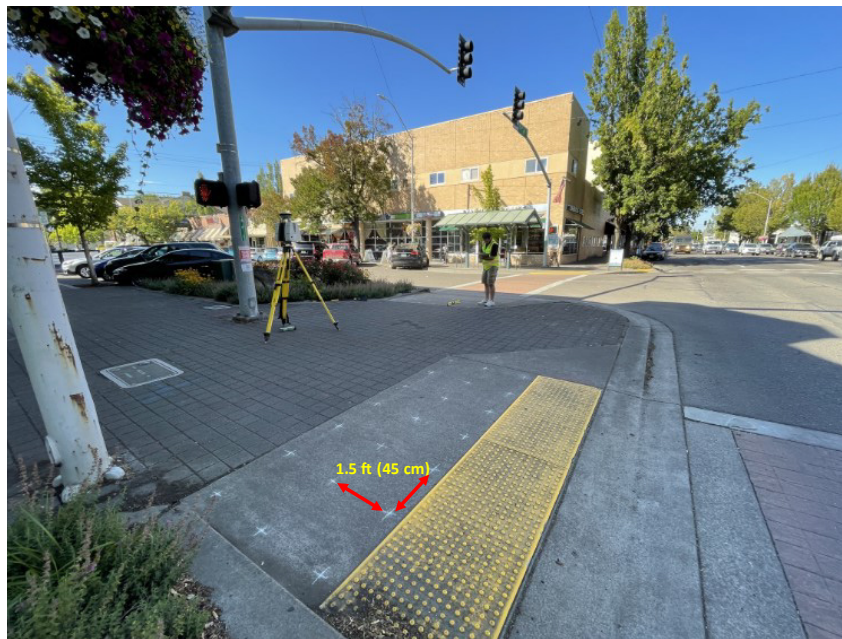
Figure 7.3: Example sampling grid marked with chalk for slope measurements.

2. Marking the sampling grid on the curb ramp: To provide a good coverage for a run on a curb ramp, the research team took samples on the curb ramp in a grid pattern with a preset spacing. The research team first made tape measurements to determine the dimensions of a slab. Then the numbers of rows and columns were calculated respectively using a 1.5 ft (45 cm) spacing. The 1.5 ft spacing was found to be a good balance between field effort and level of details (Yang, Under Review). Once the dimension of the sampling grid was determined, the research group marked the grid at the center of the slab with the center of the grid as the reference point (Figure 7.3). Note that these sampling points were used for both running and cross slope. It is also worth noting that the research team did not mark or measure the slope on the detectable surface because those slope readings can be unreliable and inaccurate. Placing the smart level on the crowns of the domes can be challenging and unstable while the space between the domes is too narrow to fit the equipment (Figure 7.4), resulting in tilt biases.

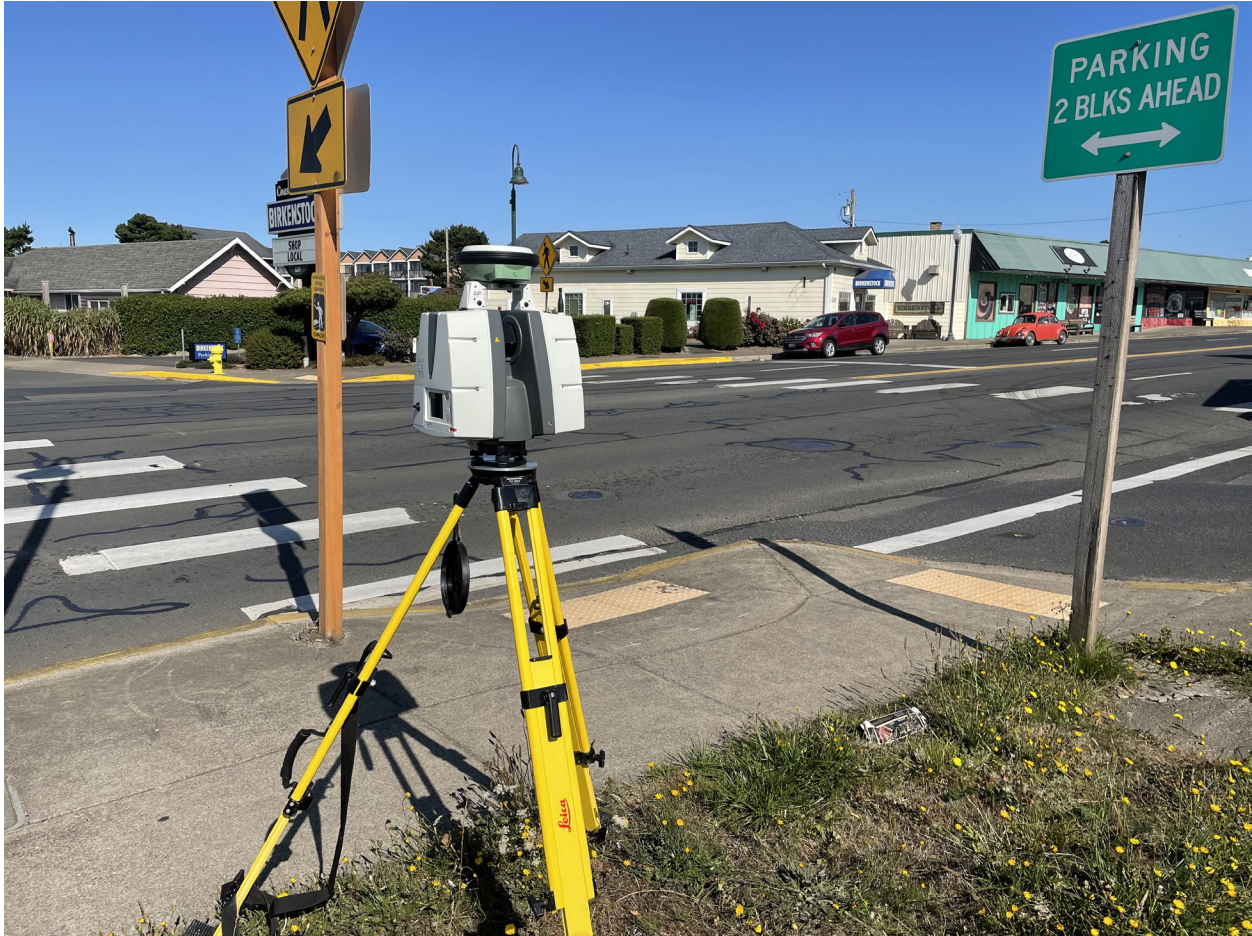
Figure 7.6: Terrestrial laser scanning data collection at a curb ramp.

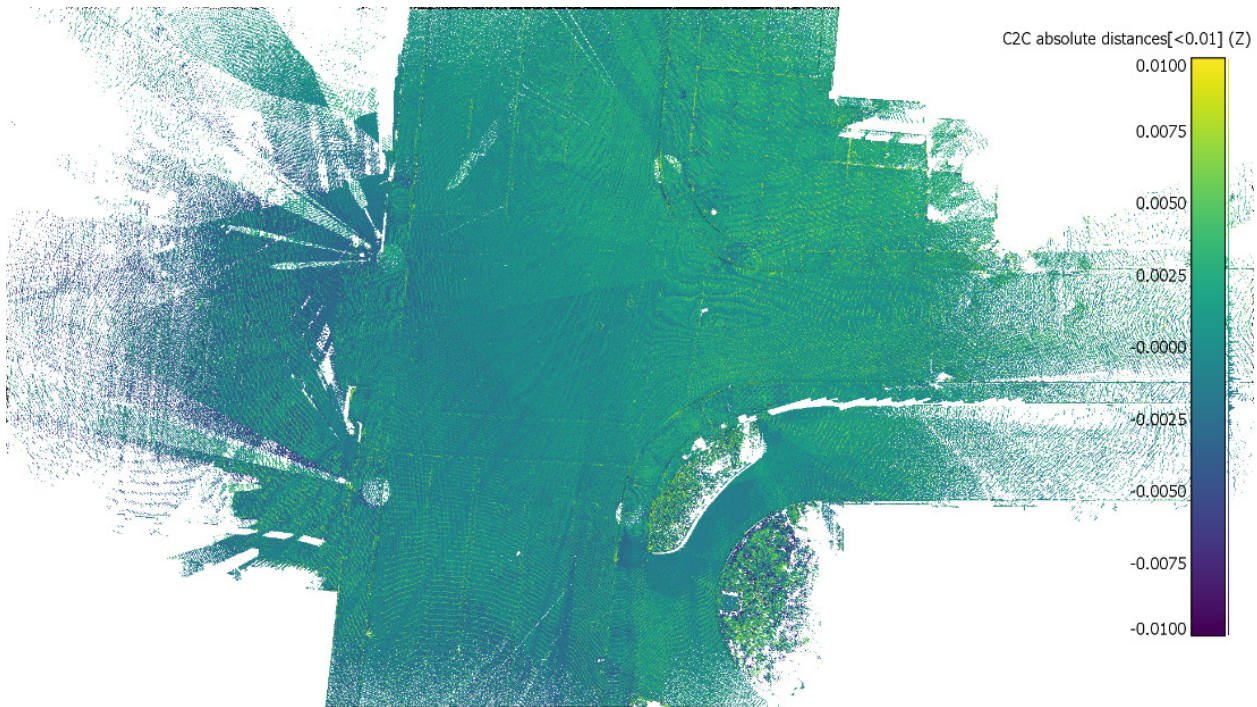
(a) Point cloud in RGB color

(b) Cloud-to-cloud comparison result (m)

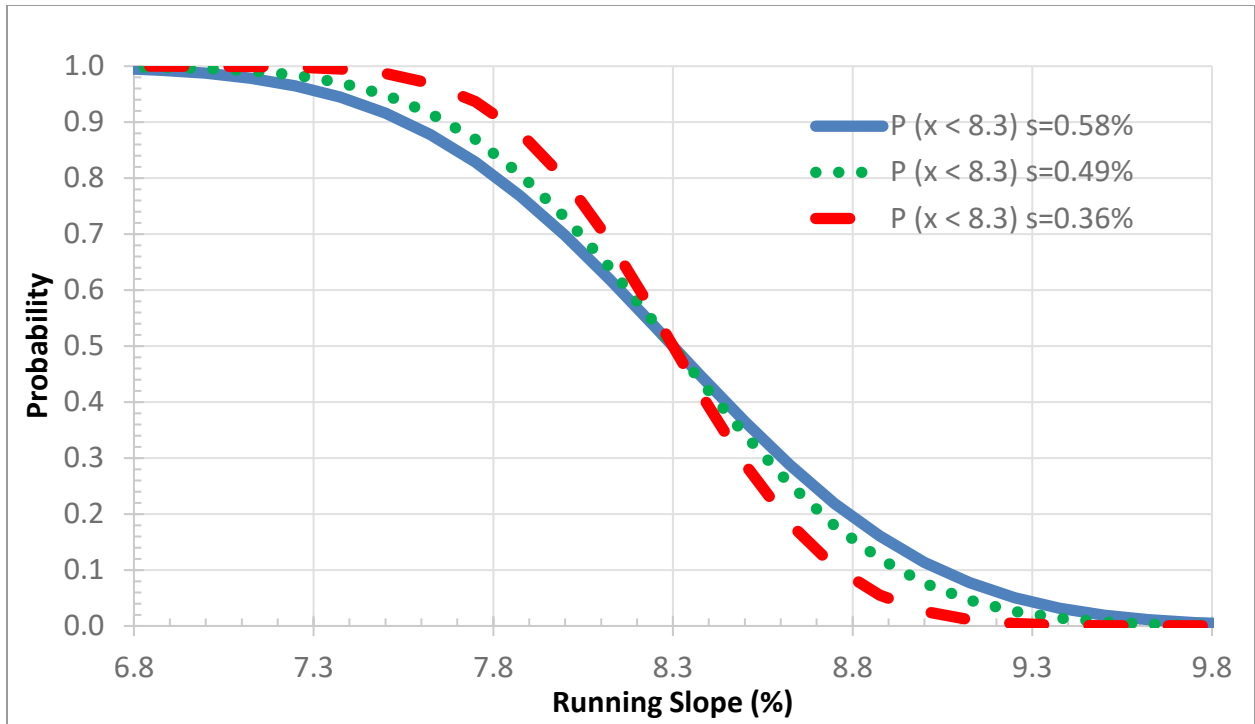
Figure 10.1. Example cross slope probability curve based on different standard deviations.

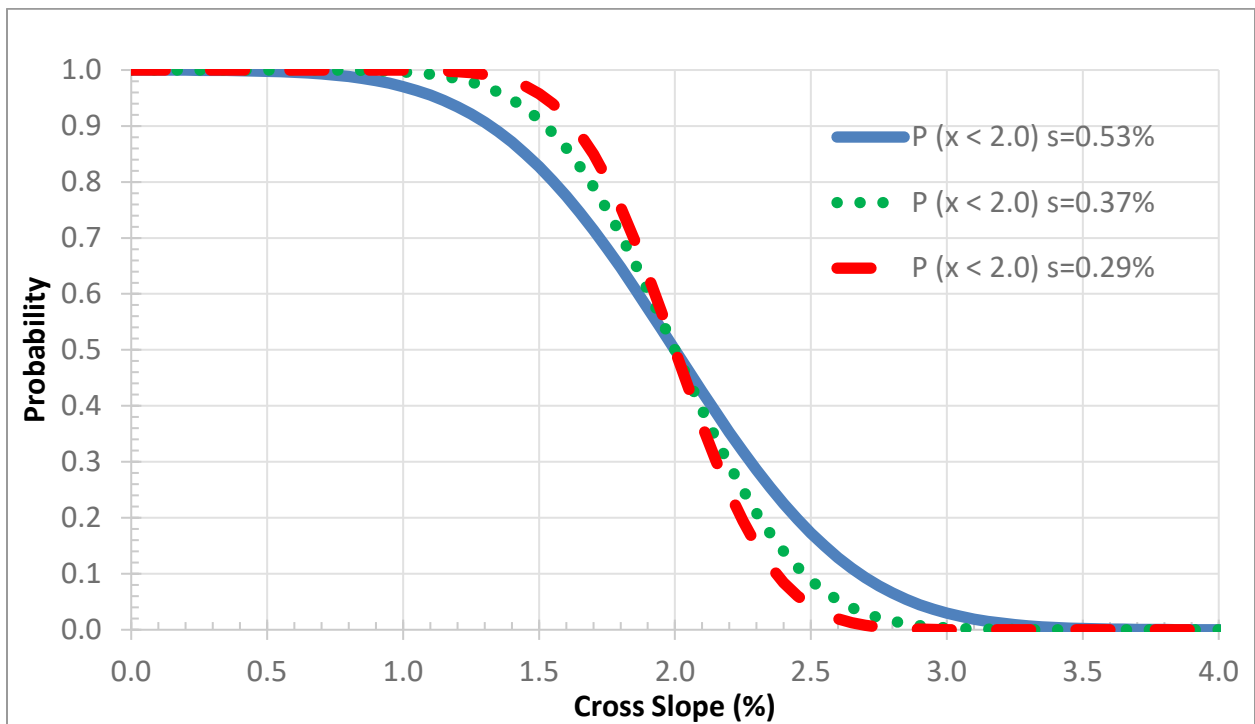
Figure 10.2. Example cross slope probability curve based on different standard deviations.
