PRACTICES FOR MAINTAINING AND RESURFACING EXISTING COMPOSITE PAVEMENTS

FHWA-HIF-23-070
January 2024

U.S. Department of Transportation
Federal Highway Administration

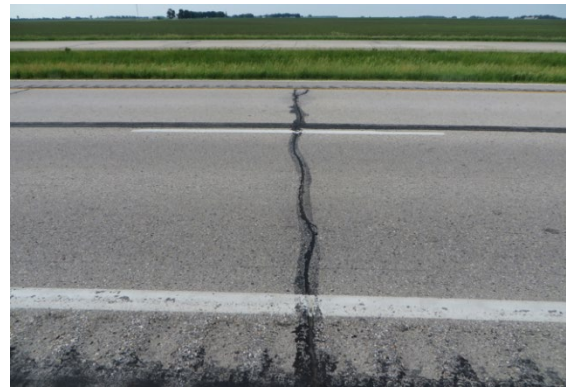
Figure 2. Reflective cracking on AC/PCC pavement.

The major distress affecting the performance of AC/PCC composite pavements is reflective cracking (see figure 2). Reflective cracks occur in the AC overlay above cracks and joints in the underlying concrete pavement, and once they appear they serve as an entry point for infiltration of water, salts, and debris that can affect the integrity of the asphalt overlay and continue the degradation of the underlying pavement layers. Furthermore, as the cracks continue to deteriorate and break down under traffic and environmental loadings, they contribute to increased surface roughness and in severe cases may also pose a safety issue.

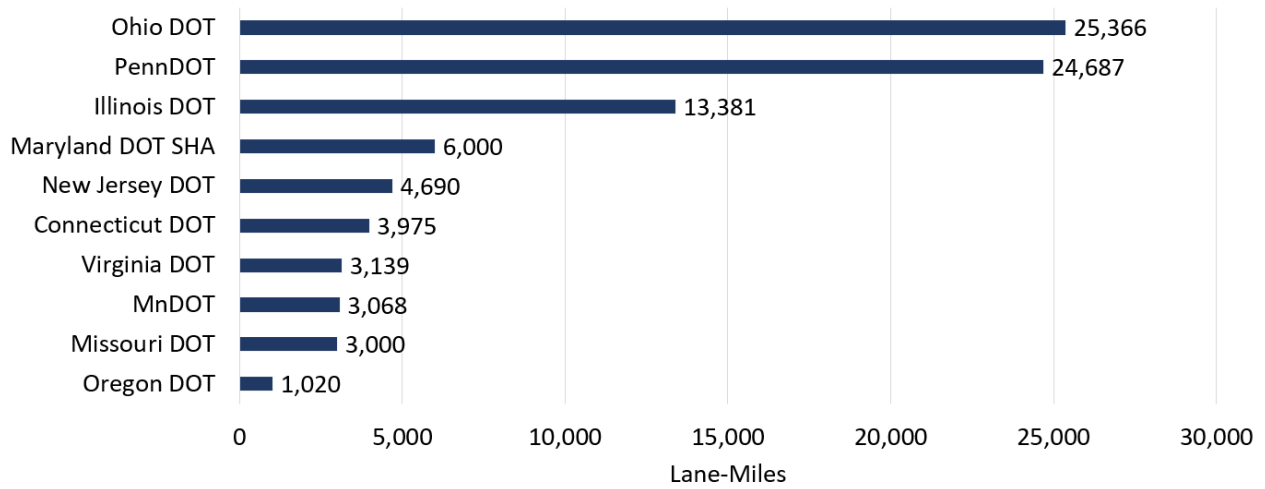
Figure 5. Composite pavement mileage for selected State DOTs.

As part of the peer exchange, the general characteristics of the participating State DOTs on several key aspects of composite pavements were documented, and these are presented in figures 5 through 10.

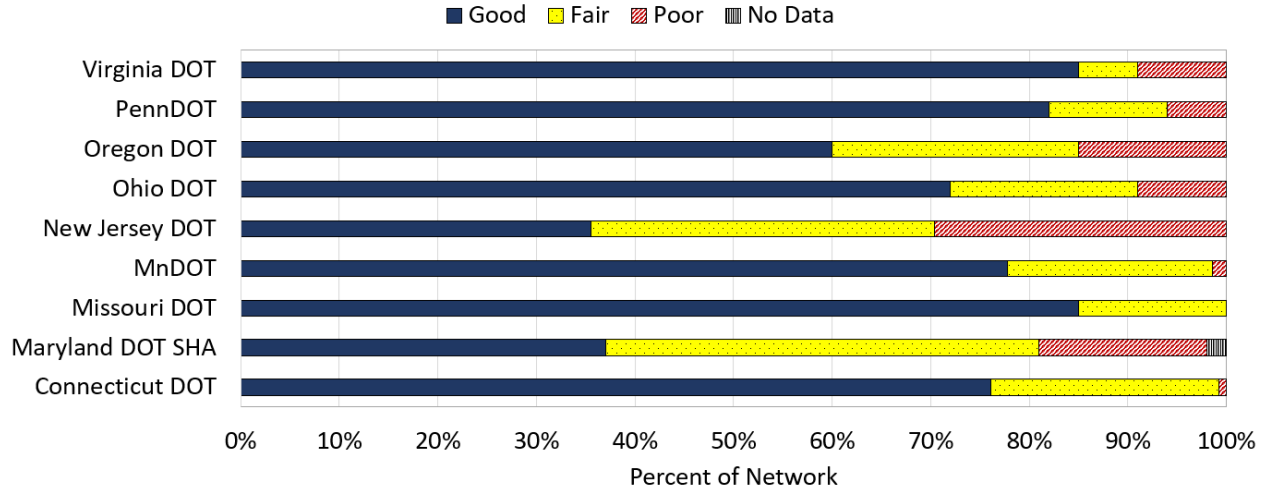
Figure 6. Composite pavement conditions for selected State DOTs.

(Note: Ratings based on agency measures)

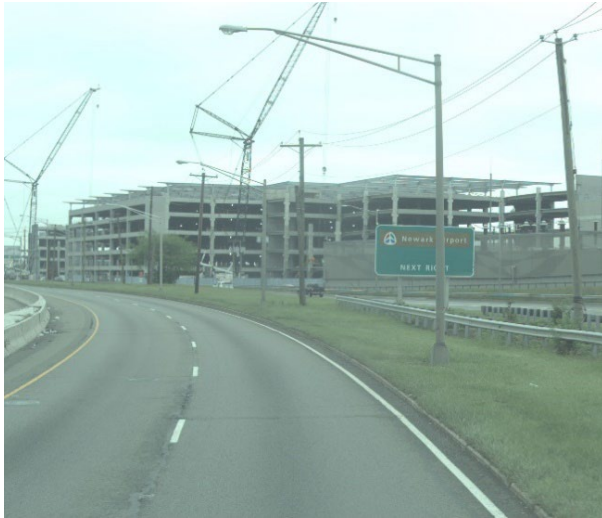
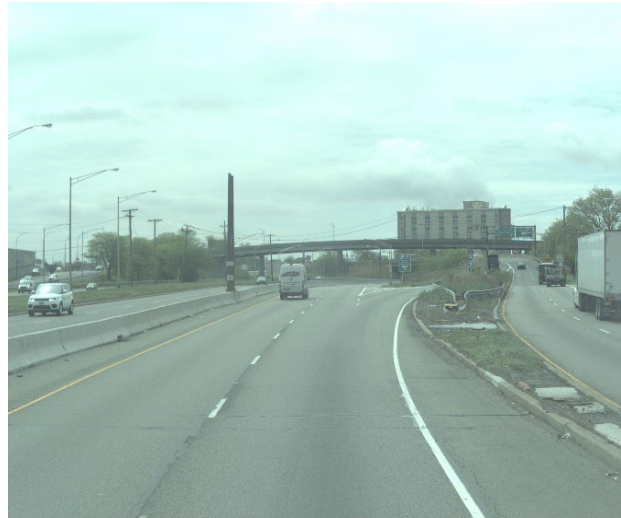
An overview of the pavement condition in 2021 after about 10 years of service is shown in figure 15. Performance data from 2020 include:

- Current SDI: 3.4.
- Current roughness: 104 inches/mi.
- Observed distresses to date: Longitudinal construction joint deterioration, isolated low-severity fatigue cracking, and low-severity joint reflective cracking.

a) NB MP 45.76

b) SB MP 45.97

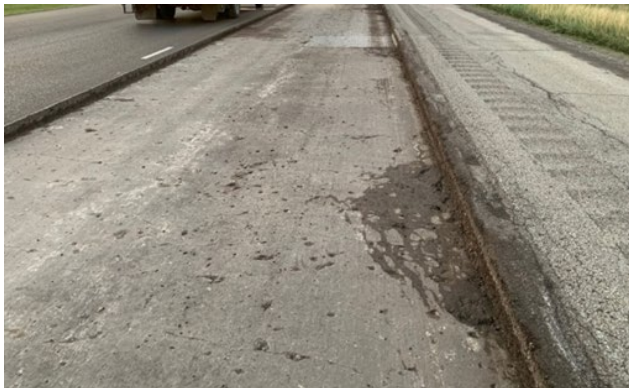
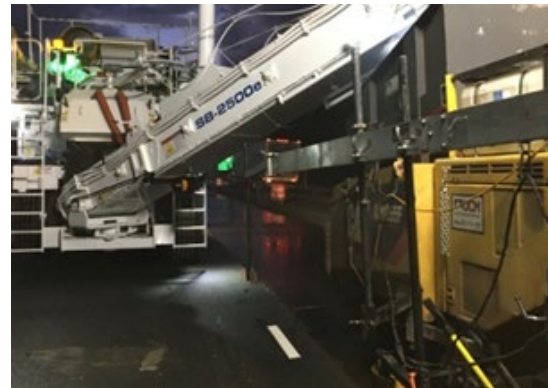
Figure 17 depicts portions of the overlay construction.

a) Typical CRCP condition under overlay.

b) Paving the center lane with MTD offset.

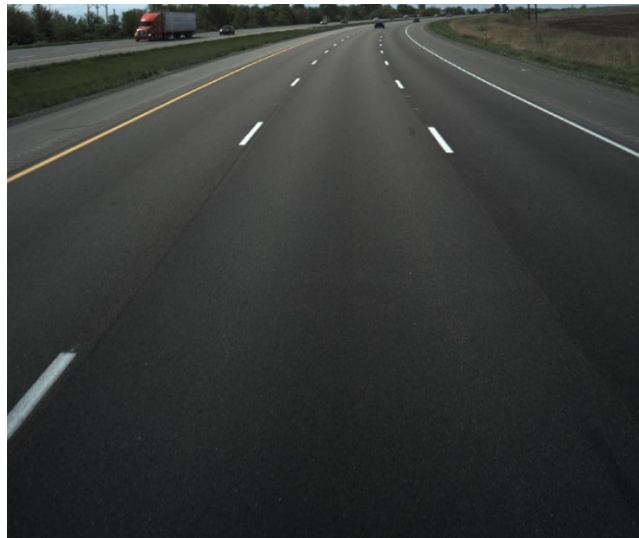
Figure 18. Overview of I-55 pavement in 2021.

- IDOT Condition Index: 8.6 (indicating a pavement in excellent condition).
- Roughness: 54 inches/mi.
- Rutting: 0.07 inches.
- Observed distress to date:
 - There are some locations where material durability issues in the underlying CRCP were identified after milling but could not be repaired prior to the overlay because of the traffic management requirements. These areas were marked and repaired after the overlay was placed. There are no new distresses in the SMA overlay.

Figure 18 provides an overview of the condition of the pavement in 2021.

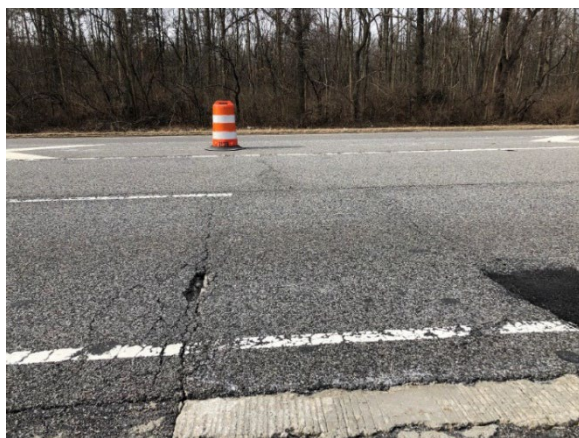
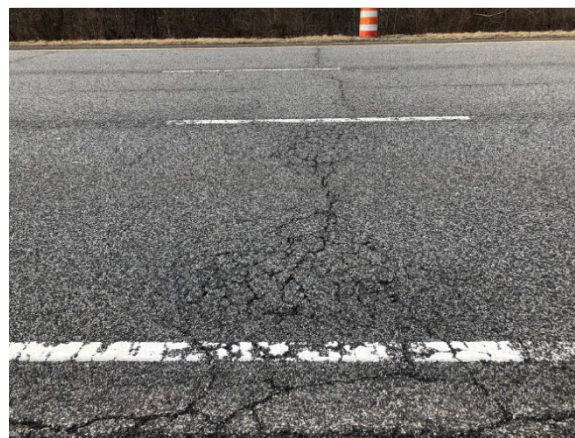
A 5.85-mile stretch of this 4-lane composite pavement (AC/JRCP) urban interstate highway was exhibiting medium-severity transverse reflective cracking. The existing composite structure consisted of a 5.5-inch AC overlay placed on a 10-inch JRCP. The original JRCP was constructed in 1961 with doweled joints spaced at 40-ft intervals. A series of AC overlays (and mill and AC overlays) had been performed in 1988, 1993, 1995, 2005, and, most recently, in 2014. Typical conditions of the 2014 AC overlay pavement are shown in figure 20.

a) Above underlying full-depth repair.

b) Above underlying transverse joint.

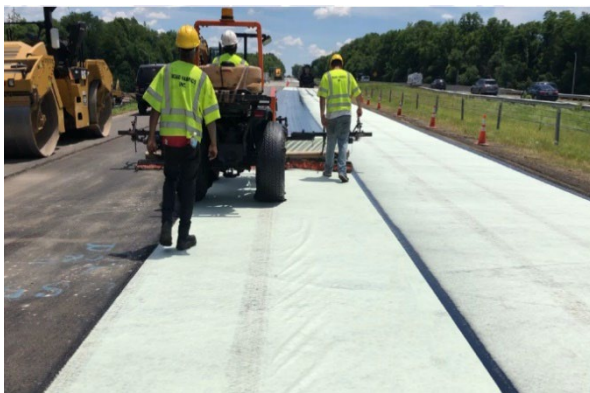
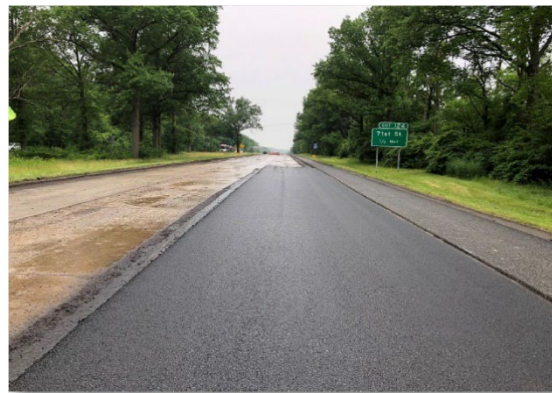
Figure 21 shows some of the construction activities from the 2019 rehabilitation.

a) Interlayer fabric installation.

b) Intermediate overlay.

- Full-depth repairs.
 - Geosynthetic paving fabric interlayer.
- Expected overlay performance.
 - More than 10 years.

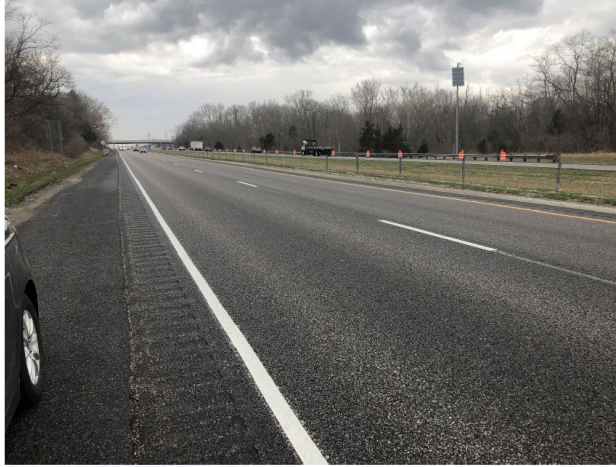
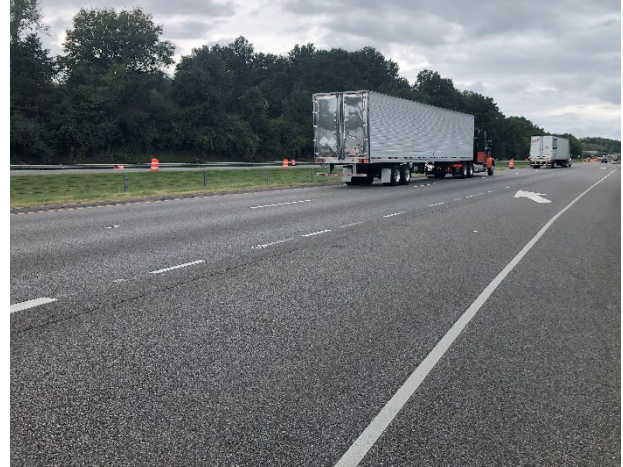
To date, the pavement has been performing very well, according to INDOT (see figure 22). The only distress that has been observed in the 2 years of service is some sporadic minor joint reflective cracking.

a) March 2021 condition.

b) September 2021 condition.

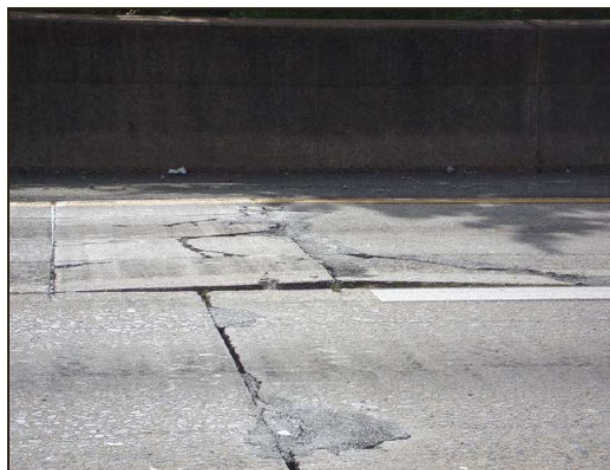
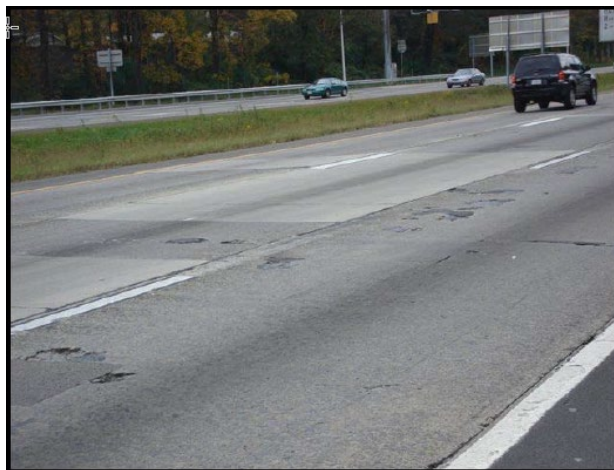
The original pavement was constructed between 1960 and 1963 with 2 lanes (from Route 50 to east of Route 123) and 3 lanes (from east of Route 123 to I-495) in each direction. It consisted of a 9-inch JRCPC with transverse joints spaced at 61.5-ft intervals. The underlying layers consisted of a 6-inch aggregate layer over a 6-inch soil-cement base. Between 1990 and 1993, the pavement structure was widened to 4 lanes in each direction, with the two new lane additions consisting of an 11-inch JPCPC with transverse joints at 15-ft intervals. The new JPCPC was constructed over a 4-inch stabilized open-graded drainage layer and a 6-inch cement-treated aggregate subbase. Typical distresses in the existing concrete pavement are shown in figure 24.

a) Deteriorated transverse joint.

b) Distress in isolated slabs.

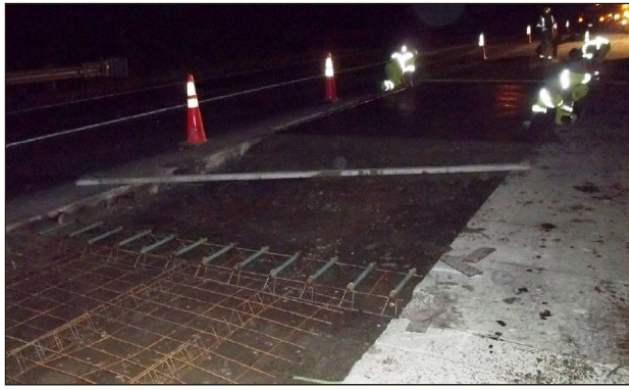
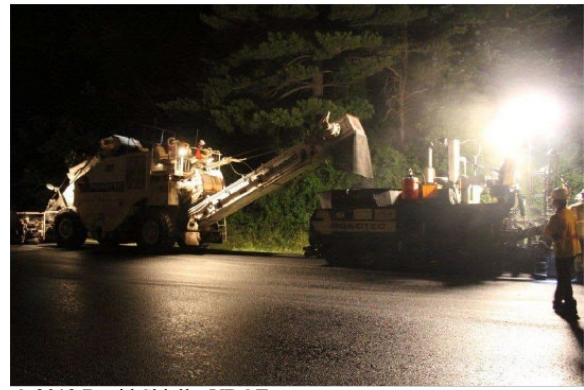
Figure 25 shows some of the construction activities associated with the project from 2012.

a) Full-depth repairs.

b) SMA overlay placement.

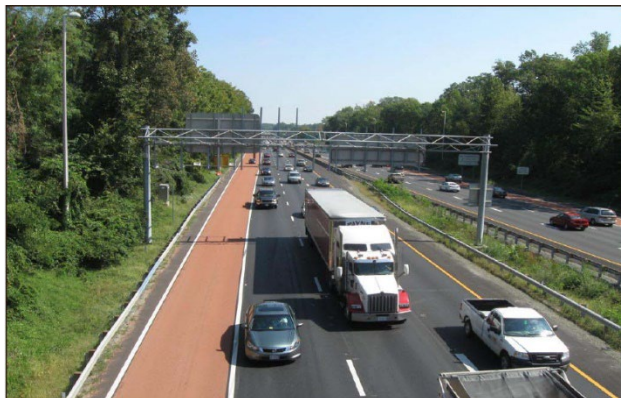
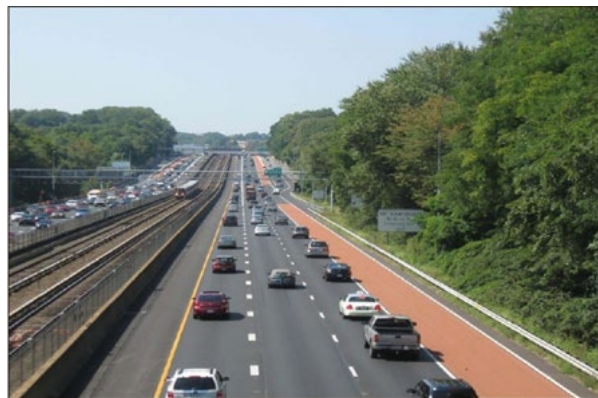
- Immediate post-construction (2012).
 - Average IRI (eastbound lanes).
 - 50, 49, and 46 inches/mile for lanes 1, 2 and 3, respectively.
 - Average IRI (westbound lanes).
 - 48, 48, 46, and 48 inches/mile for lanes 1, 2, 3 and 4, respectively.
- Prior to Removal (2021).
 - CCI: 81.
 - IRI: 69 inches/mile.
 - The pavement performed exceptionally well with only minor reflective cracking apparent in some locations.

Figure 26 shows photos of the I-66 project while in service.

a) Project with grass median.

b) Project with WMATA lines in median.
