U.S. Department
of Transportation
Federal Railroad
Administration

Full-scale Grade Crossing Impact of a Single-frame Highway Truck into an LNG Tender

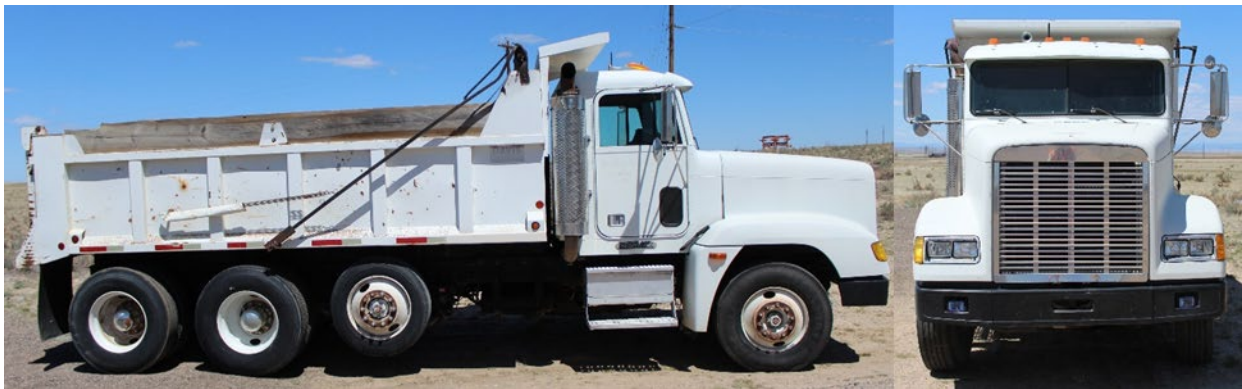
Figure 2. Side and Front View of the 1994 FLD 120 Dump Truck

M-1004 specifications require a single-frame vehicle to impact the fuel tender. A 1994 FLD 120 dump truck was selected as the single-frame vehicle for testing (Figure 2). The test conditions would result in a severe impact, necessitating a vehicle trajectory that would have to be controlled externally. In a modeling environment, the trajectory of the vehicle can easily be controlled, but during the test, control of the vehicle's trajectory is much more difficult and complex. Additionally, the M-1004 specifications provided a target test speed of 40 mph for the impact so the velocity of the dump truck needed to be controlled precisely for the test.

The team instead chose to use a dump truck converted for use as a high-rail vehicle (see [Figure 2](#)). With the dump truck modified to roll on two railroad wheelsets on existing track, the dump truck's trajectory could be effectively controlled by the railroad tracks on which it traveled. The anticipated low rolling resistance between the steel wheels and the steel rail would allow the dump truck to be "shoved" up to speed by a locomotive before it coasted into the point of impact with the tender. The dump truck would run on an existing track at TTC, while the locomotives and fuel tender would be positioned stationary at a 90-degree angle to the dump truck (as shown in [Figure 3](#)).

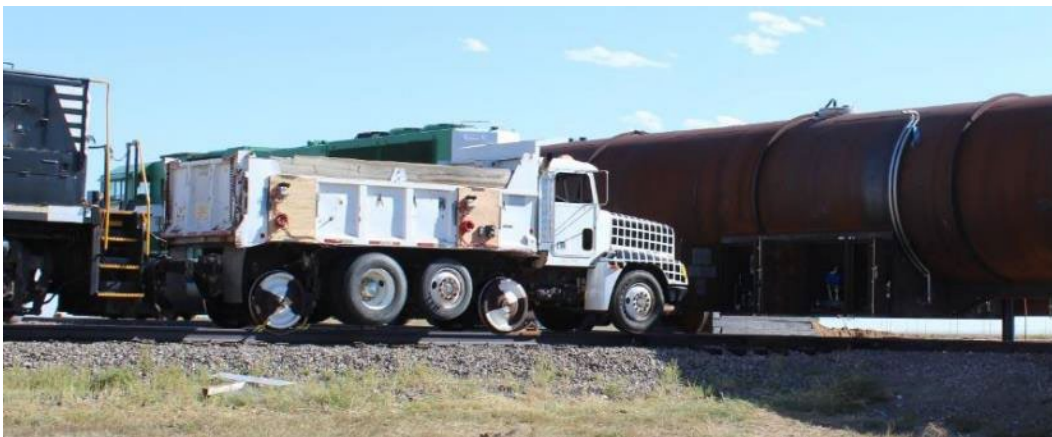
Figure 3. Oblique View of Dump Truck Aligned at the Impact Point with the Tender

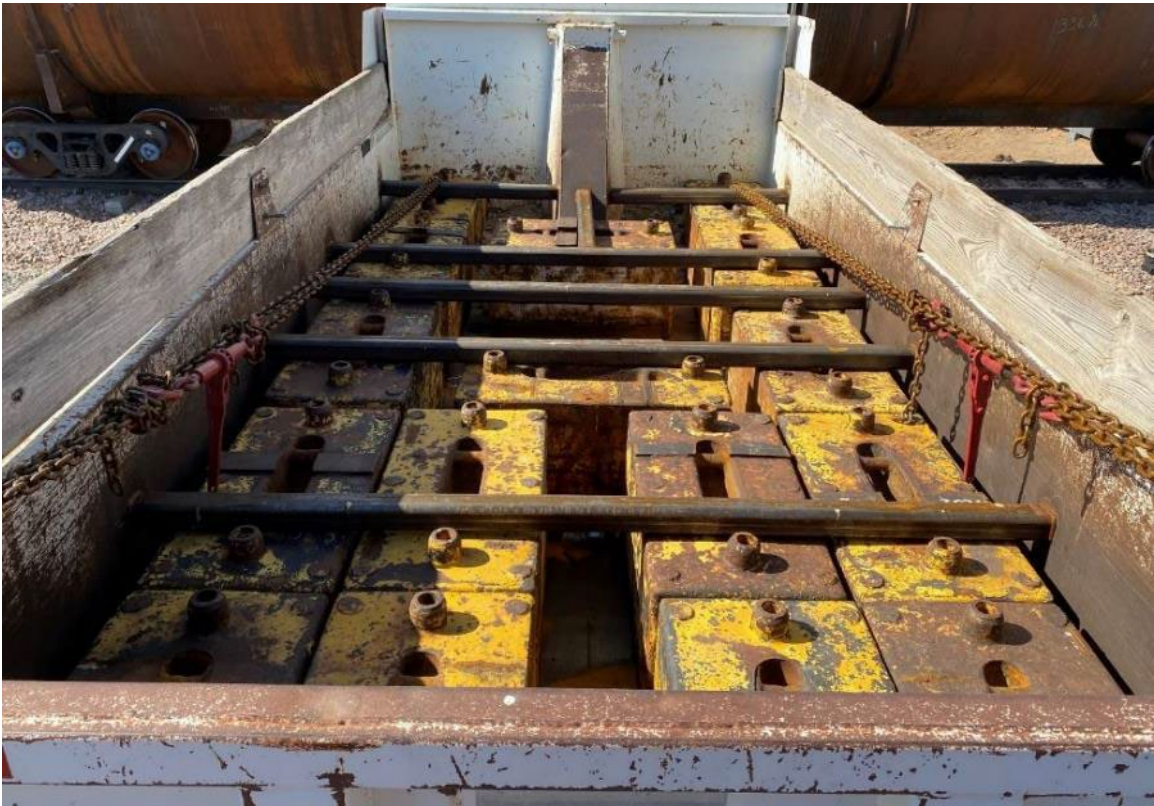
Figure 7. Arrangement of the Dump Truck Bed Loaded with Weights and Restraining System

After the suspension was fitted the team loaded the dump truck with steel weights to increase its gross weight to 80,000 lbf, as specified in M-1004. The weights were secured to the bed of the dump truck to limit their movement during impact. The arrangement of the weights and restraining system is shown in [Figure 7](#). The final gross weight of the dump truck was 81,350 lbf.

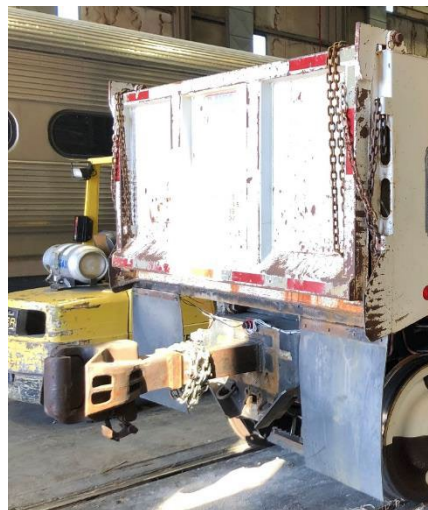
Figure 9. Railway Coupler Fitted to Dump Truck

Speed upgrade tests were performed to determine that the dump truck, modified to roll like a hi-rail vehicle, could negotiate the test track safely at 40 mph. A brake system was designed and installed and the rear of the dump truck was fitted with a railway coupler to allow the truck to be hauled by a locomotive ([Figure 9](#)).

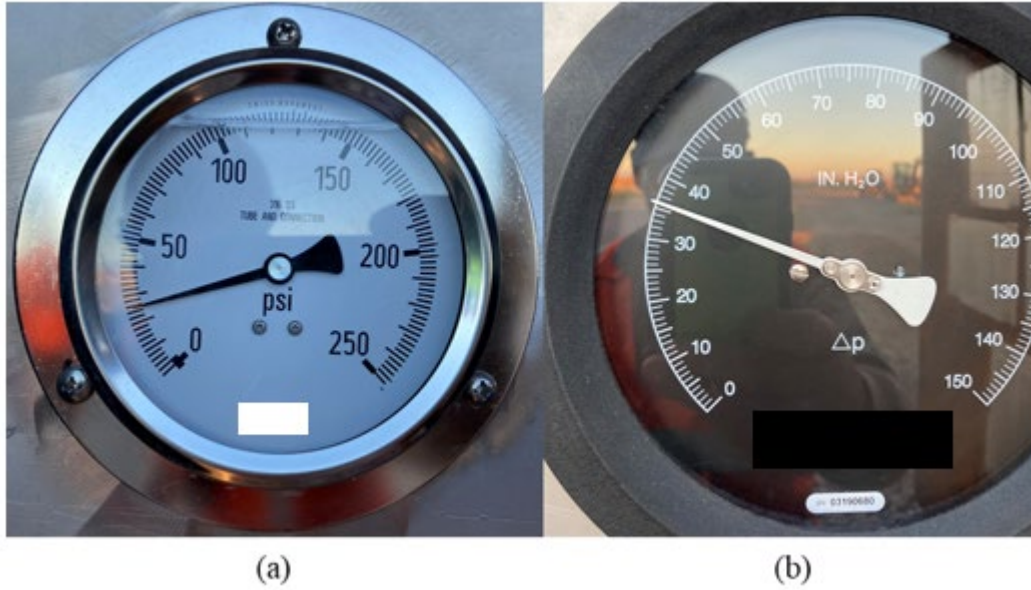
Figure 10. (a) Pressure Gauge and (b) Inner Tank Fill Volume Related to Pressure in Inches of Water

Additional details on the volume calculations are provided in Appendix G. Atmospheric pressure was assumed to be 12.3 psia [4] based on Pueblo, CO's altitude of approximately 4,700 feet [5]. Under saturation conditions (25 psig, -304.5 °F), LN2 has a density of 764.1 kg/m³ [6]. At the conditions given in M-1004, LNG has a density of 423.6 kg/m³. This left the test team with two options for filling the tank with LN2 at 25 psig. M-1004 gives a minimum initial outage value, which corresponds to a particular mass of LNG based on the volume of the tank. Using LN2, the tank could either be filled to match the equivalent *volume* of LNG that would be carried under M-1004's conditions, or to match the equivalent *mass* of LNG that would be carried under M-1004's conditions. In an impact test to a DOT-113 cryogenic tank car conducted by FRA several months prior to the tender grade crossing test, LN2 was used to fill the tank car to a similar volume as that used in service [7]. However, volume-matching was chosen in that test because the large deformation of the DOT-113 tank under the impact would be substantially affected by the initial outage. Preliminary FE modeling in this research showed that the inner tank would experience very little deformation during the grade crossing impact. Additionally, matching the volume of LNG with LN2 results in a substantially additional mass of lading. Since the grade crossing impact scenario was expected to result in significant roll of the tender, having a larger mass of liquid in the tank than normal operations could exacerbate the roll issue. Thus, the test team chose to fill the tender with a mass of LN2 that corresponded to the mass of LNG that would be carried under the conditions prescribed in M-1004. This resulted in a filling level of approximately 45 percent of the tender's volume, leaving a 55 percent outage volume. The liquid height gauge was used to monitor the filling of the tender, with a target value of 36 inches of water corresponding to the target filling volume (refer to [Figure 10](#) in [Section 2.3.2](#)).

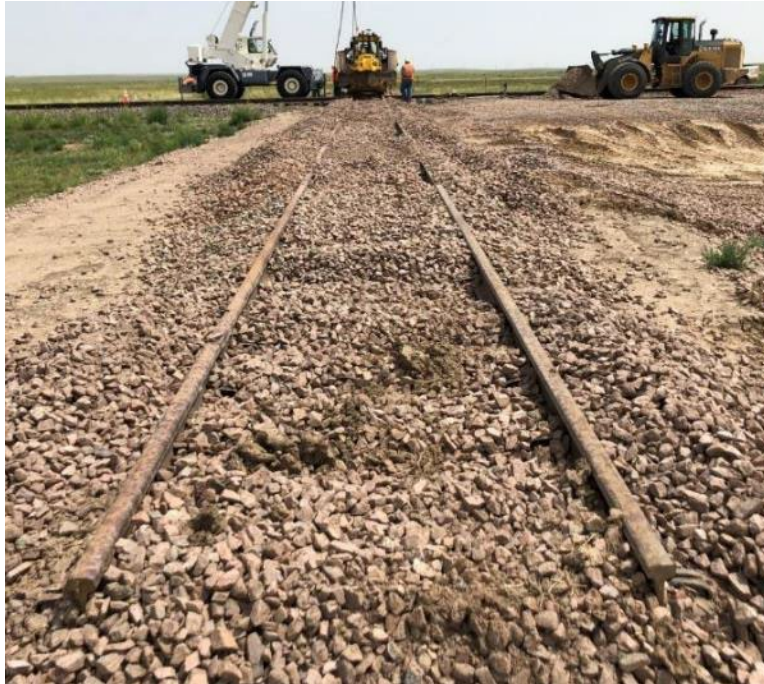
Figure 11. Track Section Under Construction (West View)

The test section of constructed track extended roughly 130 feet to each side of the center of the existing test track. The continuity of the track was broken and the section of track that was constructed was continuous from east to west. Class 3 American Railway Engineering and Maintenance-of-Way Association (AREMA) ballast was used for the ballast bed. Concrete ties supported the rails with a 24-inch center-to-center spacing. Secondhand 136RE rails and some 141RE rails were used in the track construction but brand new fasteners were used to clamp the rails to the ties. No measurements were taken to confirm the track Class, but the track was constructed and tamped to conform to FRA's Class 4 track specifications [8]. [Figure 11](#) shows the section of track under construction.

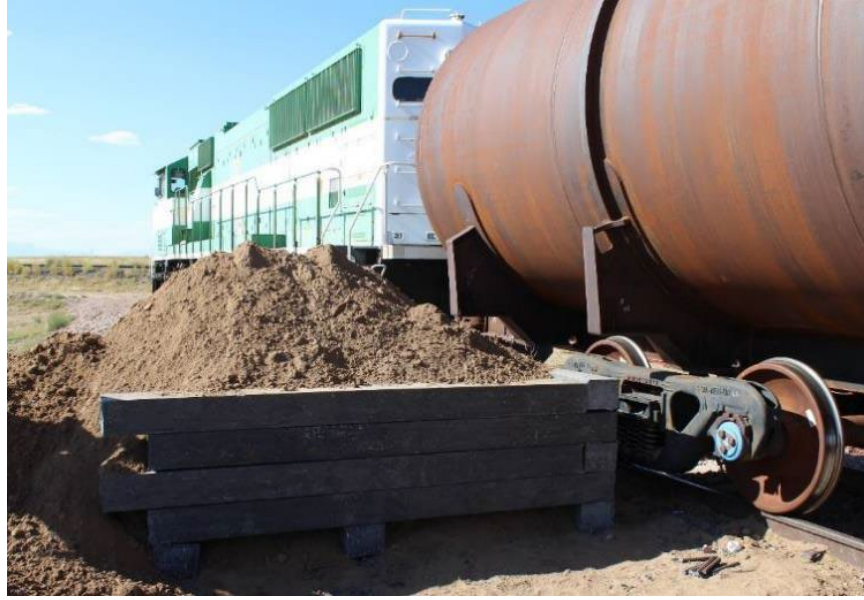
Figure 14. Roll Inhibitor Structure to Prevent Excessive Body Roll of the Fuel Tender after Impact

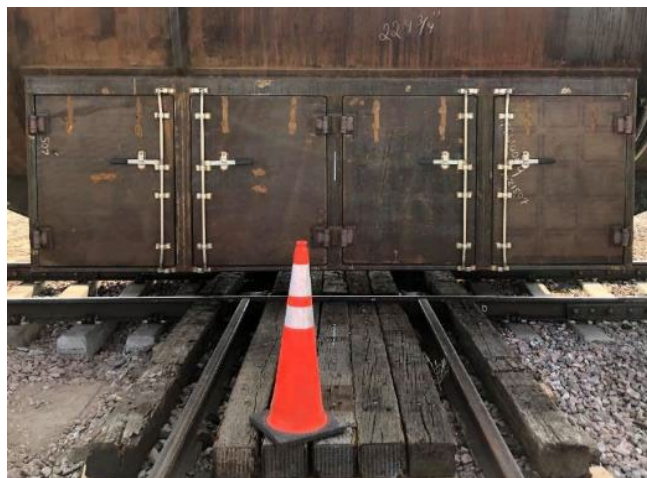
Figure 15. Alignment of the LNG Fuel Tender Housing with the Center of the Track

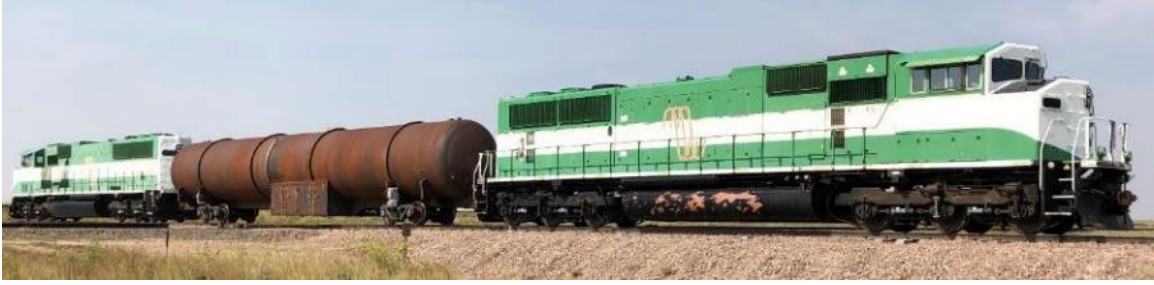
Figure 16. Overview of Test Setup with Locomotives and Fuel Tender

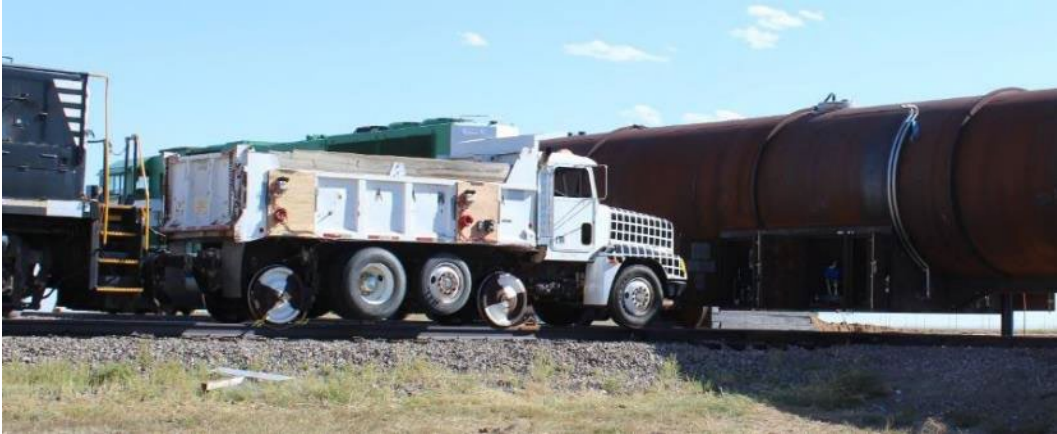
Figure 17. Pre-test Test Setup with Dump Truck Close to the Housing of the Fuel Tender

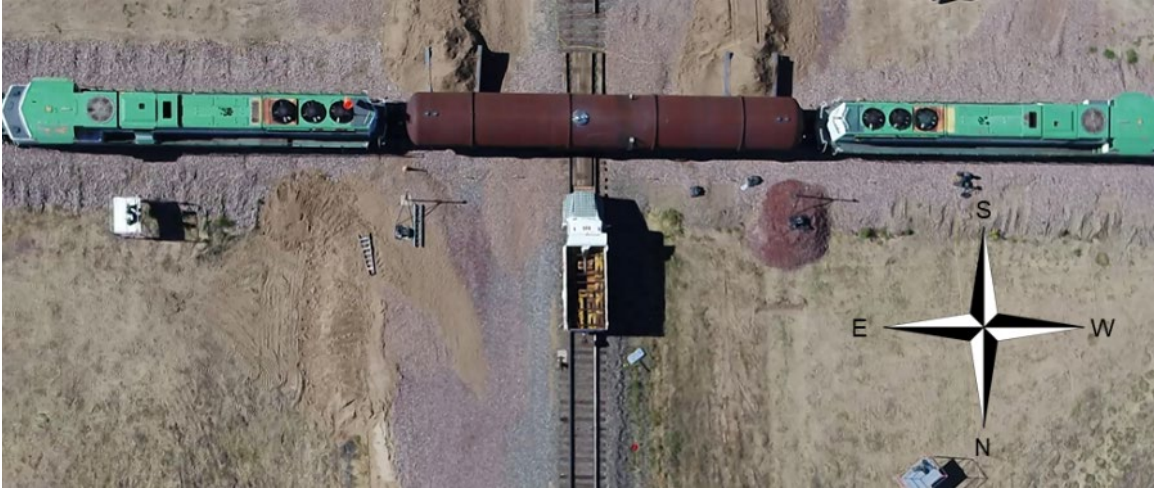
Figure 18. Aerial View of the Test Setup with the Locomotives, Tender and Dump Truck in Position

The highway-grade crossing impact test was performed on September 22, 2021, at the TTC in Pueblo, Colorado. For the execution of the test, the locomotives were lifted onto the section of track and moved to either end. The fuel tender was lifted onto the track and positioned with the center of the protective housing in the center of the level crossing, as shown in [Figure 15](#). The locomotives were coupled to the fuel tender and the couplers were forced into a draft condition. There were no brakes on the fuel tender, but the locomotives' hand brakes were set. Wedges were welded to the rails at the locomotive wheels closest to the tender to keep the locomotives from rolling closer to the fuel tender. The fuel tender was filled with LN₂, and the dump truck was prepared for the test. The test arrangement is shown in [Figure 16](#). [Figure 17](#) displays the dump truck's position near the tender protective housing. An aerial view of the test setup with the locomotives, tender, and dump truck in their pre-test positions is laid out in [Figure 18](#).

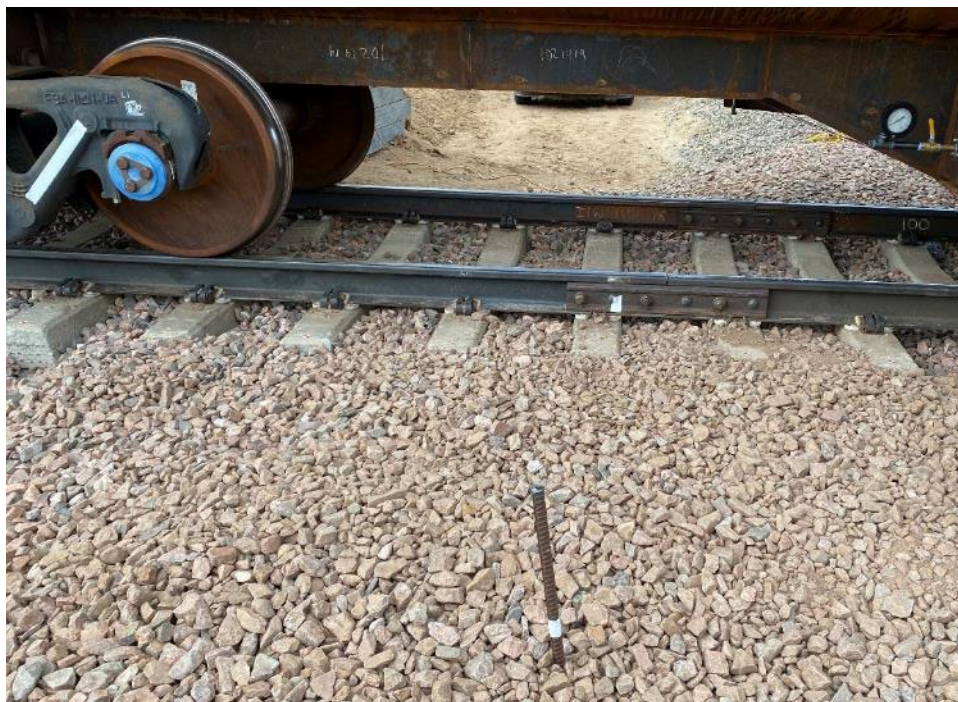
Figure 23. Fixed Measurement Point used to Assess Track Shift After the Impact

The connection of the rails to the ties and the ties to the ground is one of the model parameters mentioned but not well defined in M-1004. In the test, flexible rail fasteners were used to connect the rails to the ties and Class 3 AREMA ballast was used to construct the track bed. Additionally, a small marker was placed on the northern edge of each tie to assist in measuring displacement between pre-test and post-test tie positions. The movement of the ties relative to fixed ground points was measured before and after the impact to assess the track shift that occurred during the impact. Figure 23 shows one such fixed measurement point represented by rebar driven into the ground. Additionally, point clouds of the test area were produced before and after the impact using a drone-based system. The displacement of each tie marker during the test was approximated by post-processing the pre- and post-test drone scan data as described in Appendix J.

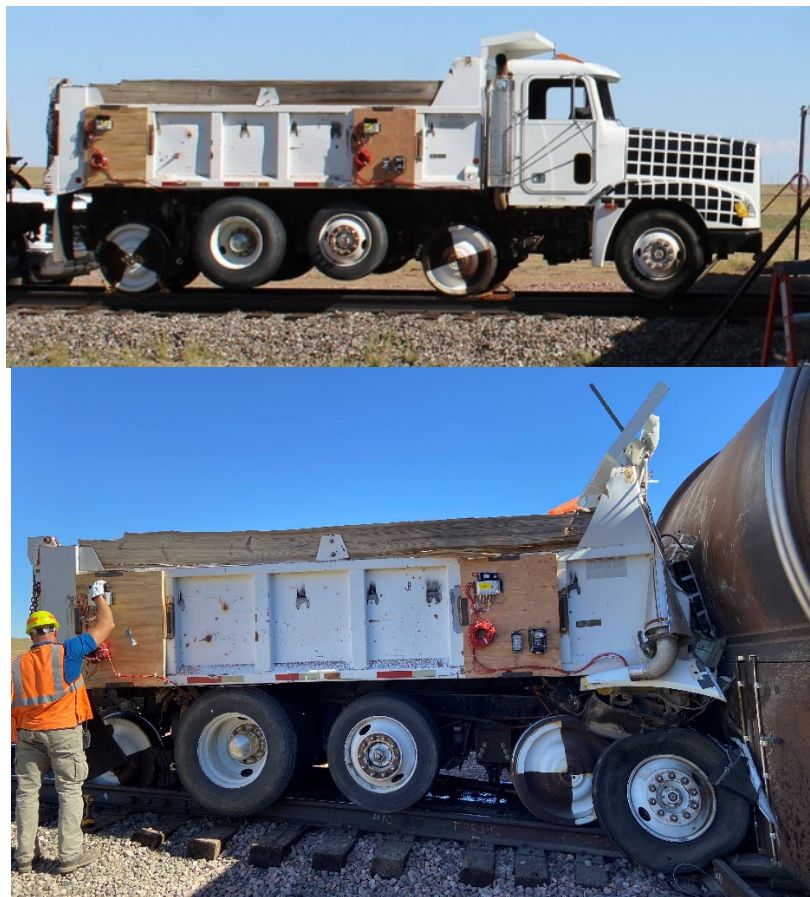
Figure 25. Pre- and Post-Test Condition of the Dump Truck

The kinetic energy of the dump truck was calculated to be 4.94 million foot-pounds (ft-lbf). The main components of the dump truck capable of energy absorption were the dump truck cab, underframe, and bed. The cab was constructed mainly from fiberglass with some structural steel and the underframe of the truck consisted of two C-channels interconnected by cross members. For the test, the dump bed was loaded with steel weights, increasing the structural rigidity of the truck bed. [Figure 25](#) shows the condition of the dump truck before and immediately after the impact. Most of the dump truck cab was destroyed, and some components, such as the seats, were compressed against the rear of the cab. The C-channel forming the underframe peeled back above the front tire of the dump truck. The rear railway wheel of the dump truck derailed.

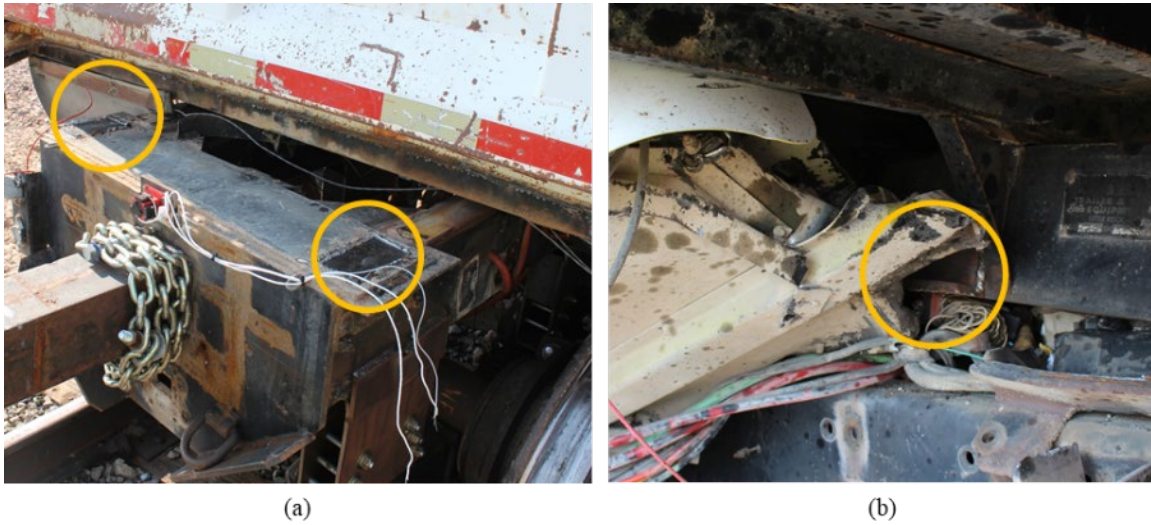
Figure 26. Failed Welds Between Dump Bed and Underframe at (a) the Rear Hinges and (b) the Angle Iron Shown in Figure 8(a)

The dump bed remained largely intact, and it, along with the underframe, moved as a self-contained unit for most of the impact. The dump bed separated from and slid on the underframe during the impact. The welds that were shown in [Figure 8](#) and the welds between the dump bed's hinges all failed during the impact. Some of the weld failures are shown in [Figure 26](#). The weights and their restraining system functioned as expected with the weights remaining attached to the dump bed and the restraining beams deforming, which allowed the weights and the dump bed to slide as a unit. The weights and restraining system can be seen in their post-impact condition in [Figure 27](#). When the bed was removed from the dump truck during test site cleanup, researchers noted that the engine had pushed the piston used to tip the dump bed into the recess

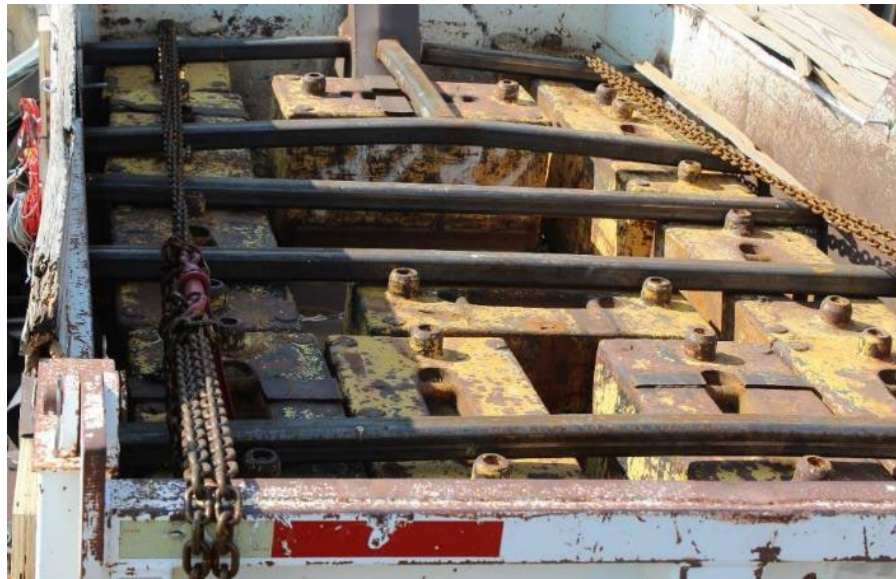
Figure 27. Condition of the Weights and Restraining System Post-Impact

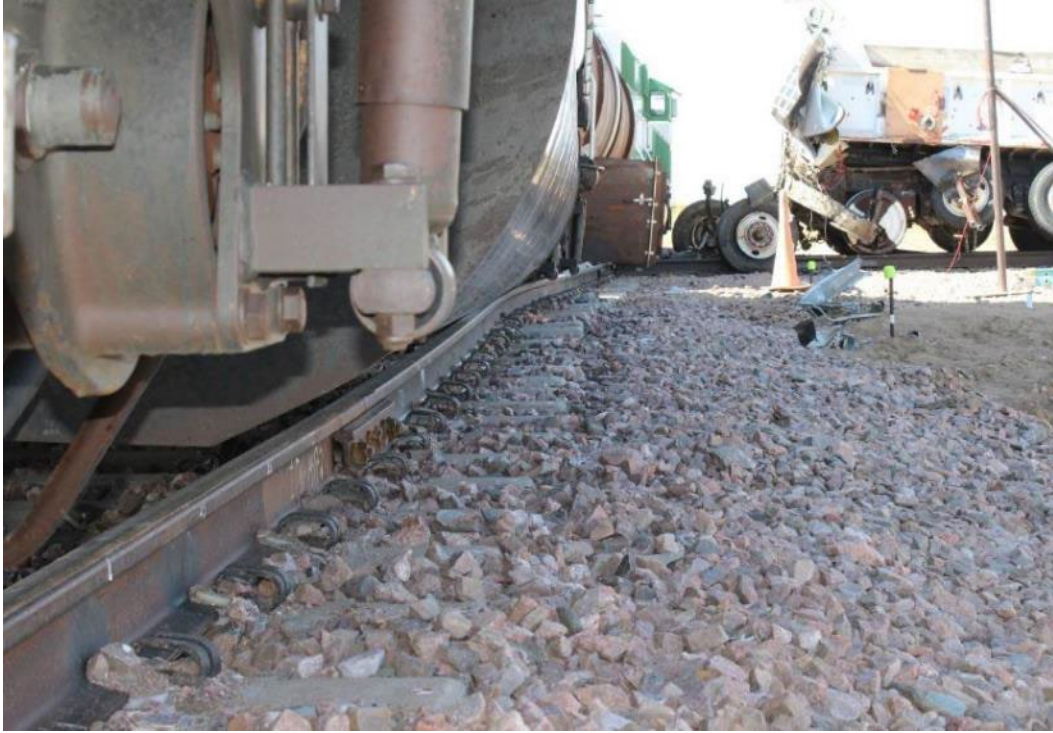
Figure 28. Track Shift on Ballast Bed

The track was not the main concern during impact. The track experienced two failures simultaneously: it shifted laterally on the ballast bed (Figure 28), and the rail on the opposite side of the struck housing rolled over (Figure 29).

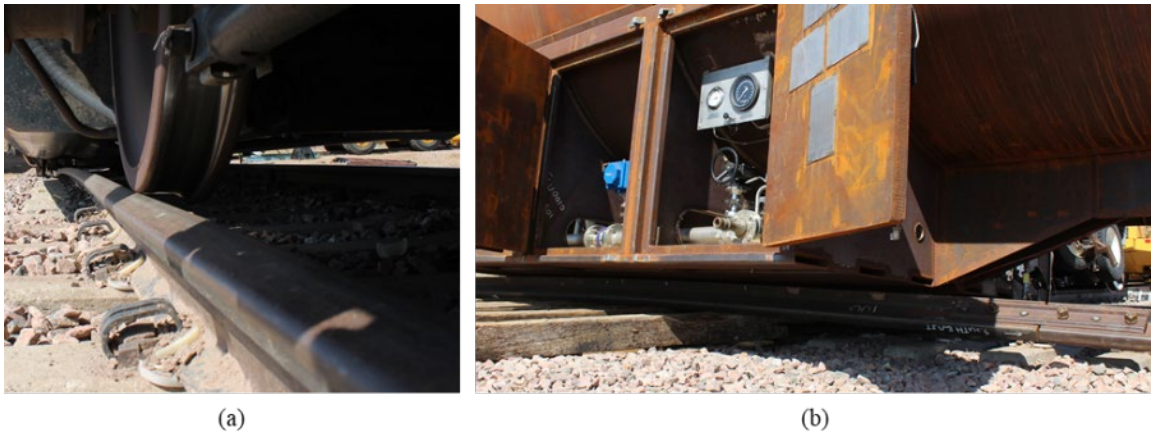
Figure 29. Rolled Rail Under (a) the East-side Locomotive and (b) the South-side LNG Fuel Tender Housing (Non-impacted Side)

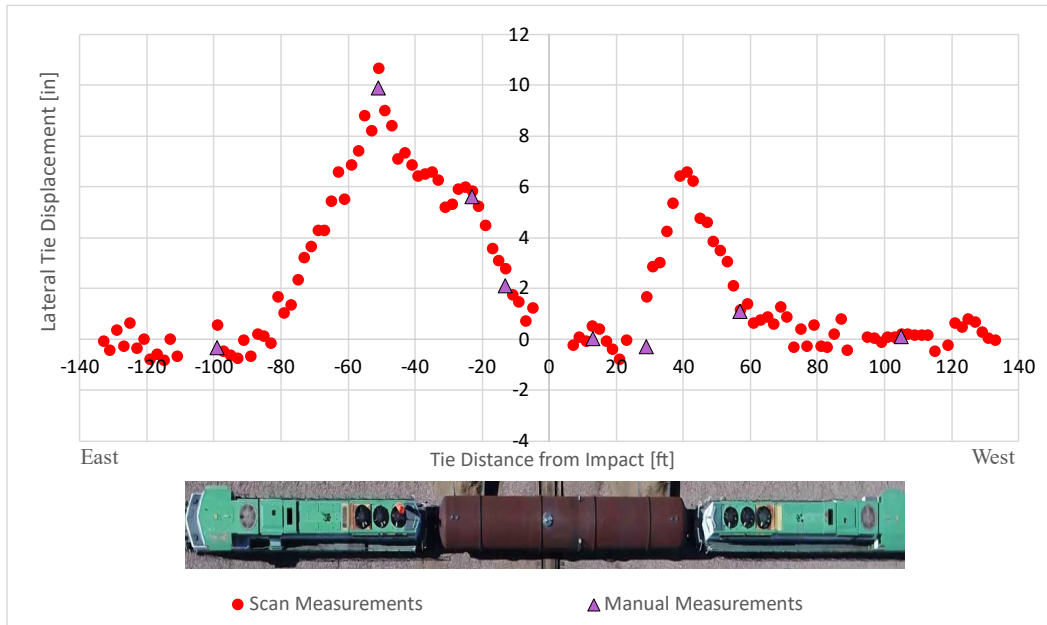
Figure 30. Lateral Tie Displacement Along the Section of Track with the Overhead Picture of the Test Setup Aligned with the Plot to Provide Scale and Positioning

east. It should also be noted that there is strong correlation between the lateral tie displacements measured manually and the lateral tie displacements calculated from the point clouds. This indicates that for this scenario, tie displacements measured from scans are sufficiently precise to be used in place of those measured manually, as well as in locations where tie displacements were not measured manually. The highest lateral tie displacement was recorded below the truck of the eastern locomotive closest to the tender, followed by the freight trucks of the fuel tender. There was effectively no tie displacement at either end of the consist at the F-end trucks of the locomotives.

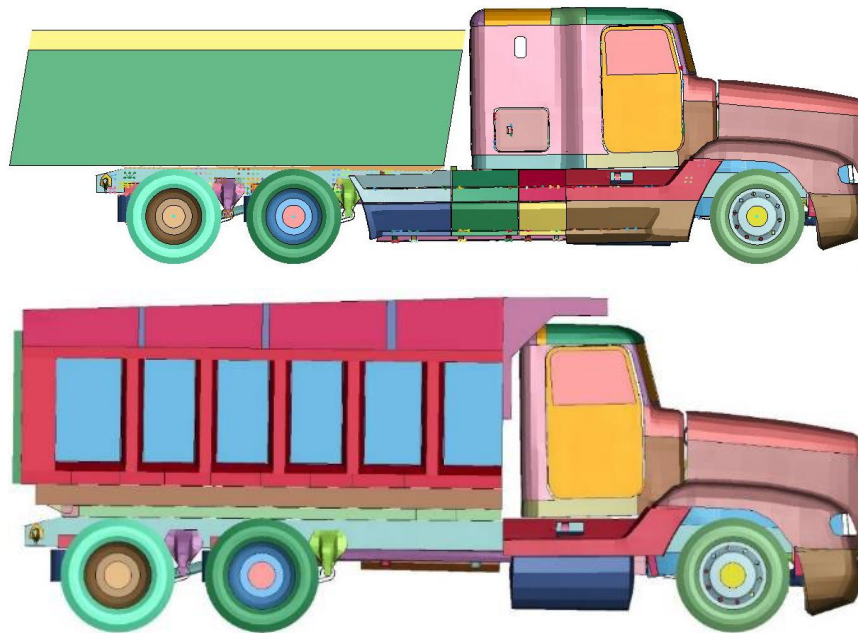
Figure 43. Preliminary (Top) and Finalized (Bottom) Finite Element Models of Dump Trucks Shared by TTI

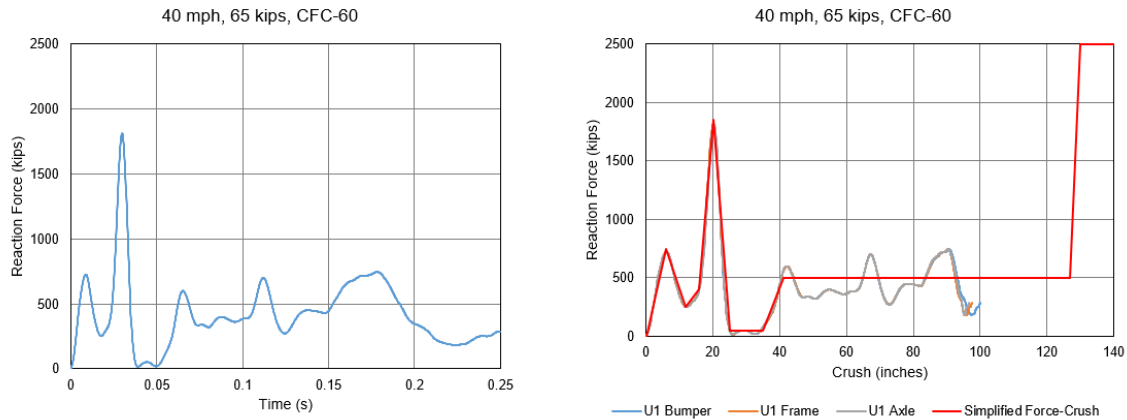
Figure 55. Force Crush Spline for TTI Dump Truck

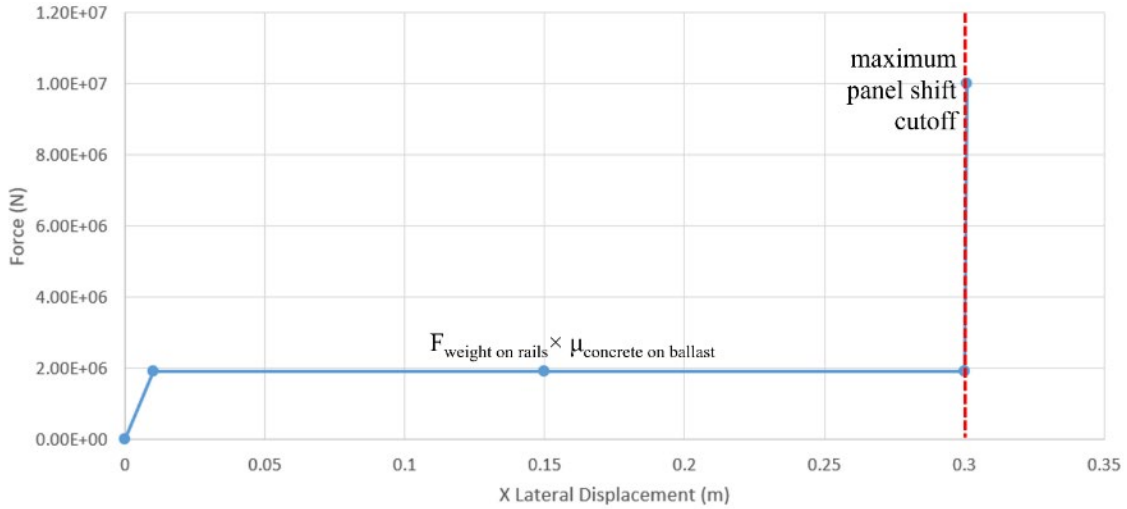
Figure 56. Modeled Track Panel Shift Spline

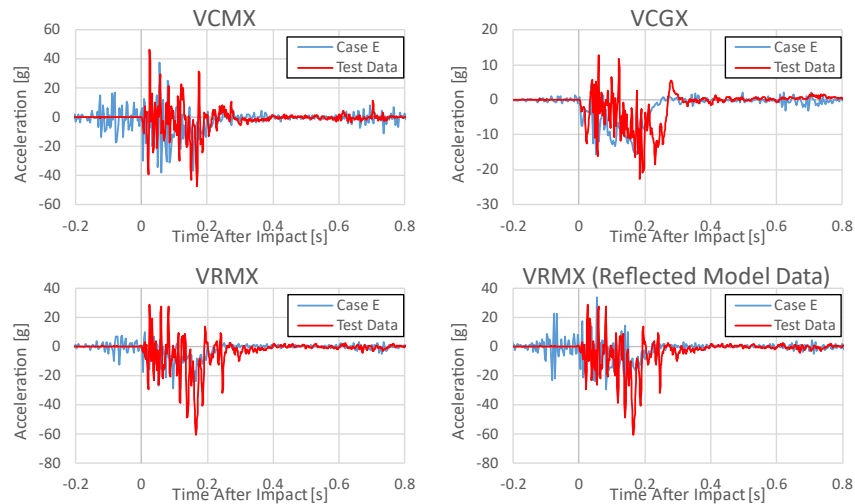
Figure 63. Measured and Case E Accelerations from Channels VCMX, VCGX, and VRMX. VRMX Test Data is also Compared with Reflected Model Data.
