# **TRAFFIC SAFETY EVALUATION OF RETROREFLECTIVE SIGNAL BACKPLATE BORDERS AT SIGNALIZED INTERSECTIONS IN MINNESOTA**

**Max Moreland, Principal Investigator**  
Minnesota Department of Transportation

**JANUARY 2024**

Research Project  
Final Report 2024-04

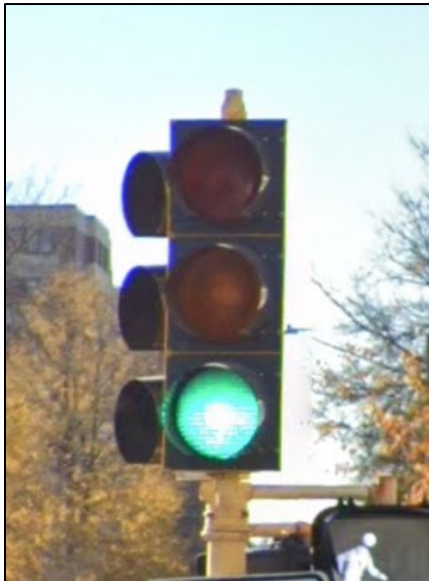
**Figure 1.1 – Signal Head without a Backplate**

Figure 1.1 shows an image of a signal head without a backplate, Figure 1.2 shows an image of a signal head with a standard black backplate, and Figure 1.3 shows an image of a signal with a retroreflective backplate.

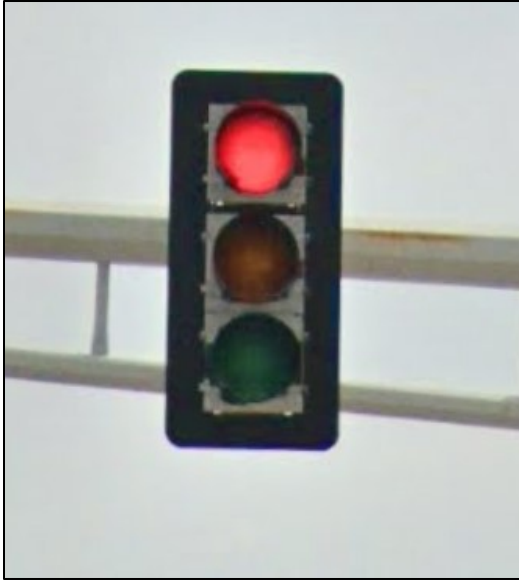
**Figure 1.2 – Signal Head with a Black Backplate**

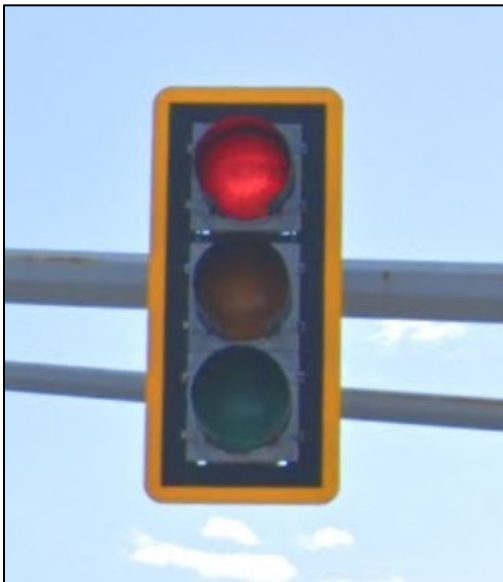
**Figure 1.3 – Signal Head with a Retroreflective Backplate**

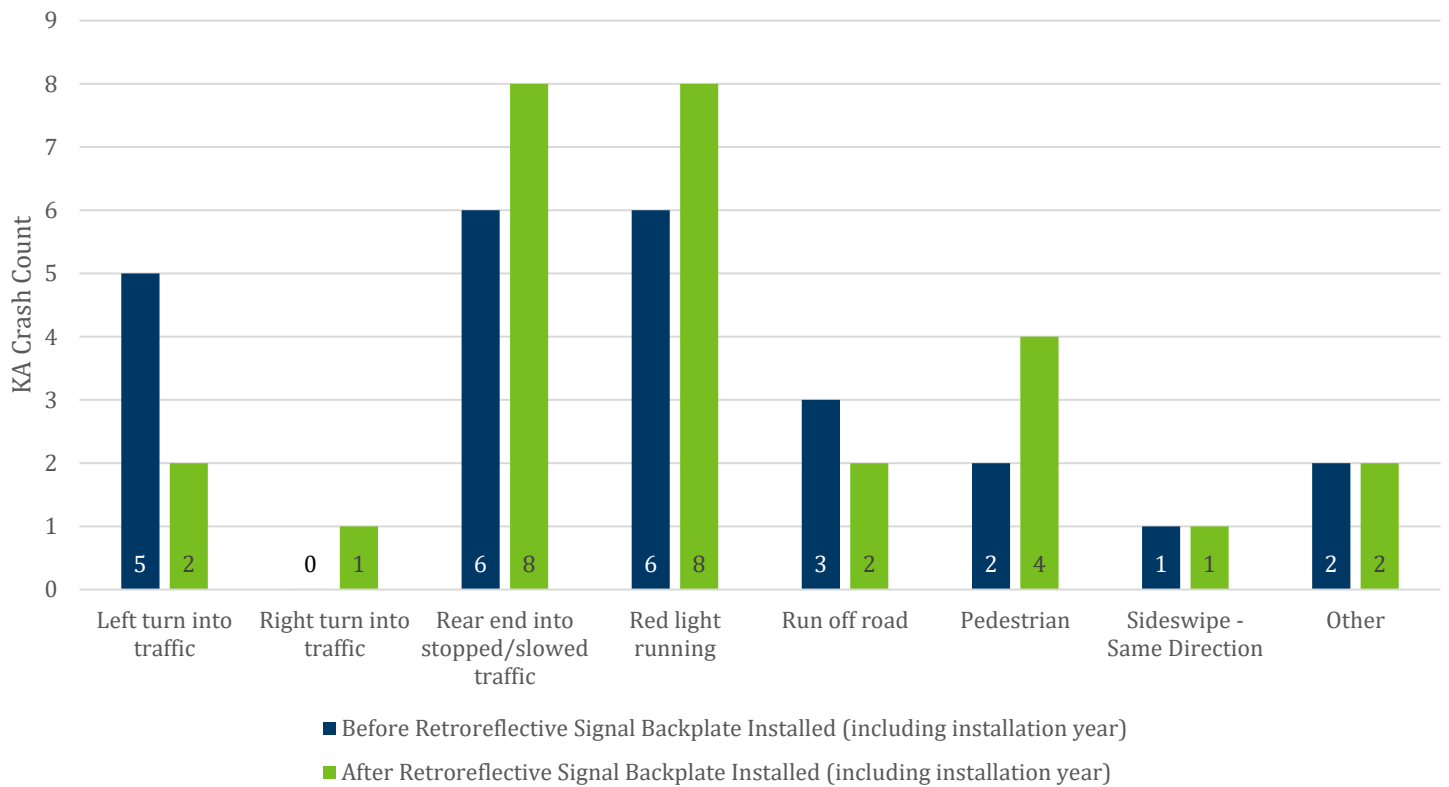
**Figure 4.1 – Before and After KA Crash Counts by Category**

As shown in Figure 4.1, there were increases in the number of KA crashes that involved right turning into traffic, rear ends, red light running, and pedestrians. The increase in some of these crash types indicates retroreflective signal backplates may not be having the desired impacts. However, the largest change in KA crashes with the addition of retroreflective signal backplates is a decrease in left turning crashes. Some agencies exclusively put retroreflective signal backplates on left turn signal heads, and the decrease seen here may indicate that is an appropriate use. However, more data and analysis would be needed to determine if retroreflective signal backplates can be tied to a reduction in left turning crashes.

Table 4.2 shows that the KA crash rates did increase in the after period compared to the before period. Though it was a statistically insignificant increase in crash rates, it warrants a look into the KA crashes that are happening at locations where retroreflective signal backplates have been installed. Using the crash data from the before-after analysis plus the data from the year of installation, all KA crashes were grouped into eight categories by type of crash. Those results can be seen in Figure 4.1.
