# Investigation of High Mast Illumination Pole Handhole Cracking

Tristan Yount  
Danqing Yu  
Caroline Bennett, Ph.D., P.E.  
William Collins, Ph.D., P.E.  
Jian Li, Ph.D., P.E.

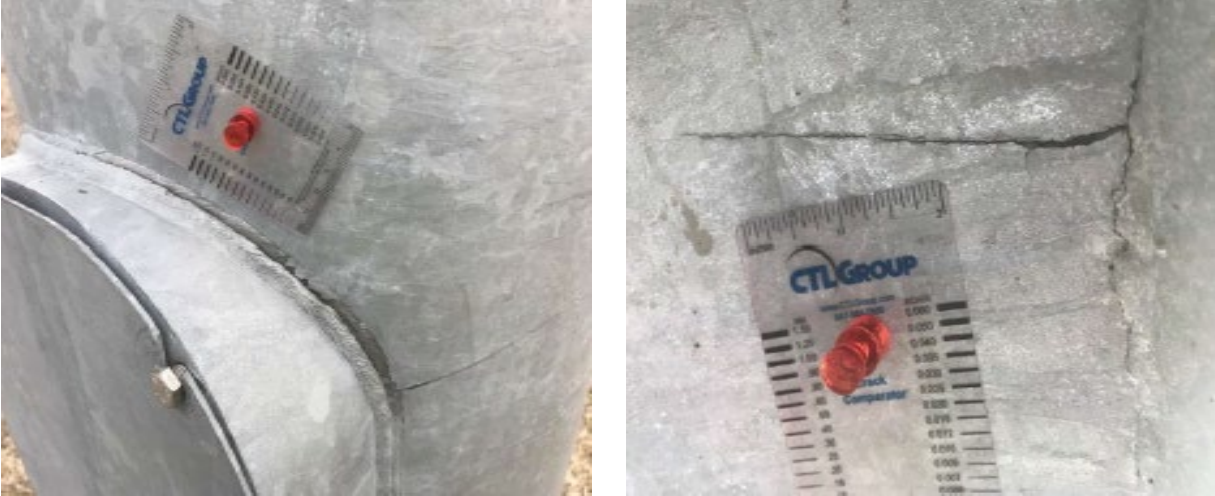
Although HMIPs are designed to resist wind-induced fatigue loading according to the AASHTO (2013) LTS Specification, KDOT recently discovered significant cracking at the handhole and base plate details of the poles after a severe winter storm, as shown in Figure 1.2. Many of the cracked poles had been very recently installed (within a year) and designed according to current specifications. The development of cracks, particularly in such a short period of time, was cause for significant concern since a pole failure would significantly endanger the safety of motorists and potentially cause substantial damage to infrastructure.

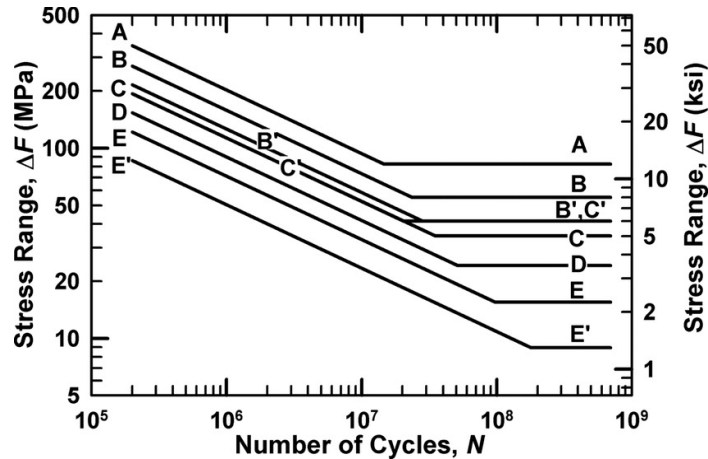
**Figure 1.3: AASHTO S-N Curves for All Design Categories (AASHTO, 2017)**

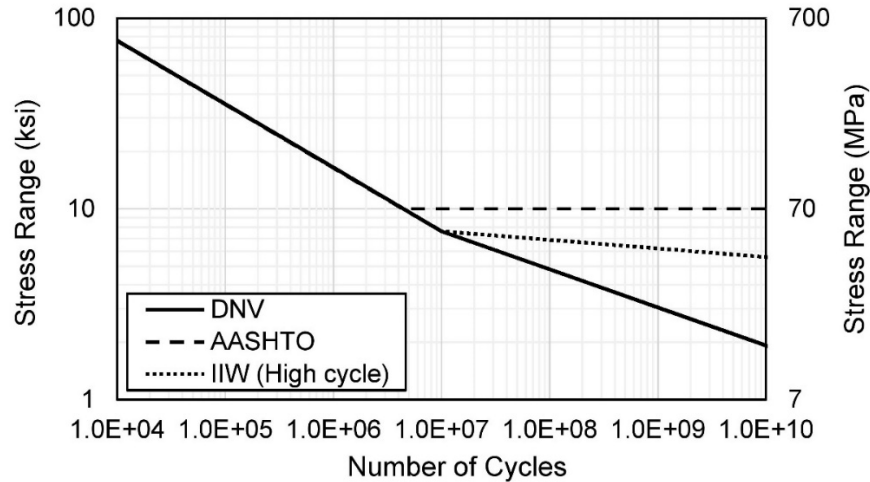
**Figure 1.5: Fatigue Resistance S-N Curve of Steel Details for Structural Hot-Spot Stress Analysis**

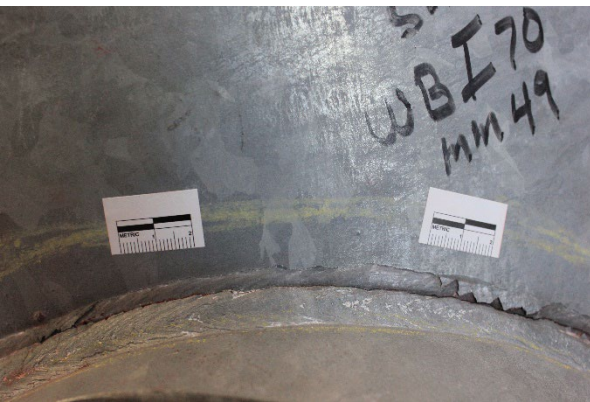
**Figure 2.2: Pole B - Extensive Cracking at Top of the Handhole Weld with Horizontal Cracks Growing into the Pole Base Metal on the (a) Left and (b) Right Sides**

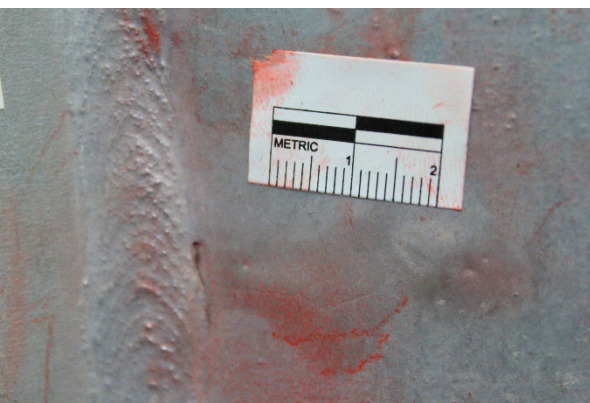
**Figure 2.3: Pole C - Extensive Cracking From (a) the Top Middle of the Handhole to (b) the Right Radius with a Horizontal Crack Growing into the Pole Base Metal**

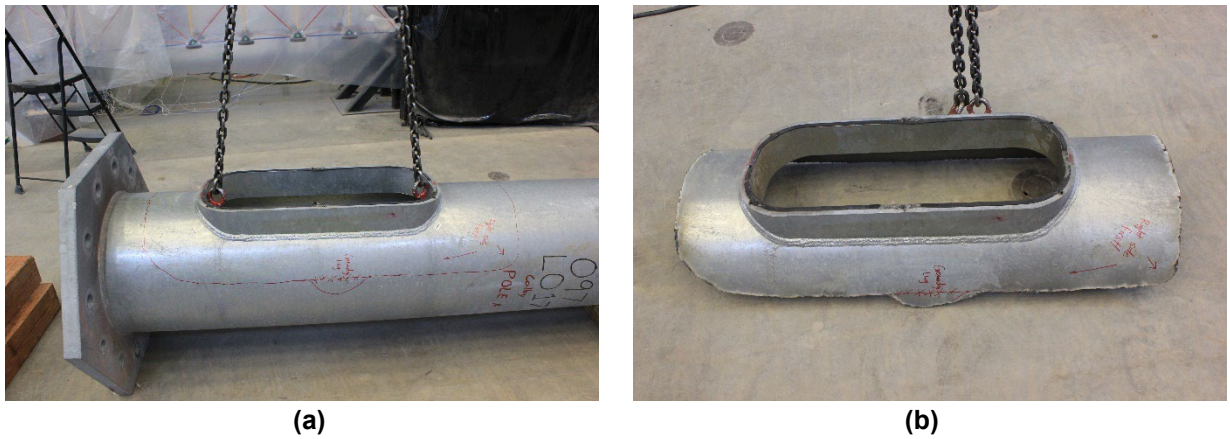
**Figure 2.5: The Supports Used for (a) Plasma Cutting Poles A and C and (b) the Handhole Removed from Pole A**

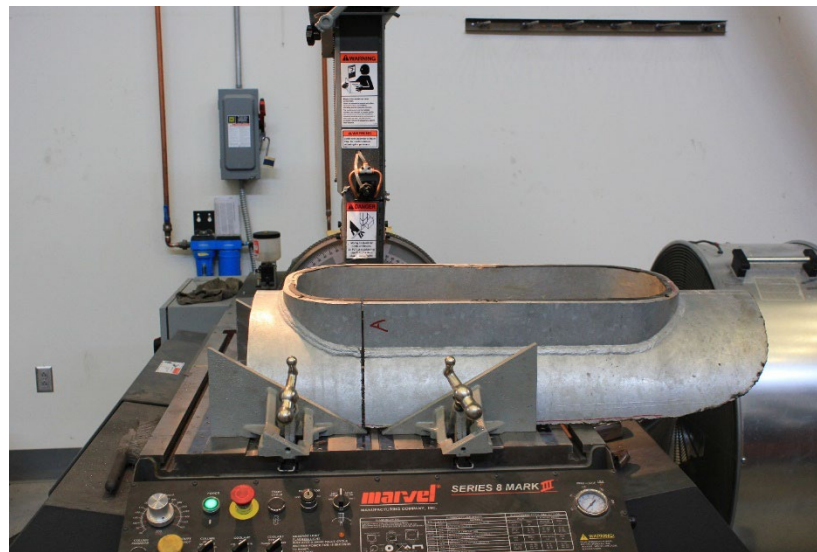
**Figure 2.7: Vertical Bandsaw Used to Further Process Each Handhole**

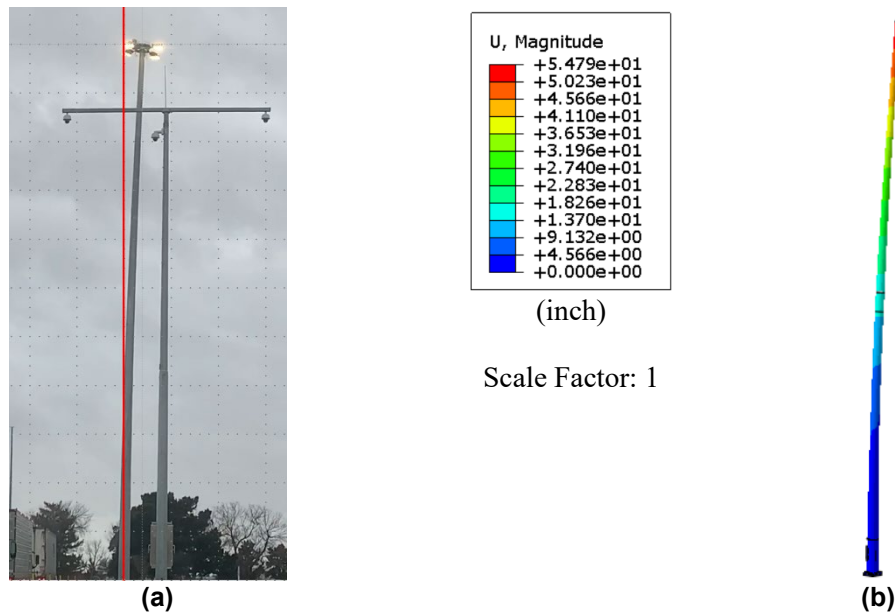
**Figure 2.17: Displacement of High Mast Illumination Pole in (a) Video Taken During the 2019 Winter Weather Event and (b) Finite Element Analysis**

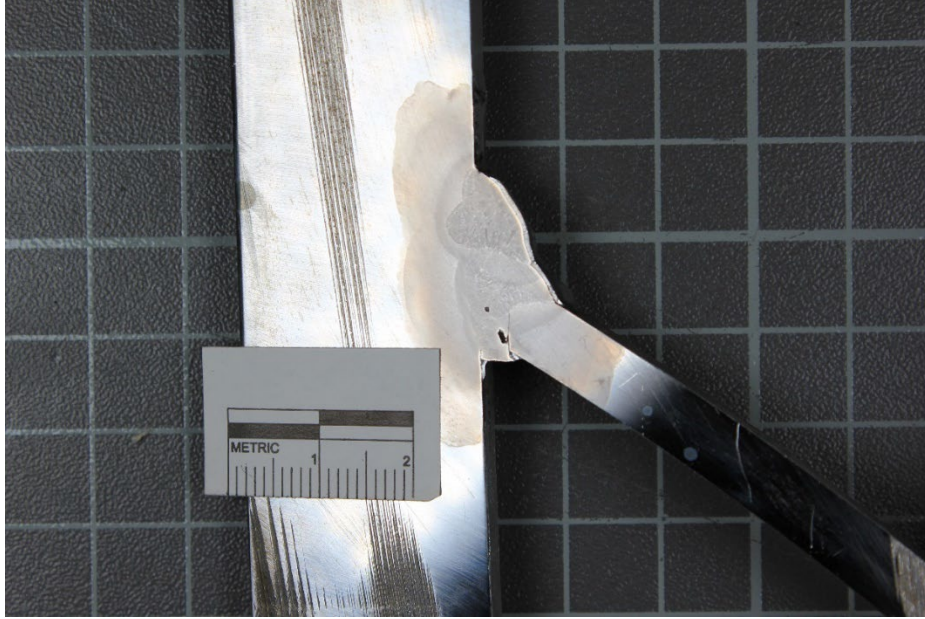
**Figure 3.6: Weld Profile of the Top Side of Section B-2-1**

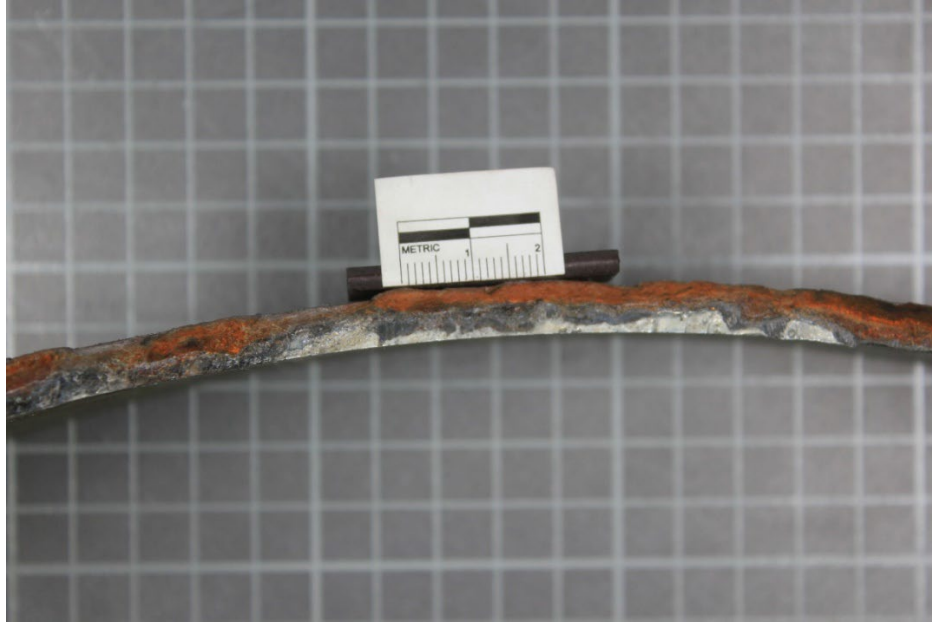
**Figure 3.9: Lack of Fusion in the Center of the Pole B Crack Surface**

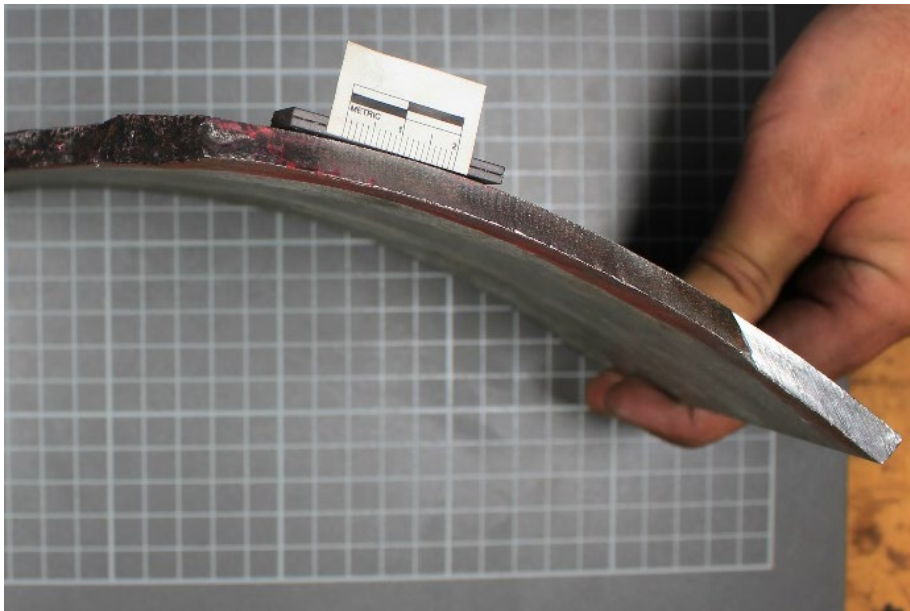
**Figure 3.15: Horizontal Crack at the Right Side of Pole C**

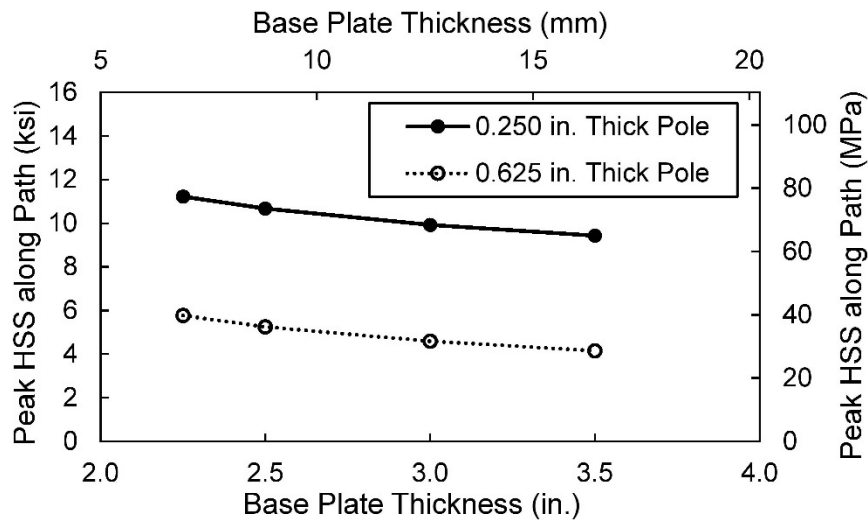
**Figure 3.41: Influence of Base Plate Thickness on Structural Hot-Spot Stresses at Base Plate Detail**

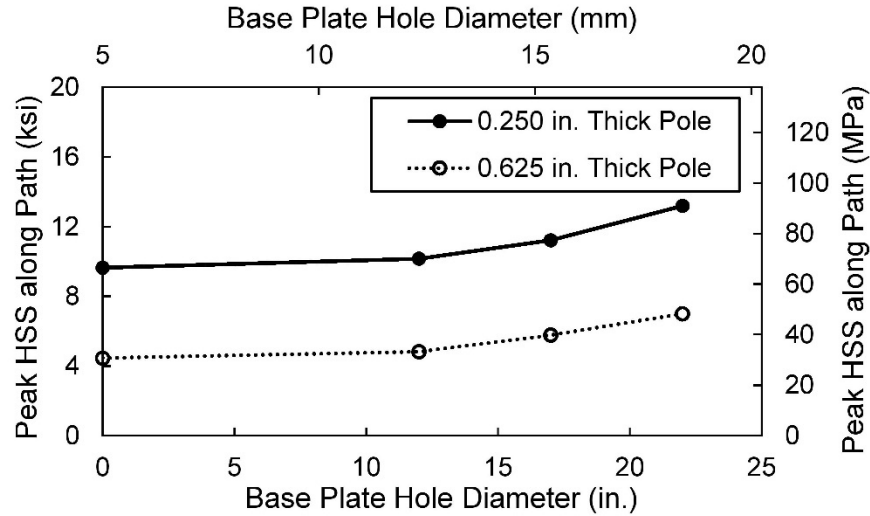
**Figure 3.42: Influence of Base Plate Hole Diameter on Structural Hot-Spot Stresses at Base Plate Detail**

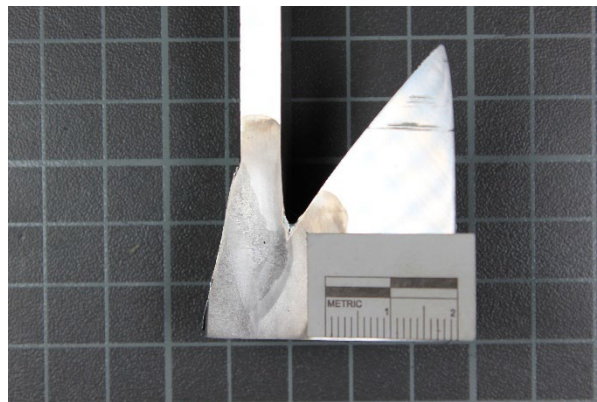
**Figure A.10: Left Side of A-3-6**

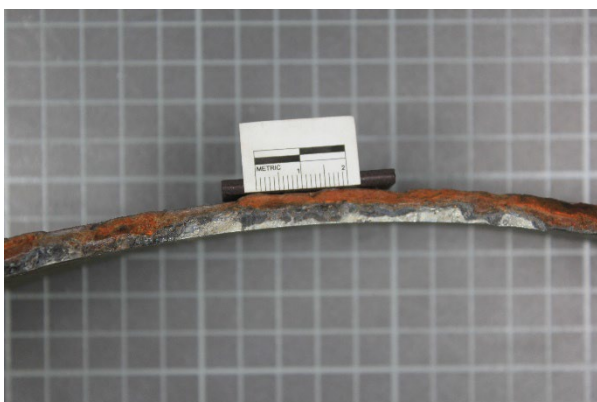
**Figure A.21: (a) Pole B Crack [1], (b) Pole B Crack [2]**

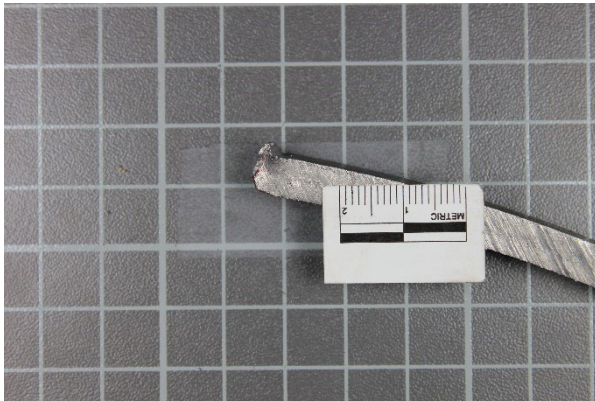
### A.3 Pole C Crack Images

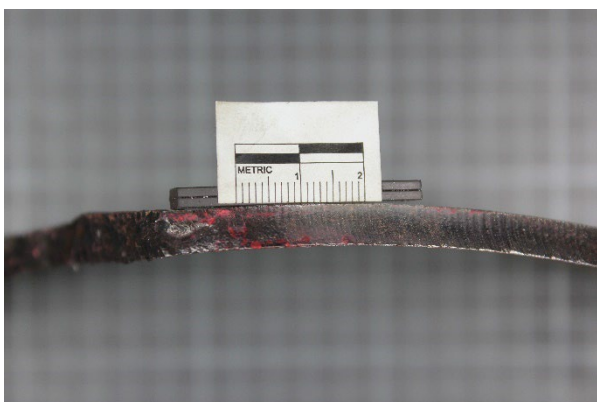
**Figure A.34: (a) Pole C Crack [3], (b) Pole C Crack [4]**

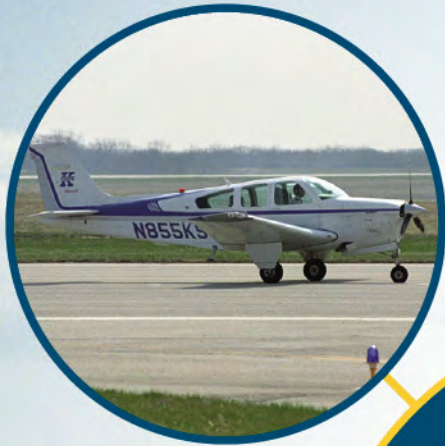
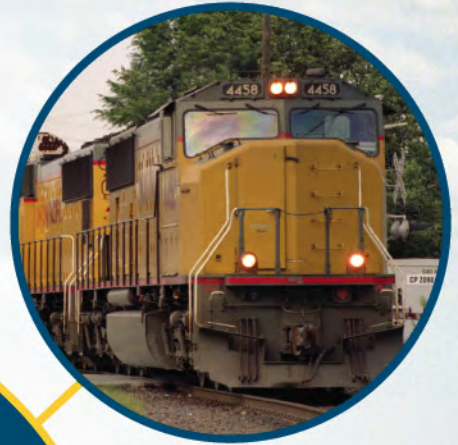
The central logo for the Kansas Department of Transportation. It features a dark blue circle with a yellow border. Inside the circle, the Latin motto "AD ASTRA PER ASPERA" is written in yellow on a banner above a semi-circle of yellow stars. Below the stars, the word "Kansas" is written in a large, white, serif font. Underneath "Kansas", the words "Department of Transportation" are written in a smaller, white, sans-serif font.
