Report # MATC-MS&T: 133-2

## Repair of Corroded Steel H-Piles Using High Performance Material - Phase II

Department of Civil, Architectural  
& Environmental Engineering  
Missouri University of Science and Technology

## **Repair of Corroded Steel H-Piles Using High Performance Material – Phase II (UHPC and FRP Repair Sections)**

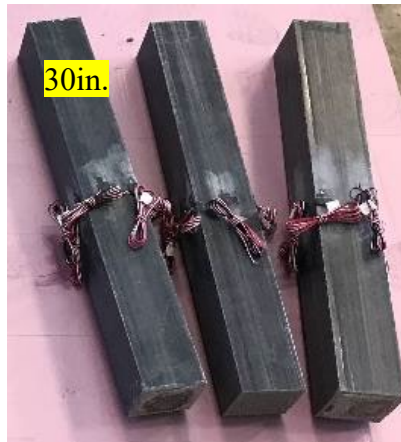
**Figure 2.1** CFPTs: (a) different length parameter, and (b) reinforced tube group

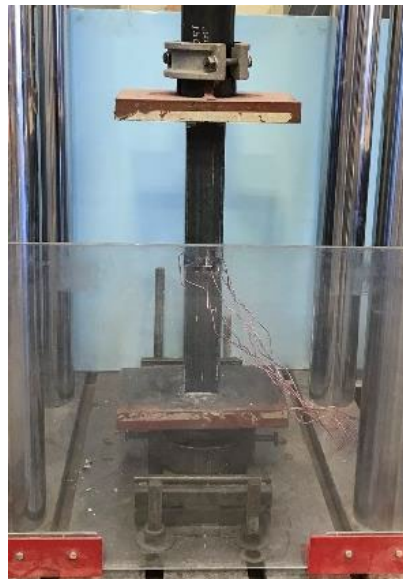
Figure 2.2 shows a 500 kips capacity MTS testing machine that was used for testing the columns. The load was applied monotonically, at a rate of 0.05in./min, until rupture occurred and the test specimen became unstable.

**Figure 2.2** Compressive test setup

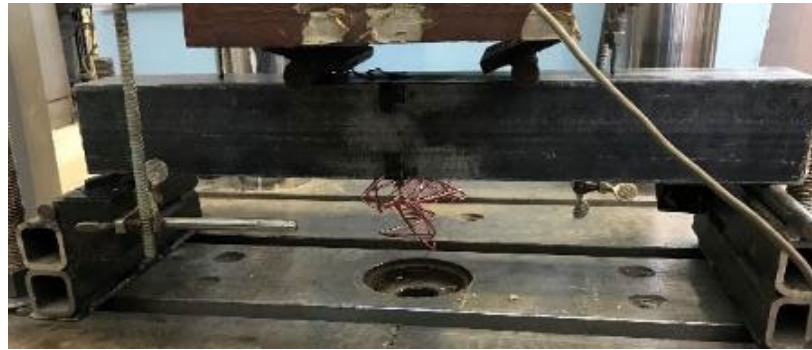
A four-point bending test was performed over a simple clear span of 27 in. following the ASTM D7250. The load was applied at two points with a load span of 9 in. Figure 2.3 shows the

Eight uniaxial strain gauges were used to measure the strains on the middle of the columns and beams. Two linear variable displacement transducers (LVDTs) were placed at the 1/3 and 2/3 points on the length of the beam to determine the deflection profile of the tested beams.

**Figure 2.3** Bending test setup

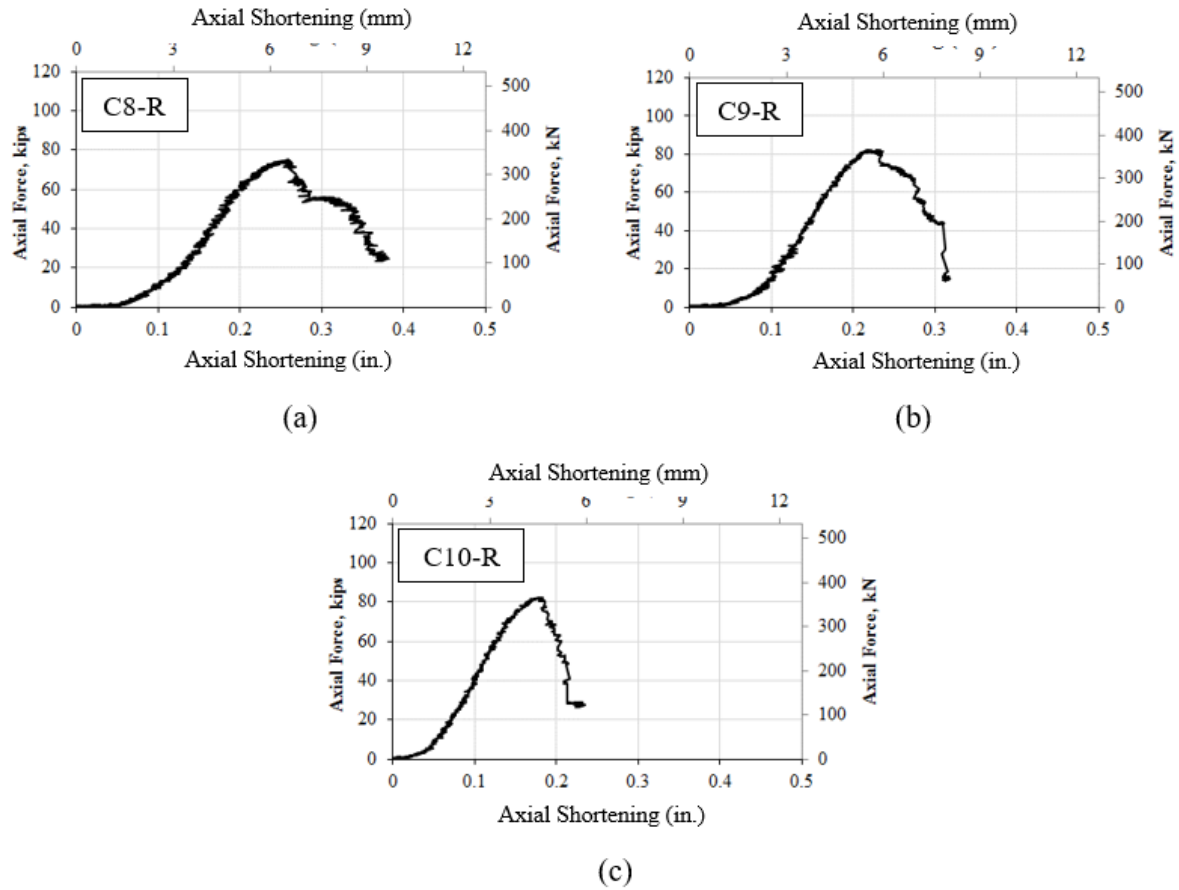
In compression test specimens, adding reinforcement to the concrete-filled FRP tube changed the axial capacities but did not change the failure mode of the tested specimens (table 2.8). All the tested specimens (C8-R, C9-R, and C10-R) failed nearly at the same load of 75.0, 82.0, and 82.3 kips respectively with deflection varying from 0.18 to 0.25 in. (fig. 2.8) with the same mode of failure which is the rupture of the FRP tube at the corners. Adding reinforcement to the plain concrete in the hollow FRP columns decreased the capacity of the section from 95.48 kips to 79.7 kips for a 17% decrease in load. Adding the reinforcement to the plain concrete in the hollow FRP tube changed the capacity but didn't change the mode of failure.

**Figure 2.8** Axial Load vs axial shortening

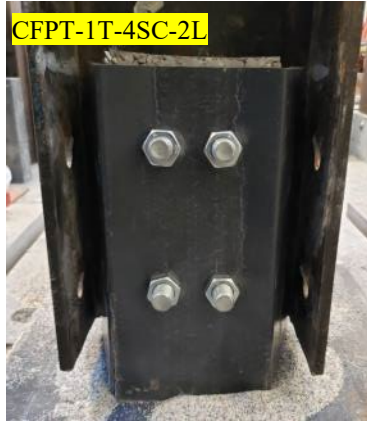
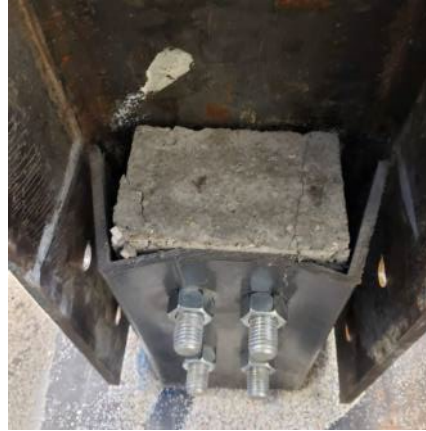
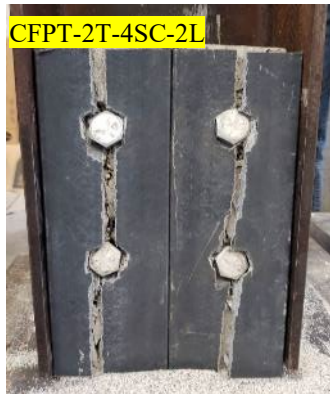
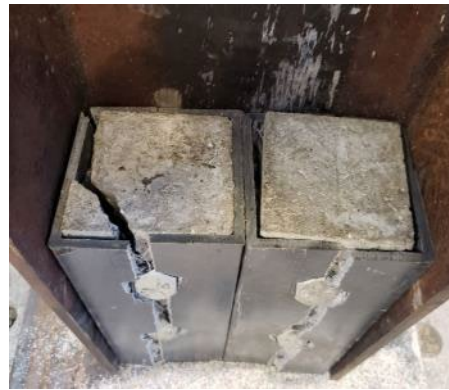
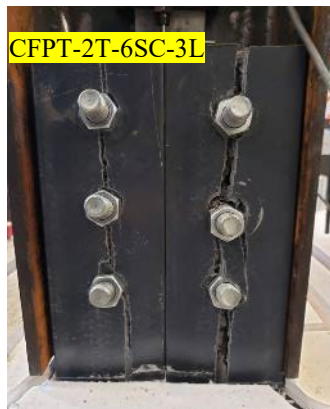
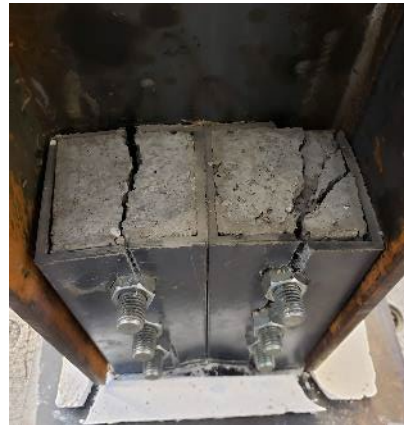
Figures 3.4b and 3.4c show the failure modes of the specimens 2T-4SC-2L and 2T-6SC-3L, respectively, which were mainly splitting failure initiating at both the concrete and CFRP and observed along the longitudinal direction passing through the center of the SCs. The peak load was 125.7 kips for 2T-4SC-2L (fig. 3.5b) and 177.2 kips for 2T-6SC-3L (fig. 3.5c).

**Figure 3.4** Failure modes of push-out tested specimens: (a) CFPT-1T-4SC-2L, (b) CFPT- 2T-4SC-2L, and (c) CFPT-2T-6SC-3L

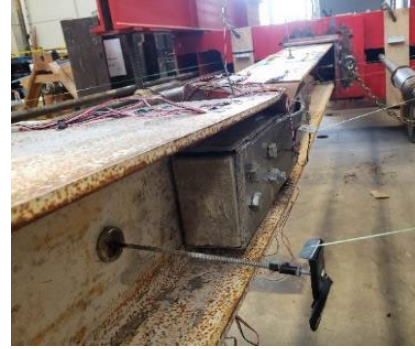
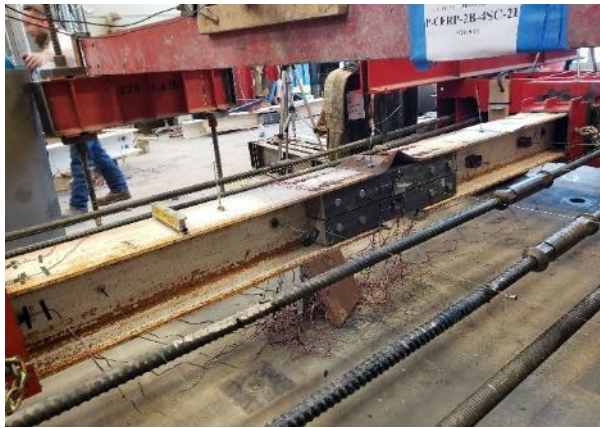
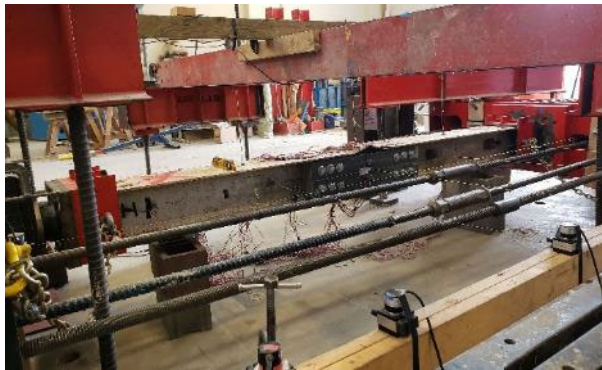
**Figure 3.7** Large-scale repaired H-pile before and after the test: (a) CFPT-1T-8SC-2L, (b) CFPT-2T-8SC-2L, and (c) CFPT-2T-12SC-3L

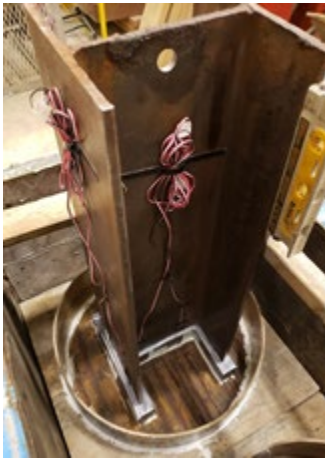
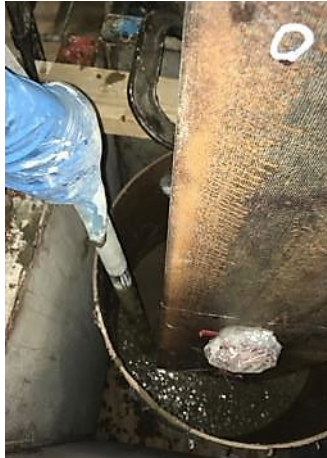
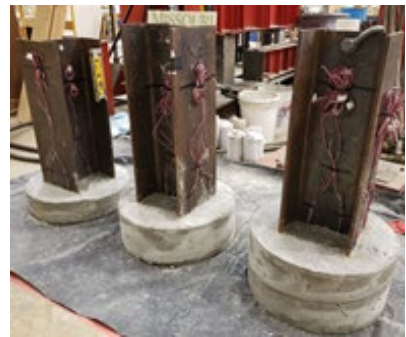
**Figure 4.2** Concrete encasement placing (a) UHPC, and (b) CC

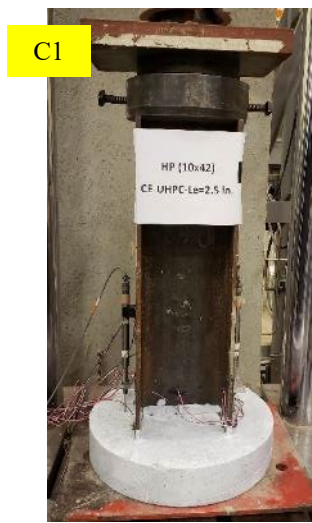
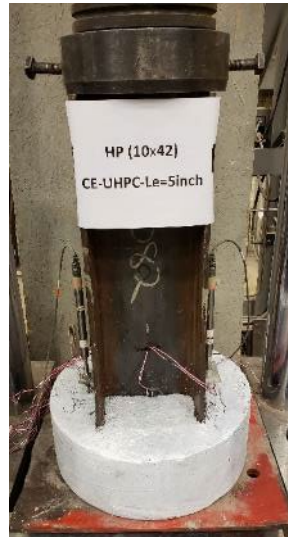
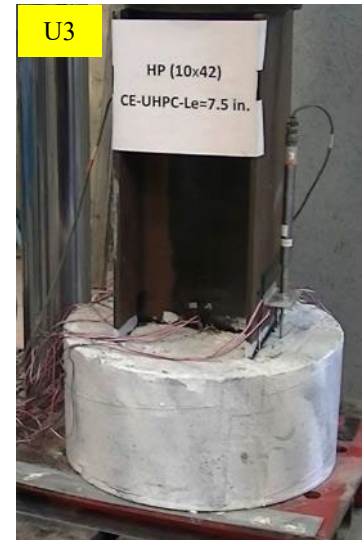
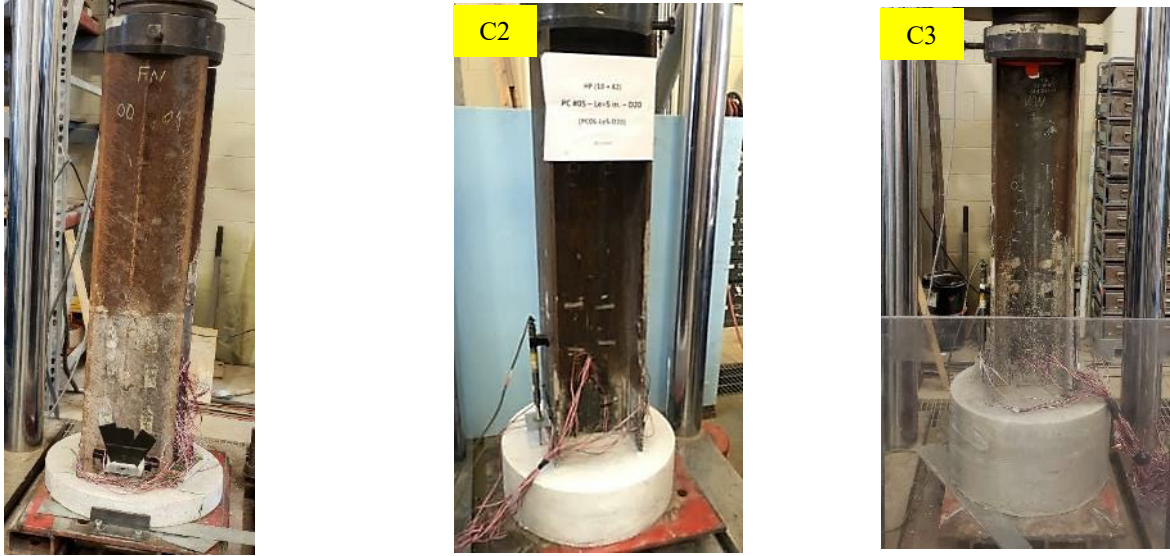
**Figure 4.3** Instrumentation of the test specimens (a) test layout, (b) strain gauges mounted on the H-pile, (c-d) LVDTs mounted on flanges of an H-pile with UHPC, and CC specimens

**Figure 4.3 cont.** Instrumentation of the test specimens (a) test layout, (b) strain gauges mounted on the H-pile, (c-d) LVDTs mounted on flanges of an H-pile with UHPC, and CC specimens

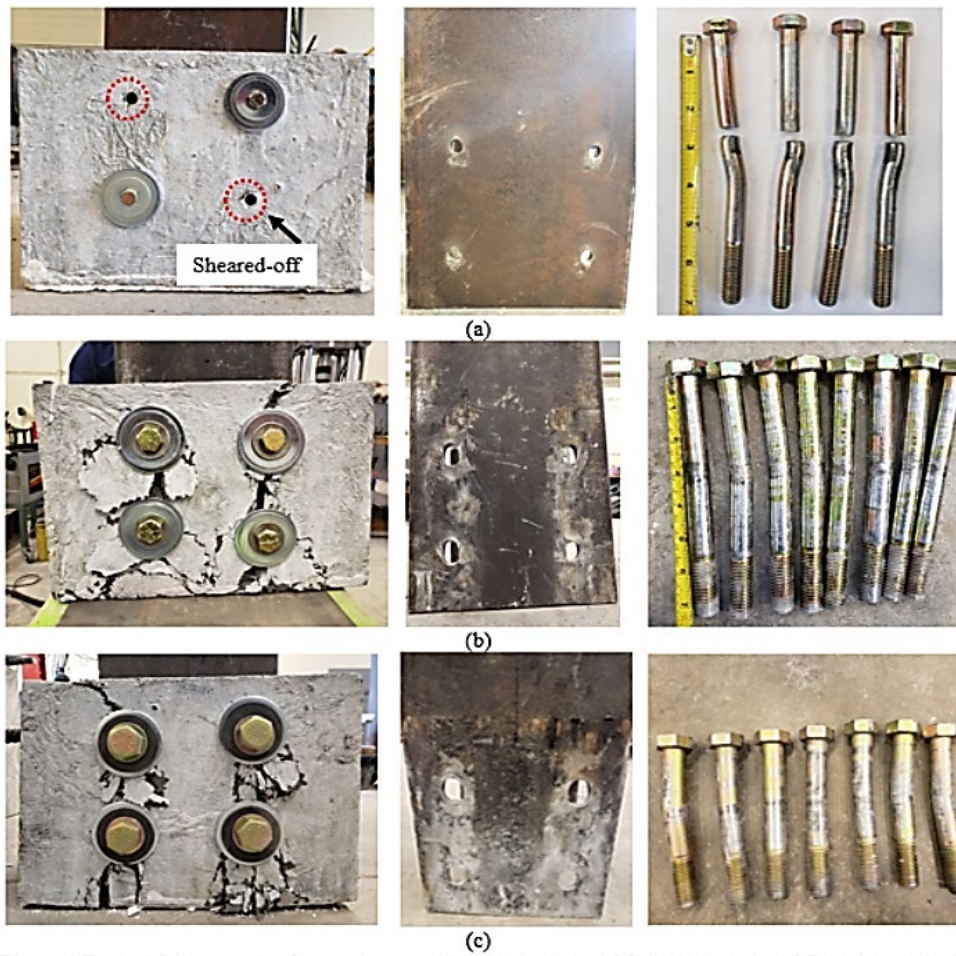
**Figure 5.5** Typical failure modes for specimens with (a)  $\frac{1}{2}$  in., (b)  $\frac{3}{4}$  in., and (c) 1 in. diameter SC

This was followed by the shearing-off of a top bolt from each flange (fig. 5.5a) and the drop of about 17%, 15%, and 21% of the  $P_{\max}$  in the case of 1.5t-1/2SC-1CG, 2.25t-1/2SC-1CG, and 2.25t-1/2SC-2CG, respectively. Further, shearing-off of a bottom bolt from each flange occurred, dropping the axial load to about 42%, 51%, and 45% of the  $P_{\max}$  in the case of 1.5t-1/2SC-1CG, 2.25t-1/2SC-1CG, and 2.25t-1/2SC-2CG, respectively. With the shearing-off of each bolt, the stepwise drop in the axial load was observed, as shown in fig. 5.6b-d,

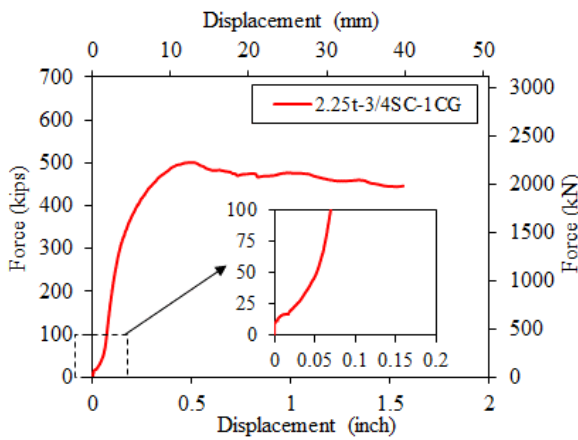
UHPC plate. With continuous loading, specimens 1.5t-1/2SC-1CG, 2.25t-1/2SC-1CG, and 2.25t-1/2SC-2CG reached their peak axial loads ( $P_{\max}$ ) of 291 kips, 287 kips, and 295 kips, corresponding to about 45- 47% of the squash load ( $P_o$ ) of the H-piles, at a displacement of 0.32 in., 0.25 in., and 0.29 in., respectively.

**Figure 5.6** Force vs displacement curves of the specimens in the UHPC-phase I testing

**Figure 5.6 cont.** Force vs displacement curves of the specimens in the UHPC-phase I testing

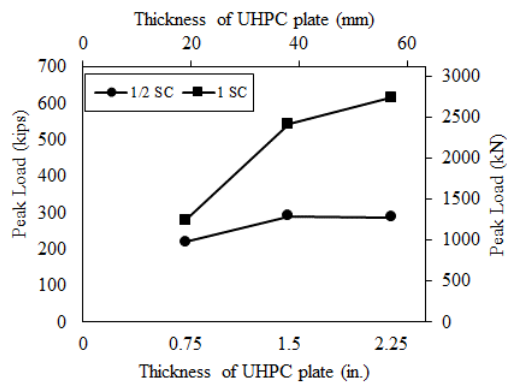
**Figure 5.7** Parameters affecting  $P_{max}$  (a) effect of the cross-sectional area of shear connector (SC), (b) effect of number of layers of CFRP grid, (c) effect of thickness of UHPC plate on peak load (P), and (d) ratio of  $P_{max}$  to the nominal squash load of H-pile

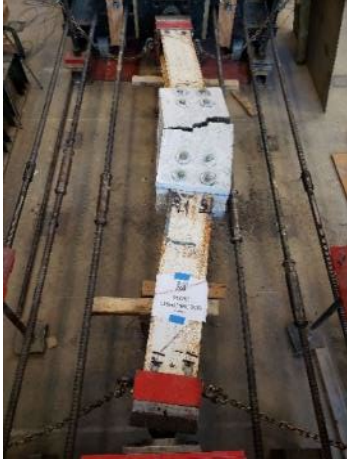
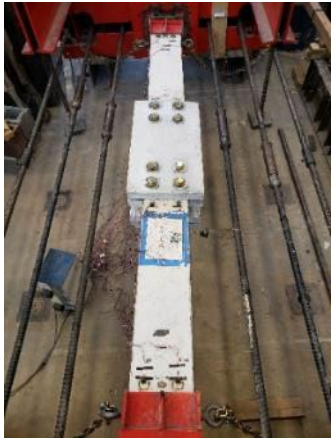
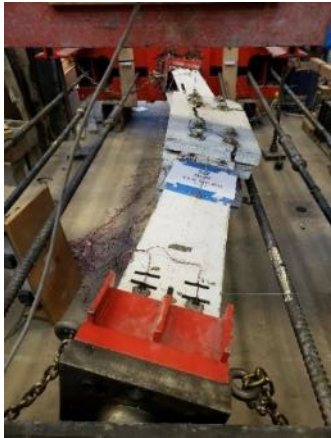
cracking and rupture of the top UHPC plate (fig. 5.8a). Similarly, for specimen UHPC-1SC-1CG, the capacity of the H-piles increased by 83% compared to the original corroded pile with the peak load reaching 430 kips (fig. 5.9b), and failure due to global buckling about the x-axis which triggered splitting cracking on the UHPC plates (fig. 5.8b).

**Figure 5.8** Repaired H-piles before and after the testing: (a) UHPC-0.75SC-2CG, (b) UHPC-1SC-1CG, and (c) UHPC-1SC-2CG

Furthermore, specimen UHPC-1SC-2CG displayed the highest increment of 124% in the axial capacity compared to the reference corroded pile reaching a peak load of 445 kips (fig. 5.9c). The failure mode was similar, however, to that which occurred during testing specimen UHPC-1SC-1CG (fig. 5.8c).
