# Development of a Cable Robot and Measurement of Stay Cable Roundness

PUBLICATION NO. FHWA-HRT-24-043

MARCH 2024

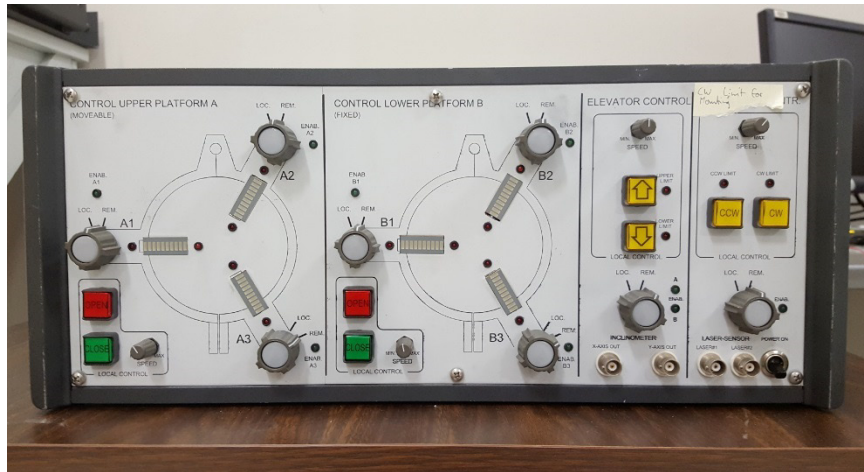
**Figure 4. Photo. The front panel of the control unit box.**

The front panel of the control unit box, shown in figure 4, contains all the knobs and buttons to manually control the robot, while the back panel has the input/output interface connector to control the robot via a computer. The back panel also contains a series of three connectors that connect the control box to wiring box no. 2 on ring B of the robot via a 15.24-m-long instrumentation cable carrying 62 stranded wires. From wiring box no. 2, the wires run through a special housing, mounted next to the hinge shaft, that connects the wires to junction boxes on each remaining ring. The wires are separated at each junction box and then connect to each individual stepper motor, sensor, or limit switch.

The robot can be manually operated using the control unit, a large box containing the electrical circuitry that controls the stepper motors and receives signal feedback from the encoders, linear potentiometers, laser sensors, and limit switches. In the control unit, eight stepper drive boards control each individual stepper motor by first selecting a turn direction and then, when an “enable” command is applied, running the motor via a clock pulse. Also in the control unit is an analog board that converts the output of the linear potentiometers from 0 to 10 V to a distance of 0–103 mm. Additionally, the analog board converts the output from the rotary encoders and creates voltages from the limit switches. The control unit contains a power supply board that generates supply voltages of  $\pm 15$  V and two power supply units that supply +24 V with 4.5 A capacity and +5 V with 4 A capacity, respectively.

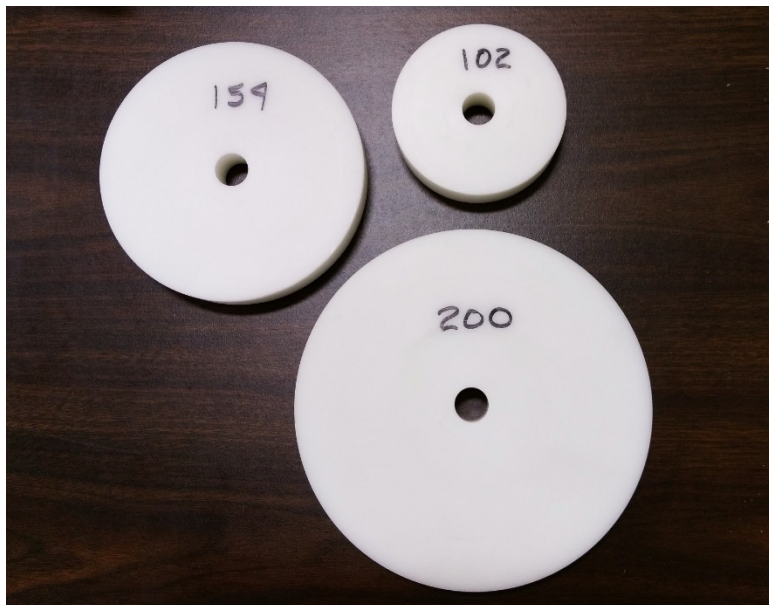
**Figure 7. Photo. The three calibration discs.**

This idea was taken a step further with a set of plastic discs that were machined on the lathe to produce perfectly smooth diameters. The three plastic discs had diameters of 102, 154, and 200 mm respectively and are shown in figure 7. A stand was built using a heavy iron weight from which an aluminum bar was mounted. The discs could be easily swapped from the bar without displacing the stand. For each disc, five measurements were taken, each time rotating the disc a short turn. Since the same pattern appeared despite each disc's rotations, for the first time there was obvious visual evidence that the patterns appearing in the measurement plots were due to the carriage and the precision ring and not the pipe itself. That the lasers were not returning data on a perfectly linear scale also became clear. Variables used to convert the laser signal, which were accurate for the 200-mm disc, would not produce the correct radius for the 102-mm disc, and vice versa. Fortunately, most cable diameters in the field are closer to the 200-mm disc; with the lasers calibrated for that distance the results were assumed to be accurate.

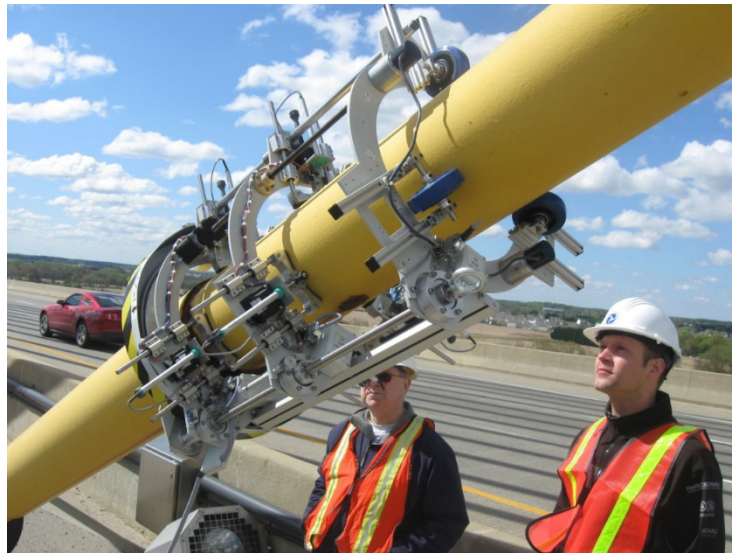
**Figure 11. Photo. The cable robot mounted on a cable at the C&D Canal Bridge.**

The initial field testing was performed on April 28, 2015, on cable South S1, the shortest cable closest to the south tower. The test was a success; the robot managed to climb 5.1 m up the cable, taking 19 measurements on the way up and back down. A few months later, the robot returned to the site and measured three additional cables. Photos of the cable robot climbing and taking

measurements at the C&D Canal Bridge are shown in figure 11 and figure 12. Figure 13 shows the laptop and control unit setup at the base of the bridge. A summary of the testing is listed in table 1.

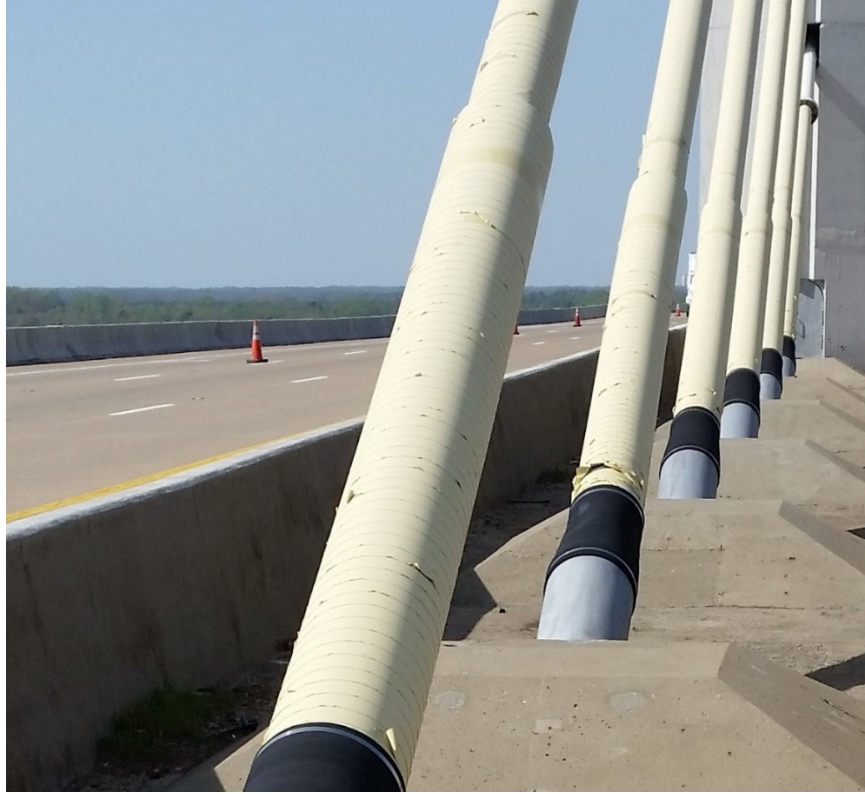
**Figure 32. Photo. Protective tape wrapped on HDPE pipe on stay cables.**

The robot tested six cables over four days of testing in early July. One unusual observation regarding this bridge: The stay cables had no helical fillets, but the HDPE pipe was wrapped in protective tape. During testing, it was noticed that areas of the tape were exhibiting signs of aging and deterioration, with some peeling and tears as illustrated in figure 32. This uneven surface with flaps of peeling tape, wrinkles, and missing pieces of tape periodically interfered with the laser measurements. Figure 33 shows a photo of the cable robot climbing a cable. A summary of the testing is listed in table 5.

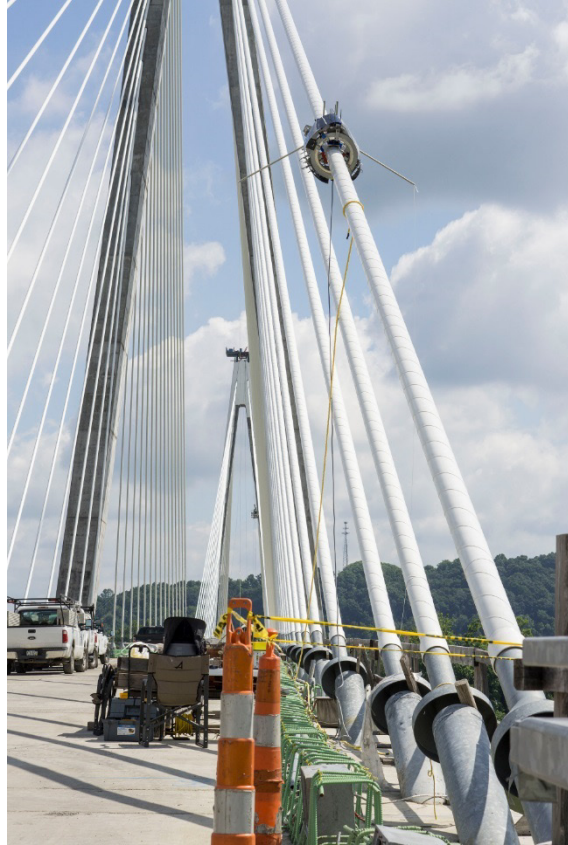
**Figure 46. Photo. The robot climbing a cable on the Ironton-Russell Bridge.**

The bridge was tested in July while it was still under construction, which provided an ideal testing environment free of vehicular traffic. At this stage of construction, the deck was fully connected and supported by the cable stays, but smaller projects such as the erection of concrete barriers and damper installation were ongoing. Eight cables in total were tested, including the longest four cables from each side span of the bridge, although one of the cables included only a single measurement due to poor weather. Figure 46 shows the robot climbing a cable at the bridge site and the laptop and other equipment set up on the bridge deck. Figure 47 shows a view from the side of the robot with the sunshade visible, a piece of sturdy plastic wrapped around the robot to prevent sunlight and shadows from interfering with the laser measurements. A summary of all testing is listed in table 7.

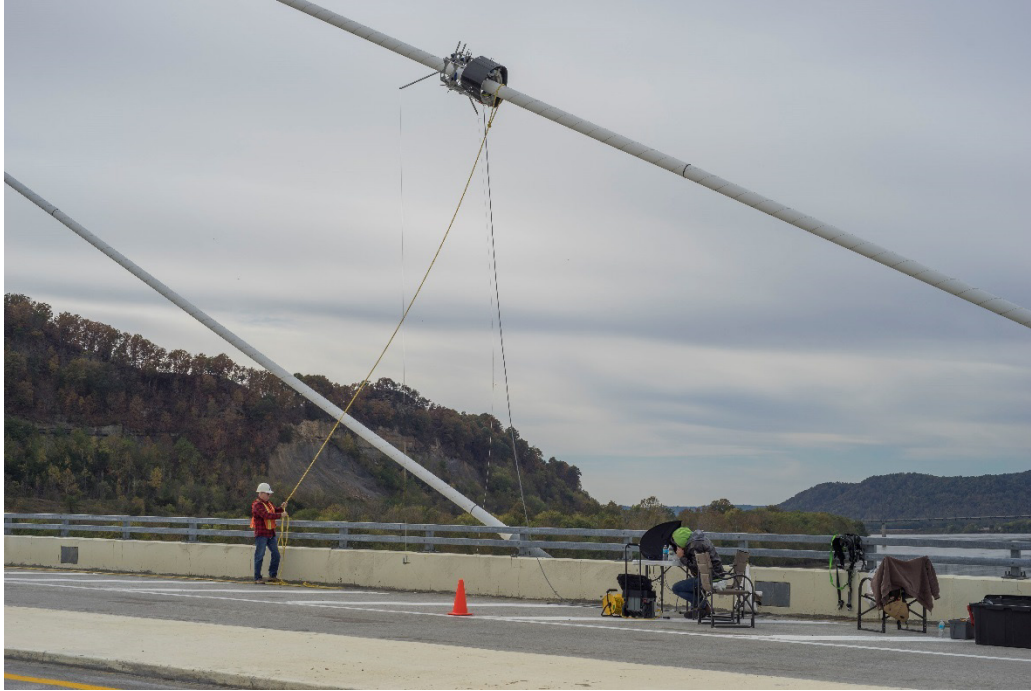
**Figure 57. Photo. The robot climbing a cable at the U.S. Grant Bridge.**

Testing occurred in two phases, the first taking place while the bridge was closed to vehicular traffic as a State contractor resurfaced the overlay of the deck. However, after three days the session was interrupted by inclement weather, which cut short the week of testing. A month later, testing resumed. By this time, the resurfacing project was complete, and the bridge had reopened to traffic. However, the bridge features a wide shoulder equal to a lane of traffic, offering enough space to safely set up all the testing equipment. An additional four days of testing were successfully completed in the second session. The presence of crossties served as an obstacle and limited the available climbing distance on certain cables. During testing, it was observed that some of the crosstie segments seemed to have little or no pretension. A photo of the robot climbing the cable is shown in figure 57. Table 9 contains a summary of all the testing.

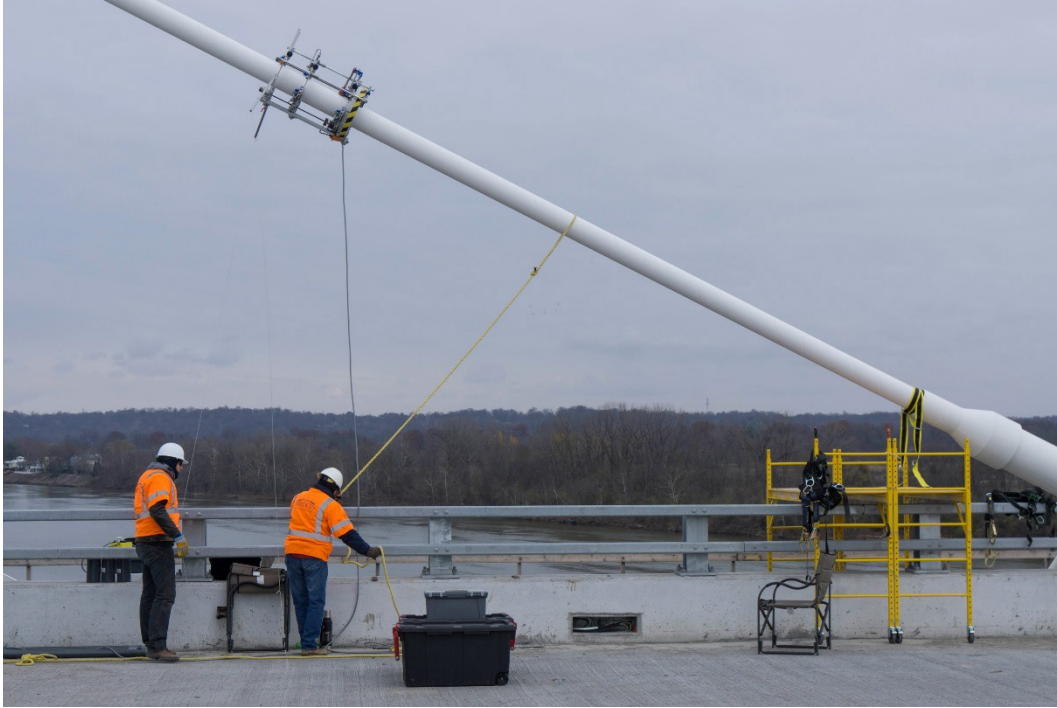
**Figure 67. Photo. The test setup on the East End Bridge, including the scaffolding near the cable anchorage.**

Testing occurred in early December 2016 while the bridge was still under construction, allowing easy access to the cables without any vehicular traffic. Due to a complex, above-deck anchorage and guide pipe system, the first measurable section of the cable was located roughly 2.44–3.05 m above the bridge deck, which required scaffolding around the concrete-and-steel barrier for accessing and mounting the robot. Figure 67 shows the robot climbing on a cable from the East End Bridge and shows the scaffolding near the anchorage used to access the cable. Figure 68 is a different angle of the test setup, which includes the entire bridge deck and the towers in the background. Table 11 contains a summary of all the testing.

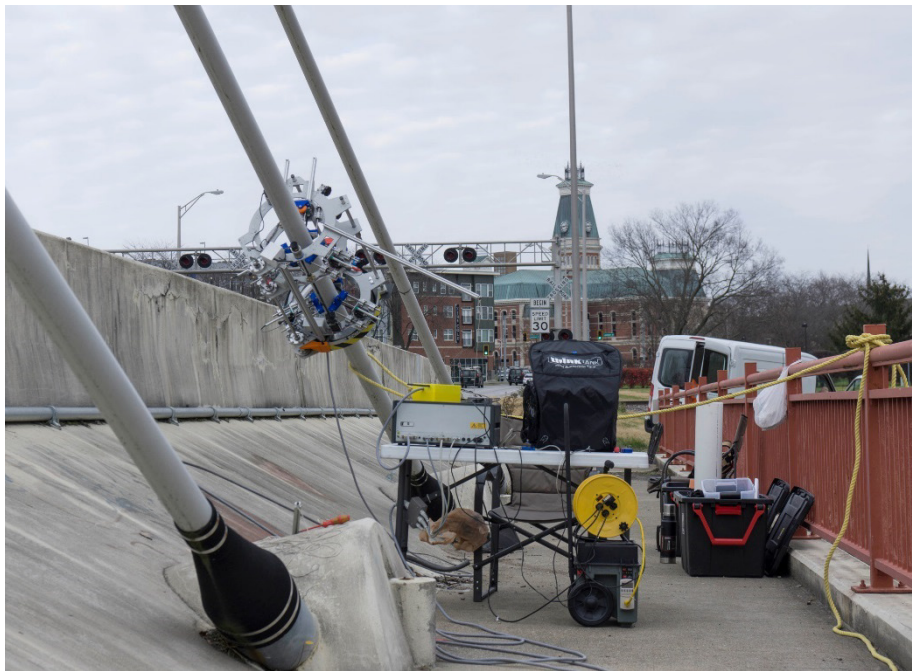
**Figure 77. Photo. The test equipment setup at Robert N. Stewart Bridge.**

A single day of testing on the Robert N. Stewart Bridge was completed in early December 2016, directly after the completion of the East End Bridge testing. The evening before, new clamp bracket heads were installed to account for the bridge's smaller cables. It was noted that the HDPE pipe on these cables was smooth and had no helical fillet. The cables' anchorages are located on the exterior of the roadway, protected by a concrete barrier and alongside a sidewalk area, which provided ample space to set up the test equipment. Photos of the test area and equipment are shown in figure 76 and figure 77. Table 13 contains a summary of all the testing.

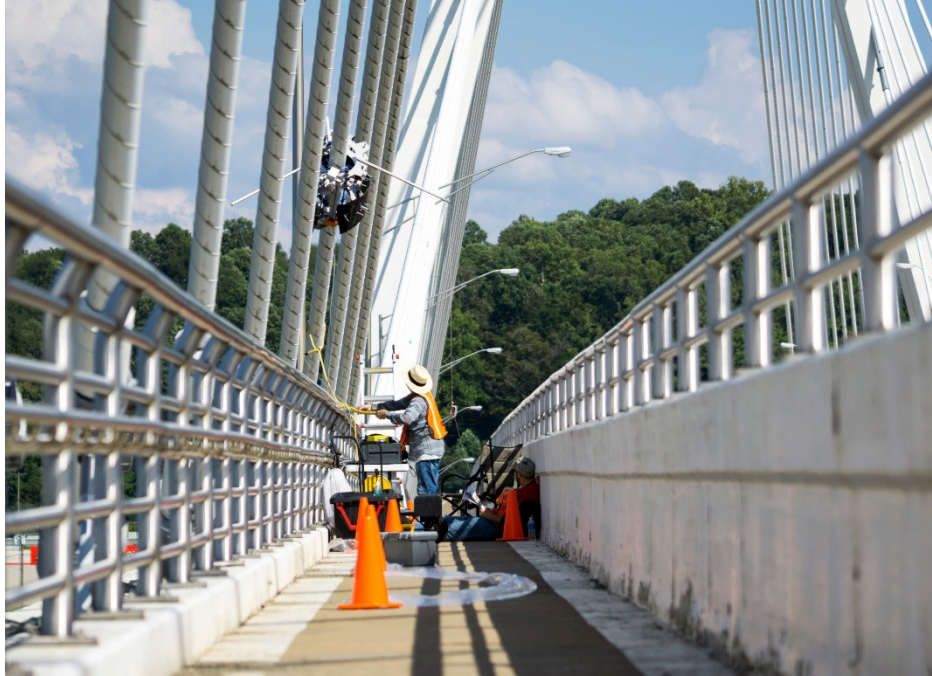
**Figure 92. Photo. The test setup for the Pomeroy-Mason Bridge on the sidewalk.**

Testing on the Pomeroy-Mason Bridge occurred in mid-August 2017 and lasted for one week. The cable anchorages are located between the outer edge of the deck section and the steel pipe fence (pedestrian railing) along the outer edge of sidewalk area. The anchorages feature a short guide pipe with a collar attached to a damper anchored to the bridge deck, but the measurable section of the cable was accessible without using scaffolding. A photo of the tower taken from the bridge's sidewalk is shown in figure 91, and the test setup is shown in figure 92. Table 17 contains a summary of all the testing.

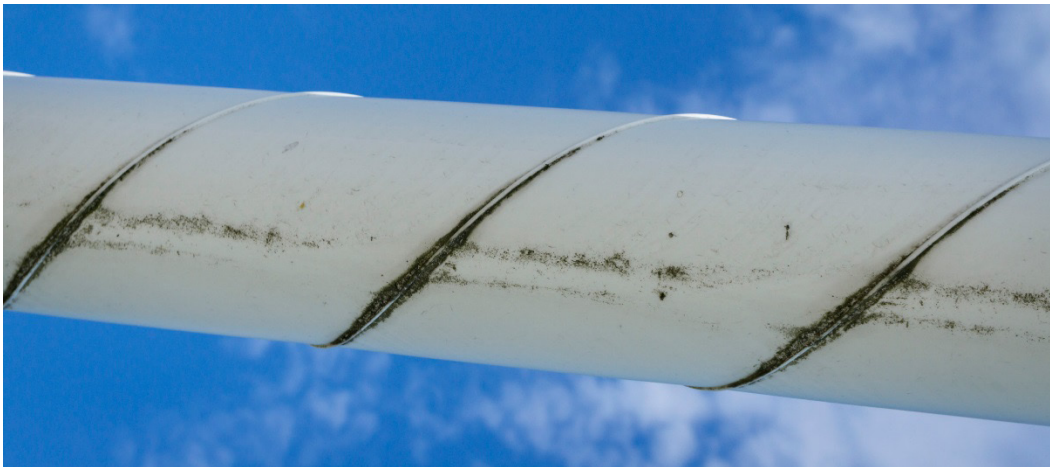
**Figure 102. Photo. Dirt collecting on the underside of a cable from the Pomeroy-Mason Bridge.**

The scans from testing show that these cables have mostly round shapes, but some of the scans contained measurable noise. During testing, it was observed that the cables were quite dirty, especially on the underside of the cable where rainwater rivulets tend to form and along the fillets themselves. A photo of the underside of a cable from the Pomeroy-Mason Bridge is shown in figure 102.

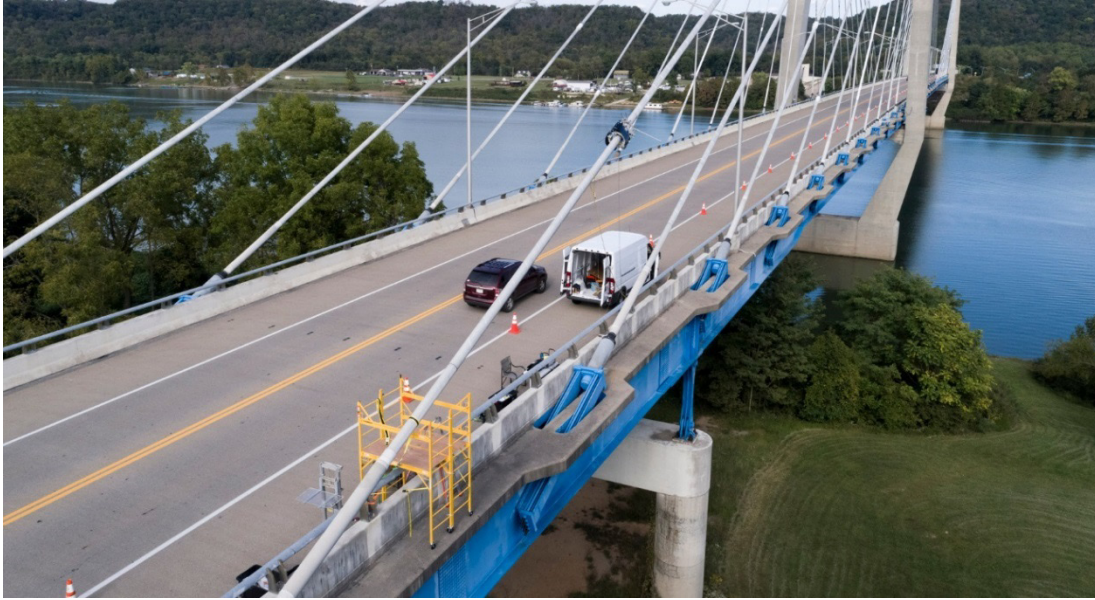
**Figure 104. Photo. An aerial view of the testing setup.**

Testing on the bridge occurred in late September 2017 and lasted for 1 week. Although the cable anchorages are positioned outside of the concrete barriers, the deck slab extended far enough past the barrier for the team to set up testing equipment and safely access the cables. The anchorages are angled steel beams that protrude through the deck slab connecting the deck girder to the cable. The cables are composed of the anchorage pipe, followed by a section of anti-vandalism guide pipe before transitioning to the HDPE pipe for the rest of the cable to the tower. Due to the height of the guide pipe, the scaffolding for mounting the robot about 1.83 m above deck level at the desired starting section of the cable. The test setup for the bridge is shown in figure 104 and figure 105. Table 19 contains a summary of all testing.

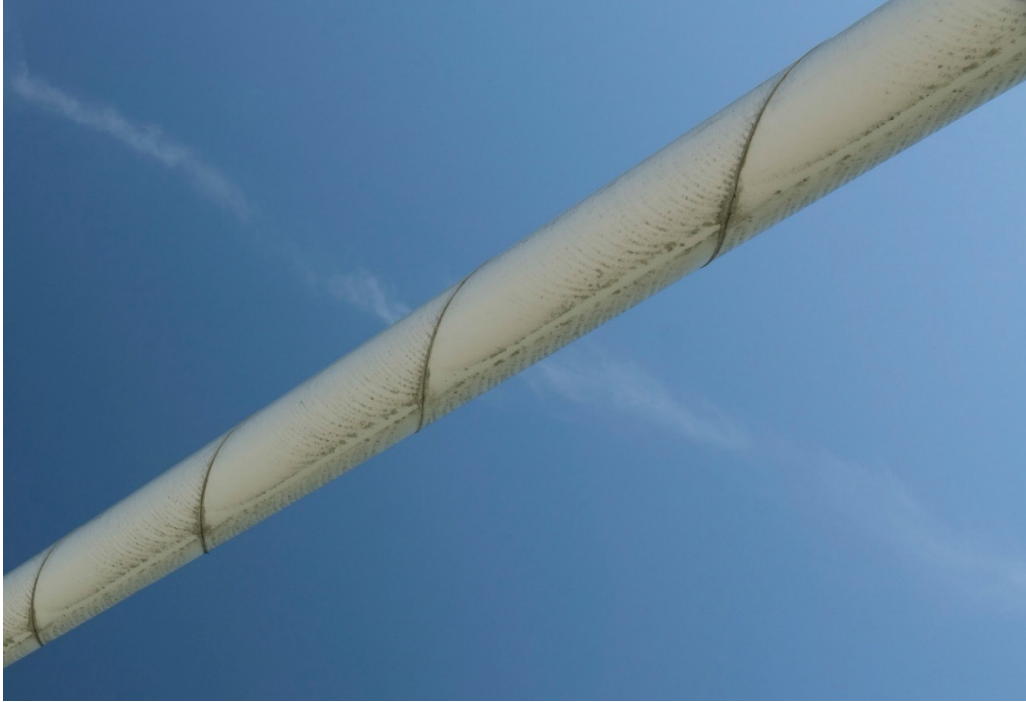
**Figure 111. Photo. Rain flow patterns in dirt on the underside of a stay cable.**

The first few measurements of each cable were on a short section that did not feature helical fillets. These initial sections varied between 2.5–2.7 m in length. The remaining sections of cable had a single helical fillet; all previous bridges tested had two helical fillets. During testing, it was observed that the cables were very dirty, especially on the underside of the HDPE pipe where rainwater rivulets tend to form on the cable. Streak lines were clearly visible (see figure 111) in the dirty surface film on the HDPE pipe, illustrating the flow of rainwater around and down the cable. Cracking was also observed (see figure 112) in selected small areas of the HDPE pipe.

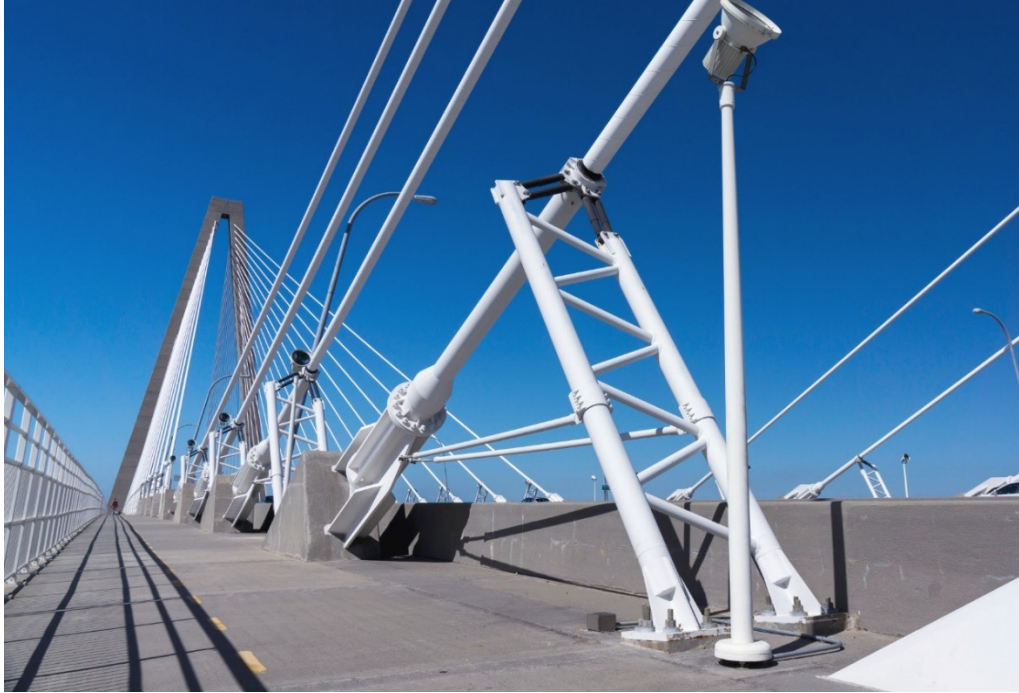
**Figure 114. Photo. The anchorages and external dampers at the center of the main span of the bridge.**

Testing on this bridge occurred in mid-October 2017. The longest cables featured steel anchorages protruding from a concrete block while the remaining steel anchorages were mounted directly to the deck itself. Figure 114 shows the anchorage mounts at the center of the bridge. A large-diameter anchorage pipe that leads into a guide pipe protects the cables' attachment to the steel anchorage. For the longer cables, external dampers are attached to the guide pipe while the remaining cables feature a steel crossbar to help brace the anchorages to the deck. The robot was mounted above the anchorage, guide pipes, and dampers. Only cables on the downstream side were tested because the protected sidewalk area provided room to set up the scaffolding and the test equipment. Due to the extreme length of the bridge, a small, motorized cart was used to transport the testing equipment from the parking area to the test site. A photo of the test setup on the bridge's sidewalk showing the scaffolding is shown in figure 115. Table 21 contains a summary of all the testing.
