Evaluating Road Resilience to Wildfires: Case Studies of Camp and Carr Fires

December 2023

¹University of California Pavement Research Center, Department of Civil and Environmental Engineering, UC Davis

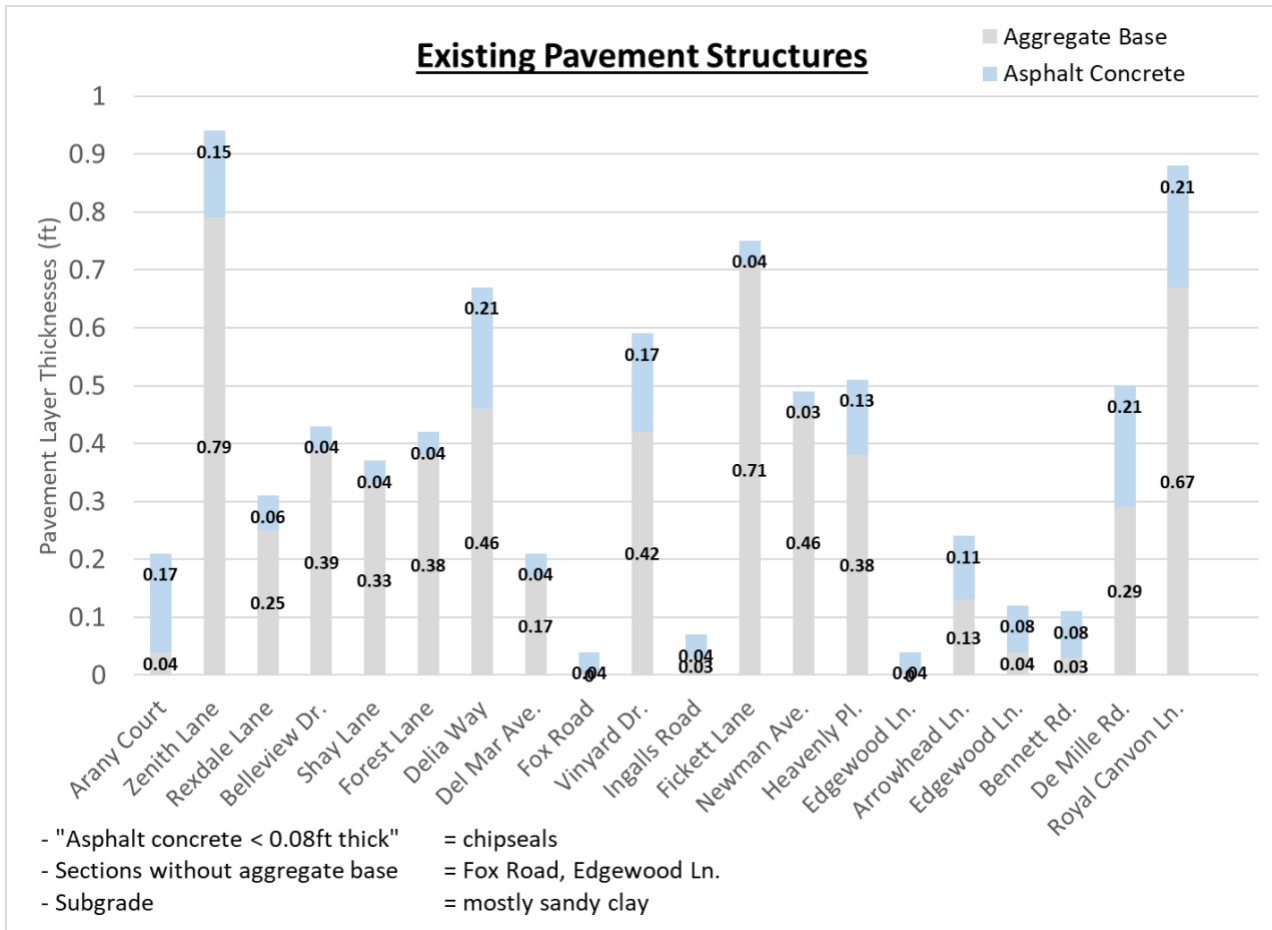
Note: AB: Aggregate Base and AC: Asphalt Concrete

Figure 8. Existing pavement cross-sections for the Off-System Zone 1

A geotechnical pavement design memorandum was then prepared for each zone within the system, detailing road rehabilitation strategies for different sections within the zone. Cores were also taken from several zone locations to study road damage further. Figure 8 shows an example of existing structures from the Off-System Zone 1.

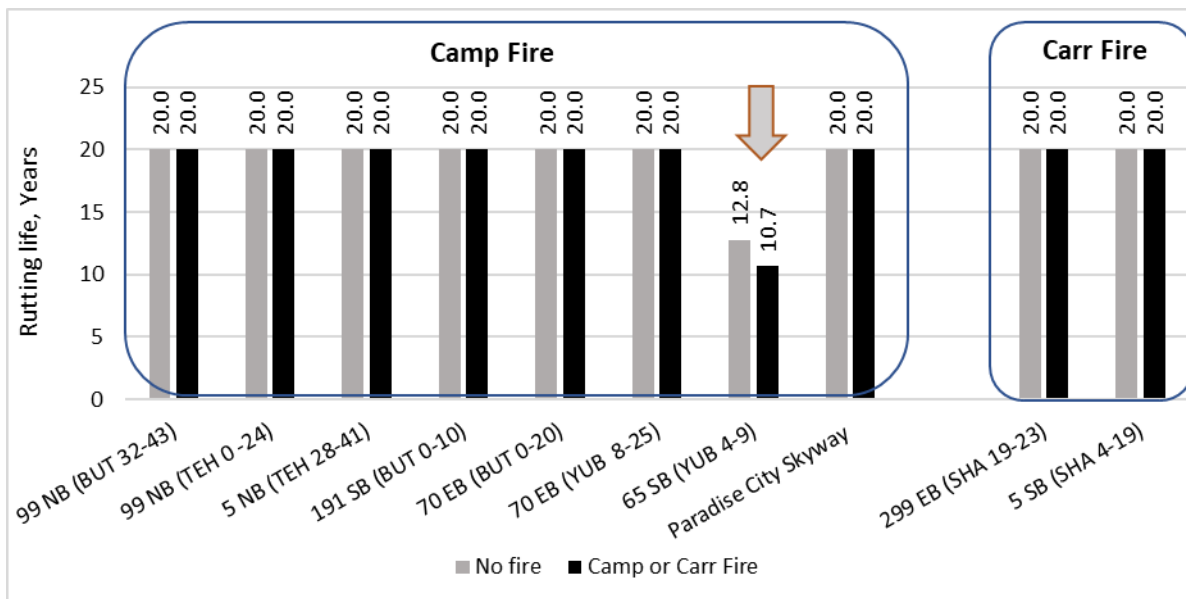
Figure 14. Impact of Fire Debris Removal generated by Camp and Carr Fires on the rutting life of the pavements on roads taken to waste management facilities (the arrow shows the impacted road)

The outcomes of the CalME simulations are presented in Figure 14 for rutting life and Figure 15 for fatigue cracking life for both the Camp Fire and Carr Fires. A rutting life of 20 years demonstrates a pavement that has passed the 0.4-inch rutting criteria. The affected pavements by the fire truck traffic are identified with a vertical arrow on each graph.

As seen in Figure 14, the structure of nearly all the simulated pavements was sufficient in terms of rutting resistance for 20 years of existing truck traffic and the additional truck traffic generated from the fire. The only exception is 65 SB (YUB 4-9), which experienced rutting before the 20-year mark. Without considering fire debris truck traffic, 65 SB (YUB 4-9) rutting life was 12.8 years, which decreased by 2.1 years due to the trucks from the Camp Fire debris removal. This is attributed to inadequate HMA (0.55 ft) and AB (0.5 ft) thicknesses in this pavement section, which were insufficient to support the existing traffic loads of 13 million ESALs. The situation was then exacerbated by the added stress from fire truckloads, which increased the TI from 12.25 to 12.37. On the other hand, Skyway demonstrated no rutting failure despite the additional truckloads of debris.

Regarding the Carr Fire, both simulated highways successfully accommodated the additional truckloads from fire debris removals without any rutting failure during the 20-year design life.

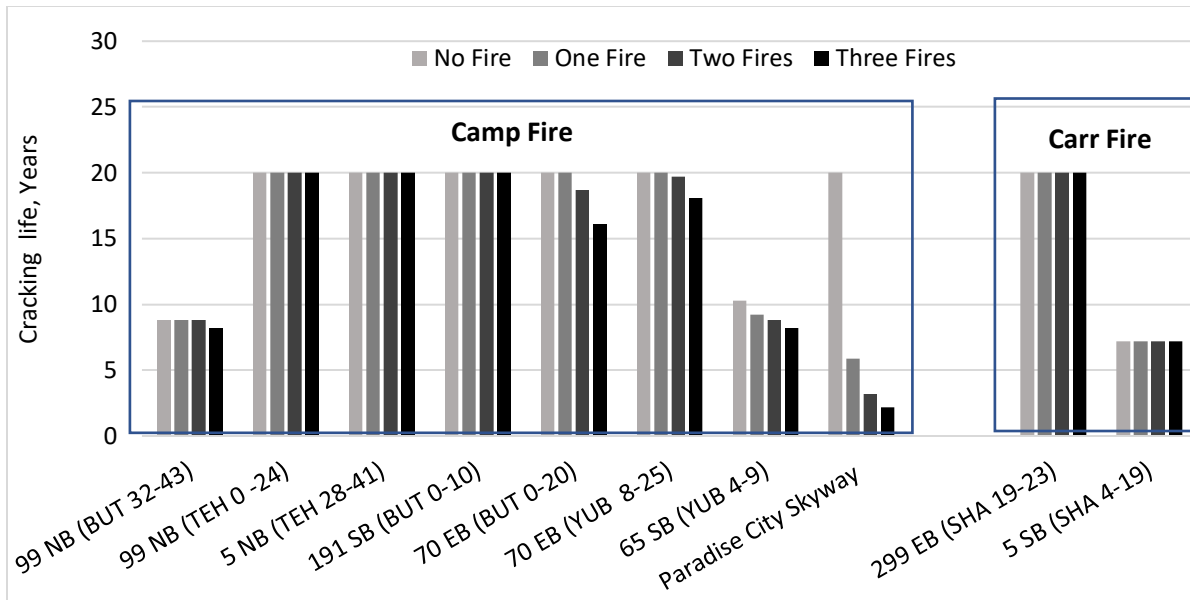
Figure 17. Impact of the first actual fires and hypothetical second and third fires on the fatigue cracking life

As shown in Figure 17, similar to the first fire, the second and third fires decreased the cracking life of 65 SB (YUB 4-9) and Skyway, while they did not change the cracking life of 99 NB (THE 0-24), 5 NB (TEH 28-41), 191 SB (BUT 0-10), 299 EB (SHA 19-23), and 5 SB (SHA 4-19) sections. However, due to the higher traffic volumes generated by considering all three fires, the cracking life of the 99 NB (BUT 32-43), 70 EB (BUT 0-20), and 70 EB (YUB 8-25) sections decreased by 0.6, 3.9, and 17.8 years, respectively.
