RESPONSE OF SAN JOAQUIN KIT FOXES TO ROAD CONSTRUCTION SITES

Contract Number 65A0903

**Prepared for the
California Department of Transportation**

November 2023

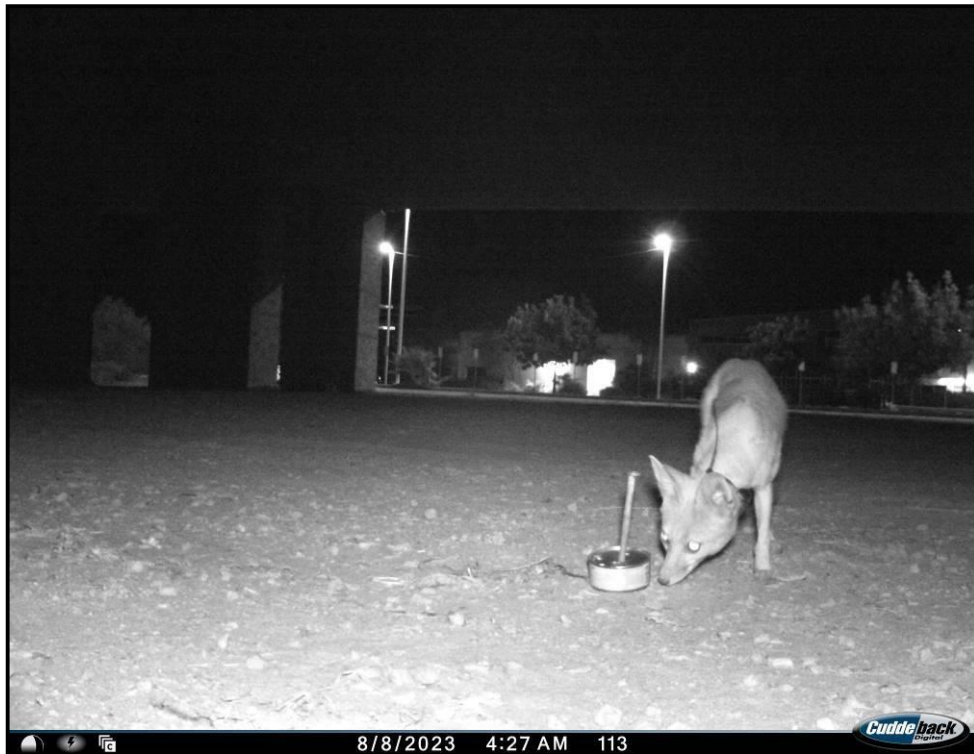
Figure 3. San Joaquin kit fox visiting a camera station under the new freeway on the Centennial Corridor study site, Bakersfield, CA, June 2023. (Photo by CSUS ESRP)

Foxes were never detected on the CC construction site during the day, although they were occasionally detected in areas adjacent to the site. Foxes were frequently detected on the MSH site, sometimes in the construction area and commonly in the materials yard (Figs. 3-5). The ones in the construction area usually moved off at daybreak. Those in the materials yard sometimes moved off the site but other times moved into or under material being stored in the yard.

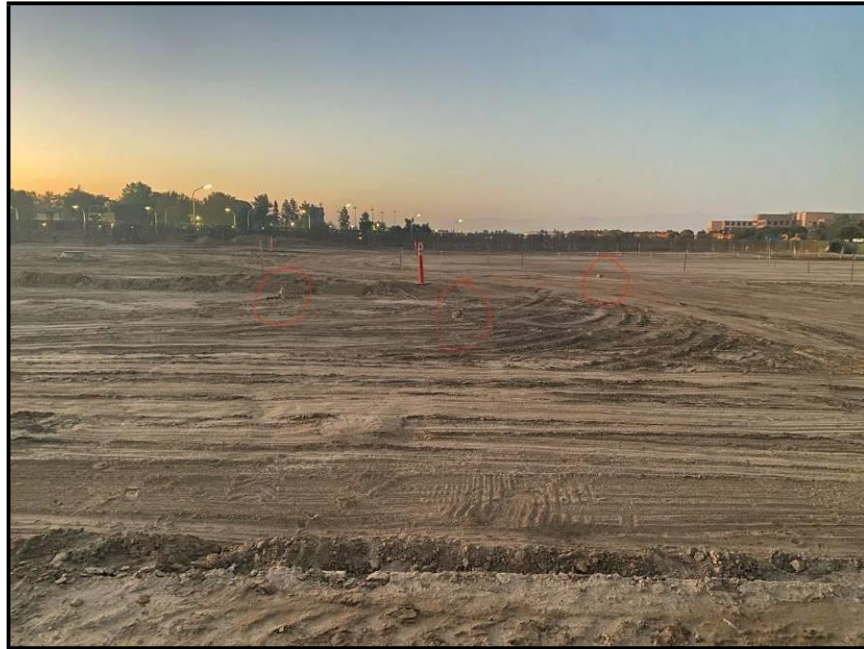
Figure 4. Three San Joaquin kit foxes (circled in red) on the construction site at the Mercy Southwest Hospital study site, Bakersfield, CA, August 2023. (Photo by E. Noel)

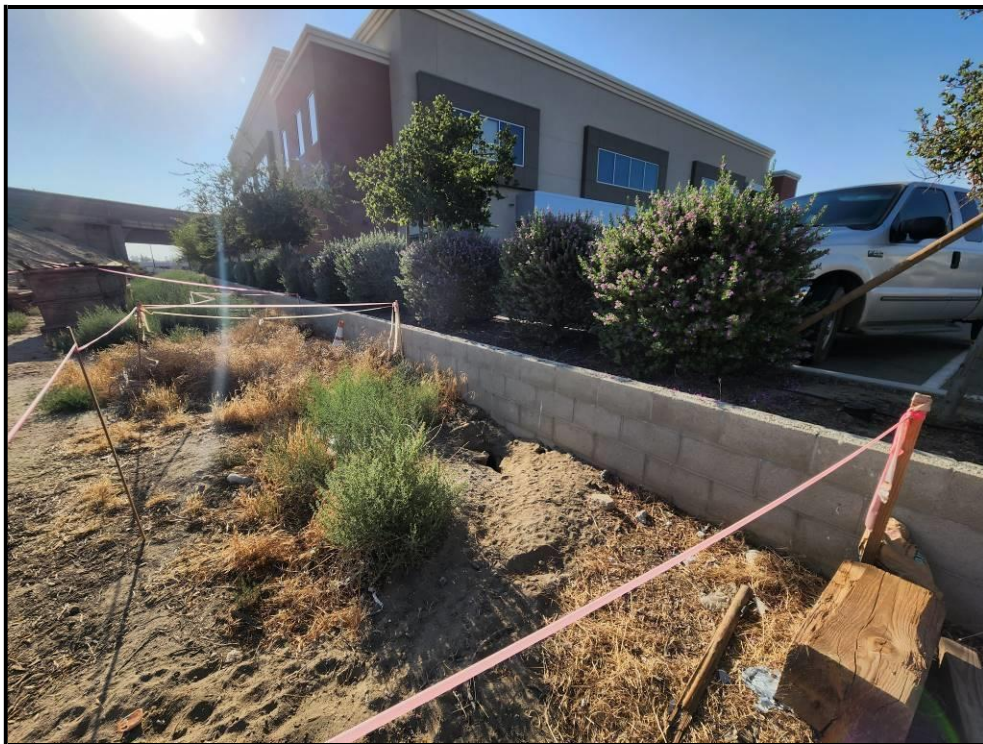
Figure 7. Earthen San Joaquin kit fox den on the Centennial Corridor study site, Bakersfield, CA, June 2023. (Photo by E. Noel)

Six kit fox dens were located at the CC site (Fig. 6). Four of these were earthen dens (Fig. 7), one was a location under a Baker tank, and one was within a stack of I-beams. The earthen dens were present prior to the initiation of construction and were avoided during construction. Six dens also were located on the MSH site (Fig. 8). Five were earthen and were present prior to the initiation of construction. One den site was under a stack of I-beams in the materials yard. One den on the CC site and four dens on the MSH

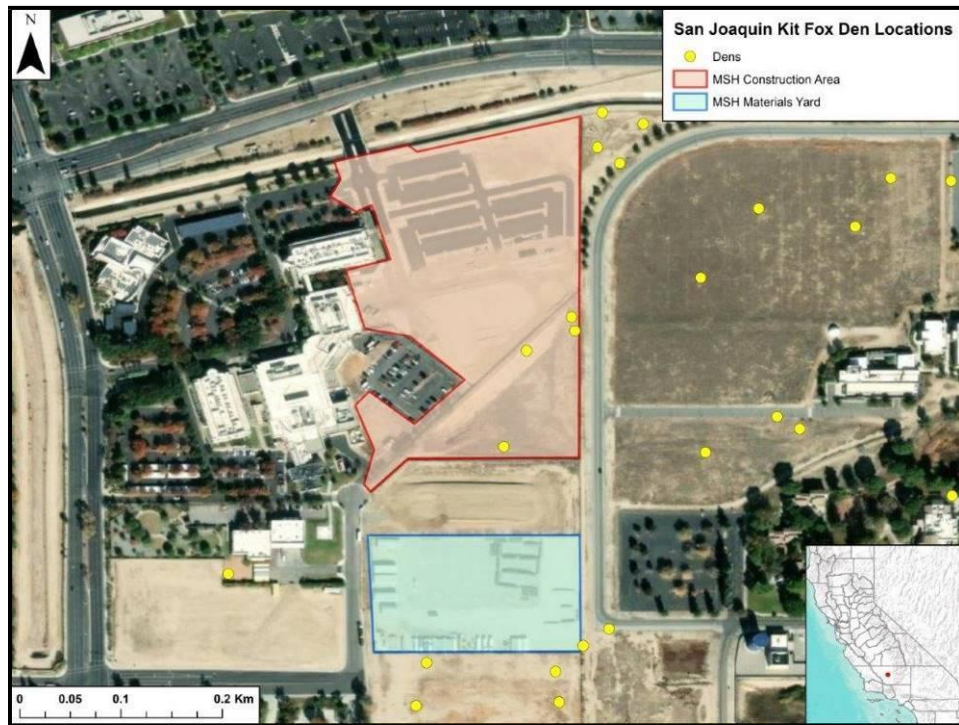
Figure 8. San Joaquin kit fox den locations on and near the Mercy Southwest Hospital study site, Bakersfield, CA, May 2024.

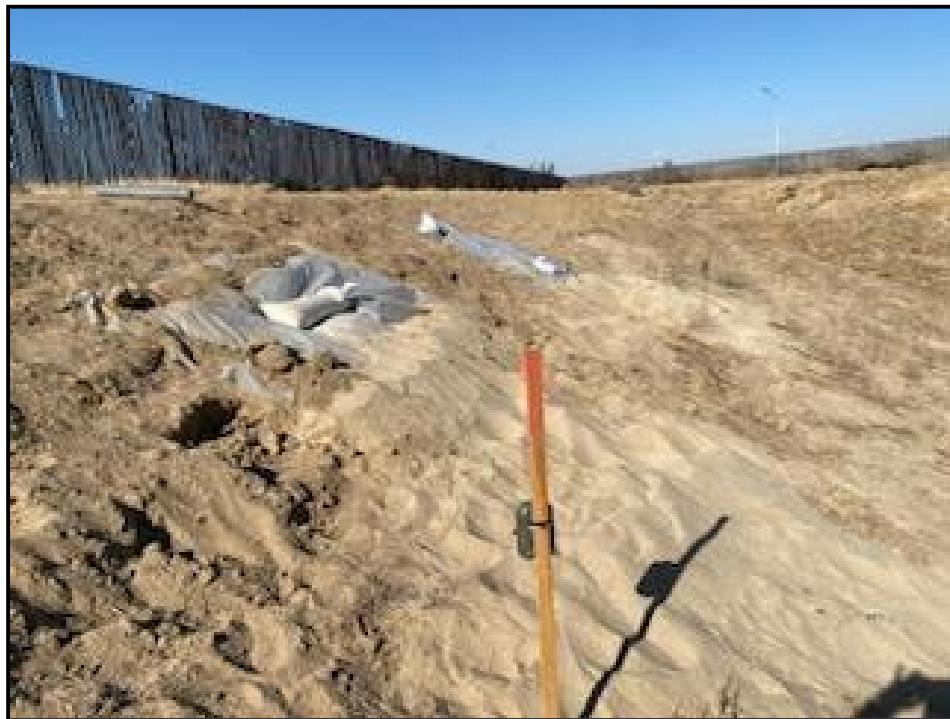
Figure 9. Covered San Joaquin kit fox dens on Mercy Southwest Hospital study site, Bakersfield, CA, August 2023. (Photo by E. Noel)

site (Fig.9) were temporarily covered to exclude kit foxes while work was being conducted near the dens.

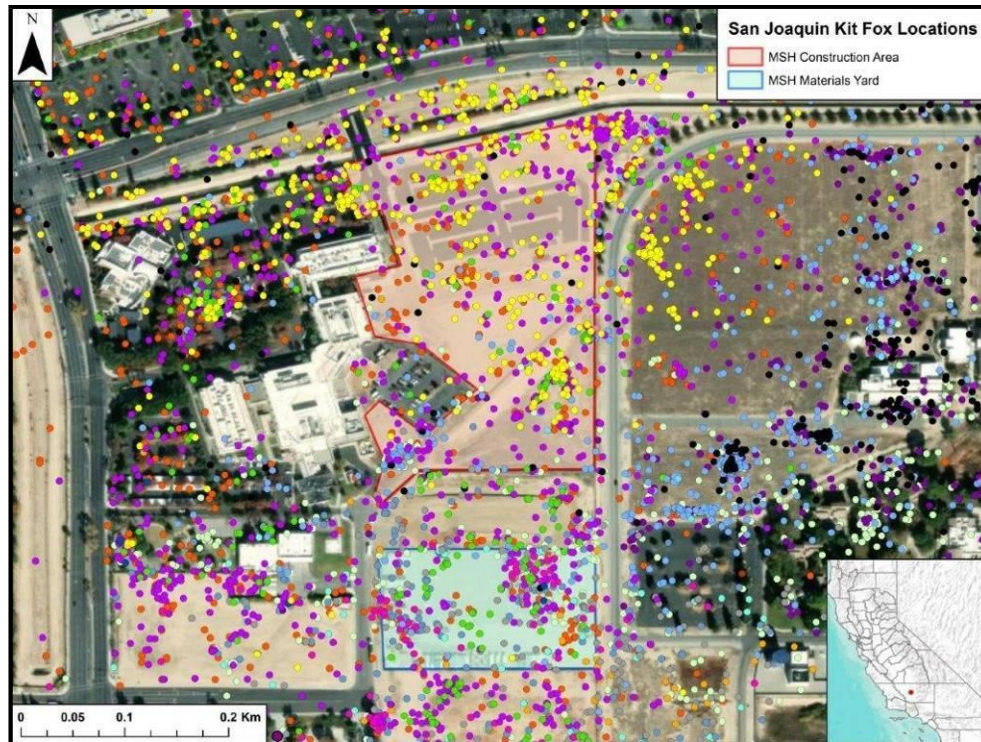
Figure 11. Telemetry locations for twenty San Joaquin kit foxes (each a different color) on the Mercy Southwest Hospital study site, Bakersfield, CA, June 2023-May 2024.

On the MSH study site, 15,379 locations were collected on 20 collared kit foxes. Of these locations, 1,194 (7.8%) were on the study site (Fig. 11). Of the 20 foxes, 15 had a least one location on the study site. The mean proportion of locations on the site for the 15 foxes was $10.3 \pm 0.1\%$ (range 0.6-26.8%). All of the locations on site were in the active construction area or the materials yard; the study site boundary did not include areas where work was not being conducted.

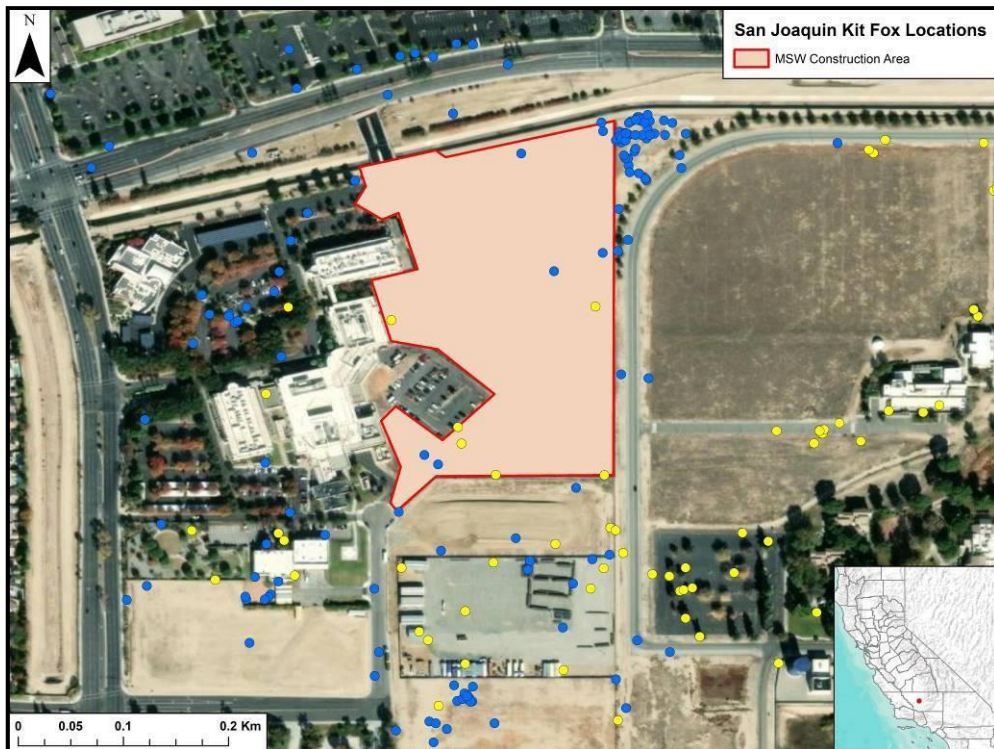
Figure 15. Telemetry locations for two San Joaquin kit foxes on the Mercy Southwest Hospital study site during March-April 2023, Bakersfield, CA.

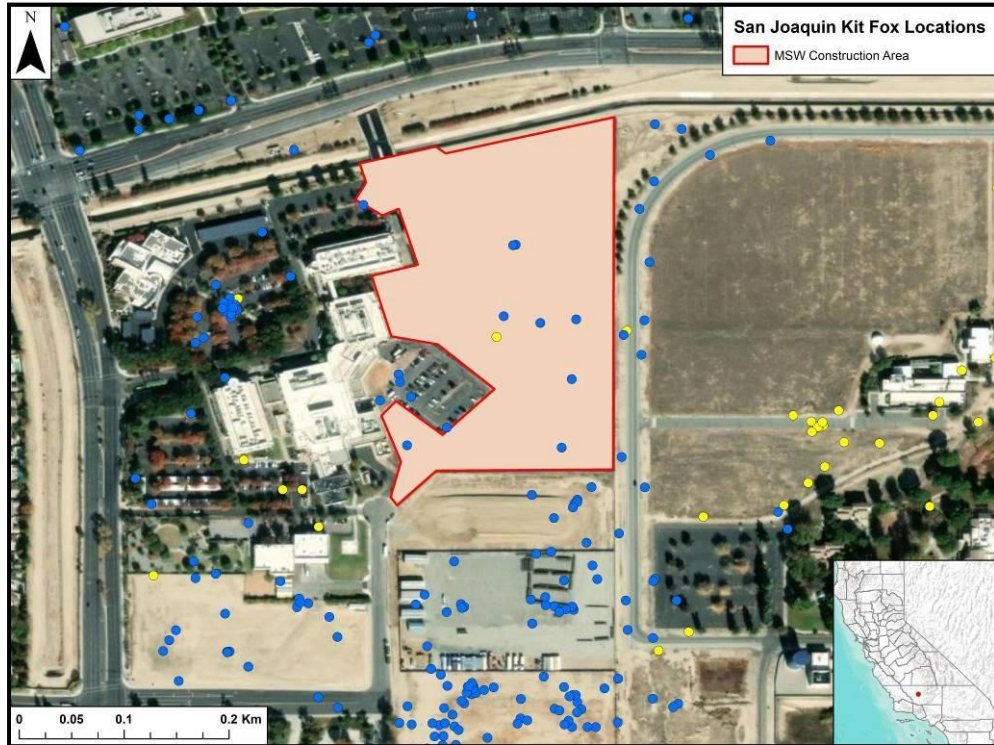
Figure 16. Telemetry locations for two San Joaquin kit foxes on the Mercy Southwest Hospital study site during May-June 2023, Bakersfield, CA.

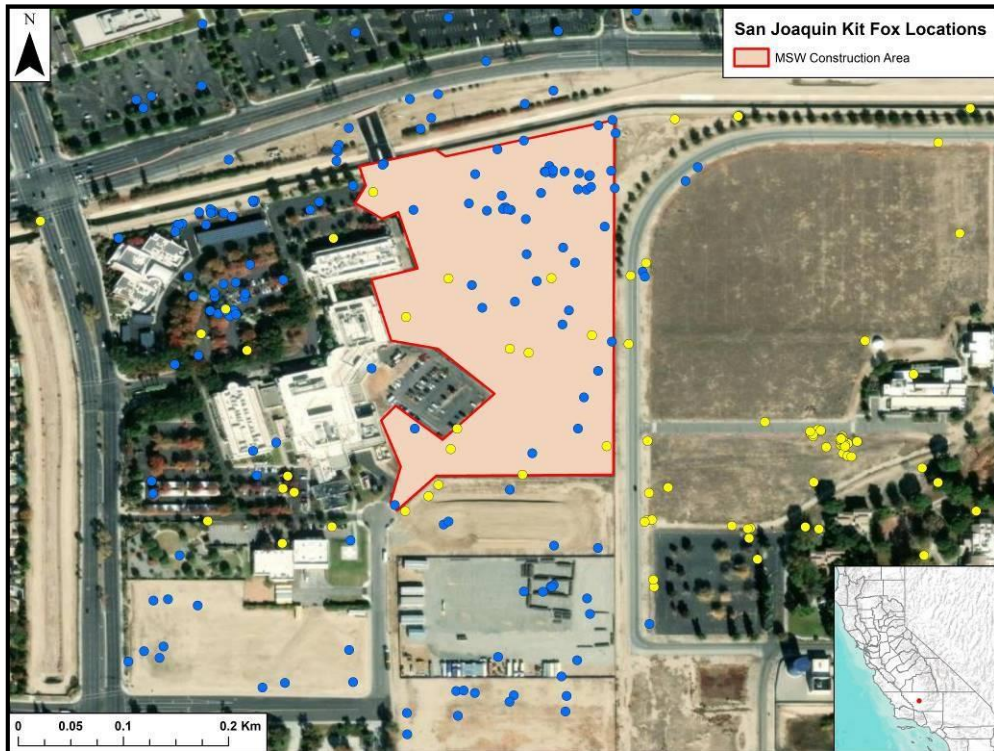
Figure 17. Telemetry locations for two San Joaquin kit foxes on the Mercy Southwest Hospital study site during July-August 2023, Bakersfield, CA.

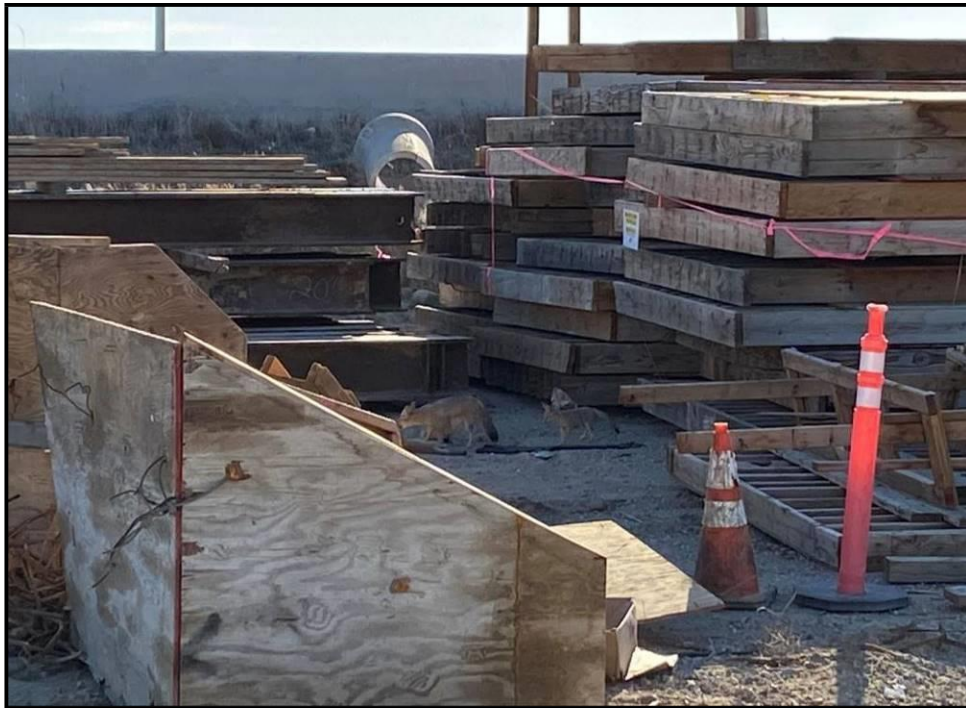
Figure 19. San Joaquin kit fox mother and pups in materials stacks on the Centennial Corridor study site, Bakersfield, CA, May 2023. (Photo by E. Noel)

More problematic is when foxes dig a new den on a construction site or choose to den under materials. In essence, they are taking up residence on the site and the duration of this residence is unpredictable. Mitigation measures are available to exclude foxes from earthen dens and eliminate the den, but the process needs to be conducted in coordination with CDFW and FWS and may require a number of days or even weeks. The worst case scenario is when kit foxes occupy a den on a site and then produce pups in that den (Fig. 19). The den then has “natal” status and mitigation measures become much more limited. To prevent “take” under the Endangered Species Act and the California Endangered Species Act, CDFW and FWS will not allow the foxes to be excluded from a natal den and a wide avoidance zone around the den commonly is required. In this scenario, the delay in work in the vicinity of the den could last for months. Work will only be allowed to continue once the foxes move out of the den on their own.

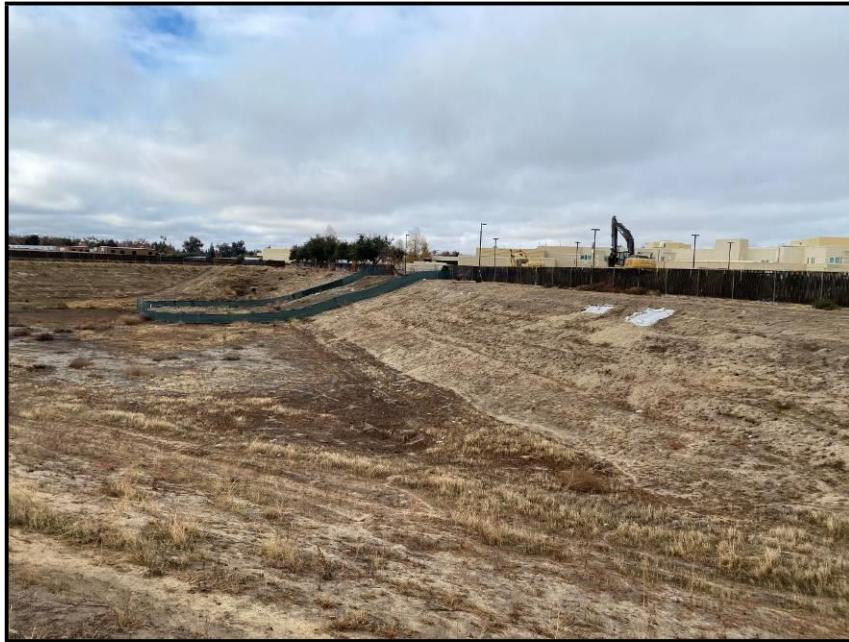
Figure 20. Privacy fencing erected around a work area at the Mercy Southwest Hospital study site, Bakersfield, CA, August 2023. Two covered kit fox dens are visible in the image and other active kit fox dens were present nearby. (Photo by E. Noel)

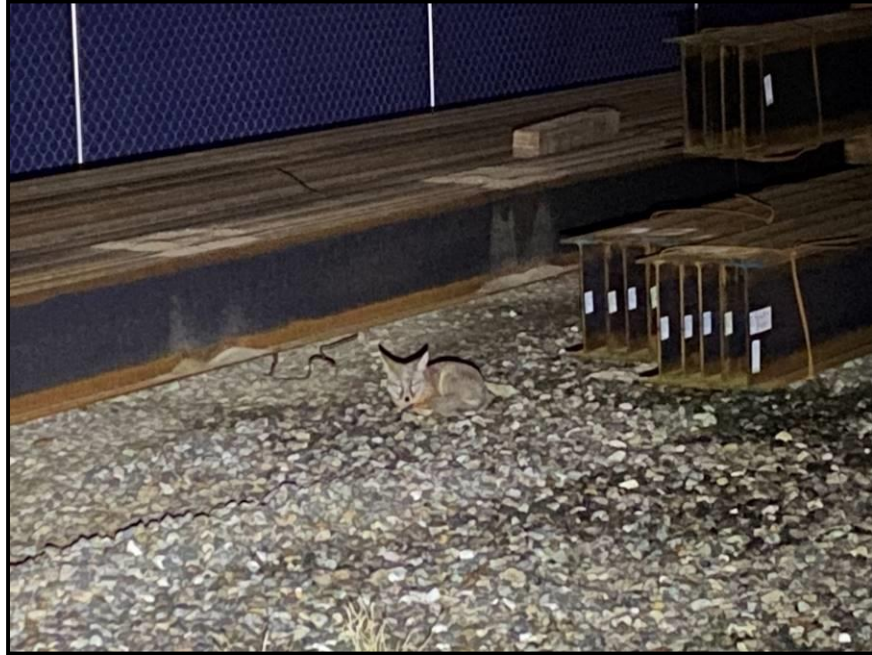
Figure 21. Kit fox near I-beams with small openings that could encourage daytime denning at the Mercy Southwest Hospital study site, Bakersfield, CA, November 2023. (Photo by E. Noel)

Staged construction materials pose a particular challenge. The stacks or piles commonly have small spaces between or under the individual pieces of materials (Fig. 21) and these spaces are extremely attractive to kit foxes for daytime resting, such as the foxes would do in a den. The situation is exacerbated if each piece of material also inherently has attractive spaces, such as is the case with pipes. Also, the longer the materials sit in one place, the greater the chances that a kit fox will discover and explore the materials for denning opportunities.

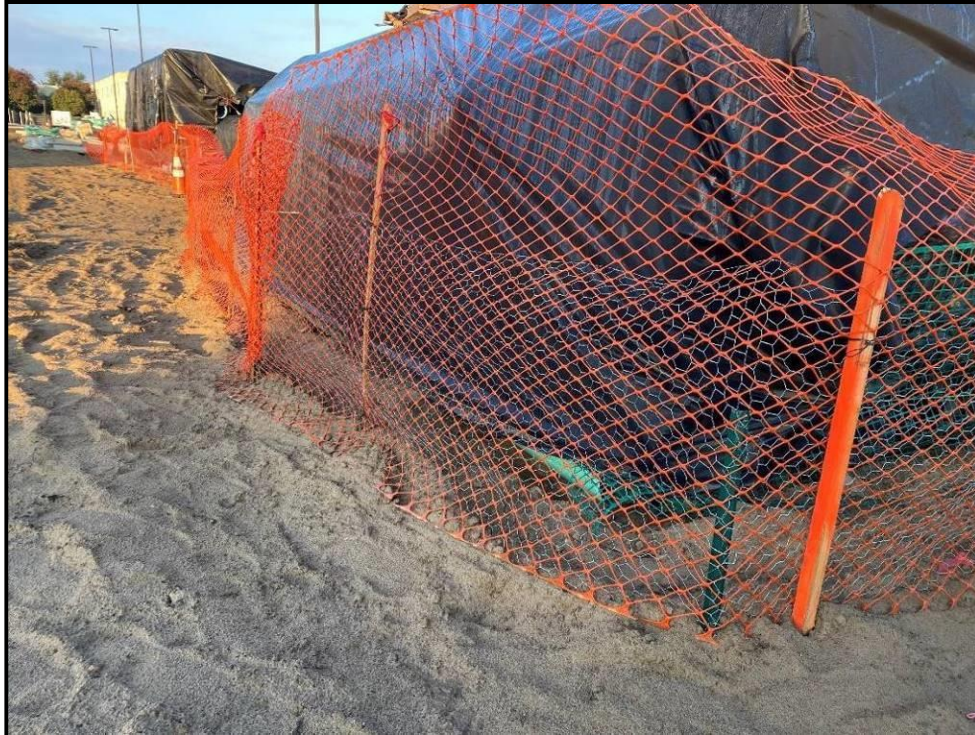
Figure 22. Plastic fencing around construction materials on the Mercy Southwest Hospital study site, Bakersfield, CA, January 2024. Note the layer of metal fencing inside the plastic fence. (Photo by E. Noel)

Two strategies to prevent foxes from using and occupying materials have had some success. One strategy is to attempt to place fencing around materials or at least to cover up openings. This might require a considerable amount of fencing depending on the dimensions of the staged materials. Then fencing should be at least 4 ft high to prevent foxes from jumping over. Several types of plastic safety fencing (e.g., PVC Vinyl Safety Fence or Heavy Duty Ridged Diamond Safety Fence) were tried around staged materials at the MSH site (Figs. 22-24). However, foxes were able to push under or chew through this fencing (Fig. 25). The addition of a second layer of more rigid material (e.g., chicken wire or hardware cloth) seemed to reduce breaching of the fence by foxes. Experimentation with other types of fencing may identify more effective designs. Small mesh size (Fig. 26) may help reduce incidents of foxes chewing holes in the fencing. For bundles of materials that are sufficiently small (e.g., items on pallets), completely wrapping the bundle in plastic or other material will help exclude access by foxes. The bottom of the fence should be anchored to the ground (e.g., sandbags or stakes) or even buried several inches if feasible to discourage kit foxes from digging under.

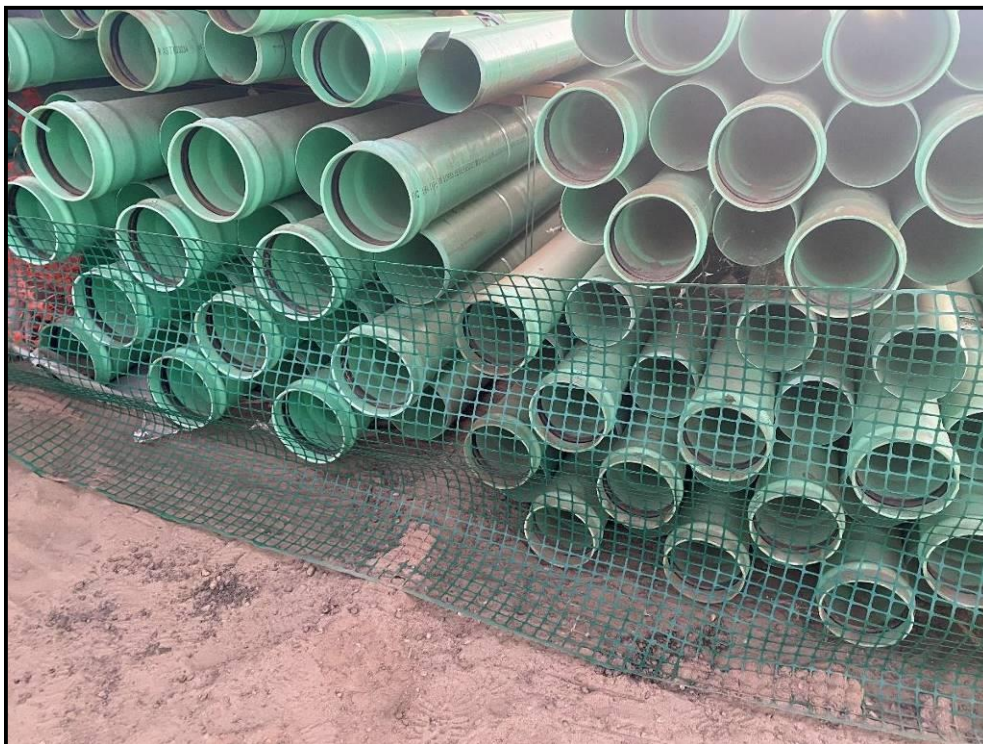
Figure 23. Plastic fencing around construction materials on the Mercy Southwest Hospital study site, Bakersfield, CA, January 2024. (Photo by E. Noel)

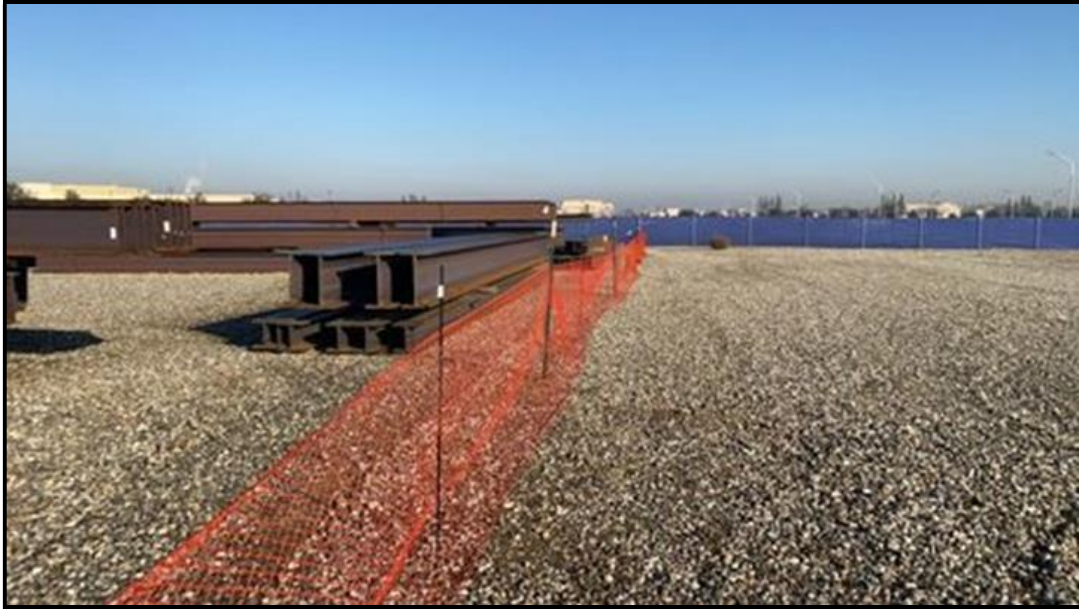
Figure 24. Plastic fencing around construction materials on the Mercy Southwest Hospital study site, Bakersfield, CA, January 2024. (Photo by E. Noel)

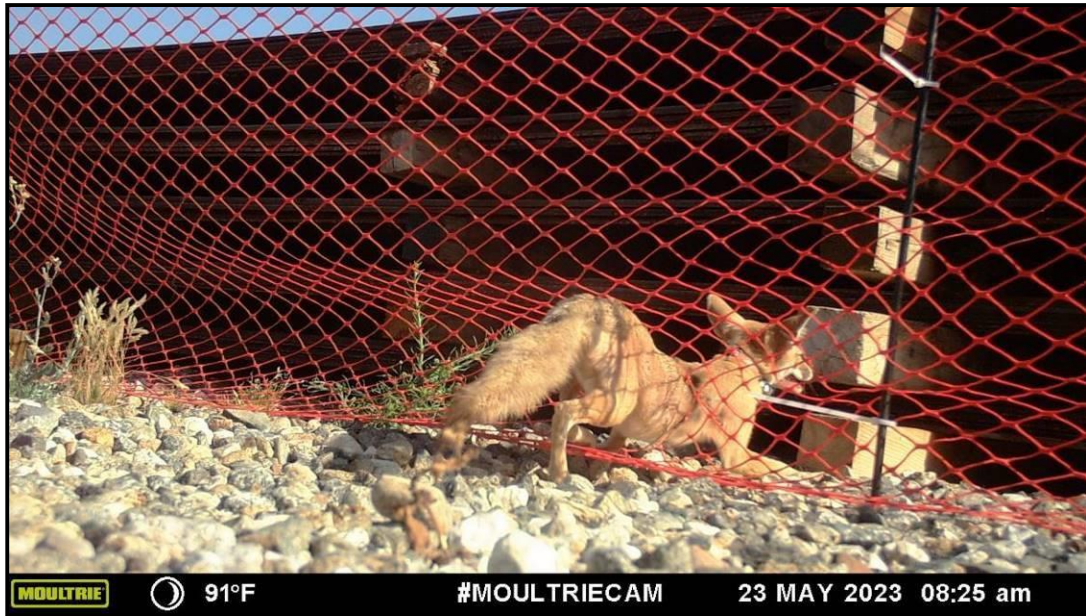
Figure 25. San Joaquin kit fox accessing construction materials through a chewed hole in the plastic fencing around the materials on the Mercy Southwest Hospital study site, Bakersfield, CA, January 2024. (Photo by E. Noel)

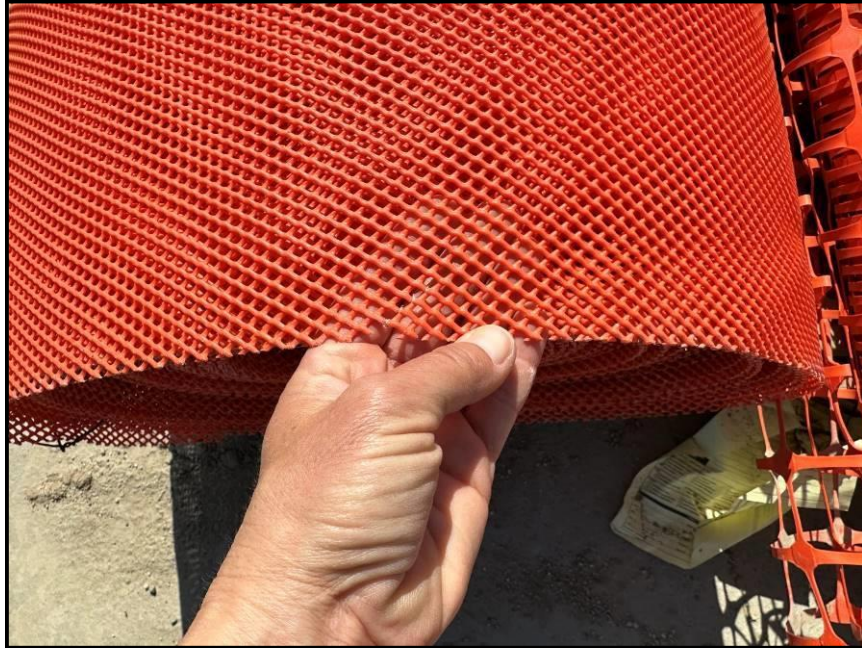
Figure 26. Fencing material with small mesh size to discourage chewing by kit foxes. (Photo by E. Noel)

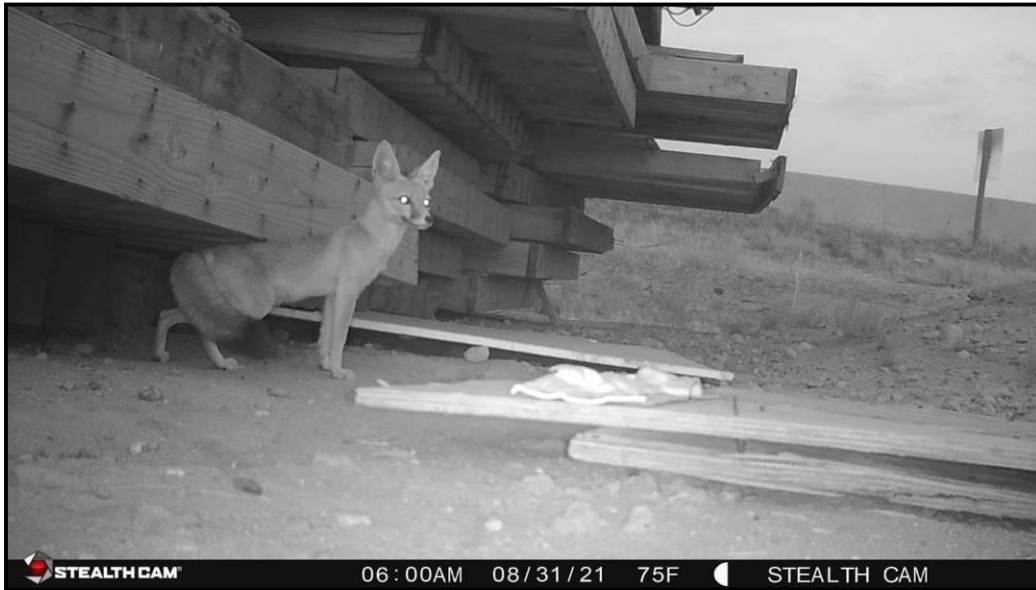
Figure 27. San Joaquin kit fox using the space under construction materials on the Centennial Corridor study site, Bakersfield, CA, May 2023. (Photo by E. Noel)

Another strategy is to elevate materials off the ground. Even elevating them 1 ft off the ground may be helpful in discouraging foxes from creating resting sites underneath. Kit foxes like to rest in small dark spaces (Fig. 27) and the larger the space and more light that shines in, the less appealing it is to foxes. On the CC site, materials were elevated on k-rails and this prevented use by foxes (Fig. 28).

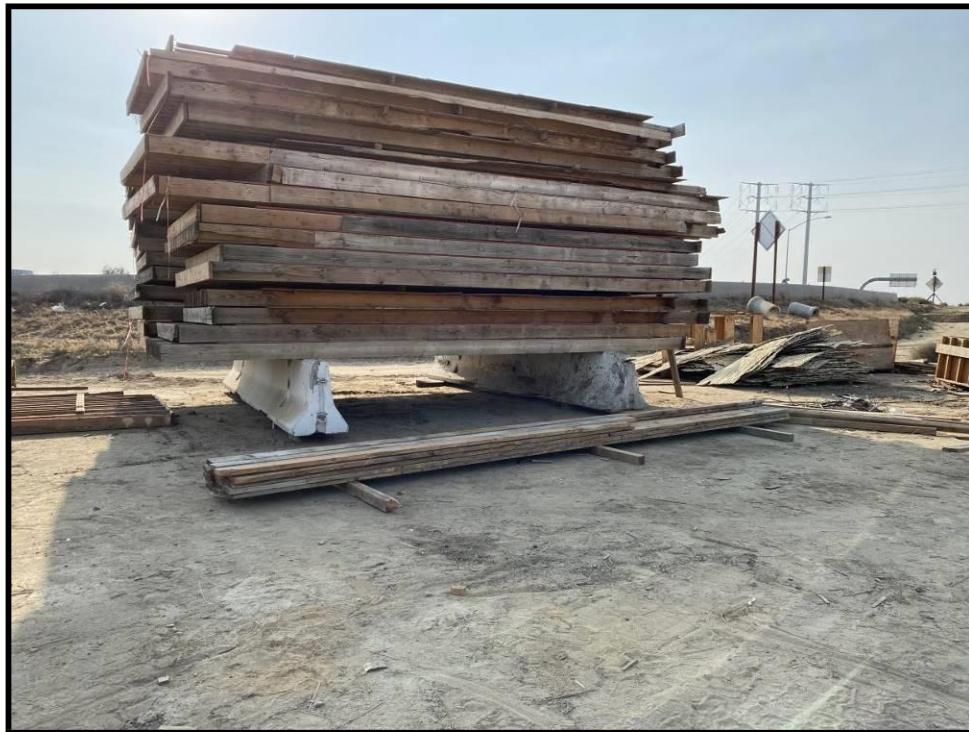
Figure 28. Construction materials placed up on K-rails on the Centennial Corridor study site in Bakersfield, CA, May 2023. (Photo by E. Noel)

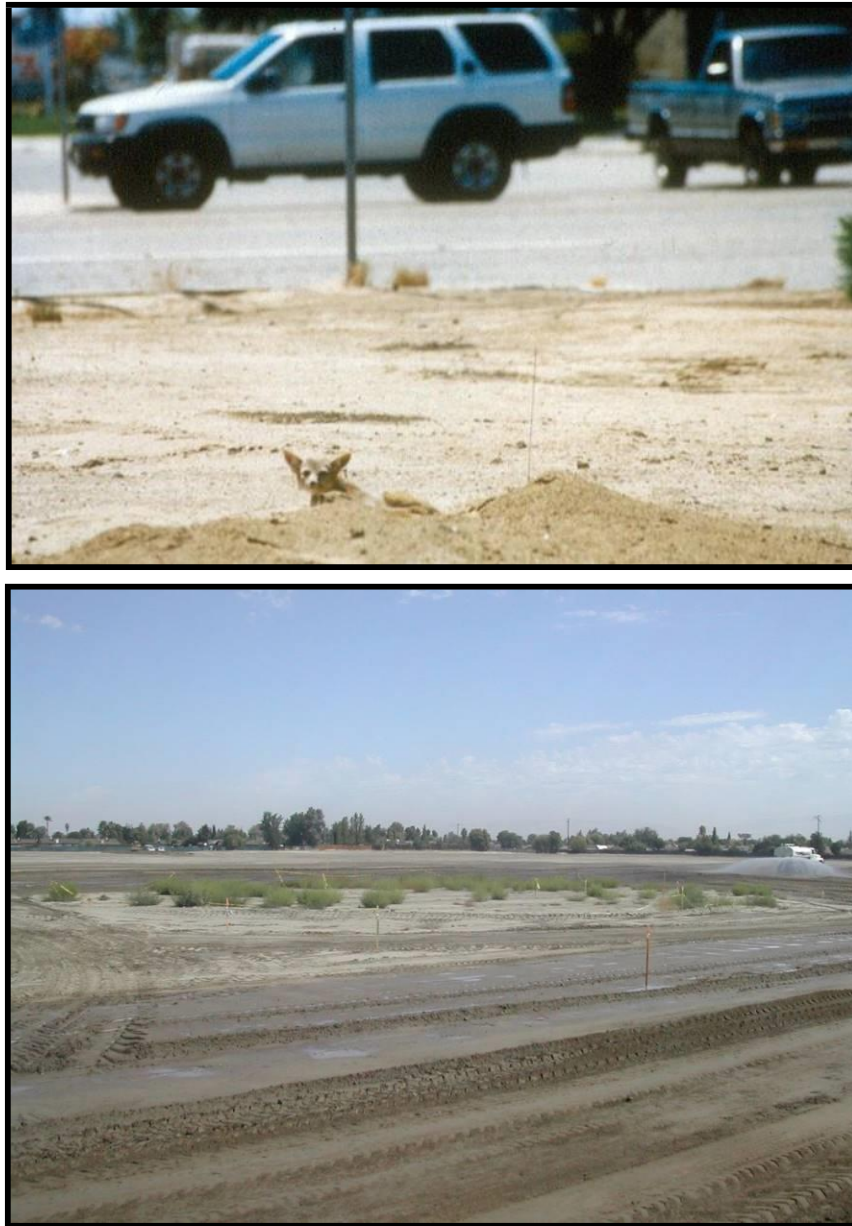
Figure 2. San Joaquin kit fox dens on sites prior to initiation of construction.

Issues involving kit fox dens on construction site typically arise due to one of two scenarios. The first is that kit fox dens may be present on a site prior to the initiation of the construction project (Fig. 2). If a den is in an area that will be directly affected by the construction, then the regulatory agencies (i.e., USFWS, CDFW) have provided protocols for monitoring the dens for use by kit foxes, and then carefully excavating and eliminating the dens when they are vacant. Sometimes, one-way doors are installed over den entrances, which allows foxes and any other animals to exit a den but prevents re-entry. If a den is in an area that will not be directly impacted by the construction, then two alternative strategies are available. One is to establish an exclusion zone around a den and allow foxes to continue using the den. A second strategy is to ensure that foxes and other animals are not in the den, block the entrances to exclude use while construction work is conducted, and the eventually reopen the den to foxes once construction is completed.

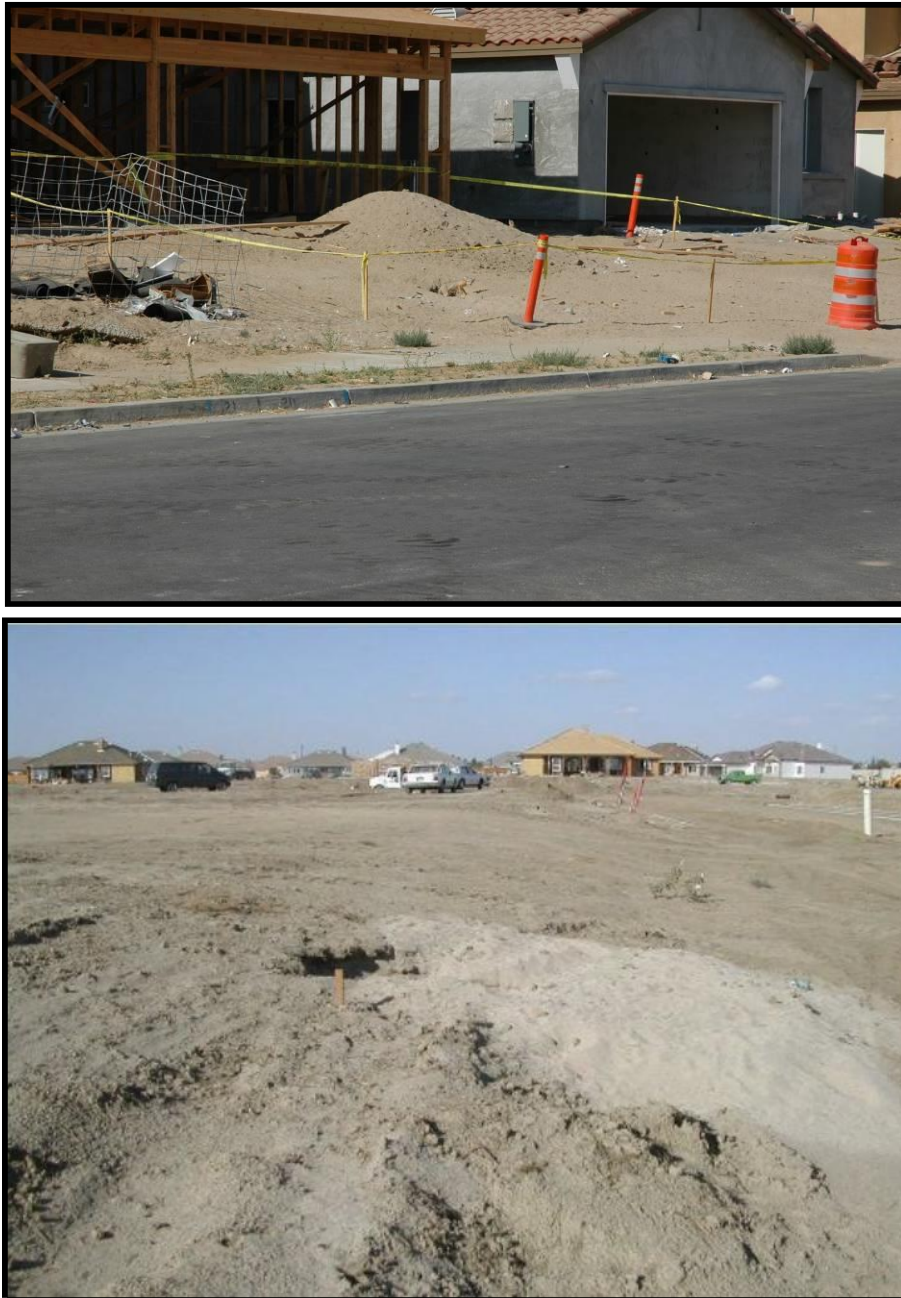
Figure 3. New San Joaquin kit fox dens that were created on construction sites after work was initiated.

A second scenario involving dens on construction sites arises when foxes move onto a site after construction has commenced and create a new den (Fig. 3). Foxes may do this because they previously had a den on the site that was excavated and they are attempting to reestablish that den. Also, kit foxes sometimes are attracted by the soft, loose soil on sites caused by construction activities. Disturbed, loosened soil is easier for foxes to dig in than is undisturbed, compacted soil. Attractants such as food dropped by workers may increase the desire of foxes to create a den on the site. When such den creation occurs on a construction site, then work in that area usually ceases until the den can be monitored and

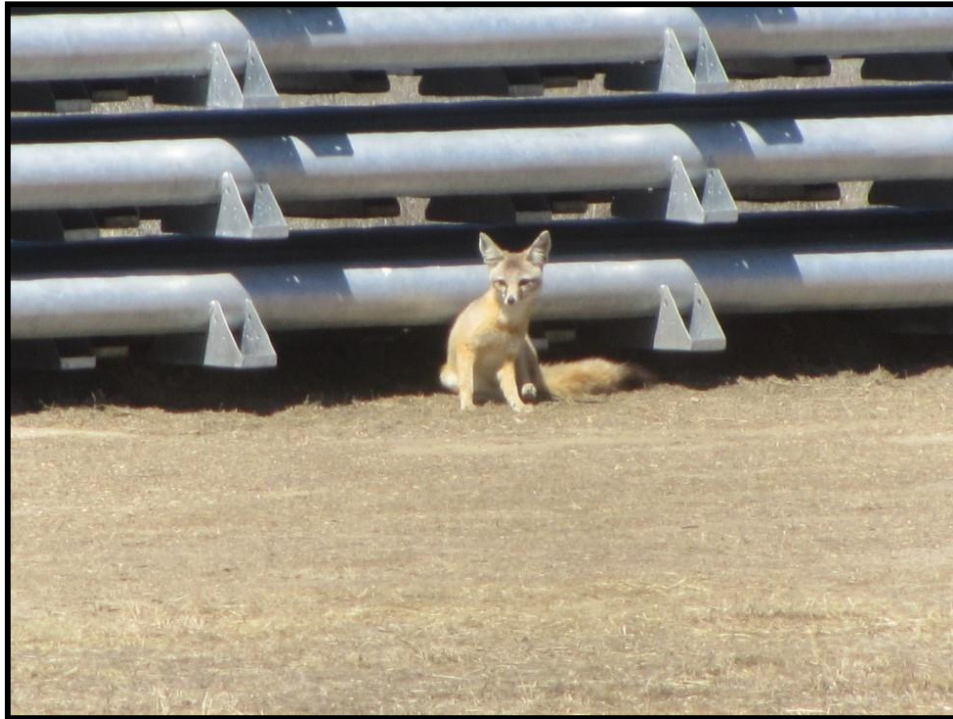
Figure 4. San Joaquin kit fox denning under a pipe rack at the Topaz Solar Farm.

Not surprisingly, kit foxes opportunistically adopt and use existing structures such as dens or burrows of other species (e.g., California ground squirrels, kangaroo rats, badger digs). Kit foxes also will readily use anthropogenic structures as dens. These include storage containers (e.g., seatrains), pipes, culverts, and piles of rubble or other materials. Staged construction materials and piles of used materials are common on construction sites, including road construction sites (Fig. 4). These constitute an “attractive nuisance” for kit foxes (and other species, such as skunks, opossums, feral cats).

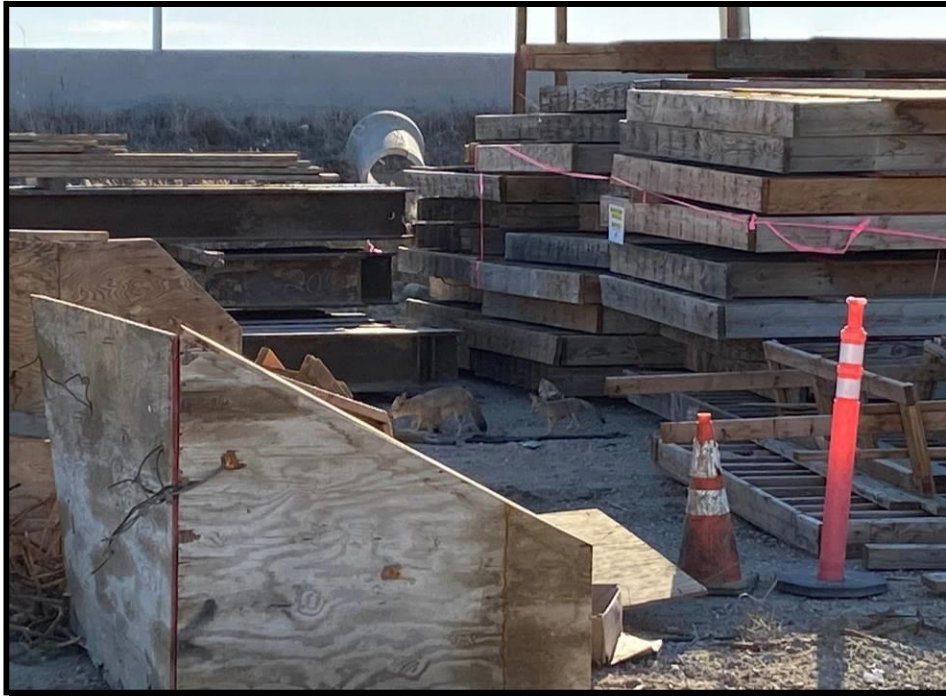
Figure 5. San Joaquin kit fox adult and pups in stacks of materials on the Centennial Corridor road construction site in Bakersfield, CA. (Photo by E. Noel)

During interviews, a number of individuals expressed that kit foxes using or potentially using staged materials and materials piles was a significant issue. In these situations, it is not always obvious that kit foxes are under the materials. Thus, there is significant potential for harm or even death of kit foxes when the materials are eventually moved for use or disposal. One recent example was from the Centennial Corridor project in Bakersfield where kit foxes took up residence under materials and even reared a litter of pups in the materials area (Fig. 5). An exclusion zone was established around the area and none of the materials could be accessed or moved until the kit foxes eventually moved to another denning location.

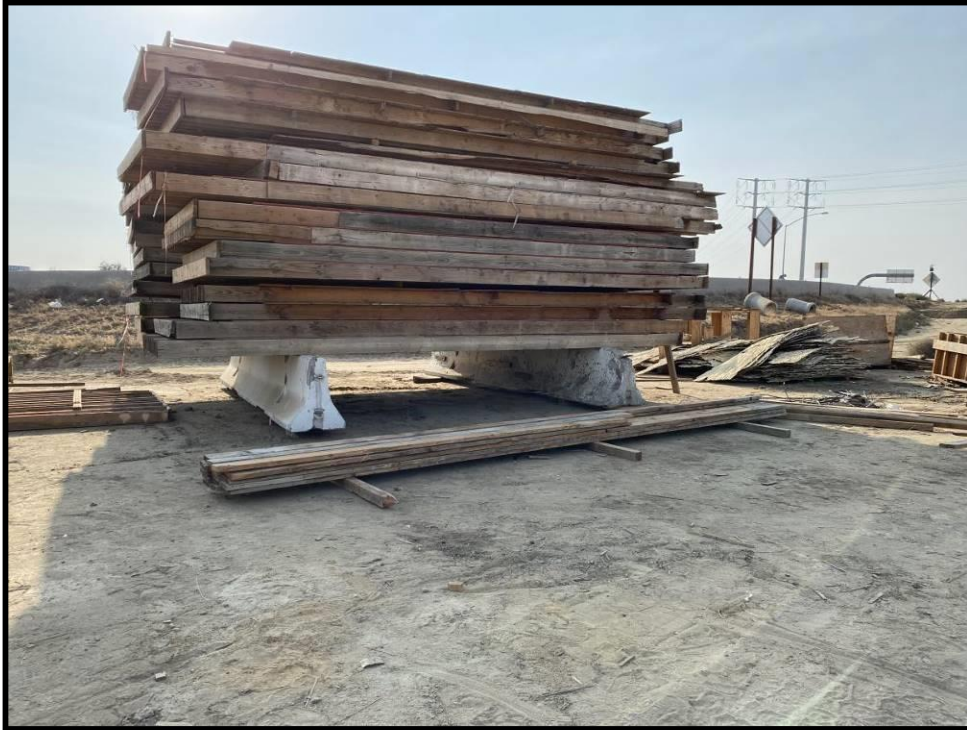
Figure 6. Construction materials placed up on K-rails on the Centennial Corridor road construction site in Bakersfield, CA. (Photo by E. Noel)

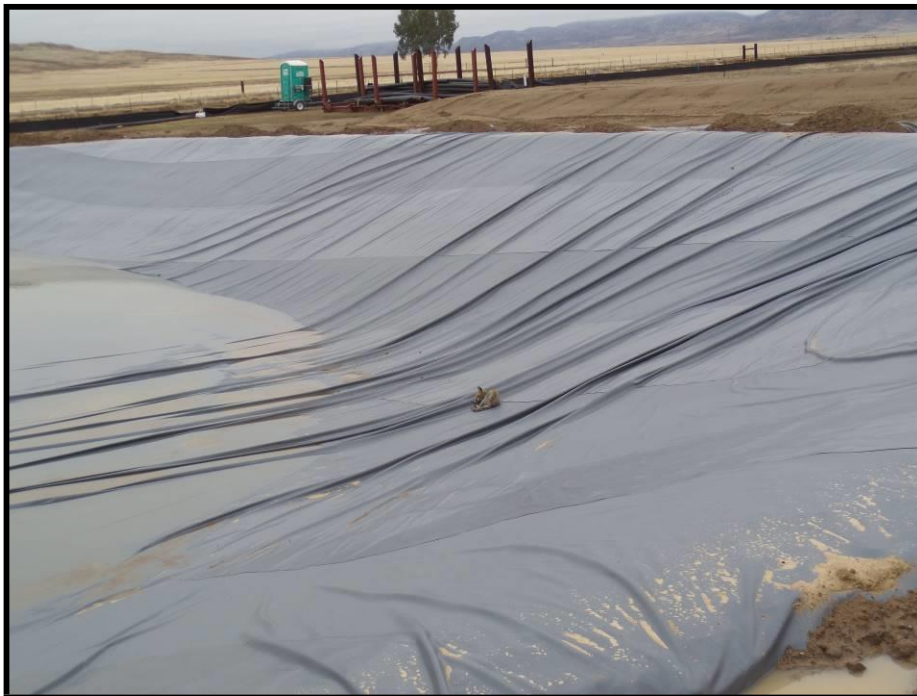
Figure 7. San Joaquin kit fox in a water containment basin on the Panoche Solar Farm construction site.

Given the difficulty in excluding foxes, other mitigation strategies have been tried. One is to put netting or some other material on top of the lining to give kit foxes traction if they enter the basin. The basin at the Mojave Desert site had steeper sides, and biologists developed “escape ladders” that were installed around the rim of the basin to allow foxes to climb out if they fell in.

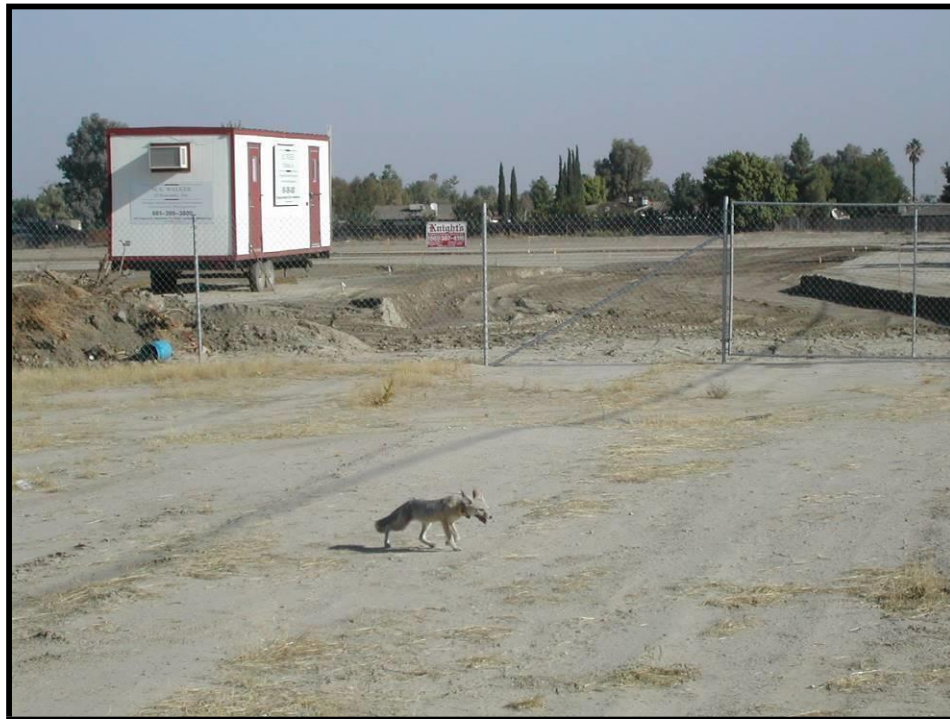
Figure 8. San Joaquin kit fox present on a residential construction site during the day.

Kit foxes entering construction sites during work: Interestingly, none of the individuals interviewed reported incidents of kit foxes being observed on construction sites while work was in progress. This may largely be a function of the nocturnal habits of kit foxes. During the day, when most work primarily occurs, kit foxes typically are in dens. Kit foxes have been observed on work sites during the day, but the incidents that we are aware of were not road construction sites (Fig. 8 and 9). However, the potential exists highlighting the value of worker training and having monitors present on-site. Also, the potential for kit foxes to appear on work sites increases considerably if work is conducted at night when kit foxes are most active.

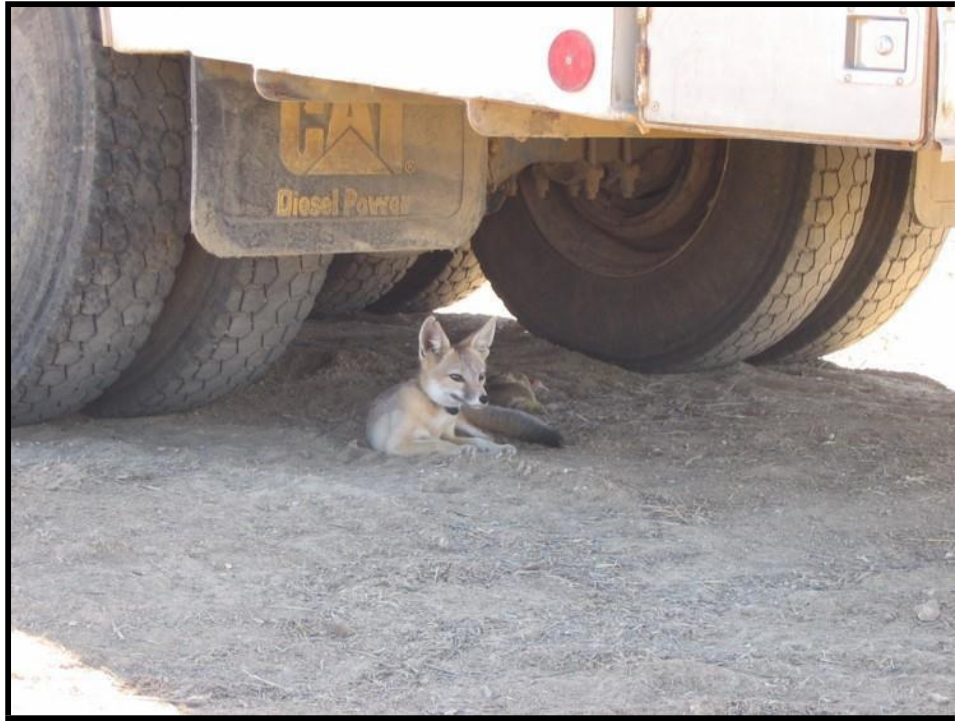
Figure 9. San Joaquin kit fox resting under a construction vehicle during the day at the Topaz Solar Farm.
