RESPONSE OF SAN JOAQUIN KIT FOXES TO ROAD CONSTRUCTION SITES

Contract Number 65A0903

**Prepared for the
California Department of Transportation**

November 2023

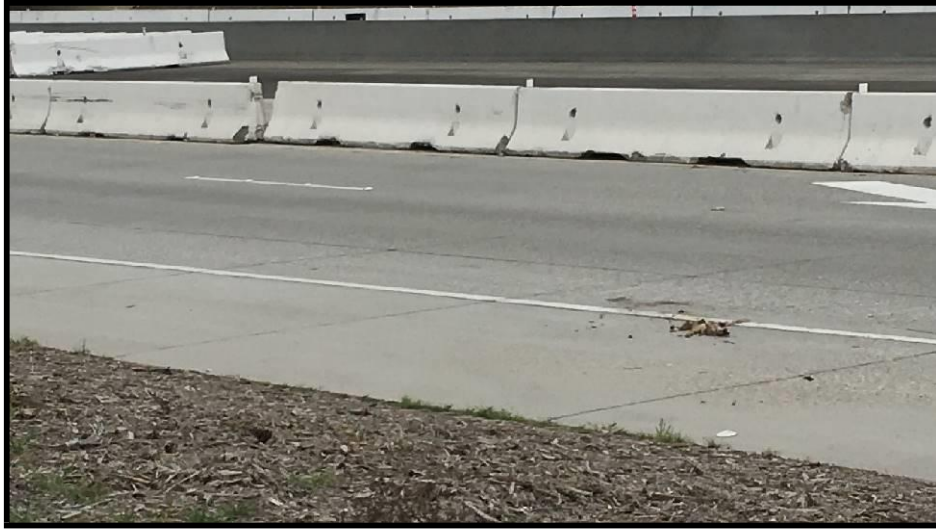
Figure 10. San Joaquin kit fox that was struck and killed by a vehicle. It is unknown whether the line of K-rails contributed to this mortality. (Photo by E. Noel)

K-rail: K-rails (commonly referred to as “Jersey barriers” outside of California) are sometimes used in road construction areas to delineate temporary traffic lanes, prevent collisions, and block vehicle or equipment access to certain areas. The K-rails generally are quite effective in achieving these goals. One drawback mentioned during interviews is that the barriers can impede or restrict animal movements. Animals also sometimes get trapped up against the barriers. Gaps are sometimes left between adjacent K-rails to allow animals to pass through the barriers. Although these gaps permit passage, animals are not able to see traffic on the other side until they pass through. Thus, if animals rush through the K-rail gaps, they may be struck by vehicles on the other side. Two kit foxes were struck by vehicles by the Morning Drive x SR 178 project area (Fig. 10) and K-rails may have had a role in the mortalities.

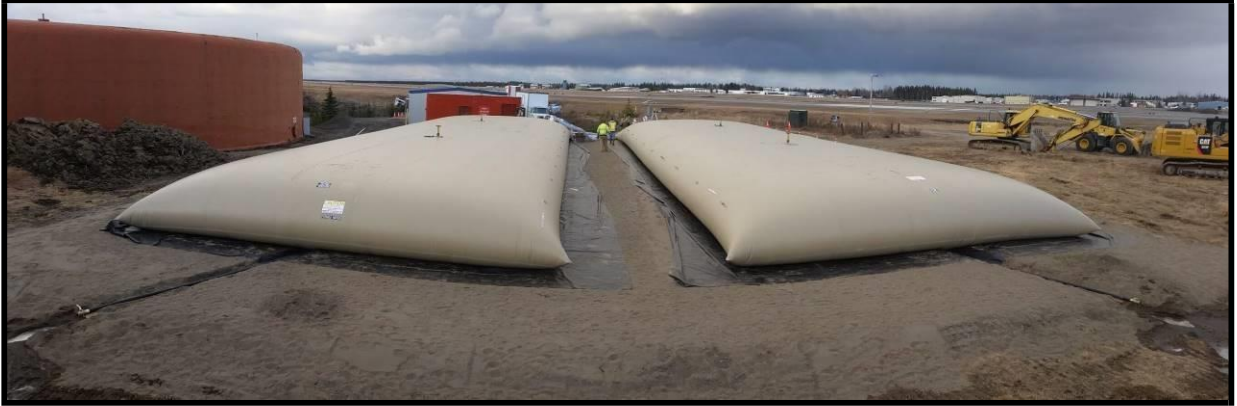
Figure 11. Two 100,000 gallon water storage bladders on a construction site.
(<https://readycontainment.com/bladder-tank-gallery/>)

large quantities of water on a site is necessary (e.g., requirements for fugitive dust control). The alternatives include water storage tanks and bladders (Fig. 11). Some bladders can hold 210,000 gallons of water while rigid tanks can hold even more water. These would not present any risk to kit foxes.
