Emerging ISTD technology uses an innovative erosion head that more accurately measures soil erosion resistance, resulting in more cost-effective foundation designs and greater reliability and resiliency in bridge performance.

INTRODUCTION

Recommended citation: Federal Highway Administration, *In-Situ Scour Testing Device (ISTD), State Demonstrations of Field Soil Tests, Scarborough, ME* (Washington, DC: 2024) <https://doi.org/10.21949/1521777>

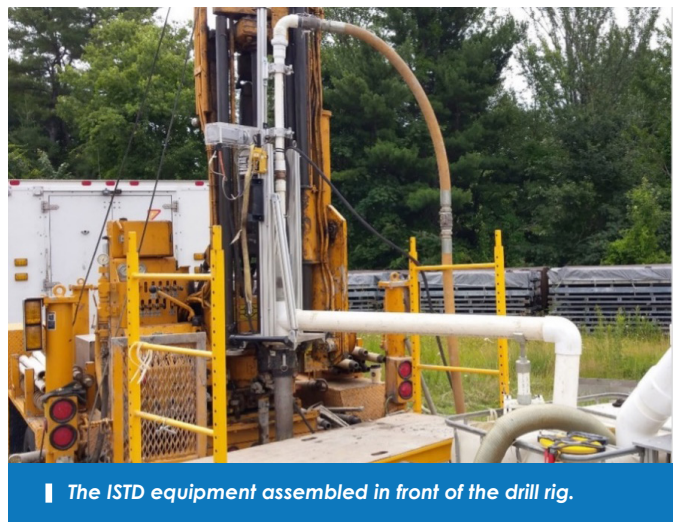
| The ISTD equipment assembled in front of the drill rig.

The next day, the drill team drilled a new boring and took extra care inserting the casing and Shelby tube. The weight of the casing easily enabled the Shelby tube to penetrate the soil without additional force. The hydraulics team assembled the remaining equipment, including the water tank, pump, piping, hoses, linear drive, and laptop and conducted the first test. The hydraulics team also brought a newly fabricated subframe assembly that supported the Shelby tube and modified the test setup so the ISTD could conduct erosion testing at ground level. The modified test setup became known as the portable scour testing device (PSTD). Soil at this site was too weak to sample in the 3.5-inch Shelby tube, so the team conducted only a mock PSTD test to validate the range of flow velocities with the new portable fire pump.

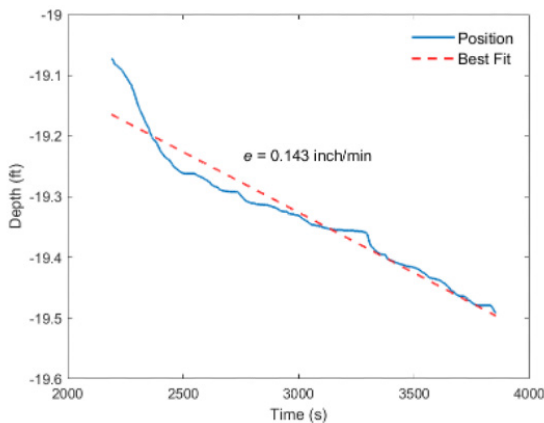
Soil layer's erosion rate (e) calculated from the slope of the best-fit line.

Of all the field demonstrations conducted for this study, this site produced some of the steadiest erosion data, likely due to the soft, easily erodible clay material. With this data, FHWA identified 10 different segments and extracted erosion rates using a best-fit line through each set of data. The corresponding mean flow rates were also calculated for each segment. The 10 data points are detailed in the Summary of Results table. The erosion rates plotted against flow rates on the related graph show the correlation between the two values. With additional data points, a nonlinear power curve can be fit to the data to extract the critical flow rate.
