# Traffic Control Device Analysis, Testing, and Evaluation Program: FY2023 Activities

Technical Report 0-7096-R3

TEXAS A&M TRANSPORTATION INSTITUTE  
COLLEGE STATION, TEXAS

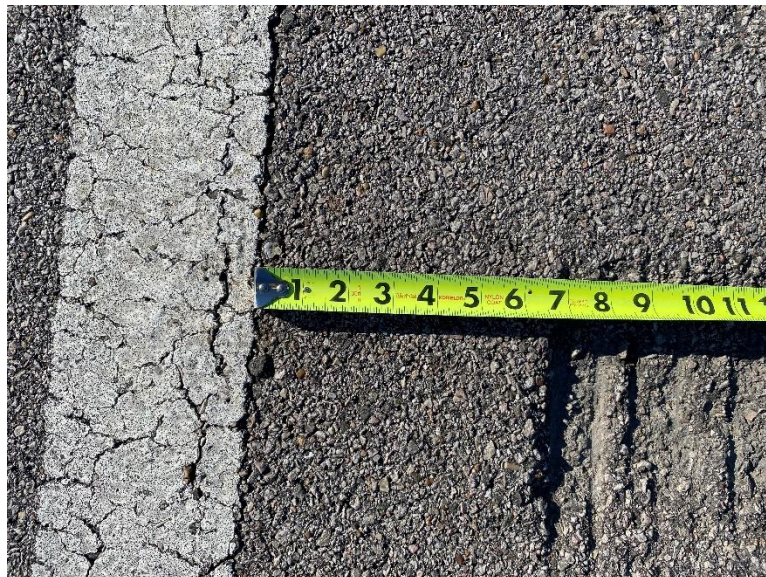
**Figure 2. Location of Rumble Strips in Before Condition.**

Researchers collected video footage for the before condition (i.e., rumble strips near the right edgeline) on January 29–31, 2020 (see Figure 2) and the after condition (i.e., rumble strips in the center of the right shoulder) on July 13–15, 2020 (see Figure 3). Each time period included approximately 24 hours of footage at each site in daytime, clear-weather conditions. The rumble strips were moved in June 2020.

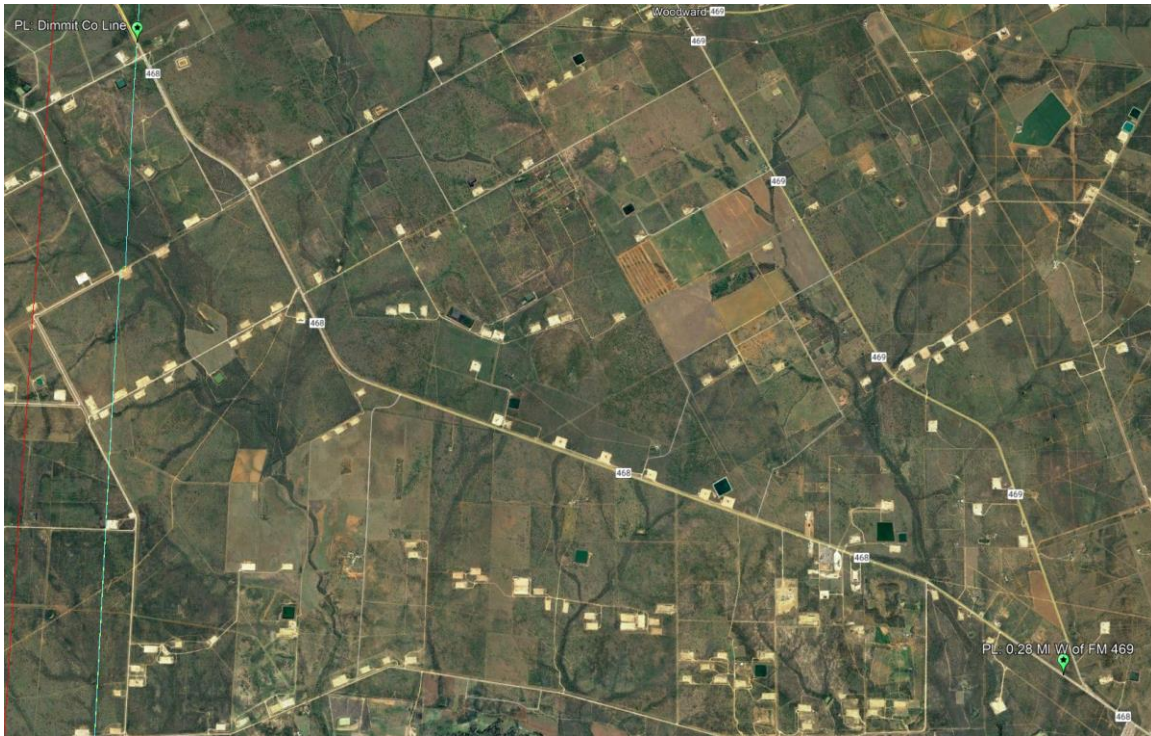
**Figure 9. FM 468 between Cotulla and Dimmit County Line.**

In August 2022, TTI researchers documented and evaluated the use of DADs on a construction project in La Salle County. The project (CSJ 1545-02-023) consisted of the rehabilitation of FM 468 from the Dimmit County line to 0.28 mi west of FM 469 (see Figure 9). TxDOT used the three-section doghouse DAD design for this project (see Figure 10). The second supplemental sign was slightly different than the current design shown in Figure 7 (i.e., does not include FLASHING YELLOW) because the standard design at the time the project began used a TURN ONLY IN DIRECTION OF ARROW sign with the three-section doghouse DAD.

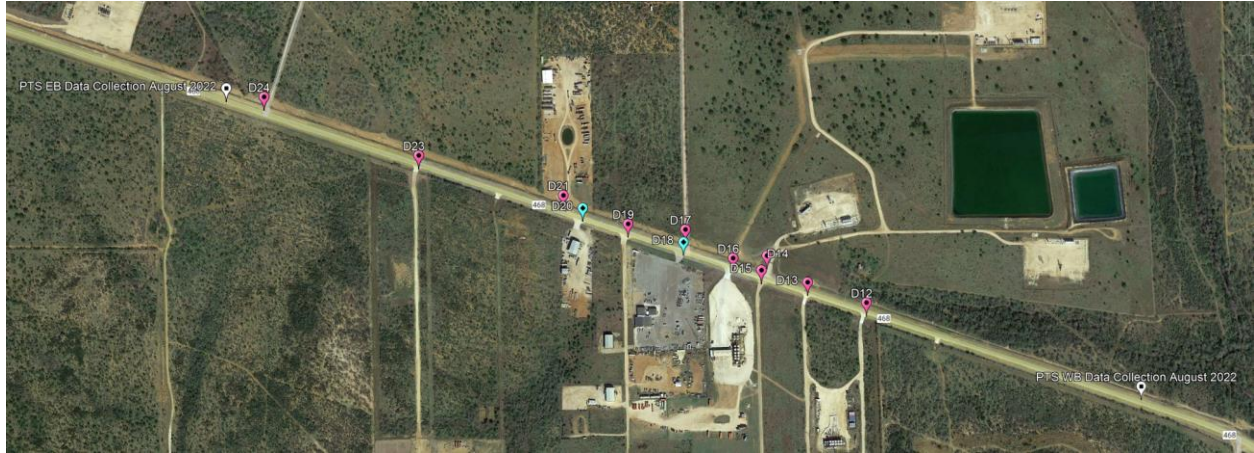
**Figure 11. FM 468 August 2022 Entire One-Lane Study Section.**

Figure 11 shows the section of roadway under construction in August 2022. The one lane section was approximately 1.4 mi long. DADs were used at 12 locations (see pink pins with circles and aqua pins with diamonds in Figure 11). On August 9–11, 2022, TTI researchers observed traffic

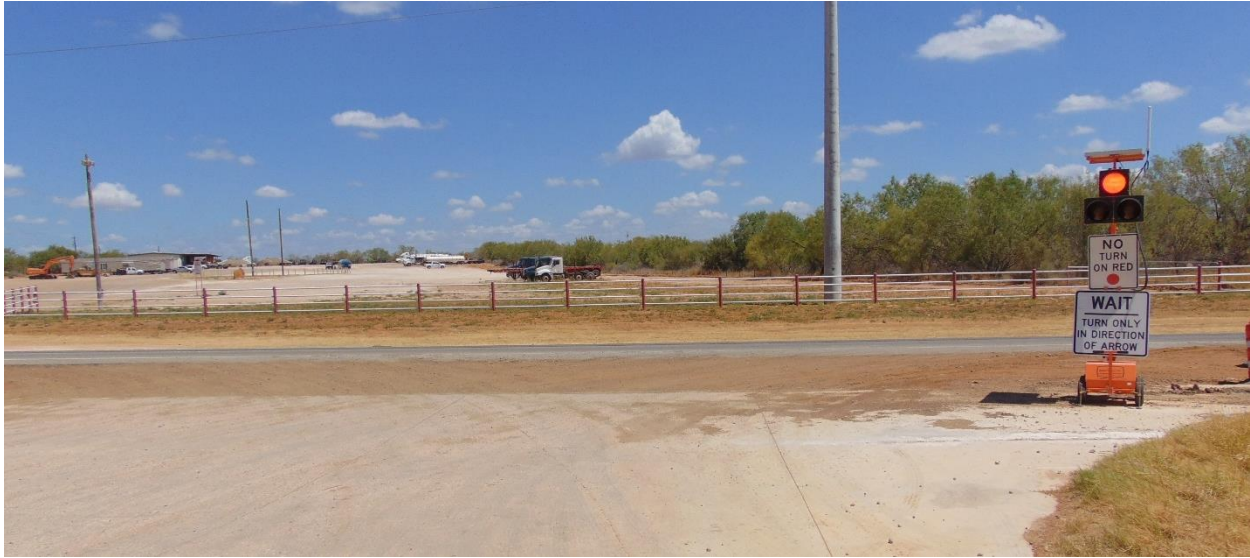
**Figure 14. Project 8 Driveway 20.**

On August 16–18, 2022, TTI researchers observed traffic approaching FM 468 from driveway 20, which served an equipment rental business (see Figure 12 and Figure 14). Driveway 20 was closer to the west end of the one-lane section (i.e., approximately 2800 ft from the PTS controlling the eastbound traffic). Data collection began around noon on Tuesday and ended around 12:30 p.m. on Thursday.

At both locations, the DAD was located on the nearside of the intersection and construction was occurring in the eastbound lanes. For both time periods, the average eastbound and westbound cycle times were approximately 4 minutes each. However, the red time was almost three-quarters of the cycle length in each direction (i.e., about 2 minutes and 45 seconds long).

Over the 48 hours and 30 minutes of data collection at driveway 20, 125 vehicles arrived at the DAD. Seventy-eight drivers (62 percent) did not comply with the DAD. However, 89 percent of violations were not necessarily unsafe driving actions. Most of the violations (65 percent) were drivers turning on red in the same direction of the subsequent flashing yellow arrow. Again, the long red time and familiar drivers may have contributed to this behavior. Twenty-four percent of violations were drivers turning on red to join the mainlane traffic queue.

Researchers did observe some unsafe driving actions at driveway 20. Seven percent of the violations were drivers that turned on red in the opposite direction of the subsequent flashing

yellow arrow (i.e., turning in the direction of oncoming traffic). Of these violations, 60 percent were drivers turning right on red when the next display was a left flashing yellow arrow, and 40 percent were drivers turning left on red when the next display was a right flashing yellow arrow. In addition, 4 percent of the violations were drivers turning in the opposite direction of the flashing yellow arrow. Of these violations, approximately two-thirds were drivers turning left when a right flashing yellow arrow was displayed, and one-third were drivers turning right when a left flashing yellow arrow was displayed. The violation rate for driveway 20 was 10.7 violations per 100 stop cycles (78 violations divided by 727 stop cycles multiplied by 100).

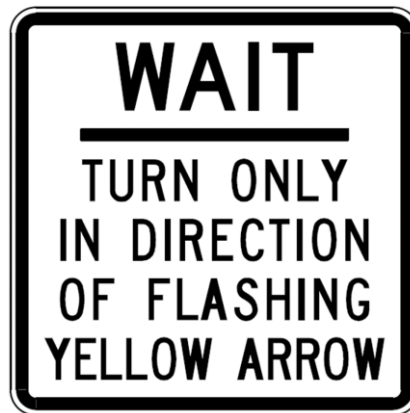
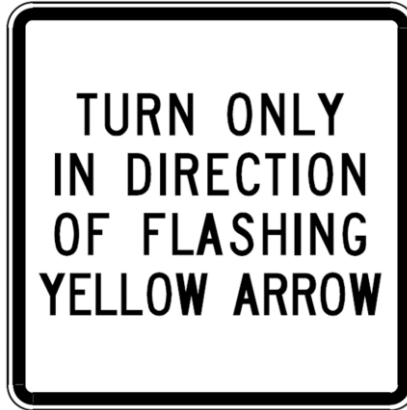
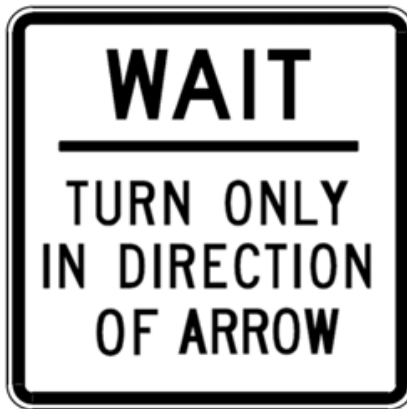
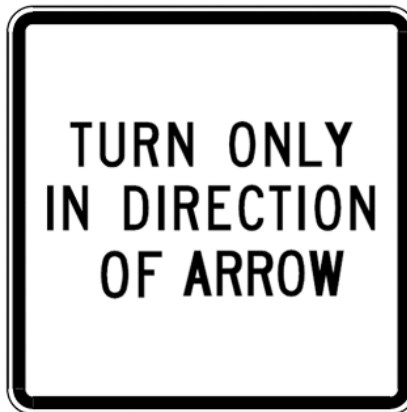
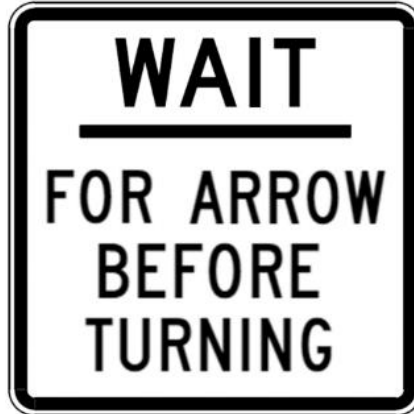
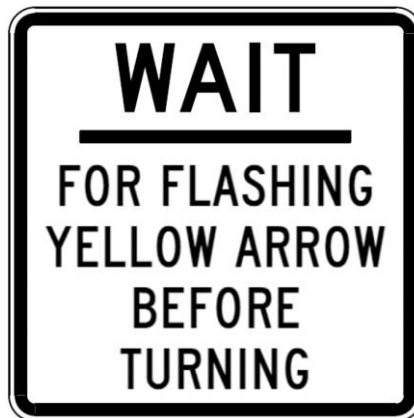
Figure 15 through Figure 20 contain the second supplemental signs studied. Treatment 1 is the sign currently used by TxDOT. Treatment 2 is the same message as Treatment 1 but without WAIT. TxDOT previously used Treatment 2 with the three-section doghouse DAD. Treatment 3 is the same message as Treatment 1 but without FLASHING YELLOW. Treatment 4 is the same message as Treatment 1 but without WAIT and FLASHING YELLOW. Treatment 5 is another sign that was recommended by Gates et al. (4). Treatment 6 is the same message as Treatment 5 but with FLASHING YELLOW added. Researchers tested treatments 1 through 6 with the three-section doghouse DAD to compare motorist understanding of these signs with and without WAIT and with and without FLASHING YELLOW. Researchers tested treatments 1, 2, and 6 with the four-section stacked DAD to compare motorist understanding with the three-section doghouse DAD.

Researchers found that only the correct answers for Treatment 3 (WAIT TURN ONLY IN DIRECTION OF ARROW) and Treatment 4 (TURN ONLY IN DIRECTION OF ARROW)

Researchers found no significant differences in correct answers when FLASHING YELLOW or WAIT was added to the second supplemental sign.

In order to assess the impact of adding WAIT to the bottom sign on the four-section stacked DAD, Treatment 1 (WAIT TURN ONLY IN DIRECTION OF FLASHING YELLOW ARROW) was compared to Treatment 2 (TURN ONLY IN DIRECTION OF FLASHING YELLOW ARROW). The only difference in this sign pair was the WAIT text. Researchers found no significant differences in correct answers when WAIT was added to the second supplemental sign.

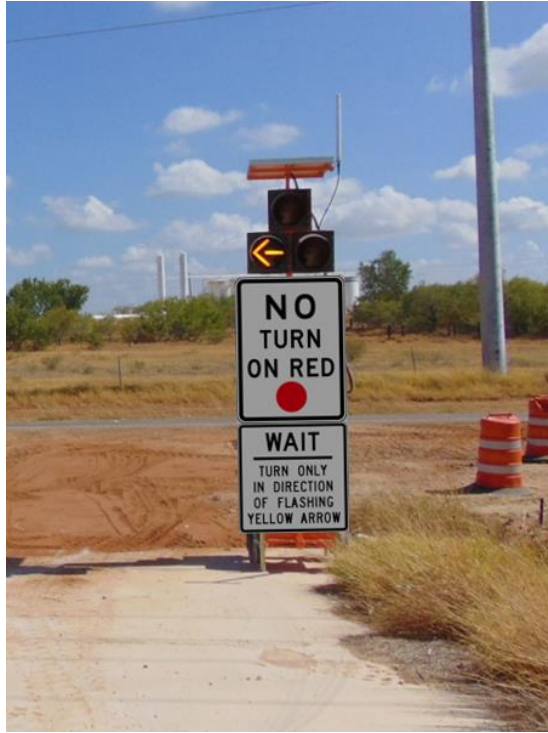
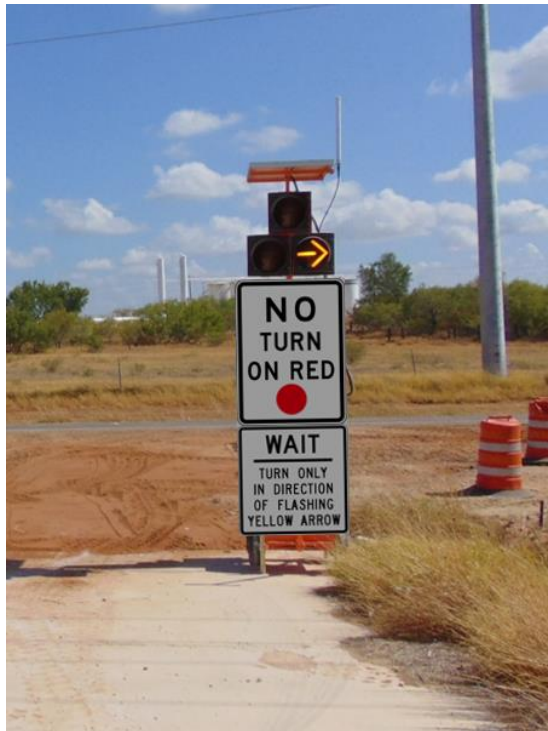
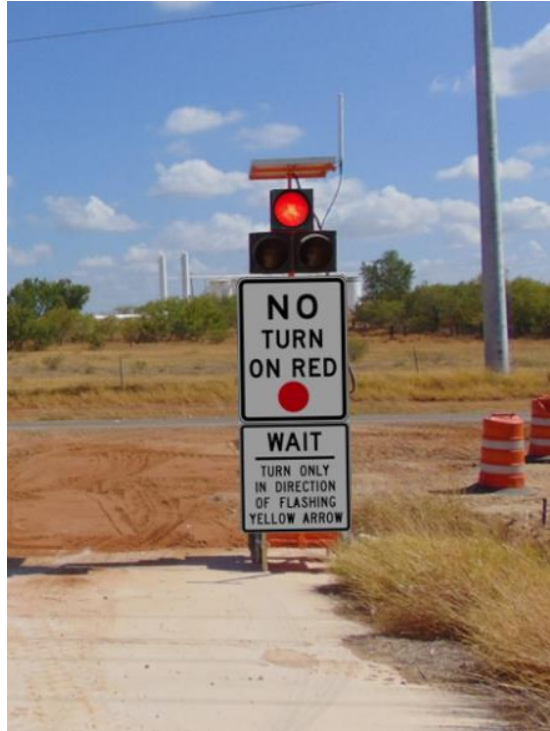
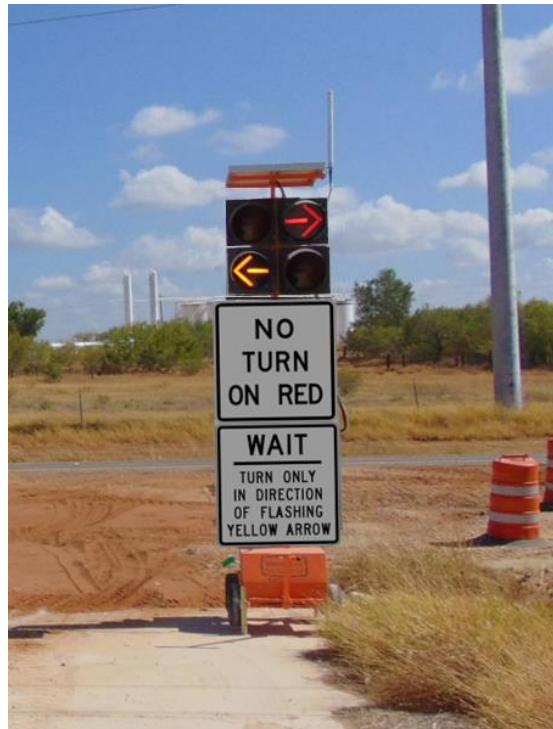
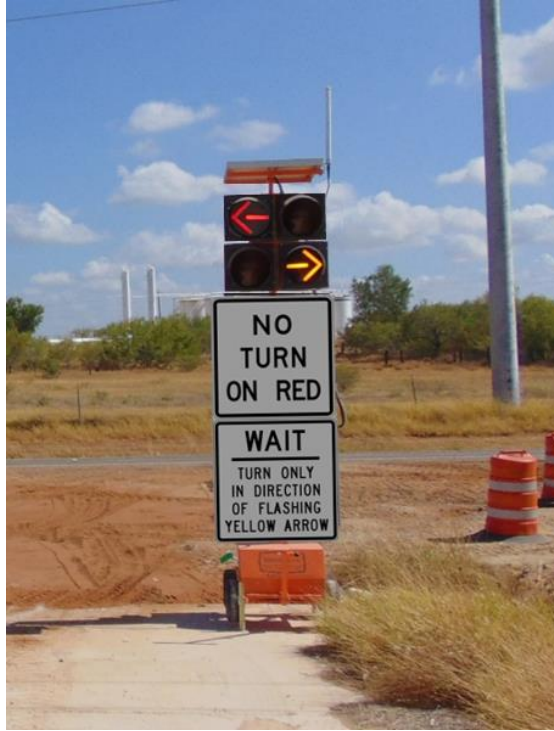
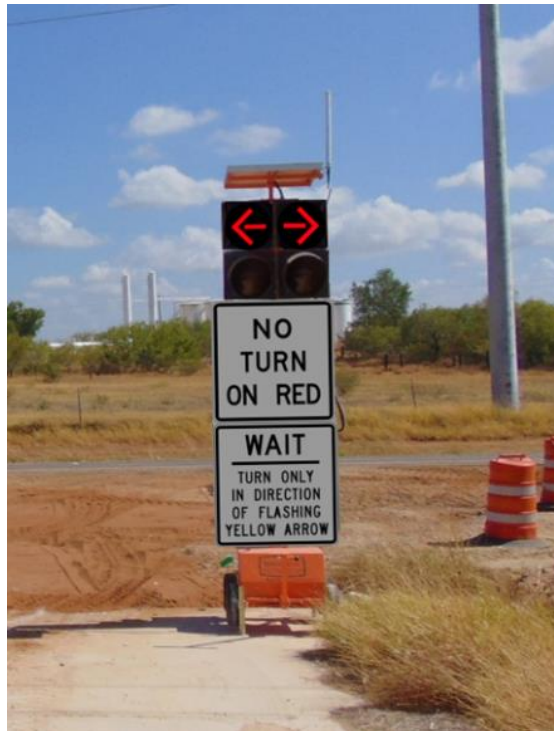
Researchers used graphics editing software to create scene view images for each desired top and bottom sign combination. Then researchers developed graphics interchange format (GIF) files to create various flashing lens indications for both DAD designs. Researchers overlaid the GIF files on the scene view images to create the displays used in the online survey. The Treatment 1 displays are shown in Figure 21 through Figure 26.

Overall, the combinations of signs and lens indications resulted in 27 different displays. There were 18 displays for the three-section doghouse DAD (consisting of proceed left, proceed right,

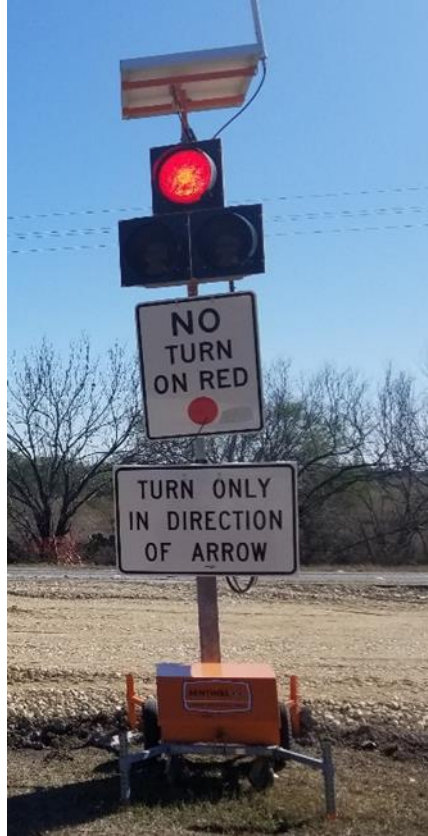
**Figure 28. Example of Recommended DAD Design.**

Based on the field study findings analyzed to date (i.e., those documented herein and those in prior reports [3]), researchers recommend the use of the three-section doghouse DAD with a NO TURN ON RED sign (R10-11) and TURN ONLY IN DIRECTION OF ARROW sign. An example of the recommended DAD design is shown in Figure 28.

The survey findings support the use of the three-section doghouse DAD since only that DAD design with either a WAIT TURN ONLY IN DIRECTION OF ARROW sign (Treatment 3) or a TURN ONLY IN DIRECTION OF ARROW sign (Treatment 4) met the minimum comprehension levels for all questions. Since adding FLASHING YELLOW or WAIT to the second supplemental sign did not impact motorist comprehension of the proper driving actions, researchers recommend using the TURN ONLY IN DIRECTION OF ARROW sign.
