**MARITIME TRANSPORTATION RESEARCH AND EDUCATION CENTER
TIER 1 UNIVERSITY TRANSPORTATION CENTER
U.S. DEPARTMENT OF TRANSPORTATION**

**Rapid Assessment of Internal Erosion Damage and Erodibility in Levees
July 2020 – December 2023**

**FINAL RESEARCH REPORT
Prepared for:
Maritime Transportation Research and Education Center**

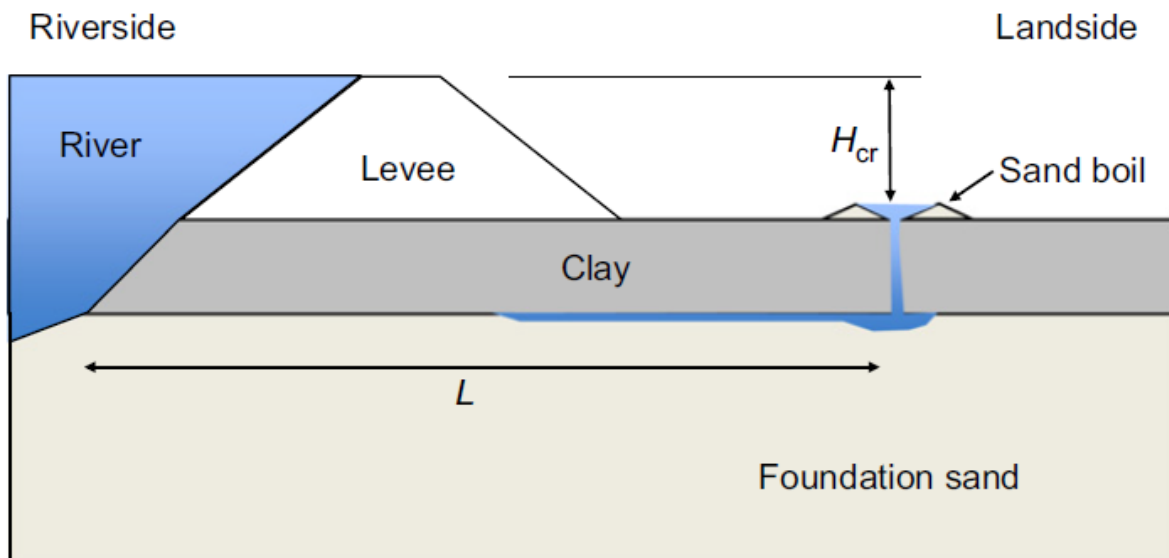
Figure 2 Conceptual model of sand boil formation and subsequent backward erosion piping with typical foundation materials for levees along meandering rivers (Robbins et al., 2020)

Surface erosion damage during levee overtopping can easily be assessed using visual methods. However, determining the extent of internal erosion damage is not possible using only visual methods. During USACE levee inspections, sand boils, and saturated areas are noted as signs of excessive seepage (Flood Damage Reduction/System Inspection Report, n.d.). Sand boils are cone-shaped deposits of granular materials that form on the land side of levees due to seepage induced by high vertical hydraulic gradients (Robbins et al., 2020). A conceptual model of sand boil formation and subsequent backward erosion piping development from Robbins et al. (2020) is presented in Figure 2.

The vertical gradients required for sand boil formation are generated during flooding due to the presence of a confining layer on the landside of the levee. These confined groundwater conditions lead to high uplift forces and sand boil formation through defects in the confining layer (Schaefer et al., 2017). Additionally, the confining layer may fracture from the uplift forces leading to sand boil formation at the point of concentrated flow (Robbins et al., 2020). Sand boils may continue

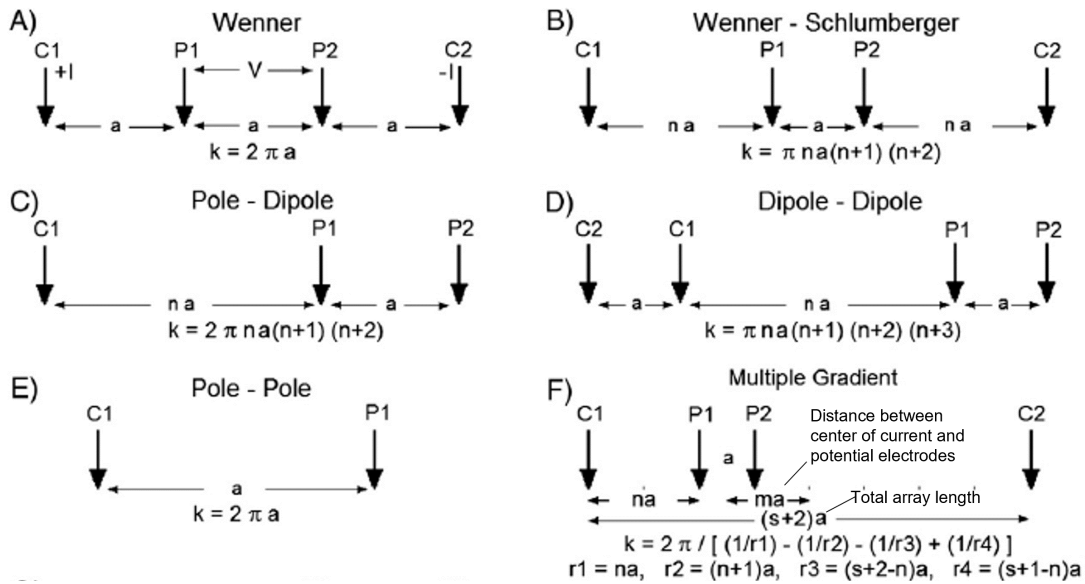
Figure 4 Common electrode array types and geometric factors (k) (modified from Loke et al. (2013))

In the DD array, the current is injected at two electrodes (electrodes A and B) and potential (electrodes M and N) is measured across another set of electrodes (Figure 4). In a dipole-dipole survey, the depth of investigation is increased by increasing the distance between the current and potential electrode pairs. The DD array is more sensitive to horizontal changes in resistivity (e.g., voids, dikes) than vertical changes (e.g., horizontal stratigraphy changes) (Dahlin & Zhou, 2004; Loke, 2022). Additionally, the DD array is more sensitive to noisy site conditions and has poorer resolution at depth than other array types (Dahlin & Zhou, 2004).

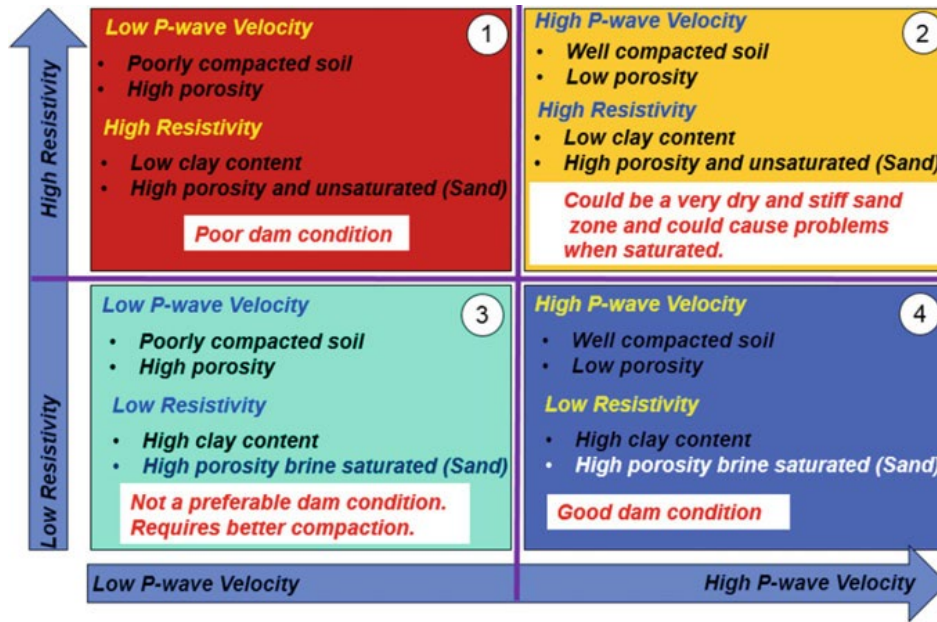
Figure 6 Conceptual design of the cross-plot analysis for the Francis Levee (Wodajo et al., 2019)

Cross-plot analysis of electrical and seismic geophysical data is another method to assess internal erosion sites on levees. In cross-plot analysis, levees are classified (in terms of safety) both on seismic velocities (V_s or V_p) and ER. Wodajo et al. (2019) used cross-plot analysis of SRT and ERT data to investigate an internal erosion site at the Francis Levee on the Mississippi River. Conceptually in cross plot analysis, as the seismic velocity increases and the ER decreases, the levee safety increases, the conceptual model of cross-plot analysis for Francis Levee from Wodajo et al. (2019) is presented in Figure 6. Wodajo et al. (2019) identified anomalous zones of low V_p and high resistivity on both the landside and riverside of the Francis Levee. Identification of anomalous zones aided in interpreting the geological cause of internal erosion at the site. Cross-plot analysis of seismic and electrical geophysical data has also been used to estimate soil type and soil parameters of levee materials (e.g., Hayashi et al., 2014, 2019). Hayashi et al. (2019) performed a cross-plot analysis utilizing CCR and MASW surveys, including approximately 670 km of surveys and 400 borings on Japanese levees. A database of shear wave velocity, ER, and soil properties (from borings) was created to allow for statistical estimation of soil type, percent fines content (F_c), the effective grain size (D_{20}), and blow counts (N -value). However, the correlations were developed for Japanese levees and cannot be applied directly to other levee systems (Hayashi et al., 2019). While the development of cross-plot relationships to soil properties at the project site is beyond the scope of this research, the work of Hayashi et al. (2019) provides insight into the interpretation of ERT and MASW results at levees. Based on a review of the existing literature, ERT and MASW were determined to be the most effective for assessing internal erosion and erodibility in levees.

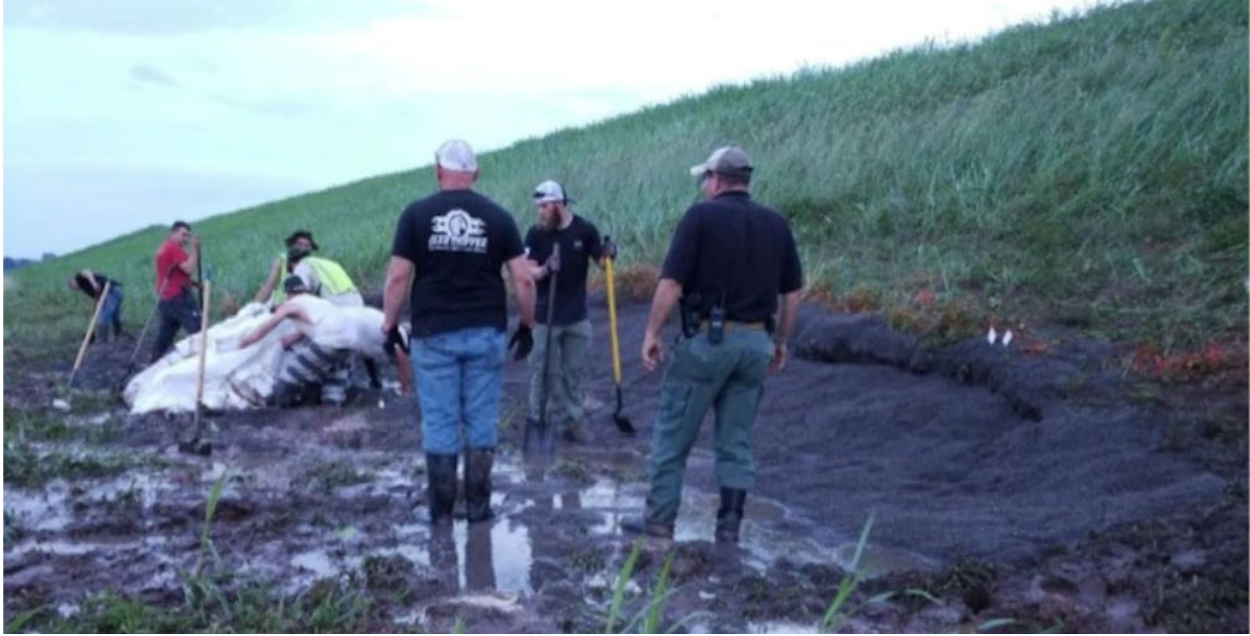
Figure 14 Placement of gravel at the base of the 2019 slide on June 25, 2019 (USACE, 2019)

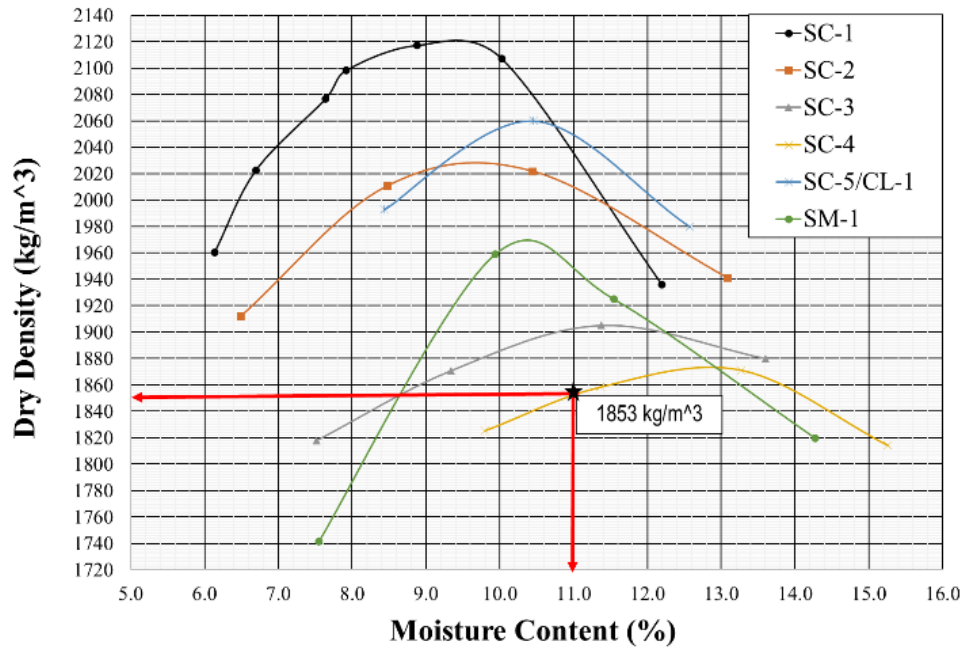
Figure 24 Moisture-density curves using standard energy for each benchmark soil with an example common density and water content point shown

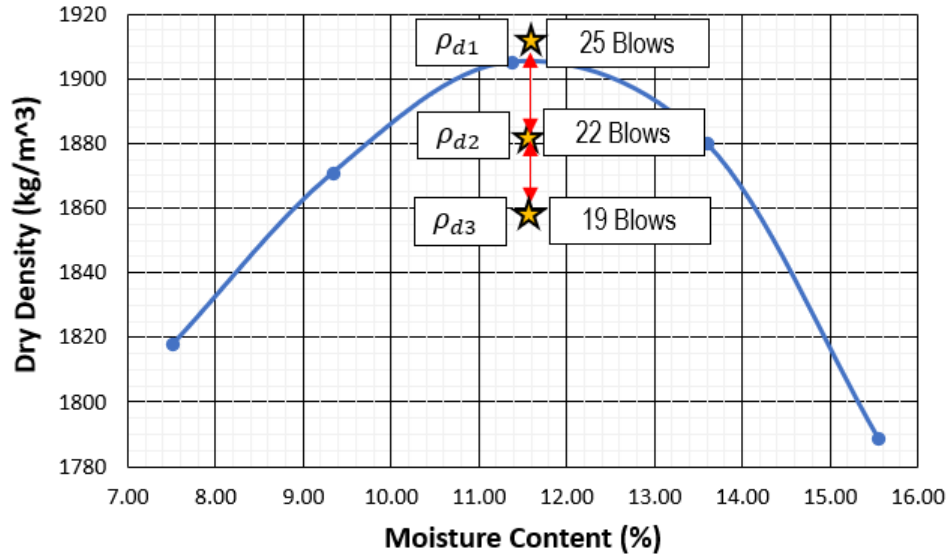
Figure 25 Number of blows used to achieve different densities while holding moisture content and plasticity index constant
