**Express Lane Marker Color Human Factors Study on Concrete and  
Open-Graded Friction Course & Impact Testing for Express Lane  
Markers Installed on Open-Graded Friction Course**

Contract Number: 800007664-01(BDV29-977-29)

**Hesham A. Ali, Ph.D., P.E., Nathan D. Schulz,  
Mohamadtaqi Baqersad, and Wanda L.  
Menges**

**Test Report No. 607531-02-1-11**

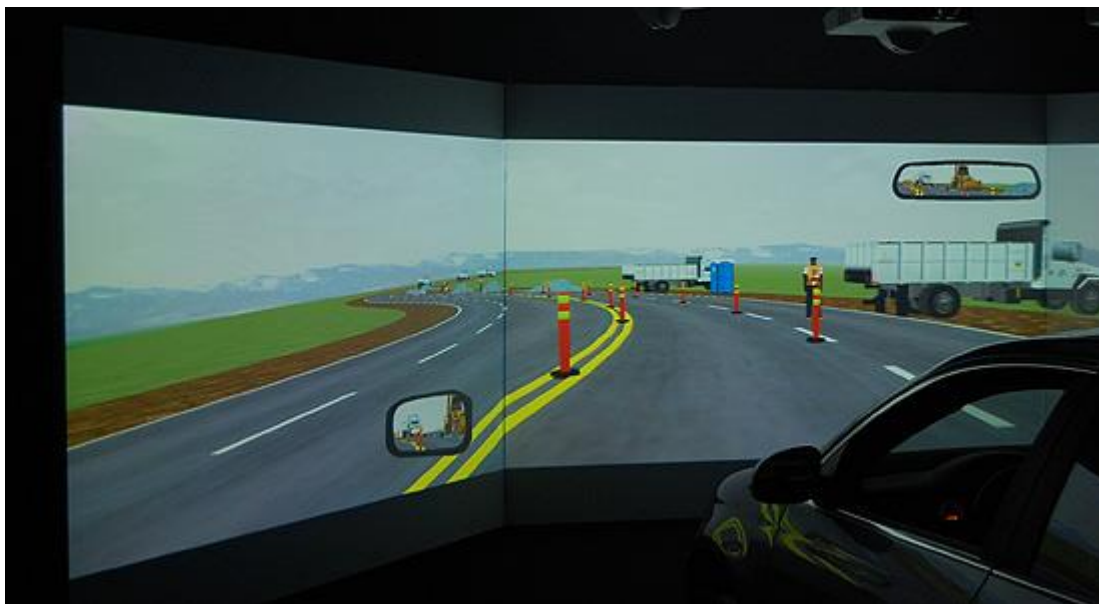
In the driving simulation test, a highway with an express lane will be simulated. The express lane will be separated from the general highway lanes by delineators. Participants will virtually drive a vehicle in the simulated environment, and the software will collect the data regarding the driver's speed and longitudinal distance from ELM when drivers detect the delineators.

*Figure 1 Driving simulation lab*

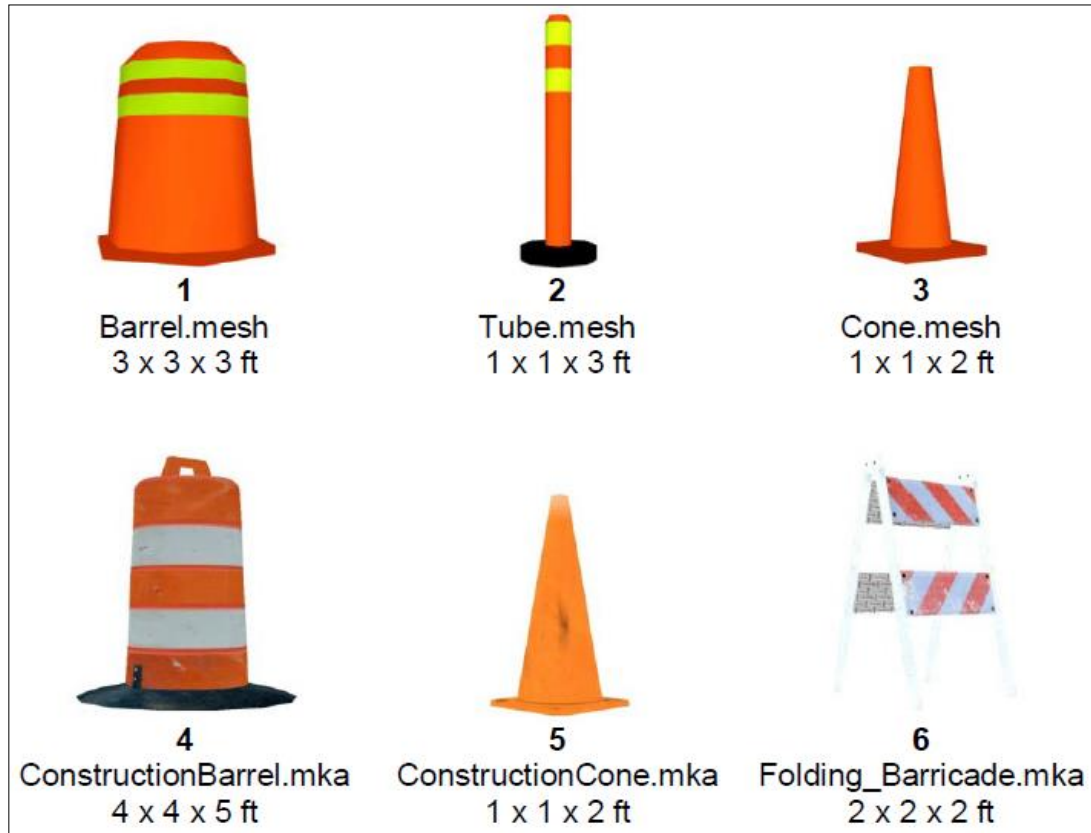
delineators. Therefore, to change the default colors, the 3D Max software will be used, and delineators with any color will be designed. Element 2 in Figure 2 will be used to construct delineators.

Figure 2: Software delineators

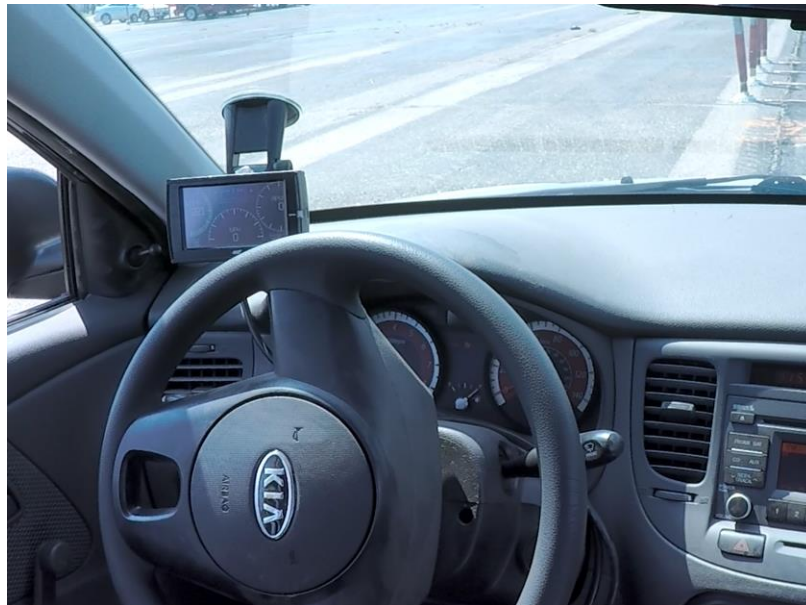
To verify the speed of the vehicle a digital speedometer is mounted on the windshield of the vehicle as seen in Figure 2.1. This digital speedometer was GPS verified to ensure the accuracy of the speed reading.

**Figure 2.1. Edge Insight Monitor.**

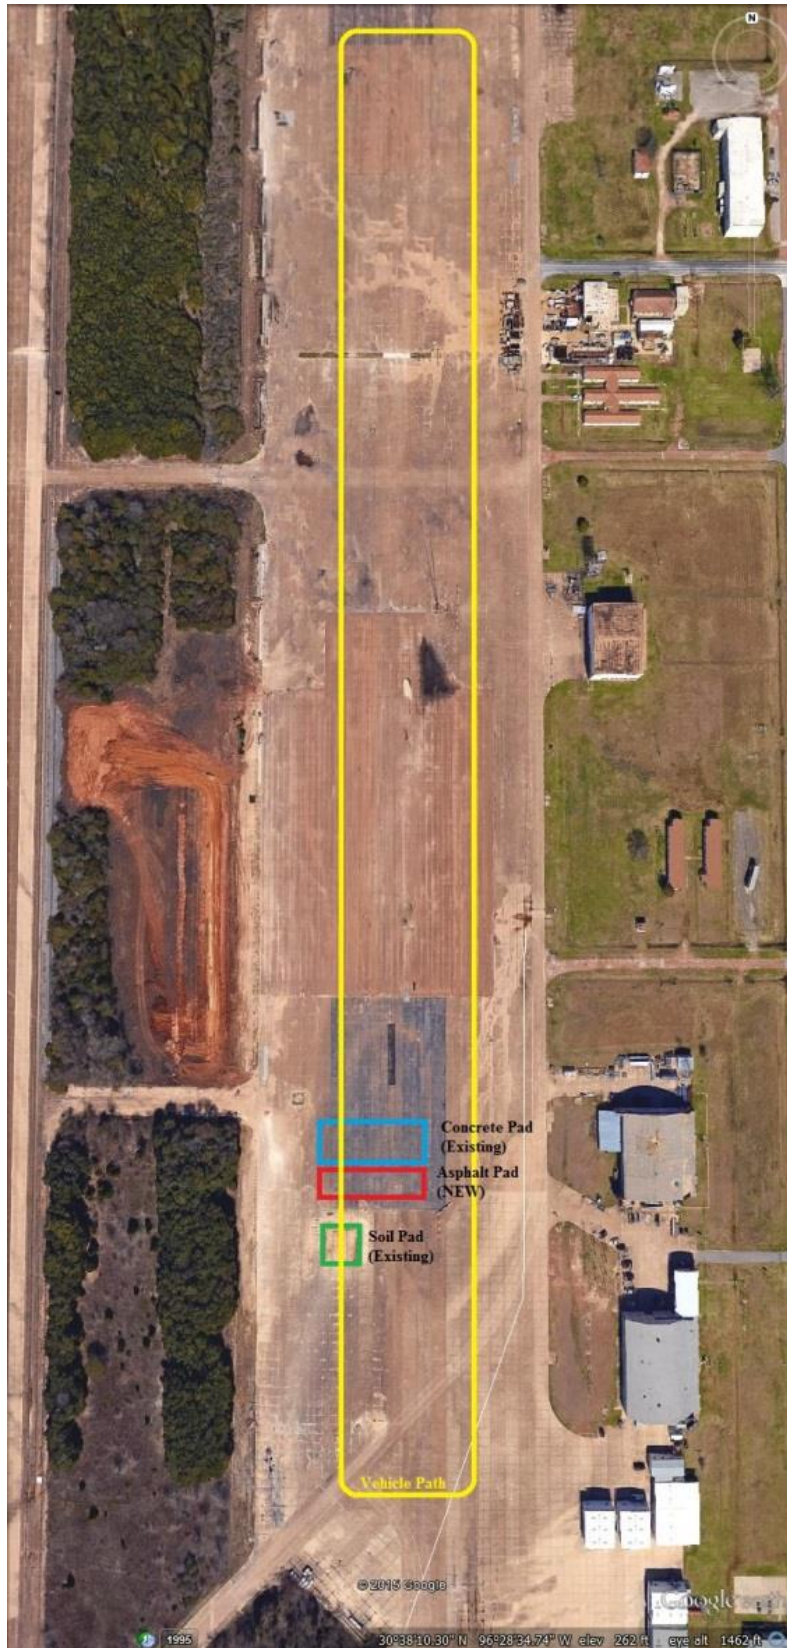
**Figure 3.1. TTI Test Facility.**

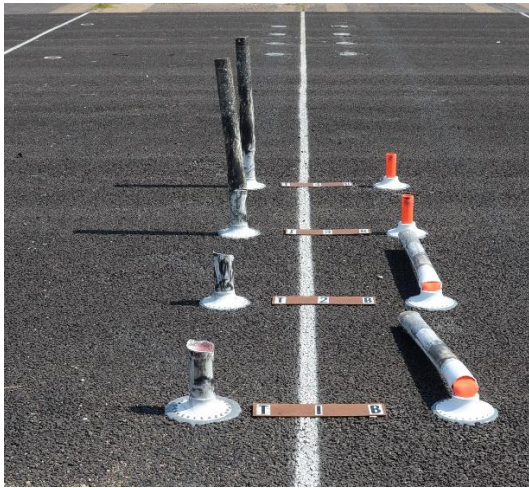
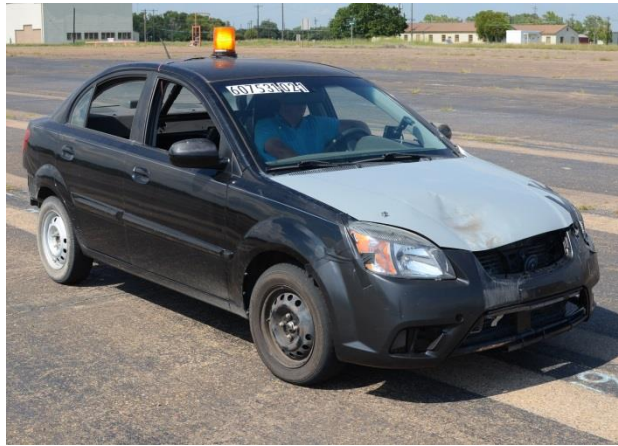
**Figure 3.5. 607531-02-1 Delineators and Test Vehicle after Testing.**

The primary mode of failure was fracturing of the samples near the base and exceeding the maximum allowable degree of list/lean.

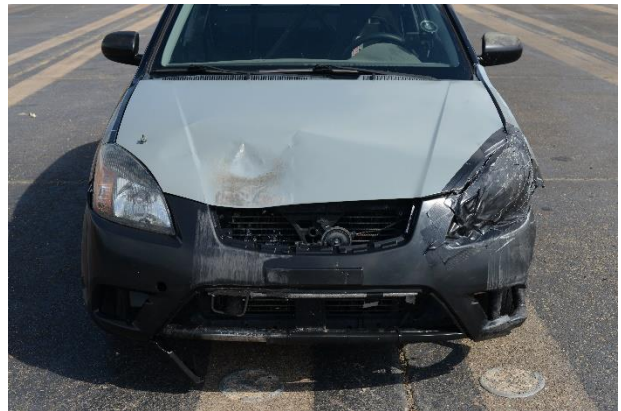
**Figure 3.9. 607531-2 Delineators and Test Vehicle after Testing.**

The primary mode of failure was fracturing of the samples near the base and exceeding the maximum allowable degree of list/lean.

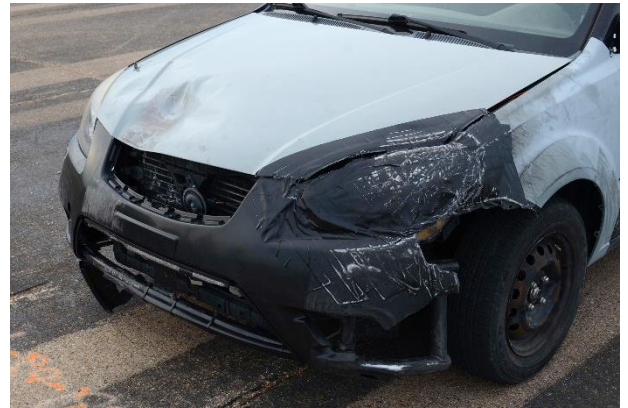
**Figure 3.18. 607531-02-4 Delineators and Test Vehicle after Testing (Concrete Surface).**

The primary mode of failure was tearing of the post approximately one foot above the base and fracture of the post at the base.

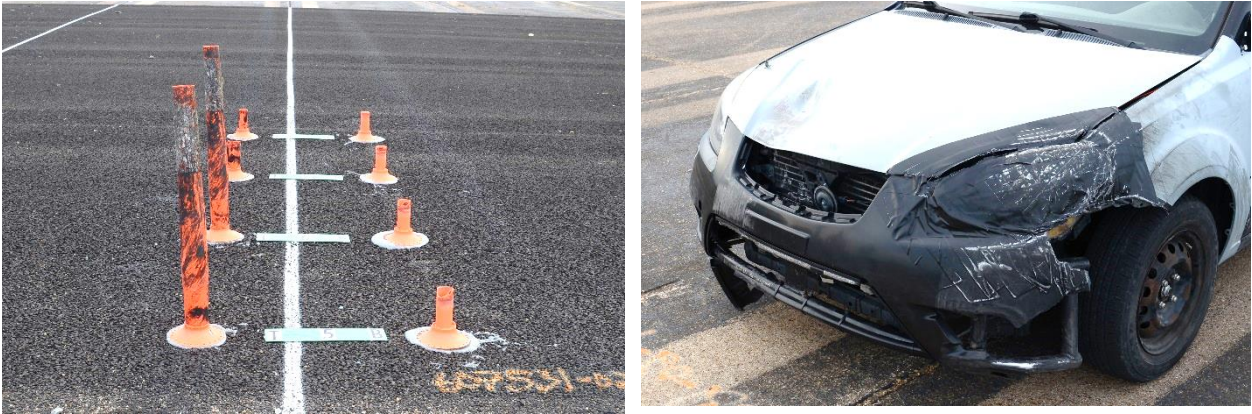
**Figure 3.20. 607531-02-4 Delineators and Test Vehicle after Testing (Asphalt Surface).**

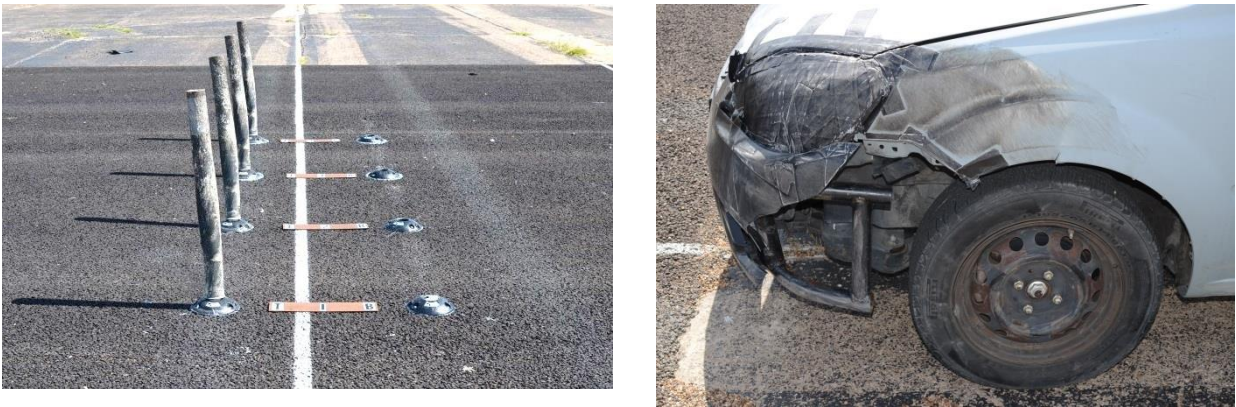
**Figure 3.24. 607531-02-5 Delineators and Test Vehicle after Testing.**

The primary mode of failure was post separation at the base. This was mainly caused by the pin tearing through the bottom of the post.

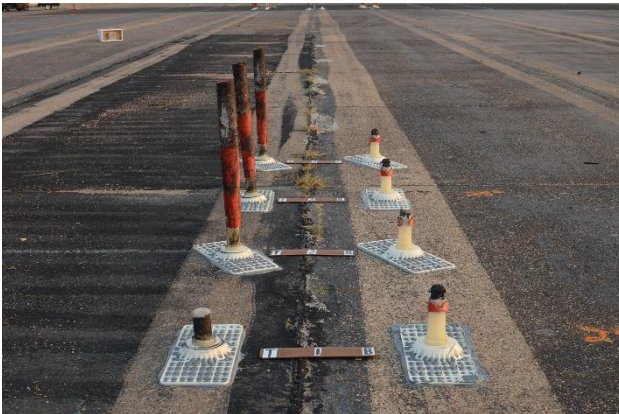
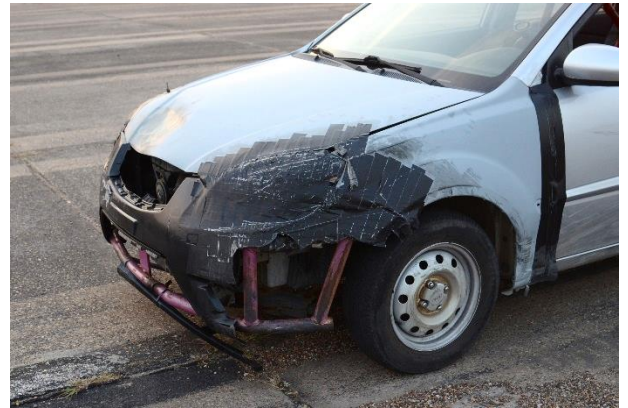
**Figure 3.36. 607531-02-9 Delineators and Test Vehicle after Testing (Concrete Surface).**

The primary mode of failure was exceeding the maximum allowable degree of list/lean and post fracture near the bolt connections.

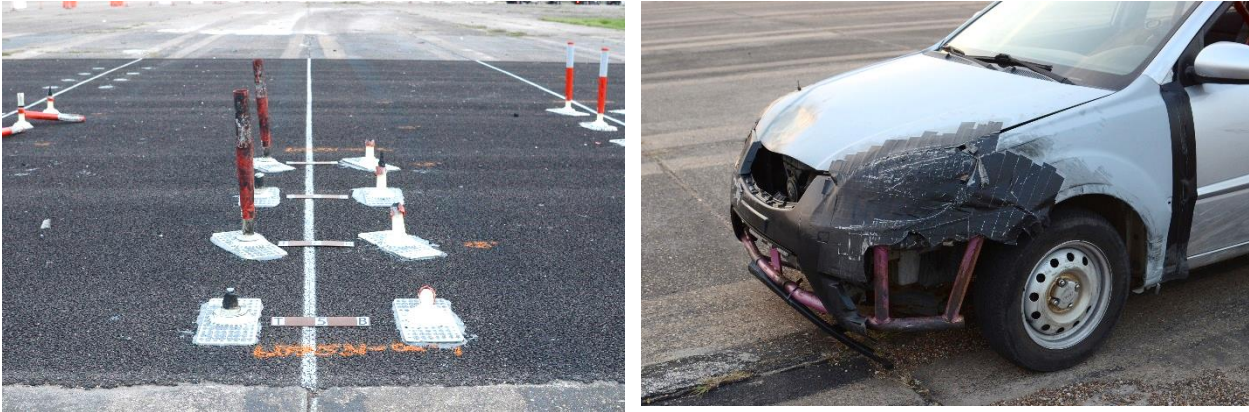
**Figure 3.38. 607531-02-9 Delineators and Test Vehicle after Testing (Asphalt Surface).**

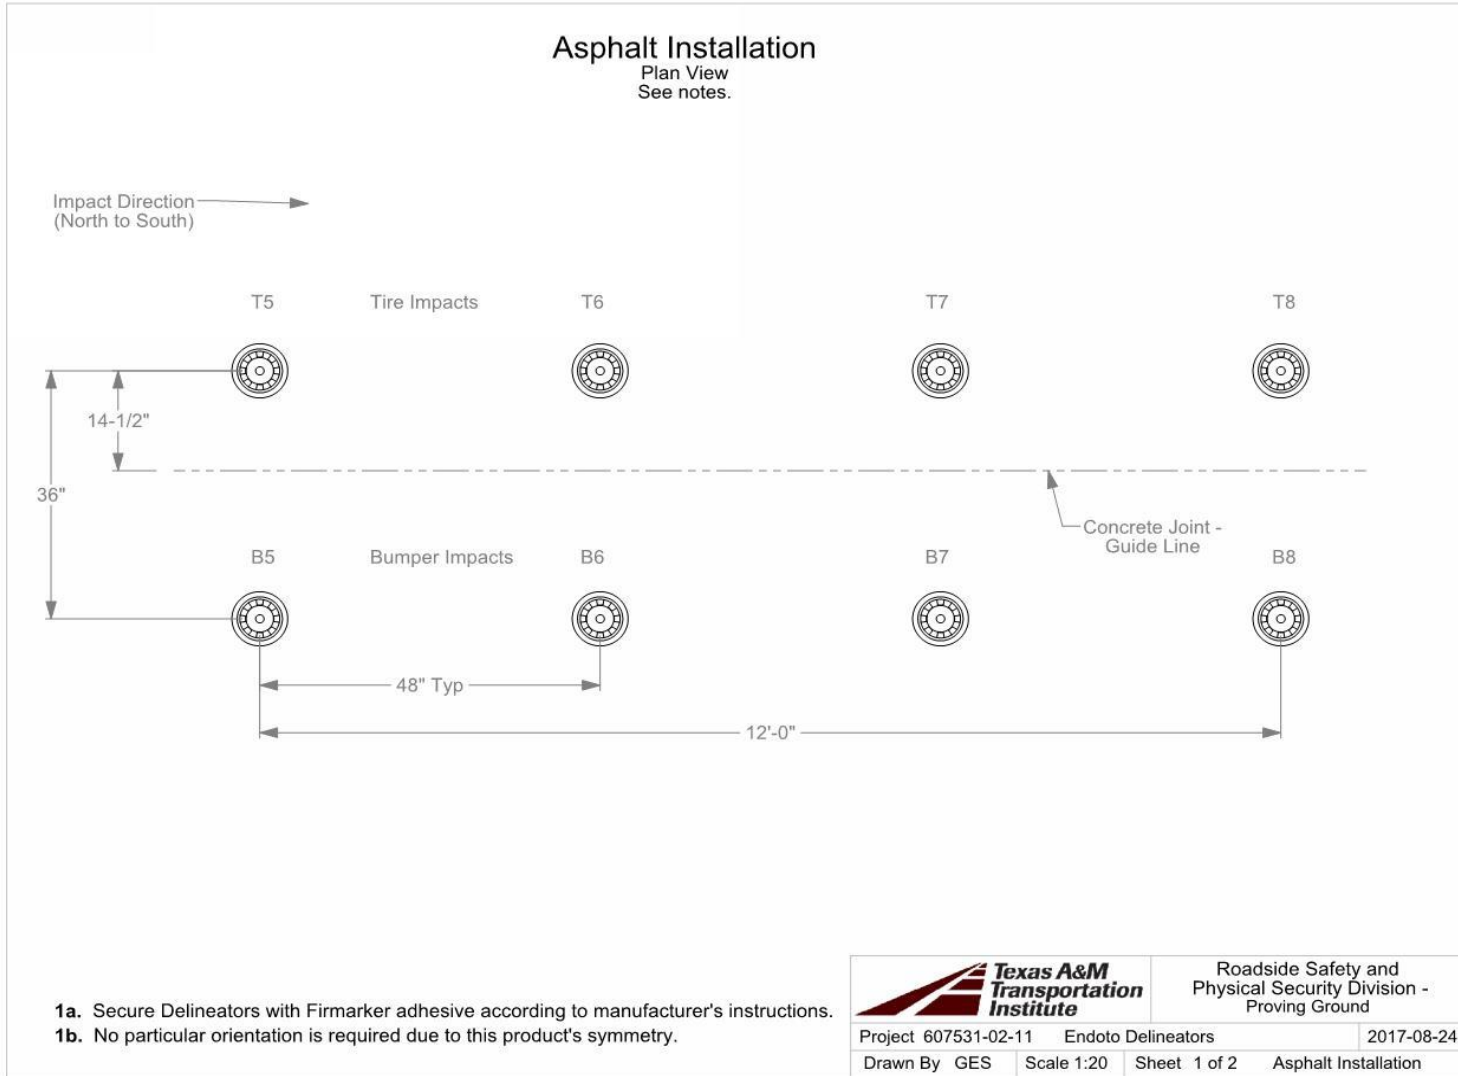
**Figure 3.44. 607531-02-11 Test Setup Details on Asphalt Surface (Epoxy).**

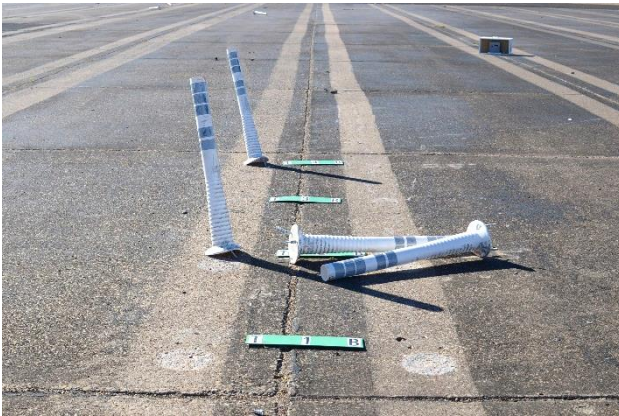
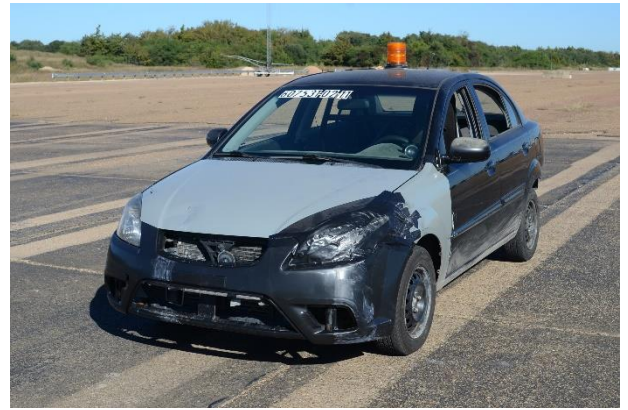
**Figure 3.47. 607531-02-11 Delineators and Test Vehicle after Testing (Concrete Surface).**

The primary mode of failure was pull out of the mechanical anchors for the delineators on the concrete surface and exceeding the maximum allowable degree of list/lean for the delineators on the asphalt surface.

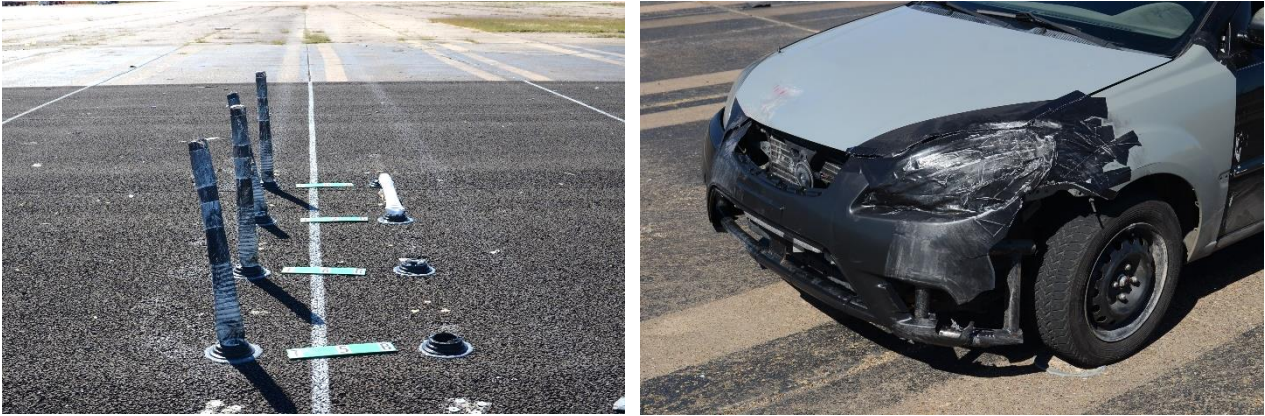
**Figure 3.49. 607531-02-11 Delineators and Test Vehicle after Testing (Asphalt Surface).**

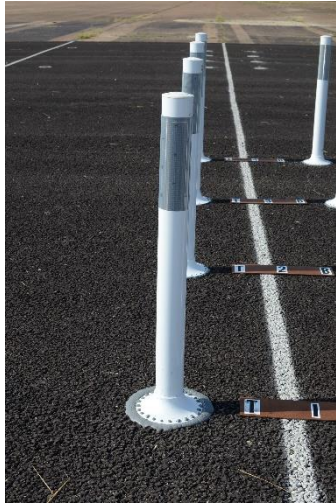
Test No. 607531-02-1, performed on July 17, 2017, was an impact durability test on 36-inch Pexco – Davidson Traffic Control Products’ City Post 8GD36ORG101 Glue Down Samples secured with FIRMmarker™ #18M900C20 2-part epoxy adhesive on asphalt as shown in Figure 3.50. The product resisted an average of 186 tire impacts, and an average of 32 bumper impacts. Table 3.11 shows a summary of the results. The primary mode of failure was fracturing of the samples near the base and exceeding the maximum allowable degree of list/lean.

**Figure 3.50. 607531-02-1 Product Sample.**

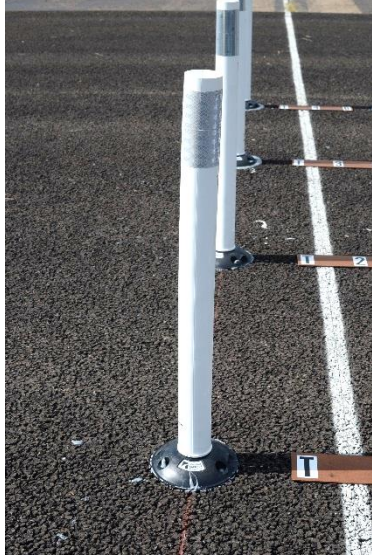
Test No. 607531-02-5, performed on July 13, 2017, was an impact durability test on Safe-Hit® Dura-Post™ Surface Mount samples, 4 each secured by SHEPX-13-K1 epoxy, and 4 each by FIRMmarker™ #18M900C20 2-part epoxy adhesive, as shown in Figures 3.55 and 3.56. With the SHEPX-13-K1 epoxy, the product resisted an average of 200 tire impacts, and an average of 24 bumper impacts. With the FIRMmarker™ epoxy, the product resisted an average of 200 tire impacts, and an average of 22 bumper impacts. Tables 3.16 and 3.17 show a summary of the results for each epoxy. The primary mode of failure was post separation at the base. This was mainly caused by the pin tearing through the bottom of the post.

**Figure 3.55. 607531-02-5 Sample (SHEPX-13-K1).**

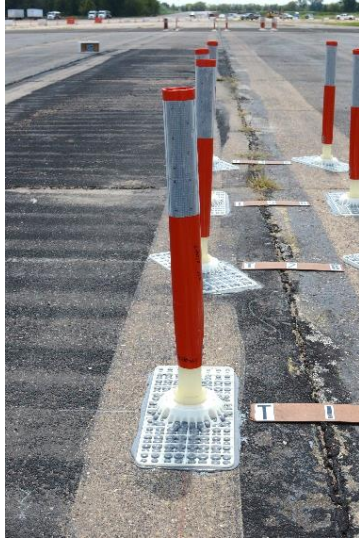
Test No. 607531-02-9, performed on September 5, 2017, was an impact durability test on Flexstake 780 Series 10-inch × 24-inch Base Tubular Surface Mount samples secured to the concrete and asphalt surfaces using E-BOND 1240/1241 2-part epoxy adhesive, 8 each on concrete surface and 8 each on asphalt surface, as shown in Figures 3.59 and 3.60. The tested delineators resisted an average of 156 tire and 24 bumper impacts on the concrete surface and 131 tire and 19 bumper impacts on the asphalt surface. Tables 3.20 and 3.21 show a summary of the results for each surface. The primary mode of failure was exceeding the maximum allowable degree of list/lean and post fracture near the bolt connections.

**Figure 3.59. 607531-02-9 Sample (Concrete Surface).**

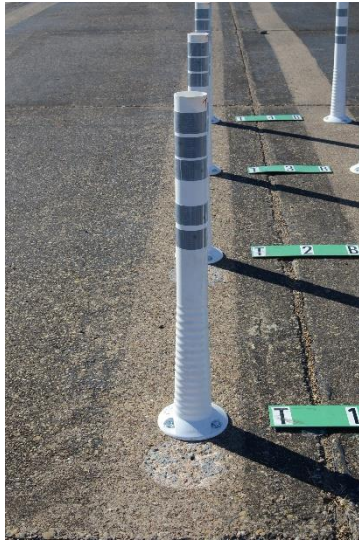
mode of failure was pull out of the mechanical anchors for the delineators on the concrete surface and exceeding the maximum allowable degree of list/lean for the delineators on the asphalt surface.

**Figure 3.63. 607531-02-11 Sample (Concrete Surface).**
