TRC1903

Investigating Concrete Deck Cracking in Continuous Steel Bridges

Department of Civil Engineering
The University of Arkansas

Final Report

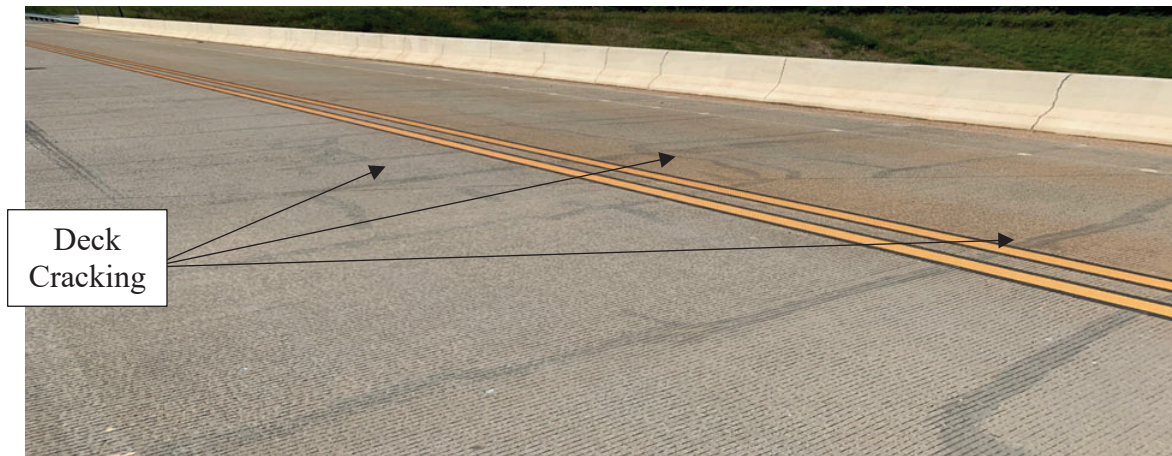
Bridge deck cracking developing prior to live load application will expand when live loads are applied and freeze-thaw cycling begins (Saadeghvaziri and Hadidi 2002). In some cases, early age cracking in continuous bridge decks can be significant (Deng, Phares, and Harrington 2016), Figure 1.

Figure 1. Cracking Prior to Applying Live Loads

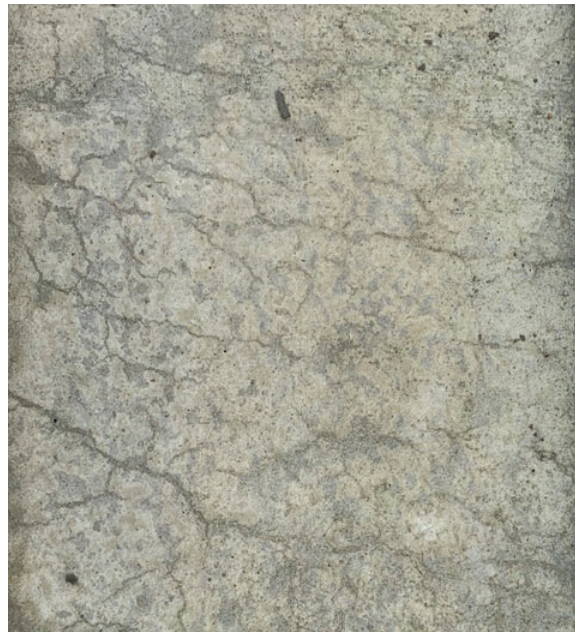
shrinkage cracks generally appear in a random pattern. Cracks from plastic shrinkage look like tears in the fresh concrete surface. These cracks tend to be shallow only affecting the top paste layer in the concrete. They are generally not a structural problem since they don't extend deep enough to affect reinforcing steel, but they can be a durability issue by deteriorating the concrete wearing surface. Plastic shrinkage can be controlled by minimizing water evaporation escaping from the concrete surface during setting. Construction procedures used to reduce surface evaporation are: fogging during concrete pouring, concrete pouring during the night, applying curing compounds or evaporation retarders, controlling internal concrete temperature, and shading the concrete deck from direct sunlight (Krauss, elson, and Nadelman 2017).

Figure 3. Example of Plastic Shrinkage Cracks in Hardened Concrete

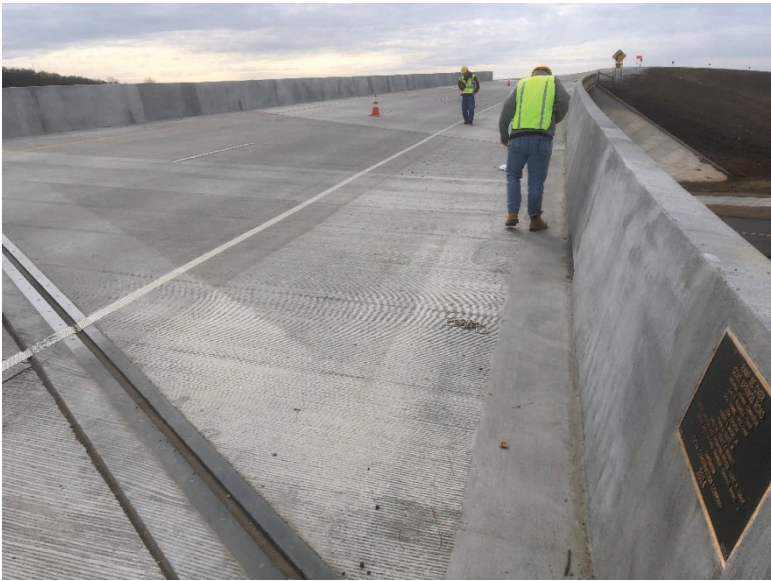
The first bridge visit was in Lowell, Arkansas (Bridge No. 07315), Figure 6. Bridge No. 07315 is an exit ramp from Interstate 49 (I-49) to Highway 612. Figure 6 shows the bridge from the northeast abutment looking southwest.

Figure 6. Bridge 07315 Lowell, AR Looking Southwest

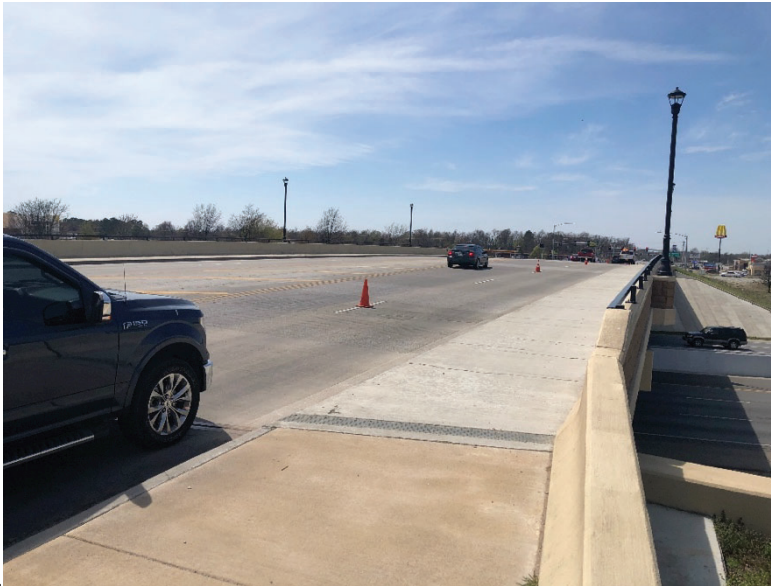
The second bridge visit was in Springdale, Arkansas (Bridge No. 05945), Figure 7. Bridge No. 05945 is a bridge width expansion project. The bridge carries Elm Springs Road over I-49. The three-span bridge with a 13° skew angle consists of seven existing girders reused from the original bridge constructed in 1982 and seven new parallel girders. The bridge deck was constructed using a continuous pour.

Figure 7. Bridge 05945 in Springdale, AR Looking to the East

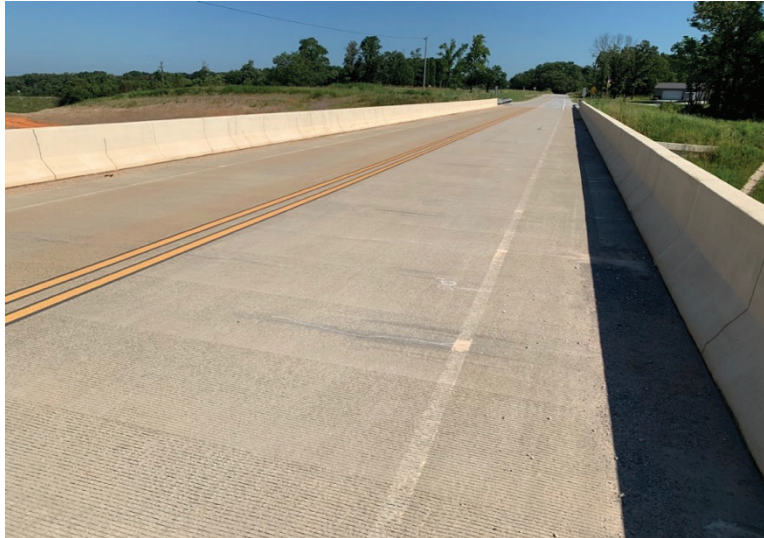
The third bridge visit was at an overpass site near Bella Vista, Arkansas where Faux Road crosses I-49. Bridge No. 07273 is a two-span continuous bridge with four welded plate steel girders and a 28° skew angle, Figure 8. The bridge was in a relatively low-traffic area. The bridge deck was constructed using continuous pour.

Figure 8. Bridge 07273 Looking Northwest

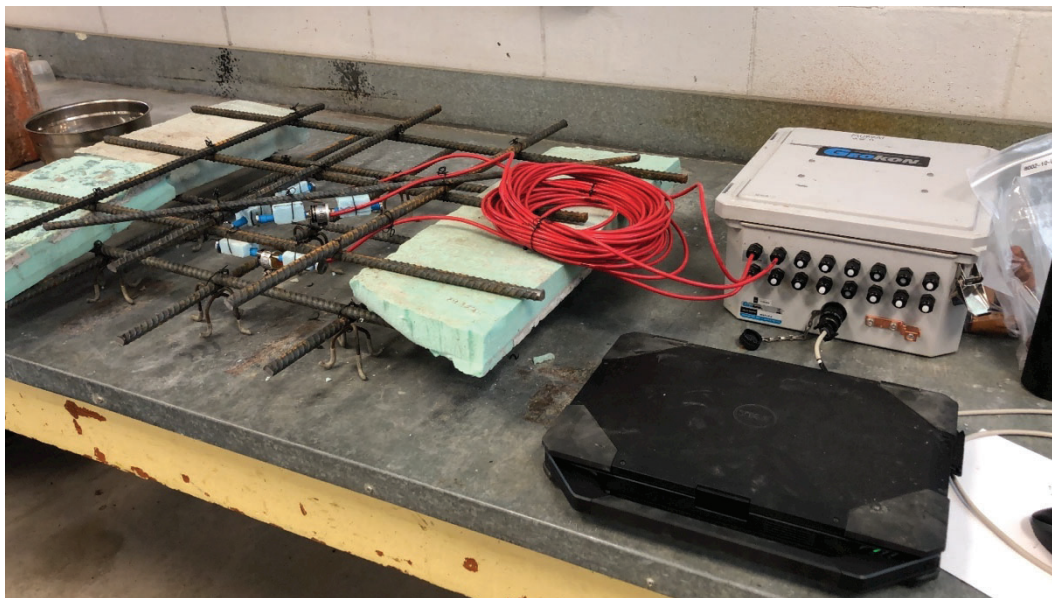
Gs. An example setup is shown in Figure 10. This figure shows a mock set up of three gauges in a rosette pattern attached to a reinforcing bar, a DAQ box, and a laptop computer. The DAQ can be set up to record strains and temperatures for the 16 attached sensors at regular intervals between 30 seconds and 1 day. For this work it was set to record every 30 minutes. The DAQ has storage to record the last 3,555 readings, approximately 74 days of data at the 30-minute acquisition rate. A computer with proprietary software is connected to the DAQ box for recording the data. The data can then be downloaded and manipulated using any spreadsheet program.

Figure 10. Data Acquisition Set-Up Showing Mock-Up VWSG Rosette and Computer

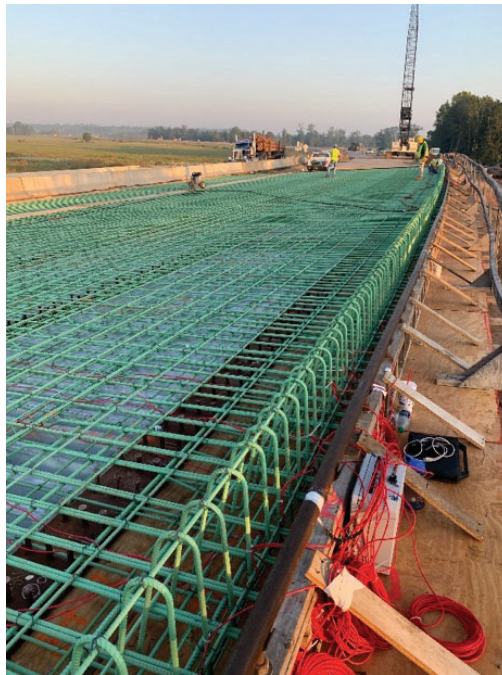
The first bridge instrumented by the researchers in this study was located near DeQueen, Arkansas, in Sevier County, Figure 11. Bridge No. 07364 carries Arkansas Highway 71 over Burke Creek. Strain gauges were installed during the Stage 2 bridge construction. Stage 2 involved the addition of new lanes to the existing bridge. The structural system is a three-span continuous steel girder bridge with a concrete bridge deck using stay-in-place forms. Stage 2 was approximately 194 ft long and 48 ft wide. The bridge was slightly curved, having a center line curvature radius of 1910 ft. The bridge cross slope is 7.70%. The concrete deck thickness is 7.75 inches. The bridge cross section is shown in Figure 12.

Figure 11. Bridge No. 07364 While Sensors were Being Installed (DAQ box shown in lower right of image)

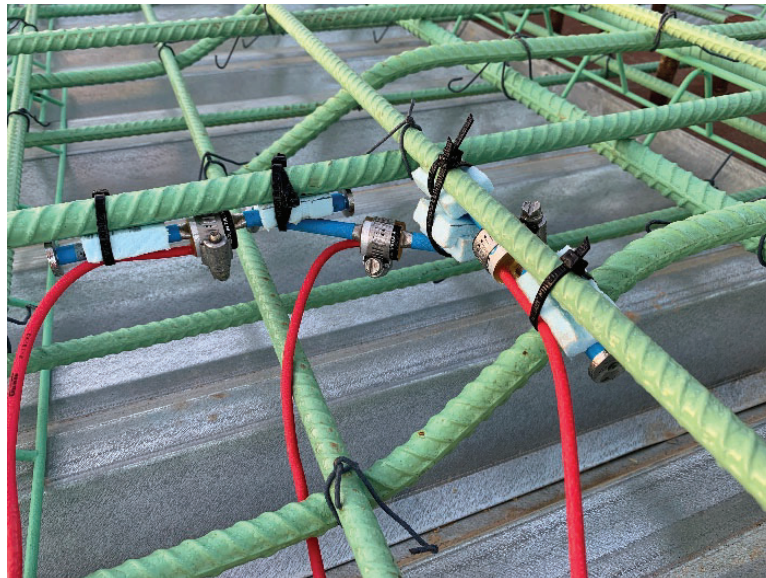
Four strain gauge rosettes were used to calculate two-dimensional principal strains at their respective locations shown in Figure 13. The remaining 20 strain gauges were positioned throughout the bridge in the bridge longitudinal axis direction. Figure 14 shows a typical strain gauge rosette.

Figure 14. Example of Strain Gauge Rosette

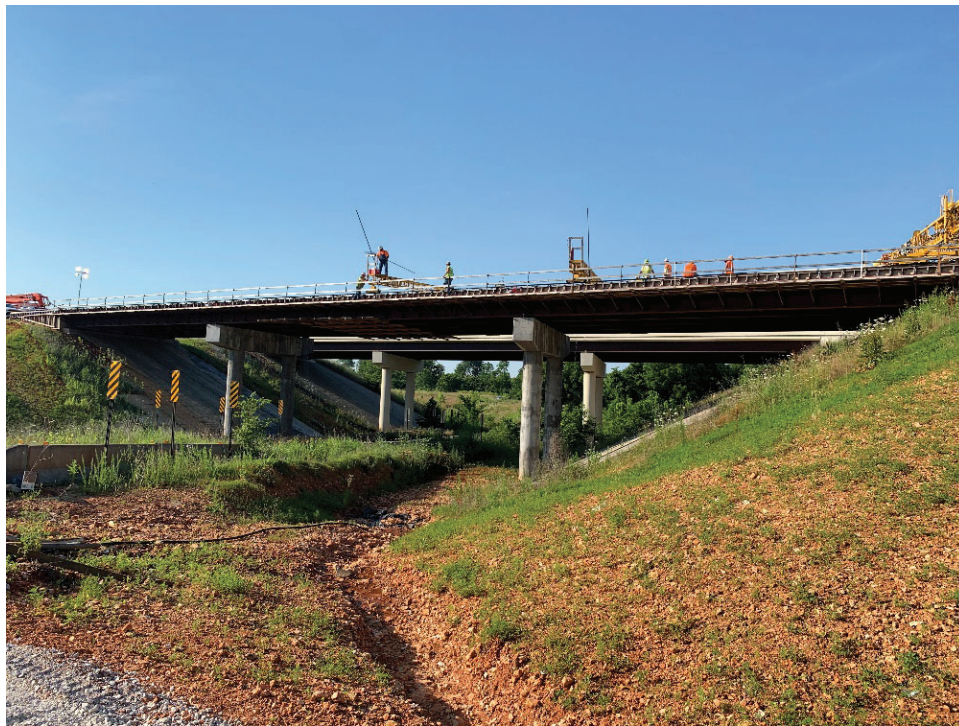
was constructed as a continuous pour beginning at the south abutment and finishing at the Pour 1 joint. An image taken from below the bridge on the day of the first deck pour is shown in Figure 15. A cross section of the bridge taken from the bridge design plans is shown in Figure 16.

Figure 15. Picture of Bridge No. A7195 Taken from the North

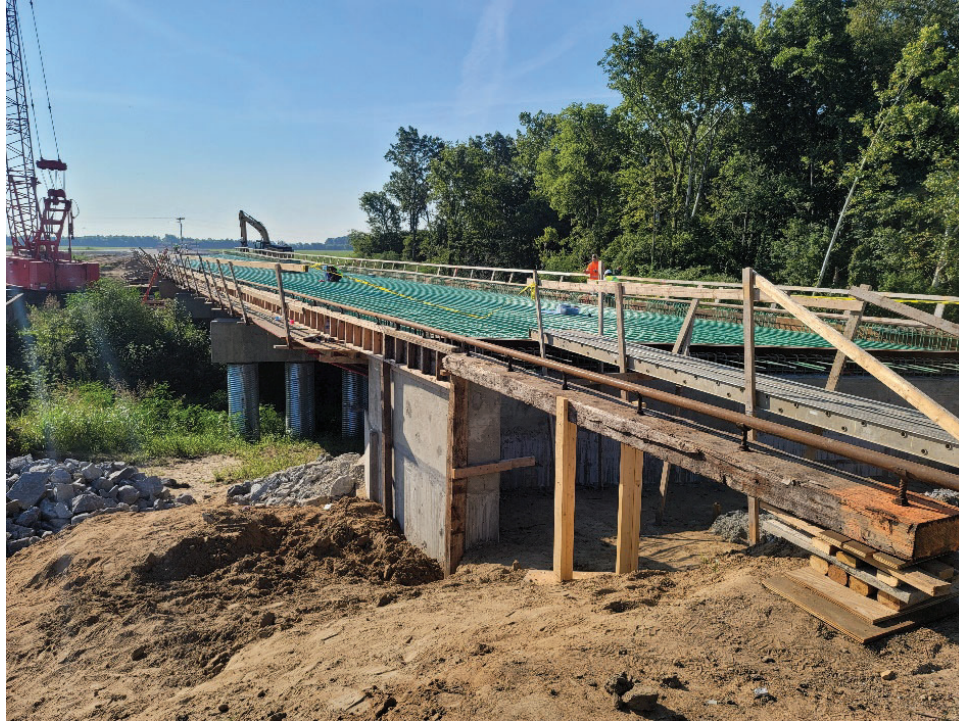
The last bridge instrumented by the research team is located near Marked Tree, AR in Poinsett County. Bridge No. 07473 carries Arkansas Highway 308 over ditch 47, a drainage ditch that drains to the St. Francis River. ARDOT gave approval to the contractor request to construct the bridge deck using a continuous pour. The bridge is a six-span continuous steel girder bridge with a concrete deck on steel deck pans. Bridge bents are at 15° skew. The overall width of the bridge is 32 ft - 6 inches. The bridge deck has a two-percent crown. The bridge deck slab thickness is eight inches. A picture of the bridge is shown in Figure 18. In addition, a bridge cross-section is shown in Figure 19.

Figure 18. Image of Bridge No. 07473 Taken from Northwest Corner

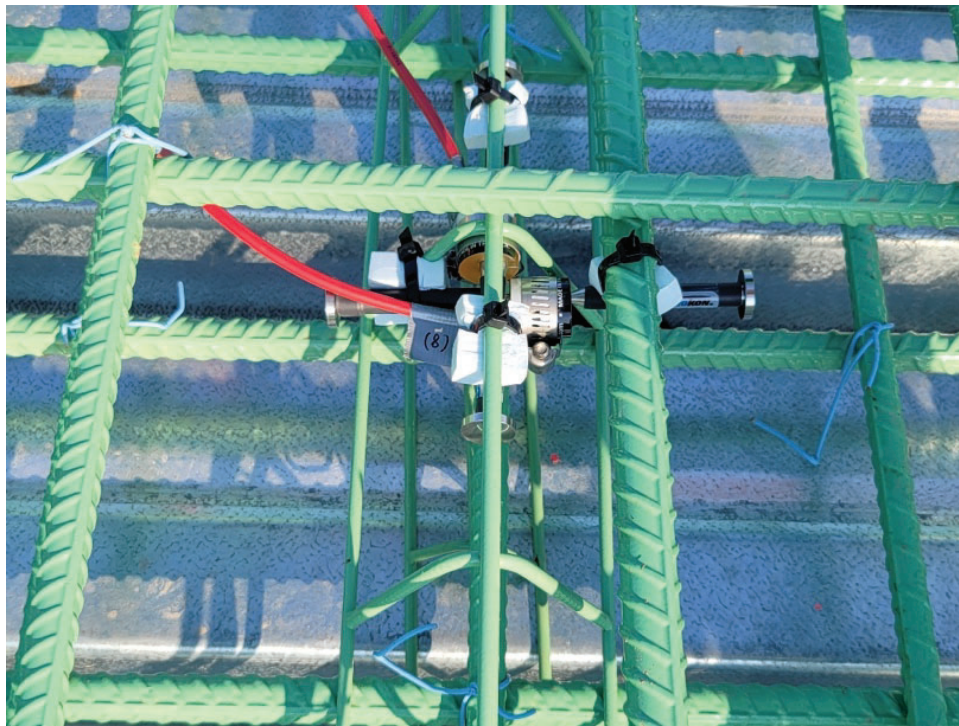
Since this bridge is longer than the two previously discussed, sensors were placed in pairs, one longitudinal sensor and one transverse sensor, along the bridge centerline, Figure 20. Because of the number of spans and symmetry, sensors were limited to the first half of the bridge poured. Sensors were installed to the top layer of reinforcing steel so that they were approximately 2.5-3 inches from the

Figure 20. Example of Sensor Installation on Bridge No. 07473, top to Bottom is Longitudinal Direction of Bridge

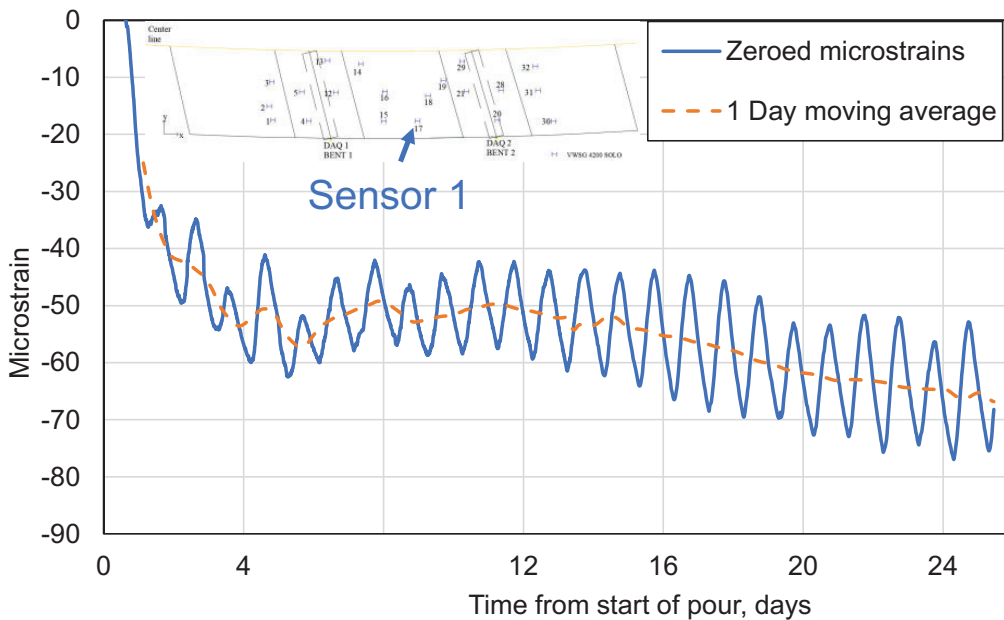
Sensor 17 is in the positive moment section of the center span. The strain history for Sensor 17 is shown in Figure 61. The same general trends can be seen as for the other sensors from this bridge. There is an initial increase in strain in the first five days, followed by gradually increasing strain over the entire measurement period. The maximum strain was recorded on Day 24 at approximately 77-microstrain.

Figure 61. Strain History for Sensor 17 from Bridge No. 07364

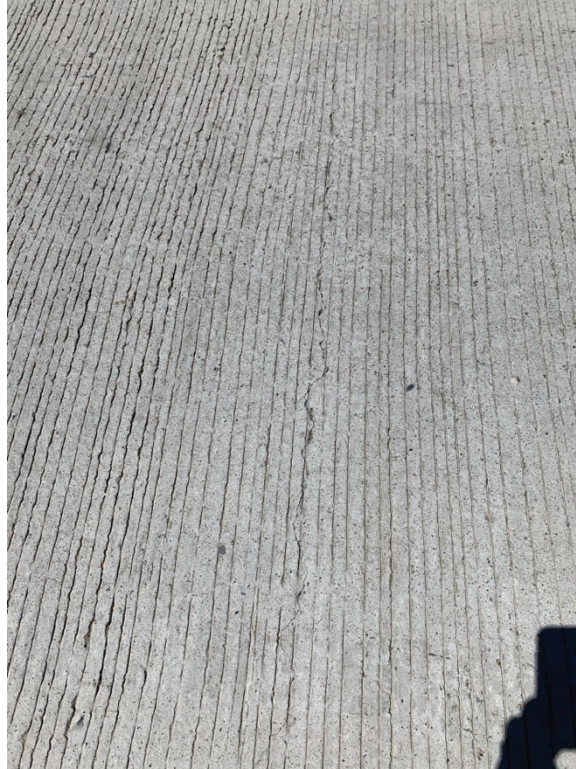
On May 6th, 2021, approximately twenty months from the date of the pour, the bridge had noticeable cracking, Figure 64 (personnel communication, Jason Efird, ARDOT). The figure shows a wide transverse crack. According to the resident engineer, most cracks on the bridge are in the transverse direction. Other cracks were observed in the longitudinal direction; however, they were limited. The types of cracking identified are indicative of early age drying shrinkage. This is substantiated by the strain histories which showed increasing strain magnitudes during the 27-day recording period. Specifically, maximum shrinkage occurred during the first 7-14 days while the concrete strength was still developing. Using American Association of State Highway and Transportation Officials (AASHTO) LRFD section 5.4 (AASHTO 2017) formulas for concrete direct tensile strength and elastic modulus, a conservative four-day - 2,000 psi concrete compressive strength results in a 325 psi tensile strength and 3,150,000 psi elastic modulus. These values calculate a 103-microstrain tensile strain at failure. Strains recorded at the transverse sensor exceeded 103-microstrain, Figure 63. The accelerated strain increases during days 0-4 corresponded to the time the deck was the weakest. The recorded strain values and trends suggest conditions leading to bridge deck cracking. Bridge No. 07364 was poured during high temperatures and curing was performed using a lithium-based spray-on curing compound. In hindsight, bridge deck cracking could have been avoided through moist curing and concrete curing tarps.

Figure 64. Cracking in No. Bridge 07364 Noticed After Deck Pour (Photo credit Jason Eford)

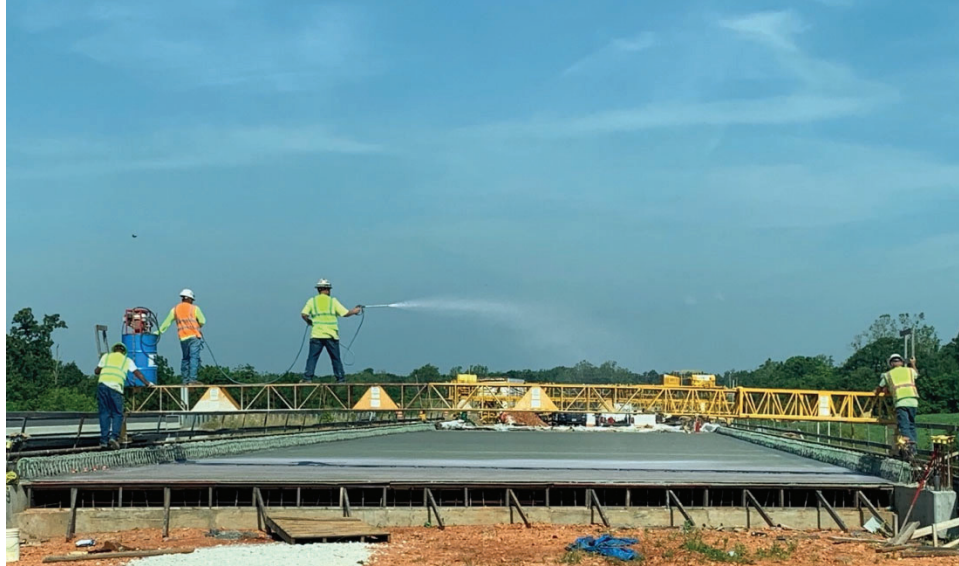
After each bridge deck pour, a brushed finish was applied to the concrete and moisture was fogged on the bridge deck periodically followed by spraying a white pigmented curing compound, Figure 65. When the concrete was adequately strong to support additional weight, hoses, wet burlap and white plastic sheeting were placed on the deck surface to maintain a moist curing environment. The sheeting remained in place for a minimum of two weeks after the pour.

Figure 65. Workers Spraying White Curing Compound on Bridge After 2nd Pour
