# 50-km/h Broadside Crash Test of a 1994 Chevrolet C2500 and the FOIL300K Rigid Pole: FOIL Test Number 97S017

Publication No.: FHWA-RD-98-082

November 1998

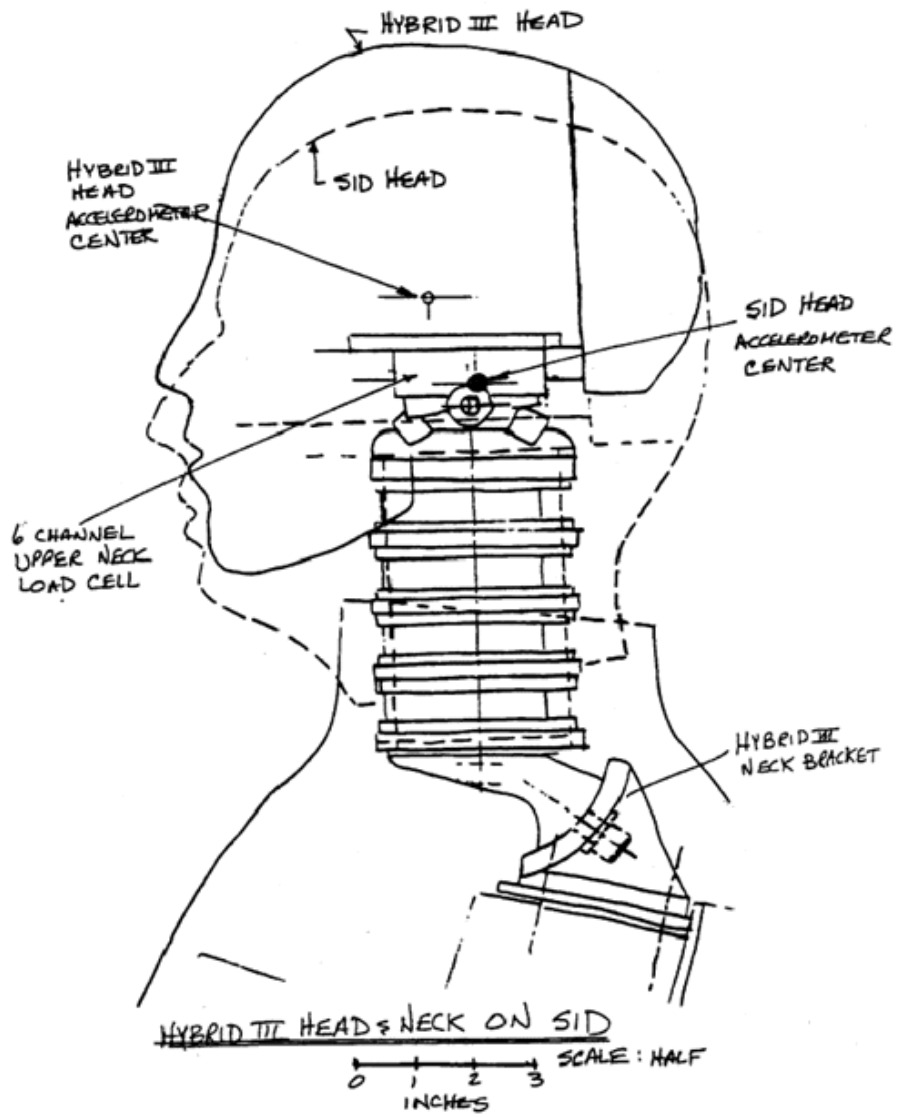
Figure 2. HYBRID III neck and head assembly on SIDH3 #28

One SIDH3, serial number 26, was placed in the driver seat. The SIDH3 was supplied by the NHTSA and was calibrated by a NHTSA-approved dummy calibration facility before shipment to the FOIL. The SIDH3 is a combination of the standard SID torso with the neck and head replaced with a Hybrid III dummy's neck and head. The neck bracket was removed from the SID and replaced with the neck bracket from a Hybrid III. This provided the necessary bolt pattern and alignment for a Hybrid III neck and head assembly. It was noted that the dummy's head had a slight twist about the neck. This may have been a result of the attachment between the neck and head or between the neck and head assembly and the dummy's torso. Figure 2 is a sketch of the modifications made to the SID. The dummy was shipped with the necessary hardware for assembly. Tools at the FOIL were used to assemble the SIDH3. Clothing consisting of white thermal underwear was purchased and placed on the dummy, along with a pair of brown hard leather shoes. Eighteen extension cables were supplied with the SIDH3. The extensions allowed for installation of connectors necessary for attachment to the FOIL data acquisition system without removing the standard dummy connectors. The transducers within the dummy were of the half bridge type and therefore completion resistors were soldered into the connectors at the data acquisition system interface.

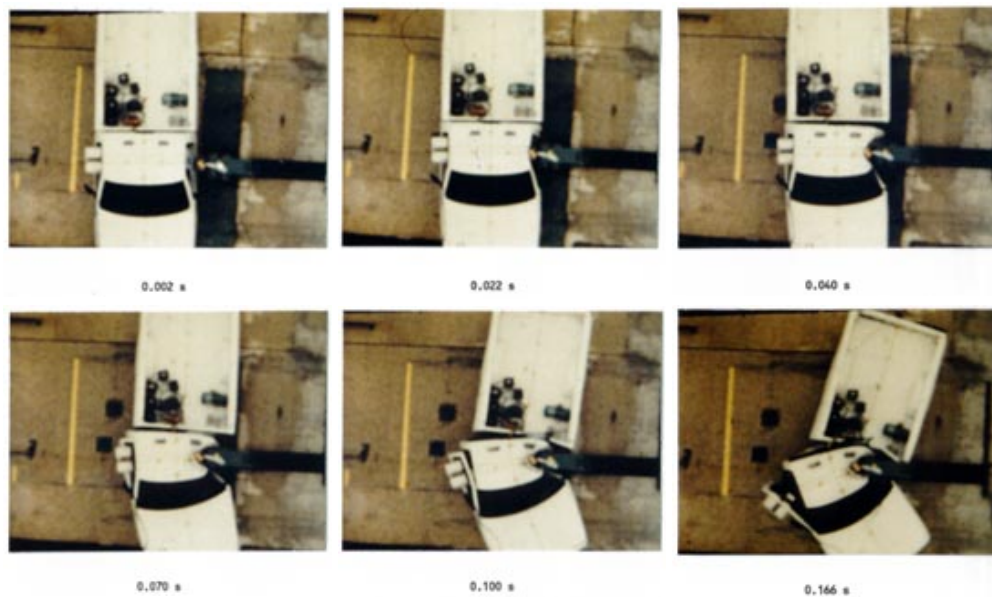
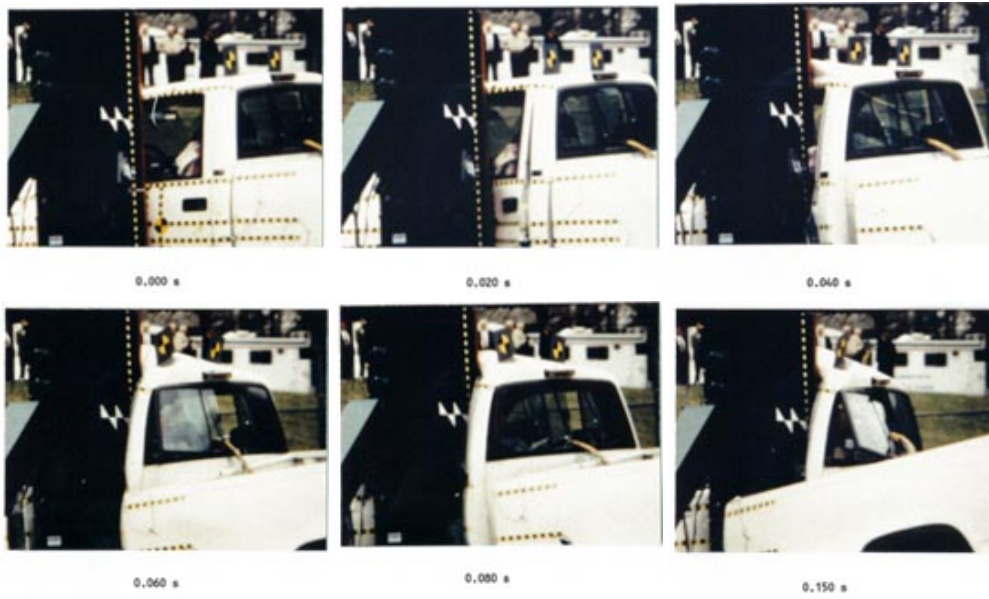
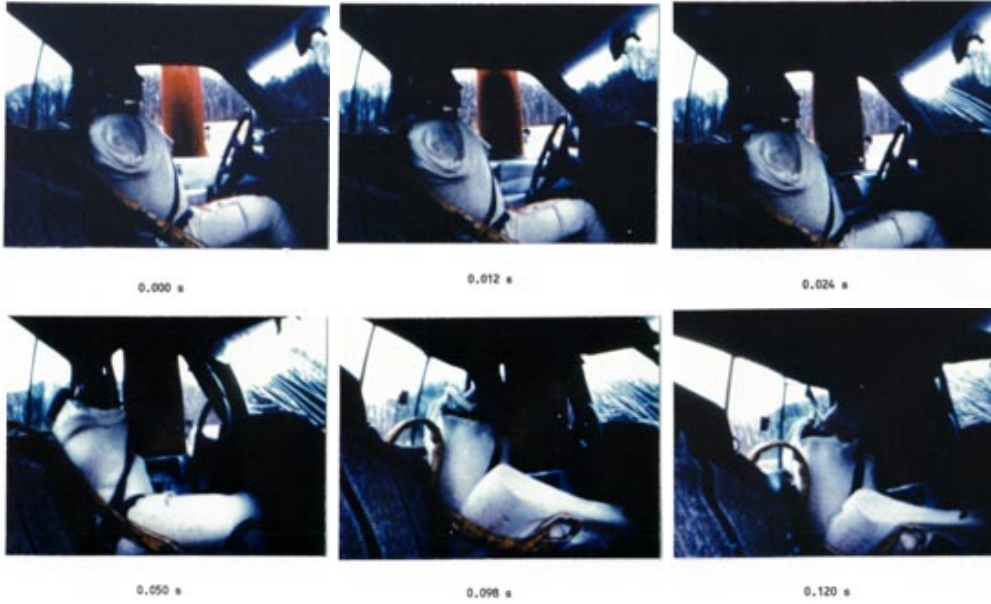
Figure 44. Test photographs during impact, test 97S017.

Occupant response. The SIDH3 remained upright during the vehicle propulsion stage. The vehicle exited the side-impact monorail and began to slide sideways along the wet concrete runway. The drop off the monorail, coupled with the frictional forces between the tires and the wet runway, slowed the vehicle and induced a vehicle roll angle of 1.8° at impact. The roll angle and vehicle deceleration caused the SIDH3 to lean toward the driver door. The pole intruded into the occupant compartment, forward of the dummy's head and in line with the dummy's pelvic region. Contact between the door and the dummy's lower torso and pelvis occurred approximately 0.016 s after impact. The penetrating door and pole propelled the pelvis to the right, rotating the dummy's head toward the B-pillar and pole. The force imparted on the pelvis also rotated the dummy in the seat and was high enough to shear the thigh-lower leg connecting bolt in each leg. The separation was not at the knee. The first indication of leg separation was at 0.042 s. The lower legs remained within the thermal underwear clothing. The seat belt buckle remained fastened throughout the test. The impact force buckled the bench seat upward (0.052 s), which imparted an upward velocity into the dummy. The B-pillar was drawn inward and forward toward the pole. The B-pillar was drawn in quick enough so as not to allow the dummy's head to protrude from the window. However, the side of the dummy's head made significant contact with the B-pillar, as indicated by large amounts of green chalk residue. The motion of the B-pillar forced the head into the side of the rigid pole within the truck cab. The head was pinched between the B-pillar and the pole. Blue chalk residue was found on the side surface of the rigid pole. The cab wrapped around the rigid pole enough to cause the dummy's head and head rest to punch out the rear window. The head was pinched between the B-pillar and the rigid pole for approximately 0.100 s. While the head was pinched and stationary, the torso continued to bounce and recoil from the pole, bending and twisting the neck.

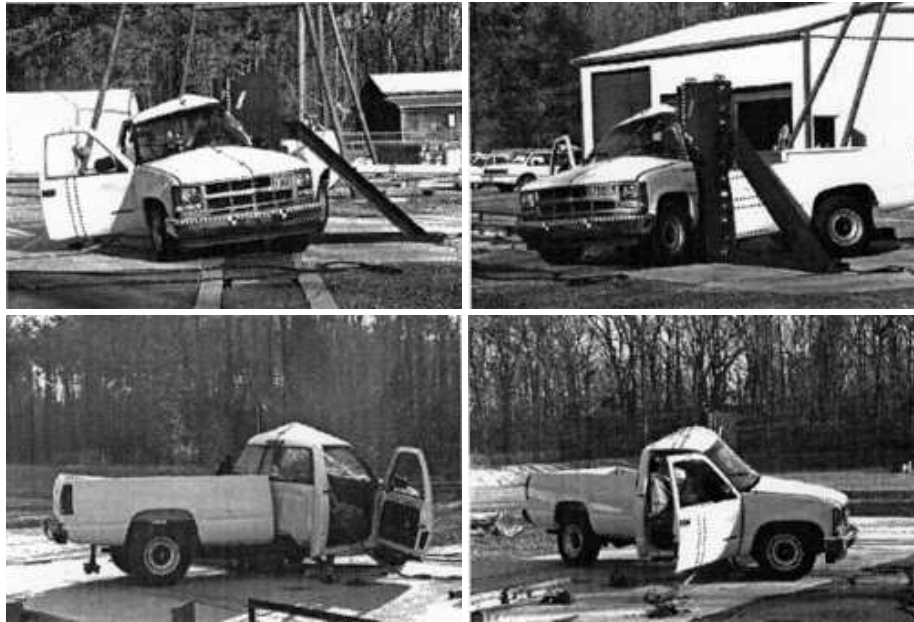
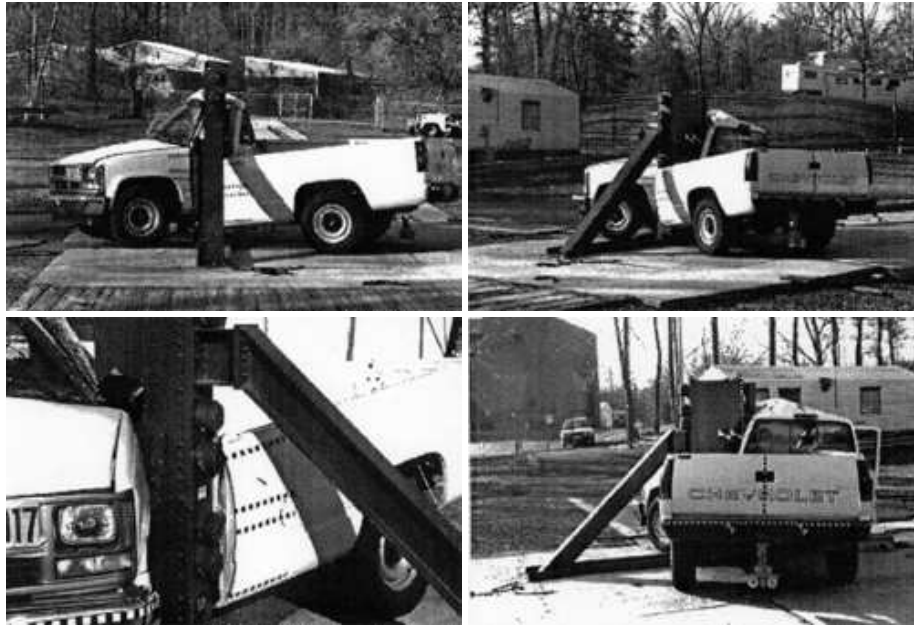
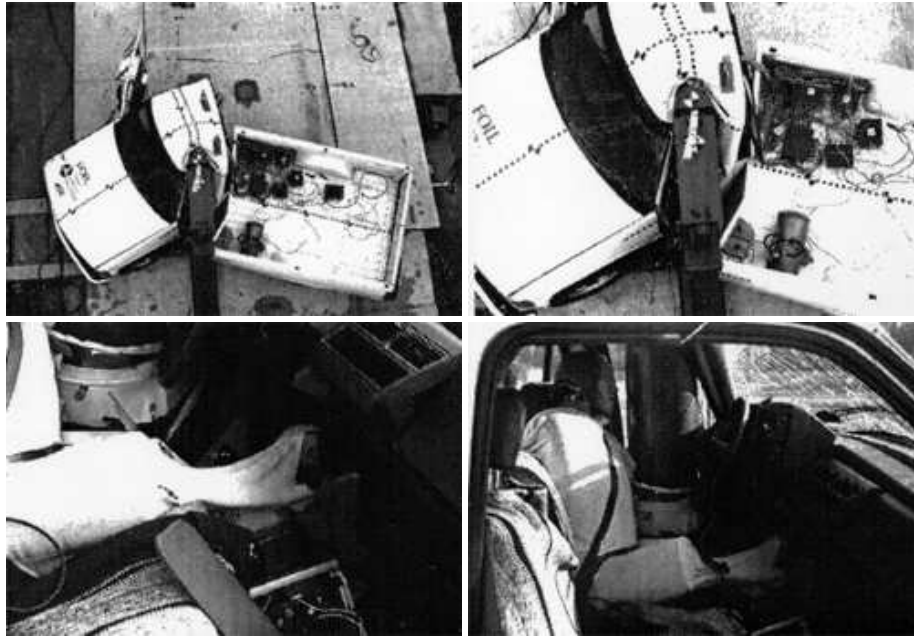
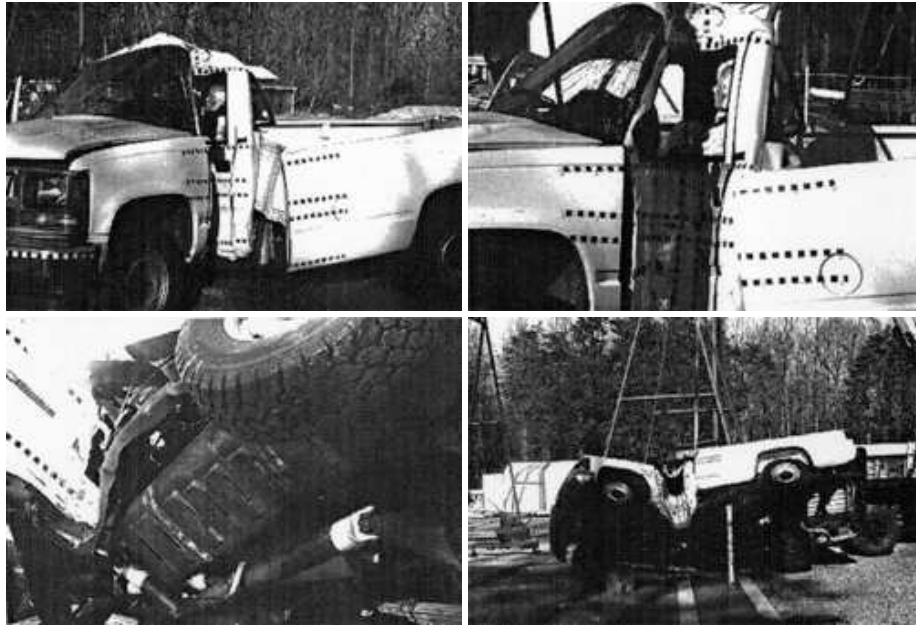
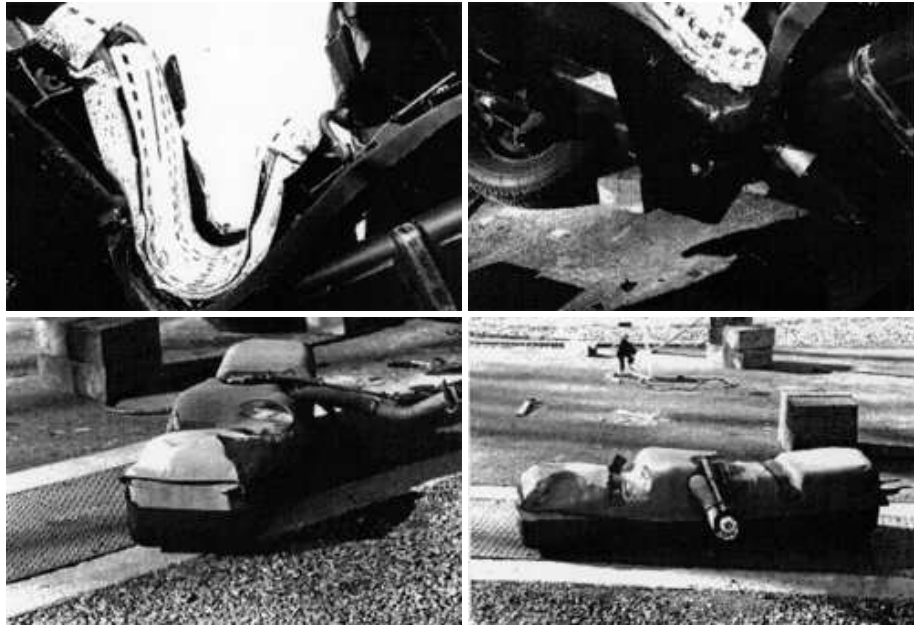
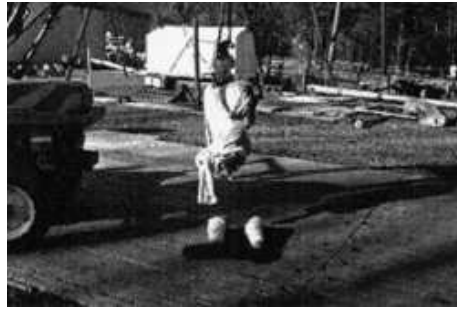
Figure 46. Post-test photographs, test 97S017.

Damage to the pickup truck was extensive. The driver door caved, the B-pillar drew inward, the windshield shattered, the dashboard and bench seat buckled, the left frame rail bent and punctured the fuel tank, the transmission mount cross member buckled, the aluminum drive shaft bent, and the cab dislodged from the frame mounts. The passenger door latch failed, which allowed the door to swing open. The driver door remained latched. The peak lateral c.g. acceleration recorded was

Visual inspection of the Chevrolet C2500 and rigid pole after the test produced immediate conclusions. The forces on the right door latch from the displaced bench seat caused the latch to fail, allowing the door to swing open. The vehicle wrapped around the rigid pole, conforming to the shape of the pole. The cab was dislodged from the frame and displaced 320 mm. The left frame rail bent and the transmission cross member buckled, touching the ground. Chalk residue on the B-pillar, pole, and door interior verified dummy contact. Both of the dummy's legs broke above the knee, at the connection between the knee joint and thigh. A similar test, test number 97S016, produced similar but much less catastrophic results. This test was conducted at 50 km/h, which is twice the energy as in test 97S016, conducted at 35 km/h. The deformation in test 97S016 was limited by the transmission mount cross member. With twice the energy present

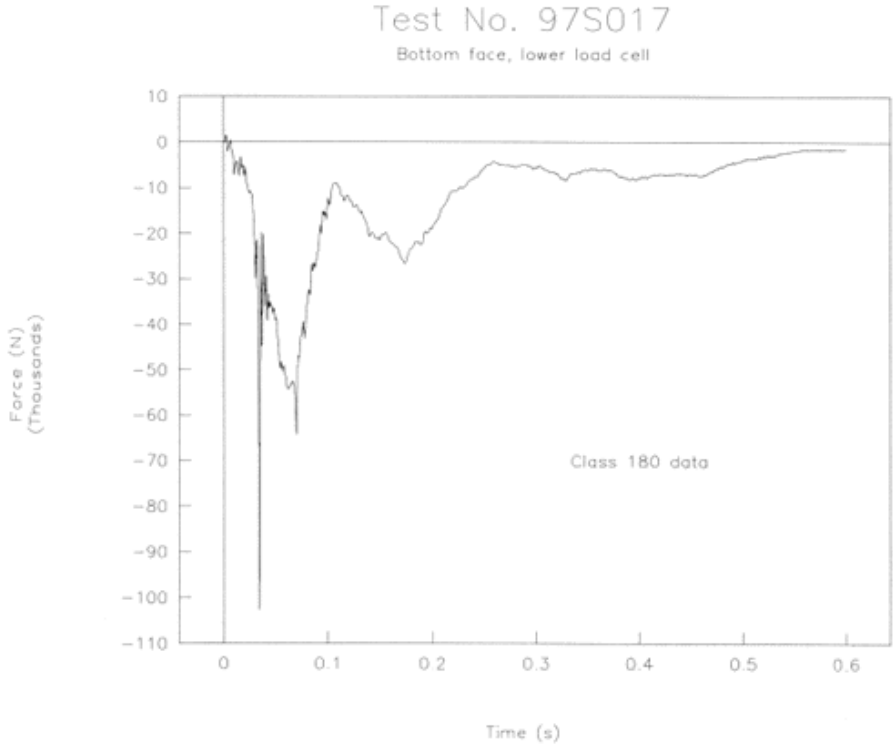
Figure 47. Rigid pole, force vs. time, bottom face lower load cell, test 97S017.

Figure 48. Rigid Pole, force vs. time, bottom face upper load cell, test 97S017.

**Figure 49. Rigid pole, force vs. time, lower-middle face lower load cell, test 97S017.**

**Figure 50. Rigid pole, force vs. time, lower-middle face upper load cell, test 97S017.**

**Figure 51. Rigid pole, force vs. time, upper-middle face lower load cell, test 97S017.**

Figure 52. Rigid pole, force vs. time, upper-middle face upper load cell, test 97S017.
