# 35-km/h Broadside Crash Test of a 1994 Chevrolet C2500 and the FOIL 300K Rigid Pole: FOIL Test Number 97S016

PUBLICATION NO. FHWA-RD-98-081

NOVEMBER 1998

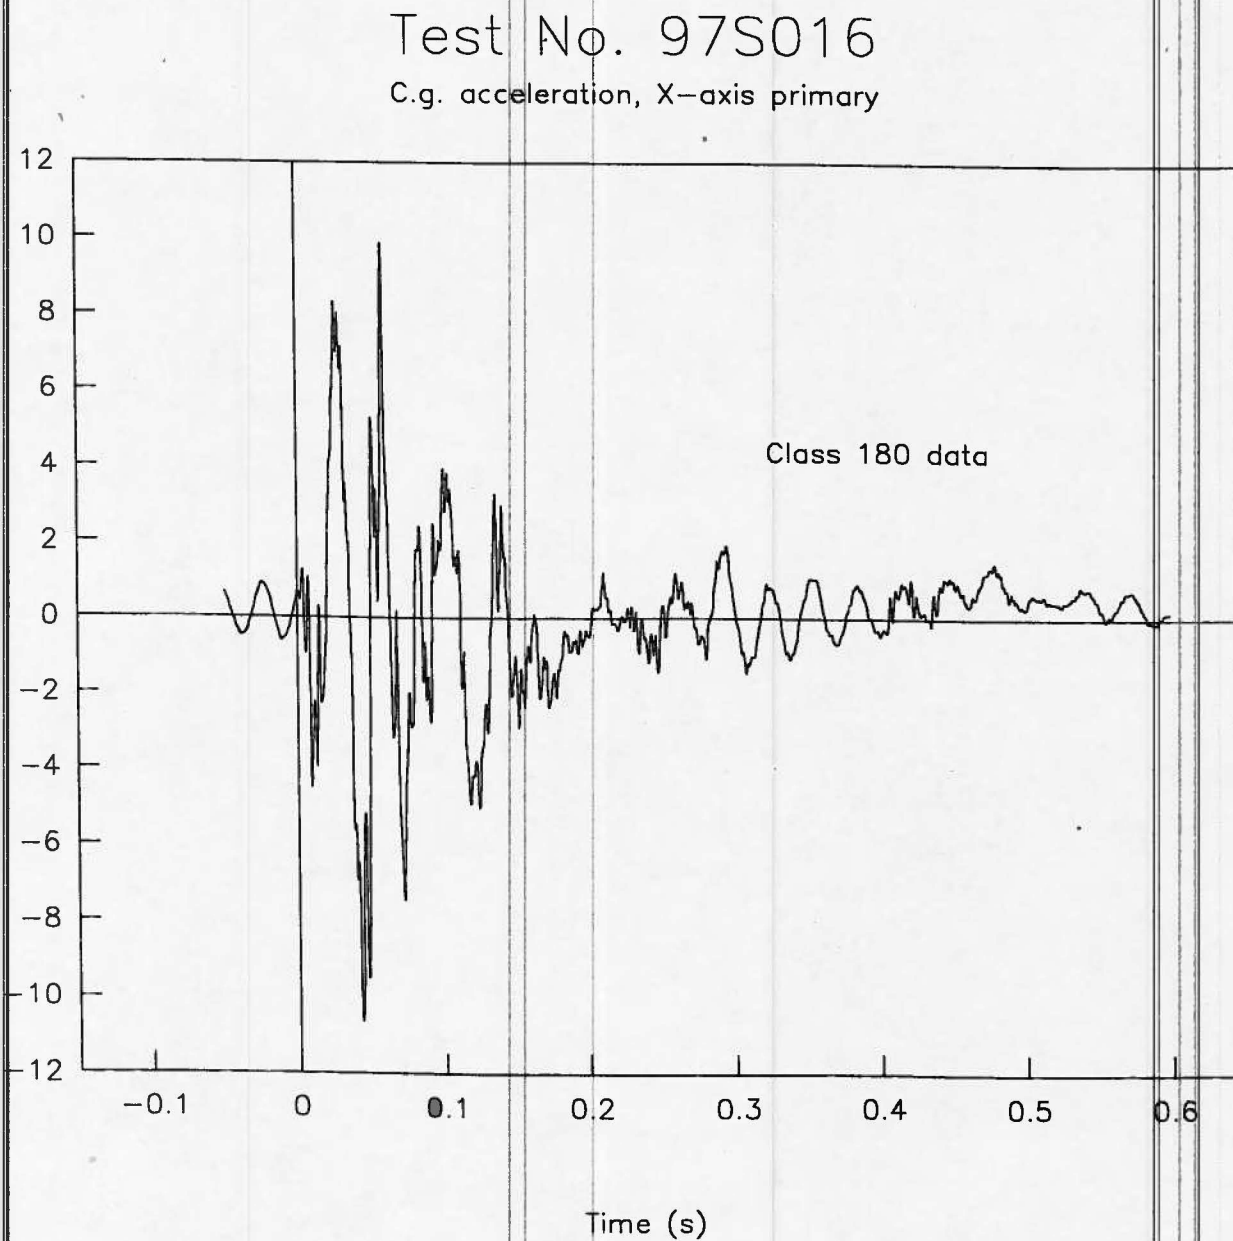
Figure 8. Acceleration vs. time, c.g. X-axis primary, test 97S016.

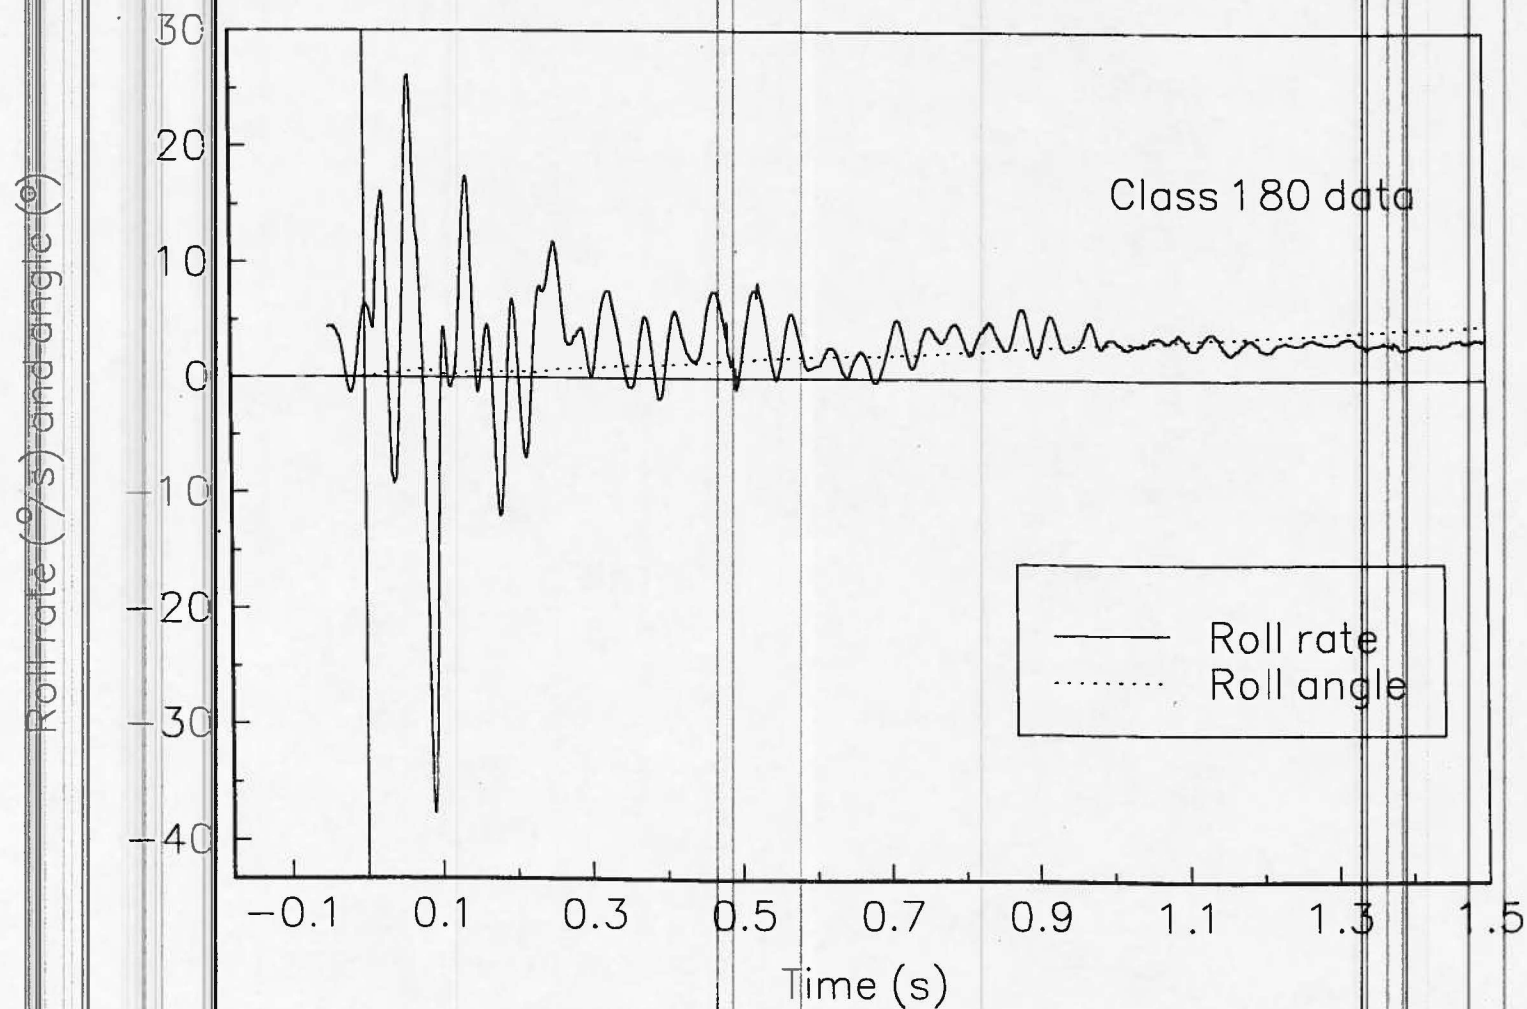
Figure 26. Roll rate and angle vs. time, test 97S016.

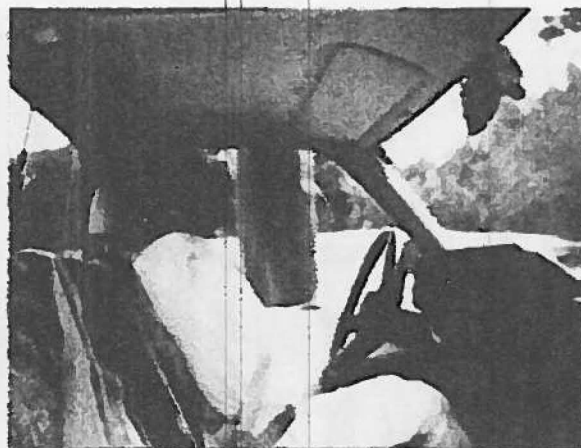
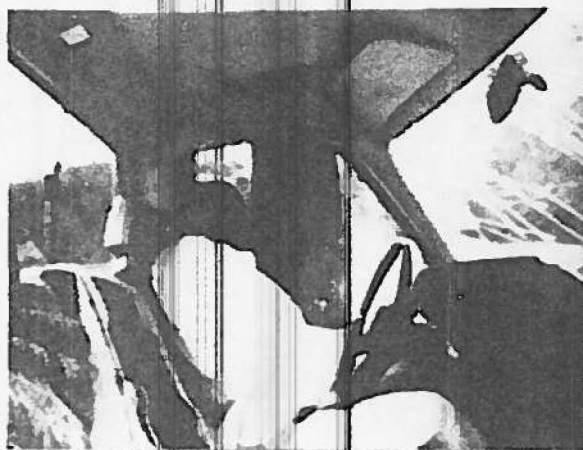
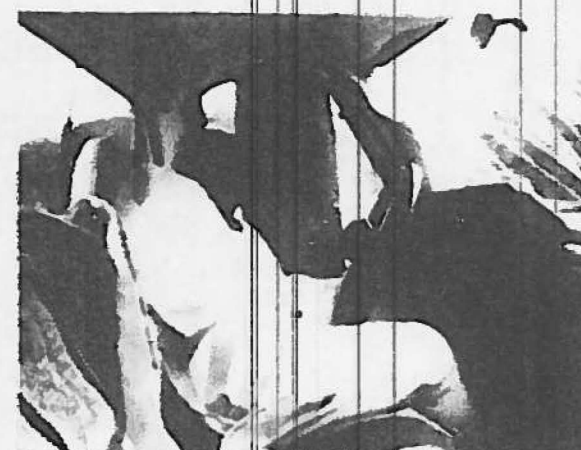
Figure 44. Test photographs during impact, test 97S016.

Figure 44. Test photographs during impact, test 97S016 (continued).

Occupant response. The SIDH3 remained upright during the vehicle propulsion stage. The vehicle exited the side-impact monorail and began to slide sideways along the wet concrete runway. The drop off the monorail, coupled with the frictional forces between the tires and the wet runway, slowed the vehicle and induced a vehicle roll angle of  $3.9^\circ$  at impact. The roll angle and vehicle deceleration caused the SIDH3 to lean toward the driver door and make slight contact. The pole intruded into the occupant compartment forward of the dummy's head and in line with the dummy's pelvic region. Contact between the door and the dummy's lower torso and pelvis occurred approximately 0.020 s after impact. The dummy torso was wedged between the seat and intruding door, the head continued toward the door and window and contacted the B-pillar before protruding through the open window (0.032 s). The femur and shoulder area made contact with the intruding door as anticipated. While the dummy's head was outside the window, the truck continued to wrap around the rigid pole. The B-pillar was drawn toward the pole and struck the rear of the dummy's head, forcing the head into the side of the rigid pole (0.058 s). The head was pinched between the B-pillar and rigid pole for approximately 0.050 s. While the head was pinched and stationary, the torso continued to bounce and recoil from the pole, bending and twisting the neck. The dummy rose up and leaned out the window enough that the left shoulder made contact with the rigid pole.

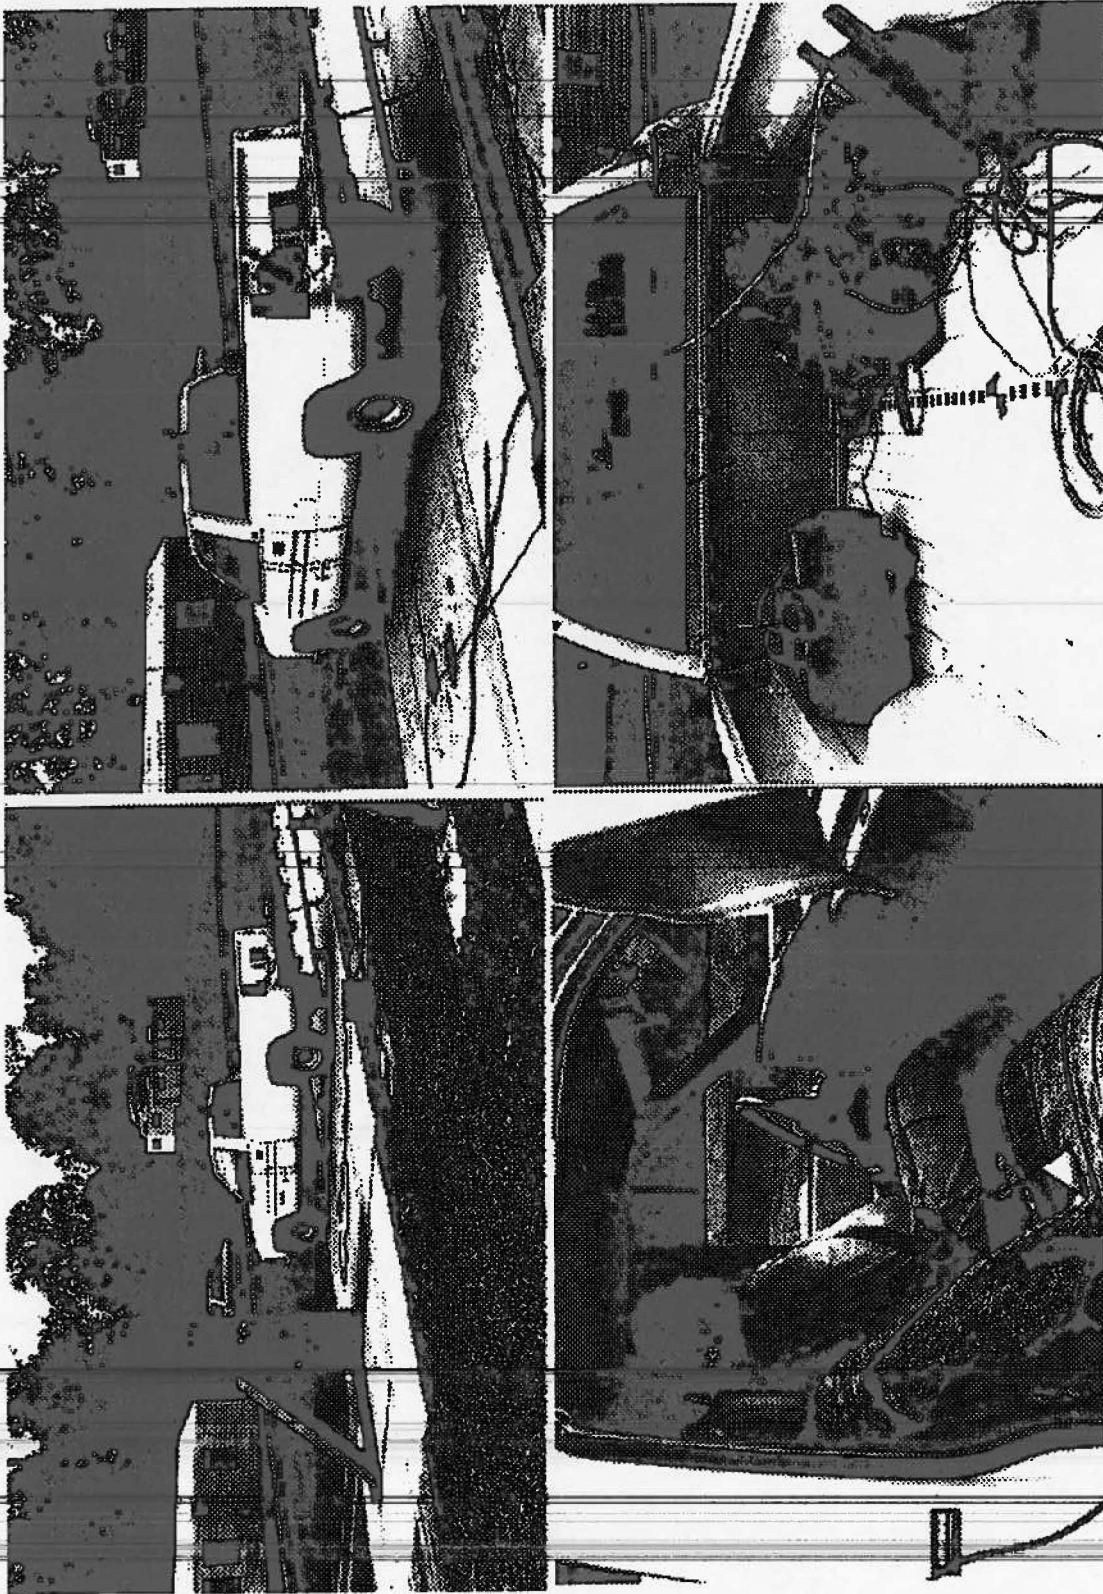
Figure 45. Pretest photographs, test 97S016.
