**Evaluation of NDOT's Sediment Barrier Practices Using Performance Data
Final Report**

Nebraska Department of Transportation

March 2024

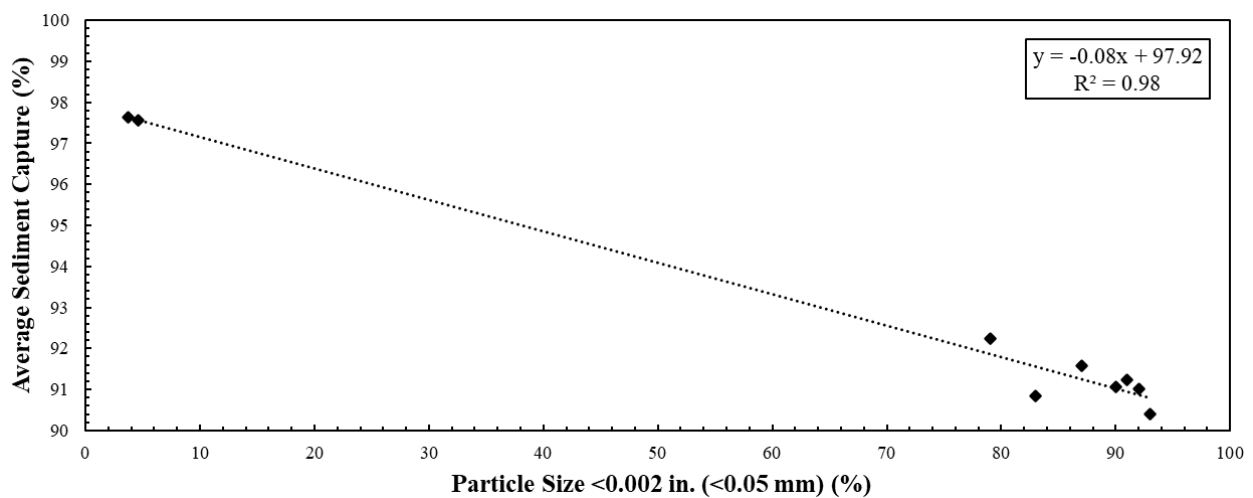
Figure 2.6 Average Sediment Capture by Percent Fines

The increased capture percentage, as well as the lower sediment load introduced and delivered through the vegetated buffer, are due to the larger average size particles and lower composition of fine particles of the sandy soils compared to the silty clay loams and silt loams. The larger soil size causes the sandy soils to be more easily capturable within the vegetated buffer due to requiring less velocity reduction to fall out of suspension (Weiss et al., 2013; Xiao et al., 2017).

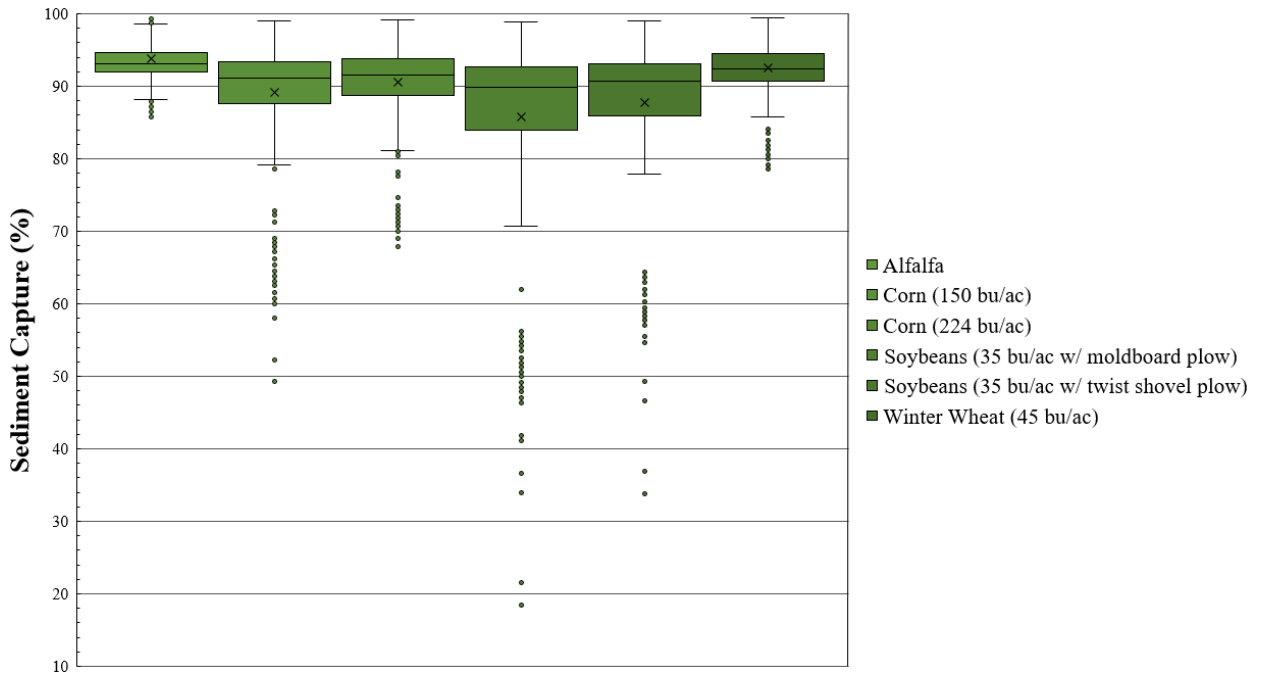
Natural grasses and row crops modeled for sediment capture within vegetated buffers varied in sediment capture. Figure 2.8 shows the distribution of sediment capture within buffers of each vegetation type. On average, capture within buffers consisting of the 12 grasses and grass-like vegetation had a higher average, 93.96%, than buffers consisting of the 6 row crops analyzed, averaging 89.94%. Additionally, the row crops, especially the two densities of corn and two methods of planting soybeans, had a much larger distribution of buffer iterations.

(a) grasses and grass-like vegetation

(b) row crops

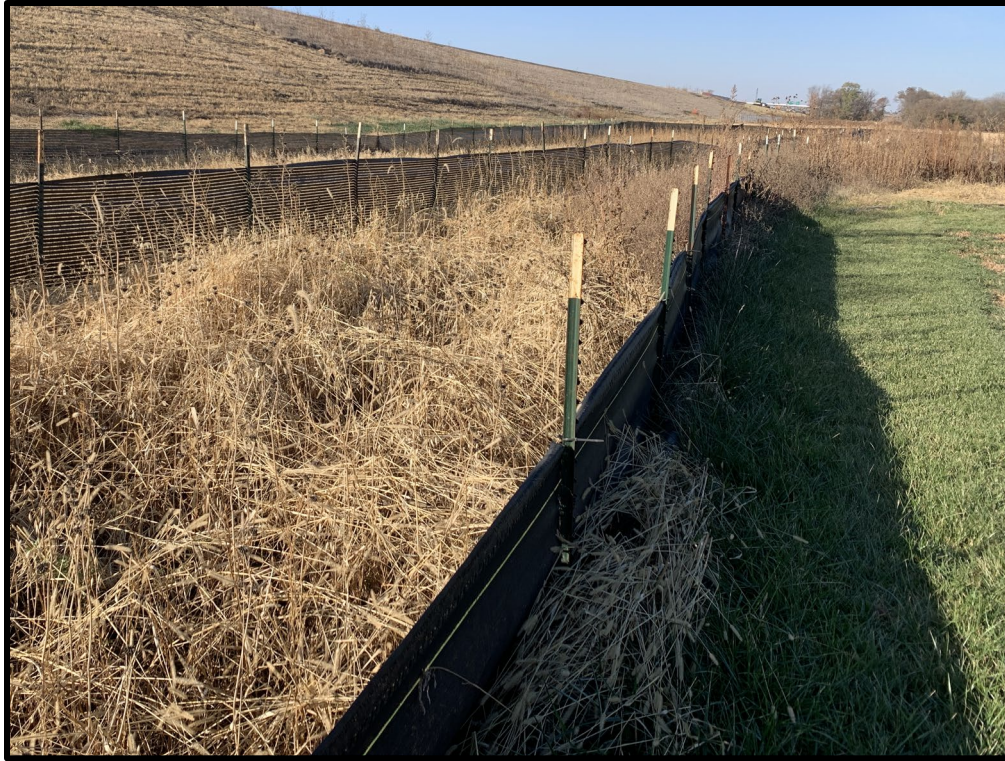
Figure 3.1 Nebraska DOT Silt Fence Installation

Silt fences are composed of a geotextile fabric attached to posts; geotextile fabric, means of attachment, and post material can vary. The purpose of silt fence installations is to intercept sediment-laden stormwater runoff and form impoundment to facilitate sedimentation to keep eroded soil on site and prevent pollution of natural water bodies and municipal stormwater systems. Silt fence is typically installed at the toes of slopes and on the perimeter of sites; long runs of fence often include j-hooks to allow for more storage area of impoundment and sediment. Installation is completed by trenching the fabric in manually or using a slicing machine to insert the fabric into the ground (USEPA, 2021a). Figure 3.1 shows a silt fence installation on a Nebraska DOT highway project.

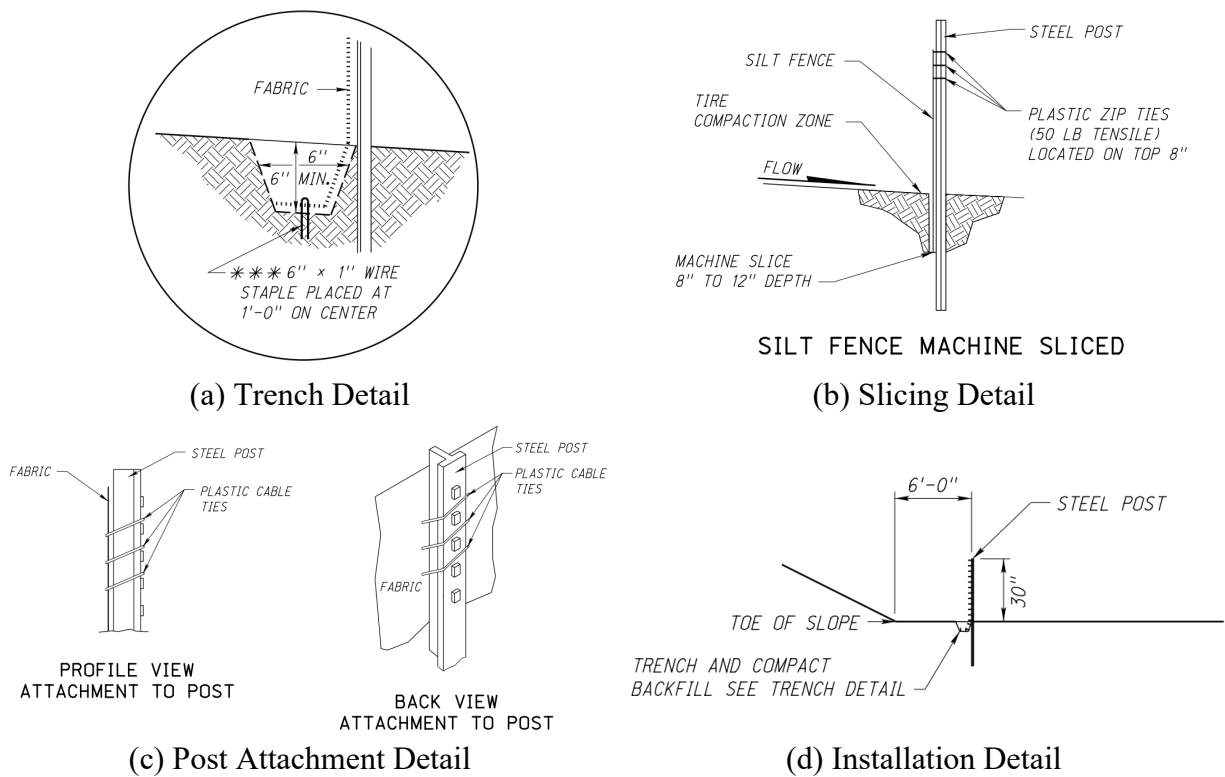
Figure 3.2 Nebraska DOT Silt Fence Installation Details

Fabric is trenched into a 6 in. (15.2 cm) deep by 6 in. (15.2 cm) wide trench and attached to the ground using staples before backfilling the trench to secure the fabric. Metal t-posts must be at least 1.25 lb/ft (1.86 kg/m) and spaced at most 6 ft (1.82 m) apart (Nebraska DOT. Figure 3.2 shows installation diagrams for the Nebraska DOT standard silt fence installation (Nebraska DOT, 2021c).

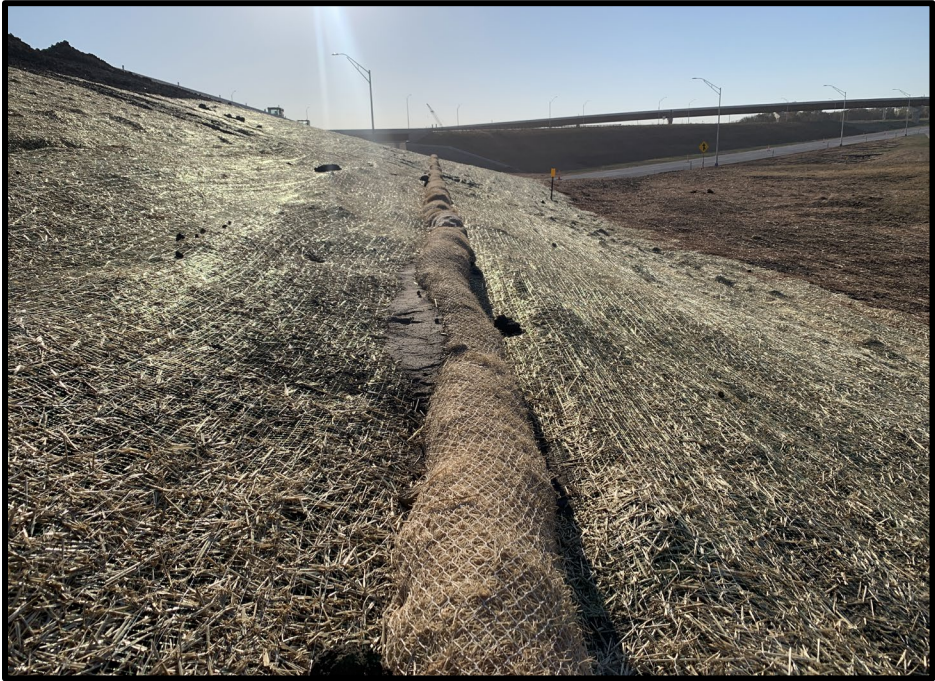
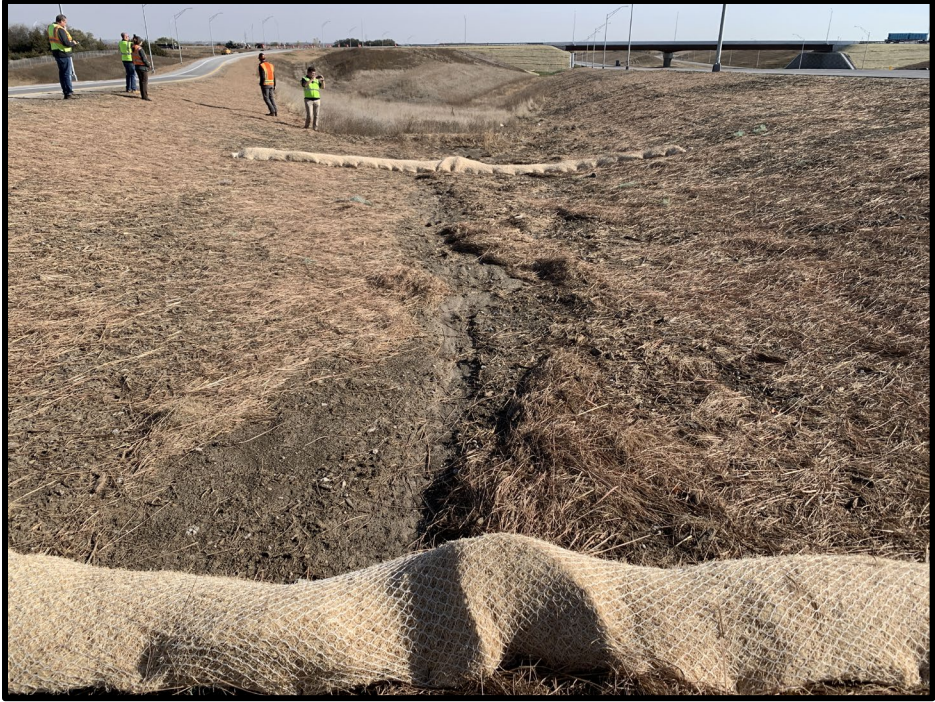
Schussler, et al., 2021). Figure 3.3 shows two applications of tubular silt checks on a highway construction project as ditch and slope protection.

(a) wattle silt check as slope protection

(b) wattle silt check as ditch protection

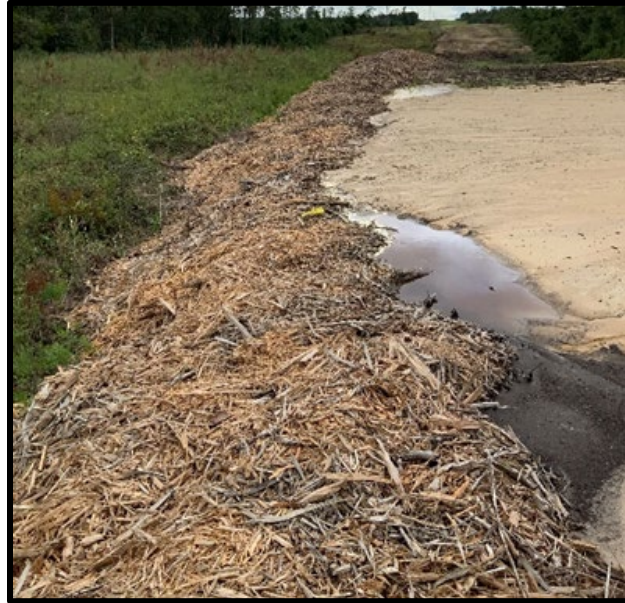
Figure 3.5 Slash Mulch Berm Installation in Alabama (photo courtesy of C. Young 2021)

installation on a construction project in Alabama and the sediment deposited upstream of the barrier.

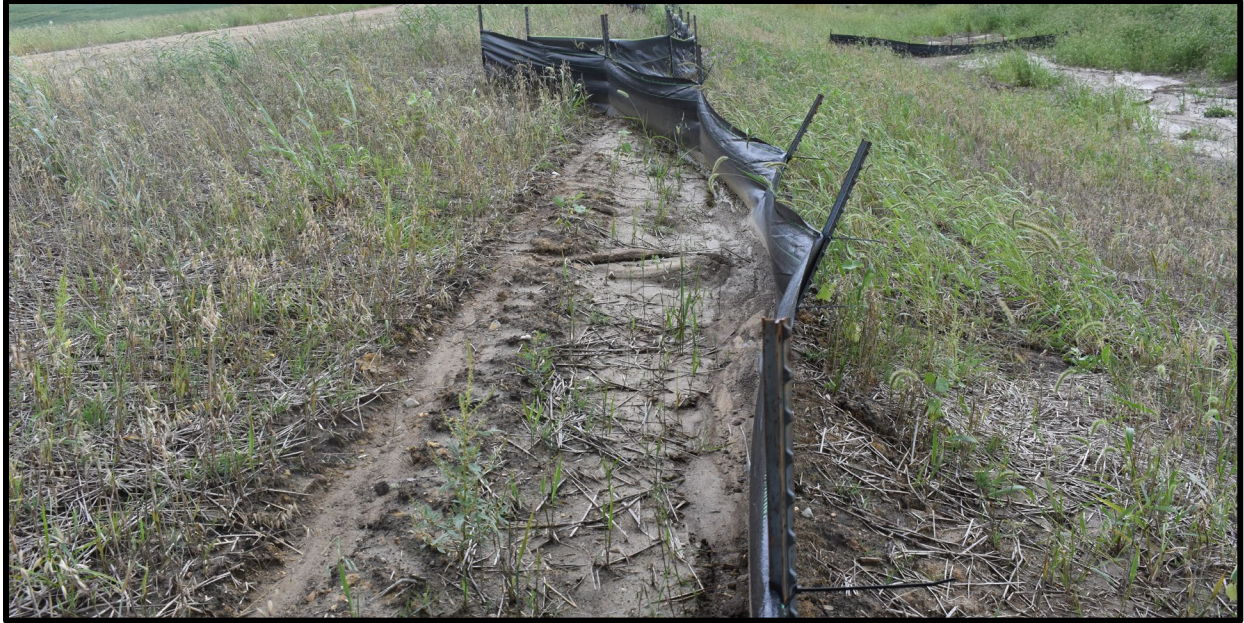
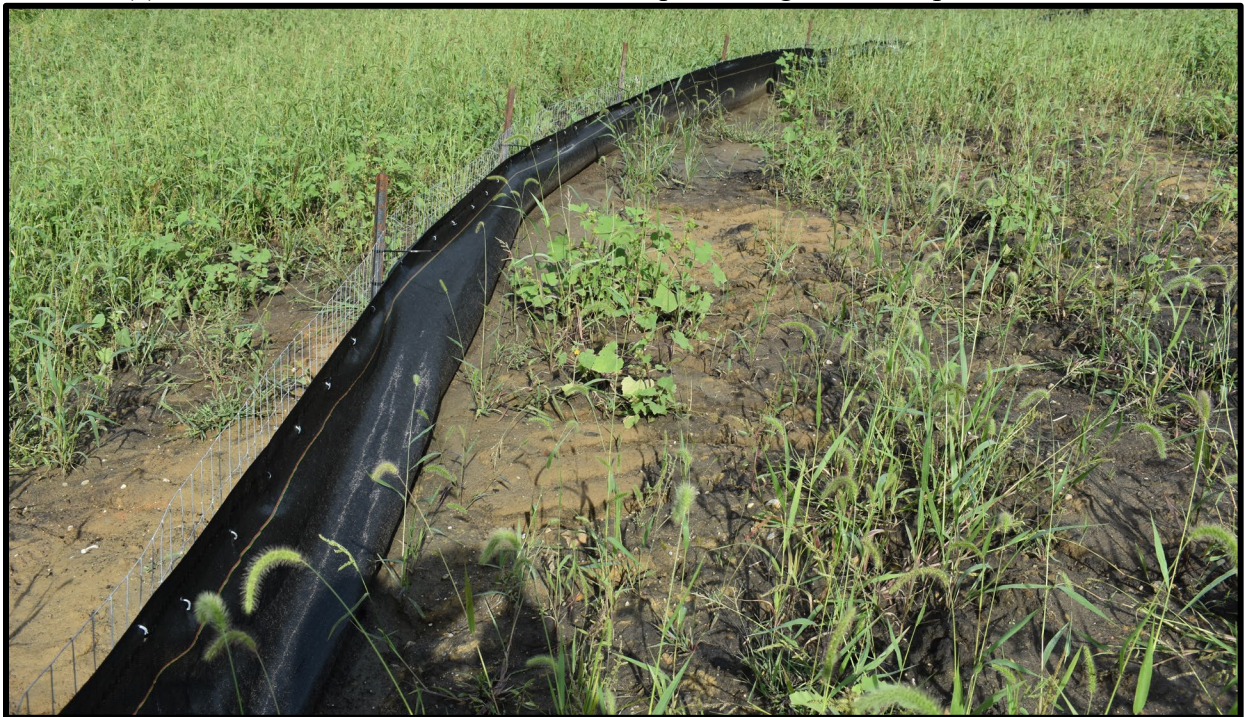
An Iowa Department of Transportation sponsored study monitored the ESC practices on a highway construction project in Tama County, Iowa, in July 2019. Runs of seven different types of silt fence installations were installed side-by-side to evaluate differences in performance between modified installations when exposed to similar stormwater runoff events. Structural performance, sedimentation, and the formation of impoundment were analyzed for all silt fence installations. Excessive post deflection leading to overtopping was found on numerous installations; modifications with reduced post spacing or added wire reinforcement did not have excessive post deflection. Figure 3.7 shows excessive sedimentation leading to excessive post deflection in the Iowa standard silt fence and not leading to excessive deflection in the modified installation with additional wire reinforcement. The authors of this study recommended either reducing post spacing or adding wire reinforcement to reduce the chance of structural failure from the standard Iowa DOT installation and adding a 6 in. (15.2 cm) offset trench to prevent undermining. However, the post spacing and wire reinforcement modifications did increase the cost of material and installation. Additionally, future research that tests modifications in a controlled environment to subject modifications and standards to identical conditions was suggested to work against the inconsistencies that are a limitation of field monitoring studies, such as storm events and runoff differences for different installations of sediment barriers (Schussler et al., 2020).

(a) Iowa standard silt fence installation experiencing excessive post deflection

(b) Reinforcement preventing post deflection

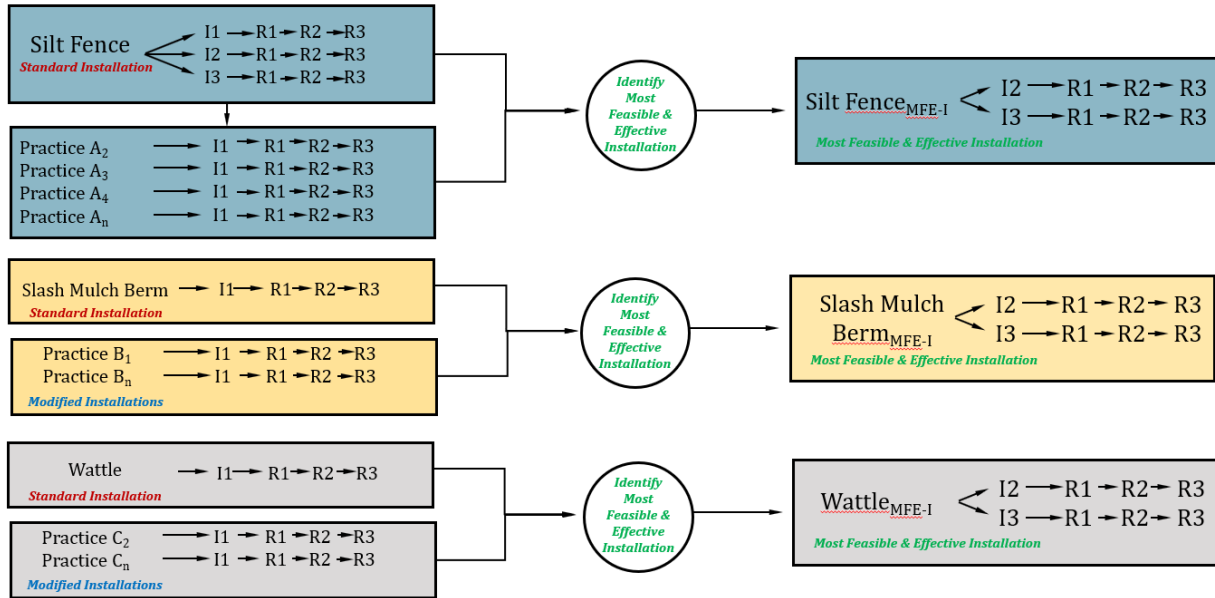
Figure 3.11 Sediment Barrier Testing Regime

To meet the research objectives of determining the effectiveness of standard Nebraska DOT sediment barriers and recommending the most feasible and effective installations (MFE-I), a testing regime of standard and modified sediment barrier installations was developed, shown in Figure 3.11. Standard installations (three for silt fence and one each for slash mulch berms and wattle silt checks) were tested under three back-to-back simulated stormwater runoff events. Additionally, for each new installation, an excessive impoundment condition was run after deposited sediment was removed, representing an extreme-case stormwater runoff event to determine performance under excessive impoundment conditions. For the extreme-case stormwater runoff event, the maximum flow rate of clean water the apparatus was able to supply was run, approximately 0.20 ft³/s (0.006 m³/s); flow was run until either a failure occurred, such as overtopping or complete failure, or the installation reached a steady-state condition where impoundment no longer was rising. Results from the testing of standard installations were used to develop modified installations that aimed to improve upon structural inefficiencies shown while also aiming to improve sediment retention and water quality improvements. After testing of modifications, the MFE-I was selected that considers performance, installation difficulty and cost; testing of the MFE-I was triplicated to generate more data for recommendations.

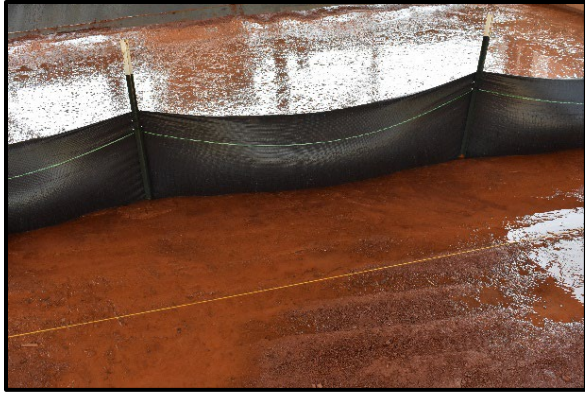
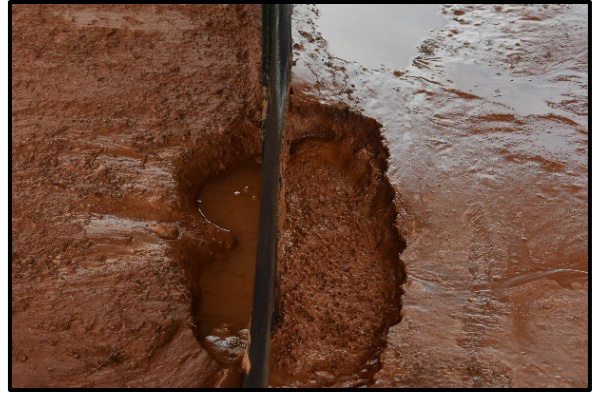
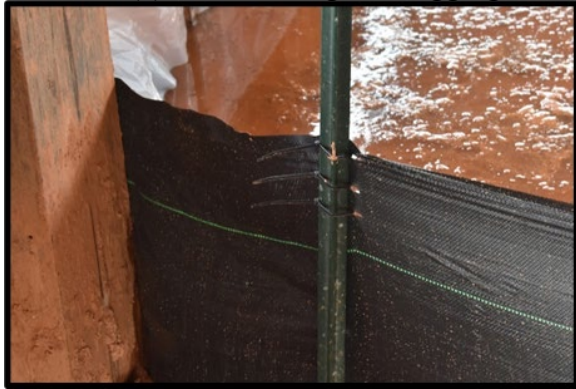
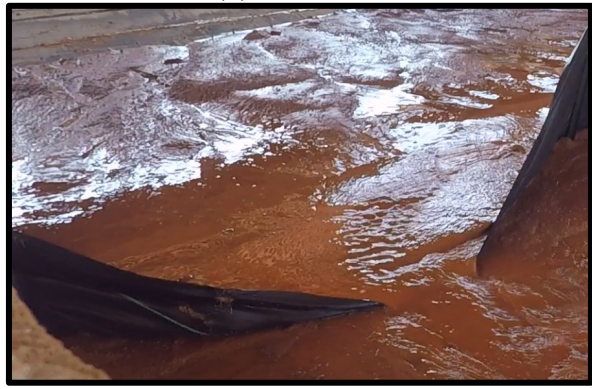
The standard Nebraska DOT silt fence installation experienced multiple structural inefficiencies after being subjected to three installations of three back-to-back simulated stormwater runoff events. Undercutting and a complete trench failure were experienced, as shown in Figure 3.13. Excessive impoundment conditions leading to complete failure and overtopping were unable to be experienced under the 2-yr, 24-hr storm conditions used in the three back-to-back simulated stormwater runoff events; however, under excessive impoundment conditions, once impoundment behind the installation reached approximately 20 in. (51 cm), due to excessive sagging, the zip-ties tore through the fabric leading to fabric separating from the posts and the installation completely failing. Figure 3.13 shows the structural performance issues shown through testing the Nebraska DOT standard installations.

(a) undermining and sagging

(b) trench failure

(c) stretching of fabric around zip-ties

(d) complete installation failure due to excessive impoundment conditions

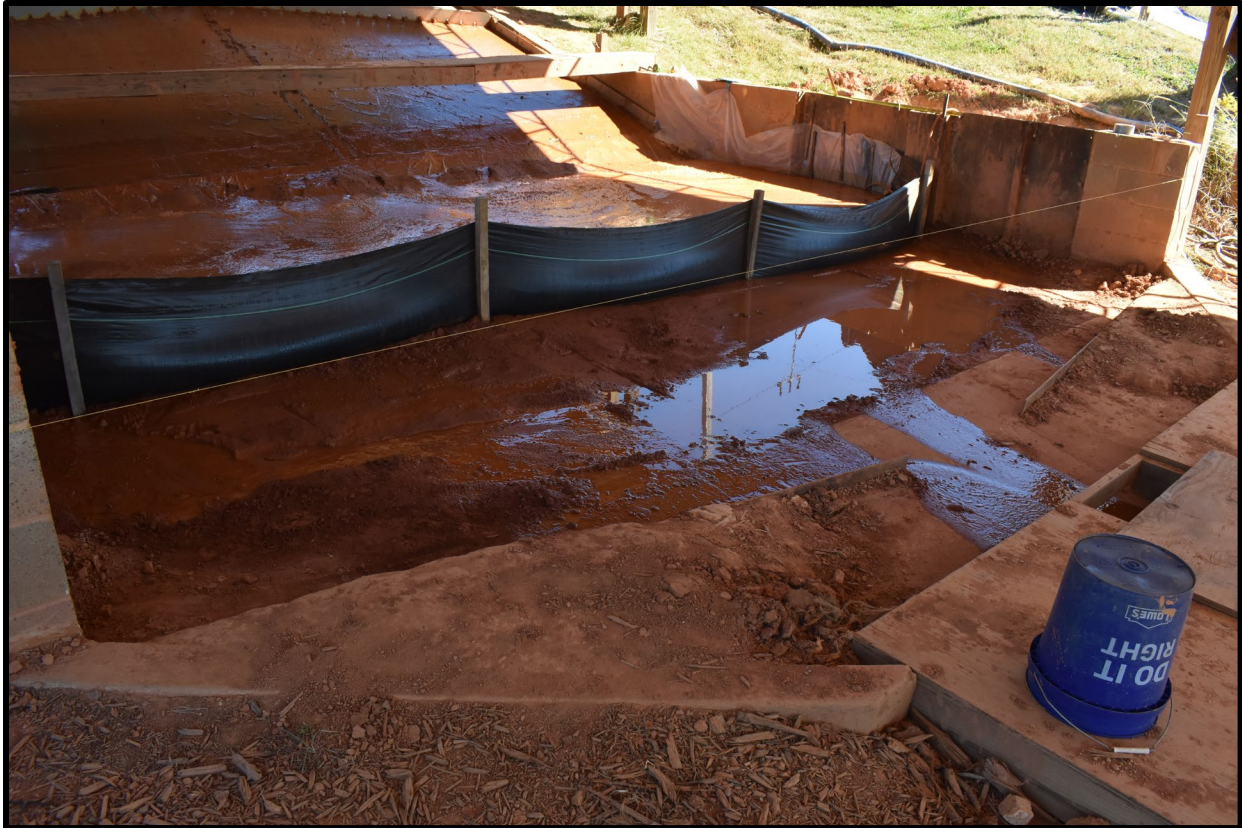
Figure 3.14 Reduced Sagging Experienced by M2

Despite the reduced height of installation, the silt fence fabric still experienced excessive sagging, leading to the effective height of the installation being reduced as much as nearly 6 in. (15.2 cm) from the height at the posts and zip-ties partially tearing through the fabric at the attachment points to the posts at the top of the fabric. The hydraulic pressure of the impoundment on the fabric led to it being pushed downstream, leading to the effective height reduction of the installation. M2, using 2 in. by 2 in. (5.1 cm by 5.1 cm) wooden posts instead of studded steel T-posts, was developed due to wooden posts allowing for the attachment of fabric to posts using staples along the entire height of the post without causing holes in the fabric instead of solely at the top of the fabric where zip-ties must be attached. Under testing of Nebraska standard conditions and the extreme-case storm event, sagging was visibly reduced compared to M1 but still occurred. Figure 3.14 shows the reduced sagging experienced by M2.

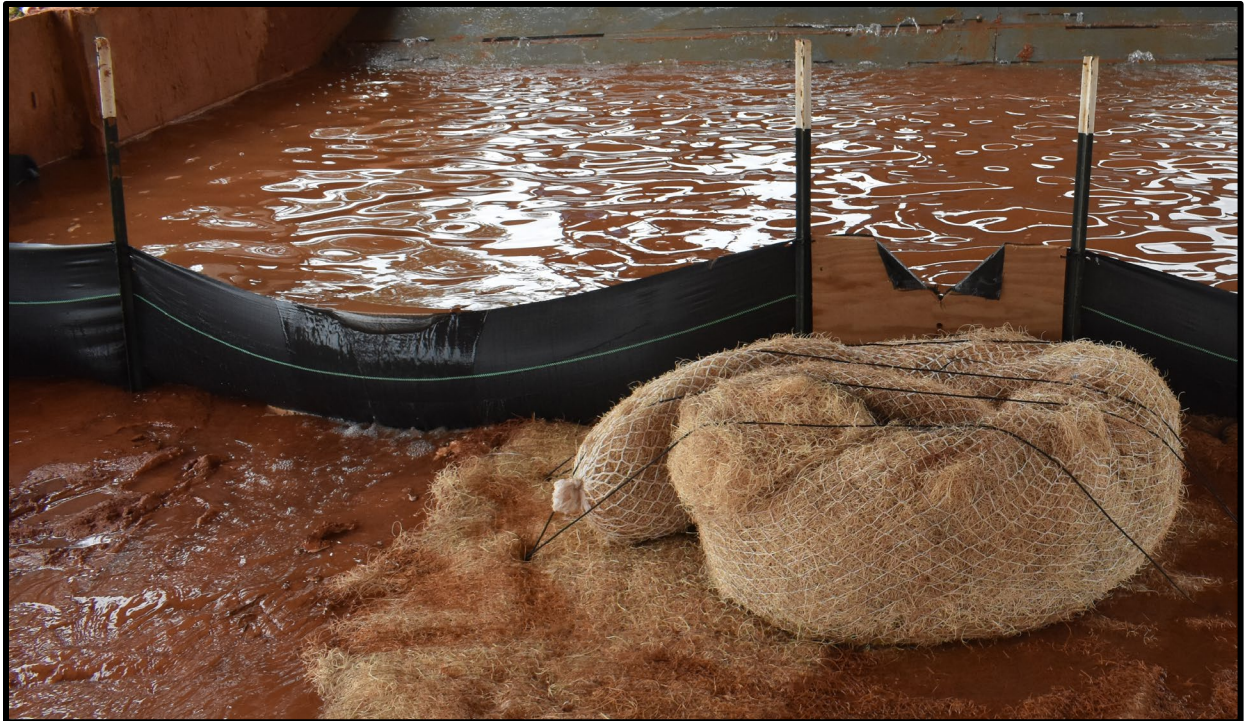
Figure 3.15 Bypassing of Overflow Weir under Excessive Impoundment Conditions

the installation experienced improved dewatering time, with dewatering completed in under 8 hours. Under an extreme-case simulated storm event, impoundment still failed to reach the overflow weir due to sagging experienced by the silt fence fabric between posts, shown in Figure 3.15.

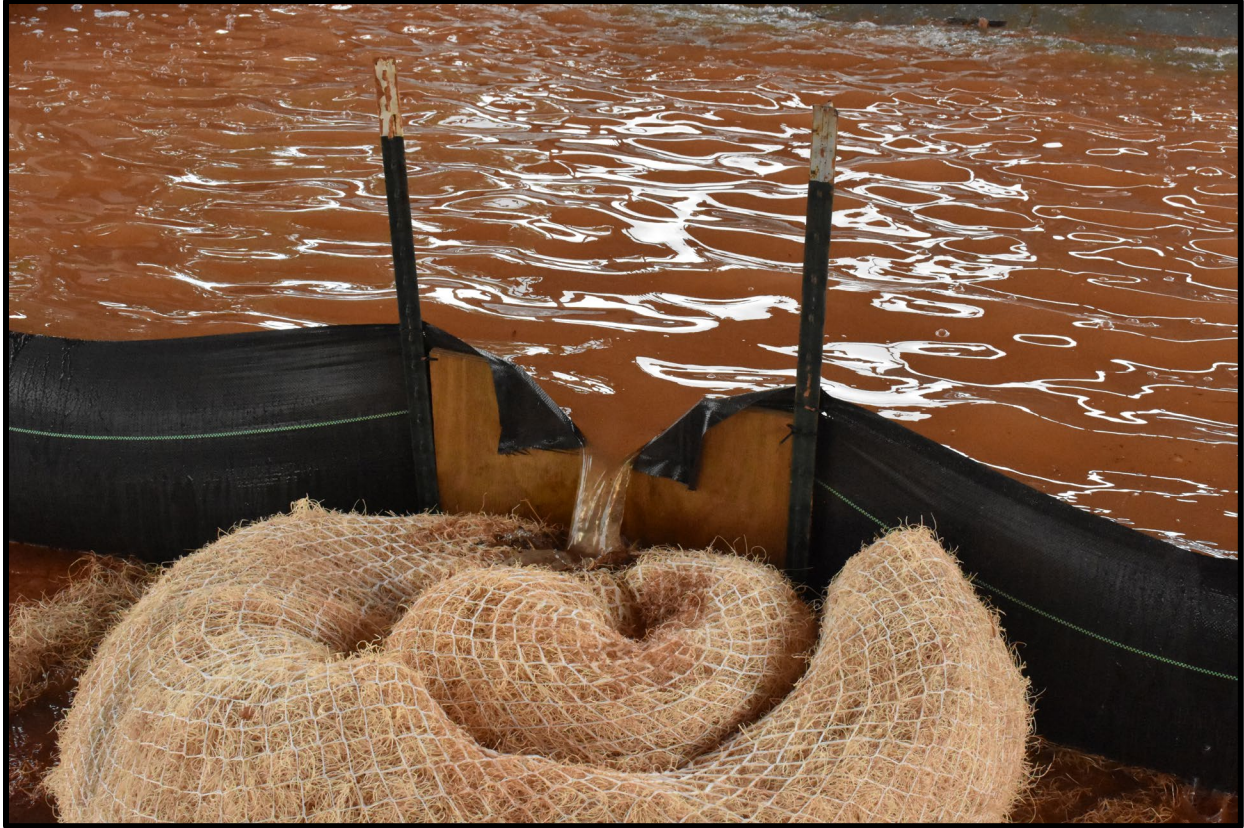
Figure 3.16 Overflow Weir Dewatering

To prevent flow from bypassing the overflow weir and splash pad and causing scour downstream, the post spacing was adjusted from 6 ft (1.8 m) to 4 ft (1.2 m) to prevent excessive sagging from occurring and ensure flow overtopped the installation only at the dewatering board. Reducing the post spacing successfully reduced sagging and led to flow overtopping at the overflow weir under excessive impoundment and not in other locations along the installation, as shown in Figure 3.16.

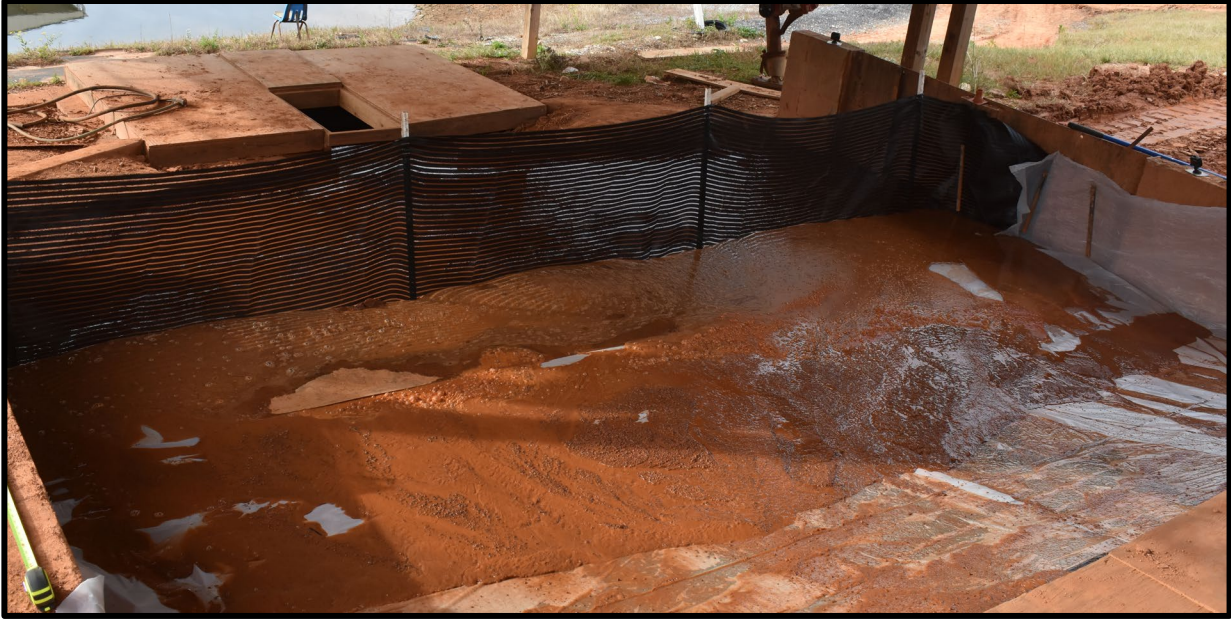
Figure 3.18 Performance of High Porosity Silt Fence Installation

The high porosity silt fence installation was not shown to form much impoundment, maxing out at 4.25 in (10.8 cm) in depth; any impoundment formed seemed to be due to the accumulation of material at the base of the installation. Figure 3.18 shows the lack of impoundment formed by high porosity silt fence installation during a simulated stormwater runoff event. The extreme-case simulated stormwater runoff did not facilitate any additional impoundment from testing of the standard conditions.

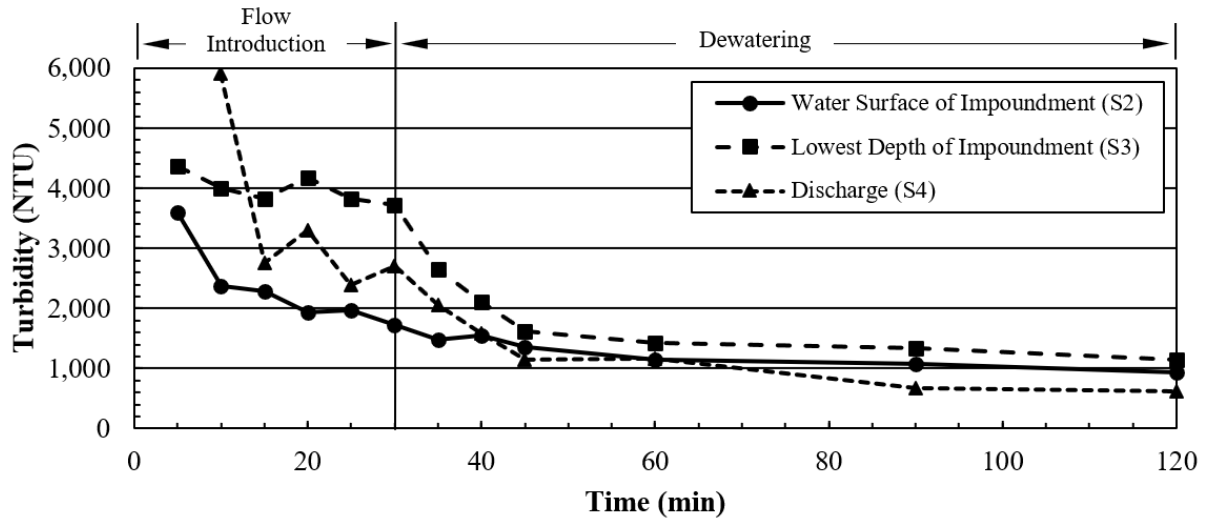
Figure 3.19 displays the average turbidity and TSS through the test period and the 90-minute dewatering period. For much of the period of sediment-laden flow introduction, the lowest depth of the impoundment had the highest turbidity and TSS, while the water's surface had the lowest. After the flow introduction stops, the turbidity and TSS lowers across all sampling locations and steadily declines; discharge turbidity and TSS drops below 1,000 NTU and 1,000 mg/L of TSS.

(a) Average turbidity over time for woven silt fence installations

(b) Average TSS over time for woven silt fence installations

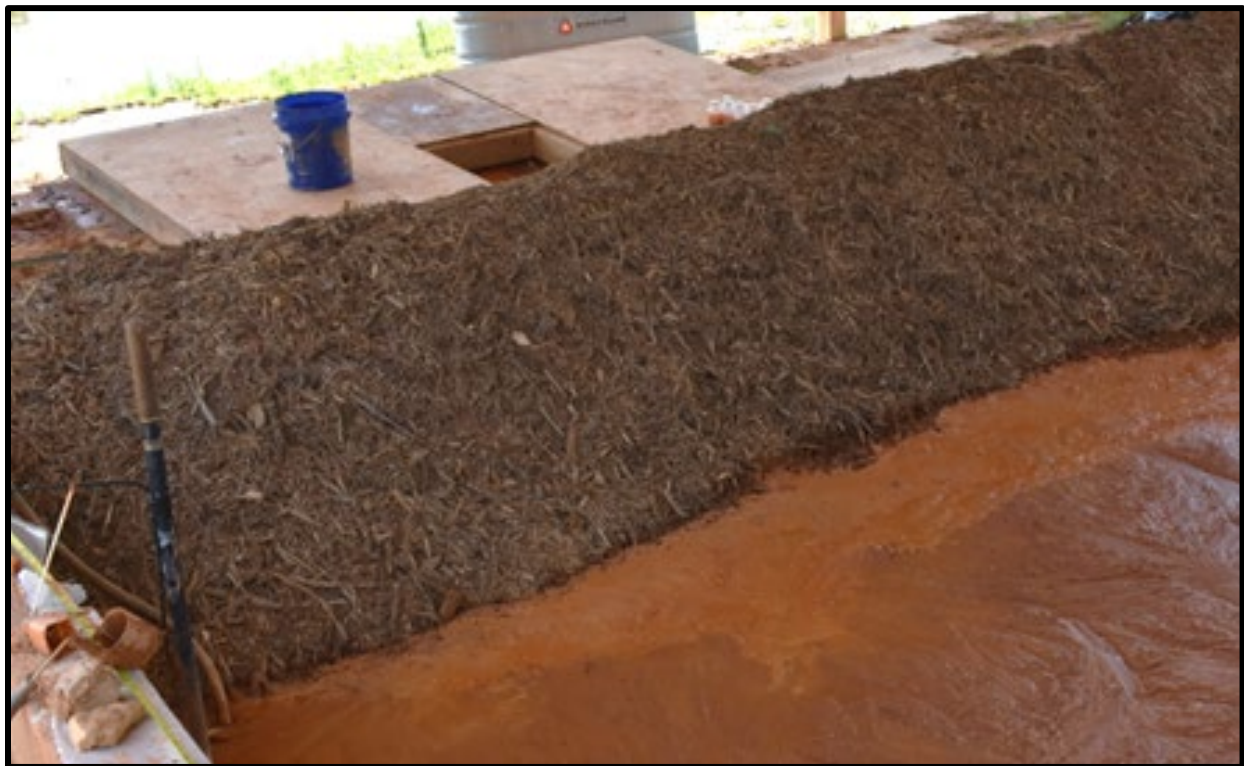
Figure 3.21 Impoundment Formed by Nebraska DOT Slash Mulch Berm Standard

The standard Nebraska DOT slash mulch berm installation facilitated only a maximum impoundment depth of 4 in. (10.2 cm); the majority of material within the berm, approximately 2.7 ft (0.82 m) of the total height, does not have any flow pass through and only is serving to ensure the berm does not wash away as runoff passes through it. Figure 3.21 shows the impoundment formed by the installation; it does not reach far up the front face of the installation. The first discharge through the installation took just over 3 minutes after the beginning of flow introduction; each subsequent test required less time for flow to pass through the installation. The little impoundment formed behind the berm dewatered within 60-min of the conclusion of flow introduction. Under the extreme-case simulated stormwater runoff, minimal additional impoundment was achieved; however, the berm remained structurally sound and there was no substantial loss of material from the berm.

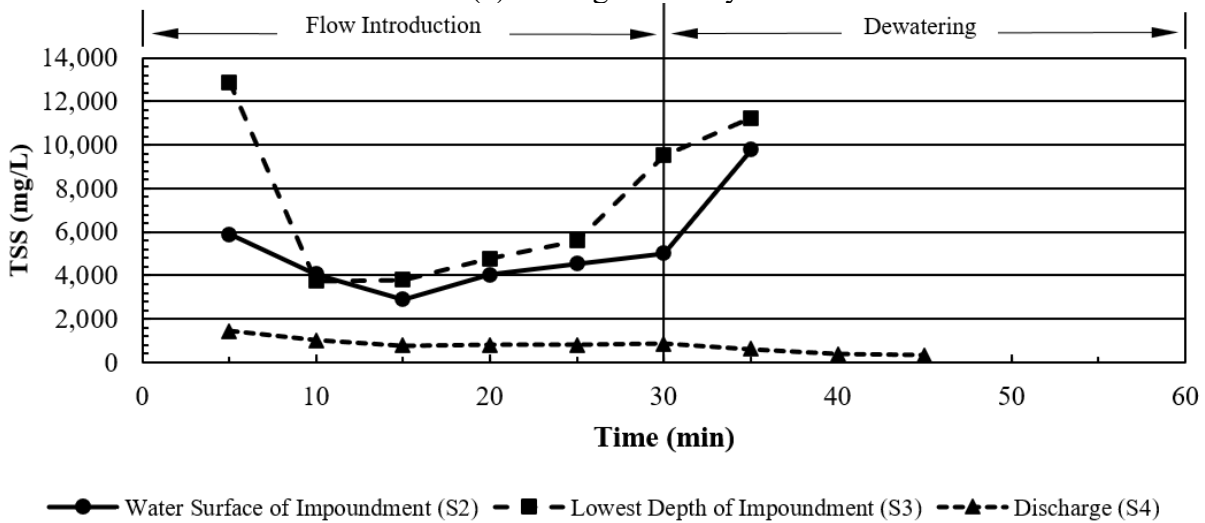
Figure 3.24 shows the average water quality over time for the slash mulch berm MFE-I installations. On average, through both the testing period and the dewatering monitoring period, the turbidity and TSS of the discharge are lower than both the top and bottom of the impoundment, indicating treatment through the installation. Additionally, for much of the test period, the turbidity and TSS of the top of the impoundment are lower than the bottom; however, both increase through the test period on average. Water quality at the two sampling locations in the impoundment also becomes similar as the dewatering period leads to lower impoundment facilitated upstream of the practice, leading to samples being taken from similar locations within the impoundment.

(a) Average turbidity

(b) Average TSS

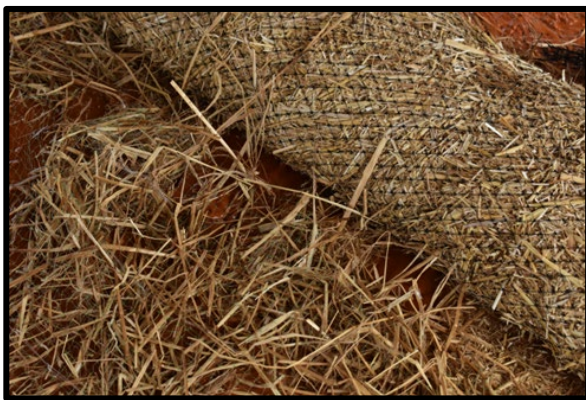
Immediately after the start of flow introduction into the standard straw wattle silt check installation, stormwater could pass beneath the installation, as shown in Figure 3.26. The stakes that attached the wattles to the ground did not facilitate ground contact with the straw wattle. Minimal impoundment was facilitated; the maximum impoundment through testing was 1.5 in. (3.8 cm), and a high flow-through rate was apparent. Due to the evident failure of the installation in facilitating any impoundment or treating stormwater, only one test of one installation was run. Additionally, no impoundment was facilitated under the higher flow rates during the extreme-case simulated stormwater runoff event.

(a) undermining

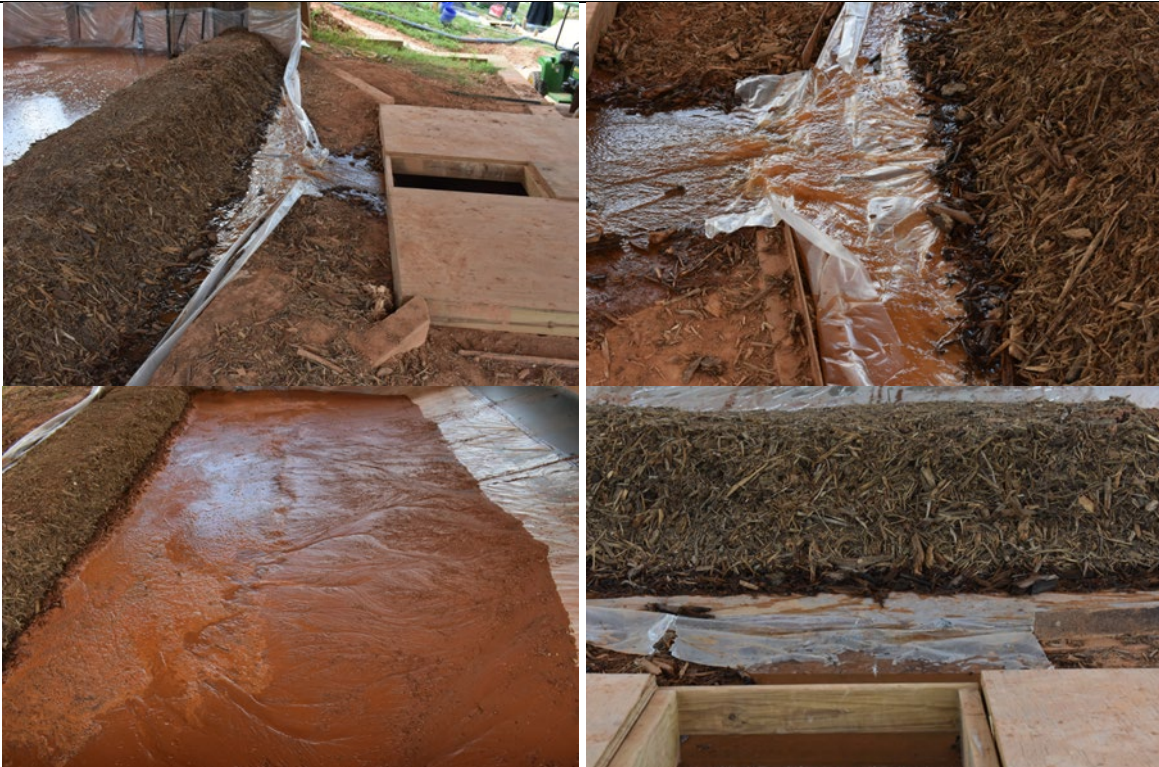
Notes: Flow through berm, sediment deposition, and only bottom of berm having flow pass through

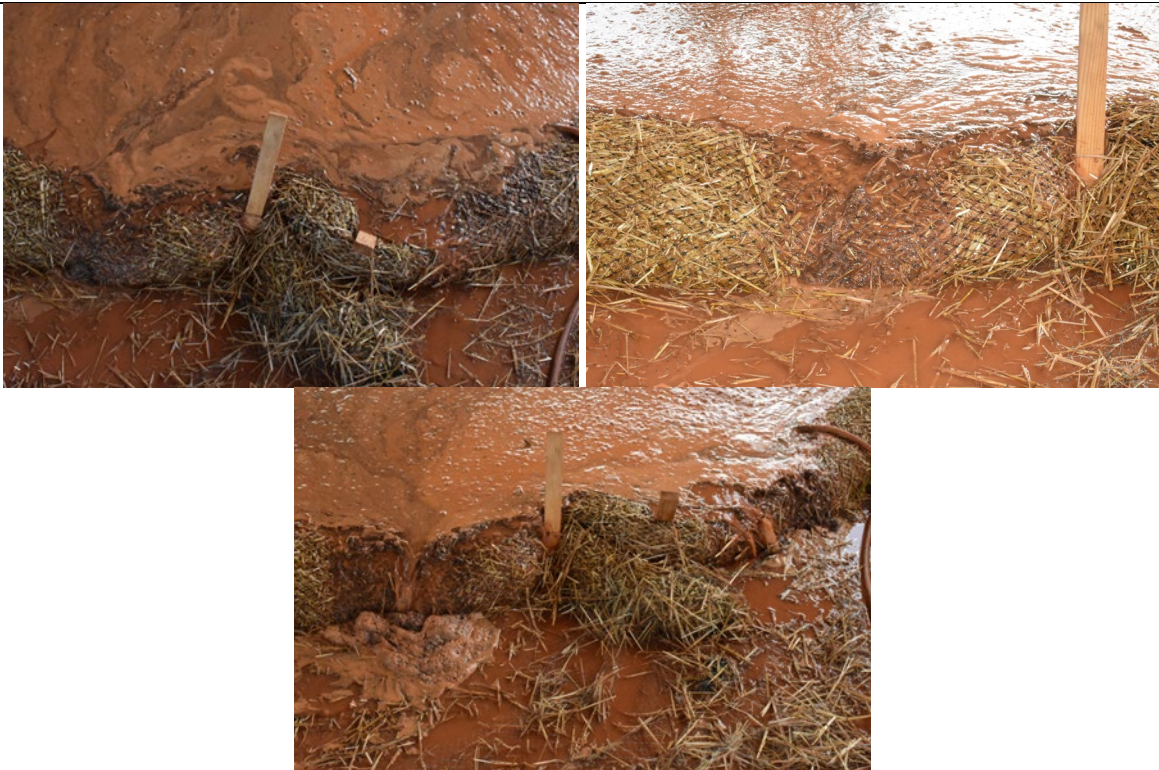
Notes: Installation overtopping under standard conditions

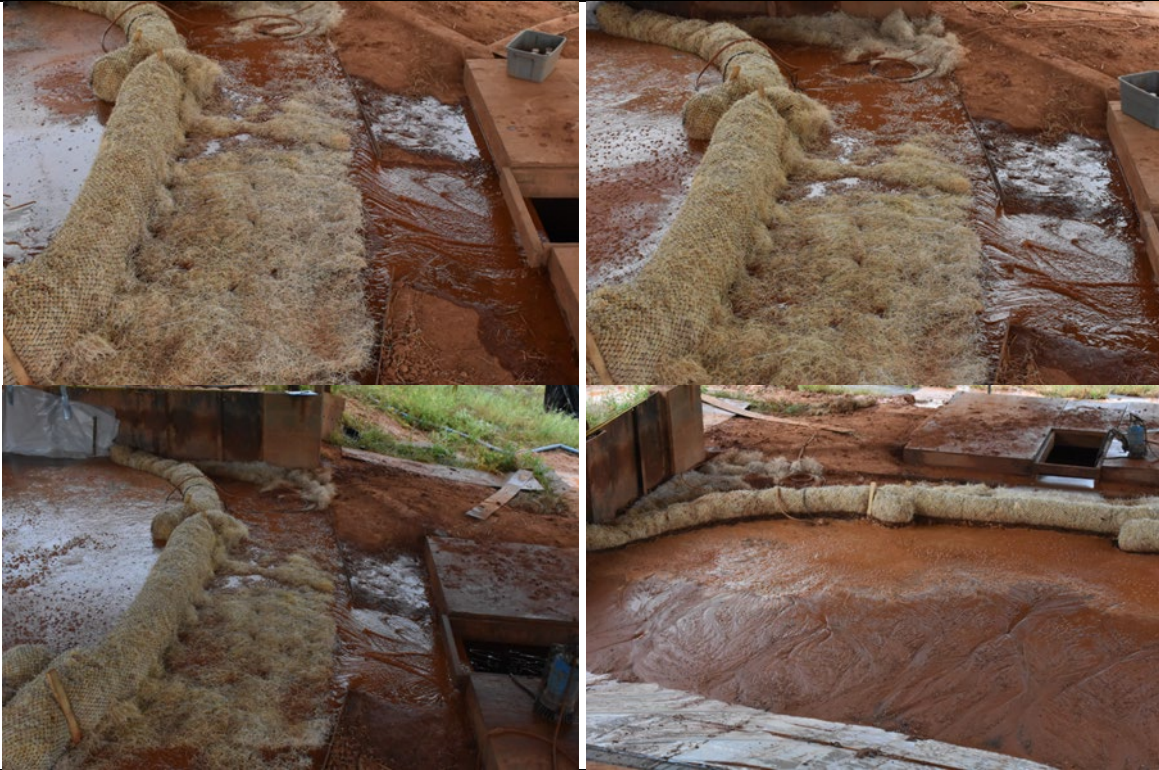
Notes: Visibly high flow-through rates and sediment deposition upstream
