**DOT/FAA/TC-24/3**

# **OEM Summary Report on the Effects of Disinfectants on Aircraft Flight Deck Materials**

March 2024

Final report

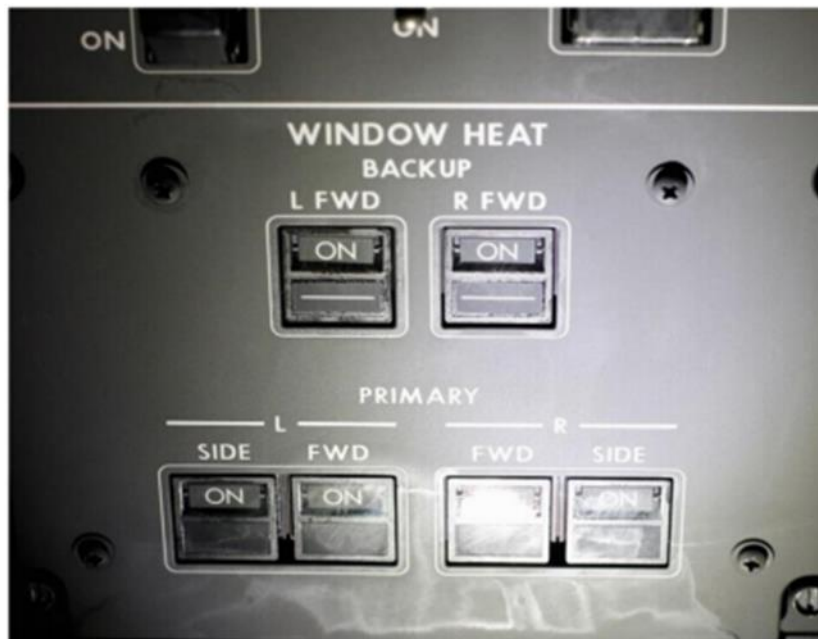
Figure 1. Sticky residue and streaks of dried Sani-Cide EX3

The results of the 70% IPA testing were based off color scheme comparisons and gloss measurements. It was determined that the disinfectant had negligible effects on the appearance of LRUs. Testing with Sani-Cide EX3 was suspended after 16 applications due to function check failures and primer adhesion failure seen on the flap module assembly. The disinfectant left behind a sticky residue even after the surface was wiped dry, as well as streaks of dried liquid shown in Figure 1. It was concluded that these poor results were likely due to the pools of liquid left by the spray bottle application method.

Sani-Cide EX3 was also tested by OEM 1 and 2, both reported significant degradation to materials and components. OEM 1 halted testing early after 16 applications due to operation failures and negative impacts on component surfaces. In OEM 2s testing, the optical test showed significant changes to the material after 10 exposures of Sani-Cide EX3.

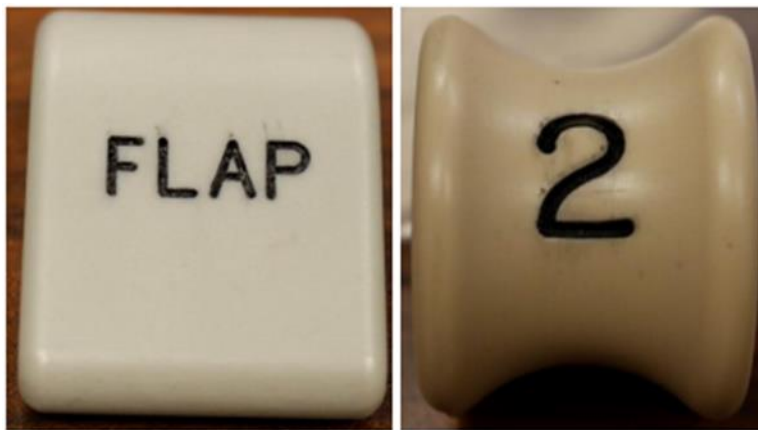
Peroxigard was tested on a parking brake assembly and seven knobs of various color schemes. All tested items were evaluated for damage by comparison with color standards, and gloss measurements were taken for only the parking brake assembly. Peroxigard was applied to surfaces using a spray bottle from 6-8 inches away. After one minute the surface was dried with a cloth, then left for 10 minutes to dry. A total of 50 applications were completed, pictures and gloss measurements were taken after every 5 applications. It was determined that Peroxigard does not adversely affect the appearance of the parking brake assembly or knobs, although after 14 applications some paint smearing occurred in the recessed labeling of two knobs (Figure 2).

Figure 2. Smearing of paint on knobs

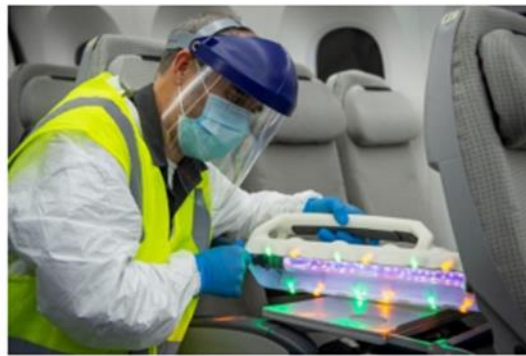
Lastly, OEM 1 tested Far-UV exposure disinfection in the flight deck (Figure 5). Their paper discussed the efficacy of 222nm Far-UV light against Sars-CoV-2, and the applicability of its use in an aircraft environment. While the majority of OEMs used UV-C light, OEM 1 used Far-UV

light. UV-C light lies in the 240 - 280 nm region of the spectrum (254 nm sources being most prevalent) and Far-UV lies in the 200 to 235 nm region (222 nm sources being the most prevalent). While both wavelengths are germicidal, Far-UV systems were more recently developed and may be safer and more effective than the UV-C systems. Testing was conducted with a mobile wand prototype that subjects target disinfection surfaces to a Far-UV 222 nm dose of 3 mJ/cm<sup>2</sup>. This dosage is effective in combating transmission of SARS-CoV-2. The wand contained a cylindrical lamp composed of krypton and a small amount of chlorine gas. An operator simply had to pass the wand over high contact surfaces to disinfect them, proving it capable of sanitizing an area such as the flight deck within 15 minutes. The study also referenced a series of exposure tests to individual electronic components in controlled environments.

Figure 5. Far-UV wand prototype

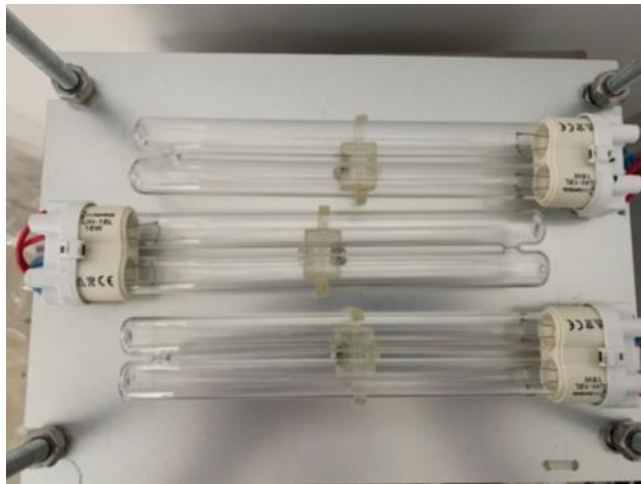
Figure 6. OEM 3 UV-C source

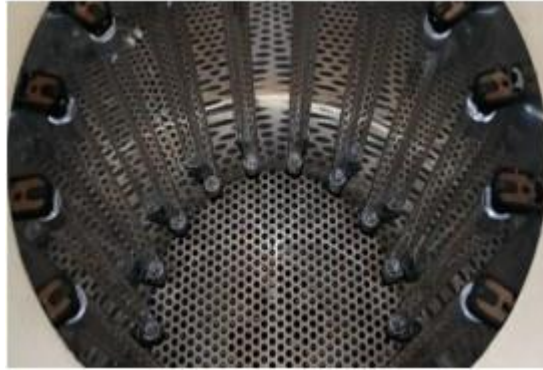
OEM 4 conducted UV-C exposure tests on a cockpit touchscreen display and cockpit instrument panels. These tests were performed to validate the lifetime exposure limits of the units. The OEM conducted testing using a Rayonet reactor equipped with 16 mercury vapor UV-C lamps arranged around the circumference of a cylinder of UV-reflective material. This reactor is shown in Figure 7.

Figure 7. Reactor used for UV-C exposures

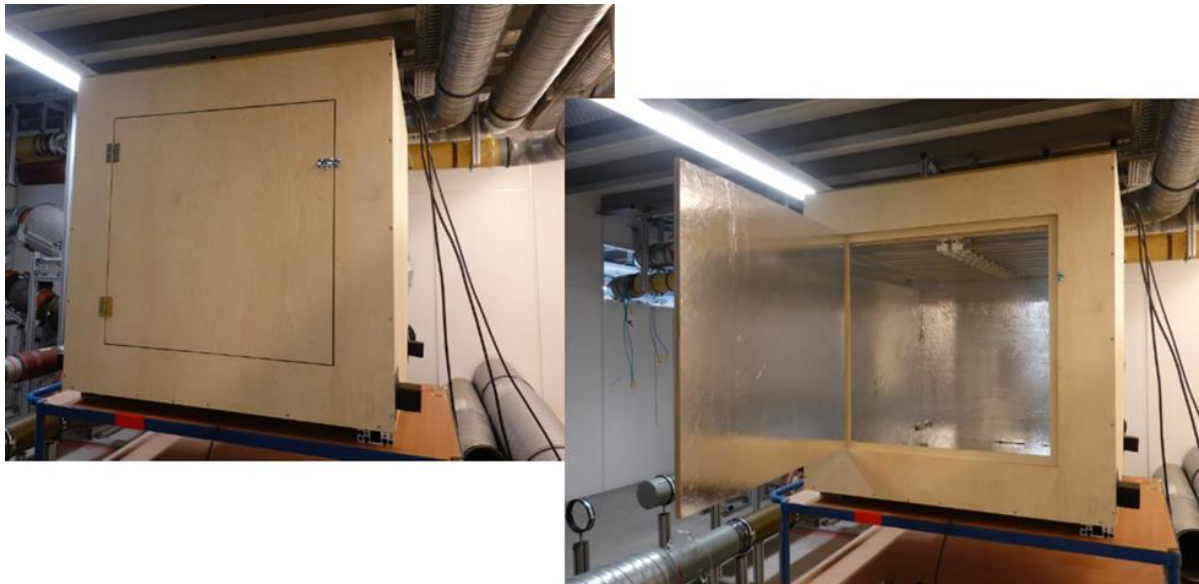
OEM 5 used 12 36-watt UV-C lamps inside a wooden 1m x 1m x 1m box (Figure 10) with aluminum inner surfaces to test the effect on materials of UV-C disinfection.

Figure 10. UV radiation box

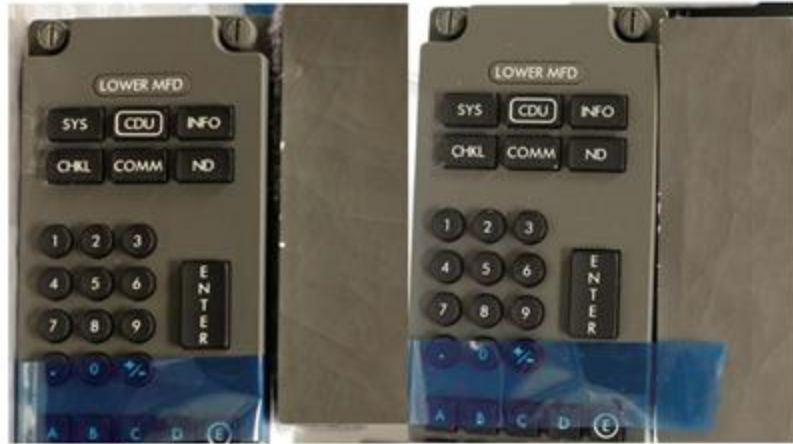
Figure 1: [redacted] gray color scheme; initial (left), after 20 cycles of 70% IPA (right)

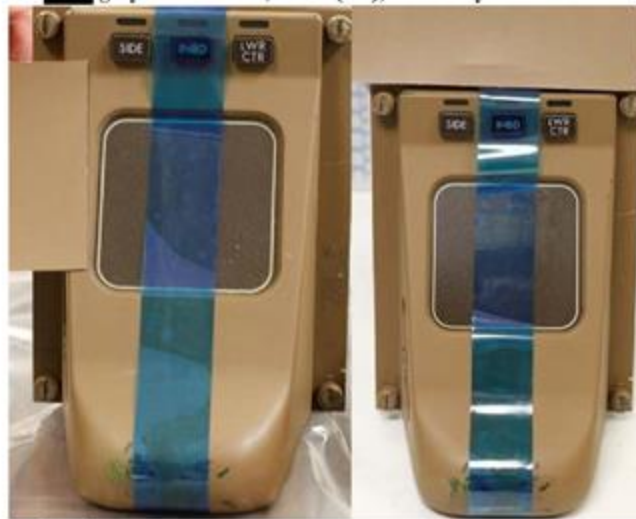
Figure 2: [redacted] brown color scheme; initial (left), after 20 cycles of 70% IPA (right)

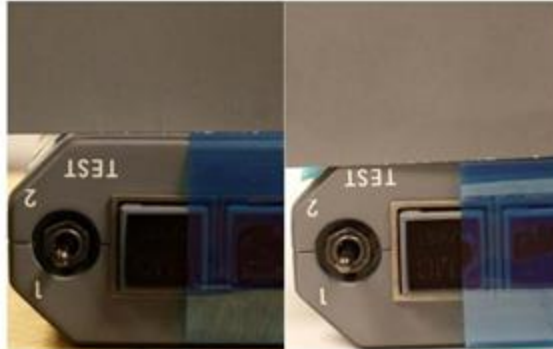
Figure 3: [redacted] gray color scheme; initial (left), after 20 cycles of 70% IPA (right)

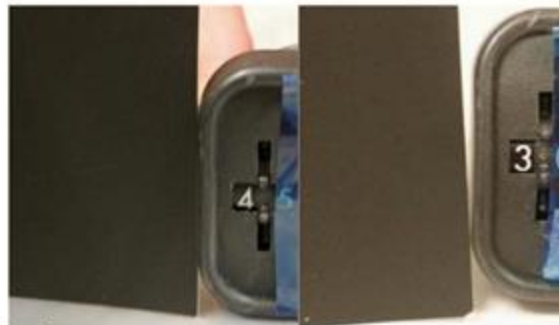
Figure 4: [redacted] black color scheme; initial (left), after 20 cycles of 70% IPA (right)

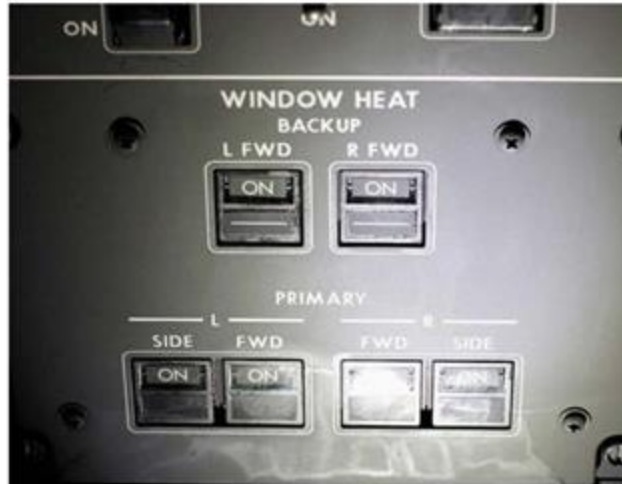
Figure 5: Example of sticky residue and streaks of dried Sani-Cide EX3 on surfaces from testing in a [REDACTED] flight deck

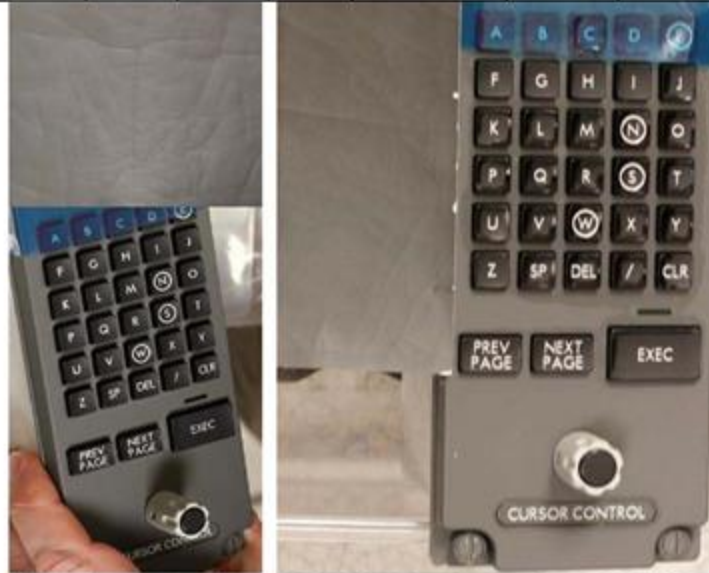
Figure 6: ■ gray color scheme; initial (left), after 16 cycles of Sani-Cide EX3 (right)

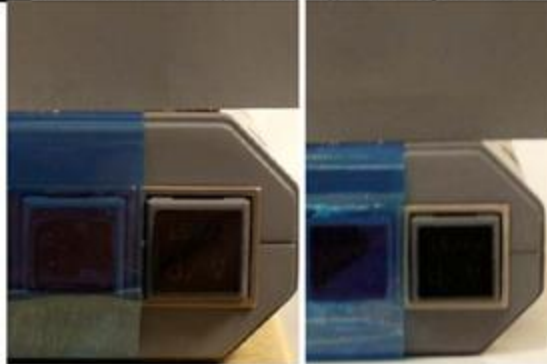
Figure 8: [redacted] gray color scheme; initial (left), after 16 cycles of SanCide EX3 (right)

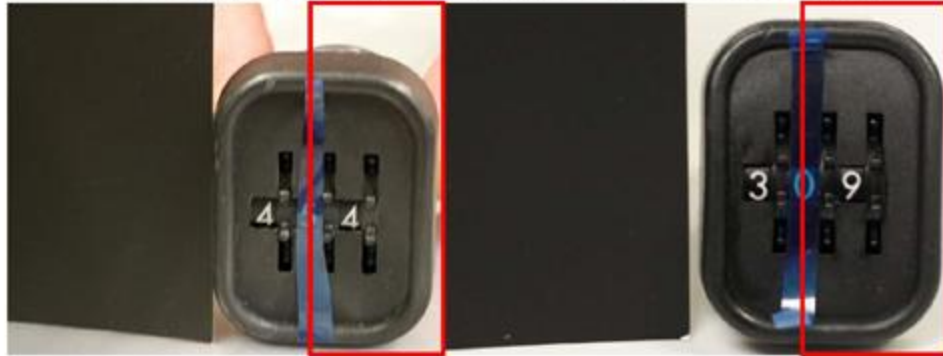
Figure 9: [redacted] black color scheme; initial (left), after 16 cycles of Sani-Cide EX3 (right)

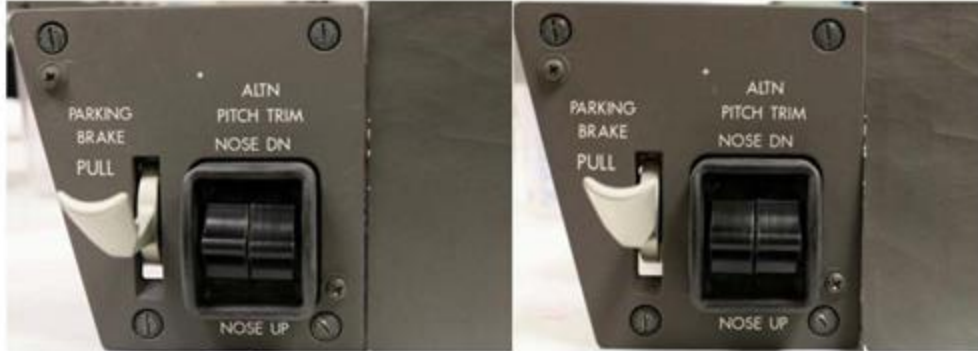
Figure 10: █ gray color scheme; initial (left), after 20 cycles of Calla 1452 (right)

The recorded gloss measurements of LRUs tested with Calla 1452 are shown in Table 5. Based on the coefficient of variation (CV), the change in gloss of the coating of the LRUs were minimal throughout the 20 cycles of testing. The pictures taken with color standards after each cycle also showed no changes in appearance. A comparison of initial and after testing pictures for each color scheme is shown in Figure 10 through Figure 13.

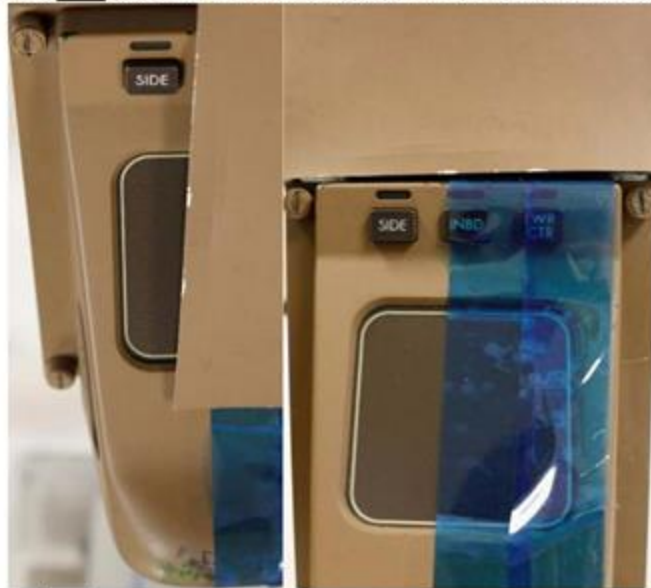
Figure 11: █ brown color scheme; initial (left), after 20 cycles of Calla 1452 (right)

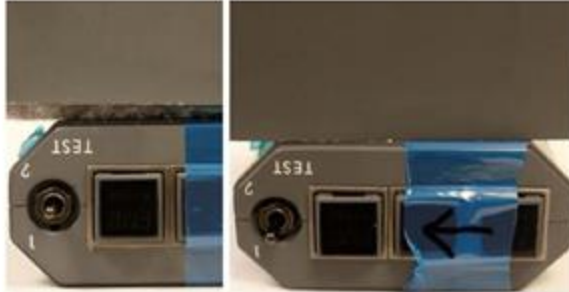
Figure 12: ■ gray color scheme; initial (left), after 20 cycles of Calla 1452 (right)

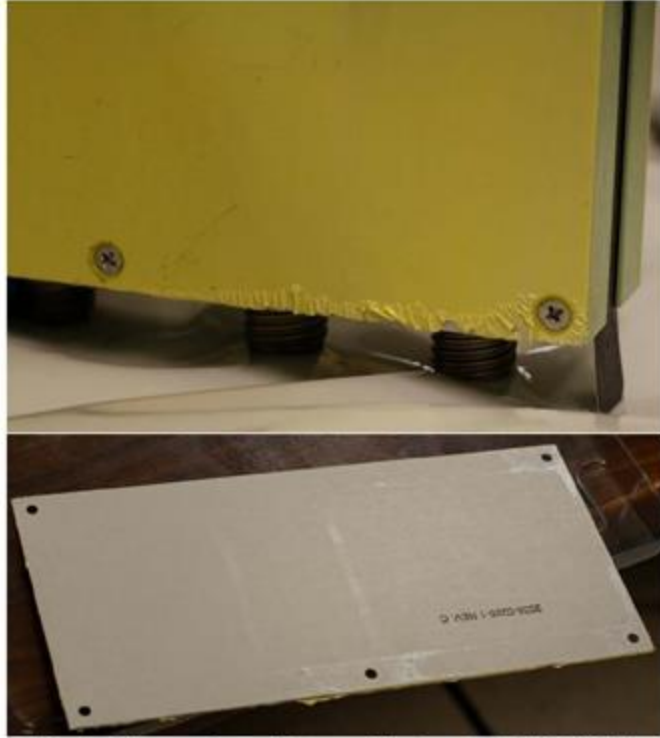
Figure A-1: Primer adhesion failure on flap module assembly due to Sani-Cide EX3 dripping down the side of the assembly (see SR17024 for additional details)

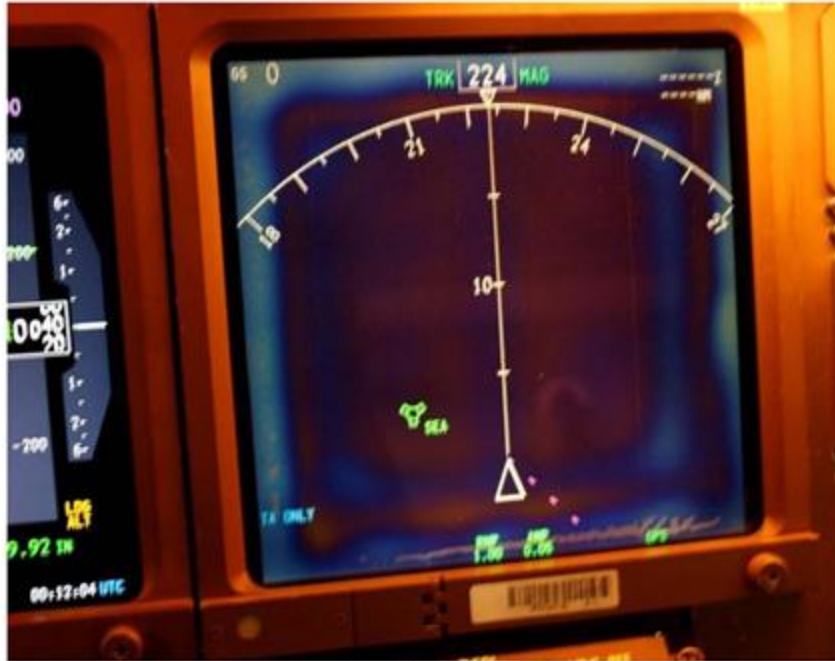
Figure A-2: Halo effect on [REDACTED] display

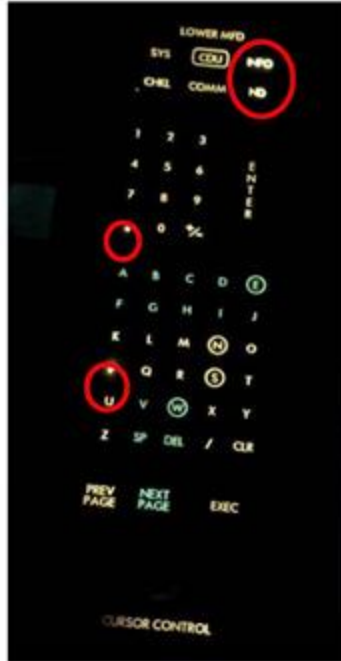
Figure A-3: Variance in backlight brightness in MKP (buttons with blue tint were covered with blue flash tape)

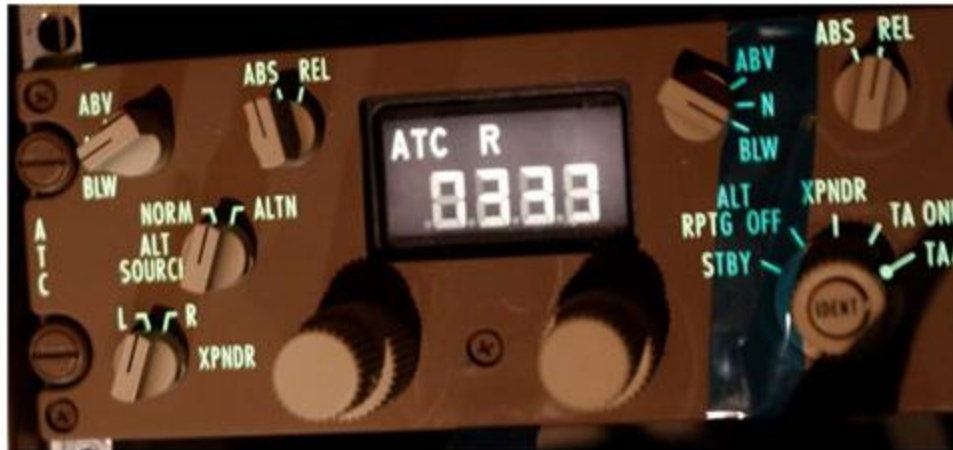
Figure A-4: Contrast issues in WXR panel display (display should read "0333")

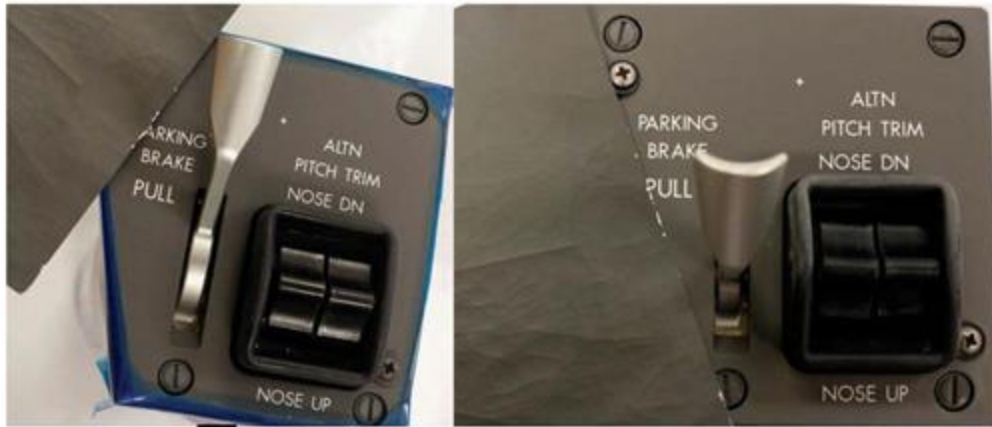
Figure 1: [redacted] parking brake assembly; initial (left), after 50 cycles of Peroxigard (right)

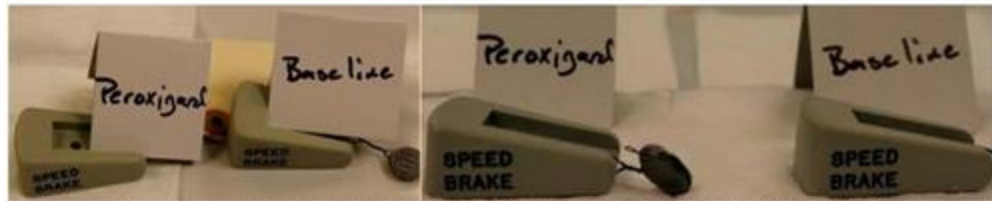
Figure 2: Gray "speed brake" knob; initial (left), after 50 cycles of Peroxigard (right)

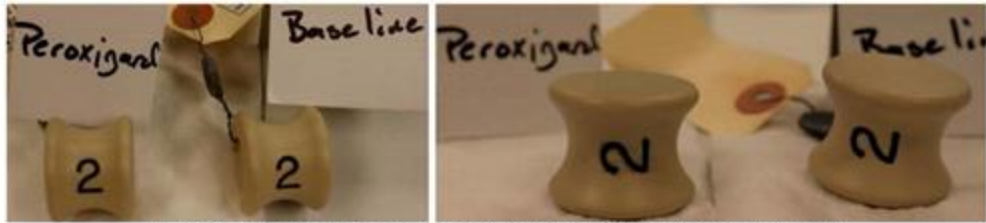
Figure 3: Tan numbered knob; initial (left), after 50 cycles of Peroxi-gard (right)

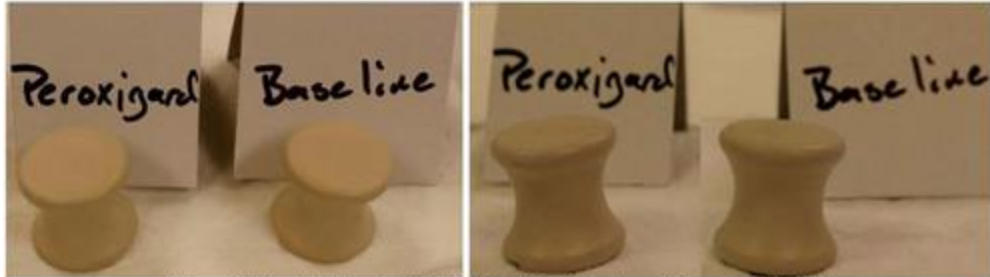
Figure 4: Tan blank knob; initial (left), after 50 cycles of Peroxi-gard (right)

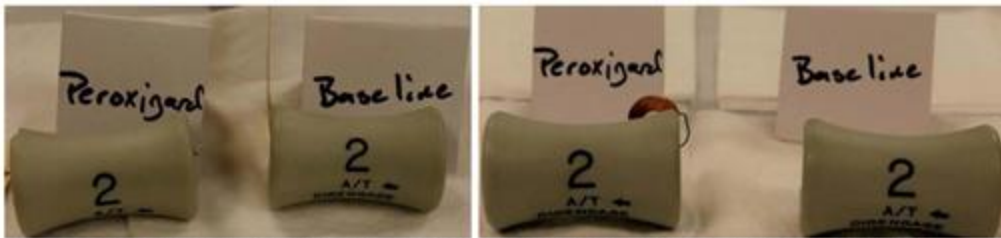
Figure 5: Gray numbered "disengage" knob; initial (left), after 50 cycles of Peroxi-gard (right)

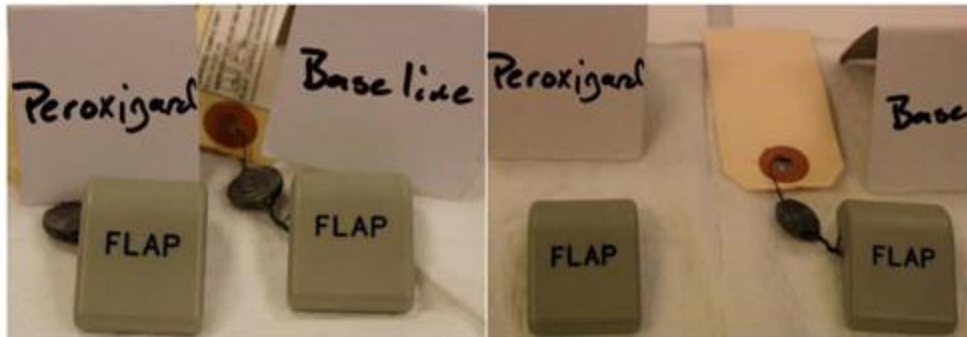
Figure 6: Gray "flap" knob; initial (left), after 50 cycles of Peroxi-gard (right)

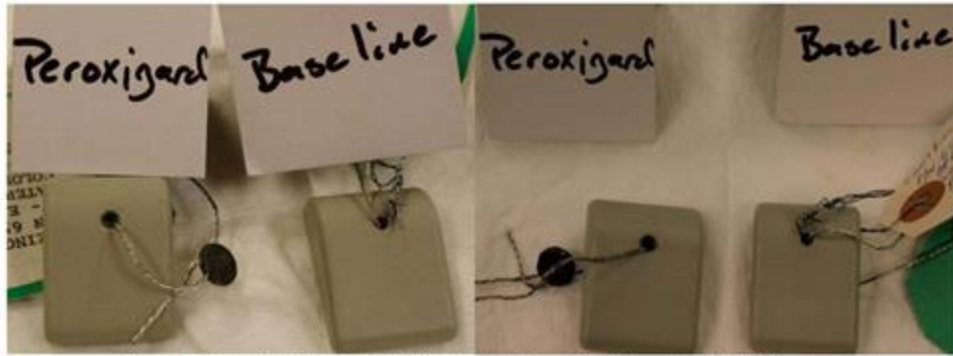
Figure 7: Gray blank knob; initial (left), after 50 cycles of Peroxigard (right)

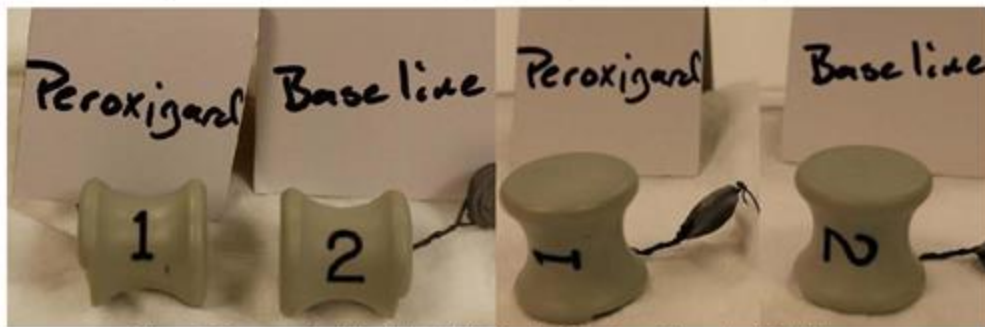
Figure 8: Gray numbered knob; initial (left), after 50 cycles of Peroxigard (right)

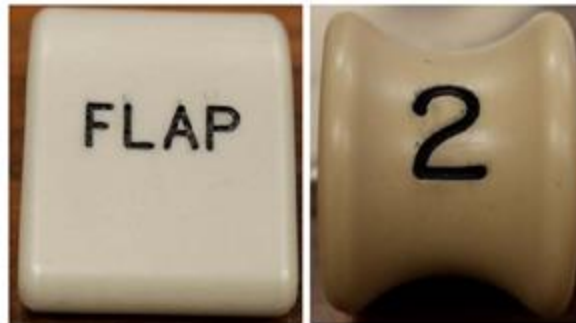
Figure 9: Smearing of paint in recessed labeling of knobs

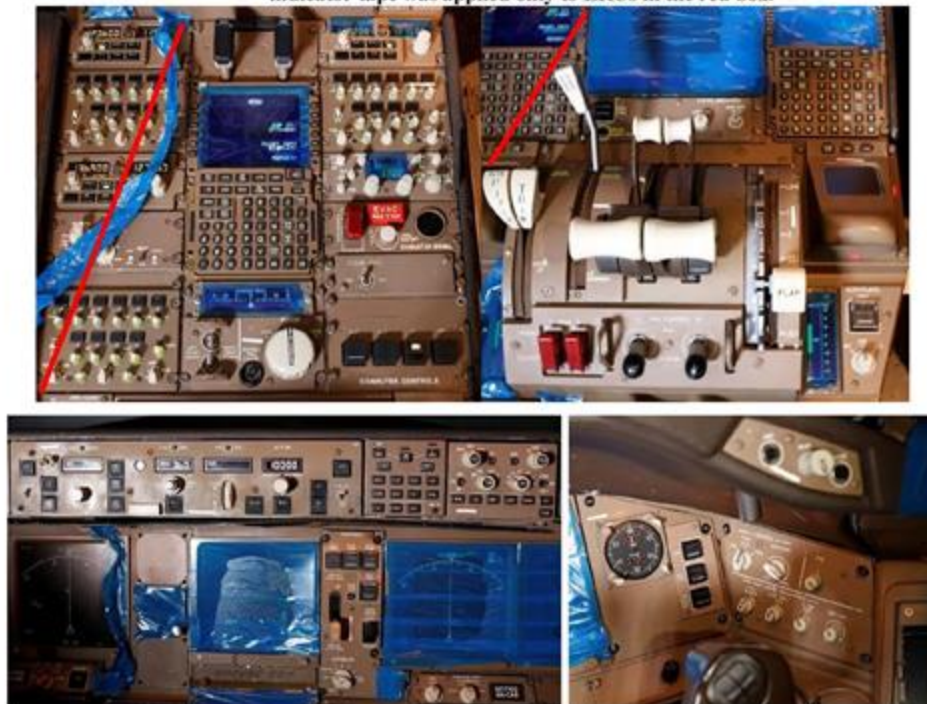
Figure 2: LRUs subjected to e-spray (LRUs under red line were not e-sprayed)

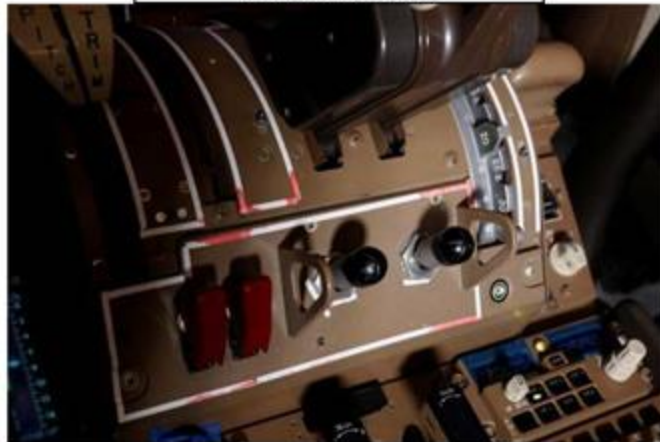
Figure 3: Largest amount of liquid ingress (indicated by red spots) under the light plates of the control stand assembly

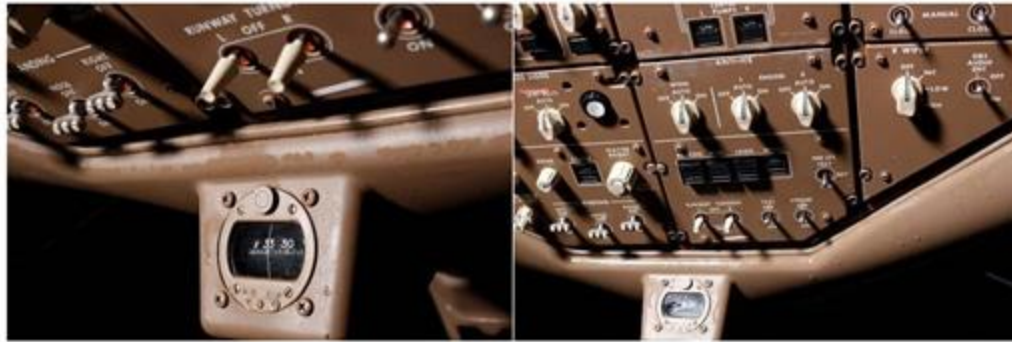
Figure 4: Liquid dripping on overhead panels after 4 coats of Calla 1452

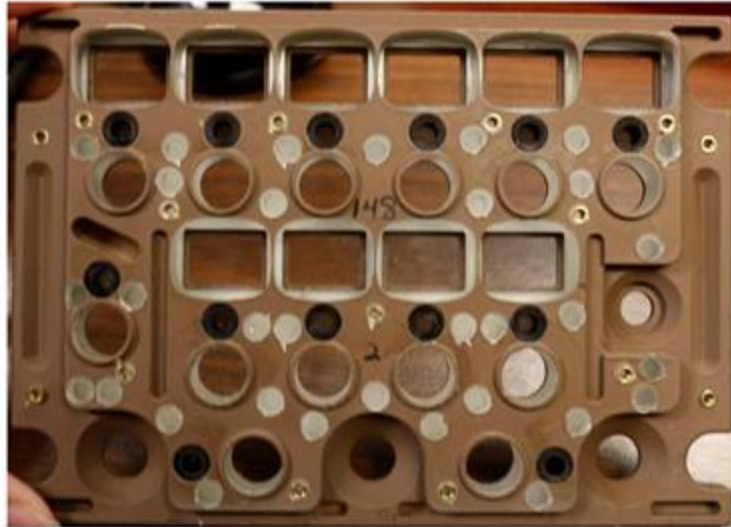
**Figure 5: Back of ACP light plate showing no signs of ingress or corrosion**

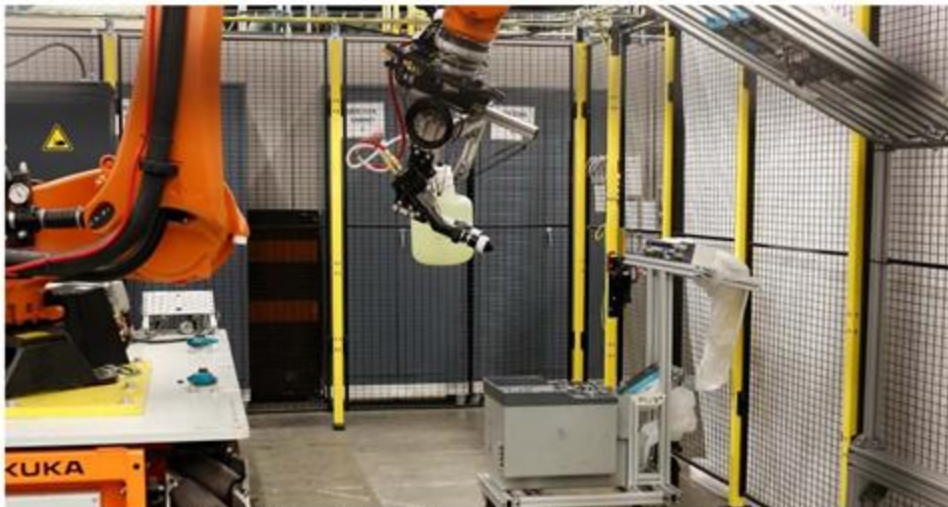
a Kuka robot. The setup is shown in Figure 3. Function checks and disassembly were performed after a total of 20 cleaning applications were conducted. Each application of Calla 1452 was performed as follows:

1. Sprayed a coat of Calla 1452 on all LRUs using the following periodicity
  - a. Sprayed all LRUs using a nominal spray line velocity of 38 inches per second and nozzle distance of 18 – 24 inches
    - Overhead LRUs: 3 alternating left/right passes moving from top to bottom each pass. Sprayed upward approximately 45° from horizontal
    - Glare shield LRUs: Single right/left pass normal to LRU surfaces
    - MKP: Single up/down pass normal to surface
    - Aisle stand LRUs: Single right/left pass, spraying downward approximately 45° from horizontal
2. Waited 3 minutes
3. Sprayed a second coat of Calla 1452 on all LRUs per step 1
4. Waited 1 hour
5. Repeated steps 1 – 4 until 20 applications were completed
6. Disassembly of LRUs
7. Performed function check of all LRUs

Figure 3: Setup of Calla 1452 e-spray testing using Kuka robot

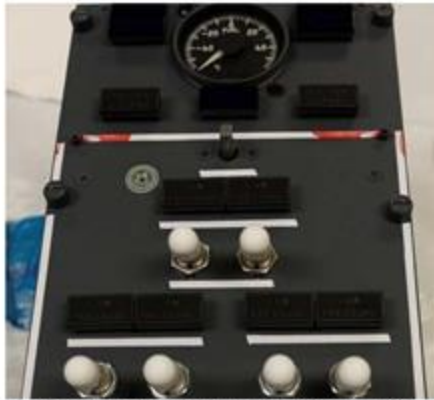
Indications of ingress were observed on the fuel control panel behind the light plate (Figure 6).

Figure 6: Indications of ingress observed on fuel control panel after set of 1 application

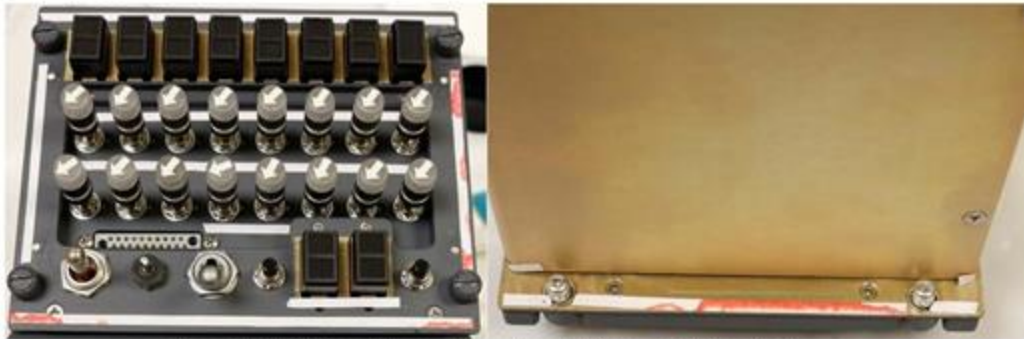
Figure 7: Indications of ingress observed on ACP after set of 4 applications

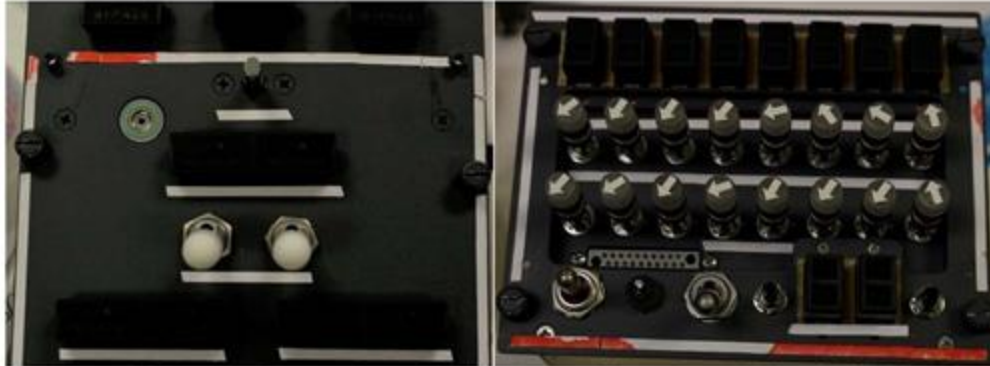
Figure 8: Indications of ingress after set of 3 applications on fuel control panel (left) and ACP (right)

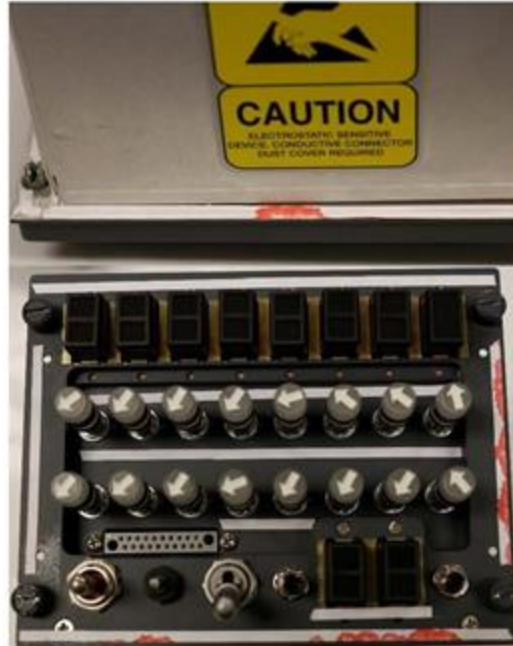
Figure 9: Indications of ingress after set of 2 applications on pressure selector panel (top) and ACP (bottom)

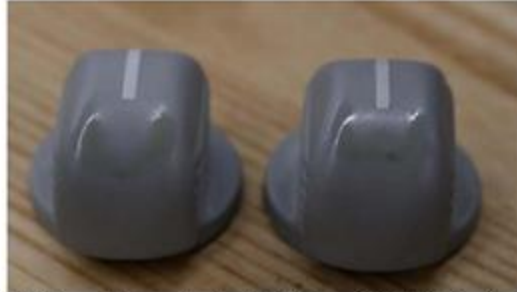
Figure 11: Calla 1452 remaining on knobs of P5-13 panel after 10 -12 minute dwell time

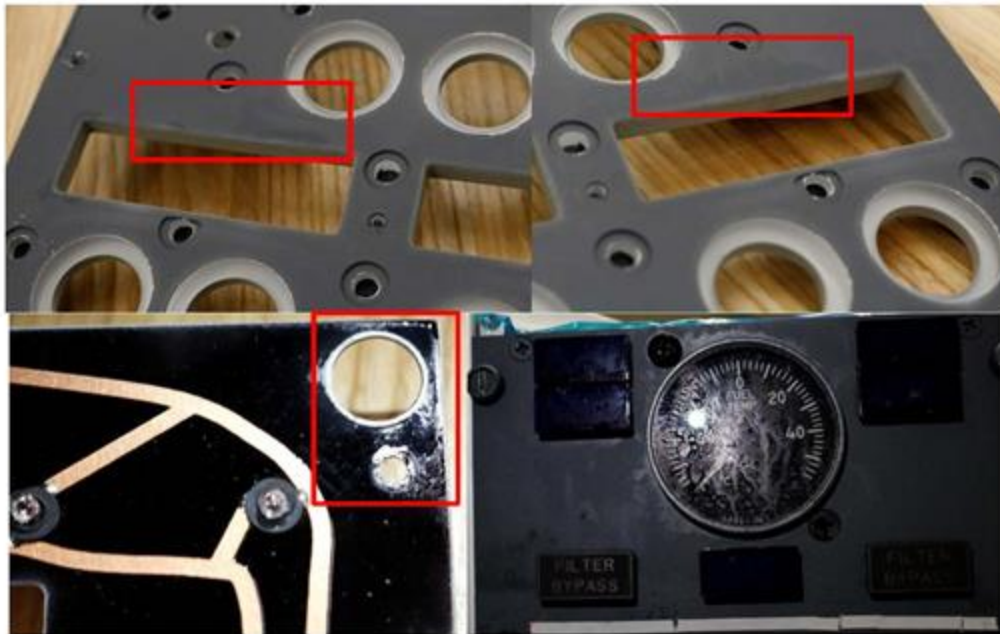
Figure 12: Moisture and residue observed on fuel control panel components

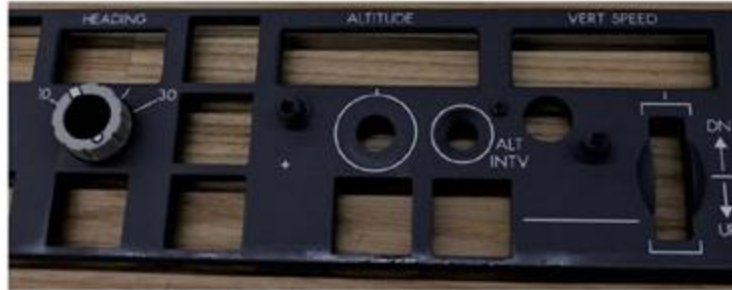
Figure 13: Calla 1452 remaining along bottom edge of MCP light plate after 10 \_ 12 minute dwell time

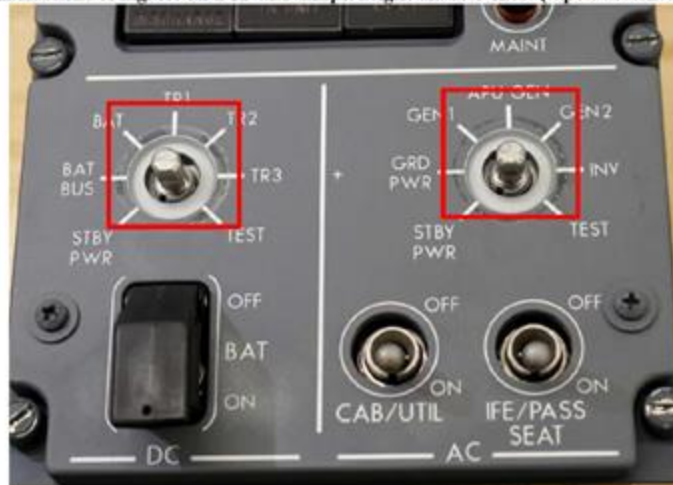
Figure 16: Calla 1452 residue build up behind knobs of P5-13 panel

After another 20 applications of Calla 1452 with the Kuka robot, or a total of 50 applications, disassembly of all LRUs was performed immediately after the last application. The results are as shown in Table 3 and Figure 16 through Figure 20. A function check was performed showing no functional issues with any of the LRUs, except for the tuning and control panel (TCP), despite exhibiting minor indications of ingress around the perimeter under the light plate assembly (Figure 15). The TCP had buttons that required several pushes to function. Some of the buttons' functionality improved with increased usage, while some other buttons continued to require several pushes to function. An additional disassembly after function check revealed that the light plate had been reassembled incorrectly with the light diffuser sheet installed between the rubber pad and the printed wiring board. As a result, the light diffuser sheet caused gapping between the rubber pad and the printed wiring board contacts. This also resulted in the light diffuser sheet being dimpled by the light emitting diodes during attempts to operate the buttons (Figure 15). When the TCP was reassembled with the light diffuser sheet in the correct location, the buttons functioned properly.

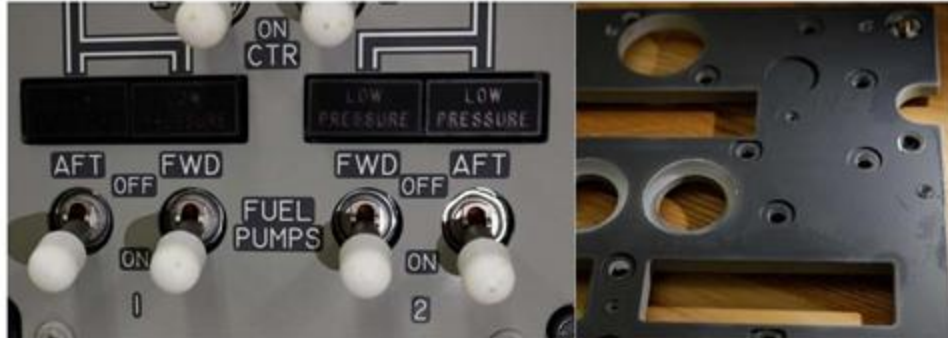
Figure 17: Calla 1452 residue on white switches and moisture on back side of light plate of fuel control panel

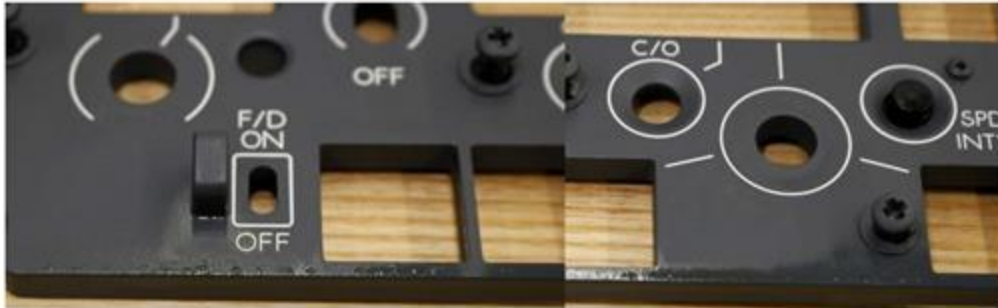
Figure 18: Calla 1452 residue and pooling along bottom edge of MCP light plate

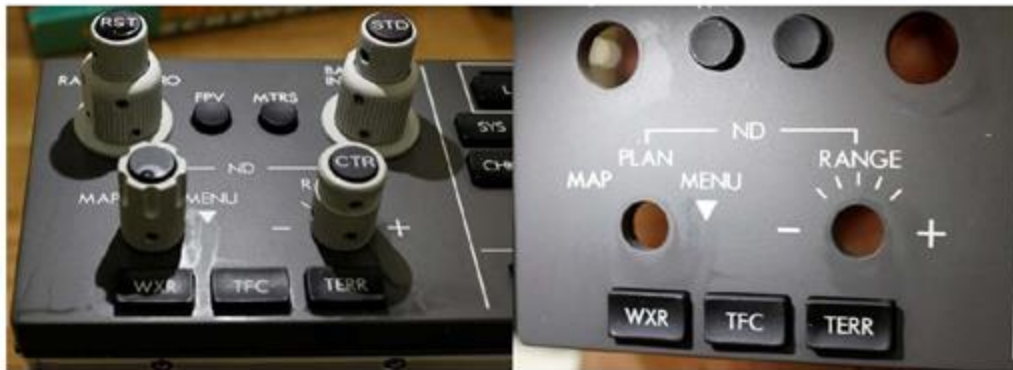
Figure 20: Indications of Calla 1452 dripping and residue on ██████ DCP

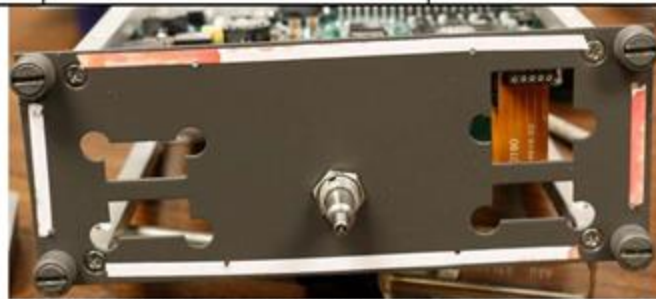
Figure 21: Minor indications of ingress on alerting and transponder control

After completion of the 40 applications of Calla 1452 with the Kuka robot in Phase III.4, or a total of 90 applications, a function check was performed first. No functional issues were found on any of the LRUs except for the alerting and transponder control despite only exhibiting minor indications of ingress around the perimeter of the LRU under the light plate assembly (Figure 21). The lights on the transponder functioned, but the transponder itself initially did function and an ICAS message was generated. Approximately 20 minutes into the function check, the transponder ICAS message cleared and it functioned as normal. The TCP that had functional issues after Phase III.3 performed as normal. The disassembly of all LRUs was performed at least 24 hours after the last application. The results of disassembly of all LRUs are as shown in Table 4 and Figure 22 through Figure 30. **Table 4: Results of disassembly of LRUs after Phase III.4 Testing**

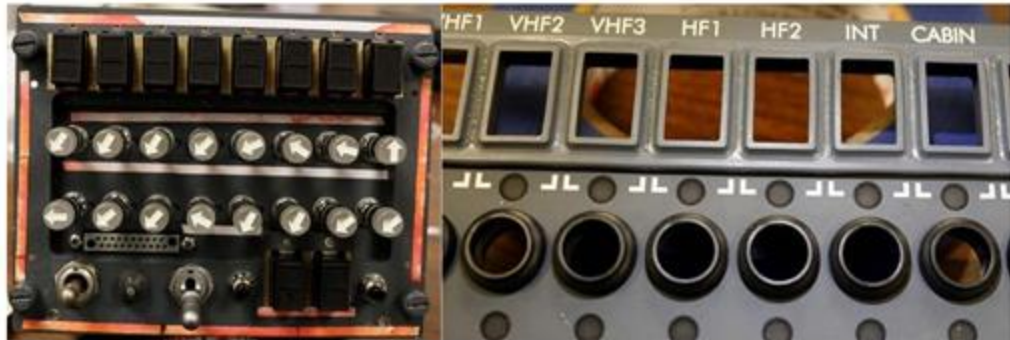
Figure 22: Indications of ingress in [redacted] ACP under the light plate and residue between button cutouts

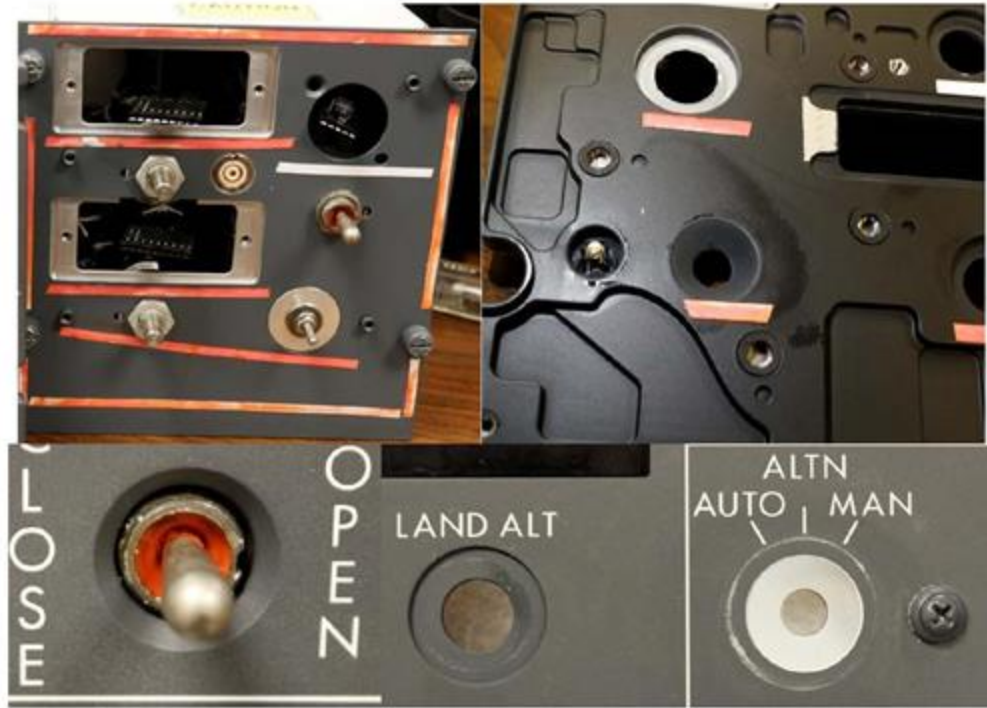
Figure 24: Indications of ingress and residue build up on cabin pressure selector panel

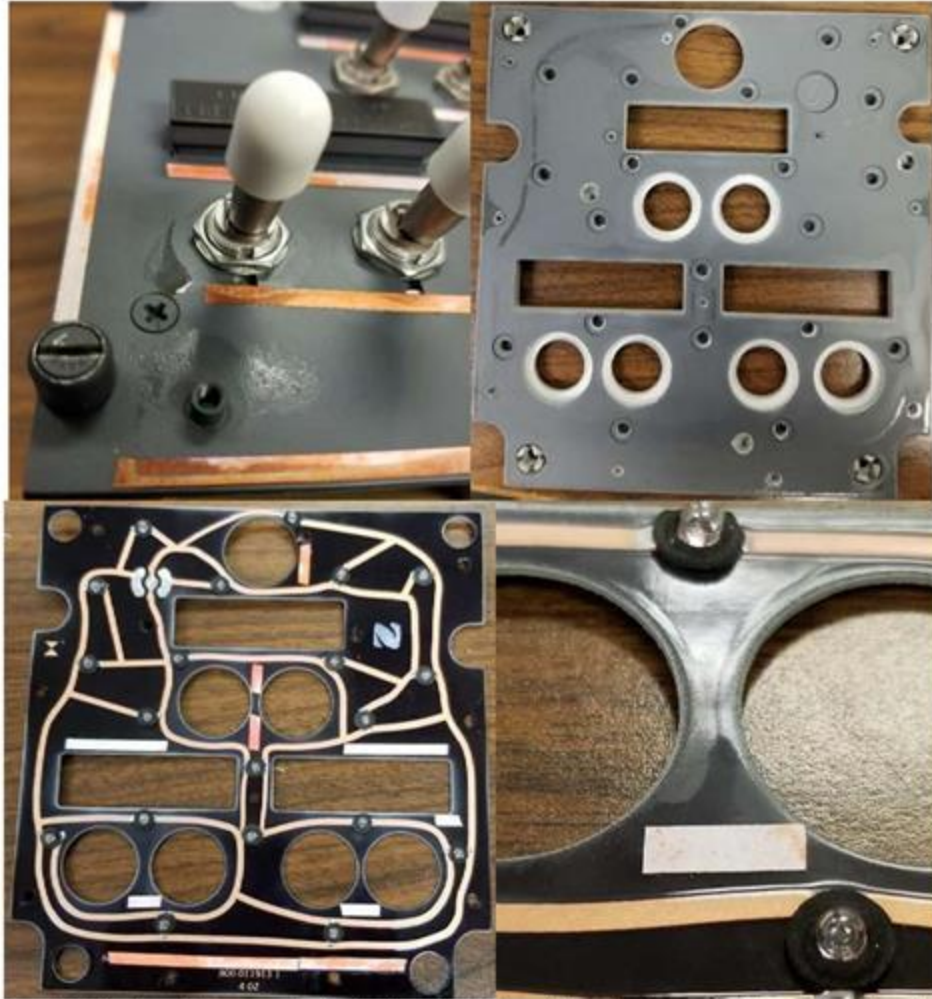
Figure 25: Indications of ingress on fuel control panel and degradation of conformal coating on circuit board

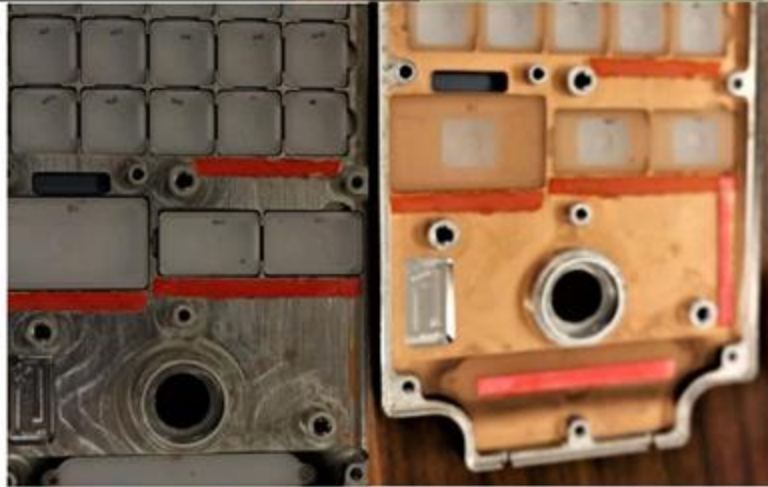
Figure 27: Indications of ingress and corrosion in MKP assembly

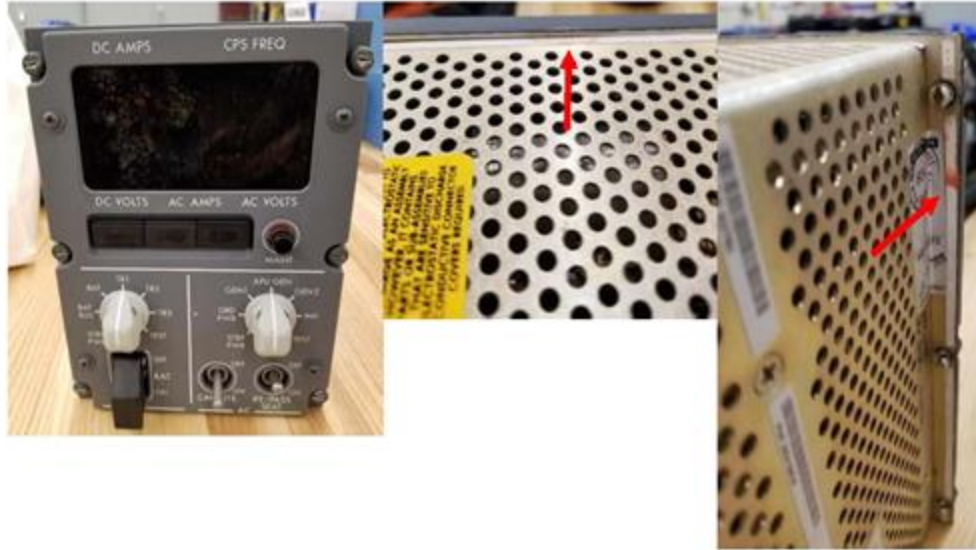
Figure 32. Left: Photo of P5-13 after 130 applications of Calla 1452. Residue was visible on the display screen. Center and Right: Photos of the same LRU, reverse side, indicating minor fluid ingress between the underside of the lip of the housing front plate and the mounting provisions, as evidenced by faint red fluid intrusion tape (red arrows).

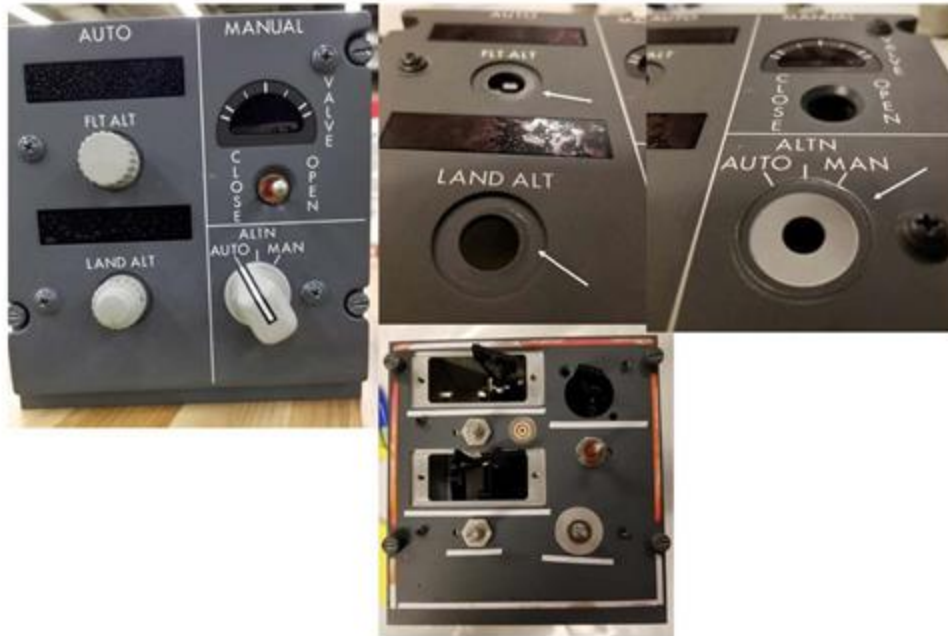
Figure 33. Left: Photo of [REDACTED] P5-6 Cabin Pressure Selector Panel after 130 applications of Calla 1452. Residue was visible on the display screens. Top Center and Right: Photos of the obverse side of the display plate after removal, showing residue on the display screens and wet residue or fluid under the knobs (white arrows). Bottom Center: Photo of the housing front plate with display plate removed. Indicator tape was red in many locations, indicating fluid ingress between the display plate and housing front plate. Evidence of moisture ingress behind the front plate was not observed visually, even with the aid of a flashlight. Due to the design of the housing, further non-destructive disassembly was not possible.

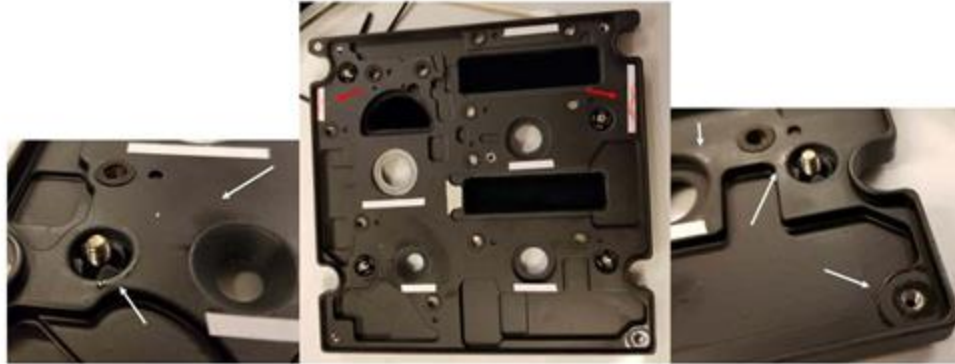
Figure 34. Photos of the [REDACTED] P5-6 Cabin Pressure Selector Panel display plate after 130 applications of Calla 1452. Wet residue (white arrows) was visible on some flat surfaces, around knob and switch holes and around fastener holes. Fluid ingress along the sides of the display plate was evidenced by red fluid detection tap (red arrows).
