**DOT/FAA/TC-24/3**

# **OEM Summary Report on the Effects of Disinfectants on Aircraft Flight Deck Materials**

March 2024

Final report

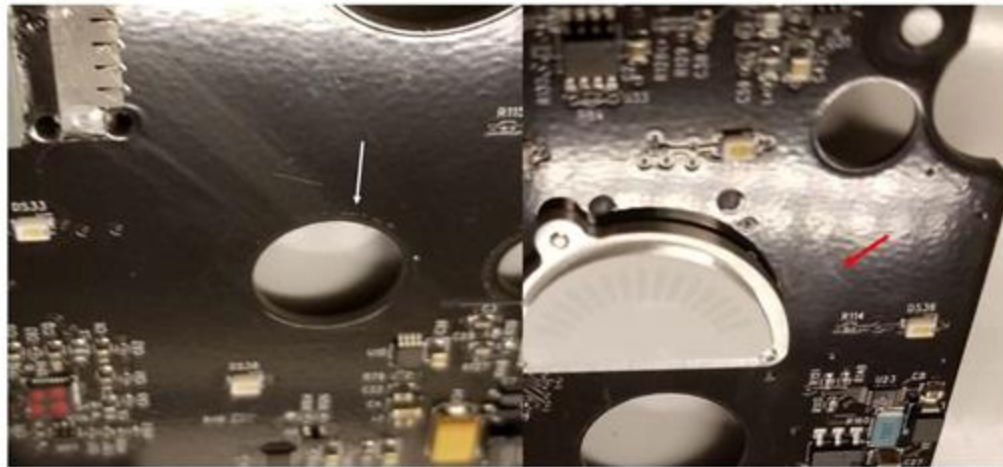
Figure 35. Photos of the [REDACTED] P5-6 Cabin Pressure Selector Panel display plate printed wiring board after 130 applications of Calla 1452. Residue (white arrow) was visible around the selector knob cutout. An evaporate trail (red arrow) was visible on the conformal coating near the semicircular LED display. These features were not thought to be direct contributors of the observed inoperative switch.

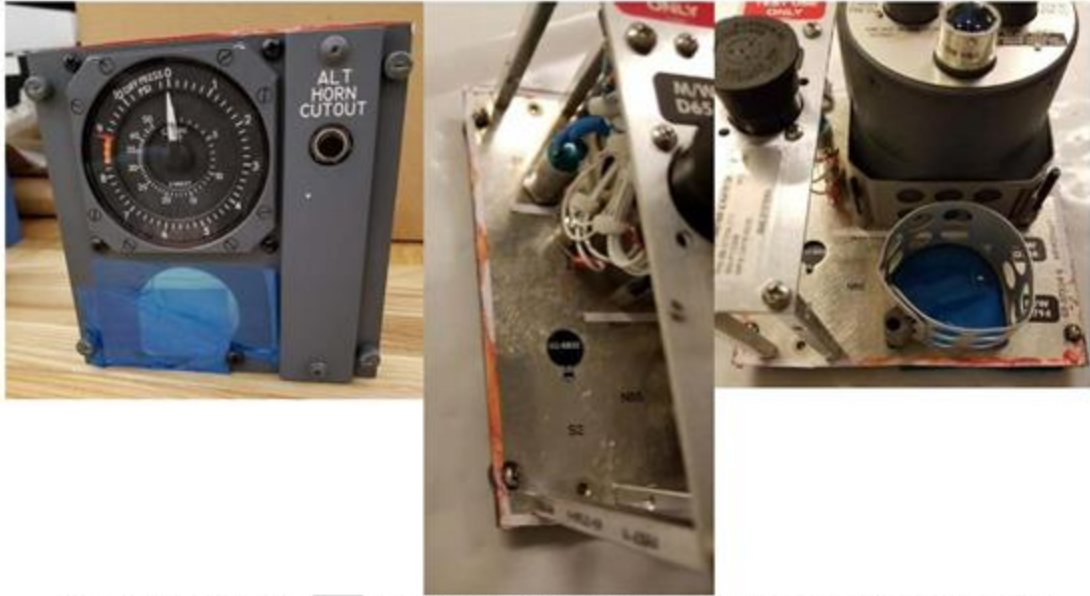
Figure 37. Left: Photo of the [REDACTED] Cabin Altimeter - Differential Pressure Indicator after 130 applications of Calla 1452. Center and Right: Photos of the same LRU, reverse side, indicating fluid ingress between the undersides of the front plate and mounting provisions, as evidenced by red fluid intrusion tape.

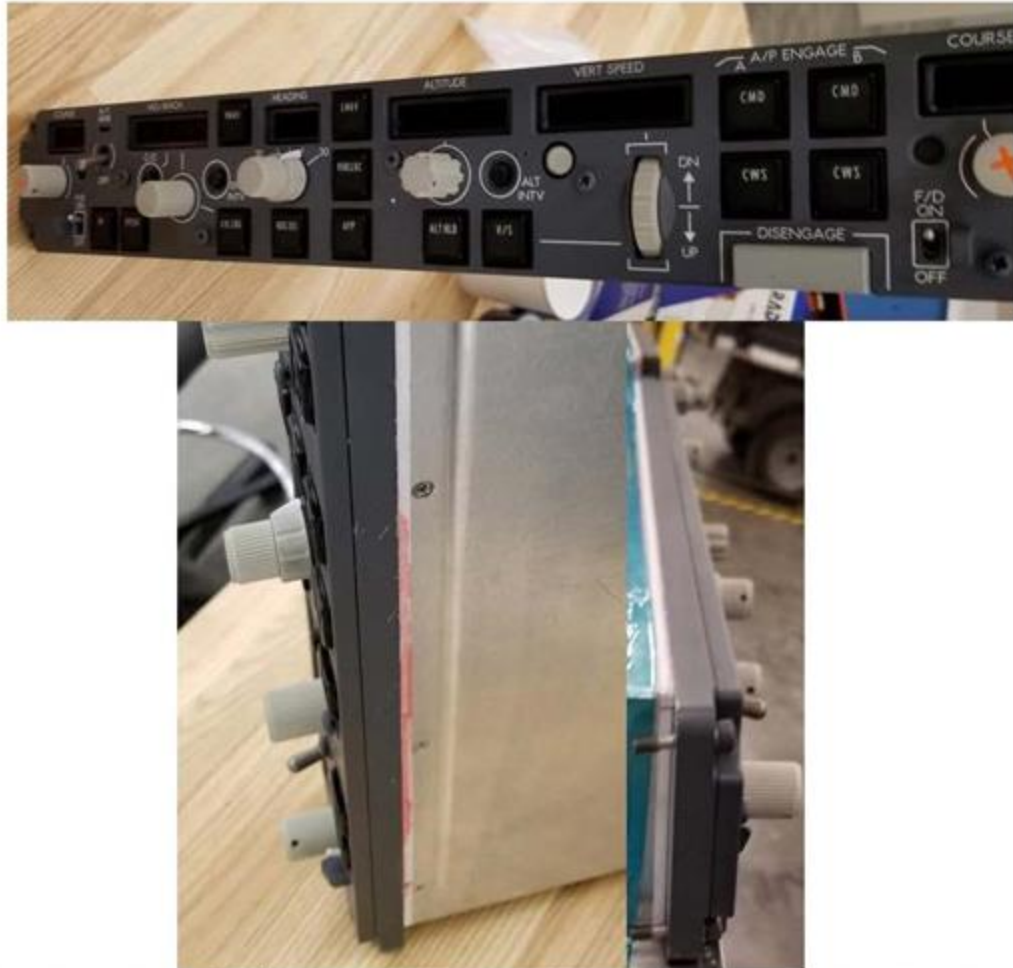
Figure 38. Top: Photo of [REDACTED] Mode Control Panel after 130 applications of Calla 1452. Bottom Row: Photos of the same LRU from the top and bottom sides, indicating minor fluid ingress between the underside of the housing and the mounting provisions, as evidenced by red fluid intrusion tape.

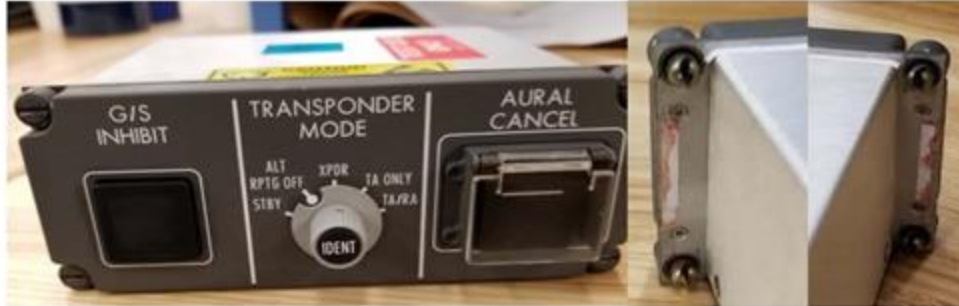
Figure 39. Left: Photo of [REDACTED] Alerting and Transponder Control after 130 applications of Calla 1452. Center and Right: Photos of the same LRU from the reverse, indicating fluid ingress between the underside of the housing and the mounting provisions, as evidenced by red fluid intrusion tape.

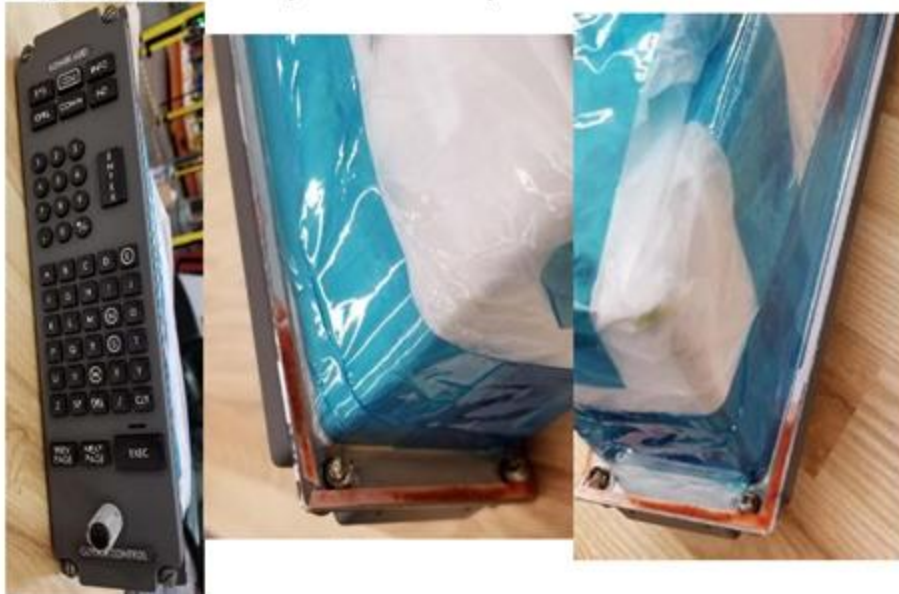
Figure 40. Left: Photo of [REDACTED] Multifunction Keypad after 130 applications of Calla 1452. Center and Right: Photos of the same LRU from the reverse, indicating fluid ingress along the underside of the housing, as evidenced by red fluid intrusion tape.

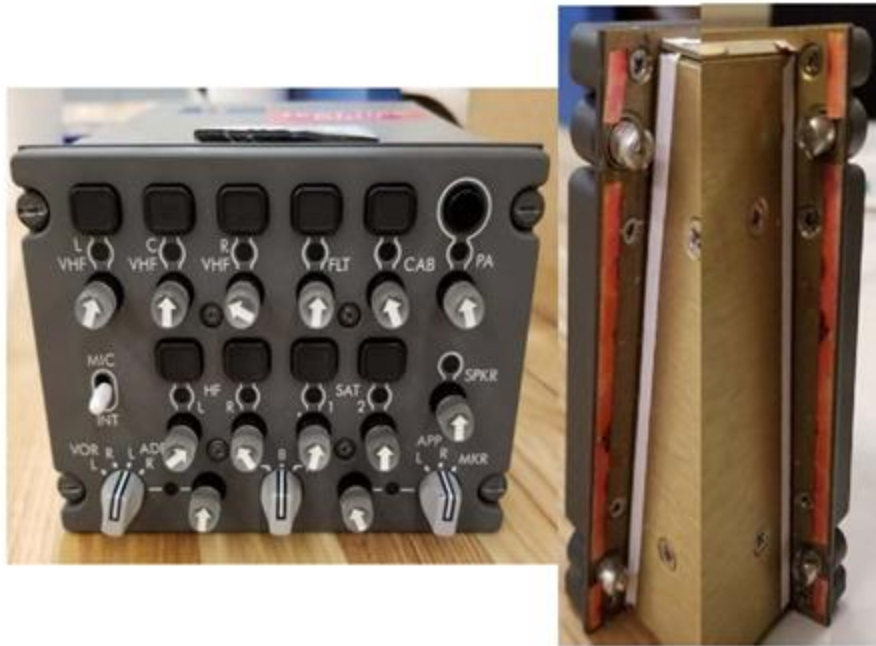
Figure 41. Left: Photo of [REDACTED] ACP after 130 applications of Calla 1452. Center and Right: Photos of the same LRU from the reverse, indicating fluid ingress between the undersides of the housing front plate and mounting provisions, as evidenced by red fluid intrusion tape.

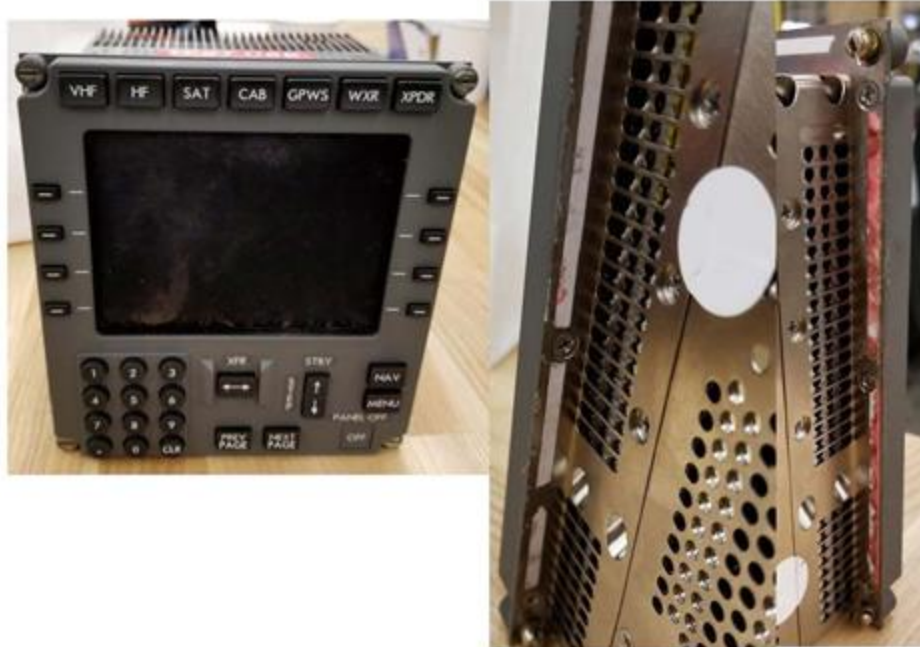
Figure 42. Left: Photo of [REDACTED] TCP after 130 applications of Calla 1452. Center and Right: Photos of the same LRU from the reverse, indicating fluid ingress between the undersides of the housing front plate and mounting provisions, as evidenced by red fluid intrusion tape.

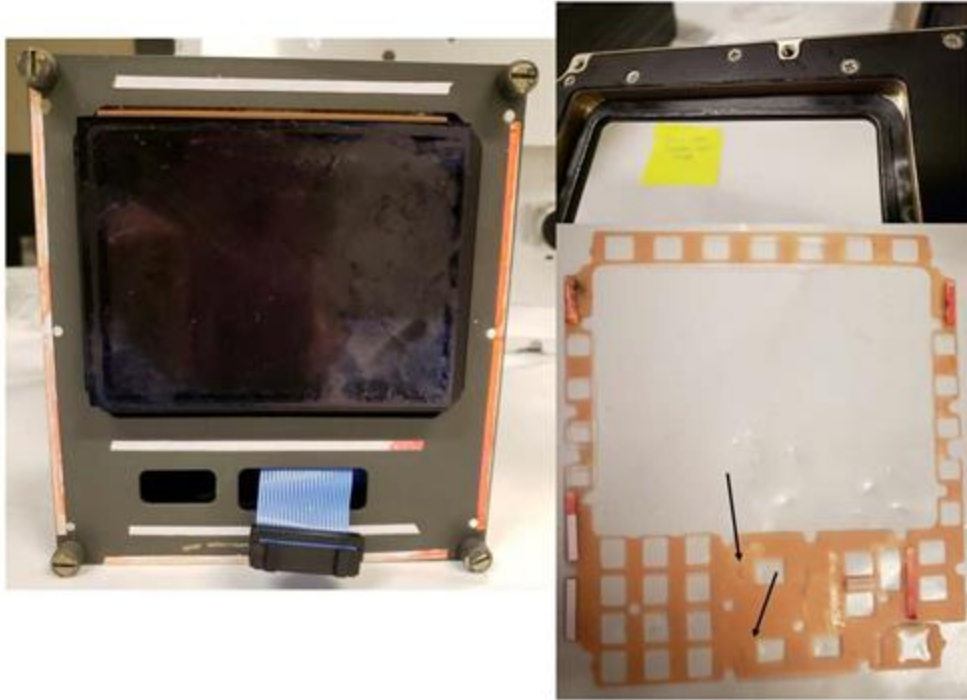
Figure 43. Left: Photo of [REDACTED] TCP after 130 applications of Calla 1452 with light plate removed. Red fluid intrusion tap indicated the extent of fluid ingress between the light plate and the front plate of the housing. Top Right: Photo of the light plate reverse side, showing wet residue along the joint common to the light plate housing and along the cut for the display screen. Bottom Right: Photo of the light diffuser showing dimple marks (black arrows) due to previous misassembly (see Phase III.3 Results), and a likely contributor to button sticking.

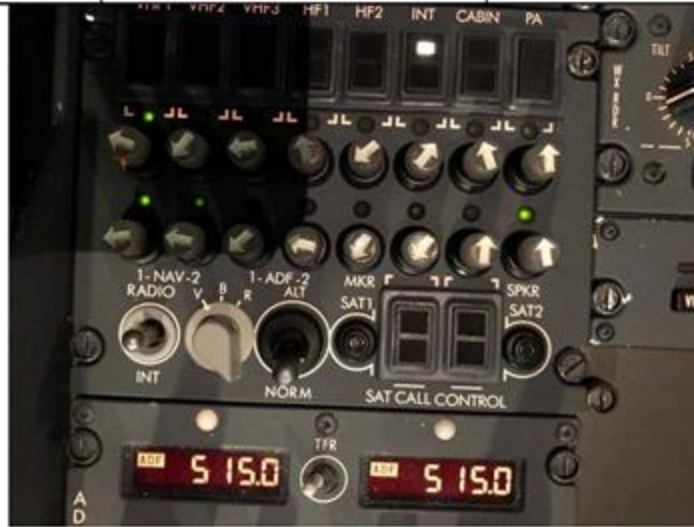
Figure 45. Multiple channel indicator lights were active simultaneously during Phase III.6 function check of [REDACTED] ACP

After completion of the 80 applications of Calla 1452 with the Kuka robot in Phase III.6, or a total of 210 applications, a function check was performed. The [REDACTED] ACP exhibited multiple volume adjustor indicator lights when all should have been off. The previously observed issue with [REDACTED] P5-6 Cabin Pressure Selector Panel remained (see Phase III.4 Results for details). The [REDACTED] ACP indicator lights failed to come on. The disassembly of all LRUs was performed at least 24 hours after the last application. Evidence of corrosion was observed on both the [REDACTED] ACP and [REDACTED] ACP printed wiring boards or components (see Figures 47 and 61). The results of disassembly of all LRUs are as shown in Figures 45 through 65.

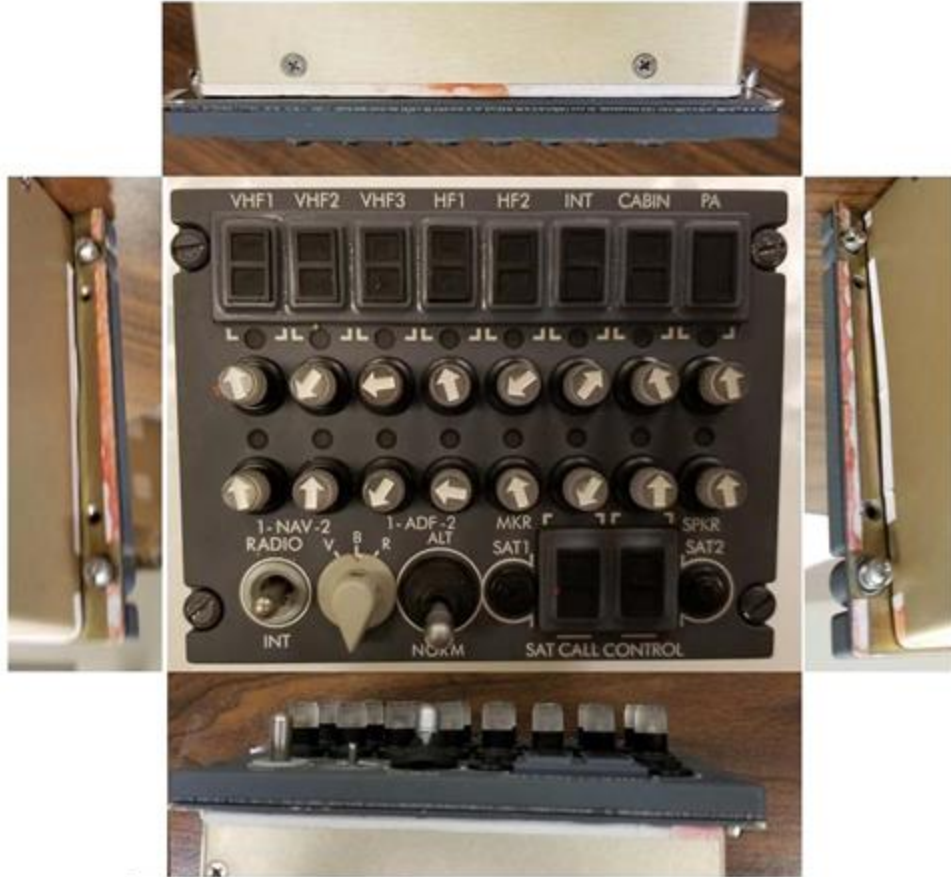
Figure 46. Photos of [REDACTED] ACP after 210 applications of Calla 1452. Photos indicate fluid ingress between the housing and mounting provisions, as evidenced by red fluid intrusion tape (photos taken after removal of light plate mounting screws).

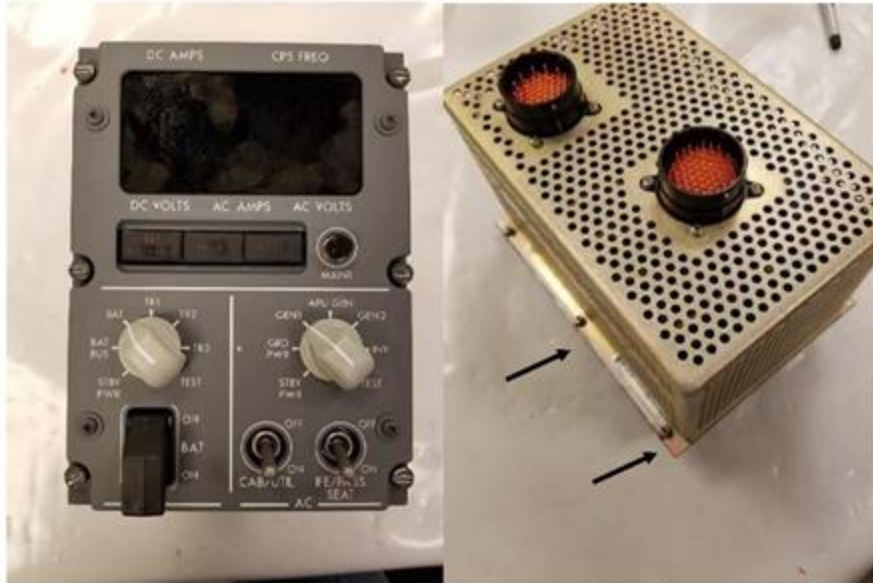
Figure 48. Photos showing external condition of [REDACTED] P5-13 panel after 210<sup>th</sup> application of Calla 1452. The indicator tape has turned red (black arrows) along an edge of the back side of the housing lip, indicating the presence of relatively small quantities of fluid ingress between the panel housing and the mounting provisions.

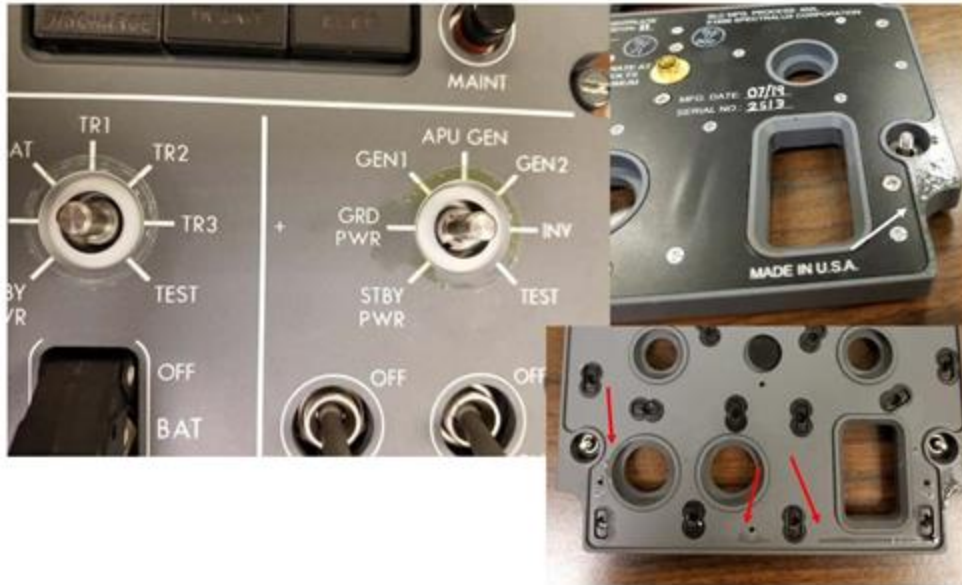
Figure 49. Photos showing condition of [REDACTED] P5-13 panel during disassembly after 210<sup>th</sup> application of Calla 1452. Left: Fluid residue was present between both knobs and the light plate. Upper Right: Fluid (white arrow) was present on the reverse side of the light plate. Lower Right: Fluid (red arrows) was present on the reverse side of the light plate, between the light plate and printed wiring board (not shown).

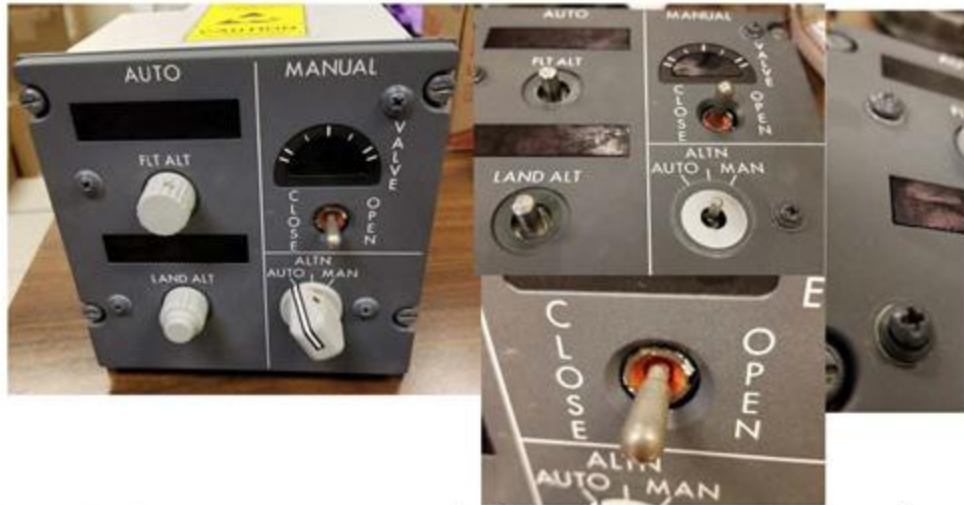
Figure 51. Left: Photo showing external condition of P5-6 Cabin Pressure Selector Panel after 210<sup>th</sup> application of Calla 1452. None of the indicator tape applied externally had turned red (not shown). Upper Center: Photo of same LRU with knobs removed. Rings of fluid residue were present under all knobs. Lower Center: Photo of manual control switch exhibiting a white powdery substance, consistent with corrosion product. Right: Photo of loosened display plate attachment screws, showing a white powdery substance coincident with a shim or washer under the fastener head.

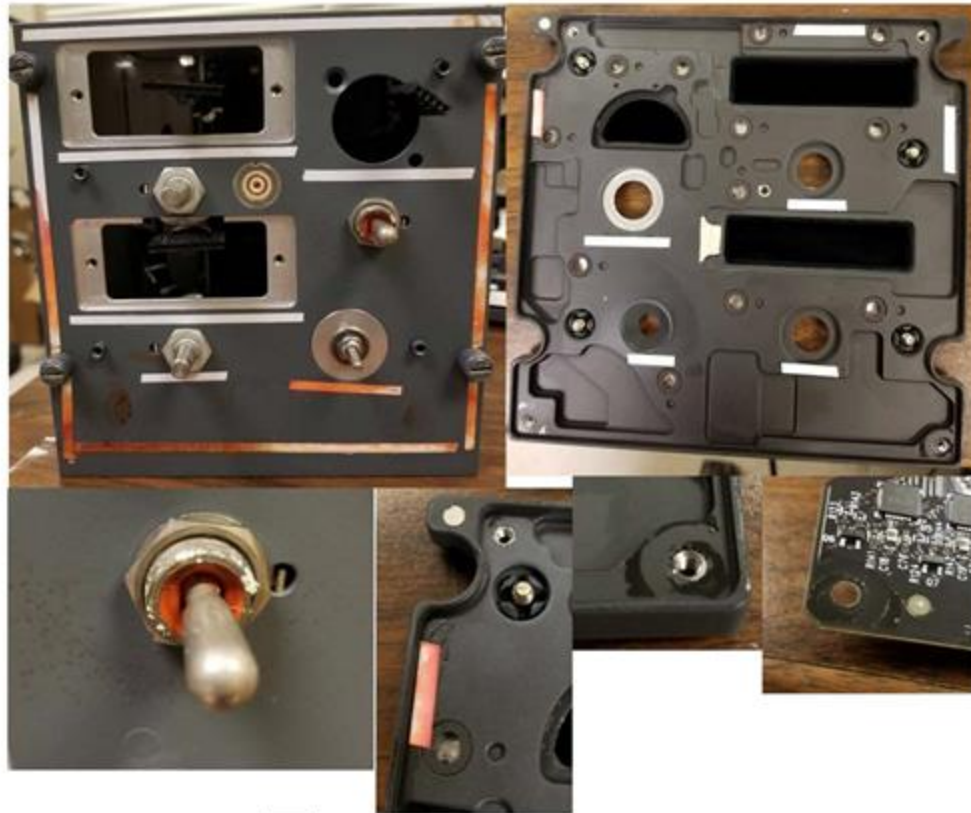
Figure 52. Additional photos of [REDACTED] P5-6 Cabin Pressure Selector Panel during disassembly. Upper Left: Photo of same LRU with display plate removed, revealing significant amounts of fluid were present between the housing front plate and the display plate, as evidenced by red indicating tape. Bottom Left: Close-up of manual control switch with white powder, likely corrosion product. Upper Right: Photo of the inside surface of the display plate with printed wiring board removed. Fluid was present around most corner inserts, and residue from previous exposure cycles remained. Bottom Center Photos: Close-ups of the red indicator tape and fluid residue around insert in corner. Lower Right: Photo of the display plate printed wiring board with fluid around the fastener hole.

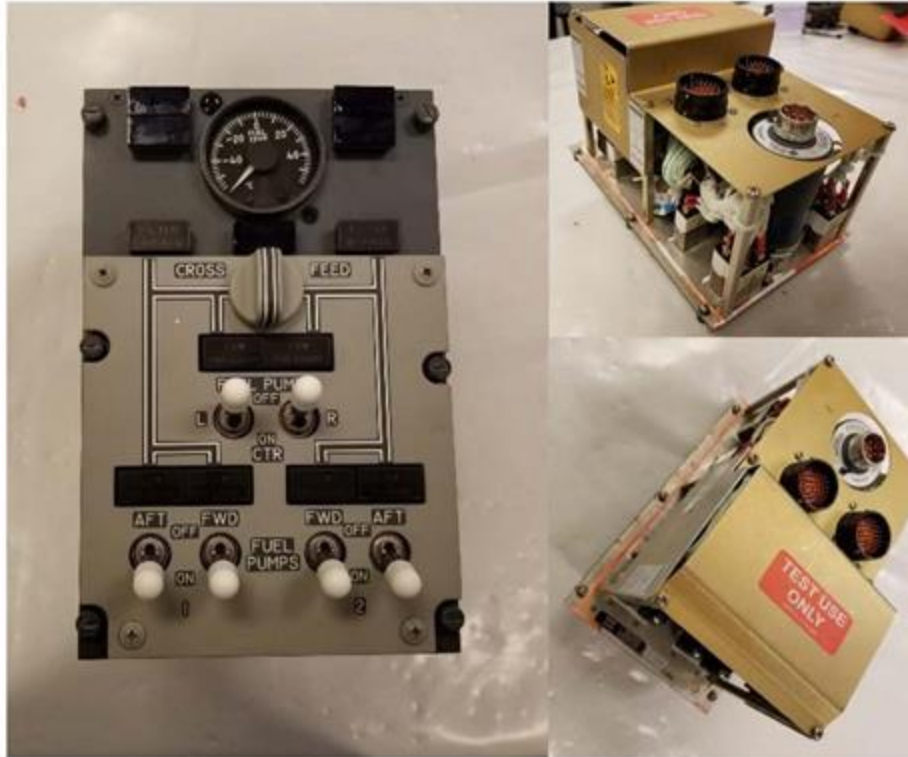
Figure 53. Photos showing external condition of Fuel Control Panel after 210<sup>th</sup> application of Calla 1452. The indicator tape was red along several edges of the back side of the housing front plate, indicating the presence of relatively large quantities of fluid ingress between the panel front plate and the mounting provisions.

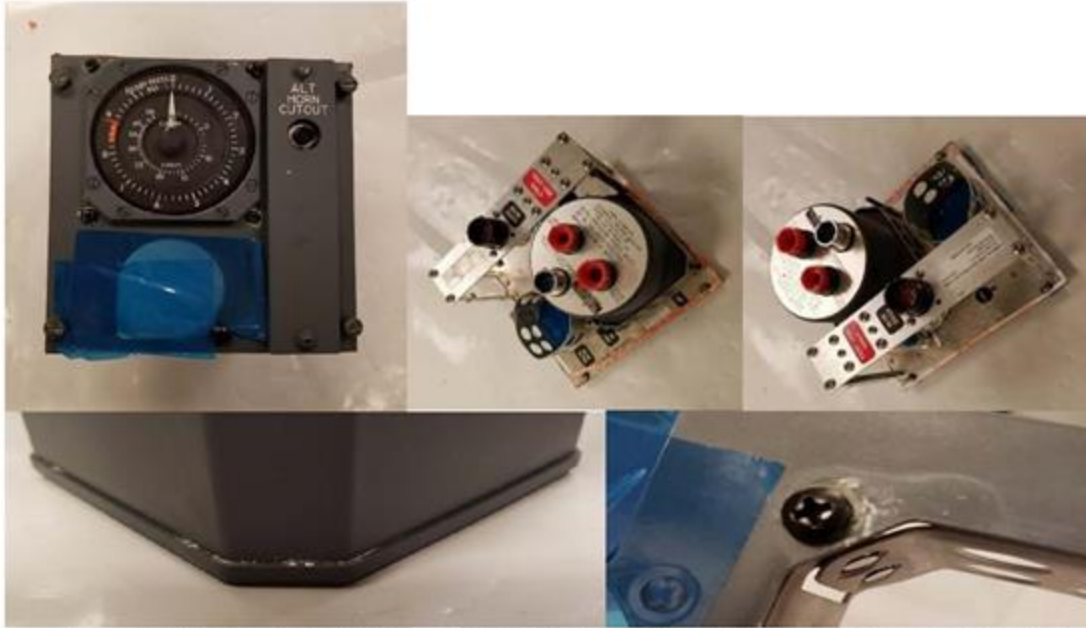
Figure 55. Photos showing condition of [REDACTED] Cabin Altimeter and Differential Pressure Indicator panel after 210<sup>th</sup> application of Calla 1452. The indicator tape has turned red along several edges of the reverse side of the front plate, indicating the presence of relatively large quantities of fluid ingress between the front plate and the panel mounting provisions. The bottom photos show a white powdery substance emanating from under a fastener screw and along the joint of the altimeter canister faceplate.

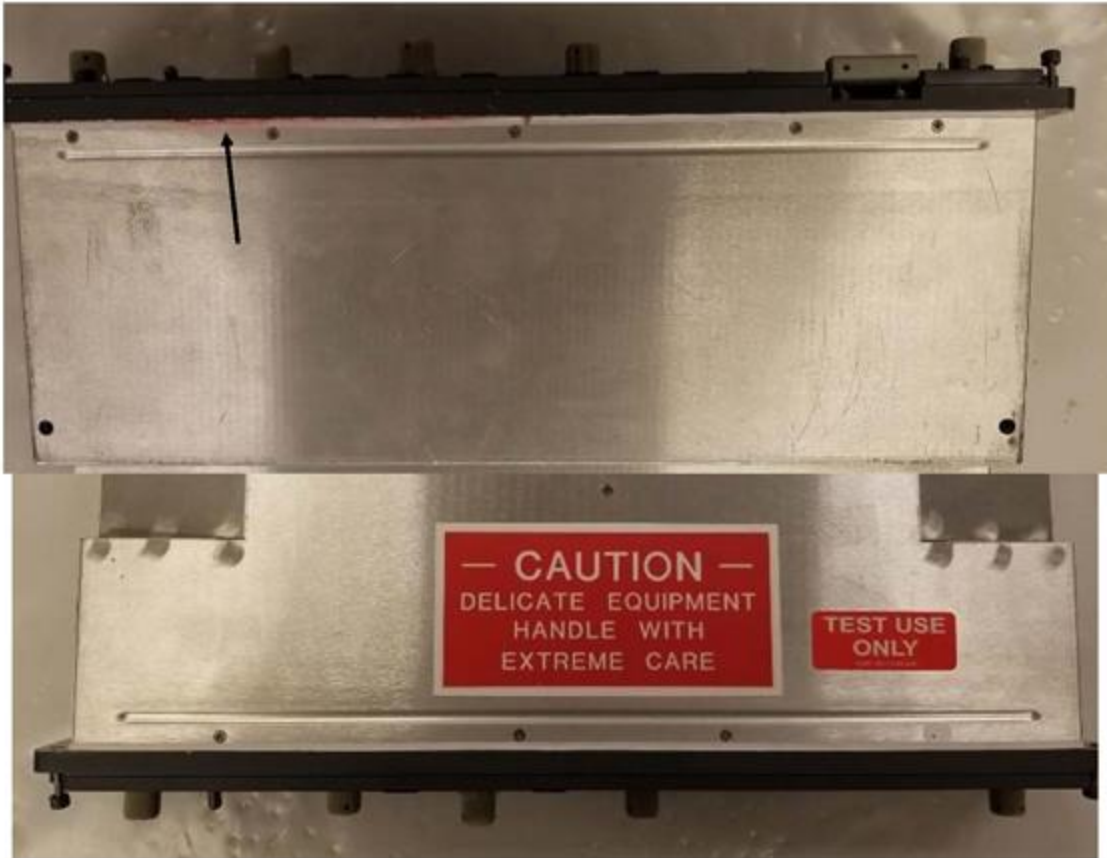
Figure 56. Photos showing external condition of [REDACTED] MCP after 210<sup>th</sup> application of Calla 1452. The indicator tape was red along some portions of the lower surface of the housing (e.g., black arrow), indicating the presence of relatively small quantities of fluid ingress.

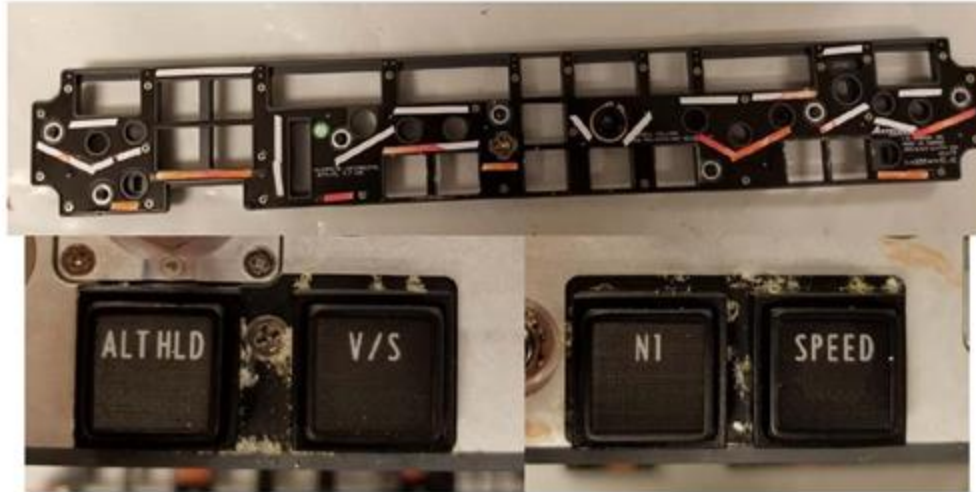
Figure 57. Top: Photo of the reverse side of [REDACTED] MCP light plate showing red fluid indicator tape, evidence of fluid intrusion. Lower Left and Right: Photos of the front of the MCP housing with light plate removed, showing a whitish powdery substance, likely corrosion product.

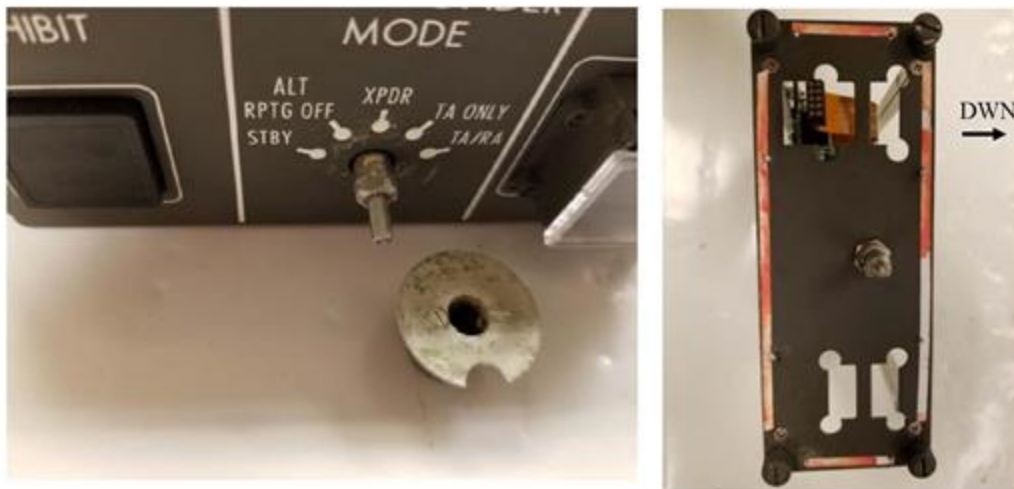
Figure 58. The [REDACTED] Alerting and Transponder Control had significant fluid ingress behind the light plate. Corrosion between the selector knob set screw and shaft was sufficient to preclude hand disassembly. Residue was present between the knob and face plate.

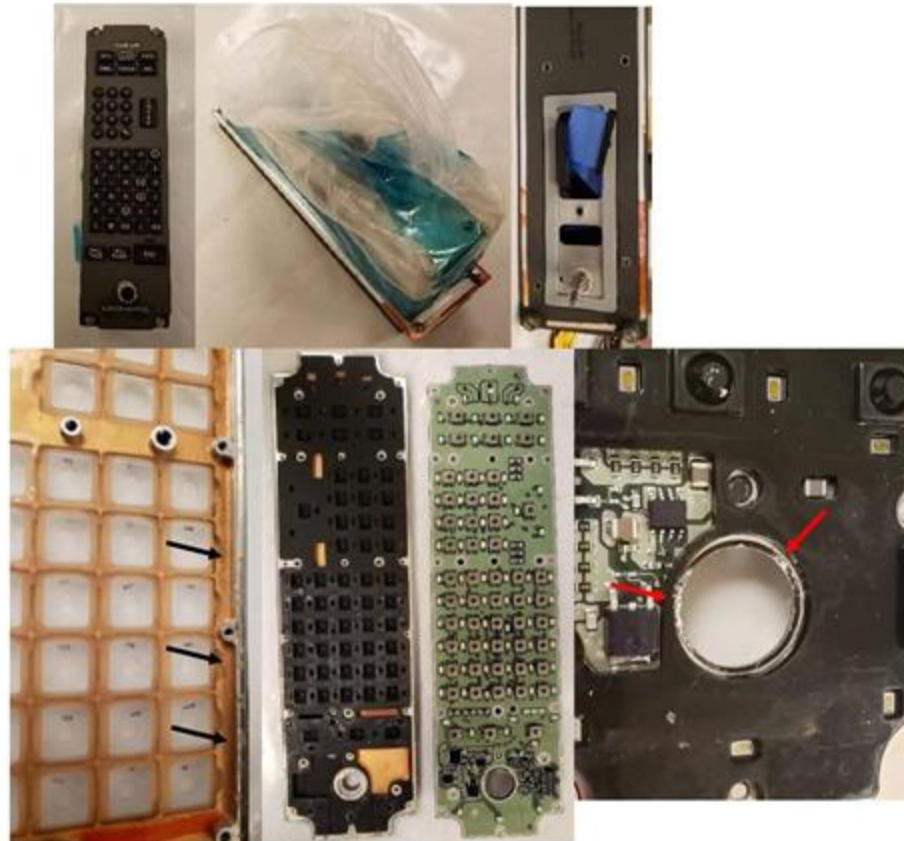
Figure 59. Photos showing condition of [REDACTED] MKP after 210<sup>th</sup> application of Calla 1452. Top Left and Top Center: Exterior condition of the MKP after spray; red tape on the reverse side of the housing lip indicated fluid ingress between the housing and mounting provisions of the test rig. Top Right: Forward face of the housing with red tape along the lower side edges indicated fluid ingress between the housing and light plate. Bottom Left: Residue (black arrows) was present along the inside corner of the reverse side of the light plate front plate, indicative of repetitive fluid intrusion and evaporation. Bottom Center: Residue was present along portions (white circle) of the rubber pad and suggests fluid contact with the mating printed wiring board surface. Bottom Right: White powder (red arrows), likely corrosion product, was present along the edge of the cutout for the dial. Also, faint whitish residue traces were present on much of the rubber pad surface.

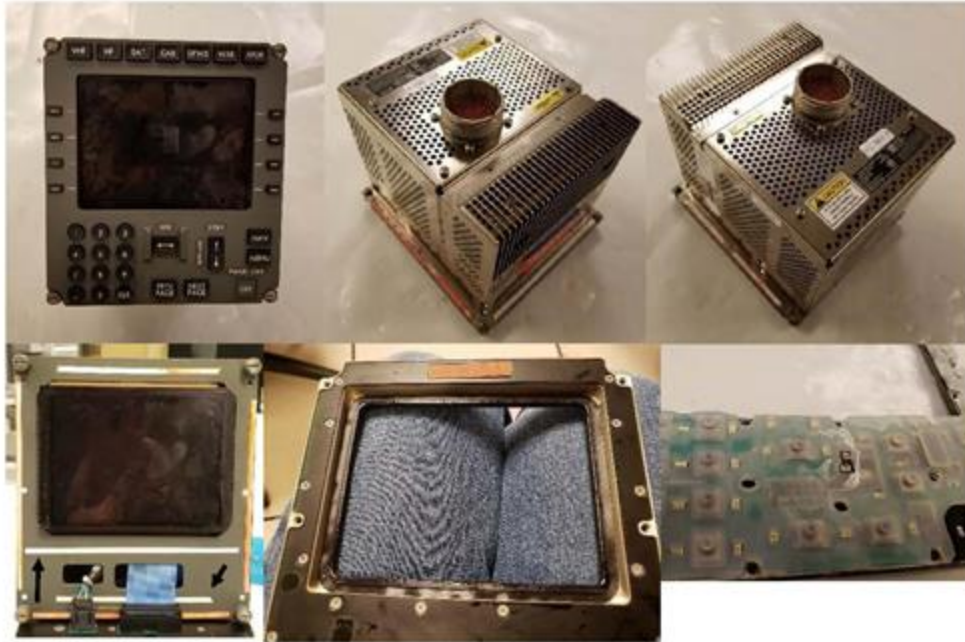
Figure 64. Photos showing condition of [REDACTED] TCP after 210<sup>th</sup> application of Calla 1452. Top Row: External condition of the TCP. The red tape along the underside edges of the housing indicated fluid intrusion between the housing and mounting provisions. Bottom Left: Photo showing the front plate of the housing with light plate removed. The presence of red tape along the majority of the side edges indicated fluid intrusion, but the pristine white tape (black arrows) suggested that much of the fluid never penetrated significantly interior from the joint edges. Bottom Center: Photo of the reverse side of the light plate. Fluid and residue were evident along the edges of the display cutout, suggesting repetitive fluid intrusion and evaporation. Bottom Right: Photo of the rubber pad inside of the light plate. Whitish residue was present on surface, indicating repeated fluid intrusion.

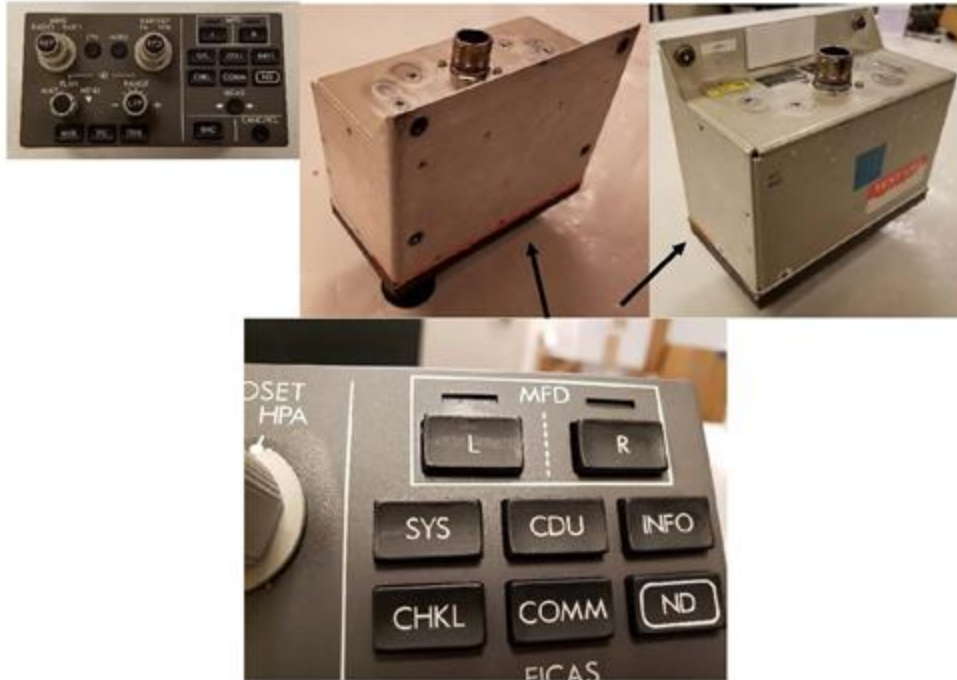
Figure 65. Photos showing condition of [REDACTED] DCP after 210<sup>th</sup> application of Calla 1452. Top Row: External condition of the DCP. The red tape (black arrows) along the underside edges of the housing indicated fluid intrusion between the housing and mounting provisions. Bottom: Photo showing the light plate. Residue (white arrows) was present on much of the DCP surface, especially around knobs and buttons.

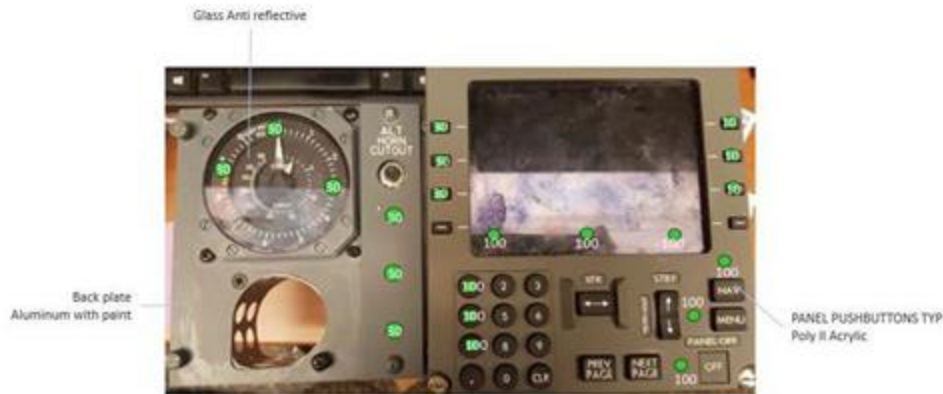
Figure 2: Example of Provided Flight Deck Hardware

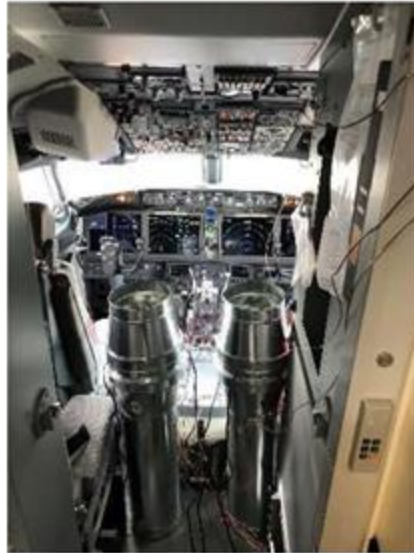
A plot of thermocouple temperature by location is summarized below. The heaters were left on for a little over 4 hours and reached temperatures between roughly 110F°-120F° depending on location. Note that the dip in heater output temperature at approximately 11:20 A.M. was due to realization that the recirculation fans were left on "Auto". In turn, the foam door was removed, recirculation fans turned off, then the heaters turned back on.

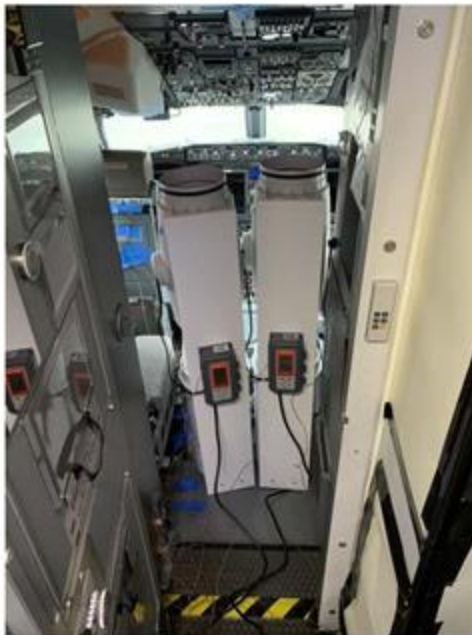
A plot of thermocouple temperature by location is summarized below. Ambient temperatures for this test were 10 to 20 deg F cooler. The heaters were left on for a little less than 5 hours and reached temperatures between roughly 100F°-130F° depending on location. As before, there was a slight dip in performance at the beginning of the test, this time due to a minor wiring issue. No heater cycling was observed during testing – at all times the airflow was sufficient to prevent the heater outlet from exceeding equipment temperature limits.

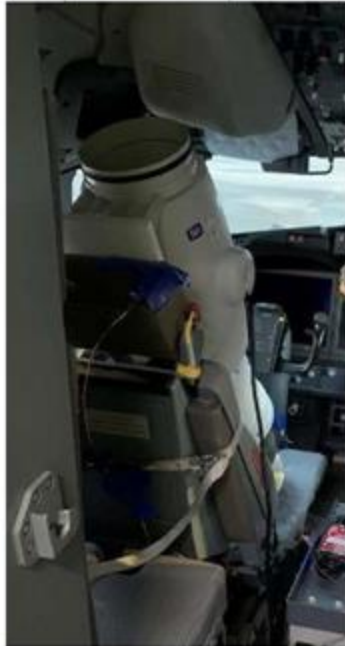
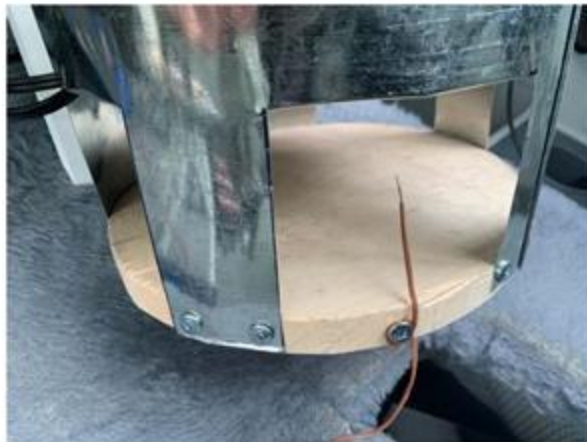
A plot of thermocouple temperature by location is summarized below. The heaters were left on for a little over 3 hours and nearly all thermocouples reached or exceeded 120 deg F.

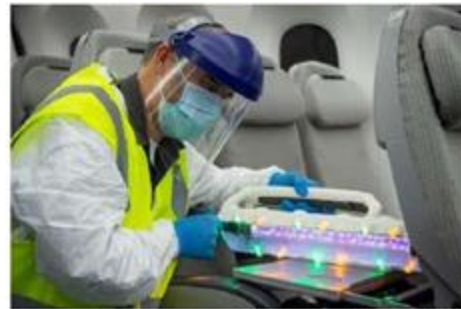
[redacted] developed a Far-UV 222 nm mobile wand prototype using a Kr/Cl cylindrical lamp, as shown in Figure 5, to address the near term need for a safe, hand-operated, fully mobile UV disinfection system for complex spaces where sensitive instrumentation may exist.

Figure 5: Kr/Cl 222 nm excimer lamp in [redacted] Far-UV 222nm mobile wand prototype.

The [redacted] Far-UV 222nm mobile wand prototype, when operated per instruction, will effectively sanitize high touch surfaces by a single operator, and be able to treat an area such as the flight deck in less than 15 minutes. It is capable of producing the 3 mJ/cm<sup>2</sup> needed for SARS-CoV-2 disinfection in a fraction of a second at operational ranges.

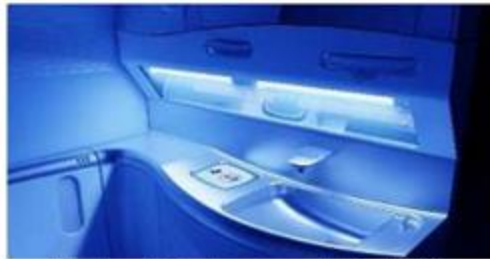
Prior to the Far-UV 222 nm mobile UV wand development effort, The █████ *Clean Cabin Fresh Lavatory* (Figure 6) was a product development study in 2016 that explored the use of a Kr/Cl 222 nm excimer lamps in a lavatory setting to disinfect the lavatory after every use. The learning and the technology developed for that project contributed significantly toward the rapid development of the █████ FarUV 222 nm mobile wand prototype.

Figure 6: █████ product development concept of Far-UV 222 nm implementation in a █████ lavatory

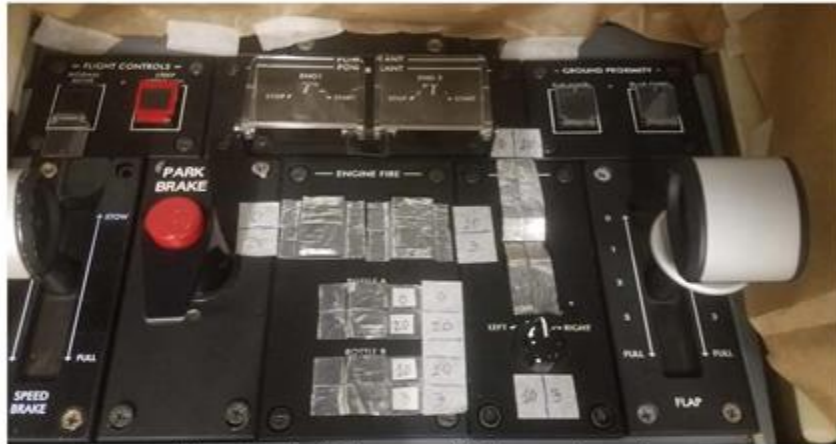
1. Cover the surround components not tested with brown paper.
2. Cover the non-metallic components under test with aluminum tape and identify each strap of tape with the energy to be tested on the component surface under this strap (see Figure 2). Identification shall be 0, 3, 10 and 20 equivalent to the energy in  $J/cm^2$ .
3. Place UV-C lamp plate over the identified components under test.
4. Add the radiometer at the level of components under test
5. Turn on UV-C lights and calculate the irradiance displacing the UV-C lamps plate of the same height of radiometer sensor (40mm in this test), wait for measure stabilization (see Figure 3). The radiometer shows irradiance values in a scale of micro-Watts/ $cm^2$ .
6. Register the stabilization time
7. Return the UV-C lamps plate to position

Figure 2 – Test Setup - push buttons and guards

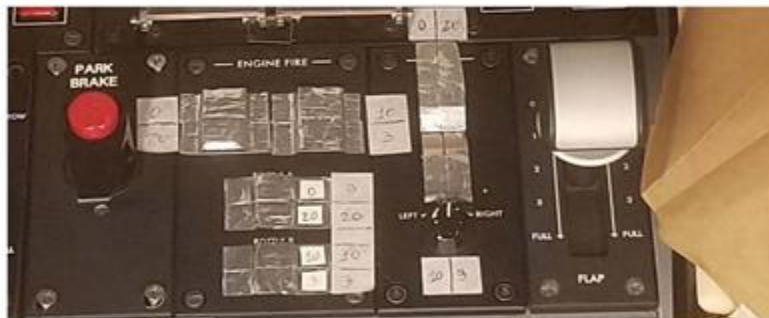
YAW knob was divided in 2 areas: 0 J/cm<sup>2</sup> energy (reference) in the left side and 20 J/cm<sup>2</sup> energy in the right side.

Figure 4 - Test setup for test 1

See Figure 4 for the areas identification in engine fire and trim panels.

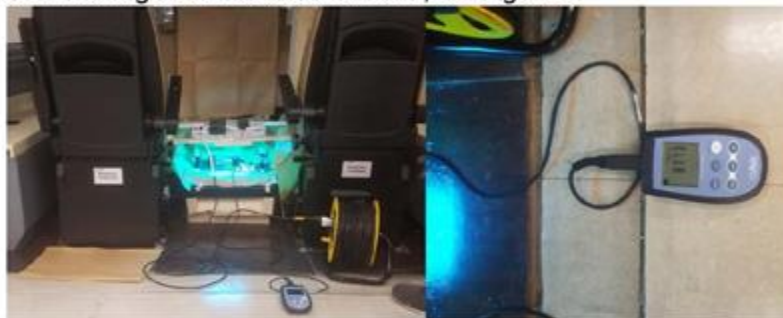
The irradiance was registered as 8.773 mW/cm<sup>2</sup>, see Figure 5.

Figure 5 - Irradiance calculation

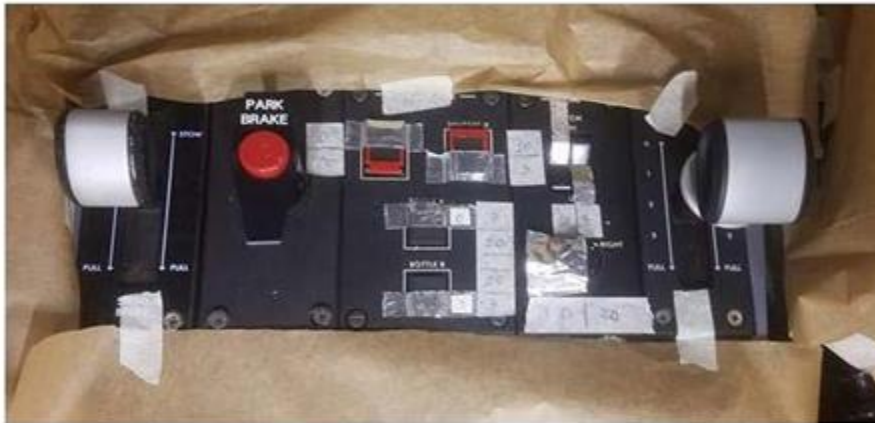
**Figure 6 - Components from test 1 after 17J/cm<sup>2</sup> of energy applied**

The Figure 6 shows the partial result after step 2 of Table 2 is completed.

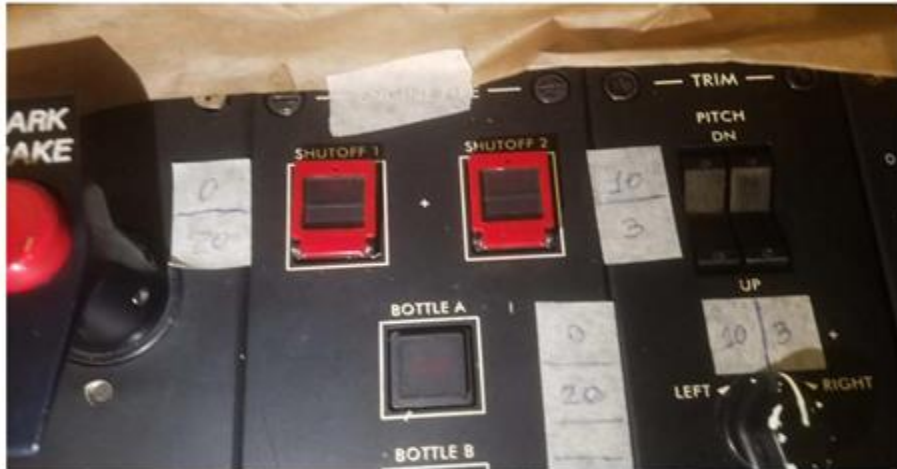
Figure 7 – Components from test 1 after test completion.

After test completion, it is possible to observe no visible change comparing components subjected to different levels of energy, see Figure 7.

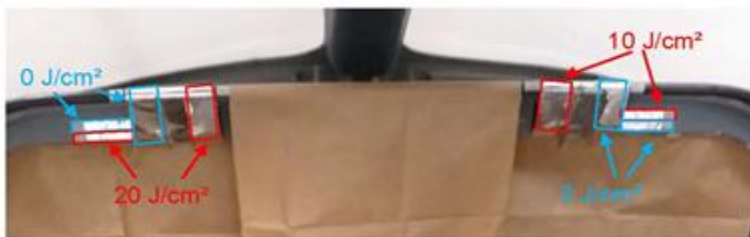
For this test it was selected the buttons for warning and caution and avionics knobs close to it. The components from left side were tested to 0 and 20 J/cm<sup>2</sup>, and components from right side were tested to 3 and 10J/cm<sup>2</sup>, see Figure 8 for energies zones identified. Figure 9 shows the UV-C lights applied for test 2 right side, during lamps warm-up (stabilization).

Figure 8 – Test 2 setup – Energy zones identification

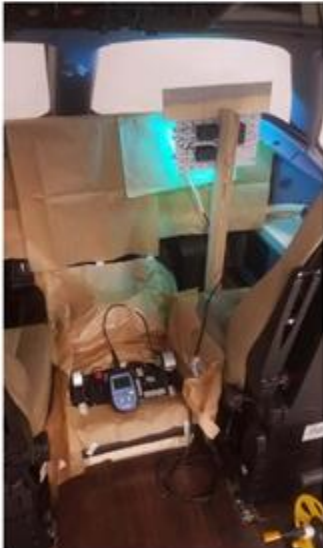
Figure 9 – Test 2 – UV-C lamp warm-up

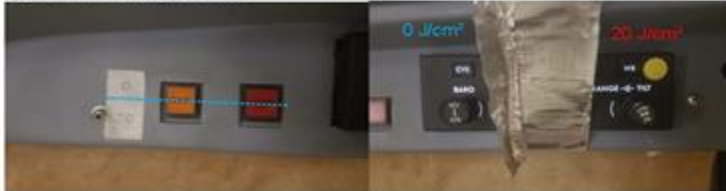
Figure 10 – Test 2 – results for 0 and 20 J/cm<sup>2</sup>

The Figure 10, Figure 11 and Figure 12 presents respectively the final results for left side and right side components

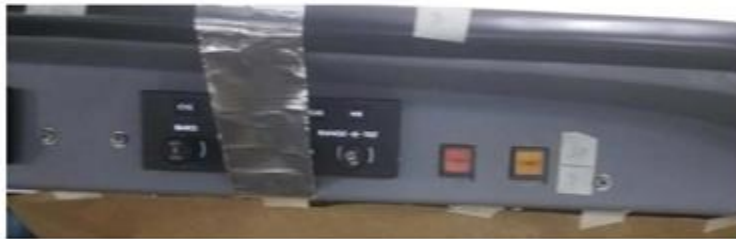
Figure 11 - Test 2 – results for 3 and 10 J/cm<sup>2</sup>

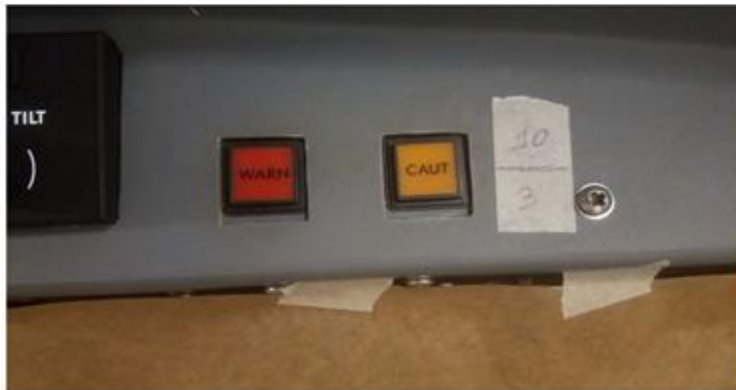
Figure 12 - Test 2 – results for 0 and 20 J/cm<sup>2</sup> - Warning and Caution pushbuttons

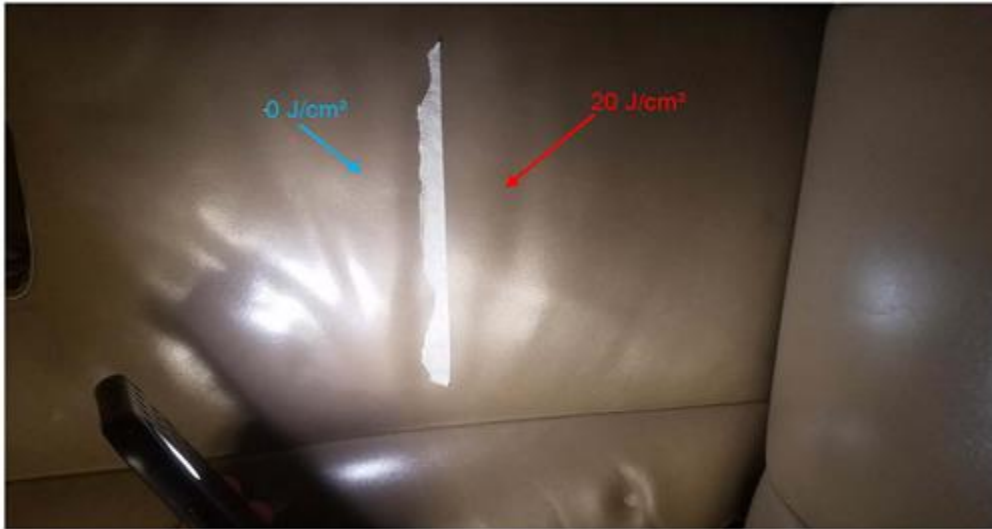
For this test it was selected the pilot seat. The components were tested to 0 and 20 J/cm, see Figure 8 for results. No visual change was observed in this color of leather.
