**DOT/FAA/TC-24/3**

# **OEM Summary Report on the Effects of Disinfectants on Aircraft Flight Deck Materials**

March 2024

Final report

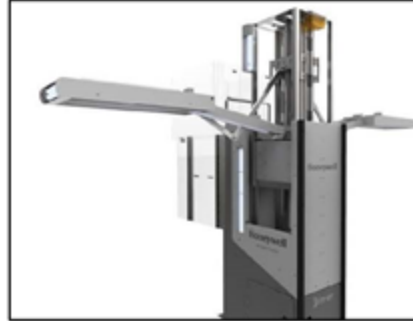
The UV Cabin System (Figure 1) is equipped with UV-C lamps and is wheeled through an aircraft cabin by an operator at a speed controlled by the operator with input from a speedometer to control level of dose. UV lights are mounted on two wings that extend over the seats of the aircraft and expose both the seats beneath the wings and the overhead compartment above them. Additional smaller UV lights are mounted on the wingtips for better exposure of the aircraft walls,

Figure 1: UV Cabin System

on the body of the cart to expose the sides of the aisle, and near the crown of the cart to expose the overhead compartment doors. Since the incident angle for the UV light on a surface changes as the cart is moved, locations that are in shadow are reduced. The lights turn on only when an operator has his/her hands on the controls, and the operator is shielded from the UV light by clear shields tested for UV safety. The relationship between the UV dose provided by this system and UV doses required to inactivate tested pathogens are described in a related white paper.<sup>2</sup>

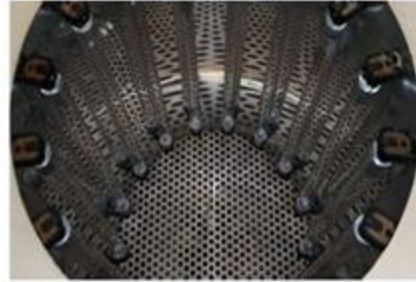
Figure 4: Reactor used for UV-C materials stability exposures provided the dose.

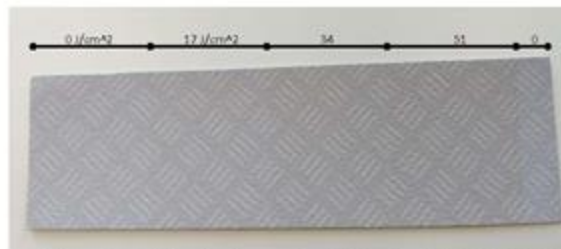
Figure 19: Schneller decorative foil laminate (P/N S016329)  
(Includes heat activated adhesive)

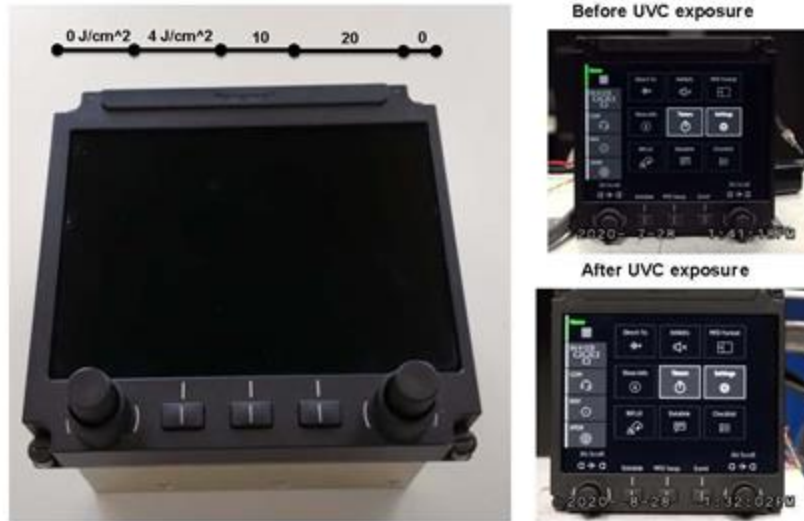
The TSC 2.0 is a cockpit touchscreen display common product currently fielded for the Pilatus PC-12 and PC-24 aircrafts. UV-C exposure testing was completed on the TSC 2.0 to validate lifetime exposure limits of the unit. Exposure on the unit varied from 0 J/cm<sup>2</sup> to 20 J/cm<sup>2</sup>. Measurements and pictures were taken pre and post exposure. A visual inspection shows no detectable changes to the display, bezel, or buttons. Quantitative luminance and chromaticity measurements of the display were taken at screen center in the 10 J/cm<sup>2</sup> exposure area of the LCD, these measurements can be seen in the table below. These measurements show negligible change pre to post UV-C exposure. The small amount of change in luminance and chromaticity can be accounted for by test setup and measurement equipment normal variations.

Figure 25: TSC 2.0 cockpit touchscreen display. Left: UV progressive doses; Right: Before and after display.

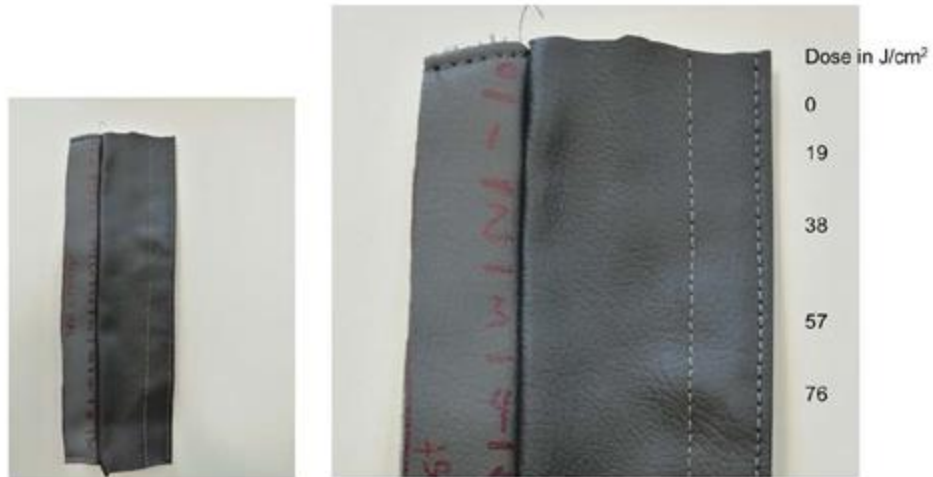
Figure 28: Leather armrest after progressive UV-C exposure. Photo on right is close up of the upper portion of the left photo, with UV-C dose marked.

The leather armrest provided appears to be the same leather as that used for the seat covering. It was used for a progressive color test by masking the sample with tape, and progressively unmasking it after incremental exposures to UV-C light. Each incremental dose was 19 J/cm<sup>2</sup>. Using our measured UV-C dose of 9.4 mJ/cm<sup>2</sup> (one treatment equals two exposures at 30 rows/min treatment speed), a cumulative dose of 19 J/cm<sup>2</sup> would correspond to 2021 treatments (5.5 years at 1 treatment/day). Figure 28 below shows the complete armrest, which received 10 incremental doses, and an expanded view on the upper portion spanning doses between 0 and 76 J/cm<sup>2</sup>. No detectable change in color is apparent.

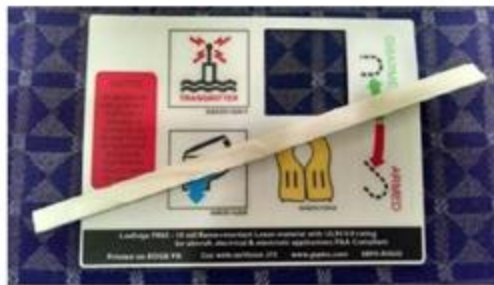
Figure 30. Colored Label Sample, Before Exposure

Gerber supplied a 6"x 4.5" LexEdge FR65-10mil label for testing. The sample had a white background with black, red, yellow and blue colors. A strip of white foam tape was placed across the sample to partially cover each color (see photo, Figure 30).

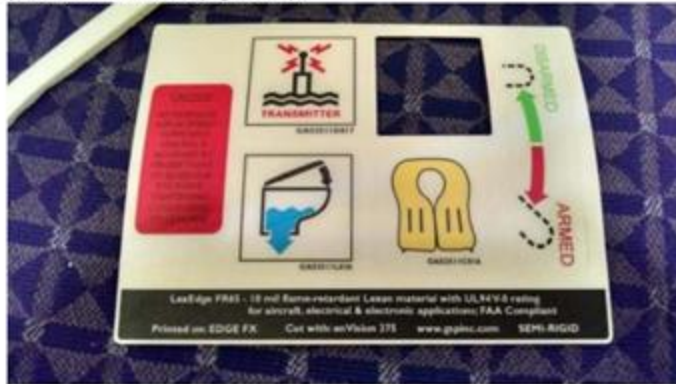
Figure 31. Colored Label Sample, After Exposure

At the conclusion of the test, we did not detect any visual or tactical differences between the exposed and unexposed portions of the label (Figure 31).

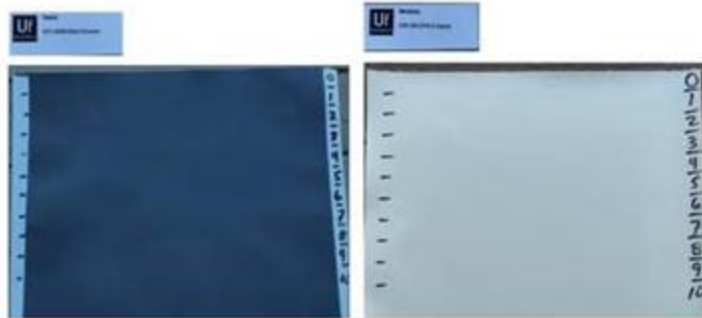
Figure 32. Ultrafabrics Samples, Progressive Exposure to 40 J/cm<sup>2</sup>

After the exposure, all fourteen Ultrafabrics samples tested revealed no detectable color change at any exposure levels. For all samples tested, the tactile "feel" as well as bending properties appeared unchanged, with no cracking visible under magnification. No formal material testing pre and post exposure was performed. The following figures show the samples tested with the progressive exposure bands marked to the right hand side of each picture (0: no exposure, 10: 40 J/cm<sup>2</sup>, with 4 J/cm<sup>2</sup> increment at each progressive band).

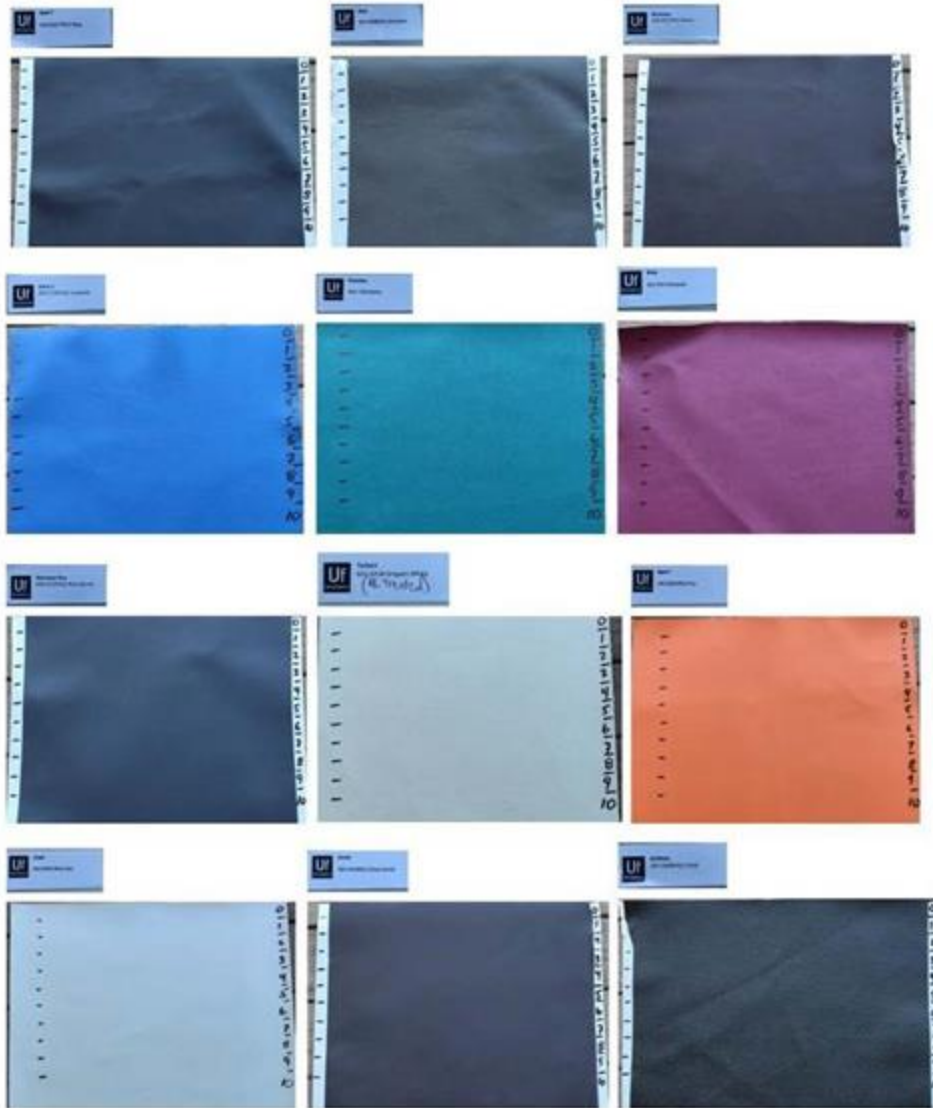
Figure 33. Ultrafabrics Samples, Progressive Exposure to 40 J/cm<sup>2</sup>

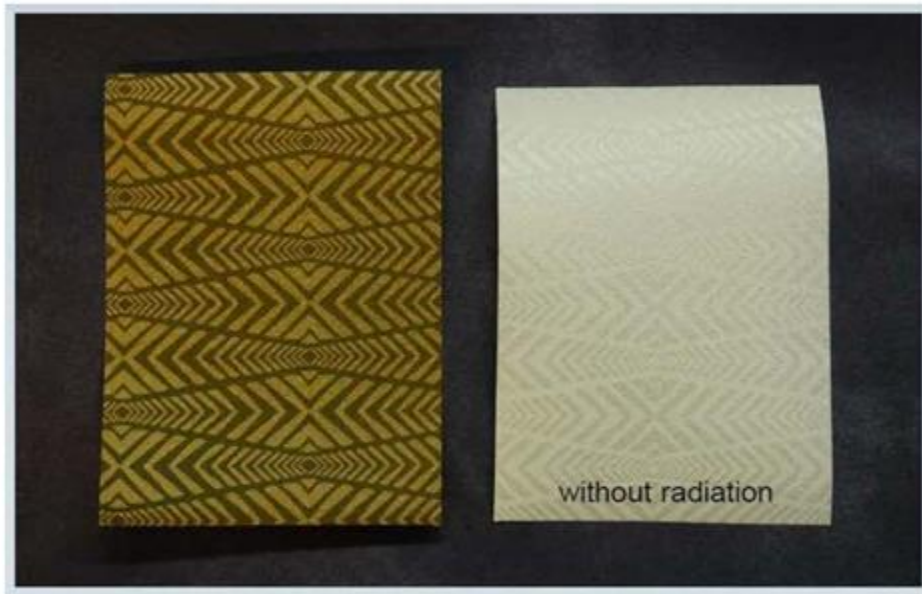
Figure 5

**Example of heavy discoloration (Decorative foil, left: irradiated, right: new)**

- discoloration, especially yellowing or whitening ("chalking")
- embrittlement of the surface
- loss of mechanical strength
- visible blinding and micro-cracks in transparencies

Due to the particular properties of UV-C radiation, defects will most likely not extend deeper than 0.5 mm into the component.

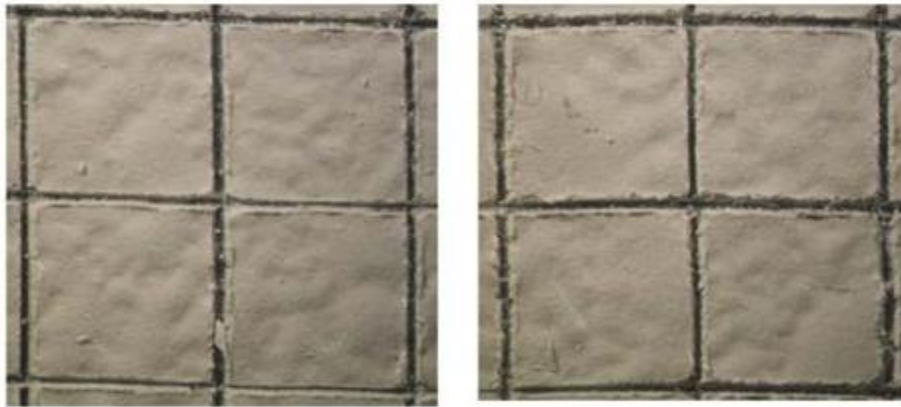
Figure 6

#### **Coating before (left) and after (right) irradiation.**

The test results show that a dose of 1 MJ/m<sup>2</sup> has influences on cabin materials.

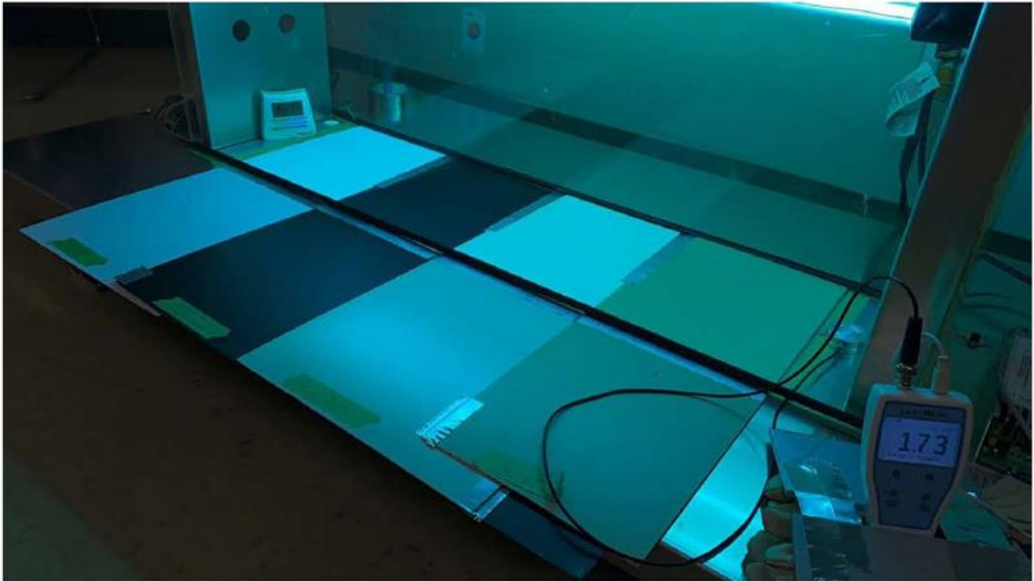
Figure 4 – Image of Set 1 with half of each material inside the acrylic cover with UVC lights and the remaining half not exposed to UVC. This image was captured on December 10, 2020 at 14:40 showing a reference reading of 1.73mW/cm<sup>2</sup>. Correcting this by the 0.7295 factor results in 254nm irradiance of 2.37 mW/cm<sup>2</sup>.

The UVC exposition was conducted over three days spanning December 9, 2020 to December 11, 2020 at aero hygenx facility. The test was witnessed by [REDACTED] in person and via Microsoft Teams. The test was also witnessed by [REDACTED] authorities for familiarization purposes. The entire duration of exposition was recorded on Microsoft Teams with some data dropouts during the 49 hours of recording. This is referred to as Set 1.

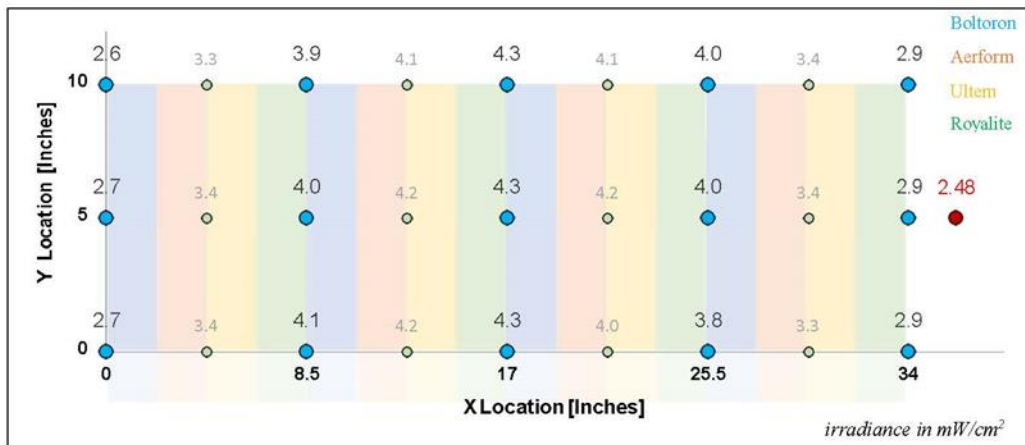
Figure 7 – The graph above shows the corrected irradiance measurements taken during Set 3. The material placement on the testbed is overlaid on the same graph to show the materials used during Set 3a. Measured values are shown in blue. Interpolated values are shown in green to facilitate calculation. The values show the steady state values in irradiance after the test chamber was allowed to reach a stable temperature and humidity.
