# Performance Monitoring of Olmsted CR 117 and 104 and Aggregate Base Material Update

**Kyle Hoegh, Principal Investigator**  
Minnesota Department of Transportation

**December 2023**

Research Project  
Final Report 2024-01

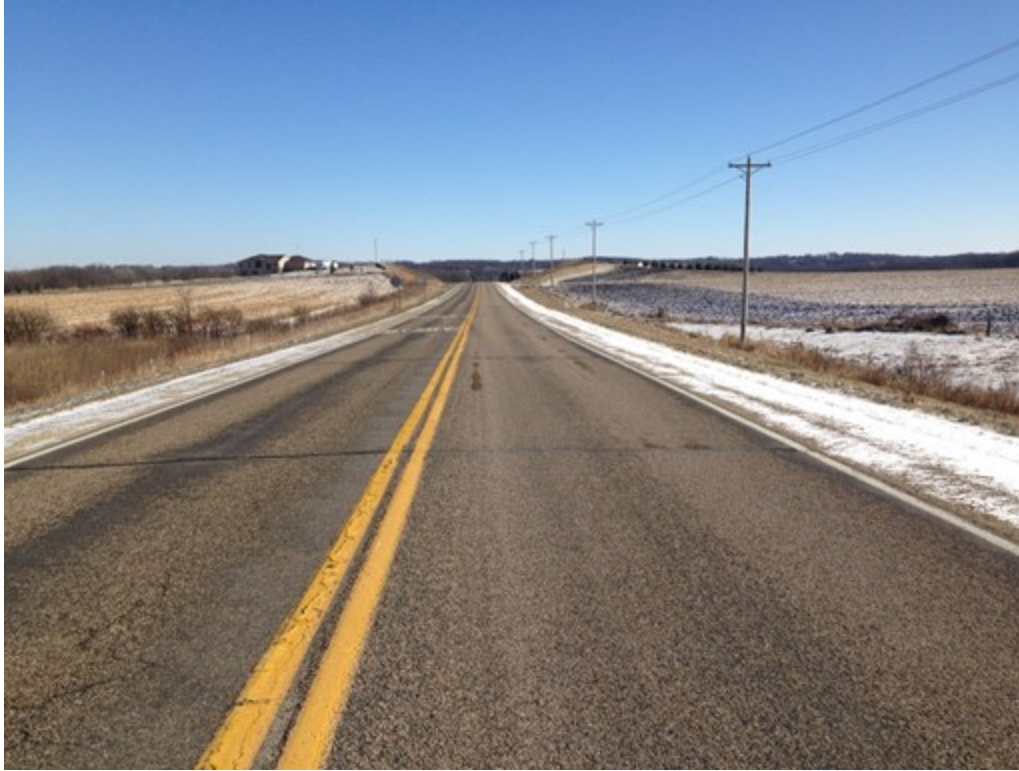
Figure 2.5 Olmsted County Road 117 (Station 105+00) 11/25/2014

Figures 2.4 and 2.5 show the roadway at station 105 in 2002 soon after construction, and again in fall of 2014. Figure 2.6 shows the as-built cross sections of the different test sections on this project.

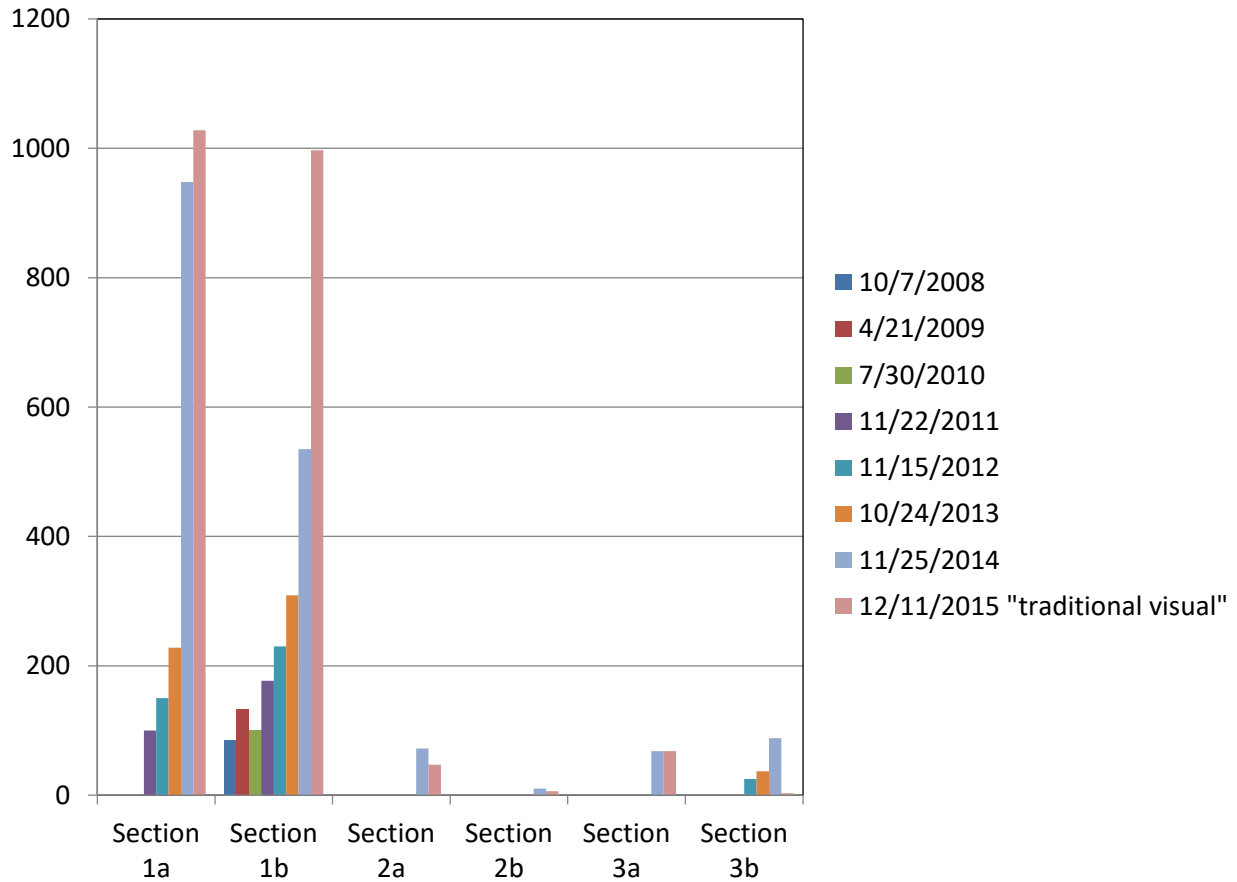
**Figure 3.5 2008-2015 Approximate Cracking Length Observed by Visual Surveys**

the service life, while the visual is presented in Figure 3.5 to put it into context for historical comparisons and crack progression analysis.

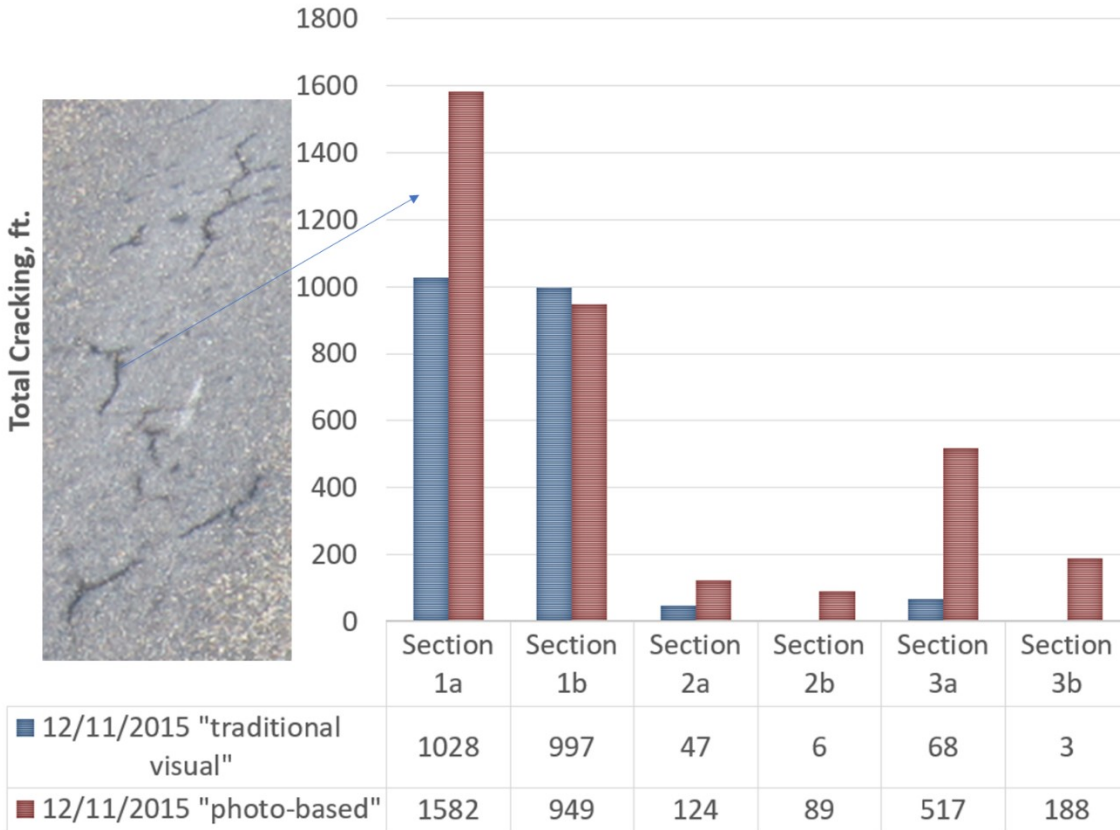
Since the progression of distress is more critical as the pavement fails, a more detailed approach was introduced in 2015 as part of the last phase of the study to verify the previous trends. This included use of photo-based visual distress identification in comparison with the traditional visual distress survey. Figure 3.5 shows a comparison of 2015 total cracking measurements of the same sections using the traditional visual and photo-based approaches in blue and red, respectively. It can be observed that, while the major trends are similar, the photo-based approach recorded a larger amount of cracking than the visual-based approach. To investigate the cause of the discrepancies, a comparison of both methods at specific 50 ft. locations, where the photo-based method identified significantly more cracking than the visual based approach, were evaluated. The photographs indicated that the larger cracking distance identified by the photo-based approach generally were caused by missed (false negative) locations using the visual-based approach. In a high percentage of the cases, distress that is visible in the photos was not represented in the corresponding visual distress survey. Figure 3.6 shows an example type of distress, superimposed on top of the chart that visual distress mapping occasionally did not mark.

**Figure 3.6 Photo-Based Versus Traditional Cracking Measurements for the Multiple Sections**

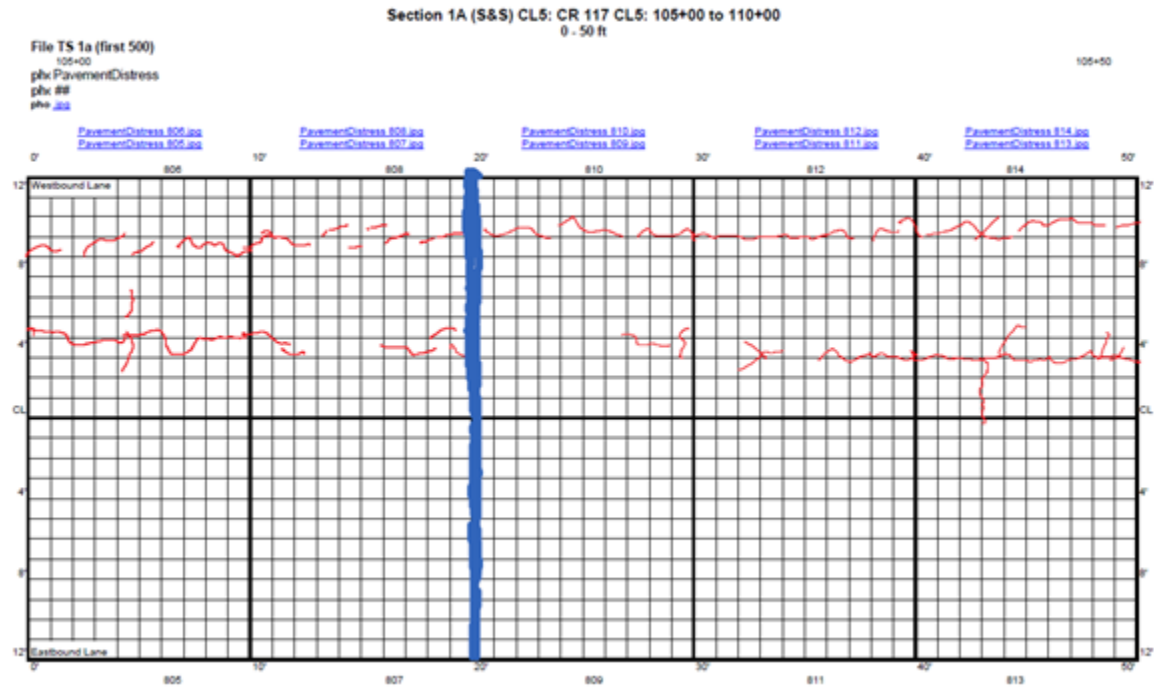
The output format of the photo-based distress map was similar to the past visual surveys where 50 ft. sections are broken into 12' X 10' subsections showing distress in both lanes. Figure 3.7 shows an example 50 ft.-section in Section 1A from 105+00 to 105+50. While the figure shown here is only a screenshot, the actual maps with corresponding linked photos were catalogued for access to all the 50 ft. subsections within Sections 1, 2, and 3. An example 10 ft. by 12 ft. photo-based distress mapping result from Section 1A 105+20 to 105+30 is shown in Figure 3.8. The black arrow shows the link used to pop up a photo corresponding to the mapped subsection. Transparent green boxes show the mapped area and corresponding photo.

Figure 3.7 Example Photo-Based Distress Mapping Result from Section 1A 105+00 to 105+50

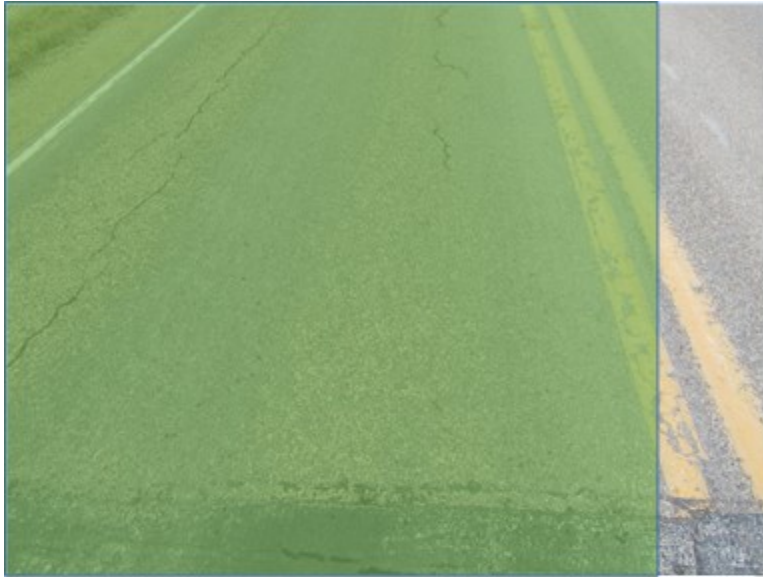
**Figure 3.8 Example 10 Ft. by 12 Ft. Photo-Based Distress Mapping Result from Section 1A 105+00 to 105+30, Where the Transparent Green Box Shows the Mapped Area and Corresponding Photo**

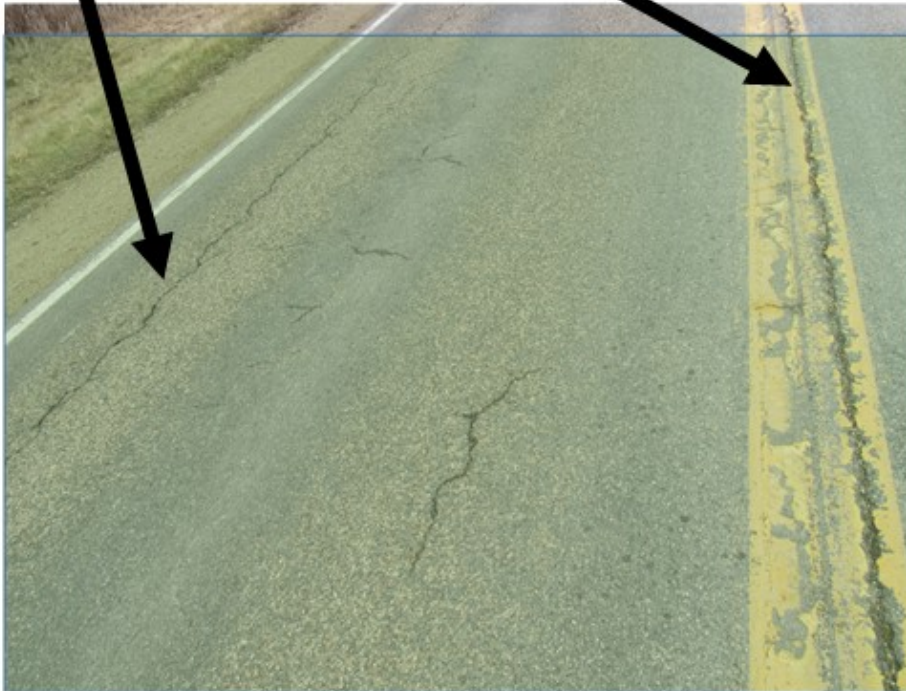
Section 1A (S&S): CR 117 CL5: 110+00 to 115+00  
250 - 300 ft

Figure 3.11 Wheel path Cracking Observed in Section 1A

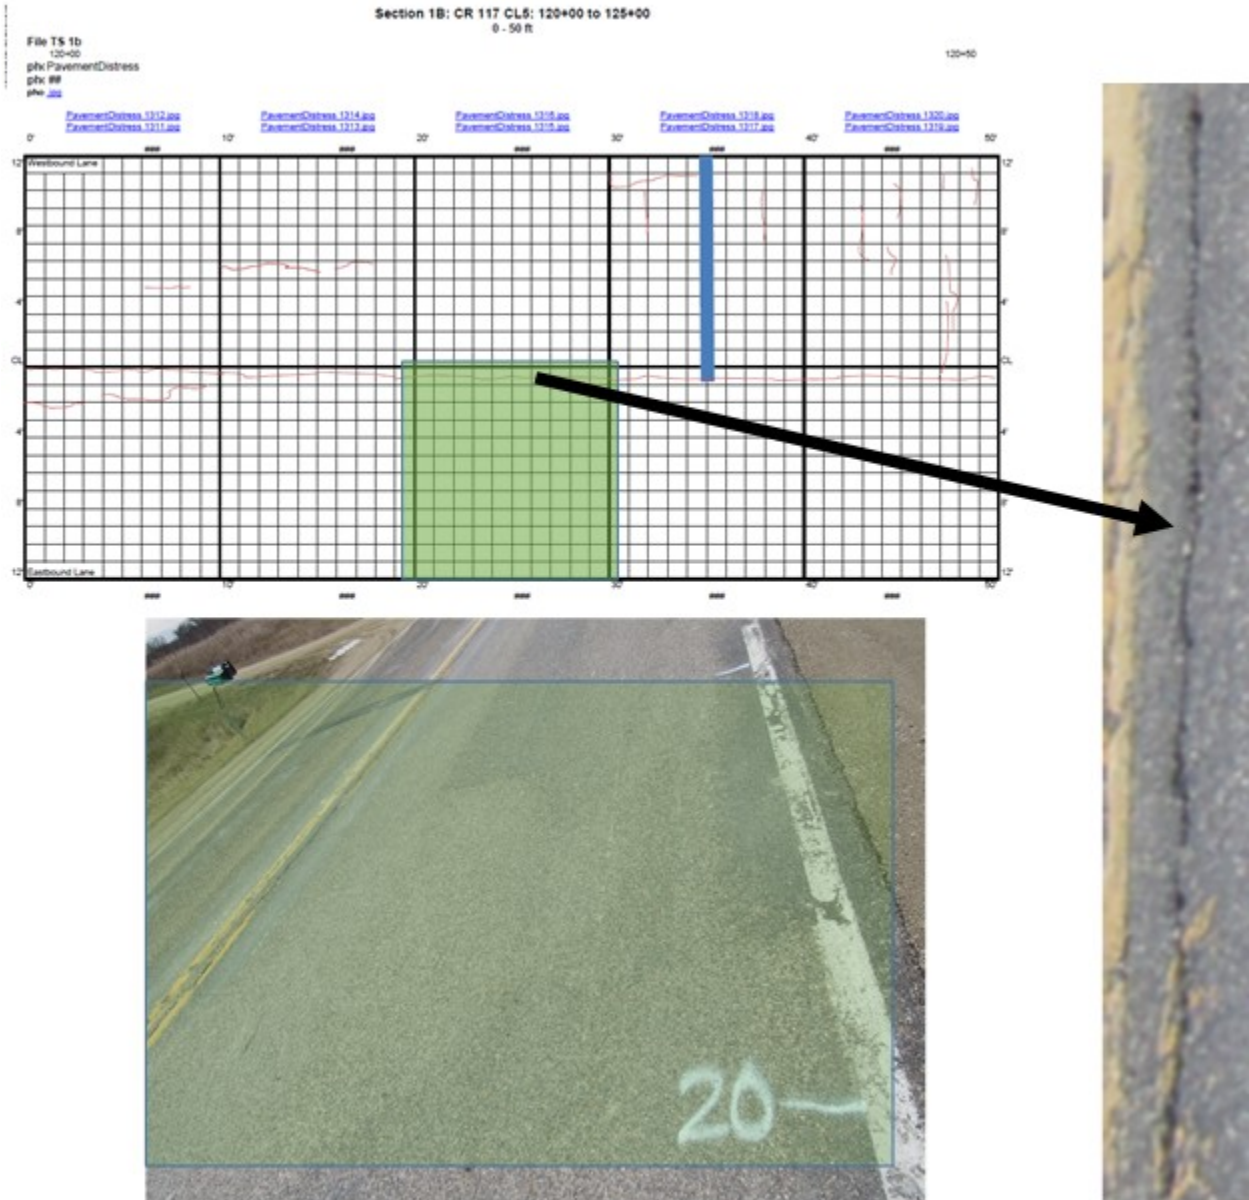
Figure 3.12 Centerline Construction Joint Deterioration and Cracking, Section 1B

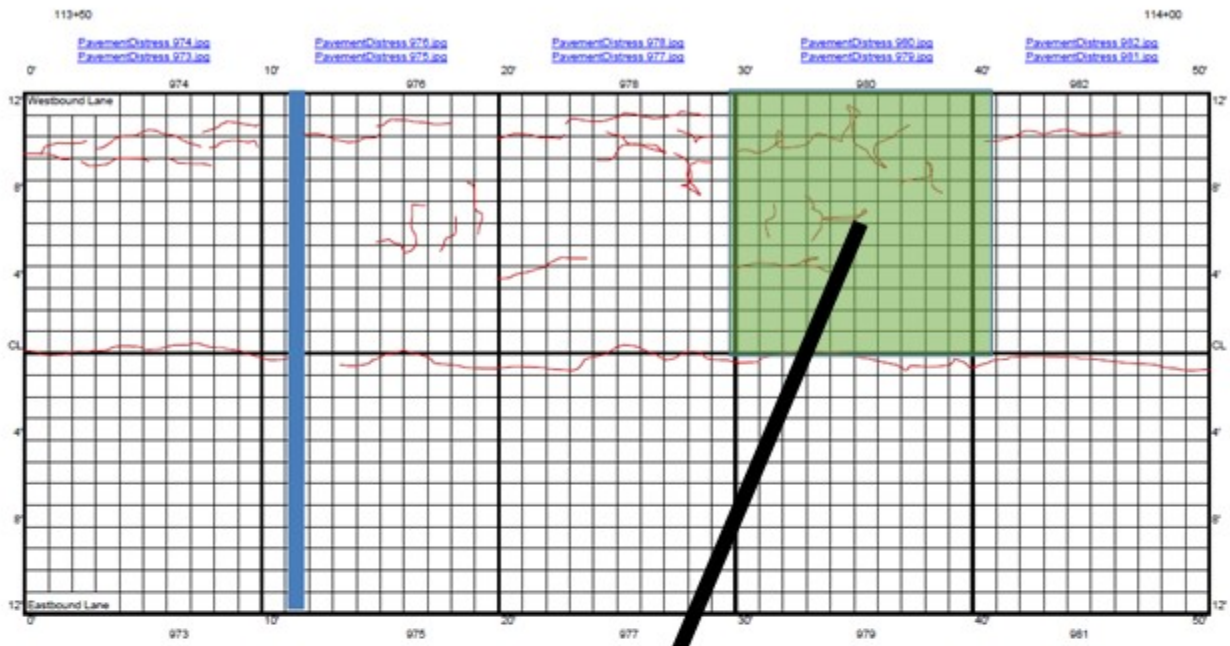
Section 1A (S&S): CR 117 CL5: 110+00 to 115+00  
350 - 400 ft

Figure 3.13 Fatigue Cracking in Section 1A

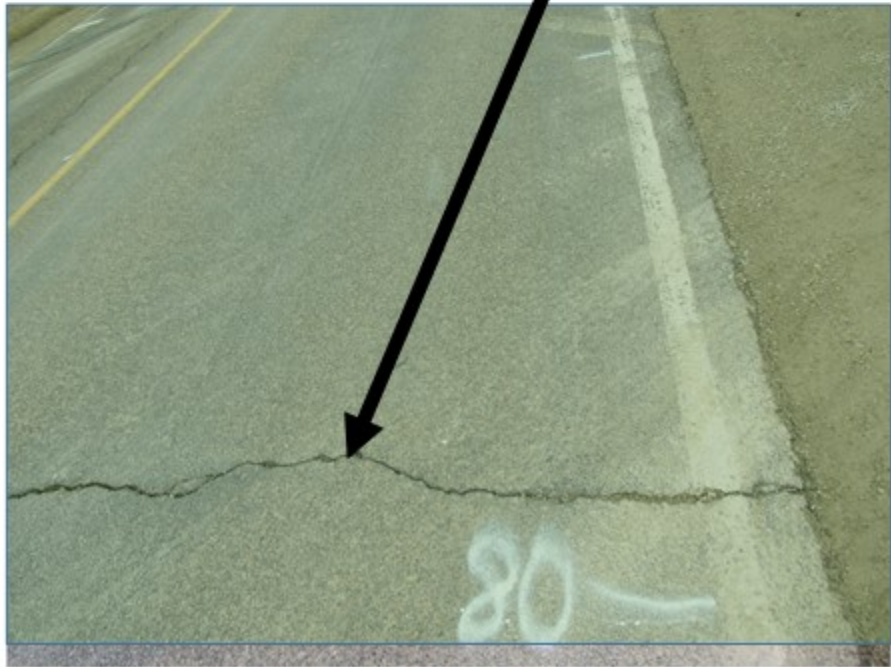
Section 1B: CR 117 CL5: 120+00 to 125+00  
50 - 100 ft

Figure 3.14 Transverse Crack in Section 1B

Sealant material in the sawn joints was showing deterioration which continued until pavement reconstruction. Multiple thermal cracks in test Section 1b progressed to cross the entire roadway and appeared to have movement and width to accelerate the sealant deterioration. Although most cracking in Section 1a was low-to-medium severity prior to the last phase, several cracks approached high severity (see figure 3.14) as the pavement approached the end of service life. In Section 1b, a significant number

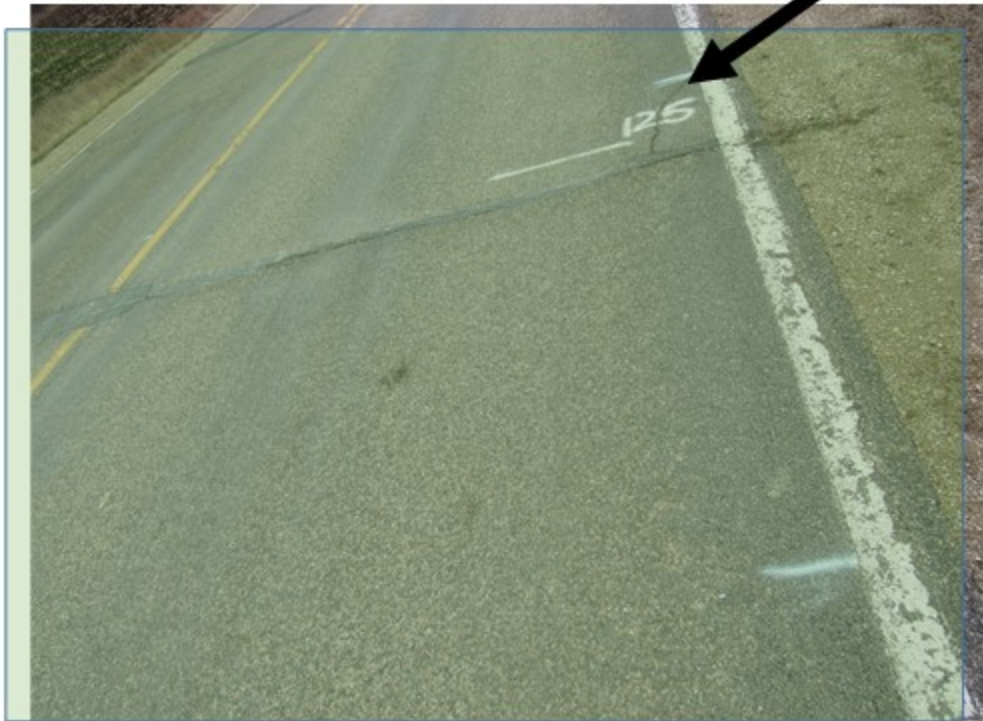
Section 1B: CR 117 CL5: 120+00 to 125+00  
450 - 500 ft

Figure 3.15 Secondary Cracking, Section 1B

of cracks widened and deteriorated to the point of high severity. Some secondary cracking occurred on the inside edges of the cracks and at the pavement edges (Figure 3.15). Very minor surface cracking was visible in the middle of the lane in Sections 2 and 3 in small areas. This appeared to be shrinkage cracking in the surface of the chip-sealant material and was not yet extending into the pavement (Figure 3.16).

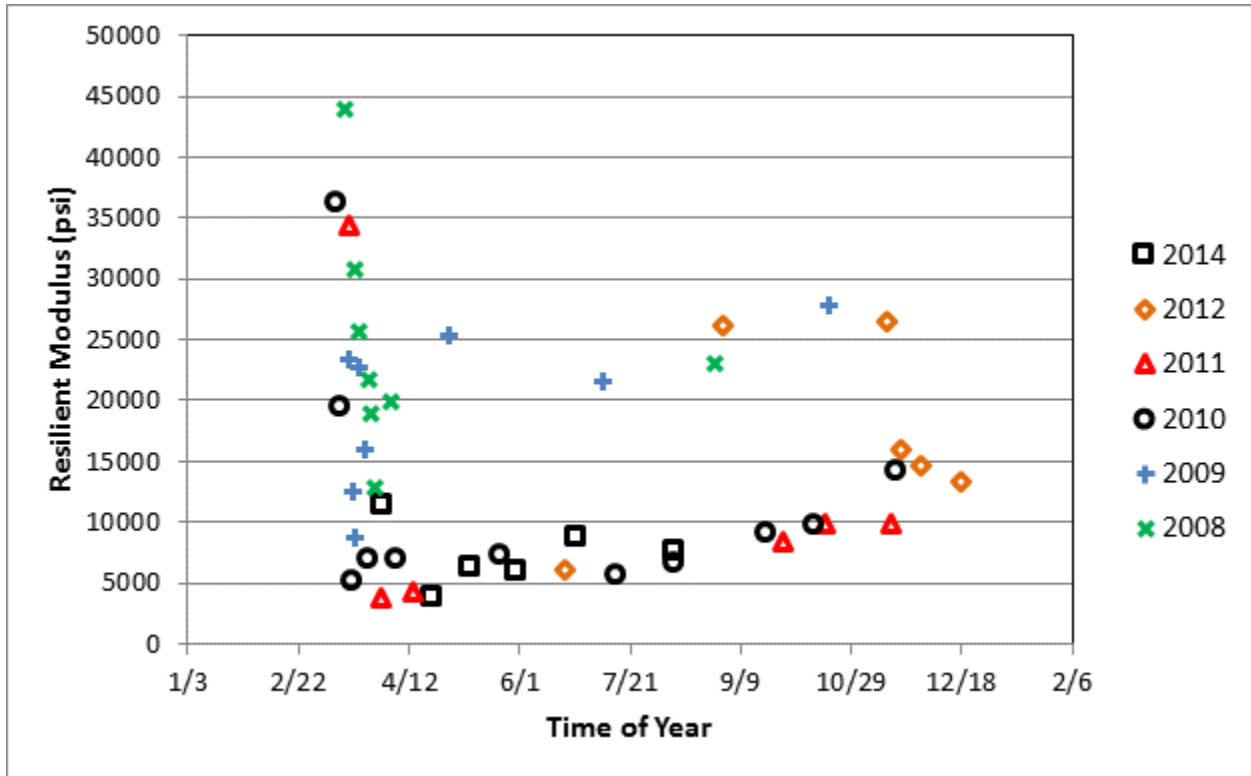
Similar results are observed when looking at the year-by-year data for each section shown in Figures 4.4 through 4.6. The clear rebound of the resilient modulus is evident in every year when observing the Class 5 base in Figure 4.4. Section 2 showed a more modest rebound except for 2009 where there was over 23,000 psi on March 30<sup>th</sup>. Section 1 showed little to no rebound except for in 2009 in which over 23,000 psi was observed on March 30<sup>th</sup>. It can be observed that there is more spread from year to year in the base data as compared to the AC layer. This suggests more uncertainty in the measurement and analysis process and/or more year by year dependence of the stiffness on weather conditions. As discussed in the following subgrade section, these extreme cases may be an effect of aliasing between the base and subgrade layers since the modulus observed in the subgrade was comparatively unusually low in those years. Saturation level would be one factor that could contribute to the observed year to year variations in the base. Additional analysis using a back-calculation procedure designed to be more stable (Tonn2010) will be performed to further investigate this phenomenon.

Figure 4.4 2008-2014 Average Back-Calculated Aggregate Base Resilient Moduli for Section 1

Figure 4.5 2008-2014 Average Back-Calculated Aggregate Base Resilient Moduli for Section 2

**Figure 4.6 2008-2014 Average Back-Calculated Aggregate Base Resilient Moduli for Section 3**

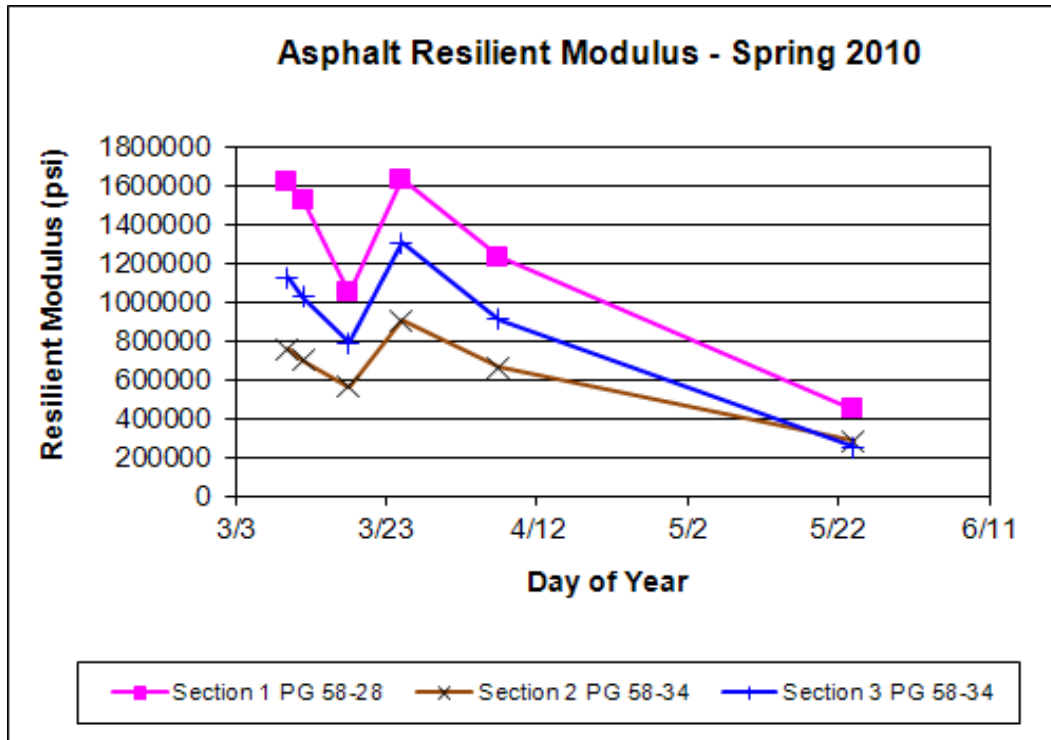
A review of spring 2010 asphalt resilient modulus (Figure 4.11) shows a difference in the stiffness of the pavements of the three sections during the spring thaw. It is expected that Section 2 and 3 (both PG 58-34) would have very similar moduli, and Section 1 (PG 58-28) would be similar to them in the summer, but somewhat stiffer in the winter. There may have been some variability in the sections with 58-34 binder; in the cooler period, the Section 3 pavement appears stiffer than the Section 2 pavement with the same binder. However, later in the summer the two are nearly identical. The Section 1 pavement has approximately twice the stiffness of the Section 2 pavement in cooler periods; and this is expected. The high cold-weather stiffness in the Section 1 asphalt is likely the cause of the thermal cracking in the un-sawn test section (Section 1b).

Figure 4.11 Asphalt Resilient Modulus, Spring 2010

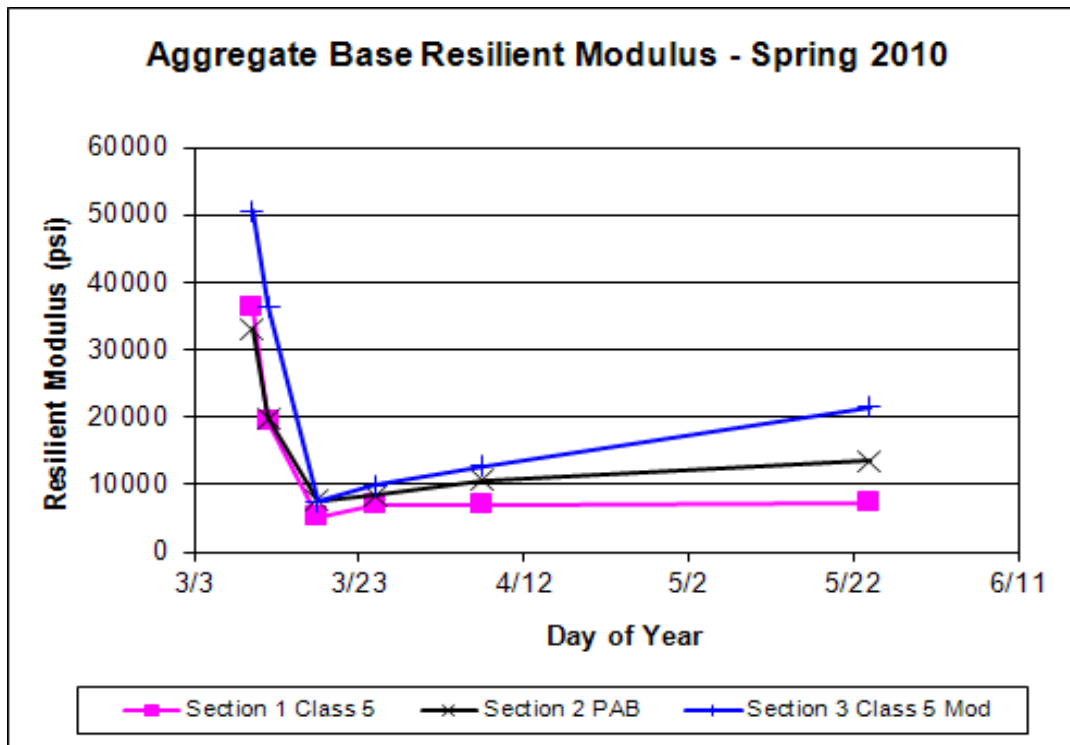
As previously stated, the conventional Class 5 does not meet the MnDOT gradation specification (exceeds 0.075 mm [#200] fraction specs), while the Class 5 Modified material would meet Standard Class 5 gradation passing #200 fraction specifications. Higher water retention due to excessive fine materials in the conventional Class 5 section would explain the higher frozen stiffness, rapid and extreme stiffness loss during the thawing period, and slower recovery observed in Section 1.

The PAB performed nearly identical to the Standard Class 5 in the frozen condition but was somewhat stiffer during the thaw and recovery. In previous years, the PAB has performed more similar to the Class 5 section through the recovery period. It is possible different rainfall patterns in previous years versus 2010 may have had different influences on base stiffness.

Figure 4.12 Aggregate Base Resilient Modulus, Spring 2010

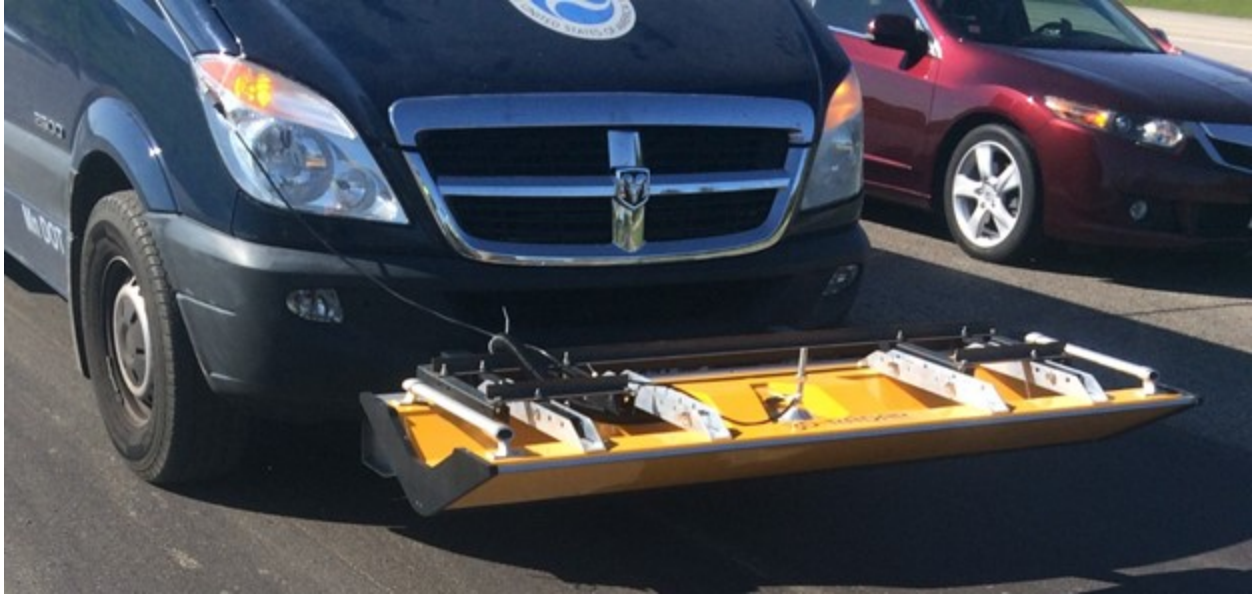
Ground penetrating radar is included in the scope of this phase of the project to inform other analysis such as the distress maps and FWD analysis. Pavement thickness variation is one parameter that affects FWD analysis and potentially pavement distress if the thickness is deficient in some areas. Thus, pavement layer thickness evaluation was performed on this project. Figure 4.18 shows the GPR antenna (yellow object mounted to the front of the van) during data collection on new asphalt pavement construction.

**Figure 4.18 GPR Antenna (Yellow Object Mounted to the Front of the Van) During Data Collection on Asphalt Pavement Construction**

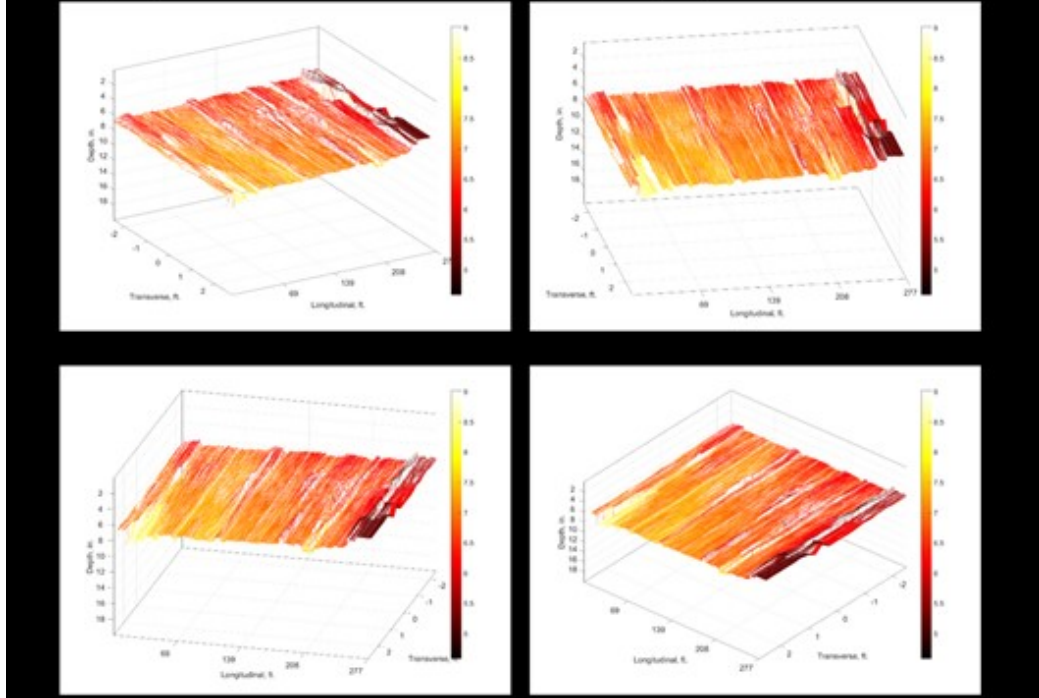
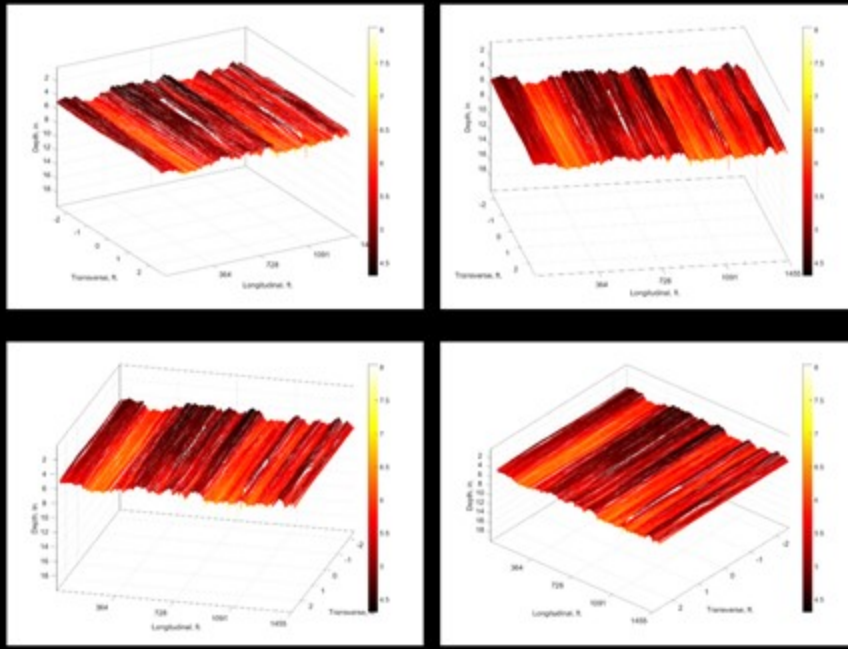
Figure 4.20 3D Reconstruction at 4 Different Angles Throughout the Title Specified Section

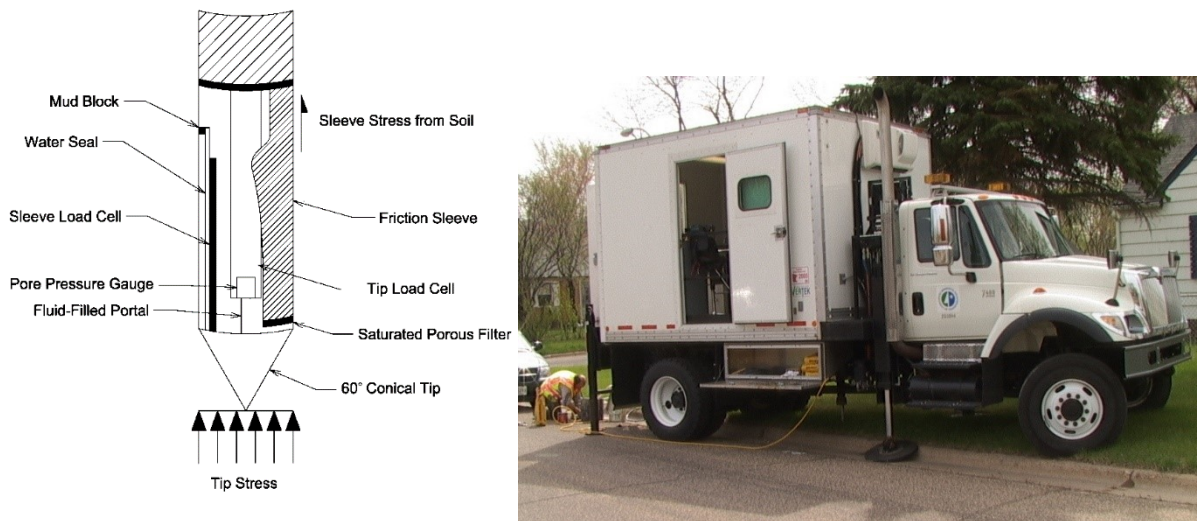
### Standard Piezo-CPT Probe

**Figure 4.32 Cone Penetrometer (CPT) Probe and Vehicle**
