# Evaluation of static and dynamic no right turn on red signs at traffic signals

**June 2024**

Research Project  
Final Report 2024-17

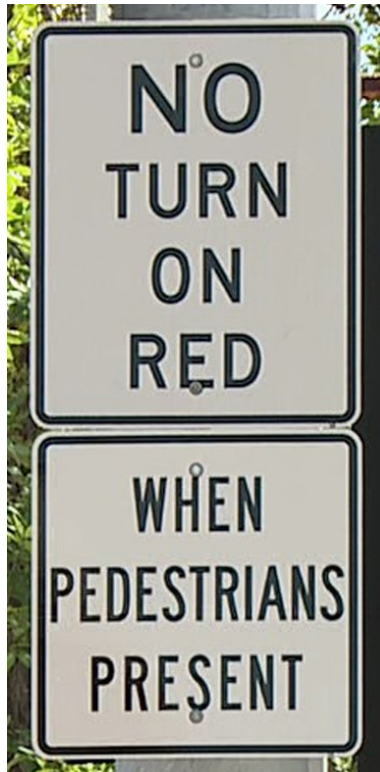
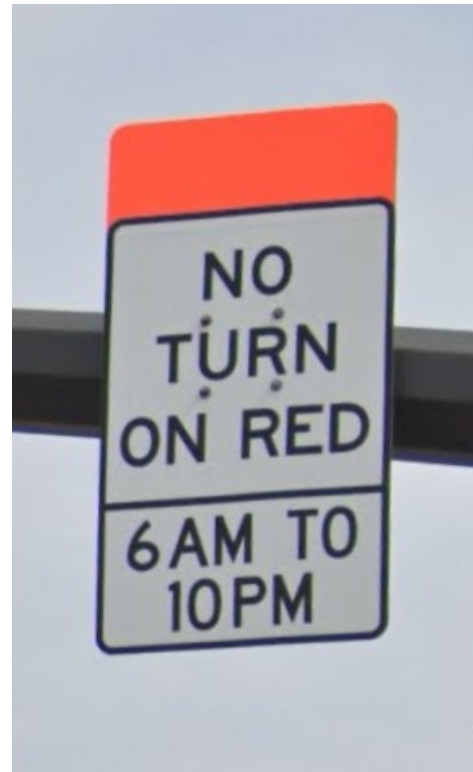
**Figure 2.1** Examples of “NO TURN ON RED” signs with supplemental signage

(a) Reminder for drivers to yield to pedestrians.

(b) Time-of-day prohibition.

A study by Insurance Institute of Highway Safety researchers examined effects of static NRTOR signs that included a note that the maneuver is prohibited when pedestrians are present, or by time of day (Retting et al., 2002). Field observations were made at 15 intersections, with different types of signs used at different sites (“control” sites, which appear to be locations where RTOR is allowed, and NRTOR signs with supplemental signs). Observations were made before and after the installation of the NRTOR signs. The researchers found that the “when pedestrians are present” NRTOR sign had about three times the number of RTORs compared to time-of-day prohibitions. The number of RTOR observations was not adequate to perform a statistical comparison.

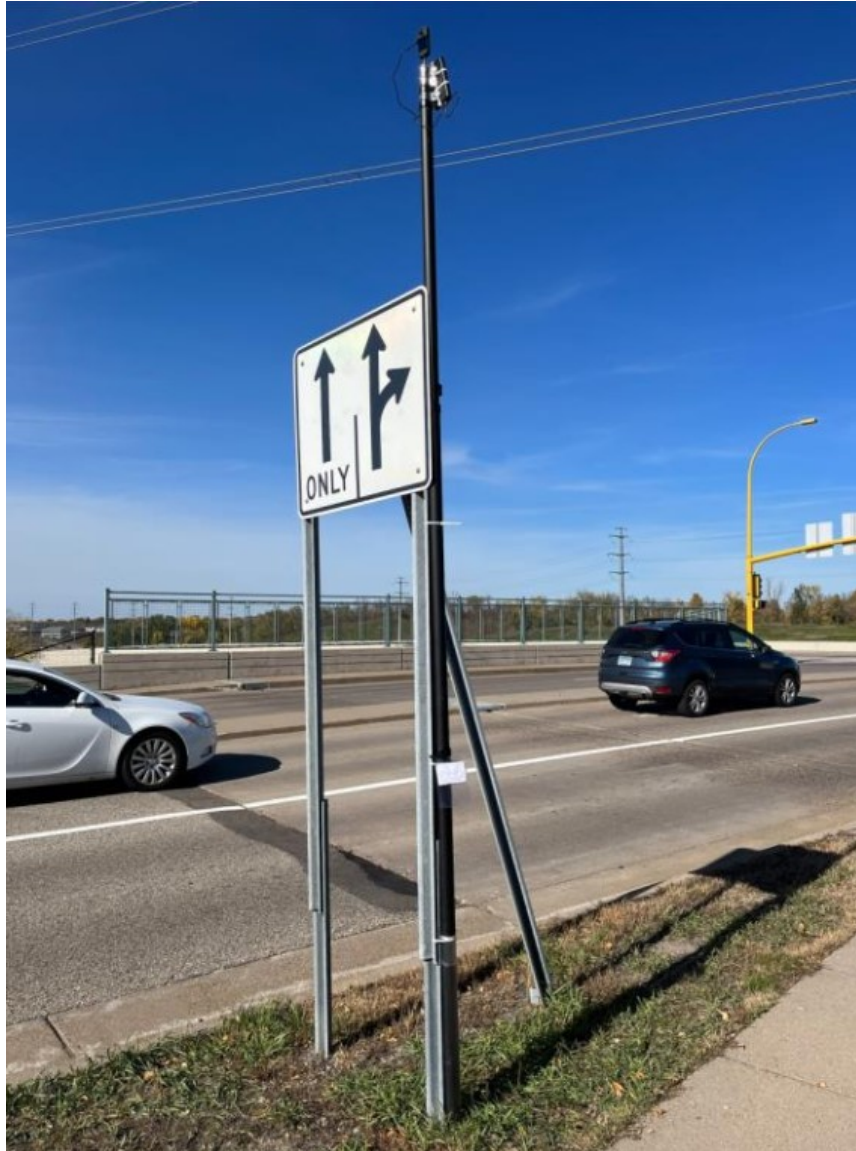
**Figure 3.1 Example view of field data collection setup used at TH 81 & Elm Creek Blvd.**

Creek Blvd, a field data collection setup was used. This consisted of an Insta360 X3 camera mounted on a pole temporarily mounted to a local sign, as shown in Figure 3.1. With the use of a portable battery, data were collected for approximately 24 hours from this location with the use of this setup. One battery changeout was required.

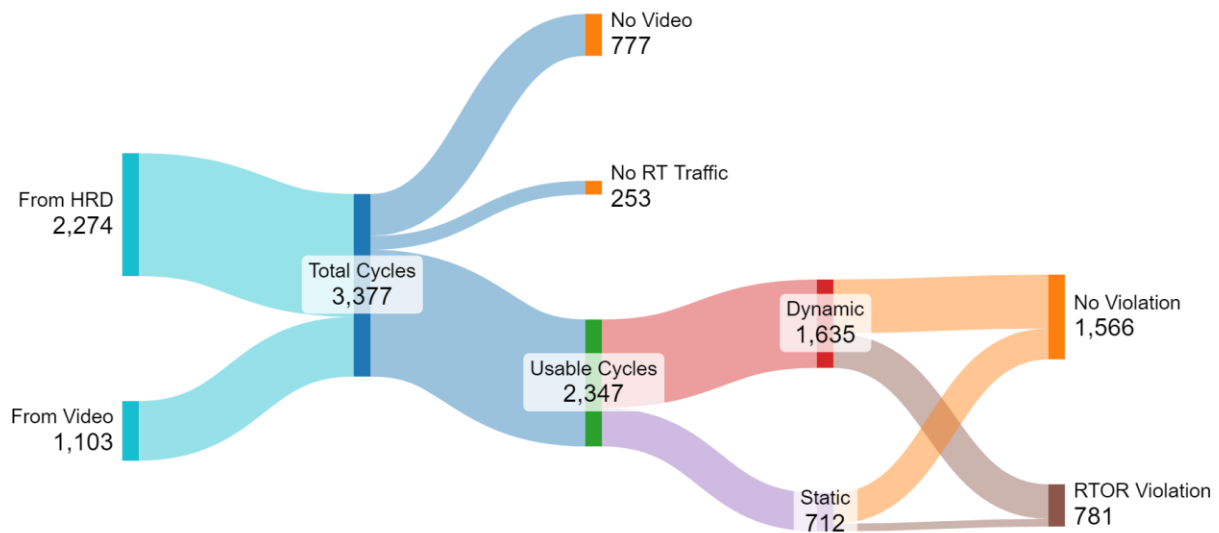
**Figure 3.3 Diagram showing the breakdown of data (HRD = high-resolution data).**

Compliance rates were calculated only for the remaining 2,347 cycles where there was right-turn traffic. Among these, there were 1,566 cycles in which no violation of the NRTOR sign took place, while there were 781 cycles in which a violation did take place. The next section explores the compliance results in greater detail.
