# Field Monitoring of a Mechanically Stabilized Earth Wall Backfilled with Lightweight Cellular Concrete

<b>1 Report No.</b> KS-24-03		<b>2 Government Accession No.</b>		<b>3 Recipient Catalog No.</b>	
<b>4 Title and Subtitle</b> Field Monitoring of a Mechanically Stabilized Earth Wall Backfilled with Lightweight Cellular Concrete				<b>5 Report Date</b> July 2024	
				<b>6 Performing Organization Code</b>	
<b>7 Author(s)</b> Robert L. Parsons, Ph.D., P.E., Hao Liu, Ph.D., Jie Han, Ph.D., P.E.				<b>8 Performing Organization Report No.</b>	
<b>9 Performing Organization Name and Address</b> The University of Kansas Department of Civil, Environmental & Architectural Engineering 1530 West 15th St Lawrence, Kansas 66045-7609				<b>10 Work Unit No. (TRAIS)</b>	
				<b>11 Contract or Grant No.</b> C2158	
<b>12 Sponsoring Agency Name and Address</b> Kansas Department of Transportation Bureau of Research 2300 SW Van Buren Topeka, Kansas 66611-1195				<b>13 Type of Report and Period Covered</b> Final Report April 2020 – June 2022

Final Report

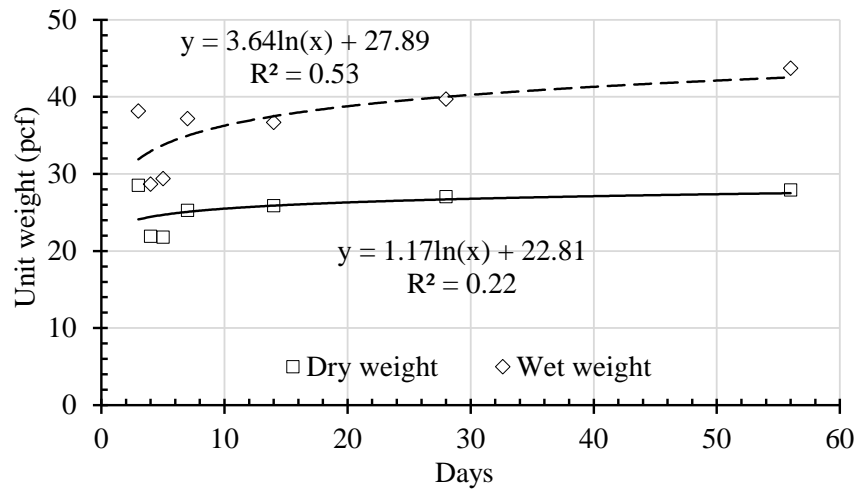
**Figure 2.3: Unit Weight of LCC Over Time**

The LCC used for this project was a mixture of cement, fly ash, water, and foam. The contents of cement and fly ash in the LCC were 75% and 25% by weight, respectively. The cast unit weight of LCC was approximately 30 pcf. Cylinder samples with a height of 6 in. and diameter of 3 in. were cast on site and cured in a moisture room for lab testing. Figure 2.3 shows the dry and wet unit weights of LCC on different days after LCC casting. Dry and wet unit weights increased from 24 pcf to 27 pcf and from 33 pcf to 42 pcf, respectively, from day four to day 56 after LCC casting. Both wet and dry weight increased with time at a decreasing rate, indicating

that cement hydration continued even up to 56 days after LCC casting. In addition, the difference between wet and dry weights increased over time, suggesting that water absorption of LCC increased over time. Figure 2.4 shows that the unconfined compressive strength of LCC also increased over time at a decreasing rate (from 89 psi at day 3 to 179 psi at day 56). According to Tiwari et al. (2017) and Taylor and Halsted (2021), LCC in this study was classified as Class II based on unit weight. As shown in Figure 2.4, the unconfined compressive strength at day 28 was approximately 158 psi, which was within the typical unconfined compressive strength of Class II LCC (i.e., 38.44–240.33 psi).

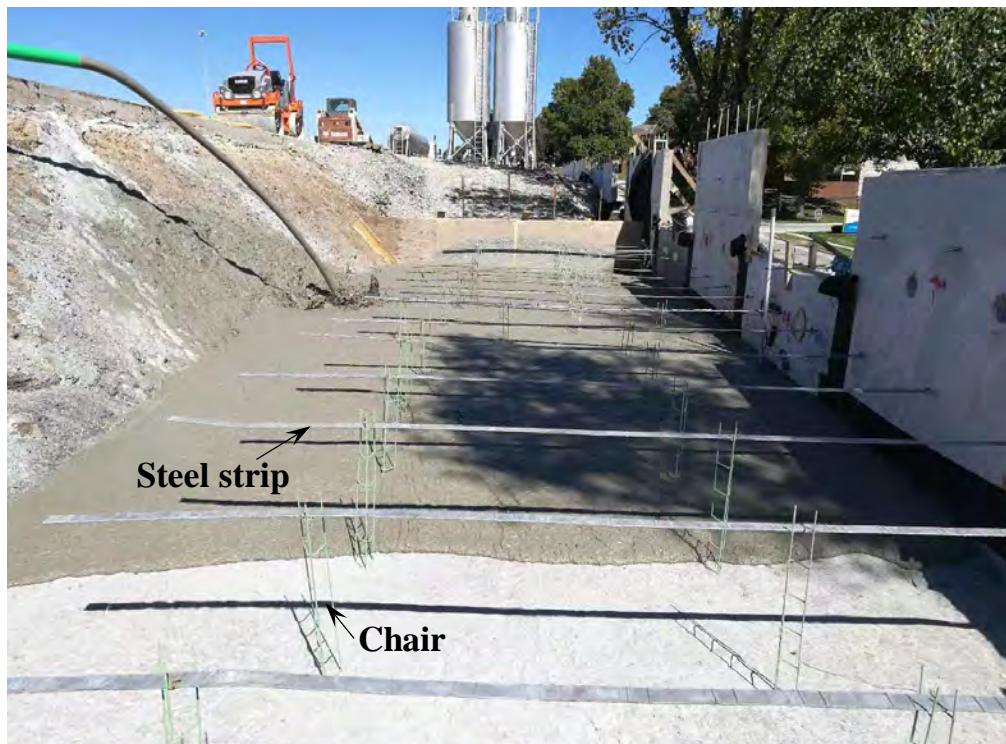
**Figure 2.5: Placement of the Second LCC Layer**

This project used ribbed steel strips from The Reinforced Earth Company. The strips were 2 in. wide by 0.16 in. thick, with a pattern of ribs to increase interaction with backfill material. Galvanization was used for corrosion protection to achieve a design life of at least 75 years. According to Jayawickrama et al. (2015), the yield and tensile strengths of this strip were 80 and 103 ksi, respectively. Figure 2.5 shows placement of the second LCC layer on September 29, 2020. Each steel strip was placed on top of at least two chairs, and the chair bases were inserted into the ground or the prior LCC layer. Chair heights were adjusted to ensure the steel strips were horizontal during strip installation.

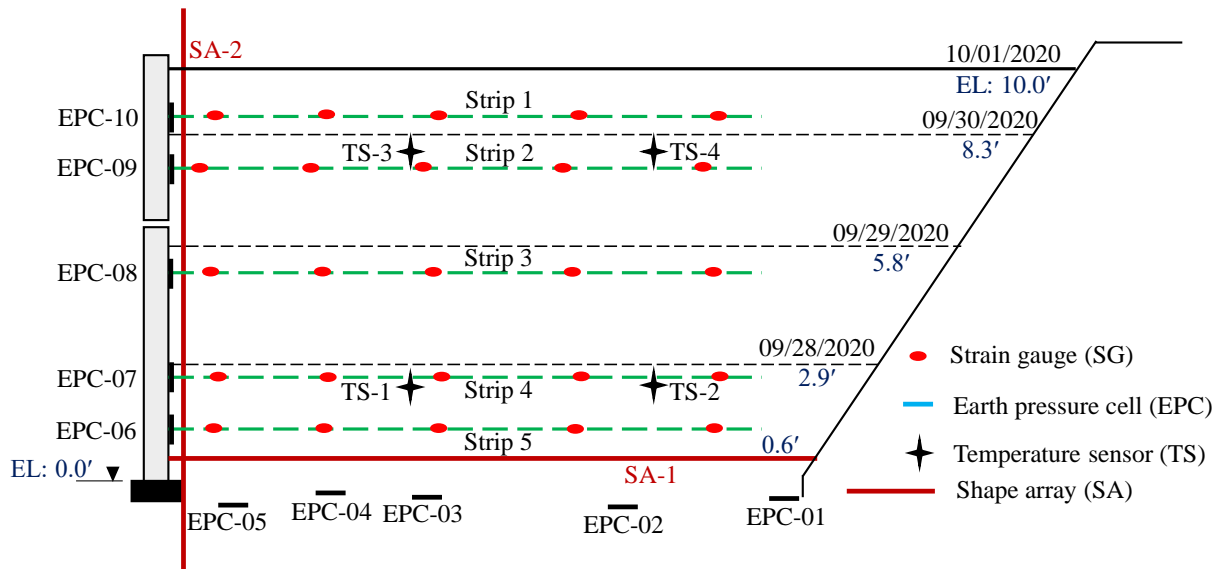
**Figure 2.7: Layout of Instrumentation**

and adjacent to the back facing of the wall panels to measure wall-facing deformations. In addition, strain gauges (Model C4A-06-125SL-350-39P from Vishay Precision Group, Inc.) were attached to five positions on each of five steel strips to measure changes of axial forces along the length of the steel strip. Since the steel strip could resist some bending moments, strain gauges were attached to both sides of the steel strip. However, due to limited channels on the datalogger, no strain gauges were attached to the bottom side of the rear ends of the lowest two strips (i.e., strips #4 and #5).

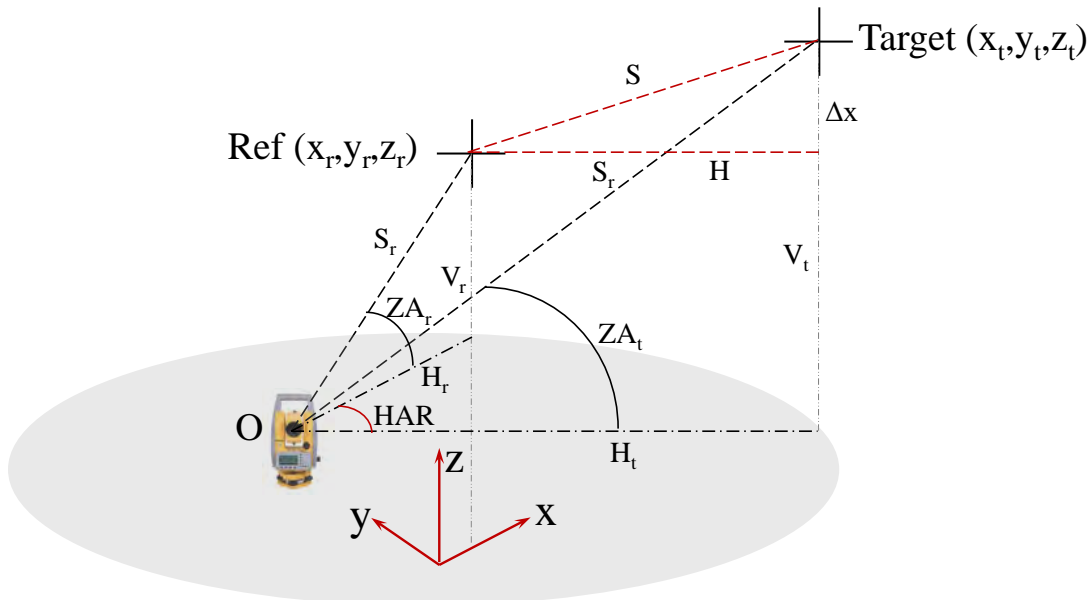
**Figure 2.9: Method for Reading Survey Targets**

The distance between the reference point and the target was calculated using Equation 2.14. As shown in Figure 2.9, if the horizontal angle between the normal direction of the wall facing and

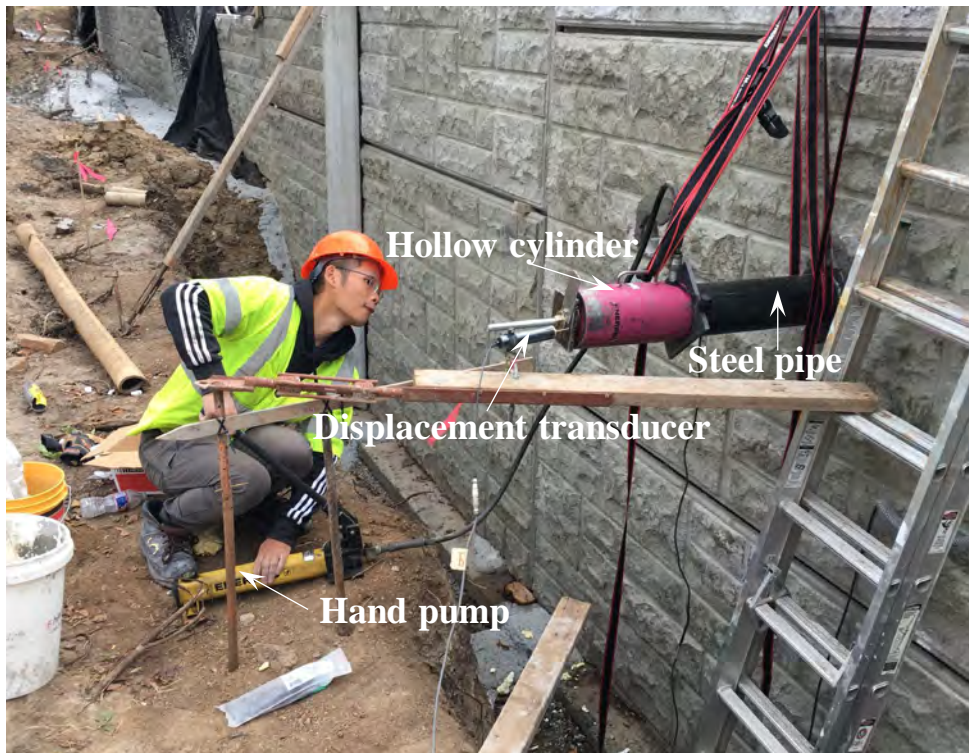
(a) Field Pullout Test Device (not to scale)

(b) Pullout Test Setup in Field

**Figure 3.1: (a) Test Device; (b) Setup**

Figure 3.1(b) shows the test setup for a field pullout test. Three ratchet straps were used to support and adjust the position of the hollow cylinder and steel pipe during installation and support the test device during the field pullout test. A displacement transducer independently supported on the ground measured the displacement of the hard cap (i.e., displacement of the front end of the steel test strip), and the load cell was used to measure the force to pull the strip. The strips were pulled out at a rate ranging from  $3.94 \times 10^{-4}$  to  $1.57 \times 10^{-3}$  in./s before reaching peak pulling force and at a rate ranging from  $3.94 \times 10^{-3}$  to  $5.9 \times 10^{-3}$  in./s after reaching peak pulling force.

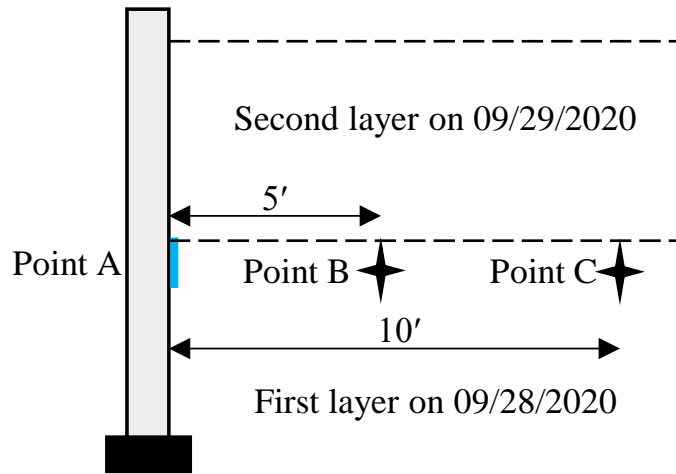
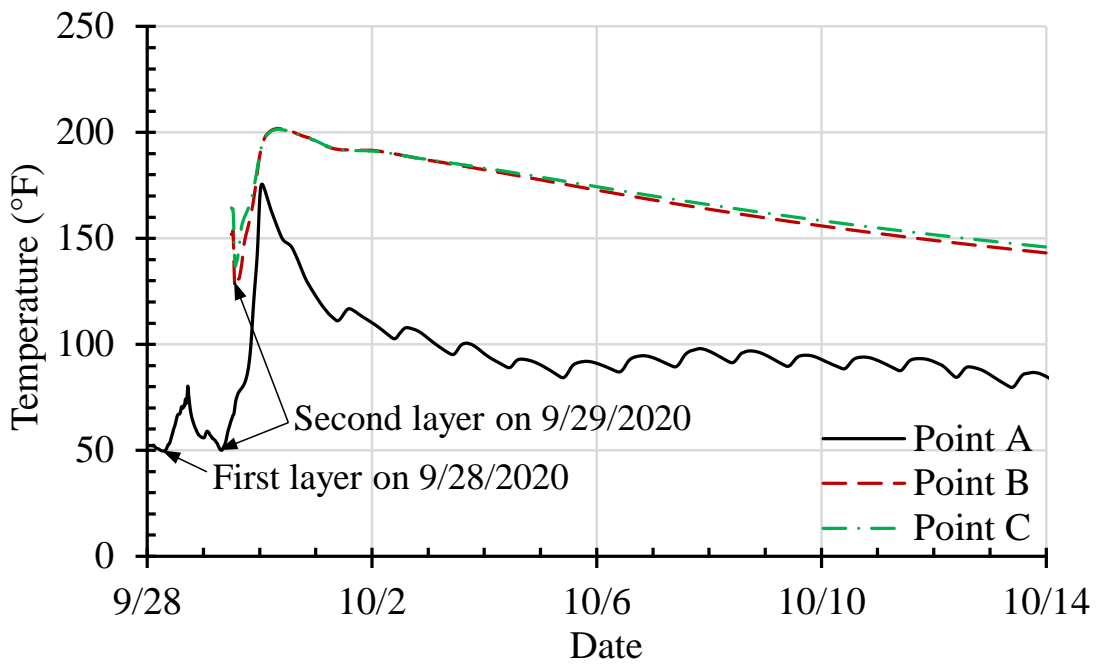
(a) Temperature Sensor Layout

(b) Temperature Change Over Time in LCC

Figure 3.2(b) shows temperature change behind the wall facing and in the LCC over time. After pouring the second lift of LCC, temperatures behind the back of the wall facing and in the LCC reached their peaks in one day. Thermal conductivity of the wall facing caused the temperature behind the wall to drop much more quickly than the temperatures in the LCC. The temperature behind the wall facing varied with daily temperature variations.

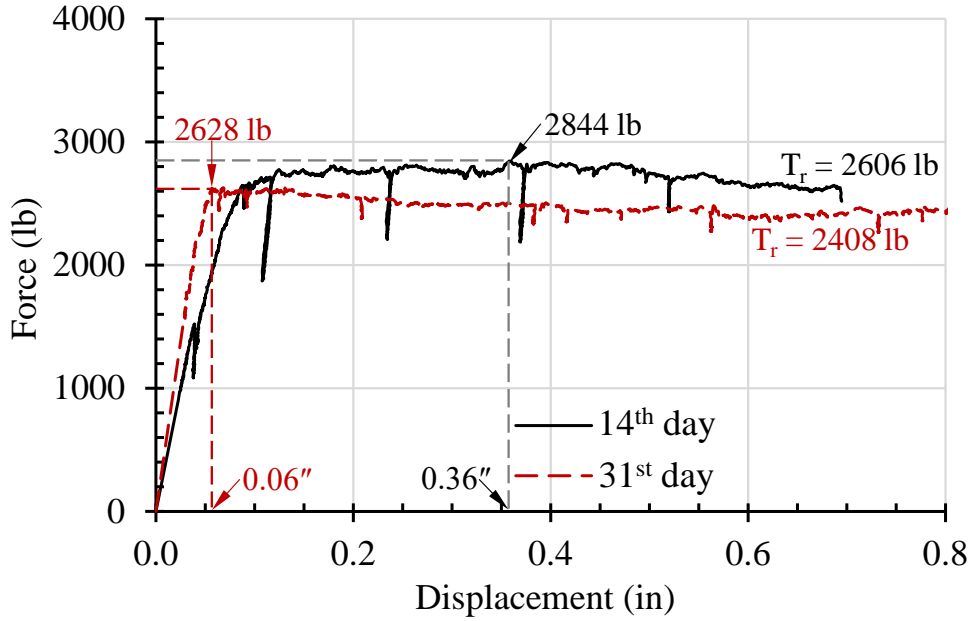
(a) Strip #1 Pulled on Day 3 and Repulled on Day 30

(b) Strip #2 Pulled on Day 7 and Repulled on Day 30

**Figure 3.3: Pullout Tests of Short Strips**

(c) Strip #3 Pulled on Day 14 and Repulled on Day 31

(d) Strip #4 Pulled on Day 31

(e) Strip #6 Pulled on Day 197

(f) Strip #7 Pulled on Day 401

Pullout capacity exceeded 2,700 lb for all test strips, and capacities were consistent among test strips with curing periods of one month or less. Pullout capacities were substantially higher for test strips with curing periods of 6 months and one year. Figure 3.3 shows the force versus displacement results for the six short strips.

after reaching peak force, followed by gradually decreasing force to a stable value as displacement increased. However, for strips #3 and #4, which were tested on days 14 and 30 after LCC casting, respectively, the force dropped gradually to a constant value after reaching peak force as displacement increased. No abrupt drops of pulling force were observed for the two strips as with the longer strip (strip #5) (Figure 3.4).

Strips #6 and #7 were tested on day 197 and day 401, respectively, to investigate the long-term pullout resistance of steel strips in LCC. No abrupt drop of pulling force after reaching peak force was observed on day 197, but an abrupt drop was observed on day 401. After reaching peak force, the pullout resistance of many strips consisted of two stages due to shear-off failure (i.e., quick drop of pulling force after reaching peak value) and pullout failure (i.e., gradual decrease of pulling force with displacement of steel strip) as described by Sayadi et al. (2016a).

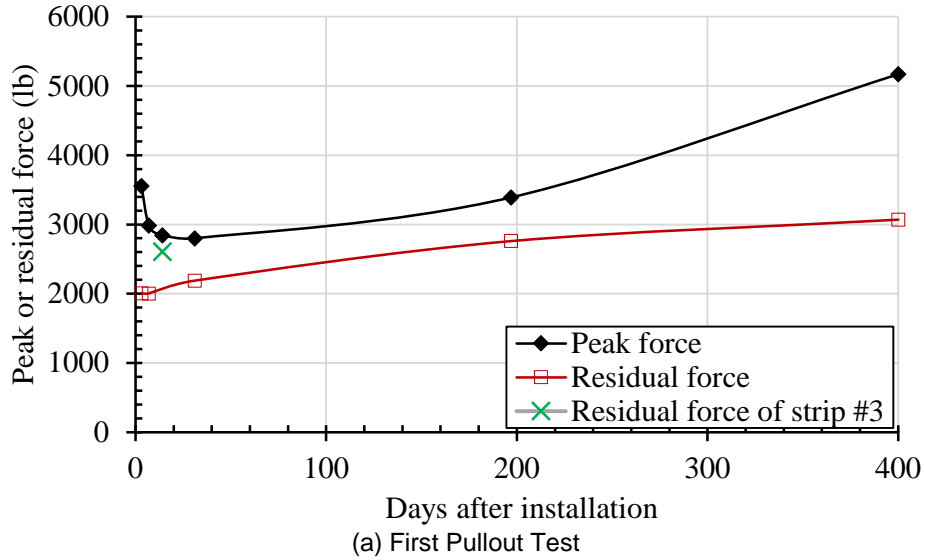
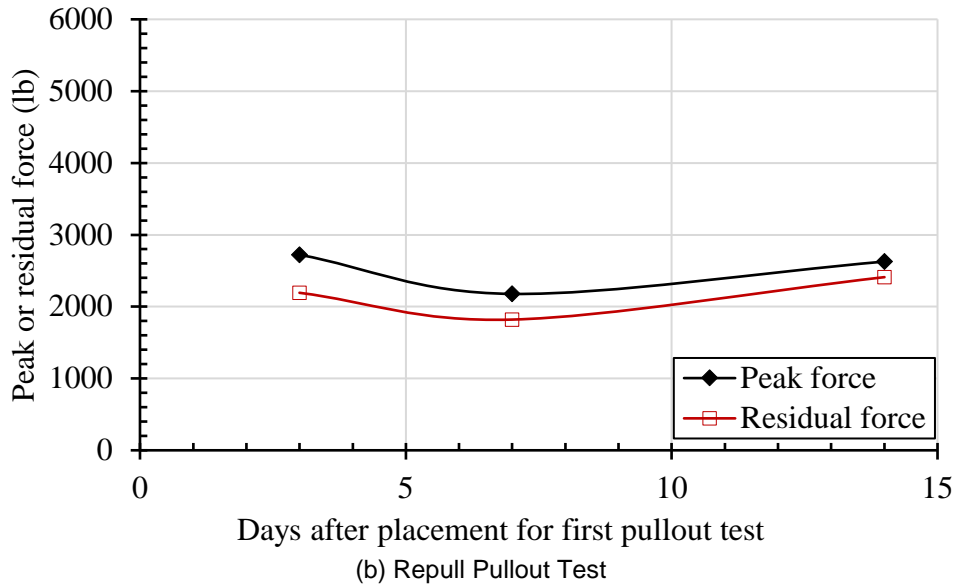
**Figure 3.4: Change of Peak and Residual Forces Over Time**

Figure 3.4 shows various post-peak behaviors after different curing periods. The cause of prominent peak/quick drop-off in strength after curing periods of three and seven days may be due to additional normal stress on the steel strip induced by high temperature in the LCC. This normal stress decreased after the LCC de-bonded from the strip during shear. However, for curing periods of 14 days or longer, the thermally induced normal stress decreased substantially due to decreased LCC temperatures, meaning no prominent peak in resistance and then a quick drop after peak resistance occurred for tests from day 14 to day 197. Although the peak resistance was observed for the final test on November 5, 2021, the very high peak and quick drop-off may be temperature and/or curing related, but more research is needed to determine if the peak and drop-off was a real event or an artifact of this test.

Figure 3.4 also shows peak and residual forces for the initial and repull pullout tests. Figure 3.4(a) shows that the peak force decreased within 14 days after LCC casting and remained constant from day 14 to day 31, after which the peak force increased over time. Due to the decrease in temperature (Figure 3.2), additional normal stress caused by LCC expansion on the steel strip decreased, potentially causing the peak force required to pull the strip to decrease over the first two weeks after LCC casting. The residual force was very consistent from the third day after LCC casting for strips #1, #2, and #4, as shown in Figure 3.4(a), indicating that the residual interaction

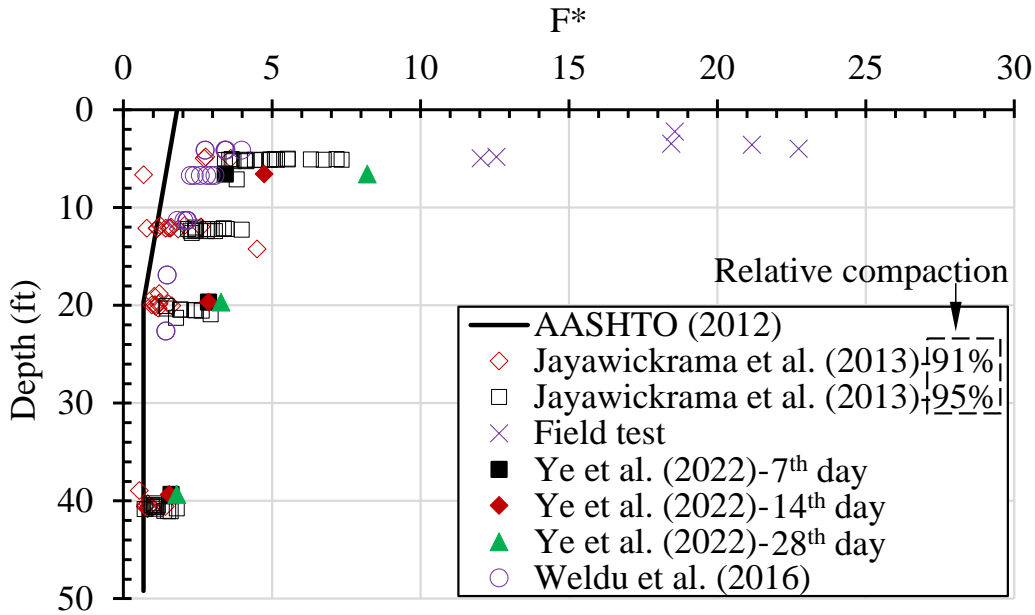
**Figure 3.6: Comparison of LCC Field Tests and Aggregate**

Weldu et al. (2016) conducted lab pullout tests for a ribbed steel strip buried in aggregates (approximate relative compaction of 94%) with various coefficients of uniformity under various normal stresses. Jayawickrama, Surles, Wood, and Lawson (2013) also conducted lab pullout tests with various degrees of relative compaction of aggregate backfill, lengths of steel strip, and normal stresses for ribbed steel strips, while Ye et al. (2022) conducted lab tests of steel strips encased in LCC under normal stresses of 209, 627, and 1,253 psf. Figure 3.6 shows pullout resistance factors calculated from pullout test results in LCC (75% cement and 25% fly ash) from lab and field pullout tests and in aggregates from lab pullout tests, as well as recommendations from AASHTO (2012), in which a coefficient of uniformity of four and an aggregate friction angle of  $34^\circ$  were used to calculate the pullout resistance factor. The unit weight of LCC and aggregate were assumed to be 32 and 127 pcf, respectively. Pullout resistance factors in LCC were larger than the values in aggregates, as shown in Figure 3.6, particularly for low normal stresses (minimal depths). Based on these results, a substantial portion, possibly the dominant portion, of LCC peak strength is a result of cohesion rather than frictional interaction among particles. Therefore, the difference between the pullout force of strips between aggregate and LCC decreased as depth increased, meaning the pullout capacity of the strip in aggregate exceeded the capacity of LCC.

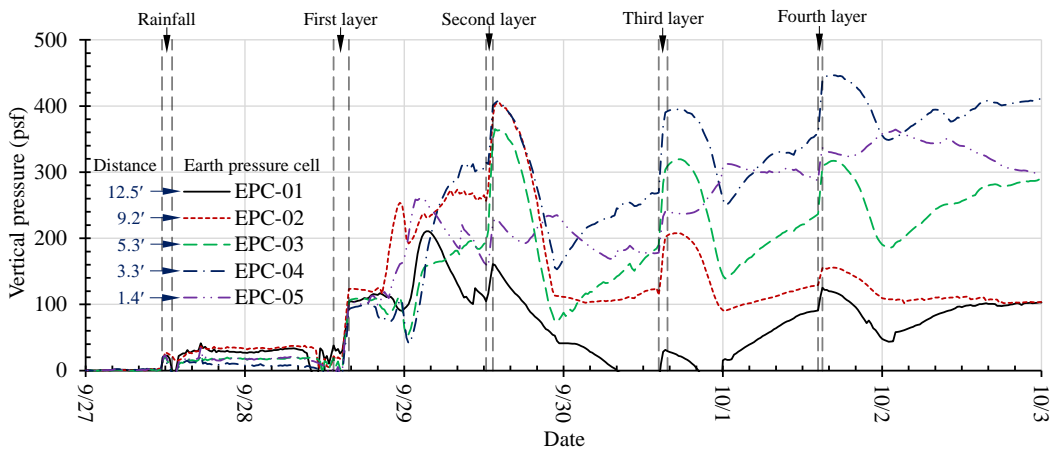
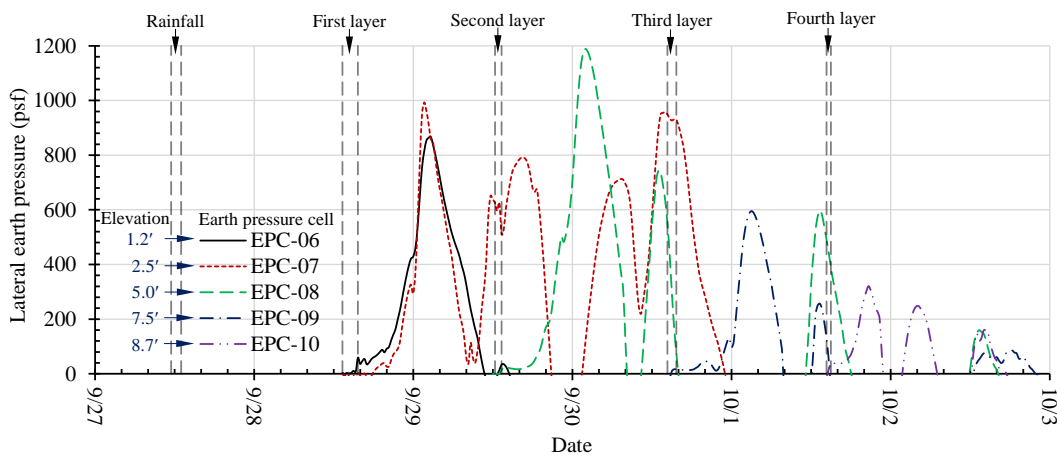
(a) At the Base of LCC Backfill

(b) At the Back Facing of Wall Panels

**Figure 4.1: Pressures during LCC Placement**

Figures 4.1 and 4.2 show pressures and temperatures, respectively, at the base of the LCC backfill and at the back facing of the wall panels during LCC placement.

Earth pressure cells EPC-01 to EPC-07 were installed on September 26, 2020, while EPC-08, EPC-09, and EPC-10 were installed on September 29, September 30, and September 30, respectively. Heavy rainfall on September 27 caused retained water above EPC-01, EPC-02, EPC-03, EPC-04, and EPC-05. This water was removed on September 28 before the first LCC layer was placed. The water accumulation and removal on the five cells could explain the measured pressure increases on September 27 and pressure reductions on September 28. From 15:40 to 20:00 on September 28, the average pressure reading for the five cells was 104 psf, which matched the weight of the initial LCC layer (1.0 m thick) ( $32 \text{ pcf} \times 3.23 \text{ ft} = 103 \text{ psf}$ ). Comparatively, EPC-06

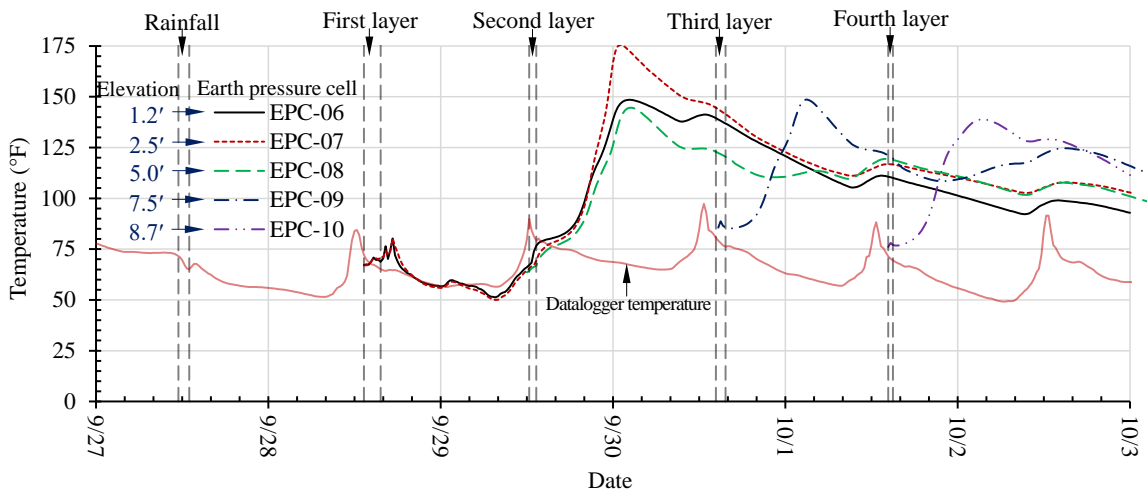
(a) At the Base of LCC Backfill

(b) At the Back Facing of Wall Panels

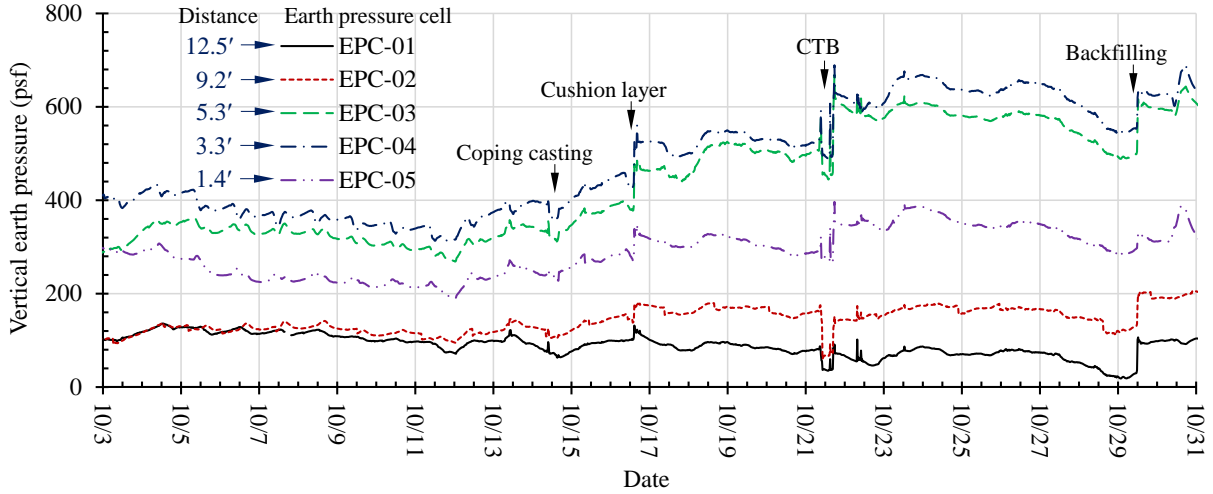
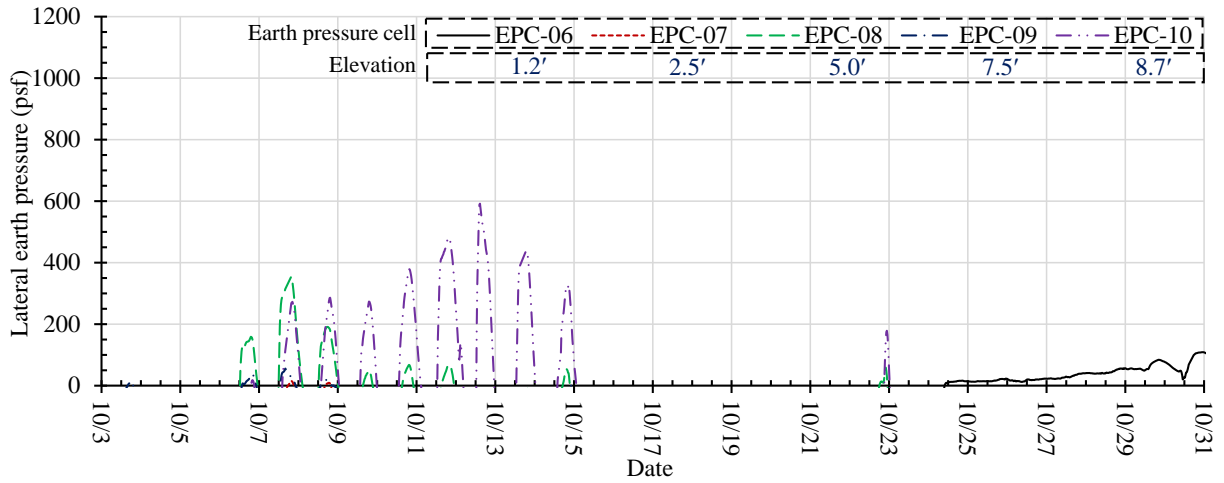
(a) At the Base of LCC Backfill

(b) At the Back Facing of Wall Panels

**Figure 4.3: Pressures During LCC Curing**

Figures 4.3 and 4.4 show pressures and temperatures, respectively, at the base of the LCC backfill and at the back facing of the wall panels during LCC curing.

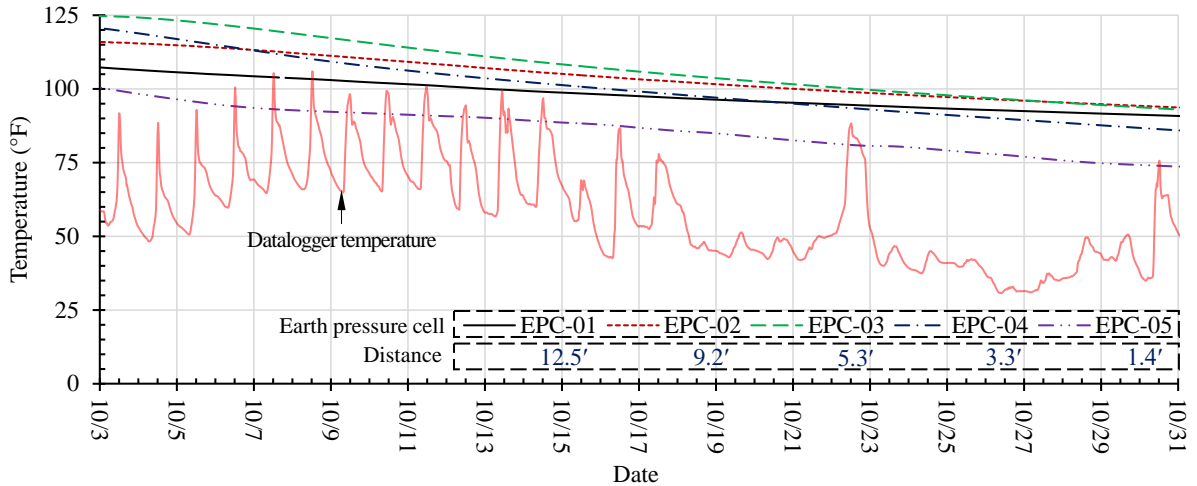
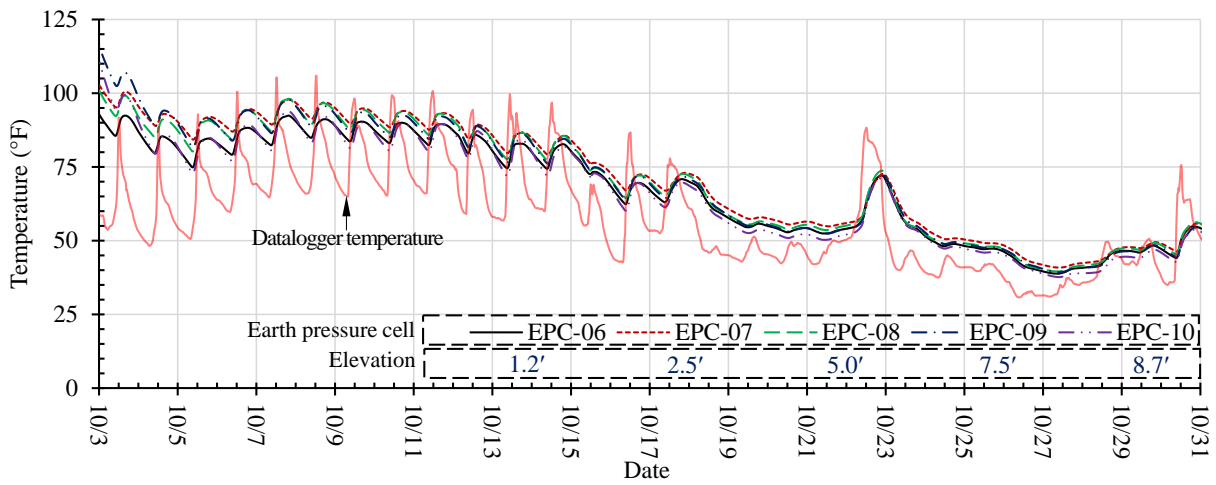
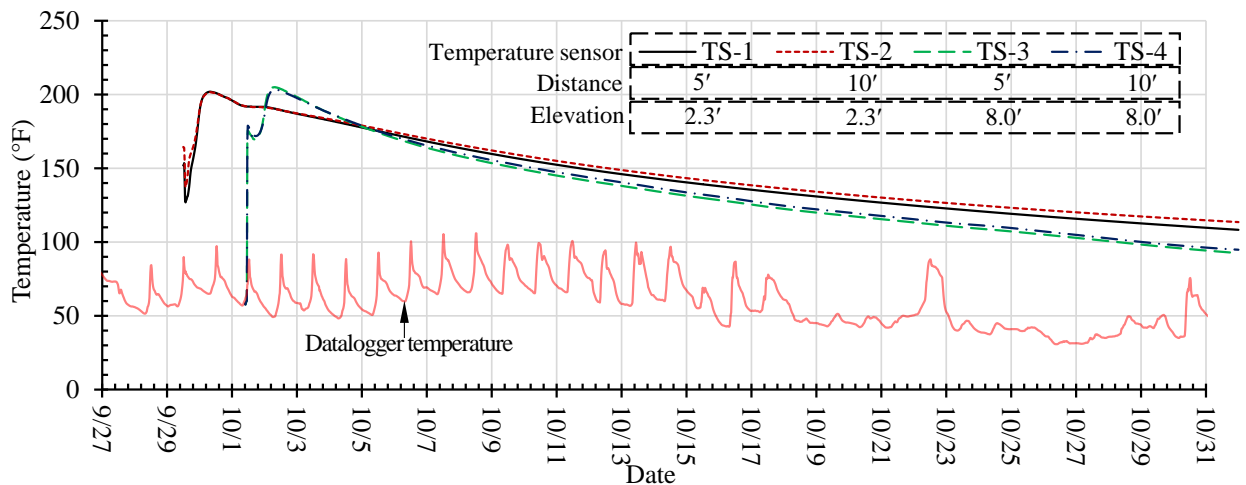
(a) At the Base of LCC Backfill

(b) At the Back Facing of the Wall Panels

(c) In the Middle of LCC Backfill

The measured temperatures at the back facing of the wall panels in the LCC peaked nearest the center of the fill mass. The peak temperatures and pressures at the face lagged the peak values of the internal LCC temperatures recorded by the datalogger because heat transfer requires time. From October 6 to 15, 2020, LCC expansion due to temperature increases likely caused the increase in lateral earth pressures behind the wall panels at elevations of 5 ft and 8.7 ft, as shown in Figure 4.3(b). However, LCC contraction due to decreased air temperature starting on October 15 meant that the lateral earth pressures at the back facing of the wall panels between October 15 and 22 were negligible.

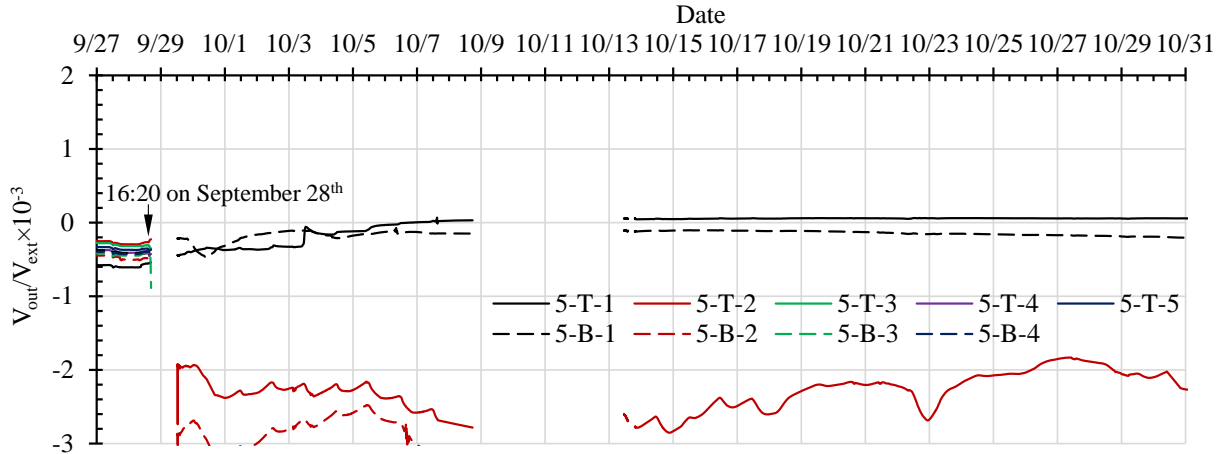
**Figure 4.5: Readouts of Strain Gauges (Strip #5)**

Figure 4.5 shows measurements of the strain gauges attached to steel strip #5, installed on September 26, 2020. These strain gauges are labeled as top (T) or bottom (B), indicating the strain gauge location, increasing from 1 to 5 as the distance from the back facing of the wall panels increased. For example, strain gauge “5-T-1” means the strain gauge was on the top side in the front end of strip #5. Strip #1 was the uppermost strip, and strip #5 was the lowermost strip.

Except for the strain gauges near the back facing of the wall panels (5-T-1, 5-B-1, 5-T-2, and 5-B-2), the strain gauge measurements on strip #5 became larger than  $2 V_{out}/V_{exit} \times 10^{-3}$  after 12:30 on September 29 (placement of the first LCC layer was finished at 15:40 on September 28). In addition, LCC temperatures near the wall panels were much lower than temperatures far from the wall panels, indicating that the high LCC temperatures may have damaged the strain gauges near the middle of the LCC mass, resulting in abnormal readings. Strain gauge damage also occurred on strips #1 through #4 (in the middle of the LCC mass); their readings were invalid because they exceeded  $2 V_{out}/V_{exit} \times 10^{-3}$ . Overall, almost all the strain gauges at locations 2–5 on the five strips displayed abnormal readings immediately following LCC placement, so only the readings of strain gauges near the wall panels (i.e., location 1) were considered valid.

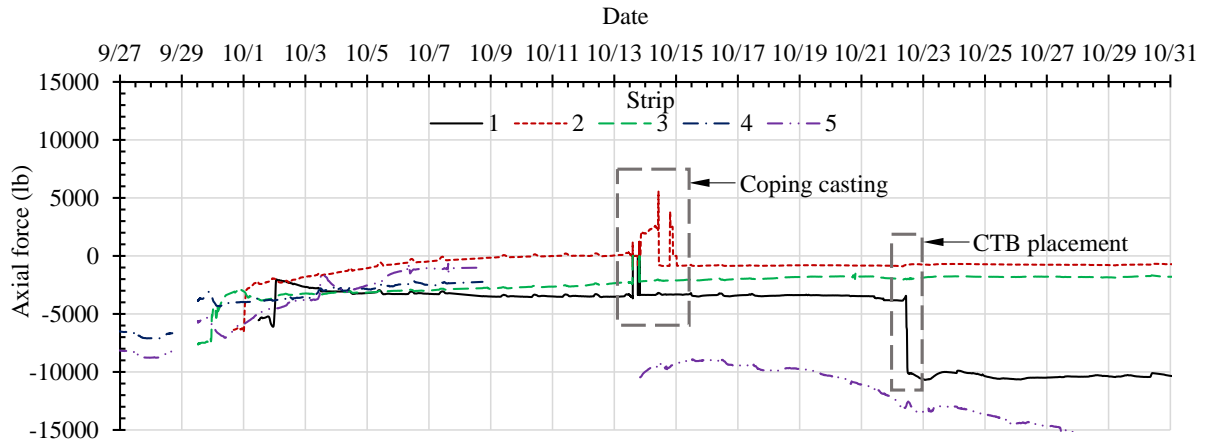
(a) Axial Force

(b) Moment

Figure 4.6 shows changes of axial force and moment at the front ends of each strip (location 1) over time.

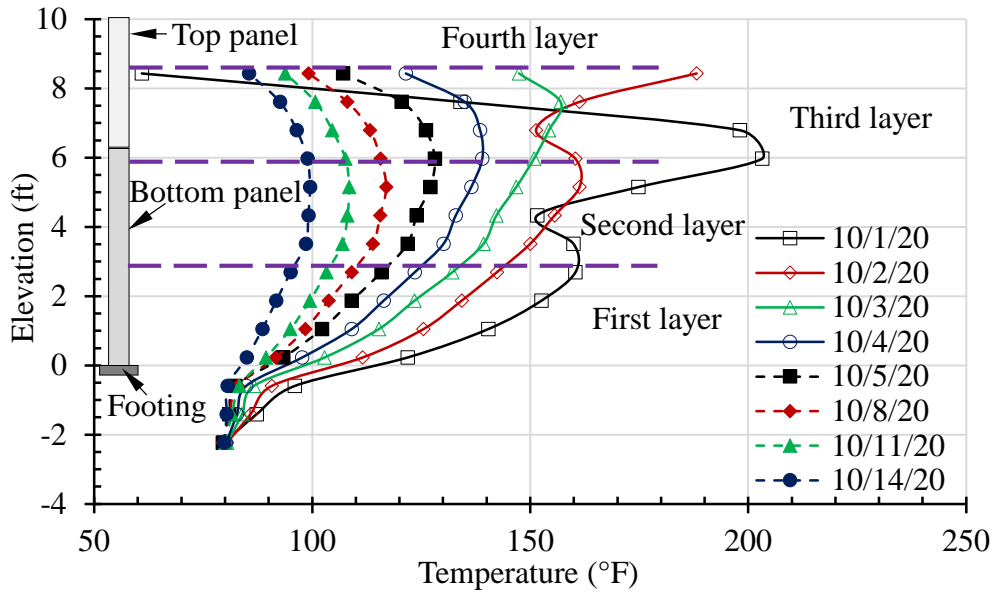
(a) Temperature Right Behind Wall Facing

(b) Displacements Perpendicular to Wall Facing

The vertical shape array was removed before 10:00 on October 14, 2020, prior to casting of the coping. Figure 4.7 shows deformations of the vertical shape array directly behind the wall panels at 00:00 (midnight) relative to the position of the array at 00:00 on October 3 and temperatures measured by the vertical shape array at 0:00 on various dates. From October 3 to October 14, temperatures within elevations from -0.5 ft to 8.5 ft decreased over time at a decreasing rate. After October 5, however, temperatures behind the wall panels increased from the -0.5 ft elevation to 5.25–5.90 ft elevations and then decreased with additional elevation. Due to temperature reduction over time starting on October 3, LCC contraction caused movements of the vertical shape array away from the wall panels, as shown in Figure 4.7.

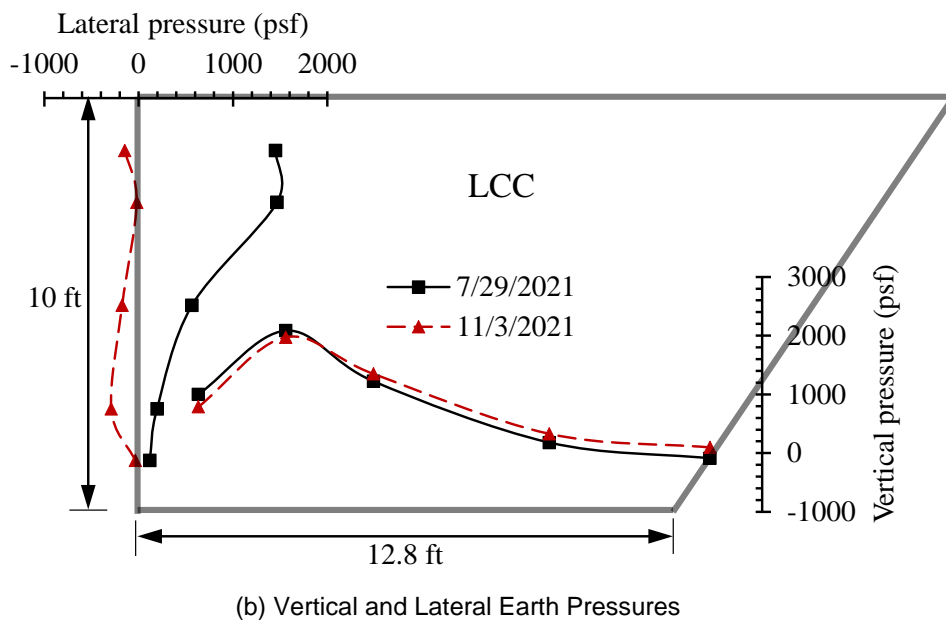
Figure 5.8: (a) Temperatures and (b) Pressures at 0:00 on July 29 and November 3, 2021

From July 14 to November 5, 2021, the highest daily air temperature was 88.0 °F on July 29, while the lowest daily air temperature was 40.6 °F on November 3. Figure 5.8 shows earth pressures and temperatures at 0:00 on these two days.

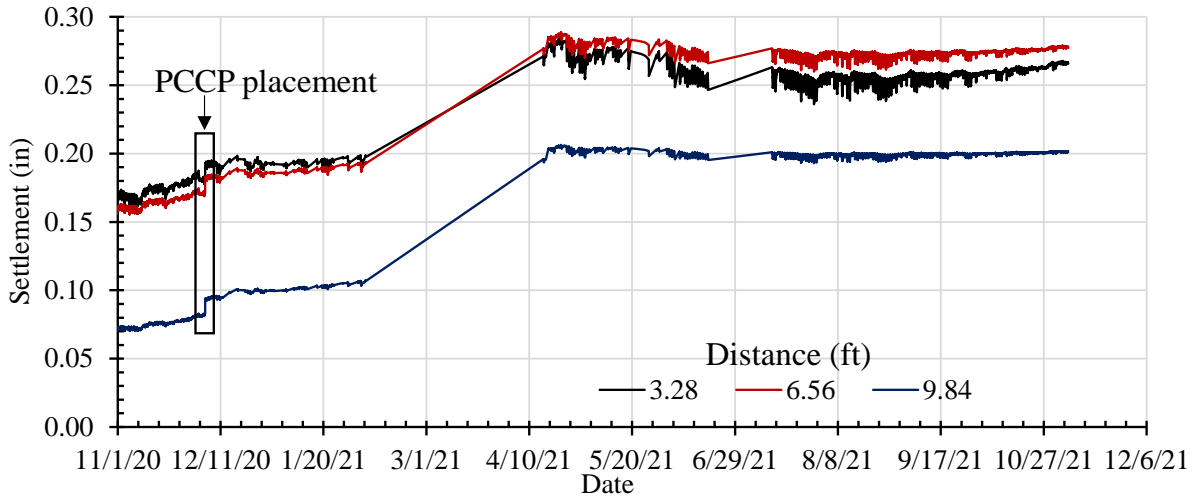
(a) Temperatures

(b) Settlements

**Figure 5.9: (a) Temperatures and (b) Settlements of LCC Measured by Shape Array**

Figure 5.9 shows temperatures and settlements (11:00–12:00 on September 28, 2020) measured by the shape array at distances of 3.28, 6.56, and 9.84 ft from the wall facing. Figure 5.9 shows that placement of the PCCP layer on December 2, 2020, induced minimal additional settlement, while Figure 5.10 shows settlements measured by the shape array before LCC placement. Since the LCC during placement was in slurry form, placement of the first LCC lift caused repositioning of the horizontal shape array, which may have caused the wavy settlement curves in Figure 5.10. The slight settlement increase from November 15, 2020, to January 17, 2021, was caused by the PCCP placement, while the settlement increase from February 3 to June 10, 2021, may have been induced by traffic loading or consolidation of the ground soil.
