IN-SERVICE PERFORMANCE EVALUATION OF KDOT'S CABLE MEDIAN BARRIER

MIDWEST ROADSIDE SAFETY FACILITY

KANSAS DEPARTMENT OF TRANSPORTATION

MwRSF Research Report No. TRP-03-436-20

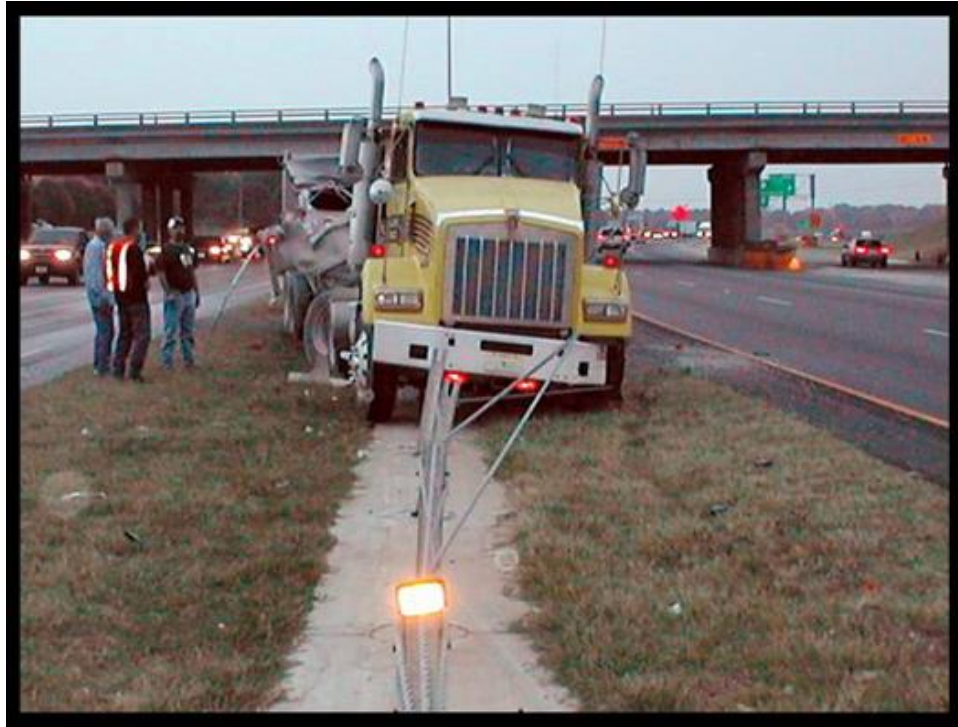
Figure 5. Large Truck Stopped by Cable Median Barrier System in Oklahoma [20]

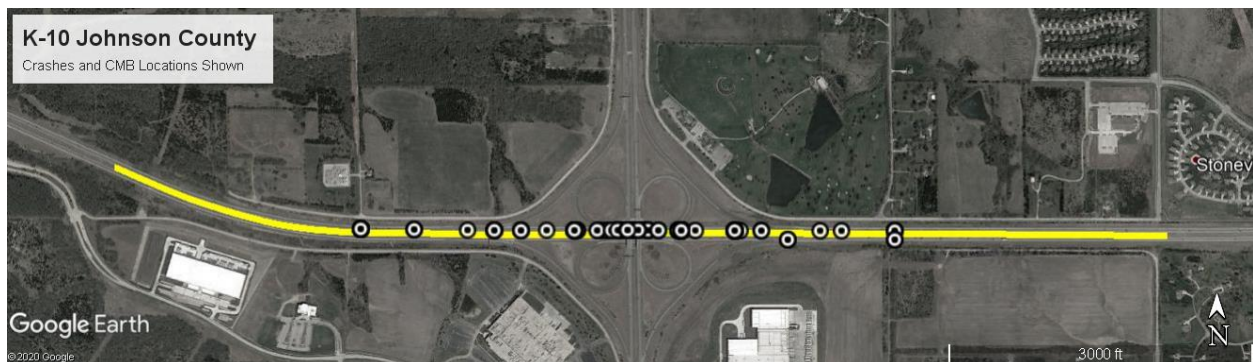
Figure 13. CMB Crashes on Kansas K-10 Roadway in Johnson County

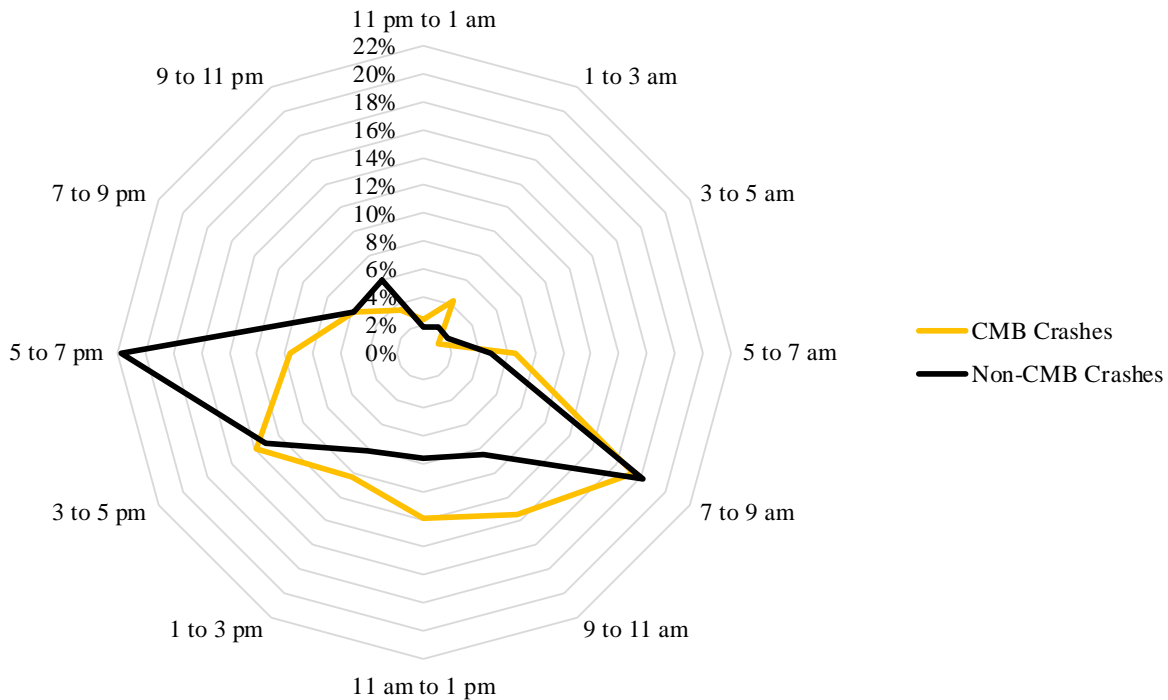
The reported time of the crash was also plotted using a “radar plot,” as shown in Figure 21. For both crashes involving CMB and non-CMB crashes, the number of crashes declined significantly after 7 pm, and peaked between 7 and 9 am and 5 to 7 pm. Approximately 67% of all crashes involving CMBs occurred between the hours of 7 am and 5 pm, compared to 56% for non-CMB crashes. Moreover, non-CMB crashes peaked between 7 and 9 am (18.2%) and 5 to 7 pm (21.8%); approximately 35% of all non-CMB crashes occurred between 3 and 7 pm and approximately a sixth (16%) of all non-CMB crashes occurred between 5 and 6 pm. Results indicate that during peak traffic hours, crashes were more likely to occur and fatigued drivers in the late afternoon were more likely to be involved in a crash.

Figure 21. Crash Time: Crashes Involving CMB and Non-CMB Crashes

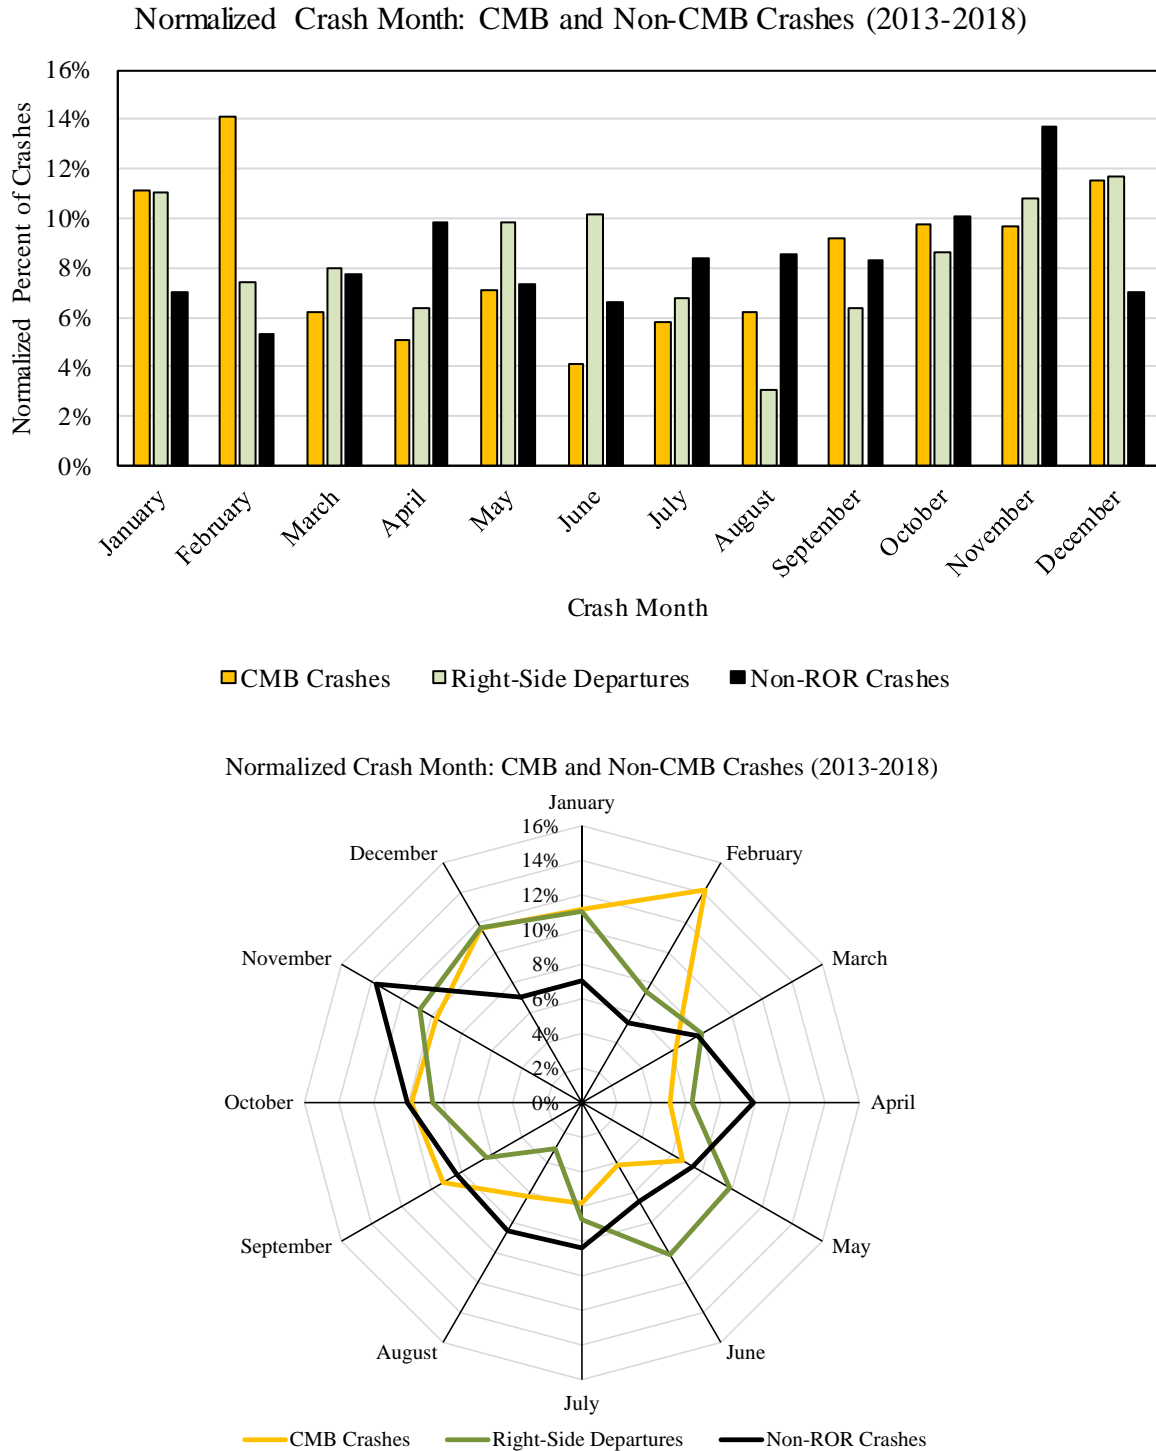
To further examine if the crashes involving CMBs were unique compared to other ROR crashes, the distributions of crash months for CMB crashes, right-side ROR crashes, and non-ROR (on-road only) crashes were compared. Results indicated that ROR crashes were much higher for both right- and left-side departures during December and January and were similar to left-side ROR, CMB crashes. Surprisingly, right-side ROR crashes were significantly less common during the months of August and September. The non-ROR crashes were again highest during October and November, with another peak in April. Non-ROR crashes (as a percent of total) were also surprisingly low for winter months of December, January, and February, even as the total number of crashes during that time period increased. No other major patterns or observations with respect to crash date were identified.

Figure 24. Crash Month: CMB Crashes, Right-Side Departure, and Non-ROR Crashes
