Automated Vehicle and Pavement Marking Evaluation in Connecticut

Final Report

CT-2326-F-23-5

Connecticut Transportation Institute

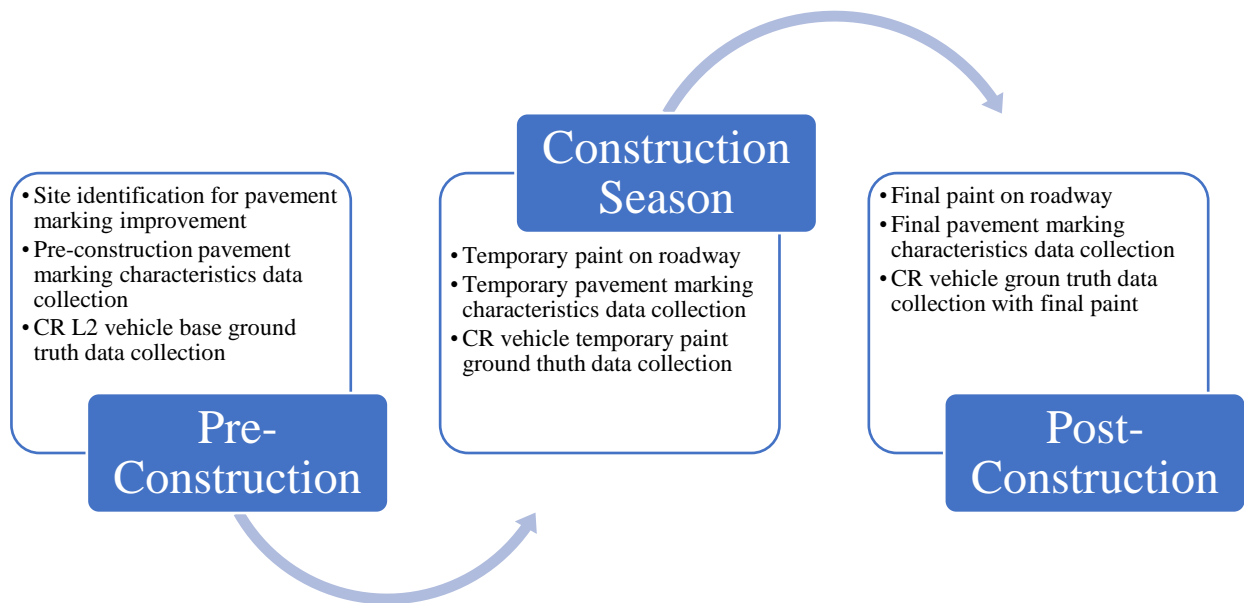
The team developed a data collection plan to achieve the objectives of this study as outlined in Figure 3-1. Two types of data were mainly collected in this study: pavement marking characteristics (retroreflectivity, width, color, contrast) and on-road ground truth data of ADAS pavement lane marking detection. Consumer reports was responsible for on-road data collection using a variety of vehicles that were representative of the most commonly commercially available, Society of Automotive Engineer (SAE) Level 1 and 2 vehicles on the market with lane detection capabilities. UConn was tasked with the collection of pavement lane marking characteristics data using a retroreflectometer for the proposed study collection route pre, during, and post updating of lane markings. The UConn team was responsible for data processing and analysis of the video data collected by CR. More details regarding video data processing and analysis are presented in Chapter 4 and 5.

Figure 3-1: Data Collection Plan.

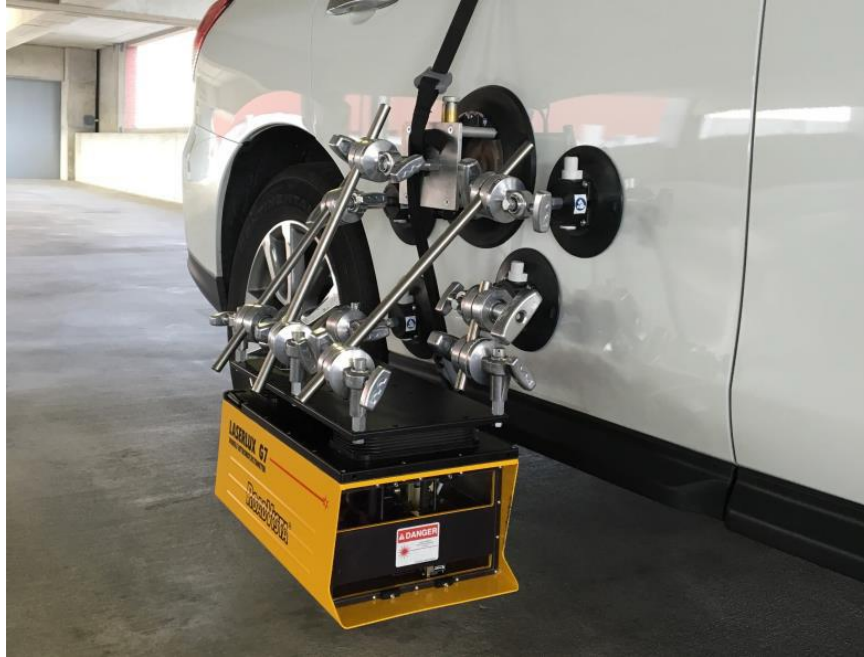
The LLG7 quickly and easily attaches to almost all vehicles with the Squid Mount™ Vacuum Cup mounting system. When deployed properly, each one of the supplied 6" (15cm) vacuum cups are rated to hold 70 lbs. (31.8 kg) and the 10" (25cm) vacuum cups are rated to hold 175 lbs. (79.5kg). The 10" (25cm) cups also come with audible alarms to warn of vacuum leaks. An illustration of LLG7 mounted to a vehicle using the provided vacuum cup is provided in Figure 3-3.

Figure 3-3: LLG7 Mounted to a Vehicle using the Squid Mount™ (Austin & Schultz, 2020).

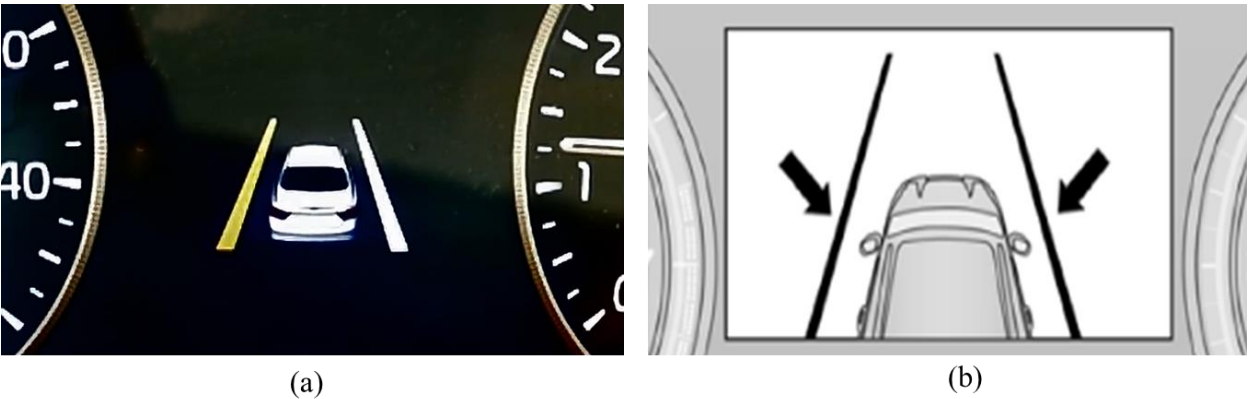
The ADAS feature that detects pavement lane line marking displays basic safety messages on the instrument cluster in front of the driver. The basic safety messages are often displayed as visual cues to provide feedback to the driver about the detected lane markings and the vehicle's position within the lane. A qualitative layout of the lane marking detection-related visual cue used in vehicles is presented in Figure 4-3 (Jeep Grand Cherokee, 2022).

Figure 4-3: A Qualitative Layout of Lane Marking Detection-Related Visual Cue; (a) Only Left Lane Detected, (b) Both Lanes Detected (Jeep Grand Cherokee, 2022).

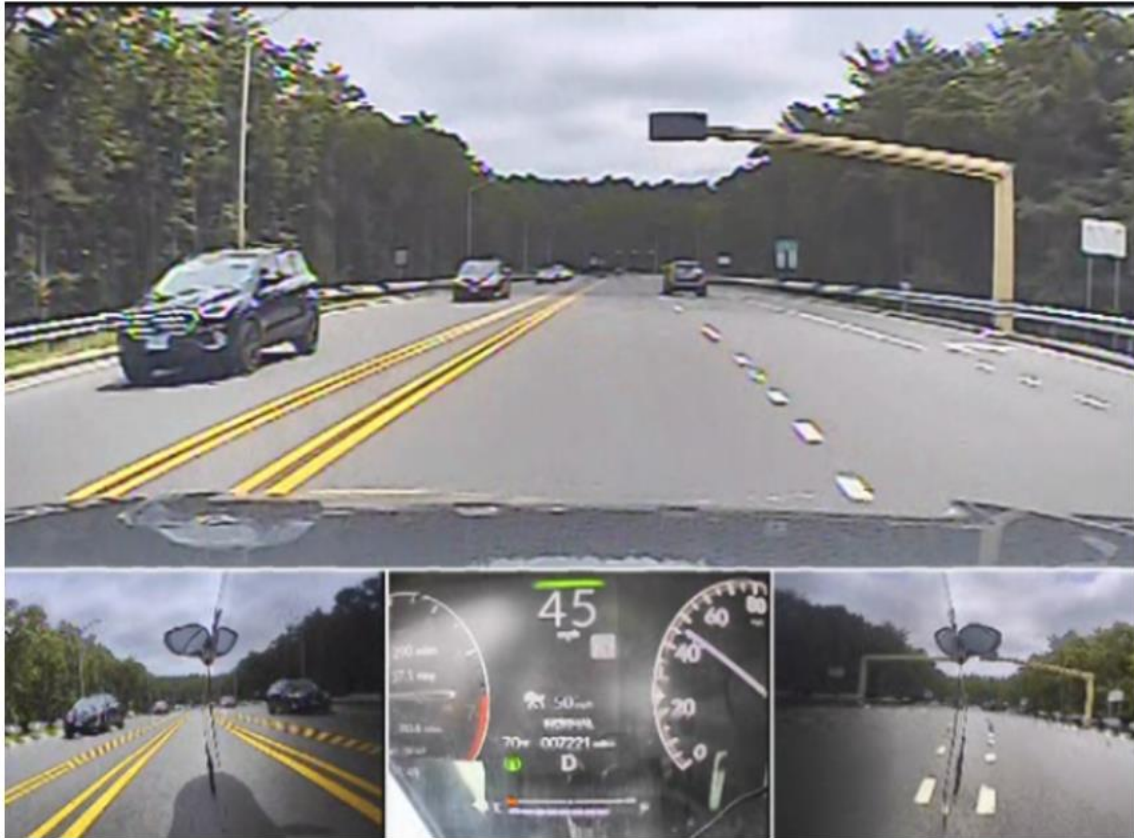
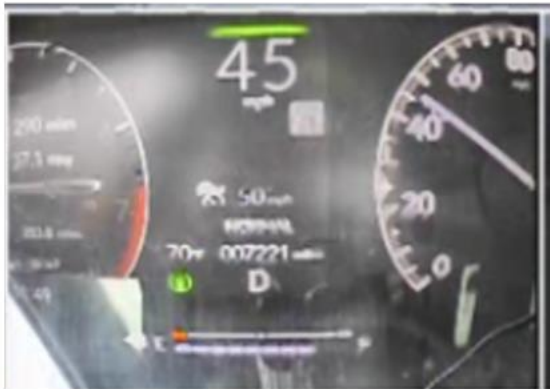
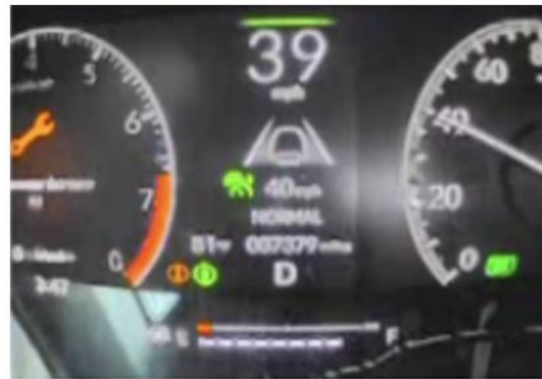
Vehicle 1: Vehicle 1 displays filled white lines on the dashboard as soon as the system recognizes the road markings. The LKAS indicator changes from white lines to green lines once the system starts operating after detecting the left and right lane markings. When lane markings are not defined, there are no lines on the dashboard. Lane departure (lane entry) indication is displayed with an amber line. Refer to Figure 4-5.

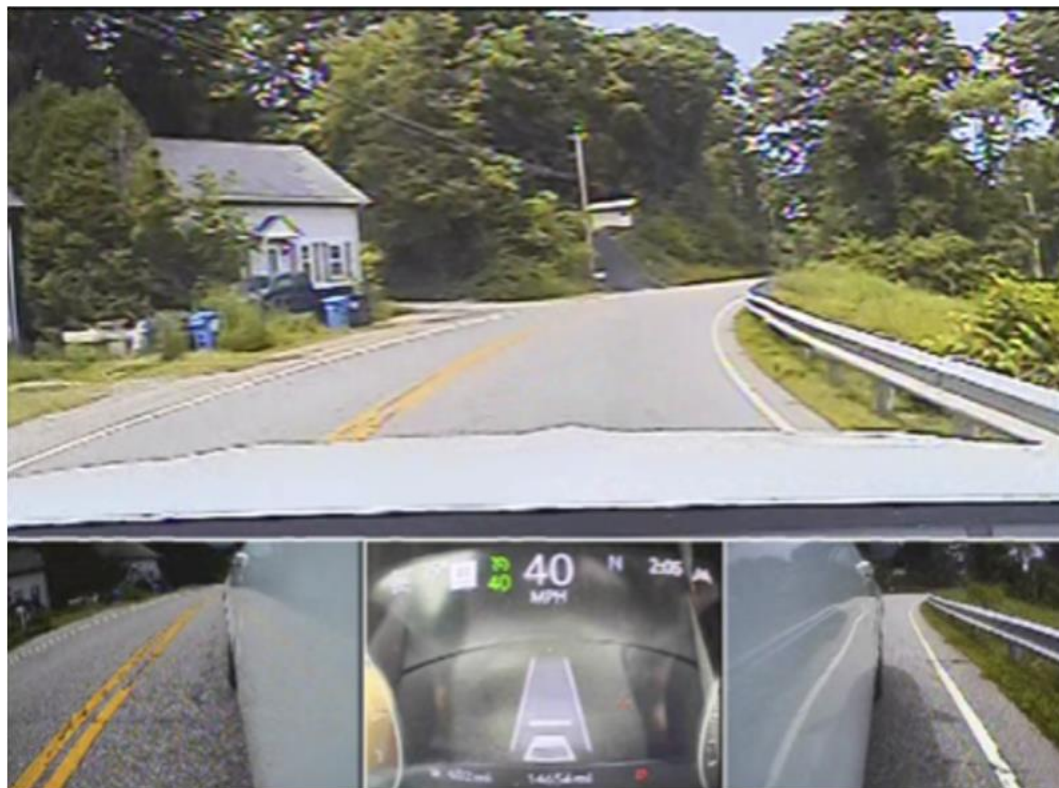
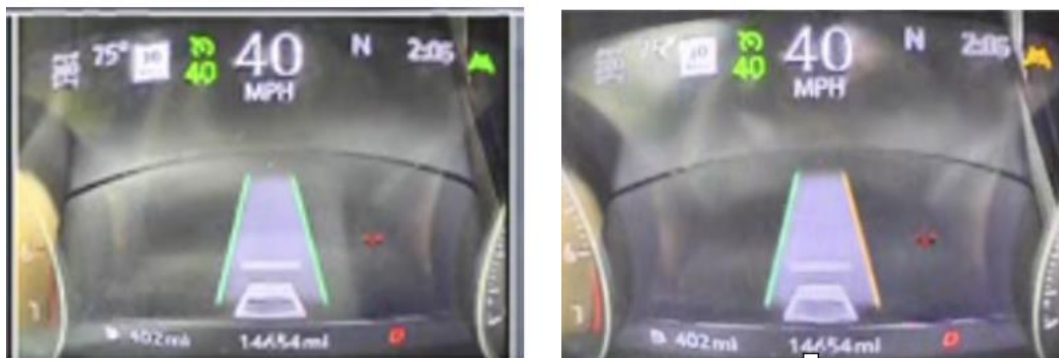
line is detected. The lane departure warning is also indicated with an orange indicator. Refer to Figure 4-6.

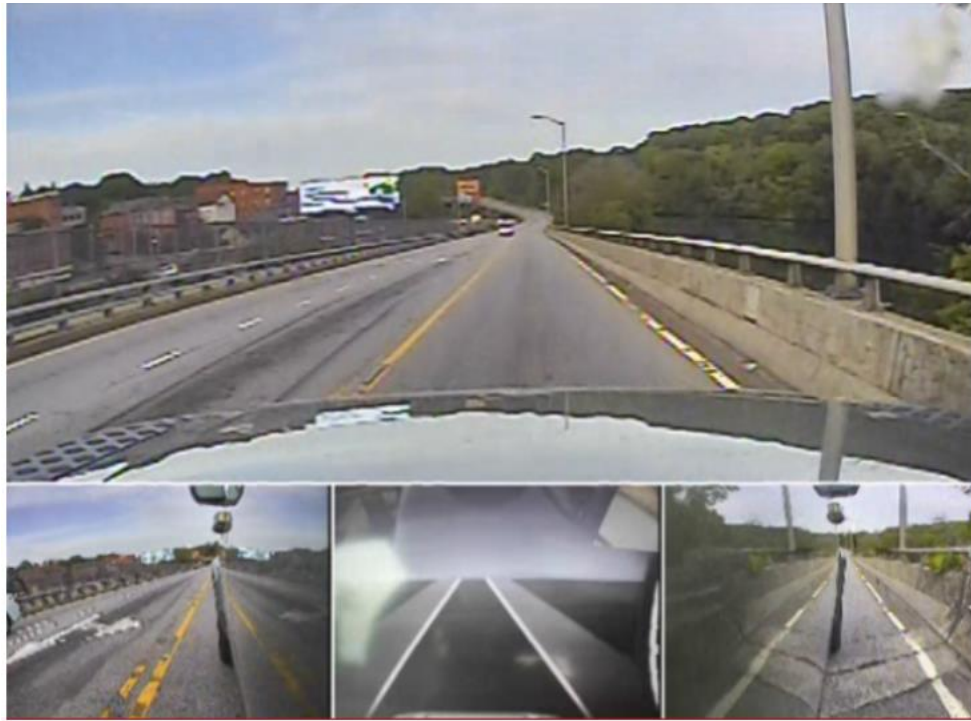
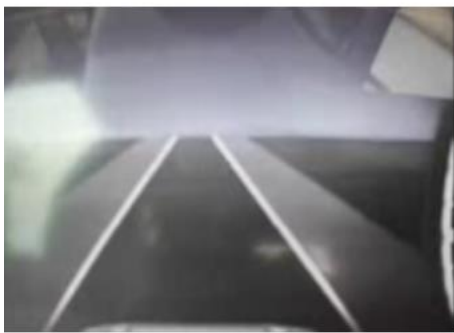
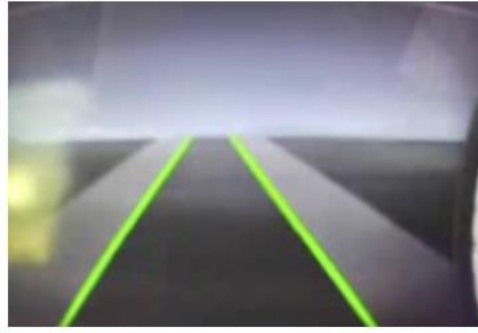
the markings, the lines on the dashboard change to green. Additionally, lane departure (lane entry) indication is displayed with a red line. Refer to Figure 4-7.

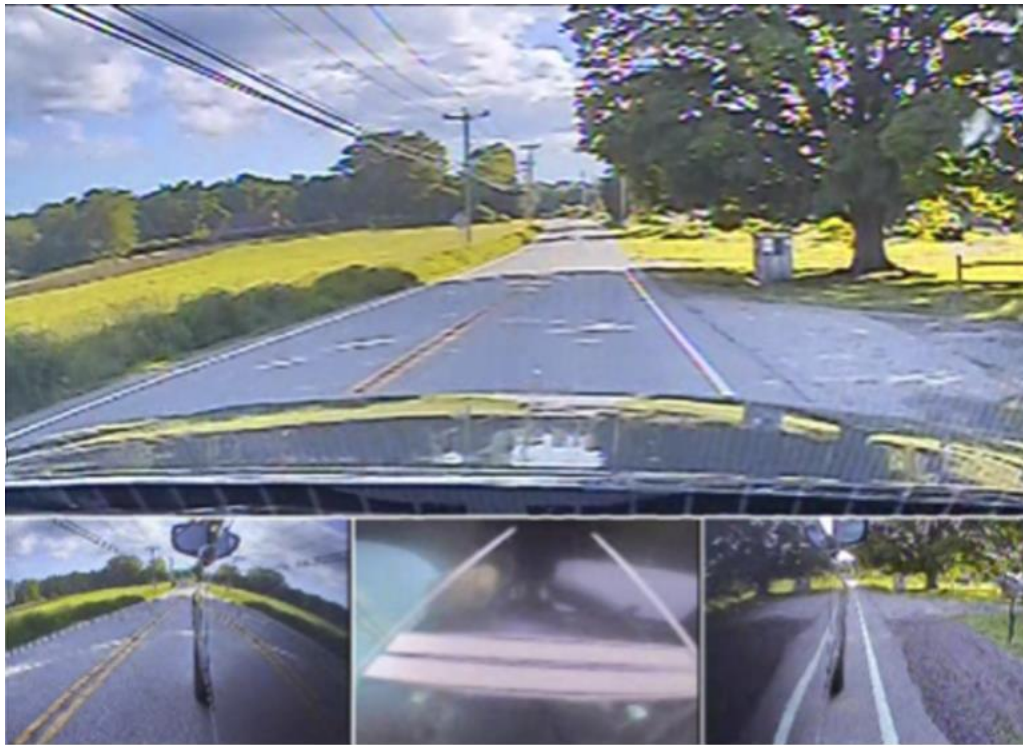
Vehicle 4: Vehicle 4 displays white lines on the dashboard as a layout for presenting lane marking detection. As the line detection system activates and the vehicle accelerates to its activation speed, the lines on the dashboard change color to green. The indication of the lane departure system is implemented using animated lane movement on the monitor. Additionally, on the side where the marking is carried out, the line on the dashboard acquires a yellow color. Refer to Figure 4-8.

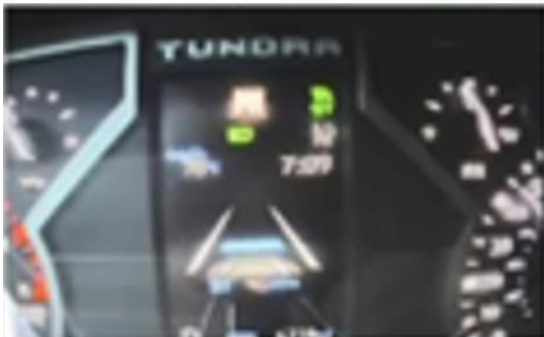
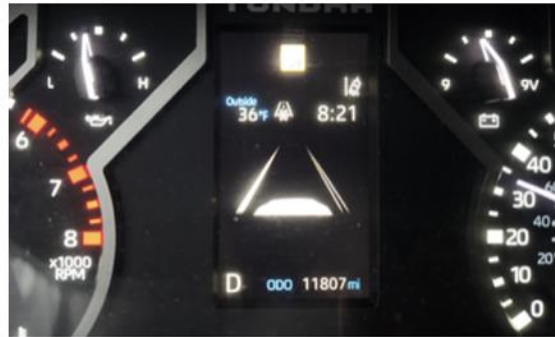
Vehicle 5: The display of Vehicle 5 shows solid white lines when the road markings are defined. When the markup definition is lost, the line on the dashboard disappears. If the vehicle leaves the lane, the white lines on the dashboard flash with orange color), which lasts three seconds. Refer to Figure 4-9.

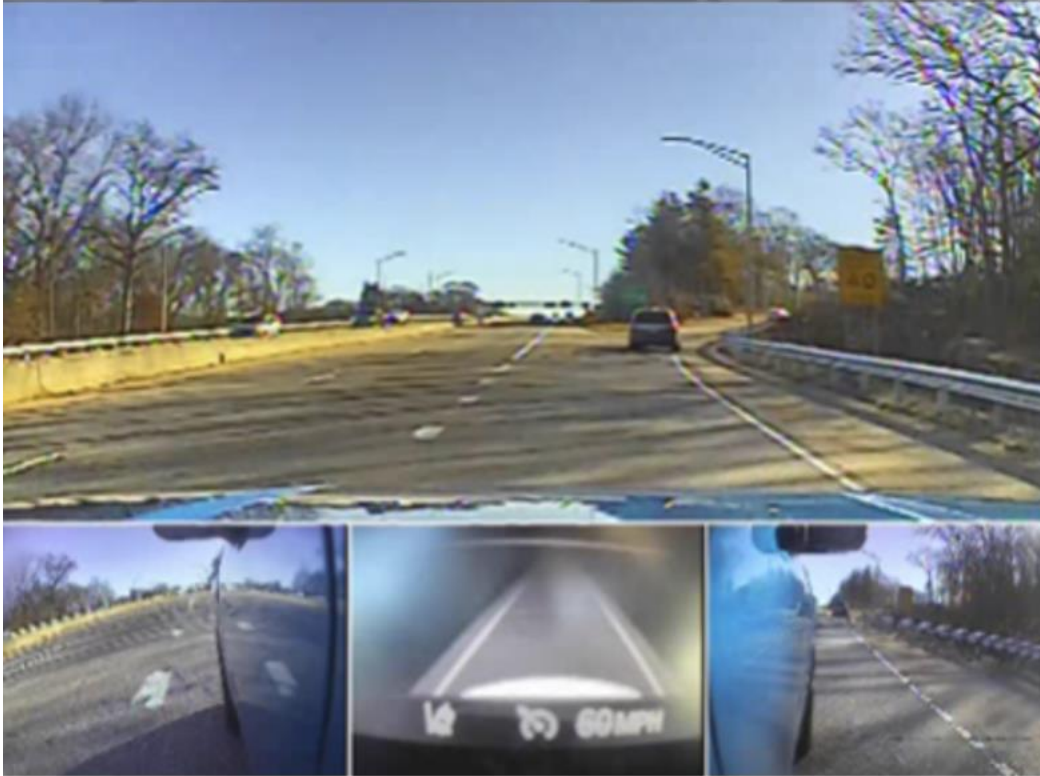
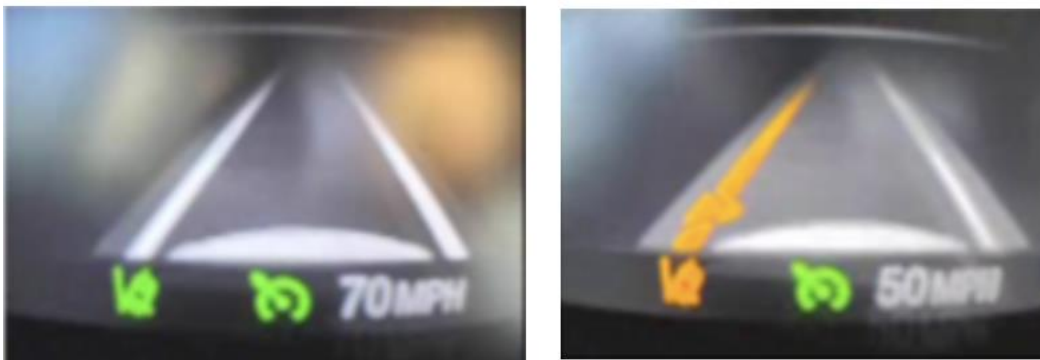
Vehicle 6: The system uses different colors for lane markings to indicate its status: gray (thin lines) shows a temporary inability to warn or intervene, white (thick lines) means the system is available or ready to intervene, yellow signifies lane-keeping aid intervention, and red indicates a lane-keeping alert warning. Refer to Figure 4-10.

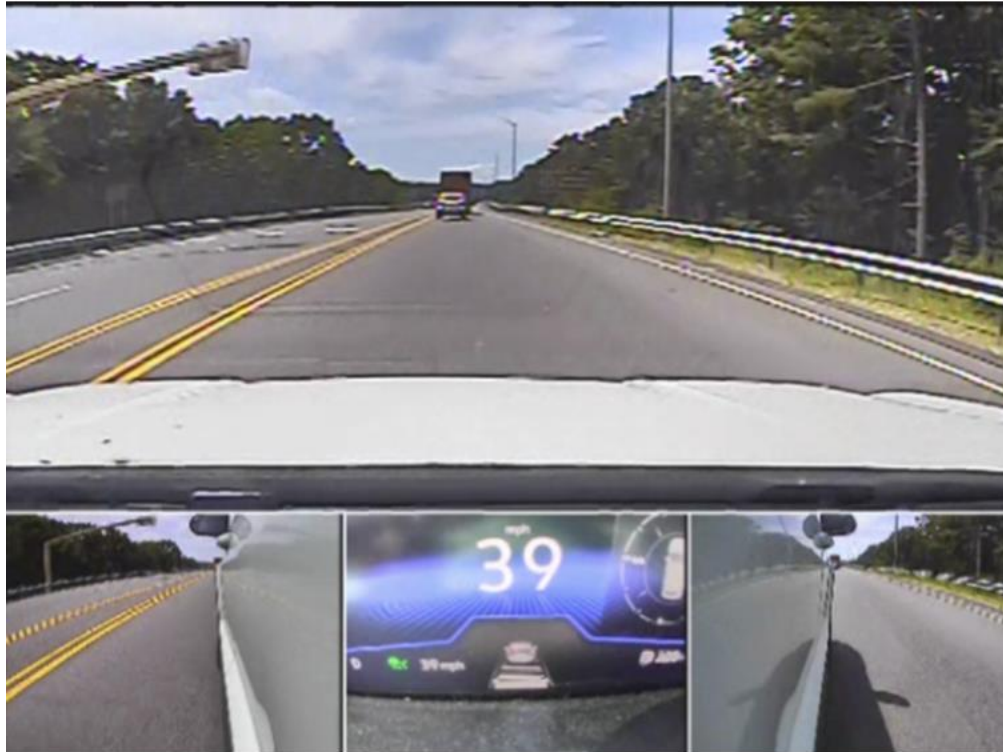
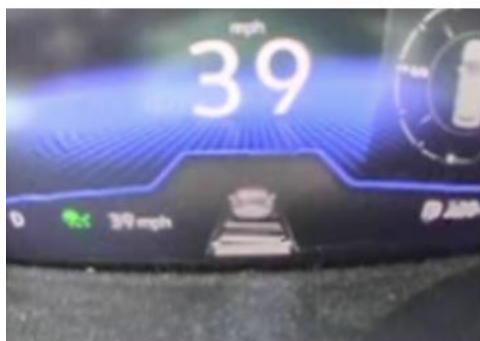
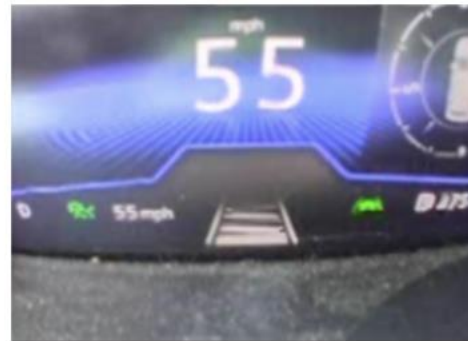
Vehicle 7: Car 6 shows thin gray lines before LKAS is activated and before any markings are detected. The indicator will turn white as soon as the system starts working after detecting the left and right lane markings. Lane departure (or lane entry) is indicated by a separate yellow indicator (depicting a car entering a road). Refer to Figure 4-11.

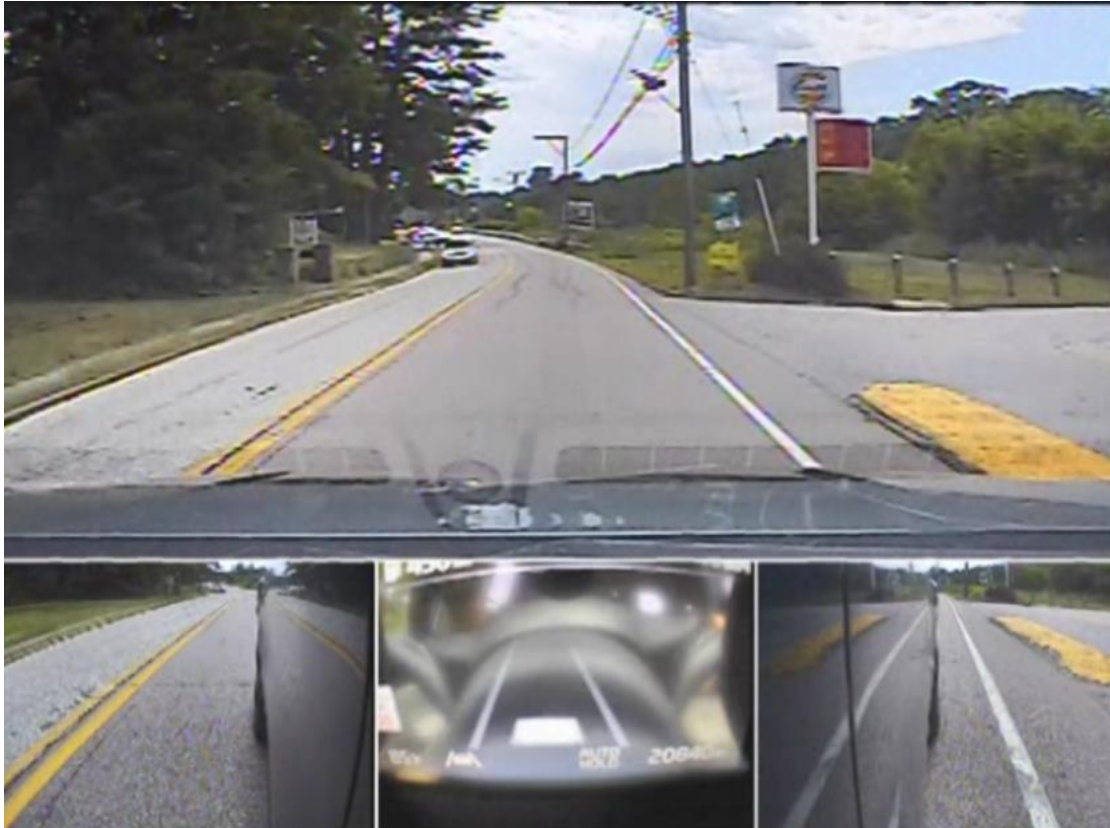
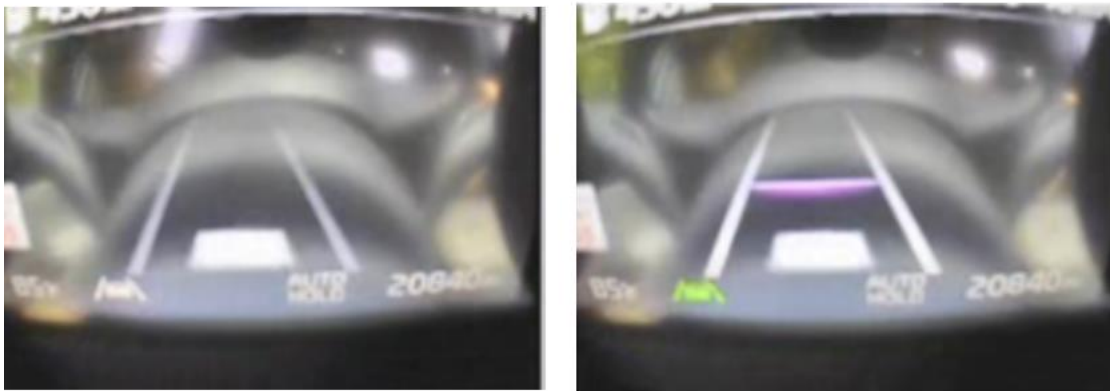
Vehicle 8: Detecting no road markings, the system displays faint, thin white lines on the screen. However, the user manual describes them as gray, while they appear white in the video. Once road markings are detected, the system slightly lengthens and thickens the lines. Lane departure (lane entry) indication is displayed with an orange line. Refer to Figure 4-12.

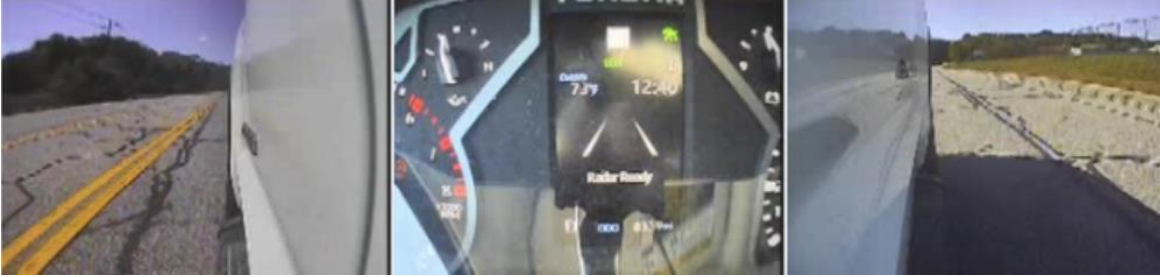
- There is little contrast between lane lines and the roadway surface;
- Driving on a road with temporary lane markings;
- Faint, multiple, or varied lane markings are visible on the roadway due to road repairs or old lane markings (Refer to Figure 4-13 and Figure 4-14);

Figure 4-14: Elements of Pavement Repair that are Perceived as Markings by ADAS.

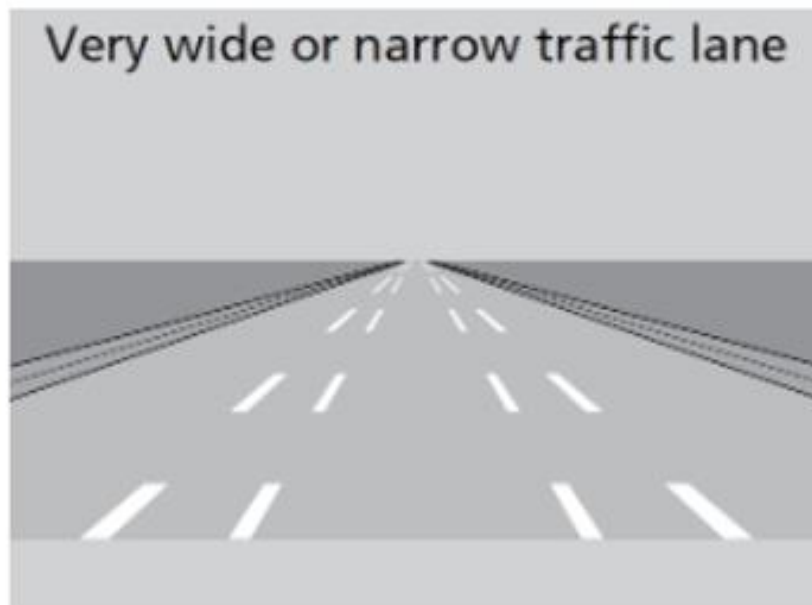
- The roadway has merging, split, or crossing lines, such as at an intersection or crosswalk;
- The lane markings are extremely narrow, wide, or changing (Refer to Figure 4-15);

Figure 4-15: Detection Issue with Very Narrow or Wide Lane Markings (Honda, 2022).

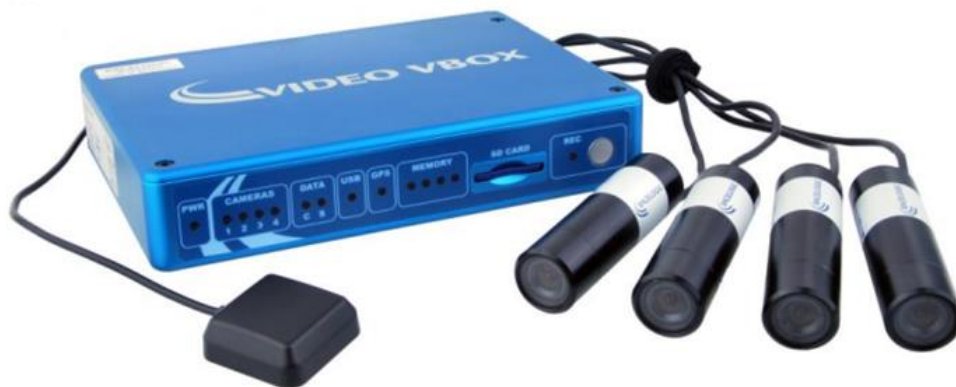
The Racelogic Video VBOX Pro (20 Hz) RLVD20P was used by CR team to collect ground truth data. The Video VBOX Pro (20 Hz) RLVD20P is a product developed by Racelogic, a company specializing in data logging and video recording solutions for motorsports and automotive testing. The Video VBOX Pro RLVD20P is a versatile data logging system designed to capture high-quality video and data from various sensors to analyze and improve driver performance, vehicle dynamics, and vehicle testing. The Video VBOX Pro is an advanced system that combines a high-quality multi-camera video recorder with a powerful GPS data logger and real-time graphics engine. A four-camera setup is used to collect data from the surrounding of the vehicle in the VBOX setup as indicated in Figure 4-17 (VBOX Automotive, 2022).

Figure 4-17: Video VBOX Pro (20 Hz) RLVD20P (VBOX Automotive, 2022).

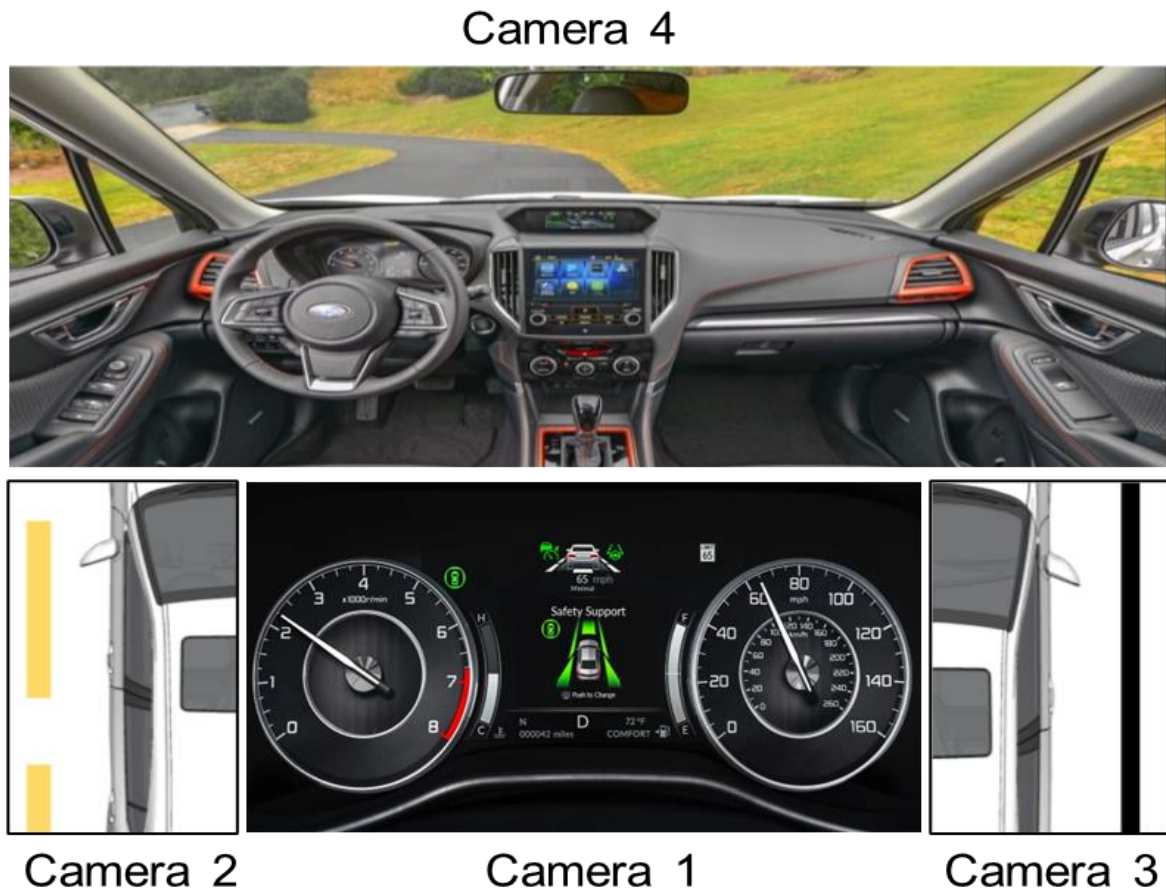
presented in Figure 4-18. As the ground-truth on the machine vision pavement lane line markings detection by vehicles with SAE Level 1 and Level 2 ADAS features are only available from the vehicle dashboard instrument cluster, a camera was installed to record the basic safety messages (lane line markings detected, lane line markings not detected, lane departure warnings) presented while conducting the test runs on real-world roadways. To validate the information from the vehicle dashboard instrument cluster on the pavement lane line detection, two (2) cameras were installed on bothsides of the vehicle to record the presence of pavement lane line markings. The 4th camera was used to record the driver’s point-of-view of the front of the vehicle.

Figure 4-18: VBOX Camera Setup Layout for Data Collection (MotorTrend, 2023).

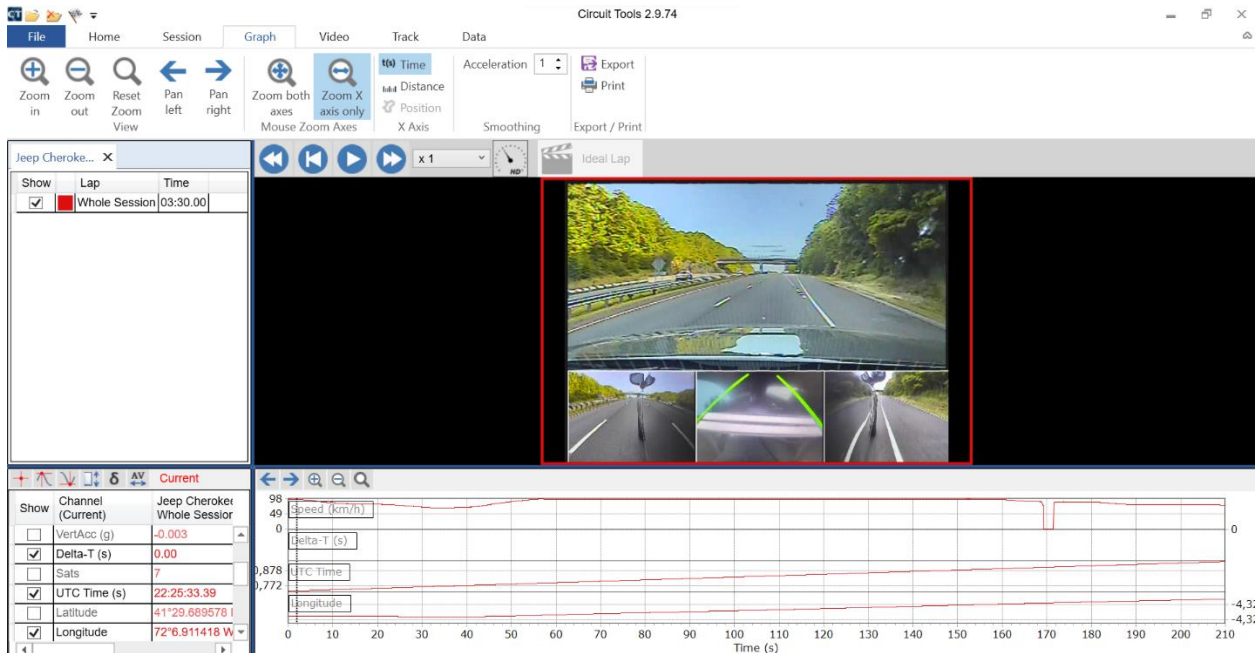
The data recorded by VBOX data logger can only be opened using VBOX Circuit Tools. The VBOX Circuit Tools is developed by Racelogic to assist in visualizing and comparing data collected using VBOX data logger from different test runs. A VBOX Circuit Tools user interface is provided in Figure 4-19.

Figure 4-19: Circuit Tools Interface.

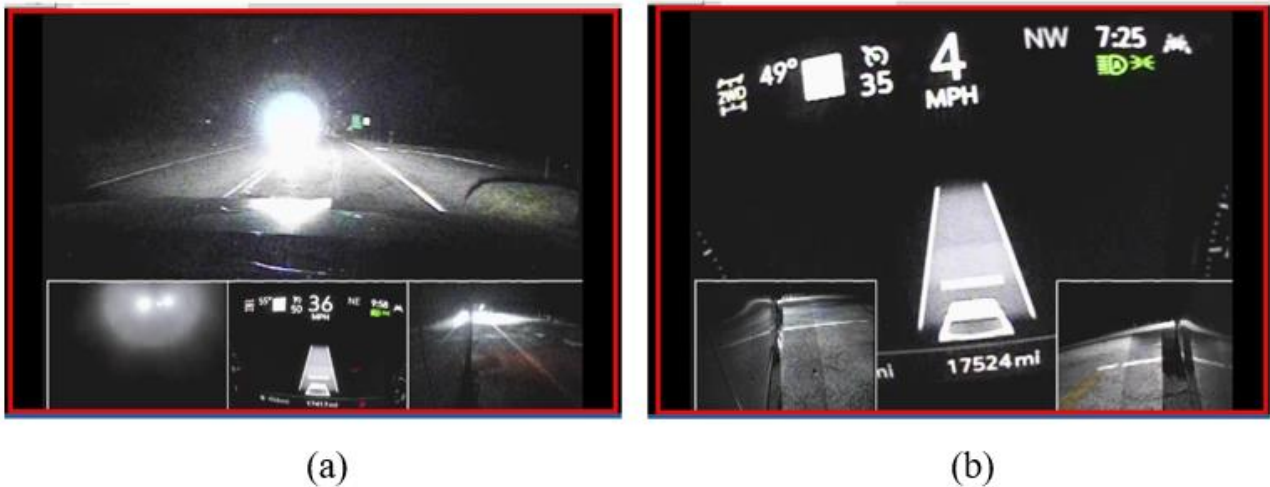
Figure 4-25: Screen Capture of Video Data (a) With and (b) Without Roadway View.

- **Camera Failure:** Due to camera hardware failures and supply chain issues relating to the replacement of a broken camera, the CR team had to utilize a three-camera setup instead of four in some test runs for ground truth data collection. There was a lack of video footage of the driver’s point of view of the roadway in these cases (refer to Figure 4-25). This absence complicated the interpretation of the traffic situation and hindered the ability to

identify the presence of markings during the video data processing. The displayed screen content only included the image from the side cameras and the dashboard view, omitting the overall road layout (Figure 4-25).

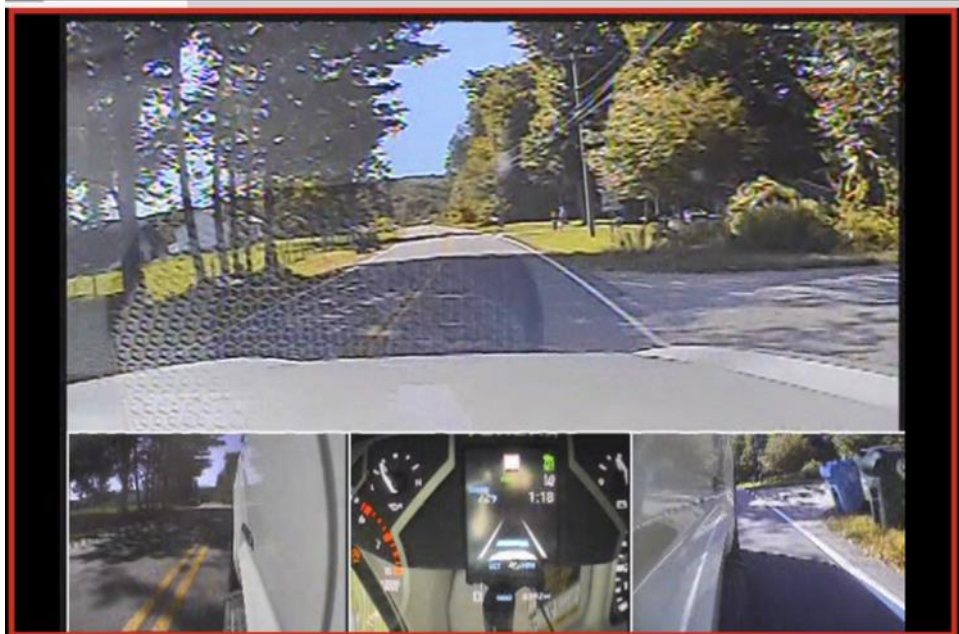
Figure 4-27: Screen Capture of ADAS Operating with Interruptions.

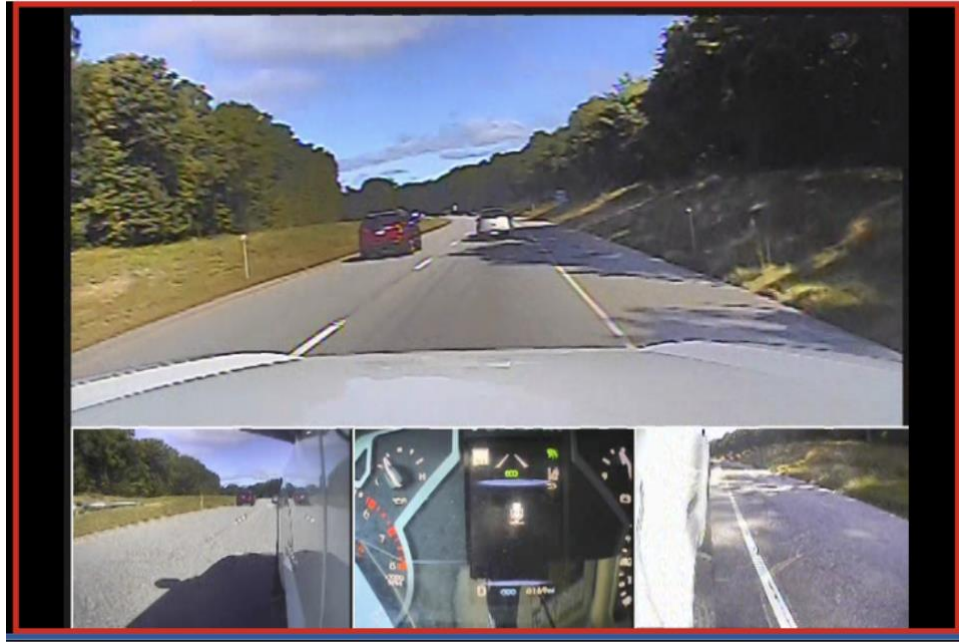
Figure 4-28: Lack of Necessary Information on the Dashboard.

lane marking detection by on-board ADAS features (Figure 4-28).

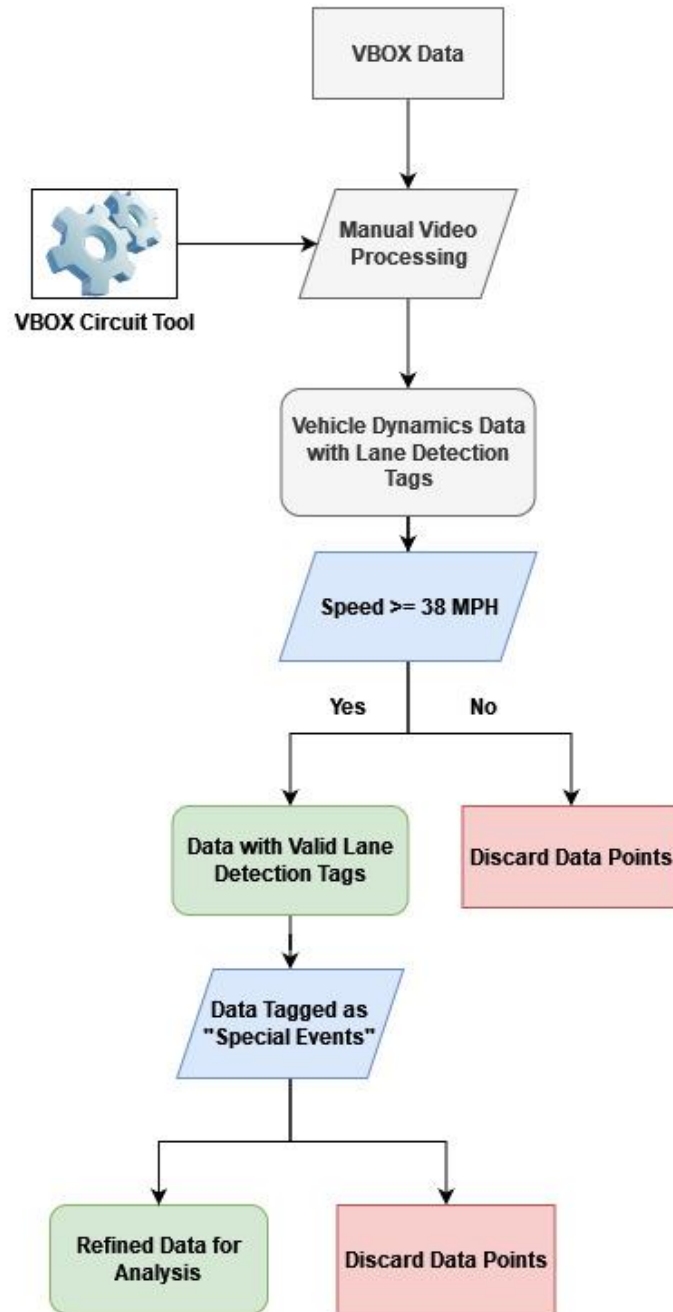
Once the raw data was manually processed by adding lane marking detection tags, the manually processed data was further processed to prepare the data for analysis. As indicated in the data processing steps, the activation of the pavement marking detection ADAS feature depends on the vehicle speed. Although all selected vehicles may have different threshold values for the activation of the onboard ADAS pavement marking detection feature, a common threshold value was selected that can be applied to all vehicles. Based on inputs from CR, a speed of 38 MPH was used as the pavement marking detection activation speed for all vehicles used to collect data in this study. A layout of the workflow to prepare the final dataset for analysis is provided in Figure 5-1.

Figure 5-1: Workflow for Final Data Preparation for Analysis.

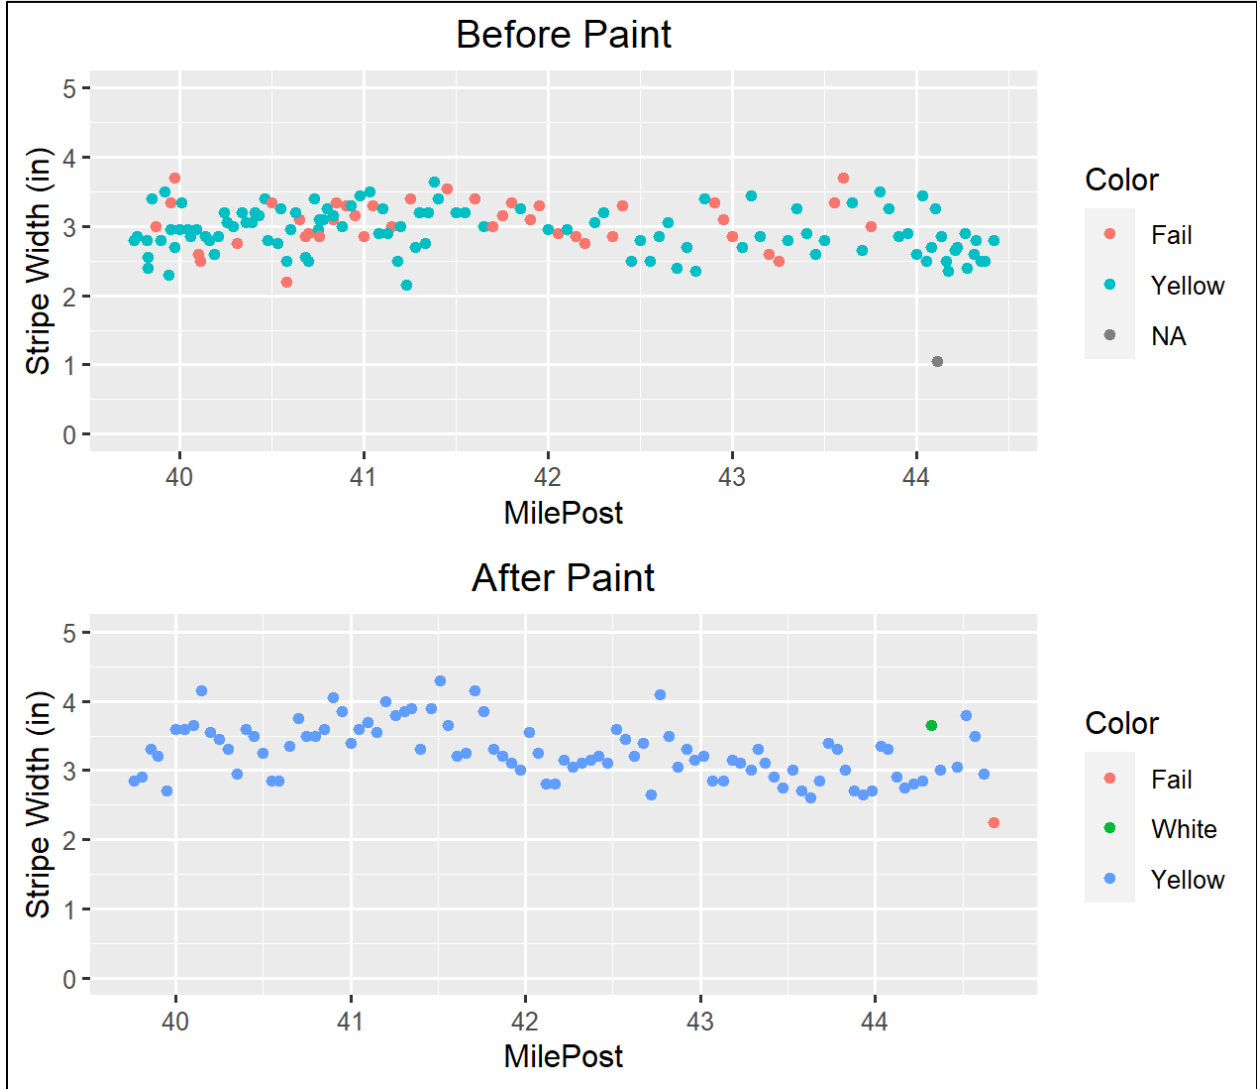
Figure 5-6: Comparison of Centerline Stripe Width and Color Distribution in Before and After Period on Route 12N_VIP_1201.

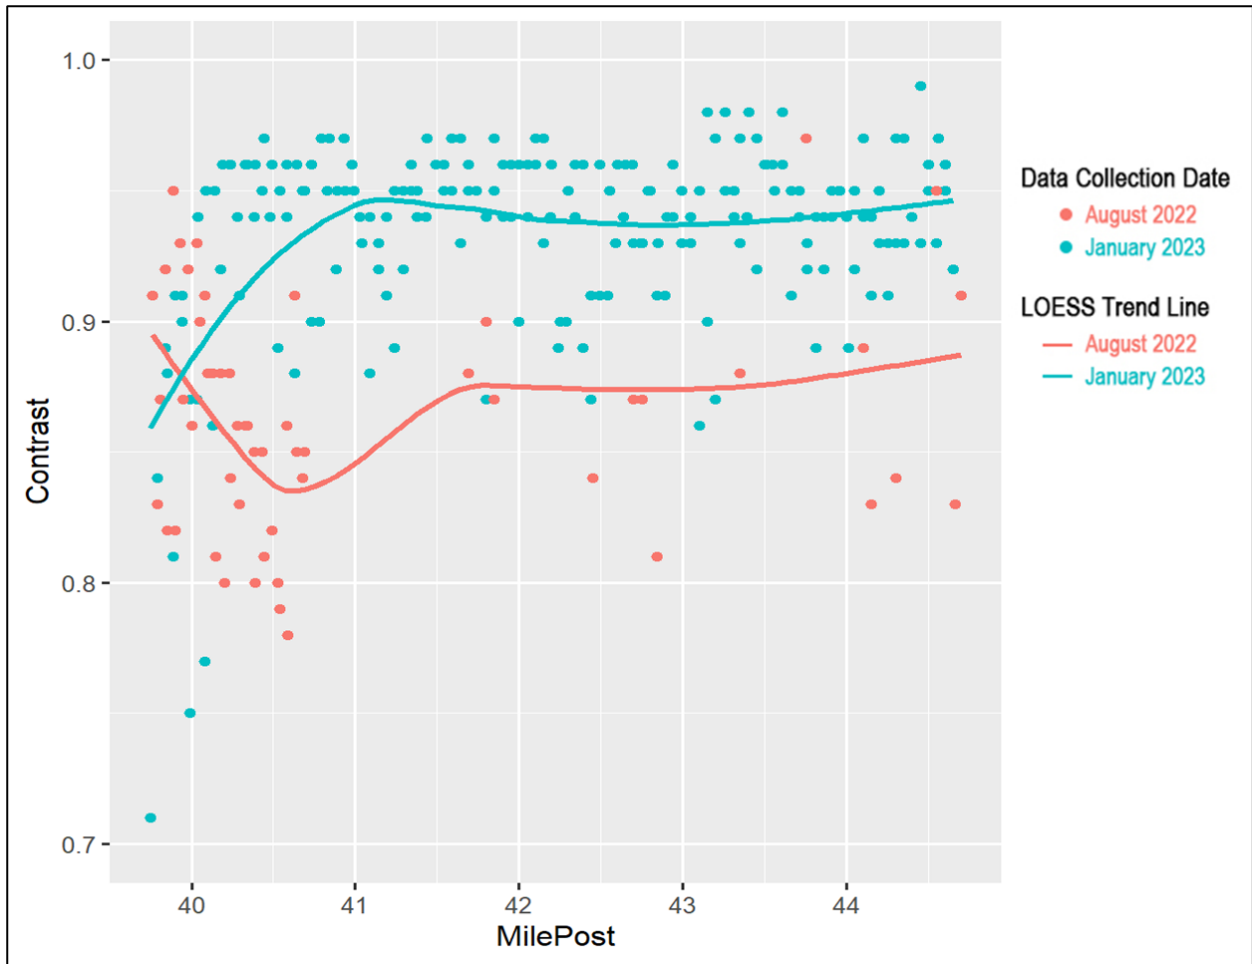
Figure 5-8 Comparison of Edgeline Contrast Distribution in Before and After Period for Route 12N_VIP_1201.

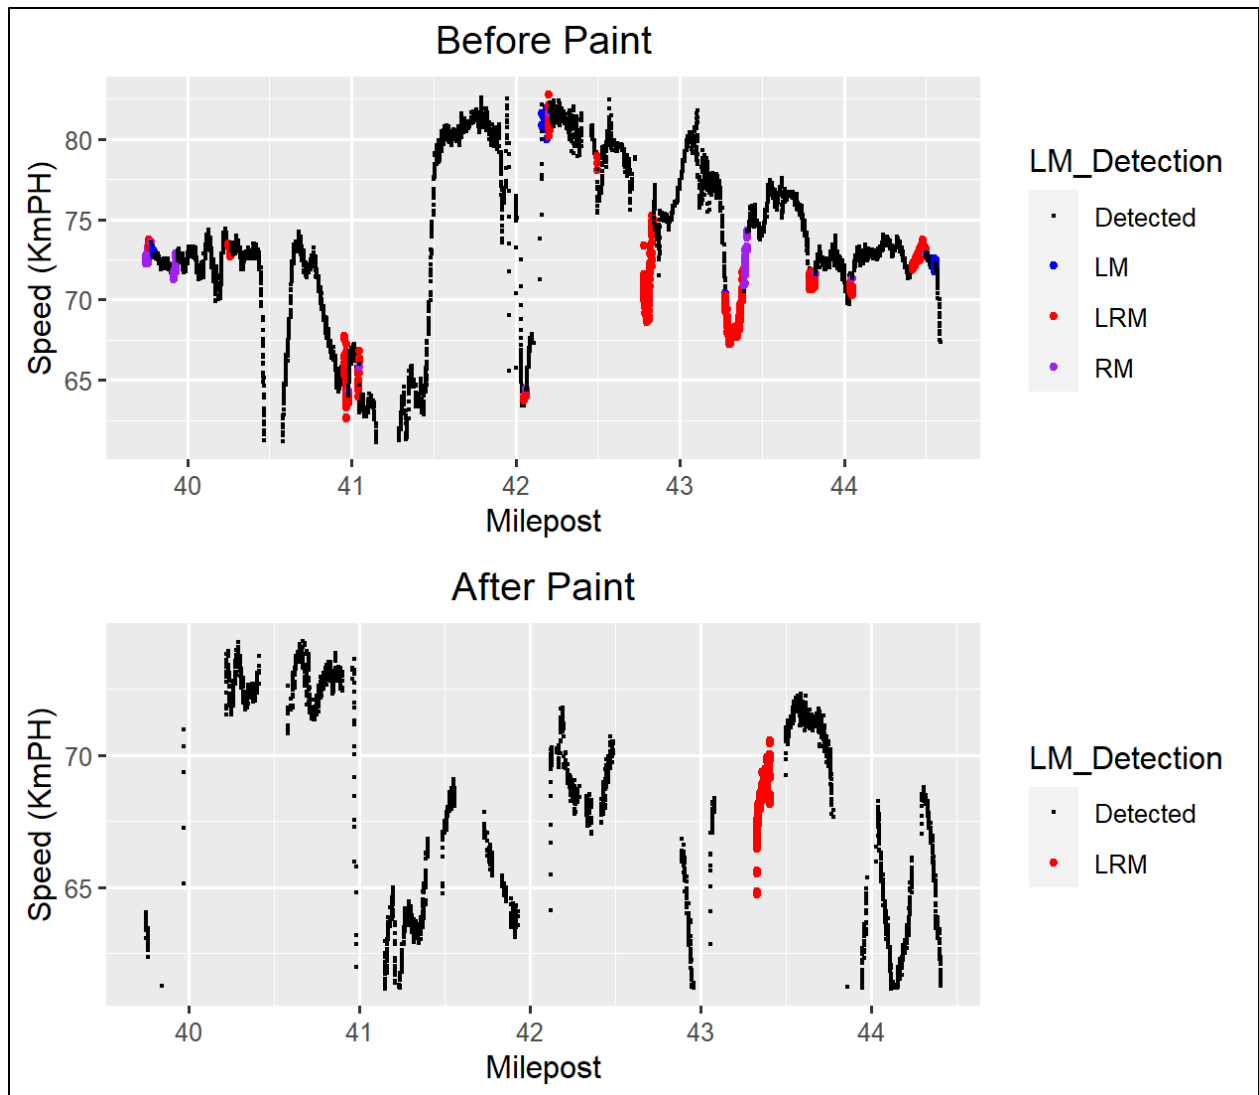
Figure 5-9: Comparison in Vehicle 2 ADAS Pavement Marking Detection in Before and After Period During Daytime on Route 12N_VIP_1201.
