Automated Vehicle and Pavement Marking Evaluation in Connecticut

Final Report

CT-2326-F-23-5

Connecticut Transportation Institute

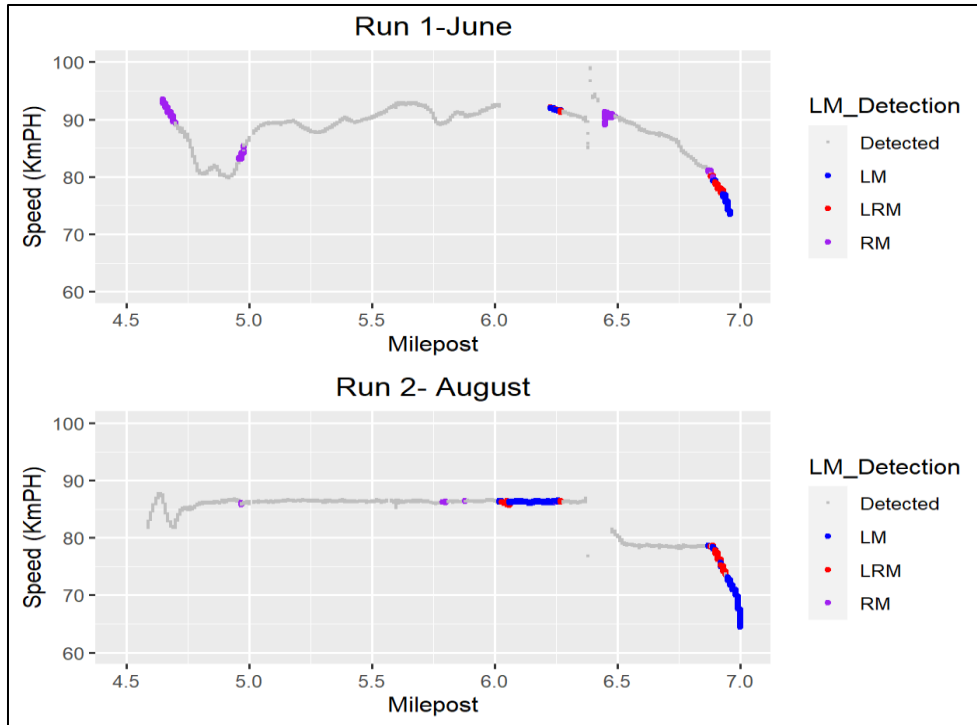
Figure 5-11: Distribution of Pavement Marking Detection Events for Two Consecutive Daytime Runs (Before Final Paint) on Route 2A-E_VIP_930 Site.

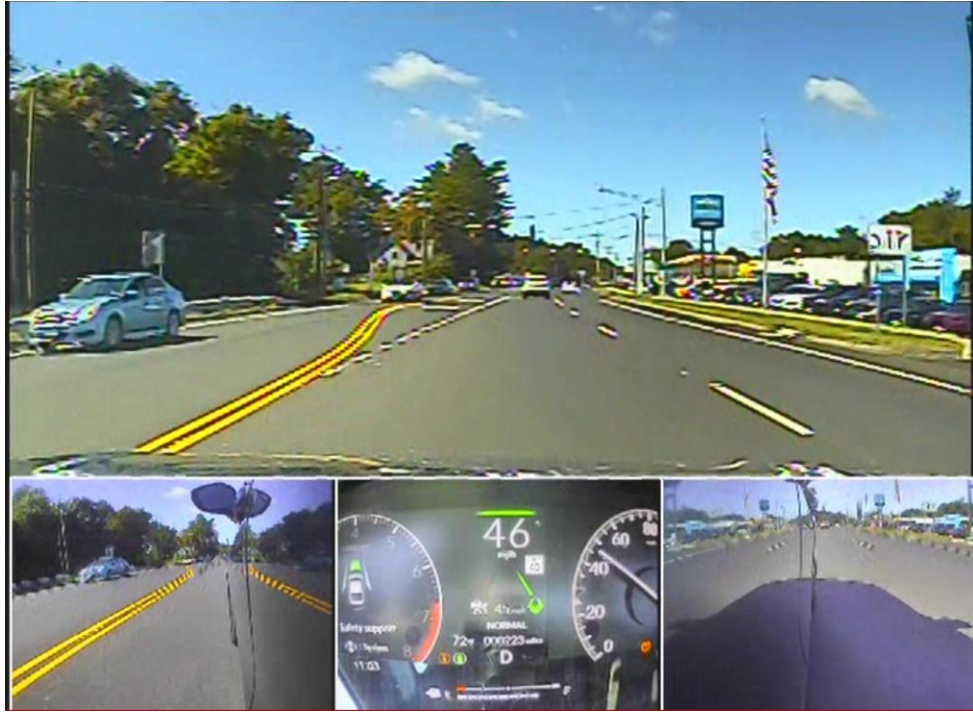
Figure 5-13: Failure to Detect Lane Marking with Changes in Marking Type and Color.

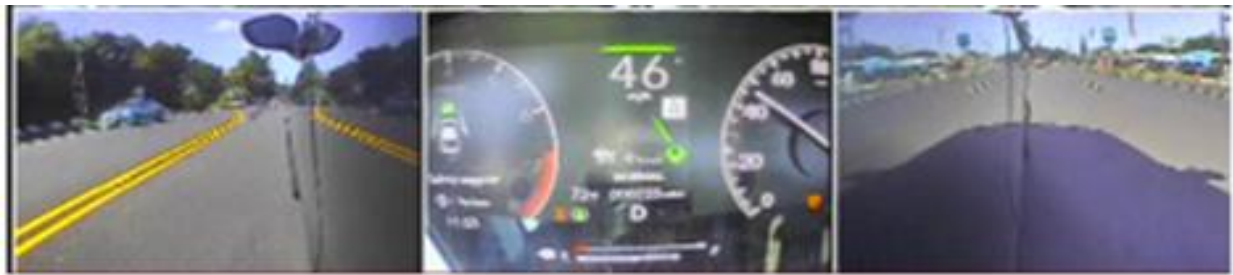
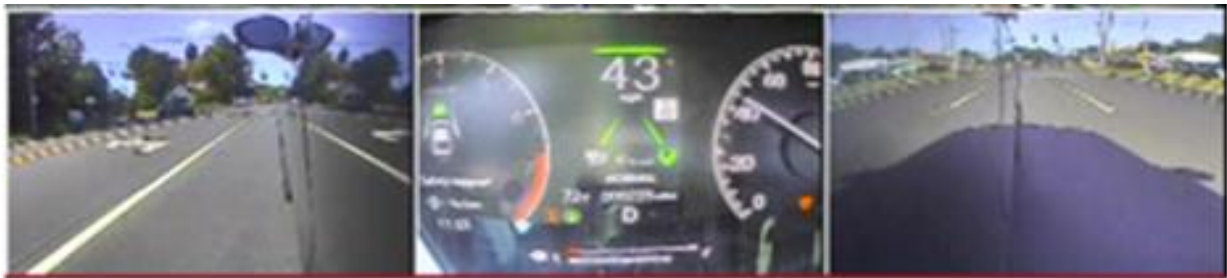
Figure 5-14: Delay in Re-engaging Pavement Marking Detection; (a) Not Detected, (b) Detected After 3 Seconds.

As depicted in Figure 5-13, the on-board ADAS was unable to detect pavement marking of the left lane marking when it changes from a double-solid yellow line to a dashed white line. The on-board system continuously detected the double-solid yellow marking until it changed to a dashed white line. Another notable observation from the same run was that the on-board ADAS was able to re-engage in detecting pavement markings after 1-2 seconds. This observation indicates that the system has a time lag in re-engaging to detect lane line markings or the visual cues were provided after 1-2 seconds once the system re-engage in detecting pavement markings. Figure 5-14 presents the screen capture taken after three seconds since the instance presented in Figure 5-13.

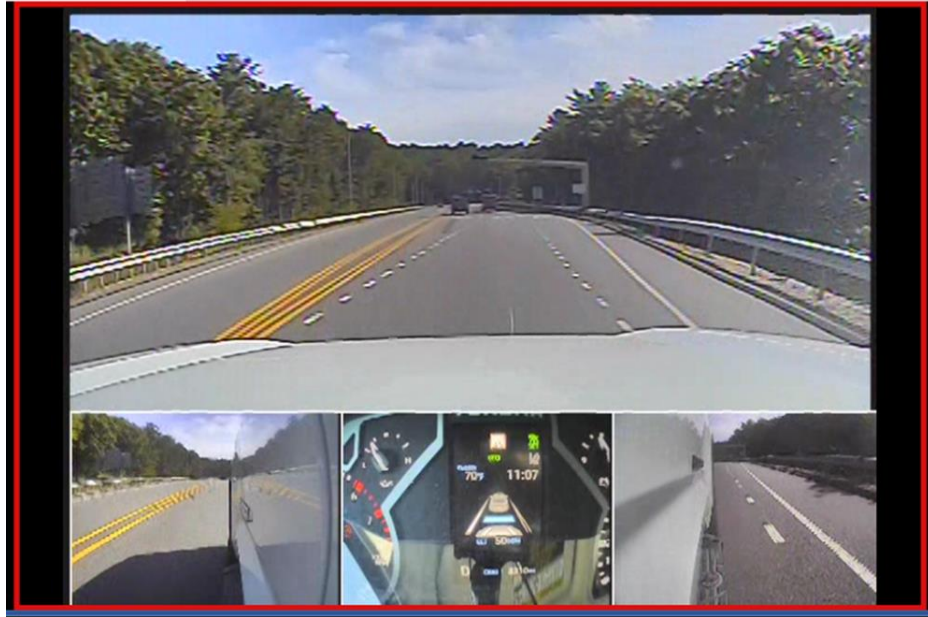
Figure 5-15: Failure to Detect Lane Marking with Changes in Marking Type.

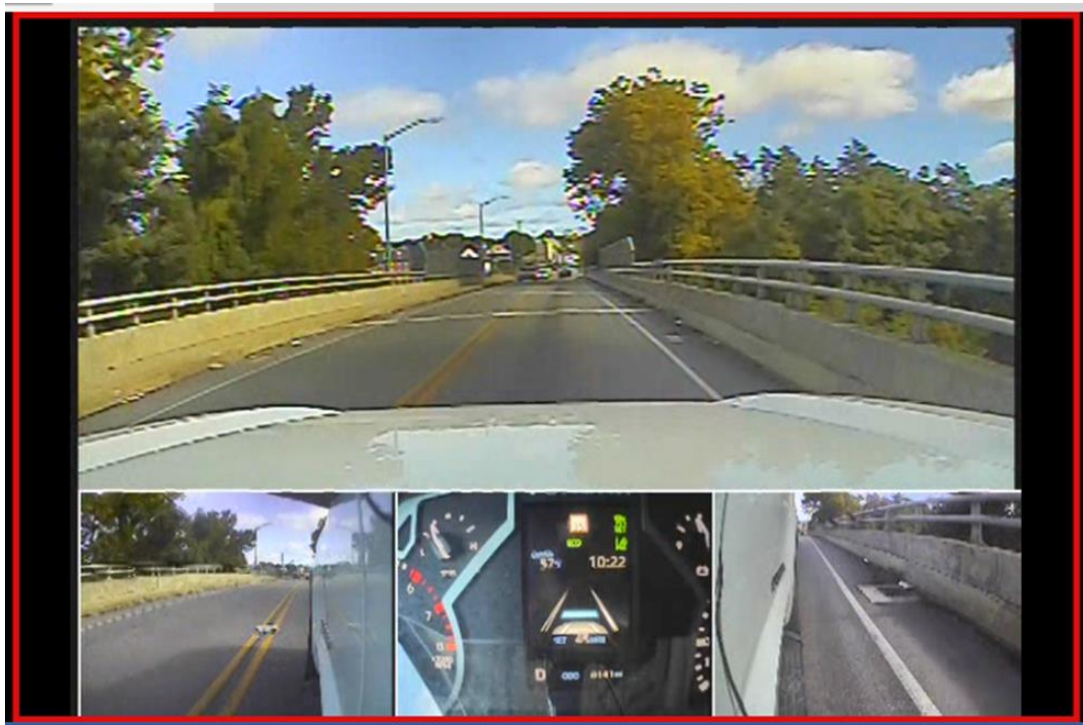
Figure 5-16: Failure to Detect Lane Markings Due to Object on the Marking.

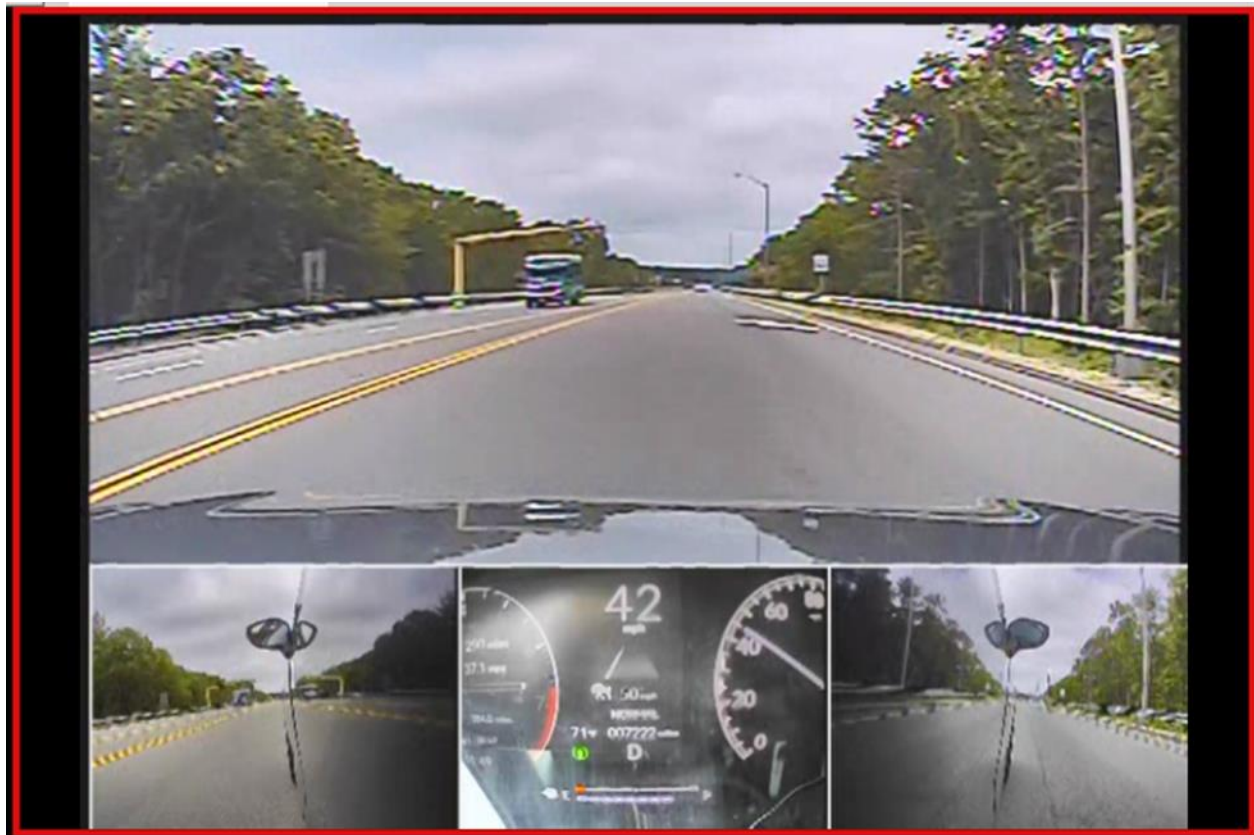
Figure 5-17: Failure to Detect Lane Marking in Wide Lane.

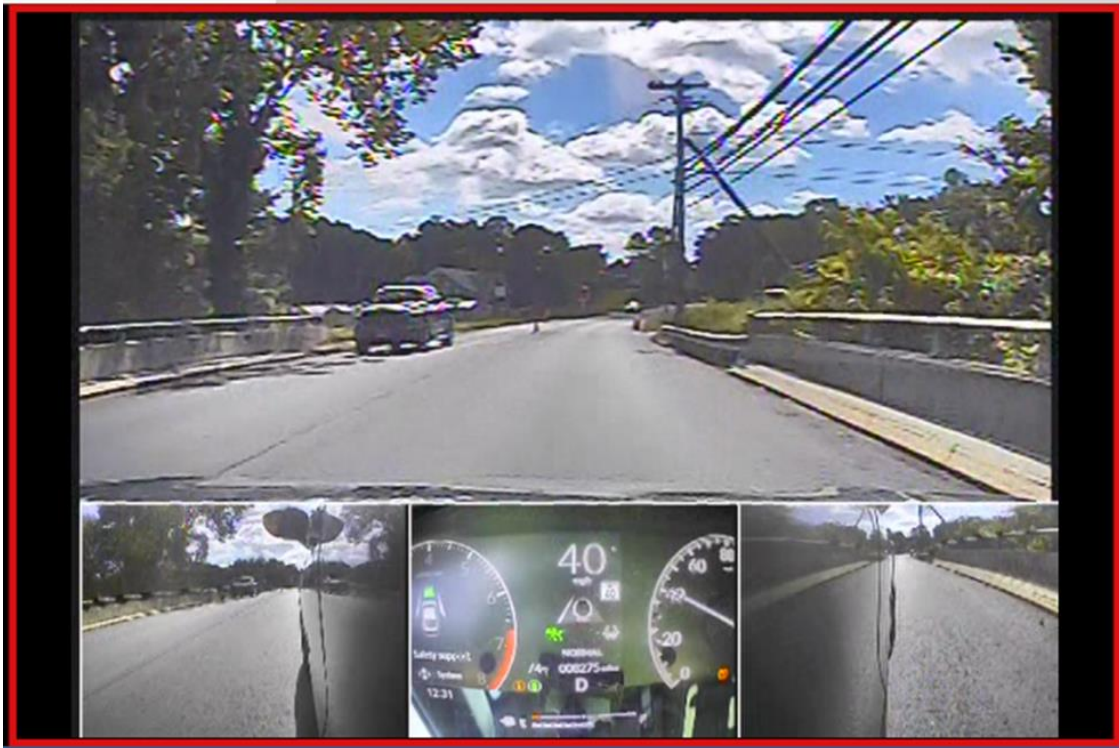
Figure 5-18: Detected Pavement Joint as Lane Marking.

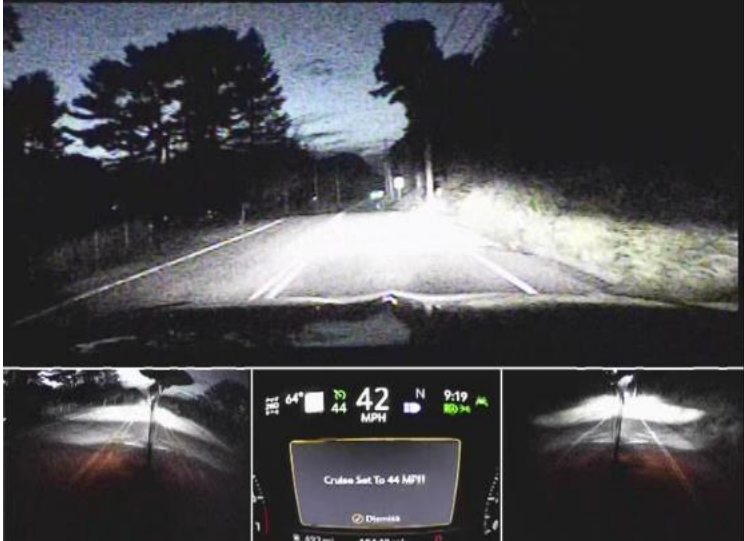
99	<p>The definition and indication of line markings are interrupted by a service message, specifically one regarding the cruise control setting. It is not possible to ascertain with certainty whether the LKAS determines the road markings.</p>

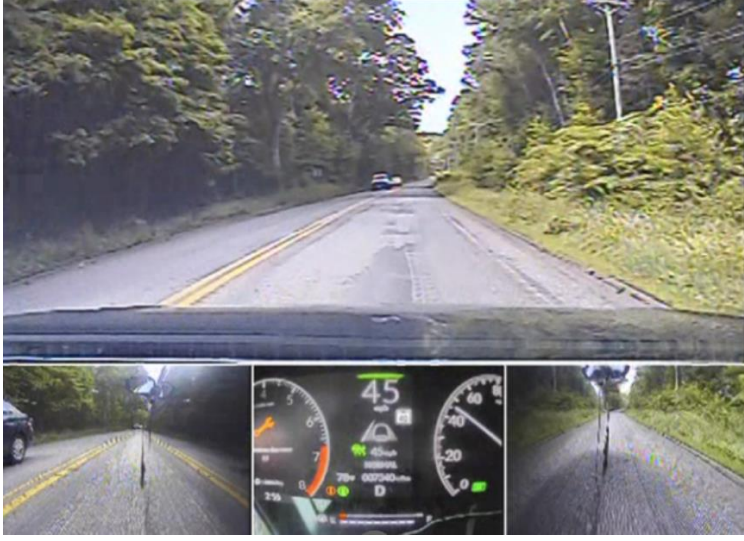
99	<p>The top layer of asphalt is removed from the road surface, and traffic cones are installed. In most cases, there are line markings on one side. However, old and intermittent (low-quality) line markings can also be present. In such situations, the system may become confused, incorrectly determining markings where they don't exist and failing to detect them where they should.</p>
	NM	<p>There are no lane markings due to freshly laid asphalt pavement.</p>
