DOT/FAA/TC-24/14

Airport Pavement Multiple-Event Roughness Detection and Evaluation

August 2024

Final Report

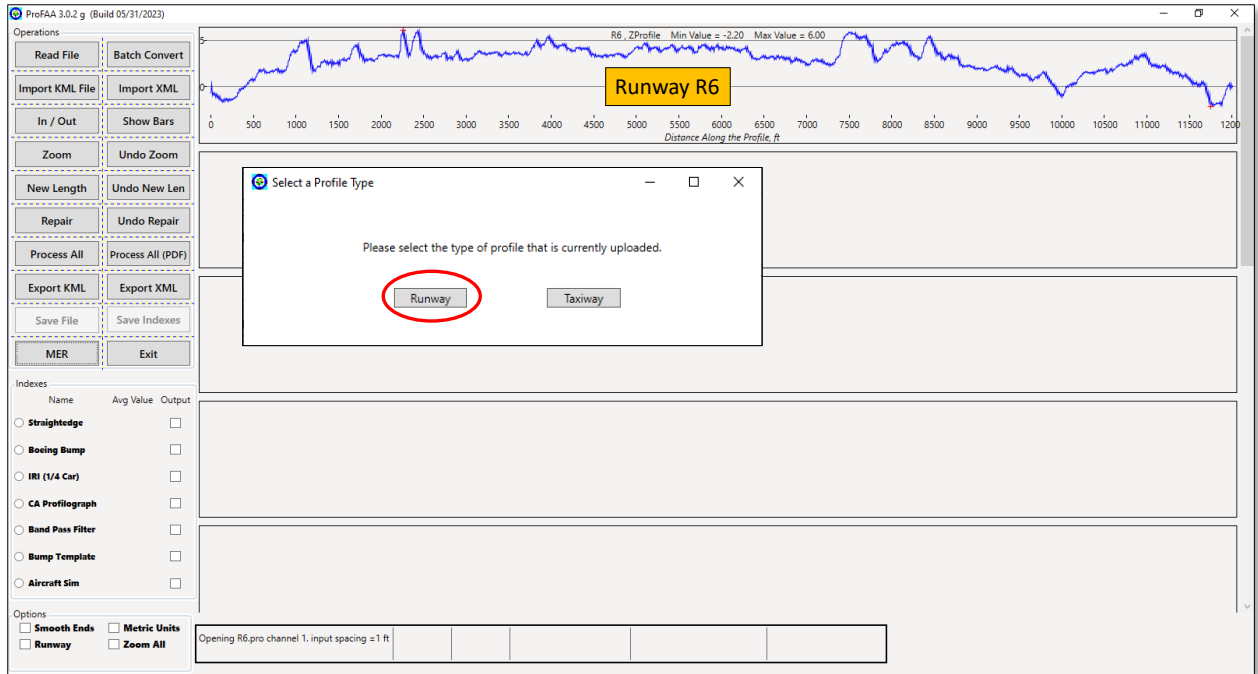
Figure 4 shows the ProFAA opening screen after selecting the profile to be analyzed and the MER operation. The Select Profile Type window will pop up when the MER button is selected. Runway R6 was selected for this example because it demonstrates how two bump events were detected with the PI-100 analysis tool. The orange comment boxes in Figures 4 and 5, which designate Runway R6, PI-100, PI-25, 12-foot RSE, and BBI, are intended as a highlight for the report; they do not appear as part of the actual ProFAA plot.

Figure 4. ProFAA Opening Screen after a Runway Profile has been Selected

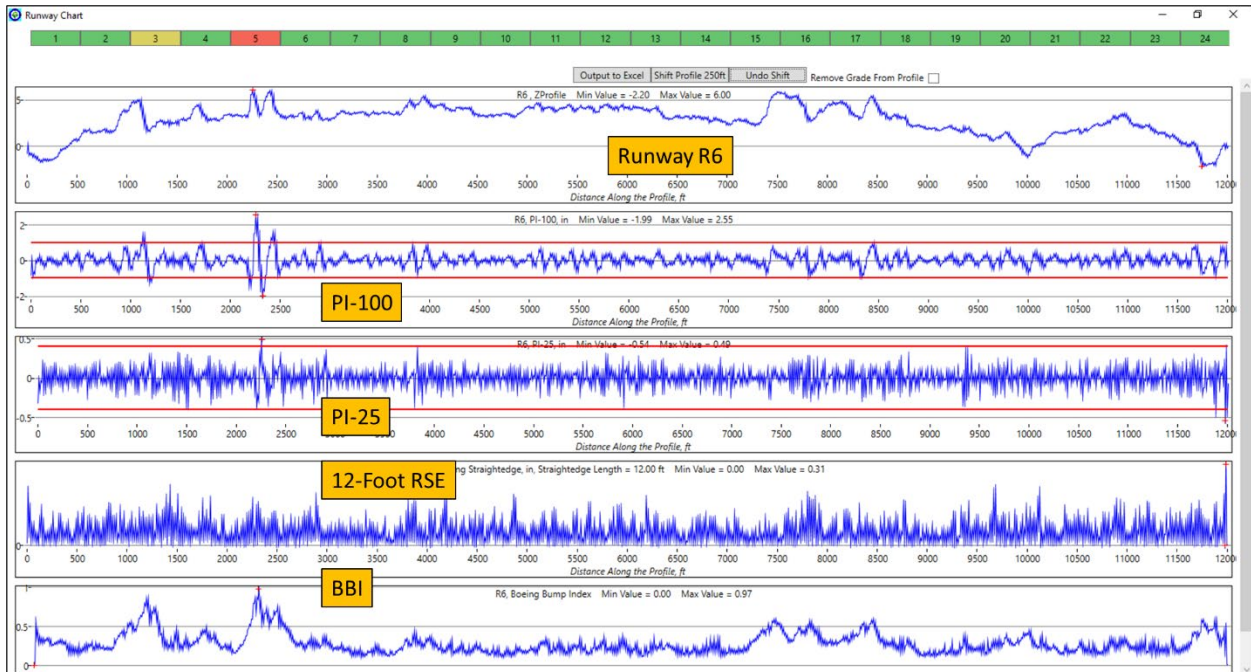
The color-coded results are displayed in 500-foot sections as shown in Figure 5. The results for PI-100, PI-25, the 12-foot RSE, and BBI analyses are also plotted automatically.

Figure 5. ProFAA MER Plot of Runway R6

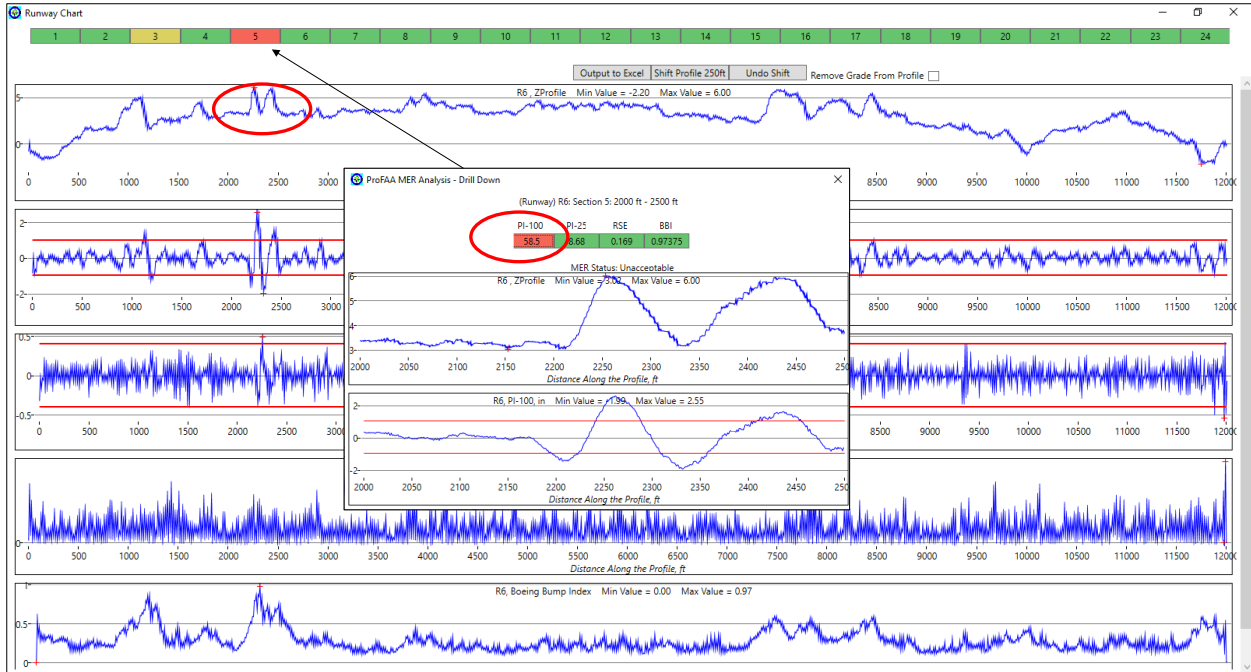
Figure 6 is a screenshot that demonstrates the left-click function on Section 5. It displays the PI-100, PI-25, 12-foot RSE, and BBI results for that section and the plot of the profile in that section. Left clicking again, this time on PI-100, will plot the PI-100 results for that section. Similarly, the user can left click on PI-25, 12-foot RSE, or BBI to view those results.

Figure 6. Screenshot Showing the Left-Click Function on Section 5

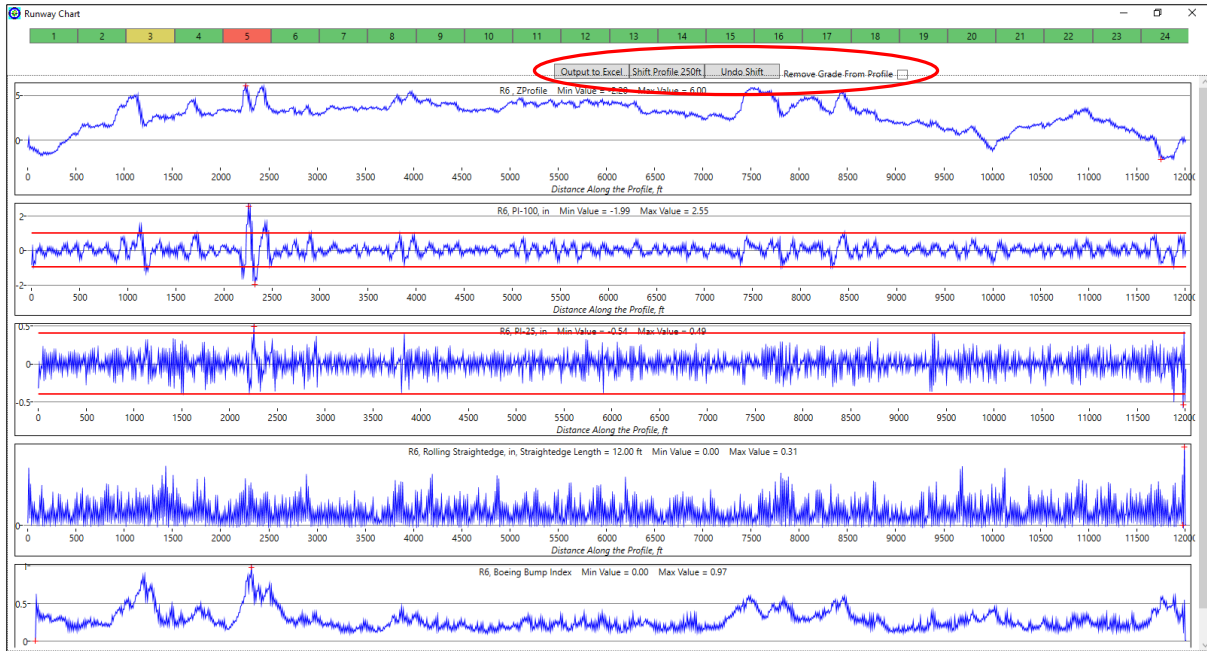
Figure 7. Shift Profile Option

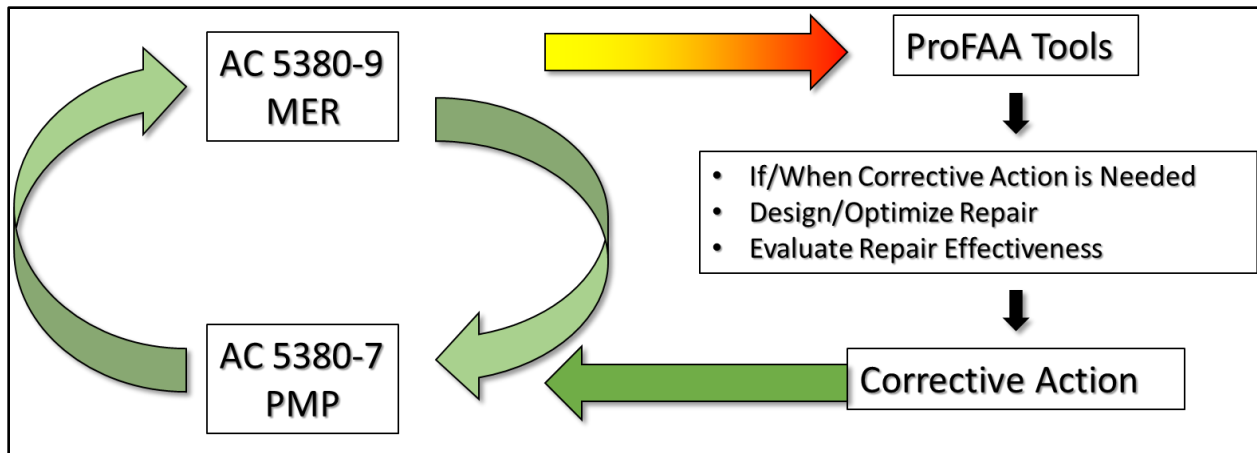
Researchers also reviewed AC 150/5380-7B for potential impacts from the MER process. It was determined that the MER process added to ProFAA will have an impact on airport pavement management practices. The primary purpose of the review was to provide recommendations regarding the changes made to ProFAA, and how the addition of the MER module in ProFAA will impact this AC. A suggested approach was to include the MER process into a proactive PMP regarding pavement roughness detection, quantification, and corrective action. Figure 10 depicts the version of the proactive PMP.

Figure 10. Proactive Approach for Pavement Management Regarding Roughness

The recommended changes should define the three types of roughness based on how they impact aircraft response. The MER procedure in ProFAA should be illustrated showing how runway and taxiway roughness can be located and quantified in a color-coded plot. It should also suggest how AC 150/5380-9, AC 150/5380-7, and ProFAA can work together to proactively monitor and maintain acceptably smooth airport pavements. It describes how the synergistic approach can aid in decision-making regarding if, how, and when corrective action is needed. This concept is illustrated in Figure 10.

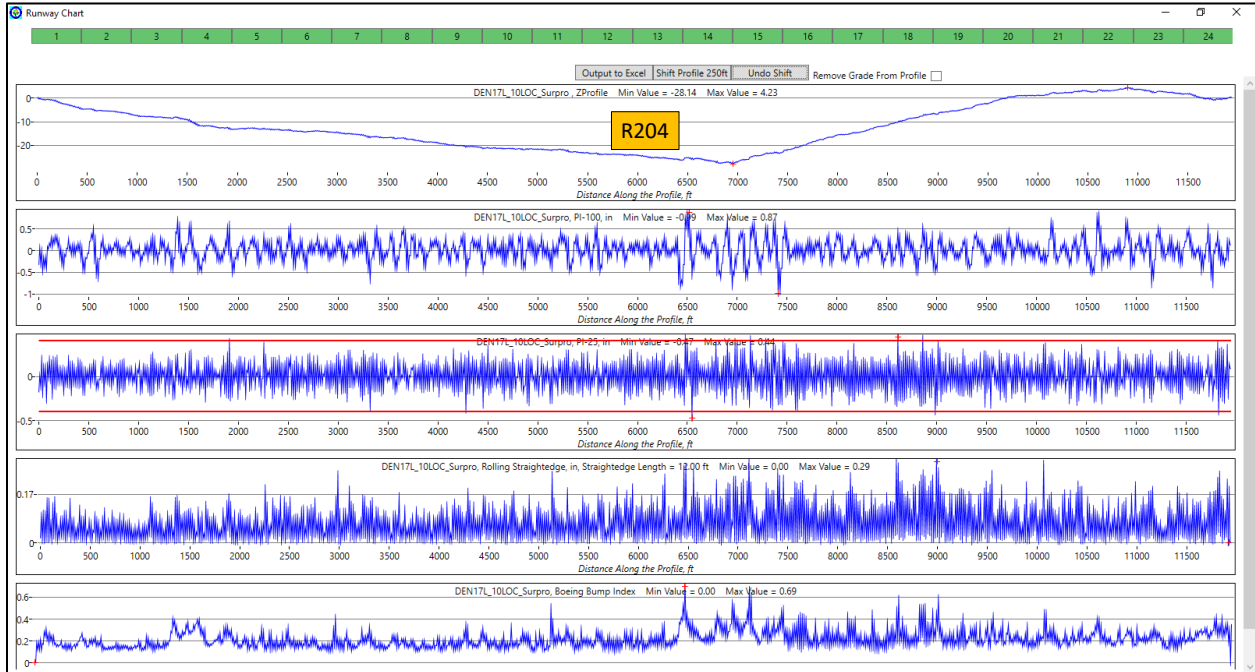
Figure A-4 shows R204, a smooth PCC runway. The profile was measured with a SurPRO. APRas 100-knot taxi and takeoff and landing simulations found it acceptable.

Figure A-4. MER Analysis Results of Runway R204

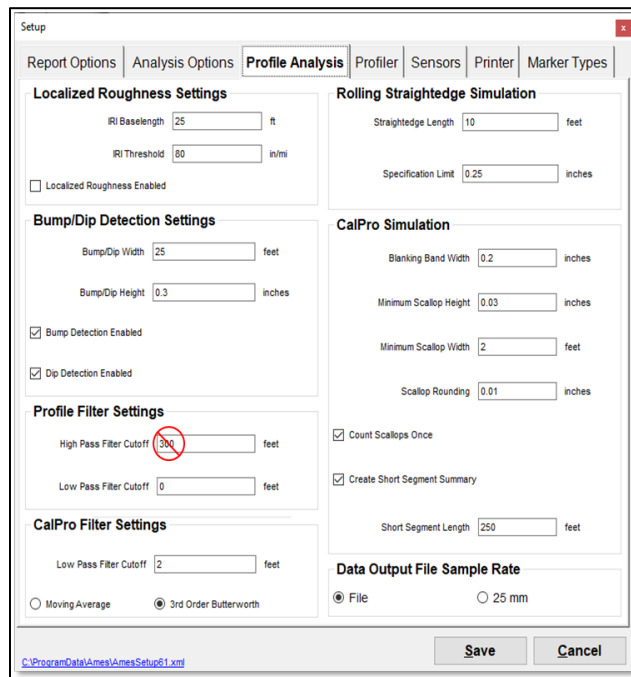
The purpose of this technical note is to document the results of a limited profiler comparison study to evaluate the impact of using “no filtering” when measuring a profile using the AMES 8200 inertial profiler.

Figure B-1. Screenshot of AMES Software Showing “No Filter”

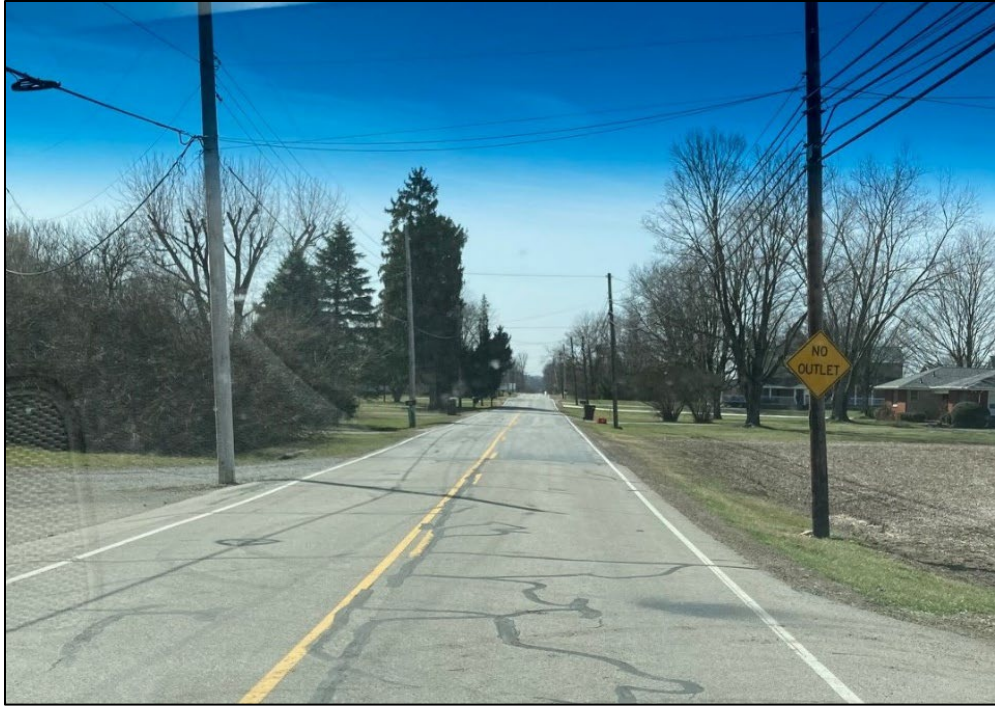
The test was conducted on March 13, 2023, on an active county road in Clark County, Ohio. (Figure B-2). Even though traffic was very light, it was not practical to lay out a reference line to follow. Another reason this site was chosen was that it had visible Type 2 and Type 3 roughness.

Figure B-2. Photo of Lower Valley Pike Test Site

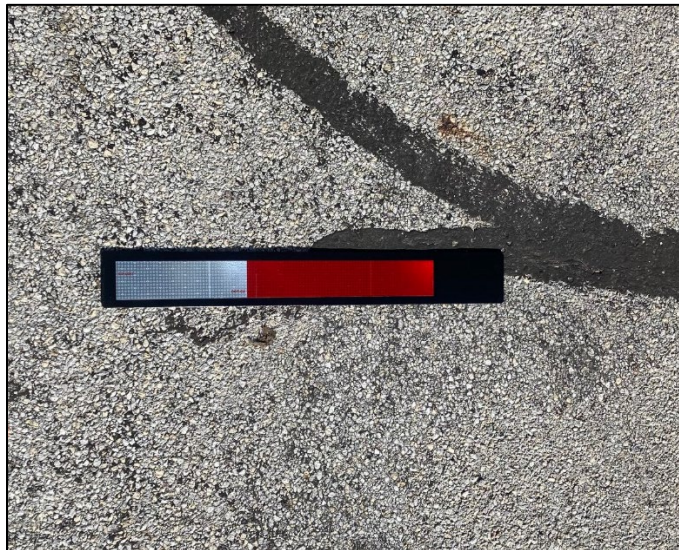
The AMES profiler had approximately 300 feet to accelerate to 30 MPH (test speed) and unlimited space to decelerate. Reflective tape (Figure B-3) was used to trigger the AMES start and stop locations.

Figure B-3. Reflective Tape that Triggers AMES Profiler

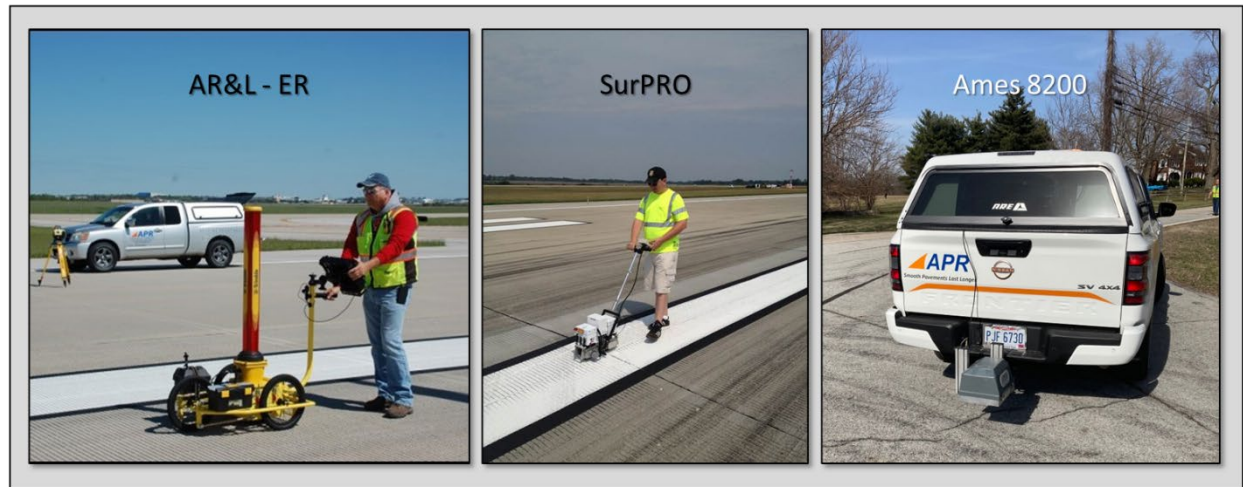
- The Auto Rod & Level
- The SurPRO 4000
- The AMES 8200 Inertial profiler

Figure B-4. Photo of All Three Profiling Devices

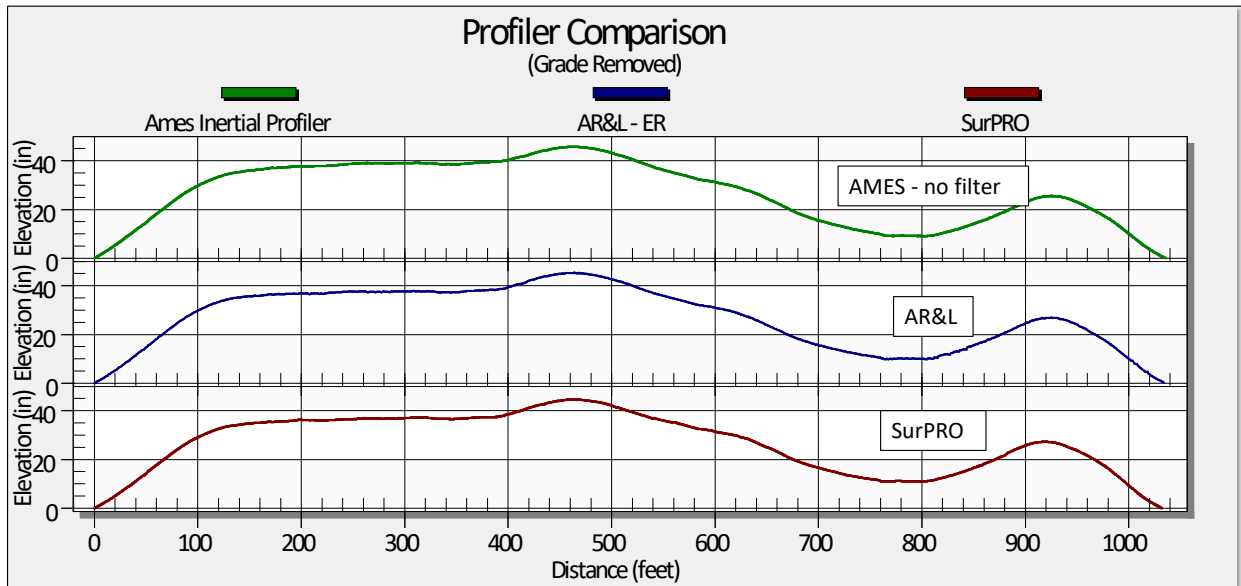
Figure B-5 is a plot of the profiles measured with all three units with the end-to-end grade removed. This shows very good correlation between profiling units. Figure B-6 is the same plot with the end-to-end grade included. The AMES inertial profiler does not carry the grade changes for the full 1,035-foot test section. Table B-1 shows the actual change in elevation in 1,000 feet (two 500-foot sections) for three passes of each unit. Table B-2 shows the distance traveled by each unit for the full 1,035-foot test section for three passes of each unit.

Figure B-5. Plot of All Three Profilers with the End-to-End Grade Removed

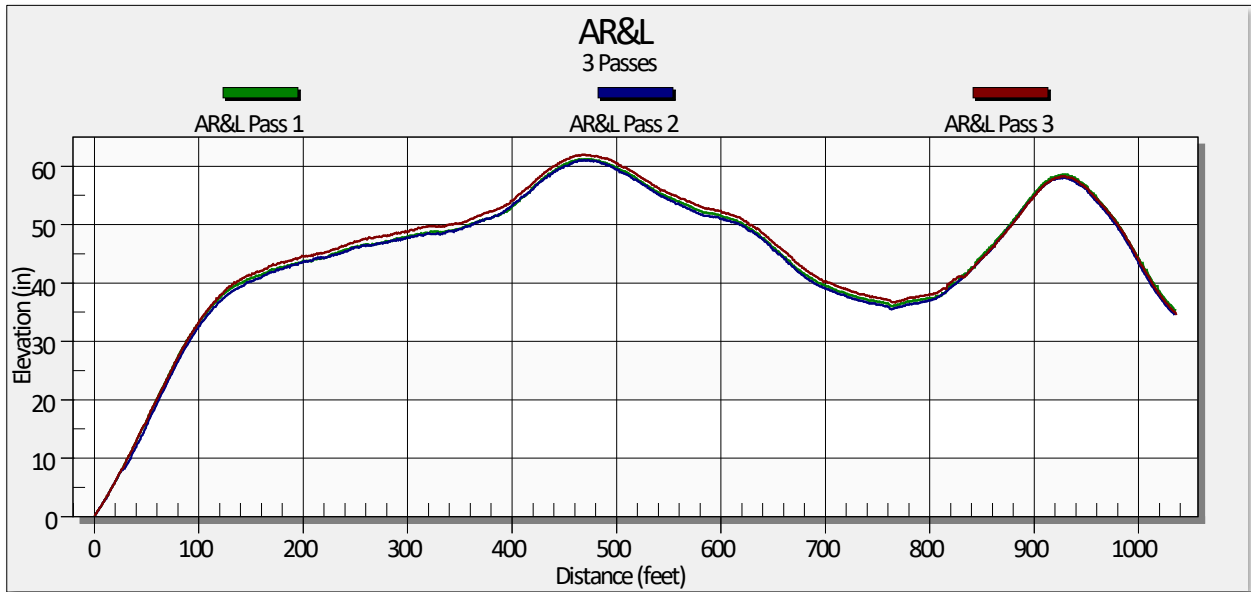
Figure B-7 shows the repeatability between passes for the AR&L. Figure B-8 shows the repeatability between passes for the SurPRO. Figure B-9 shows the repeatability between passes for the AMES.

Figure B-7. Plot of Three Passes with the AR&L

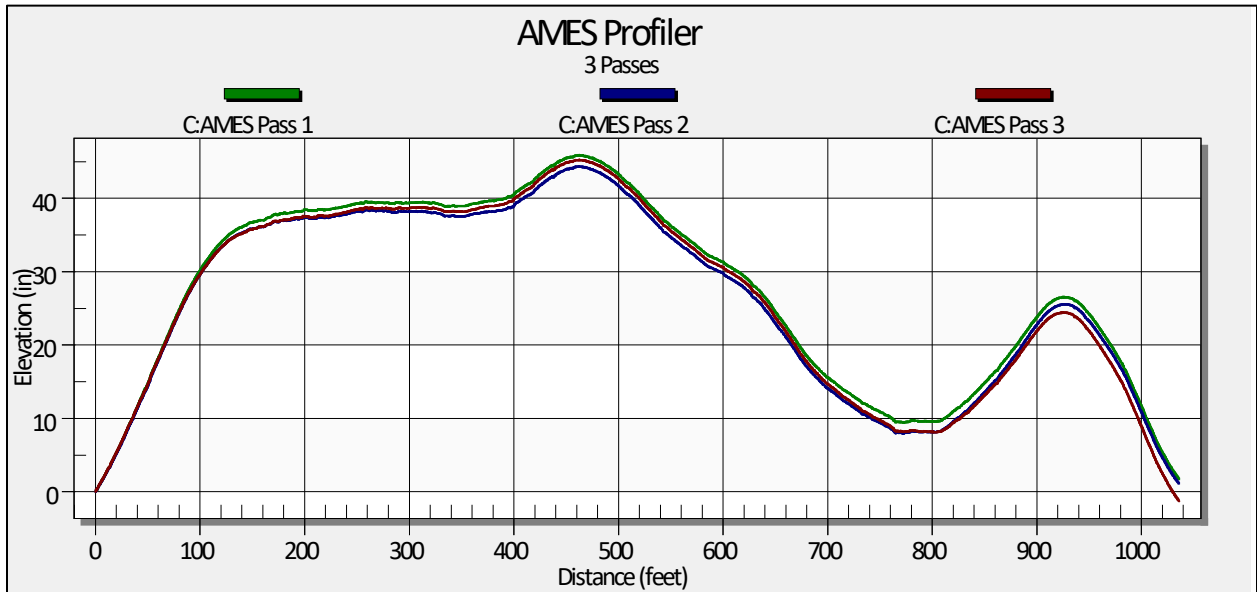
Figure B-9. Plot of Three Passes with the AMES Inertial Profiler

The AMES unit fails to track end-to-end grade changes as accurately as true profilers. Consequently, using the AMES profiler to establish a baseline is not recommended unless the data can be updated periodically with true profiler data.

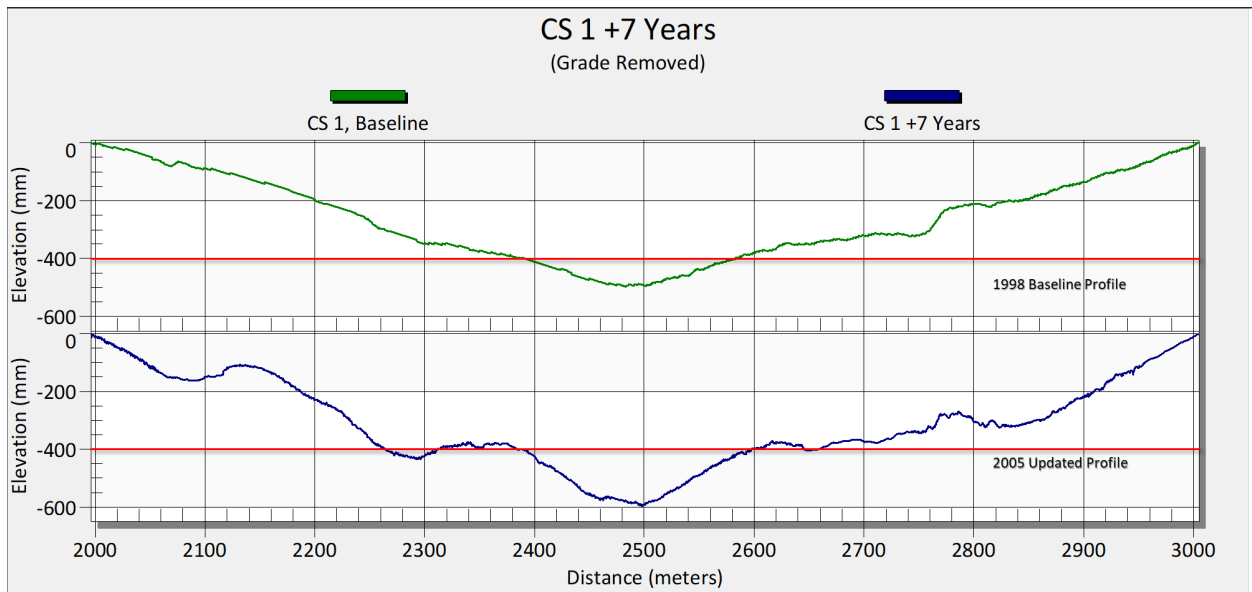
The first example shows how the baseline profile comparison method was successful in quantifying the effect of differential settlement and helped the airport make decisions about timely pavement repairs. The overall shape of the runway is consistent; however, waviness in the profile is clearly seen 7 years later (Figure D-1). This area, called an "Area of Interest," is a good example of differential settlement. Figure D-2 enlarges the area of interest and is plotted with the overall grade removed. Additionally, elevation reference lines are added to help quantify the change over time.

Figure D-2. Case Study 1 Area of Interest Enlarged with Elevation Reference Lines

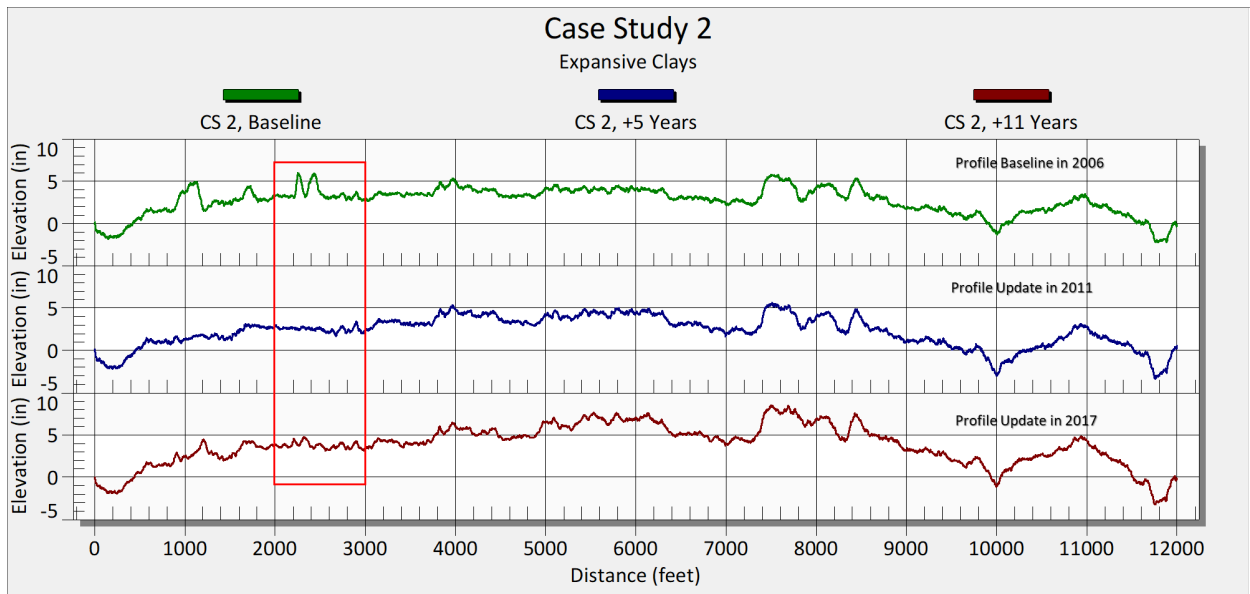
Case Study 2 is a situation where expansive clays have created back-to-back bumps. As shown in Figure D-3, there are three lines of survey, one each for three separate points in time. The baseline for this runway was measured in 2006. The runway was then rehabilitated (at some point before 2011) and remeasured in 2011. These two bumps have been effectively removed. This runway was measured again in 2017, and the bumps could be seen redeveloping. Figure D-4 enlarges the Area of Interest of this runway.

Figure D-3. Case Study 2 Pavement Heaving Due to Expansive Clays in the Subgrade

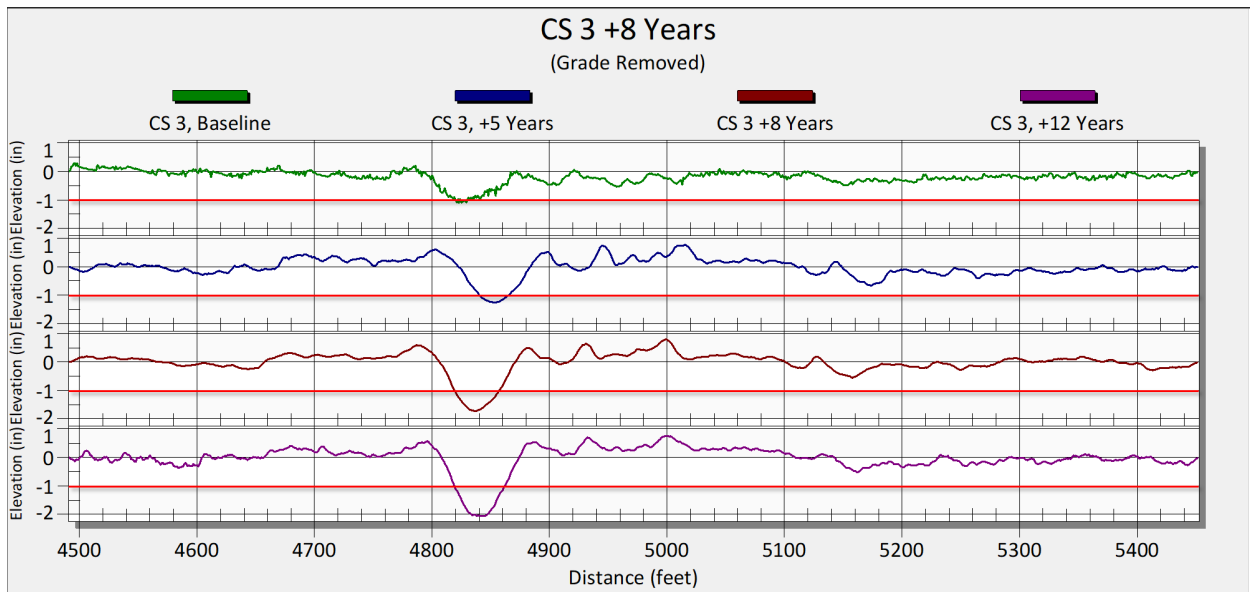
Case Study 3 documents the history of settlement occurring on a utility tunnel underneath a runway. The baseline profile of this runway was measured in 2005 and then resurveyed in 2010, 2013, and 2017. Figure D-5 clearly shows the settlement getting deeper with each successive survey. Figure D-6 is an enlarged plot of the Area of Interest for this runway.

Figure D-6. The Area of Interest for Case Study 3 Plotted with Grade Removed

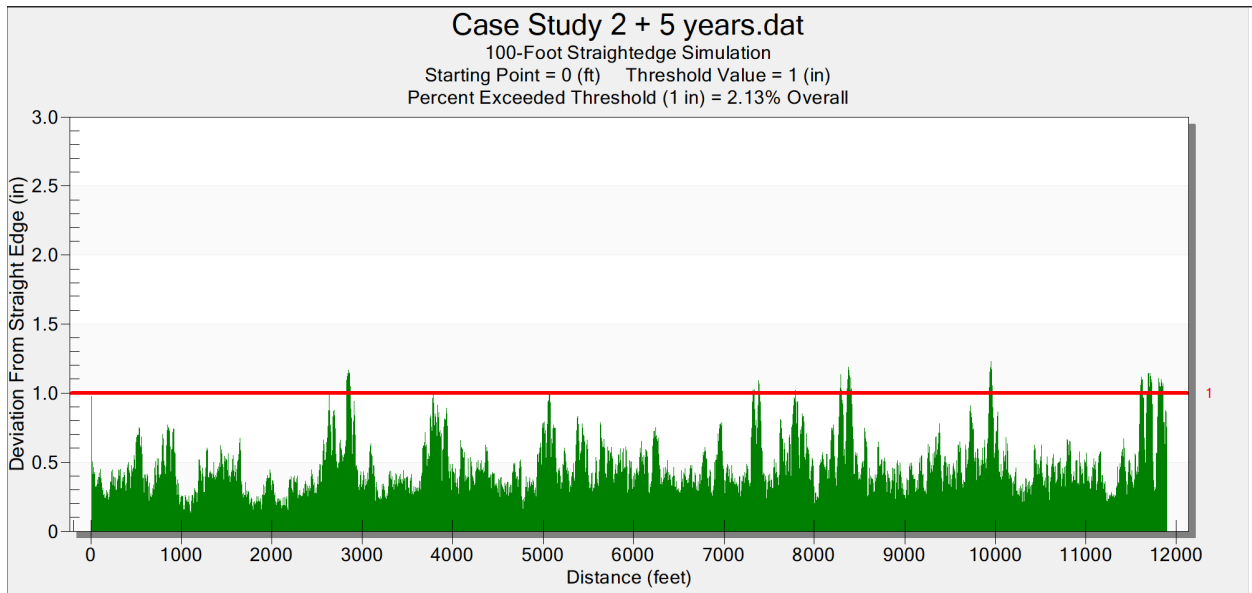
Figure D-23. Plot for 100-Foot Straightedge Analysis for Case Study 2 5 Years After the Baseline

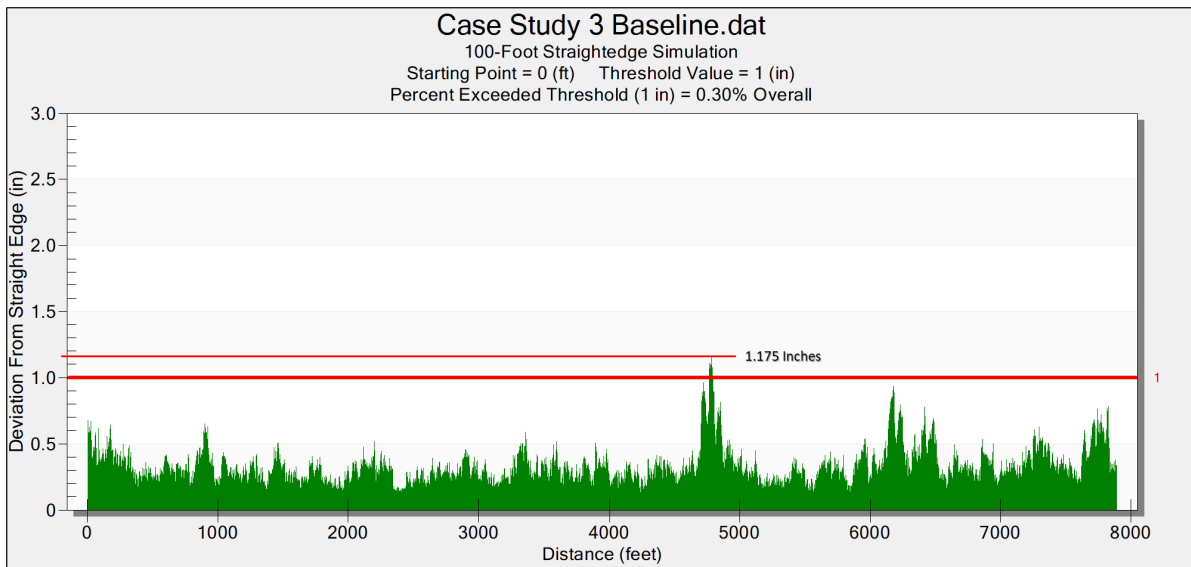
Figure D-25. Plot for 100-Foot Straightedge Analysis for Case Study 3 Baseline Profile

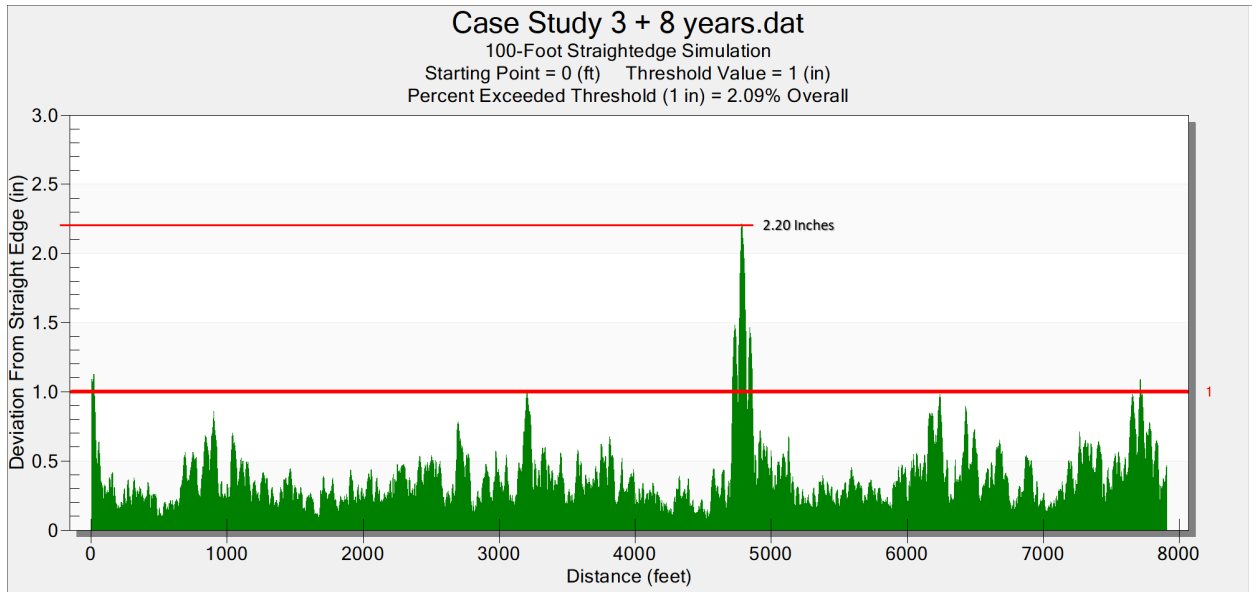
Figure D-27. Plot for 100-Foot Straightedge Analysis for Case Study 3, 8 Years After the Baseline

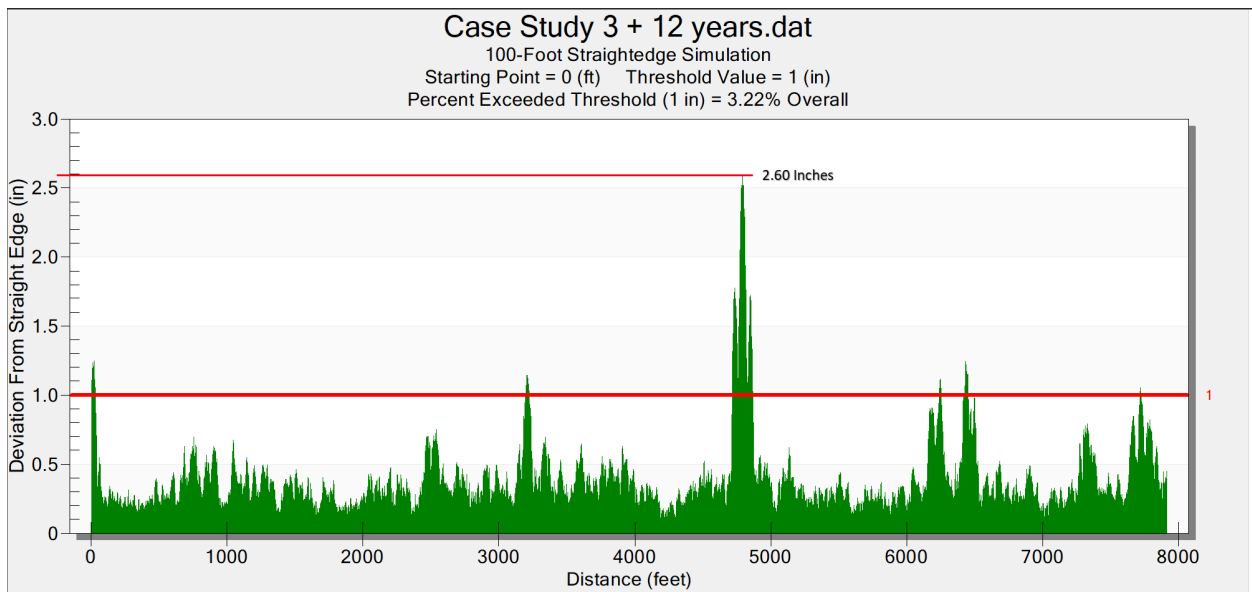
Figure D 28. Plot for 100-foot Straightedge Analysis for Case Study 3, 12 Years After the Baseline

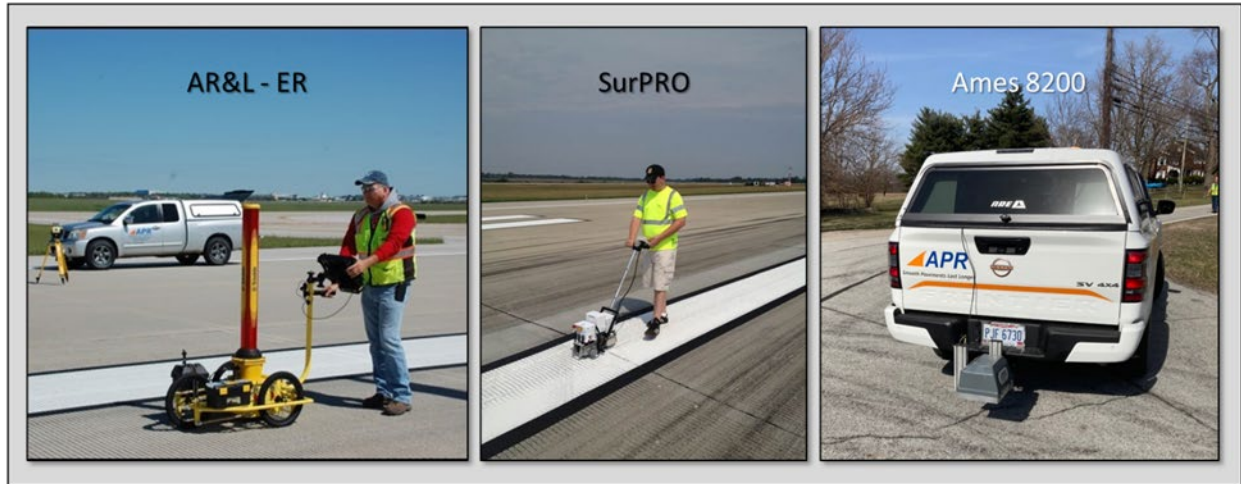
Figure D-31. The Three Types of Profilers Used in this Comparison Study
