# JOINT TRANSPORTATION RESEARCH PROGRAM

## Field Handbook for Maintenance and Preservation Treatments of Concrete Pavements

**Mohammadreza Mirzahosseini, Jan Olek,  
Dulcy M. Abraham, Prashant Ram, Kurt Smith**

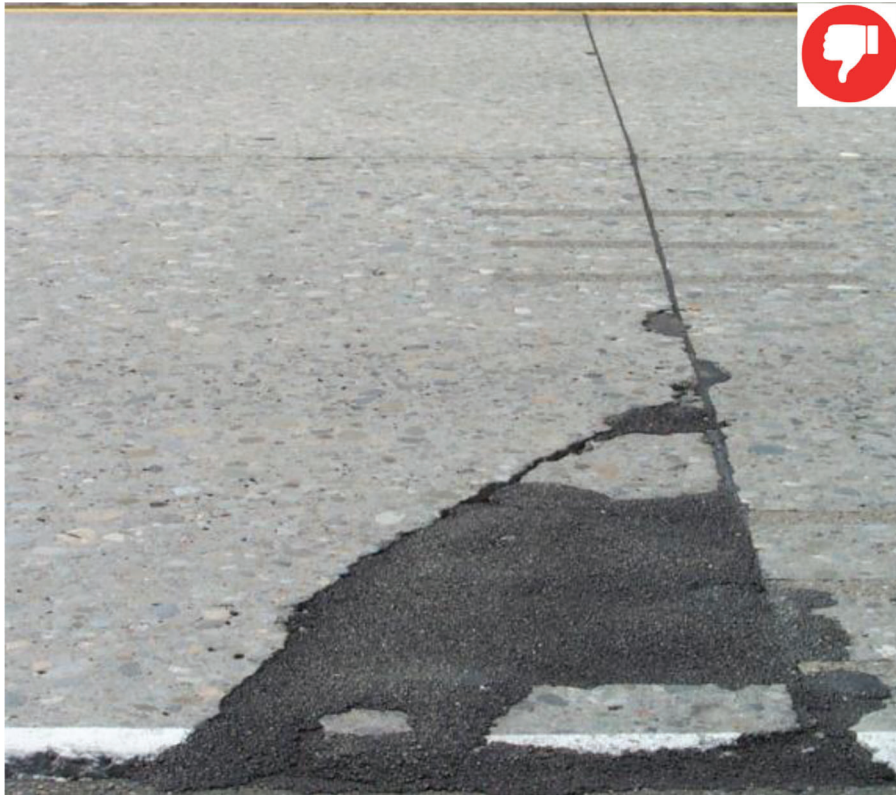
Improper use of asphalt mix patch to repair corner break (© Photo by Applied Pavement Technology (APTech)).

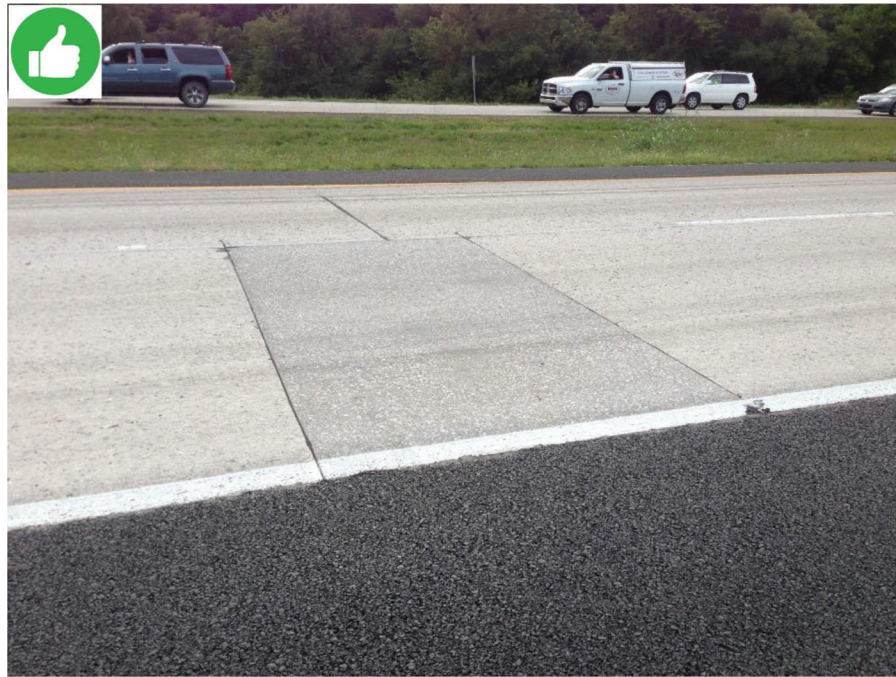
Properly installed full depth patch and associated joints (© Photo by Applied Pavement Technology (APTech)).

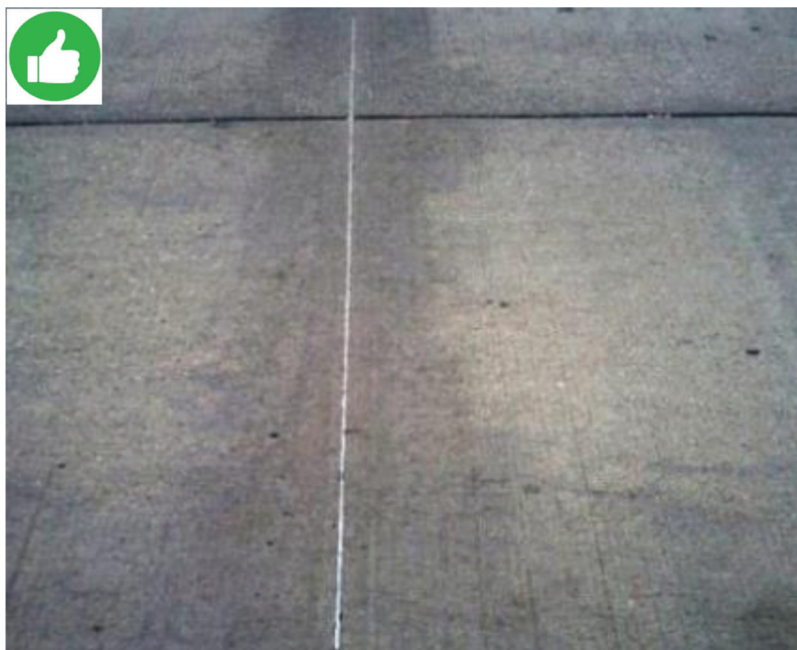
A well-sealed joint that helps reduce the ingress of moisture which may exacerbate “D” cracking (Zhang, 2013).

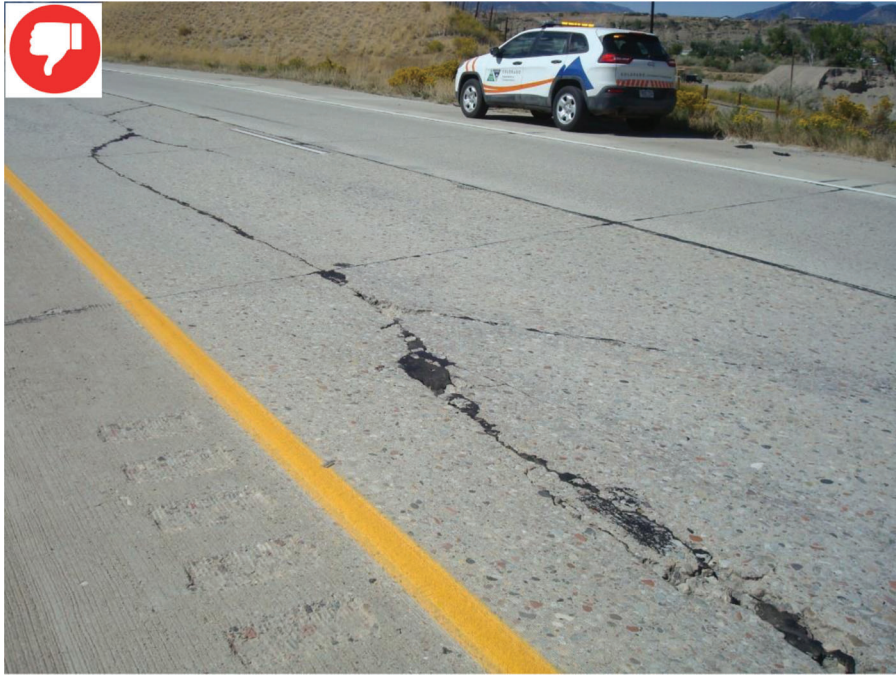
Poorly sealed longitudinal crack (© Photo by Applied Pavement Technology (APTech)).

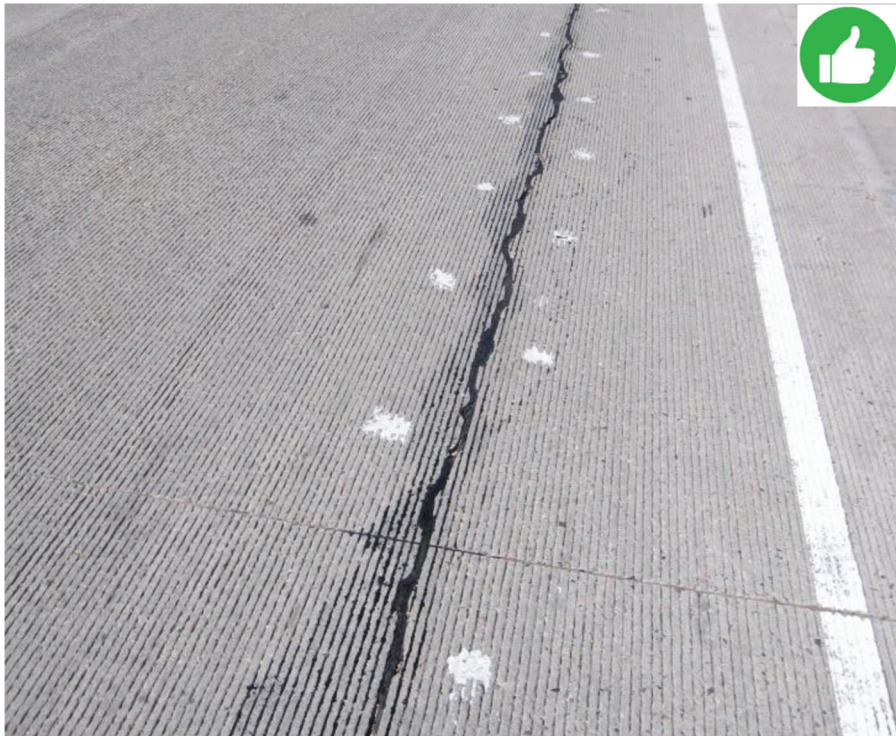
Well-sealed longitudinal crack repaired by cross-stitching (ACPA, n.d.).

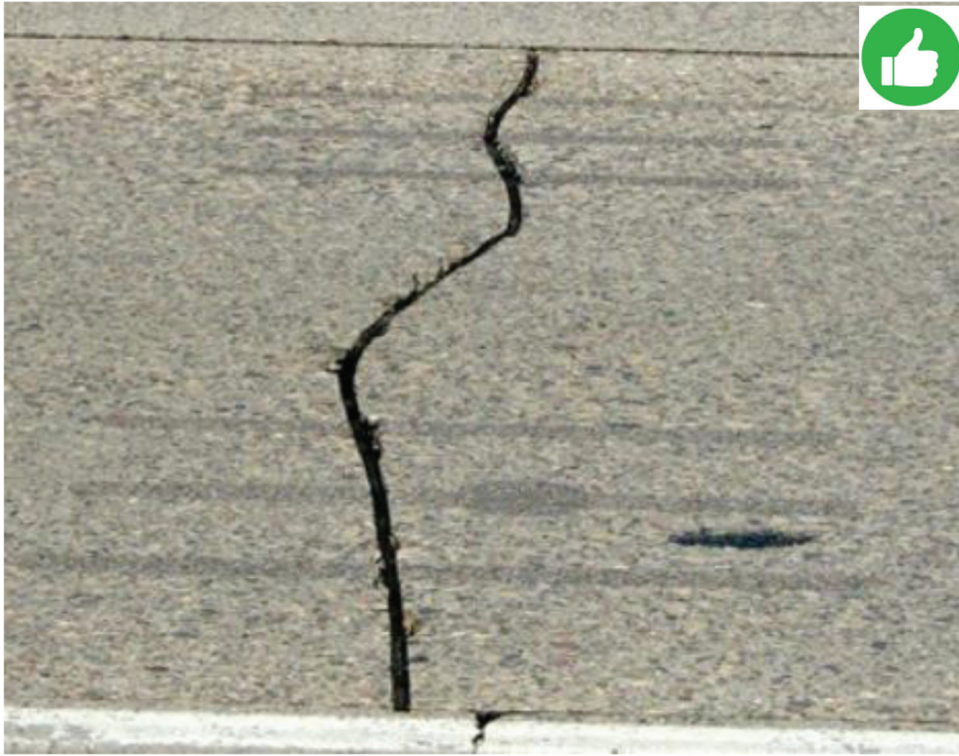
Crack sealing and retrofit load transfer across a moderate-severity transverse crack (Smith et al., 2022).

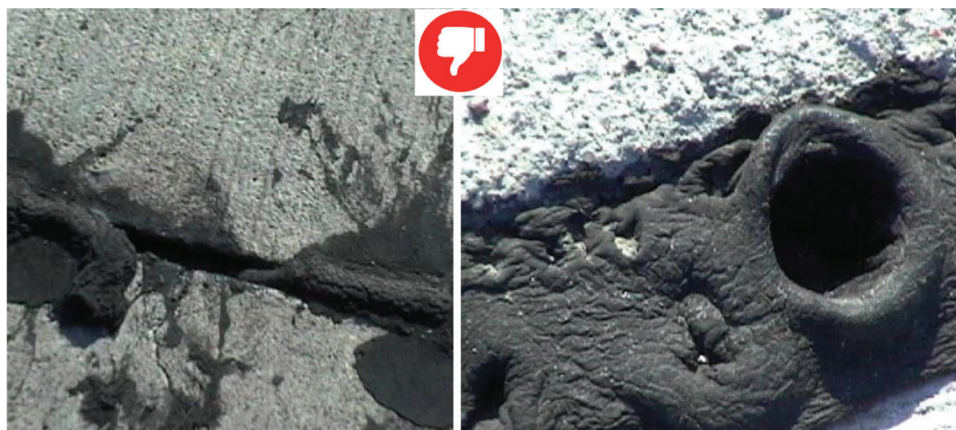
Improperly installed joint sealant (voids and discontinuities in the sealant material)  
(© Photos by Applied Pavement Technology (APTech)).

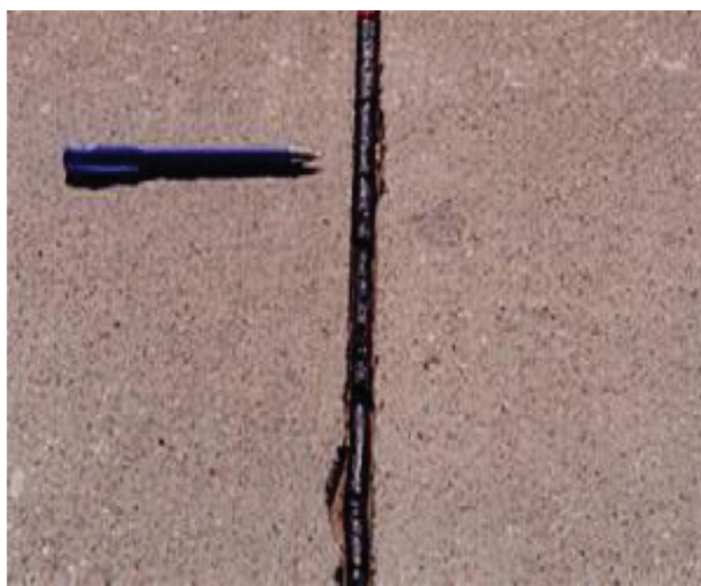
Joint seal damage (INDOT Office of Aviation, 2022c).

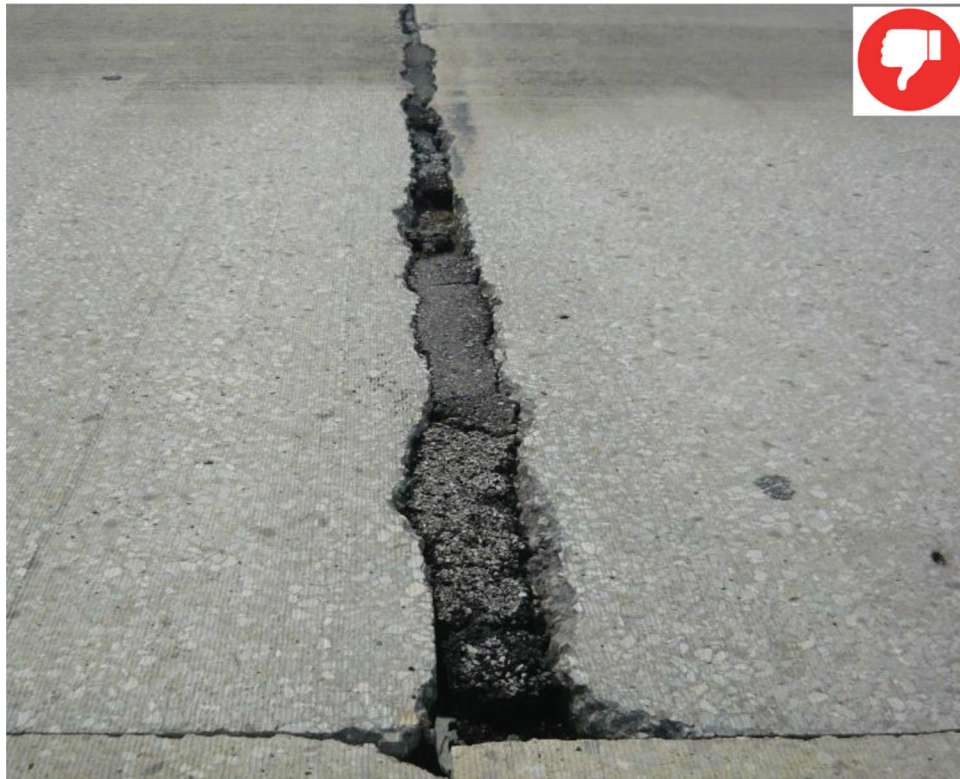
Temporary patching approaches to repair high-severity damage may not be an appropriate long-term solution (Burger, 2017).

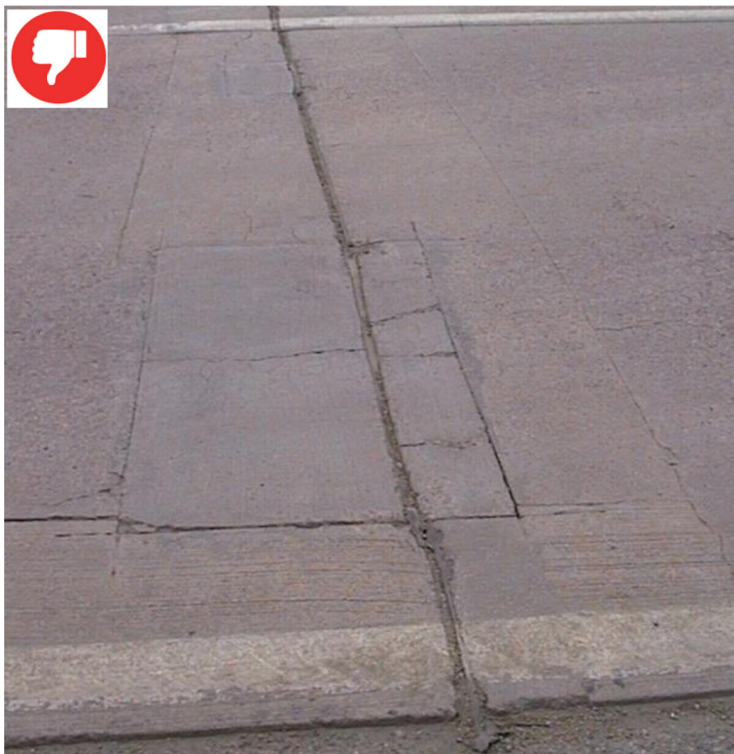
Deteriorated PDP (© Photo by Applied Pavement Technology (APTech)).

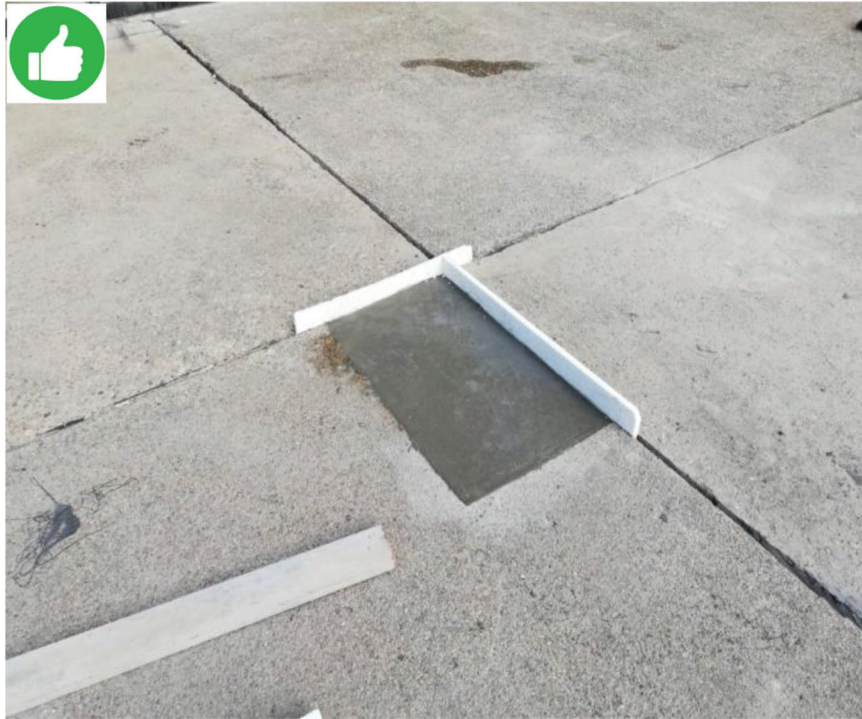
Properly installed PDP to repair spalling of the transverse joint (Rodeco Group, n.d.).

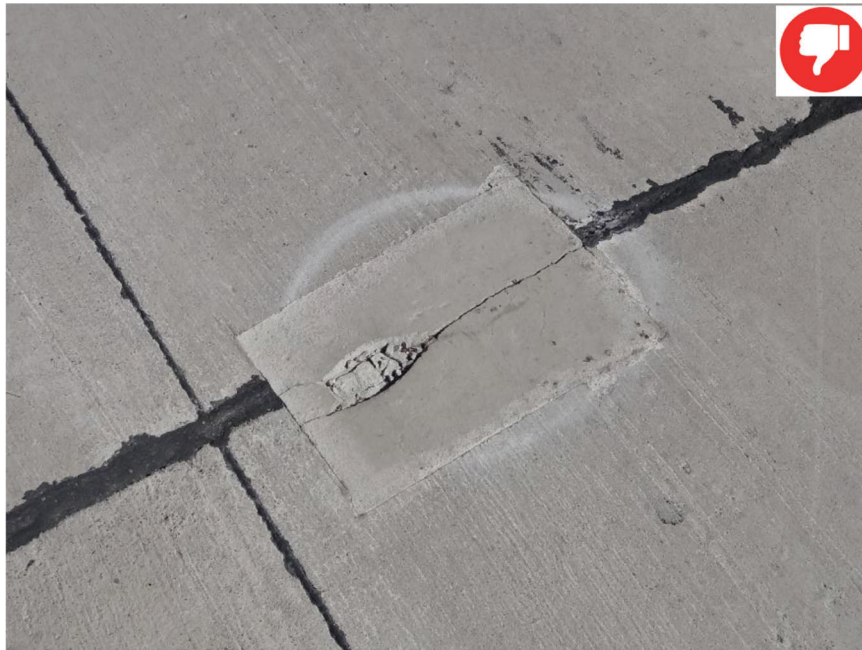
PDP installed without proper joint preparation (© Photo by Applied Pavement Technology (APTech)).

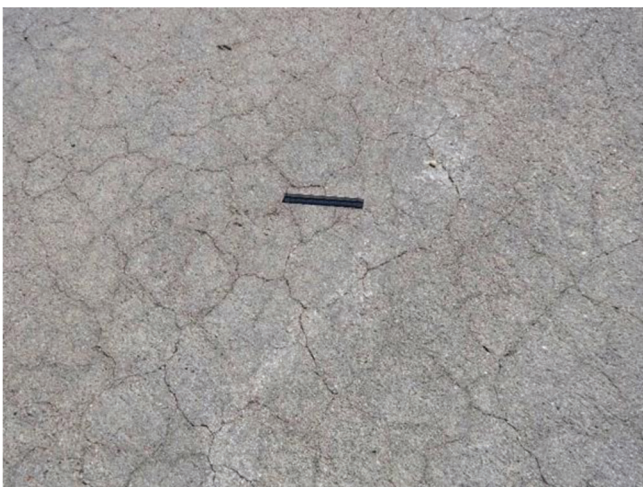
Map cracking on PCC pavement (© Photo by Applied Pavement Technology (APTech)).

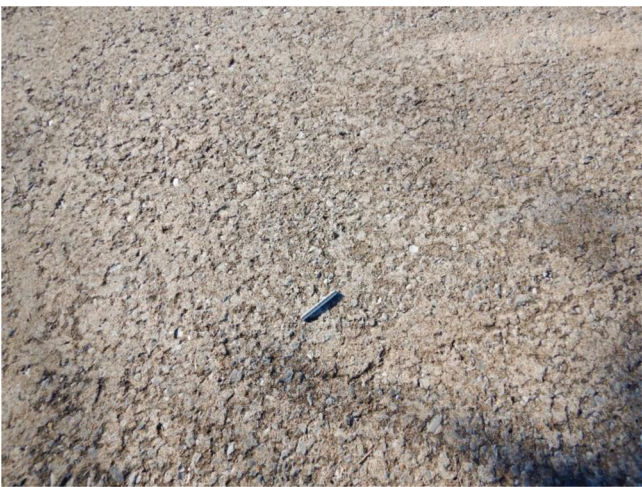
Scaling of concrete pavement (© Photo by Applied Pavement Technology (APTech)).

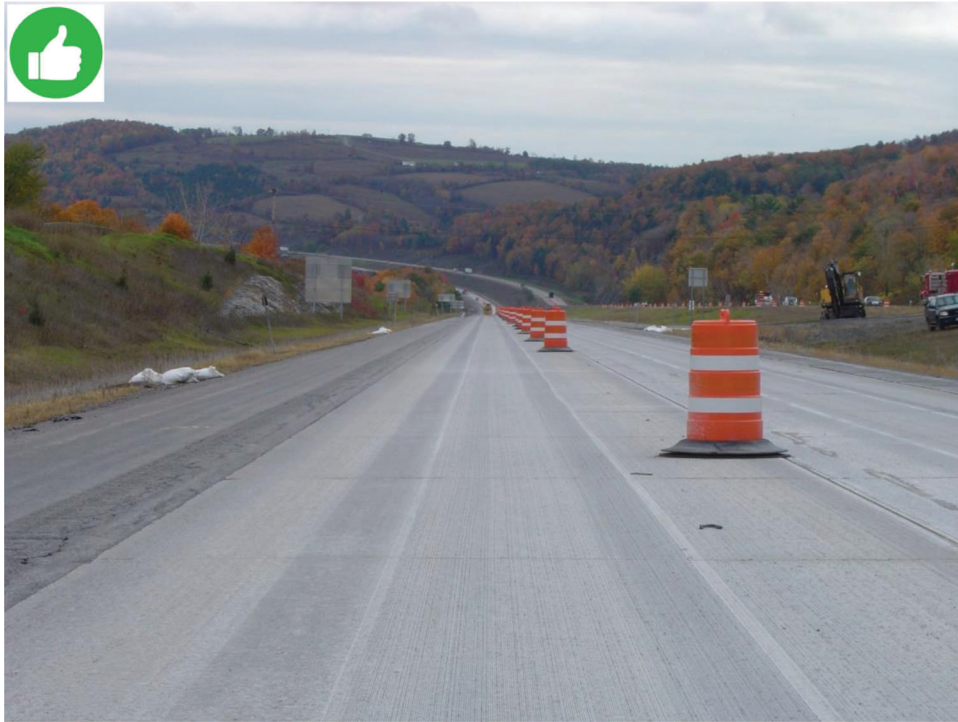
Example of proper diamond grinding to address faulting on JPC pavements (J. Roberts, personal communication, August 7, 2023).

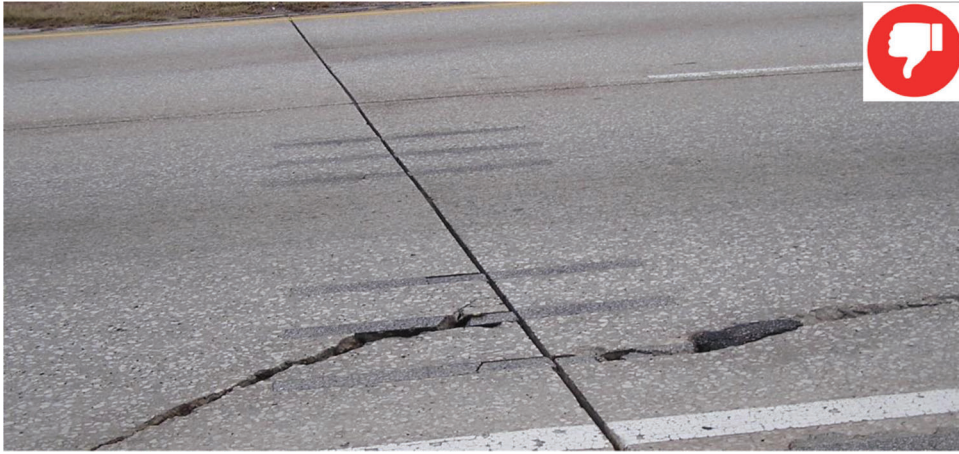
Cracks in the pavement leading to deterioration of grout in the RTL (© Photo by Applied Pavement Technology (APTech)).

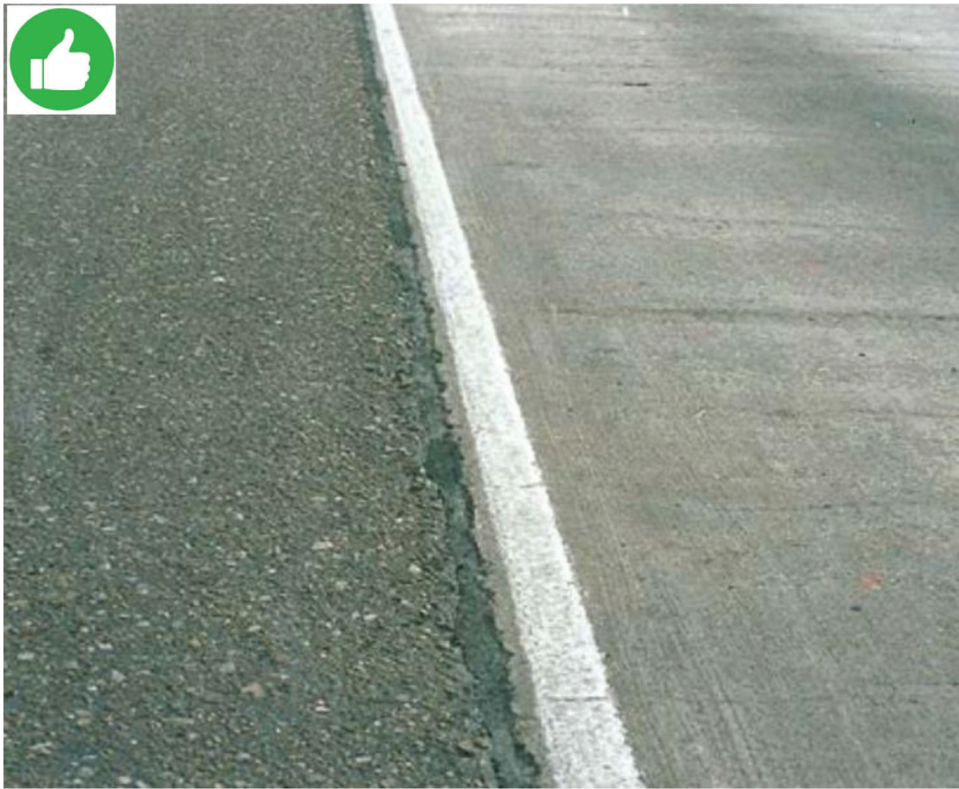
Effective sealing of the shoulder-lane joint (FHWA, 2014).

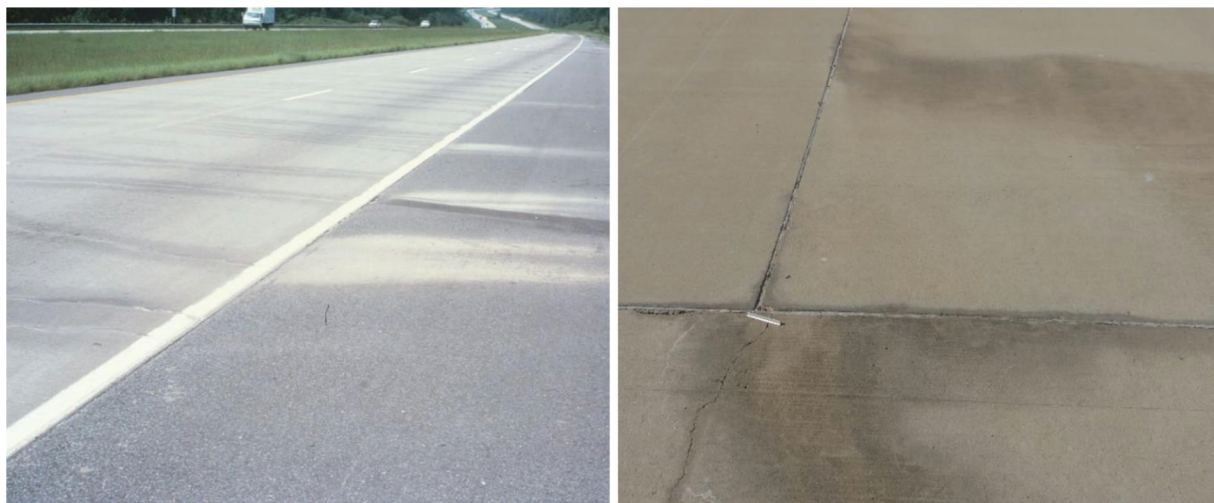
Example of water bleeding and pumping on CRCP (left) and JPCP (right) (© Photos by Applied Pavement Technology (APTech)).

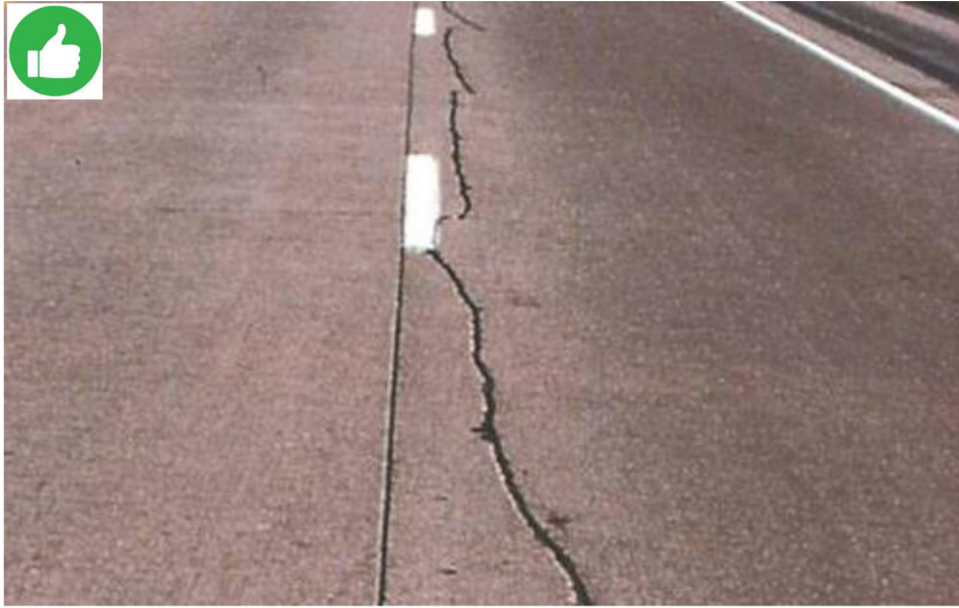
Properly sealed longitudinal crack with moderate severity (© Photo by Applied Pavement Technology (APTech)).

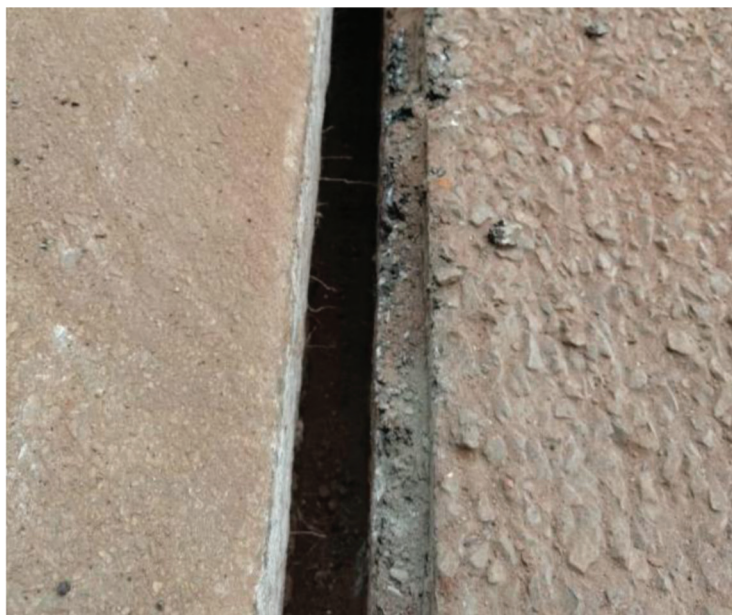
Example of lane-to-shoulder separation (VEA Group, 2019).

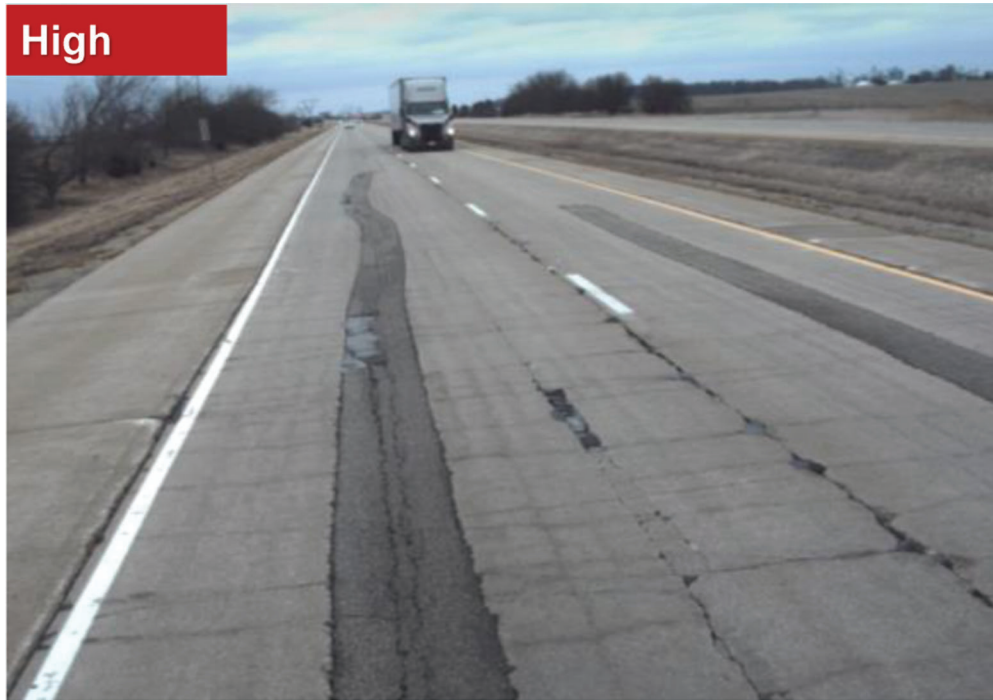
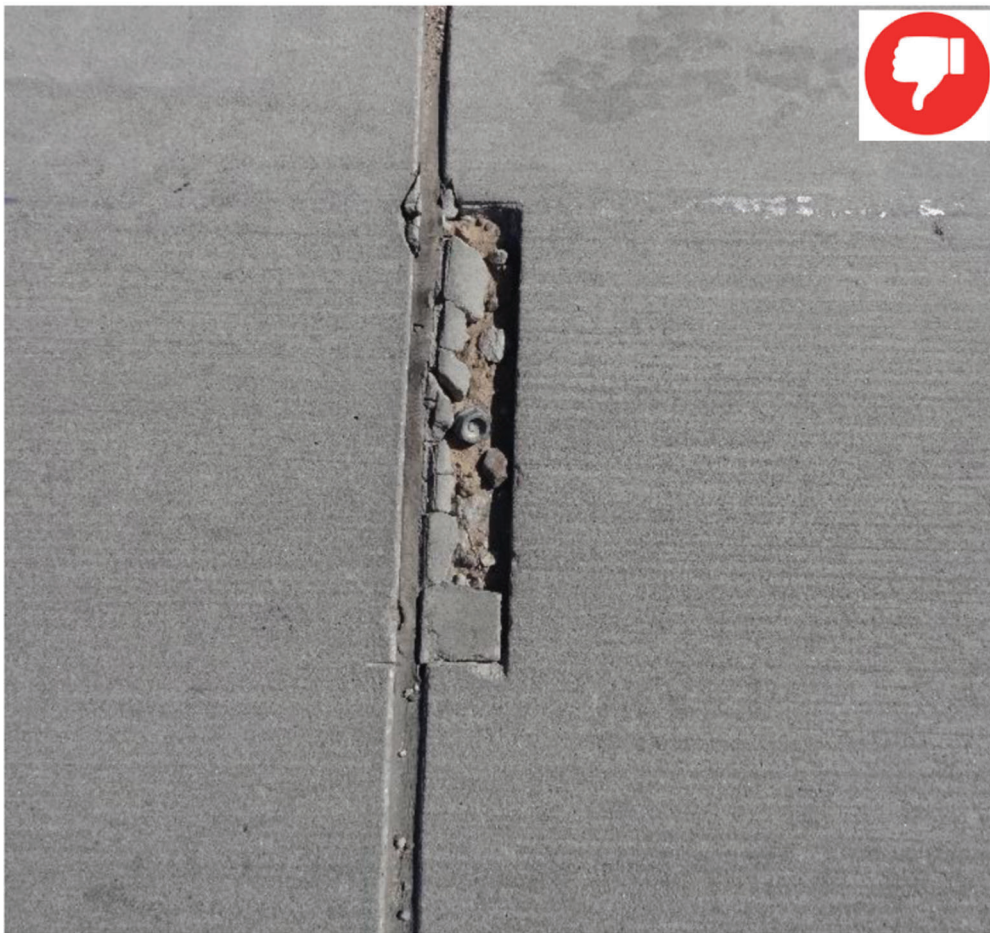
Failed PDP that was used to address joint spalling (© Photos by Applied Pavement Technology (APTech)).

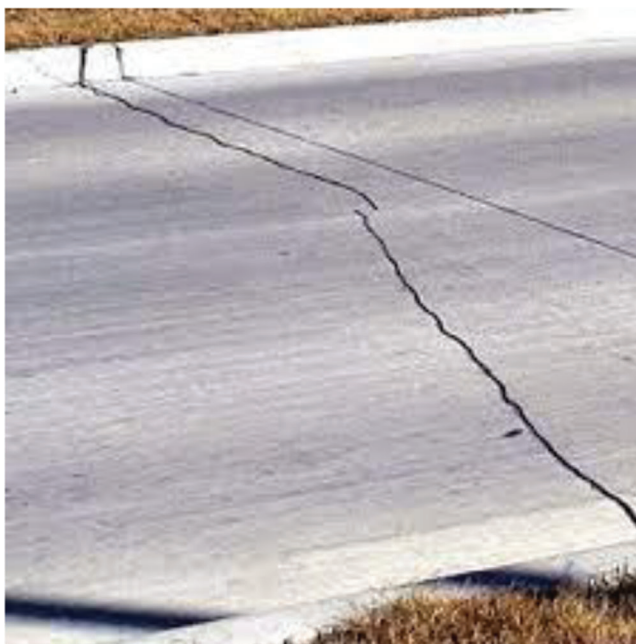
Sealed transverse crack on concrete pavement (Texas Transportation Institute, 2008).

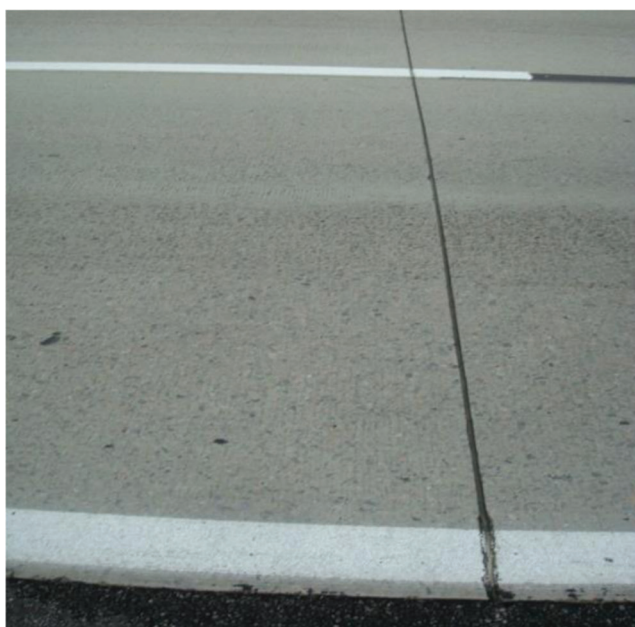
Sealed contraction joint on concrete pavement (© Photo by Applied Pavement Technology (APTech)).

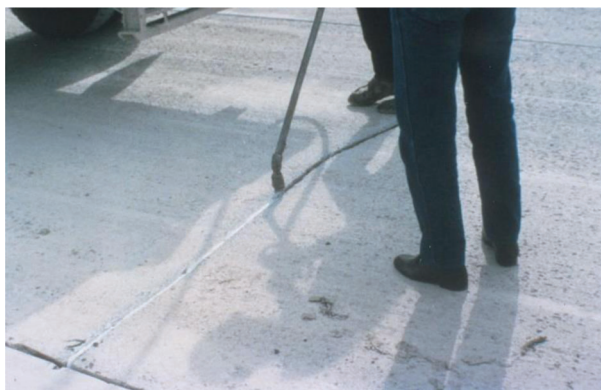
Sealing of a transverse joint in concrete pavement (Part A Step 4 Construction Steps) (© Photo by Applied Pavement Technology (APTech)).

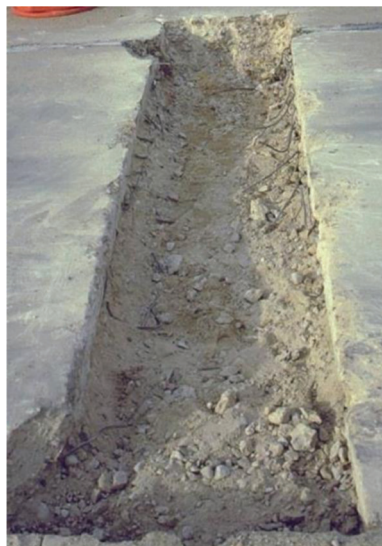
Removal (Step 3) of distressed concrete pavement using breakup and clean-out method for FDP implementation (© Photo by Applied Pavement Technology (APTech)).

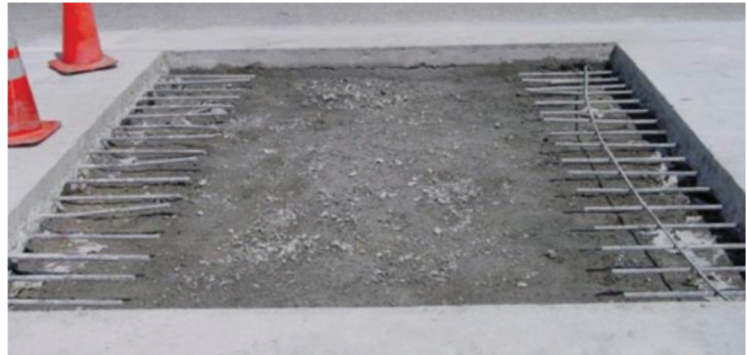
Prepared CRCP repair area (Step 4) with exposed reinforcing steel (Smith et al., 2022).

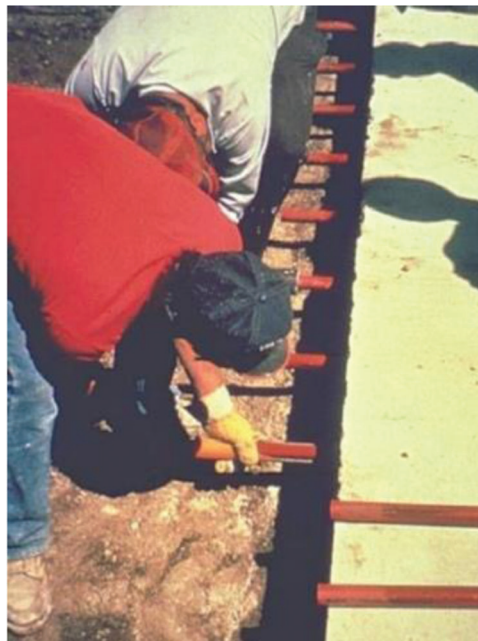
Installation of dowel bar (load transfer) (Step 5) in FDP implementation on a JPCP (© Photo by Applied Pavement Technology (APTech)).

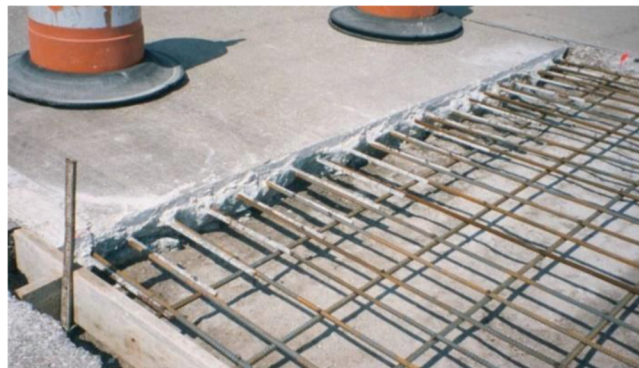
Restoration of both longitudinal and transverse steel in a CRCP FDP project (Step 5) (© Photo by Applied Pavement Technology (APTech)).

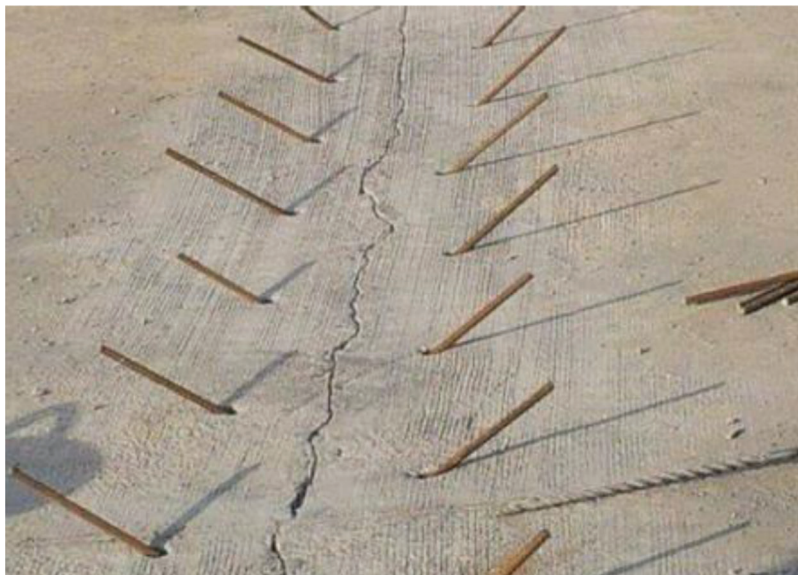
Implementation of a cross-stitching method to repair a longitudinal crack (Daily Civil, n.d.).

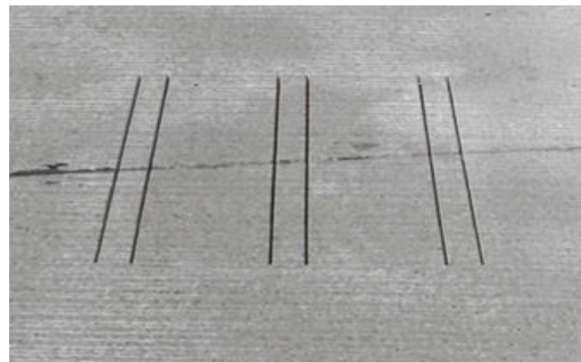
Slot creation (Step 2) of concrete pavement  
(Photo from J. Uhlmeier, personal communication,  
May 14, 2024.)

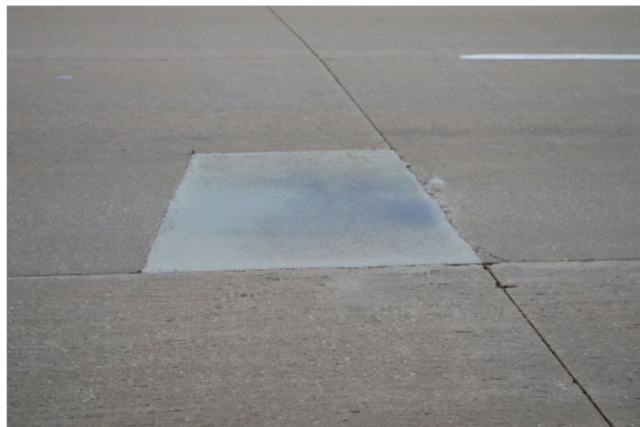
Completed concrete partial depth patch at the corner of a concrete slab (© Photo by Applied Pavement Technology (APTech)).

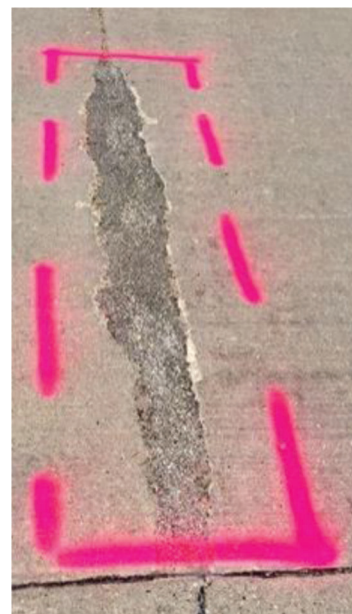
Properly marked PDP area (Step 1)  
(Smith et al., 2022).

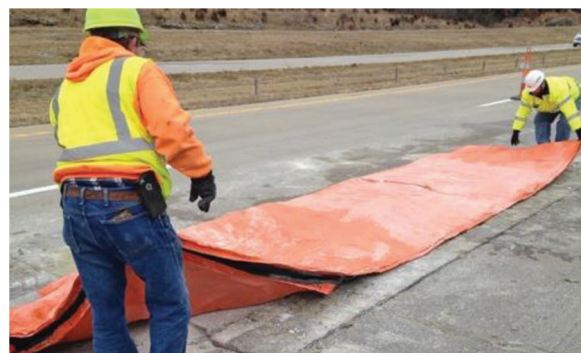
Insulating blanket being placed on finished PDP in cold weather conditions (Step 9) (Smith et al., 2022).

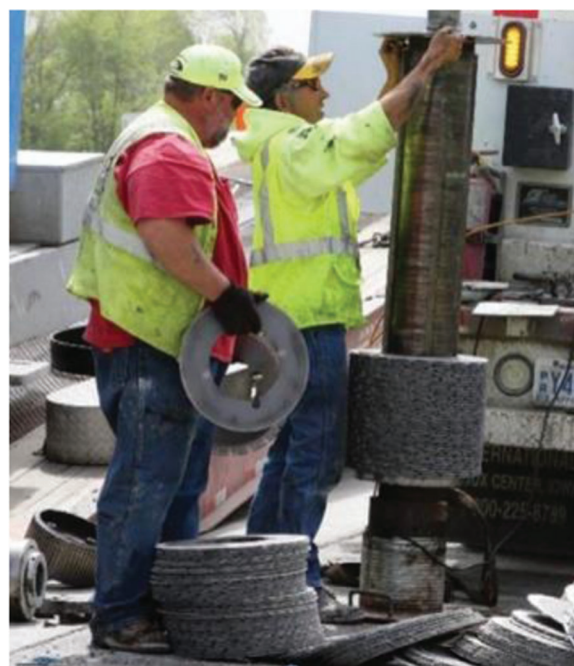
Stacking spacers and blades on a diamond grinding machine's cutting head (Smith et al., 2022).

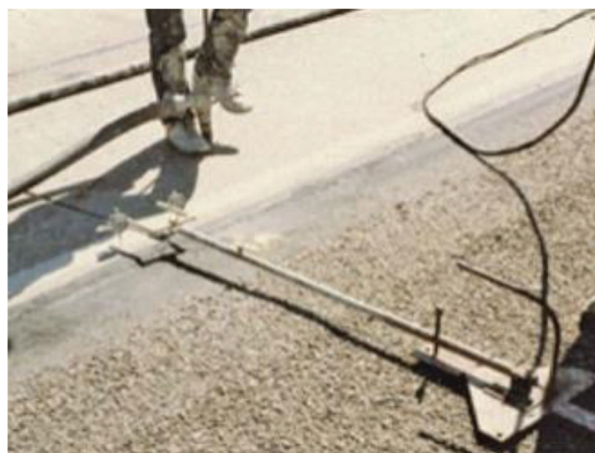
Mechanical methods of monitoring slab uplift using cement grout injection (Smith et al., 2022).

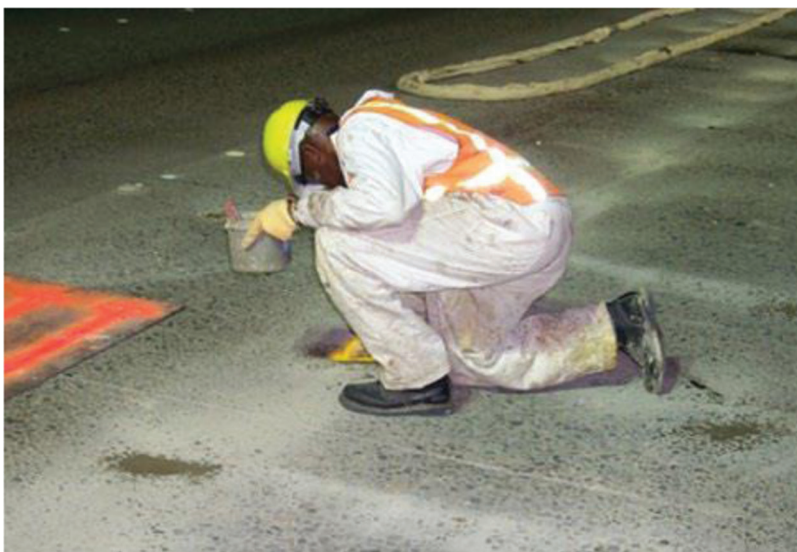
Patching drill holes after removal of temporary plug-in cement grout slab
