# **Framework of Asphalt Balanced Mix Design (BMD) for New England Transportation Agencies**

**Prepared for  
The New England Transportation Consortium  
December 31<sup>st</sup>, 2020**

**Project No. 18-2**

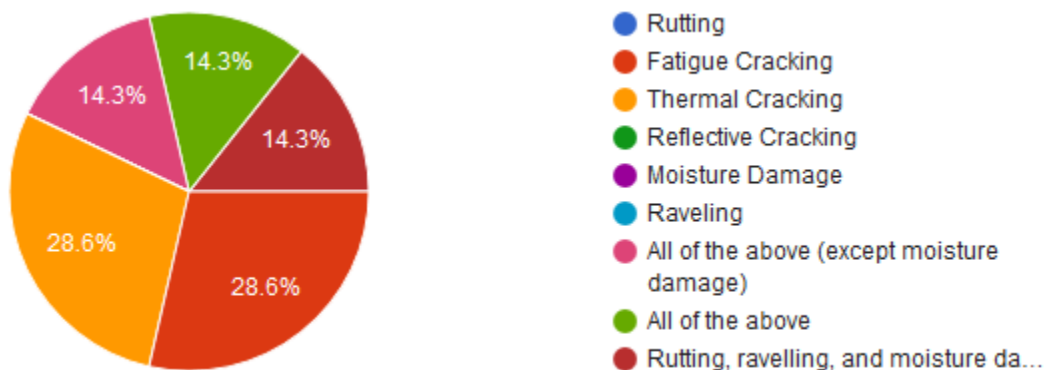
**FIGURE 1 Predominate Distresses Noted by New England State Transportation Agencies**

The survey results were reviewed, compiled and analyzed. Figure 1 illustrates the distribution of predominate asphalt pavement distresses observed by the NETC agencies. The highest noted distresses at 28.6% (2 responses each) were thermal cracking and fatigue cracking. A combination of rutting, raveling and moisture damage; all distresses, and all distresses except moisture damage all received one response (14.3%). A majority of respondents (71.4%) stated that certain distresses are more commonly observed in different regions of their state with thermal and fatigue cracking being the most commonly observed. Based on these distresses noted in the survey, candidate performance test(s) were discussed and recommended in Section 4.0 of this final report.

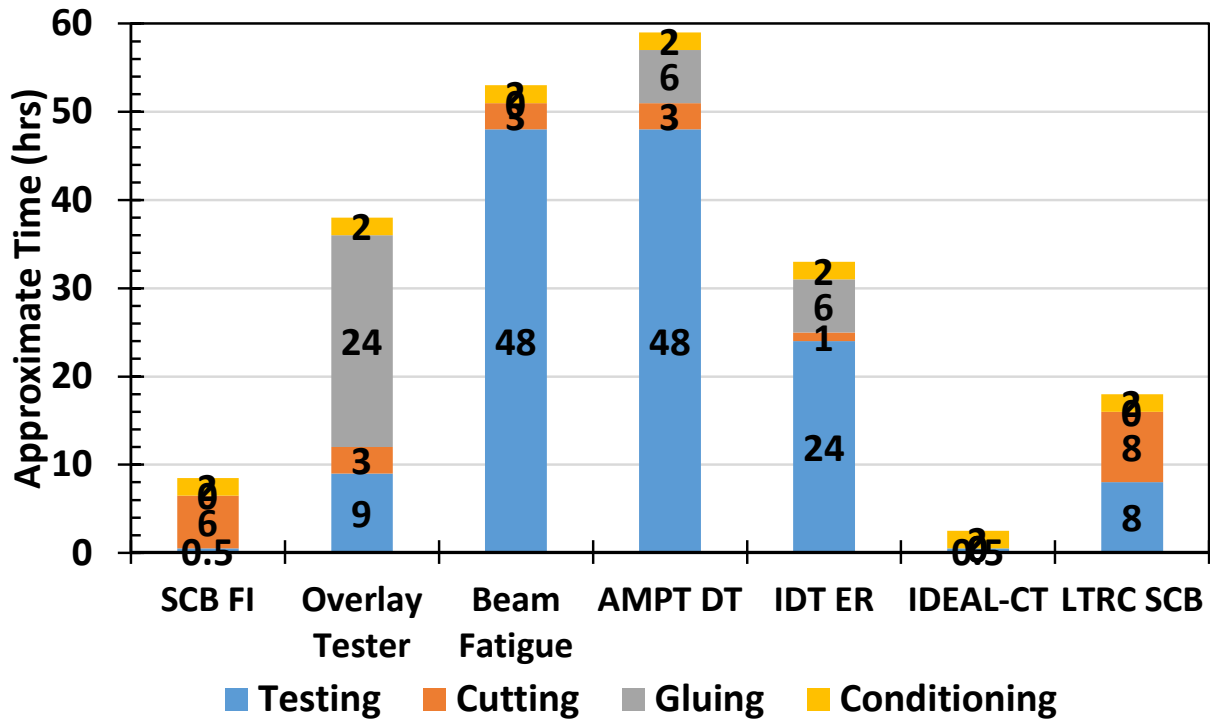
**FIGURE 2 Time Requirements to Various Fatigue Cracking Test Procedures**

Table 2 captures the general test method information regarding estimate costs and time required to conduct the test (specimen preparation, conditioning, and testing time) for currently recognized intermediate temperature fatigue cracking tests. As the table indicates, the most expensive test procedure to implement would be the Flexural Beam Fatigue, primarily due to the necessity of purchasing a brick compactor for specimen preparation. The second most expensive fatigue cracking test would be the Direct Tension Cyclic Fatigue. The least expensive test procedures would be the SCB Flexibility Index, IDEAL-CT Index and SCB-LTRC. Regarding the time required for sample preparation and testing, the Direct Tension Cyclic Fatigue test is the most time consuming with the IDEAL-CT being the quickest to conduct (Figure 2). It should be noted that testing time can generally be decreased as the technicians gain additional experience. Conditioning times can also be reduced by utilizing a secondary environmental chamber for specimen conditioning, which can greatly increase the productivity of testing.

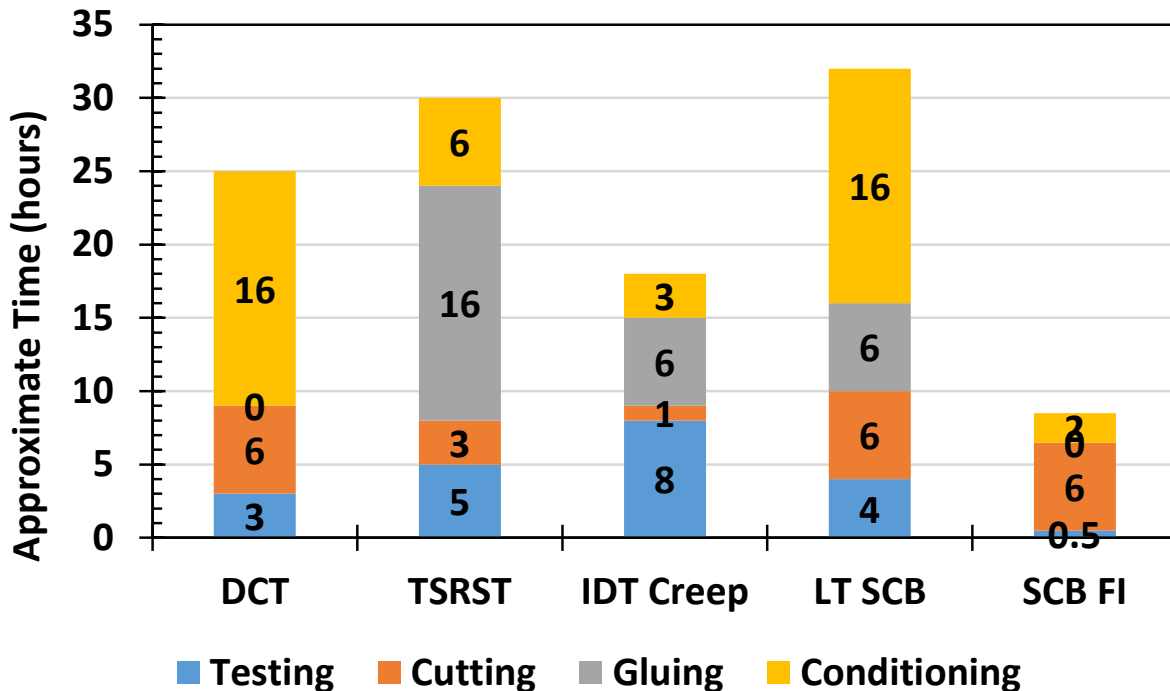
**FIGURE 3 Time Estimate Requirements to Conduct Thermal Cracking Test Method**

Testing time (Figure 3) was found to be somewhat similar for some of the test procedures, mostly due to the requirements for conditioning. It was estimated that the IDT Creep Compliance and Strength test would be the quickest test procedure to conduct with the DCT test being the second quickest thermal cracking test to conduct. The Low Temperature SCB and TSRST tests were found to be the most time-consuming thermal cracking tests. It should be noted that testing time can generally be decreased as the technicians gain additional experience. Conditioning times can also be reduced by utilizing a secondary environmental chamber for specimen conditioning, which can greatly increase the productivity of testing.

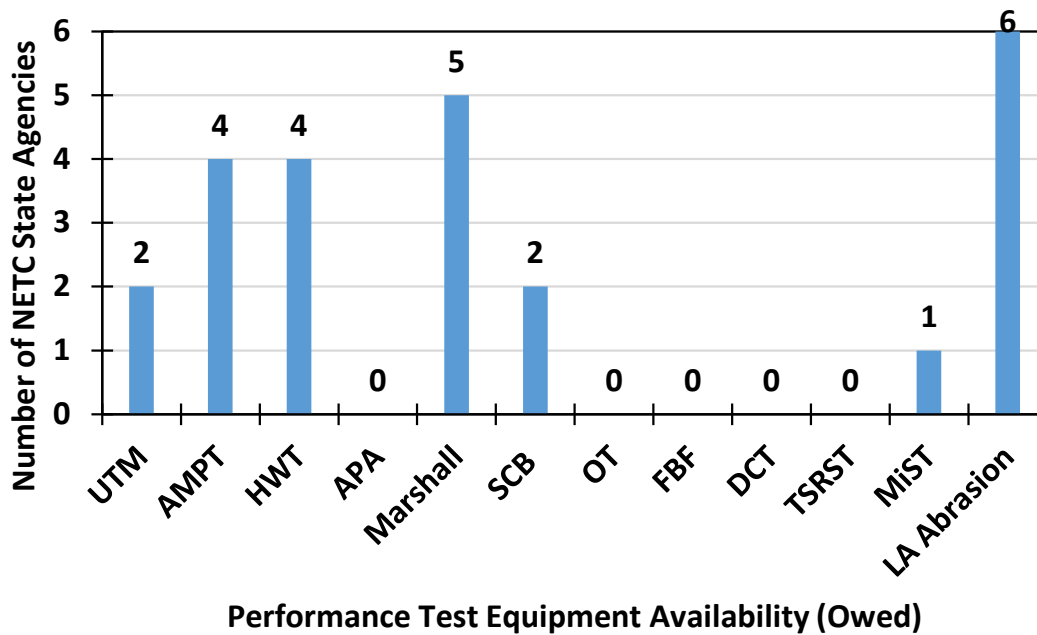
**FIGURE 6 Performance Test Equipment Currently Owned/Housed by NETC State Agencies**

- 2 of the 6 states own a universal testing machine (servo-hydraulic or screw driven). It was not noted as to whether or not the units are operating on a daily or weekly basis
- 4 of the 6 states own an Asphalt Mixture Performance Tester, AMPT (with the New Hampshire DOT's at the University of New Hampshire)
- 4 of the 6 states own a Hamburg Wheel Tracking machine (with Connecticut DOT's at the University of Connecticut)
- 5 of the 6 states own a Marshall and Stability Flow device
- 2 of the 6 states own a standalone Semi-circular Bend (SCB) Flexibility Index device
- 1 of 6 states (Maine) owns a MiST device for moisture susceptibility testing
- 6 of 6 states own an LA Abrasion Machine

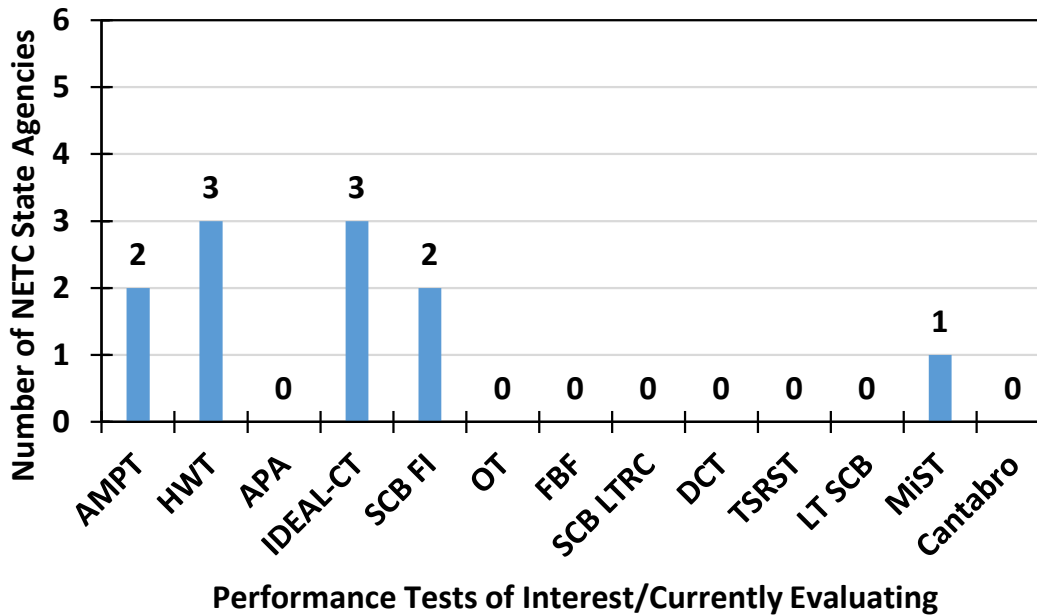
**FIGURE 7 Performance Test Procedures of Interest and/or Currently Evaluating by the NETC State Agencies**

- 3 of 6 NETC state agencies have shown interest in using the Hamburg Wheel Tracking (HWT) and IDEAL-CT test procedures
- 2 of 6 NETC state agencies have shown interest in using the Asphalt Mixture Performance Tester (AMPT) and SCB Flexibility Index
- 1 of 6 NETC state agencies have shown interest in looking at the MiST device for moisture damage potential

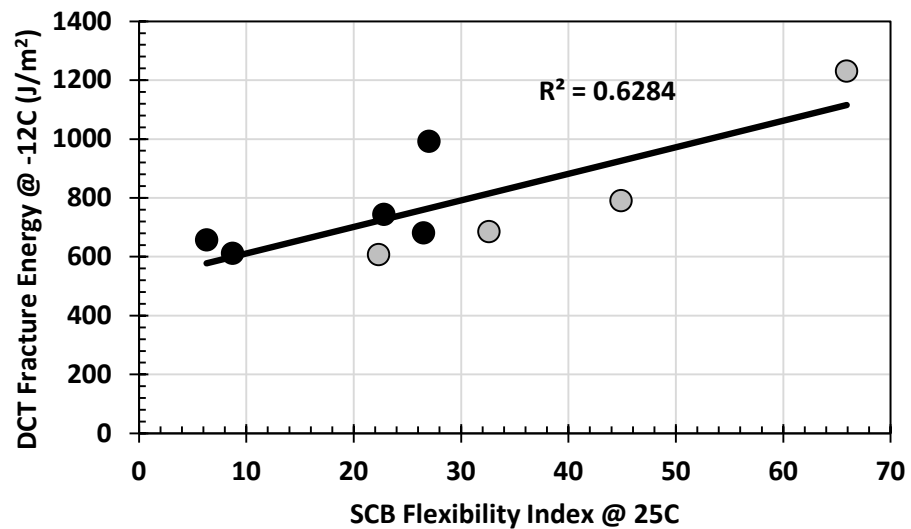
**FIGURE 9 Comparison of DCT and SCB FI Performance for PennDOT’s LLAP Projects (Black Circles = Lab Mixed; Gray Circles = Field Cores)**

some work conducted by Rutgers University for PennDOT’s Long Life Asphalt Pavement (LLAP) projects containing both 9.5 mm NMA SMA and 19 mm NMA dense graded asphalt mixtures. Both the DCT test at  $-12^{\circ}\text{C}$  and the SCB FI at  $25^{\circ}\text{C}$  are required testing procedures. The results show that a relationship does exist between the two test methods, but perhaps could be improved by looking at different testing temperatures. Varying loading rates in the SCB FI could also be evaluated, but would eliminate the use of the Marshall compression machine from testing. Testing could also be conducted during the mixture design phase using both tests to establish initial baseline. Such “surrogate” type testing would need to be conducted for each state’s own materials if a database and general relationship were to be implemented.

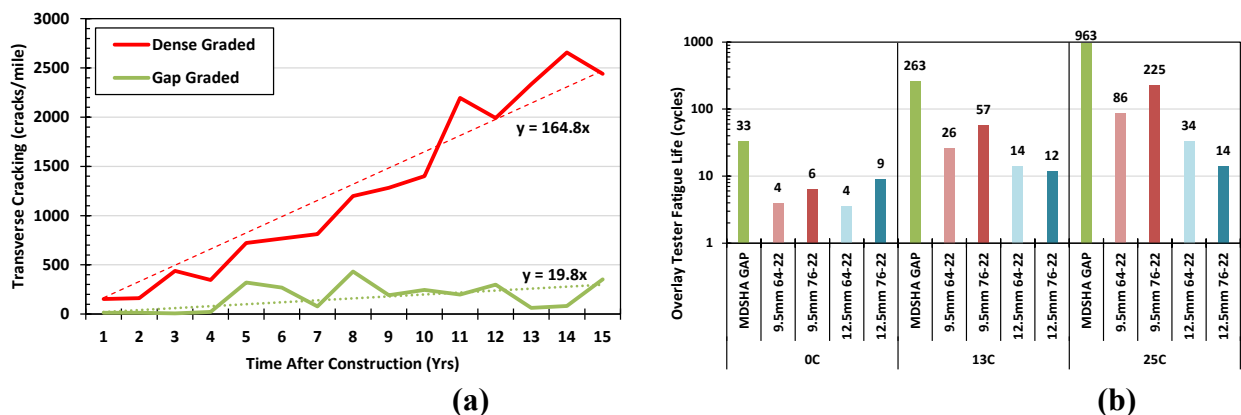
**FIGURE 11 Maryland State Highway; (a) Pavement Management System Results; (b) Overlay Tester Fatigue Life Results (6)**

3. Based on the general information described above and shown in Figures 11a and 11b, some initial performance criteria can already be proposed;
  - a. Combining the results of Figures 11a and 11b, for composite pavement use, minimum performance in the Overlay Tester at 25°C should be >900 cycles. Granted, it can be assumed that with higher values of Overlay Tester even lower reflective cracking would occur. However, there will also be associated costs for which each state agency would need to consider.

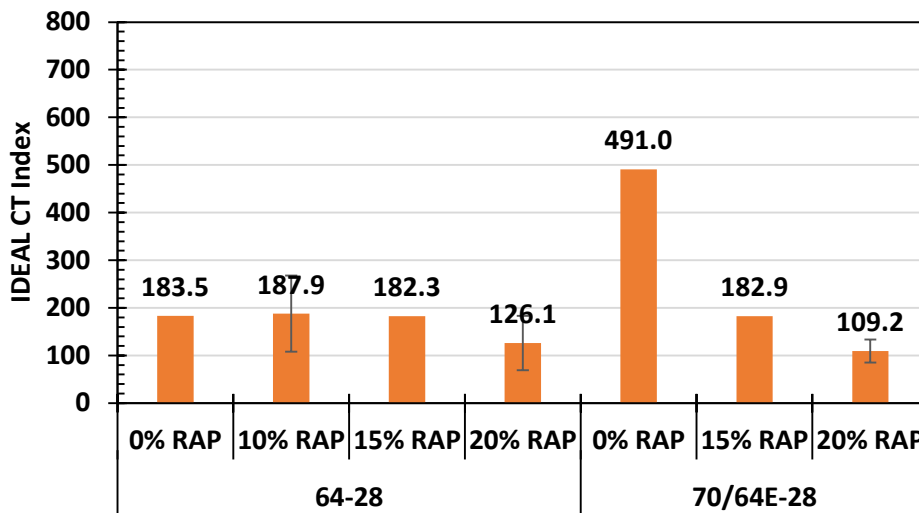
**FIGURE 13 MaineDOT IDEAL-CT Index Values for Different RAP Contents and Polymer Modified Asphalt Binders**

- For the PG64-28 asphalt binder, 0% to 15% RAP content results in very similar IDEAL-CT Index results. However, as the RAP content increased to 20%, there was a significant decrease in the values, similar to the results in Figure 12;
- The use of polymer-modified asphalt binders (PG64E-28 and PG70E-28) resulted in a significant increase in IDEAL-CT performance at 0% RAP. However, once RAP was added to the polymer-modified asphalt binders, the results were extremely similar to the unmodified PG64-28 asphalt binder results.

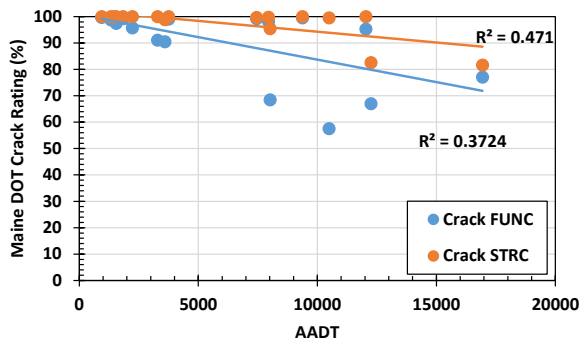
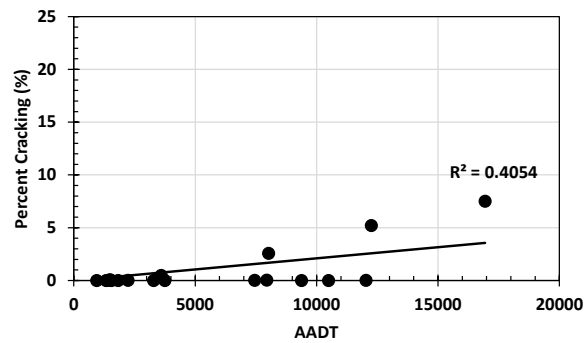
Figure 16 shows the same cracking indices from Figure 15, but this time, compared to the Average Annual Daily Traffic (AADT). Pavement designs are commonly done with Average Annual Daily Truck Traffic (AADTT) as it is well known that truck traffic generates a significantly larger amount of distress on a pavement than car traffic. However, Percent Trucks was not provided in the data, so the traffic information is represented by AADT. In Figure 16, there does appear to be a moderate relationship between the MaineDOT PMS cracking indices and AADT. This would suggest that within the timeframe these particular asphalt mixtures were placed, the primary factor creating the measured cracking distress was the traffic. Therefore, traffic levels may need to be included in future performance criteria for Maine’s Balanced Mixture Design.

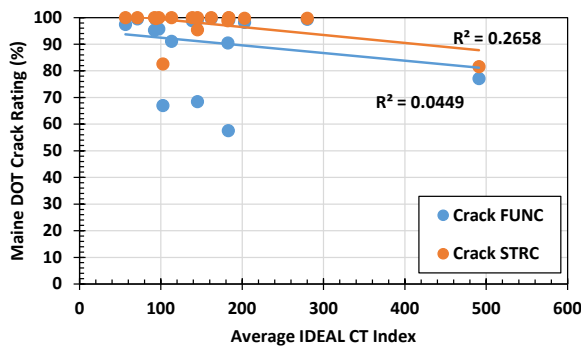
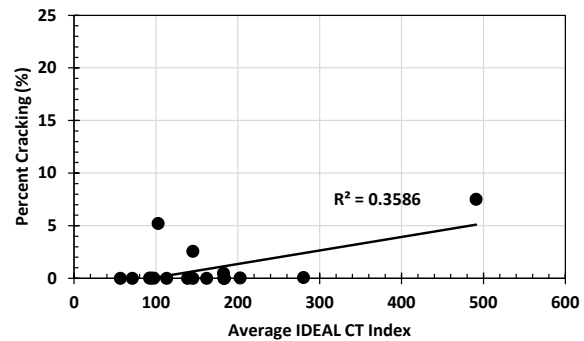
An initial attempt was made to directly compare the IDEAL-CT Index values to the MaineDOT PMS cracking indices. Figures 18a and 18b show the results of the analysis. The overall trends are counter-intuitive than one would expect or hope. The results in Figures 17a and 17b show that as the IDEAL-CT Index value increases, the measured cracking in the field also increases. One would expect that good performing asphalt mixtures (i.e. – higher IDEAL-CT Index values) should result in better field cracking performance.

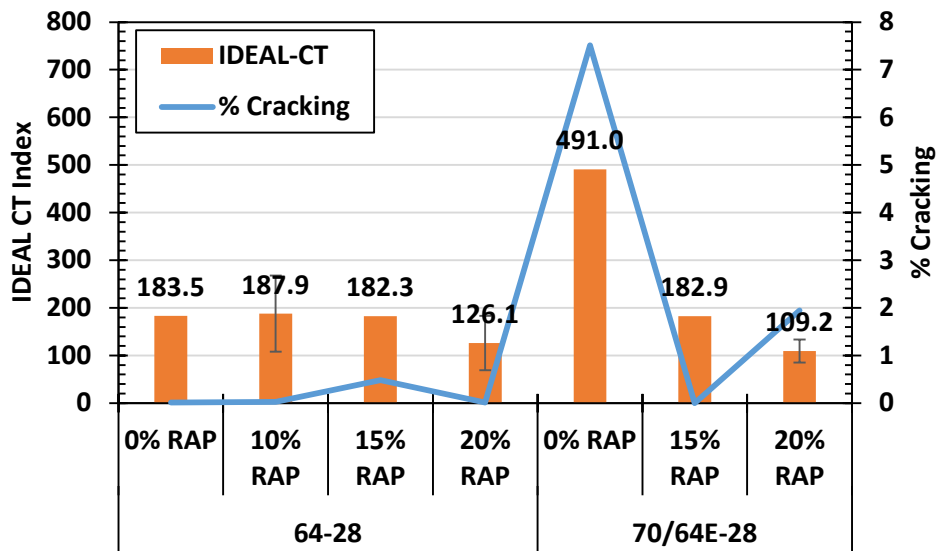
FIGURE 18 IDEAL-CT Index and MainedOT % Cracking for Different Asphalt Binder Grades and RAP Contents

Additional analysis was conducted to determine why the relationship between lab and field cracking did not follow an expected trend. Figures 18 through 20 show the asphalt mixtures broken out by asphalt binder grade and RAP percentage while compared to the MaineDOT cracking indices. Overall, the PG64-28 asphalt binder mixtures appeared to have lower field cracking when compared to the polymer modified PG64E-28 and PG70E-28. In fact, the pavement section with the worst cracking performance also happened to be the section with the PG70E-28 asphalt binder. Once again, this is counter intuitive to what one would expect as this would have to be a highly polymer modified asphalt binder.

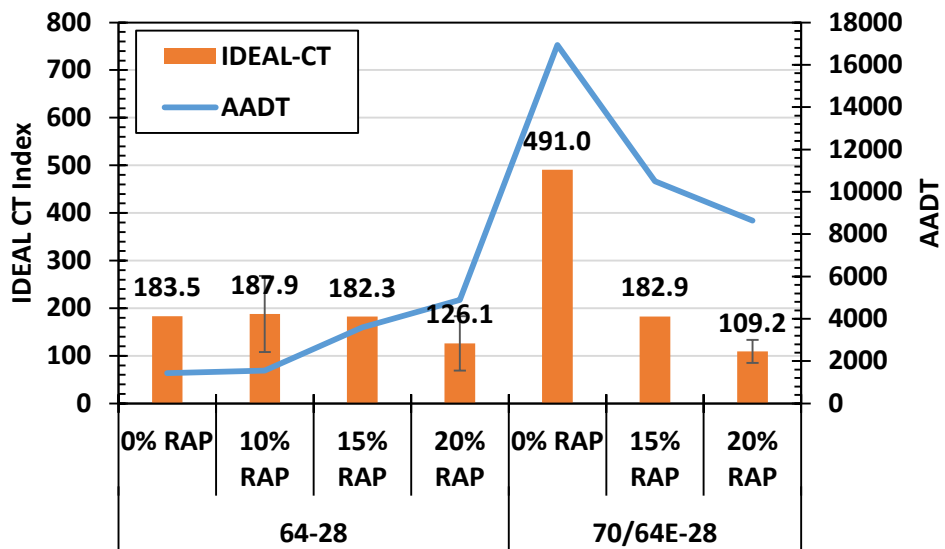
**FIGURE 21 Resultant IDEAL-CT Index Values for Different Asphalt Mixtures with the Pavement Sections' Traffic Volume (AADT)**

The previous figures showed a troubling situation occurring where the polymer-modified asphalt mixtures were under-going higher levels of field cracking within the first five years of service life. However, as shown earlier, the field cracking was found to be related to the traffic levels (AADT). AADT and the IDEAL-CT Index values were plotted against the different asphalt mixtures (PG grade and RAP content). Figure 21 shows the results of the analysis. It is clear from the graph that higher traffic levels are associated for the polymer-modified asphalt mixtures. In fact, the PG70E-28 pavement section that achieved the IDEAL-CT Index had the highest level of traffic. Figure 21 clearly demonstrates how significant the impact of traffic volume was in the analysis, and that traffic levels should be included in the performance criteria.

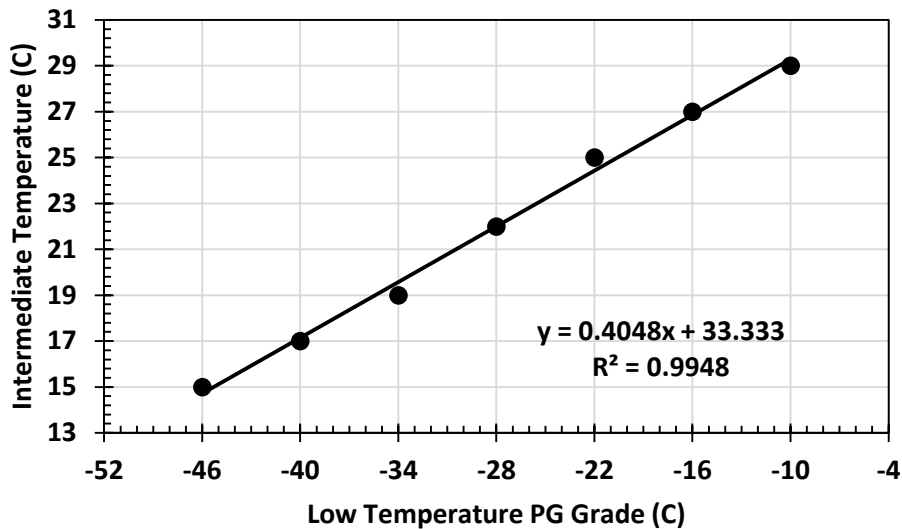
**FIGURE 25 Recommended Intermediate Temperature for Fatigue Cracking Analysis Based on Representative Low Temperature PG Grade (7)**

MaineDOT should also look at whether or not the test temperature of 25°C is best to represent their climate conditions when utilizing the IDEAL-CT test. Work conducted under NCHRP Project 9-59 recommended that a better method to represent intermediate test temperature is to utilize the low temperature PG grade and the relationship shown in Figure 25 (7). Using the LTPPBIND3.1 software, the low temperature PG grade was determined at a 98% reliability. This shows Maine has two different low temperature grades; -28°C along the coastal area and -34°C inland (Figure 26). The resultant intermediate test temperatures, based on the recommendation from NCHRP 9-59, would then be 22°C and 19°C, respectively.

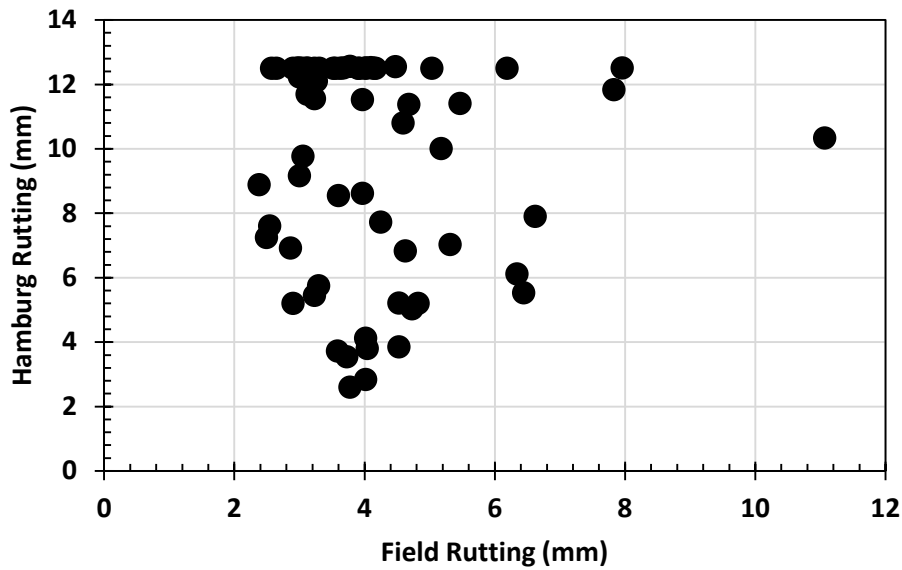
**FIGURE 27 Measured Field Rutting vs Hamburg Wheel Tracking Rutting of Asphalt Mixture Placed on Pavement Sections**

A first attempt at comparing the field measured rutting and the Hamburg rutting is shown as Figure 27. As the figure clearly shows, no direct relationship existed between the test data and field rutting based on their raw measurements.

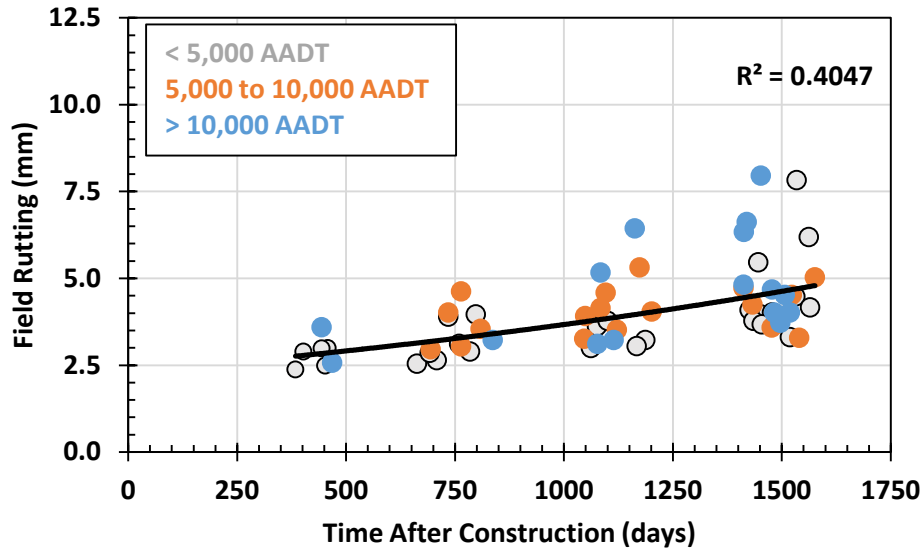
**FIGURE 29 Field Rutting vs Time After Construction in Maine**

To determine if the field rutting did increase with time, the field rutting from the laboratory test data pavement sections were compared against the time after construction. The data set was also filtered to show the AADT (Figure 29). The data in Figure 29 does actually show the magnitude of field rutting increases over time, at least within the four year period of the provided test data. It should be noted that these are not the same sections evaluated each year, but different pavement sections of similar asphalt mixtures with similar Hamburg Wheel Tracking properties.

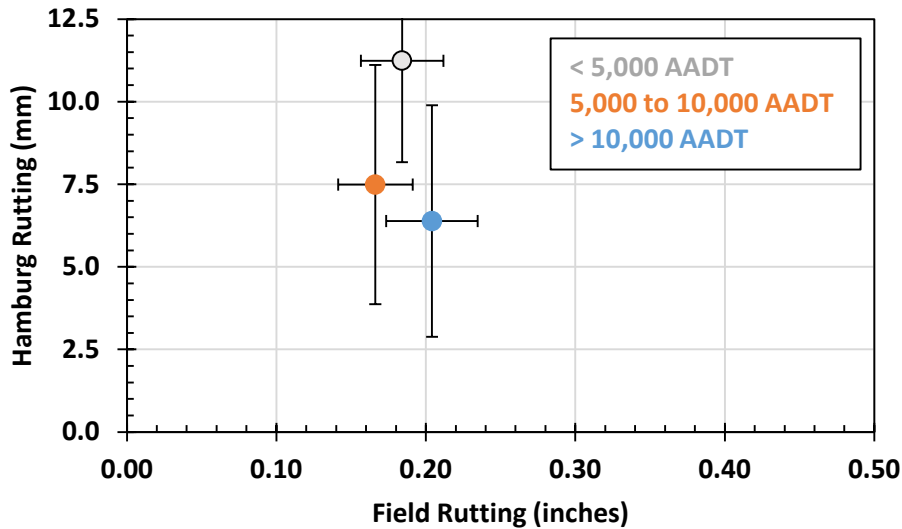
**FIGURE 31 Average Field Rutting vs Average Hamburg Rutting (Error Bars Represent Standard Deviation Above and Below Average)**

performance would fall in the “average” area, somewhere between 0.15 inches and 0.30 inches. This would indicate that a selection for the criteria of Hamburg rutting should not deviate much more than what the average values currently fall on. By selecting a lower Hamburg rutting magnitude would be very conservative since the pavements are not showing severe rutting issues, while selecting a higher value may actually lead to field rutting higher than the 0.15 - 0.20 inches currently witnessed. Utilizing this rationale, Figure 32 was developed and represents the “PASS-FAIL” Hamburg Wheel Tracking rutting criteria for different AADT levels on Maine’s asphalt pavements. The rutting criteria is based on testing the asphalt mixtures to 20,000 loading cycles at a test temperature of 45°C.
