Evaluation of Modern Locomotive Crashworthiness Performance

1. REPORT DATE (DD-MM-YYYY) 05-09-2024		2. REPORT TYPE Final Report		3. DATES COVERED (From - To) 09/2021-06/2023	
4. TITLE AND SUBTITLE Evaluation of Modern Locomotive Crashworthiness Performance				5a. CONTRACT NUMBER 693JJ621C000016	
				5b. GRANT NUMBER	
				5c. PROGRAM ELEMENT NUMBER

9. SPONSORING/MONITORING AGENCY NAME(S) AND ADDRESS(ES) U.S. Department of Transportation Federal Railroad Administration Office of Railroad Policy and Development Office of Research, Development and Technology Washington, DC 20590				11. SPONSOR/MONITOR'S REPORT NUMBER(S) DOT/FRA/ORD-24-35

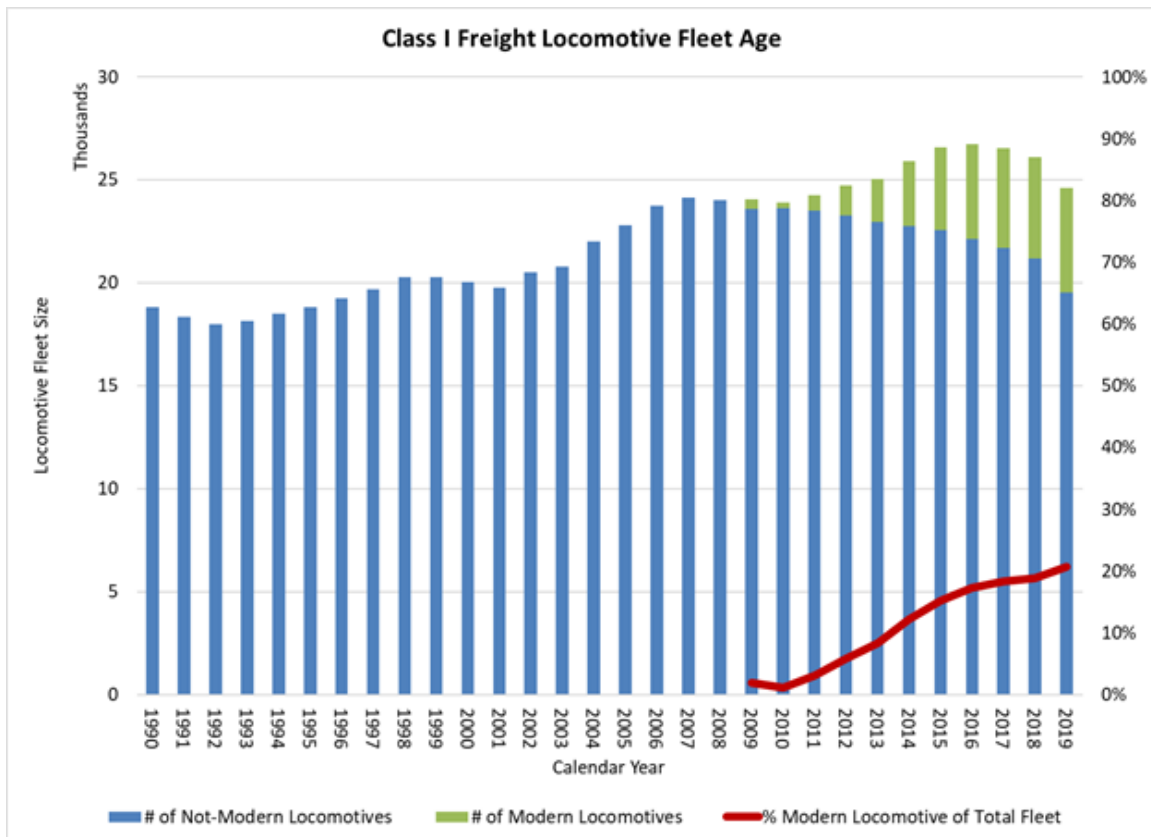
Figure 1. Class I Freight Locomotive Ratio of Modern to Non-Modern Locomotives

The team analyzed the freight railroad locomotive fleet records and found that modern locomotives constituted a small fraction of the total road locomotives in the inventory of Class I railroads, from 2 percent in 2009 to 21 percent in 2019 (U.S. Department of Transportation, 2020). [Figure 1](#) depicts the locomotive fleet size from 1990 to 2019, showing the number of modern locomotives relative to the non-modern locomotives after 2009, when the AAR S-580-2005 crashworthiness requirements were mandated.

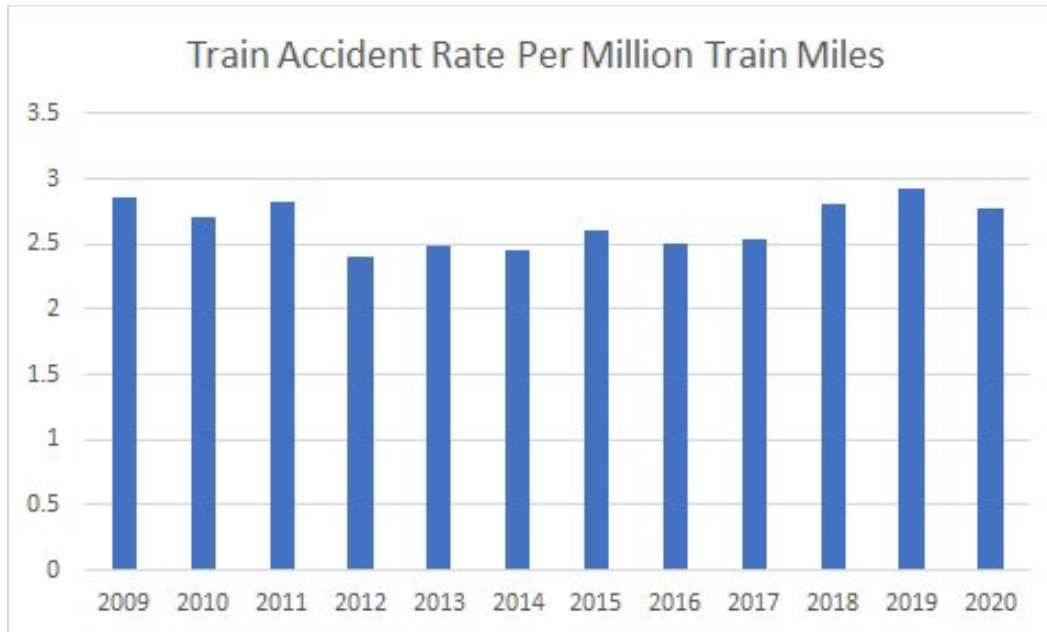
Figure 2. Accident/Incident Rates per Class I Freight Million Miles (U.S. Federal Railroad Administration, 2021)

[Figure 2](#) depicts the variation of accident/incident rates of U.S. Class I freight railroads throughout the decade after modern locomotives were introduced.

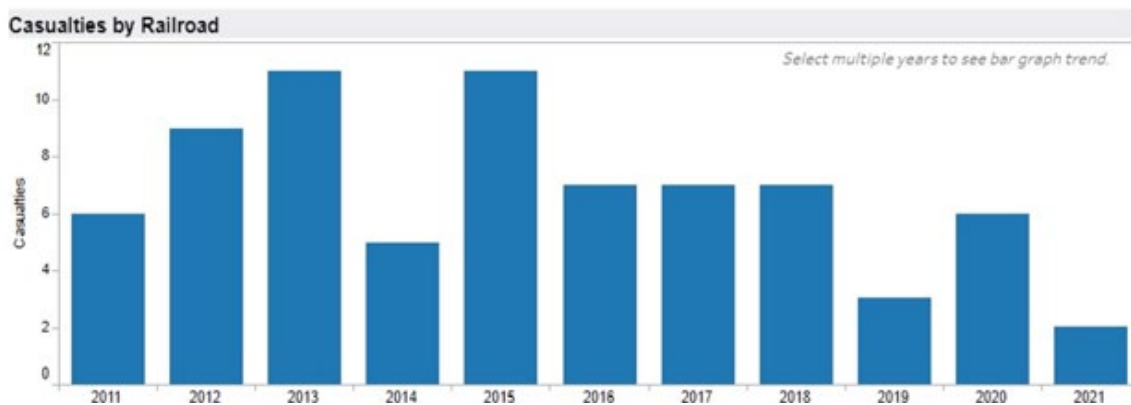
Figure 3: Number of Post-Accident In-cab Casualties of U.S. Class I Freight Railroads in Revenue Service (U.S. Federal Railroad Administration, 2021)

Figure 3 shows the trend in post-accident in-cab casualties since the introduction of modern locomotives, with a decreasing number of casualties in the second half of the decade.

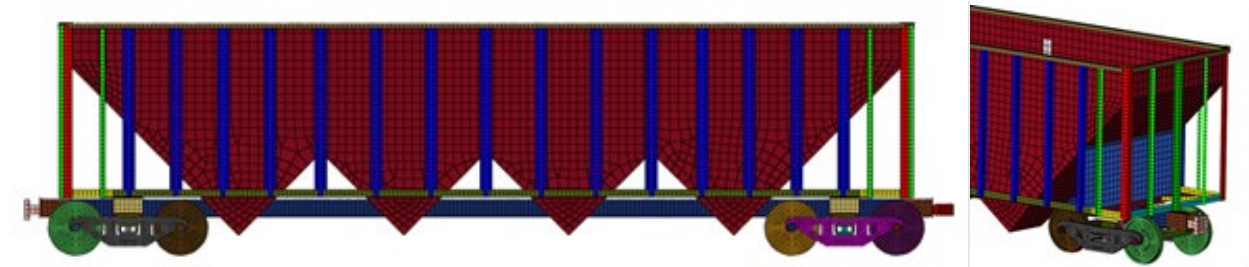
Figure 9. Original Open-Top Hopper Car FE Model

Figure 9 depicts the original open-top hopper car model, consisting of 42,029 elements (34,820 shell, 7,175 solids, and 34 beam/discrete) and 61 parts. The open-top hopper car is modeled in detail (fine mesh), while all the other train cars are modeled in coarse mesh since they are not directly involved in the crash.

The locomotive of TTC Test 1 crushed only the open-top hopper car. The mesh elements are predominantly coarse, particularly away from the impact zone, and become finer near the location of impact. Employing larger elements would stiffen the model and hinder the reasonable failure of the material or the weld surrounding it. The mesh quality of the model is presented in Table 12.

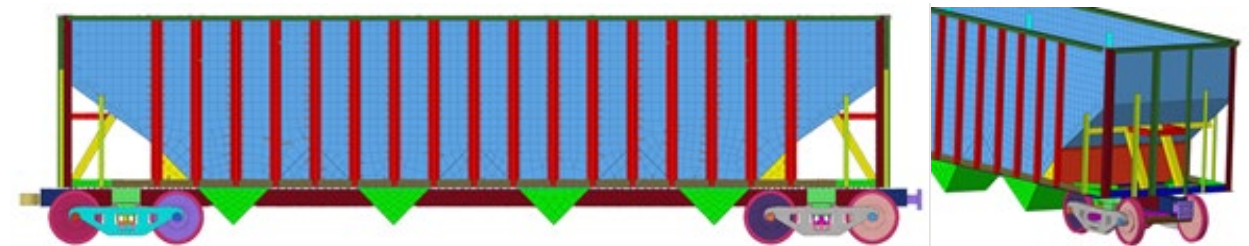
Figure 10. Updated and Modified Open-Top Hopper Car FE Model

The open-top hopper car model was revised to accurately reflect the specific car used in TTC Test 1 using images from the report and crash test video. Figure 10 displays the ultimate form of the FE model, while Figures 11 and 12 show the pre-crash images of the open-top hopper car.

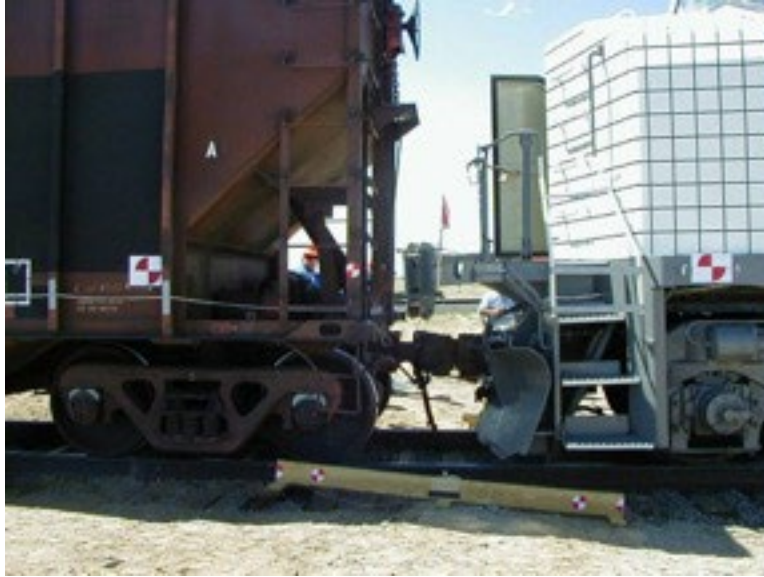
Figure 11. Pre-Crash Image of TTC Test 1 Hopper Car

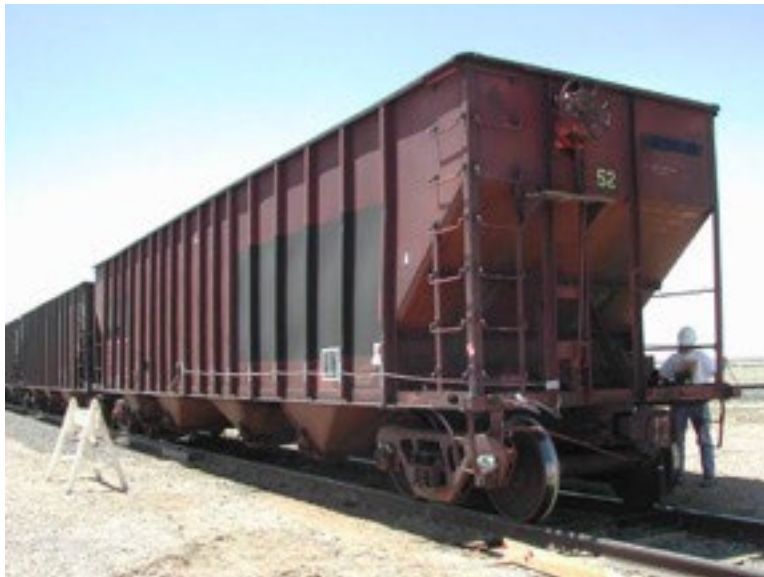
Figure 12. Pre-Crash Image of TTC Test 1 Hopper Car

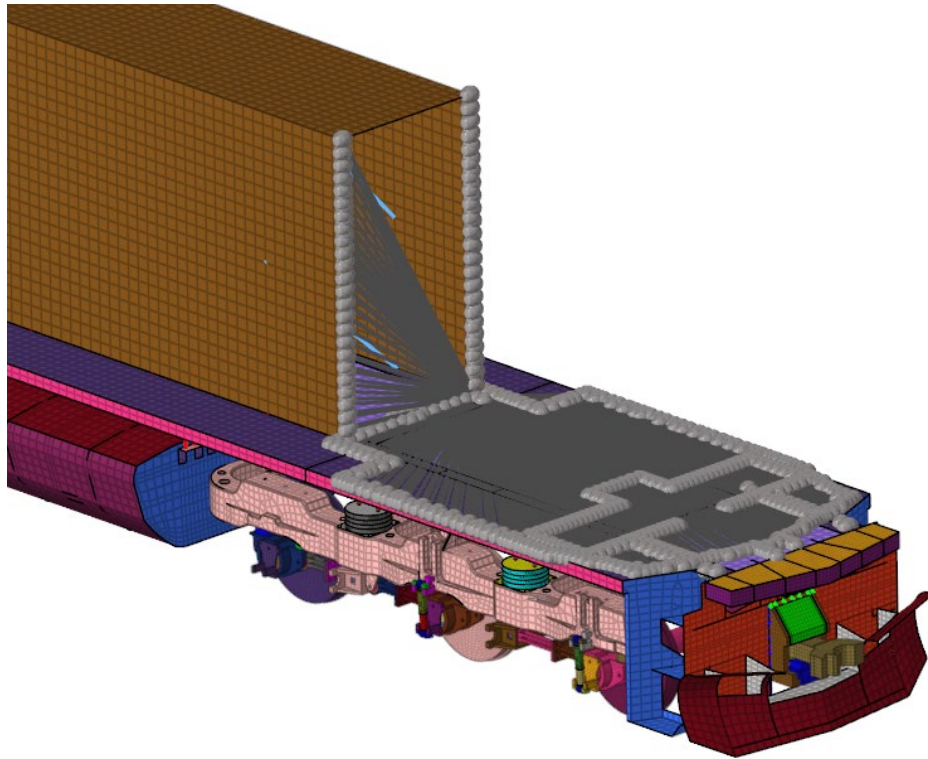
Figure 13. Locomotive Nodal Rigid Body Constraint (Cab and Hood Not Shown)

In the locomotive model, a single connection was initially used between the cab and the collision posts and the locomotive itself, employing *CONSTRAINED_NODAL_RIGID_BODY. This connection spanned a considerable area, as depicted in the highlighted nodes in [Figure 13](#), and artificially increased the stiffness of the locomotive. To rectify this, the constraint was removed and replaced with multiple spot-welds, enabling local connections among nearby elements.

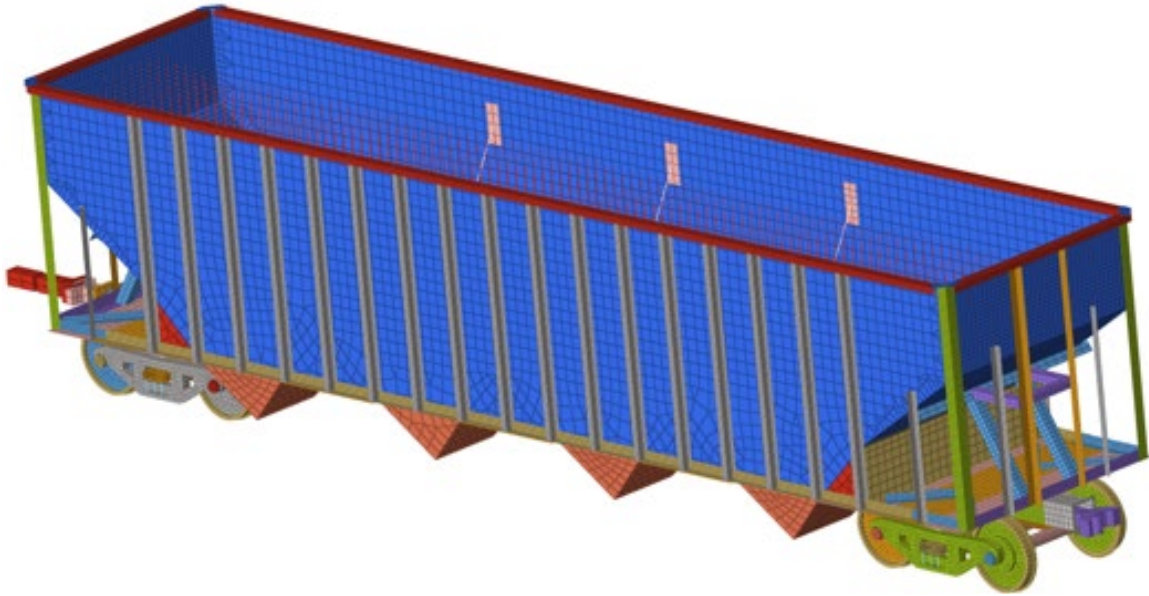
Figure 16. Modified Open-Top Hopper Car FE Model

The first target consist car model used is shown in Figure 16. This model utilizes a fine mesh, comprised of 101,482 elements (94,273 shell, 7,175 solids, and 34 beam/discrete) and 64 parts. The mesh predominantly consists of elements larger than 50.8 mm (2 inches), and approximately 6.0 percent of elements are smaller than 25.4 mm (1 inch). The Jacobian and warpage values are negligible. This open-top hopper car weighs about 200,000 lbf (90.7 tons). To match the target consist, the coarse consist shown in Figure 15 was repeated multiple times in lines. The total number of consists behind the stationary open-top hopper car is 35 cars. The stationary freight consist has a weight of 9,100,000 lbf (~4,127.7 tons). The average car weight is approximately 252,000 lbf (114 tons).

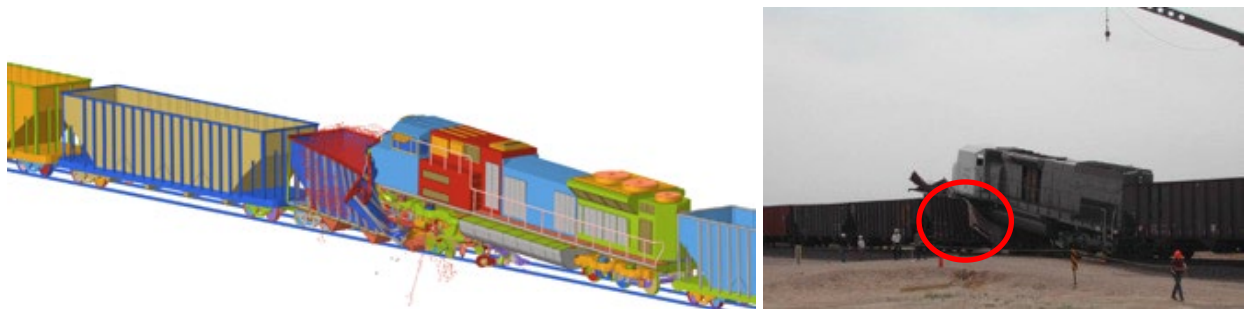
Figure 31. Post-Impact Crush Comparisons, Overview

Both images of the test in Figure 31 and Figure 32 appear to be taken from the left-hand side of the locomotive. The picture in Figure 31, taken after the crash, shows the extended lateral section of the hopper car's side wall outer shell (see circle). The picture in Figure 32 reveals a missing portion of that side wall outer shell. It appears that the extended lateral section of the side wall was taken away from the hopper car during the removal of the locomotive. The team investigated these images carefully, examined the tearing, fine-tuned the spot-weld failure, and utilized the correct modeling techniques to enhance the validation.

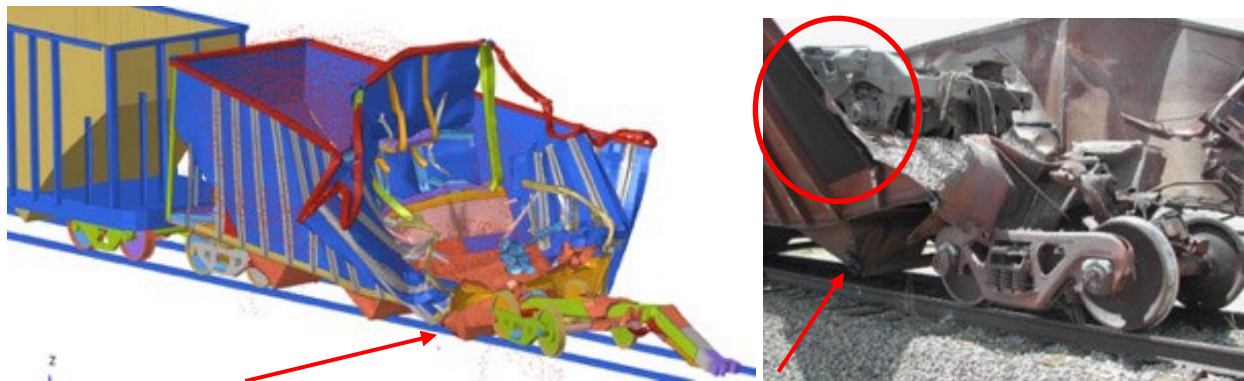
Figure 32. Post-Impact Crush Comparisons, Close-Up

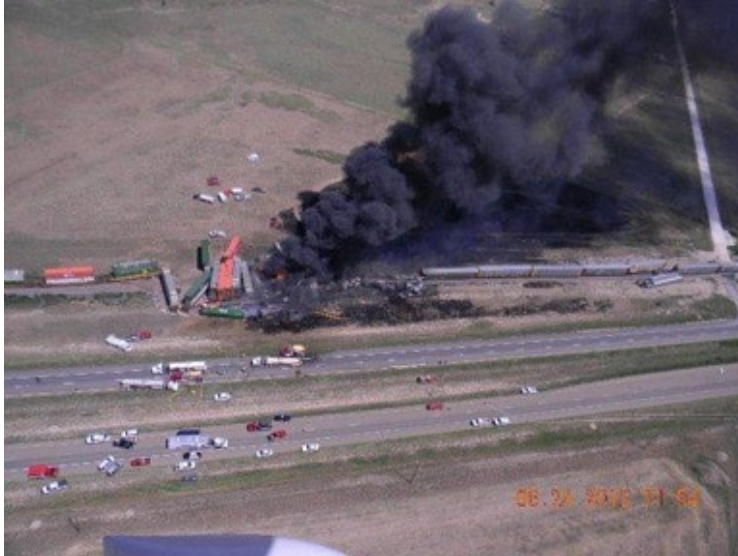
Figure 33. NTSB RAR-13-02 Head-On Collision Near Goodwell, OK, Overview

The accident caused severe damage and multiple fatalities. The eastbound locomotive crew lost two members. The westbound train's engineer also perished, and the conductor sustained injuries. The NTIS Report number is PB2013-107679/DCA12MR005. The incident resulted in the derailment of 3 locomotives and 24 cars of the eastbound train and 2 locomotives and 8 cars of the westbound train, causing the release of fuel and a large fire. The eastbound locomotives involved in the accident were UP8542 (lead), UP5482 (second), and UP7914 (third), built between 2005 and 2008. The westbound locomotives were UP8692 (lead) and UP4855 (second), built in 2011. All locomotives were retired due to the extensive damage caused by the fire, estimated to be approximately \$14.8 million. Three post-crash pictures are presented in the following two pages.

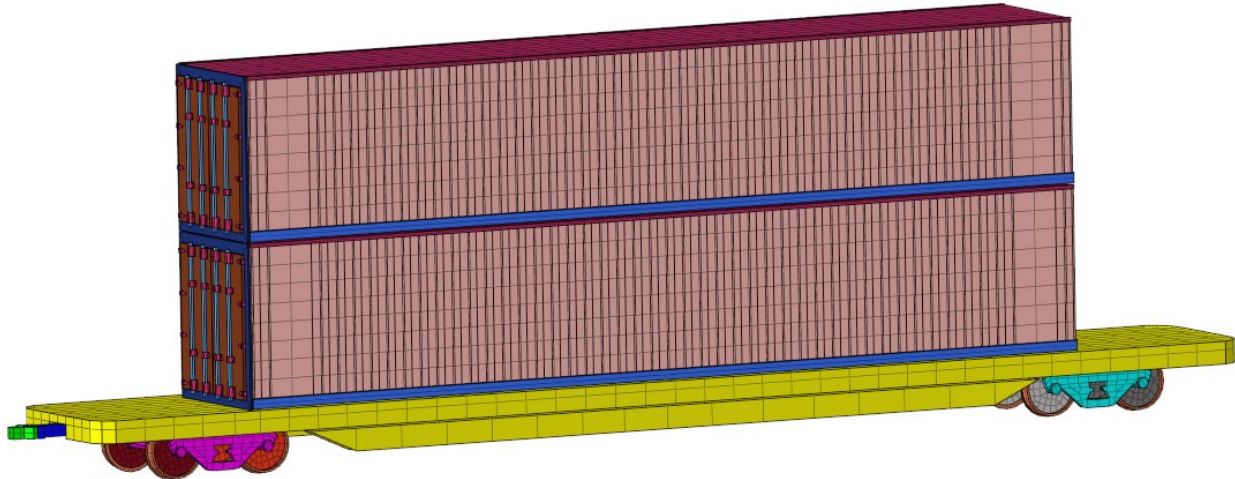
Figure 51. Ship Car FE Model

Locomotive	Total Number of elements	Total Number of Parts	Solid Elements	Shell Elements	Beam Elements	Rigid Elements	Nodal Rigid Elements
Ship Consist Car	12,252	20	2,612	9,634	0	3,302	0

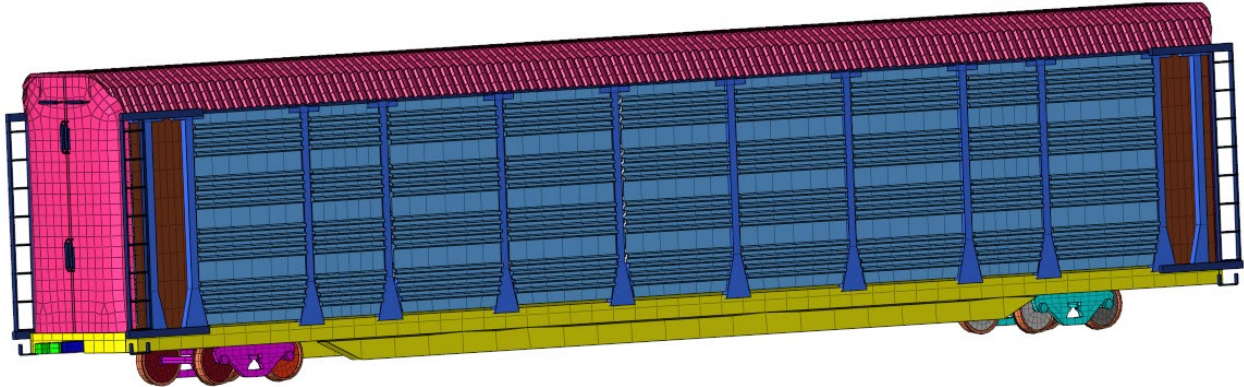
Figure 53. FE Model of the Auto-Rack Car

Locomotive	Total Number of elements	Total Number of Parts	Solid Elements	Shell Elements	Beam Elements	Rigid Elements	Nodal Rigid Elements
Ship Consist Car	22,446	19	2,862	19,578	0	4,814	0

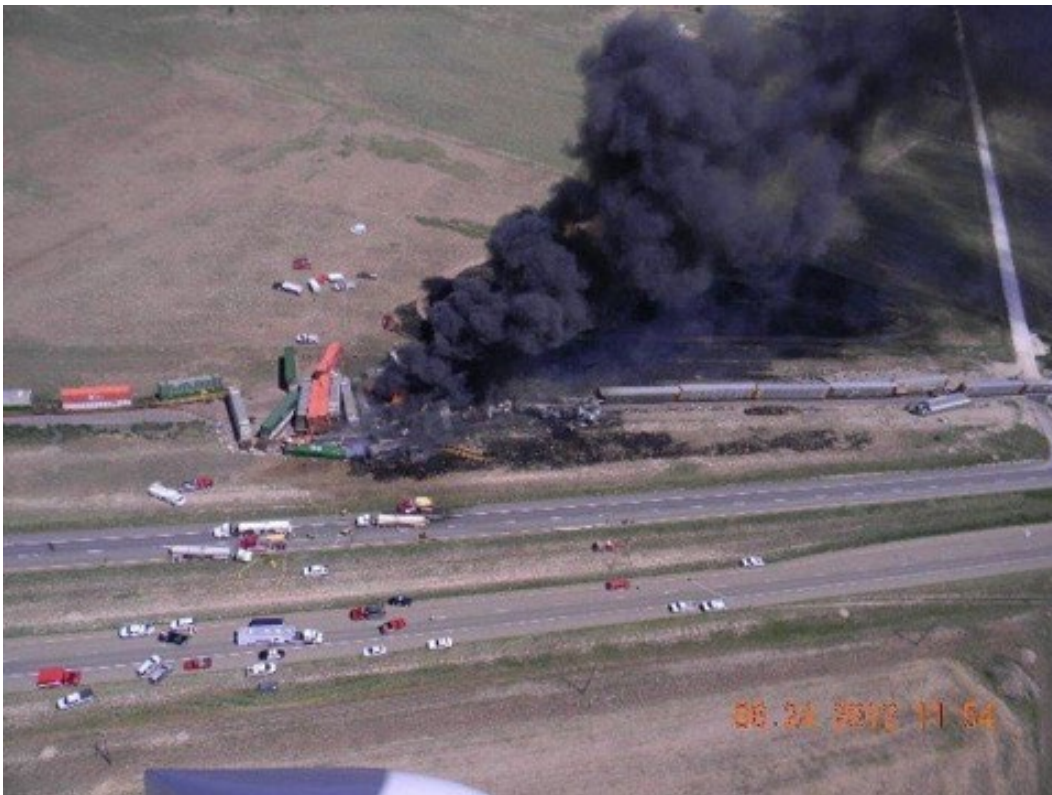
Figure 78. NTSB RAR 13-02 Post-Impact Comparison Between the Crash and Simulation, Close-Up of Crash

As previously noted, the NTSB reports lack extensive visual documentation, as their focus is primarily on crash causation. However, the team was able to obtain a few additional post-crash images of the scene to compare side-by-side with the simulation. It should be noted that the simulation stopped at 20 seconds, while the actual crash scene continued beyond that time frame. [Figure 78](#) through [Figure 85](#) present a comparison between crash scenes and the simulation. The locomotives and adjacent road rail cars' behaviors observed in the simulation appear to closely resemble those in the actual test.

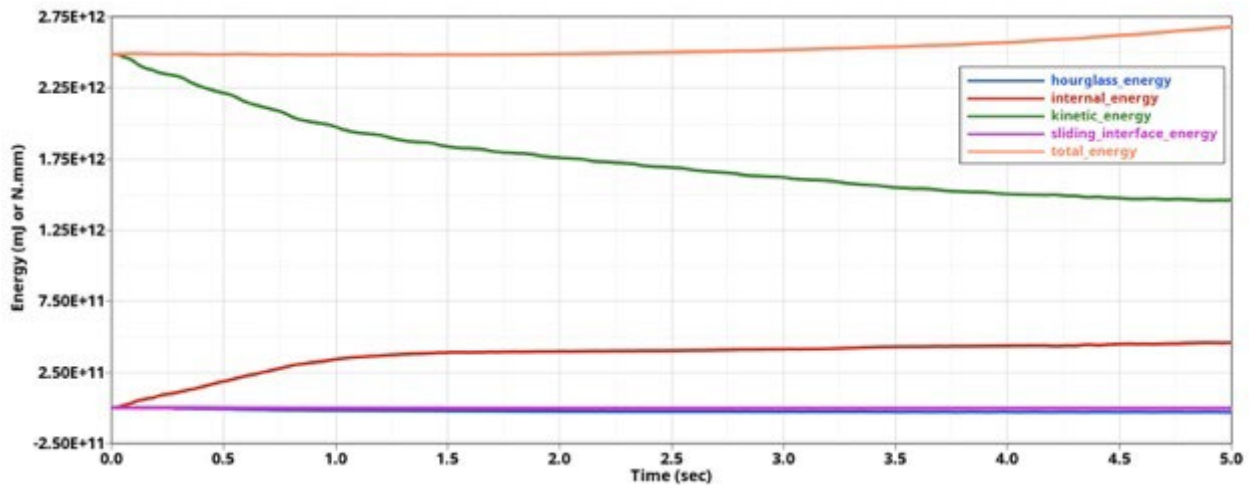
Figure 86. Simulation Energies

Figure 86 displays the energy balance of the simulation. The total energy remained stable for the initial 5 seconds of the simulation, with a variation of less than 7.2 percent. The hourglass energy remained below 1 percent but went slightly into the negative zone, indicating that the internal energy offset the kinetic energy. This figure suggests that the model operated as anticipated during the simulation, with no unusual effects observed. However, the total energy started to change over time, since the locomotives and freight cars began to derail, resulting in a shift in the overall energy balance.

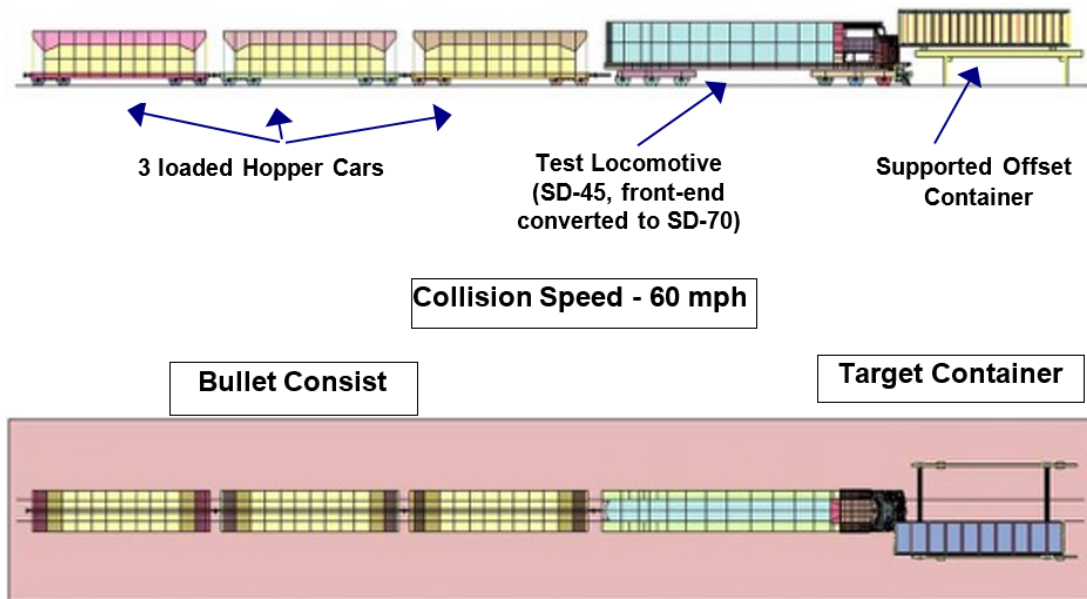
Figure 87. Original Model Set-up (From Test 6 Report)

Test 6 involved a locomotive and three consist cars colliding with a stationary consist at a speed of 60 mph. The stationary consist was comprised of an elevated, offset 40-ft intermodal container weighing 65,900 lb (29.9 tons). [Figure 87](#) shows the original test setup.

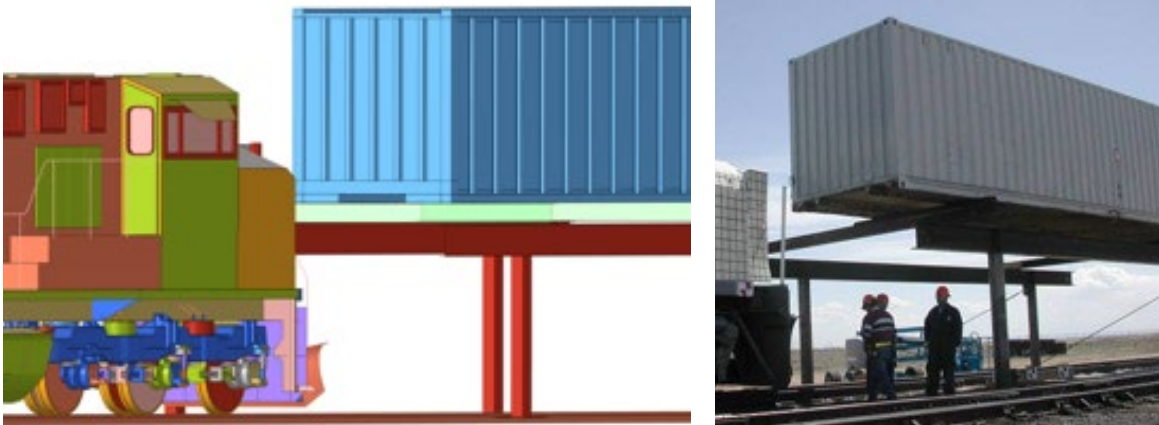
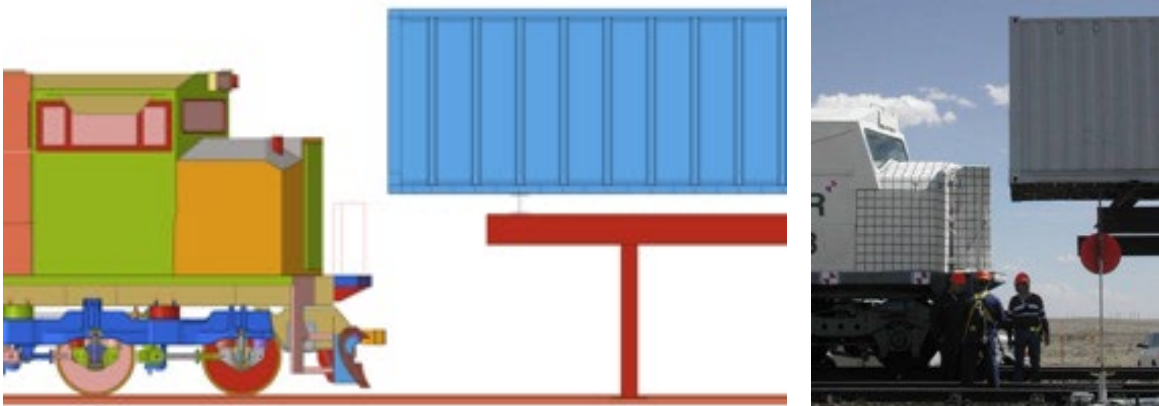
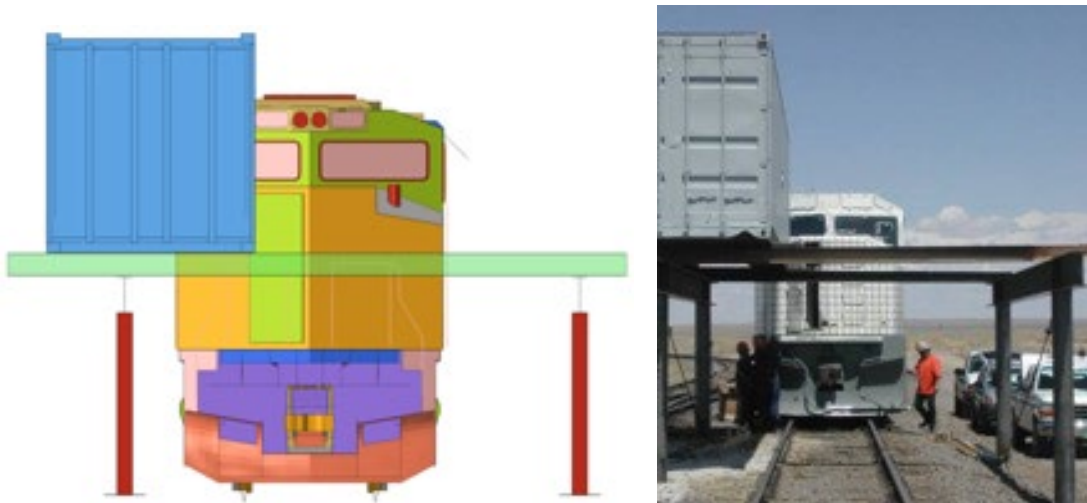
Figure 88. Test 6 Pre-Impact Comparison

Figure 89. Test 6 Pre-Impact Comparison

Figure 90. Test 6 Pre-Impact Comparison

The FE model was configured to replicate the test setup, following the same methodology as the previous tasks. The locomotive and the three bullet consist cars were modeled in a similar fashion, with respective weights of 379,450 lb (172.2 tons), 262,700 lb (119.2 tons), 257,700 lb (116.9 tons), and 257,750 lb (119.2 tons). The intermodal container weighed approximately 65,900 lbf (29.9 tons). A side-by-side view of the models is depicted in [Figure 88](#) through [Figure 90](#).

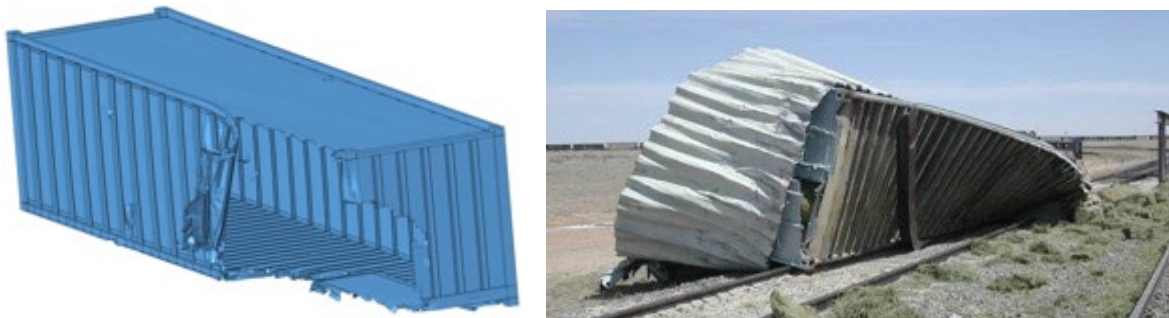
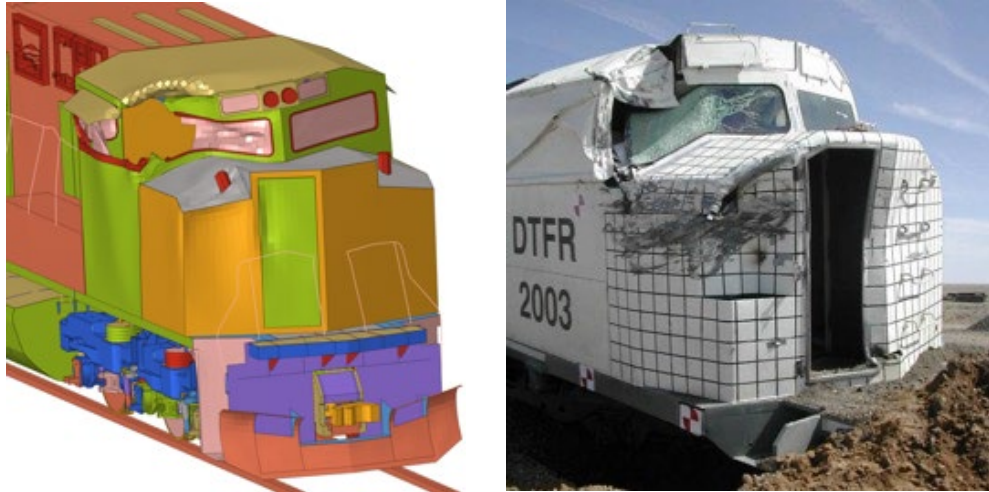
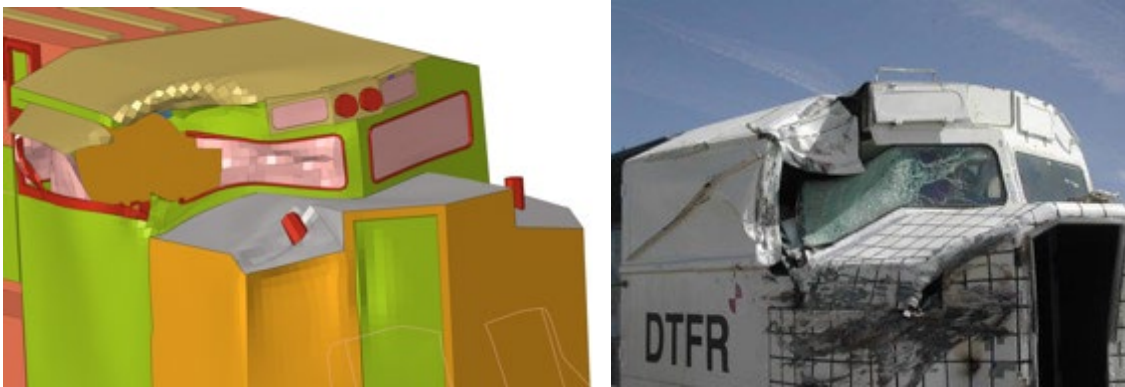
Figure 102. Post-Impact Crush Comparison

Figure 103. Post-Impact Crush Comparison

Figure 104. Post-Impact Crush Comparison

Photographs comparing the test and simulation post-impact are displayed in [Figure 102](#) through [Figure 104](#). The test pictures depict the extent of damage sustained by the locomotive and the container. The simulation successfully captured a similar tearing behavior. While the container in the test fell to the ground, the simulation exhibited comparable crush behavior, although it did not reach the ground. Note that the simulation only covered a single second of the crash test, and there was still forward motion of the locomotive and falling motion of the container beyond that timeframe. Considering that this task specifically focused on the locomotive loading, longer simulation times were deemed irrelevant and not included.

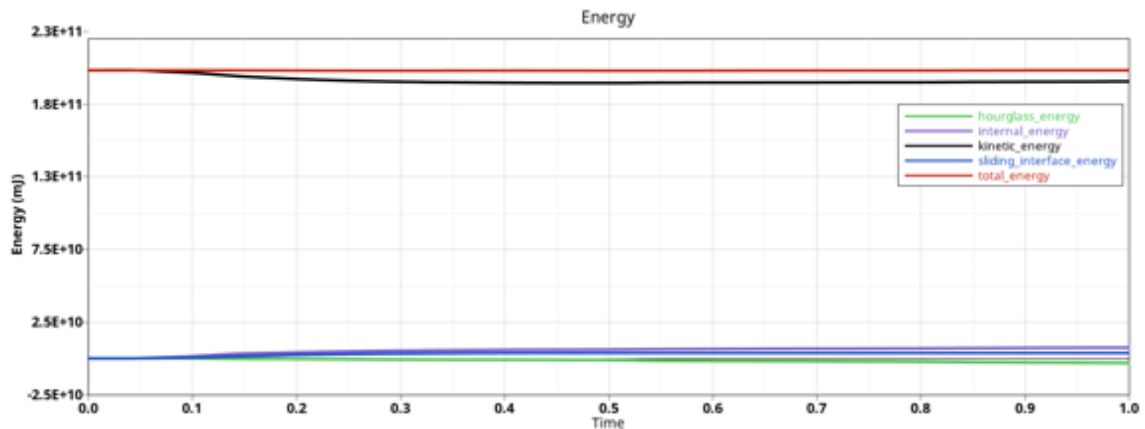
Figure 105. Simulation Energies

The figure indicates that there were no anomalous effects, suggesting that the model performed as expected during the simulation. The consistent energy balance observed reinforces the reliability of the simulation results.

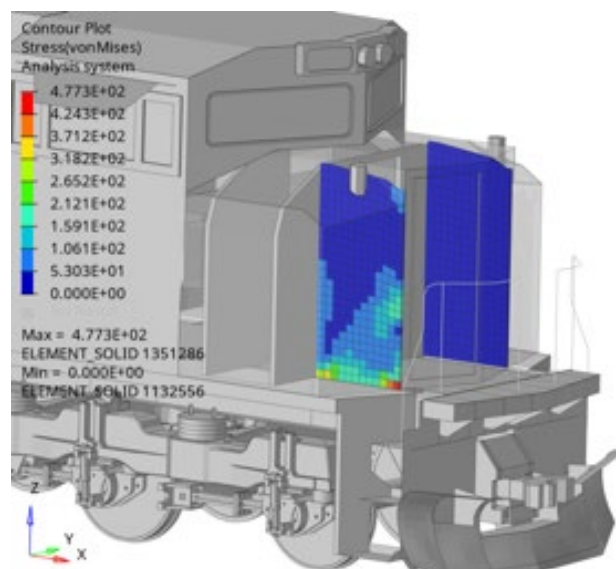
Figure 106. S-580: 750,000/500,000 Collision Post Loading

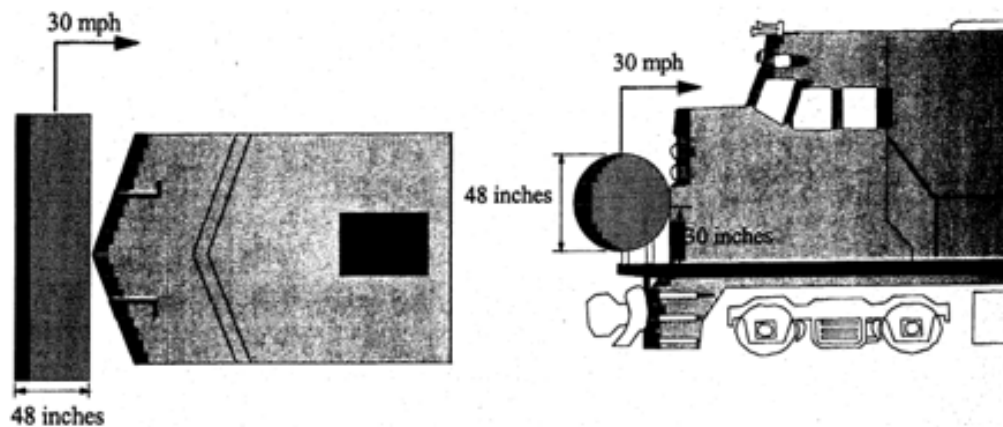
Figure 107. S-580: Cylindrical Shape of 126 in (length) at 30 mph
