# JOINTED PLAIN CONCRETE PAVEMENT DESIGN AND CONSTRUCTION REVIEW

Study SD2008-06  
Final Report

South Dakota State University  
Department of Civil & Environmental Engineering  
Brookings, SD 57007

September 2012

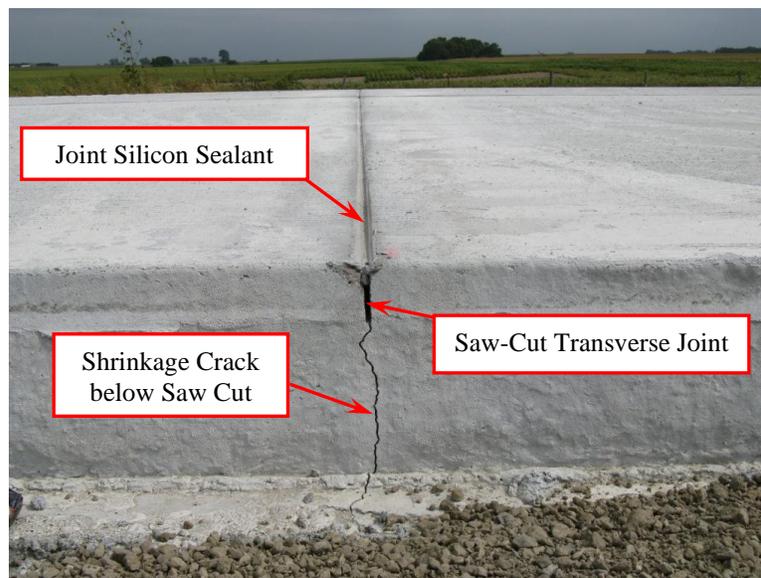
**Figure 2.2: Saw-Cut Joint (with Joint Sealant)**

Jointed plain concrete (JPC) pavements for interstate highways are common in the upper Midwest. In JPC pavements, the concrete's dimensional changes due to thermal effects are accommodated at pre-determined saw-cut contraction joints. In the absence of properly designed joints, new concrete pavement will experience random cracking within 72 hours after placement due to plastic shrinkage caused by moisture loss. Random cracking negatively affects the long-term durability of a concrete pavement and is aesthetically unpleasing. The preplanned transverse joints are saw-cut across the entire pavement width and are placed at constant intervals. The joint spacing is normally between 12 and 20 feet. Wheel load transfer at the joint between two adjacent slabs is accomplished by means of steel dowel bars that are embedded in the concrete at the joint location. Figure 2-1 shows a two-lane JPC pavement under construction on I-29 north of Brookings, SD. Figure 2-2 shows a saw cut joint with a shrinkage crack extending along the depth of the concrete pavement.

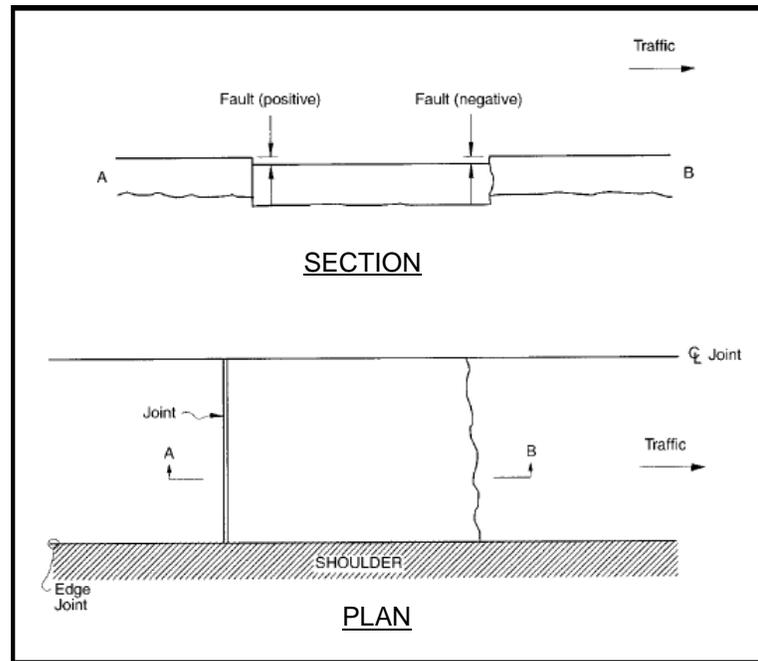
Figure 5.1: Faulting at Transverse Joints and Cracks (Miller and Bellinger 2003)

Faulting is the difference in elevation across a joint or crack. It may be caused by the loss of support beneath the slab due to pumping. When load transfer at a joint is inadequate, the potential for joint faulting increases. Faulting reduces the ride quality of the roadway. The repair costs of a roadway due to faulting increases the maintenance cost for that roadway dramatically. Figure 5.1 shows schematic plan and section views of positive and negative faults. Positive and negative faults are defined as decrease and increase in the pavement surface elevation, respectively, while moving in the direction of traffic (see Figure 5.1).

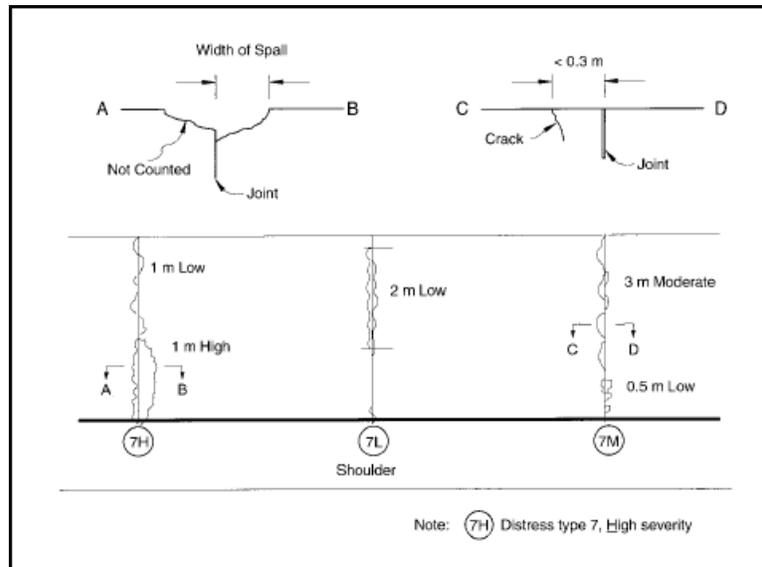
Figure 5.2: Spalling of Transverse Joints in JPC Pavements (Miller and Bellinger 2003)

Figure 5.2 shows schematic plan and cross sectional views of joint spalling. Spalling can be classified as high (H), low (L), and moderate (M) severity spalling as shown in Figure 5.2.

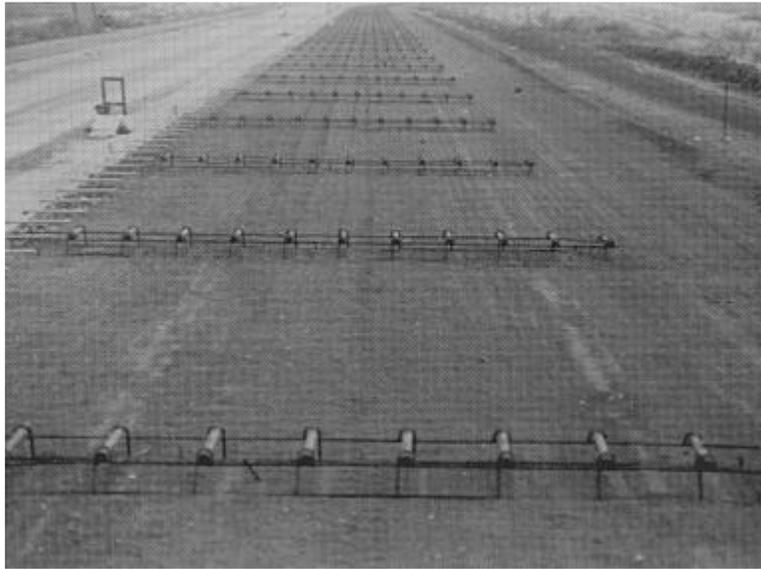
**Figure 5.3: Typical Dowel Bar Configuration Used in South Dakota (SDDOT 2007)**

lane. Common practice is to use 12 dowel bars across a 12 foot lane (SDDOT 2007). Figure 5.3 shows the typical dowel bar configuration used in South Dakota.

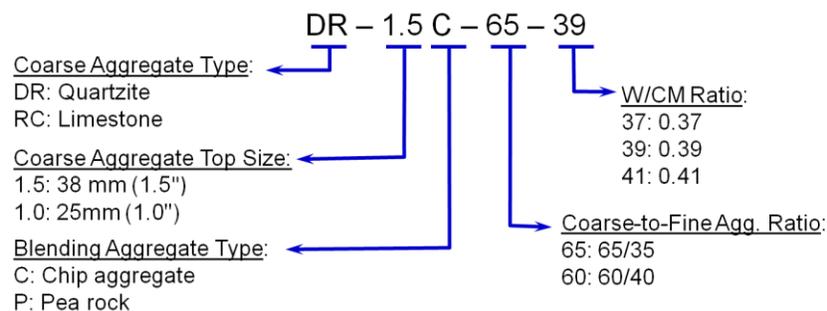
Figure 6.1: Concrete Mix Labeling

Each mix design was labeled with a string of alpha-numeric characters representing the different parameters. Figure 6.1 shows the mix labeling scheme.

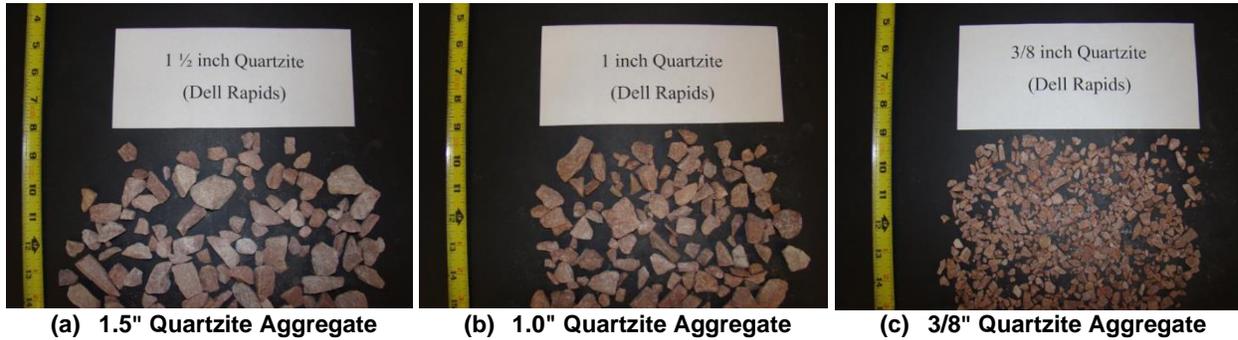
Figure 6.2: Quartzite Coarse Aggregates

The aggregates used for preparing the concrete mixtures in this study were provided by SDDOT and obtained from different locations in South Dakota. The aggregates were delivered to the materials lab at SDSU inside bins that were labeled for the aggregate top size. The quartzite coarse aggregates (1.5", 1.0", and 3/8" chip) were obtained from Dell Rapids, the limestone aggregates (1.5", 1.0", and 3/8" chip) were obtained from Rapid City, and the 3/8" pea rock and sand were obtained from Brookings. The quartzite, limestone, and pea rock aggregates are shown in Figure 6.2, Figure 6.3, and Figure 6.4, respectively.

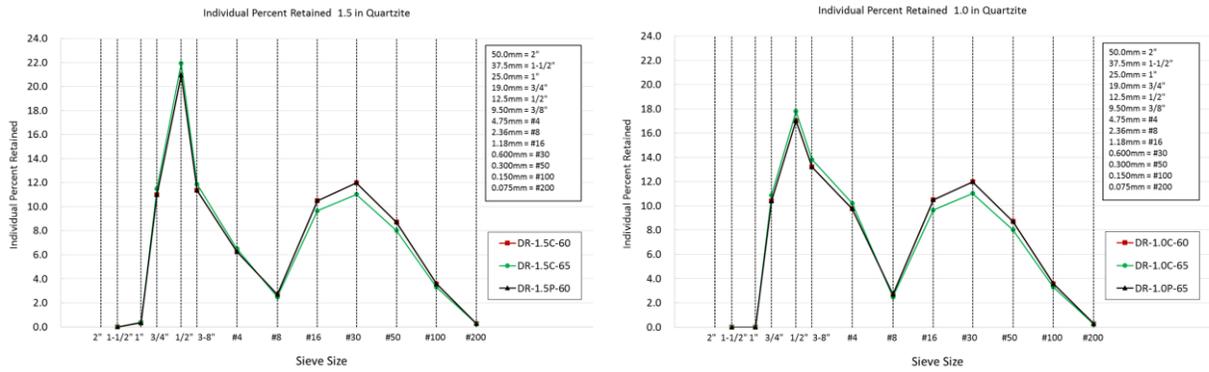
**Figure 6.7: Combined Total Aggregate Gradation for the Quartzite Aggregate Mixes**

The combined aggregate total gradation for the quartzite and limestone mixes are shown in Figure 6.7 and Figure 6.8, respectively.

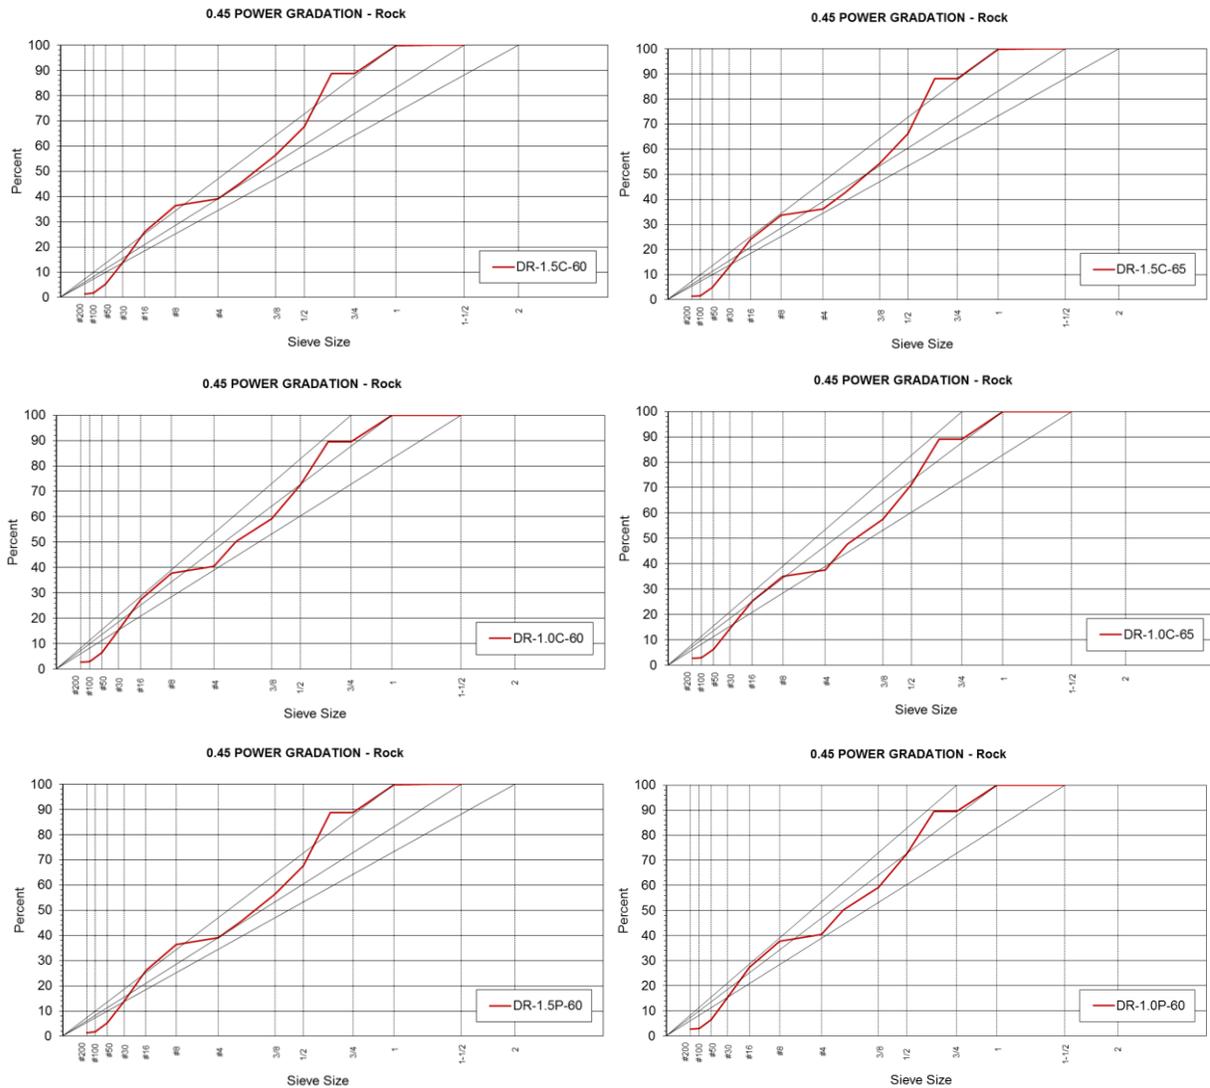
Figure 6.9: 0.45 Power Gradation for the Coarse Aggregates of the Quartzite Mixes

The 0.45 Power gradation for the coarse quartzite and limestone aggregate mixes are shown in Figure 6.9 and Figure 6.10, respectively.

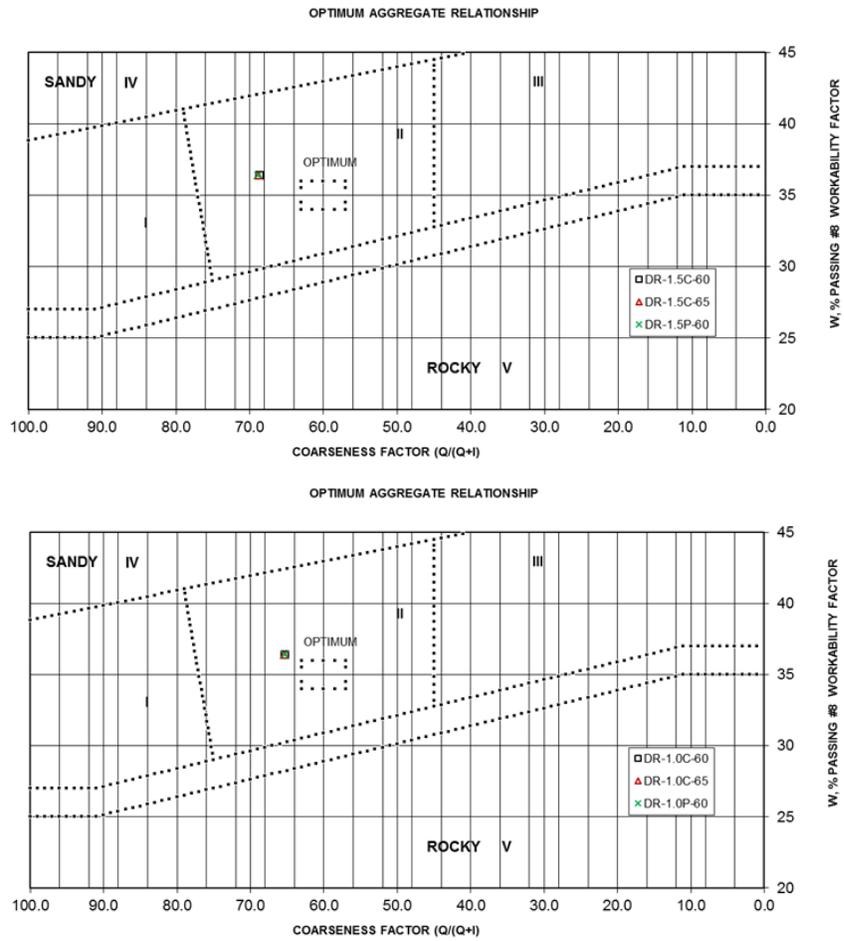
Figure 6.11: Coarseness Factor Charts for the Quartzite Aggregate Mixes

The coarseness factor (workability) charts for the quartzite aggregate and limestone aggregate mixes are shown in Figure 6.11 and Figure 6.12, respectively. The charts indicate that all mixes plotted in Zone II which is ideal for slabs on ground (Harrison, 2004).

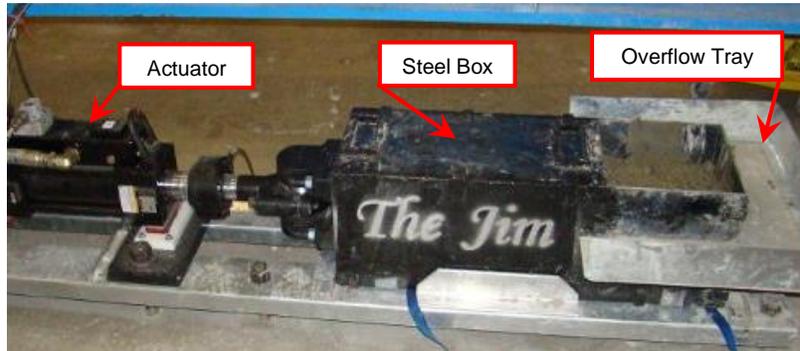
thus pushing and displacing the concrete in front of the squeegee pad. The actuator head is moved at a uniform speed of 1/2" per second for a total distance of 10". As the concrete gets displaced and consolidated inside the box, the excess concrete overflows through the top opening. The actuator load and displacement are recorded at approximately 1/2" displacement intervals.

(a) Workability Test Apparatus at the Beginning of the Test

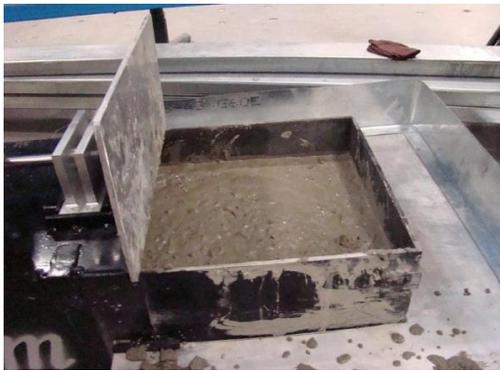
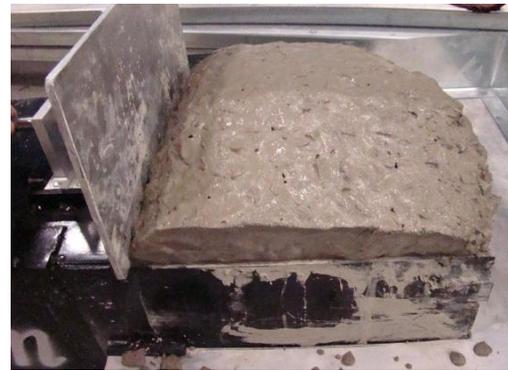
Figure 6.14: Concrete Workability Test Apparatus

(b) Concrete Sample During the Test

(c) Concrete Overflow at the End of the Test

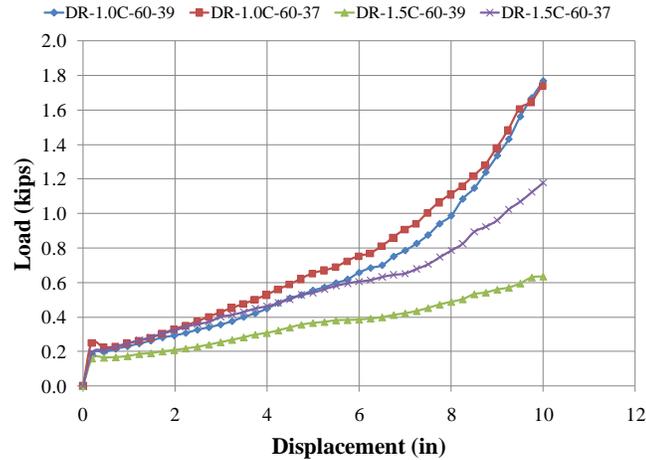
Figure 6.16: Measured Load-Displacement of Four Workability Tests

Freshly mixed concrete specimens were tested for workability using the test apparatus and procedure described in Section 6.2.2.1. Figure 6.16 shows a plot of the test data for four different concrete mixtures. The area under each curve represents the Work done on the respective concrete specimen. Using the measured work, the specific work was determined for each mix combination of the mix design matrix described in Section 6.1.1. Table 6.9 presents a summary of the specific work values obtained from the workability test.

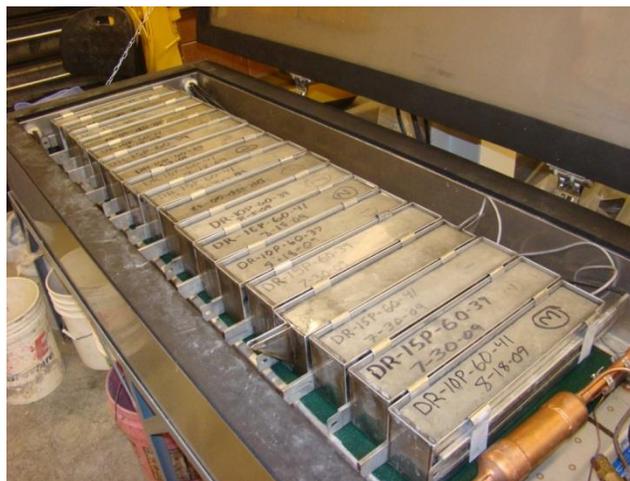
**Figure 6.19: Beam Specimens in the Freeze-Thaw Cabinet**

Standard 3" x 4" x 16" concrete beams were prepared and tested for resistance to rapid freeze-thaw cycles. The specimens were moist cured for 14 days before they were placed in the freeze-thaw cabinet for testing. Figure 6.19 shows beam specimens placed in the freeze-thaw cabinet.

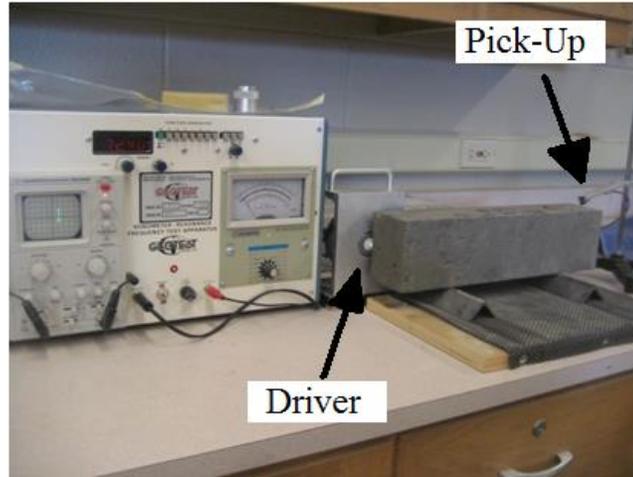
**Figure 6.20: Measurement of Concrete Fundamental Frequency Using a Sonometer**

The fundamental transverse resonant frequency of the beam specimens was measured using a sonometer. Prior to subjecting a specimen to freeze-thaw cycles, the specimen's initial fundamental frequency was measured. Subsequent frequency measurements were made on specimens in thawed condition at intervals not exceeding 36 freeze-thaw cycles. The fundamental transverse frequency of those specimens that were expected to experience rapid deterioration (i.e. specimens with pea rock) was measured at intervals of 10 freeze-thaw cycles. Figure 6.20 shows one of the beam specimens being tested with a sonometer.

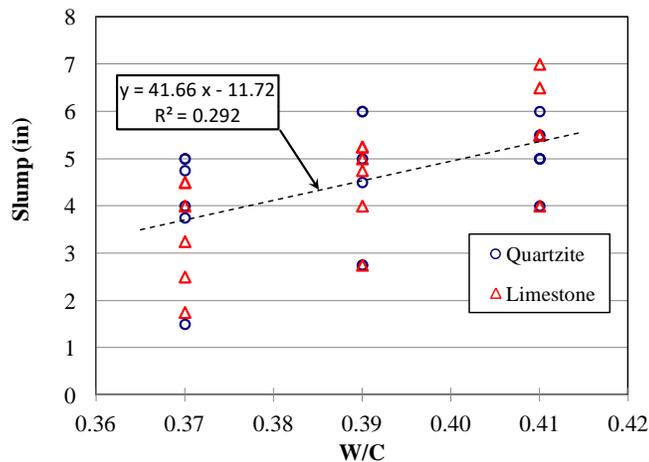
Figure 6.21: Slump vs. W/C Ratio

Since the correlation between workability and slump was being assessed, it was important to verify that the measured slump values were consistent with the expected trend that slump increases with an increase in w/c ratio. The experimental data plotted in Figure 6.21 shows that the slump followed the expected trend. The linear regression of the data points has a correlation coefficient R of 0.540, which indicates a moderate strength correlation between slump and w/c ratio.

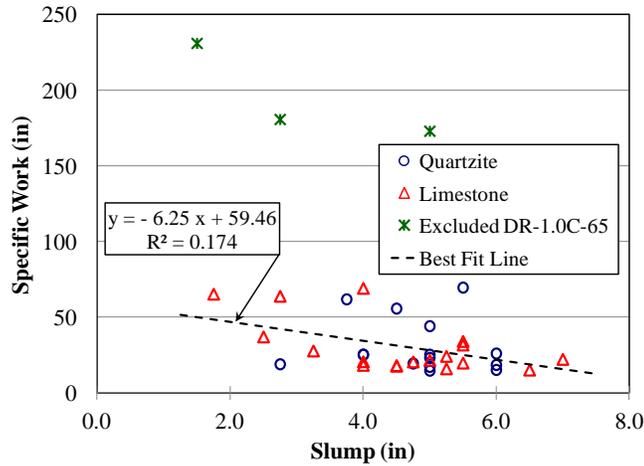
Figure 6.22: Specific Work vs. Slump

A plot of the specific work versus slump is presented in Figure 6.22. Also shown in the figure is the best fit line. In constructing the best fit line, data from mixes DR-1.0C-65-41, -39, -37, which exhibited significantly higher specific work than the other mixes, were excluded from the analysis to avoid skewing the results. The best fit line shows that as slump increases, the specific work decreases; however, the correlation coefficient R of -0.422 indicates a weak negative correlation between specific work and slump. Moreover, the extremely high specific work values exhibited by the DR-1.0C-65 mixes could not be explained by the corresponding slump values. Thus, workability is highly influenced by factors other than slump.

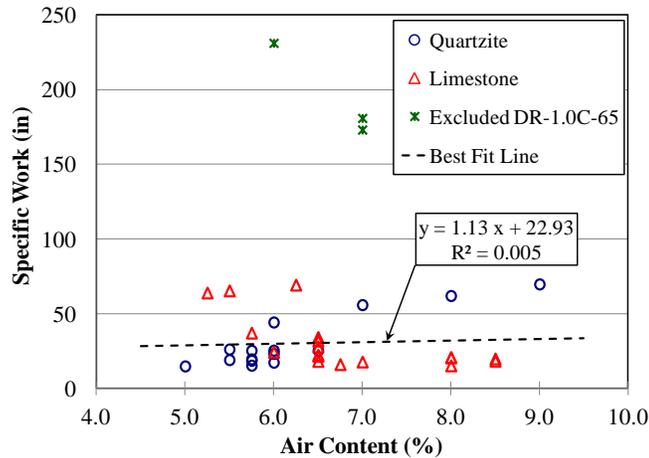
Figure 6.23: Specific Work vs. Air Content

Figure 6.23 shows a plot of specific work versus air content. The best fit line does not include the data from mixes DR-1.0C-65 which exhibited significantly higher specific work than the other mixes. The correlation coefficient R of 0.07 indicates that there is no correlation between specific work and slump.

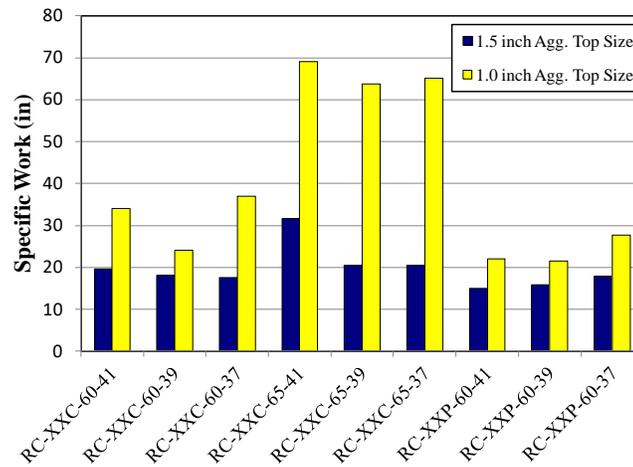
Figure 6.24: Specific Work for the Limestone Aggregate Mixes

maximum aggregate size mixes exhibited specific work higher than their 1.0" maximum aggregate size counterpart mixes.

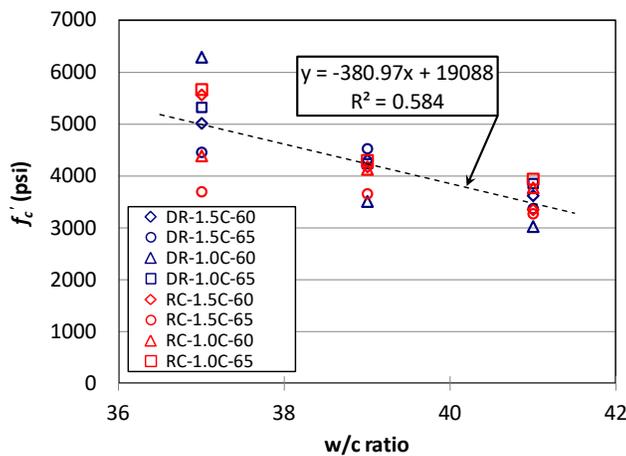
**Figure 6.26: 28-Day Compressive Strength versus W/C Ratio**

Figure 6.26 shows a plot of the measured 28-day compressive strength ( $f'_c$ ) versus w/c ratio. Data from mixes with pea gravel is not reflected in the plot because the pea gravel mixes exhibited poor freeze-thaw durability and, therefore, the respective strength test data were of no significant value. Also shown on the figure is the linear regression line with a correlation coefficient R of -0.764. The linear regression analysis indicates a moderately strong negative correlation between the 28-day compressive strength and w/c ratio.

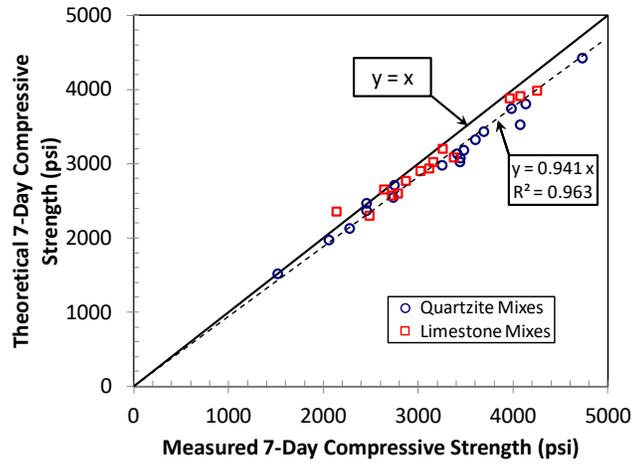
Figure 6.27: 7-Day Theoretical and Measured Compressive Strength

A plot of the theoretical versus measured 7-Day compressive strengths for both quartzite and limestone mixes is presented in Figure 6.27. In the plot, the theoretical equation is represented by the 1:1 solid line ( $y = x$ ) and the measured results are represented by data points scatter. The coefficient of correlation  $R$  of best fit line is 0.970. This indicates a very strong correlation between the theoretical and measured results. The experimental and theoretical values predicted by Equation 6.3 also are in excellent agreement; the slope of the linear best fit line of 0.941 is only 5.9% less than 1.

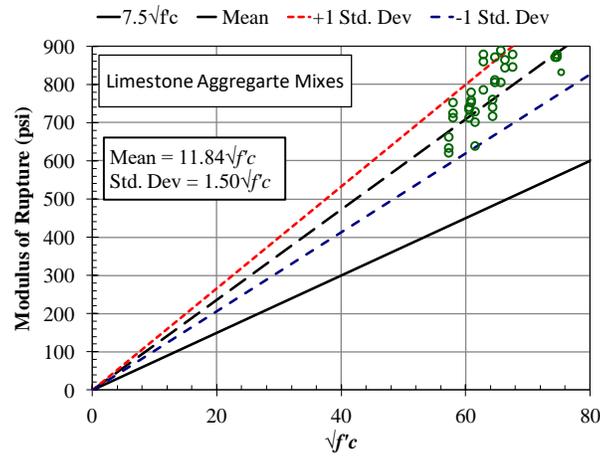
Figure 6.28: Measured  $f_r$  versus  $\sqrt{f'_c}$  for the Limestone Aggregate Mixes

Plots of the measured modulus of rupture  $f_r$  versus  $\sqrt{f'_c}$  for the limestone and quartzite aggregate mixes are presented in Figure 6.28 and Figure 6.29, respectively.

8. The measured modulus of rupture was higher than the value obtained from the ACI code empirical equation. The mean  $f_r$  for the limestone mixes is  $11.84\sqrt{f'_c}$  with a standard deviation of  $1.5\sqrt{f'_c}$ . The mean  $f_r$  for the quartzite mixes is  $9.90\sqrt{f'_c}$  with a standard deviation of  $0.75\sqrt{f'_c}$ . Both means are above the value obtained from the code empirical equation of  $7.5\sqrt{f'_c}$ .

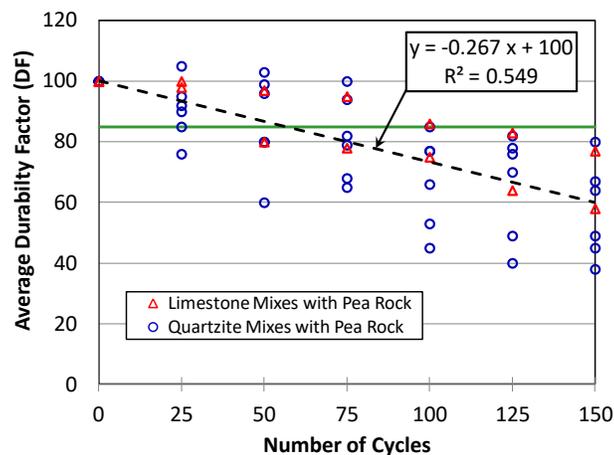
Figure 6.30: Durability Factor Change with Number of Freeze-Thaw Cycles-Mixes with Pea Rock

The freeze-thaw durability test results were compared to a durability factor (DF) of 85. A DF of 85 has been used as a standard for good freeze-thaw durability performance in previous research applications (Wong et al. 2000). The variation of the DF with the number of freeze-thaw cycles is shown in Figure 6.30 and Figure 6.31 for the mixes with and without pea rock, respectively.

9. Mixes with pea rock exhibited rapid durability degradation with increased number of freeze-thaw cycles, whereas those without pea rock showed mild durability degradation. At the end of 150 freeze-thaw cycles, all of the mixes with pea rock had a durability factor (DF) less than the acceptable limit of 85, with most of them significantly below 85. On the other hand, all of the mixes that did not contain pea rock had a DF higher than 85.

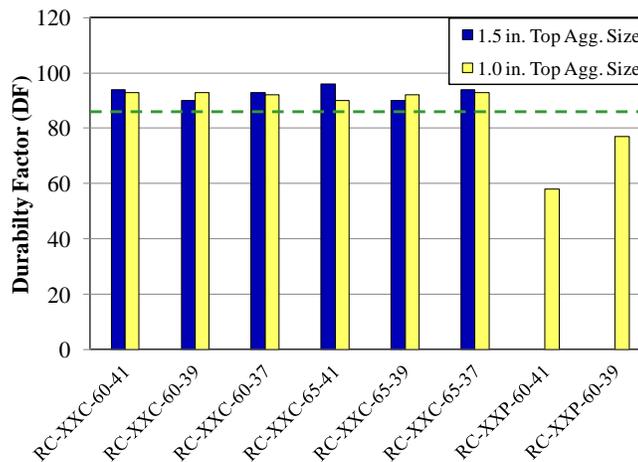
**Figure 6.32: Durability Factor for Limestone Aggregate Mixes**

The final DF values for the different mixes at 150 freeze-thaw cycles are shown in Figure 6.32 and Figure 6.33 for the limestone and quartzite aggregate mixes, respectively. The variation in the DF among the mixes that did not contain pea rock was insignificant. When the pea rock mixes are excluded, the average DF for the 1.5" and 1.0" limestone mixes is 92.8 and 92.2, respectively, and that for the 1.5" and 1.0" quartzite mixes was 94.3 and 93.3, respectively. The DF varied between 90 and 96 for the limestone mixes, and between 91 and 96 for the quartzite mixes. The narrow range of variation in the DF indicates that when pea rock was not used, the DF values were insensitive to the aggregate type, aggregate top size, w/c ratio, or fine-to-coarse aggregate ratio.

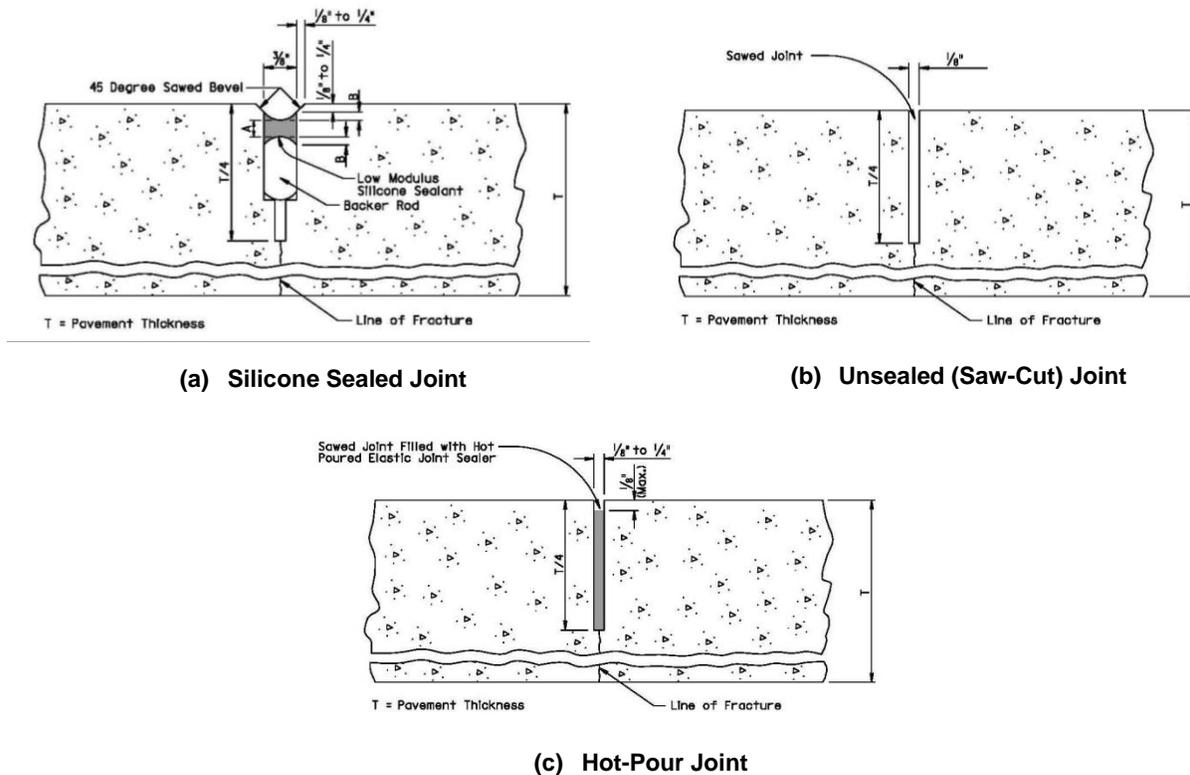
Figure 7.1 shows details of the three joint types. The silicone sealed joint, which is the standard transverse joint type specified by SDDOT, is saw cut in two runs. In the first run, the cut is made 1/8" to 1/4" wide and one-quarter the pavement thickness deep. In the second run, approximately the top two-thirds portion of the cut depth is widened to 3/8" to allow for the placement of a backer rod and the silicone sealant. The silicone sealant is placed approximately 3/16" to 5/16" deep into the joint and is finished at 1/8" to 1/4" below the surface of the pavement. The unsealed joint is cut to 1/8" wide by one-quarter the pavement thickness deep. The hot-pour joint is cut to approximately 1/8" to 1/4" wide by one-quarter the pavement thickness deep, and then filled with a hot-pour sealant up to a maximum of 1/8" from the top of the pavement.

(a) Silicone Sealed Joint

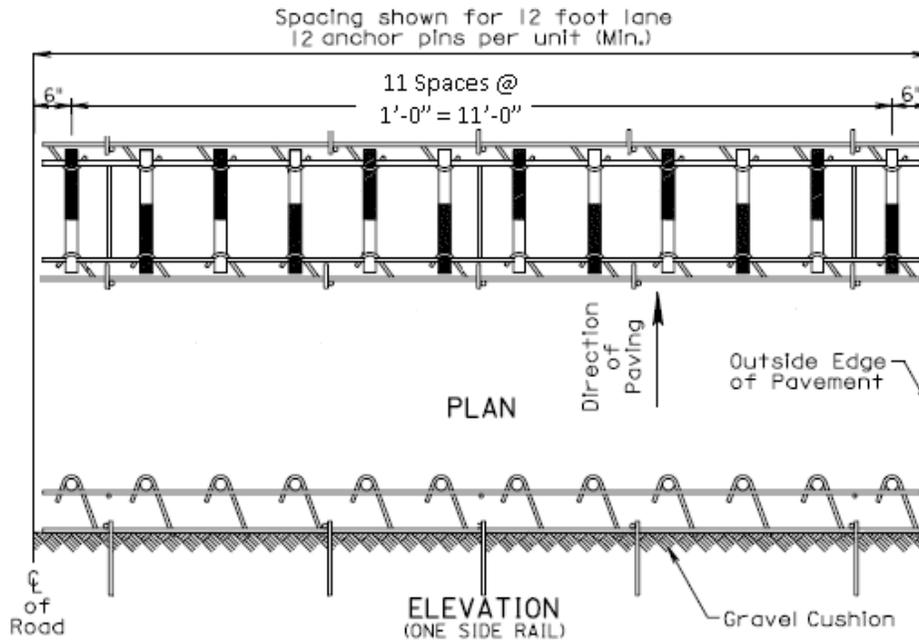
**Figure 7.2: Typical Standard SDDOT Dowel Bar Configuration for 12' Lanes**

The standard dowel bar configuration used for 10" or thicker JPC pavement in South Dakota consists of 12 dowel bars placed within a 12' wide lane. Figure 7.2 shows the arrangement of a normal dowel bar configuration. With a standard dowel bar arrangement the first dowel bar at each edge of the lane is placed at 6" from the edge of the lane and the dowels are spaced at 12" on center. The standard transverse contraction joint spacing that corresponds to a standard dowel configuration is 20'.

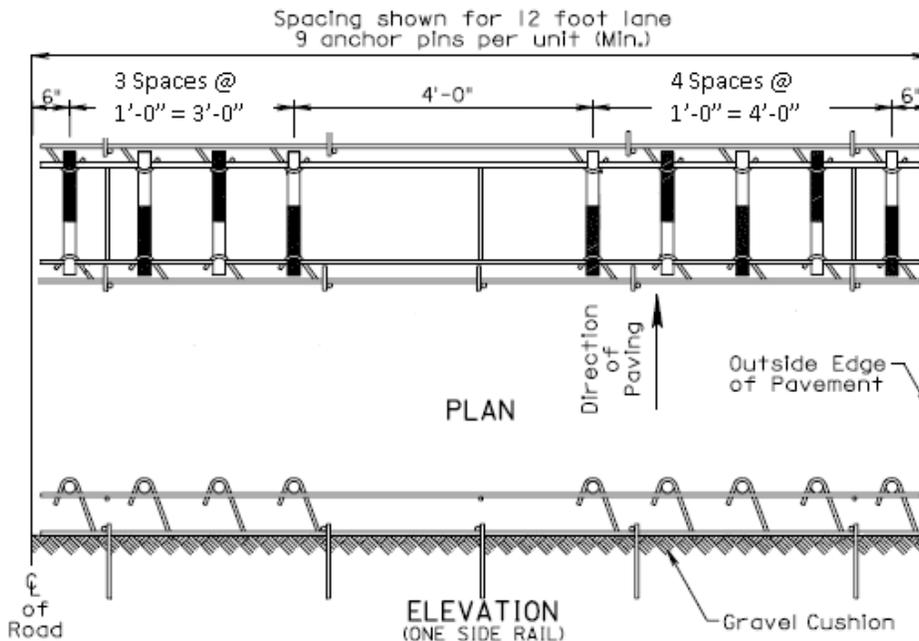
**Figure 7.3: Typical Reduced Dowel Bar Configuration for 12' Lanes**

The reduced dowel bar configuration used for 8" to 9" thick JPC pavement in South Dakota consists of 9 dowel bars placed within a 12' wide lane. Figure 7.2 shows the reduced dowel bar configuration where 5 bars and 4 bars are placed on the outside edge and the inside edge of the pavement, respectively. Similar to the standard dowel bar arrangement, the first dowel bar at each edge of the lane is placed at 6" from the edge of the lane and the dowels are spaced at 12" on center. The standard transverse contraction joint spacing that corresponds to a reduced dowel configuration is 15'.

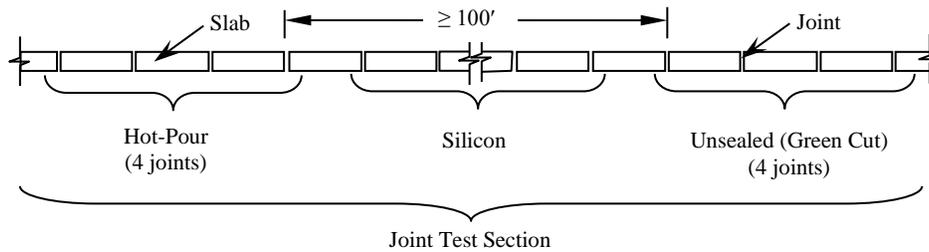
**Figure 7.5: Schematic View of a Typical Joint Test Section (Brookings, Butte, and Yankton Test Sites)**

Except for the test section at the Union County test site, a typical joint test section incorporated one group of four successive unsealed (saw-cut) joints, one group of four successive hot-pour sealed joints, and one group of multiple successive silicone sealed joints placed over a minimum of 100' of highway length separation between the unsealed and the hot-pour sealed joints. Outside the test section, all of the joints were silicone sealed. This layout allowed for collecting data from the two interior joints of each joint group in order to minimize any interactive effects that might exist between two adjacent joints of different types. The joint spacing was 20' for test sections in the Brookings County test site and 15' for the test sections in the Butte County and Yankton County test sites. Figure 7-5 shows a schematic view of a typical Joint test section layout.

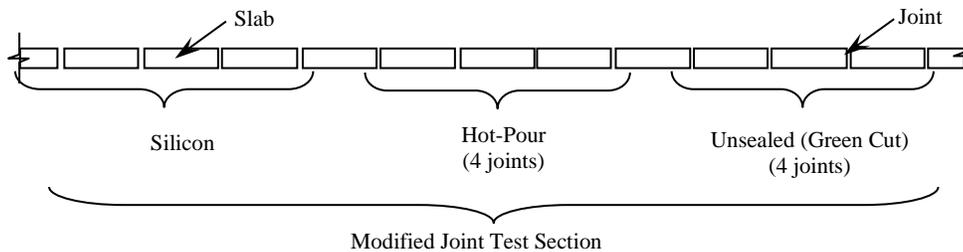
**Figure 7.6: Schematic View of a Modified Joint Test Section (Union County Test Site)**

The layout of the Joint test section at the Union County test site was slightly different than that at the other test sites. The Joint test section in the Union County site was instrumented with moisture sensors placed under the joints. In order to minimize the length of the wiring needed between the sensors and the data acquisition system, the hot-pour sealed and the unsealed joint groups were placed next to each other, and the silicone sealed joints were placed everywhere else. Figure 7.6 shows the modified Joint test section layout used at the Union County test site.

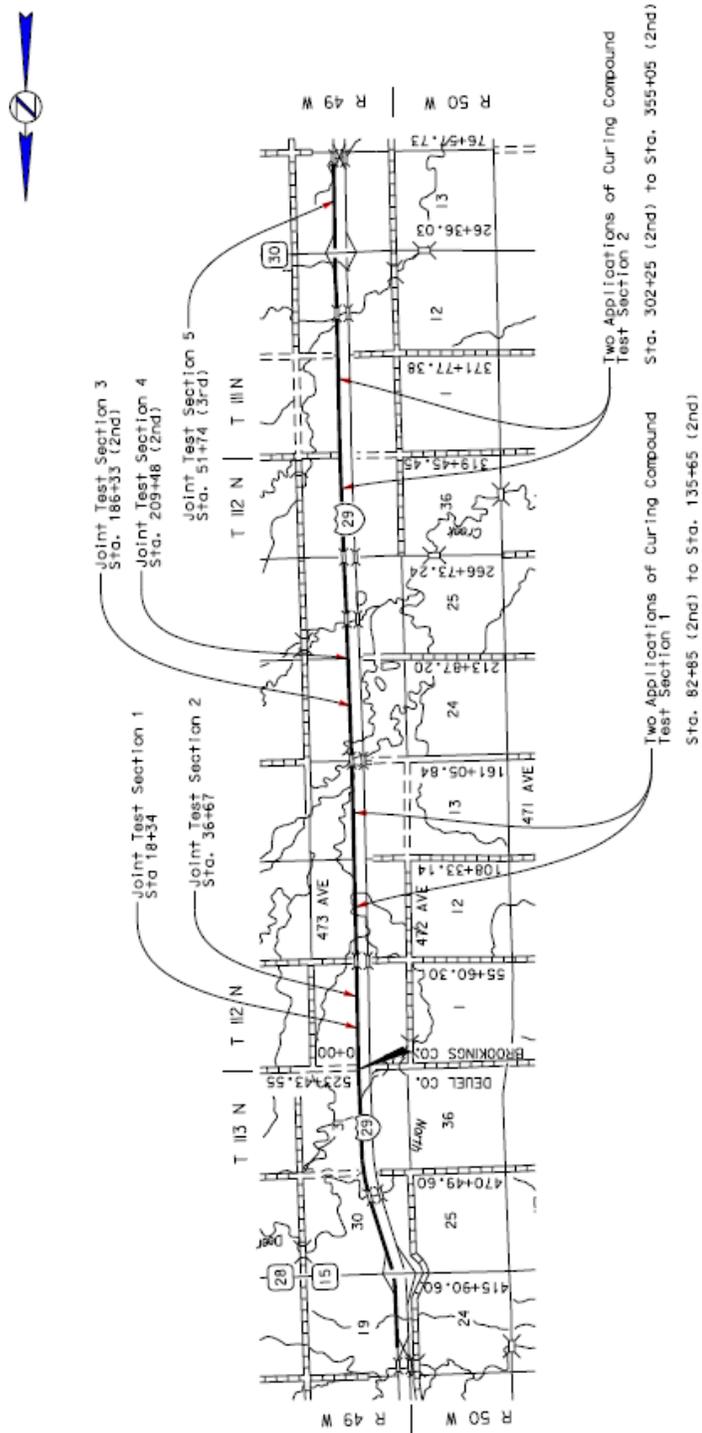
Figure 7.7: Location of Test Sections at the Brookings County Test Site

Five Joint test sections and two Curing Compound test sections were incorporated at each of the Brookings County, Butte County, and Yankton County test sites. The Union County test site incorporated only one Joint test section. The length of the Curing Compound test section was approximately one mile at the Brookings County and the Butte County test sites, and approximately 500' at the Yankton County test site. Figures 7.7 through 7.10 show the locations of the test sections within each of the test sites.

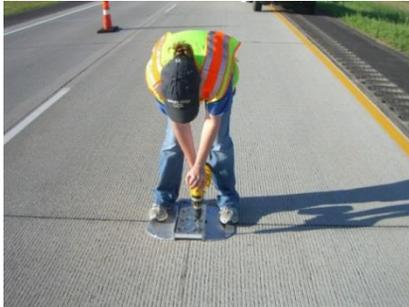
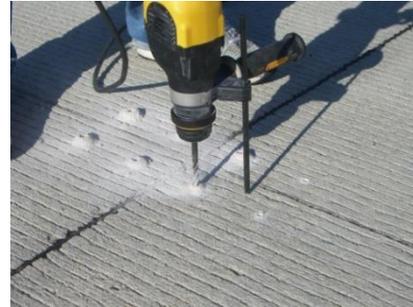
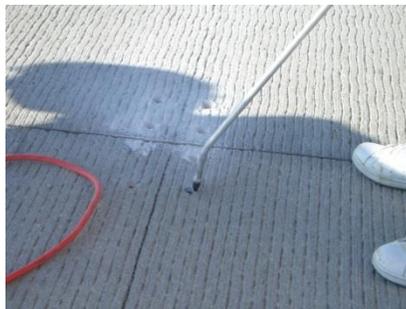
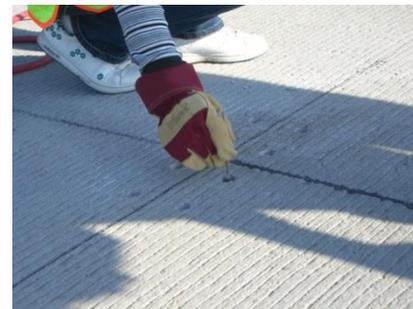
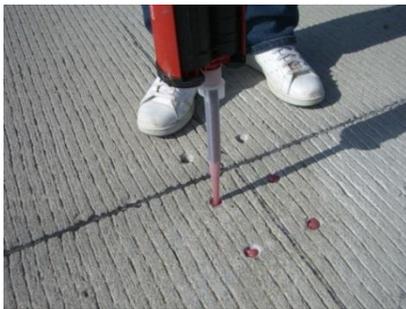
Vertical 5/16" diameter holes were drilled in the pavement at the pilot holes. The indented bolts were then epoxy glued inside the drilled vertical holes such that the top of the hex head was flush with or slightly below the pavement surface. The epoxy adhesive used to anchor the bolts was Hilti-HIT-RE 500. The epoxy adhesive data sheet is presented in Appendix C. Figure 7.14 shows the sequence of the installation process.

(a) Drilling pilot holes

(b) Drilling 5/16" diameter holes

(c) Air blowing concrete dust

(d) Cheching hole depth

(e) Filling holes with epoxy adhesive

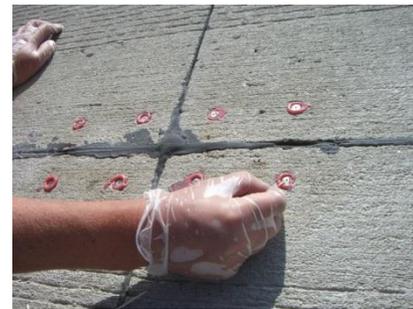
(f) Setting stainless steel bolts inside holes

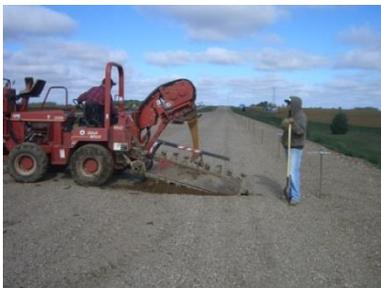
**(a) Trenching the subbase**

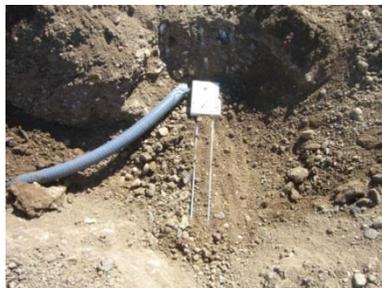
**(b) Placement of the Moisture Sensor**
