Tolerances for Placement of Tie Bars in Portland Cement Concrete Pavement

Study SD2011-09

Final Report

Prepared by
South Dakota State University
Brookings, SD 57007

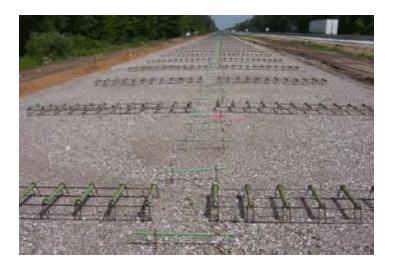
Figure 5-1: Tie Bars prior to Placing Concrete (Perera, Kohn, & Tayabji, 2005)

For sawed joints, tie bars can be installed either prior to paving using p-stakes or seats or mechanically during paving using automatic inserters. Using p-stakes or seats to place tie bars prior to paving is the most common way to install tie bars in South Dakota. This method involves setting the tie bars in p-stakes or on seats that have been attached to the roadway base prior to paving. Tie bars installed in p-stakes prior to placing concrete is illustrated in Figure 5-1.

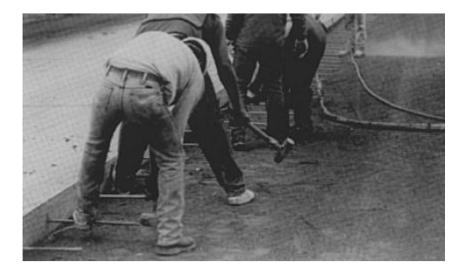
Figure 5-2: Installation of Drilled-in Tie Bars (South Dakota DOT, 2016)

have been drilled into the face of the hardened concrete (Figure 5-2). An epoxy adhesive is used to form a bond between the tie bar and the hardened concrete.

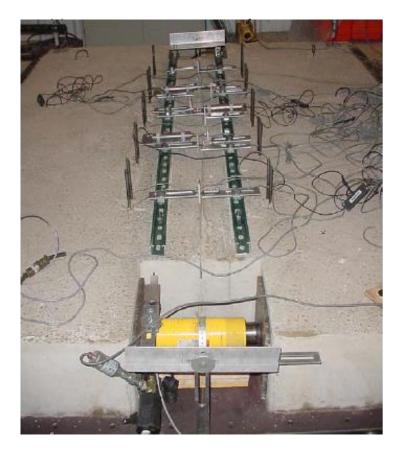
Figure 5-8: A 5-Dowel Bar Specimen (Buch, Varma, & Prabhu, 2007)

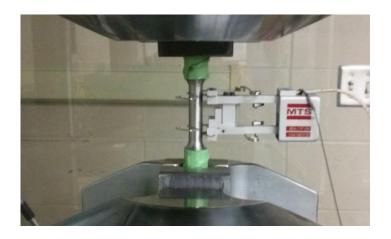
Figure 6-1: Tensile Test of a Dog-Boned Tie Bar Sample

A tensile test was performed according to ASTM E-8 (2013) on a dog-boned sample made from a tie bar. Due to loading capacity limitations of the tensile testing machine the tie bar samples, a middle segment was machined to a diameter of 0.35 in. in order to capture the ultimate strength. A 25 mm. gauge length MTS extensometer was attached to the dog-boned tie bar sample to measure the tie bars extension along the gauge length (Figure 6-1).

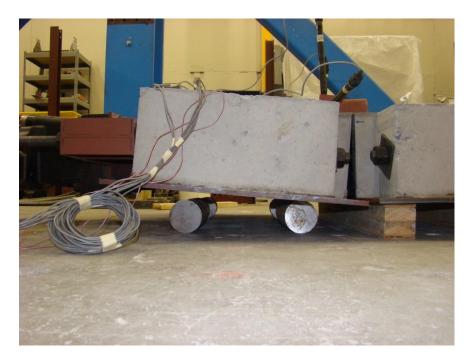
Figure 6-16: Slab Rotation During Testing of Specimen VT-4-1

The couple created by the eccentric loading caused the joint plane to rotate, thus inducing compressive stresses in the concrete at the top of the joint. Figure 6-16 shows the rotation resulting from the eccentric loading. The couple tends to increase the tension force in the tie bar for a given applied actuator load.

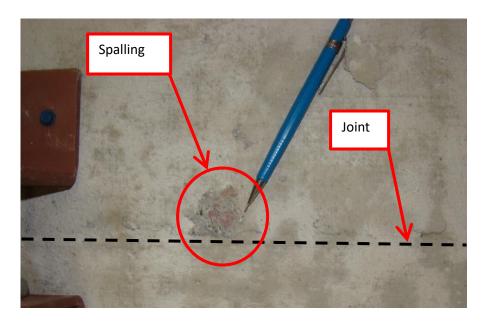
Figure 6-17: Spalling of Compression Concrete at the Joint

Increasing the actuator load caused the joint rotation and compressive concrete stresses to increase to a level that induced concrete crushing and spalling at the top of the joint (Figure 6-17).

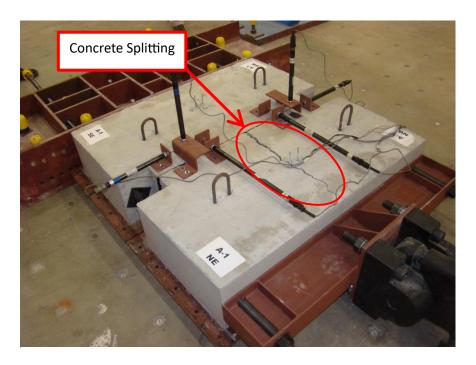
Figure 7-3: Bond Failure of Specimen A-1

In all three aligned specimens the tie bar yielded prior to bond failure. Bond failure occurred by splitting of the concrete along the length of the tie bar. The longitudinal crack and bond failure of specimen A-1 are shown in Figure 7-2 and Figure 7-3, respectively.

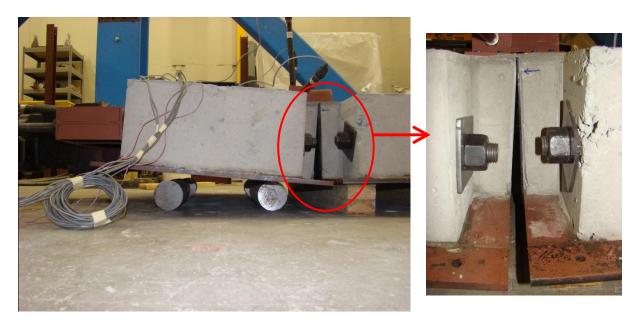
Figure 7-5: Joint Rotation of Specimen VT-4-1

Specimens VT-1-1, VT-2-1, VT-3-1, and VT-4-1 were not restrained against joint rotation resulting in an eccentric loading condition. Joint rotation of specimen VT-4-1 and bond failure of specimen VT-3-1 are shown in Figure 7-5 and Figure 7-6.

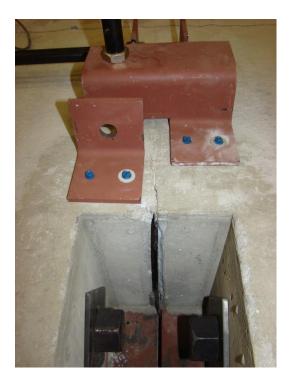
Figure 7-7: Reduced Joint Rotation of Specimen VT-4-2

The remaining four specimens VT-1-2, VT-2-2, VT-3-2, and VT-4-2 were restrained to prevent joint rotation. Restrained specimens during testing were documented through photography (Figure 7-7 and Figure 7-8).

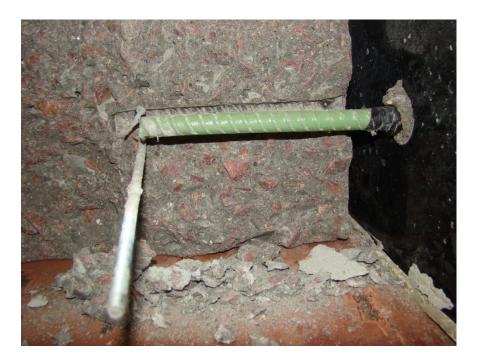
Figure 7-16: Specimen LT-7-2 Failure Plane

The eight longitudinal translation specimens were tested while restrained against rotation, as shown in Figure 7-15. All specimens failed due to bond failure after the tie bar had yielded. Bond failure occurred by splitting of the concrete along the length of the tie bar. Pictures taken during testing are shown in Figure 7-15 and Figure 7-16.

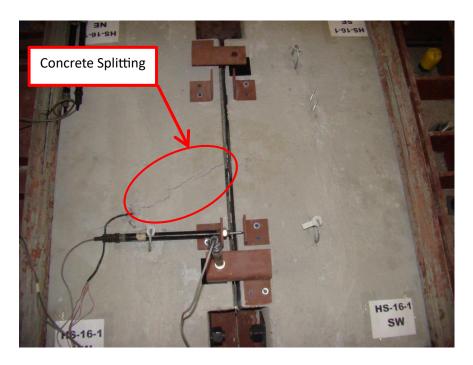
Figure 7-19: Bond Failure of Specimen HS-16-1

The eight vertical skew specimens were tested while restrained against rotation. In all eight of the horizontal skew specimens, the tie bar yielded prior to bond failure. Bond failure occurred by the splitting of the concrete along the length of the tie bar. There was photo documentation throughout the process of testing (Figure 7-19 and Figure 7-20).

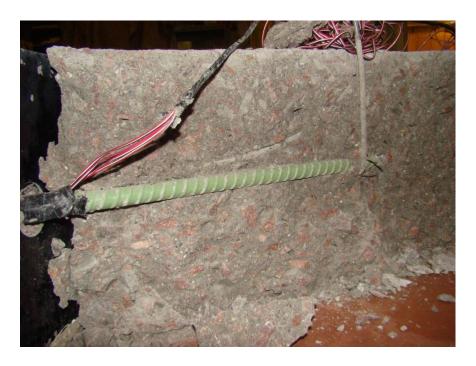
Figure 7-20: Specimen HS-16-1 Failure Plane
