SD2013-01-F

Precast Bridge Girder Details for Improved Performance

**Study SD2013-01
Final Report**

Prepared by
South Dakota State University
Brookings, SD 57007

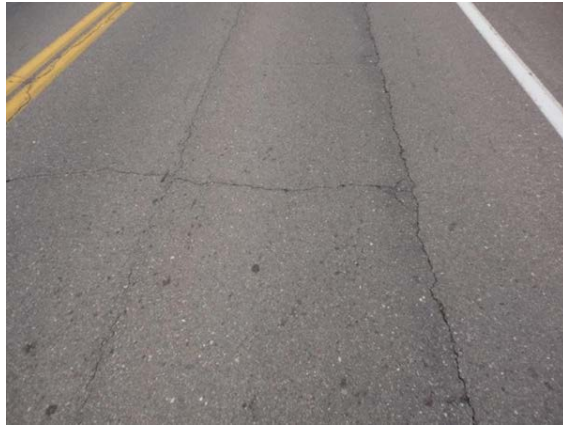
Figure 2-2: Reflective Cracking of the Asphalt Overlay

Short-term maintenance such as asphalt overlays can temporarily seal the longitudinal joints. However, asphalt overlays are costly and have a tendency to form reflective cracks directly above the longitudinal joints. Reflective cracks allow water and deicing chemicals to penetrate the longitudinal joints. An example of reflective cracking and concrete deterioration at a double tee bridge is shown in figures 2-2 and 2-3, respectively.

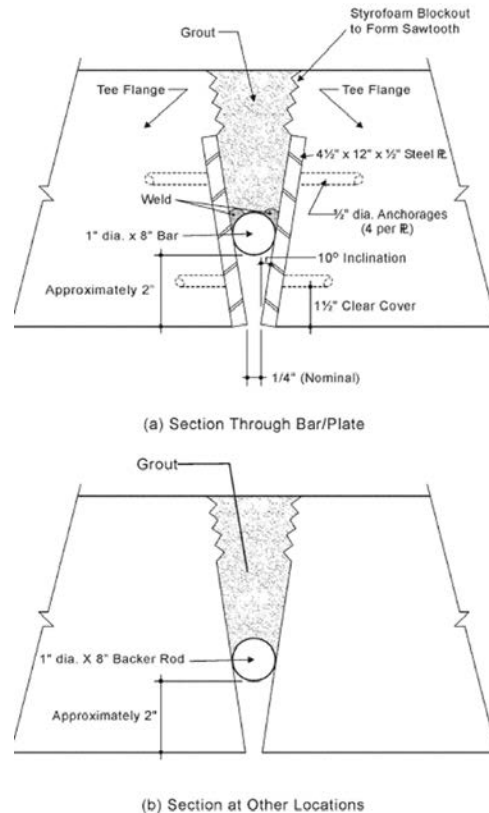
Figure 5-2: Proposed Simple Detail for TxDOT Girders (Jones, 1998)

The proposed “simple” detail consisted of discrete steel welded connections and a grouted shear keyway. The connection consisted of two steel plates, one in each girder, embedded into the deck concrete and a 1 in. diameter bar that was placed between and welded to the plates. This detail resulted in a narrow continuous grouted keyway that extended over the length of the girder. Figure 5-2 shows details of the “simple” joint.

Fatigue loads, used to represent vehicle live loads ranging from an initial 16 kips to a peak of 24 kips, were applied to the “simple” specimen at a rate of three cycles per second for a total of 1.5 million cycles. Monotonic load tests were performed at intervals ranging from 50,000 to 250,000 cycles to measure the stiffness of the system by applying a 20 kip load. Once cyclic loading was complete, the grout was removed around the steel joint and no signs of failure or degradation were visible.

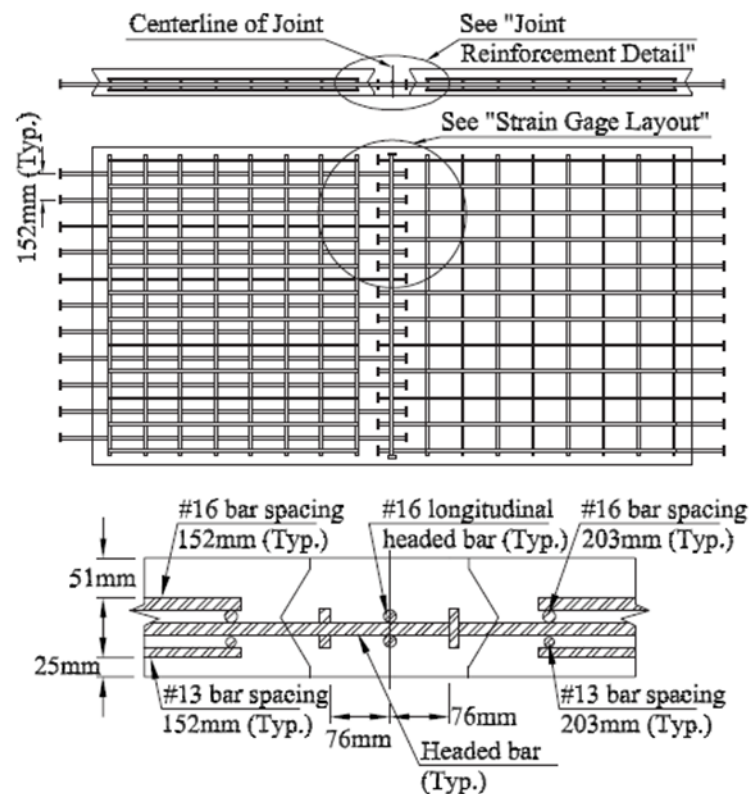
Figure 5-3: Joint Detail by Li et al. (2010)

The longitudinal joint was 8 in. wide at mid-depth and tapered to 6 in. at the top and the bottom of the deck. The joint reinforcement consisted of No. 5 headed bars that were staggered with an overlap of 6 inches in grouted keyway as shown in figure 5-3. Headed reinforcement was used rather than conventional reinforcement to develop the reinforcement in a relatively narrow joint width.

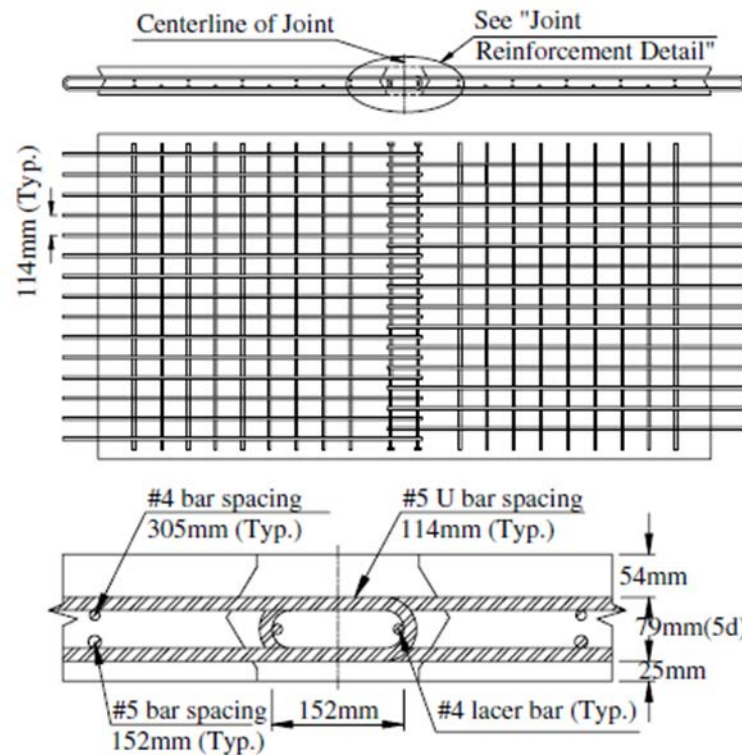
Figure 5-4: U-Bar Joint Reinforcement Detail

The longitudinal joint was 8 in. wide at mid-depth and tapered to 6 in. at the top and the bottom of the deck. The joint reinforcement consisted of No. 5 U-bars that projected out of the deck and into a grouted keyway. An illustration of the U-bar detail is shown in Figure 5-4. No. 4 lacer bars were placed through the U-bars to develop the U-bars. The testing procedure and instrumentation were similar to those used in the study by Li et al. (2010).

The results of the tests indicated that the fatigue loading had little impact on the U-bar joint behavior and strength. After the end of the 2-million cycle fatigue test, the slab specimen was successfully subjected to a ponding test with no leaks through the longitudinal joint. The U-bar detail was considered a viable connection system for the longitudinal joint between adjacent decked bulb tee girders.

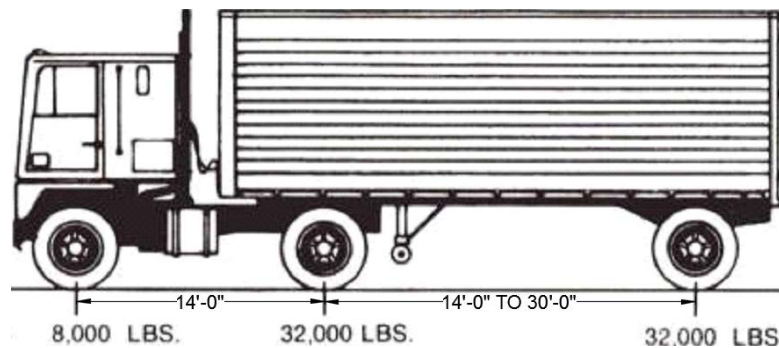
Figure 7-1: HL-93 Truck (AASHTO 2012)

The bridge girders were designed for HL-93 live loading (AASHTO, 2012). HL-93 live loading consists of a design truck or a tandem, and a design lane load. The design truck comprises a pair of 32 kip axles and an 8 kip axle with axle spacing as shown in Figure 7-1. The design tandem comprises two 25 kip axles spaced 4 ft apart. The design lane load consists of a 0.64 klf load that is distributed along the bridge length and spread over a deck width of 10 ft. The bridge girders were designed by Cretex Concrete Products Inc. using the program PS Beam (Eriksson Technologies, 2011).

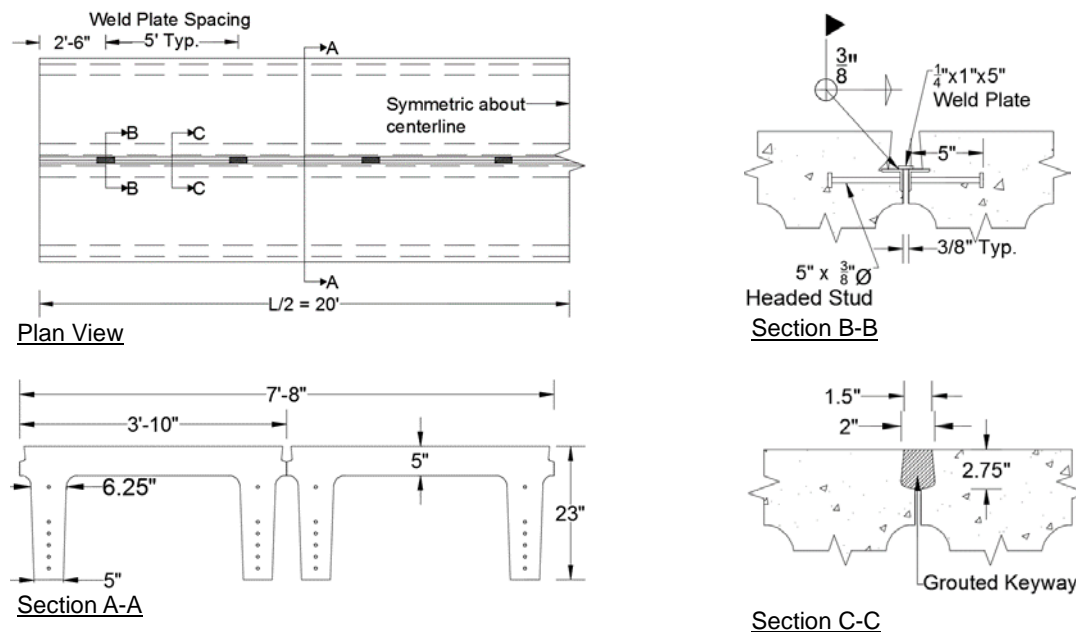
Figure 7-4: Details of the “Conventional” Specimen

long welded headed studs for anchorage into the concrete. The plate was field-welded to the two steel angles using 3/8 in. fillet weld.

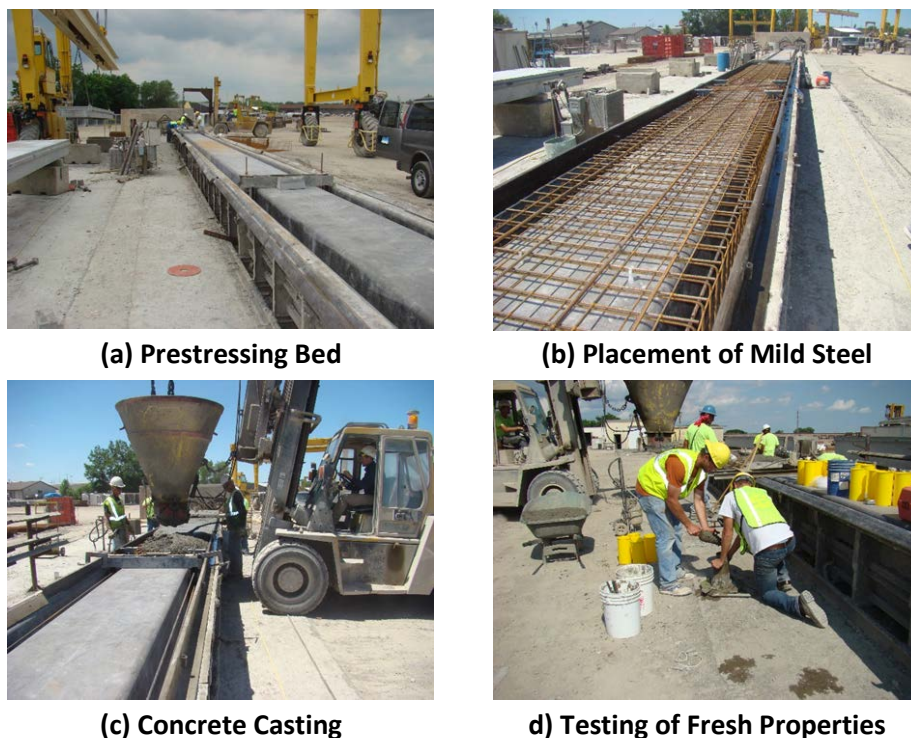
Figure 7-8: Fabrication of the Girders for the “Conventional” Specimen

During concrete casting, SDSU personnel tested the fresh concrete properties and prepared 15 standard 12 in. by 6 in. concrete cylinders. At release, the concrete strength was 6,300 psi which was greater than the specified minimum release strength of 5,000 psi. Before de-tensioning, strain gage readings were taken. The girders were then de-tensioned by torch cutting each strands simultaneously on the two girders. After de-tensioning, strain values were once again recorded. Figure 7-8 shows a sequence of pictures during fabrication.

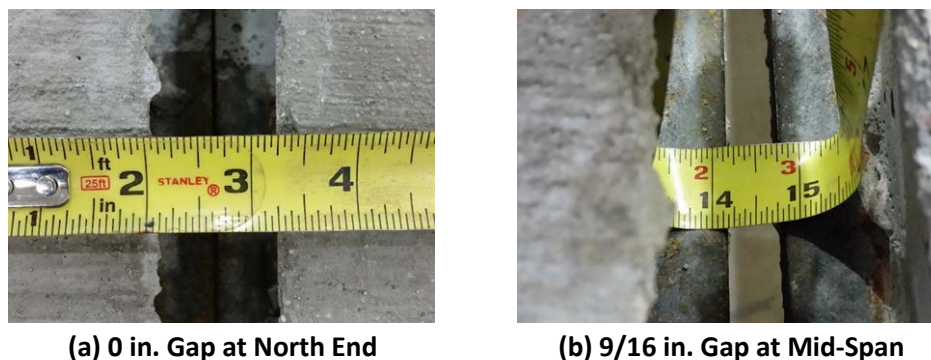
Figure 7-10: Varying Gap at Bottom of Longitudinal Joint of the "Conventional" Specimen

After the girders were set in place, the difference in camber between the two girders did not exceed 0.25 in. The gap at the bottom of the longitudinal joint varied from 0 in. to 9/16 in. Figure 6-10 shows the gap between the welded connections in the longitudinal joint.

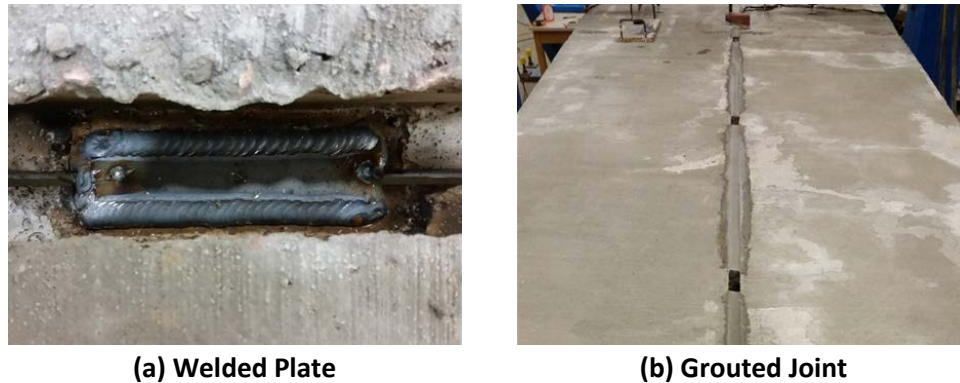
Figure 7-11: Connection at Longitudinal Joint of the “Conventional” Specimen

then filled with the grout mix. Test cubes were cast and the slump was measured during grouting. In normal construction practices, the longitudinal joint would be grouted along the entire joint length. However, to allow for visual monitoring of the welded connections during the test, 6-in. gaps were left ungrouted at the locations of those connections. Figure 7-11 shows the welded plates and the grouted joint with block-outs for monitoring the welded connections.

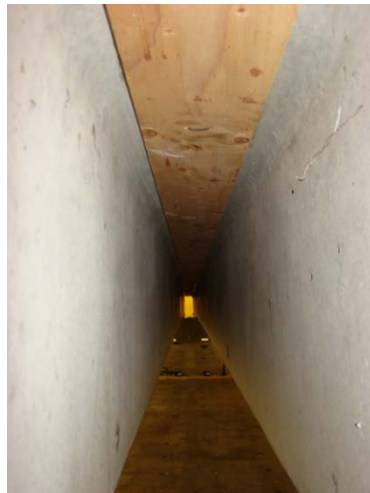
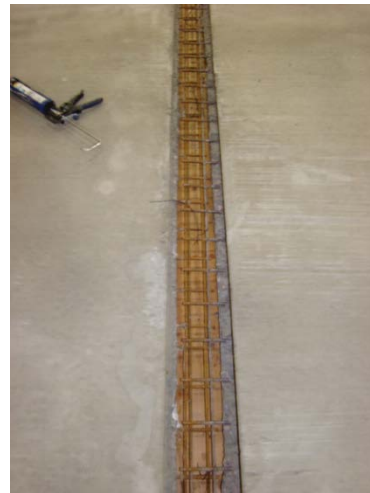
Figure 7-13: Joint Formwork for the “Proposed” Specimen

The girders were shipped to the Lohr Structural Laboratory on August 5, 2014. The girders were unloaded and placed in position on top of the reaction blocks. Placing the second girder in position required some adjustment to be made at the overlapping wire mesh. The wire mesh from the second girder was bearing against the wire mesh from the first girder and preventing a full seating of the second girder. A crow bar was used to slightly separate the two layers of wire mesh and allow for the second girder to be fully seated on the supports. The adjustment process was simple and practical for field applications. The bottom of the longitudinal joint was formed with a 5 in. wide strip of plywood that was tied to the wire mesh. Steel wire ties were placed every two feet to hold the formwork in place. In field applications, the plywood form could be suspended from the first girder prior to placing the second girder then pulled up and tied into place. The longitudinal joint was then filled with the grout mix. Figure 7-13 shows the plywood form at the longitudinal joint.

(a) Bottom Side

(b) Top Side

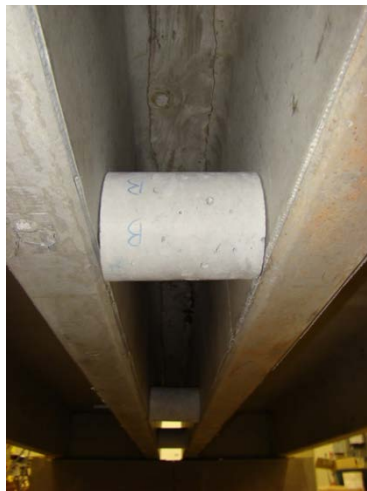
Figure 7-14: Restraining Diaphragm in Place

The restraining diaphragms were installed at 5 ft spacing, starting at mid-span for a total of seven diaphragms. Figure 7-14 shows a diaphragms in place.

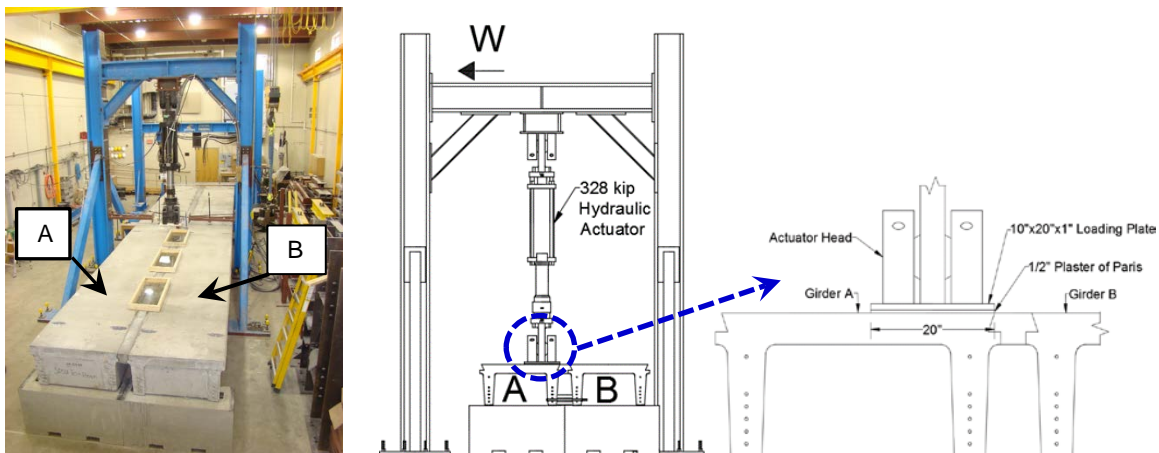
Figure 7-16: Details of the Test Setup

Details of the test setup are shown in Figure 7-16. The girders were labeled “A” and “B”, with girder “A” being the loaded girder and girder “B” being the trailing girder. Loading was applied at the mid-span of girder “A” by means of a 328 kip hydraulic actuator. The load was spread over a 10 in. x 20 in. loading steel plate, instead of the 16 in. x 16 in. plate proposed by the research team to the technical panel in a memorandum on May 15, 2014 (shown in Appendix C), to simulate the contact area specified by AASHTO (2012). The plate was placed at the edge of the longitudinal joint to maximize the shear stresses through the shear keyway. To investigate susceptibility of the joint to water seepage before and during loading, three 4 ft long wood dams were placed directly on top of the longitudinal joint and were filled with water prior to testing.

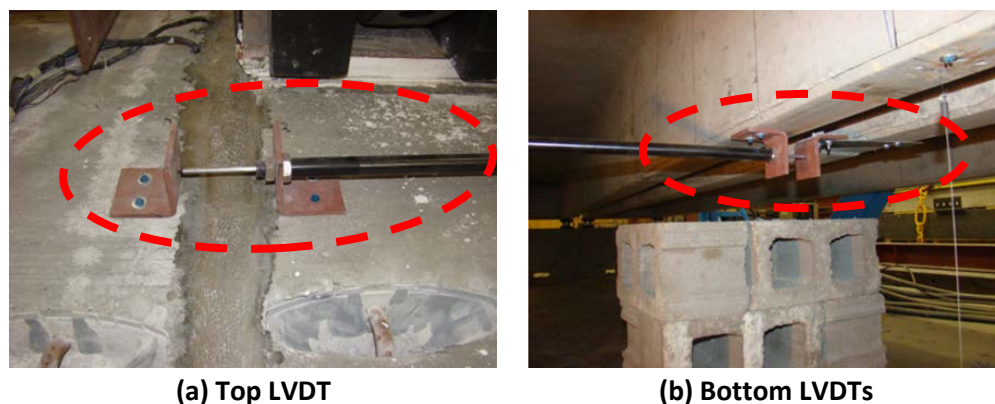
Figure 7-20: LVDT System for Measuring Joint Transverse Rotation

The mid-span joint rotation in the transverse direction was measured with a pair of LVDTs. The LVDTs were placed transversely across the longitudinal joint at the top and the bottom of the specimens, as shown in Figure 7-20, to measure the movement of one girder relative to the other across the joint. The measurements from the top and bottom LVDTs were used to determine the angle of rotation between the two girders. The LVDTs had to be placed at 1.5 ft from mid-span to clear the actuator's head.

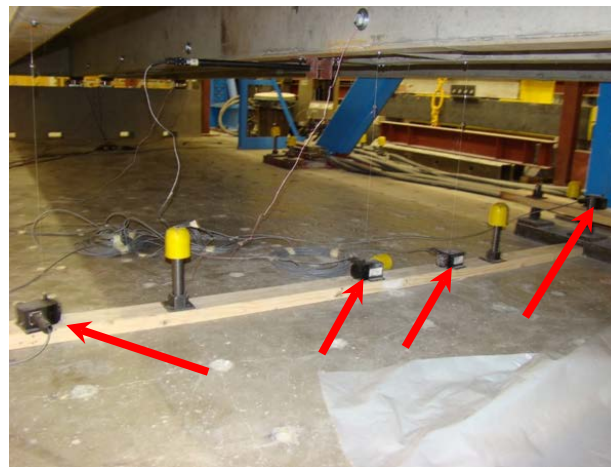
Figure 7-22: Cable Extension Transducers

The LVDTs used for measuring vertical deflections had a maximum stroke of 4 in. A set of four cable extension transducers were used to capture deflections that would exceed the LVDT stroke as the specimen is tested for strength. Under each girder stem, a cable extension transducer was bolted to the floor and the cable was fastened to the bottom of the girder stem. Figure 7-22 shows the cable extension transducers in place.

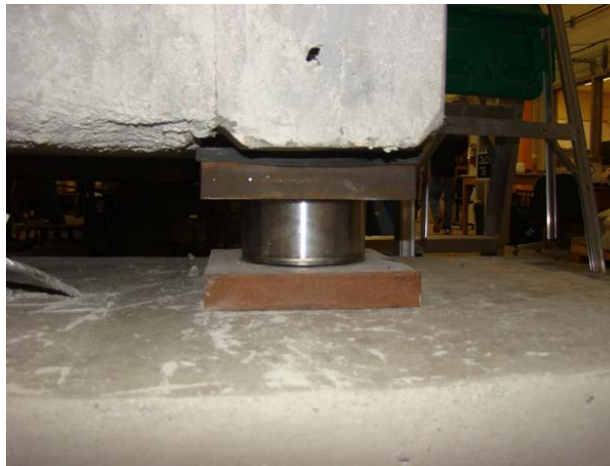
Figure 7-23: Load Cell for Measuring Reactions

Reactions at each of the four girder stems were measured on one end using 100-kip load cells. Under each stem, a load cells was placed between 6 in. × 6 in. × 1 in. steel plates to ensure a flat bearing surface. An elastomeric pad was placed on top of the steel plate where the girder stem would be seated. Figure 7-23 shows one of the load cells in place under the girder stem.

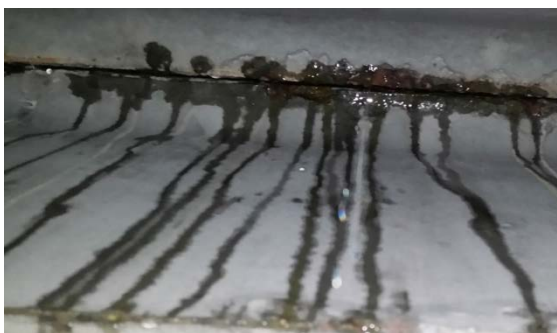
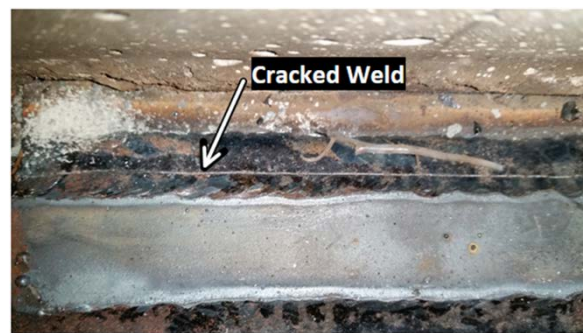
Figure 8-2: Deterioration of the Joint in the “Conventional” Specimen

The first sign of joint deterioration appeared at approximately 15,000 cycles when water from the water dam closest to mid-span started to seep through the longitudinal joint. At 31,500 cycles, the welded connection located at 2.5 ft south of mid-span failed when the weld connecting the welded plate and the angles cracked longitudinally along the length of the connection. The same type of connection failure occurred at 2.5 ft north of mid-span at 37,500 cycles. The welded connection at 7.5 ft south of mid-span failed at 44,000 cycles. At 56,000 cycles, connection failure occurred at 7.5 ft north of mid-span. The test was stopped at 56,000 cycles because the specimen was no longer capable of transferring shear adequately across the longitudinal joint. As the connections failed, the resulting moment in Girder A increased and a ½-in. long flexural crack was noticed at the bottom of the east stem on Girder A at 56,000 cycles. The flexural crack may have resulted from a spike in the applied load between 38,000 and 44,000 cycles. Figure 8-2 shows signs of joint deterioration.

(a) Water Seepage through the Joint

(b) Failure of Welded Connection

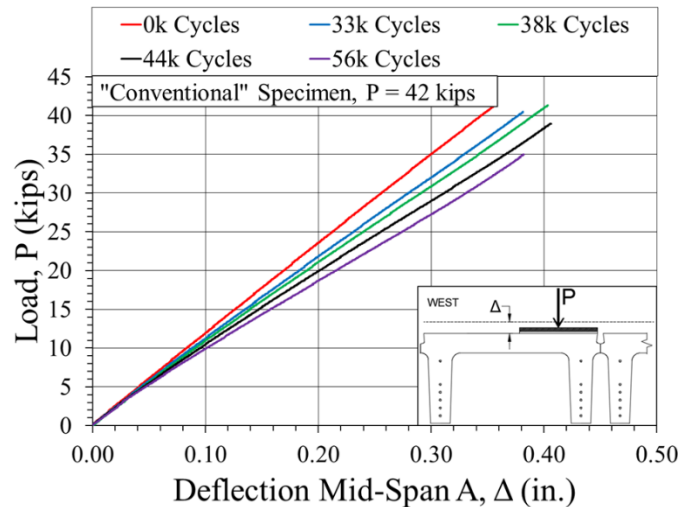
Figure 8-3: Measured Stiffness during Fatigue I – “Conventional” Specimen

load-deflection graphs from the load tests are presented in Figure 8-3. The load tests show the reduction in stiffness as the welded connections failed. The first three measurements have an approximately linear load-deflection; however, the load test data at 44,000 cycles and 56,000 cycles are slightly non-linear, suggesting a flexural crack may have occurred between 38,000 and 44,000 cycles.

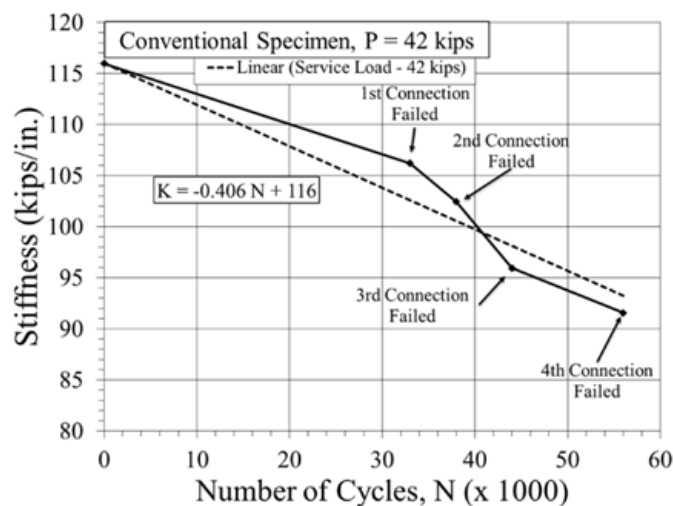
Figure 8-4: Stiffness Degradation during Fatigue I – “Conventional” Specimen

The measured stiffness values are plotted in Figure 8-4 against the number of load cycles. A “best fit” line was added to show the effective rate of stiffness degradation during the Fatigue I test. The stiffness reduced from an initial value of 116 kip/in to a final value of 92 kip/in with a stiffness degradation effective rate of 0.406 kip/in/1000 load cycles.

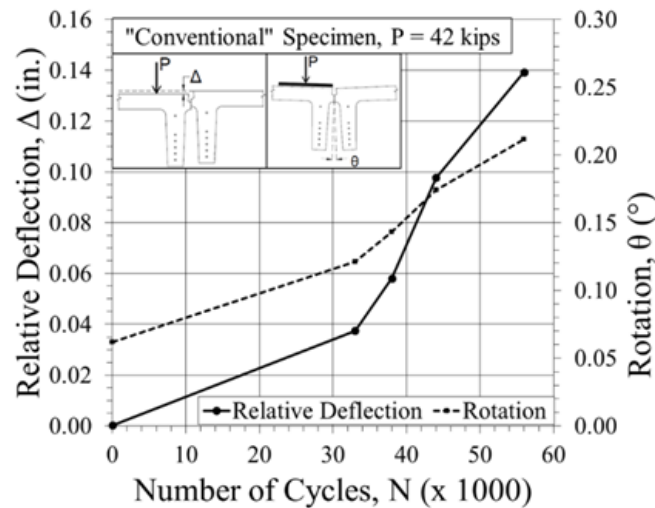
Figure 8-5: Relative Deflection and Joint Rotation during Fatigue I – “Conventional” Specimen

Figure 8-5 shows the measured relative deflection and joint rotation versus the number of load cycles. The values plotted in Figure 8-5 corresponded to an applied monotonic load of 35 kips. The relative deflection and joint rotation increased by 0.14 in. and 0.21 degrees, respectively when the number of load cycles increased from 0 to 55,000. Figure 8-6 shows the relative deflection between Girder A and Girder B during the Fatigue I test.

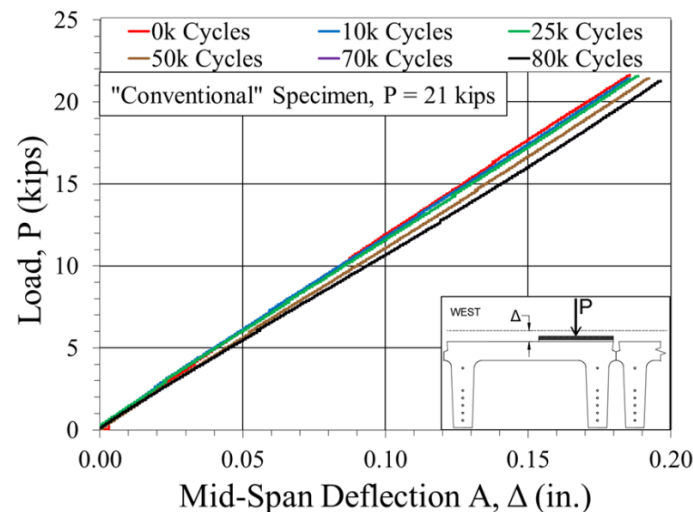
Figure 8-7: Measured Stiffness during Fatigue II – “Conventional” Specimen

two girders. The load-deflection results from the monotonic load tests are presented in Figure 8-7. The load-deflection plots were approximately linear suggesting that the girders were acting as uncracked. Although Girder A was cracked in the previous test, the prestressing force prevented the development of tensile stresses at the bottom of the section under the 21 kip load.

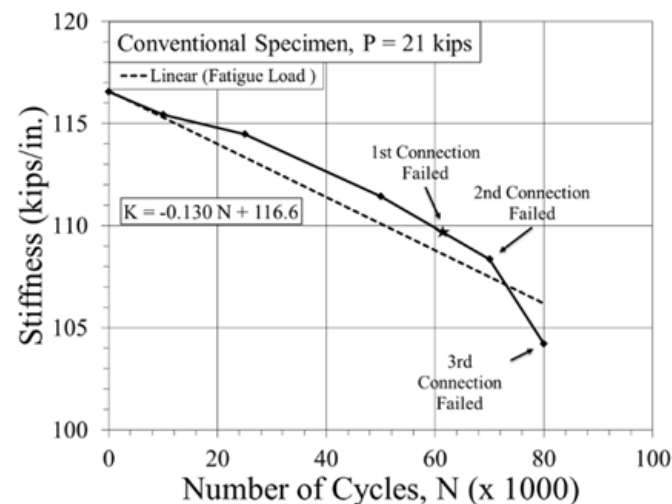
Figure 8-8: Stiffness Degradation during Fatigue II – “Conventional” Specimen

The measured stiffness values are plotted in Figure 8-8 against the number of load cycles. The stiffness reduced from an initial value of 116.5 kip/in to a final value of 104 kip/in with an effective stiffness degradation rate of 0.130 kip/in/1000 load cycles. Doubling the fatigue load level to 42 kips resulted in more than three times the stiffness degradation rate.

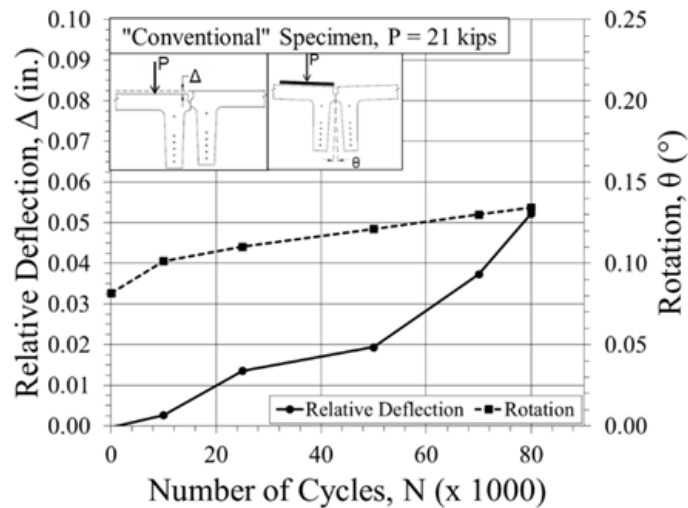
Figure 8-9: Relative Deflection and Joint Rotation during Fatigue II – “Conventional” Specimen

Figure 8-9 shows the measured relative deflection and joint rotation. For the Fatigue II load, the relative deflection and the joint rotation increased by 0.05 in. and 0.13 degrees, respectively when the number of load cycles increased from 0 to 80,000.

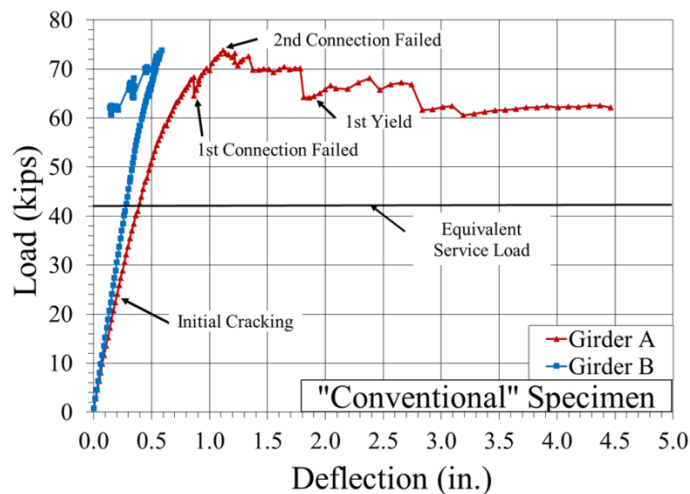
Figure 8-10: Measured Load-Deflection during Strength Test – “Conventional” Specimen

The longitudinal joint was repaired to its original condition prior to performing the strength test. The repair was done following the procedure presented in Section 8.2.2. Figure 8-10 shows the load-deflection plot. The deflection of Girder A at the equivalent service load of 42 kips was 0.4 in. At a load of 69.4 kips the welded connection at 2.5 ft north of mid-span failed when the connecting plate underwent significant double curvature bending as the two girders started to separate vertically. This was followed by complete separation between the angle and its embedded headed stud. The peak load reached during the test was 73.8 kips at a displacement of 1.12 in. measured at girder A. The peak load occurred immediately before the second connection failed at 2.5 ft south of mid-span. After the second connection failed, the deflection of girder B started to decrease with an increase in the actuator’s head displacement, indicating decreased shear transfer across the joint. The first prestressing strand yielded at the bottom of girder A when the load dropped to 66.1 kips at a displacement of 1.9 in. Plots of the measured strains are presented in Appendix G. The test was stopped after the longitudinal joint had completely separated. Figure 8-11 shows the “Conventional” specimen at failure.

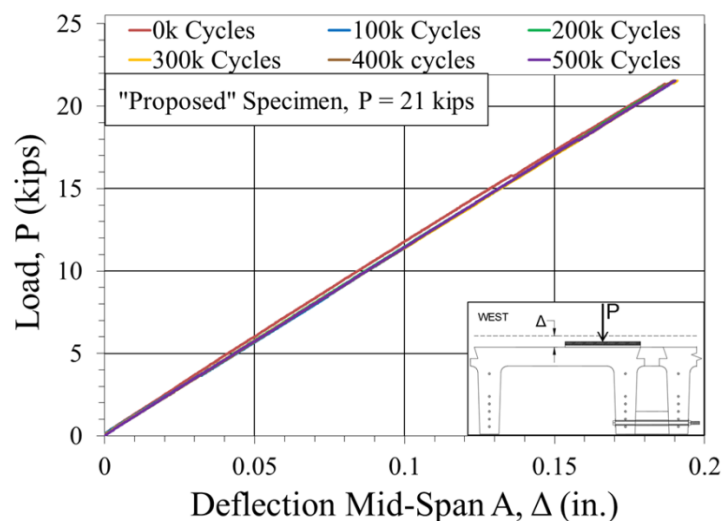
Figure 8-14: Measured Stiffness during Fatigue II with 7 Diaphragms – “Proposed” Specimen

The “Proposed” specimen was first fatigue tested while all seven diaphragms between the stems were in place. A 21-kip load was applied at 1 cycle per second for a total of 500,000 cycles. No signs of joint deterioration or leakage were observed. Stiffness measurements were made periodically. The stiffness of the specimen was determined in a fashion similar to that of the “Conventional” specimen described in Section 8.2.1. The load-deflection graphs from the stiffness tests are presented in Figure 8-14. The measured stiffness values are plotted against the number of load cycles in Figure 8-15. The stiffness reduced from an initial value of 114.3 kip/in to a final value of 113.3 kip/in with negligible effective stiffness degradation rate of 0.0023 kip/in/1000 load cycles.

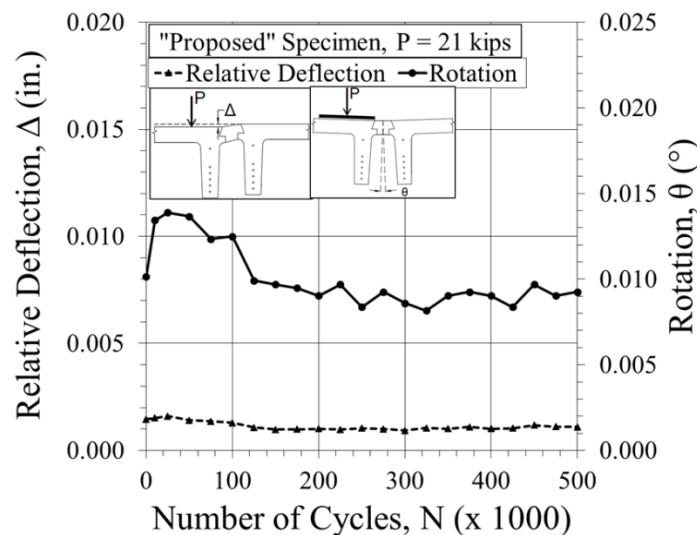
Figure 8-16: Relative Deflection and Joint Rotation during Fatigue II with 7 Diaphragms – “Proposed” Specimen

Figure 8-16 shows the measured relative deflection and joint rotation versus the number of load cycles. The values plotted in Figure 8-6 corresponded to an applied monotonic load of 21 kips. The changes in the relative deflection and joint rotation with increased loading cycles were negligible.

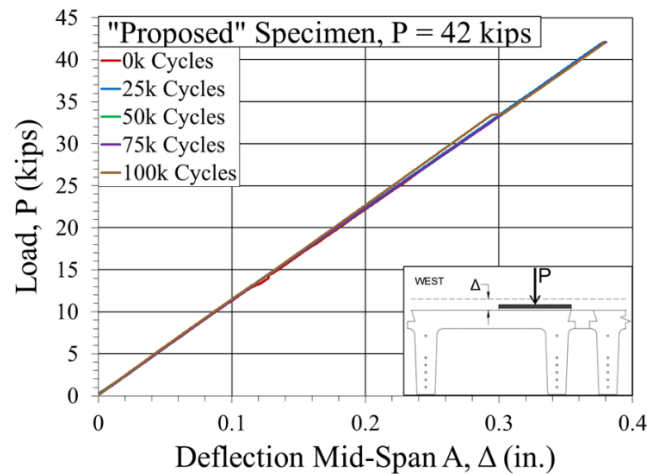
Figure 8-20: Measured Stiffness during Fatigue I – “Proposed” Specimen

Following the Fatigue II tests, the “Proposed” specimen was subjected to Fatigue I loading (42 kips) without any diaphragms for an additional 100,000 cycles. The specimen did not exhibit any noticeable signs of joint deterioration or loss of stiffness. The load-deflection graphs from the stiffness tests are presented in Figure 8-20 and the corresponding stiffness values are plotted in Figure 8-21. Figure 8-22 shows a plot of the relative deflection and joint rotation. The stiffness, relative deflection, and joint rotation remained essentially unchanged with added number of load cycles.

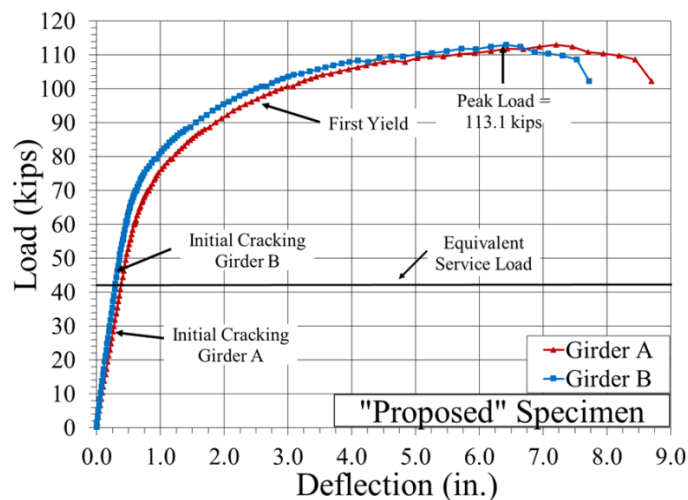
Figure 8-23: Measured Load-Deflection during Strength Test – “Proposed” Specimen

The “Proposed” specimen was tested for strength without the diaphragms. The load-deflection plot for the strength test is shown in Figure 8-23. The first flexural cracks appeared on the interior stem of girder A (Stem AE) at a load of 28 kips. Although this flexural crack was not noticed during fatigue testing, visual inspection during the static test revealed that the east stem was cracked prior to the test. Girder B initially cracked at the interior stem (Stem BW) at an applied load of 46.3 kips. The deflection of Girder A at the equivalent service load of 42 kips was 0.31in. The first strand yield occurred at a load of 96.5 kips and a corresponding displacement at the center of Girder A of 2.6 in. Plots of the measured strains are presented in Appendix G. The maximum load reached during the strength test was 113.1 kips at a displacement of 7.2 in. measured at the center of girder A. The longitudinal joint remained intact and girder B trailed closely the deflection of girder A during the entire test until flexural failure of the specimen was initiated by crushing of concrete at mid-span in girder A. The failed specimen is shown in Figure 8-24.

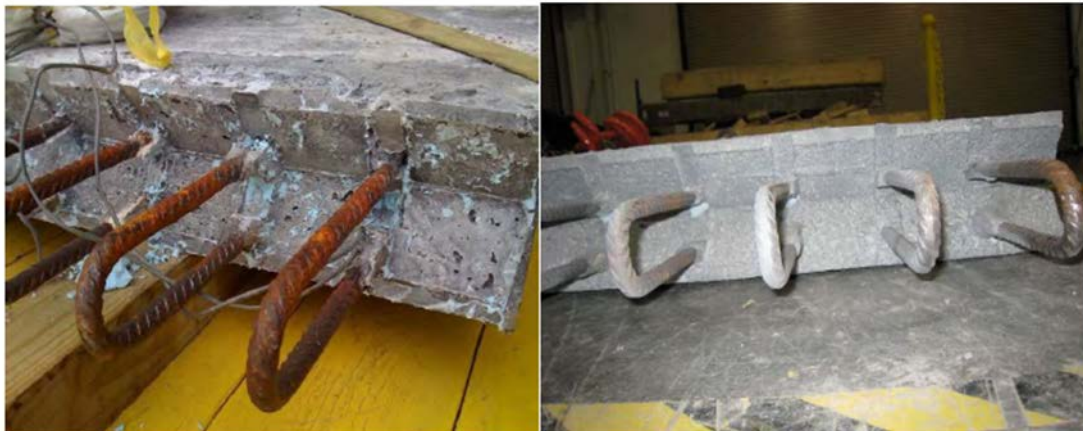
Figure I.5-1 U Bars at Joint

An overnight cure grout with no extension (aggregate) was used to test the U-bar detail and a 7-day grout with 60% extension was used in the joint of the U-bar detail. Both were non-shrink grout. They also developed a design matrix based on environmental conditions to select joint closure material.
