Federal Railroad  
Administration

RR 24-10 | September 2024

## EFFICACY OF INCREASED FLASH RATE OF RAILROAD GATE FLASHERS

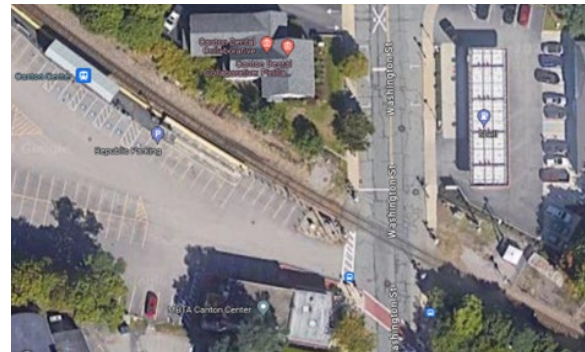
**Data Collection and Analysis:** The grade crossing location selected is on Washington Street in Canton, MA (ID# 546 729P). This is a public, at-grade crossing equipped with 8-inch mast-mounted flashers and 4-inch gate-mounted flashers on each of the two approach lanes. It also has pedestrian gates in all four quadrants.

The MBTA is the primary operating railroad using the crossing, with an estimated 28 trains per day on weekdays. There is no weekend commuter rail service. The Canton commuter rail station lies to the west of the crossing on the south side of the tracks, as shown in [Figure 2](#).

**Figure 2. Washington Street Grade Crossing (Canton, MA)**

The research team collected data via two video cameras connected to a digital video recorder and mounted to a utility pole on the northwest corner of the crossing. Grade crossing violations were classified into three types:

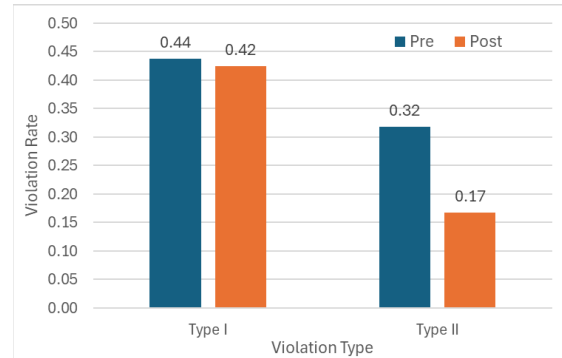
Figure 3 shows the violation rates for Type I and Type II violations for both periods. The Type I violation rate decreased by about 5 percent between the pre and post periods, from 0.44 to 0.42 violations per activation. The Type II violation rate showed a more dramatic decrease

between the periods, from 0.32 to 0.17 violations per activation (a decrease of about 47 percent).

**Figure 3. Violation Rates between the Pre and Post Periods**

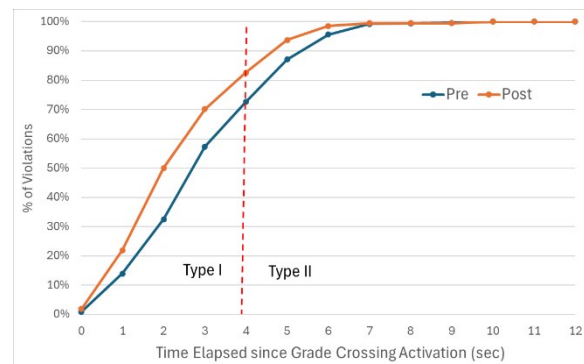
Figure 4 shows the percentage cumulative distribution of violations by elapsed time since grade crossing activation for both periods. This figure shows that for the post-installation period, fewer violations occurred later into the activation after the installation of the rapid flashers.

**Figure 4. Percentage Cumulative Distribution of Violations by Time Elapsed since Grade Crossing Activation**

For observed violations, the average time of violation was 3.4 seconds for the pre-installation period. For the post-installation period, the average time of violation had decreased by 18 percent to 2.8 seconds. This means that violations tended to occur earlier in the activation after the rapid flashers' installation.
