U.S. Department
of Transportation
Federal Railroad
Administration

LiDAR Grade Crossing Data Collection and Storage Services for High Profile Grade Crossings

1. REPORT DATE (DD-MM-YYYY)		2. REPORT TYPE Technical Report		3. DATES COVERED (From - To) 8/18/2022 – 12/18/2023	
4. TITLE AND SUBTITLE LiDAR Grade Crossing Data Collection and Storage Services for High Profile Grade Crossings				5a. CONTRACT NUMBER	
				5b. GRANT NUMBER	
				5c. PROGRAM ELEMENT NUMBER

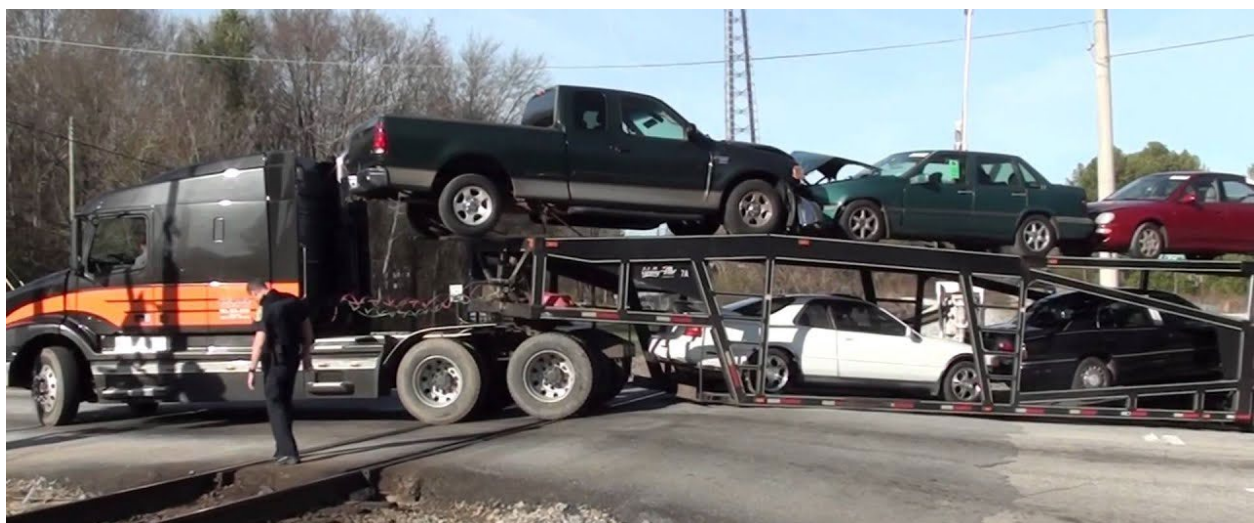
However, humped crossings can pose a significant risk to the passage of long, low-clearance vehicles such as automobile transport trailers, heavy equipment transports, and other low-clearance trailers. [Figure 3](#) shows an automobile transport trailer that has become stuck on a humped crossing. As these vehicles pass across the grade crossing, their long wheelbases cause the supporting axles to contact the roadway at points on either side of the tracks. When both contacts points are lower than the tracks, in the case of a humped crossing, more undercarriage clearance is required to pass over the crossing. This can result in long-wheelbase, low-clearance vehicles becoming stuck on the tracks.

Figure 3: A automobile transport trailer stuck on a humped high-profile grade crossing

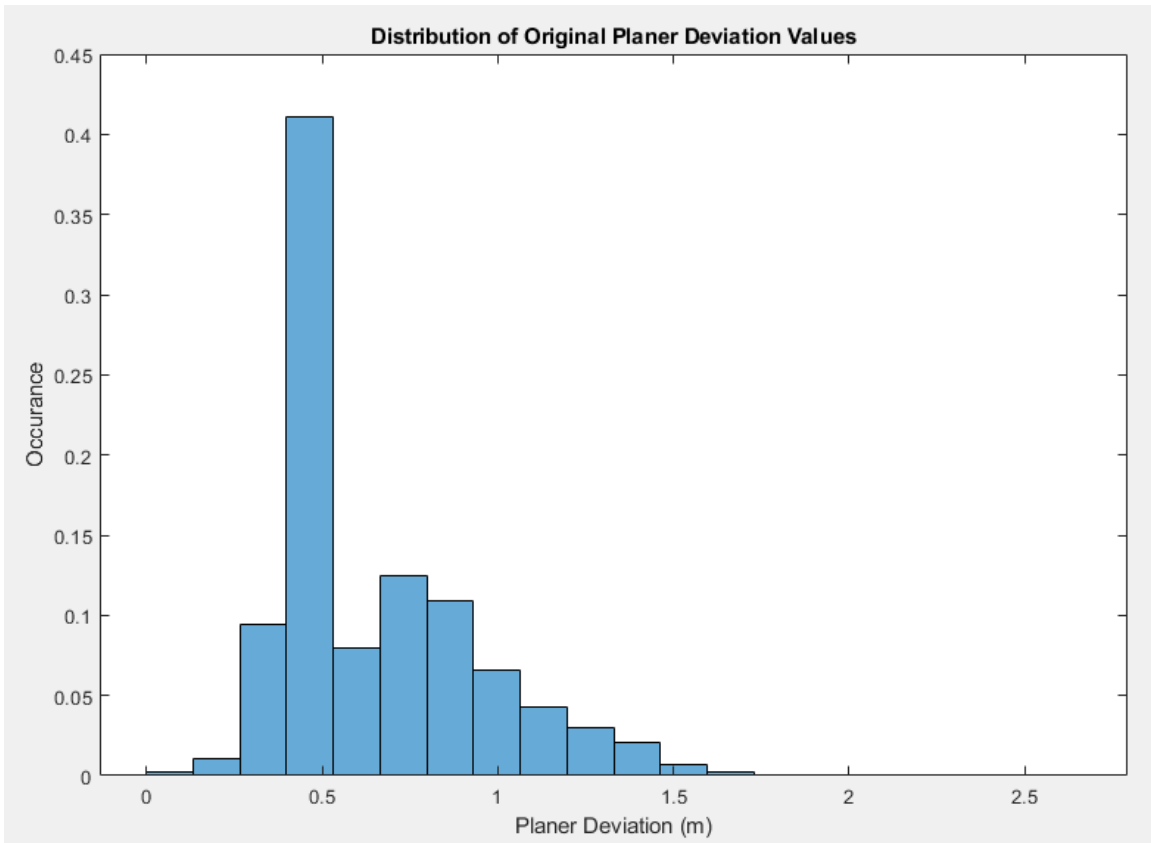
Figure 7: Distribution of grade crossing planer deviation values collected in 2019 and 2020

The dataset showed only 0.08 percent of the crossings surveyed were within the recommended AASHTO guidelines for planer deviation and 13.2 percent measured more than 1 meter of planer deviation. The manual review of grade crossing scans discussed in [Section 2.3](#) found these erroneous measurements were primarily attributed to sharp roadway intersection angles, vegetated roadways or adjacent areas, or multiple tracks in the crossing.

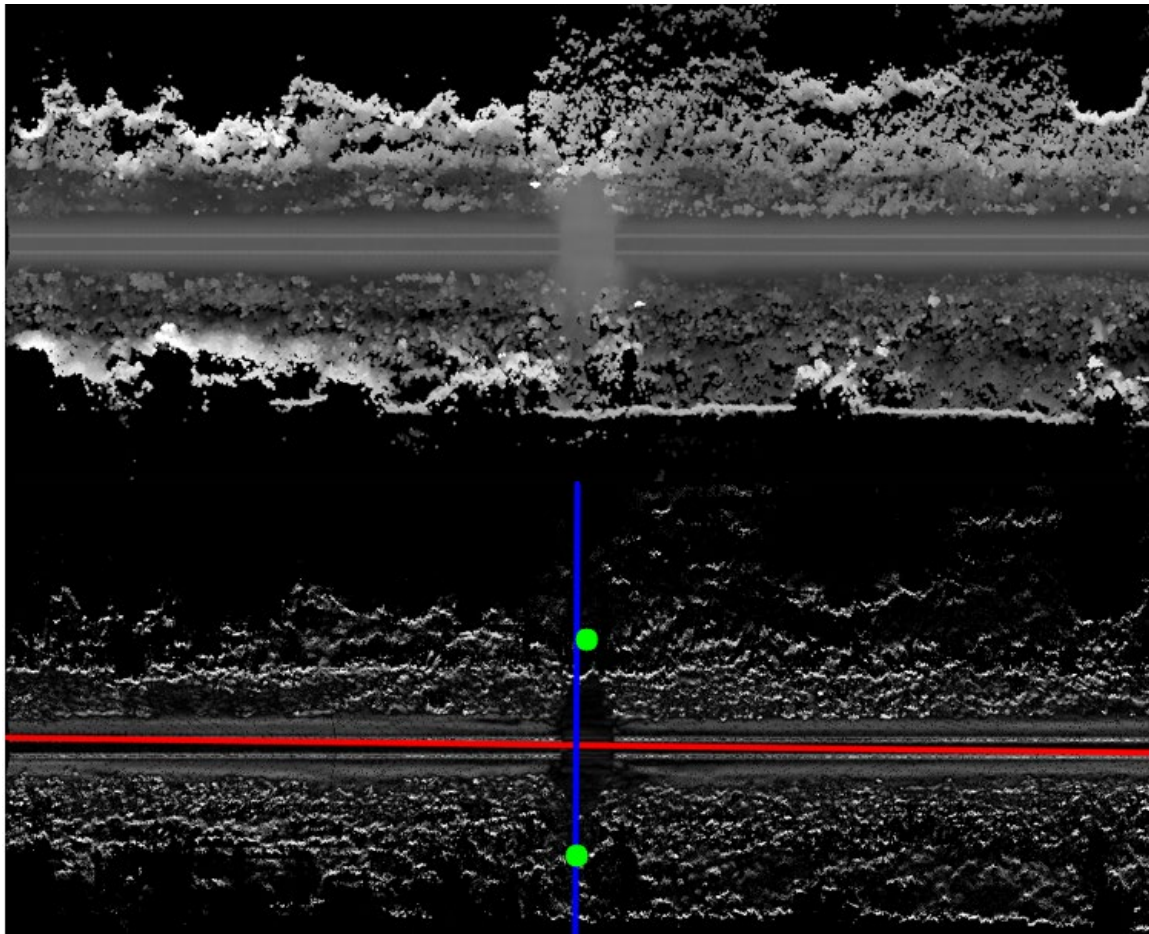
surrounding vegetation. When this occurs, the algorithm will often report segmentation confidence of approximately 30 percent. Figure 18 shows a heavily vegetated farm crossing. Although the algorithm did correctly identify locations within the roadway for measurement of the planer deviation, the PMF was unable to effectively smooth all vegetation from the roadway. This resulted in inaccurate planer deviation measurements because the elevation of the remaining vegetation was included in the reported measurement.

Figure 18: Unpaved farm crossing with approximately 0.5 - 1m vegetation resulting in 30 percent confidence

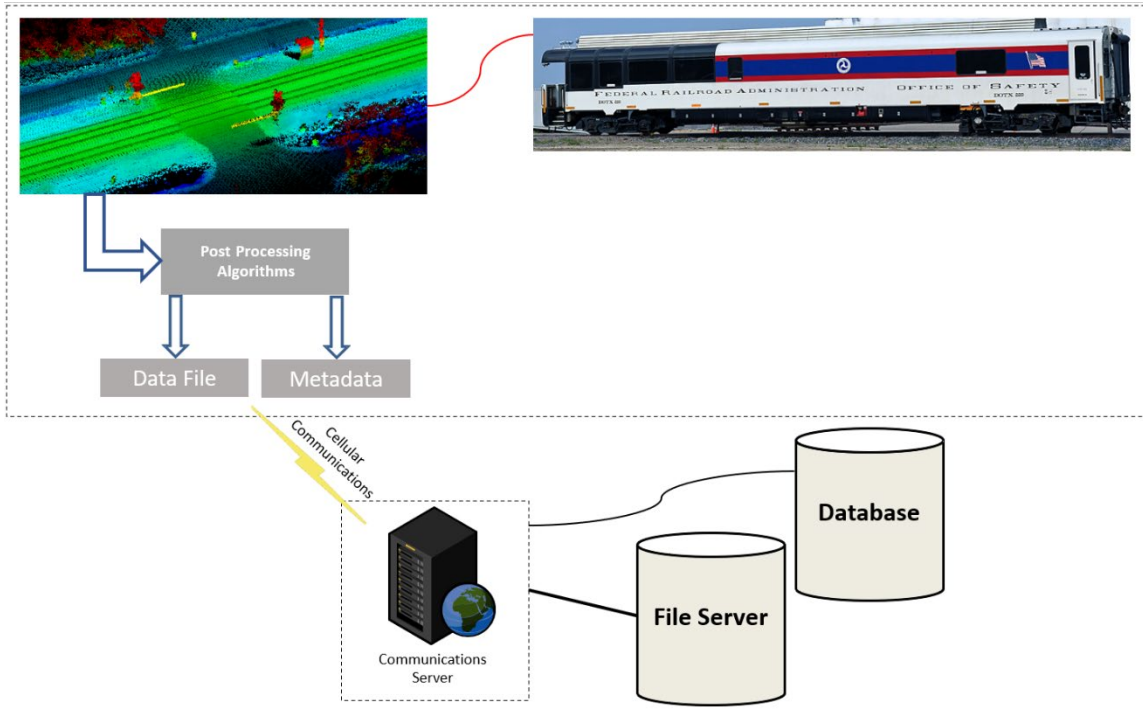
To streamline the data workflow, the post processing routines were integrated into the on-board data collection software (Figure 21). This allowed for ongoing collection of grade crossing data with lower labor costs, while reducing the time required to access and review new grade crossing data. To implement this updated data workflow, the post-processing algorithms were integrated into the geofencing and data collection software onboard the ATIP vehicles.

Figure 21: Schematic showing updated data flow with onboard processing and cellular transfer

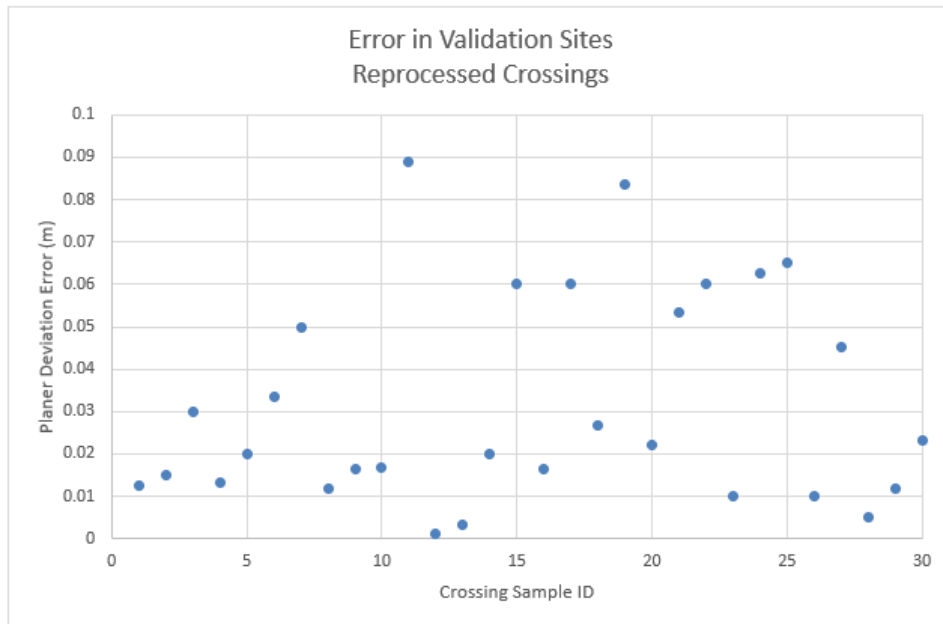
Figure 28: Error in algorithm output at reprocessed crossings with greater than 0.25-meter change in planer deviation

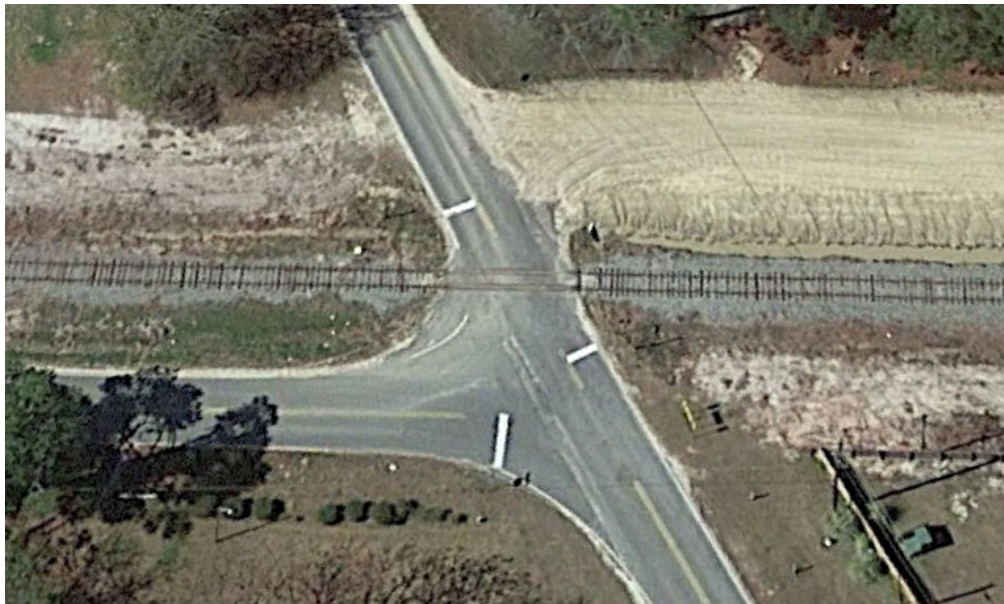
The largest error found during validation occurred at crossing 732405Y. This is a complex crossing with a paved road intersecting the tracks at approximately 45° and a secondary road that parallels the track and merges at the crossing ([Figure 29](#)).

Figure 29: Satellite imagery showing crossing 732405Y

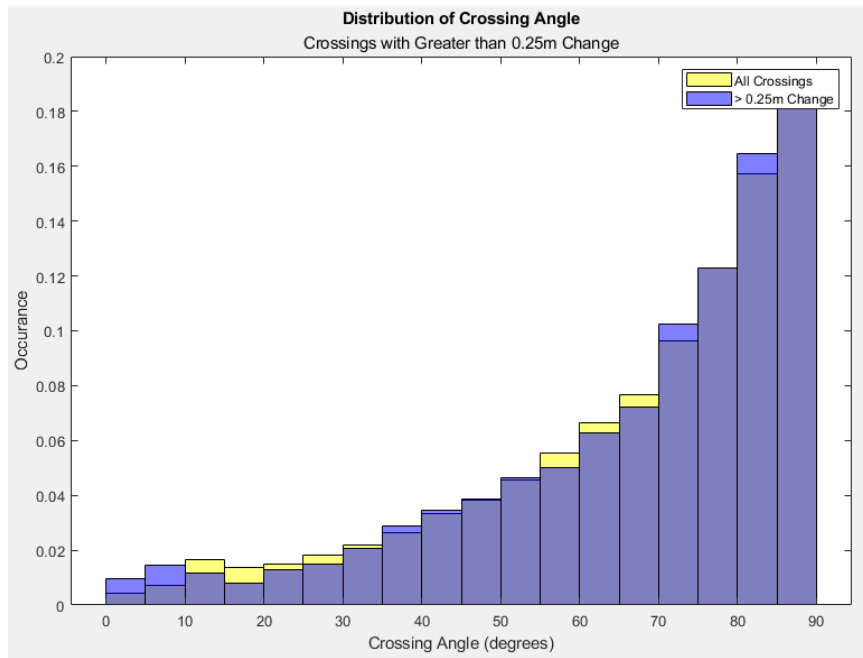
Figure 42: Histogram showing distribution of crossing angle for locations with a change in reported planer deviation greater than 0.25 m

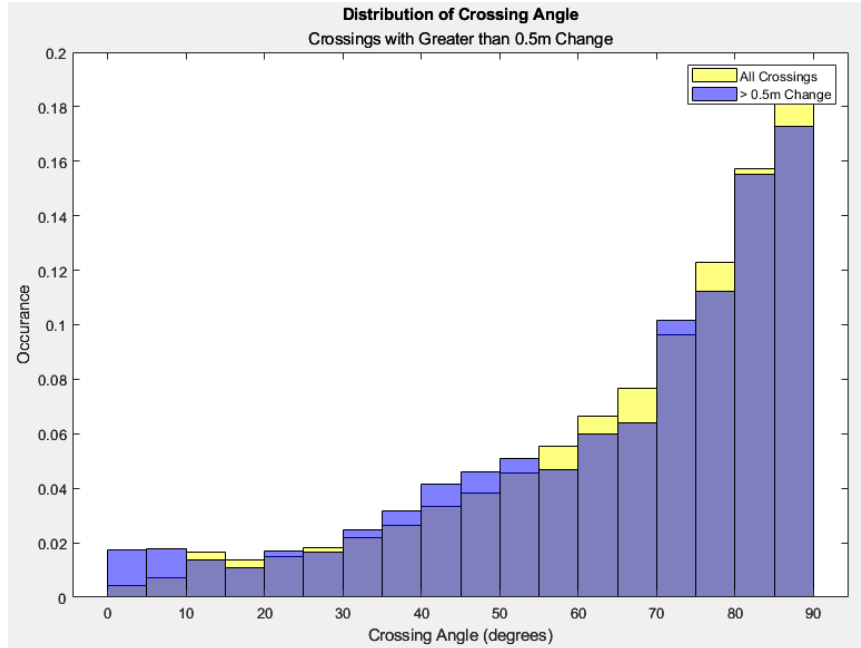
Figure 43: Histogram showing distribution of crossing angle for locations with a change in reported planer deviation greater than 0.5 m

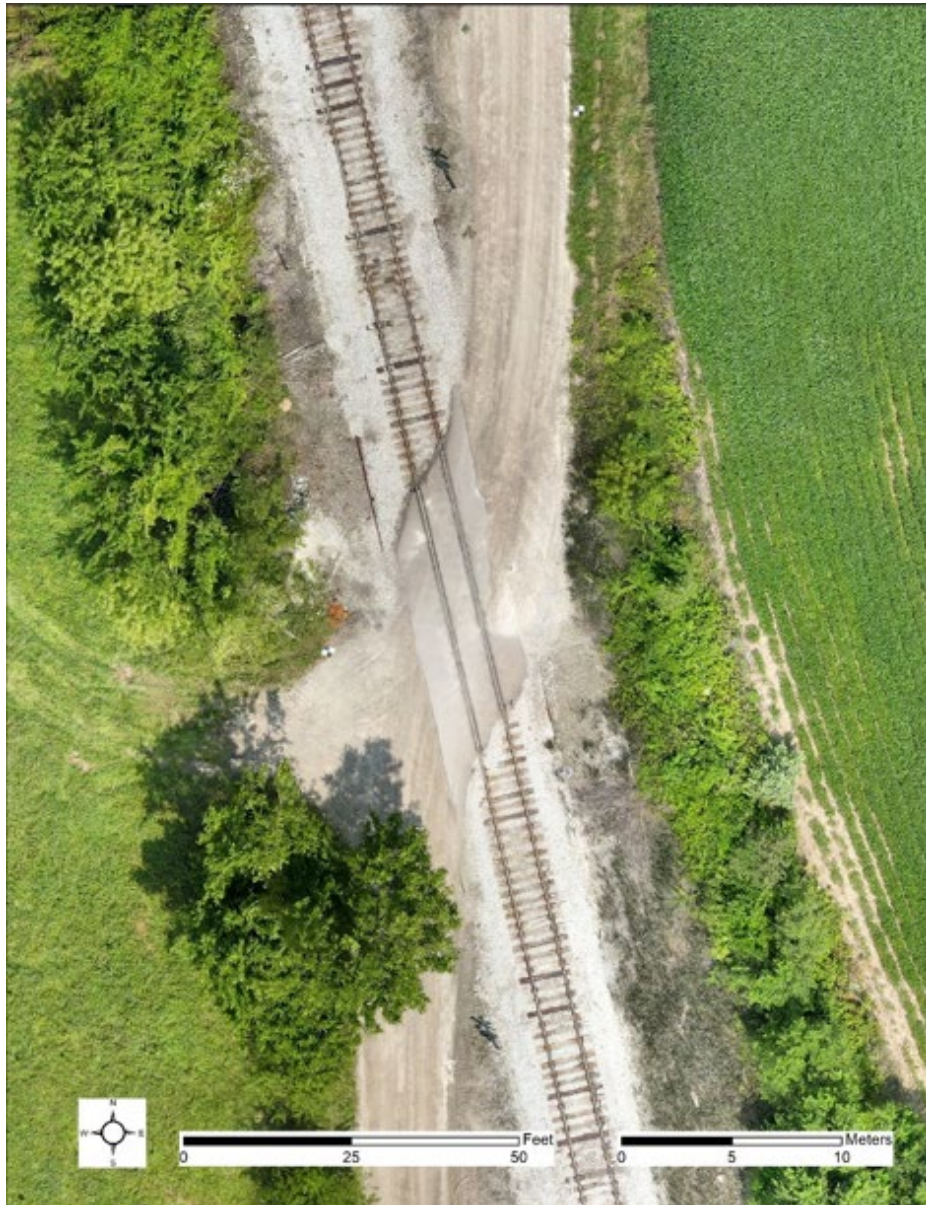
Figure 55: Overhead view of crossing 000165X - Dundee Azalia Road collected using the Crossing-i system
