Pavement Design Around Utilities – Best Practice

Jeff Stempihar, Principal Investigator
Nichols Consulting Engineers, Chtd.

June 2024

Research Project
Final Report 2023RIC09

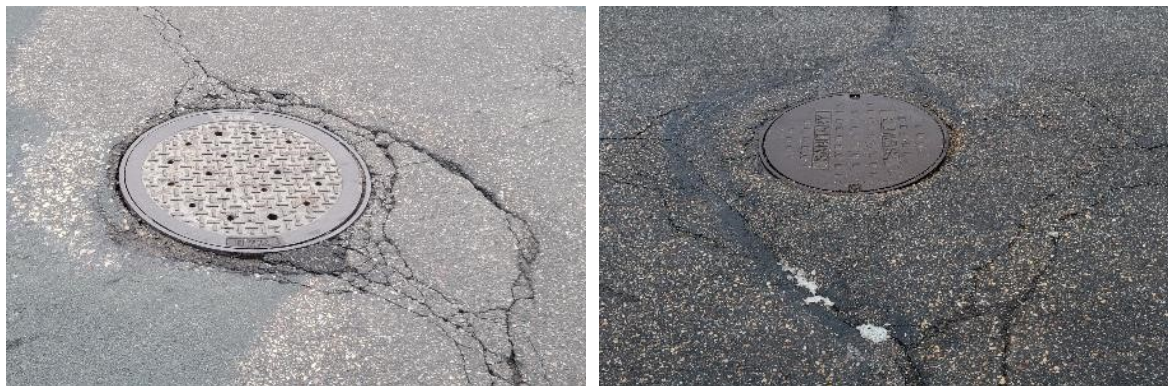
Figure 1. Examples of common pavement distresses around utility covers (courtesy NCE).

Asphalt concrete pavement surrounding utility structure covers (e.g., catch basin inlets, manholes, gate valve covers,) often settles, cracks, or breaks up over time. In addition, potholes frequently form at construction joints between the patch (surrounding the cover) and the roadway pavement as well as at the pavement interface with the utility cover. These pavement distresses (Figure 1) are especially pronounced in cold climates (e.g., Minnesota), can create ride quality issues and hazards for vehicles and snowplows, and often require additional maintenance. They can be attributed to factors such as design requirements, collar material type and cut shape, construction practices, frost heave, and backfill settlement. Differences in design details (e.g., cut shapes, collar material type, frame and cover adjusting materials) and construction practices can result in differences in performance, but pavement performance around utility covers is not well documented, and technology transfer across agencies is difficult.

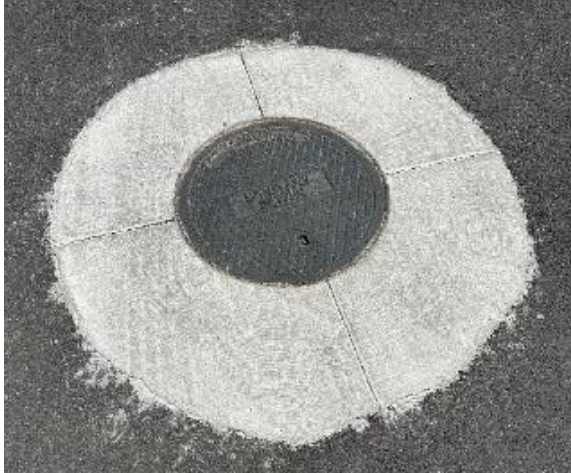
Figure 2. Example concrete collar scored at quarter points to initiate cracking (AzMAG detail) (courtesy NCE).

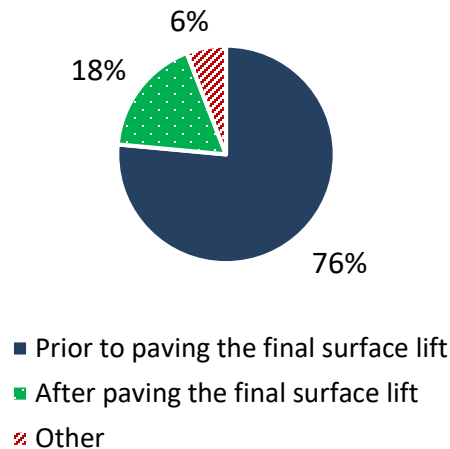
During asphalt concrete paving projects, 26 respondents adjust the utility cover assembly prior to paving the final surface lift, while 6 respondents adjust the utility cover assembly after the final surface lift (Figure 3). One “other” response mentioned the addition of steel adjustment rings after each paving lift so that finished pavement does not need to be cut. Another “other” response reported boxing the casting in 6 ft × 6 ft (1.8 m × 1.8 m) concrete after the final surface lift is paved.

Figure 3. Timing of utility cover adjustment during asphalt concrete paving projects.

Utility cover adjustment is typically done either prior to or after paving the final surface lift (Figure 3). Pavement surrounding utility structures is more prone to distress if not raised to grade after paving at least one lift. In fact, one 2004 study showed that over 35% of utility covers that were raised to grade before paving had damaged pavement (Rinne, 2004).

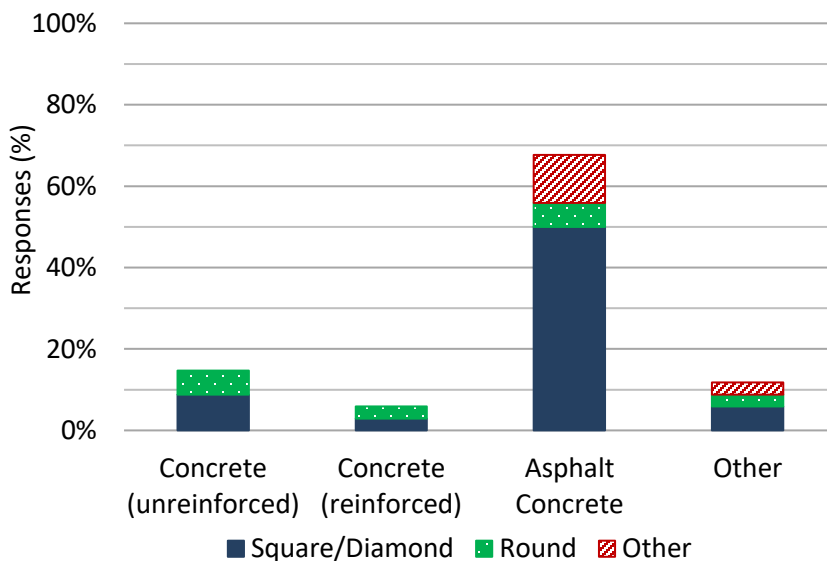
Most respondents (68%) use asphalt concrete for utility collar material (Figure 5). Of these, 74% use a square/diamond collar cut shape, 9% use a round cut shape, and 17% use other cut shapes. Twenty-one percent of respondents use concrete collar material, and of these, 71% use unreinforced concrete and 29% use reinforced concrete (Figure 5).

Figure 5. Collar material and cut shape.

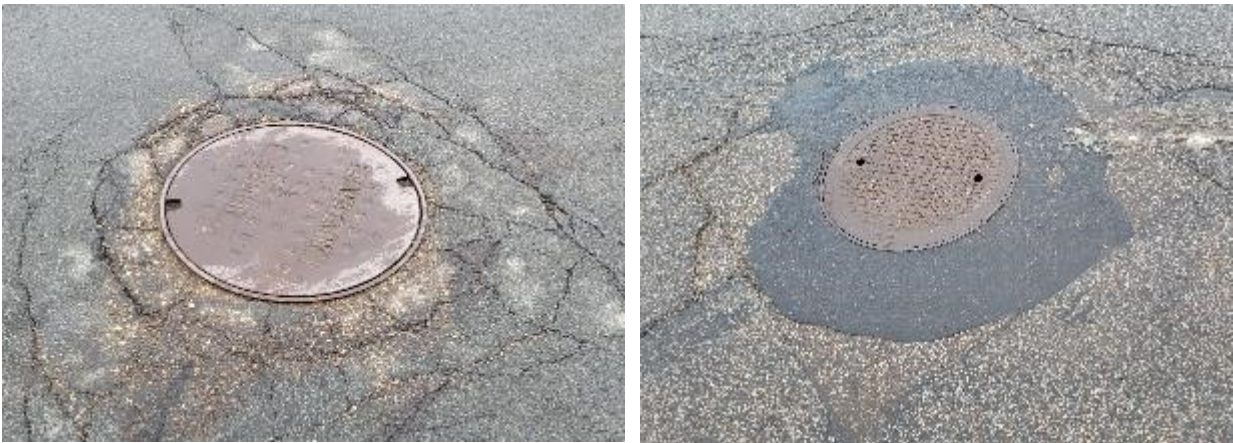
Pavement surrounding utilities is prone to distresses such as cracking, settlement, and potholes (Figure 7). It is important to understand the factors contributing to these distresses to make informed decisions about current and future practices.

Figure 7. Pavement distresses around utility structure covers in Minnesota (courtesy NCE).

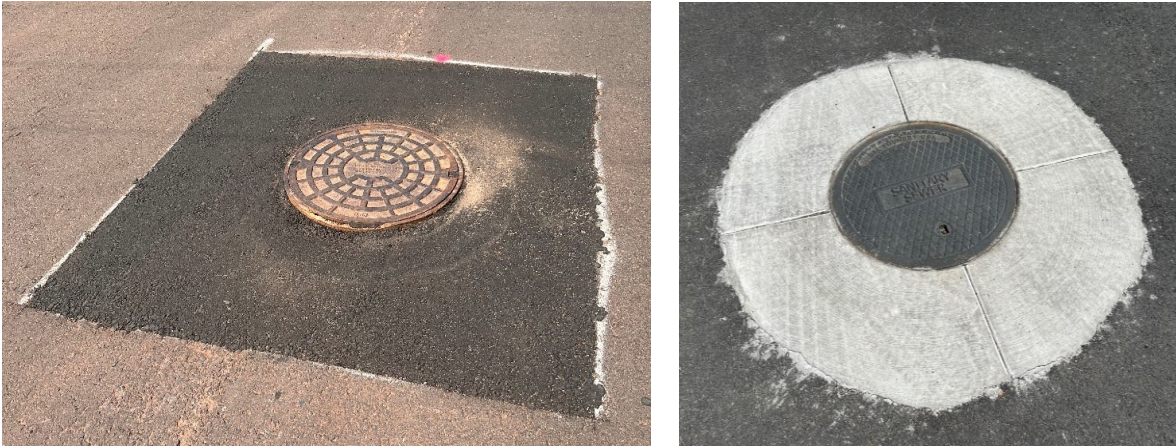
When choosing utility collar material and cut shape, no “one size fits all” approach was identified. Factors such as cost, climate, dominant pavement distresses, agency experience, past performance, and material availability should be considered to determine what collar material and cut shape work best for an agency. Many agencies reported success with square/diamond cut asphalt collars, while some reported success with round cut concrete collars. It is important to note that while few agencies use a round cut with a concrete collar, those that do reported success with this method. Figure 8 shows an example of a square cut with asphalt concrete collar and a round cut with concrete collar.

Figure 8. Example of square cut with asphalt collar (prior to paving the surface course) and round cut with concrete collar, after paving the surface course (courtesy NCE).

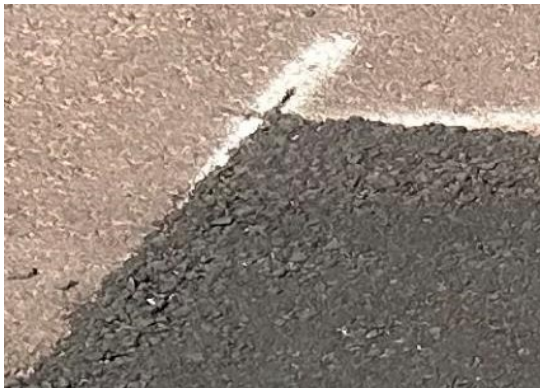
One concern with the square/diamond cut is that cracking can initiate from planes of weakness that are created at each corner as well as from sawcut overruns into adjacent pavement (Figure 9).

Figure 9. Example of sawcut overrun into adjacent pavement (square patch) (courtesy NCE).

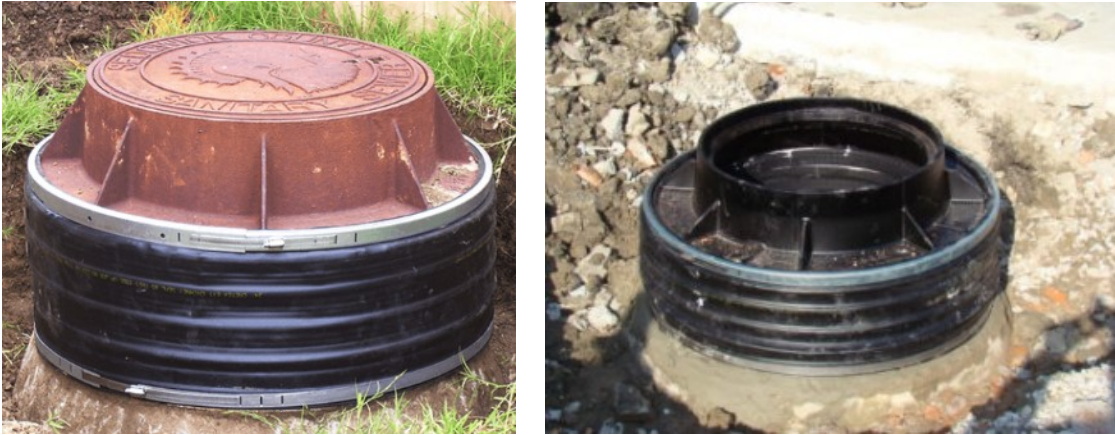
Two agencies reported success mitigating the effects of frost heave with a chimney seal (Figure 11). Chimney seals provide a watertight seal between the utility structure casting and the concrete cone supporting it. According to Cretex Specialty Products, the manufacturer of chimney seals used by one of the agencies, chimney seals allow for movement within the confines of the surrounding backfill, providing up to two inches of vertical movement without stretching the material (Cretex Specialty Products, 2023). A watertight seal can help prevent water leaks from intruding into the pavement layer, which may help with frost heave issues or settlement due to migration of fines into the utility structure.

Figure 11. Example of a chimney seal (<https://cretexseals.com/product/x-85-external-seal/>).

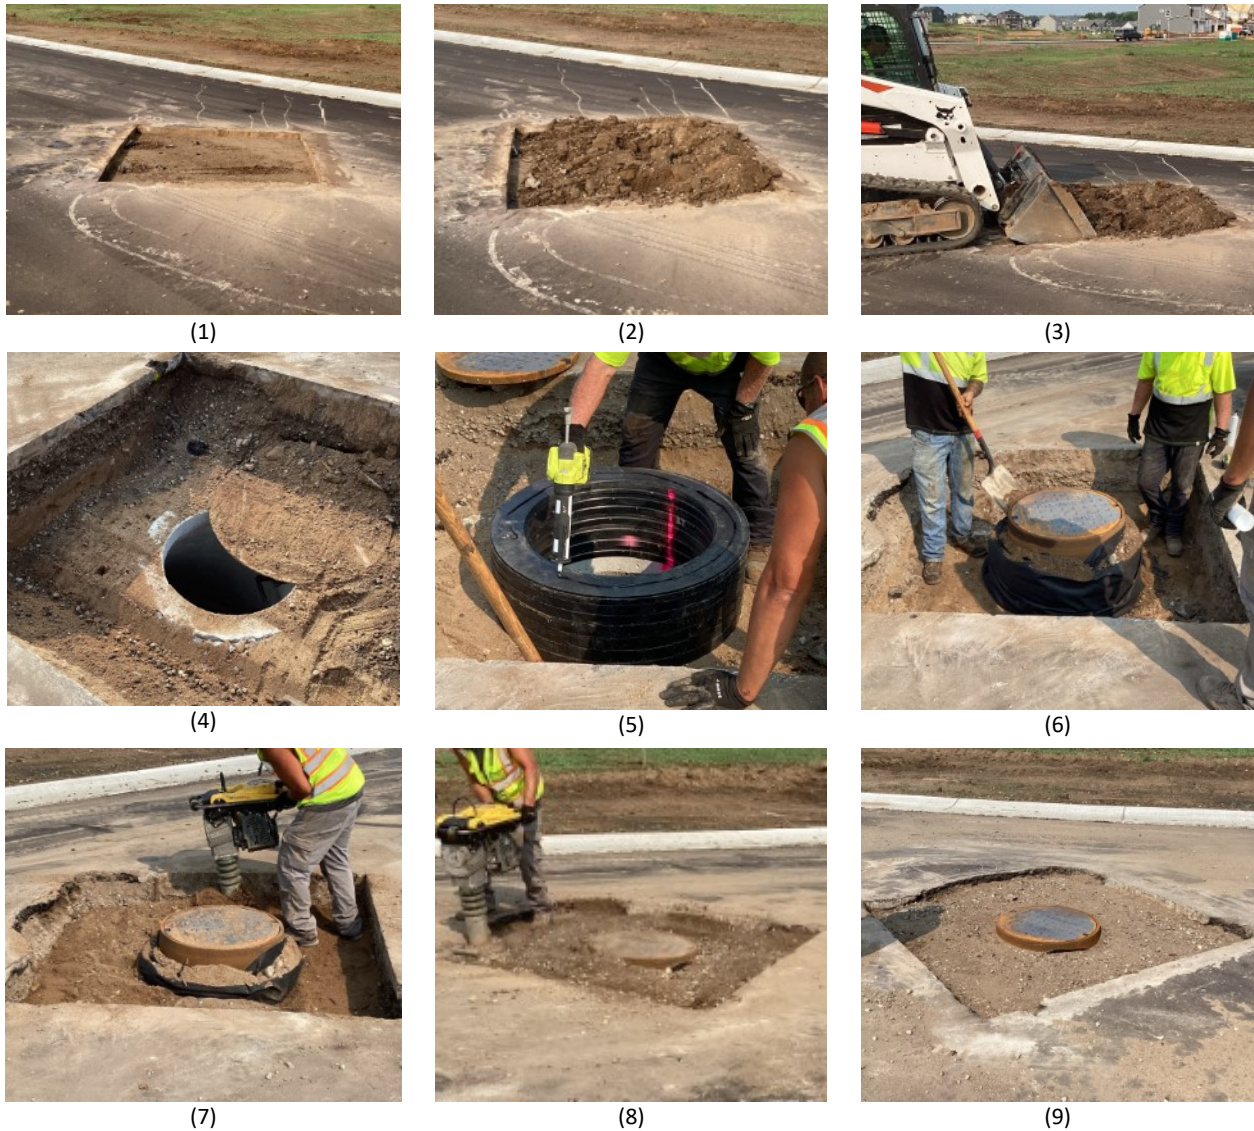
1. Sawcut pavement for utility collar.
2. Loosen unbound material.
3. Excavate unbound material.
4. Expose utility structure.
5. Install and seal adjusting rings.
6. Install casting and lid and wrap with material (e.g., fabric) designed to reduce movement of fines into the structure.
7. Install sand backfill layer (one lift in this case) and compact with 3 passes using a handheld compactor. Perform density testing.

8. Install aggregate base layer and compact. Perform density testing.
9. Prepare area for pavement patch.

Figure 12. Unbound materials compaction sequence as part of utility cover adjustment (courtesy City of Woodbury, MN).
