**August 2024**

**Report No. 24-061**

# Development of Improved Inspection Techniques Using LiDAR for Deteriorated Steel Beam Ends

**University of Massachusetts Amherst**

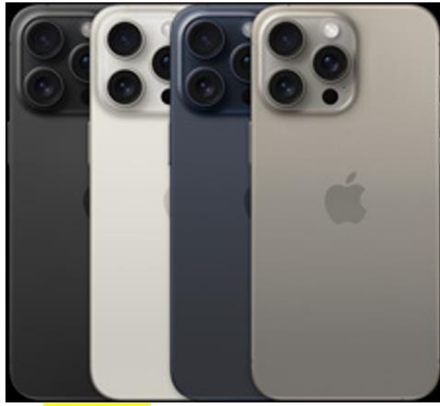
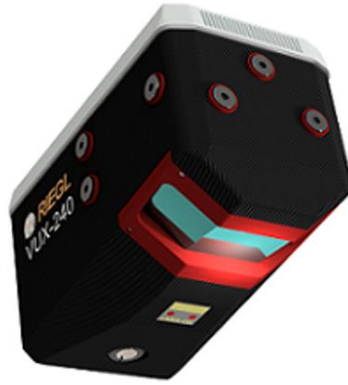
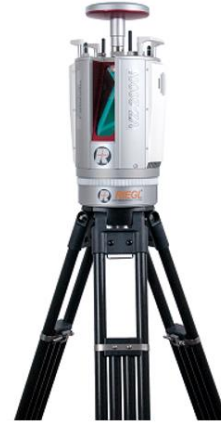
**Figure 2.2: LiDAR Scanning Tools**

There have been significant developments in the multitude of LiDAR technologies that have flourished following the creation of the laser and development of the LiDAR concept. The equipment that is currently available in today’s market spans LiDAR units that can be mounted on drones, larger terrestrial LiDAR scanners, and even LiDAR onboard smartphones such as the iPhone (12). Each of these scanners has a variety of applications and accuracy and have a significant range in cost. For example, the iPhone 15 Pro Max costs \$1199 dollars but does not currently have the accuracy or range of the terrestrial Riegl scanners, which could cost hundreds of thousands of dollars depending on the unit chosen (12,13). Examples of current LiDAR units on the market can be found in Figure 2.2 below.

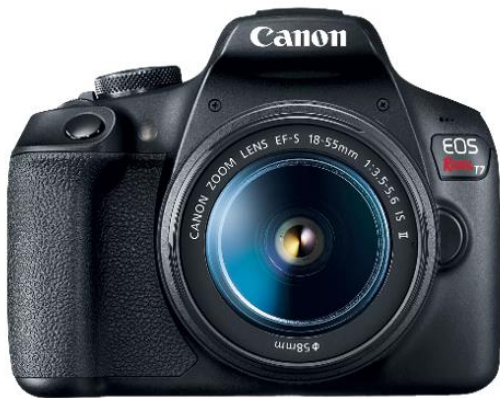
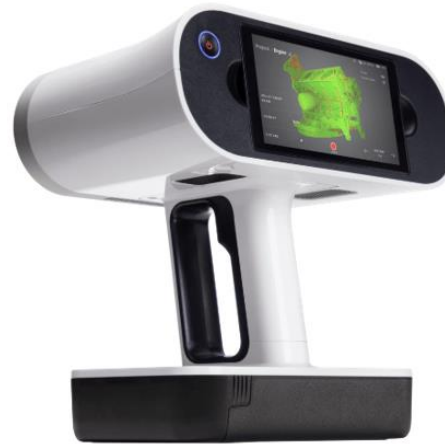
**Figure 2.4: Photogrammetry data capture devices**

With a large range of photogrammetry applications and methodologies, the equipment that is currently available in today's market has expanded greatly since photogrammetry's first use. Because photogrammetry at its foundation relies heavily on image overlap and stitching, the hardware that can be used to perform photogrammetric techniques can span cellular devices to DSLR cameras, or even be imbedded into handheld scanners. Additionally, drones or unmanned aerial vehicles can be outfitted with cameras to perform photo capture for photogrammetry. Two examples of devices that can capture data for photogrammetry, an EOS Rebel T7 EF-S 18-55mm IS II camera and the Artec LEO Scanner, are shown in Figure 2.4 below (17, 18).

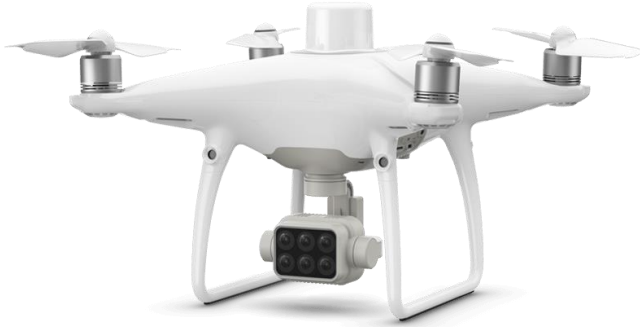
**Figure 2.5. The DJI P4 Multispectral Drone (35)**

deterioration but can also be used to create a 3D model, or what is commonly referred to as a “digital twin” of the structure being captured. In practice, there are many drones across the market that allow for LiDAR units, cameras, or other recording equipment to be mounted to the drone system for scanning or photography. There are also select companies such as DJI, which has drones outfitted with RGB cameras and multispectral cameras for scanning, and Wingtra, which has drones outfitted with cameras and systems for photogrammetry and even for thermal imaging (35, 36). An example of a DJI drone with an embedded multispectral camera system is shown in Figure 2.5 (35).

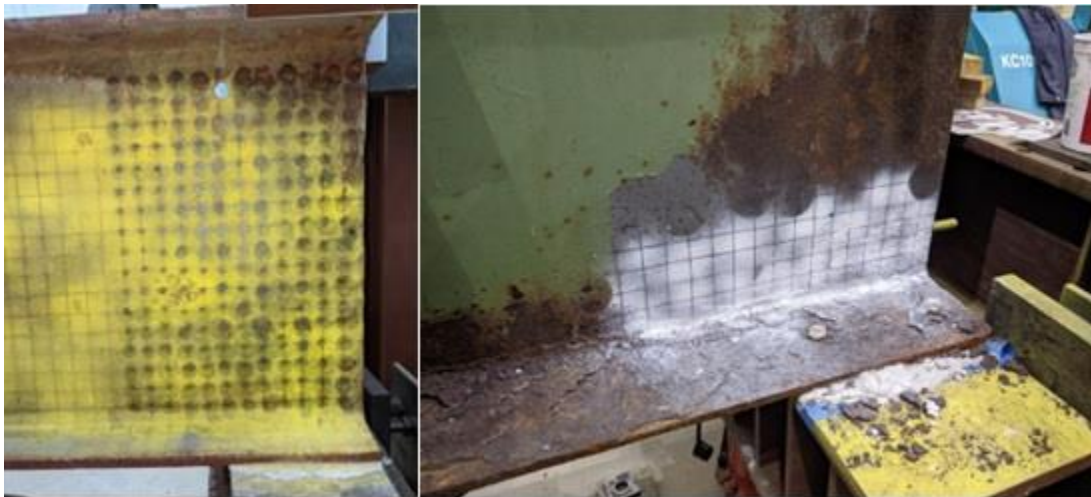
**Figure 3.1: Point measurement grids for PocketMIKE (67) ultrasonic thickness gauge**

For Laboratory Beams 1 and 2, thickness grids were created to take evenly spaced point measurements of the web thickness to create a grid that would represent the thickness profile of the corroded beam web. Additionally, these point measurements were used as a means to check or validate the data taken from the 3D scanners. The tool that was used by the research team for these point measurements was the GE PocketMIKE, which is an ultrasonic thickness gauge that is used, or is an equivalent, to a hand tool used by bridge inspectors to measure web thickness (67). The PocketMIKE was tested against a steel block of known thickness to test the performance of the tool while measurements were taken in the laboratory and field setting (67). These thickness grids were only generated in the laboratory as time and accessibility limited this from being used in the field. While this is the case, several point measurements were taken in the field-scanning task of this project. Representative thickness grids from Laboratory Specimens 1 and 2 are found in Figure 3.1 below.

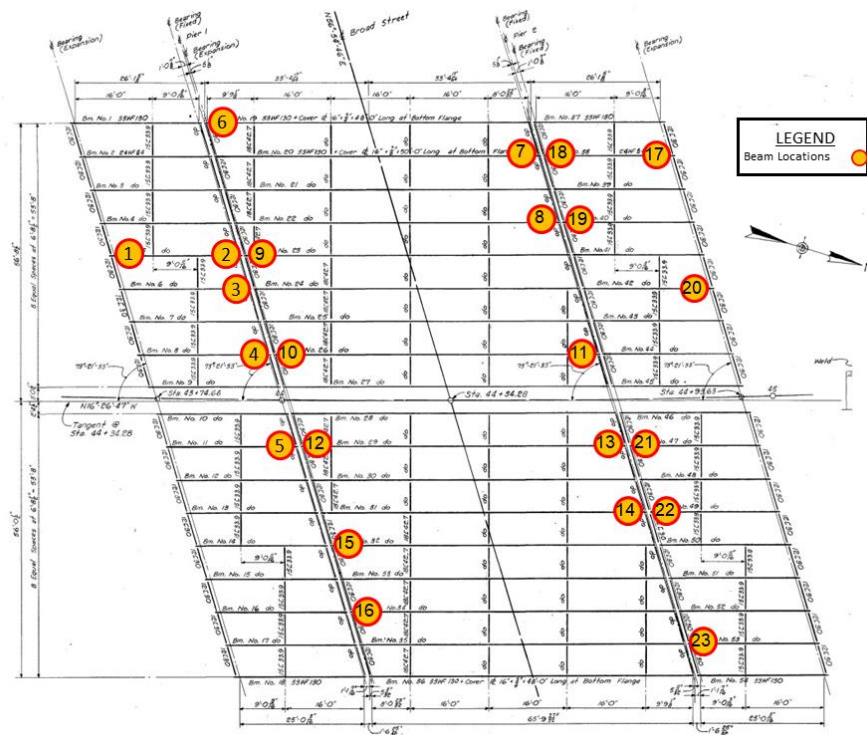
Figure 3.2. Example scanning plan for a highway bridge

To access the beam ends of interest on a structure, it is typical that they could be reached using a bucket truck/snooper, a ladder, and sometimes by foot. Any and all of these tools can be used, but it is important to plan (as done in current practice) for which areas of the bridge will need each tool, as the larger utilities, like the bucket truck or snooper, will require lane closures. Additionally, proper path planning will allow for one lane closure at a time where multiple beams can be scanned in sequence. Figure 3.2 below shows a bridge plan where all of the beams in the middle span of the bridge required a bucket truck to access. To optimize the scanning path, the research team scanned the beam ends on one side rather than scanning by beam. For example, using the sketch in Figure 3.2, the research team would choose to scan beam ends 6, 9, 10, 12, 15, and 16 in that order so the same lane on the left would remain closed and the MassDOT crew would not have to switch between lane closures. This kind of planning can maximize the beam ends scanned while minimizing time and cost.

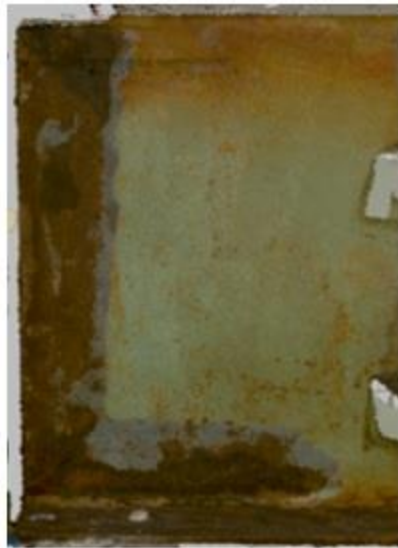
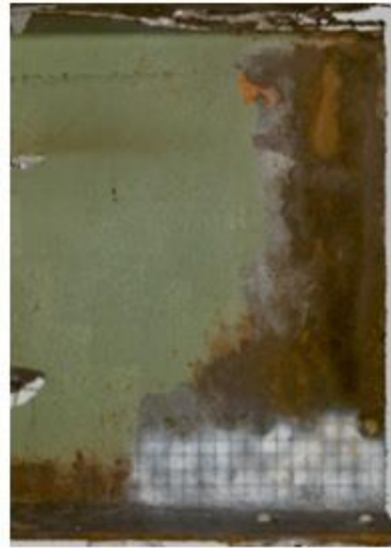
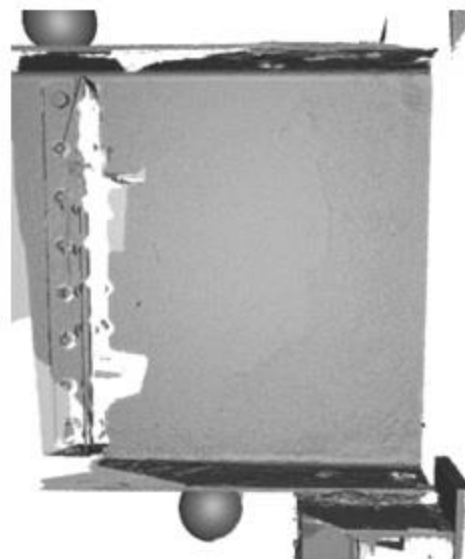
**Figure 4.3: Laboratory beam 2**

Laboratory Beam 2 came from the 3801 bridge in Jay, Maine. Per laboratory measurements and structural drawings, a B33×132 was assumed to be the shape of the structural member. The Artec Leo handheld scanner was used to document the beam end's corrosion. The area of most critical section loss can be observed at the very top of the web in this specimen, and moderate section loss was present at the base of the web.

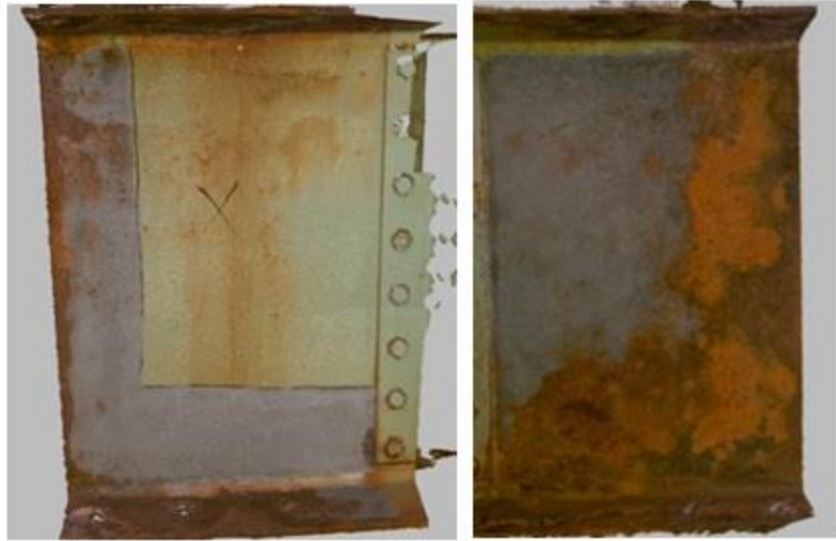
**Figure 4.5: Laboratory beam 3**

Laboratory Beam 3 came from the 3801 bridge in Jay, Maine. Per laboratory measurements and structural drawings, a B33×132 was assumed to be the shape of the structural member. The Artec LEO handheld scanner was used to document the beam end's corrosion (70). The area of most critical section loss can be observed at the base of the web in this specimen. A unique property of this specimen was the variation in severity of the corrosion observed on either side of the web; one side of the specimen exhibited little to no corrosion induced section loss while the other side houses most of the section loss.

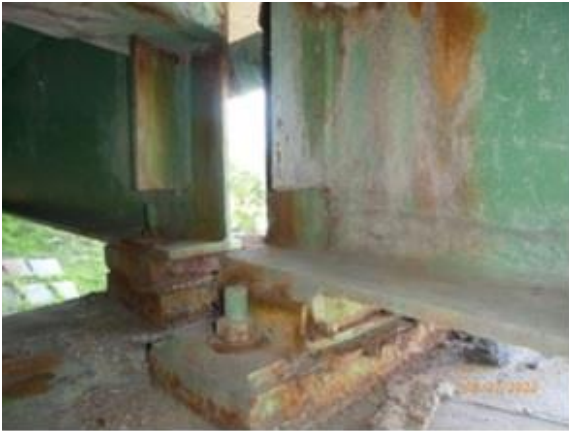
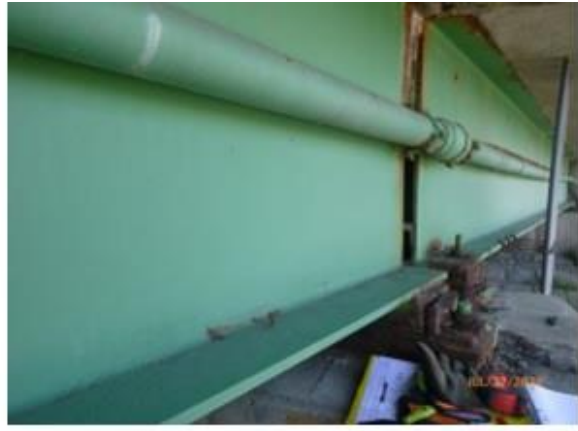
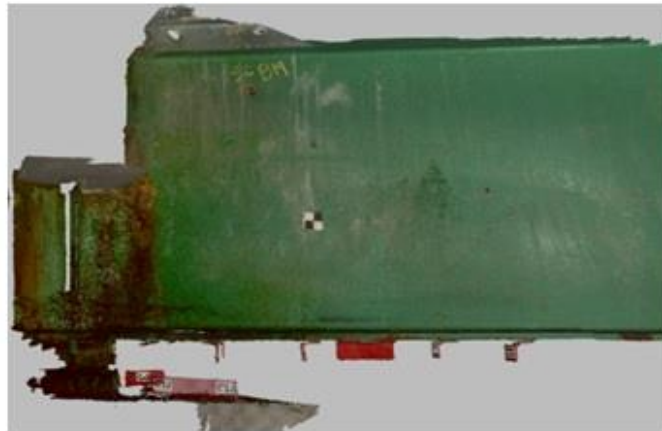
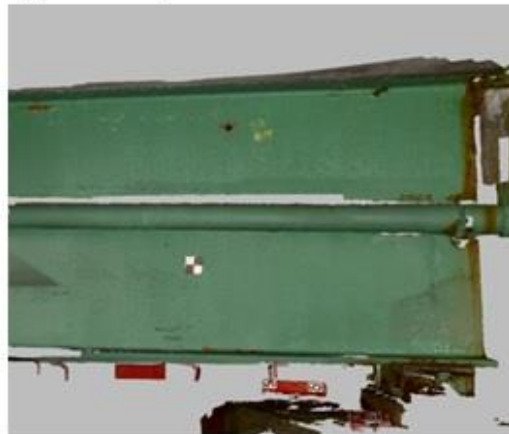
**Figure 4.11: Field Beam 1**

The photographs for Field Beam 1 in (a,b) were provided by MassDOT as part of a previous inspection. The individual scans for the sides of Field Beam 1 can be seen in (c,d). It is clear here how one side of the beam end exhibits more corrosion than the other. Additionally, the pipe or obstacles in general that impair the vision of the scanner prevent taking a reading on the web where the pipe is present.

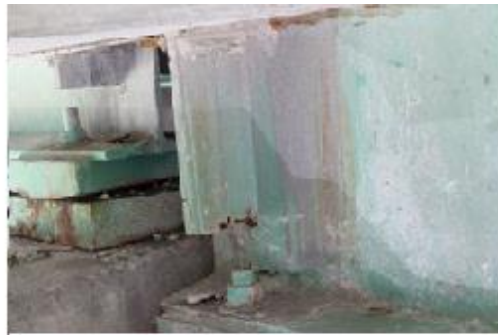
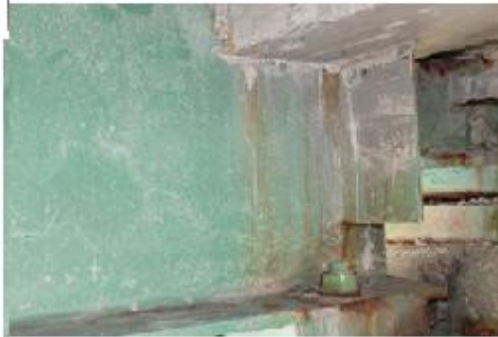
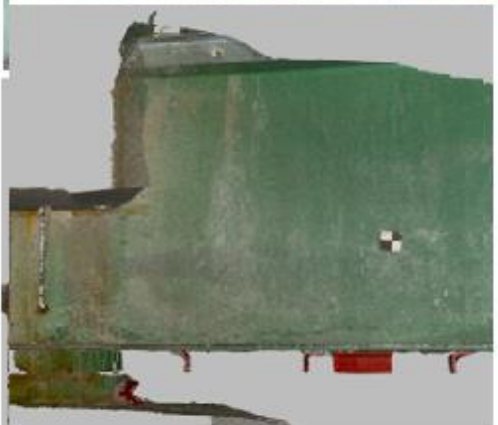
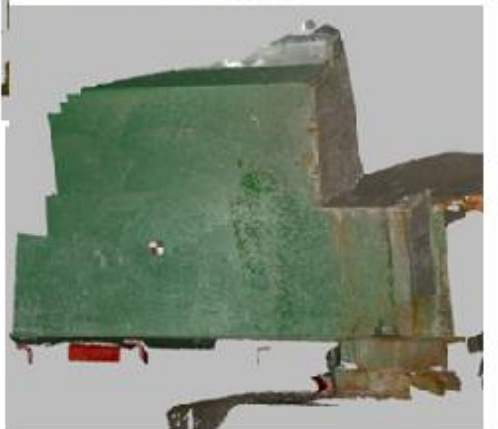
The photographs in (a,b) for Field Beam 2 were taken by the research team. The individual scans for the sides of Field Beam 2 can be seen in (c,d). Visually, there is limited “new” corrosion damage that can be seen in the scan due to a repaint. Although this is the case, the section loss damage is visualized in Figure 4.14.

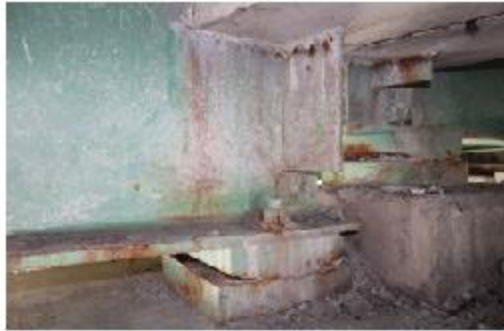
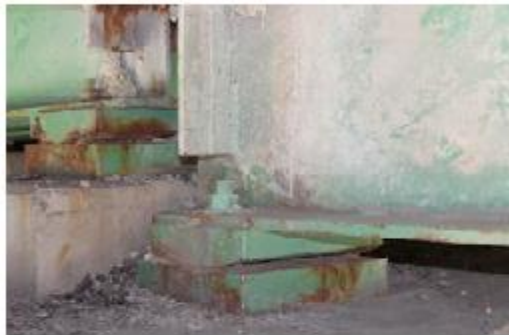
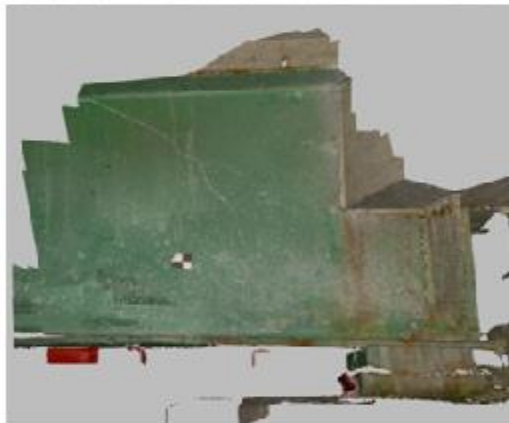
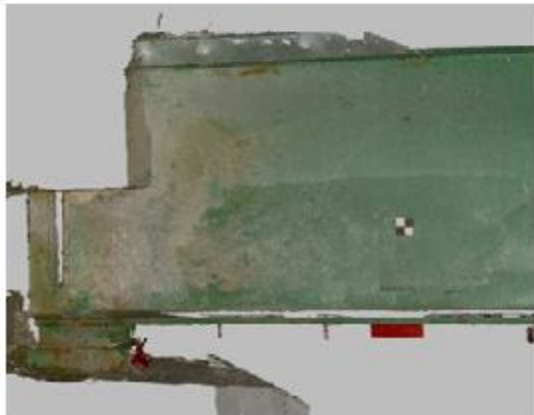
The photographs in (a) for Field Beam 3 were taken by the research team. The individual scans for the sides of Field Beam 2 can be seen in (b). There is limited “new” corrosion damage that can be seen in the scan due to a repaint. Additional debris can be seen on the web around the stiffeners and the concrete diaphragm present. The research team conducted these on-site scans “as is”; therefore, the beam was not cleaned, but the research team advises these areas be cleaned. Additionally, limited debris extended into the base of the web, which was the area of interest for the project. The resulting section loss damage is visualized in Figure 4.16.

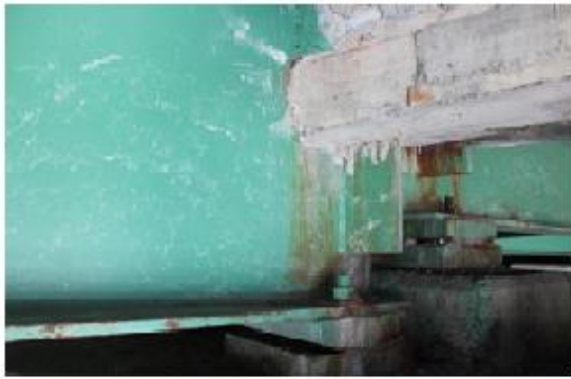
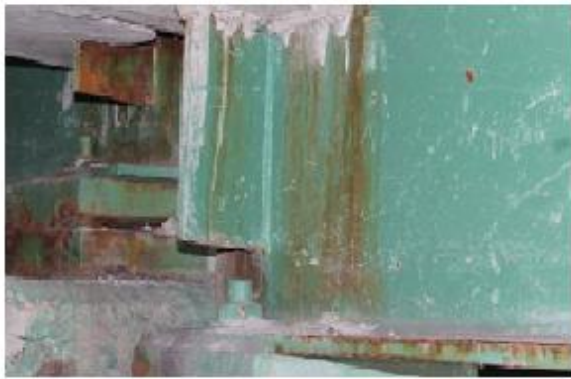
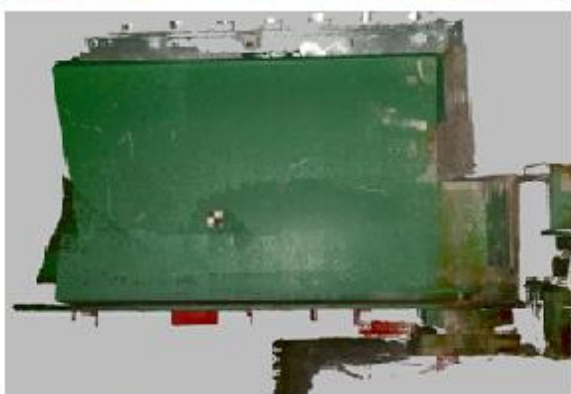
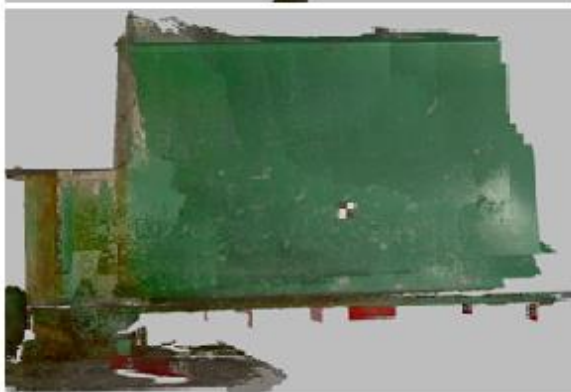
The photographs in (a,b) for Field Beam 4 were taken by the research team. The individual scans for the sides of Field Beam 2 can be seen in (c,d). There is limited “new” corrosion damage, similar to Field Beams 1 and 2, that can be seen in the scan due to a repaint. There is some rust staining and limited debris below the concrete diaphragm. The resulting section loss damage is visualized in Figure 4.18.

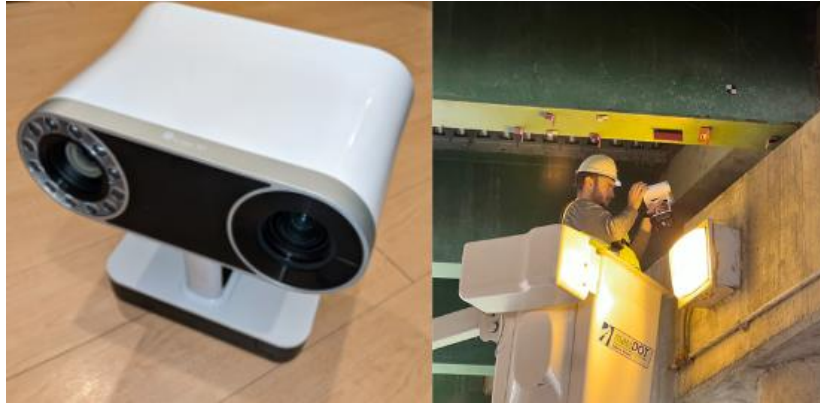
**Figure 5.1: LEO scanner**

The LEO has a long-lasting battery, making it easy to use for approximately 4 hours of scanning with few breaks and can last longer where scanning is not being performed constantly (70). It is worth noting that hours of battery life vary depending on how much scanning is being performed, if temperature control is being used for normalizing the system temperature (drains about 3 times faster), and if HD mode is being used for higher quality scans (70). The recommended operating temperature is between 59 and 95 degrees Fahrenheit and up to 80 percent humidity but can use the temperature control option for environments not in this range (49). The LEO is equipped with high memory storage (400 GB) for storing many projects from the same inspection (70). The LEO provides a touchscreen on board to display and check the scans performed (70). The full storage of the LEO will sustain an estimate of 80 or more beam ends in non-HD mode and approximately 40 in HD mode (70). These files can easily be transferred via micro-SD cards or Ethernet; in the field, it is possible to transfer files to micro-SD and clear the internal storage for more scans. It is recommended to avoid this and to transfer all the scans when done with the field work for the day if the internal storage proves sufficient for the work being done that day. The LEO’s small size and low weight of approximately 5.7 pounds allows for maneuverability and reaching the beam ends on foot if necessary or used in equipment like a bucket truck or snooper (see Figure 5.1) (70).

Left: the LEO scanner (70). Right: an inspector operating the LEO (70) and performing a beam end scan from a bucket truck on a highway bridge.

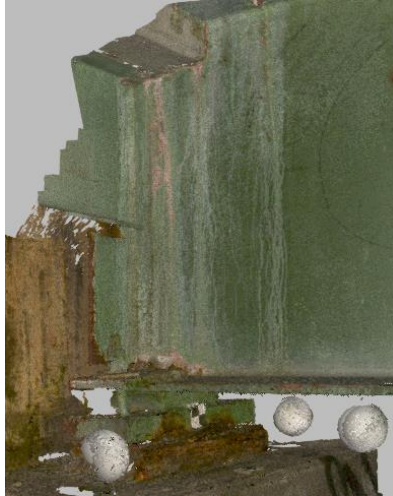
**Figure 5.3. Registration SEKO (73) spheres on a corroded beam specimen.**

Additional amenities required for scanning are registration tools or objects, which are objects that are shared by each scan to align the independent sides of a beam end (independent point clouds) into the same coordinate system. Setting up the registration objects is key for the best alignment and to accommodate the variability of scanning situations found due to obstacles and the layout of structures. The principle for placing registration points is to set the objects in all directions in a non-coplanar pattern (i.e., to place registration objects so there is variation in their location in the X, Y, and Z directions) and ideally on either side of the beam end of interest to ensure a better alignment. Proper alignment is critical as errors here can create gross inaccuracy. Registration objects that are the most successful are objects with matte surfaces, unique/diverse textures, and preferably lettering. An example of a registration layout for a corroded end can be found in Figure 5.3.
