MID-AMERICA TRANSPORTATION CENTER

Report # MATC-UNL: 004-24

MASH TL-6 Evaluation of a 62-in. Tall, Single-Slope, Concrete Median Barrier

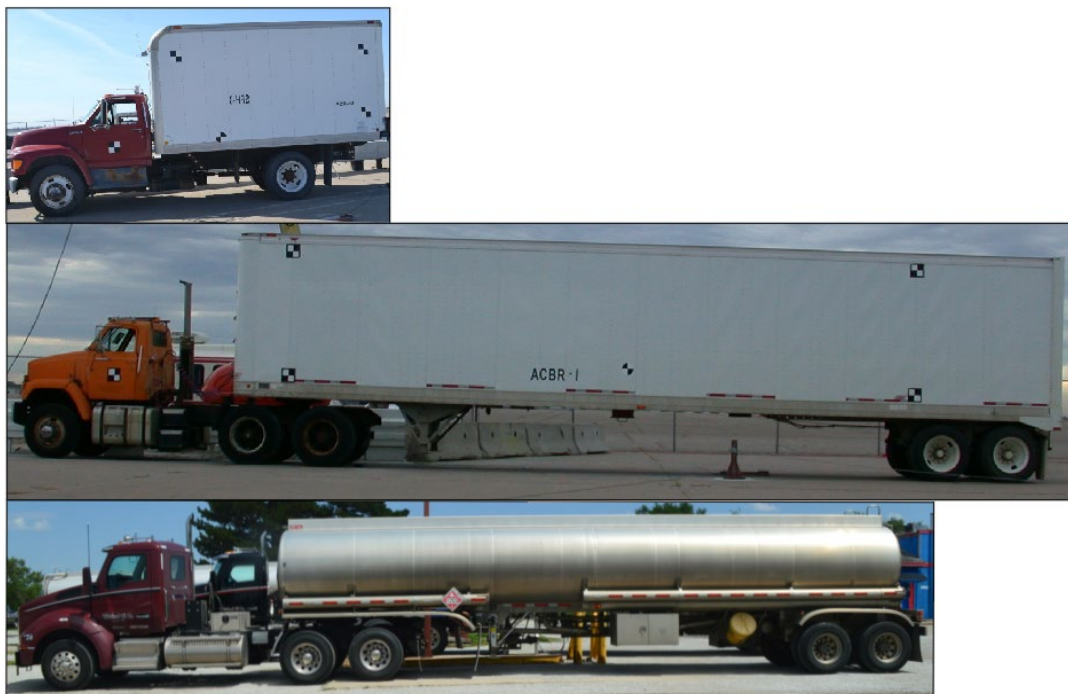
Figure 1.1 TL-4 (22,000-lb), TL-5 (79,300-lb), and TL-6 (79,300-lb) Vehicle Side View [3]

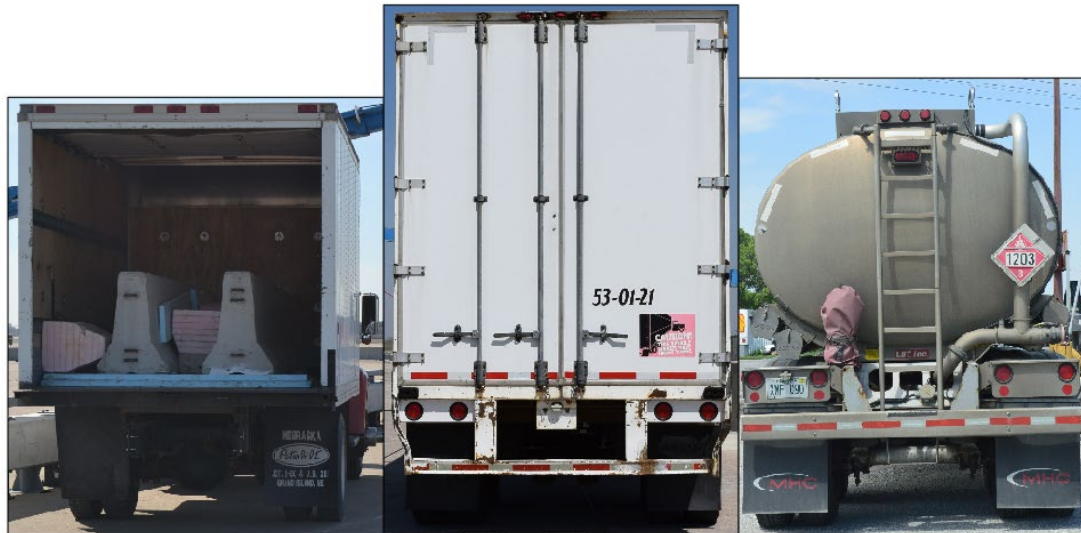
Figure 1.2 TL-4 (20,000-lb), TL-5 (80,000-lb), and TL-6 (80,000-lb) Vehicle Rearview [3]

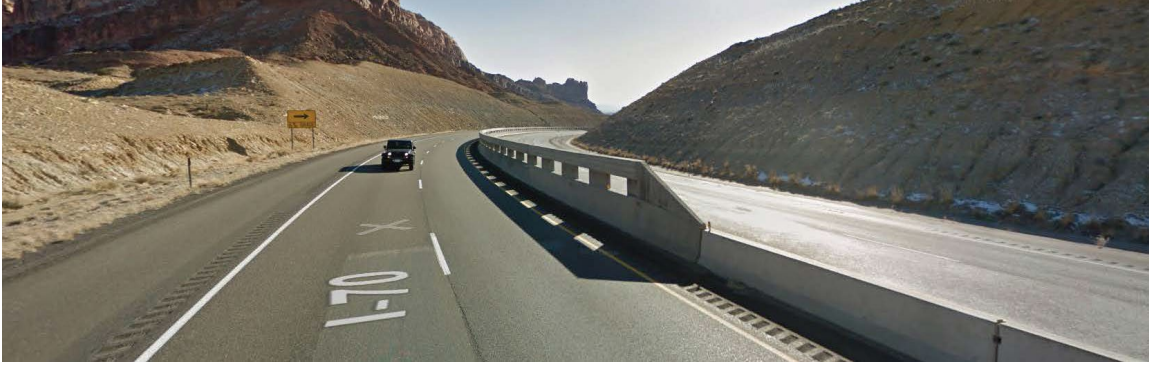
Figure 2.5 Utah DOT 84-in. Tall Roman Wall Installation [3]

The Utah DOT installed an 84-in. tall modification of the TTI Roman Wall in a narrow median on a large curve on Interstate 70, as shown in Figure 2.5. The Utah DOT has also utilized an 84-in. tall solid concrete wall, which was installed on the roadside to shield a railroad line adjacent to a curved highway, as shown in Figure 2.6.

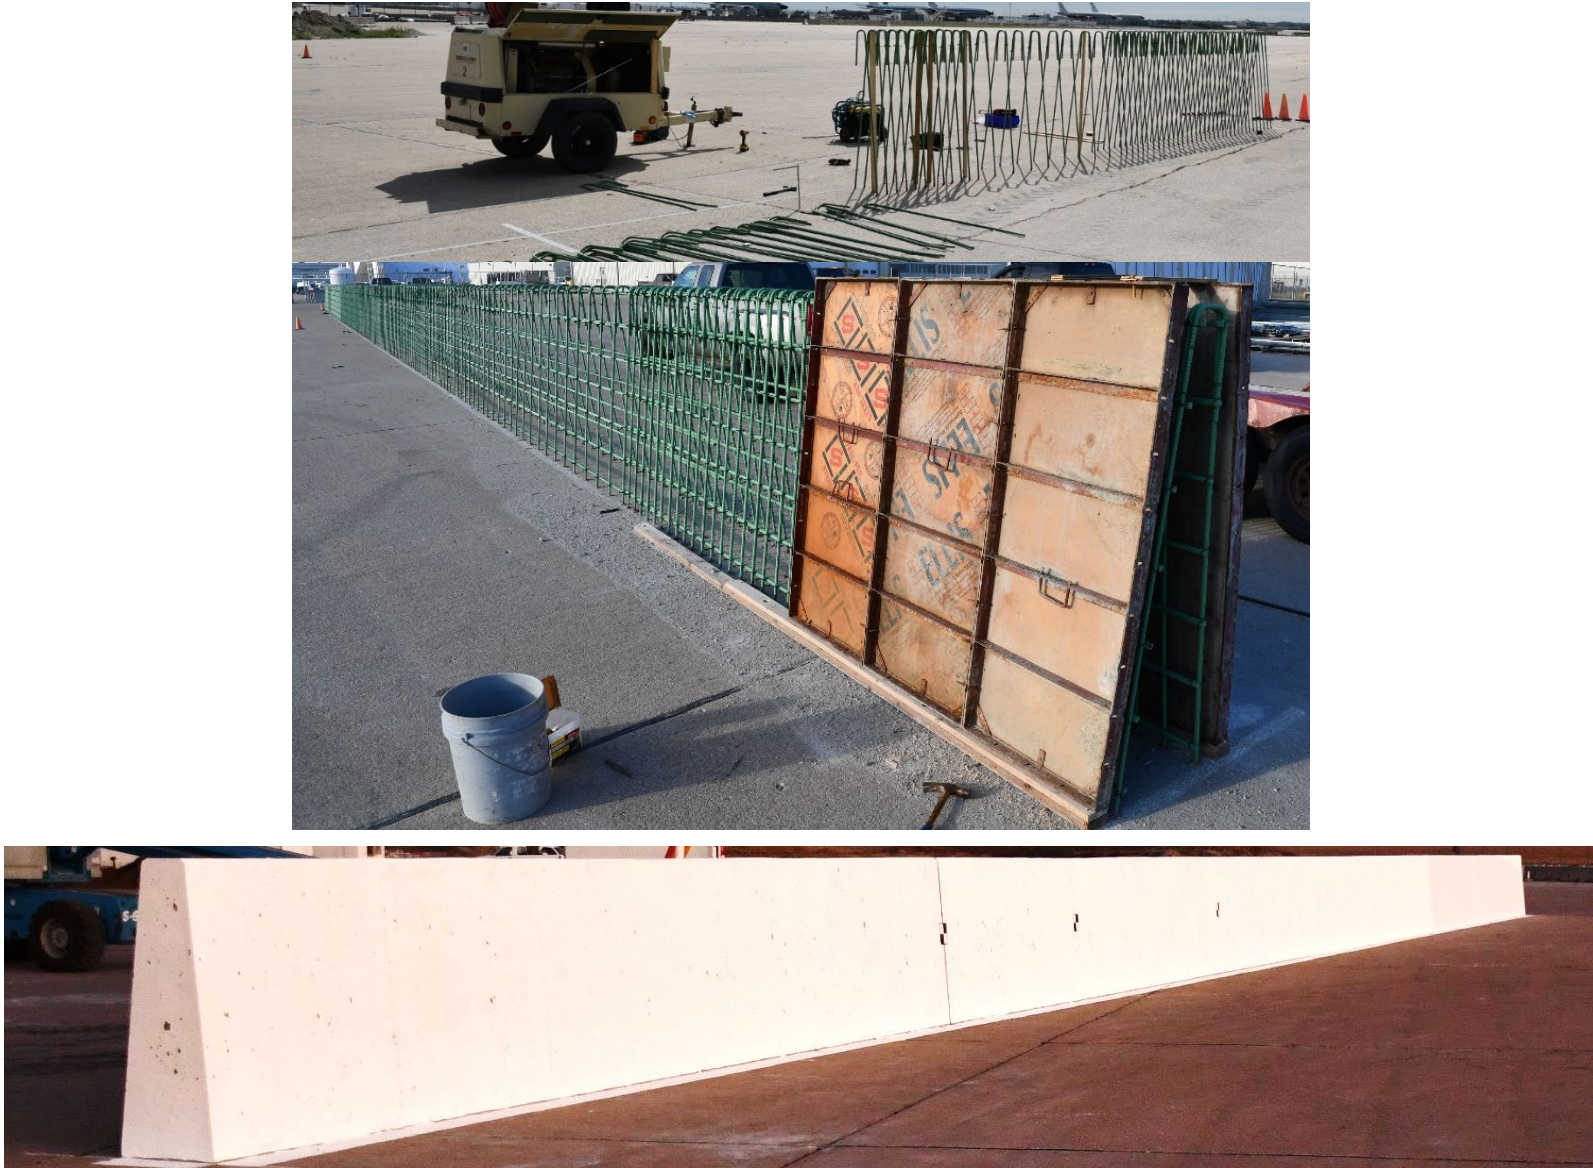
Figure 3.13 Test Article Construction, Test No. MTL6-1

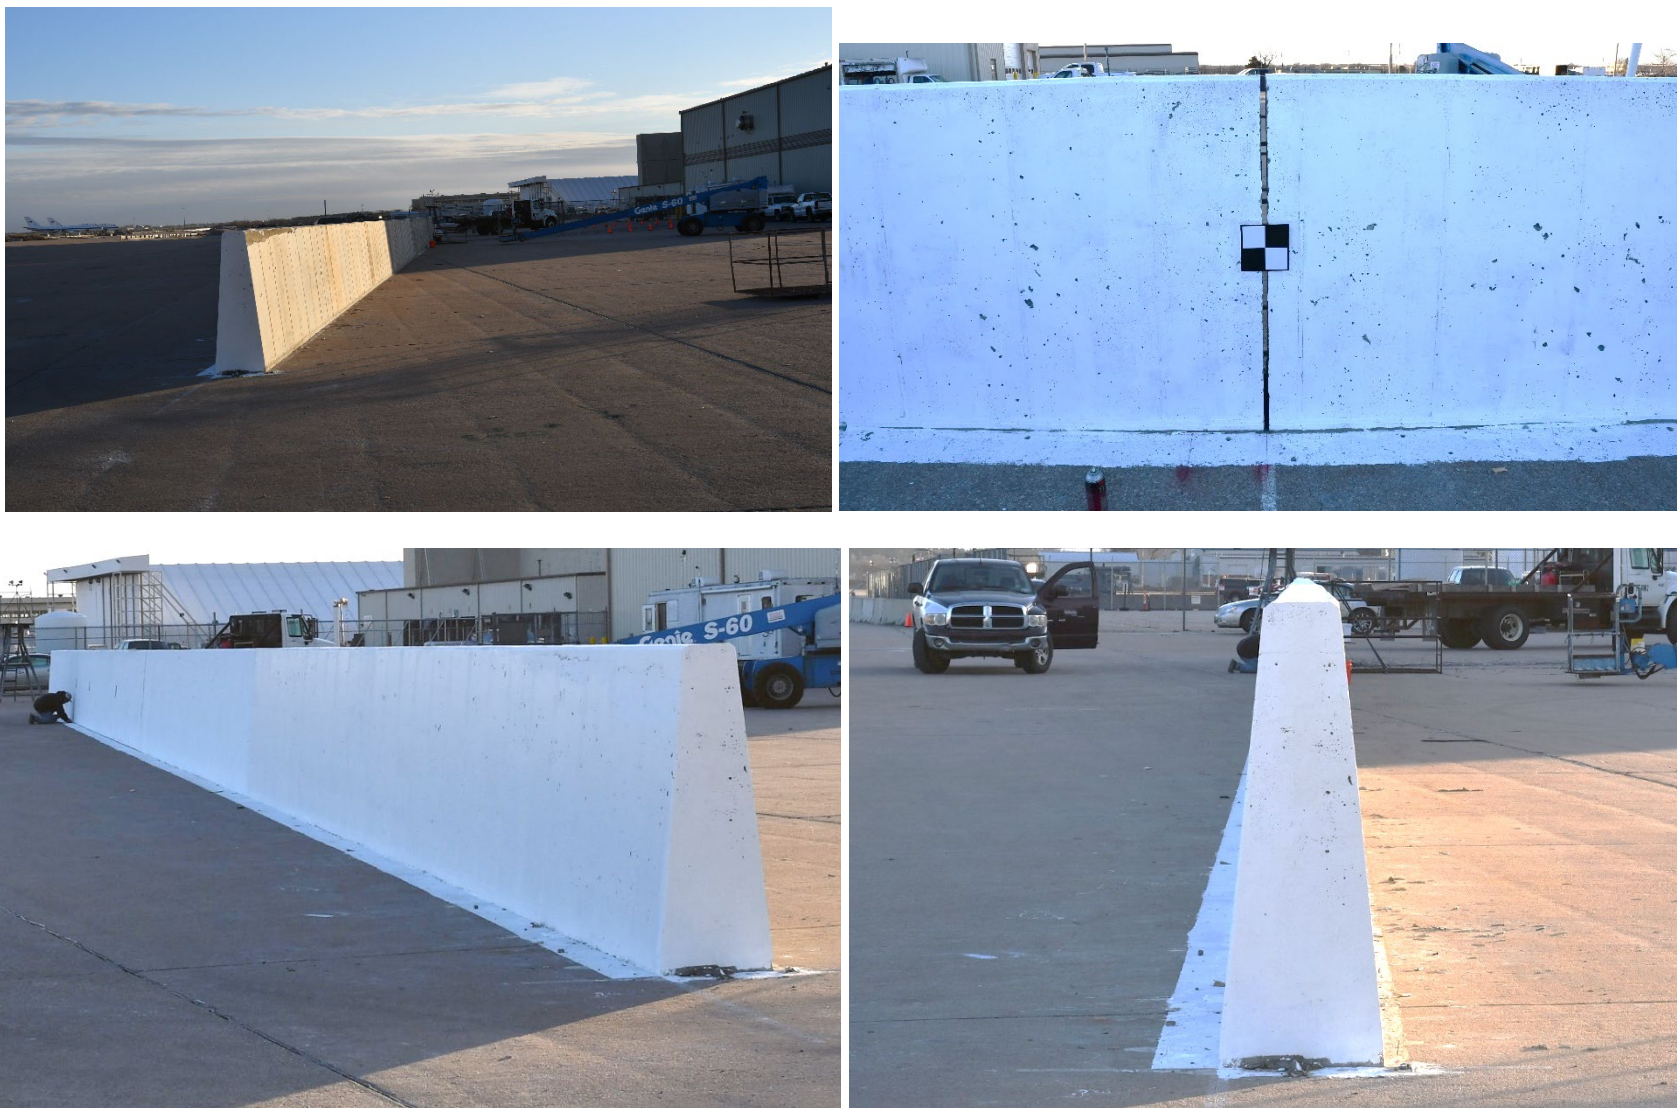
Figure 3.14 MwRSF Optimized TL-6 Single-Slope Barrier Installation, Test No. MTL6-1

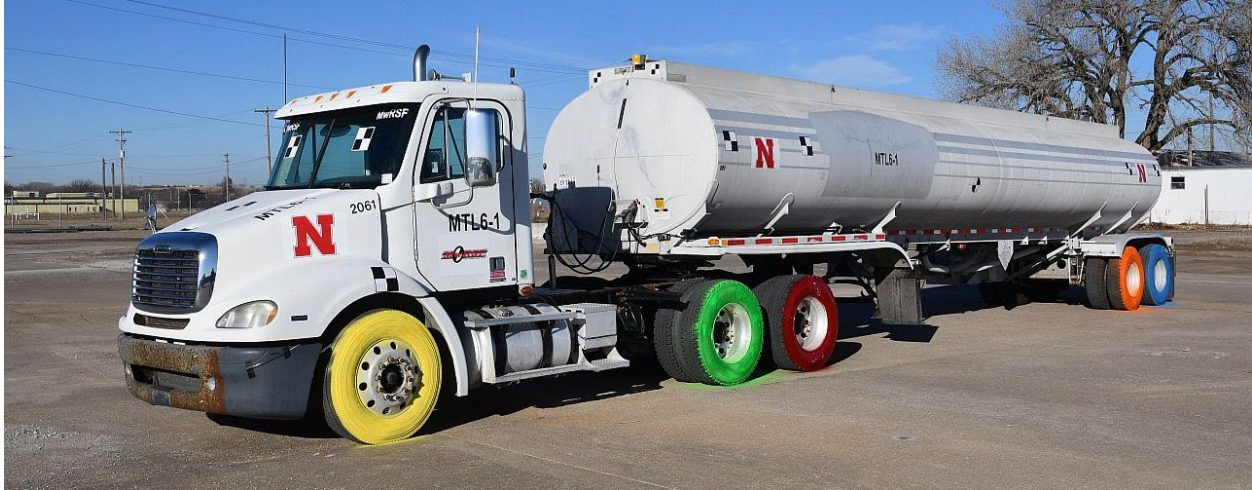
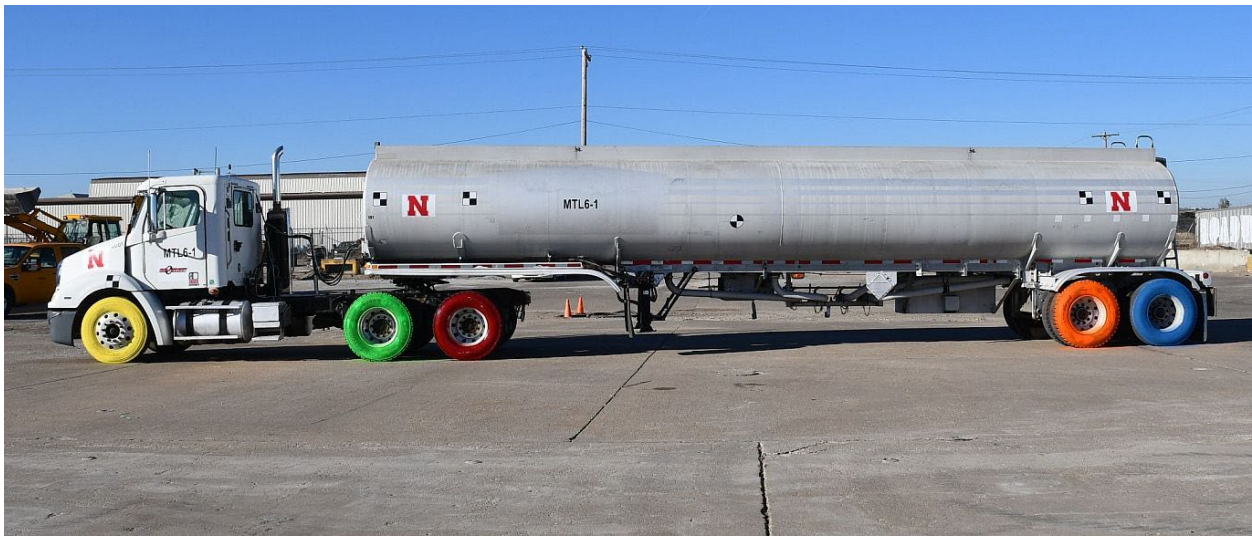
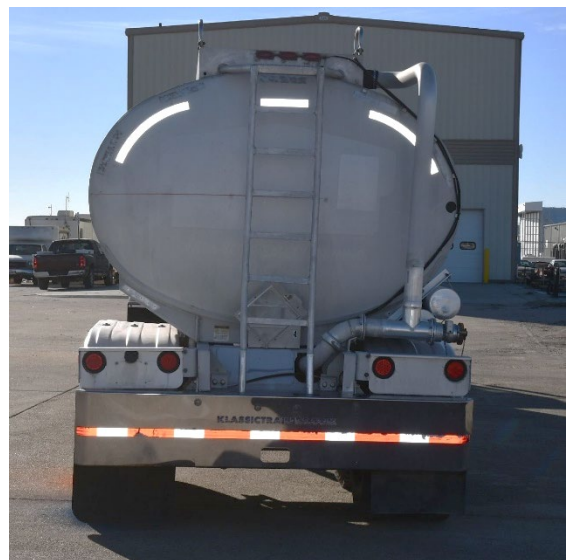
Figure 5.3 Test Vehicle, Test No. MTL6-1

The test vehicle consisted of two separate entities: the truck and trailer, which were connected with a pinned bracket connection known as the “fifth wheel.” The truck was less than 12 years old as specified by MASH requirements for heavy trucks. The trailer consisted of a 1996 Fruehauf (LBT) BKZ 4466 trailer. Note that although MASH provides a recommended 12-year maximum age of the test vehicle, no guidance was provided for recommended age of the trailer. Thus, the research team selected a trailer which was consistent with the dimensions shown in MASH, with construction similar to in-production models of trailers, and which was similar to the model used in computer simulations. The trailer had a payload capacity of 9,500 gallons distributed in four tanks. The four tanks had capacities of 4,000 gal, 1,200 gal, 1,500 gal, and 2,800 gal from front to back, respectively. The rear tandem to the fifth wheel connection was 34 ft – 9 in. long, and 32 ft – 11½ in. measured from the center of the rear tandem axle to the estimated center of the truck tandem rear axle. The overall trailer length was 42 ft – 6 in. The trailer tank jacket, bulkheads, baffles, and pipe connections were constructed from aluminum alloy structural materials consistent with modern liquid petroleum transport tank specifications.

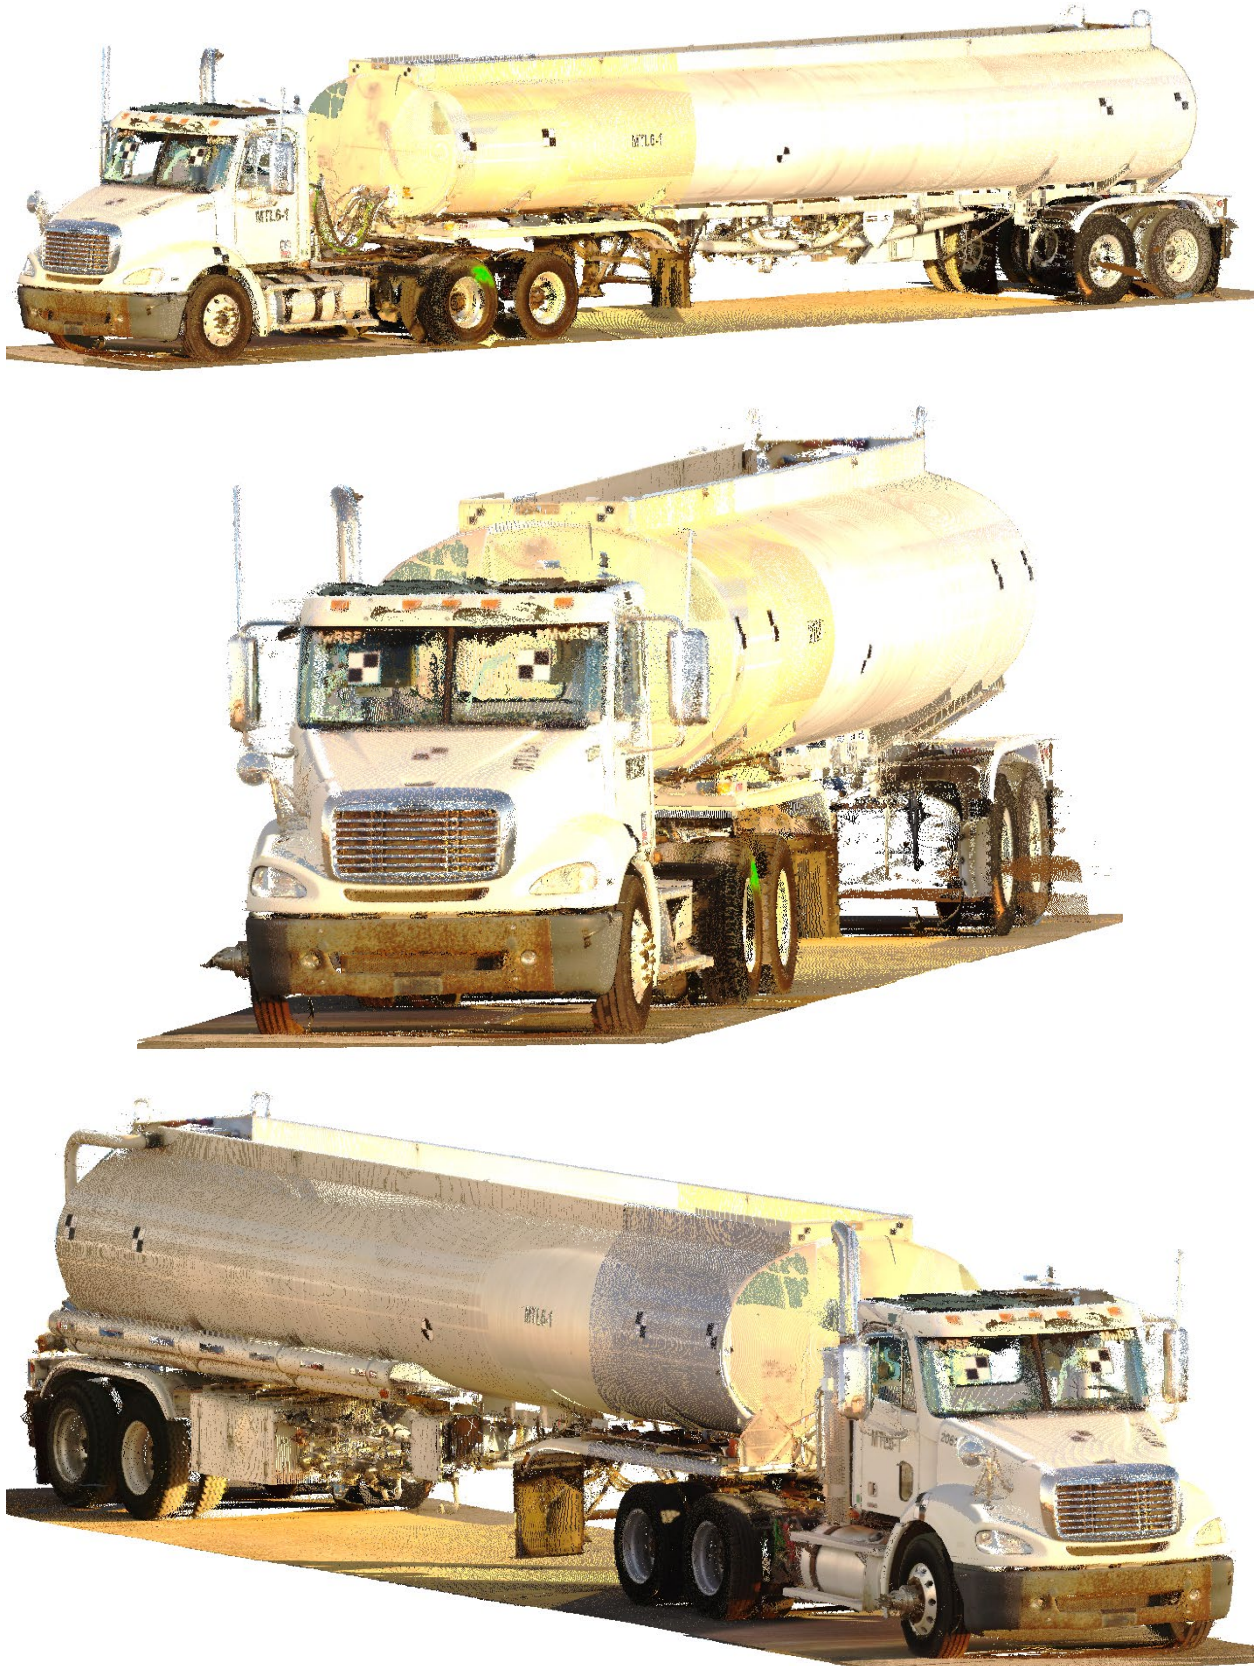
Figure 5.12 Images of 3D Point Clouds of Test Vehicle, Test No. MTL6-1

Prior to the test, the test vehicle consisting of the tractor, tank trailer, and fifth wheel assembly were mapped to a colorized point cloud using a FARO Focus X130 with an accuracy of 0.1 in. and a resolution of ± 0.02 in. Scans were collected for pre-test and post-test geometry and the final resting position of the vehicle relative to the point of impact. The pre-test scan of the test vehicle is shown in Figure 5.12.

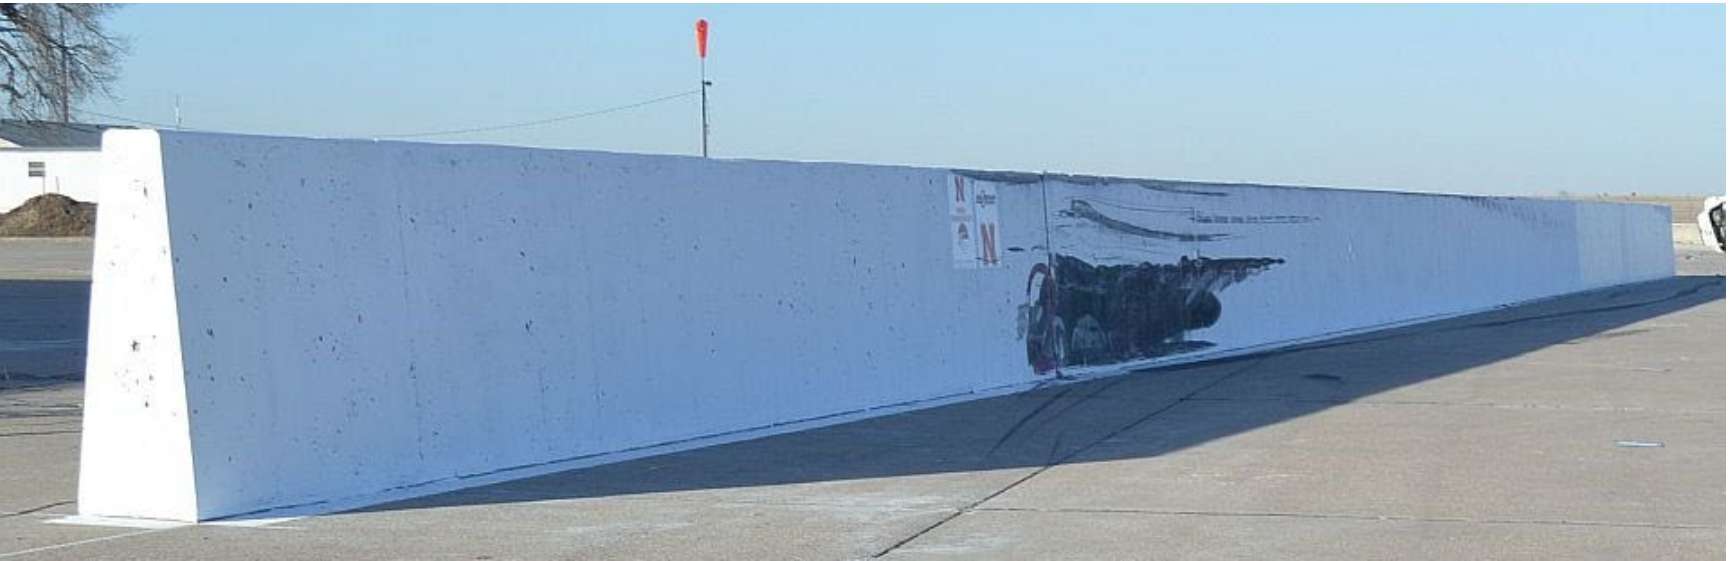
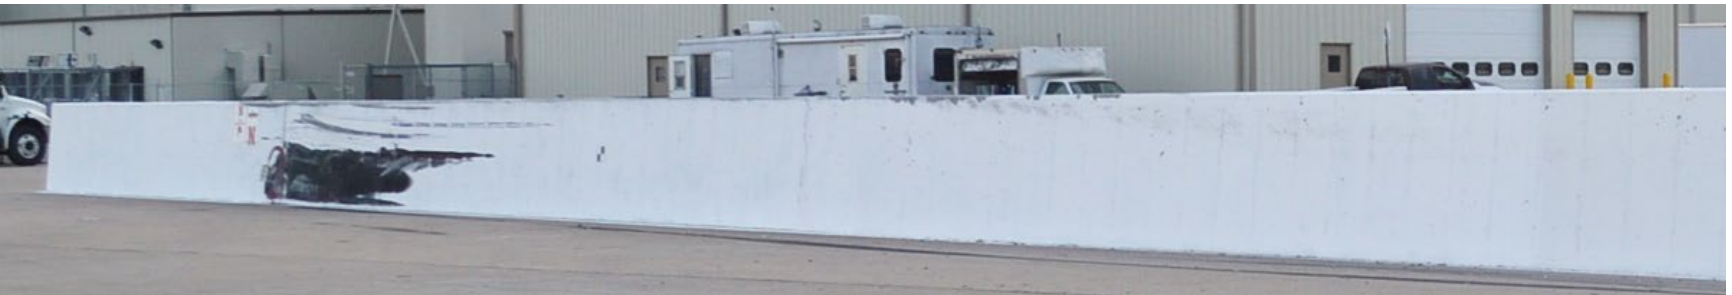
Figure 6.11 System Damage, Test No. MTL6-1

Additional gouging and chipping were observed on the front face of the barrier, in the 3 ft to either side of the expansion joint. At the expansion joint location, the top-front corners of the barrier segments were broken off to a depth of approximately ½ in. as was 13 in. of the upstream front edge, beginning 5 in. above the tarmac. No reinforcing bars were exposed by this damage.

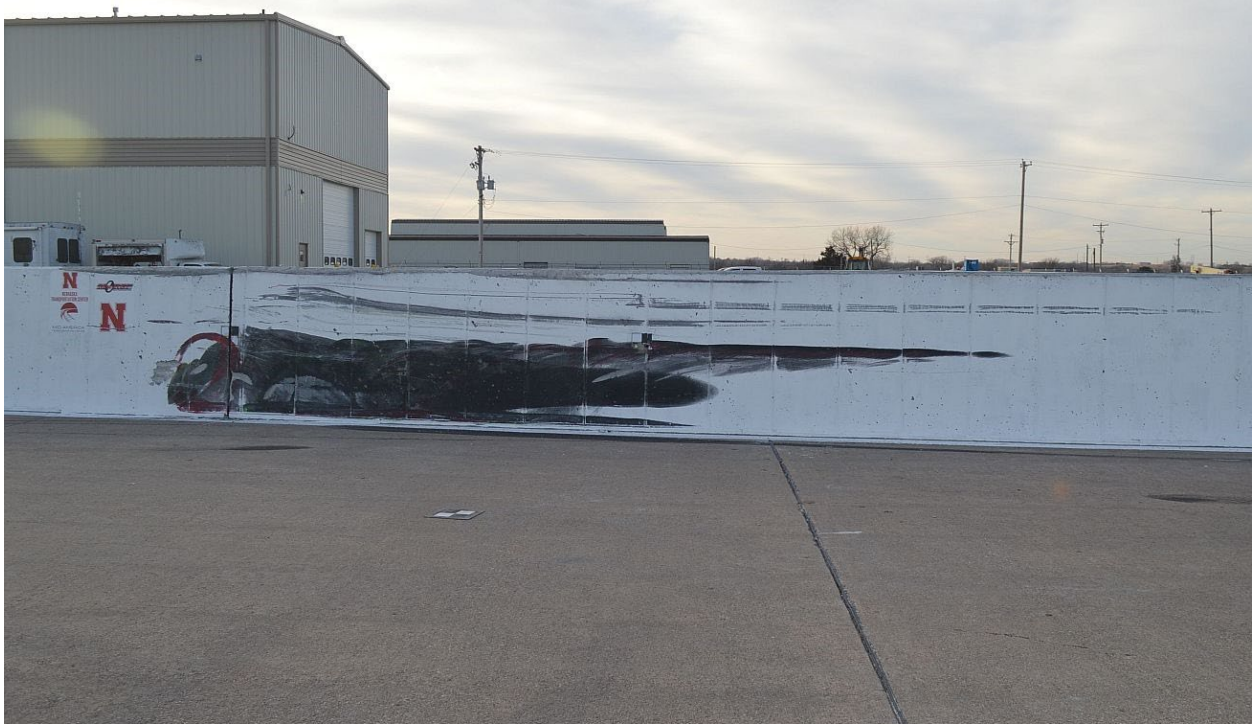
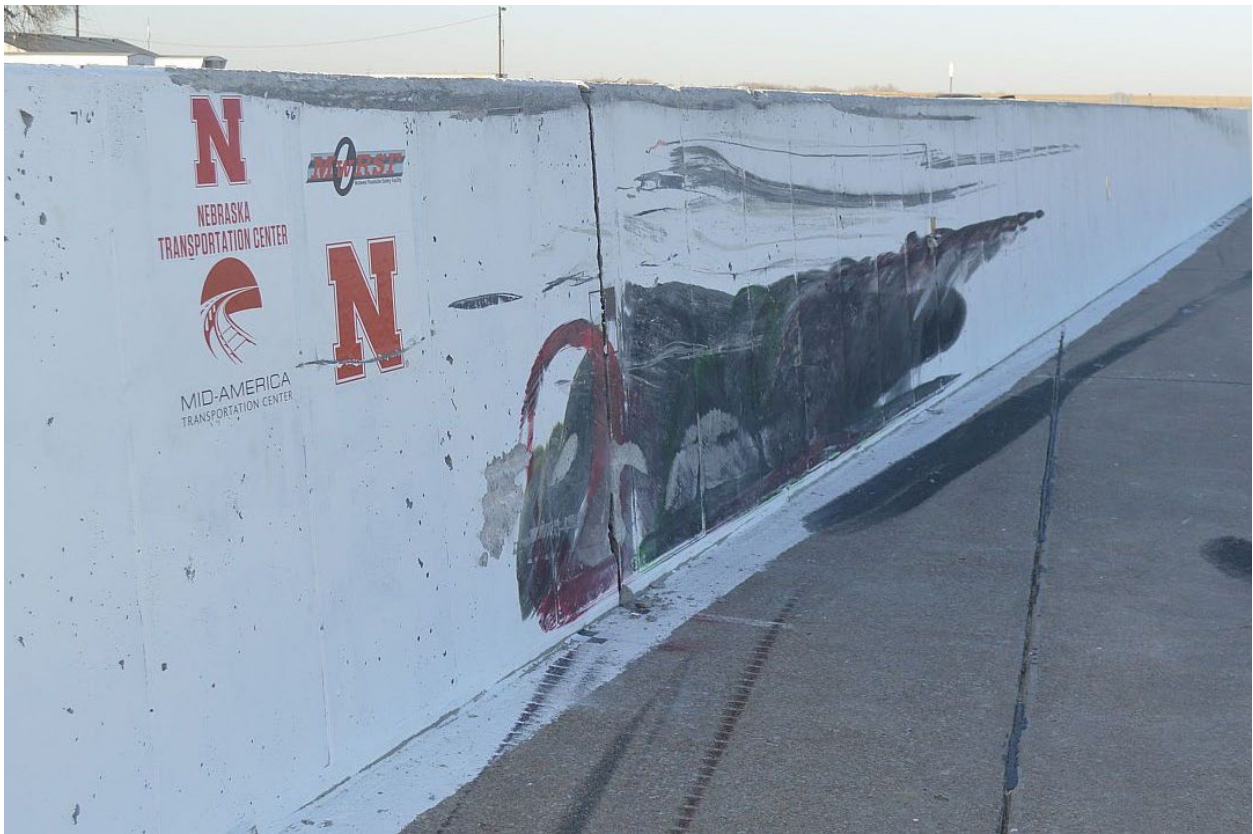
Figure 6.12 System Damage, Test No. MTL6-1

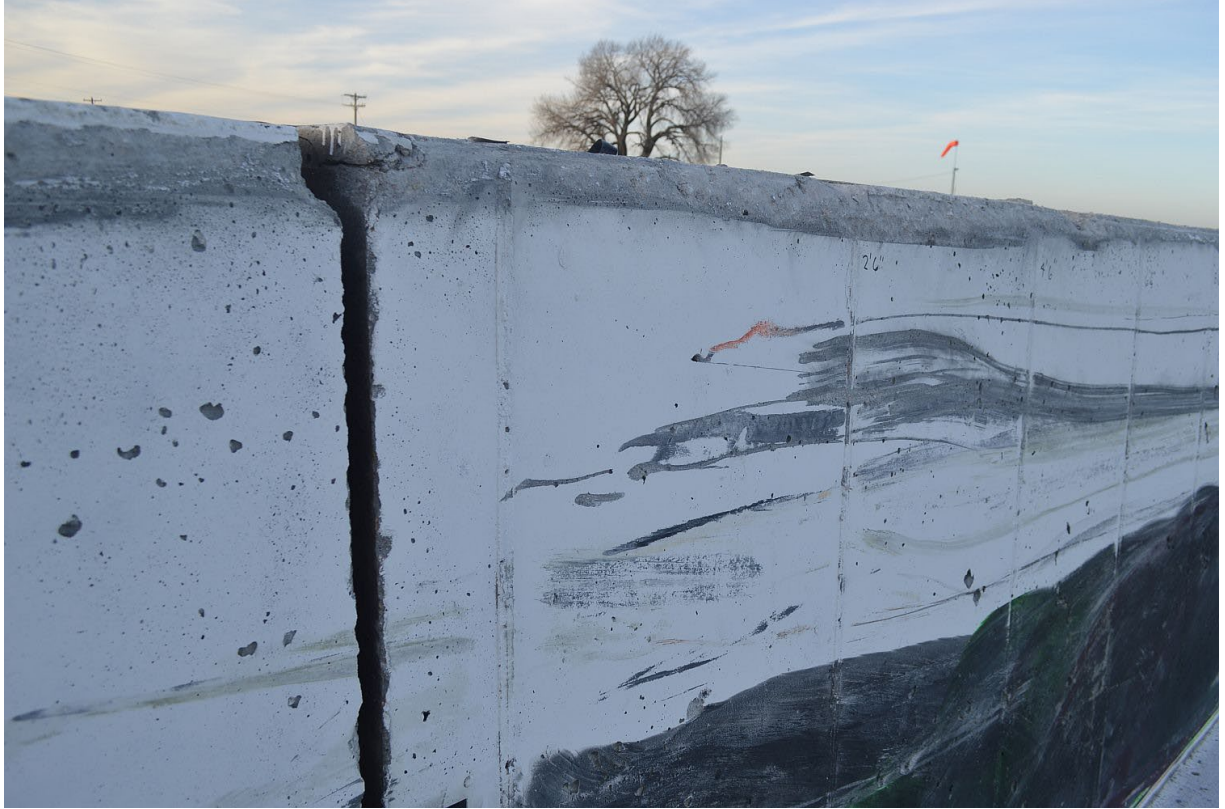
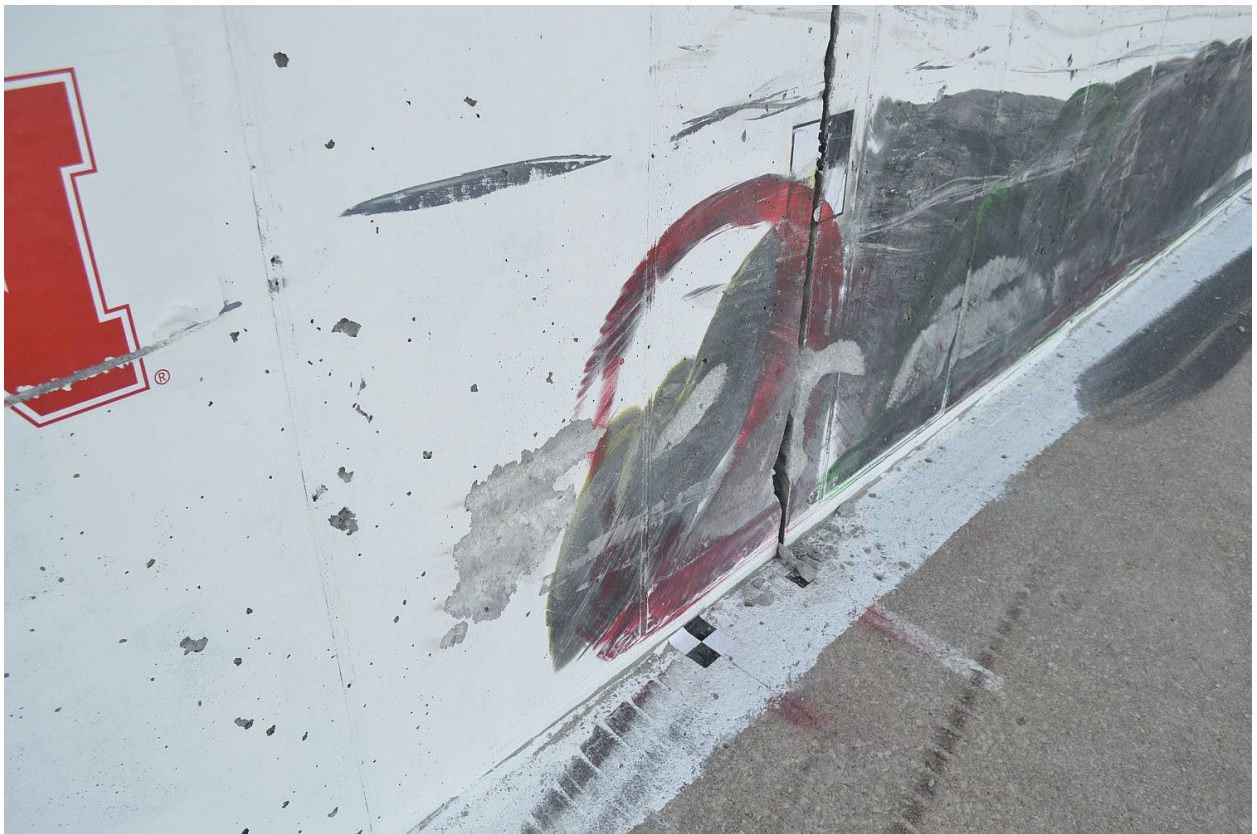
Figure 6.13 System Damage Near Expansion Joint, Test No. MTL6-1

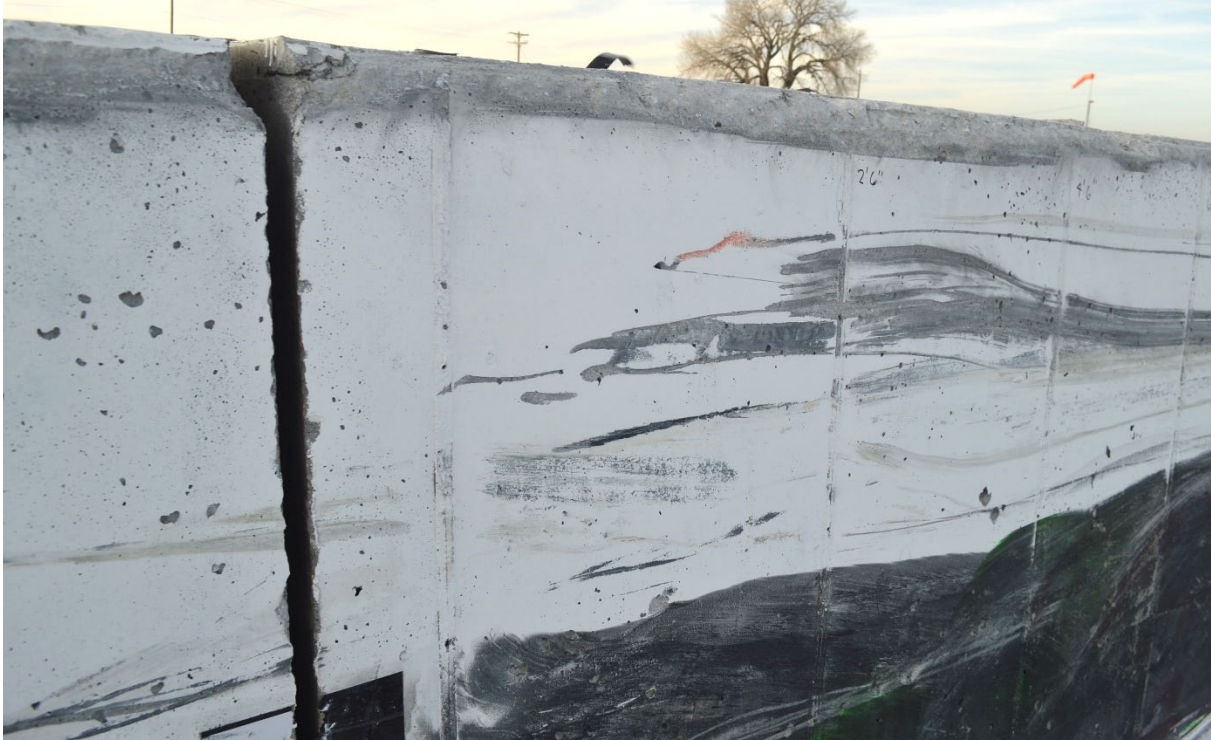
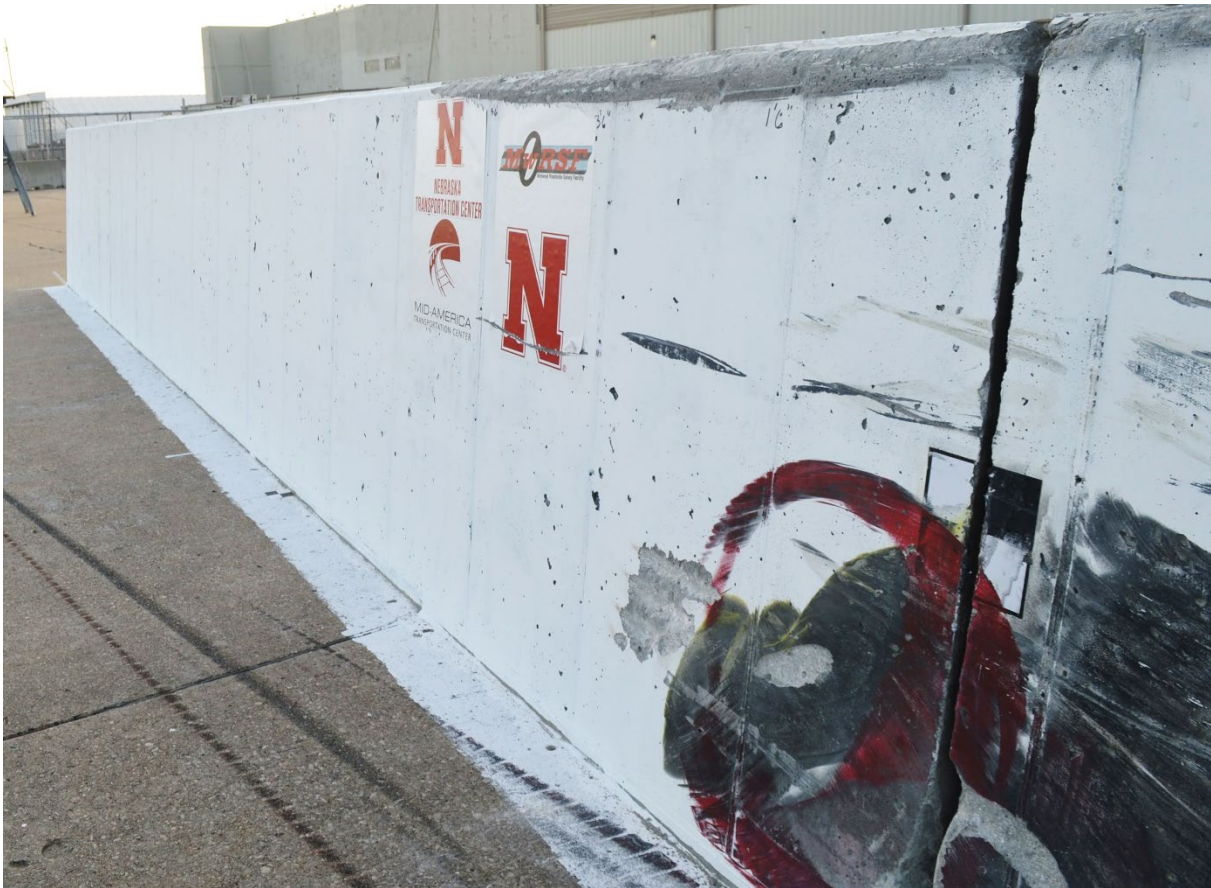
Figure 6.14 System Damage Near Expansion Joint, Test No. MTL6-1

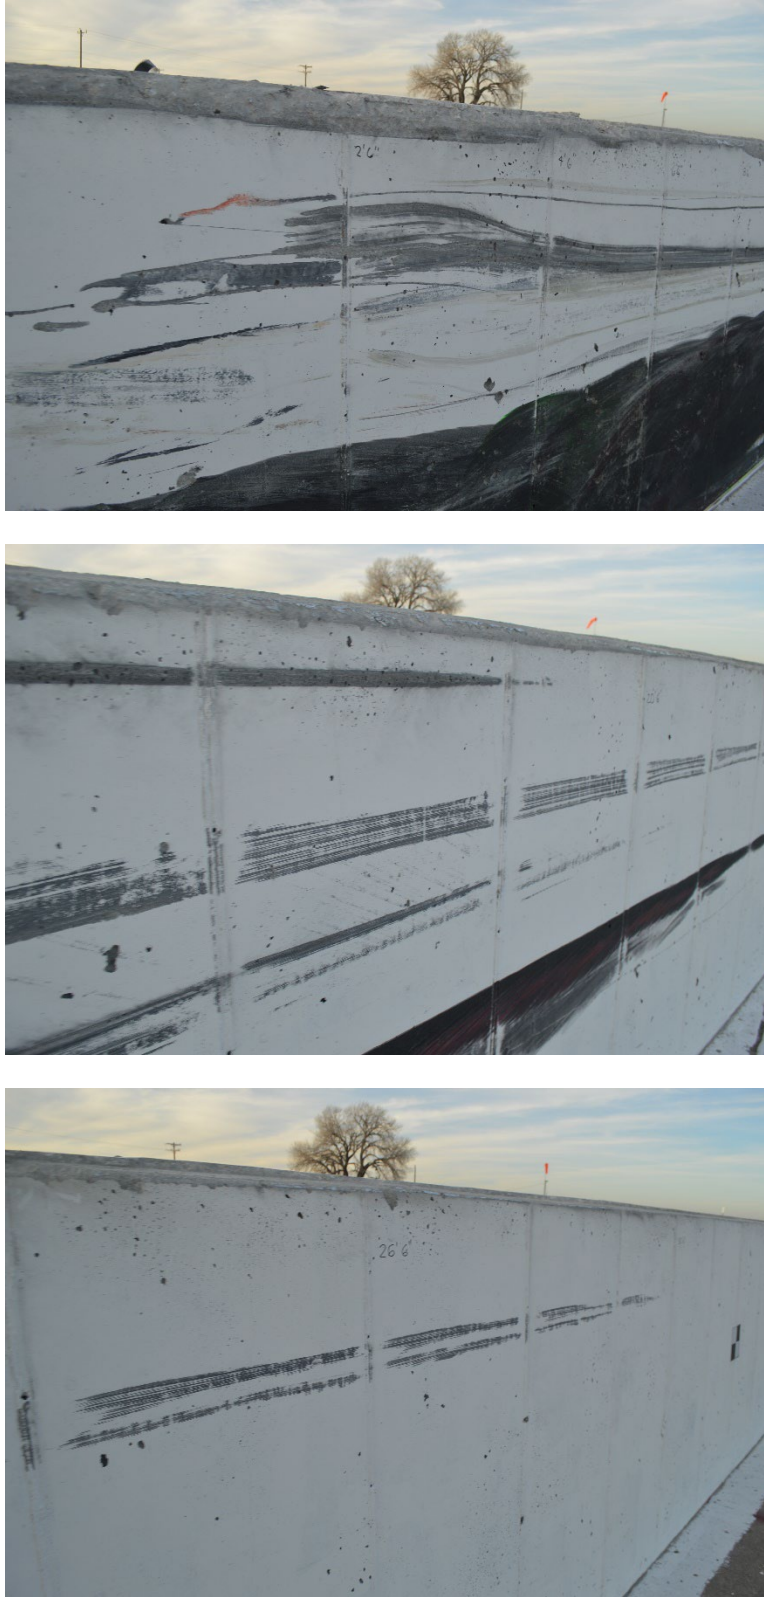
Figure 6.15 Scraping Damage along Top Impact-Side Edge of Barrier, Test No. MTL6-1

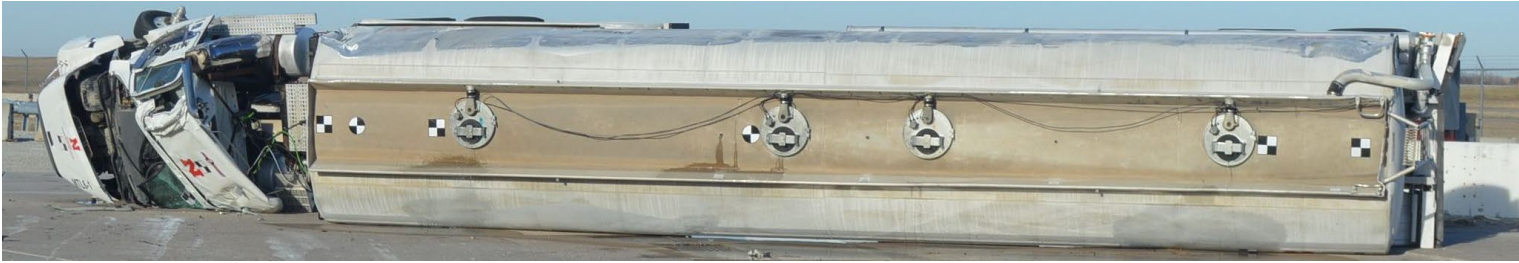
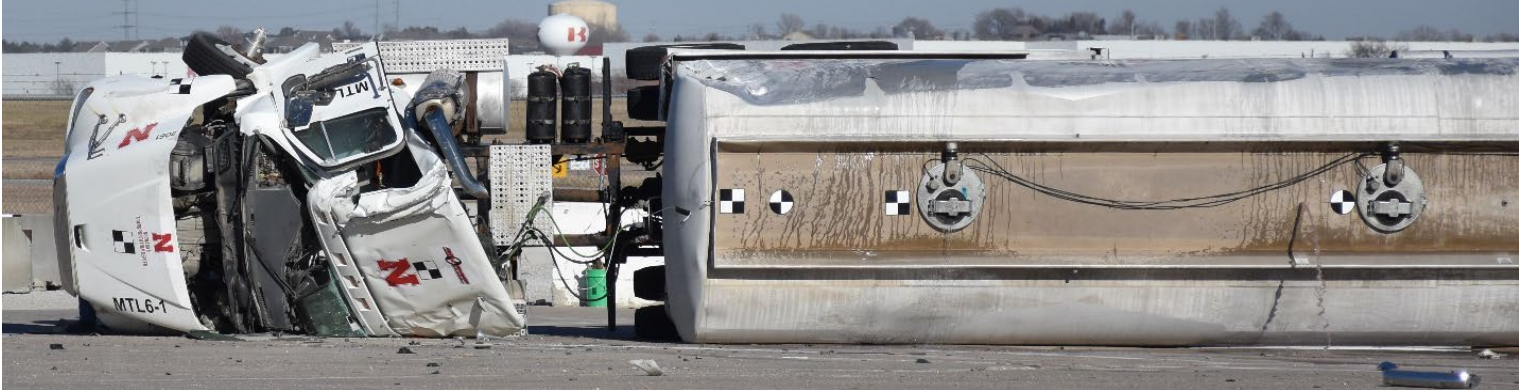
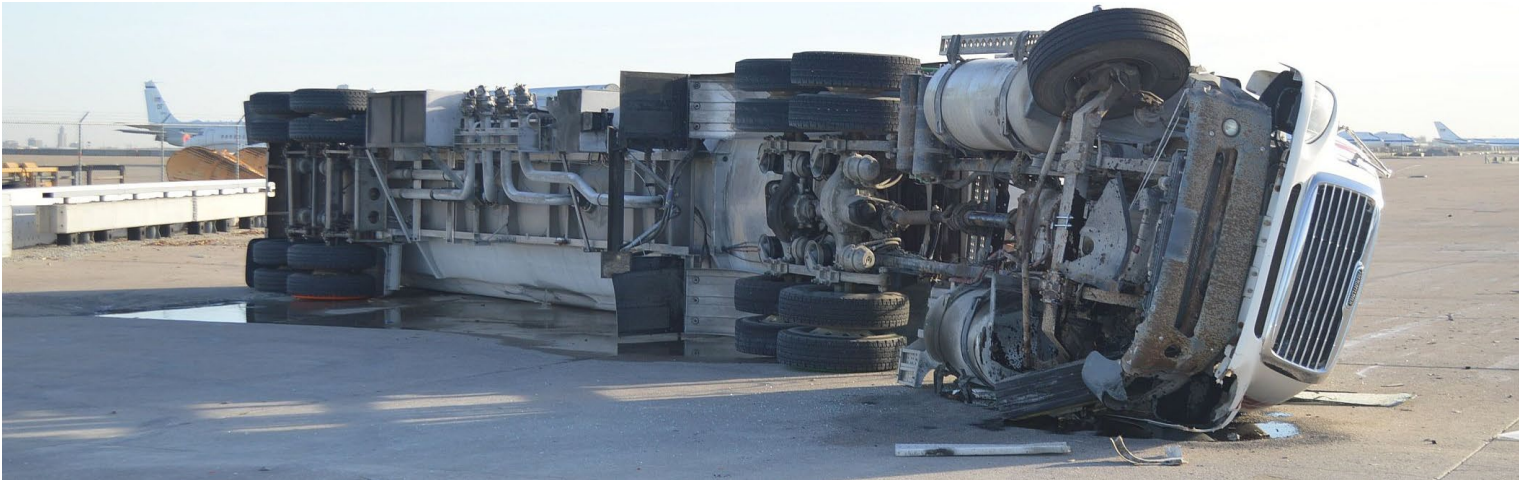
Figure 6.17 Vehicle Damage and Final Rest, Test No. MTL6-1

long. The top of the trailer was scraped, and the longitudinal safety rails were slightly deformed. One tear was observed in the undercarriage of the tank. The suspension, wheels, frame, and undercarriage of the trailer were not damaged.

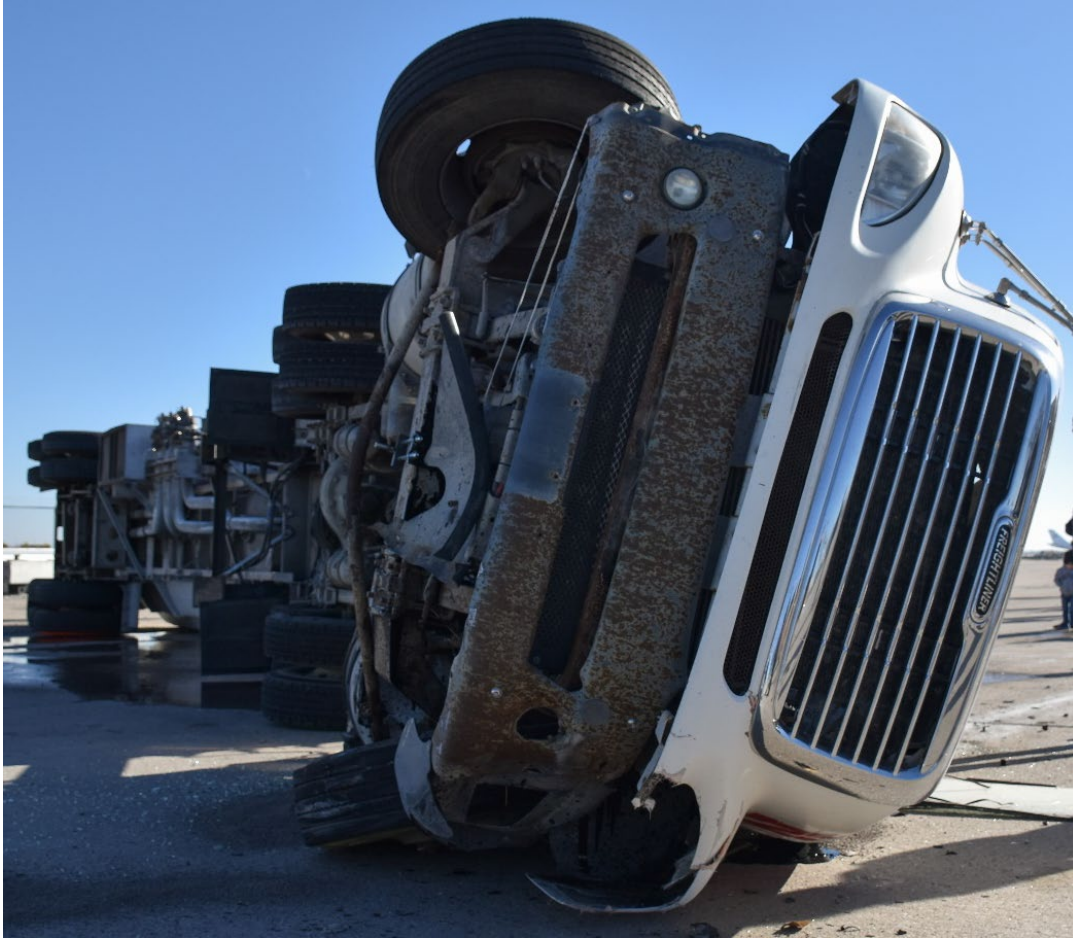
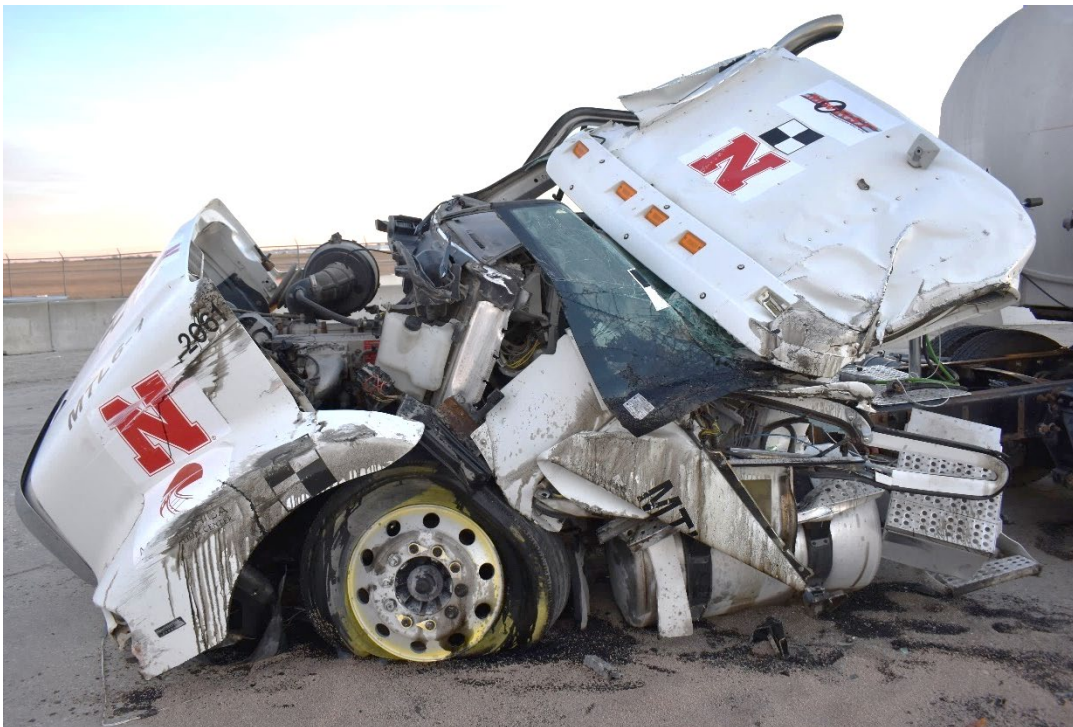
Figure 6.19 Tractor Damage, Test No. MTL6-1
99
