MID-AMERICA TRANSPORTATION CENTER

Report # MATC-UNL: 004-24

MASH TL-6 Evaluation of a 62-in. Tall, Single-Slope, Concrete Median Barrier

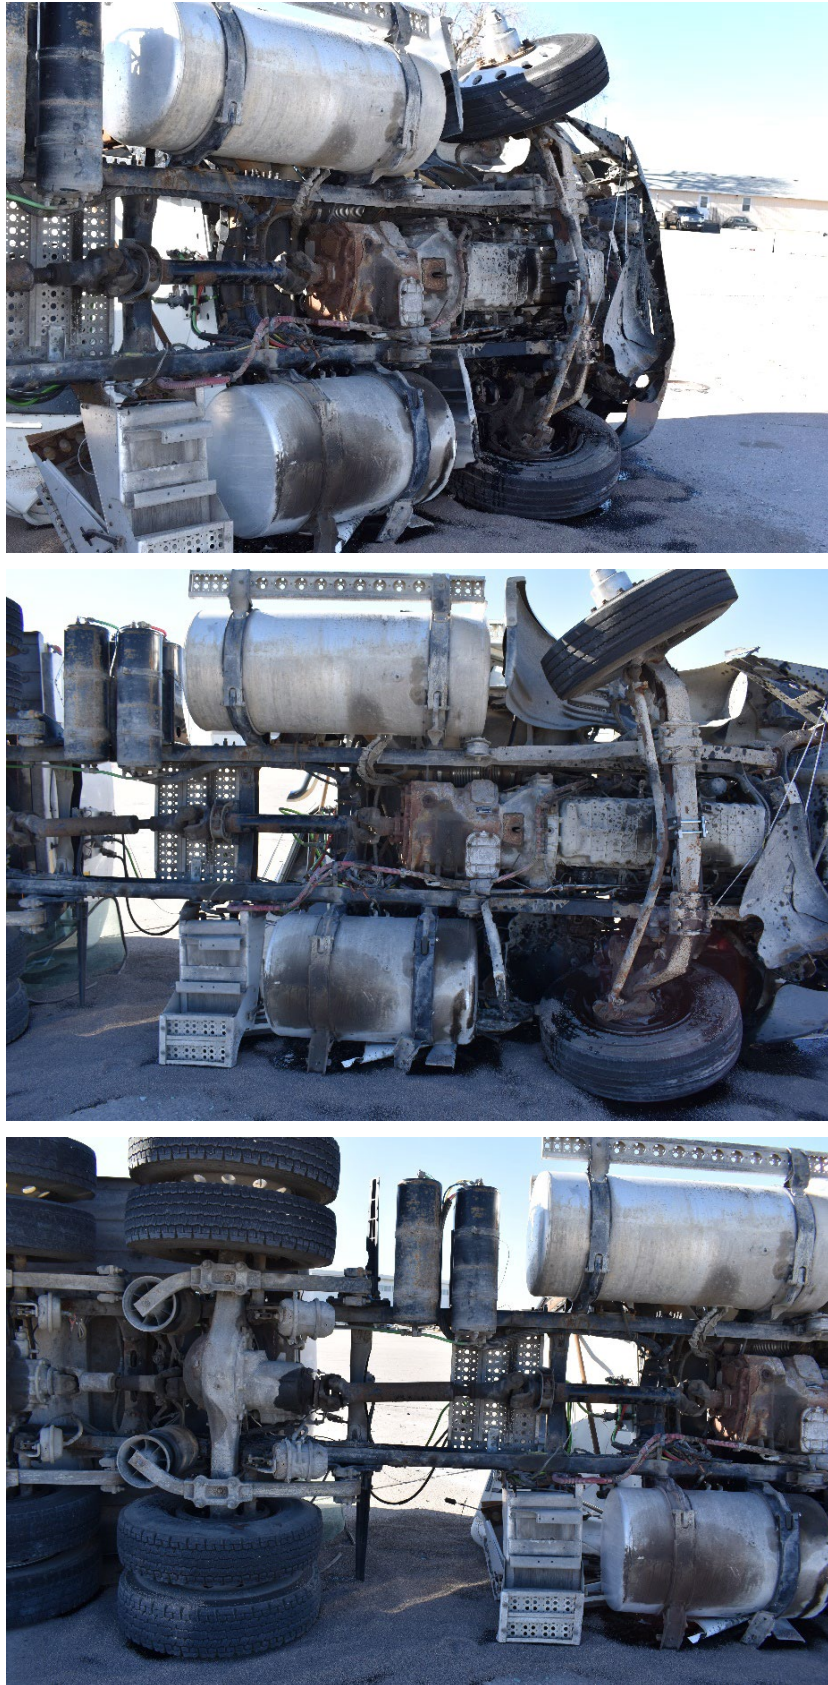
Figure 6.20 Tractor Undercarriage Chassis Damage, Test No. MTL6-1

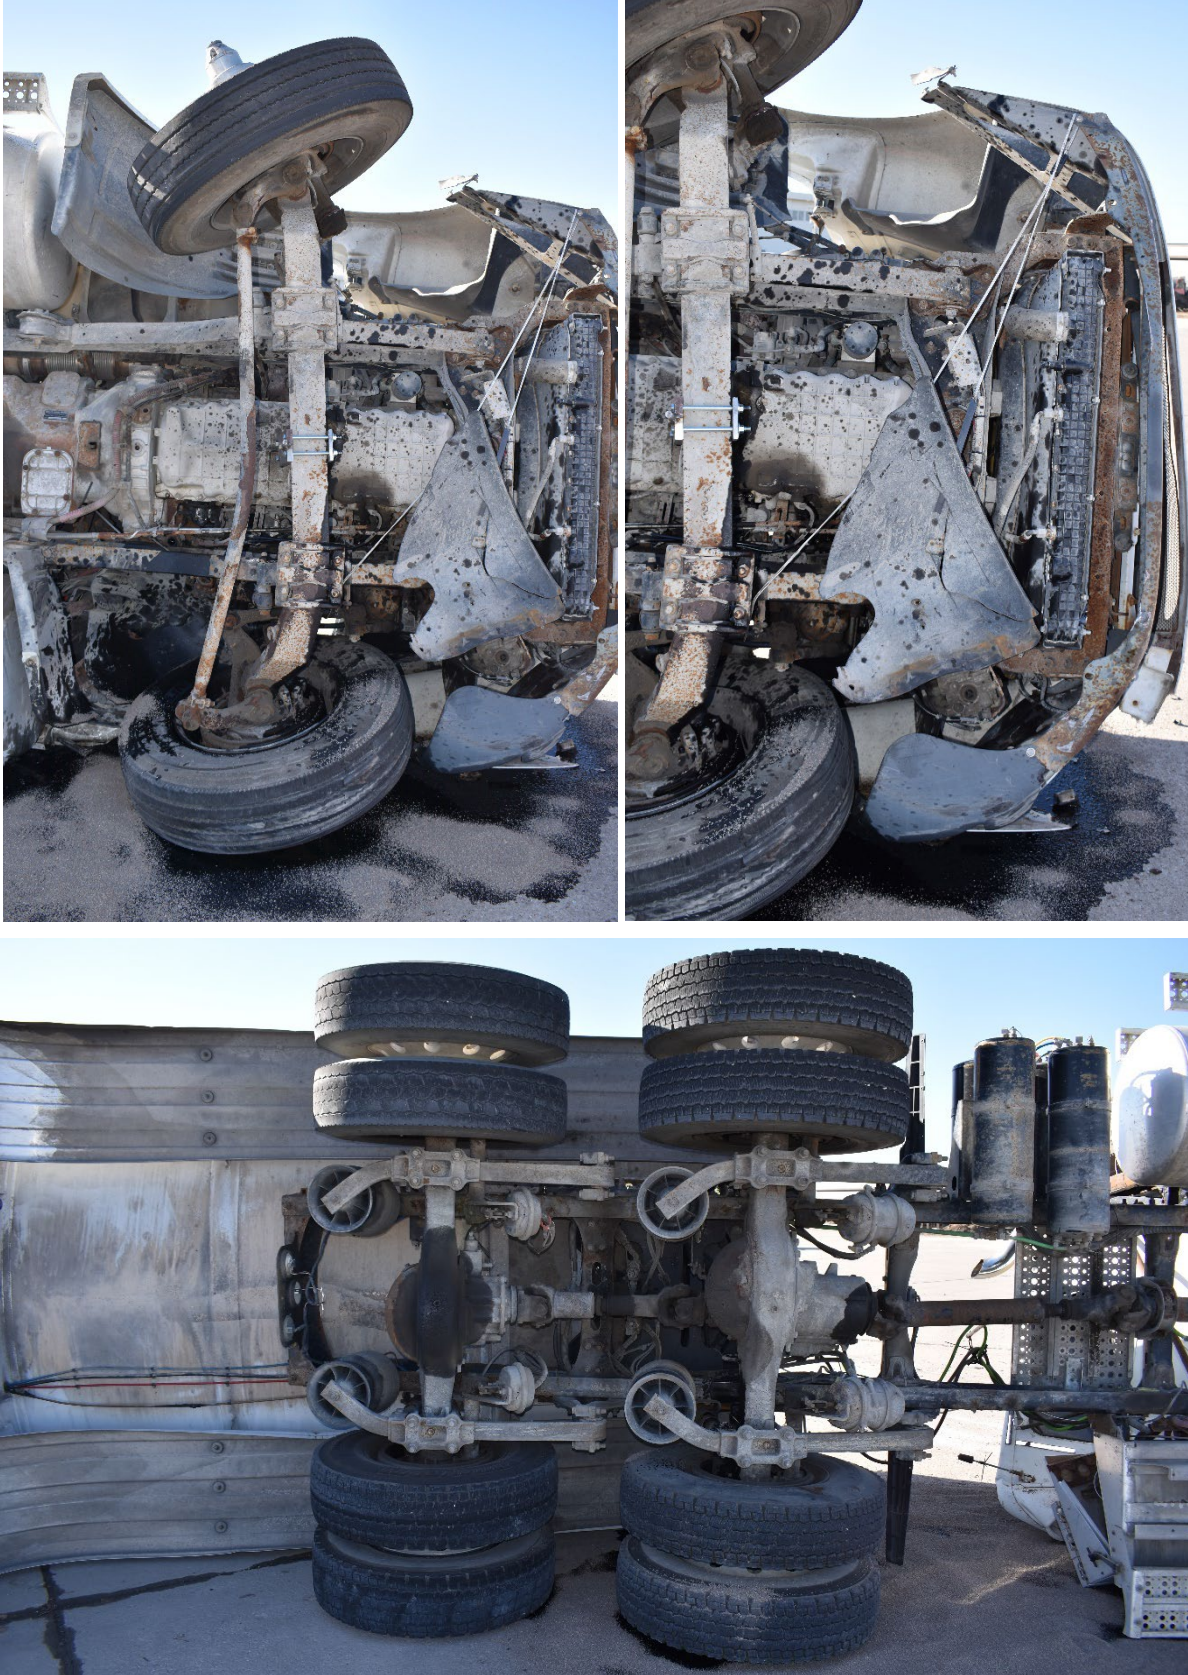
Figure 6.21 Tractor Suspension Damage, Test No. MTL6-1

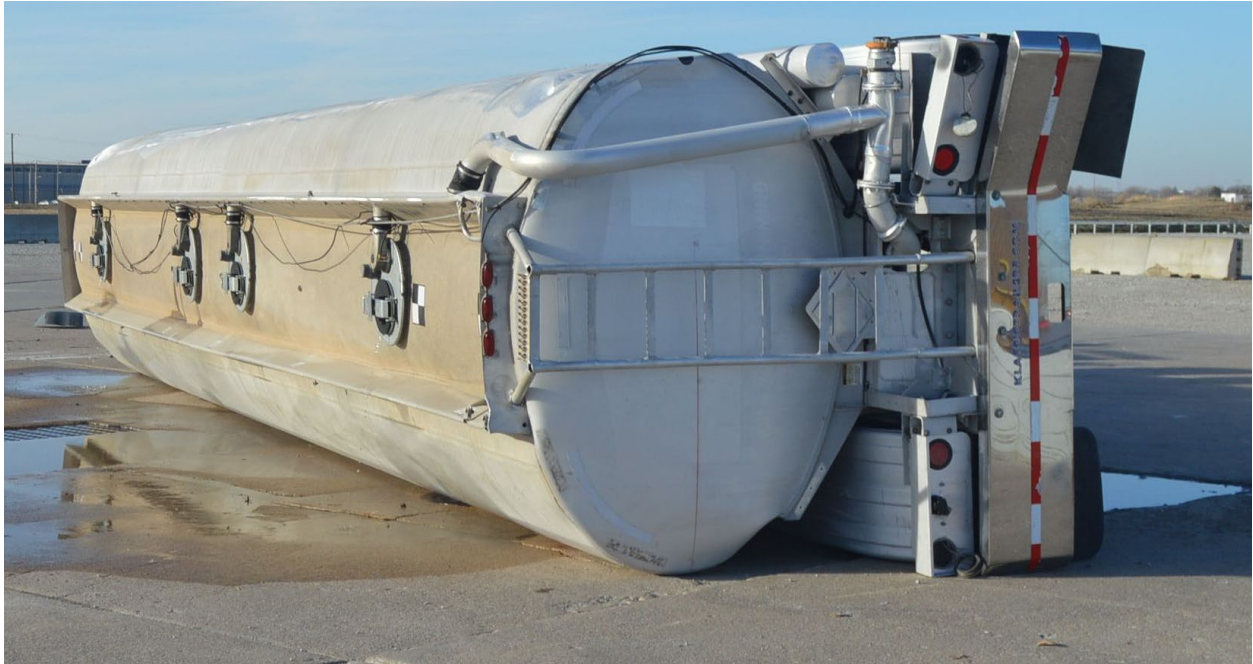
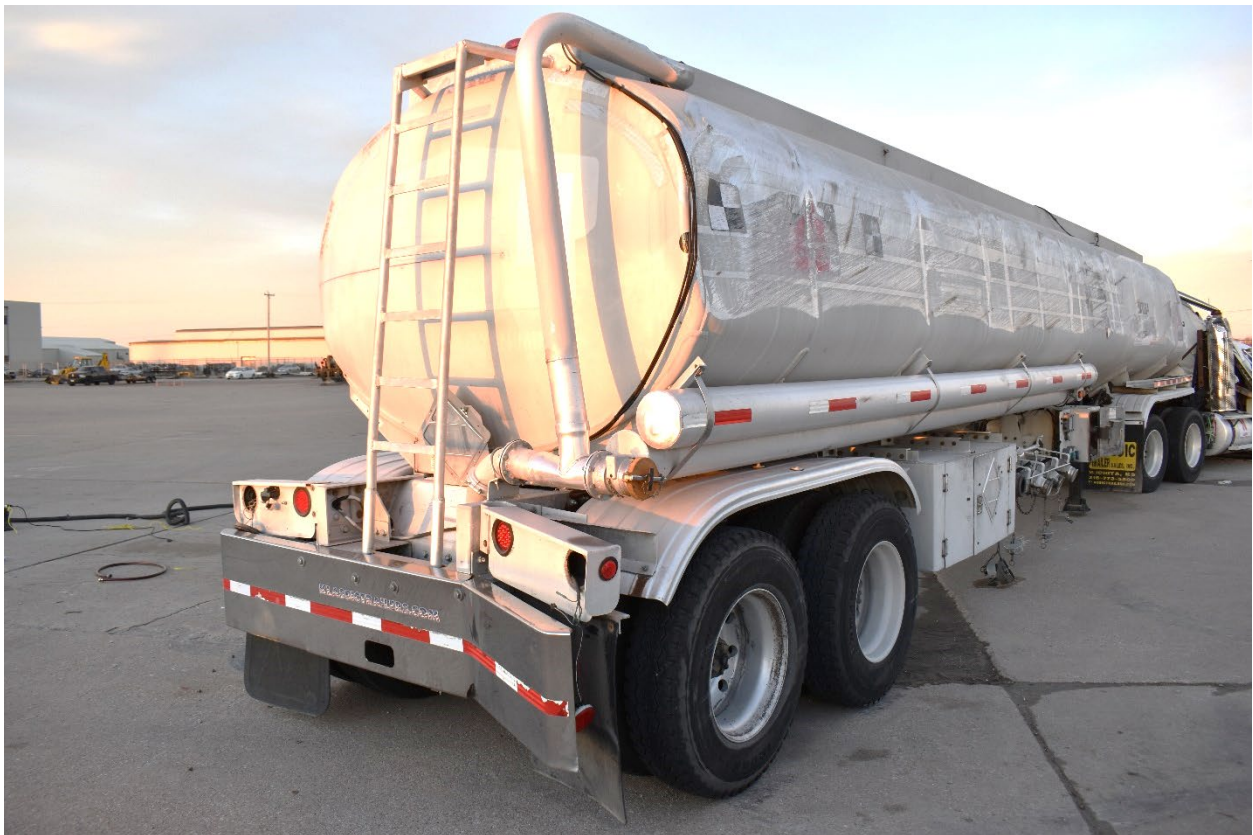
Figure 6.22 Trailer Damage, Test No. MTL6-1

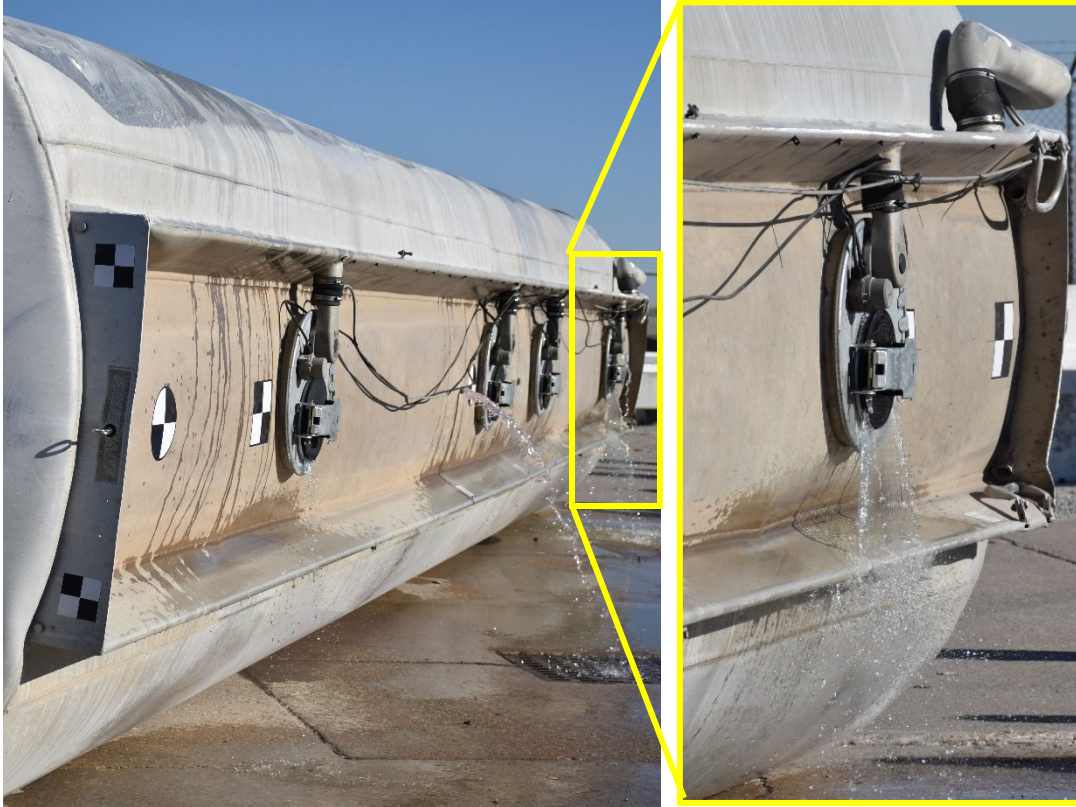
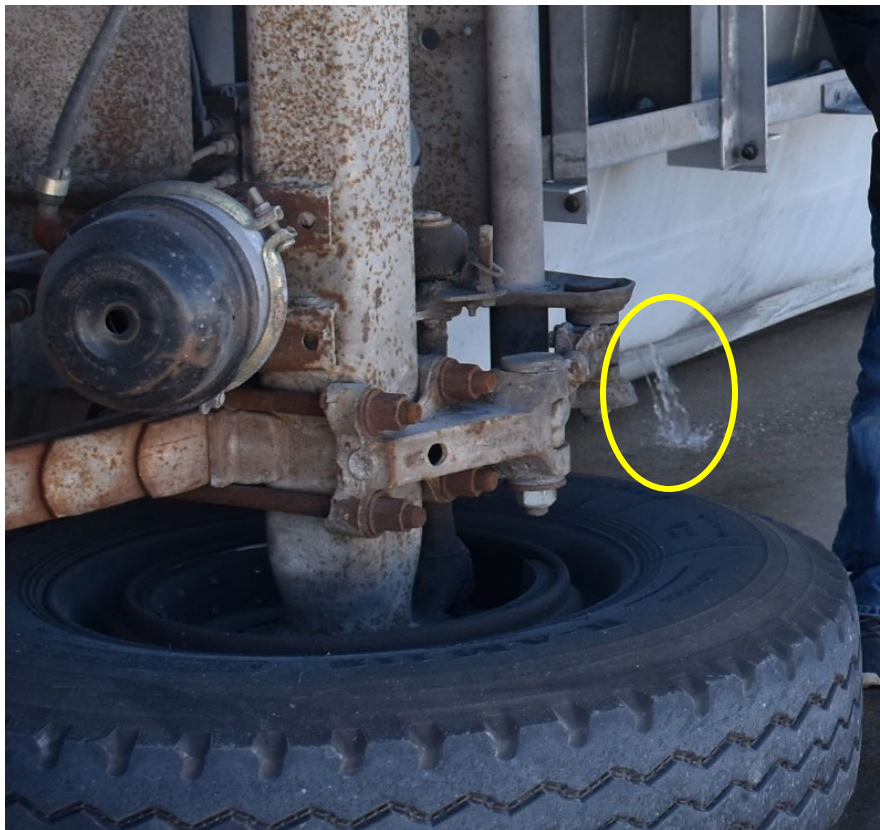
Figure 6.24 Locations of Trailer Leaks, Test No. MTL6-1

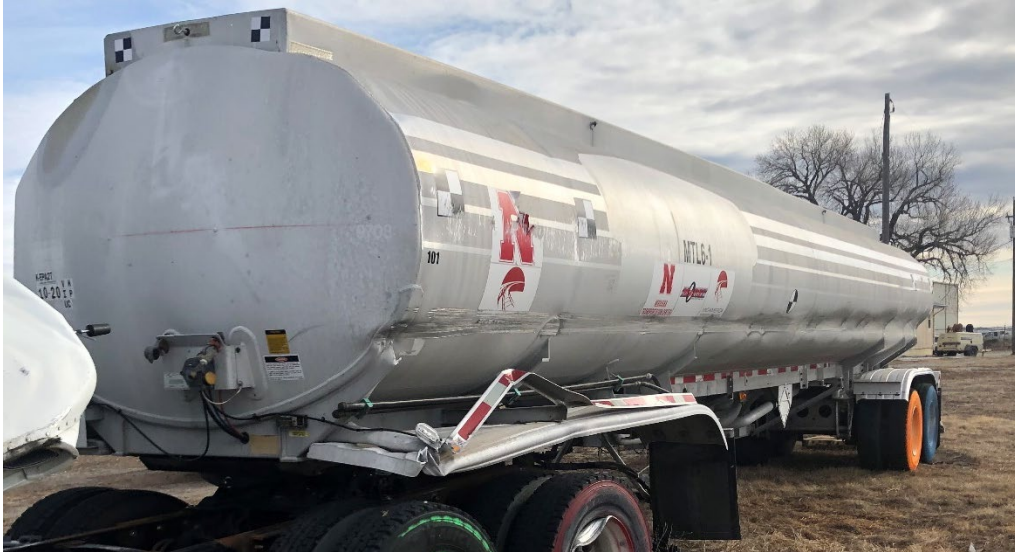
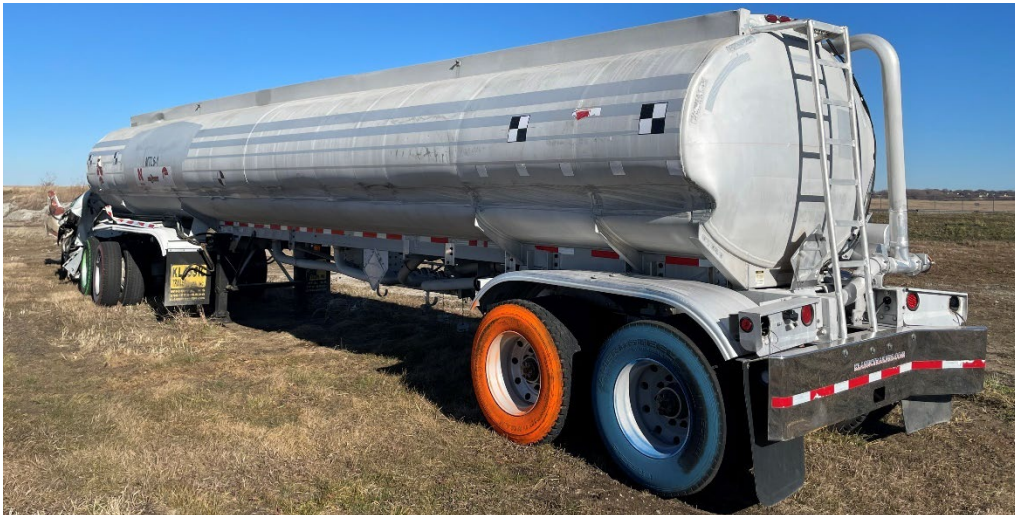
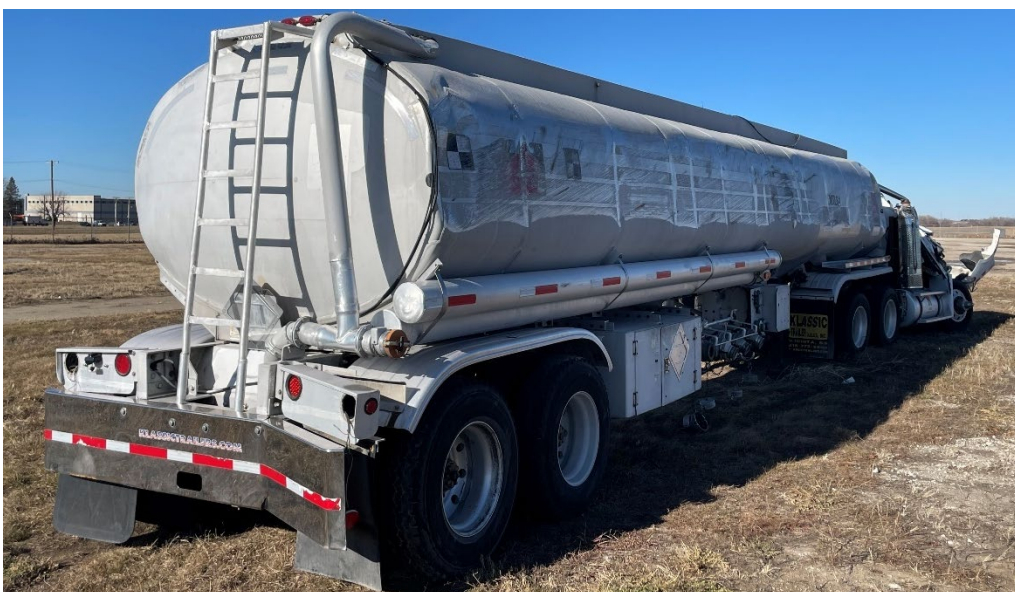
Figure 6.25 Trailer Damage After Uprighting, Test No. MTL6-1

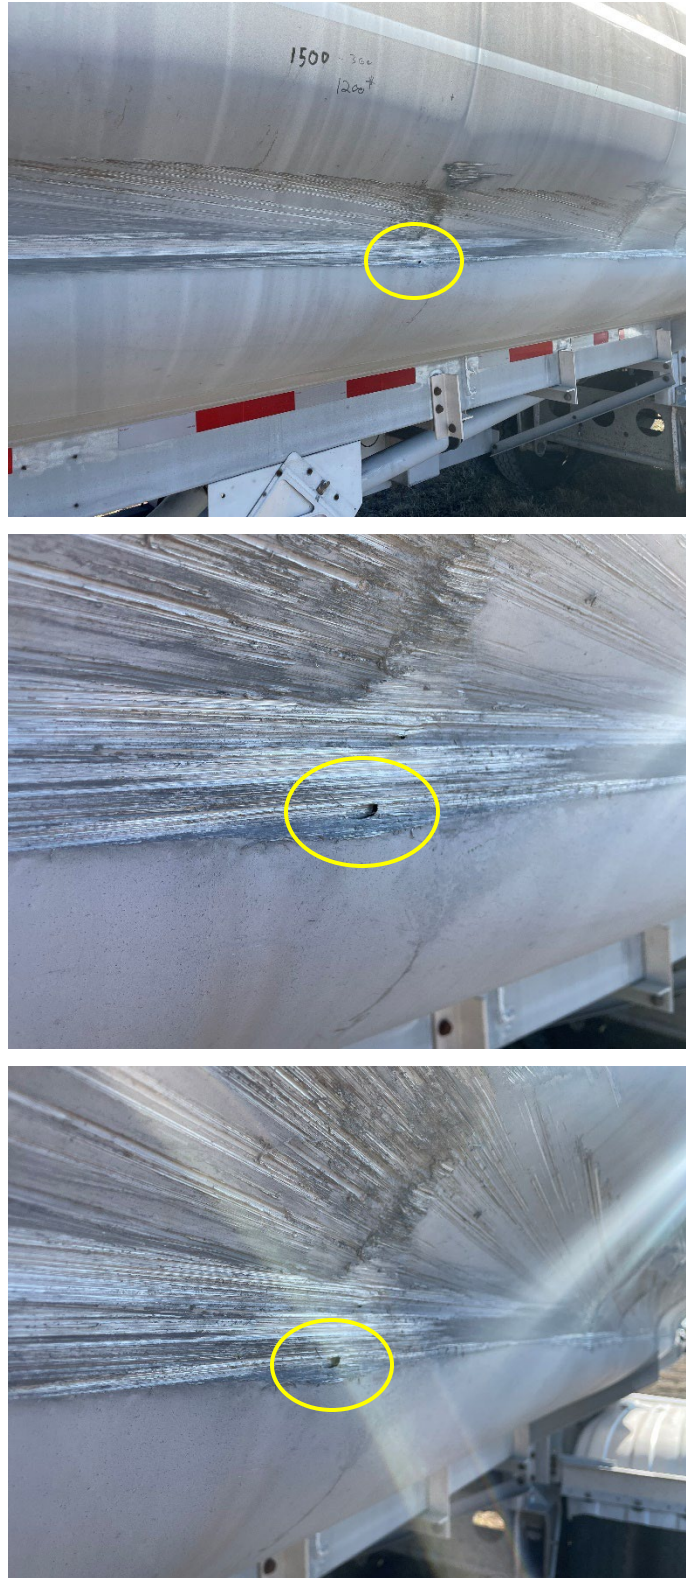
Figure 6.26 Pinhole Damage in Trailer After Being Uprighted, Test No. MTL6-1

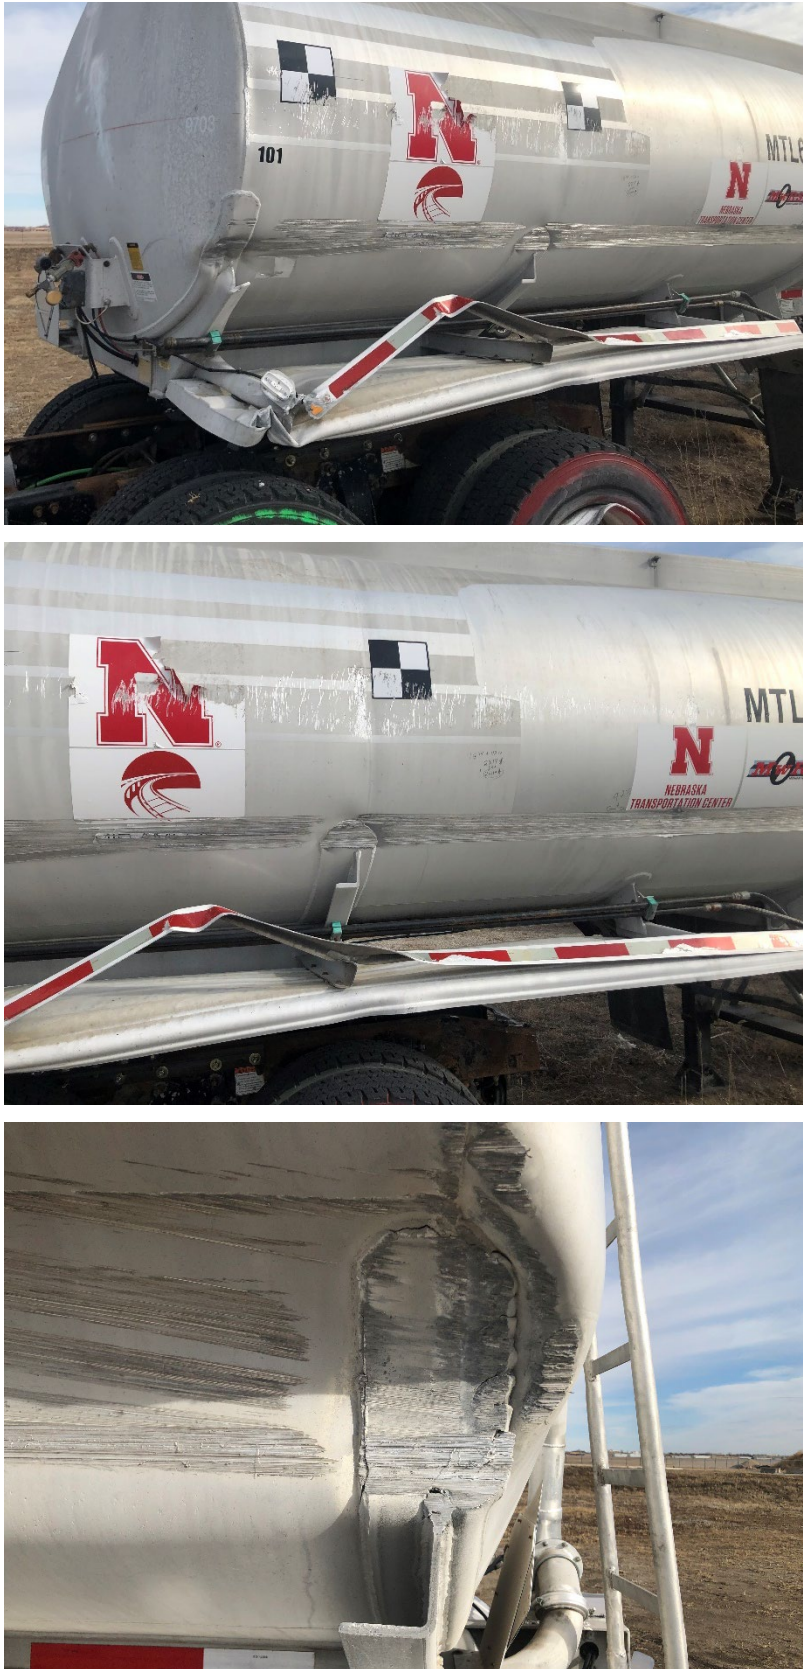
Figure 6.27 Trailer Damage on Impact Side After Being Uprighted, Test No. MTL6-1

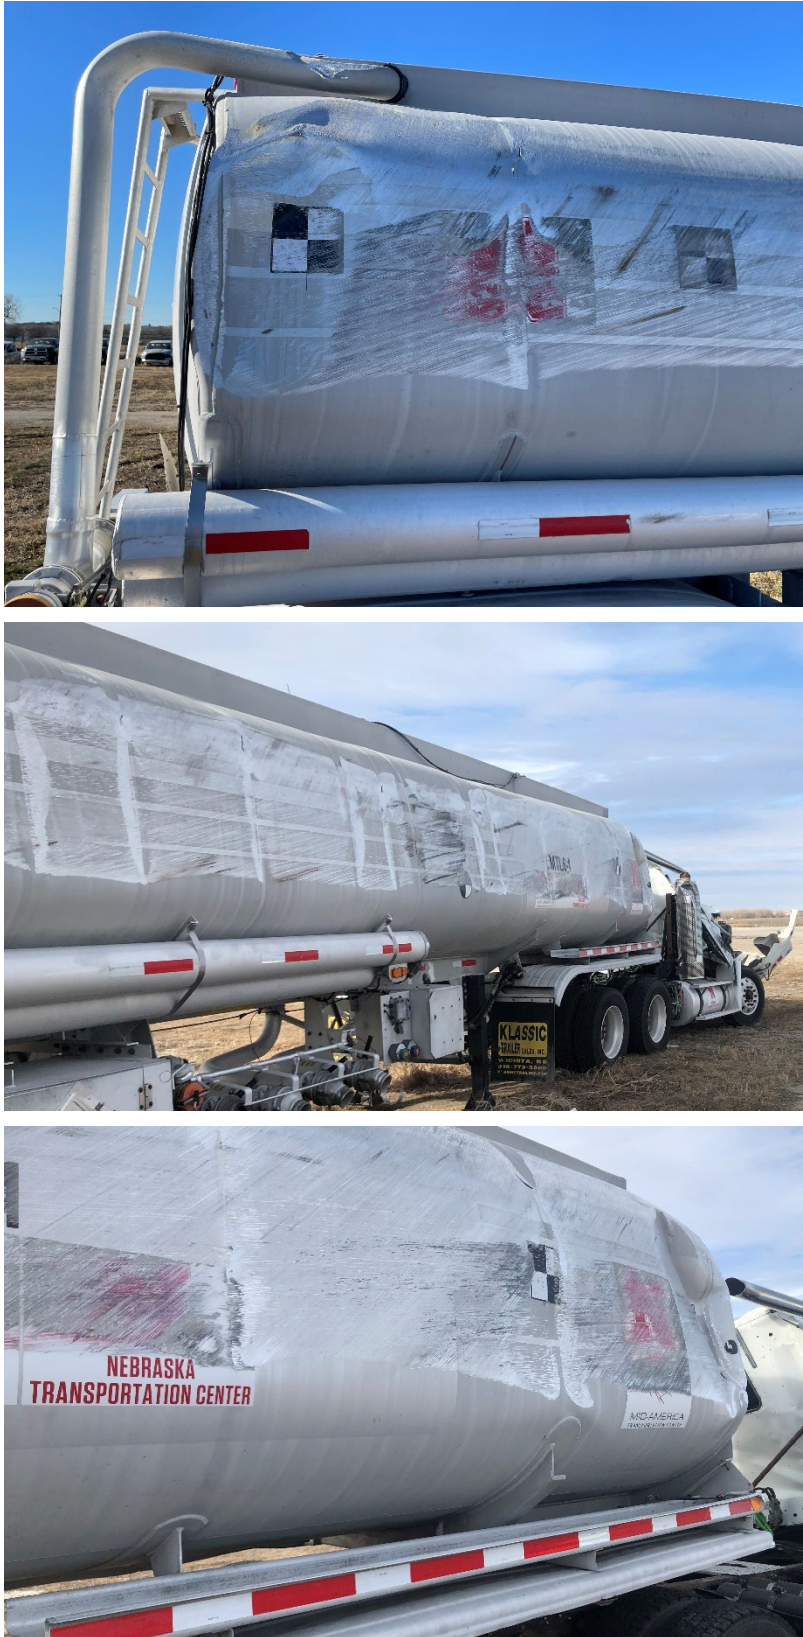
Figure 6.28 Trailer Damage on Non-Impact Side After Being Uprighted, Test No. MTL6-1

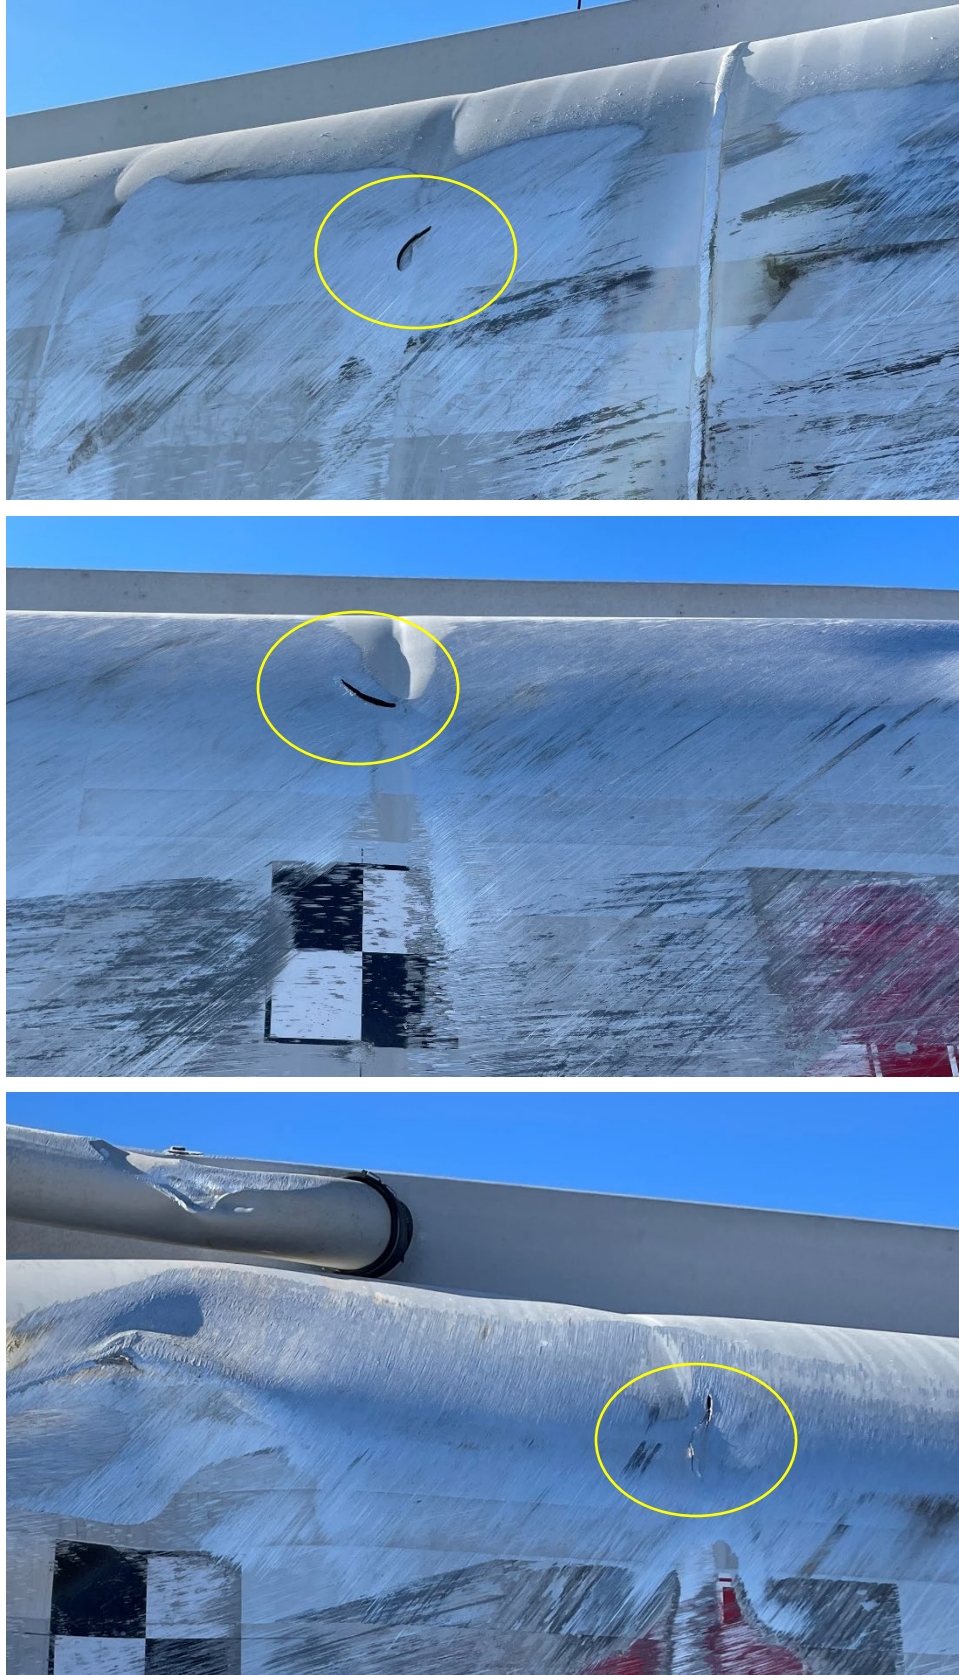
Figure 6.29 Tears in Trailer Jacket on Non-Impact Side, Test No. MTL6-1
109

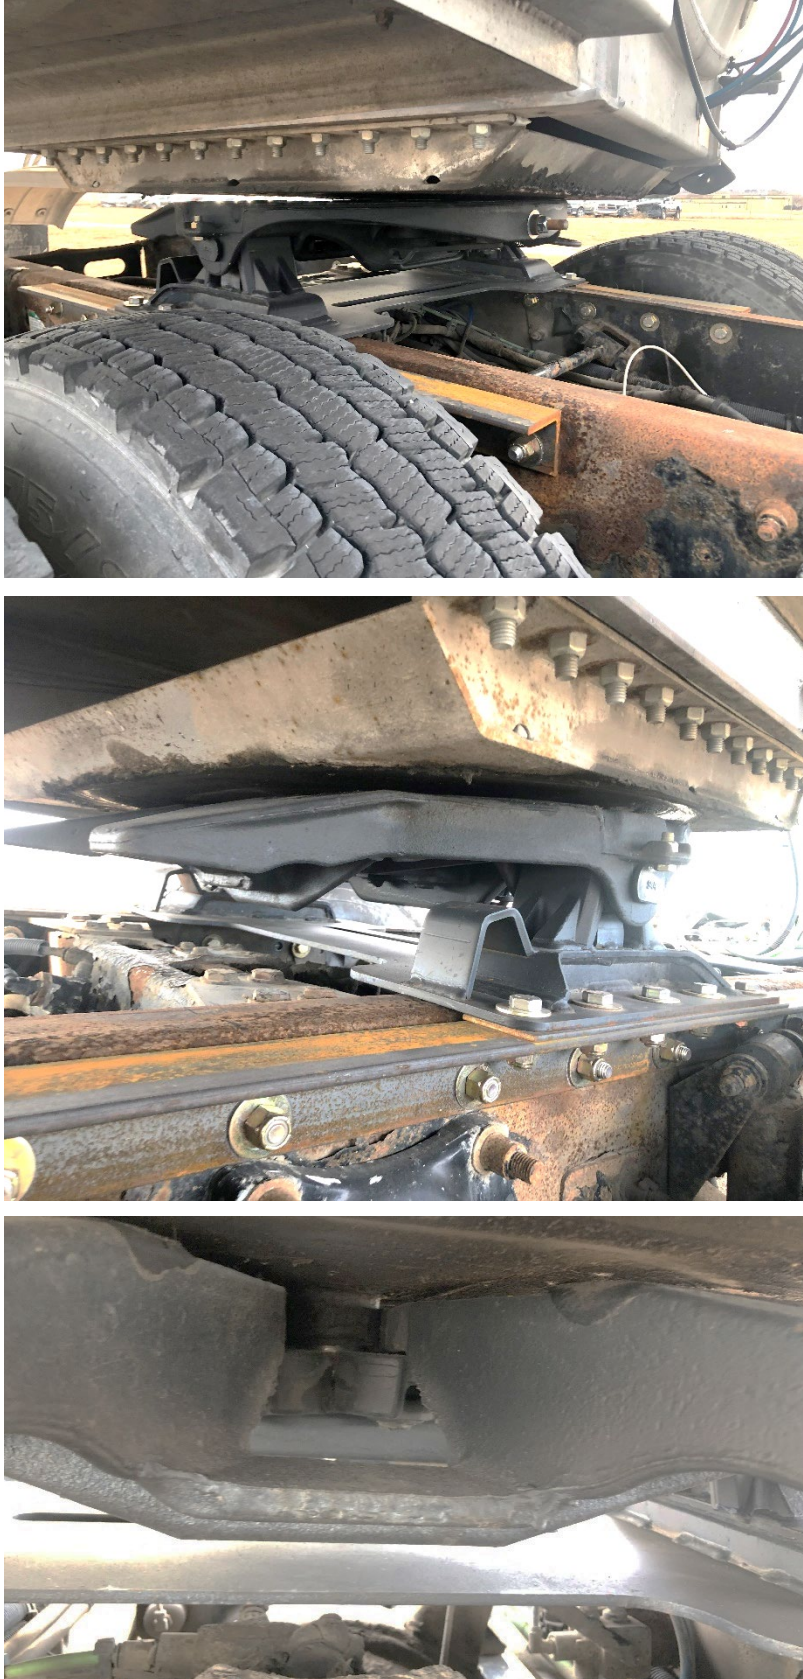
Figure 6.30 Fifth Wheel Damage, Test No. MTL6-1

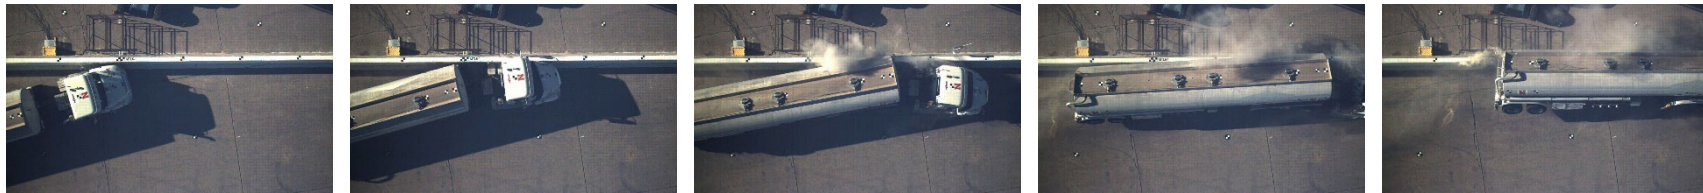
- Test AgencyMwRSF
- Test Number..... MTL6-1
- Date..... 12/8/2021
- MASH Test Designation No.6-12
- Test Article..... MASH TL-6 Concrete Barrier
- Total Length187 ft – 6 in.

- Key Component – Concrete Barrier
 - Length187 ft – 6 in.
 - Height..... 62 in. from top of tarmac
- Soil Type..... Coarse, crushed limestone (well-graded gravel)

- Test Article DamageMinimal
- Maximum Test Article Deflections
 - Permanent Set..... N/A
 - Dynamic..... 0.4 in.
 - Working Width..... 37.2 in.
- Transducer Data
