Report # MATC-MS&T: 133-3

Final Report

Performance of Corroded Piles Subjected to Eccentric Loads Before and After Repair - Phase III

September 2024

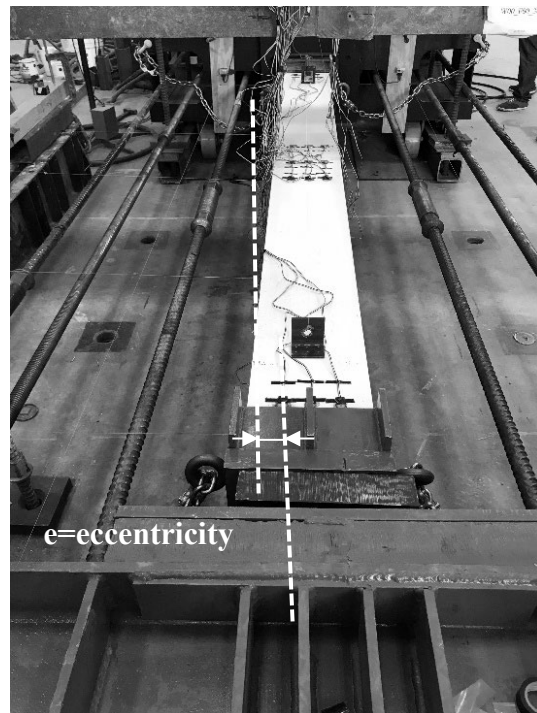
Figure 1.1 Representative column for eccentricity

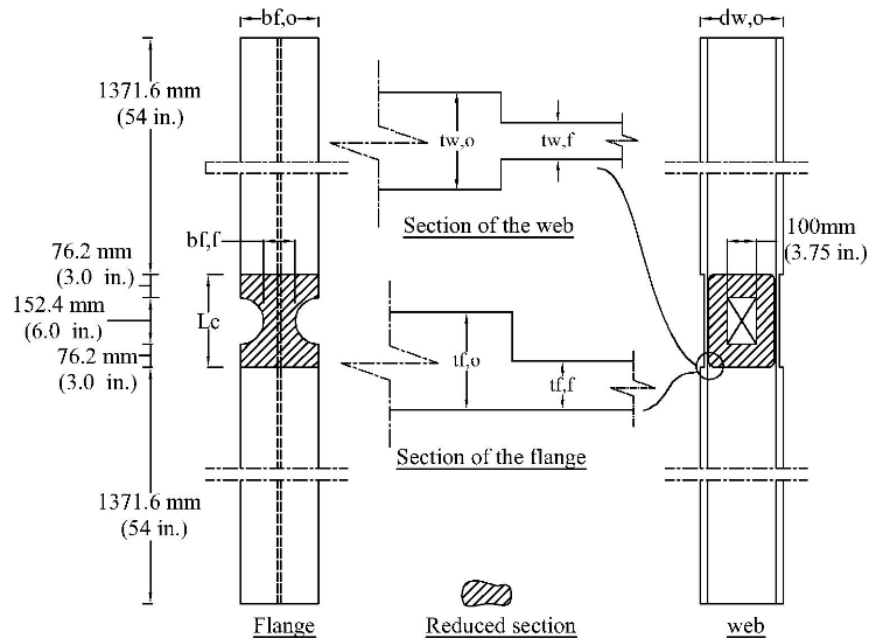
Figure 1.2 Schematic of milling configuration

by reducing the thickness over a 304.8 mm (12 in.) section located in the middle of each pile. The measured geometric properties of the smallest cross-section of the tested specimens are presented in Tables 1.2 and 1.3.

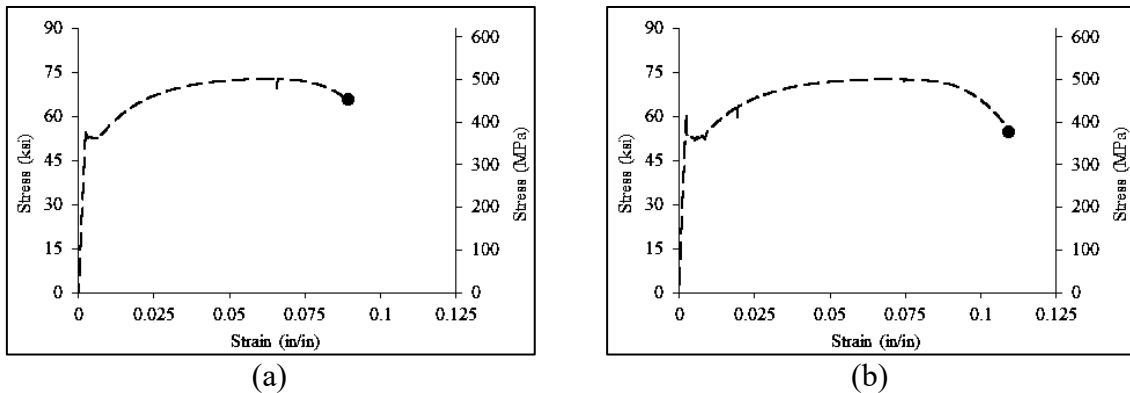
Figure 1.3 Steel H-piles average stress-strain curve (a) flange, and (b) web.

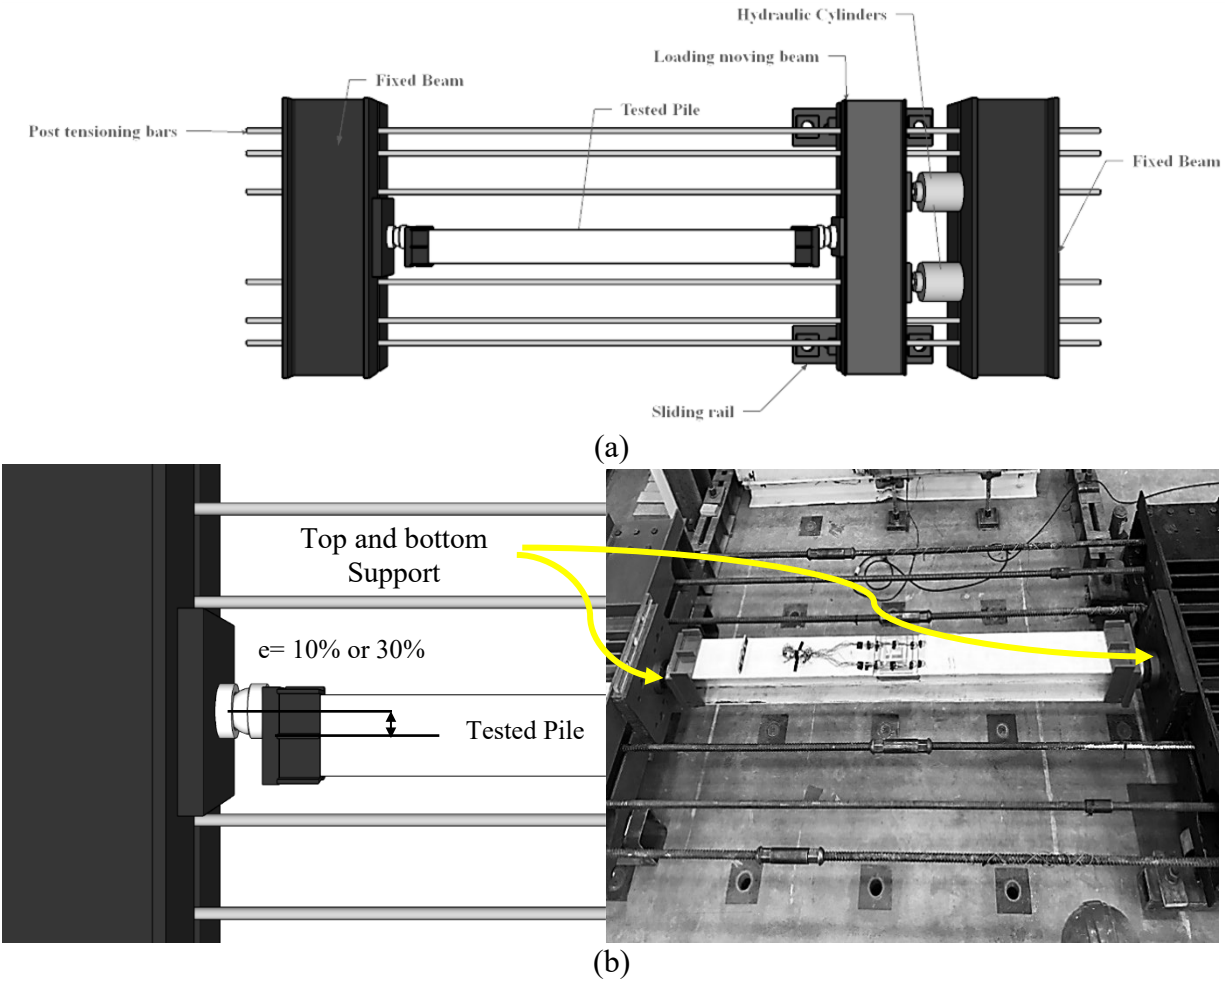
Figure 1.4 Test setup: (a) drawing, and (b) picture.

Each specimen had pin-pin boundary conditions. Each end of a specimen was placed inside a steel box, which was attached to a semi-sphere at the required eccentricity (Fig. 1.4). The semi-sphere was allowed to move on a swivel plate which in turn was connected to either the moving beam at one end of the pile or the fixed beam at the other end. The load was applied against the moving beam using two 2225 kN (500 kips) hydraulic cylinders and an oil pump with an average rate of 155 kN/min (35 kips/min) until failure occurred.

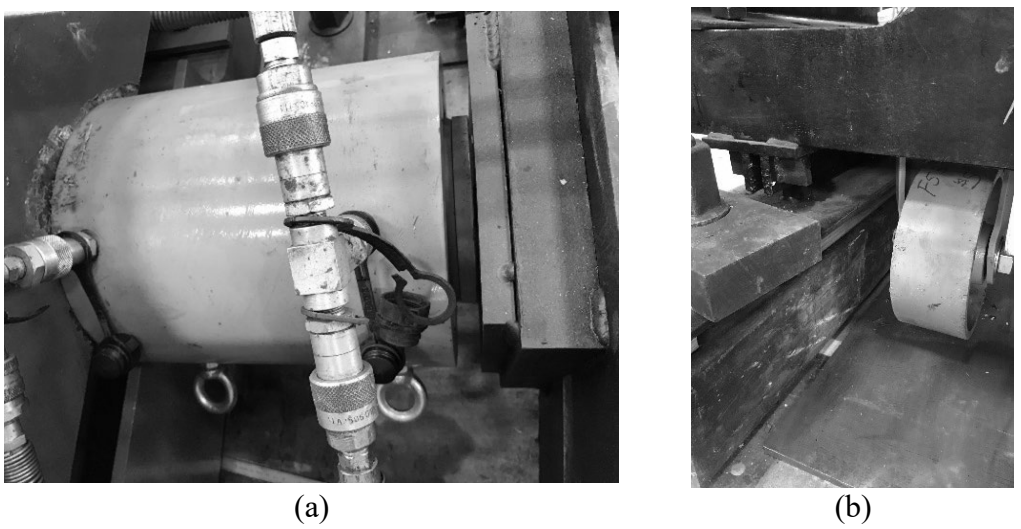
Figure 1.5 Loading instruments: (a) hydraulic jack, and (b) rail track with rolling cylinders.

Six 890 kN (200 kips) load cells were placed on post-tensioning bars to record the applied force on each bar, which represented the total force applied to a test specimen. To measure the loads in the bars, each bar also had a strain gauge that was monitored during the test. Furthermore, to monitor the behavior of each specimen, forty-nine strain gauges were attached to seven sections over the length of the specimen: two sections located near the ends and the remaining five sections located in the middle of the specimen where the corroded sections were simulated (Fig. 1.8). Each section had seven strain gages distributed uniformly on the web and flanges using one of two profiles, based on the reduced section of the pile (Fig. 1.8).

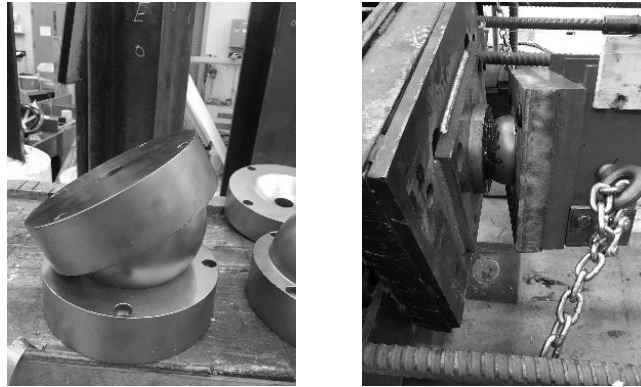
Figure 1.6 Swivel plates (a) maximum rotation, and (b) installed in the setup.

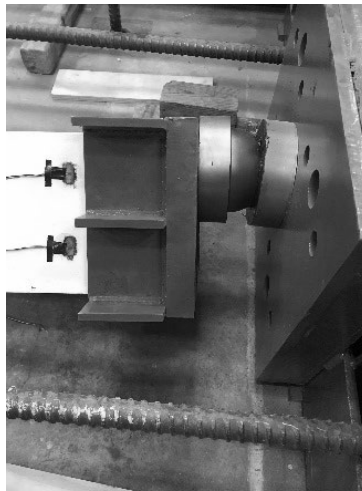
Figure 1.7 Eccentricity of the swivel with the pile.

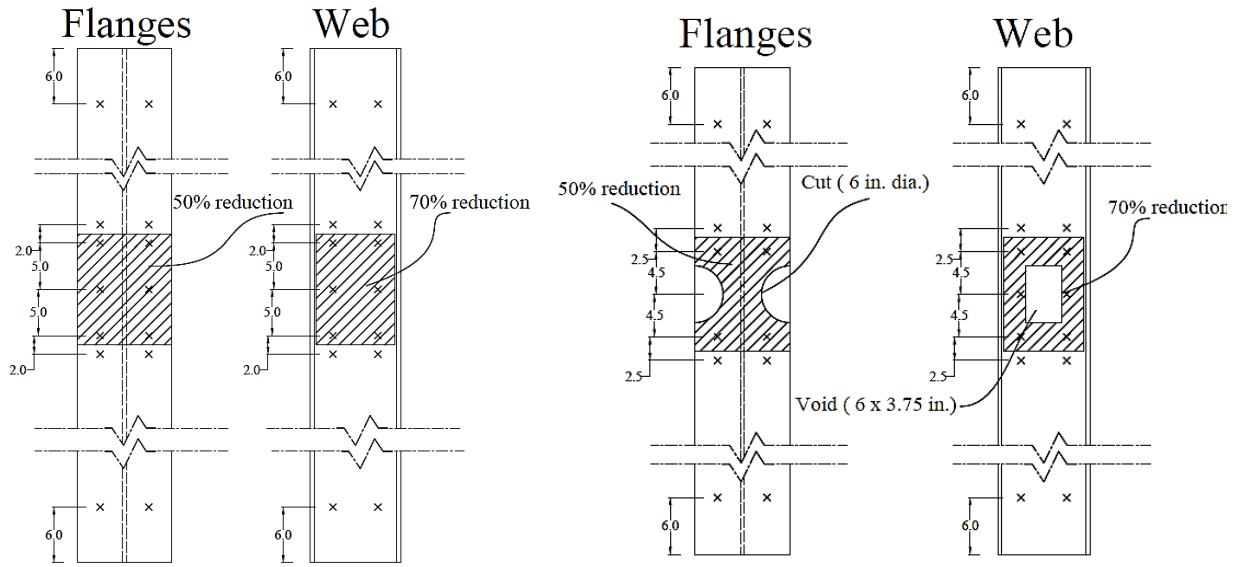
(a) (b)
 Figure 1.8 Distribution of the strain gages on H-piles: (a) Type 1, and (b) Type 2.

The Axial shortening of each specimen was measured using three string potentiometers (SPs). Two SPs were connected between the moving beam at one end of the pile and the fixed beam at the other end of the pile. The third SP was connected along the length of each pile. The axial strengths of the piles were calculated using the design procedures of the American Institute of Steel Construction (AISC) [22].

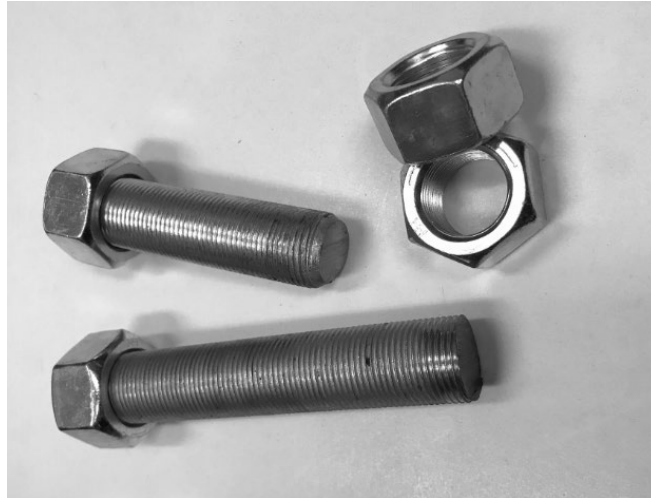
Figure 2.1 All threaded bars and heavy-duty nuts used as HSs.

The required number of shear studs installed on the steel pile was also determined. The shear resistance (P_u (hs)) of the HS was calculated according to provisions for steel headed-stud anchors in composite columns in AASHTO_LRFD [25] (eq. 2.2) to transfer the load, F , from the steel pile to the repair system.

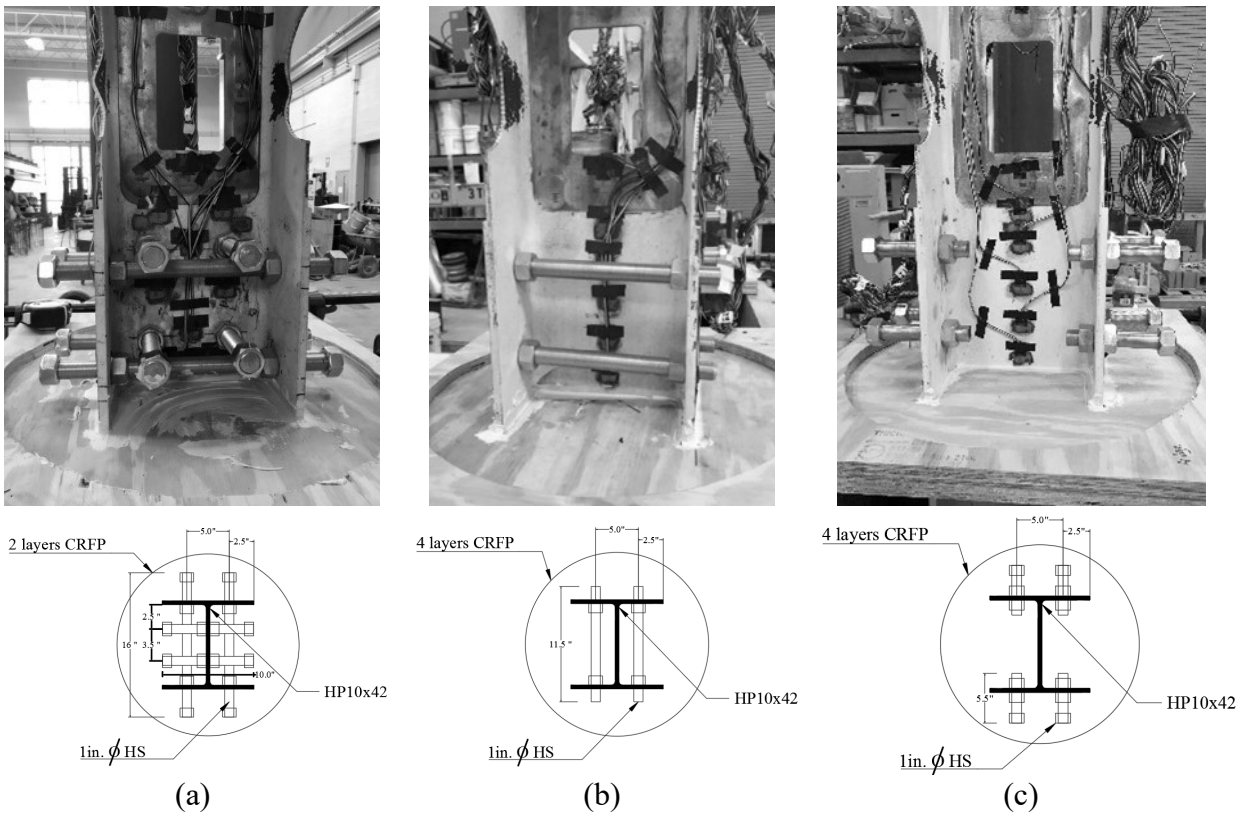
Figure 2.2 Distributions of the HSs in the three H-piles: (a) R-1, (b) R-2, and (c) R-3.

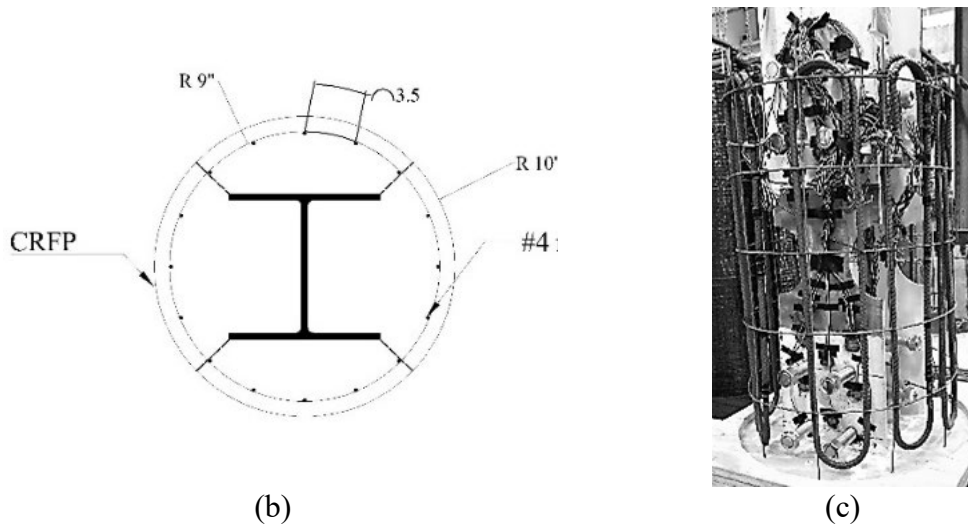
Figure 2.3 Longitudinal reinforcement in the repair region: (a) closed bar profile, (b) distributions of rebars, and (c) reinforcement cage

The reinforcing bars have been designed to withstand a bending moment corresponding to an e/t of 5% at the yield strength of the uncorroded H-pile. However, due to the availability and even distributions of the rebar, the bending moment capacity of the rebar corresponded to an e/t of 6.22% at the yield strength of the uncorroded pile. Eight #4 two-leg closed bars with 180 hooks were used (Fig. 2.3). The shape of the bars was selected to ensure there was an adequate development length for #4 bars per ACI 318 (ACI318 2014).

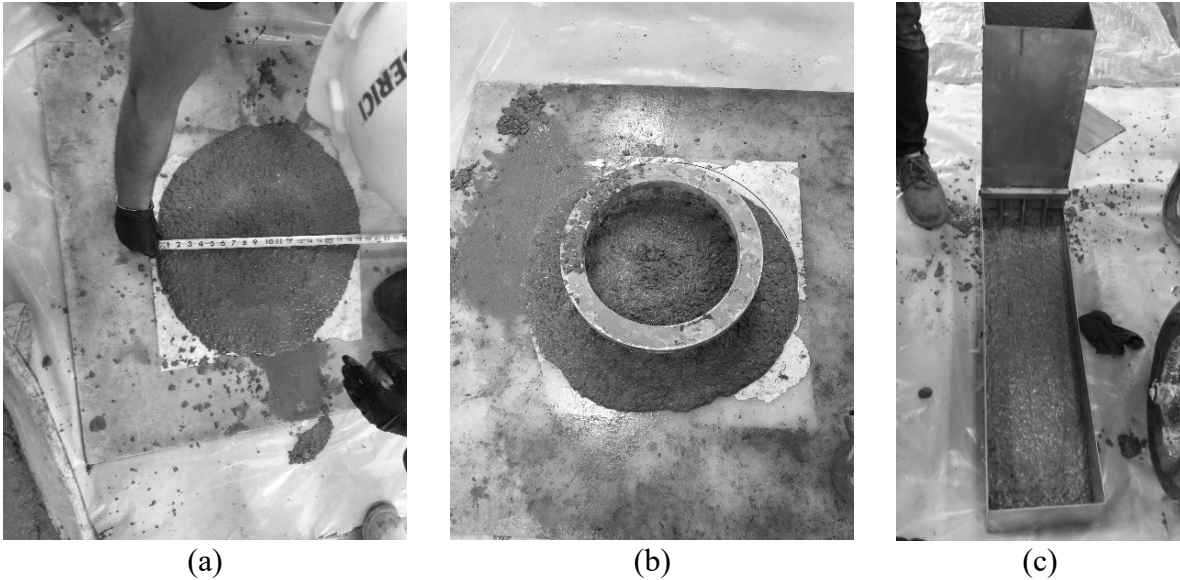
Figure 2.4 ASTM tests: (a) Slump flow, (b) Passing ability using J-ring, and (c) L-box.

The SCC had a slump flow of 546 mm (21.5 inches) in diameter. Passing ability was tested using J-Ring to determine the flowability of the concrete with a 533 mm (20 inch) diameter (Fig. 2.4). Blocking assessment per ASTM C1611 found the difference between the slump flow and J-ring flow was 12.6 mm (0.5 inch); therefore, there was no visible blocking. An L-box test was also carried out per ASTM C1621.

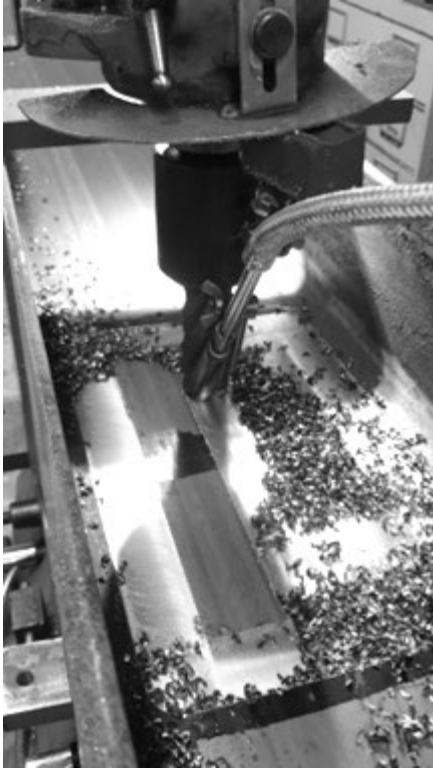
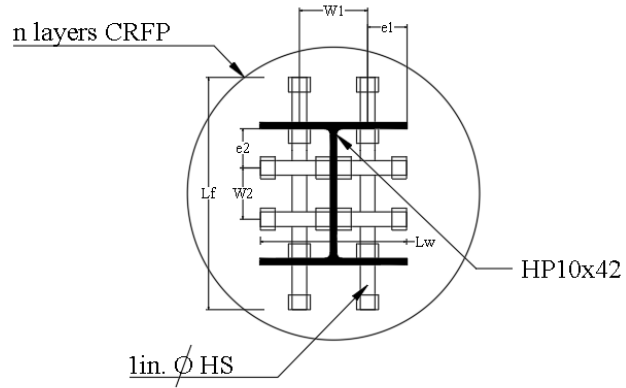
Figure 2.5 (a) Magnetic drill used to drill holes for the HSs, and (b) general distribution for studs

After straightening the tested piles to restore their original alignments, the required number of holes for the HSs were drilled in the webs and flanges using a magnetic driller (Fig. 2.5 and Table 2.2).

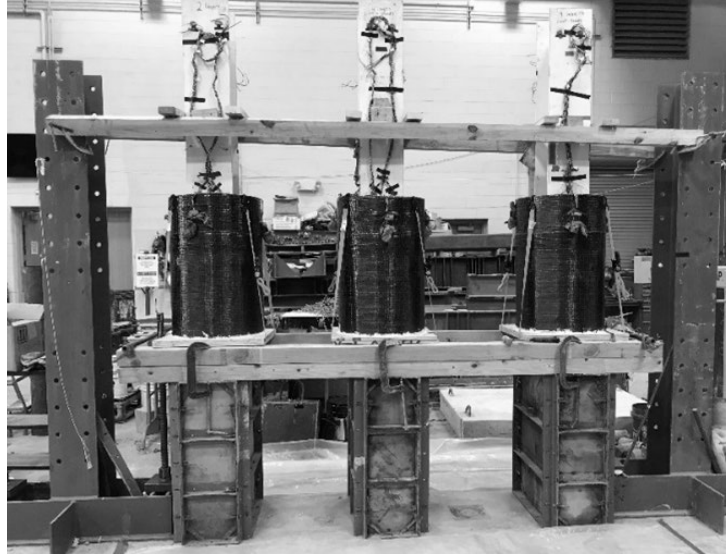
Figure 2.6 Specimens after CFRP Installation

The CFRP jacket was inserted from the top of the corresponding pile and placed atop the end cap. The interface joint between the jacket and end cap was sealed with fast-dry caulk. The steel cage was also inserted from the top of the pile and fixed in place inside the CFRP jacket. SCC filled the CFRP jackets (Fig. 2.6).

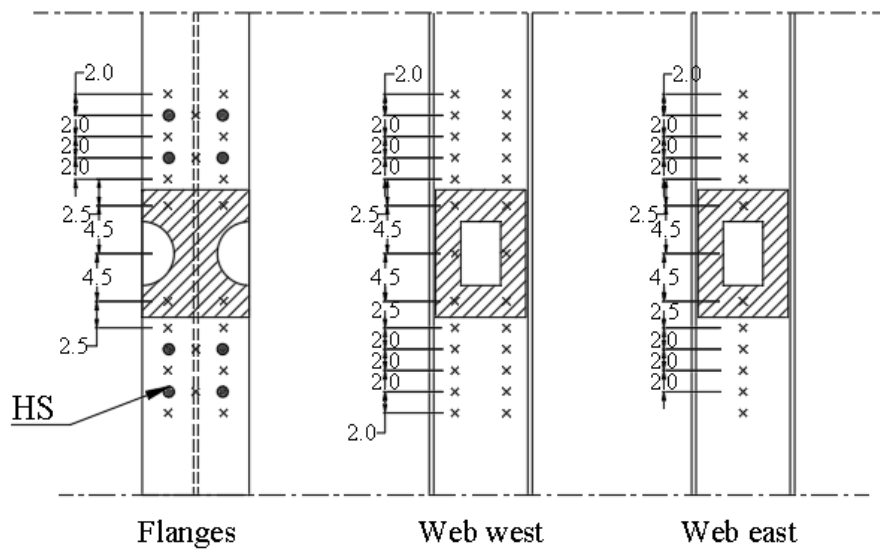
Figure 2.7 Strain gauges distribution on the flanges and web of H-pile

Ninety-two strain gauges were attached to the web and flanges of each H-pile specimen (Fig. 2.7) before casting the concrete to measure the axial strains.

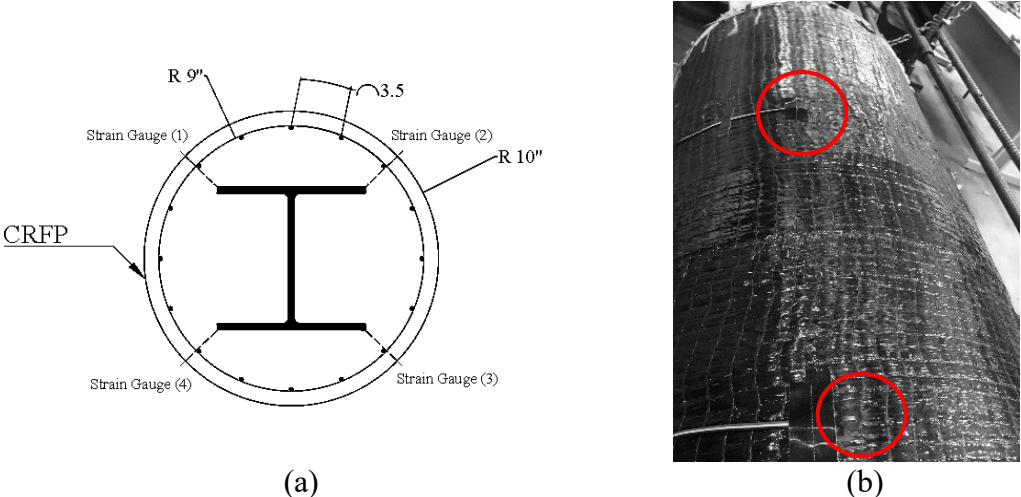
Figure 2.8 Strain gauges distribution on the CFRP cross-section (a) Cross section (b) longitudinal direction

Additional twelve strain gauges were mounted on each CFRP jacket to measure the hoop strains during testing (Fig. 2.8). Twelve strain gauges were attached to the longitudinal rebars to monitor the axial strains. Eight string pots were installed to measure the displacements of each H-pile in both the horizontal and vertical directions (Fig. 2.8).

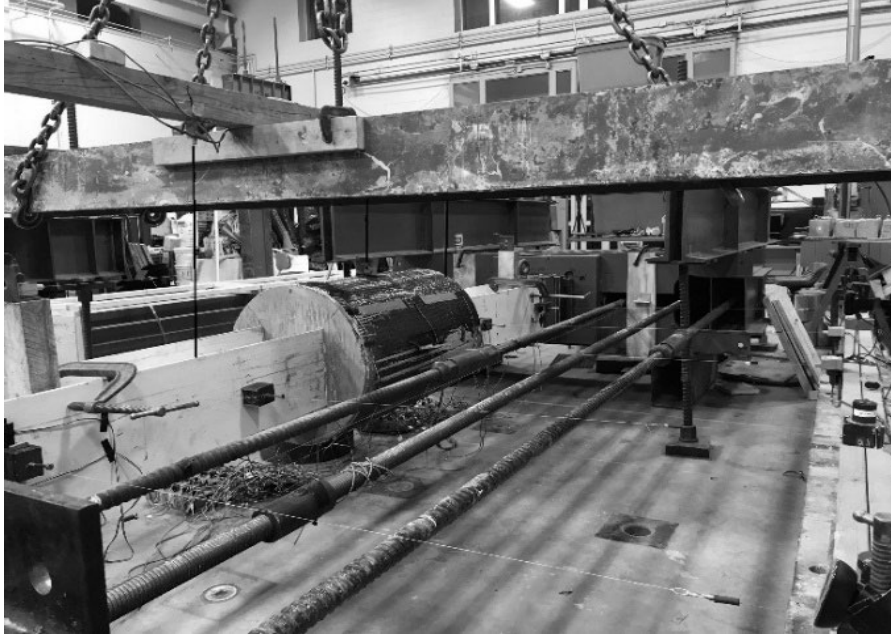
Figure 2.9 String potentiometer vertical and horizontal measurements

Once the CFRP jackets were filled with concrete, they were left to cure at an ambient temperature of $23 \pm 2^\circ \text{C}$ ($73 \pm 3^\circ \text{F}$) inside the laboratory (Fig 2.6). The formwork was removed after three days, and the piles were installed in the test setup described in Chapter 2 of this report. The specimens were axially loaded (Fig. 2.9) and the test results are discussed in the next chapter.

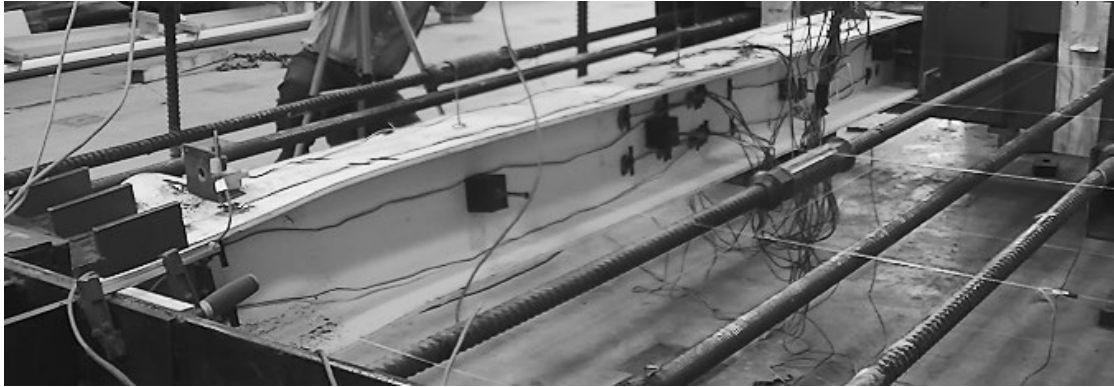
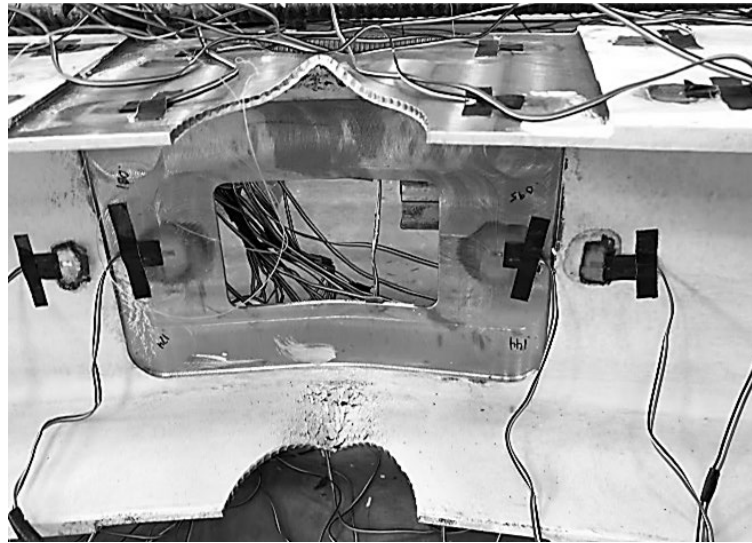
Figure 3.1 Failure during the experimental W00-F00, and (b) W70V-F50C

Table 3.1 shows the results for the tested piles. The web of W00-F00 yielded at one end of the pile followed by local buckling of the flanges which gradually dropped the pile strength until it failed at an axial load of 2970 kN (669 kips) (Fig. 3.1). Similarly, W70V-F50C-0% suffered from the flange and web yielding locally at 667 kN (150 kips), which triggered global buckling at the middle section of the pile. Then the load dropped gradually until all strength was lost at the cross-section. (Fig. 3.2).

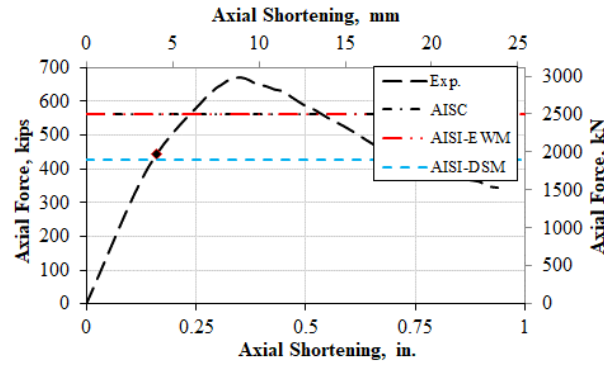
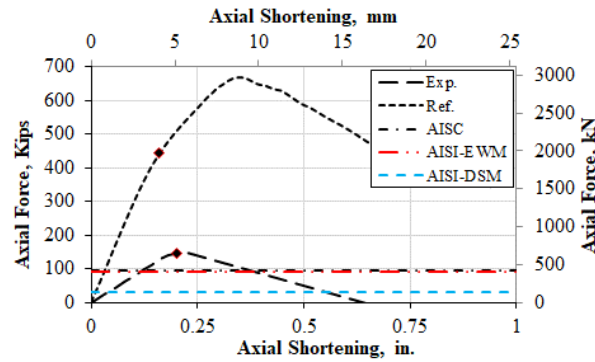
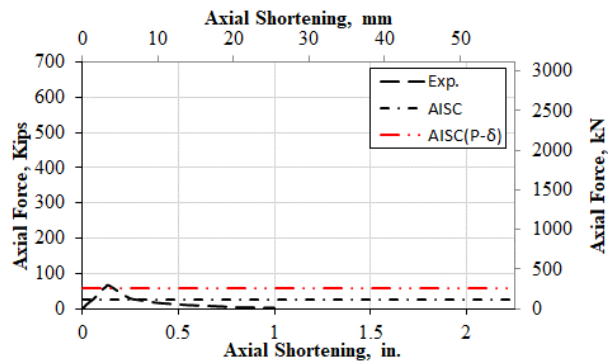
Figure 3.2 Axial force vs Axial shortening relation: (a) W00-F00 (Ref.), (b) W70V-F50C, (c) W70V-F50C-10%, (d) W70V-F50C-30%

For the severe corrosion specimens, piles W70V-F50C-10% and W70V-F50C-30% failed at 290 kN (65 kips) and 174 kN (39 kips) with a 57% and 74% drop in capacity, respectively compared to the similar pile with no eccentricity, where the flange and web suffered from local yielding that triggered global buckling at the critical section on the middle at the axial shortening of 5.1 mm (0.2 in.) and 4.8 mm (0.19 in.), respectively. Here the piles sustained a residual capacity of 267 kN (15 kips) and 89 kN (20 kips), which represents 23% and 51% of the peak load at a displacement of 50.8 mm (2 in.) (Fig.3.2).

group with a drop in capacity of 74% compared to an average of 63% for the same specimens with no eccentricity (Fig.3.2).

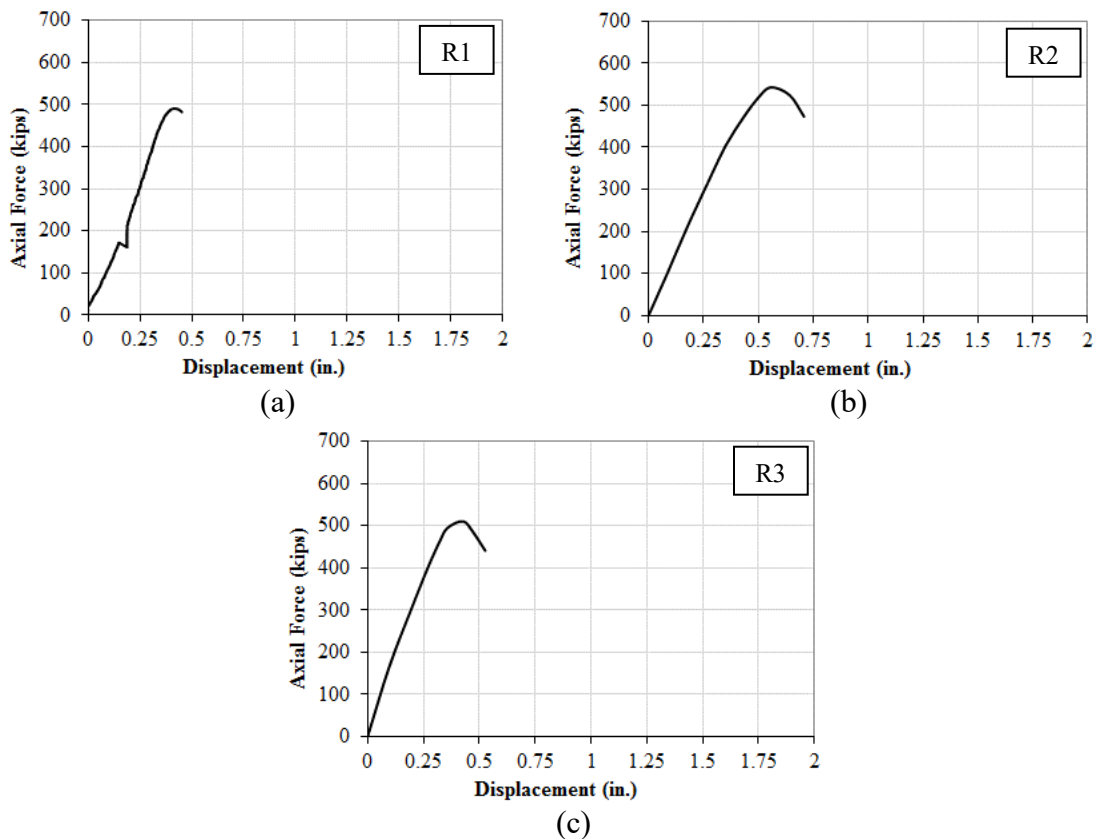
Figure 3.3 illustrates the axial force versus axial shortening of the repaired piles. As shown in Figure. 3.3 (a), the peak load of specimen R1 was 2228 kN (490.3 kips) with a capacity increase of 272% from the original pile W70V-F50C.

Figure 3.3 Experimental axial load vs. displacement curves (a) R1, (b) R2, and (c) R3

The peak load was accompanied by yielding stress at the section of the steel pile just outside the concrete jacket. For the repaired R2 specimen, the peak load was 2466 kN (542.5 kips) where the pile section locally failed followed by global buckling afterward. For the

repaired R3 specimen, the peak load was 2,318 kN (510 kips) and it failed due to local buckling accompanied by global buckling in the pile (Fig. 3.3).

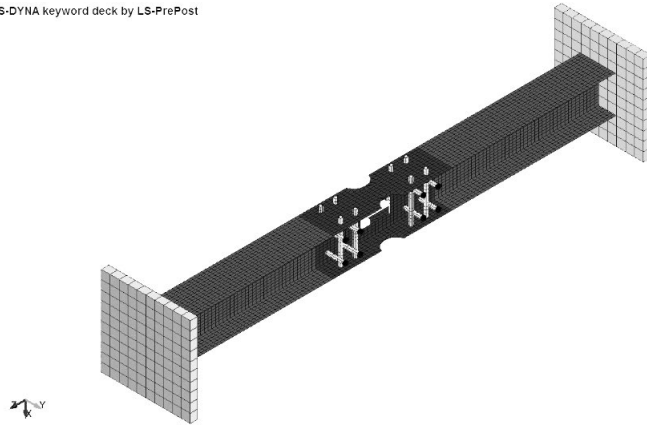
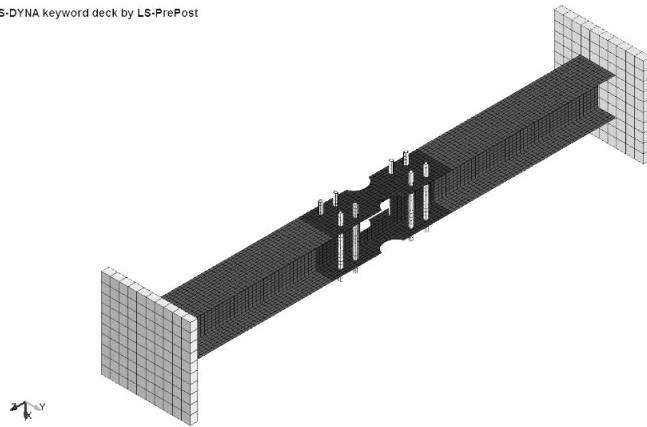
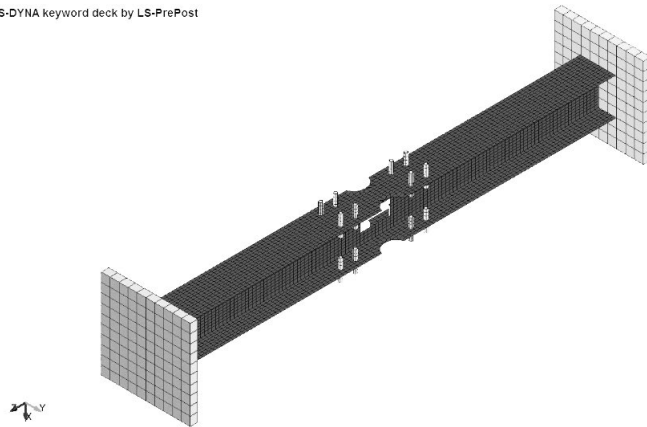
Figure 4.1 FE of the repaired piles and HSs layout of (a) R1, (b) R2, and (c) R3.

The geometric properties and material properties of the repaired steel pile is illustrated in Section 4.1. Figure 4.1 shows the general 3D view of the FE modeled retrofitted piles. A sensitivity analysis was conducted to determine the different element sizes. The element type and size were determined according to a sensitivity study, which indicated that the chosen type and size provided best predictions for the strengths and deformations of the piles. Each FE model had approximately 41,862 elements and 35,857 nodes. Figure 4.2 shows the final finite element model of the different parts of the simulated retrofit steel H-pile.

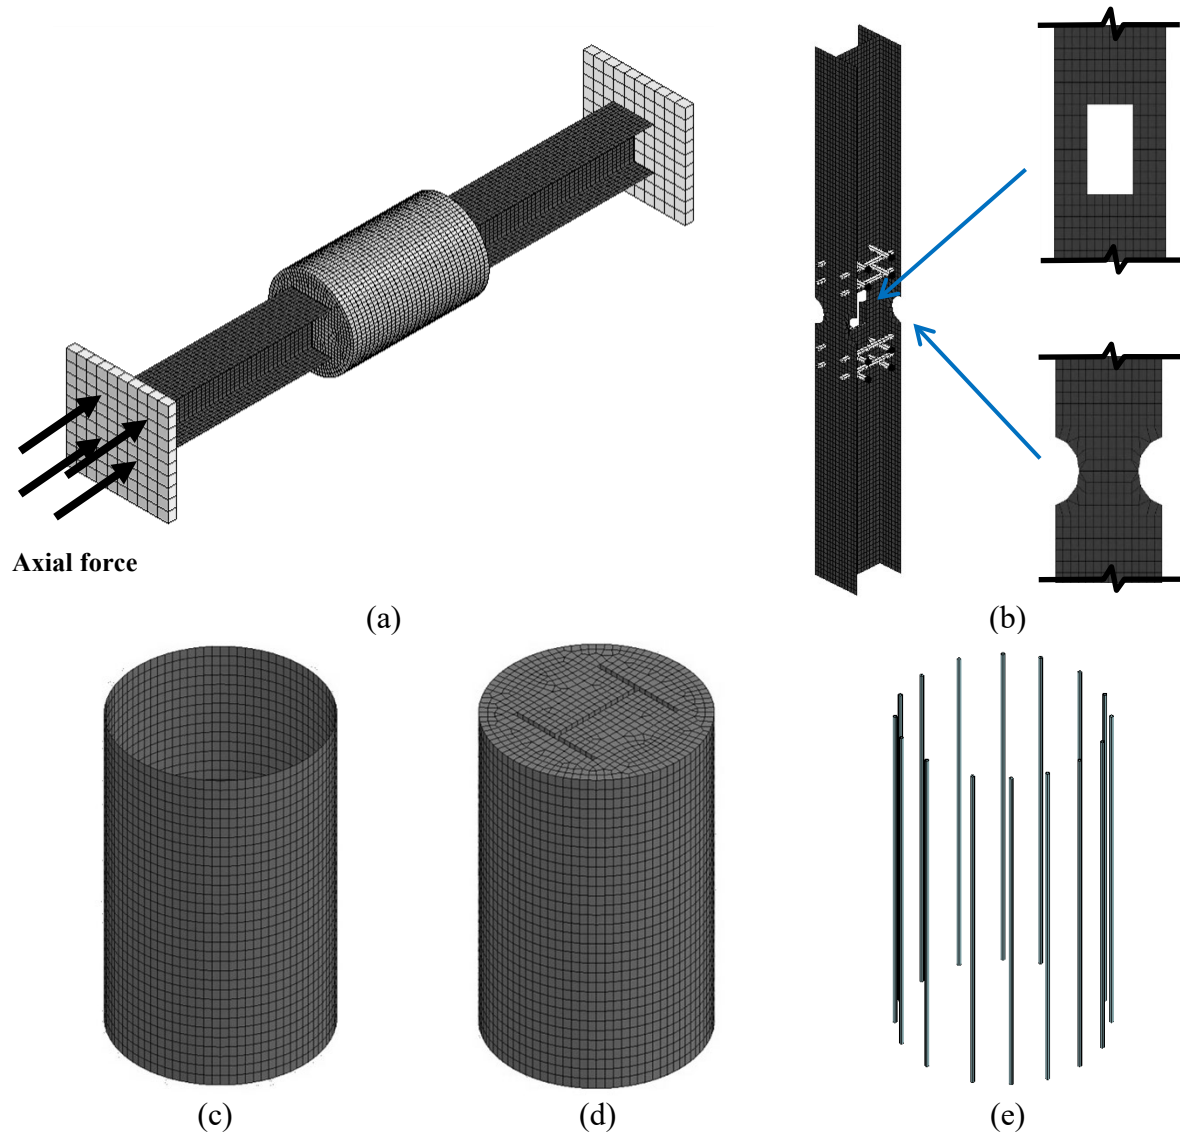
Figure 4.2 FE modeling: (a) 3D view of the repaired steel pile, (b) steel H-pile, (c) CFRP tube, (d) concrete filling, and (e) steel rebar.

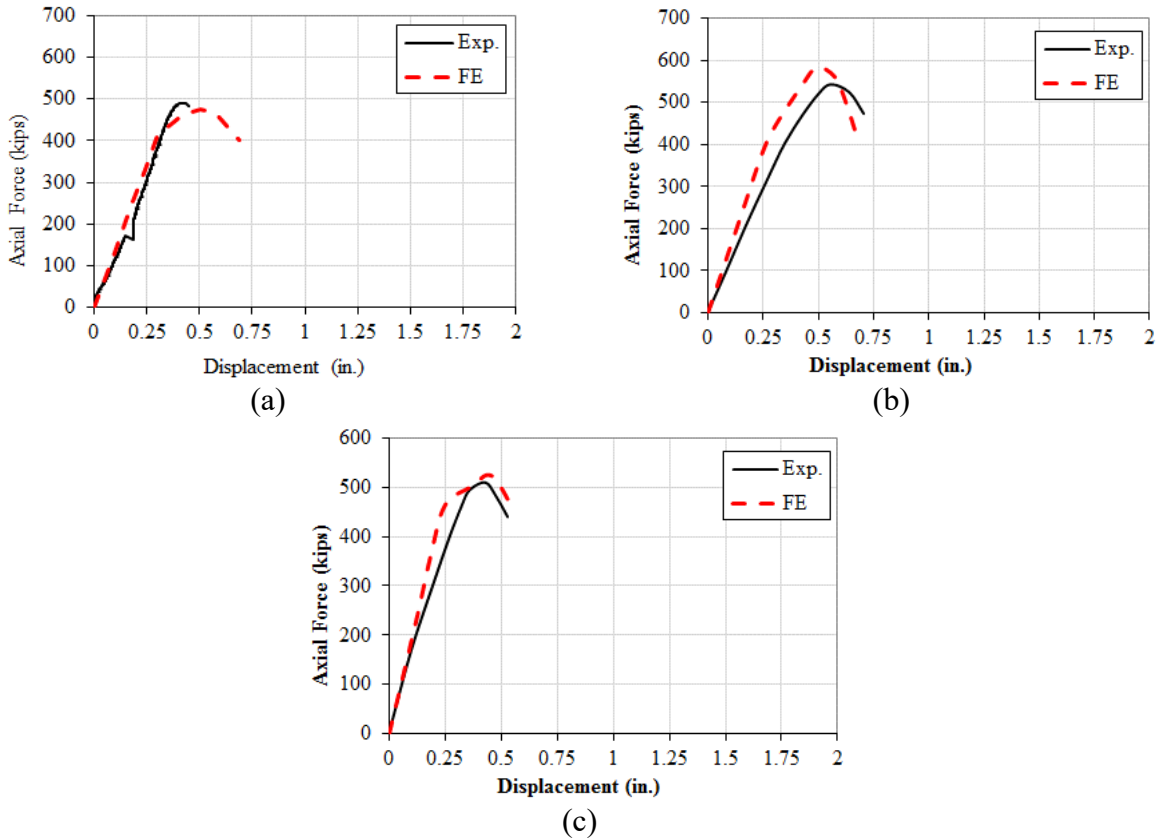
Figure 4.3 Axial load vs. displacement curves (a) R1, (b) R2, and (c) R3.

The repaired piles with 70% void in the web and 50% cut in the flange thickness demonstrated a localized failure mode in the experimental test. The FE model was able to predict the axial-load displacement response and pre-peak behavior for the piles accurately. Comparison of the measured and predicted responses and peak loads for these piles suggests that failure was imminent. For the piles with 70% reduction in the thickness of the flanges, the onset of non-linearity of the repaired piles was predicted accurately. However, the initial stiffness was accurately predicted for the retrofitted steel pile R1, while it was 10% and 6% higher than the measured values for piles R2 and R3, respectively.

This occurred as the steel piles underwent large plastic deformation during straightening the piles prior to the repair. Hence, large residual stresses were generated, and it was difficult to simulate them accurately in the FE.

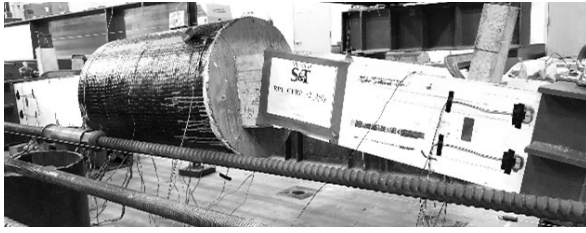
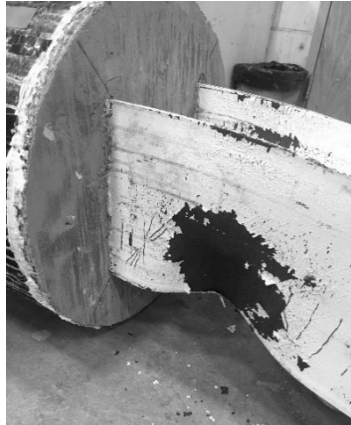
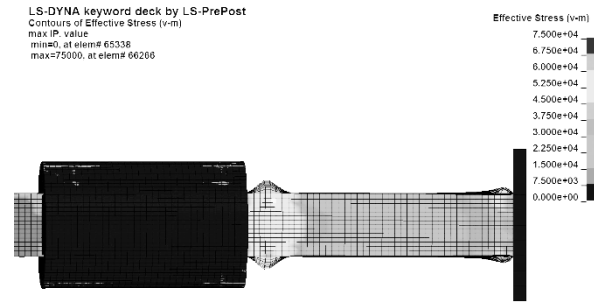
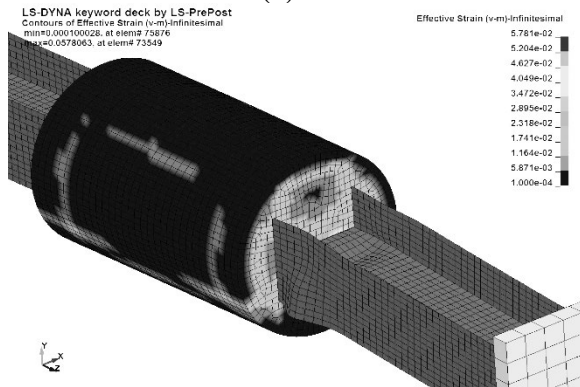
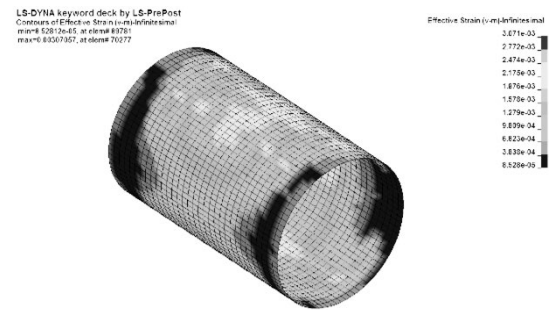
Figure 4.4 Failure modes of the simulated repaired pile R1 (a) exp., (b) FE whole system, (c) Exp. steel pile localized buckling, (d) FE steel pile localized buckling, and (e) concrete encasement stress concentration

The predicted failure modes of the simulated piles R1 and R3 were flange local buckling outside of the repaired region followed by global lateral deformation (Figs. 4.4). As shown in Figure 6.14, by comparing the deformed shape of the tested piles and the corresponding deformed shape obtained from the FE models, the model accurately predicted the failure mode and deformation pattern of these two tested piles (Fig. 4.14). Figure 6.14 (a and b) shows the global deformation of the repaired pile after 12.7 mm (0.5 in.) axial displacement.

Figure 4.4 (c and d) shows a closer view of the steel pile-damaged region, where the steel pile section yielded and then buckled at a distance of 940 mm (37 in.) from the loading plate. Figure 4.4 (e) reveals some stress concentration appeared in the simulated concrete encasement, observed as minor cracks in the experimental test (Fig. 4.5). Figure 4.4 (f) indicates stress concentrations in the middle of the CFRP jacket at the ultimate loading stage.

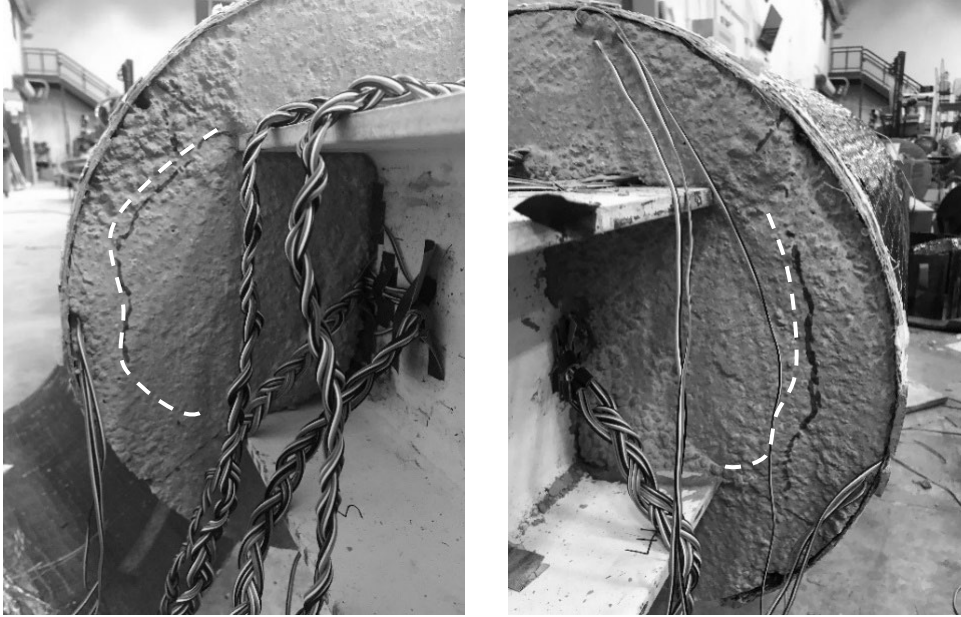
Figure 4.5 Stress concentration at the tips of flanges on the concrete encasement.

This is due to the thinnest CFRP jacket used in R1 (2-ply) method compared to the other methods (with 4-ply) was less stiff in the hoop direction. Moreover, the large concrete encasement expansion occurred in that region. No rupture was found in the simulated CFRP jacket, matching the experimental test observations. Figure 4.6 indicates stress concentrations at the tips of the flanges in the CFRP jacket at the ultimate loading stage for pile R2. This pile demonstrated rupture of the CFRP jacket, which occurred along the tips of the bottom flange of the simulated pile.

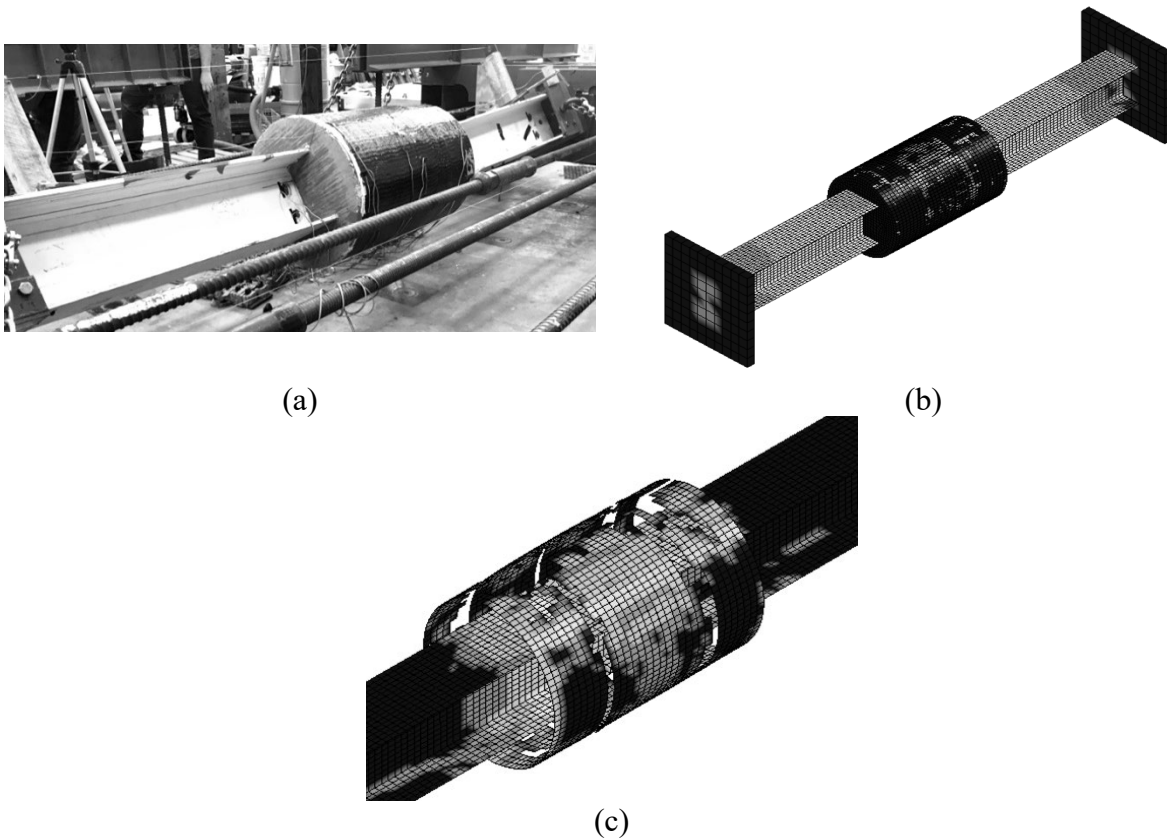
Figure 4.6 Failure modes of the simulated repaired pile R2 (a) exp., (b and c) FE.

The FE model shows a large concrete encasement expansion at the flange sides towards the CFRP jackets leading to high hoop stress on the latter followed by rupture. However, this was not observed with the tested pile using R2 where no CFRP rupture was noticed (Fig. 4.6).

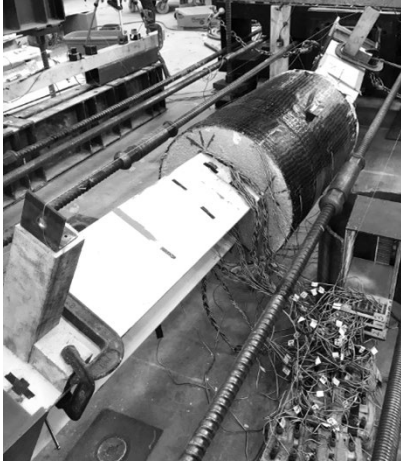
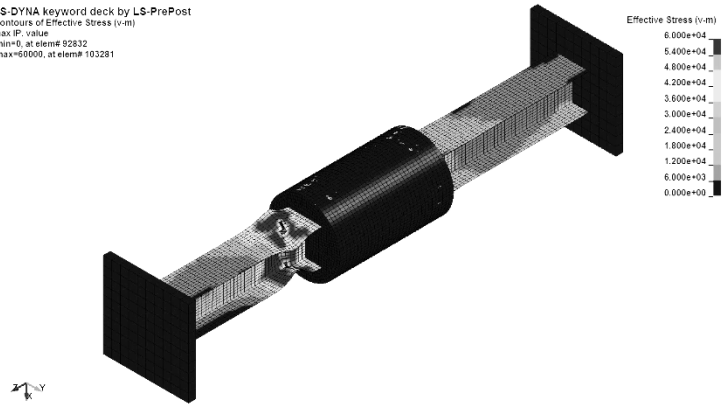
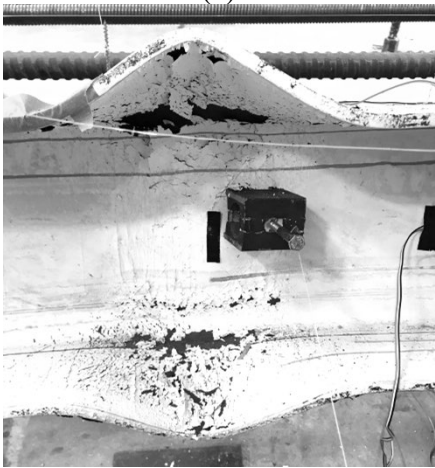
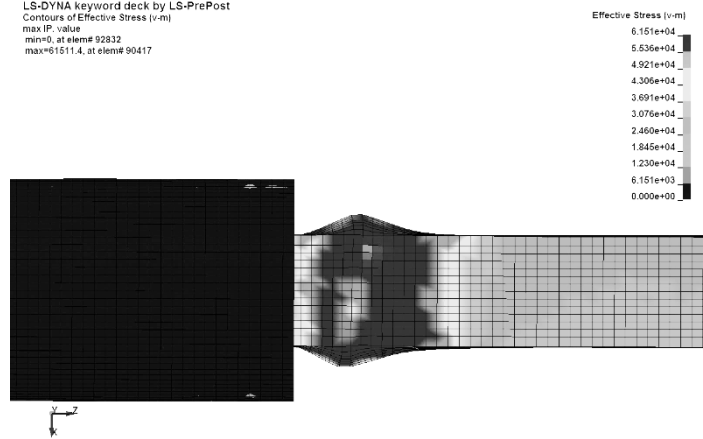
Figure 4.7 Failure modes of the simulated repaired pile R3 (a and c) exp., (b and d) FE.
