MPC 24-536 | S. Ni, A. Sorensen, I. Unobe and A. Pokhrel

IMPACT OF VEHICLE FIRES  
ON POLYMER CONCRETE  
BRIDGE DECK OVERLAYS

# **Impact of Vehicle Fires on Polymer Concrete Bridge Deck Overlays**

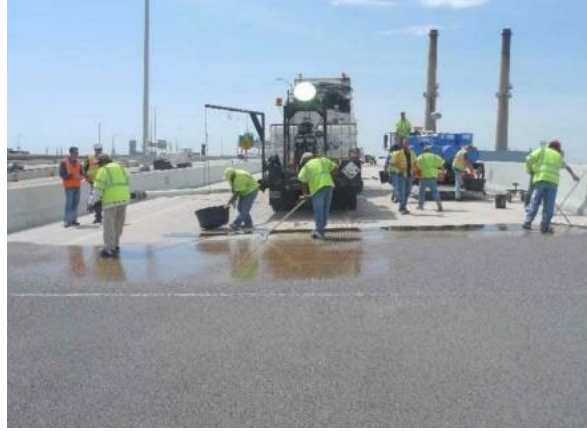
**Figure 2.1** Overlaying concrete bridge deck with polymer concrete [23]

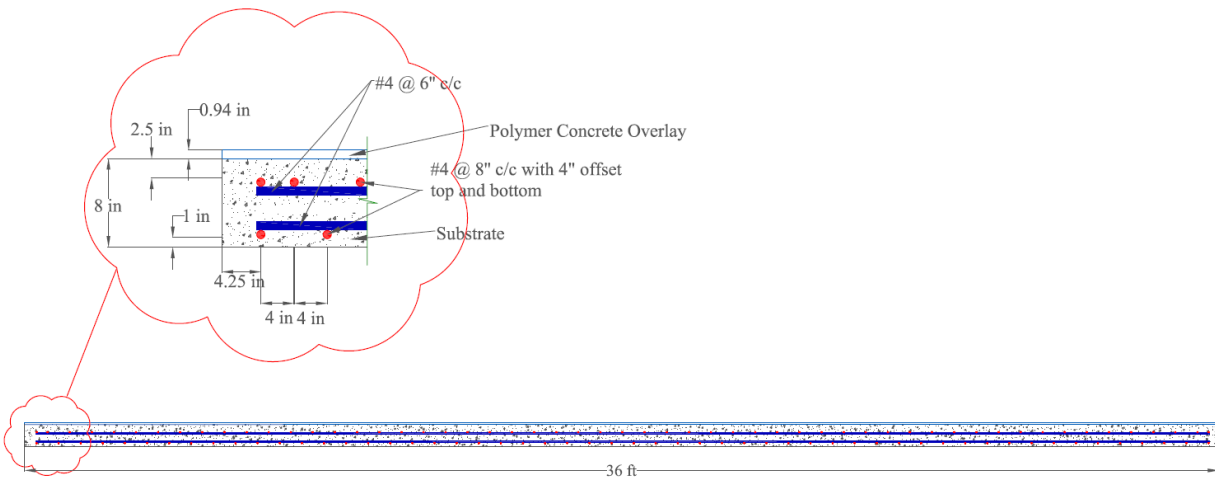
**Figure 3.3** Section A-A

The layout of reinforcement is shown in Figures 3.1 to 3.3. Figure 3.1 shows the plan view of the reinforcement layout, while Figures 3.2 and 3.3 show the cross-section view of the reinforcements for the 20 ft and 36 ft directions, respectively. Call outs are used to offer a detailed view of the reinforcements in both cross-section figures. Figure 3.4 shows the various stages of the construction process for the concrete slab.

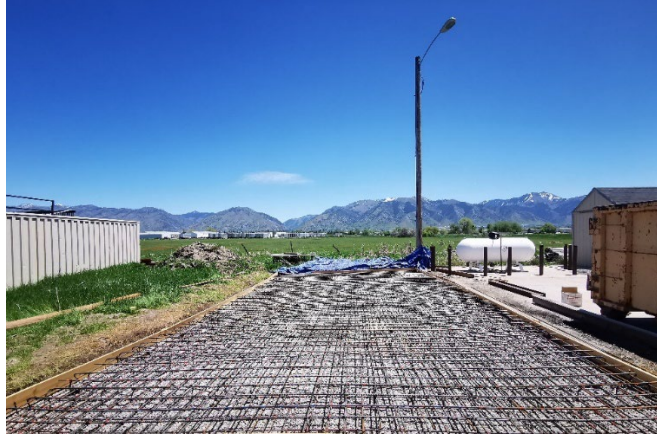
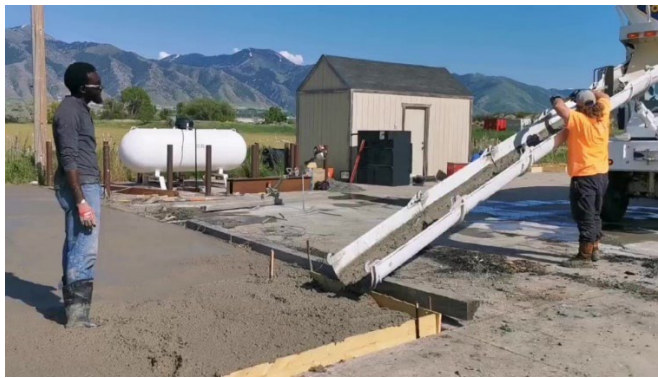
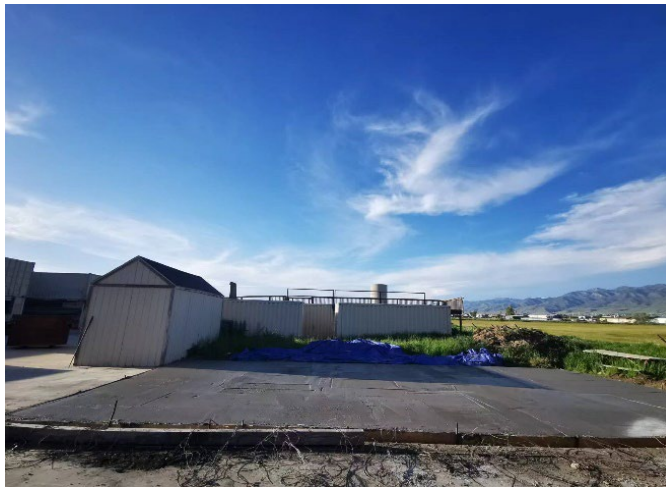
**Figure 3.4** a) Rebar placement for the slab b) pouring the concrete and c) the finished concrete after pouring

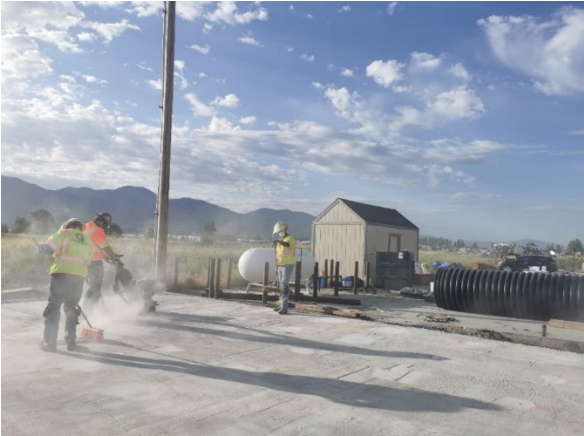
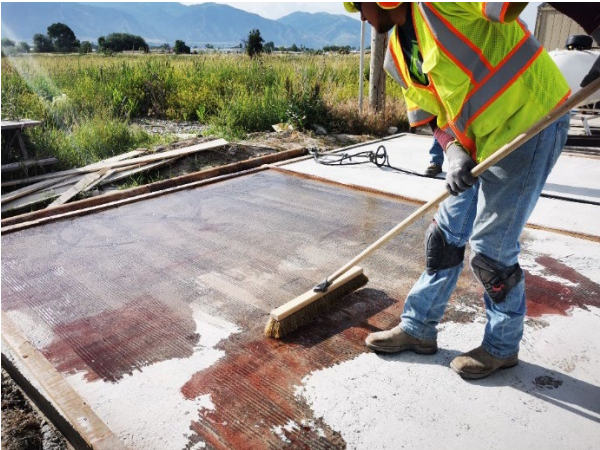
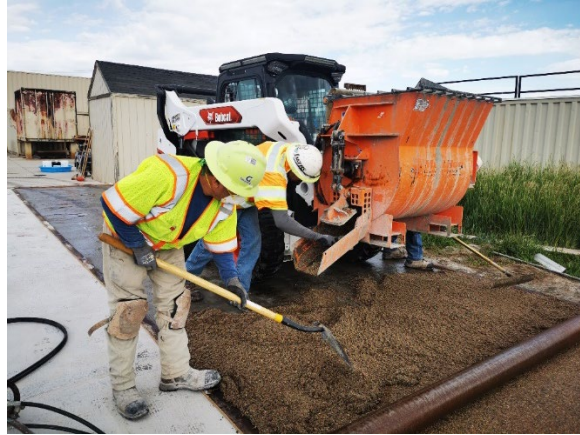
**Figure 3.5** Construction of polyester polymer concrete overlay a) preparing the surface using grinders, b) pouring the HMWM primer, and c) pouring the PC

The HMWM resin primer was first mixed and applied uniformly to the concrete surface immediately after mixing. Next, the polyester resin and hardener were blended. This was then mixed with the aggregate in a mixer until uniform in texture and appearance. This mix was then poured onto the prepared concrete slab after 15 minutes from the time of the HMWM resin primer application.

After leveling off the PC surface, finishing sand was then applied over the PC before initial set of the overlay. After applying the finishing sand, the PC was then allowed to cure for at least four hours before further work could be done on it. Figure 3.5 shows the various stages in laying the PC overlay on the concrete slab.

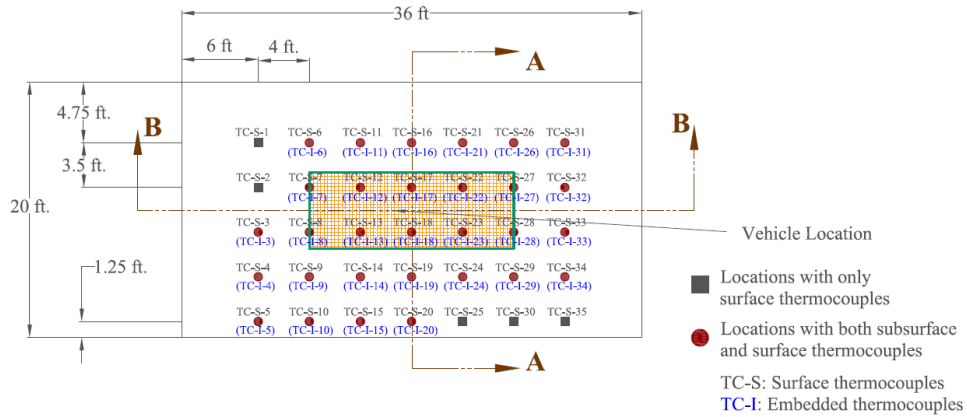
**Figure 3.6** Layout of thermocouple sensors at both the surface of the overlay and at the interface between the overlay and concrete

The thermocouples were distributed evenly across the panel. This placement was done to ensure that the thermal exposure of the panel surface and substrate concrete were adequately captured. Additional thermocouples were placed near the side closest to the gas tank, where temperatures were expected to possibly be significantly higher than elsewhere on the panel. Thus, collecting more temperatures in this region proved useful for analyzing the effects of the temperature on the panel. Figure 3.6 shows the position of the thermocouples across the surface of the panel. Each thermocouple wire was extended at least 15 feet beyond the edge of the panel for safety to ensure that all personnel and equipment used in collecting the data stayed at a safe distance from the fire. Table 3.1 shows the different types, location, and quantity of sensors used in the experiment.

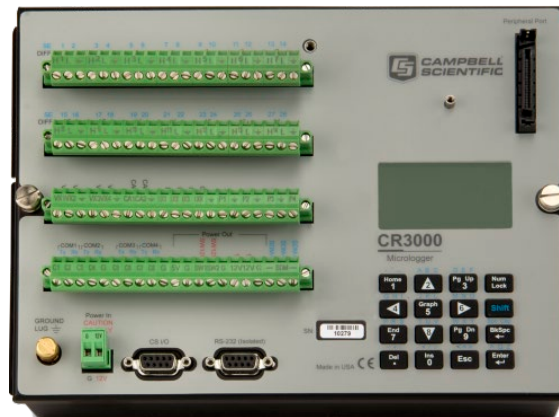
**Figure 3.7** CR3000 Data Acquisition System

Several data acquisition systems from Campbell Scientific Inc. (CR 1000, CR1000X and CR3000) were used to collect the temperatures over the test duration. The data acquisition frequency was set to 1s, thus meaning a temperature and heat flux was recorded from each thermocouple and heat flux sensor every second over the duration of the test. An example of a data acquisition system is shown in Figure 3.7.

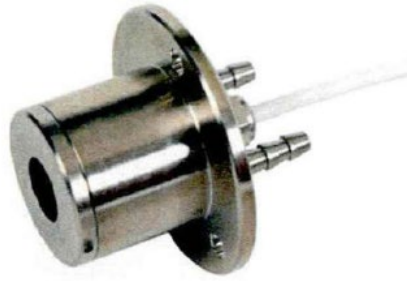
**Figure 4.5** MedTherm 64 series heat flow meter

Beyond temperatures, flame radiation is another important parameter to quantify the thermal harm of flame to the surrounding environment. Two heat flux meters were installed to measure the radiant heat flow at the back and on one side of the burning vehicle to quantify the heat radiation flux at these locations. These sensors were placed 12 feet from the center of the vehicle (around 9 ft from the edge) and 18 feet from the center (around 10 ft from the edge), at the side and rear, respectively, with both at a height of 4 feet from the panel surface, as shown in Figure 4.4. MedTherm 64 series water-cooled protection wide-angle heat flux sensors, with a range of  $10\text{kW}/\text{m}^2$ , were used in the test [74]. These Schmidt Boelter type sensors measure both radiant heat flow and convective heat flow. During the experiment, the heat flow meters were continuously water cooled to ensure the accuracy of measurements. Cooling the heat flux gauges with water helped to ensure that their surfaces remain close to the ambient temperatures, maximizing the convective heat transfer and minimizing radiative losses. The gauges' surfaces are also coated with high emissivity paint to maximize the absorbed radiation. Figure 4.5 shows an example of a heat flux sensor used, and Table 4.2 gives the parameters of the sensor.

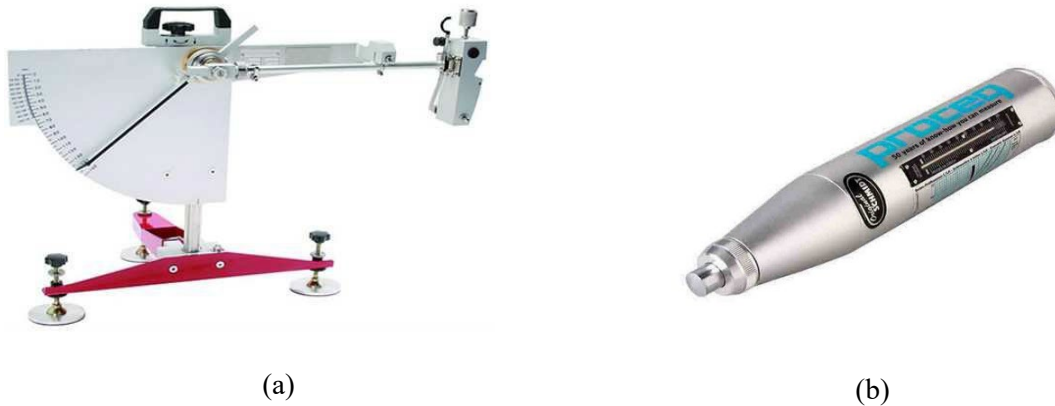
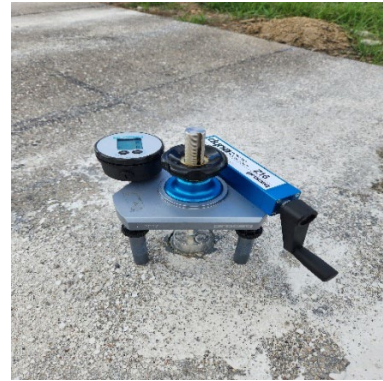
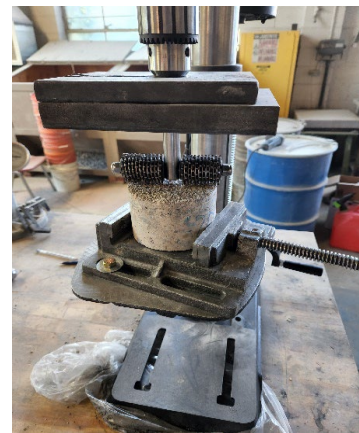
**Figure 5.1** Instruments and equipment used for the performance tests: a) British pendulum tester for skid resistance, b) Rebound hammer for surface hardness, c) FLIR T640 IR camera for delamination, d) Proceq Dyna Z16, e) Falling head setup for water penetration, f) Setup for abrasion resistance tests, g) Wenner probe array for resistance to chloride penetration tests

Figure 5.1 shows the instruments and equipment used for the different tests. To determine control values for the destructive test, 4-inch cores were collected from an extension made to the main slab, constructed to the same specifications and at the same time as the area to be tested. Other cores were also made in this area to test the strength of the PC overlay to substrate concrete bond before the vehicle fire. These control tests enabled a comparison of the test results before and after the fire and quantitatively determined the changes to the PC material due to exposure to high temperatures. The locations for the pre-fire tests and the drilled cores are as shown in Figure 5.2, and the number of tests for each experiment is shown in Table 5.1.

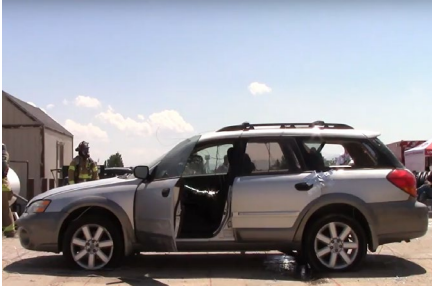
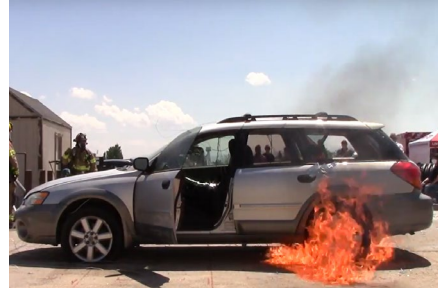
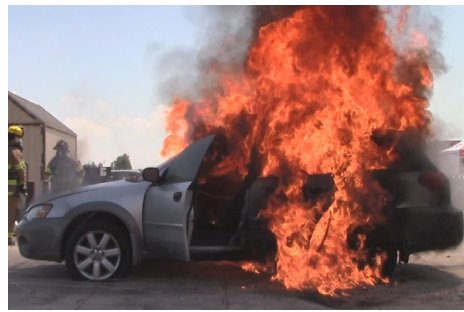
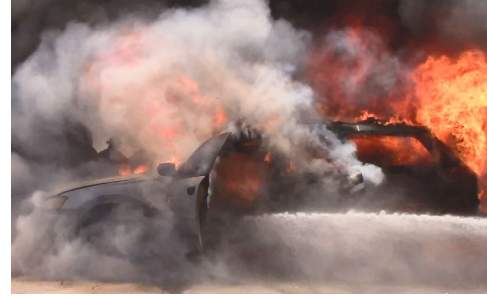
138	Small explosions due to the ignition of rear airbags.	225	Firefighters began to put out the fire

**Figure 6.1** Burning process of the vehicle fire

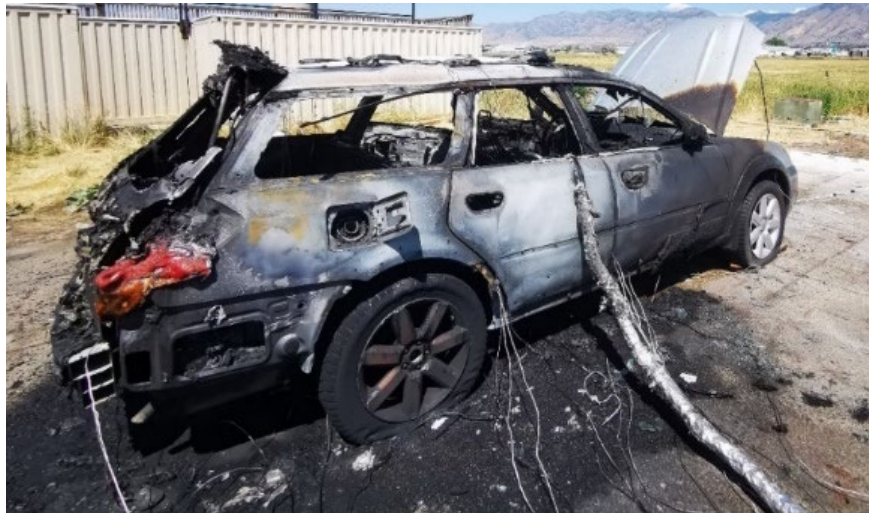
**Figure 6.2** Burned vehicle

Figure 6.2 shows the burned vehicle after the test. Most of the vehicle sustained significant damage, but the front and engine compartment were relatively undamaged due to the intervention of firefighters to put out the fire. Later examination of temperature data shows that the temperatures within the engine compartment did not rise significantly. The short duration of the fire limits the possibility of extrapolating the results to longer lasting fires and the response of PC overlays exposed to such scenarios. Also, during the test, firefighters consistently used water hoses on surrounding infrastructure to keep them cool and prevent the spread of the fire beyond the panel. The water from the hoses could potentially have affected the vehicle fire.

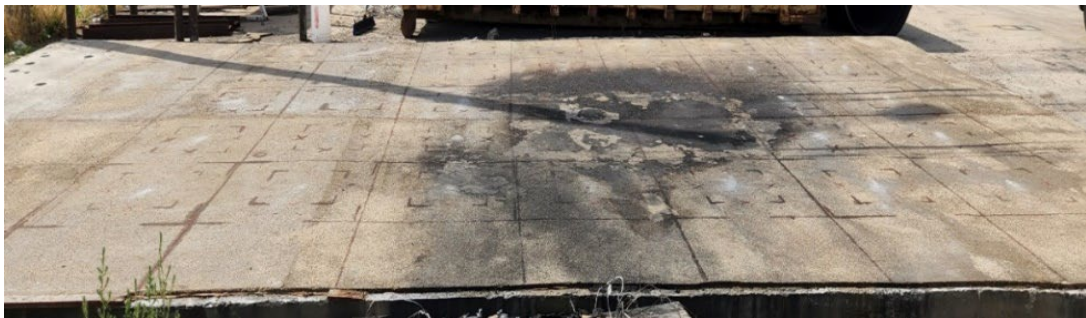
**Figure 6.5** Post-fire surface of the panel

After the vehicle fire, the burnt vehicle was removed from the panel and the surface cleaned of debris using water and a brush. Figure 6.5 illustrates the extent of damage caused by the vehicle fire on the panel after the surface was cleaned. It is evident that the fire damage is concentrated in the area directly under and around the vehicle's location. This is due to the proximity of this area to the burning vehicle. It was observed that some of the finishing sand placed on the PC overlay had started peeling off due to the degradation of the polymer resin and the water flushing. The polymer resin in some parts of the panel surface experienced thermal decomposition, leaving the surface charred. Other parts of the panel surface do not show these effects. The subsequent observation of the temperatures recorded in different areas reveal that the areas showing these visible effects were also those which recorded significant temperature increases. As a result, the post-fire investigation of the panel's properties was focused on this specific area.

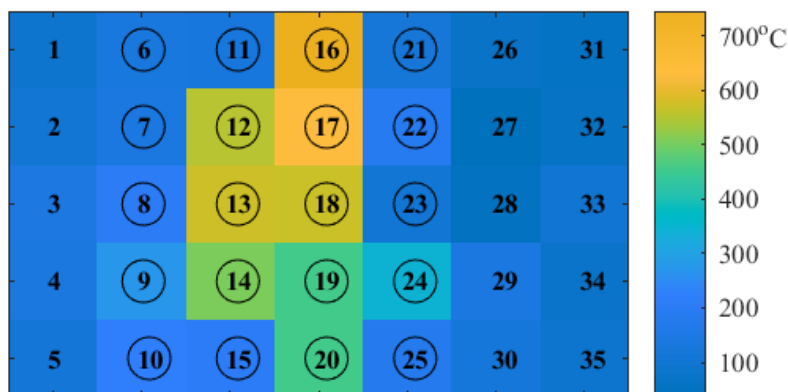
**Figure 6.7** Maximum recorded temperature at different locations over the surface (circles shows the locations for post-fire test sampling)

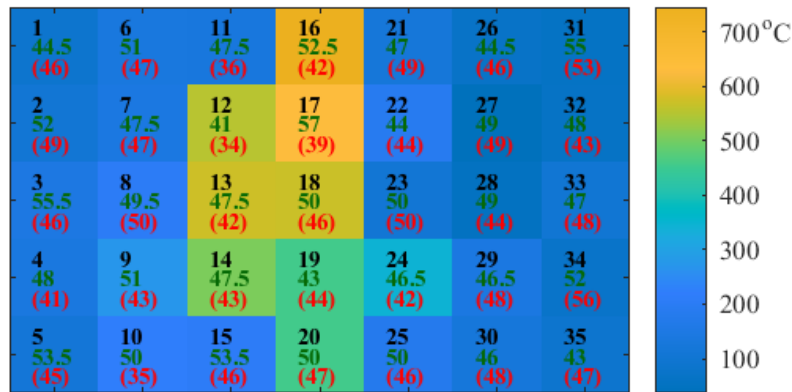
**Figure 7.2** Pre-fire and post-fire surface hardness results (green values are pre-fire surface hardness and red values are post-fire surface hardness)

Similar to the skid resistance test, the surface hardness tests were carried out on the same locations prior to and after the vehicle fire test. Figure 7.2 presents the results of these non-destructive tests at the specific locations where they were conducted both before and after the vehicle fire. The figure includes a thermal map of the surface with the maximum recorded temperature at each location, the location indices, and results (pre-fire results are in green and post-fire results are in red and brackets) for the surface hardness tests. A decline in the surface hardness due to the fire exposure can be observed across the surface. Over the entire surface, this resulted in an average drop in hardness from 48.8 to 45.7, representing an 8% decrease. Within the areas exposed to very high temperatures from the vehicle fire (between locations #6 and #25, as indicated in Figure 6.7), this change was more pronounced with the surface hardness reducing from 48.8 to 43.6 after the vehicle fire, representing an 11% drop in surface hardness.

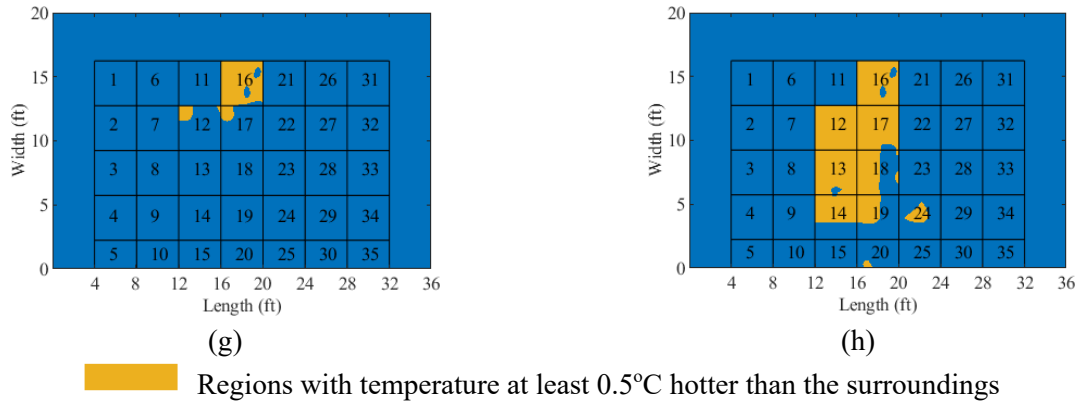
**Figure 7.3** Panel surface a) thermal map before fire exposure, b) thermal map after fire exposure, c) thermal map before fire test with average temperatures subtracted, d) thermal map after fire test with average temperature subtracted, e) hot spots before fire exposure identified within each sub image, f) hot spots after fire exposure identified within each sub image, (g) hot spots before fire exposure identified by comparing hot areas with cool areas, (h) hot spots after fire exposure identified by comparing hot areas with cool areas.

Although the described processing steps helped mitigate the effect of environmental variations, they did not entirely eliminate these effects. Ideally, alternative methods such as using UAVs to capture thermal images of the entire panel in a single thermal image could further mitigate this issue, reducing the impact of environmental changes, and ensuring that the temperature differentials obtained are more reliable for assessing delamination.

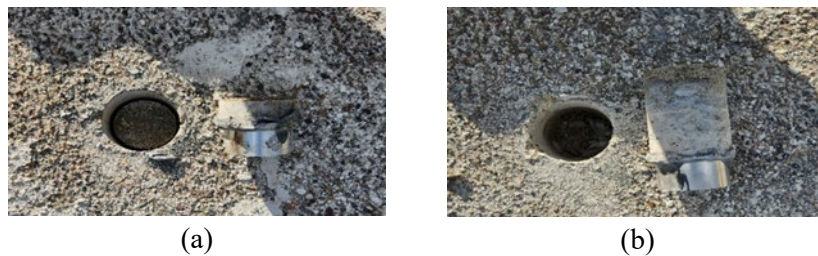
**Figure 7.4** Failure modes recorded during bond strength tests a) bond failure and b) failure in substrate

To determine the nominal bond/tensile strength of the PC overlay to the concrete substrate, five tests were carried out at the added-on section of the slab. Failures that occur in the substrate concrete are recorded as tensile strengths, while those that occur in the bond between both materials are recorded as bond strength. The resulting strengths from these tests range from 298 psi to 327 psi. The resulting average strength of the samples was computed as 312.7 psi. Four of the tests resulted in failure in the substrate concrete and one resulted in failure in the bond between the overlay and the substrate concrete. This indicates that the bond strength of the overlay exceeds the tensile strength of the underlying concrete. Figure 7.4 provides examples of the two different failure modes as they occurred at different areas of the surface. After the vehicle fire, similar tests were carried out around the locations marked out in Figure 6.7, and the failure modes recorded for these tests are shown in Figure 7.5. In the figure, the colors represent the maximum temperatures recorded during the test, and the circled numbers indicate areas where the failure mode was bond failure. It is evident that bond failure prevailed in the tested regions of the panel, rather than concrete breakout, which differs from the findings of the pre-fire tests. The increased observed bond failures indicate a clear reduction in bond strength due to heat exposure. Notably, these areas experiencing bond failure align with the regions exposed to the highest temperatures during the vehicle fire test.

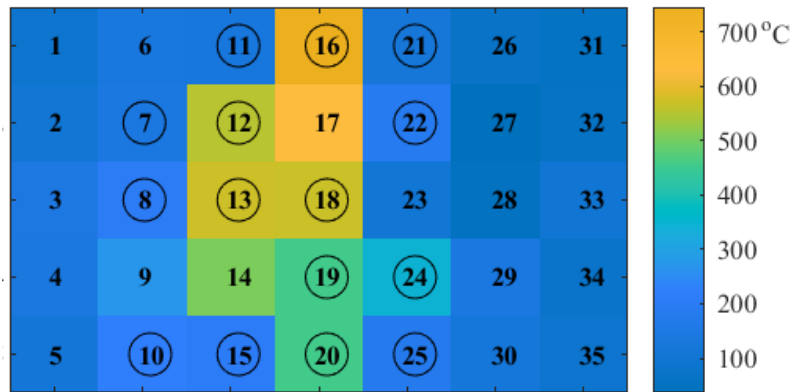
**Figure 7.5** Failure mode in bond strength test (colors represent the maximum recorded temperatures, and the circles around numbers represent locations with bond failure).

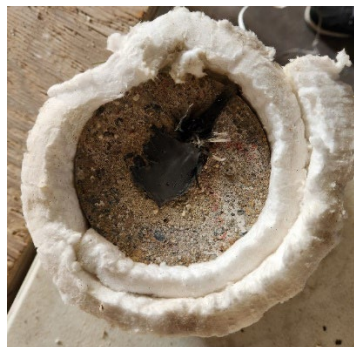
**Figure 7.6** A core sample with PC overlay insulated before exposing to heat in a furnace

As explained in Section 5.5, the water penetration test was carried out on the same samples before and after heat exposure to eliminate any variability in coefficient of permeability attributable to variations in material composition among different samples. The coefficients of permeability in the water penetration tests were determined using the falling head principle. Each sample was insulated leaving only the PC surface exposed, as shown in Figure 7.6, and then exposed to one of two different temperatures (350°C and 700°C) for a specific duration (60 seconds, 180 seconds, and 300 seconds) at a rate of heating of 3°C/s to mimic the exposure of the panel to high temperatures during the vehicle fire test.

The falling head test was repeated after allowing the samples to cool down to ambient temperature, and the relative change in permeability at different temperatures computed and used to characterize the change in permeability of the PC overlay after exposure to high temperatures. The results of water penetration tests are shown in Table 7.1. Table 7.1 shows a notable increase in the coefficients of permeability in the samples after the vehicle fire test. As the duration of heat exposure increases, so does the relative increase in permeability, with a particularly high 370% increase in this value for those samples exposed to 700°C for five minutes. This indicates a reduction in the ability of the overlay to resist water ingress after exposure to high temperatures. This increase in permeability also increases the exposure of the substrate concrete to water and chemicals, which can lead to further damage and deterioration of the panel.

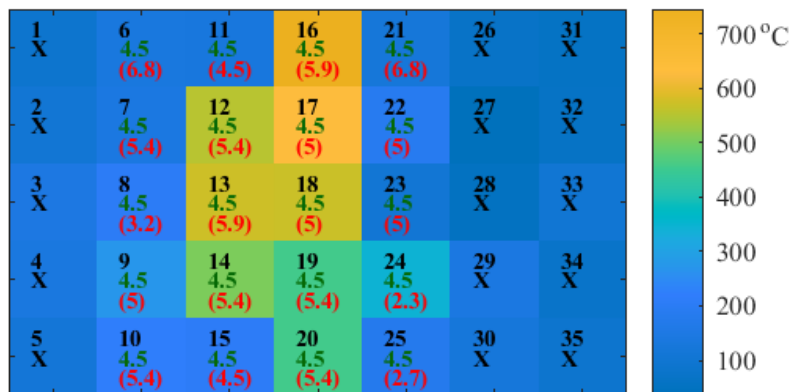
**Figure 7.7** Pre-fire and post-fire abrasion resistance results. The change in weights overlaid on the surface temperature map (green values are pre-fire weight changes and red values are post-fire weight changes. “X” indicates areas where no cores were taken) (units are grams).

The abrasion resistance of a sample is determined by measuring the amount of material removed using rotating cutters. This is done by comparing the weight of the sample before and after running the cutters on its surface. For the pre-fire tests, five core samples were tested, and the average weight loss of the samples was computed. This average value is considered as the expected weight loss for the PC surface and describes its abrasion resistance. After the vehicle fire, a core sample was collected from each location marked in Figure 6.7 and tested. The results of the abrasion resistance tests, including both the pre-fire average value and the post-fire location-specific values, are presented in Figure 7.7. Each location on the figure includes a location index number, the average change in weight of core samples prior to the vehicle fires (in green), and the change in weight of the sample collected at the location after the vehicle fire (in red and brackets). The background color of each area represents the maximum temperature recorded in the area. The weight loss after abrasion testing was found to be greater in the samples that were exposed to the vehicle fire compared with the pre-fire average (4.5g weight loss for samples before the vehicle fire compared with 5g weight loss after the fire, representing an average of 11% increase in weight loss). This suggests a reduction in the abrasion resistance of the overlay. This decrease in abrasion resistance can be attributed to thermal degradation of the polymer matrix, resulting in a reduction of mechanical properties and increased susceptibility to wear and tear. This could lead to a reduction in the service life of the overlay and the need for regular maintenance and repair.

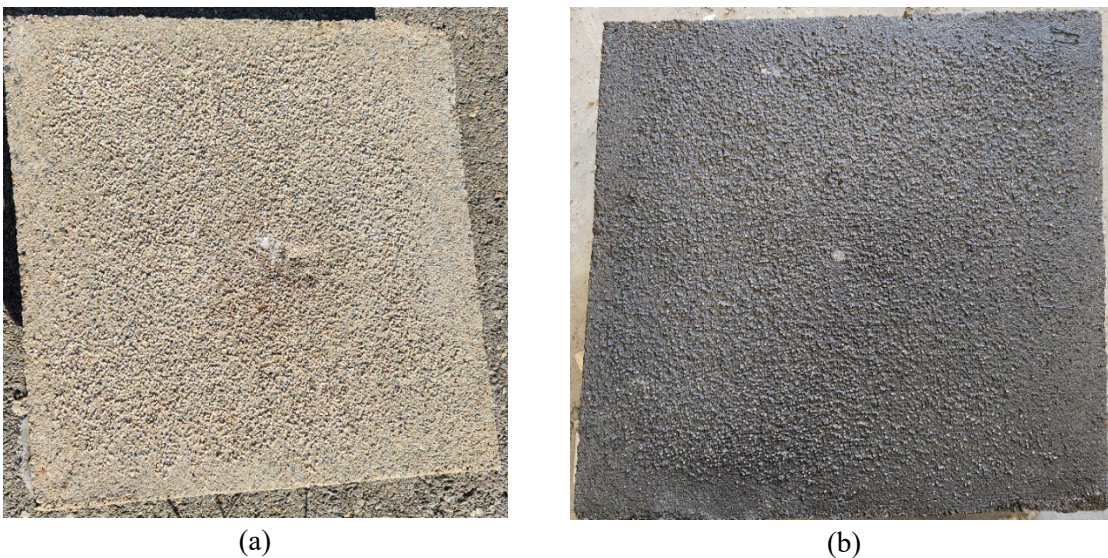
**Figure 8.1** Test slabs a) control slab without intumescent layer and b) slab with intumescent layer applied

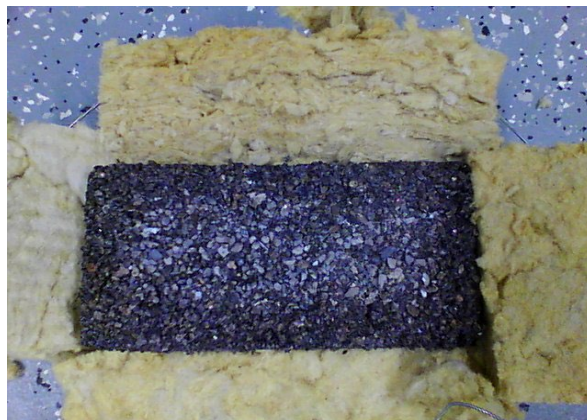
**Figure 11.1** Sample with sides insulated to prevent heat input from sides

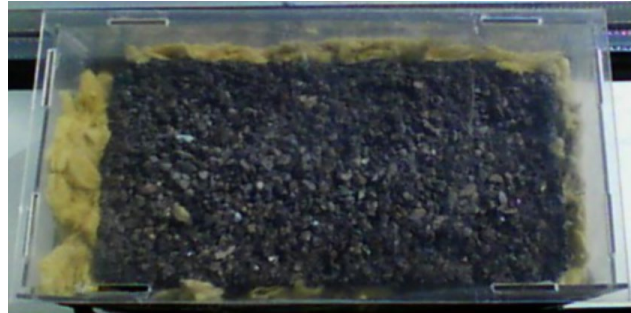
**Figure 11.6** Insulated sample in display case
