Field Evaluation of At-Grade Alternative Intersection Designs, Volume II—Safety Report

PUBLICATION NO. FHWA-HRT-24-155

OCTOBER 2024

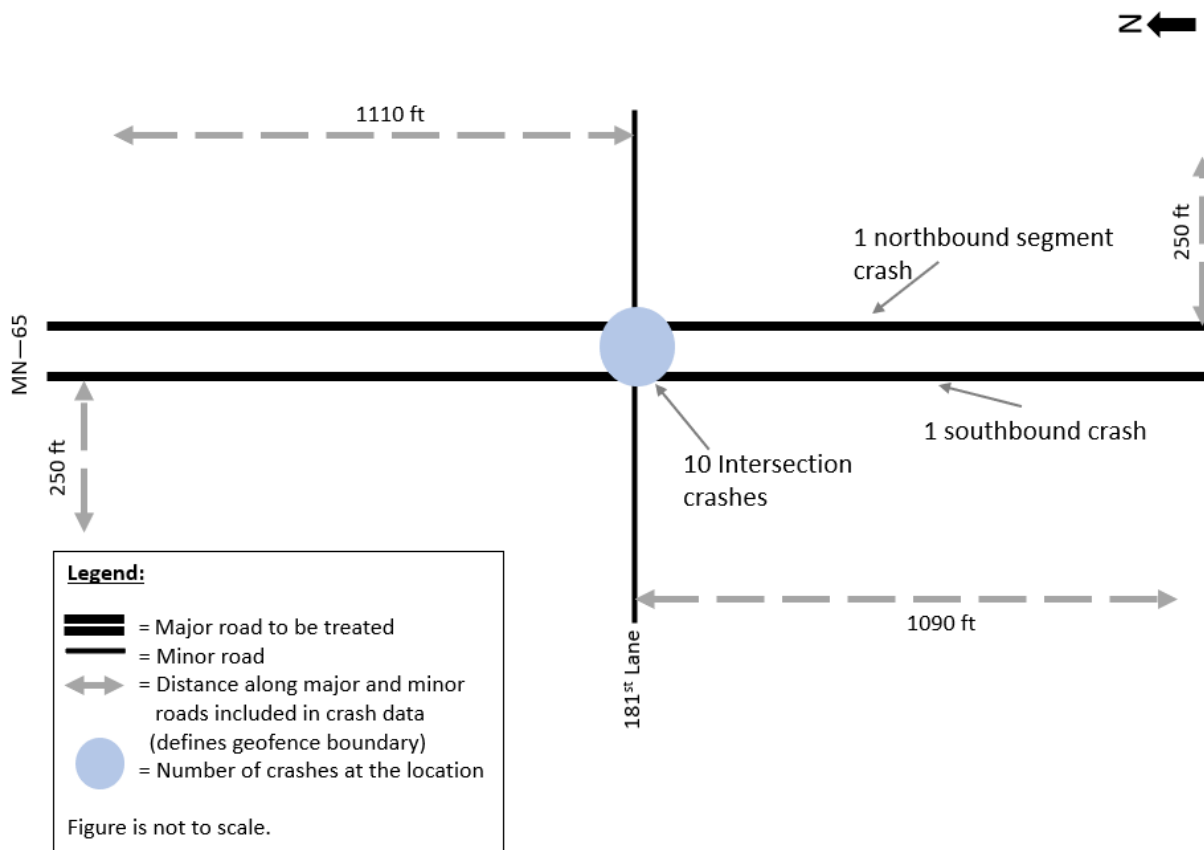
Figure 11. Illustration. Number of crashes by location for the before period (66 mo) for MN-65 at 181st Avenue Northeast.

The Minnesota Department of Transportation (MnDOT) converted the conventional unsignalized intersection at MN-65 and 181st Avenue Northeast to an unsignalized RCUT. Before construction of the signalized RCUT at 181st Avenue NE, the intersection experienced an average of 2.2 crashes per year (table 2). The number of crashes during the after period was similar to the before period (2.3 crashes per year). This observation suggests that the number of crashes remained almost constant throughout the total study period. This site experienced one fatal angle crash in 2013 and another fatal angle crash in 2016 (both occurred during the before period). The number of crashes per location is shown in figure 11 for the before period and in figure 12 for the after period.

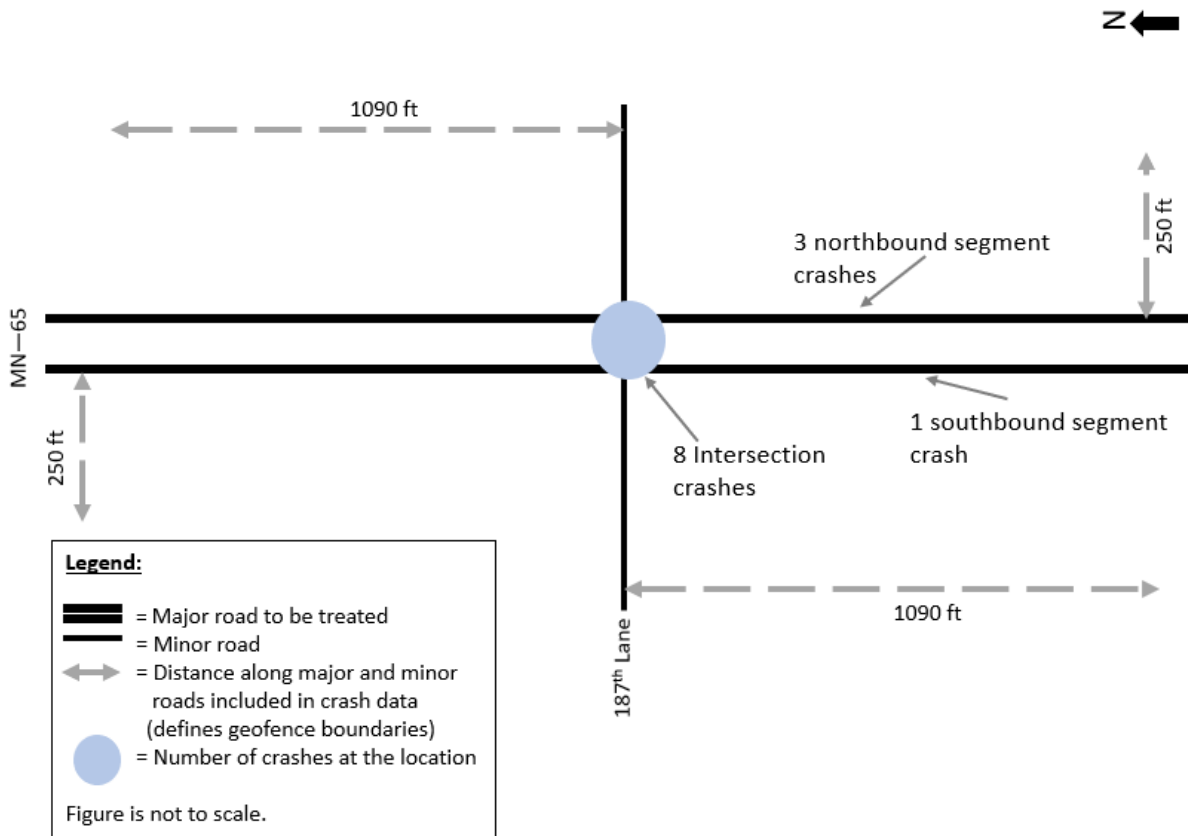
Figure 13. Illustration. Number of crashes by location for the before period (66 mo) for MN-65 at 187th Lane Northeast.

Before construction of the RCUT at 187th Lane Northeast, the intersection experienced an average of 2.2 crashes per year (table 2). Following construction, this number of crashes increased to 5.3 crashes per year. However, as previously noted, the sample size is small, so this observation cannot be statistically verified. Table 5 shows that the proportion of KABC crashes decreased in the after period, indicating that fewer fatal and injury-related crashes occurred. Figure 13 provides an overview of the number of crashes for the before period by location. Figure 14 provides that information for the after period. In both periods, the crashes occurred at the main intersection, with most being in the center of the intersection rather than on the minor road approaches.

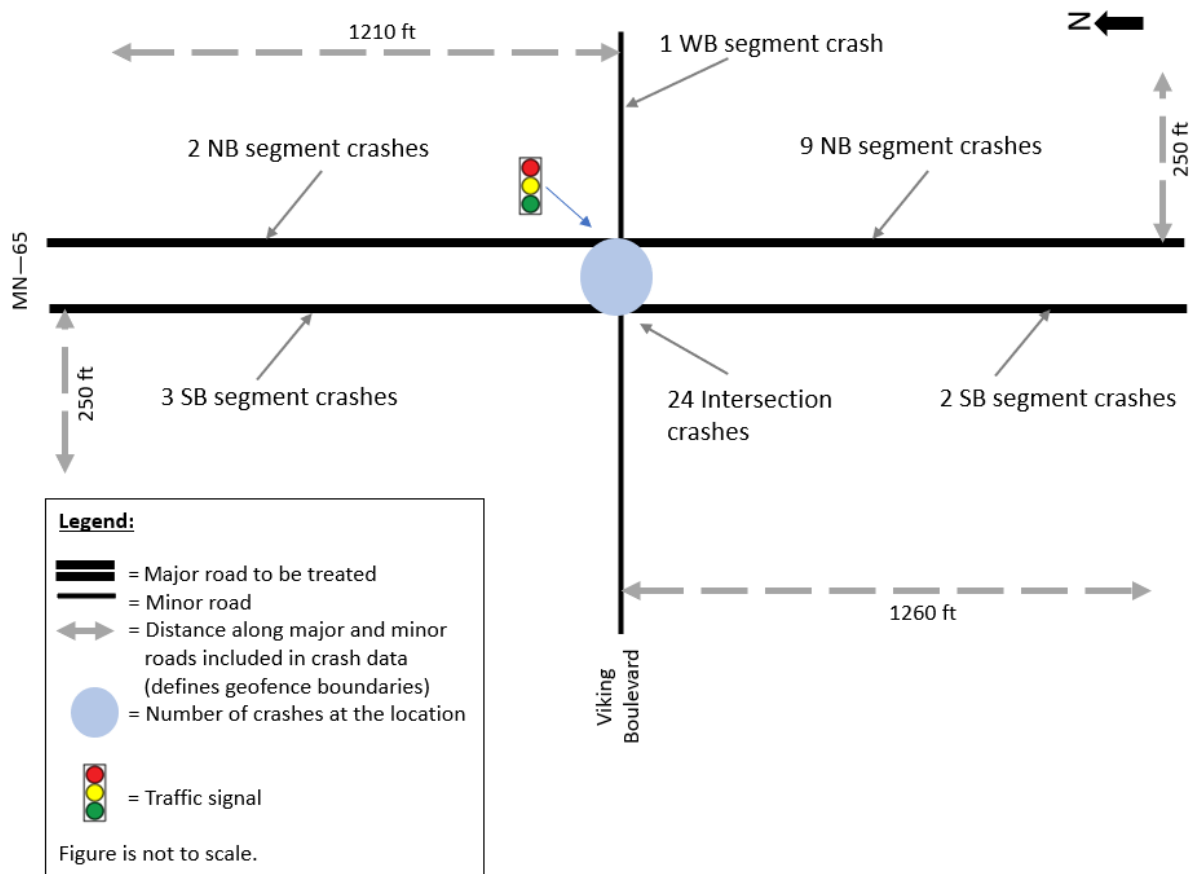
Figure 16. Illustration. Number of crashes by location for the before period (66 mo) for MN-65 at Viking Boulevard Northeast.

As indicated in the short bullet list at the beginning of chapter 4, the research team could only capture limited crash data and so conducted a simple before and after analysis comparison. The team assembled before and after data for the number of crashes and the severity of crashes at the Viking Boulevard Northeast signalized RCUT location. Figure 16 shows the number of crashes by location for the before period. Figure 17 shows that information for the after period. Most of the crashes occurred at the intersection for both the before and after periods.

Before construction of the signalized RCUT at Viking Boulevard NE, the intersection experienced an average of 7.5 crashes per year (table 2). Construction of the RCUT occurred from July 2018 through August 2019. Following construction, the number of crashes decreased to 4.5 crashes per year after excluding the crash data for 2020 because of COVID-19 (table 2). However, as previously noted, the sample size is small, so this observation cannot be statistically verified. A fatal crash occurred at the intersection in 2019 and another occurred in 2020. The 2020 fatal crash was an angle crash in the central intersection. The 2019 fatal crash was a single vehicle roadway departure. The total number of KABC crashes decreased by 9 percent from the before period to the after period (table 5).

Before the construction of the RCUT, the most common crash type at the intersection was the rear-end collision (table 6). Following construction, the most commonly observed crash types were rear-end and other crash types, as shown in table 6.

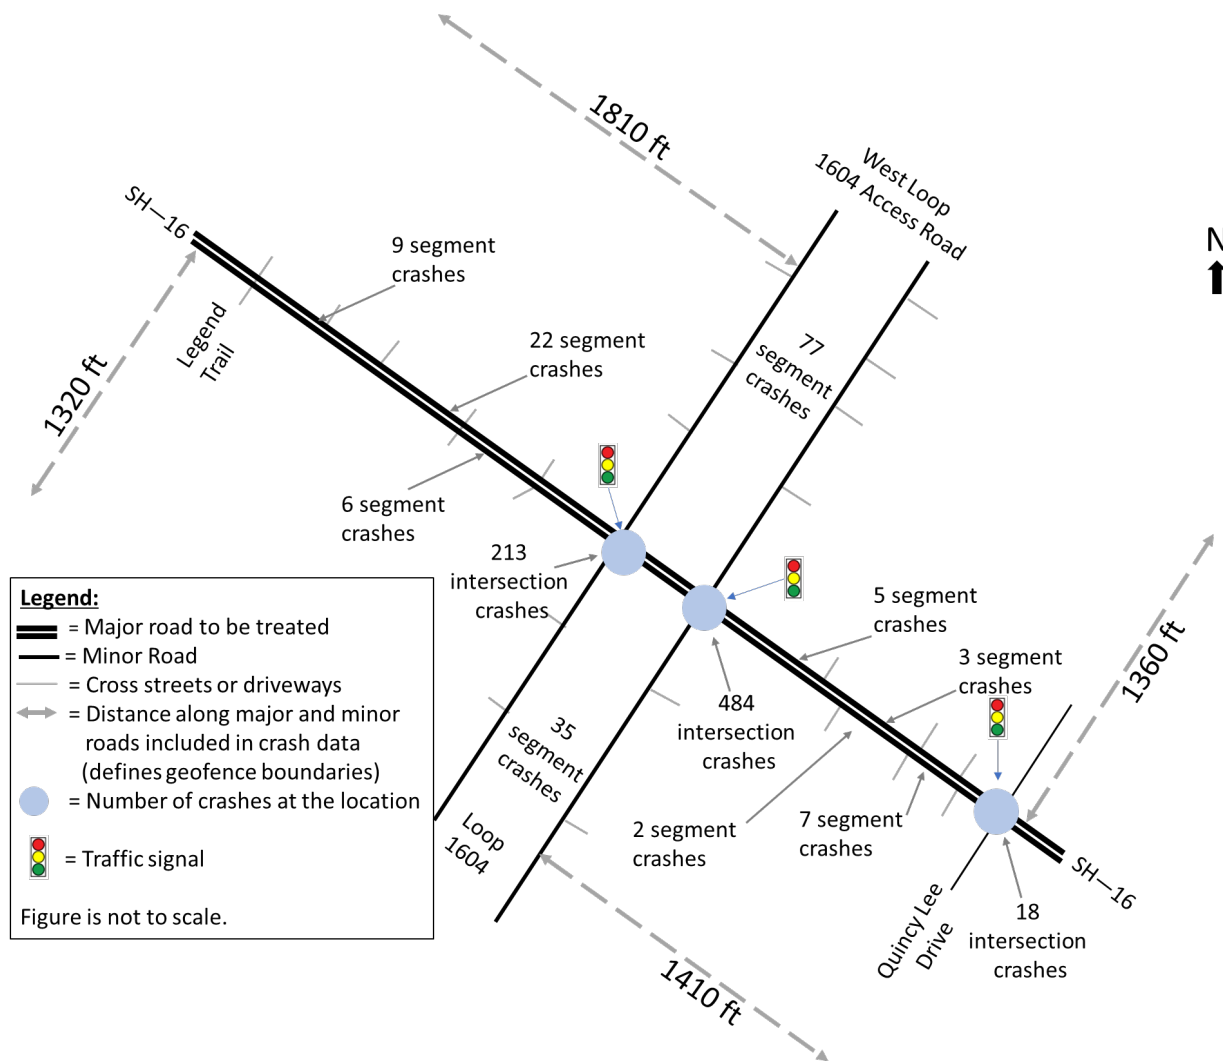
Figure 18. Illustration. Number of crashes by location for the before period (56 mo) for SH-16 at West Loop 1604 Access Road in San Antonio.

Figure 18 provides an overview of the number of crashes by location within the corridor for the before period. Figure 19 provides that information for the after period, which does not include the data for the COVID-19 period, year 2020. These figures also provide the limits of the crash data. Because the influence area for an alternative intersection can reach beyond the center of the intersection, the research team used a geofence for data boundaries. Figure 18 and figure 19 provide the limits used for this site. Texas crash data include the latitude and longitude of the crash, and these values were used to group the crashes to the nearest intersection or driveway. The latitude and longitude for crashes within a Texas freeway and frontage road corridor are coded to the centerline of the freeway, hence the presence of the crash counts along the center the freeway in figure 18 and figure 19. The research team removed any clearly identified freeway crashes from the analysis for this study.

As previously indicated, the research team could only capture limited after crash data and so conducted a simple before-after analysis comparison. Like the unsignalized RCUT analysis, the team assembled before and after data for the number of crashes, the severity of crashes, and the crash type at the Texas displaced left diamond location and for several hundred feet along each approach to the interchange. A traffic signal is located at the central intersection and upstream where the left-turn traffic crosses over to the outside lane (previously the Texas U-turn location).
