1. Report No. FHWA/TX-98/1265-2		2. Government Accession No.		3. Recipient's Catalog No.	
4. Title and Subtitle CONSOLIDATION OF CONCRETE WITH EPOXY-COATED REINFORCEMENT				5. Report Date April 1997

# **CONSOLIDATION OF CONCRETE WITH EPOXY-COATED REINFORCEMENT**

Research Report No. 1265-2

*“Structural Integrity of Epoxy-Coated Bars”*

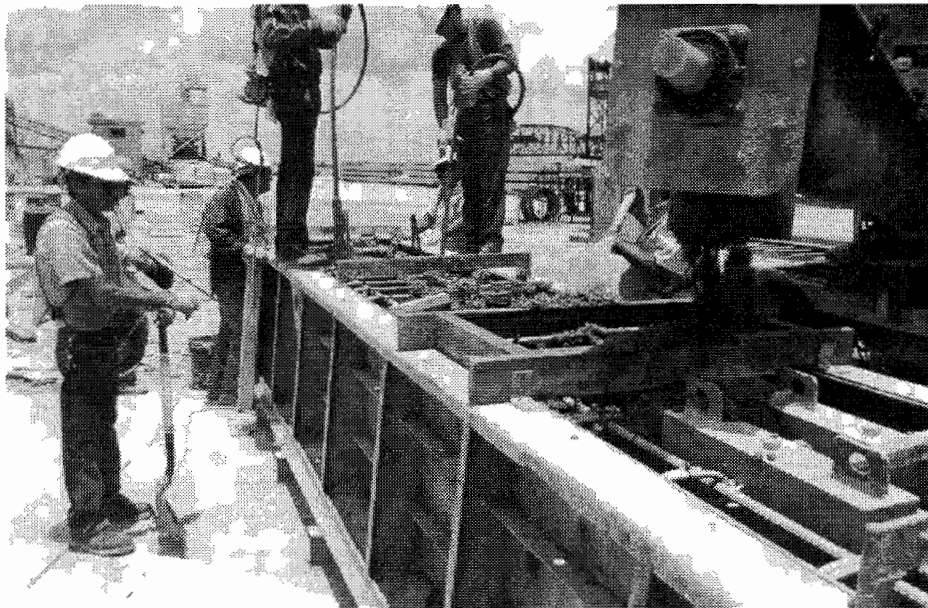
(a) Precast element reinforced with epoxy-coated steel

(b) Vibration of concrete in precast element

*Figure 1.2 Concrete placement procedure in precast pier cap*

Concrete placement is the last possible procedure during which the coating on reinforcement will be damaged before the rebar is put into service. Any damage during concrete placement cannot be seen nor repaired. Figure 1.2 shows the epoxy-coated reinforcing cage of a precast element bounded by metal formwork, and the same element in the midst of the concrete placement procedure.

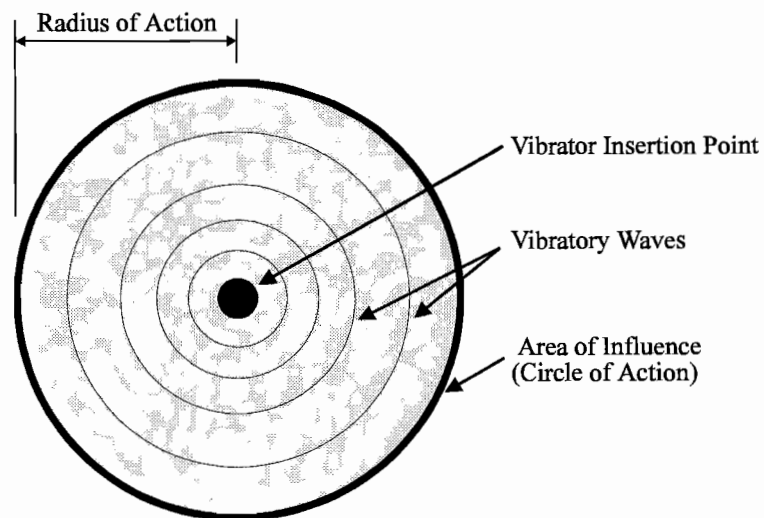
*Figure 1.4 Area of influence for concrete vibrator*

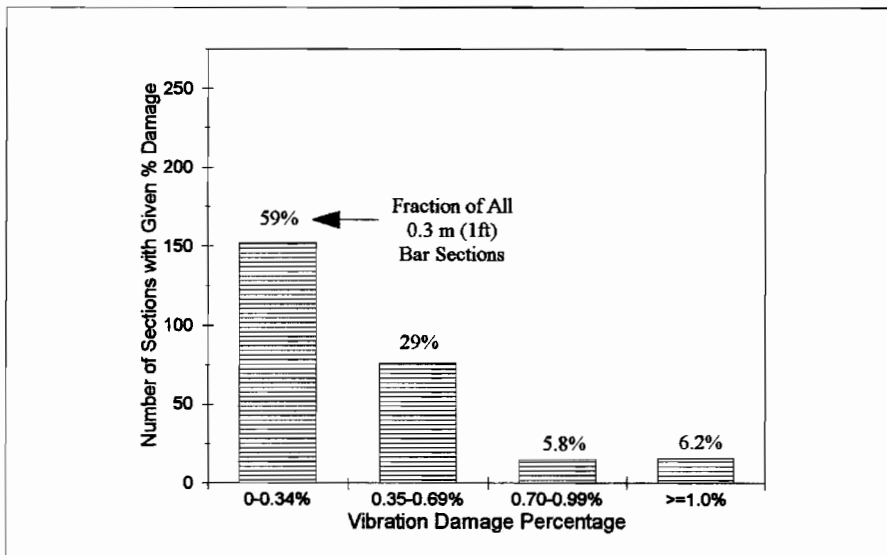
Figure 2. 17 Histogram of damage percentages for 0.3 m (1 ft.) horizontal bar sections from column, footing and slab specimens

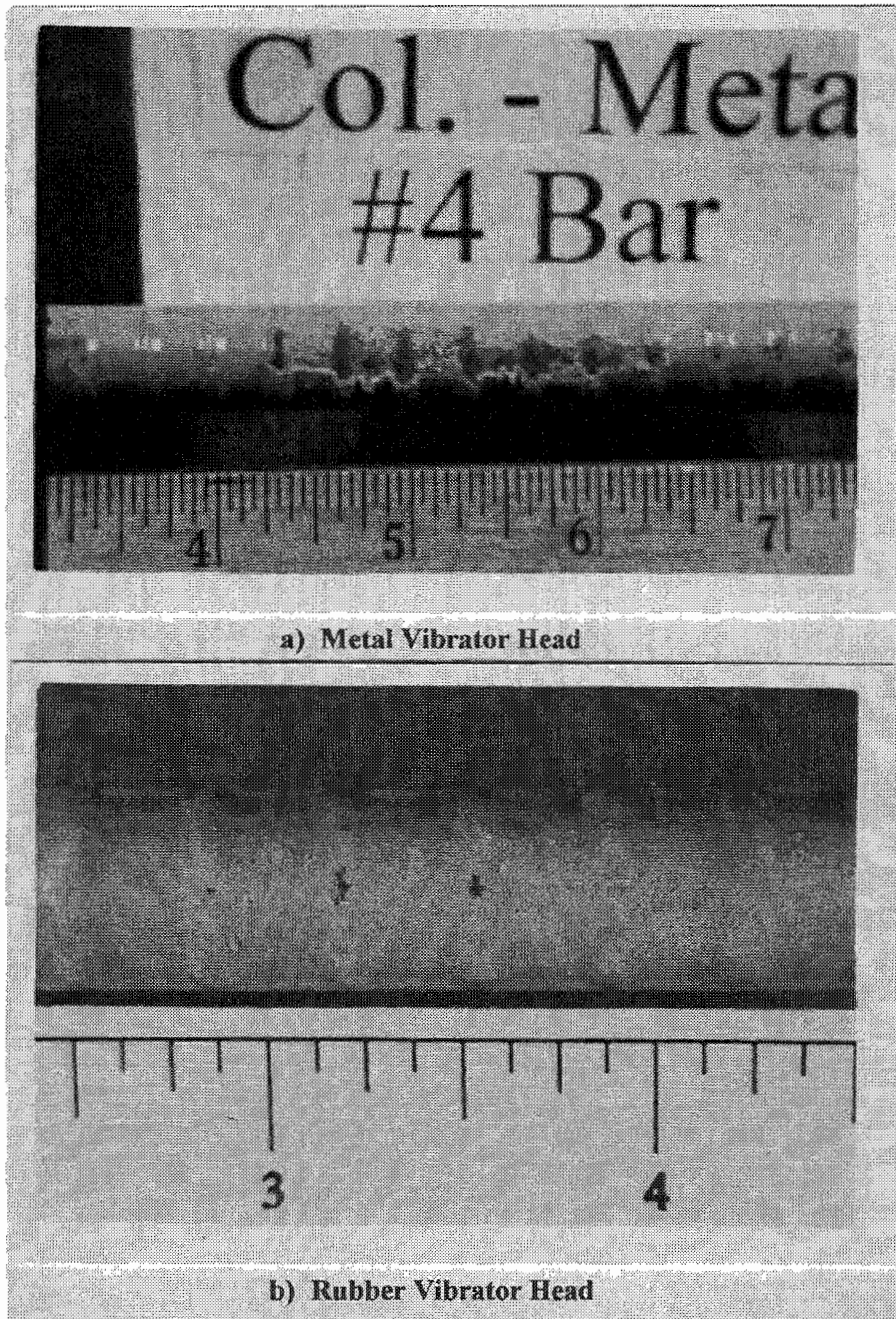
Figure 2. 19 *Vibration damage to epoxy coating*

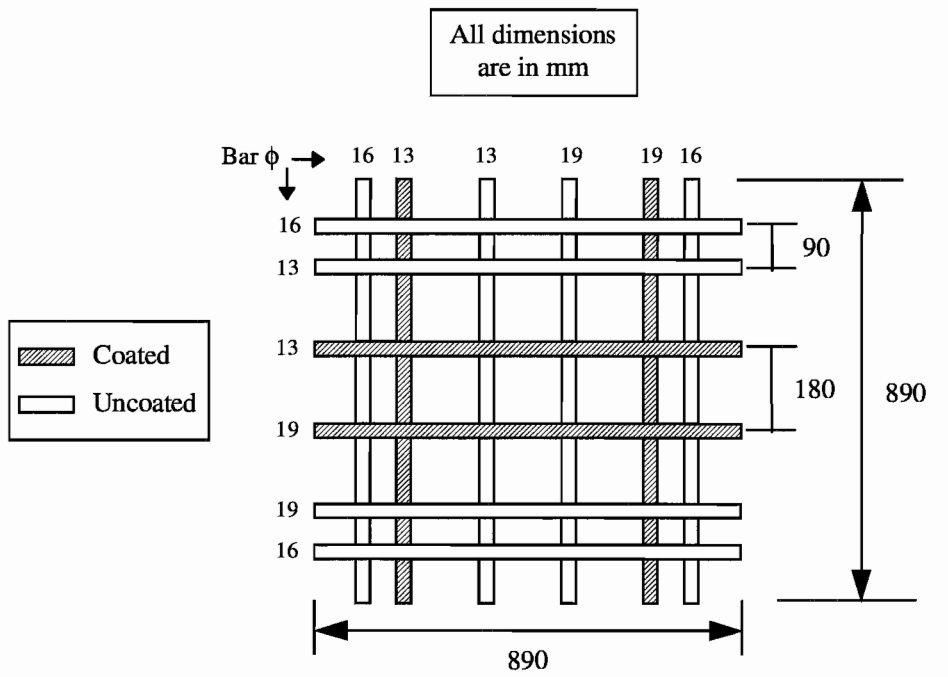
a) Reinforcement Mats

b) Side Elevation

Figure 4. 8 Layout of reinforcement in Specimen R18
