DOT HS 813 360

December 2022

# **NHTSA Special Crash Investigations: Comprehensive Study of 2019 U.S. Pediatric Vehicular Hyperthermia Fatalities**

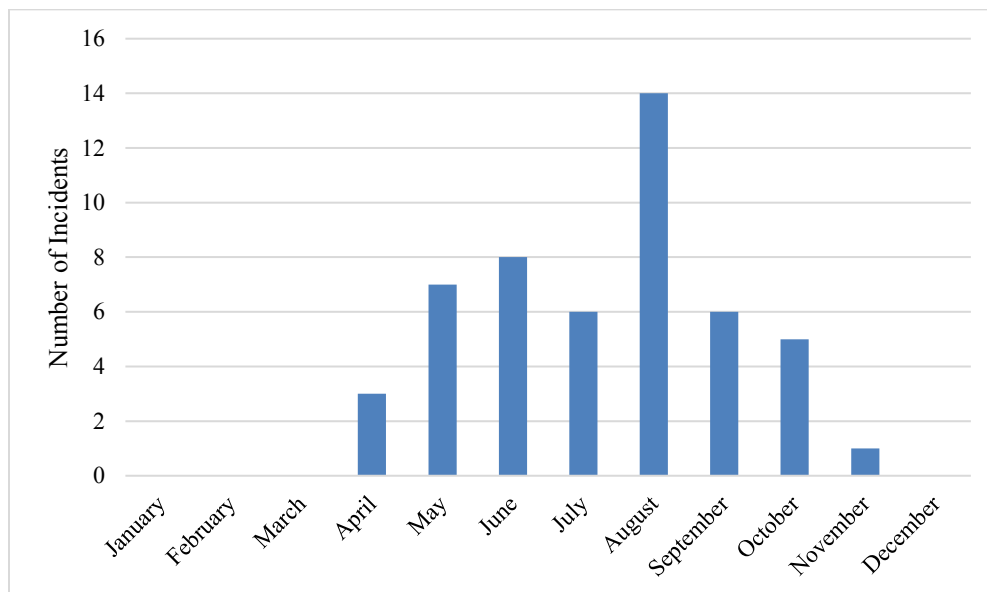
Figure 3. Number of Heatstroke Incidents by Month

The distribution of the incidents by month is presented in Figure 3. August has the highest incident occurrence at 14. Thirty-four of the 50 incidents occurred during the summer, June to September. The remaining cases typically occurred in Sun Belt States where temperature conditions are usually higher throughout the year. The exceptions are the incidents described by Case Nos. CR19010 and DS19030, which both occurred during May in New Jersey and Indiana.

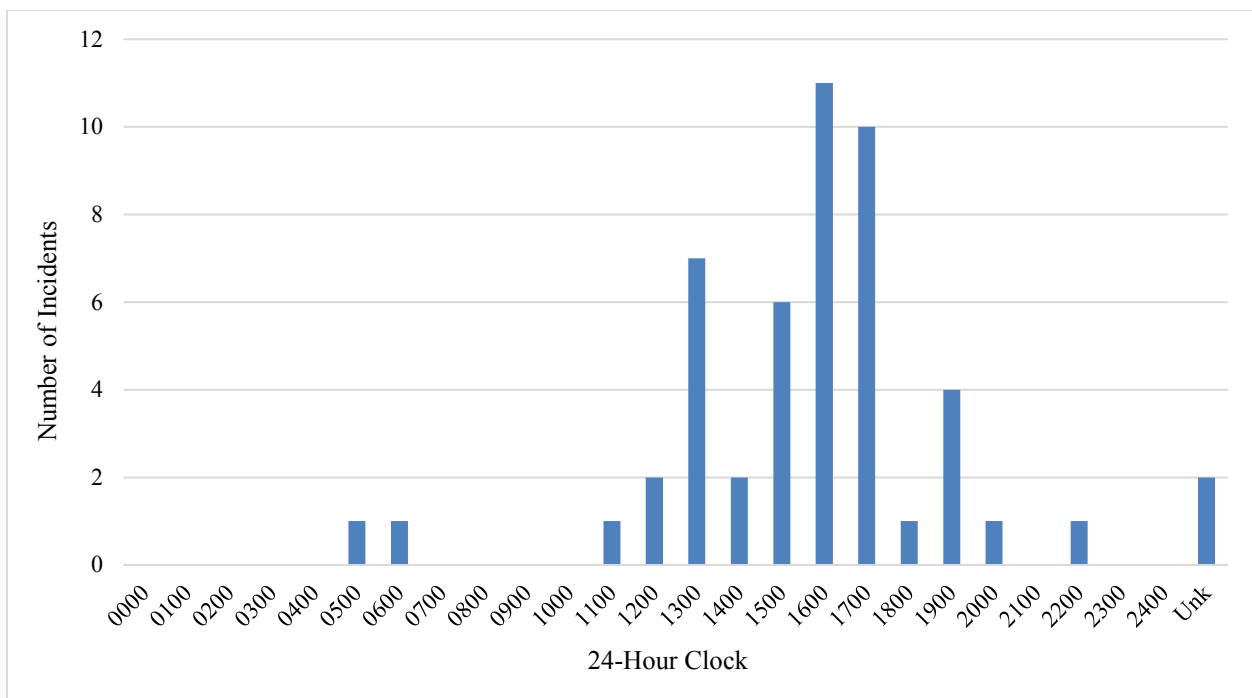
Figure 4. Time the Child Was Found

The times the children were found is presented in Figure 4.<sup>24</sup> Of the 50 incidents, the time was known, approximated, or calculated in 48 cases. In 45 incidents, the children were found between 1100 and 2059 hours. The children were found in the 1600-1659 time period in 10 incidents and from 1700 to 1759 hours in 10 incidents. There were 2 incidents where the children were found in the early morning, at 0500 hours (Case No. DS20010) and 0627 hours (Case No. DS19042).

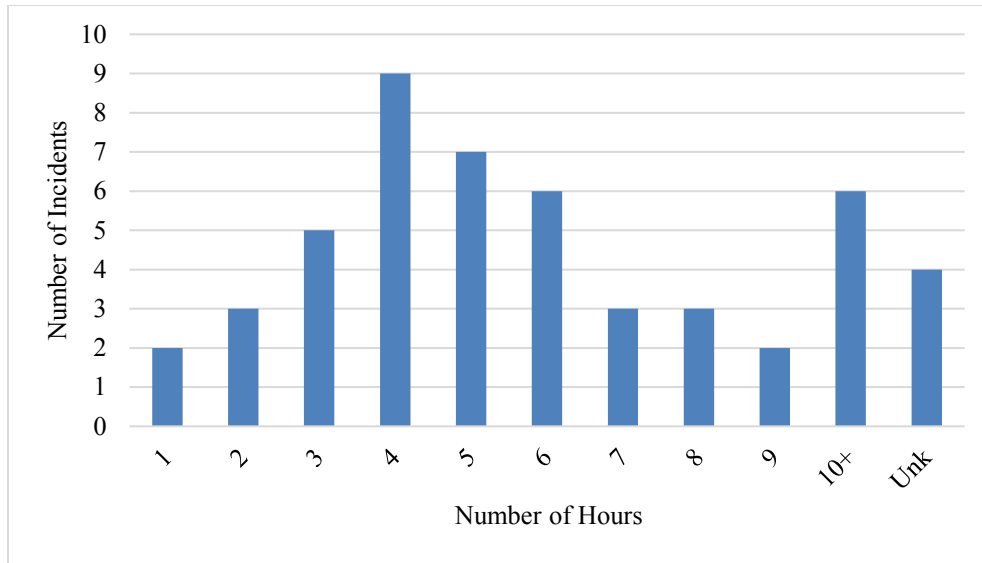
Figure 5. Critical Time Duration Child Left Unattended

For each incident, the critical time duration is defined as the estimated time from when the caregiver initially left the vehicle, or the child gained access to the vehicle until the time the child was found. The critical time duration was known or approximated in all but 4 incidents, and was rounded to the nearest whole hour as shown in Figure 5. On average, the duration the child was left unattended in a vehicle for these cases is approximately 6 hours. The shortest duration was approximately 45 minutes (Case No. CR19021). There were 6 incidents where the child was left unattended for approximately 10 hours or more,<sup>25</sup> with the longest incident, Case No. DS19042, spanning up to 17 hours, as previously noted.

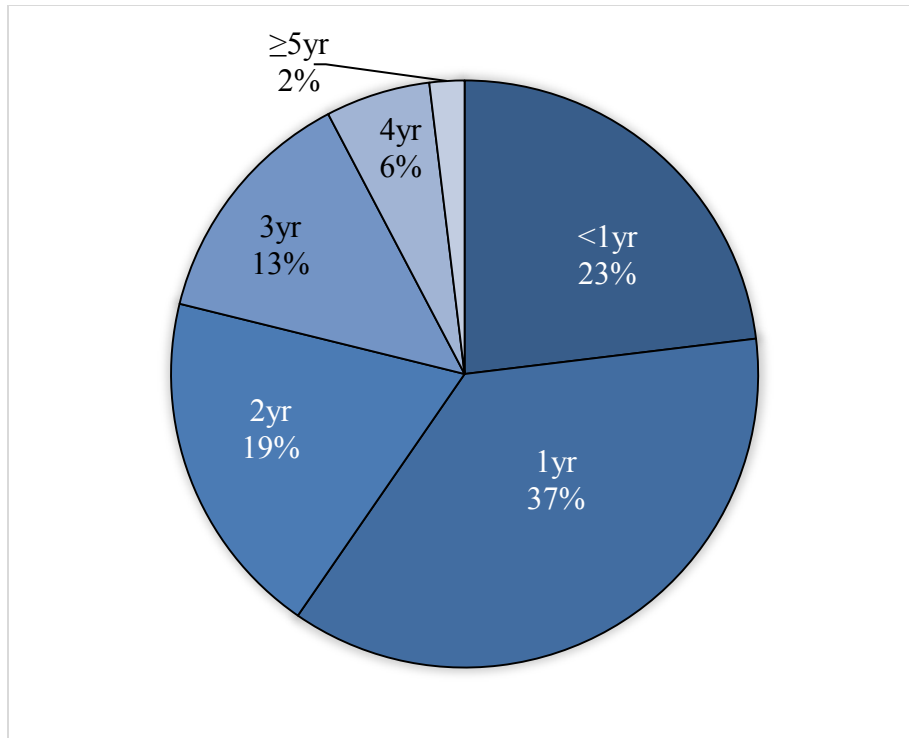
Figure 15. Age Distribution for Heatstroke Deaths

The average child age for this study was approximately 2 years old (23 months). Ages in Figure 15 are rounded down to the whole year. For example, a 20-month-old is a 1-year-old child in this representation. All children in this dataset were 4 years old or younger, except for Case No. CR19020, which involved a 13-year-old female with special needs who reportedly was knowingly placed and left in an unattended vehicle by her caregivers. The age group with the most PVH fatalities in 2019 is 1 to 2 years old, at 37 percent. Collectively, 79 percent of the 2019 PVH fatalities involved children under 3.

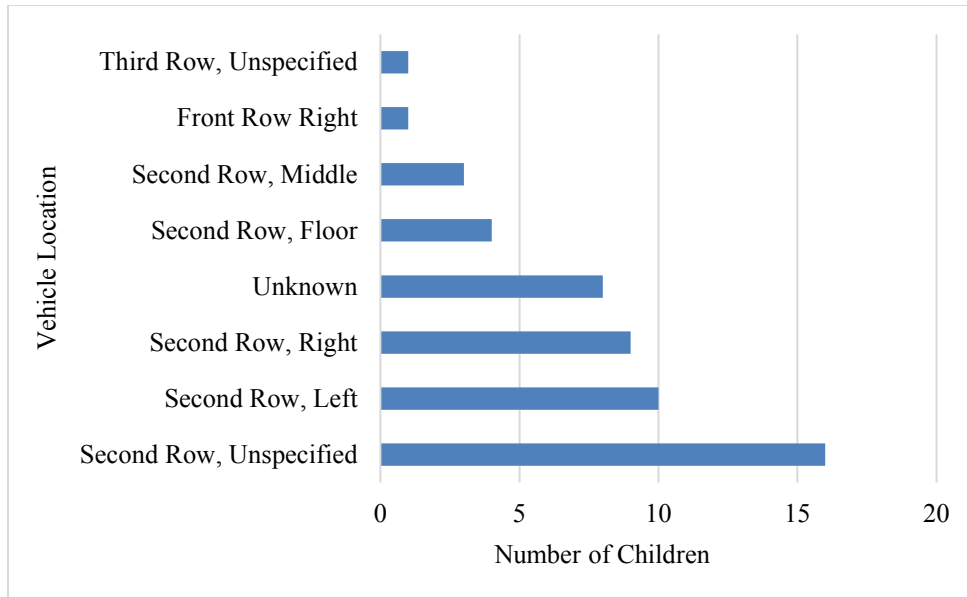
Figure 16. Seating Location in Vehicle Where Children Were Found

Figure 16 shows the location in the vehicle where the child was found. This location was specified by vehicle row for 44 of the 52 children. The narratives for all hyperthermia cases imply that the children were found in occupant compartments of vehicles. There was no indication any child was found locked in a trunk, even regarding the 8 children where the vehicle location is listed as “Unknown.” At least 80 percent of the children were found in the second row of the vehicles, of which 4 children<sup>37</sup> were specifically found on the second-row floors of the vehicles. One child (Case No. DS19040) was found in the front row passenger seat and one child (Case No. CR19012) was found in the third row of the vehicle. Both children were restrained by their CRS.

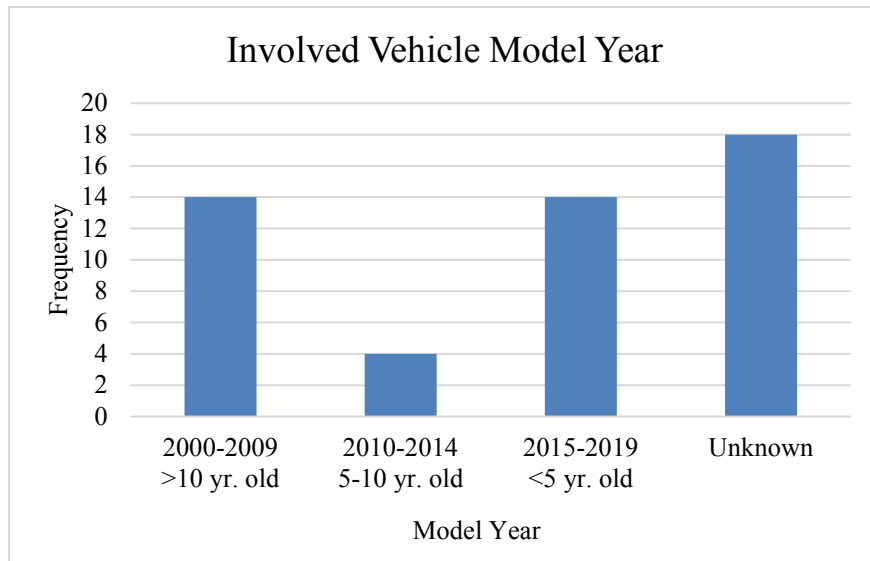
Figure 17. Model Year Distribution for Subject Vehicles

Vehicle model year was reported for 64 percent of the vehicles. Figure 17 shows the model year distribution for these 32 vehicles. The oldest<sup>38</sup> reported vehicles were MY 2000 and the newest<sup>39</sup> were MY 2019. Fourteen vehicles were less than 5 years old at the time of the incidents and 14 vehicles were over 10 years old. For 18 vehicles, the MY was not reported, classifying these vehicles as “Unknown.”

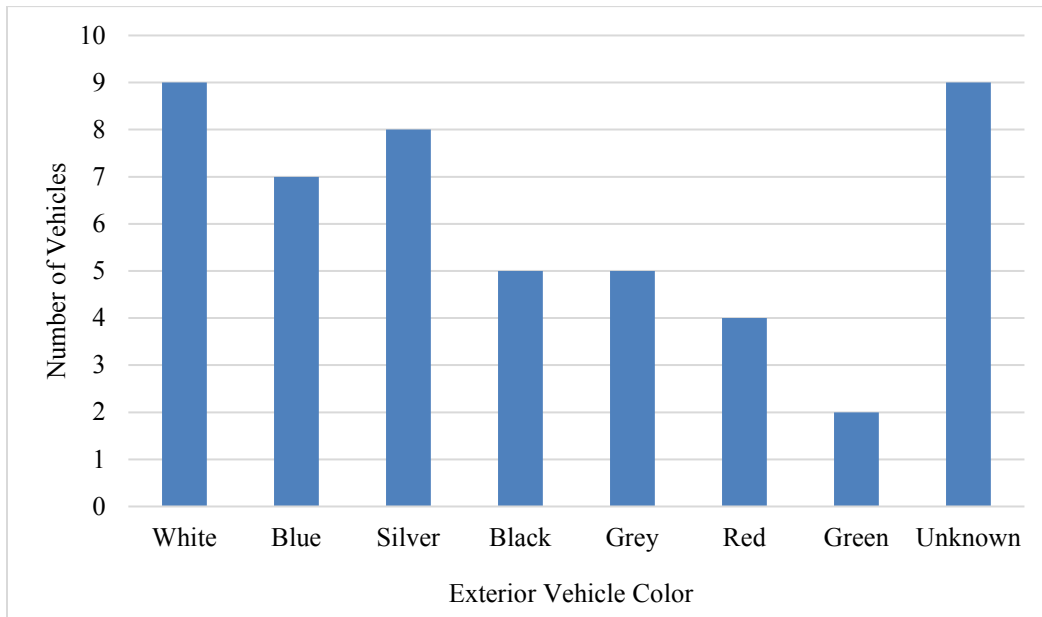
Figure 19. Exterior Color of Involved Vehicle

Vehicle color was listed for 82 percent of subject vehicles, as seen in Figure 19. The vehicle colors with the greatest number of associated hyperthermia incidents were white (9 vehicles), silver (8 vehicles), and blue (7 vehicles).

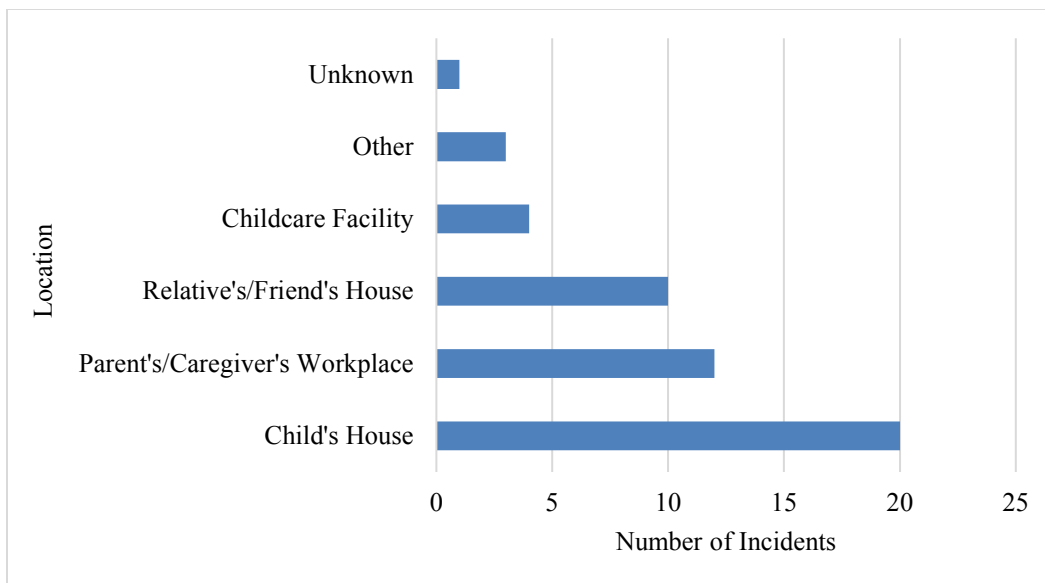
Figure 20. Vehicle Location When Children Found

The vehicle locations where the children were found were reported in 92 percent of PVH incidents, as shown by Figure 20. Note that location only references where the vehicle was located when the child was physically found and may not include an intermediate stop or critical

Children were most commonly found at their home residences (20 incidents) followed by the caregiver workplaces (12 incidents) and relatives or friends' residences (10 incidents). Children were found at daycare facilities in 4 incidents.<sup>40</sup> It should be noted, no "found" location had the subject vehicle parked in a garage or under covered parking.

In the 3 incidents with location listed as "Other," the children were found at a grocery store (Case No. CR19023), an auto parts store (Case No. DS19030), and a car wash (Case No. DS19043). The found location was unknown for only one incident, Case No. DS19040, in which the location documenting the caregiver's whereabouts and overall timeline leading up to the incident were unable to be verified.

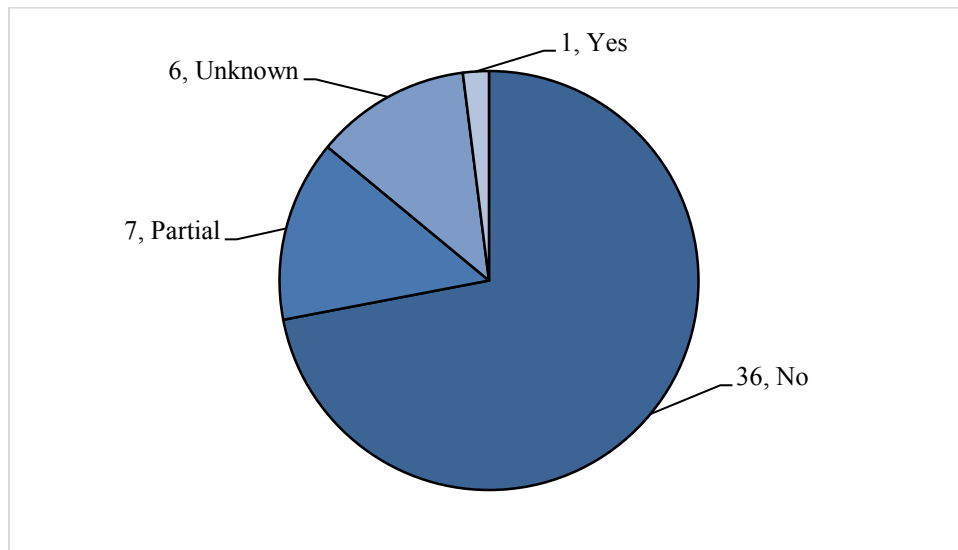
*Figure 21. Vehicle Shade Status During Hyperthermia Events*

Figure 21 shows whether the subject vehicles were parked in the shade or were fully exposed to the sun during the hyperthermia events as determined by the SCI investigations. Note that no subject vehicles were parked in garages or under covered parking, and were therefore fully exposed to environmental and location conditions, such as shade from trees or buildings.

Included in this “Unknown” category is Case No. DS20010, which resulted from the vehicle’s high heater temperature setting, not from environmental conditions.

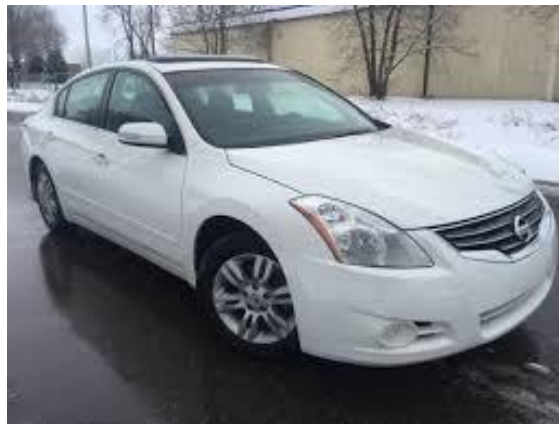
*Figure 1. Exemplar 2010 Nissan Altima*

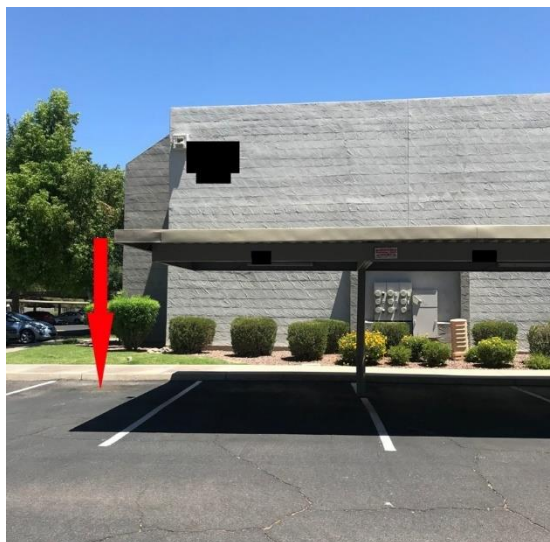
The incident occurred in the morning to late afternoon in the parking lot of an apartment complex. The parking lot was surfaced with asphalt and delineated with parking spaces and driving isles. Some parking spaces were covered by overhead shade structures. The white 2010 Nissan Altima 4-door sedan was parked on the south side of the apartment building and was facing north in an uncovered space adjacent to a shade structure (Figure 2). Residents were assigned parking spaces and the Nissan was parked in its assigned space. There are entrances to the two-story apartment building on the east and west sides.

*Figure 2. Incident site, parked position to left of shade structure, looking north.  
Image from local resident.*

The location of the caregiver's apartment in the building is not known. The distances from the apartment to the parking place is unknown. There were no windows providing a view of the parked Nissan. After discovering the child, the father moved the Nissan from its original location to a covered space in the lot as police and fire personnel arrived.

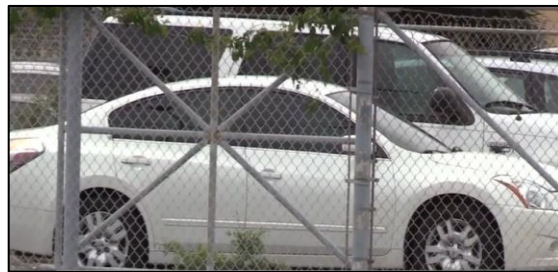
*Figure 1. Involved 2011 Nissan Altima in police impound. Image obtained from an online news outlet.*

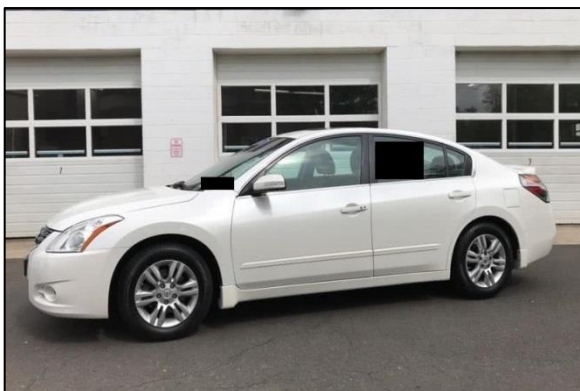
The vehicle was a 2011 Nissan Altima (Figure 2) identified by VIN 1N4AL2AP8BNxxxxxx. The vehicle was a white 4-door sedan, with an interior of unknown color. The police reported it had deep-tinted windows. As standard equipment, the Nissan's interior had front row bucket seats with a fixed center console and a three passenger second-row split-bench seat (Figure 3). All seat positions were equipped with manual 3-point lap and shoulder seat belts and adjustable head restraints. The second-row interior door release levers were flush-mounted with recessed pockets in the upper forward portion of the door panels. The aft hinged lever required a pull-force to open the doors. A manual lock/unlock lever was located directly above the hinge point

*Figure 2. Exemplar 2011 Nissan Altima*

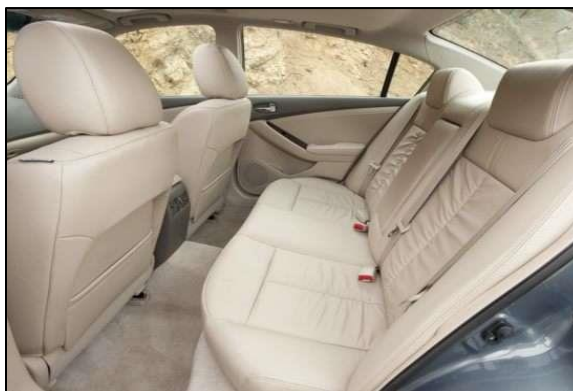
*Figure 3. Second-row seat of an exemplar 2011 Nissan Altima*

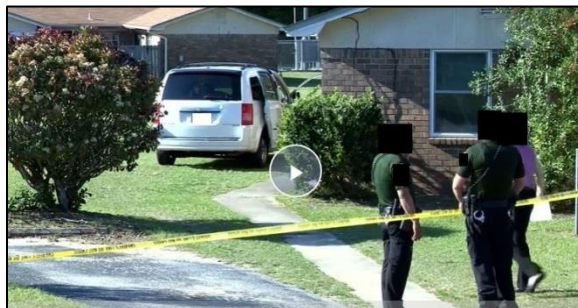
*Figure 1. Northerly view of the Chrysler minivan parked on the lawn area. Image obtained from online news outlet.*

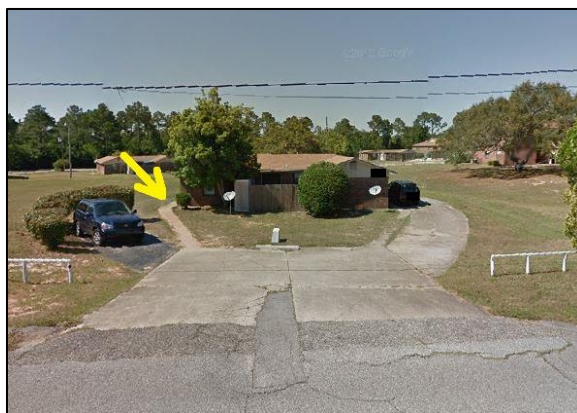
This hyperthermia incident occurred in the yard of an apartment complex (Figure 2) that consisted of ranch-style duplexes and two-story multi-apartment buildings. The Chrysler minivan was parked on the lawn by the entrance door of a single-story duplex. The building was oriented north-south with the entrance door on the west side of the building. A driveway was located on the north side of a two-lane street that provided access to the duplex. The driveway split in a Y to provide access to both units. The east side driveway continued to the east side of the building directly opposite an entry door. The west side driveway terminated to a parking area. A sidewalk provided access to the west side of the building. A wide lawn surrounded the side and back yard of the building. The Chrysler was driven along the sidewalk and parked on the lawn area opposite the west front door. In this position the vehicle was facing north with full exposure to the late morning and afternoon sun. There were no trees to shade the vehicle. The incident diagram is included at the end of this report.

*Figure 2. Arrow indicates the parked location of the Chrysler minivan. May 2011 image obtained from an online mapping system.*

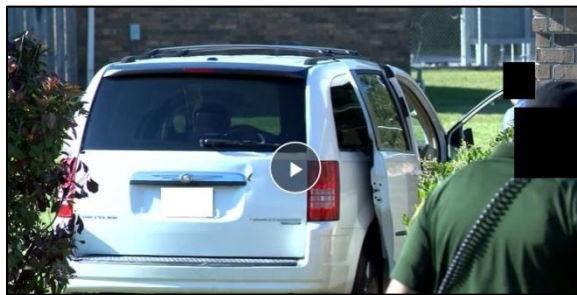
The vehicle in this hyperthermia death investigation was a late-model Chrysler Town and Country minivan (Figure 3). The exterior color was white and it had deep-tint AS3 windows for the second-row doors, rear quarter windows, and the backlight. The interior color was beige. Throughout this incident, the operable side window was closed. The interior had power-operated windows and door locks.

*Figure 3. On-scene images of the Chrysler minivan. Image obtained from an online media outlet.*

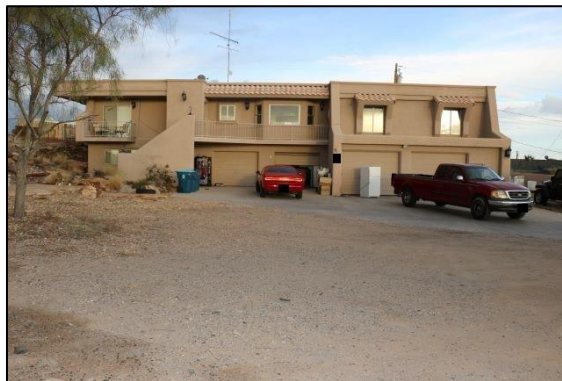
*Figure 1. Incident site looking southeast, guest parking area in foreground (police photo)*

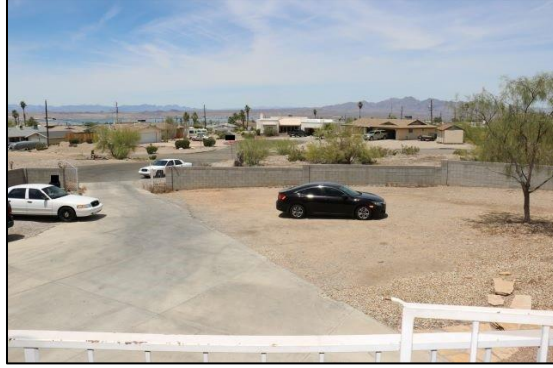
Figure 3. 2016 Honda Civic view from residence looking northwest. Image obtained from local law enforcement.

<sup>2</sup> Police returned the vehicle to the incident site for their investigation. The placement of the vehicle was an approximation of its location during the incident.

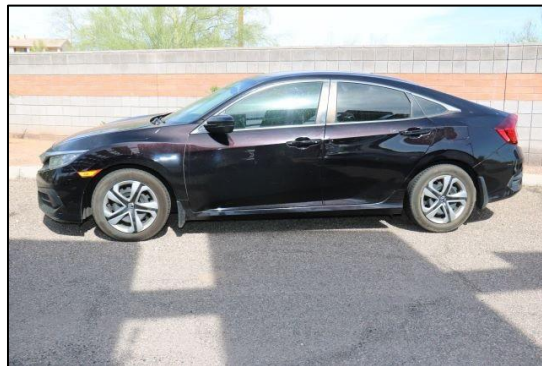
The vehicle was a 2016 Honda Civic LX 4-door sedan identified in the police report by VIN 19XFC2F53GExxxxxx (Figure 4). The Honda had standard daytime lights, air conditioning, power steering, tilt steering, power brakes, antilock brakes, power windows, power sun/moon roof, and satellite radio. It had a 2.0-liter, 4-cylinder, gas engine and front-wheel drive. The security system included an immobilizer/keyless entry with alarm. The vehicle’s exterior color was “Crystal Black Pearl” (black) and the interior colors were beige upholstery for the seat cushions and backs with black door panels, dash, carpet, and trim.

Figure 4. The 2016 Honda Civic. Image obtained from local law enforcement

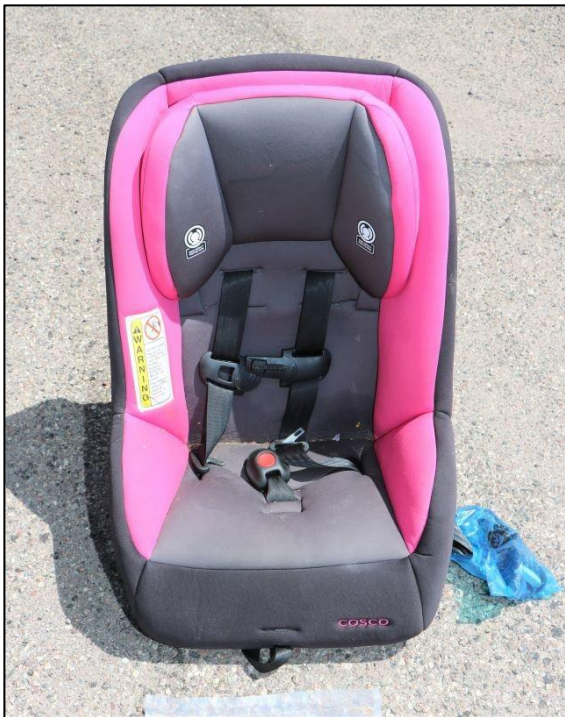
*Figure A-3. Cosco MightyFit 65 CRS (police photo)*

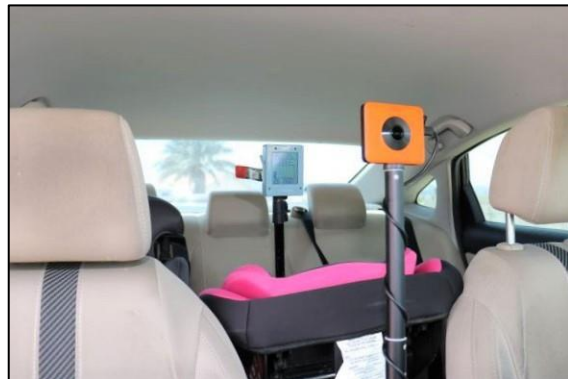
*Figure A-4. Police temperature testing, 2016 Honda Civic (police photo)*

Approximately 2 hours following the incident and after securing the Honda in a police lot, police conducted temperature reading tests of the Honda's interior. The tests were conducted from 1523 to 1640 hours when conditions and ambient temperatures were similar to the time of the incident. The tests revealed the following results.

- With the air conditioner turned off, the maximum temperature of the CRS backrest read 49.3 °C (120.8 °F) and the lowest temperature read 47.3 °C (117.2 °F).
- With the air conditioner turned on for 20 minutes at the lowest setting,<sup>3</sup> the maximum temperature of the CRS backrest read 42.8 °C (109.0 °F) and the lowest temperature read 40.0 °C (104.0 °F).

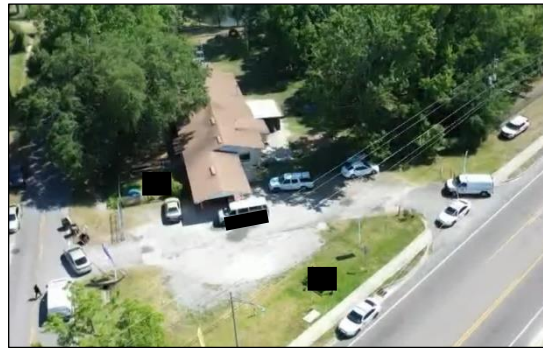
The incident occurred during the morning and afternoon hours in a small parking lot of a local daycare facility (Figure 2). The parking lot was surfaced with gravel with no visibly marked parking spots. The parking lot is located on the north side of the daycare facility. The property contains trees along the east, south, and west sides of the daycare facility. Some shade can be cast onto the parking lot from a tree on the east side of the daycare facility. Additionally, the daycare facility provides some shade on the southernmost part of the parking lot. The daycare van was parked on the south side of the parking lot next to the entrance of the daycare facility facing east.

*Figure 2 Overhead view of incident site. Imaged obtained from an online news outlet.*

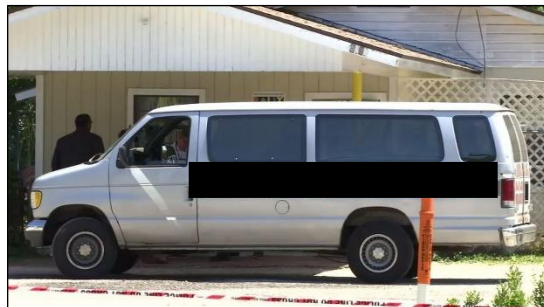
The vehicle in this hyperthermia case was a Ford E-Series van of an unknown year (Figure 3). There is no data from online media sources referring to the vehicle and local law enforcement

agencies have not returned any calls pertaining to this investigation. According to images obtained from online news sources, the van had tinted right side, left side, and rear windows.

*Figure 3. Unknown Year Ford E-Series Daycare Van. Image obtained from an online news outlet.*

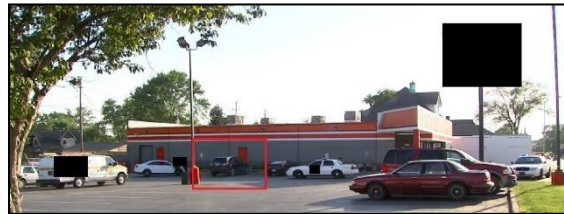
The parking lot of the auto parts store was the only location known to SCI to have been associated with the incident. The parking lot was the vehicle's location after the incident and the child's location when she was first observed by the caregiver to be in medical distress (Figure 1). The parking lot was located on the east side of the business at the rear entrance and was paved with asphalt and delineated with marked parking spaces. It was unknown if there were other vehicles around or if the vehicle was in shade. The incident occurred on a weekday during business hours in an urban area so the parking lot and surrounding area were likely populated with other vehicles and customers coming and going. An incident site diagram and incident site satellite view for the auto parts store and parking lot are included at the end of this report.

*Figure 1. 2010 Saturn Outlook in auto parts store parking lot, looking west. Image obtained from online news source.*

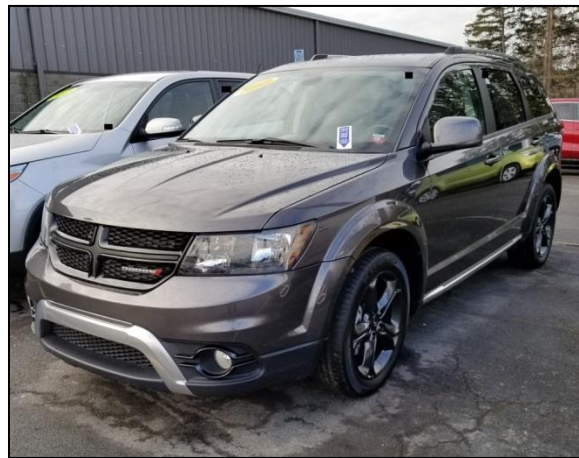
*Figure 1. Front left oblique view of an exemplar 2017 Dodge Journey*

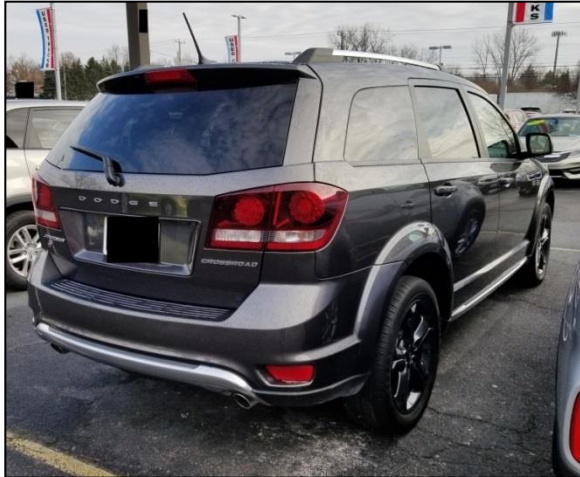
The vehicle was a 2017 Dodge Journey, a crossover-type SUV with four forward-hinged doors and a rear lift gate (Figure 2). Standard configuration is seating for seven (2/3/2) with front row bucket seats, a three-passenger split-bench second-row seat with forward folding seat backs (Figure 3) and sliding seat tracks to facilitate access to a two-passenger, third-row seat. All seat positions had adjustable head restraints.

*Figure 2. Back left oblique of an exemplar 2017 Dodge Journey*

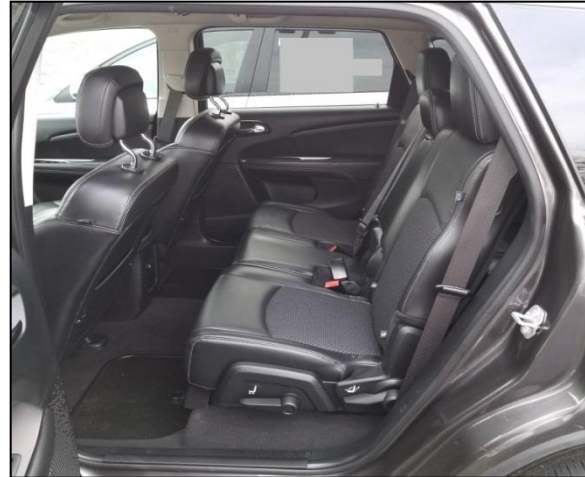
*Figure 3. Second-row interior view of an exemplar 2017 Dodge Journey*

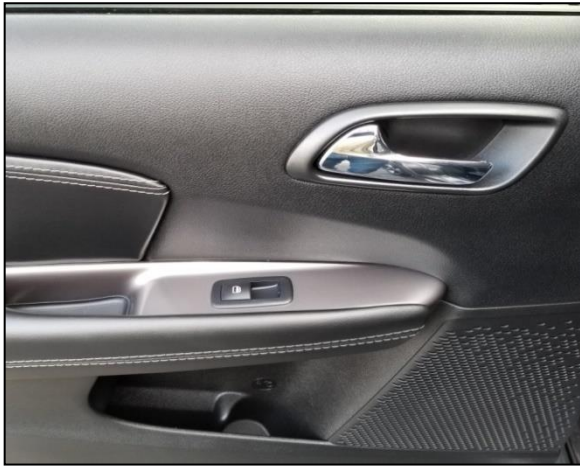
The interior door release levers of the Dodge were flush-mounted pull levers (Figure 6). A pocket was formed into the door panel to provide access to the levers. The levers were not equipped with mechanical lock/unlock mechanisms. Each door was equipped with a lock stalk on the top aft aspect of the door panel (Figure 7). This stalk protruded 3 cm (1 in) above the door panel in the unlocked position and protruded 1 cm (0.375 in) above the door panel in the locked position. In the locked position, the 6 mm (0.25 in) diameter stalk could be pulled to unlock the

*Figure 6. Second-row interior door release lever of an exemplar Dodge Journey*

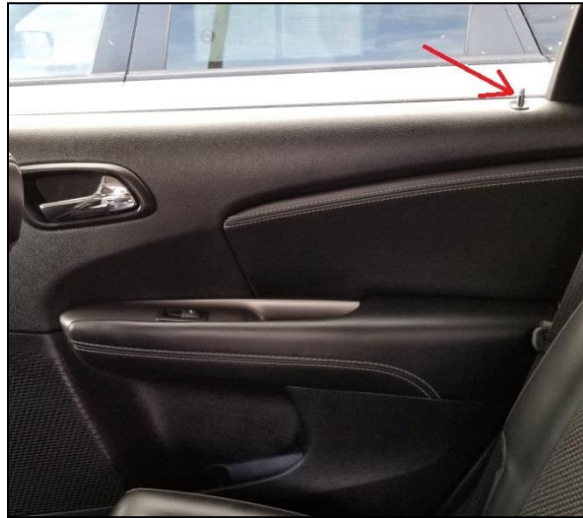
door. It remains unknown if a 4-year-old child could physically grip and pull this stalk to unlock the door.

*Figure 7. Lock stalk in unlocked position on the second-row right door of an exemplar Dodge*

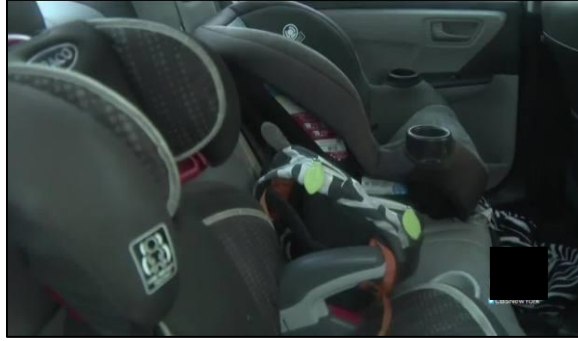
The interior door release levers of the Toyota Camry were flush-mounted pull levers (Figure 2). A pocket was formed into the door panel that provided adequate access to the levers. The levers did not have mechanical lock/unlock mechanisms. Each door had a lock stalk on the top aft aspect of the door panel.

Figure 2. Second-row of Toyota Camry. Image obtained from an online news outlet.

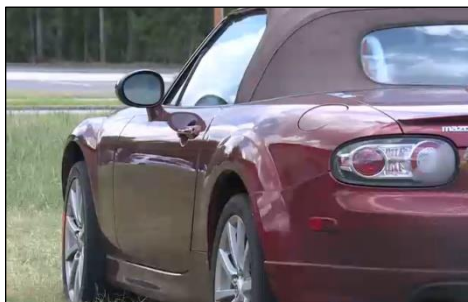
The vehicle in this hyperthermia case was a maroon Mazda Miata, model year unknown (Figure 1). It had two forward-hinged doors. All side windows were AS2 glazing with no tint. All windows were closed during this incident.

*Figure 1. Mazda Miata. Image obtained from an online news outlet.*

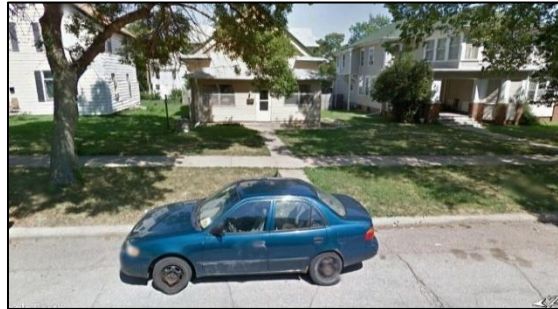
This incident occurred on a city street in front of a private residence. The residence was located on the east side of the roadway (Figure 2). The Chevrolet was parked facing south on the west side of the asphalt roadway. The distance from the residence to the vehicle was approximately 18 m (59 ft). There were shade trees in the area but the vehicle appears to have been in an unshaded area. There were other vehicles parked on the roadway but their proximity to the case vehicle was not known.

*Figure 2. Incident site, looking east. Image obtained from internet mapping software.*

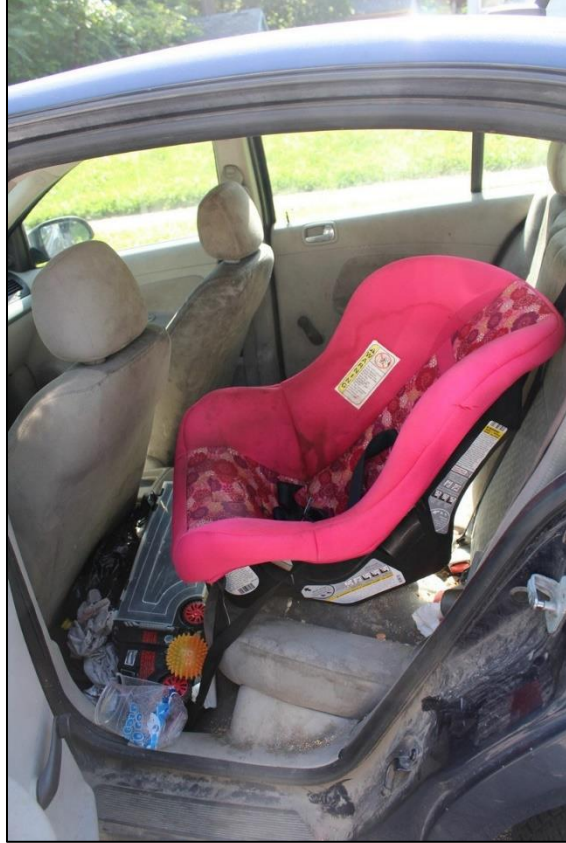
The child had been placed in a forward-facing Cosco Scenera NEXT convertible CRS placed in the second-row left seat position (Figure 3). The CRS had a 5-point harness and can be anchored using either the vehicle seat belts or Lower Anchors and Tethers for Children (LATCH). The CRS was not anchored to the vehicle at the time of the police investigation. The CRS was designed to be used rear-facing for children weighing 2.2-18.1 kg (5-40 lbs) and 48-101 cm (19-40 in) tall and forward-facing for children weighing 9.9-18.1 kg (22-40 lbs) and 73-109 cm (29-43 in) in height and at least 1 year old. The child met the age, weight, and height requirements for a forward-facing CRS.

*Figure 3. Cosco Scenera NEXT convertible CRS. Image obtained from local law enforcement.*

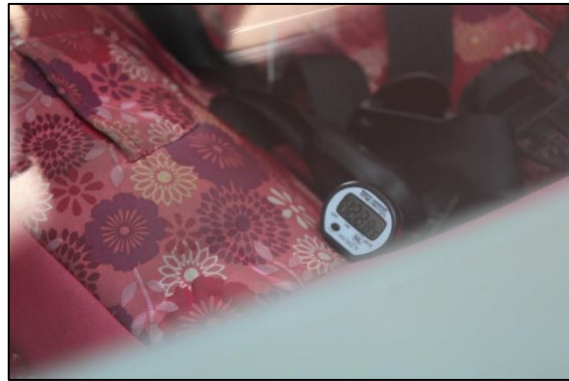
*Figure A-2. Vehicle interior temperature (police photo). Image obtained from local law enforcement.*

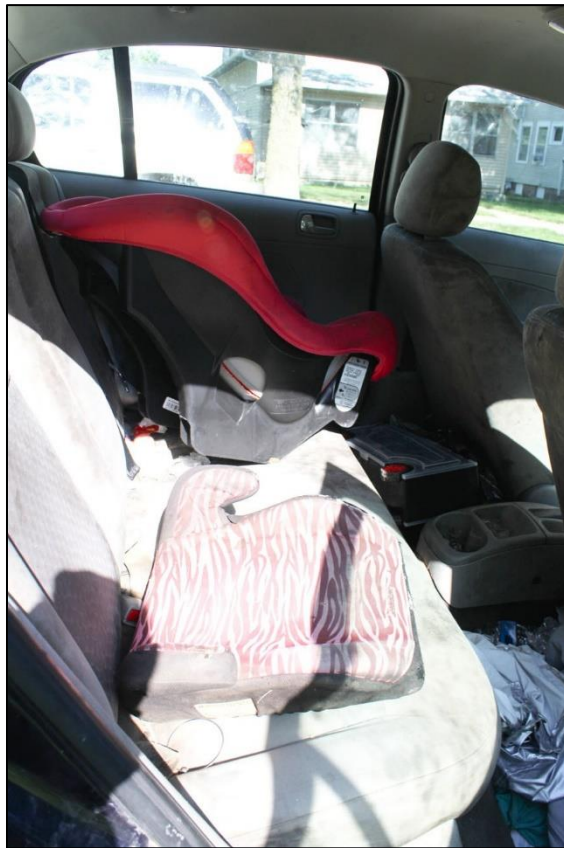
*Figure A-3. Second row, 2010 Chevrolet Cobalt (police photo). Image obtained from local law enforcement.*

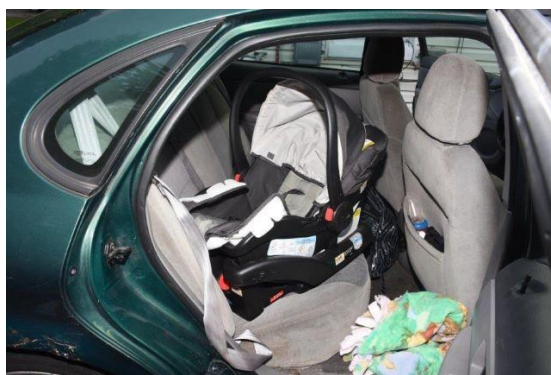
The primary caregivers and vehicle drivers were the child's parents. The time spent and distance driven prior to their arrival at the incident site on the morning of the incident was unknown. Prior to the trip, one parent placed the child in a rear-facing Graco SnugRide Click Connect 30 infant safety seat installed in the second row of the vehicle (Figure 3). The child was dressed in a sun dress of an unknown description and a diaper. The caregivers and child returned home at approximately midnight from a trip to visit family. They parked the vehicle facing northwest in the driveway of the grandmother's residence. A media photo obtained from the internet suggested the vehicle was parked approximately 7 m (23 ft) from the front entrance to the residence. At the time of their arrival, the nighttime it was dark with some ambient lighting likely present from nearby residences.

*Figure 3. Graco SnugRide Click Connect 30 CRS, 2000 Ford Taurus. Image obtained from local law enforcement.*

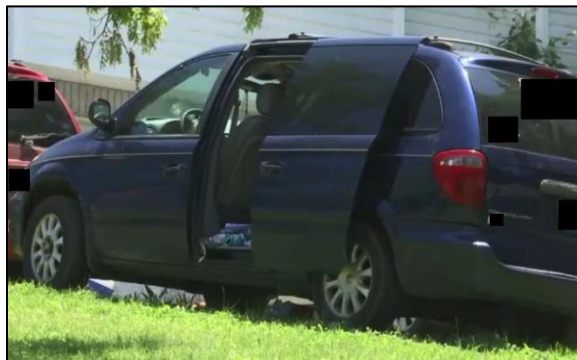
The vehicle was a 2002 Chrysler Town and Country minivan (Figure 4). The Chrysler exterior was blue with a gray interior with leather seating. It had two forward-hinged front doors, two sliding doors for the second row, and a rear lift gate. The windows for the sliding doors, the rear quarter windows, and the backlight were AS3 deep tint. Two large decal-type displays were present on the backlight. At the time of the incident, the operable front door and rear quarter windows were closed. The windows of the second-row sliding doors and backlight were fixed. The interior seating was front and second-row captain's chairs with a third-row bench seat providing seating for up to seven occupants. The police reported the Chrysler had been parked and was not in service by the family. They also reported the interior was littered with trash.

*Figure 4. 2002 Chrysler Town and Country minivan. Image obtained from an online news outlet.*

The locking system was power. The police reported the vehicle was unlocked at the time of the incident. The mother of the child told police the doors were hard to open. This vehicle had power-sliding doors that could be manually opened with resistance from the power mechanism.

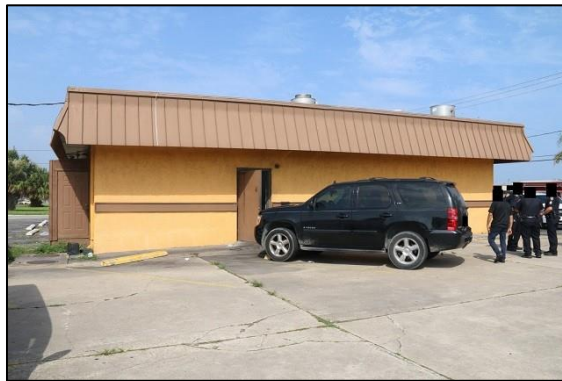
The incident occurred in Texas in a restaurant parking lot. The property included a single-story restaurant with a flat roof. The parking lot was paved in asphalt on the north, east and south sides and concrete on the west side. The Chevrolet was parked on the west side of the building facing northeast approximately 2 m (6 ft) from the restaurant service entrance (Figure 2). During the time of the incident, no shade was present around the vehicle. It was unknown how many other vehicles may have been parked nearby or the duration of their presence. Police photos taken following the incident show no other vehicles in the immediate area but they may have cleared the area due to their investigation. The caregiver was working a shift inside the restaurant and given the size of the restaurant could not have been more than 22 m (72 ft) from the vehicle at any time. During the incident, other vehicles drove by or stopped near the Chevrolet, including the child's 25-year-old mother, who came to the incident site, opened the second-row right door of the Chevrolet, and removed the CRS from the vehicle. She was unaware of the child's presence on the floor and left the incident site thinking he was in the care of a family member. Additionally, other employees or visitors to the restaurant were close to the vehicle. An incident site diagram and incident site satellite view are included at the end of this report.

*Figure 2. Incident site, 2007 Chevrolet Tahoe, looking east. Image obtained from local law enforcement.*

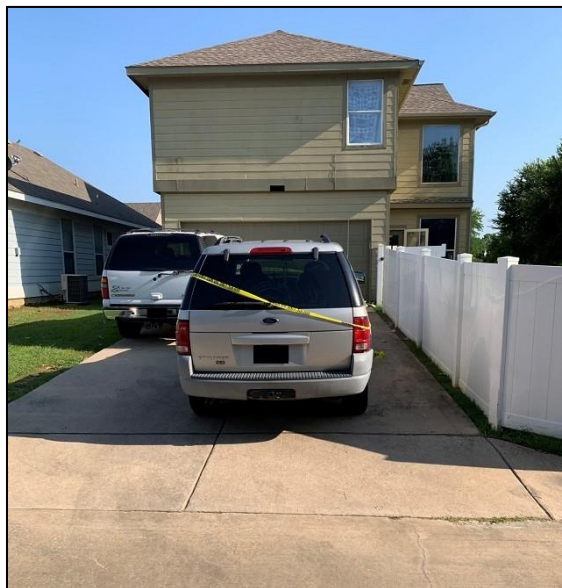
The incident occurred in Texas on private property in a residential area that included a concrete driveway and a two-story, single-family residence with a hip roof, surrounded by a grass lawn and wooden fence on the west side and a neighboring residence on the east side (Figure 1). The front of the residence faced south toward an east/west street and the back faced north toward an east/west alley. The driveway was oriented north to south and was located on the north side of the residence between an attached garage and the alley. The driveway measured 5.8 m (19.0 ft) wide and 10.0 m (32.8 ft) long and sloped downward at an estimated grade of negative 8 percent from garage to alley. The driveway was bordered on the west edge by a wooden fence measuring approximately 1.5 m (5.0 ft) tall. Four mature trees aligned in a north to south orientation were located 6 m (20 ft) west of the fence on the west side of the residence. Another two-story residence and driveway were located close to the east side of the incident residence. At the time of the incident, the Ford was parked facing south in the driveway at an estimated distance of 4 m (13 ft) north of the garage. According to the police report, no shade was present at the vehicle location and the Ford was in direct sunlight for the duration of the incident. It was unknown if other vehicles were present during the incident. Police photos taken post-incident show a second vehicle parked in the driveway. The mother and four children were present in the home in addition to the child who was in the vehicle.

*Figure 1. Incident site and 2002 Ford Explorer, looking south from alley. Image obtained from local law enforcement.*

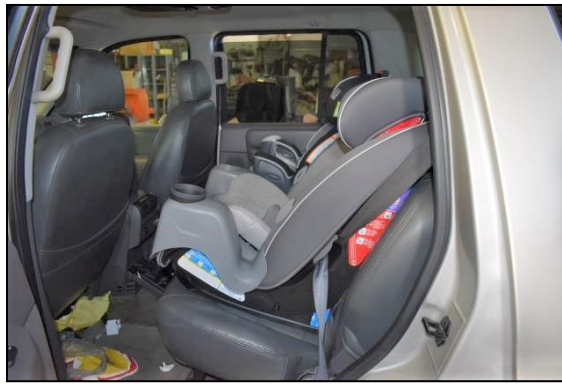
The vehicle was a 2002 Ford Explorer XLS 4-door SUV identified in the police report by VIN 1FMZU62K02Zxxxxxx (Figure 2). The Ford had a 4.0-liter, 6-cylinder, flex-fuel engine and rear-wheel drive. Standard equipment included air conditioning, power windows and passkey security system. The vehicle's exterior color was "Silver Birch Clearcoat Metallic" (silver) and the interior color was "Graphite" (dark gray) leather.

*Figure 2. Interior view, 2002 Ford Explorer. Image obtained from local law enforcement.*

The Ford had exterior pull type door handles. All four doors had interior power door locks. A press of the control locked or unlocked all four doors. All four interior doors had interior manual door lock knobs located above the inside door release handle.

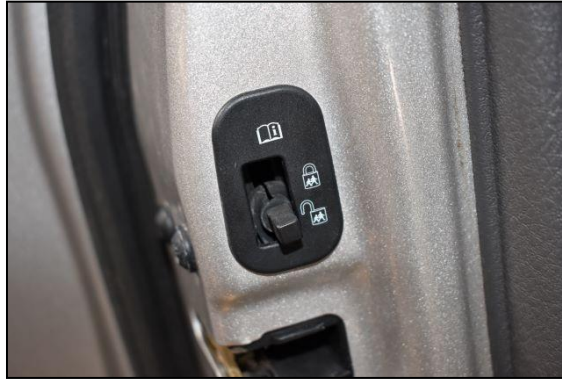
The second-row doors had manual child safety door locks that when set to the locked position prevented the doors from opening when pulling the interior handle (Figure 3). Police photos indicated the child safety door locks were disengaged at the time of their investigation and it was confirmed in their report. The vehicle was unlocked during the incident.

*Figure 3. Child proof door lock, second-row left, 2002 Ford Explorer. Image obtained from local law enforcement.*

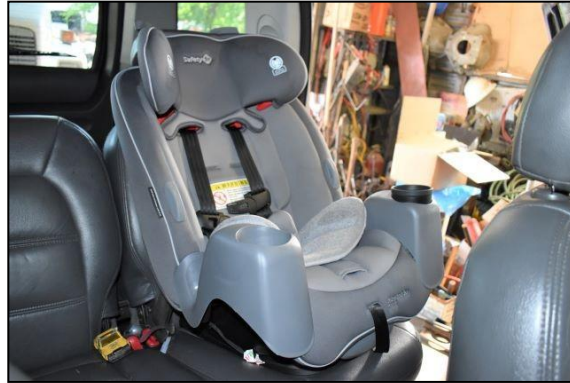
The child was restrained in a forward-facing Safety 1st Grow 'n' Go 3-in-1 convertible CRS in the second-row left seat position (Figure 4). It was installed using the vehicle's lap and shoulder seat belt and police indicated it was installed correctly and appeared to be very stable. During the trip, the child used the 5-point harness. The child was not covered by a blanket or other object.

Figure 4. Safety 1st Grow 'n' Go 3-in-1 CRS (police photo)

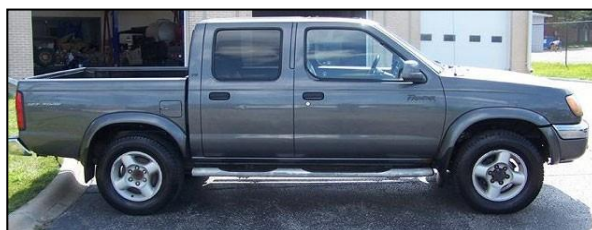
This report documents the remote investigation of the hyperthermia death of an 11-month-old female left unattended in a parked 2001 Nissan Frontier pickup (Figure 1) for approximately 3 hours during daylight in Texas in June 2019. The investigation was intended to determine the events leading to the incident, the actions of the caregiver/guardian, the vehicle characteristics and equipment, the environment/scene conditions and layout, and the activities of the driver. The incident was identified as part of a hyperthermia study by NHTSA and assigned to the SCI team in October 2019.

*Figure 1. Exemplar 2001 Nissan Frontier*

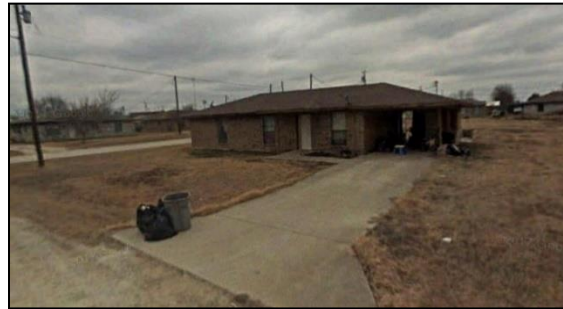
The incident occurred in Texas on private property in the driveway of a single-story residence oriented in a northwest direction and was surfaced in concrete. The driveway led from the street to a covered carport (Figure 2). There were no shade-producing structures or vegetation near the vehicle. There were at least two other vehicles present in the driveway near the time the child was discovered. An incident site diagram and incident site satellite view are included at the end of this report.

Figure 2. View of residence, looking northwest. Image obtained from internet mapping software.

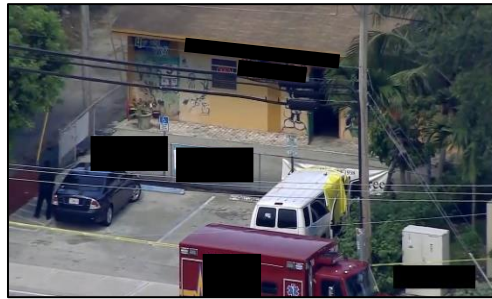
This report documents the remote investigation of the circumstances surrounding the hyperthermia-related fatality of a 2-year-old male left unattended in a Ford E-350 daycare van (Figure 1) for approximately 5 hours by the female driver in Florida in July 2019. The police reported that the driver arrived at the daycare facility and turned off an audible safety alarm on the Ford E-350 prior to disembarking the child occupants. As the children exited the van, the driver failed to physically check each seat for occupied positions. The 2-year-old was left belted in the van for approximately 5 hours, where he expired. The driver was charged with one count of aggravated manslaughter. This incident was identified by NHTSA and assigned to the Special Crash Investigations group for further research in October 2019.

*Figure 1. Incident Scene. Image obtained from an online news outlet.*

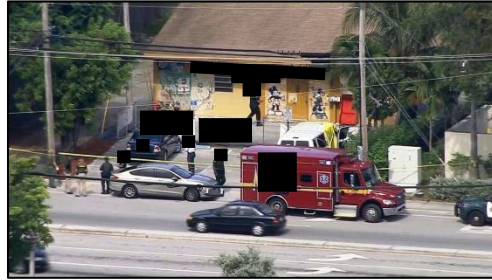
The incident occurred in the morning and early afternoon in a small parking lot of a local daycare facility (Figure 2). The parking lot had four parking spaces and was located on the west side of the daycare with trees located on the north and south sides of the parking lot resulting in shade coverage of almost the entire parking lot. The Ford E-350 Super Duty passenger van, model year unknown, was parked in the southern most parking spot facing east.

*Figure 2. Incident Scene. Image obtained from an online news outlet.*

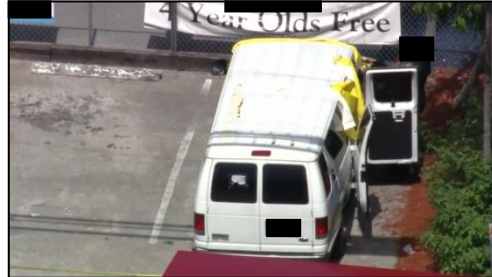
The vehicle in this hyperthermia investigation was a Ford E-350 Super Duty passenger van of unknown model year. The exterior color was white. It had three forward-hinged doors and one rear-hinged door. All side windows were AS2 glazing with deep tint as reported by online news media sources.

*Figure 3. Ford E-350 Super Duty passenger van. Image obtained from online news outlet.*

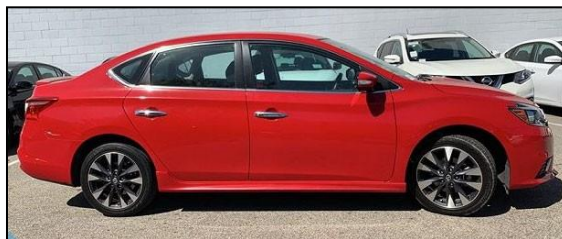
This report documents the remote investigation of the hyperthermia death of a 3-year-old male who was left unattended in a parked 2008 Nissan Sentra (Figure 1) for an extended period during daylight in Indiana in July 2019. The investigation was intended to determine the events leading up to the incident, the actions of the caregiver/guardian, the vehicle characteristics and equipment, the environment/scene conditions and layout, and the activities of the driver child. The incident was identified as part of a hyperthermia study by NHTSA and assigned to the SCI team in October 2019. The incident/investigation report and a summary of autopsy findings were obtained. Requests for police photos were unsuccessful.

*Figure 1. Exemplar 2008 Nissan Sentra*
