DOT HS 813 360

December 2022

# **NHTSA Special Crash Investigations: Comprehensive Study of 2019 U.S. Pediatric Vehicular Hyperthermia Fatalities**

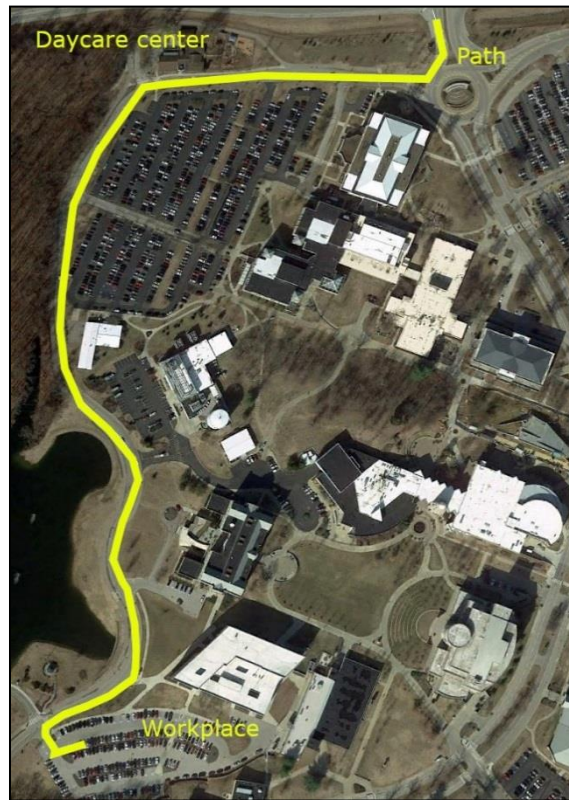
daycare facility, and then parked the Nissan near his workplace (Figure 2). The daycare center was approximately 0.67 km (0.42 miles) north of the father's workplace.

*Figure 2. Caregiver route to workplace*

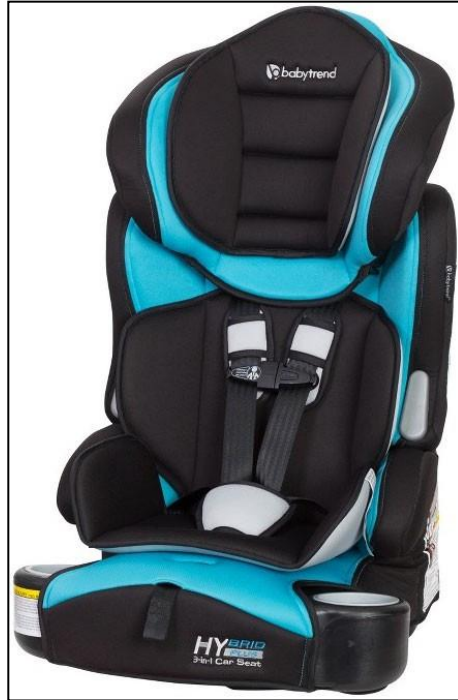
It was not known if the child was covered or if there were any sight-related restrictions. The child was seated in a forward-facing Baby Trend 3-in-1 high-back CRS (Figure 3). The CRS is designed as be used as follows.

- Forward-facing 5-point internal harness seat designed for a child 9.9 to 22.6 kg (22 to 50 lbs) and 73 to 121 cm (29 to 48 in) tall
- High-back booster designed for a child 13.6 to 45.3 kg (30 to 100 lbs) and 96 to 127 (38 to 50) tall
- Backless booster designed for a child 18.1 to 45.3 kg (40 to 100 lbs) and 106 to 144 (42-57) tall

*Figure 3. Baby Trend 3-1 high back (exemplar)*

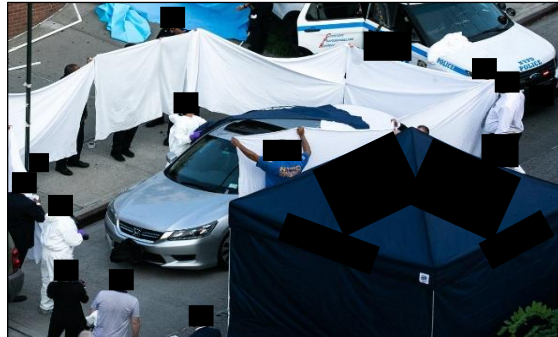
This report documents the remote investigation of the circumstances surrounding the hyperthermia-related fatalities of 1-year-old twins left unattended in the second-row seat of a Honda Accord (Figure 1) for 8 hours by their 39-year-old father in New York in July 2019. The police reported that the father drove to his workplace with the twins restrained in two CRSs. He parked in the parking lot and went to work at 0800 hours. He returned to the Honda at 1630 hours and began to drive home when he discovered the children in the CRSs. He immediately stopped the car, exited the vehicle, and yelled for help. Emergency responders determined the siblings, a male and a female, were deceased. The incident was identified by NHTSA and assigned to the Special Crash Investigations group for further research in October 2019.

*Figure 1. Honda Accord. Image obtained from online news outlet.*

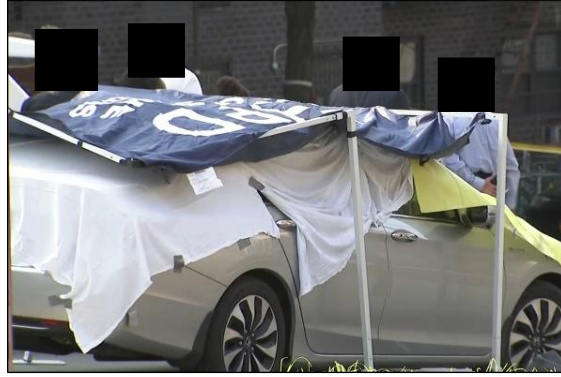
The vehicle in this hyperthermia case was a Honda Accord (Figure 2) model year unknown. The exterior color was silver. It had four forward-hinged doors. Standard configuration is seating for five (2/3) with the front-row bucket seats and a three-passenger split bench second-row seat. All side windows were tinted AS2 glazing. It is not known if the windows were closed or open during this incident.

*Figure 2. Honda Accord. Image obtained from online news outlet.*

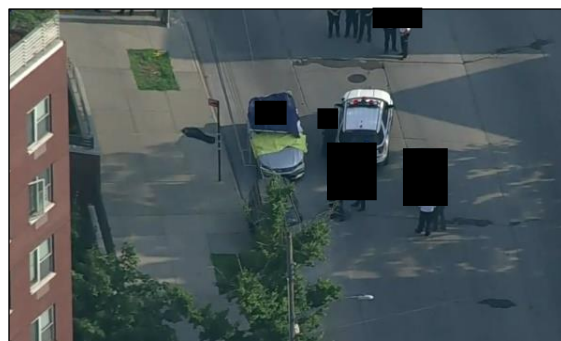
After the father had parked the Honda Accord, he exited the vehicle, forgetting the children in the second row, and proceeded into his place of employment where he stayed for the duration of his work shift. At approximately 1630 hours, the father walked to the parking lot and entered the Honda Accord. The father drove approximately two city blocks when he noticed the children were still in their CRSs. The father pulled off the side of the roadway (Figure 3), exited the vehicle, and began yelling for help.

*Figure 3. On-scene image. Image obtained from online news outlet.*

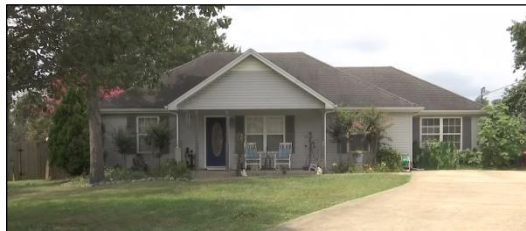
This report documents the remote investigation of the circumstances surrounding the hyperthermia-related fatality of a 3-year-old male left unattended in a vehicle for approximately 2 hours by his 23-year-old father in Tennessee in July 2019. The police reported that the father parked the vehicle in the driveway of his residence (Figure 1) and left the child in the vehicle at approximately 1515 hours. The father went into the house and fell asleep. Police found the child unresponsive in the vehicle at 1715 hours. The child was pronounced deceased at the scene. The father was charged with aggravated child abuse, neglect, and first-degree murder

*Figure 1. Incident Site. Image obtained from online news outlet.*

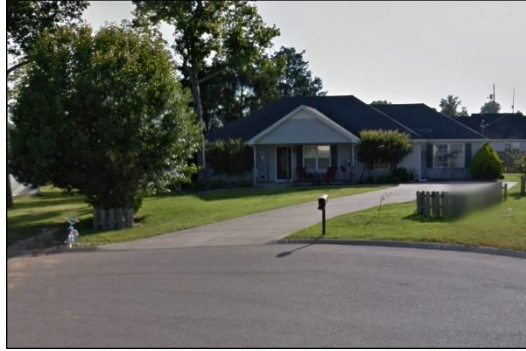
Upon arriving at the residence, the father of the child parked the vehicle in the driveway (Figure 2) and exited the vehicle at approximately 1515 hours. The father then proceeded into the house leaving the child in the vehicle alone. At this time, online sources stated that the father went to sleep.

*Figure 2. Driveway of incident site. May 2013 image obtained from an internet-based mapping system.*

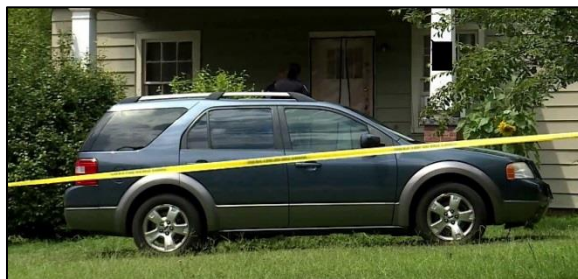
This report documents the remote investigation of the circumstances surrounding the hyperthermia-related fatality of a 10-month-old female child in Virginia in July 2019, who was left unattended in a Ford Freestyle (Figure 1) of unknown model year for an undetermined length of time by her mother. The mother secured the child into a rear-facing CRS in the second row of the vehicle. It was reported that the mother took the child with her to go grocery shopping. After shopping, she then drove home, and parked the Ford on the front lawn of her residence. The mother then left the child in the vehicle while she unloaded the groceries. The total length of time the child was left unattended in the vehicle was not disclosed. The mother stated she left the vehicle's rear door open and only left the child in the Ford for 20 minutes. When she went back to get the child, the infant was unresponsive. The mother called the emergency response system and police and fire fighting personnel arrived on site. The child was transported to the emergency room of a local hospital where staff attempted to revive her. She was pronounced deceased due to hyperthermia. No charges were filed against the mother.

*Figure 1. Ford Freestyle. Image obtained from an internet news site.*

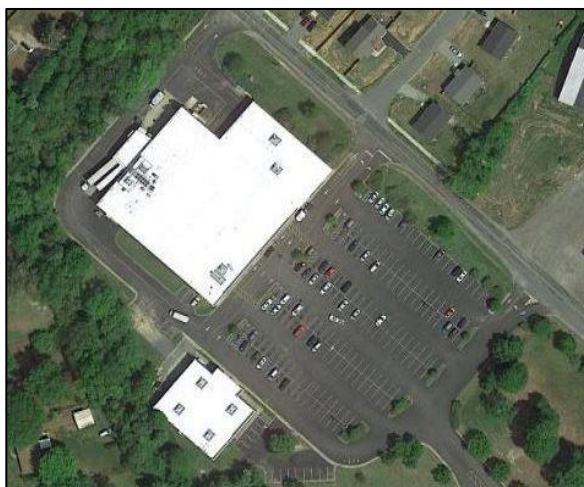
This incident occurred as the Ford traveled between two locations, distanced approximately 2 km (1.3 mi) apart. The mother placed the child in the vehicle and drove to a grocery store where she shopped. It was reported in the media that while the mother was grocery shopping, the child was knowingly left unattended in the vehicle. The parking lot was an open-air lot, surfaced with asphalt with standard delineation of parking spaces. The front of the grocery store was oriented in a southeasterly direction. Parking delineations were parallel to the building with vehicles parked in northeast and southwest headings (Figure 2).

*Figure 2. Satellite view of the grocery store parking lot. Image obtained from internet mapping software.*

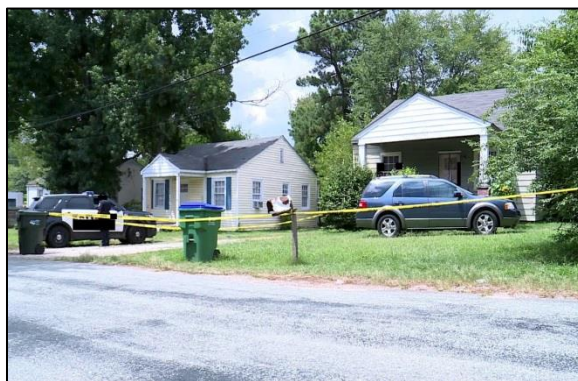
The site where the child was retrieved from the vehicle was the front yard of the family residence. The single-story house was located on a two-way city street that was oriented in an east and west direction. The house was on the north side of the street with the front of the house facing south. A shared stone driveway for the neighboring residence was located on the west edge of the property line. The front yard consisted of mowed grass with a single tree located at the east property line. This tree did not provide shade to the yard or the front of the residence. On her return to the residence, the mother parked the Ford on the front lawn facing east (Figure 3). The driver's door was directly in line with the front steps and the front entrance door to the residence.

*Figure 3. Residence and the parked position of the Ford. Image obtained from an online news outlet.*

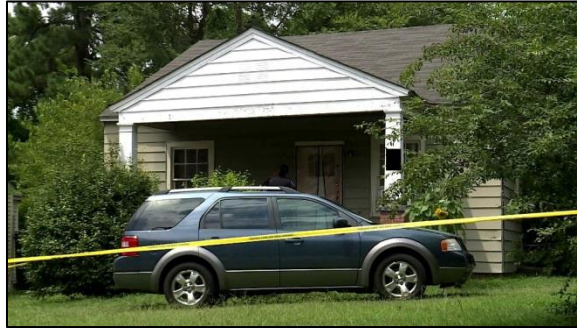
After she completed her shopping, the mother drove back to her residence and parked the Ford on the front lawn facing in an easterly direction. The right side of the vehicle was exposed to the mid-day sun. According to news articles, the mother stated the child was having a tantrum and she left the child in the Ford for an unknown time as she unloaded the groceries. The mother stated the child was in the vehicle for 20 minutes with the door open. When the mother returned to retrieve the child from the Ford, she found her cold to the touch, dripping in sweat, and unresponsive. The mother carried the child into the residence, where she placed the child in cold bath water in an attempt to revive her without success. The mother called the emergency response system. Police and fire department personnel responded to the call with police arriving at 1359 hours.

*Figure 4. Parked position of the Ford on the front lawn of the residence. Image obtained from an online news outlet.*

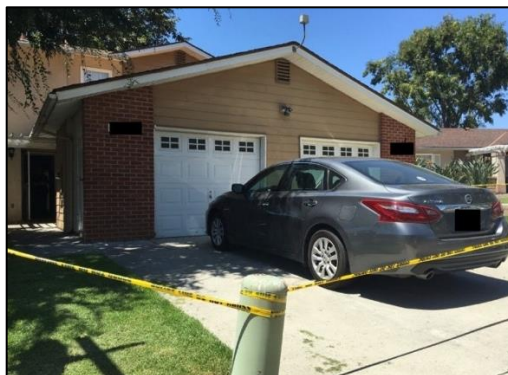
This report documents the remote investigation of the hyperthermia death of a 20-month-old female who was left unattended by her mother in a parked silver 2018 Nissan Altima 4-door sedan (Figure 1) for an extended period during daylight in California in August. The investigation was intended to determine the events leading up to the incident, the actions of the caregiver/guardian, the vehicle characteristics and equipment, the environment/scene conditions and layout, and the activities of the drove child. The incident was identified as part of a hyperthermia study by NHTSA and assigned to the SCI team in October 2019. The crime and autopsy reports and a partial court record were obtained.

*Figure 1. 2018 Nissan Altima at incident site, looking north. Image obtained from online news outlet.*

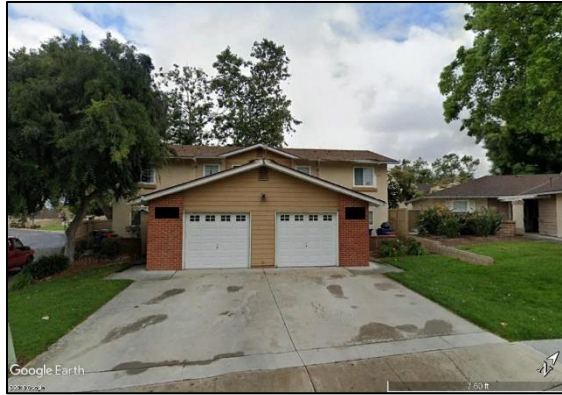
This incident occurred at a private residence in an urban area during early summer morning to mid-day. The residence was a two-story duplex facing southeast and situated on a corner lot (Figure 2). The structure had an attached two-car garage with a concrete driveway that led to a residential street. There were trees along the driveway to the west, but they would not have provided any shade during the times the child was in the vehicle. It was dark as the incident began at 0030 hours. There was a streetlight located 23 m (77 ft) southwest of the driveway that provided some illumination. An incident site diagram is included at the end of this report.

*Figure 2. Incident site. Image obtained from internet mapping software.*

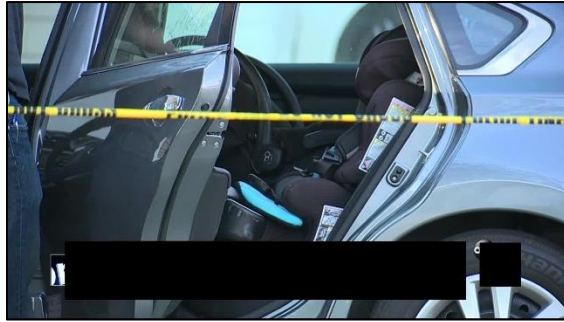
The child was wearing a pink top and a diaper. She had been placed in a forward-facing combination CRS with an adjustable head rest and the 5-point harness (Figure 3). The seat padding color was dark brown.

*Figure 3. CRS, 2018 Nissan Altima, second row left. Image obtained from online news outlet.*

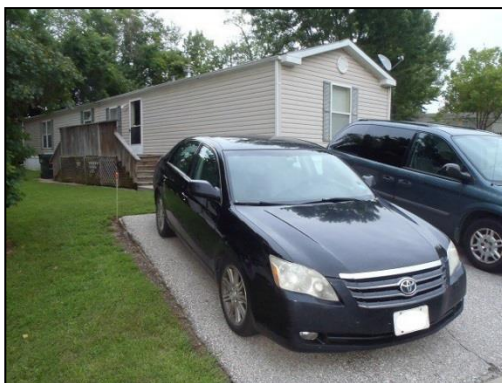
This incident occurred in August 2019 in Kansas. The incident site was the uncovered parking pad of a single-family residence on a residential street (Figure 1). The child was in the custody of his great-grandparents. On the day of the incident, the great-grandparents and child attended church and had lunch at a restaurant, after which the great-grandmother and child returned home in the Toyota.

*Figure 1. Incident site looking north, 2007 Toyota Avalon in foreground. Image obtained from local medical examiner.*

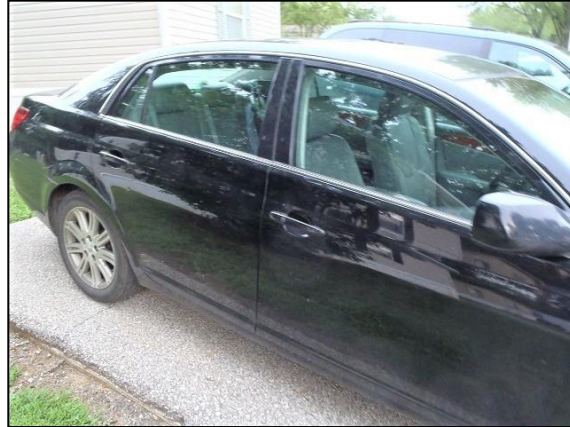
The vehicle was a 2007 Toyota Avalon Limited, 4-door sedan identified by the VIN 4T1BK36B27Uxxxxxx (Figure 2). The vehicle's exterior color was "Indigo Ink Pearl" (dark blue) and the interior color was light grey with perforated leather seat trim. The Toyota had a 3.5-liter, 6-cylinder, gas engine.

*Figure 2. 2007 Toyota Avalon. Image obtained from local medical examiner.*

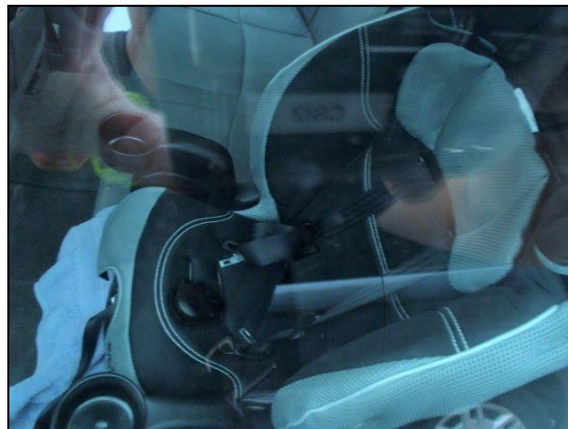
*Figure 3. Evenflo Chase LX CRS, second-row left position, 2007 Toyota Avalon. Image obtained from local medical examiner.*

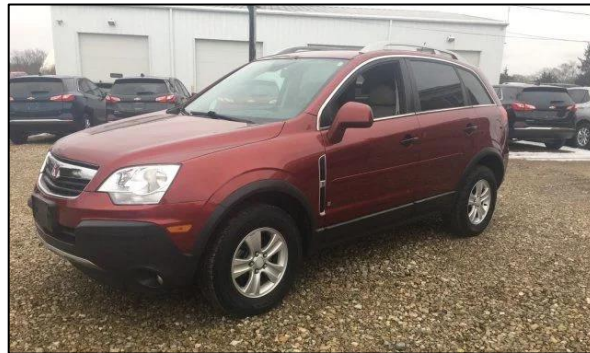
*Figure 1. Front left oblique view of an exemplar 2009 Saturn Vue*

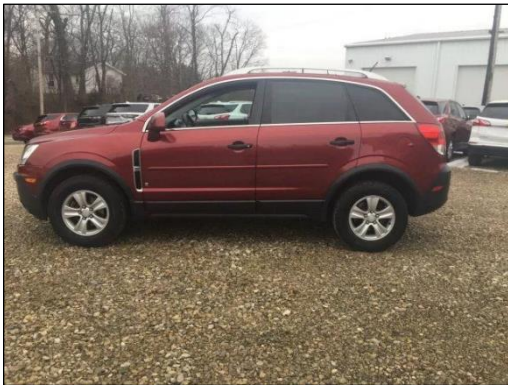
The vehicle in this hyperthermia investigation was a 2009 Saturn Vue XE SUV, exemplar vehicle shown in Figure 4. The subject Saturn has the VIN 3GSCL33P19Sxxxxxx. The exterior color was red. Exterior configurations consisted of four front forward-hinged doors and a rear lift gate. Standard configuration is seating for five (2/3) with front row bucket seats and a three-passenger split-bench second-row seat with folding seat backs (Figure 5). All seating positions except for the second-row middle position were equipped with adjustable head restraints.

Figure 4. Left side view of an exemplar 2009 Saturn Vue XE

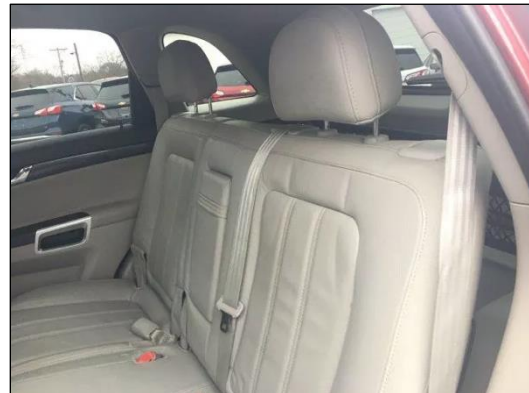
Figure 5. Second-row interior view of an exemplar 2009 Saturn Vue XE

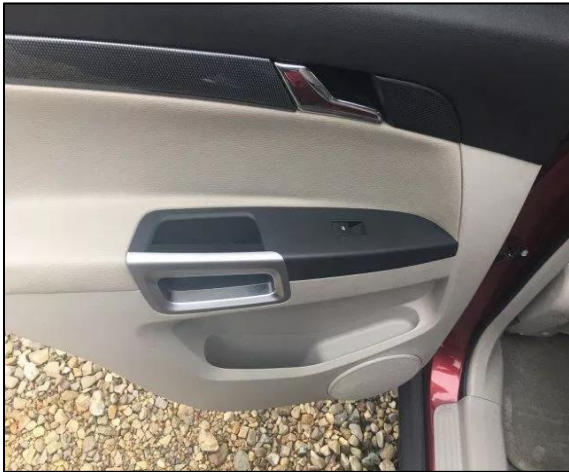
*Figure 6. Second-row interior door release of an exemplar 2009 Saturn Vue XE*

The interior door release levers of the Saturn were flush-mounted (Figure 6). A pocket was formed into the door panel that provided adequate access to the lever. The levers were not equipped with mechanical lock/unlock mechanisms. All doors were equipped with lock stalks on the top aft aspect of the door panels (Figure 7).

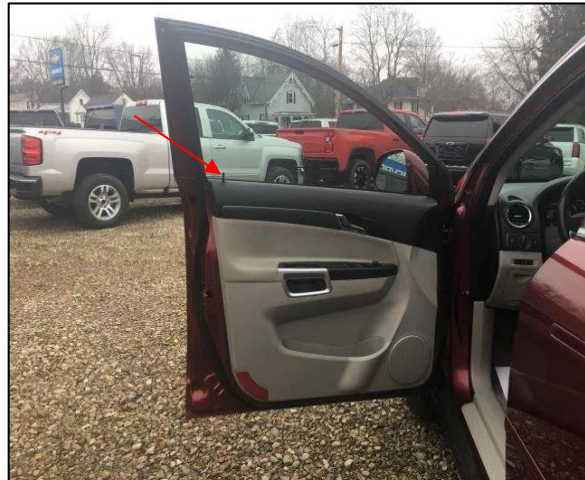
*Figure 7. Driver's interior door release of an exemplar 2009 Saturn Vue XE*

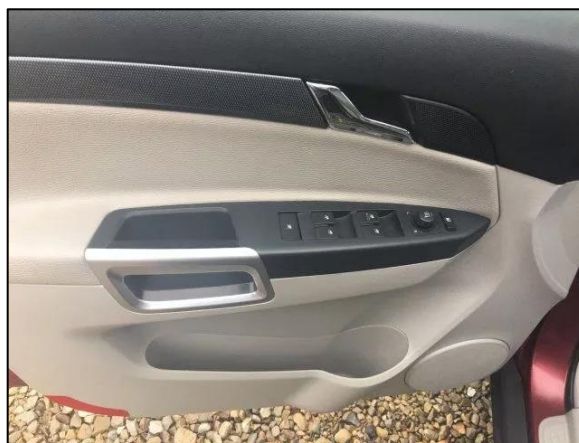
*Figure 8. Power window and door lock switch console on the driver's door panel of an exemplar 2009 Saturn Vue XE*

The central locking system of the Saturn was power. A key fob had lock and unlock switches. With a single touch of the switch, all four doors including the lift gate could be locked and unlocked. On the interior of the Saturn, lock and unlock switches were located on the front panels, mounted horizontally forward of the door closer handle that were incorporated into the armrests. The driver's door switch panel (Figure 8) included the power window switches and a lockout switch for the front right and second-row power windows. The interior lock switches were push-type switches. The second-row door panels were not equipped with power lock switches.

The locking logic of the Saturn was the same whether using the key fob or the front door panel-mounted switches. All four doors would be locked or unlocked by a single touch of the switch. Once inside the Saturn, with the power locking system in the unlock mode, all four doors could be opened by pulling on the interior door release levers. In the locked mode, the front door levers would release the power lock for that door. Upon egress of a front door, the second-row doors remained locked.

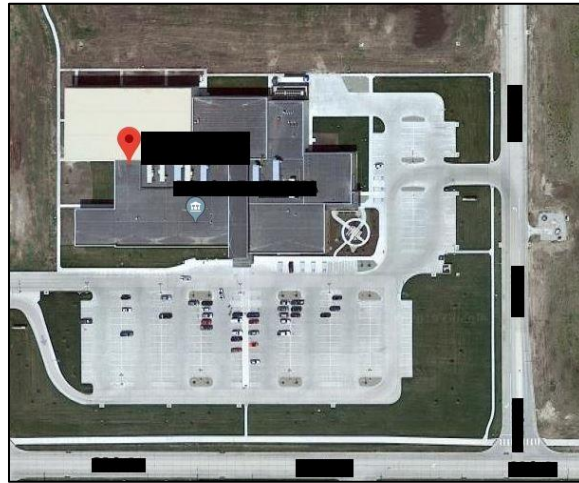
*Figure 2. Satellite view of the incident site. Image obtained from internet mapping software.*

This incident occurred over a 9.75-hour period in daylight. The Toyota was parked on an open concrete parking lot in full view of the sun. There were no structures or trees to shade the vehicle. The parking lot was located on the east side of the single-story commercial building (Figure 2). Painted white parking lines were oriented in an east and west direction. The Toyota was parked facing in a westerly direction. During the day, other vehicles were parked in this lot. The professional building was located adjacent to a hospital and housed businesses that had frequent appointments; therefore, many vehicles entered, parked, and exited the lot throughout the day.

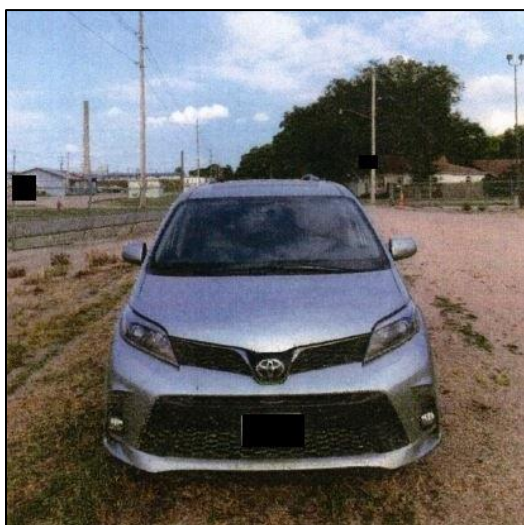
Figure 3. Police image of the parked position of the Toyota during the temperature test

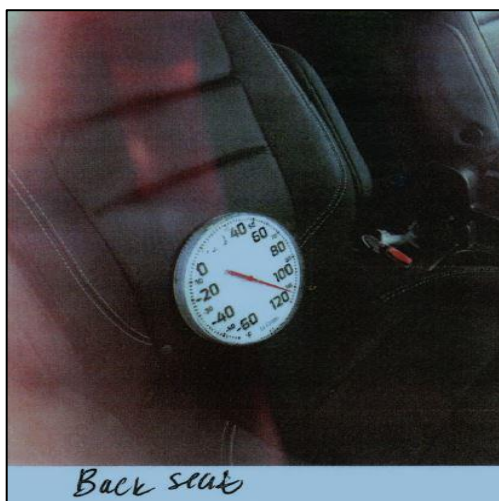
Figure 5. Police second-row image of the temperature of police temperature test

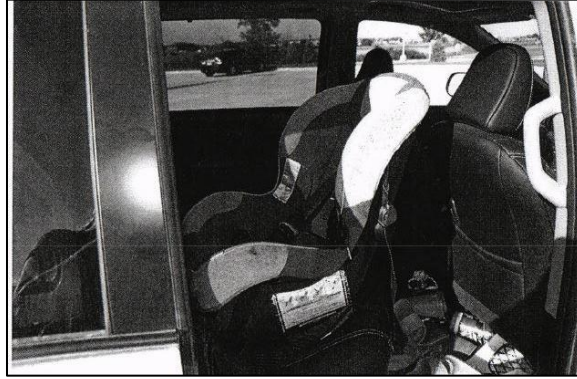
*Figure 6. Police image of the rear-facing CRS in the second-row right of the Toyota*

The child was positioned and secured in a rear-facing CRS (Figure 6) installed in the second-row right position of the Toyota. The CRS was a Graco Comfort Sport convertible seat, black and tan in color. Manufacturer specifications for the Graco CRS in the rear-facing mode was for children weighing from 2 to 18 kg (4 to 40 lb) with their head 3 cm (1.0 in) below the handle and for children in the forward-facing mode weighing from 9 to 29 kg (20 to 65 lb), up to 124 cm (49.0 in) tall. The CRS had the LATCH and belt paths in the shell of the CRS for both forward- and rear-facing positions. Based on the available images, the CRS was installed with the LATCH system. The CRS had a 5-point harness system with a chest clip. Vertical adjustments of the shoulder harness straps were manually adjusted at the back of the CRS shell.

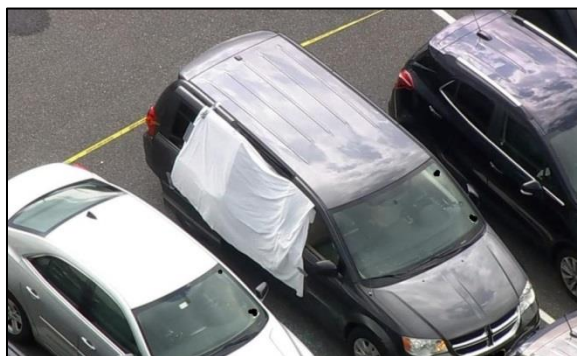
*Figure 1. On-scene image of the Dodge Caravan. Image obtained from online news outlet.*

This report documents the remote investigation of the hyperthermia-related fatality of a 22-month-old female forgotten and left unattended in a Dodge Caravan (Figure 1) for approximately 9 hours by her 60-year-old uncle, the legal guardian/caregiver, in New Jersey in August 2019. The uncle placed the child in a forward-facing CRS and forgot to drop the child off at daycare. He made two driving trips during the morning before parking the Dodge in a large open public parking lot that serviced a train station. Other family members arrived at the daycare facility at 1530 hours and learned the child had not been dropped off that day. Following a call to the uncle, the family members drove to the parking lot and found the child unresponsive in the CRS of the closed and locked minivan. They fractured the right front door window to gain access to the Dodge. A call was placed to the emergency response system, which dispatched police, fire, and EMS to the scene. Attempts to resuscitate the child were unsuccessful and she was pronounced deceased at the scene. The uncle was charged with fourth-degree abuse and neglect of a child.

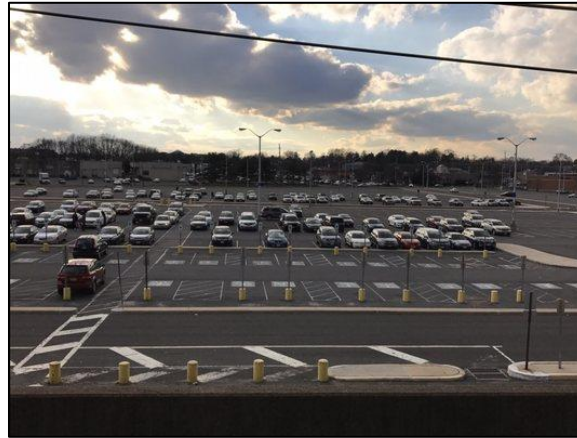
*Figure 2. Southwesterly view of the parking lot*

This hyperthermia incident occurred in a large parking lot of a train station in daylight. The parking lot was surfaced with asphalt and was delineated with parking spaces and driving lanes (Figure 2).

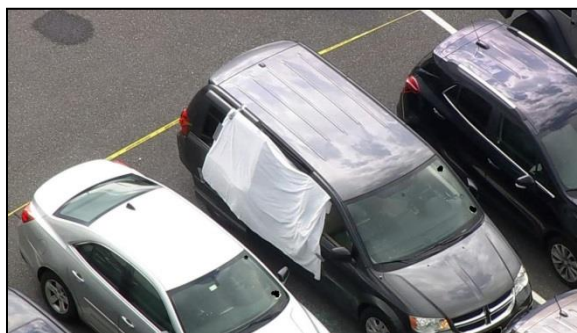
*Figure 3. Overhead image of the Dodge Caravan. Image obtained from an online news outlet.*

The vehicle in this hyperthermia incident was a Dodge Caravan minivan (Figure 3), model year unknown. The vehicle was gray in exterior color with deep tint AS3 privacy glass from the B-pillar rearward, including the backlight. The Dodge did not have a roof window. During this incident, all operable windows and doors were closed. The power locking system was engaged as the doors were locked.

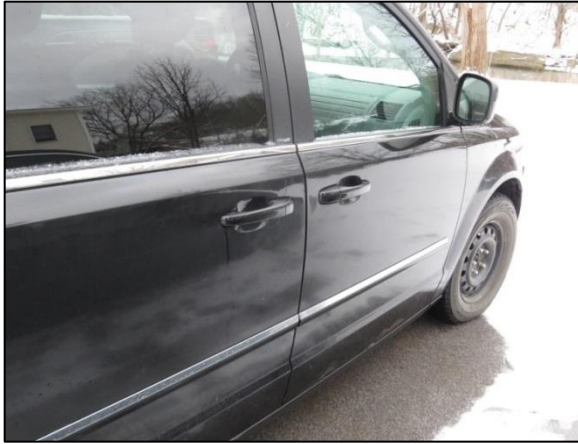
*Figure 4. Exterior door handles on an exemplar vehicle*

The exemplar Dodge had power sliding second-row doors. The four exterior door release handles were pull-type that protruded beyond the side profile of the doors. A recessed pocket was formed in the door skin to facilitate a hand grip around the door handle.

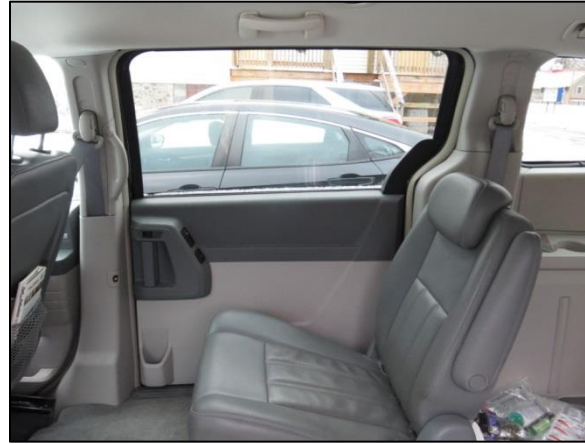
*Figure 5. Second-row right interior door panel, door release lever and the lock lever of an exemplar vehicle*

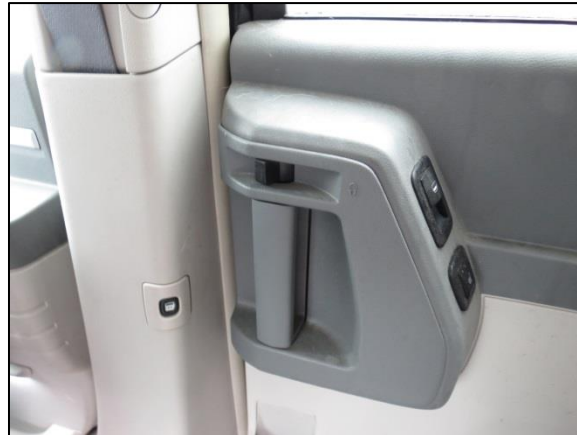
*Figure 6. Door release lever and lock lever on right rear sliding door of an exemplar Dodge*

The second-row sliding interior door release handles were vertically oriented at the forward aspects of the door panels (Figure 6). These handles allowed an occupant to manually unlatch and open the door, or to unlatch and allow the power mechanism to open the door. A switch was mounted on the aft aspect of the B-pillars to allow an occupant to open the power door by pushing the vertically oriented switch.

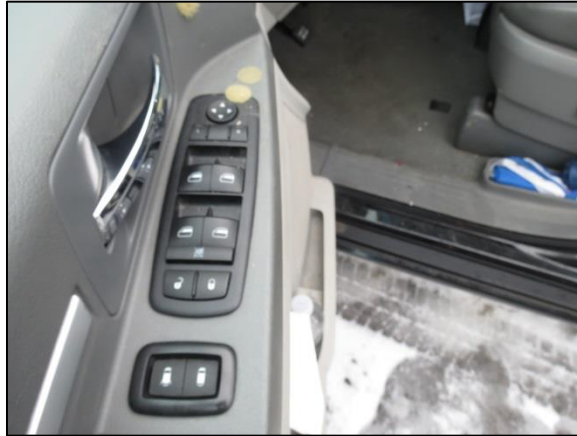
*Figure 7. Power lock/window switches on driver's door panel*

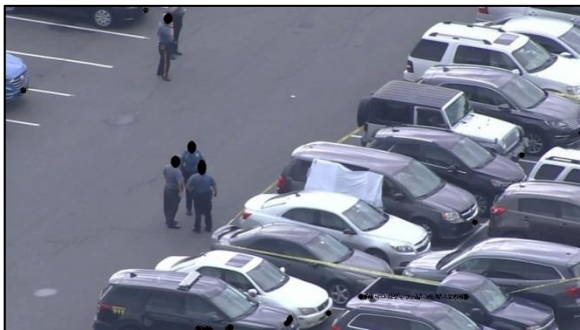
*Figure 8. Parked position of the Dodge Caravan. Image obtained from an online news outlet.*

He awoke at 1130 hours to leave his residence for his assigned work shift. The uncle left his residence, entered the Dodge, and drove to the train station where he parked the Dodge in the open-air parking lot (Figure 8). He parked behind a compact SUV and between a compact 4-door sedan to his right and a compact SUV to his left. These vehicles did not shade the Dodge Caravan. The uncle exited the vehicle, locked the doors and proceeded to work. It is unknown if he worked at the train station or used the rail line as a secondary form of transportation to his workplace.

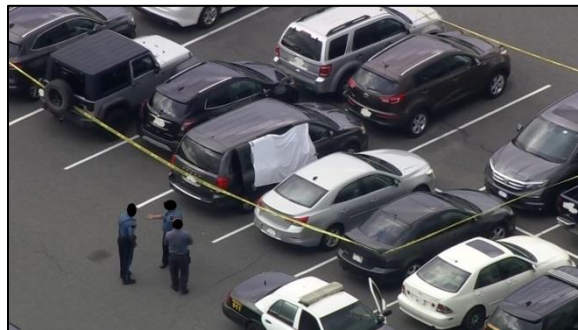
*Figure 9. View of the parked Dodge Caravan and its surrounding vehicles. Image obtained from an online news outlet.*

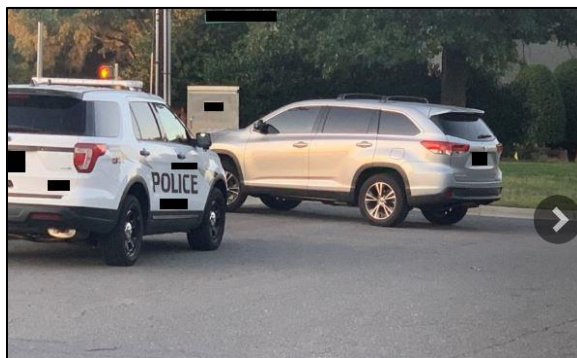
*Figure 1. 2019 Toyota Highlander. Image obtained from an online news outlet.*

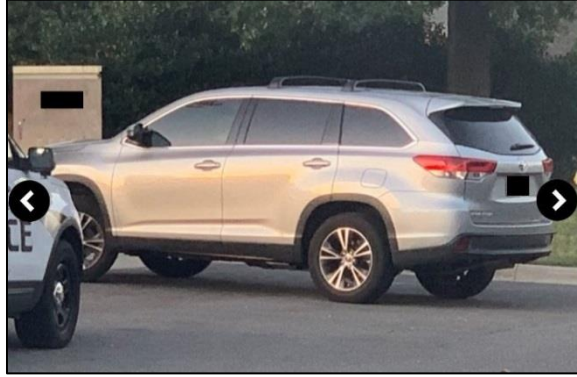
*Figure 2. 2019 Toyota Highlander. Image obtained from an online news outlet.*

The vehicle was a 2019 Toyota Highlander LE 4-door SUV (Figure 2). The exterior color was silver. It had deep tint AS3 windows for the second-row doors, the rear quarter windows, and the backlight. All operable door windows were closed throughout the duration of this incident. The Toyota did not have a roof window. The interior seating surfaces of the Toyota were black cloth and consisted of three rows of seats (2/3/3) for seating of eight occupants. The front row consisted of bucket seats with adjustable head restraints; the second row was a three-passenger split bench with forward folding seat backs and adjustable head restraints, and the third row was a three-passenger split bench with adjustable head restraints. Interior safety systems consisted of frontal air bags, front-seat-mounted air bags, and inflatable curtain air bags. All seat positions were equipped with 3-point lap and shoulder seat belts. The second-row left and right positions and the third-row center position had LATCH. Although unconfirmed by police documentation, it appeared the CRS was secured to the vehicle with the LATCH system.

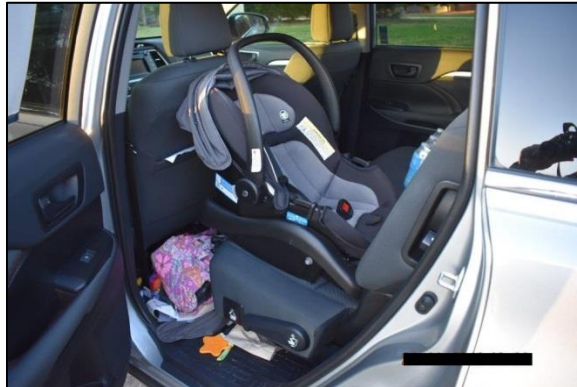
*Figure 3. Installed position of the Safety First rear-facing CRS in the Toyota. Image provided by the investigating police department.*

The CRS was documented by police as a Safety First infant seat (Figure 3). Images of the CRS depicted the unit to consist of the carrier and the detachable base. The CRS appeared to be secured to the vehicle by the LATCH belt in the second-row left position. The CRS was installed rear-facing with the forward aspect of the carrier against the driver's seat back. The carry handle was adjusted up over the head area of the child. The integral 5-point harness system was intact with the shoulder harness straps adjusted to the top position. The chest clip was in-place on the shoulder harness straps.

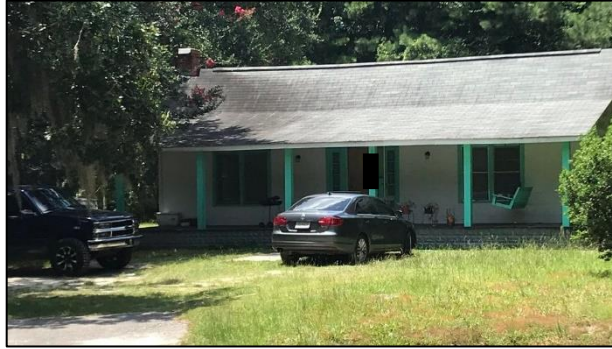
Figure 1. Unknown year 4-door sedan at the incident site. Image obtained from an online news outlet.

The incident occurred in the late morning to late afternoon in August. The 4-door sedan was parked at the caregiver's residence in the driveway facing in a westward direction (Figure 1). There were trees throughout the entire property that provided partial shade over the driveway during this incident.

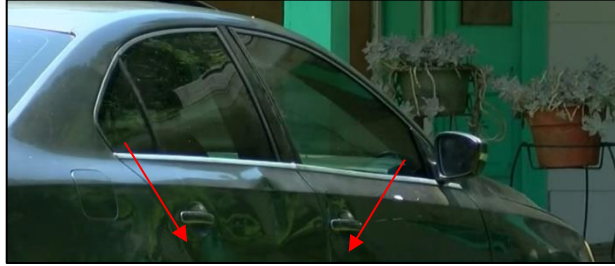
*Figure 2. Unknown year 4-door sedan at the incident site. Image obtained from an online news outlet.*

The exterior door handles were pull-type handles (Figure 2) that protruded beyond the profile of the doors. A recessed pocket was formed into the door panel to provide adequate grip space for the handle. Online news sources reported that the doors of the 4-door sedan were locked at some point during the duration of this incident.

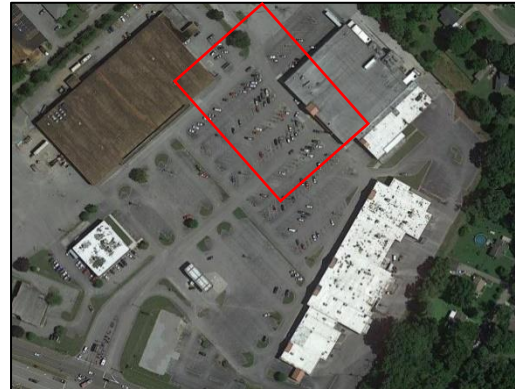
*Figure 2. Incident Site -Grocery Store Parking Lot. 2020 image obtained from internet mapping software.*

The Nissan Altima was parked among other vehicles in both parking lots. However, the exact location of the Nissan Altima in the parking lot could not be determined. In both parking lots, the Nissan Altima was exposed to full sun as there was no shade present from trees or structures.

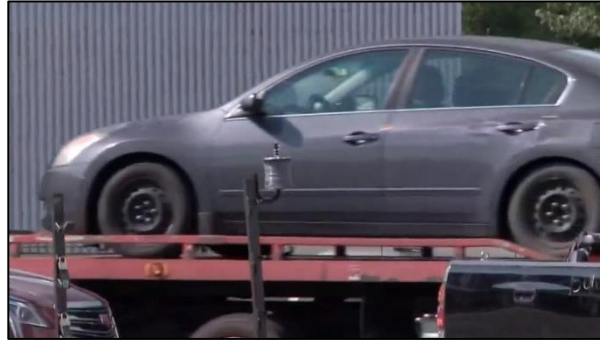
*Figure 3. Image of Nissan Altima. Image obtained from an online news outlet.*

The vehicle in the hyperthermia investigation was a Nissan Altima (Figure 3), model year unknown. The exterior color was gray. It had four forward-hinged doors. Standard configuration is seating for five (2/3) with the front row bucket seats and a three-passenger split bench second-row seat. All side windows were AS2 glazing without tint. It is unknown if the windows were closed or open throughout this incident.

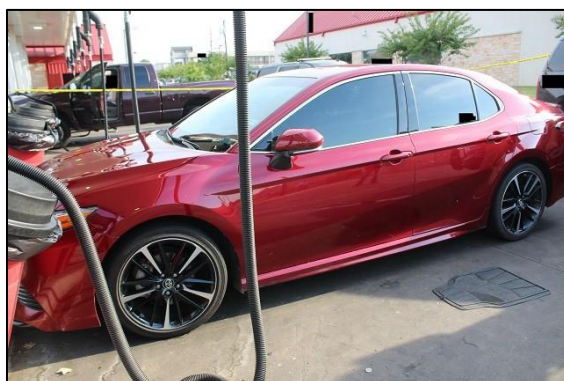
*Figure 1. 2018 Toyota Camry. Image obtained from local law enforcement.*

This incident occurred in August 2019 in Texas. The child was a 9-month-old female and the vehicle was a 2018 Toyota Camry XSE (Figure 1). The incident occurred in several locations including the driveway of the child's residence, a car dealership, and a car wash facility, among others. The primary caregiver at the time of the incident was the child's 31-year-old father, who forgot to take the child to a daycare facility in the morning and instead left her behind in the vehicle throughout the day while he worked at home and drove to several destinations attending to various activities. While in the vehicle, the child was intermittently attended and unattended, but the father had forgotten her whereabouts until late in the afternoon when he discovered her while parked at a car wash facility. The child had been in the second-row seat of the Toyota for approximately 6 hours when the father opened a second-row door to discover her seated in her rear-facing CRS. The father removed the child from the vehicle and called 911 at 1715 hours and emergency responders pronounced the child deceased on-scene. On the day of the incident, the high temperature was 35 °C (95 °F).

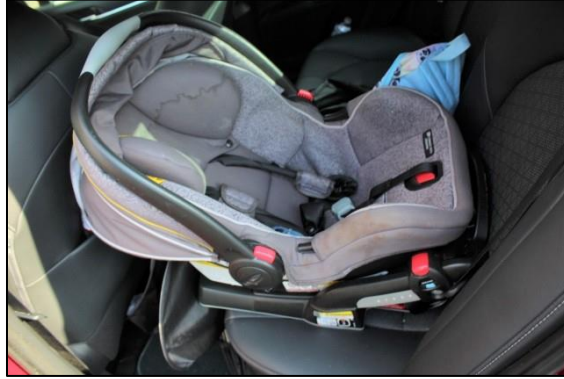
*Figure 3. Graco SnugRide Click Connect 40 CRS, second row, 2018 Toyota Camry (police photo)*

The household included the 31-year-old father, 23-year-old mother, and 9-month-old female child. On the morning of the incident, the child was placed in a rear-facing Graco SnugRide Click Connect 40 CRS in the second-row left seat position (Figure 3). A small backpack containing baby clothes and diapers was placed on the second-row seat near the CRS. The father drove the Toyota with the mother and child present to the mother's workplace. The trip was intended to make two stops, the first at the mother's workplace and the second at the child's daycare facility. The distance from their residence to the mother's workplace was approximately 26 km (16 m) with an estimated travel time of 20 to 30 minutes. The distance from the workplace to the daycare was approximately 27 km (17 mi) with an estimated travel time of 25 to 30 minutes. The distance from the daycare to the residence was approximately 2 km (1 mi) with a travel time of 3 to 5 minutes.

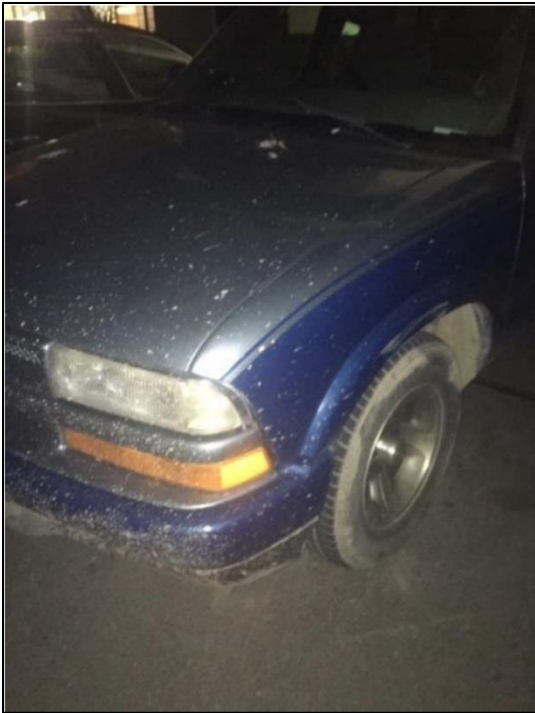
*Figure A-2. Left front, 2000 Chevrolet S-10 pickup (police photo)*

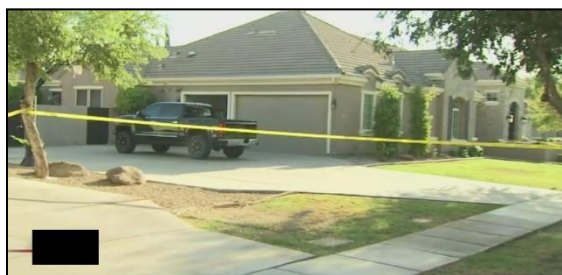
*Figure 3. Vehicle at incident site, looking southwest. Image obtained from an online news outlet.*

After dropping off the 5 and 7-year-old children at school the father took the 3-year-old home. He parked the GMC in the driveway adjacent to the residence, perpendicular to the garage doors, and facing south (Figure 3). The driver returned to the residence from 0815 and 0830 hours.

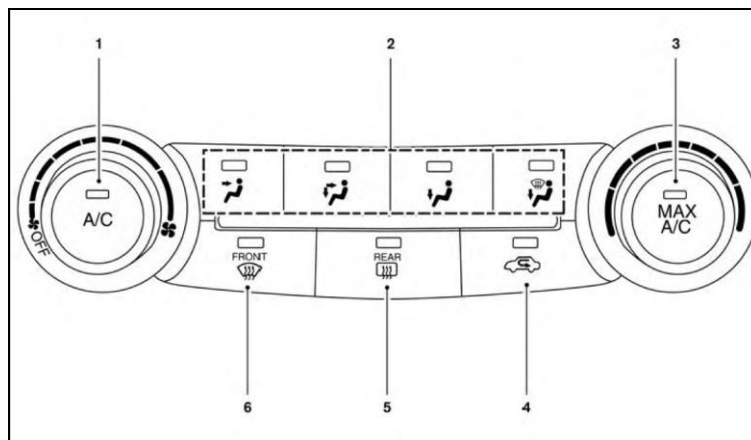
Figure 3. Temperature/fan controls, 2016 Nissan Altima. Image obtained from manufacturer website.

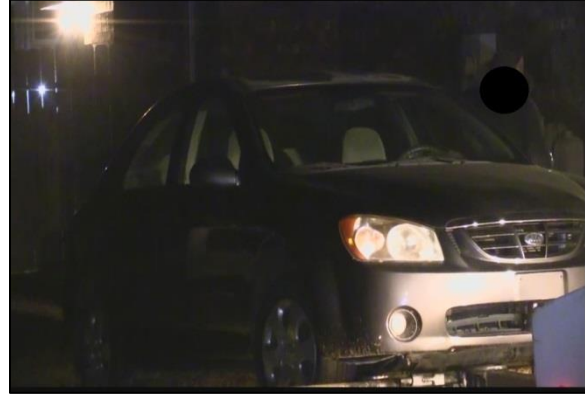
*Figure 3. The Kia Spectra. Image obtained from an online news outlet.*

The vehicle was a 2006 Kia Spectra 4-door sedan (Figure 2). The Kia was parked in the fenced backyard of the residential property. The vehicle was reported as operable at the time of this incident with battery power, but parked in the fenced yard for unknown reasons. The exterior color was gray with a matching gray cloth surfaced interior. The glazing was standard with an AS1 windshield and AS2 door and backlight glazing. There was no aftermarket deep tint film applied to the windows. The interior had seating of five with front bucket seats and a three-passenger second-row bench seat. The four outboard positions had head restraints. Figures 3 and 4 are on-scene images of the Kia Spectra.

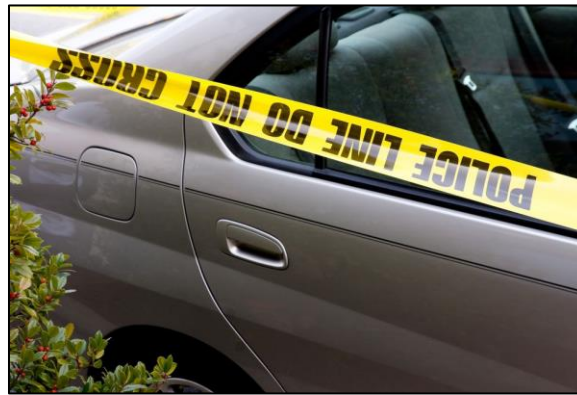
*Figure 4. Right rear door and second-row seat of the Kia Spectra. Image obtained from an online news outlet.*

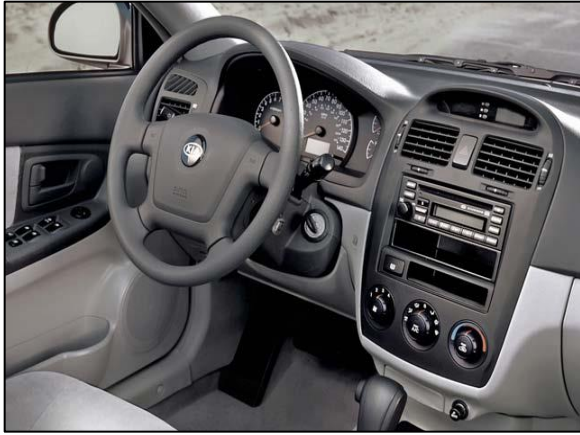
*Figure 5. Front row of an exemplar Kia Spectra*

The exterior door levers were flush-mounted with a recessed pocket for finger access to provide a vertical pull-force to open all four doors. The locking system was power-activated via a remote key fob or the master lock switches on the front door panels. All four interior door panels had manual lock levers. The levers roated on a vertical axis and were mounted directly above the door release levers. Both the lock lever and the door release lever were flush-mounted with a recessed pocket to provide finger access. The lock levers were not highlighted with high visibility (orange) markings. In the locked mode, the lock levers were flush to the door panel. In the unlocked position, the lock levers protruded toward the interior of the occupant compartment. The police detective stated that the doors did not “pop open” when the interior door release levers were pulled to the unlatched position. He further speculated that the children never tried to push on the doors open when pulling on the door release levers. Figure 5 shows the driver’s door panel and the power window switches and door release lever. Figure 6 is a view of the second-row interior and door panel, door levers, and locking levers of an exemplar 2006 Kia Spectra. Both images are of an exemplar vehicle. At the time of this incident, all operable door glazing was closed and the vehicle was unlocked.

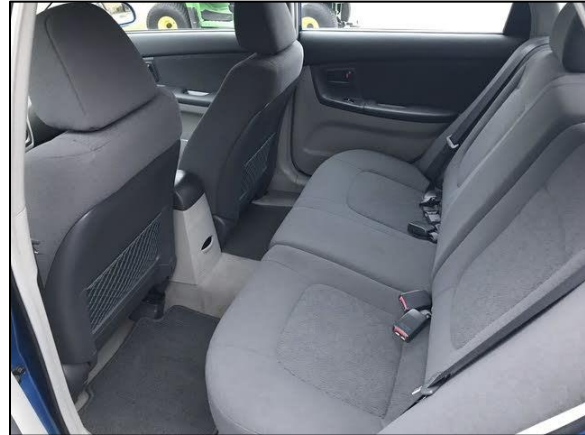
*Figure 6. Second row of an exemplar Kia Spectra and the door lever and locking lever highlighted*

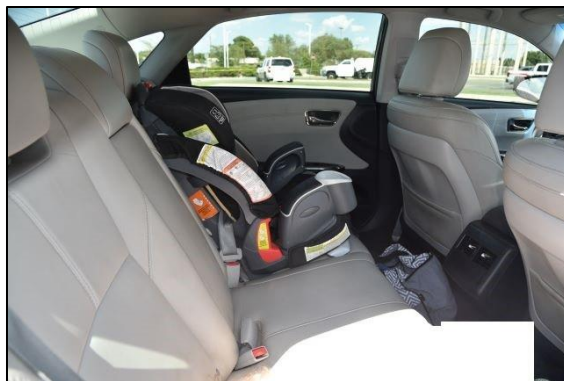
*Figure 3. Graco Nautilus 65 CRS, second row, 2015 Toyota Avalon (police photo)*

The friend had a full-time day job in addition to caring for the child part-time. One of her tasks as caregiver was to drop the child off at her daycare on weekdays. The friend placed the child in a forward-facing Graco Nautilus 65 3-in-1 CRS in the second-row left position (Figure 3). The CRS was installed using the vehicle's lap and shoulder belt routed through the forward-facing channels. The friend buckled the retaining clip restraining the child with the internal 5-point harness and placed a gray and white diaper bag containing item for the child on the floor in front of the second-row left seat position, where the CRS was installed. The friend later told police that the child was awake at the beginning of the trip and that she was a quiet child.

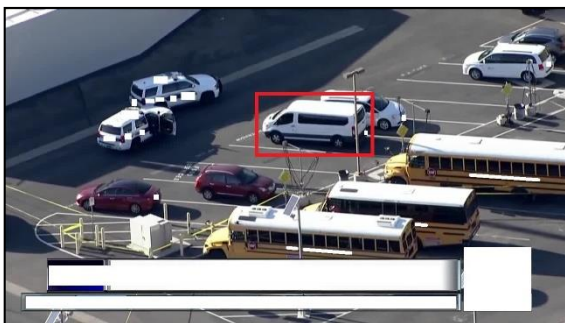
The parking lot was on level ground. The area where the Ford was parked consisted of 10 parking spaces, configured side by side with white striping at a 45-degree angle diagonal to the driving lanes. The parking space closest to the building began 2 m (6 ft) south of the south wall and the column of spaces extended south from there. The Ford was parked in the sixth space south of the building’s south wall (Figures 2 and 3). Five of the 10 spaces were occupied when police arrived following the incident and three vehicles were parked between the Ford the south wall and 20 m (66 ft) from the nearest building entrance. A white van was parked in the space to the right of the Ford. None of the parking spaces were covered; the autopsy report indicated the Ford was parked “outdoors in full sun” and satellite images showed the parking lot to be unshaded for parts of the day.

*Figure 2. Incident site looking north, 2018 Ford Transit 350 XL. Image obtained from online news outlet.*

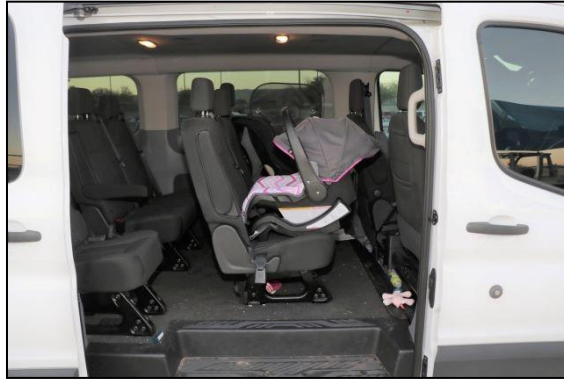
On the day of the incident, CRSs were installed in the second-row left and right seat positions. In the left seat position a Disney Baby Scenera NEXT Luxe Convertible CRS was installed in a forward-facing orientation using LATCH. This CRS was not in use at the time of the incident. In the right seat position an Evenflo Nurture Infant Car Seat was installed in a rear-facing orientation using LATCH with a stay-in-vehicle base. The CRS was multicolored and had an adjustable carry handle, retractable canopy system, and internal 5-point harness system. The caregiver later reported to police that, prior to the incident, the child was sleeping, the canopy was in the open position and raised above her, and it blocked his view of her from his position in the driver’s seat (Figure 4). A few small toys and personal items were strewn around the floor of the vehicle. No dangling or hanging objects were present. Evidence obtained by police suggested the caregiver likely placed a briefcase containing paperwork and personal items on the front passenger seat or floor space while driving to and from work.

*Figure 4. Evenflo Nurture CRS, 2018 Ford Transit 350 (police photo)*

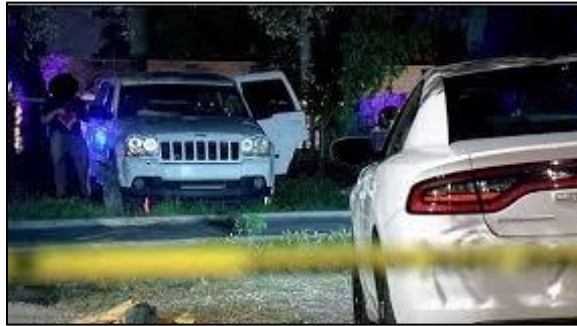
The vehicle was a 2008 Jeep Grand Cherokee (Figure 3). The exterior color was white with a black interior. The Jeep had deep tint AS3 glazing for the second-row door windows, rear quarter windows, and the backlight glazing. It was not equipped with a roof window. Based on an exemplar vehicle inspection, standard equipment consisted of power-operated windows and a power-actuated locking system. The second-row interior door panels had pull-type door release levers in the lower mid-aspect of the door. A color-coordinated rotating lock lever was located above the door release lever. This lever could be manually rotated to unlock the door from the inside. The door release lever and the lock lever were flush-mounted to the door panel with a finger pocket to provide access. There was no locking stalk on the top surface of the door panel.

*Figure 3. 2008 Jeep Grand Cherokee. Image obtained from an online news outlet.*

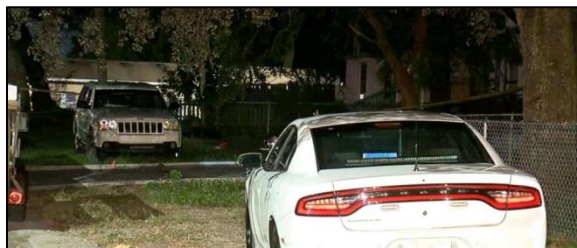
The father's routine was to drive family members to various locations in the Jeep prior to returning home, parking the Jeep, then entering his work vehicle and departing for work. This trip included dropping the child off at a daycare facility. On the morning of this incident, the child was placed in a CRS in the second row of the Jeep, two other children, and the mother entered the Jeep. The father drove the vehicle and dropped the mother off at her workplace. He then proceeded to drop the children off at their school. The father neglected to drop the child off at the daycare facility and returned to the family residence where he parked the Jeep on a lawn under the shade of numerous large deciduous trees (Figure 4). In this parked position, the Jeep was facing in a westerly direction and shielded from view of people passing by and through the intersection. The father exited the Jeep and locked the vehicle with all windows closed. He then entered his work vehicle and departed the residence for the day.

*Figure 4. Parked position of the Jeep facing north. Image obtained from an online news outlet.*
